ARCHITECTURAL/HISTORIC INVENTORY FORM

1. Survey No. SL-AS-036-001		2. Survey Name: Architectural Survey of Old Ferguson West	
3. County: St. Louis		4. Address: 1 Carson Rd.	
5. City: Ferguson	Vicinity: <input type="checkbox"/>	6. UTM:	7. Township/Range/Section
8. Historic name (if known):		9. Present/other name (if known): Whistle Stop	
10. Ownership: <input type="checkbox"/> Private <input checked="" type="checkbox"/> Public		11. Historic use (if known): TRANSPORTATION/rail-related	11. Current use: COMMERCE/restaurant & RECREATION/museum

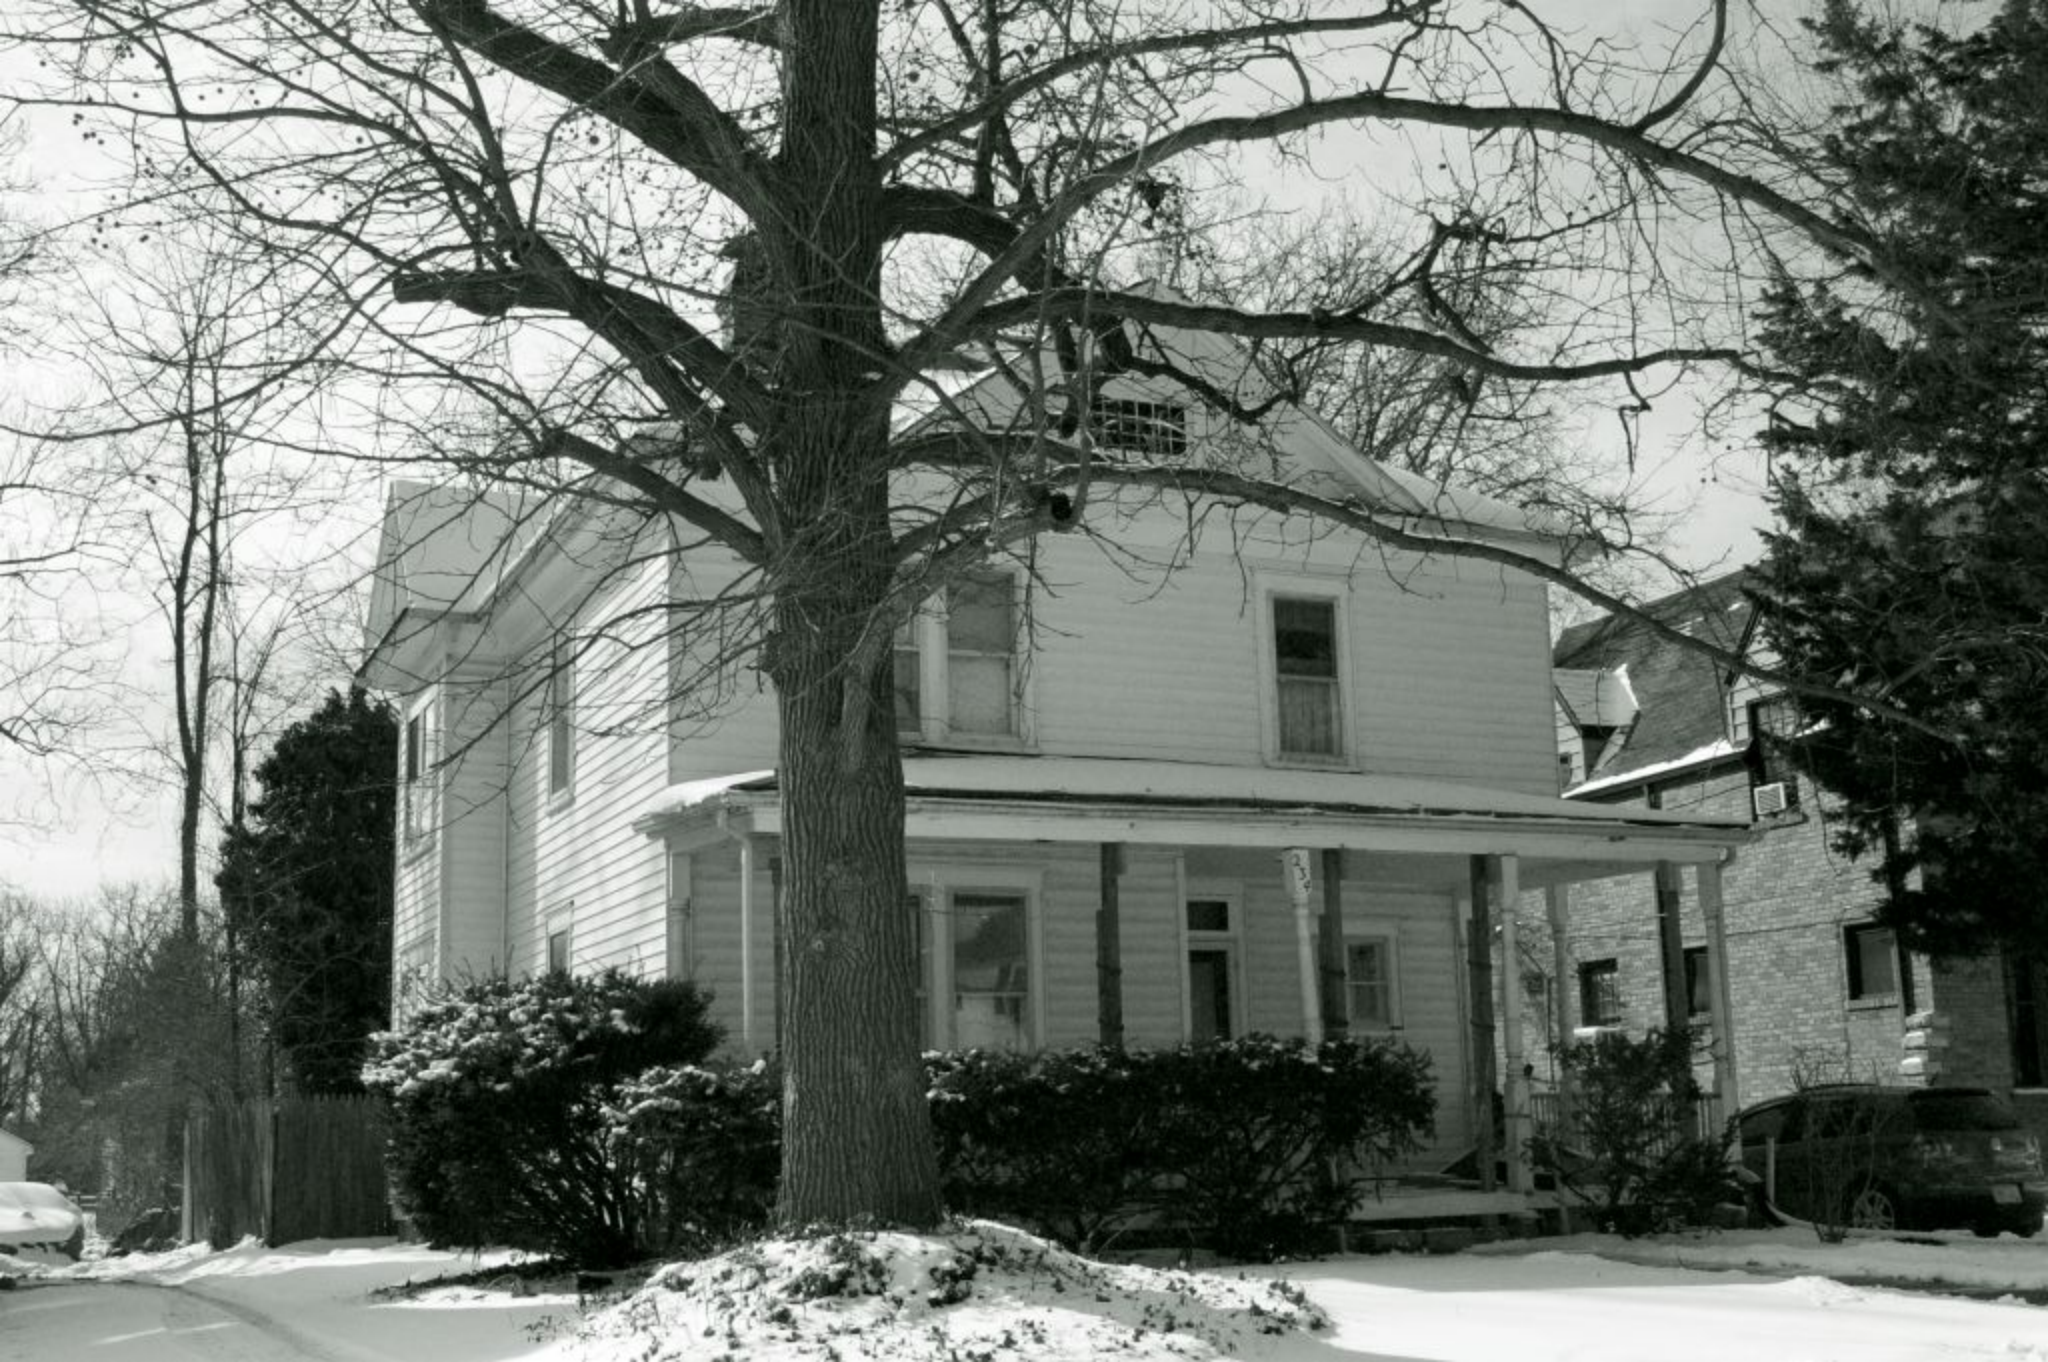
2009 Survey Update: Since the 1983 Survey the house has been sided with vinyl siding, but care was taken to leave the original wood trim around the doors and windows exposed as well as the original fishscale shingles in the cross gable ends. Between the time of the summer survey update in 2009 and the winter photography, the front porch apparently experienced damage or the beginnings of renovations since one of the original turned posts is missing and there are temporary braces to help support the porch roof, but the original balustrade remains.

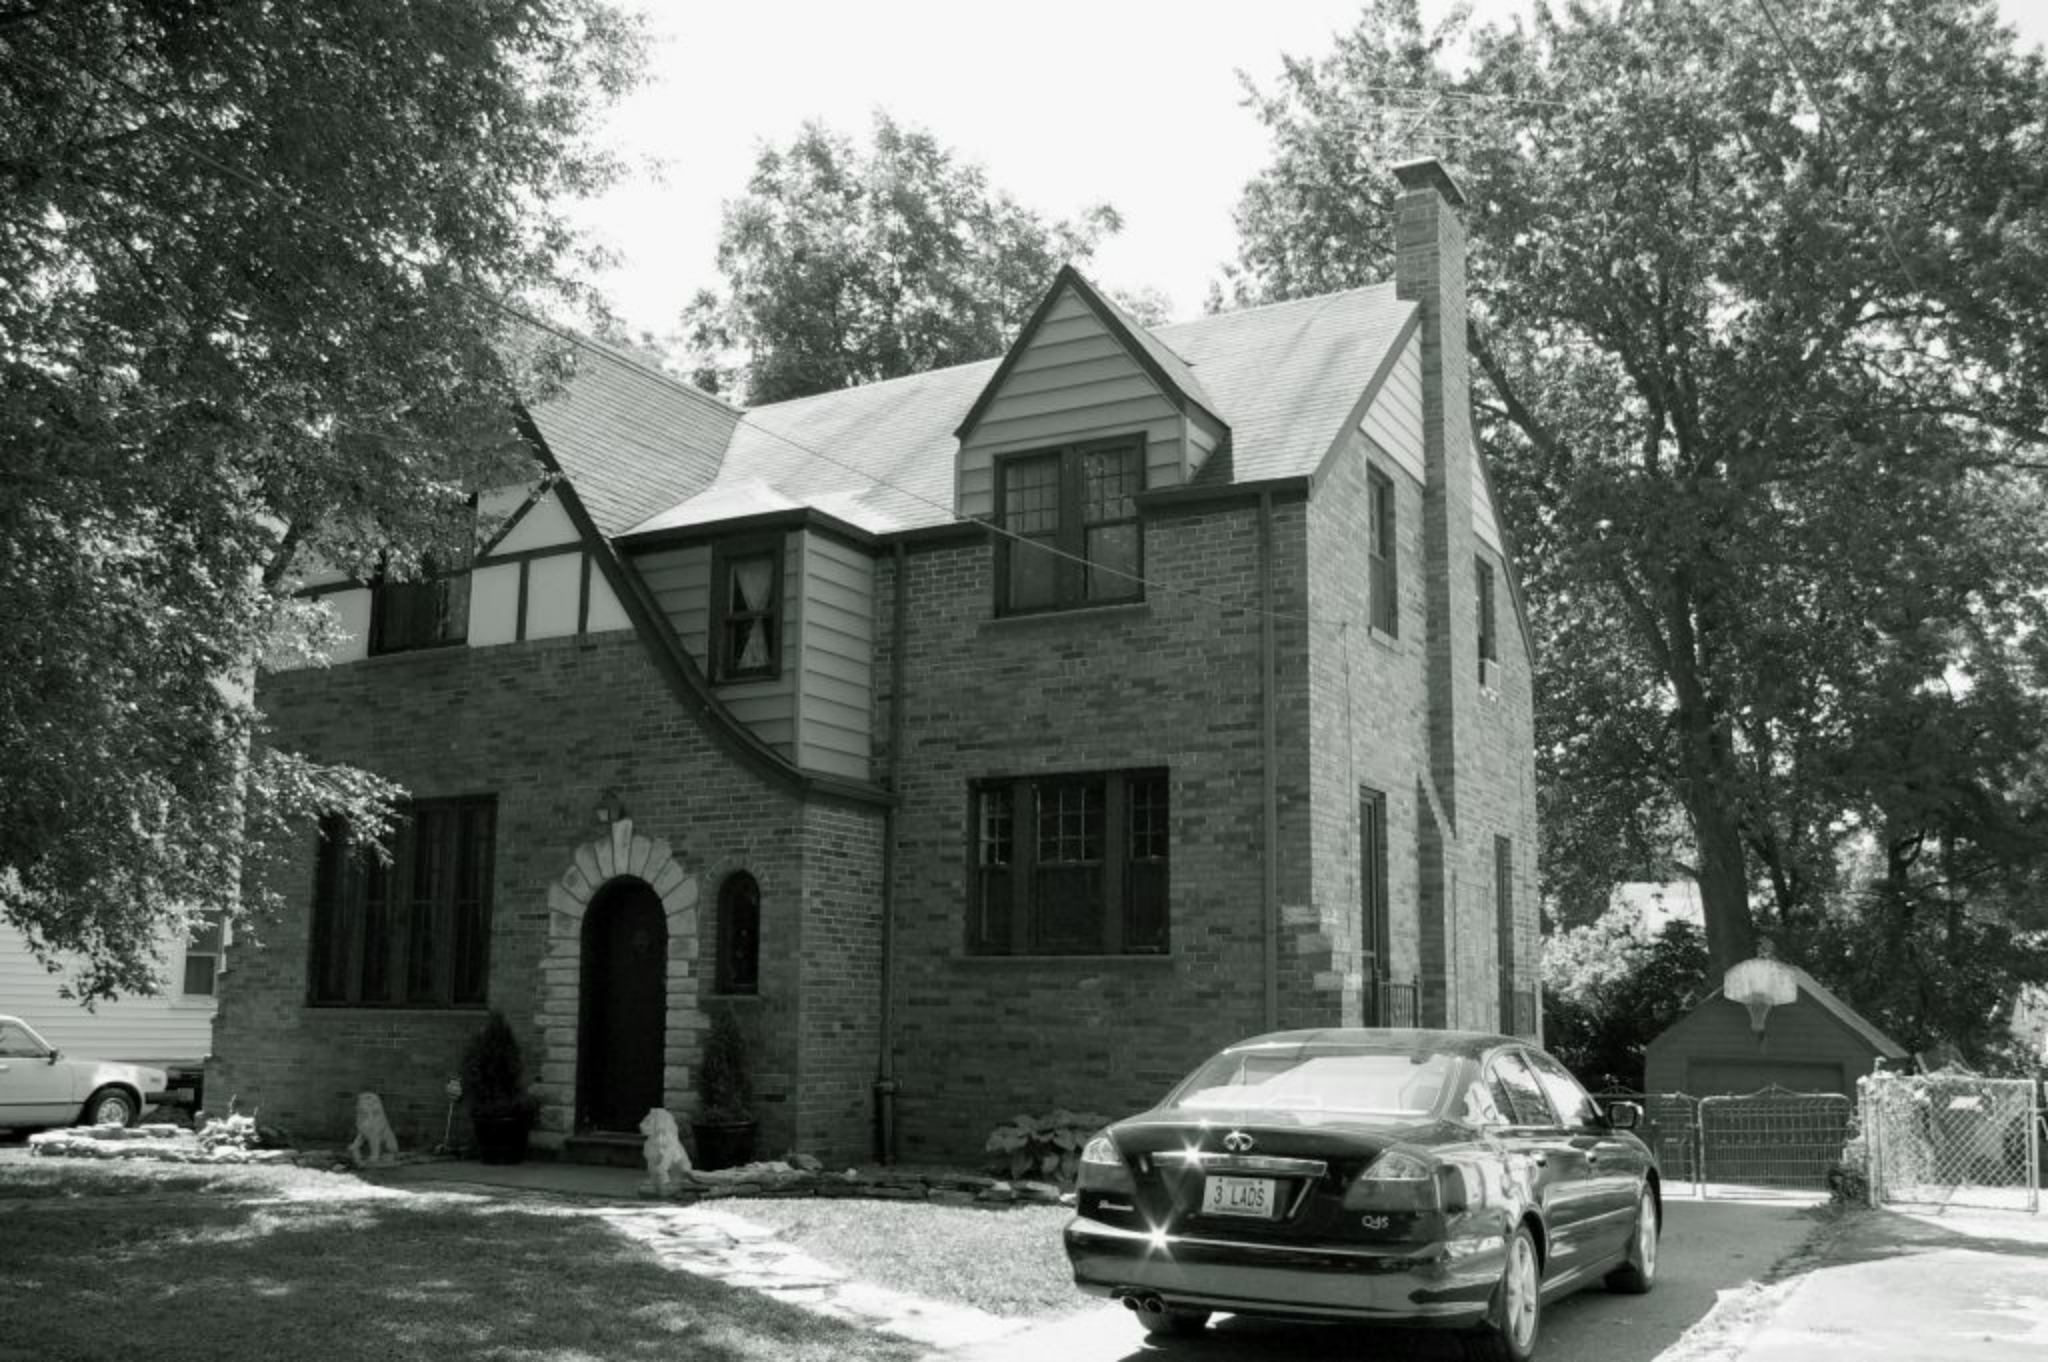
This Tudor Revival house is two stories tall, with multicolored brick walls and rock-faced, ashlar limestone accents, especially at the foundation, around the round arched door and on the stepped wingwalls on each corner of the three bay facade. The house is side gabled with a large cross gabled, projection that spans the eastern two bays, with the roofline curving down to the first floor in the center bay over the entry door. The end of this front facing gable has half timbered stucco on the second floor around the paired, sashed windows. Next to the round arched, wood plank entry door is a small side window and above is a shallow hipped dormer nestled on top of the curve of the cross gabled roof. To the east of the entry door is a series of four multipaned, casement windows while the west bay has a triple window unit of sashed windows with a gabled wall dormer above with paired sashed windows. On the west elevation is a central, end wall brick chimney. Some of the windows have storm screens, and they all appear to be the original windows. The sashed windows have multipaned upper sashes. The only major alteration is the use of wider aluminum siding on the dormers and side gable end.

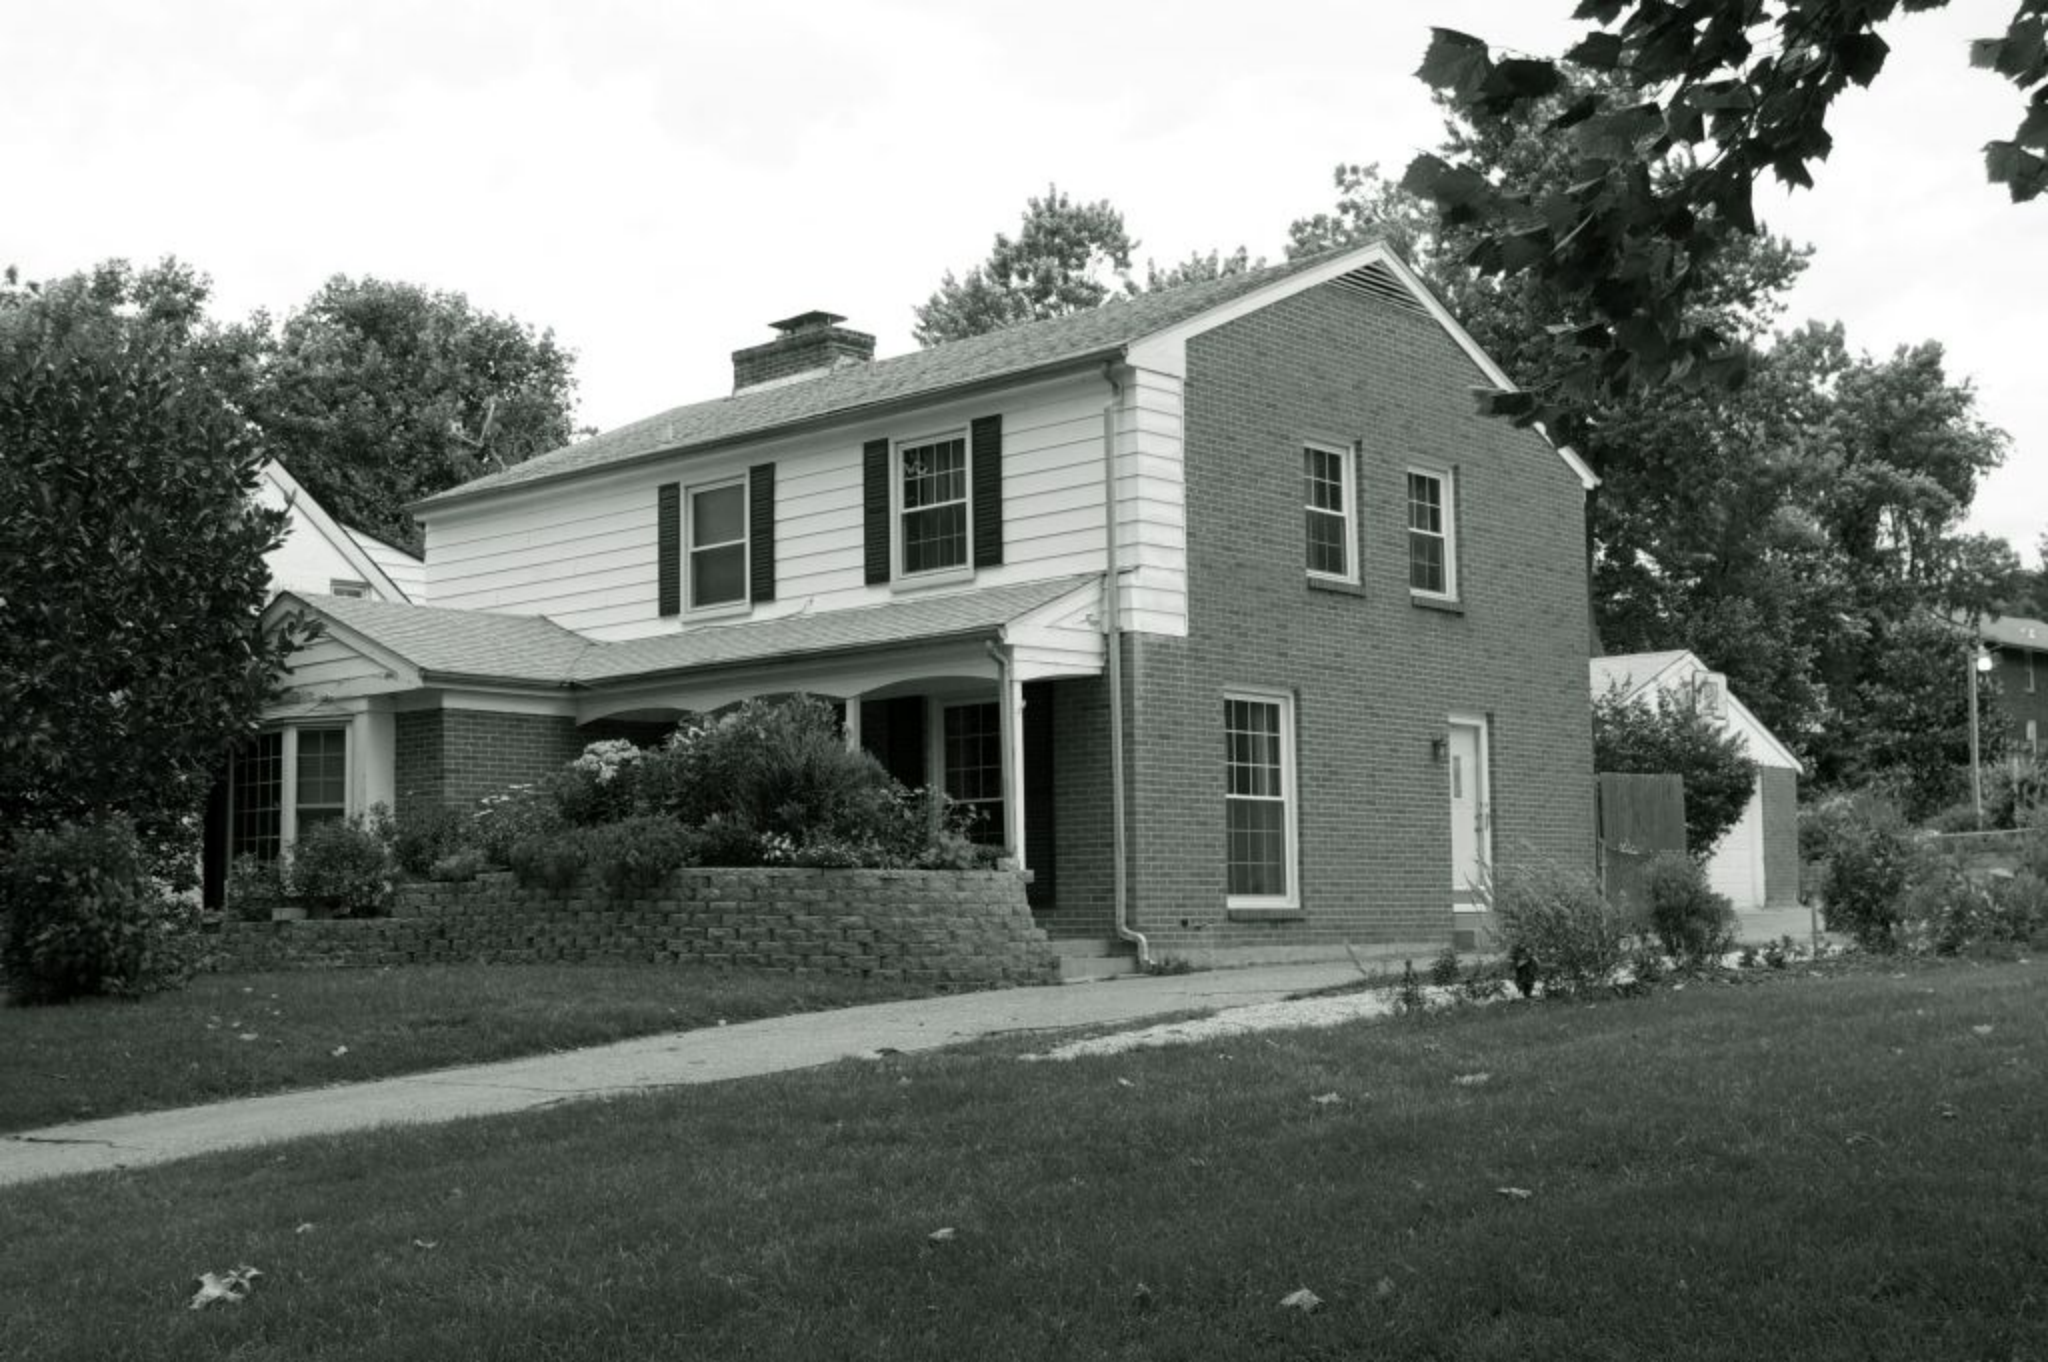
This two story shallow pitched side gabled house is a more modern Colonial Revival design. Although most of the house is brick, the second floor of the facade is clad with aluminum siding (probably the original material). There is a one story, end gabled wing on the facade with a bay window on its facade and siding in the gable end. Across the remainder of the facade is a shallow, shed roofed porch with slightly arched openings between the porch posts; this covers the concrete porch floor, slightly elevated from the grade. The facade has shuttered multipaned sashed windows on both levels.

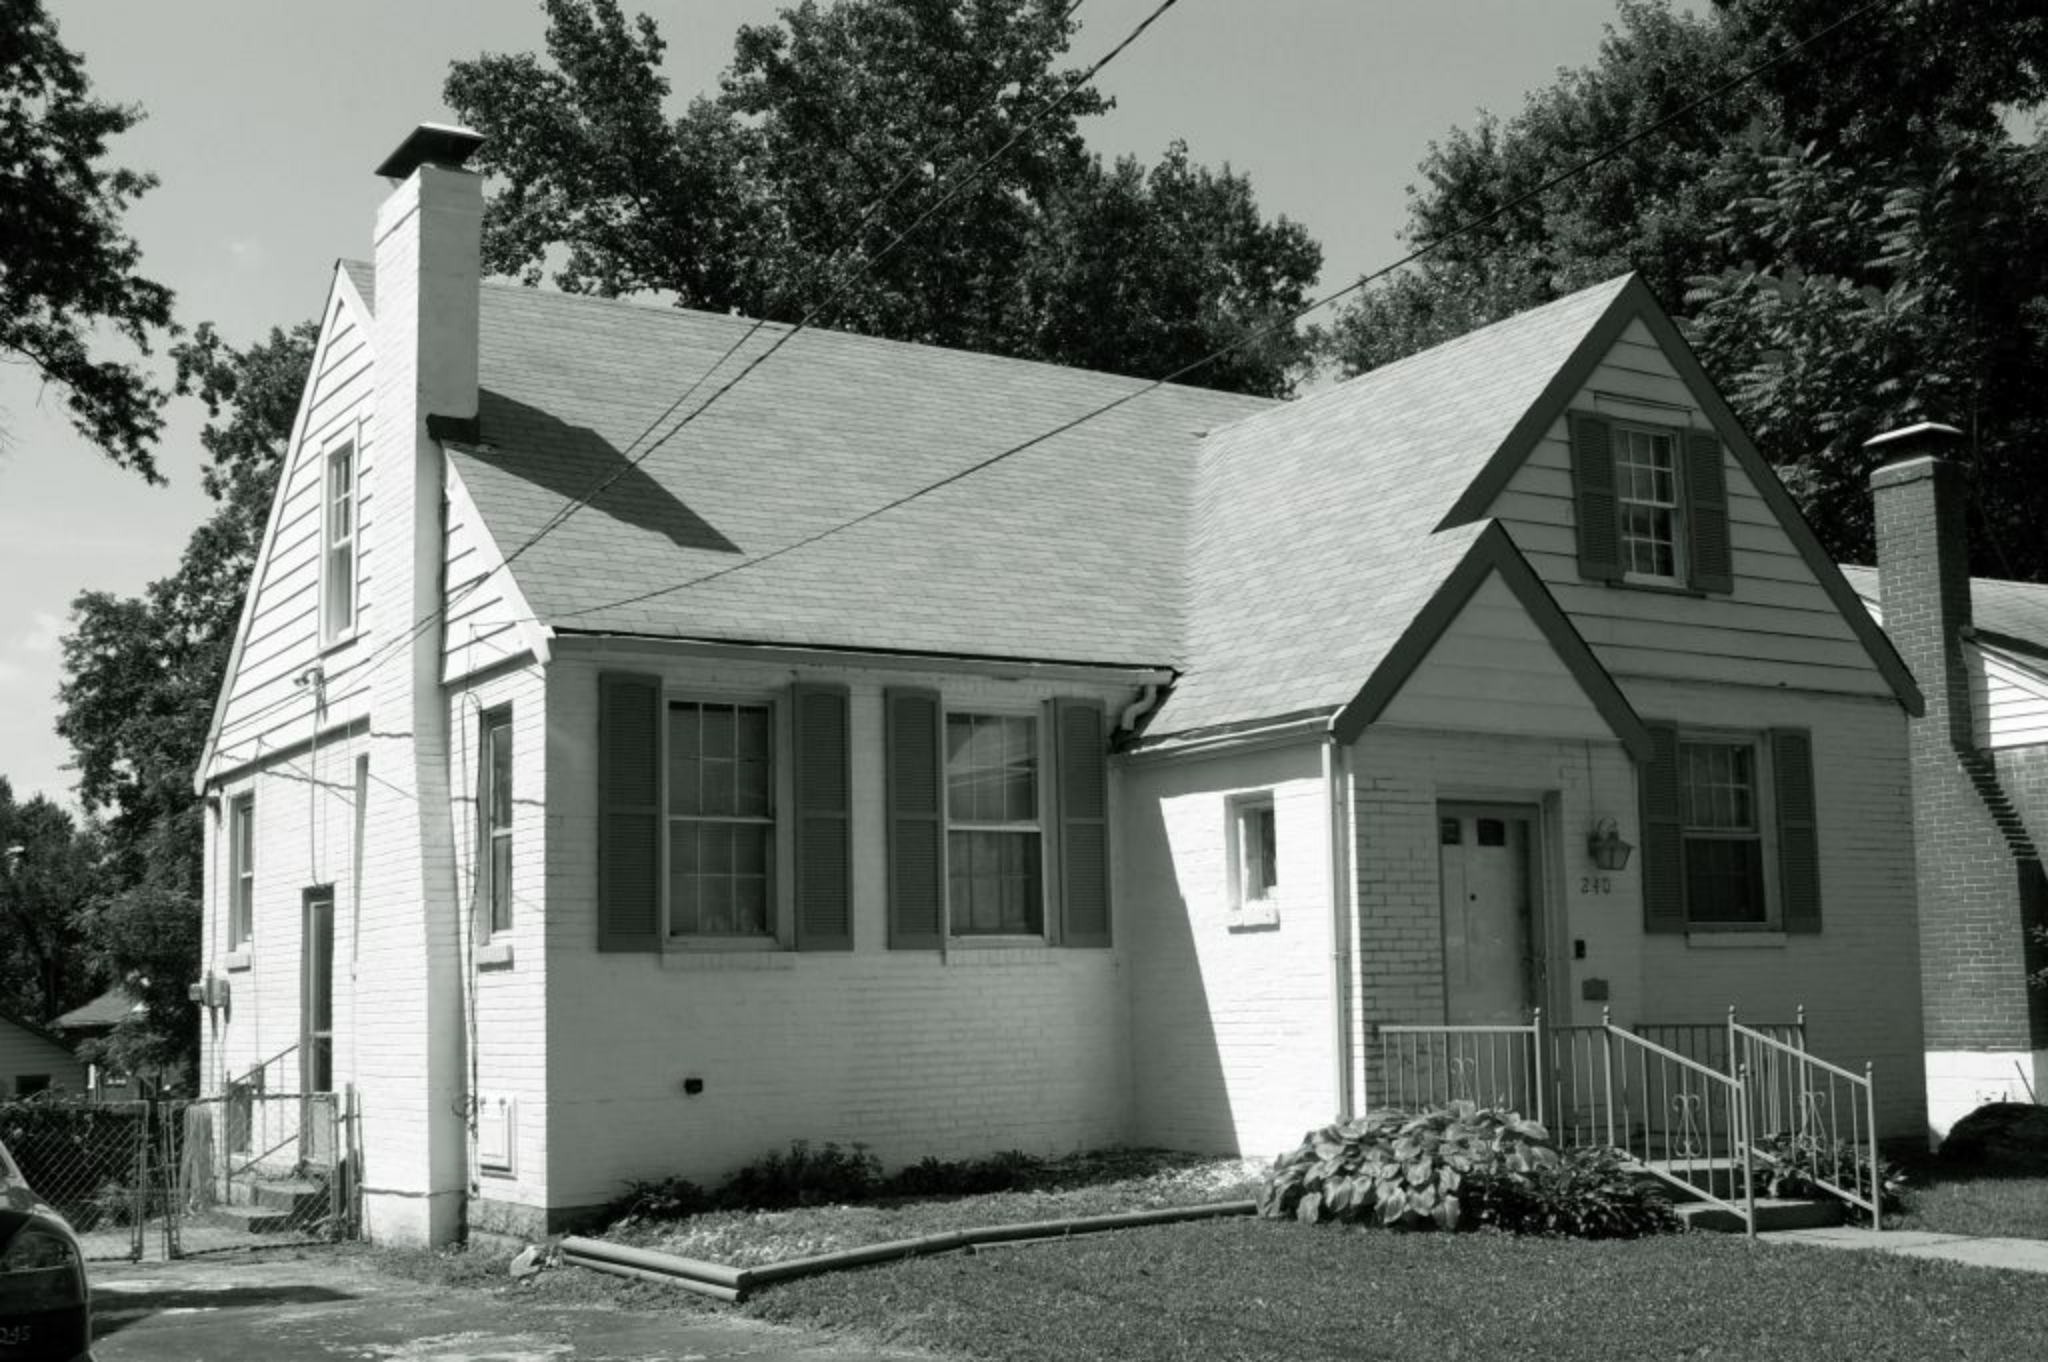
This 1.5 story, side gabled, painted brick Tudor Revival house has a cross gable that spans the western two bays and merges with a projecting, one story, small gabled vestibule which has a wood paneled entry door with small rectangular lights in the top two panels. On the side elevation of the vestibule is a small, fixed, wood framed window. In the other three bays of the first floor there are multipaned, wood sashed windows with shutters. The one to the west is 8 over 8 while the others are 6 over 6, as is the second floor shuttered window in the gable end and those on the side elevations. There is a low concrete stoop with iron railings spanning the vestibule. On the east side of the house is a brick end wall chimney and a side entry door with concrete steps, accessing the driveway. The drive leads to the rear entry on the basement of the attached garage. The windows have storm screens, the gable ends have been clad with wider aluminum siding, and the brick has been painted.

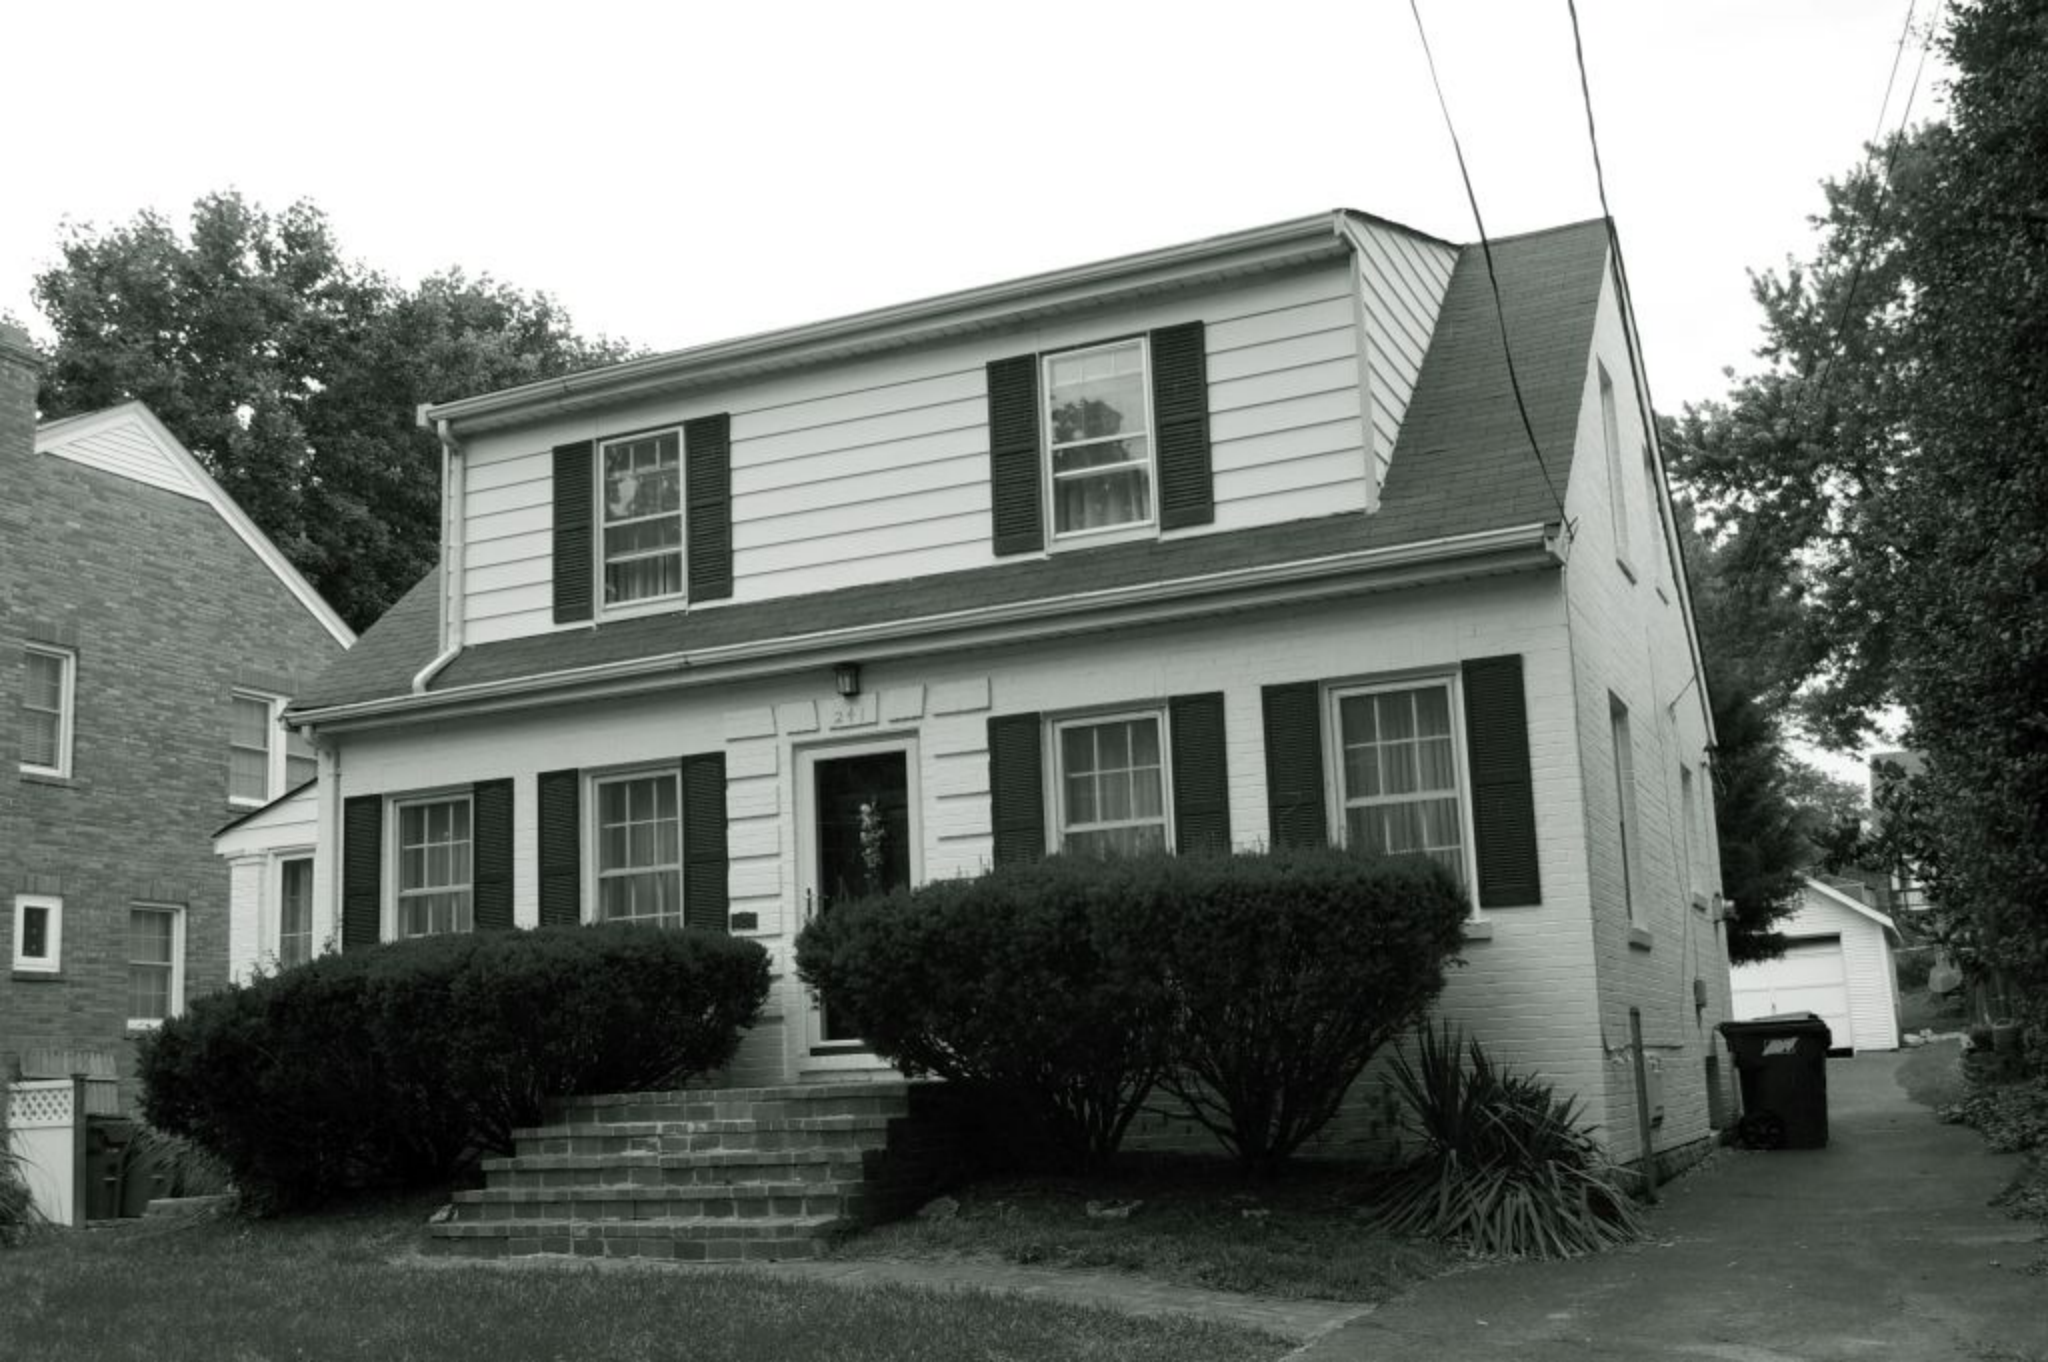
This 1.5 story, side gabled, Cape Cod house has a symmetrical facade. Around the central entry, projecting rectangles of brick form a quoined treatment for the paneled door. In front of the entry there is a shallow brick stoop with a series of very shallow brick steps. To either side of the entry there are two, shuttered, 6 over 6 wood sashed windows. Above, there is a full width shed roofed dormer with shuttered 6 over 6 wood sashed windows. Although it is shown as an open porch on the 1950 fire insurance map, on the west side is a side shed roofed, one story sunroom, with brick corner piers and brick halfwalls. It has paired wood, multipaned casement windows (three sets on the facade and two pairs on the side). Since the sunroom has a faux stone foundation like the house, it is apparently original to its construction. There is a brick end wall chimney projecting above the roof of the sunroom. The house has storm windows and storm doors, the brick walls have been painted and the dormer has been sided with aluminum.

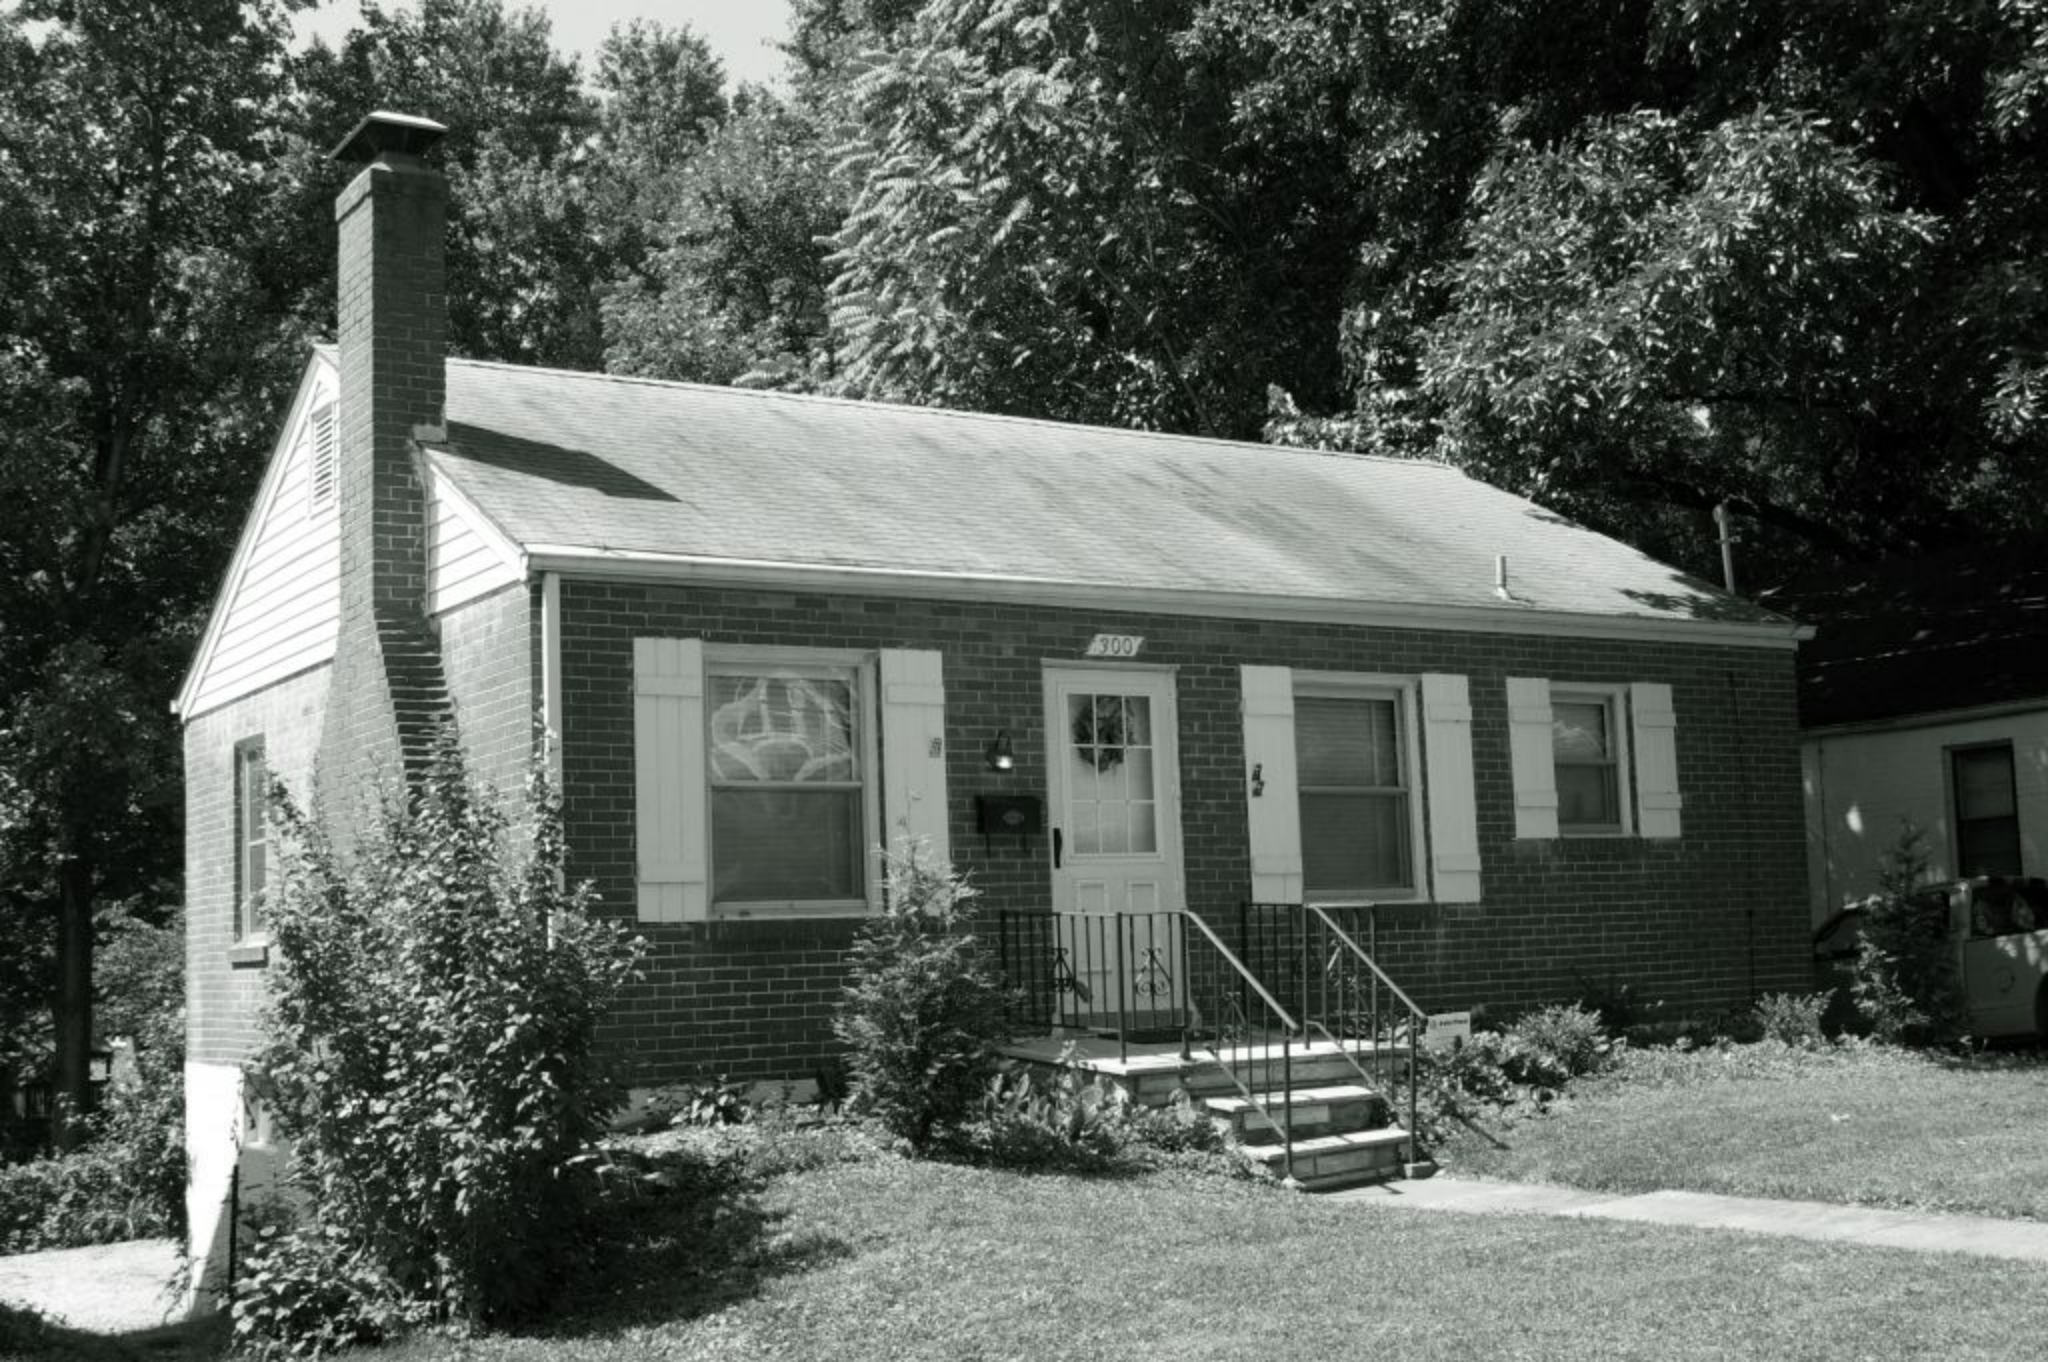
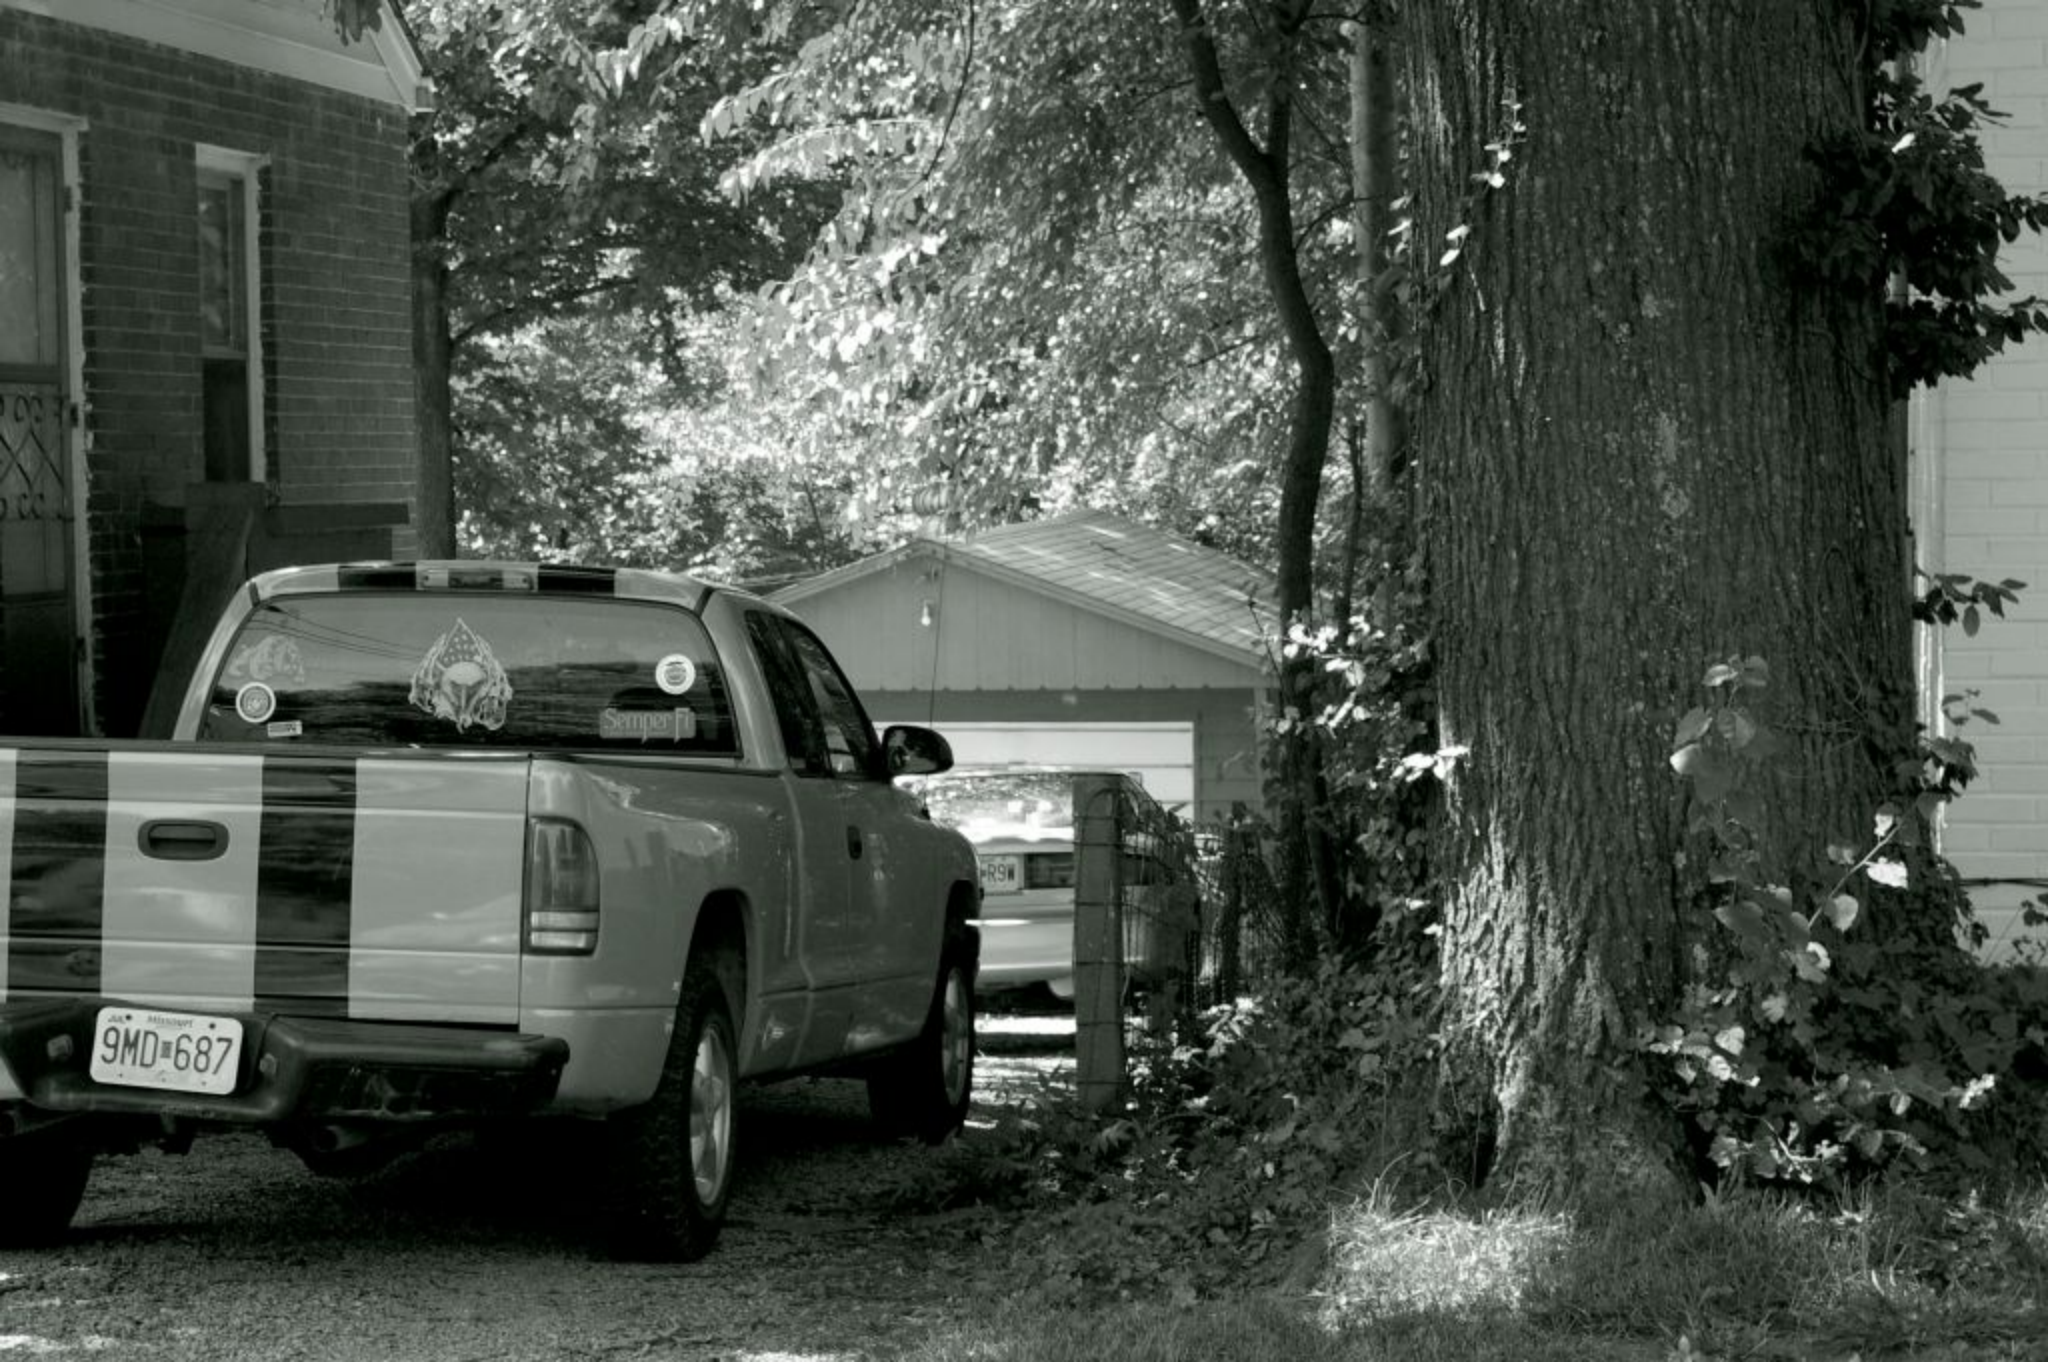
This simple, one story, brick Cape Cod house has a side gabled roof with a four bay facade. The window on the west end is smaller than the two larger windows flanking the simple wood entry door with its concrete stoop and iron railings. The windows on the facade retain the original wood plank shutters and the house retains its original 1 over 1 wood sashed windows, but they have aluminum combination storms that have been added. There is an end wall red brick chimney on the east side and on the west side is a side doorway with its own concrete stoop that exits to the driveway. The end gables of the house have been clad with aluminum siding, but this may be original given the date of the house.
