ARCHITECTURAL/HISTORIC INVENTORY FORM

1. Survey No. SL-AS-036-001		2. Survey Name: Architectural Survey of Old Ferguson West	
3. County: St. Louis		4. Address: 1 Carson Rd.	
5. City: Ferguson	Vicinity: <input type="checkbox"/>	6. UTM:	7. Township/Range/Section
8. Historic name (if known):		9. Present/other name (if known): Whistle Stop	
10. Ownership: <input type="checkbox"/> Private <input checked="" type="checkbox"/> Public		11. Historic use (if known): TRANSPORTATION/rail-related	11. Current use: COMMERCE/restaurant & RECREATION/museum

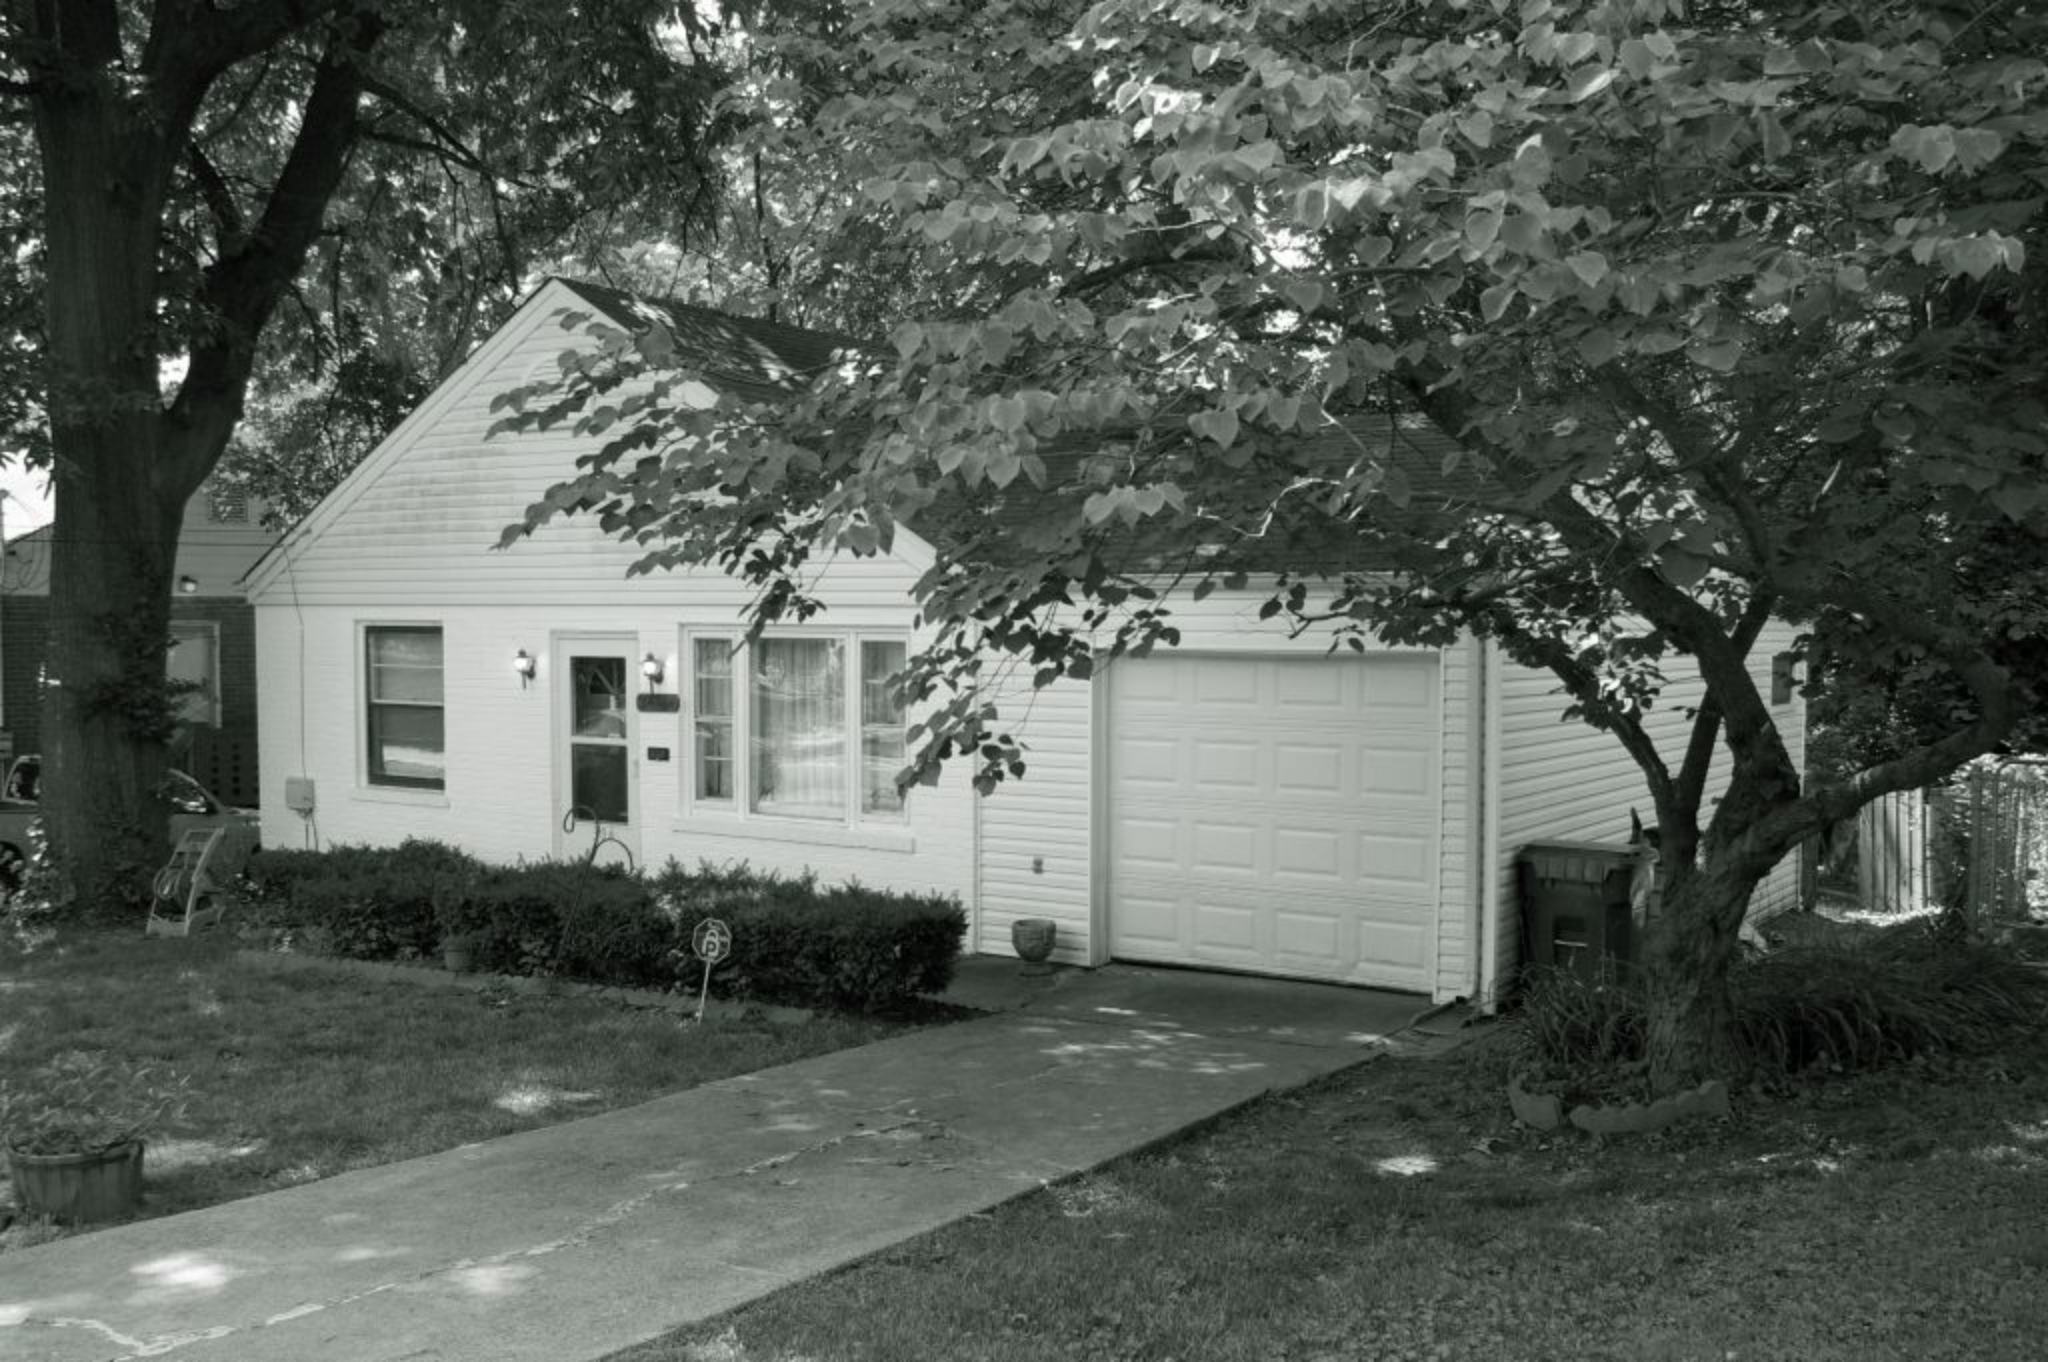
This one story end gabled, painted brick house has three bays on the main house facade and across the front, at the west end is a side gabled wing, with a one car garage. The simple wood entry door with lights near the top has a low concrete pad and sidewalk paralleling the facade and leading to the concrete driveway. To the east side there is a 2 over 2 (horizontal light) sashed window and to the west is a large picture window consisting of narrow 2 over 2 (horizontal light) wood sashed windows flanking a large plate glass window. The simple design now has painted brick on the main house with vinyl siding on the garage and gable end. The attached garage is part of the original design, clearly visible on the 1950 fire insurance map. The windows have storm screens added and there is a storm door on the front entry.

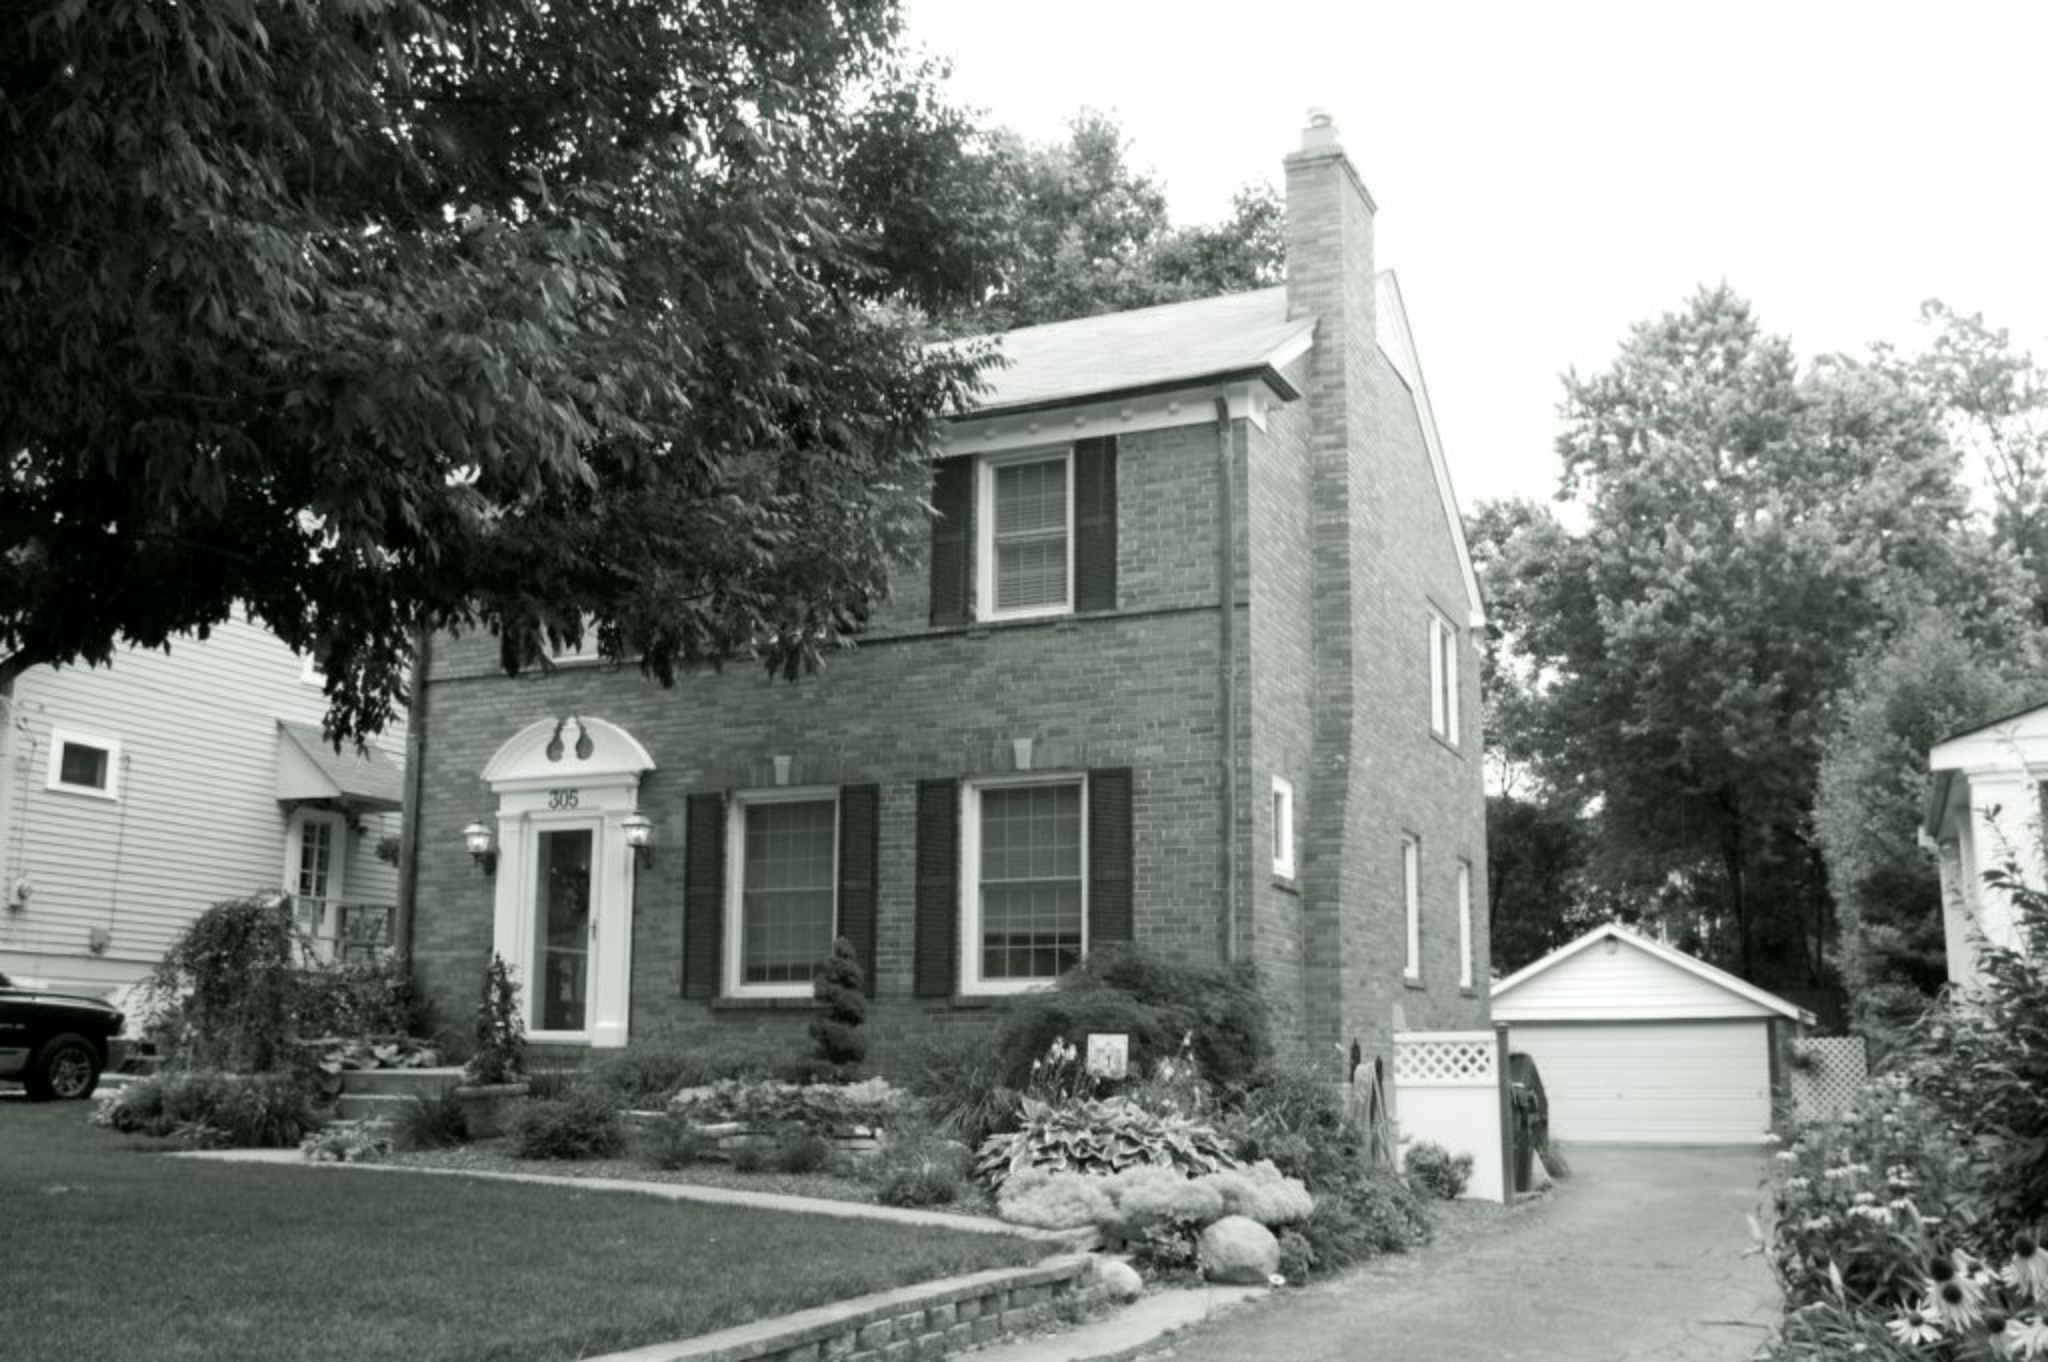
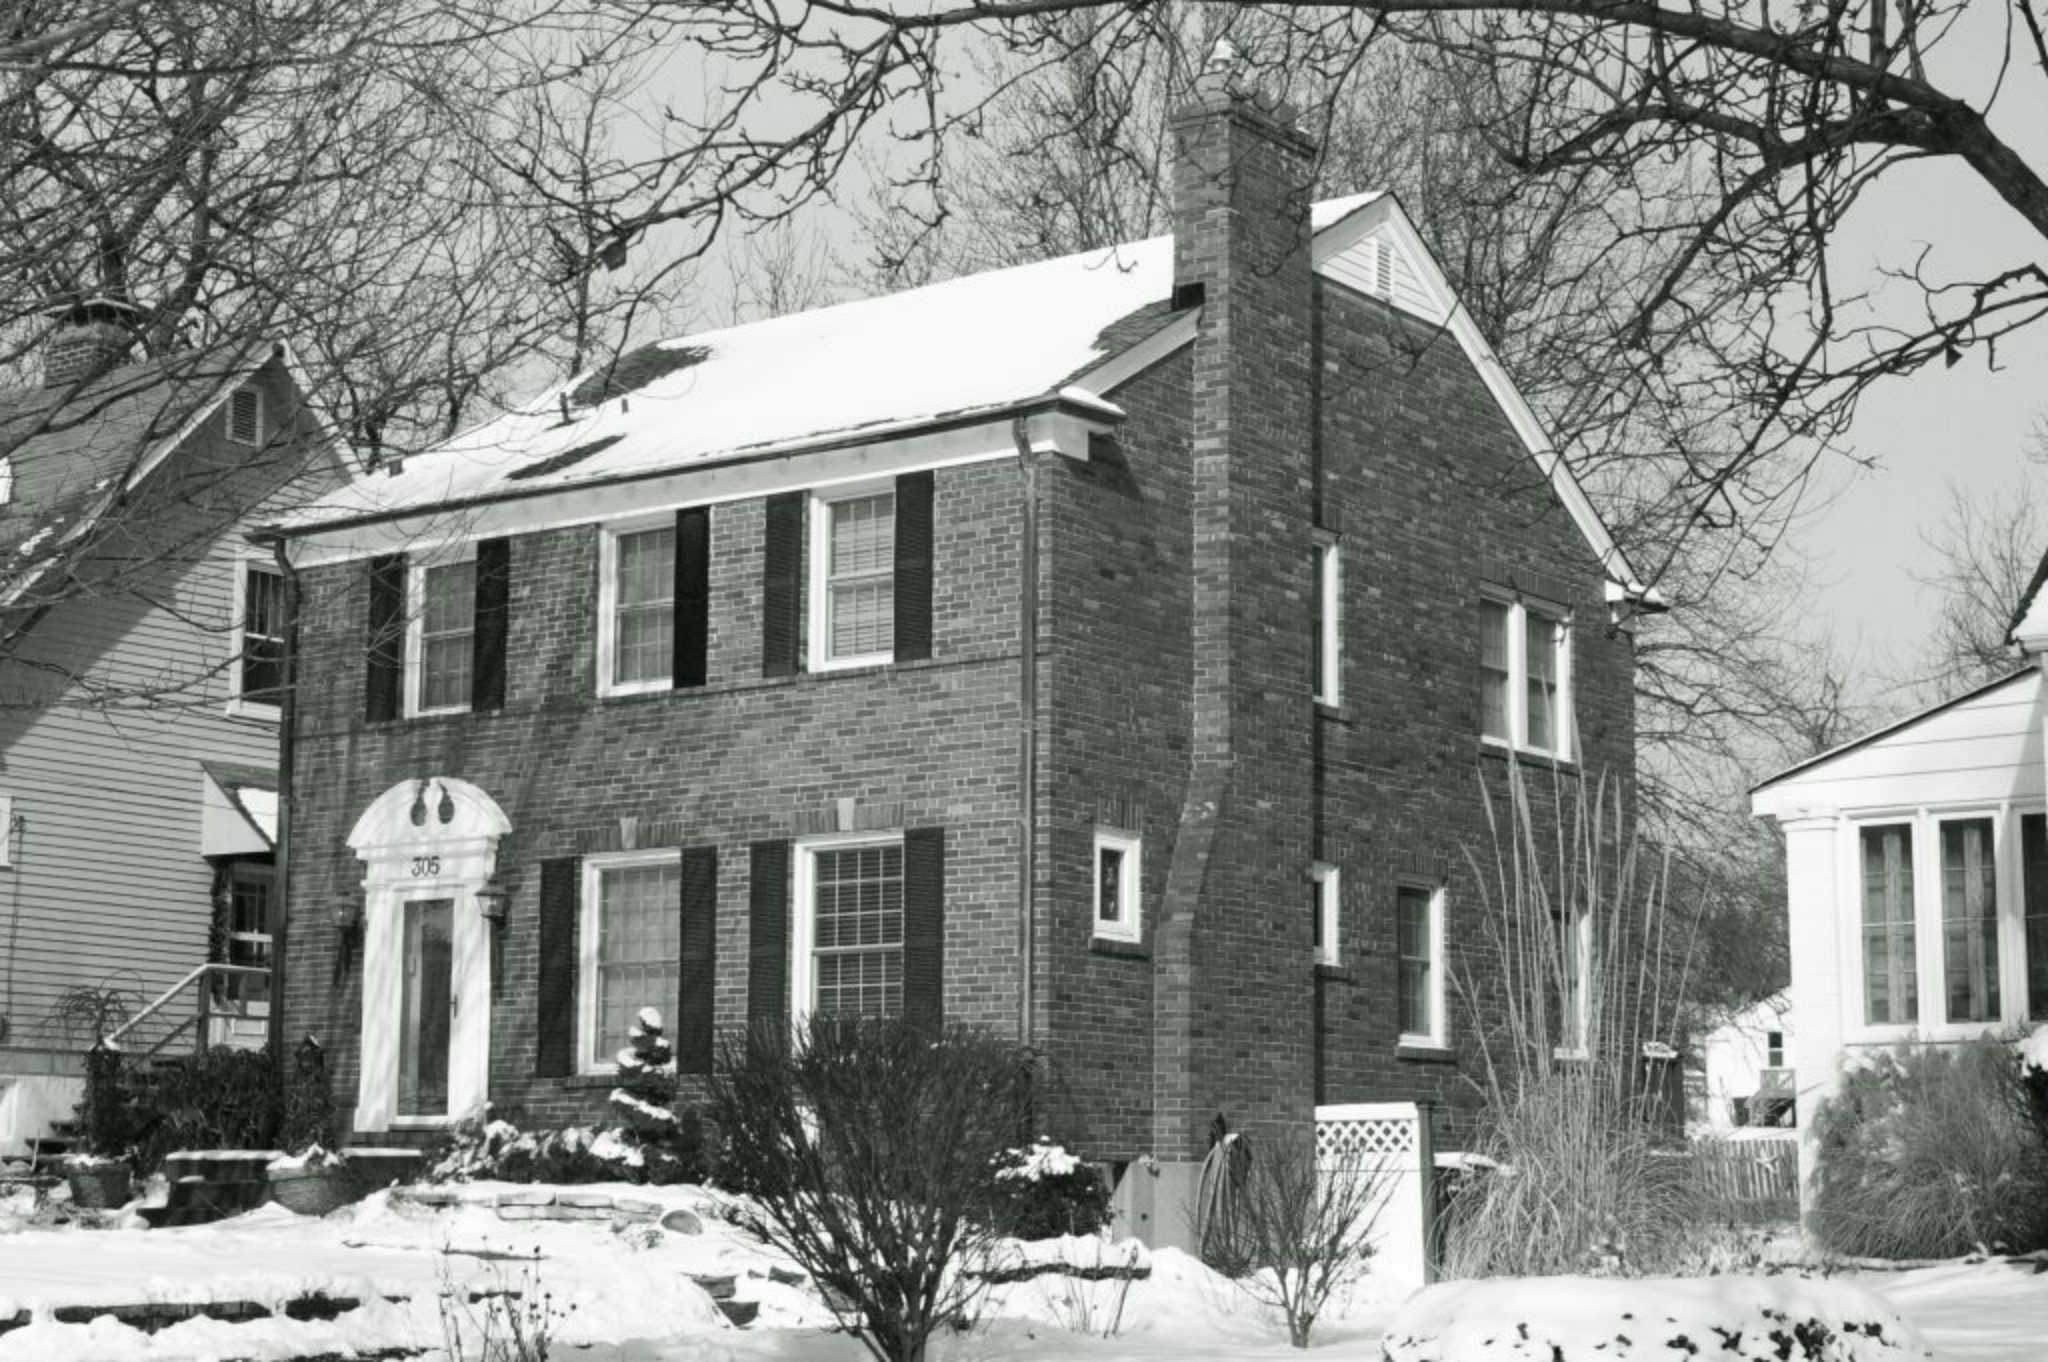
This two story, side gabled, Georgian Revival house is divided into three bays on the facade with 12 over 12 wood sashed windows on the first floor in the east two bays and 6 over 6 wood sashed windows in the three bays of the second floor, all with faux shutters. The first floor windows are highlighted by a soldier course brick lintel with keystone and the second floor sill is formed by a continuous projecting brick sill. The boxed soffit on the facade has dentils, forming an entablature crowned by the copper gutter. The entry door is located in the west bay and has pilasters supporting an entablature and arched, broken pediment. In front of the entry is a shallow concrete stoop. The front door appears to be a paneled metal door. There is an end wall brick chimney on the east elevation. There are storm windows and a full view storm door that have been added.

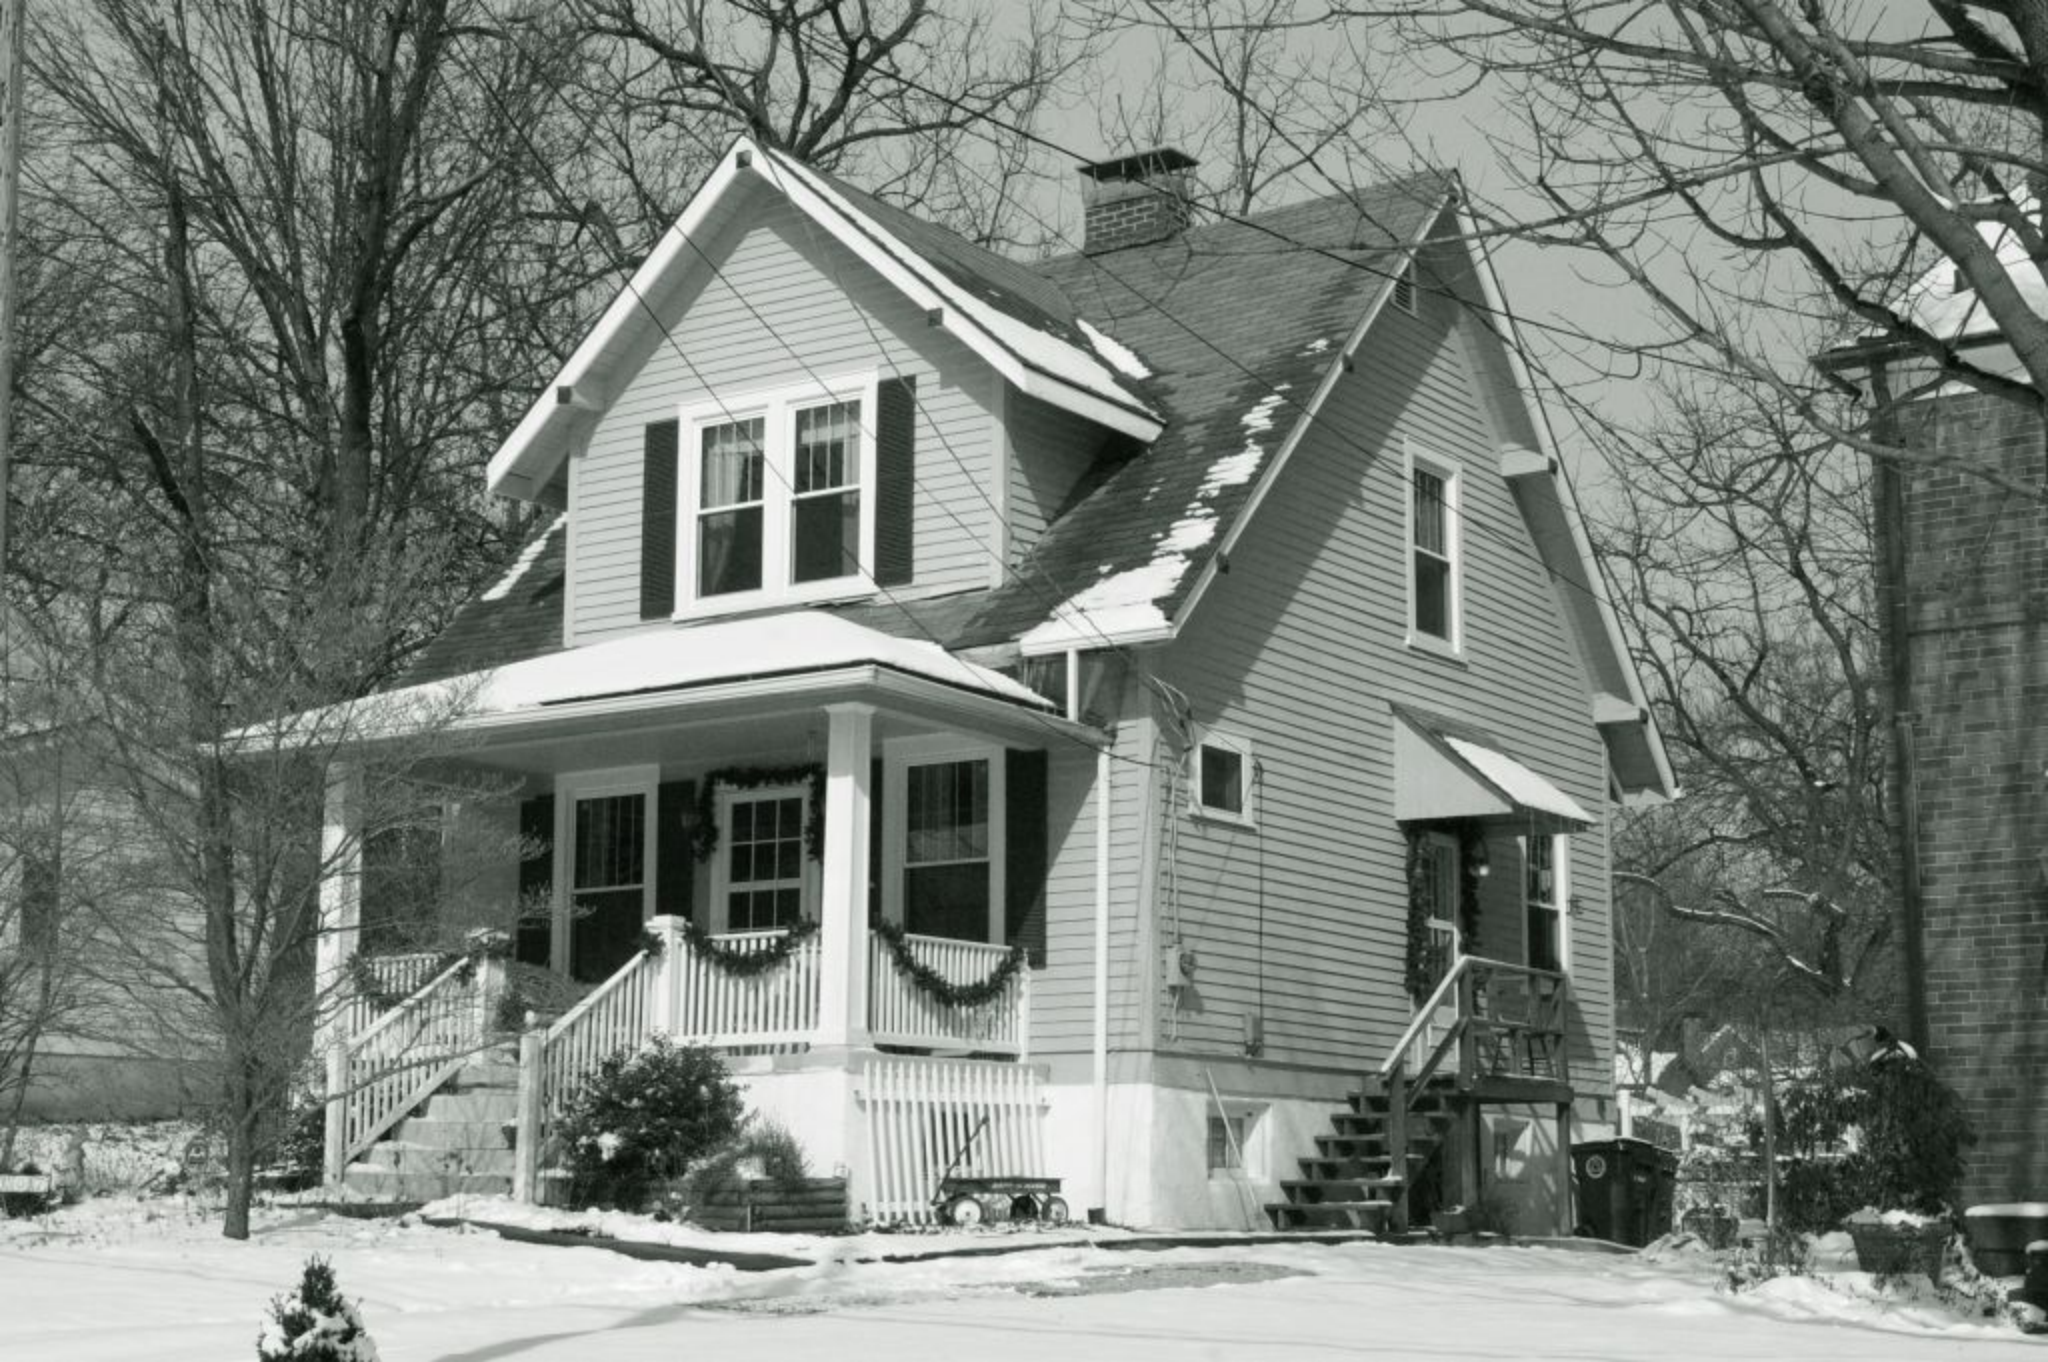
2009 Survey Update: Since the 1983 survey storm windows and a storm door have been added to the house and porch railings have been installed, appropriately made for this era house, but there were not any railings in the 1983 photo. The side steps have been rebuilt in wood with wood railings of unpainted wood.

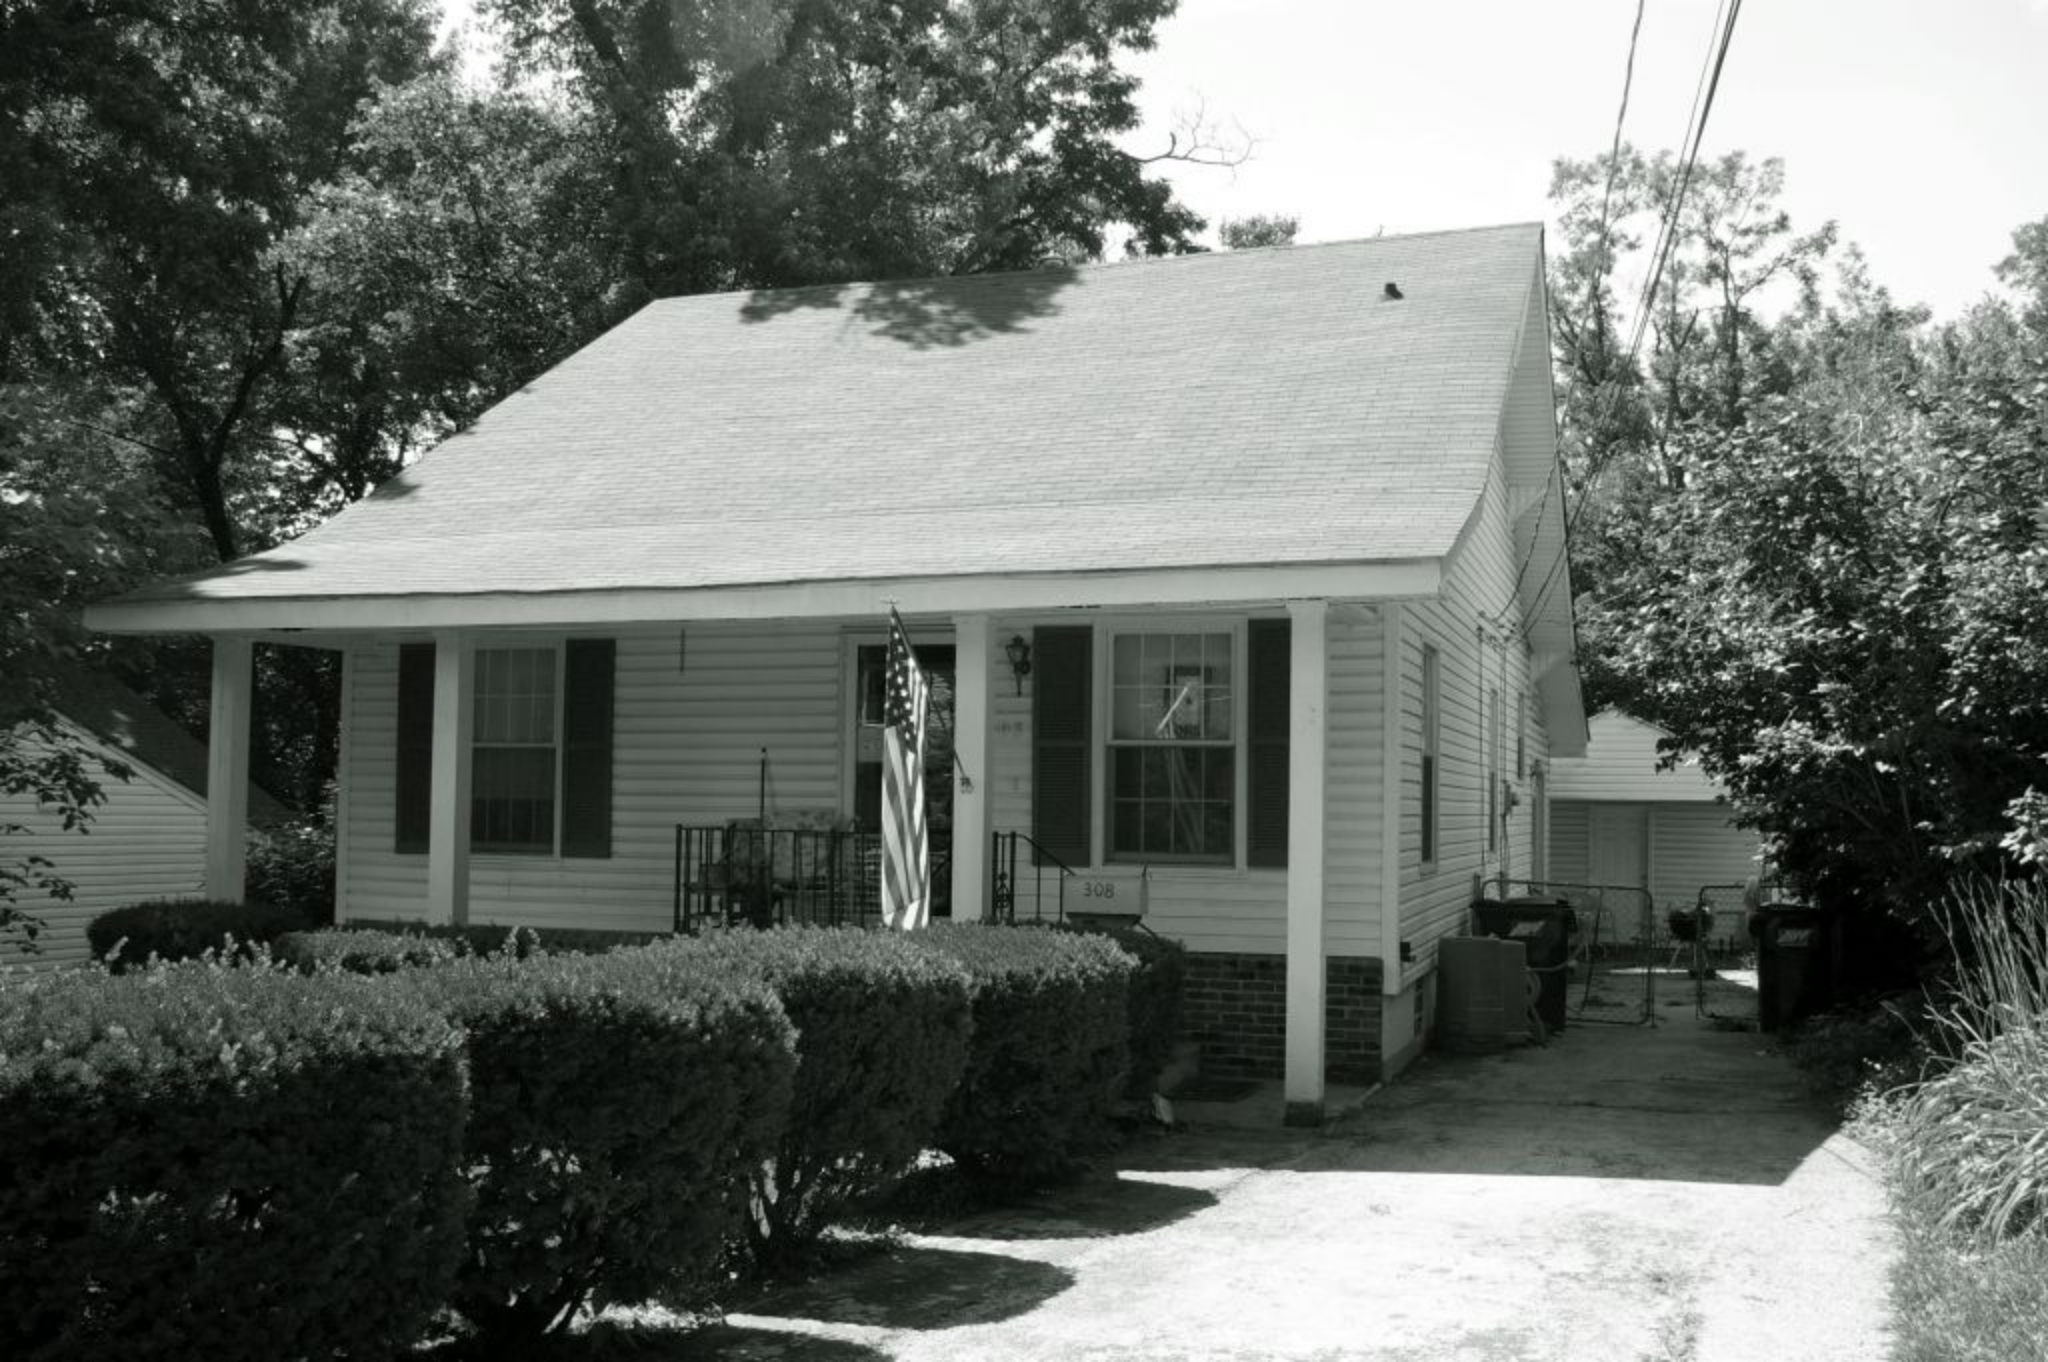
This side gabled, wide eaved house with its integrated full width porch appears to have originally been a simple Craftsman bungalow, but the front porch posts have been modified, extending them to the ground, eliminating the porch floor and veneering the area that was originally below the porch floor with brick. Under the porch roof, a small concrete stoop with iron railings has been installed. The 8 over 8 wood sashed windows appear to be original to the house, but the shutters (on the front) appear to be recent replacements. The original stucco foundation is still visible on the side next to the driveway but the entire house has been clad with vinyl siding, including the knee braces (a Craftsman feature) that support the cave overhang.

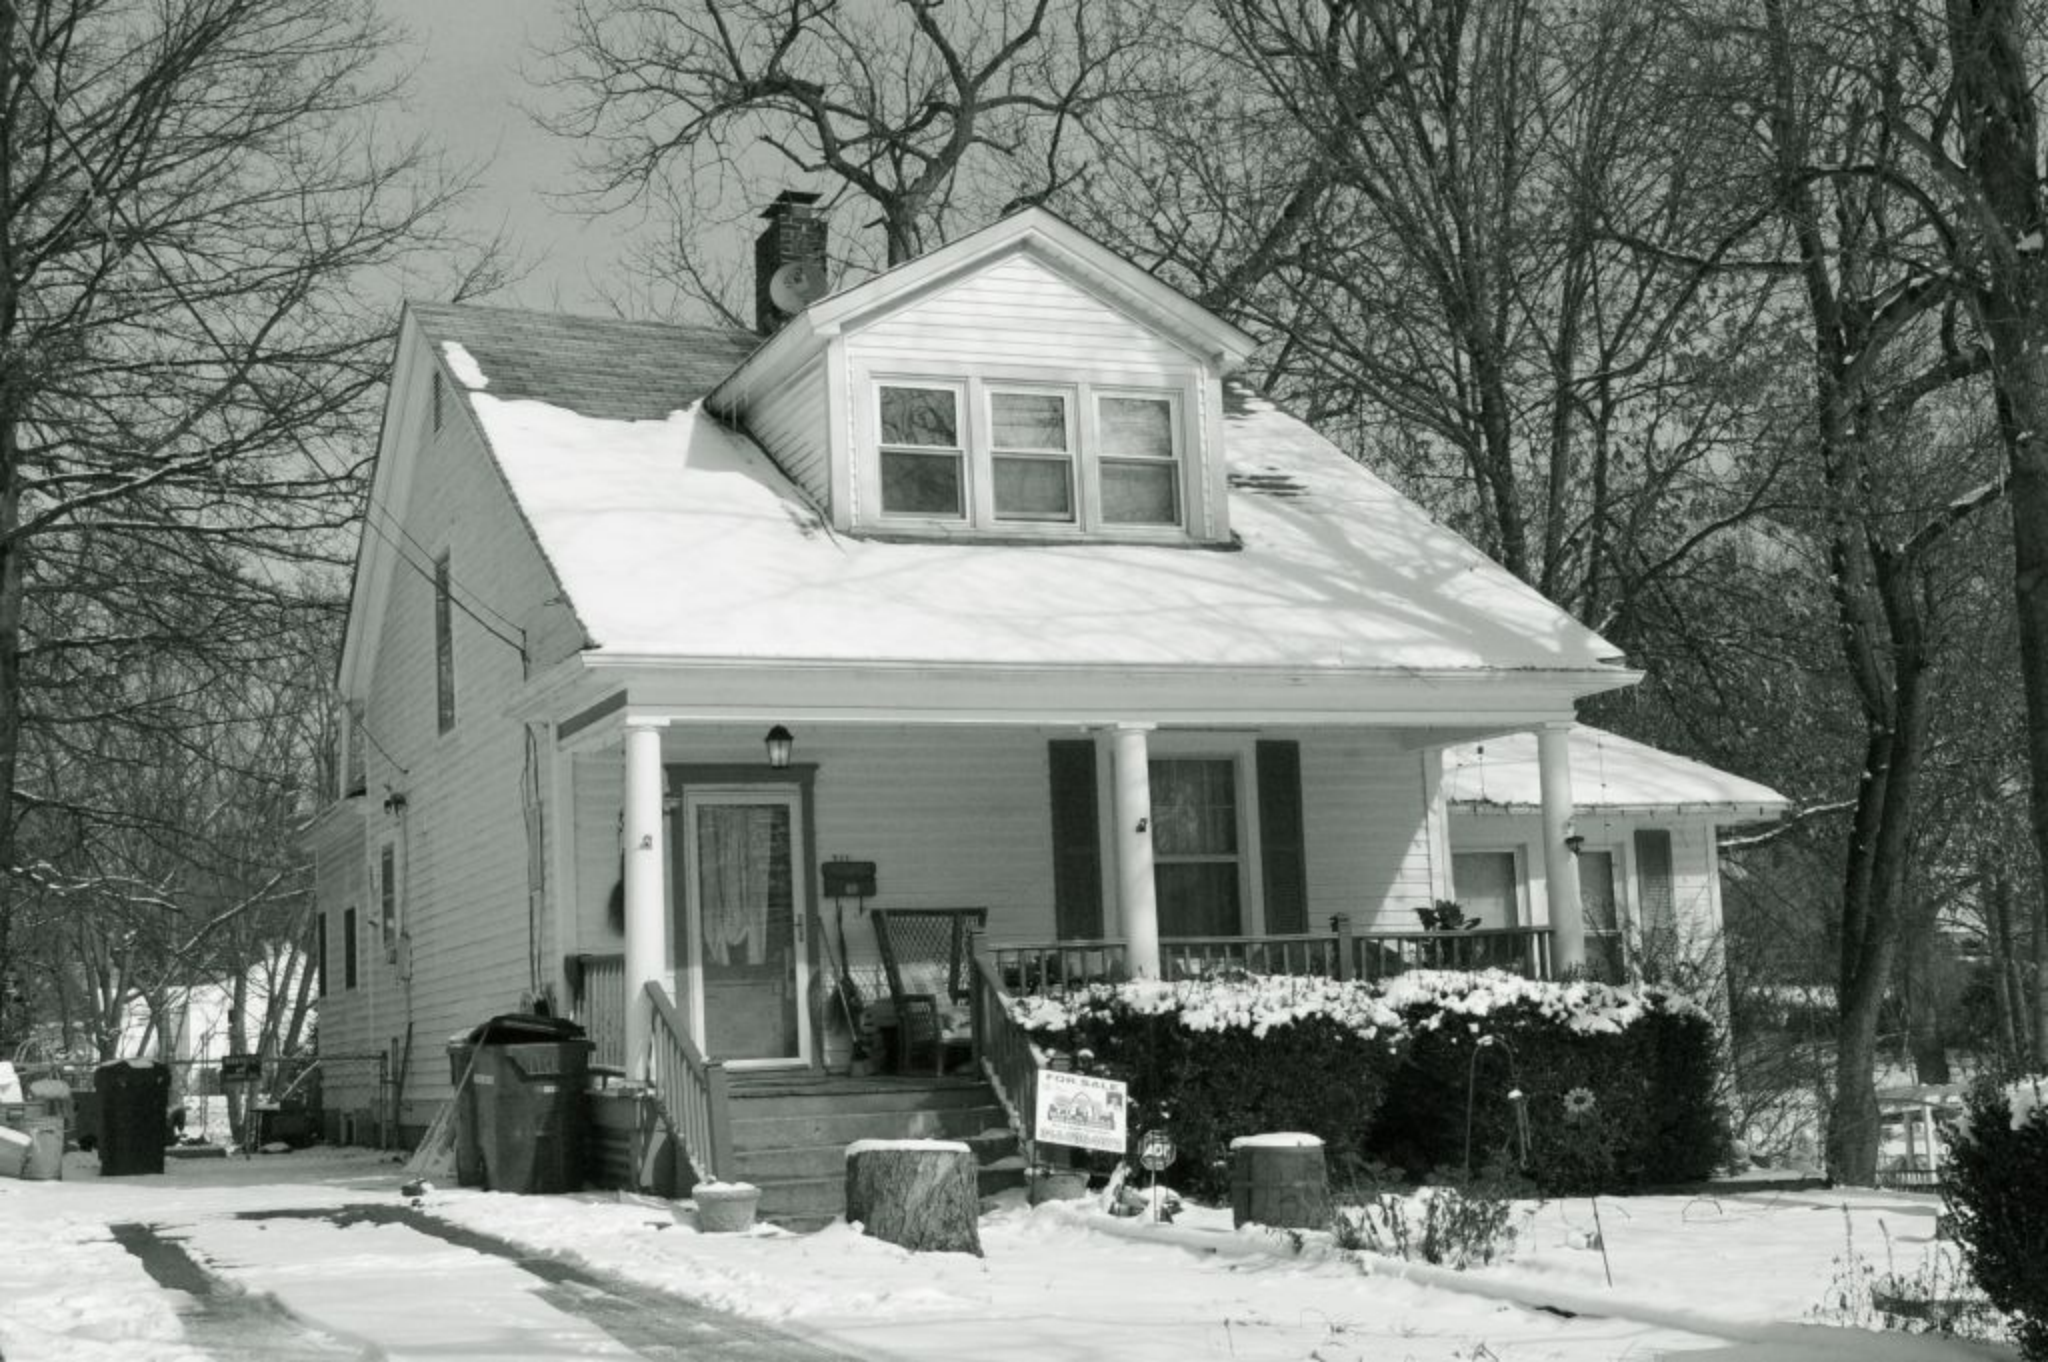
2009 Survey Update: Since the 1983 survey, the front dormer has been clad in vinyl siding and has replacement vinyl windows, but the other windows on the house appear original, including the 8 over 1 window on the facade with the 3/4 light wood door. The house did not have railings in 1983, but now has new wood railings appropriately built for this era house but they are not painted and it is unclear whether this house had railings originally. Otherwise, the house is unaltered from the 1983 period. The small sunroom wing on the east side and the rear one story addition were apparently built after 1950 since they do not appear on the fire insurance map.

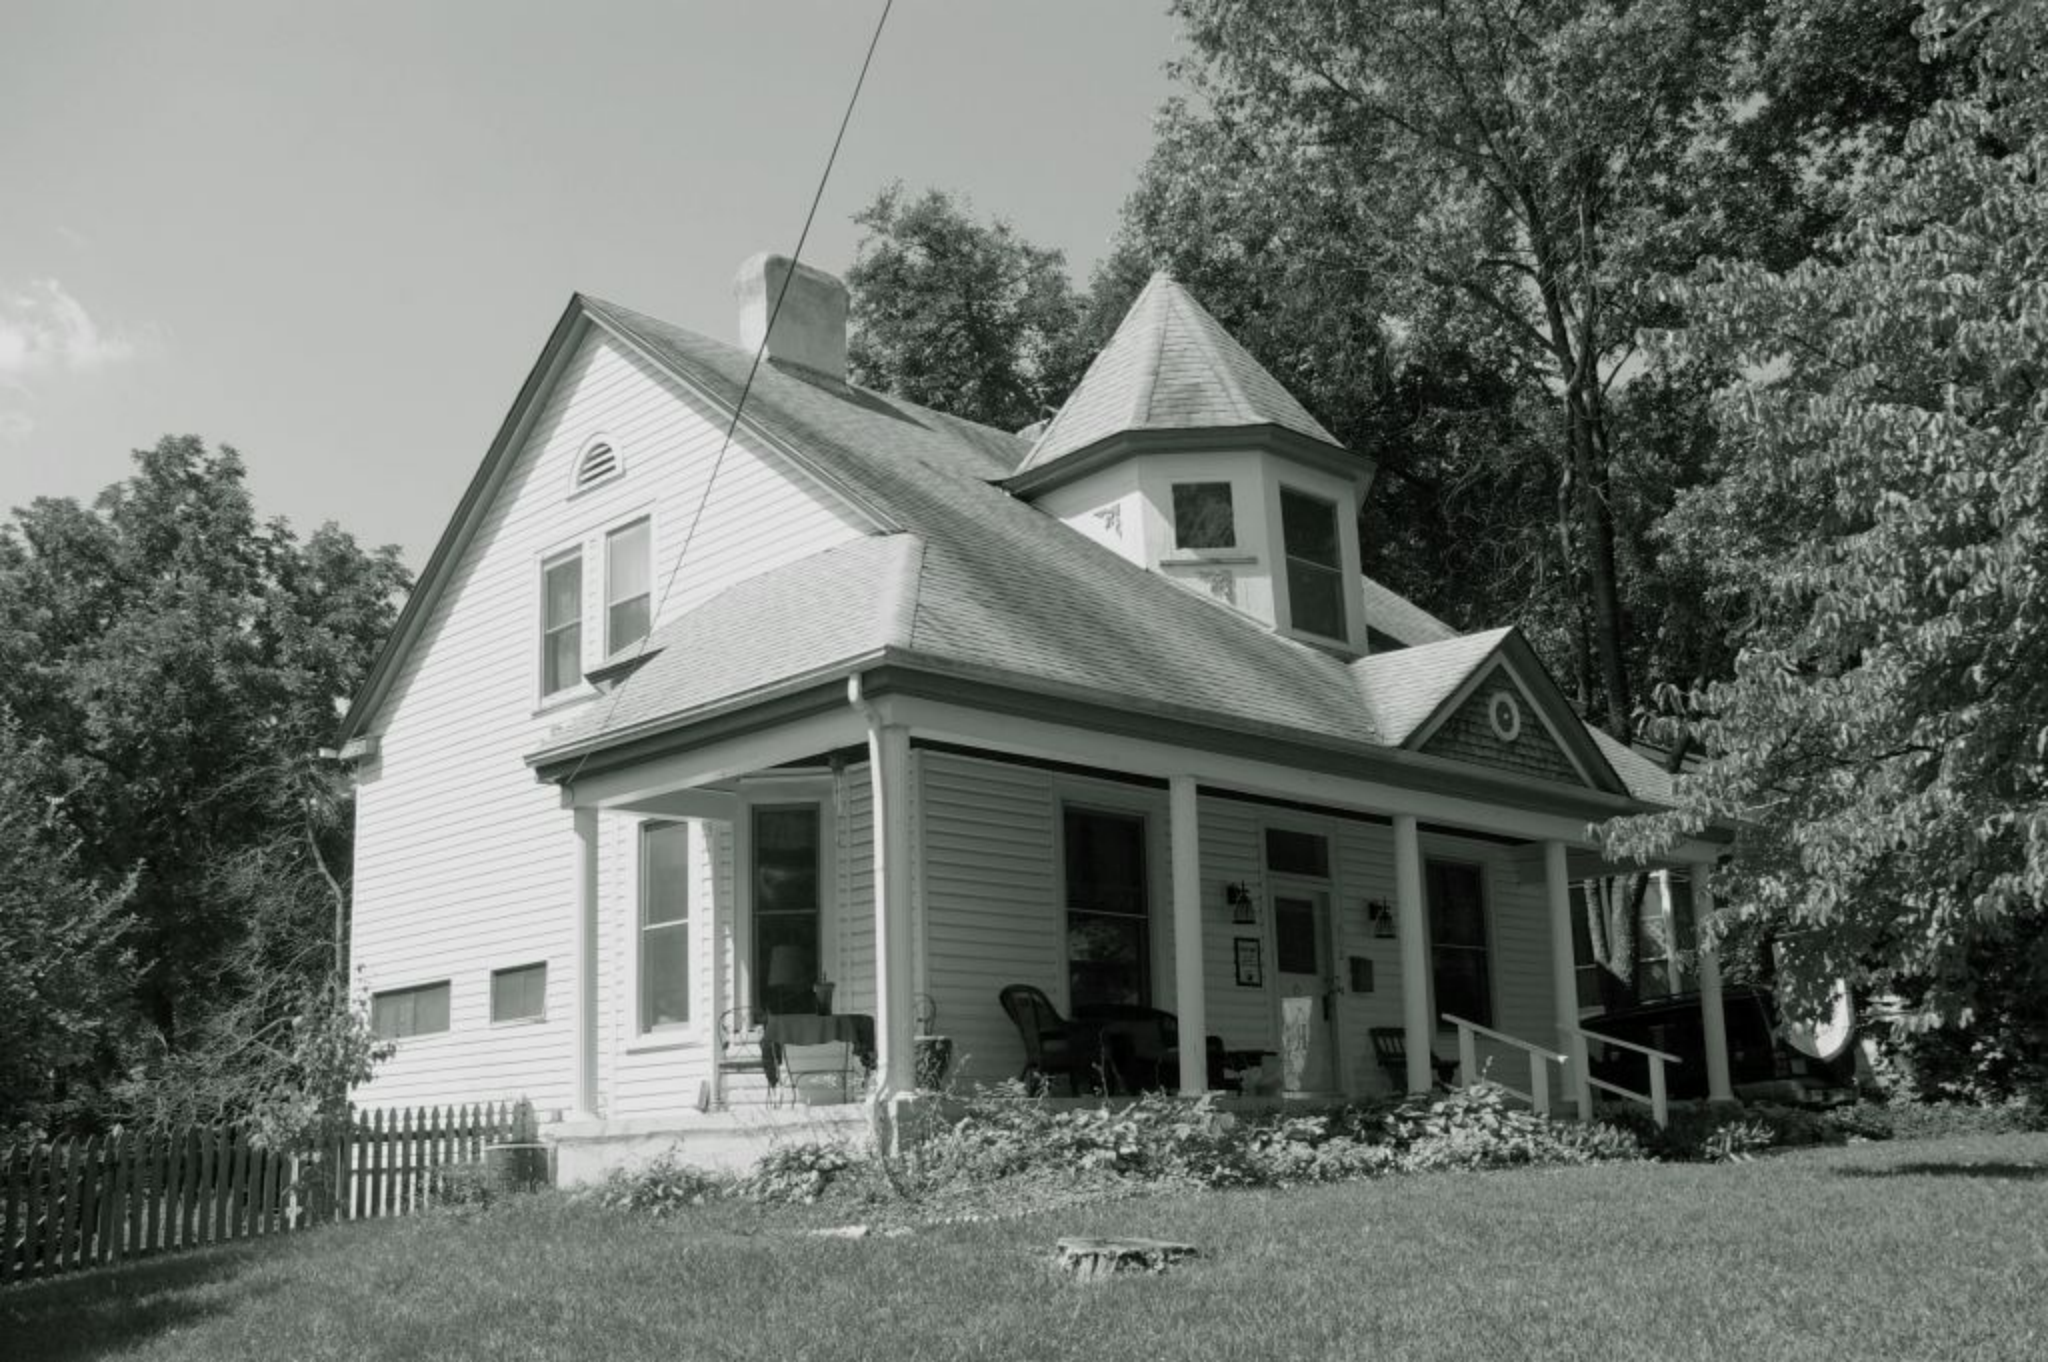
2009 Survey Update: The lattice work porch supports (which may not have been original) have been replaced with new fluted columns that seem out of proportion for this building since they are missing any capital. The transom that was blocked in previously has been reopened, but the house has been clad with vinyl siding and the windows on the east side (near the rear) are modern, horizontal profile windows. The historic wood sashed windows have storm screens. The gable end on the porch has had wood shingles added but the rosette is original to the house (not visible in the 1983 survey photo, but described in that survey). The second floor octagonal tower still retains its original wood walls and embossed decorative details. The chimneys have been coated with stucco but still retain the corbelling at the cap underneath the stucco.
