ARCHITECTURAL/HISTORIC INVENTORY FORM

1. Survey No. SL-AS-036-001		2. Survey Name: Architectural Survey of Old Ferguson West	
3. County: St. Louis		4. Address: 1 Carson Rd.	
5. City: Ferguson	Vicinity: <input type="checkbox"/>	6. UTM:	7. Township/Range/Section
8. Historic name (if known):		9. Present/other name (if known): Whistle Stop	
10. Ownership: <input type="checkbox"/> Private <input checked="" type="checkbox"/> Public		11. Historic use (if known): TRANSPORTATION/rail-related	11. Current use: COMMERCE/restaurant & RECREATION/museum

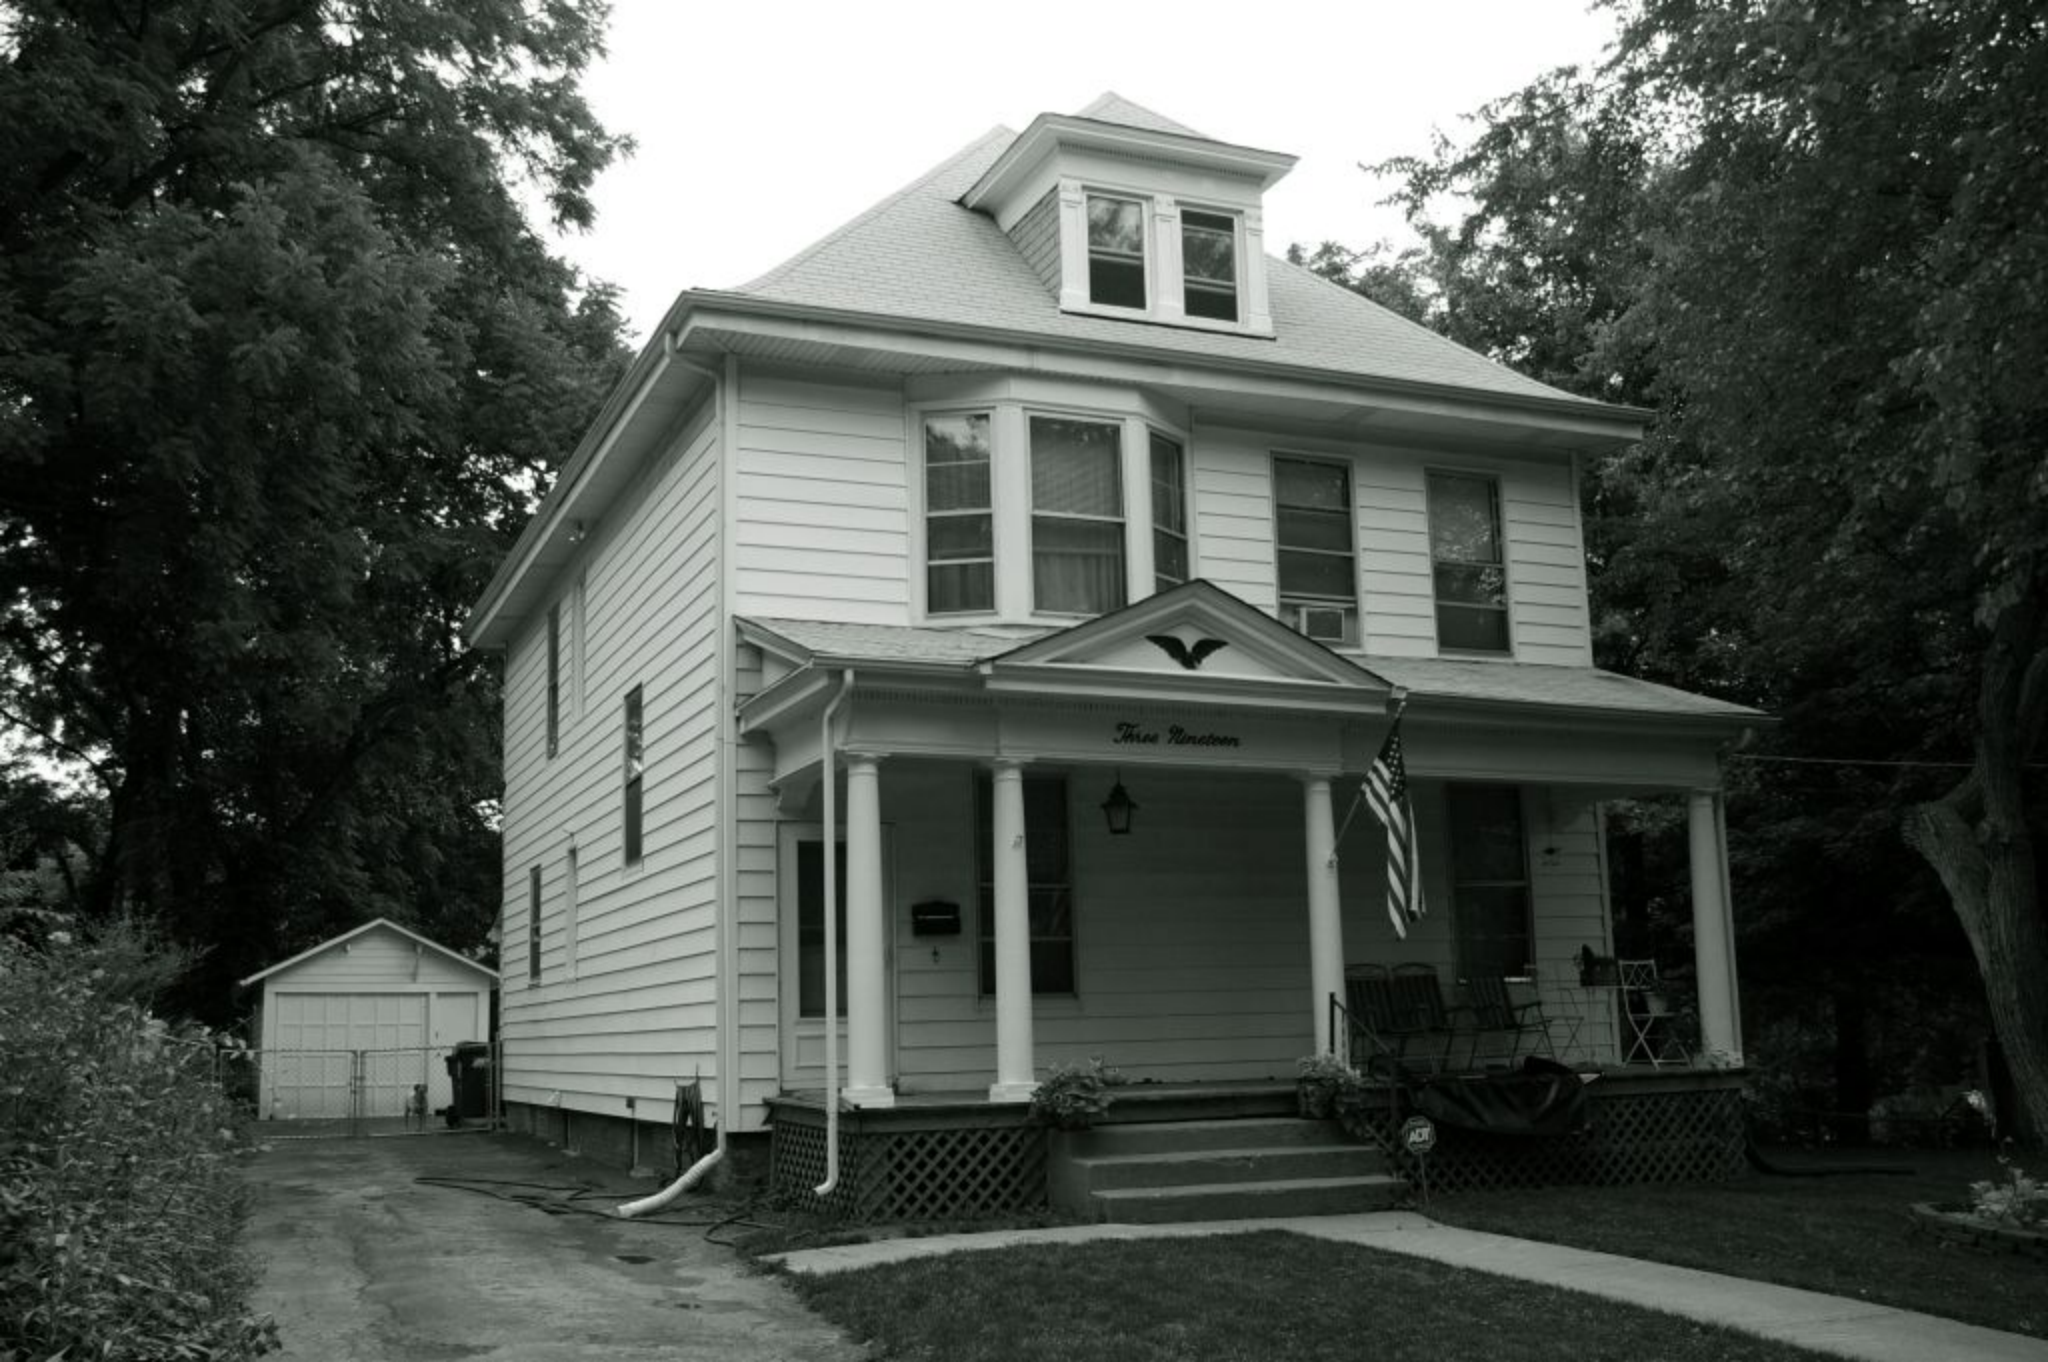
2009 Survey Update: Since the 1983 survey, aluminum storm windows and doors have been added. Otherwise the house appears not to be further altered, still retaining the alluminum siding.

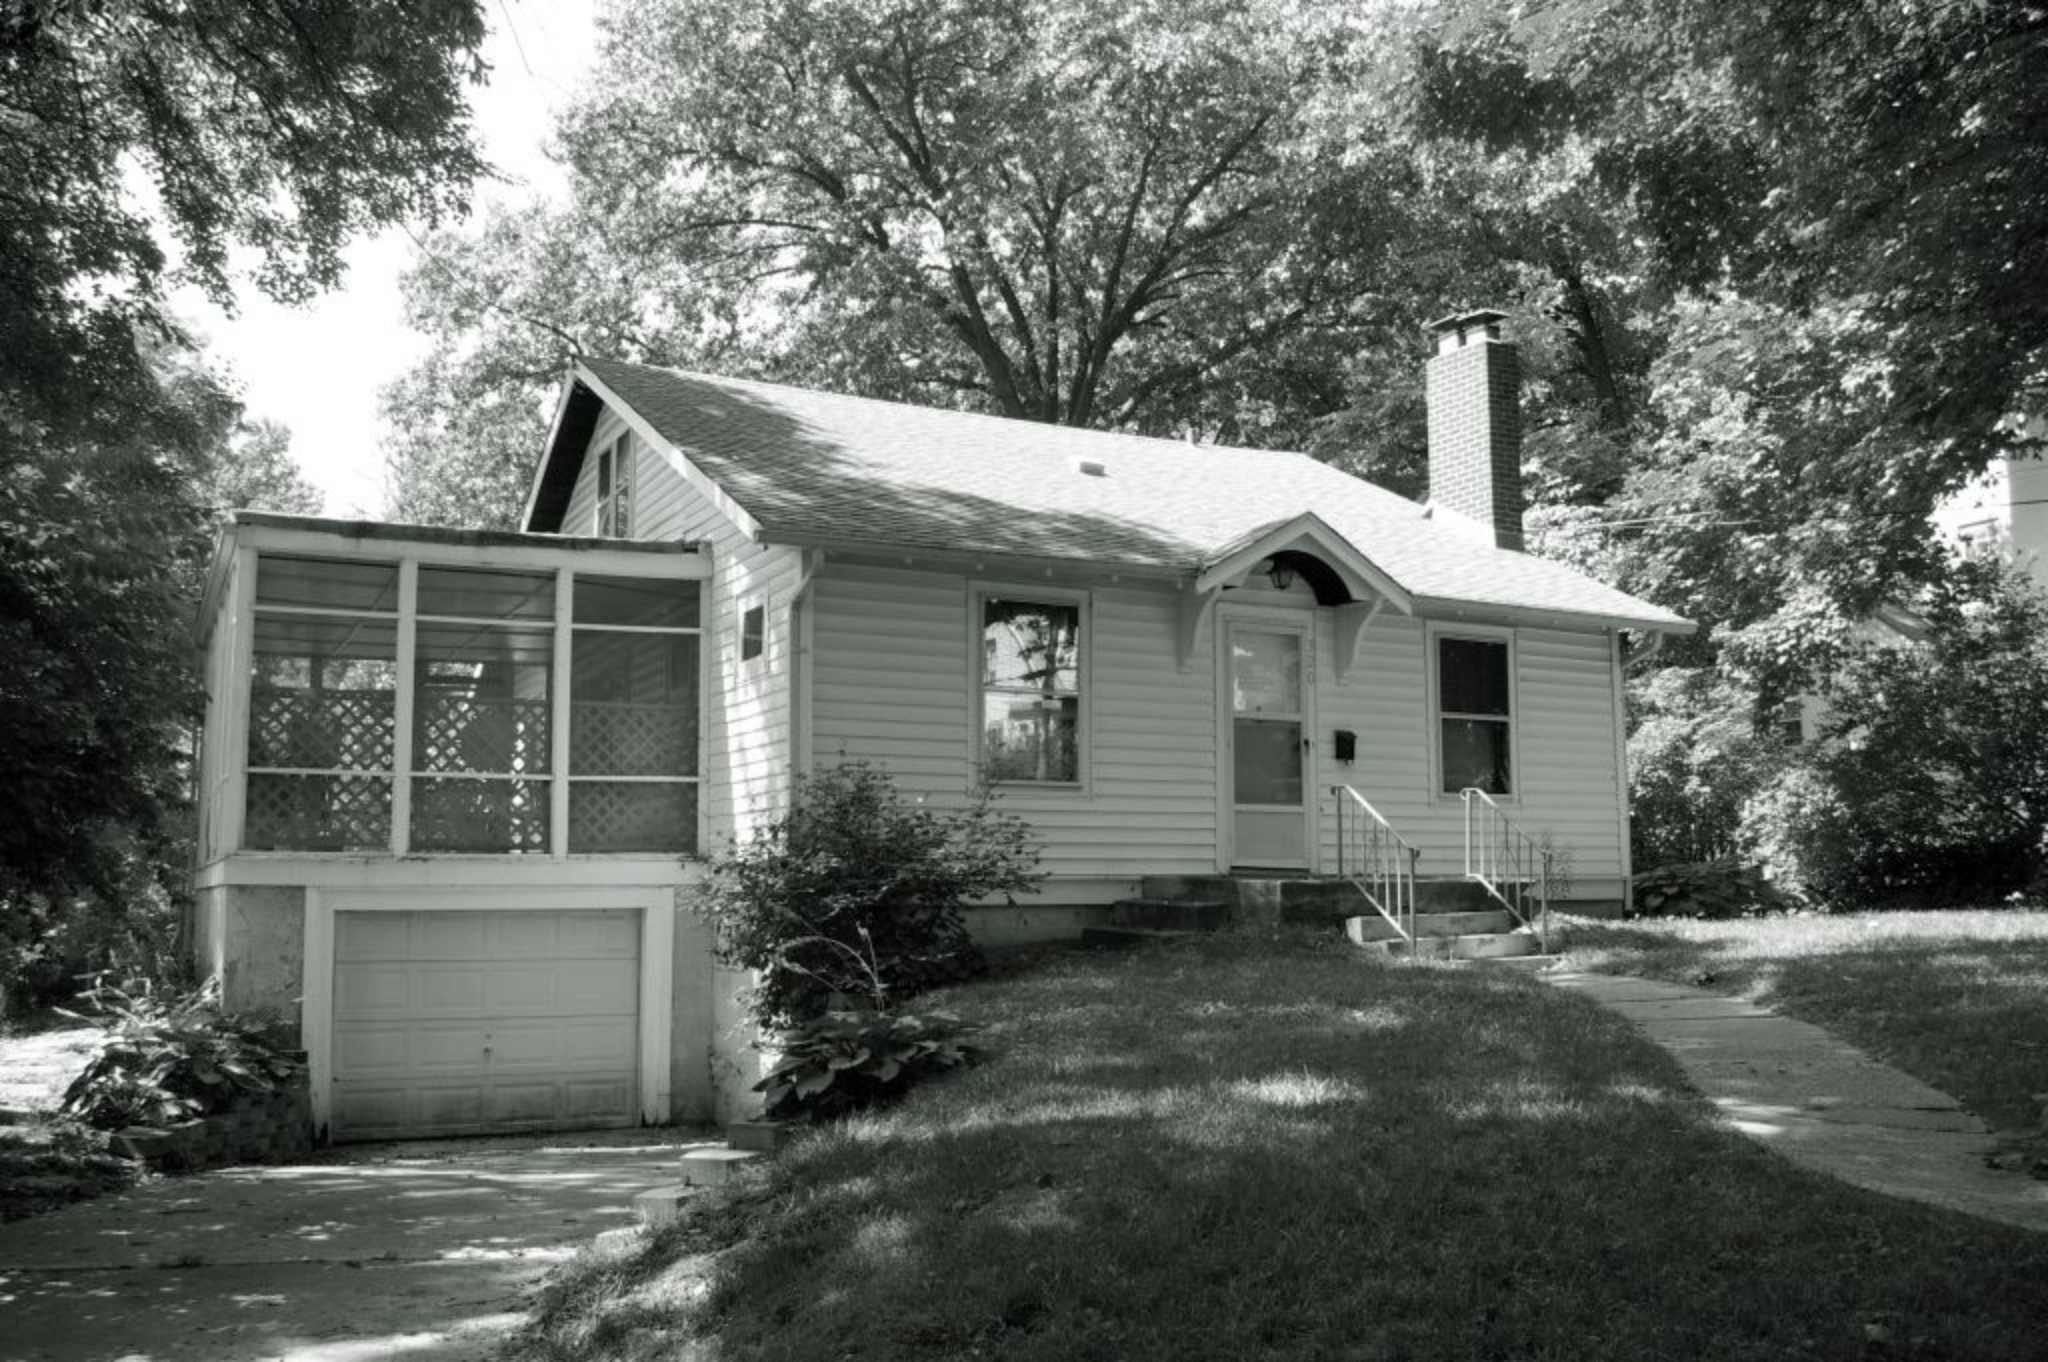
This 1.5 story, side gabled, frame house has a symmetrical facade with 3 over 1 wood sashed windows with storm screens on either side of a central, simple entry door. Over the door is a gabled roof, arched on the underside, with curved braces for support. There is a simple concrete stoop in front. On the west elevation, there are small, high wood framed windows (with wood storms) flanking the end wall brick chimney and on both sides there are paired, wood sashed windows on the second floor. From the front entry stoop, in addition to the steps leading to the meandering sidewalk to the street, there is a series of steps leading down the hillside adjacent to the facade. These are very old and appear original to the stoop, seeming to indicate that the adjacent driveway was there at the time of construction, but the basement level, one car, stucco garage with a rooftop flat roofed, screened porch, was not shown on the 1951 fire insurance map. Even so, it appears to be a contributing element to the original design of the house. The house is basically Craftsman in design, with its exposed roof rafters, 3 over 1 windows, braced gabled roof over the entry. The major alteration to the house is the vinyl siding and the metal storm windows and storm door.

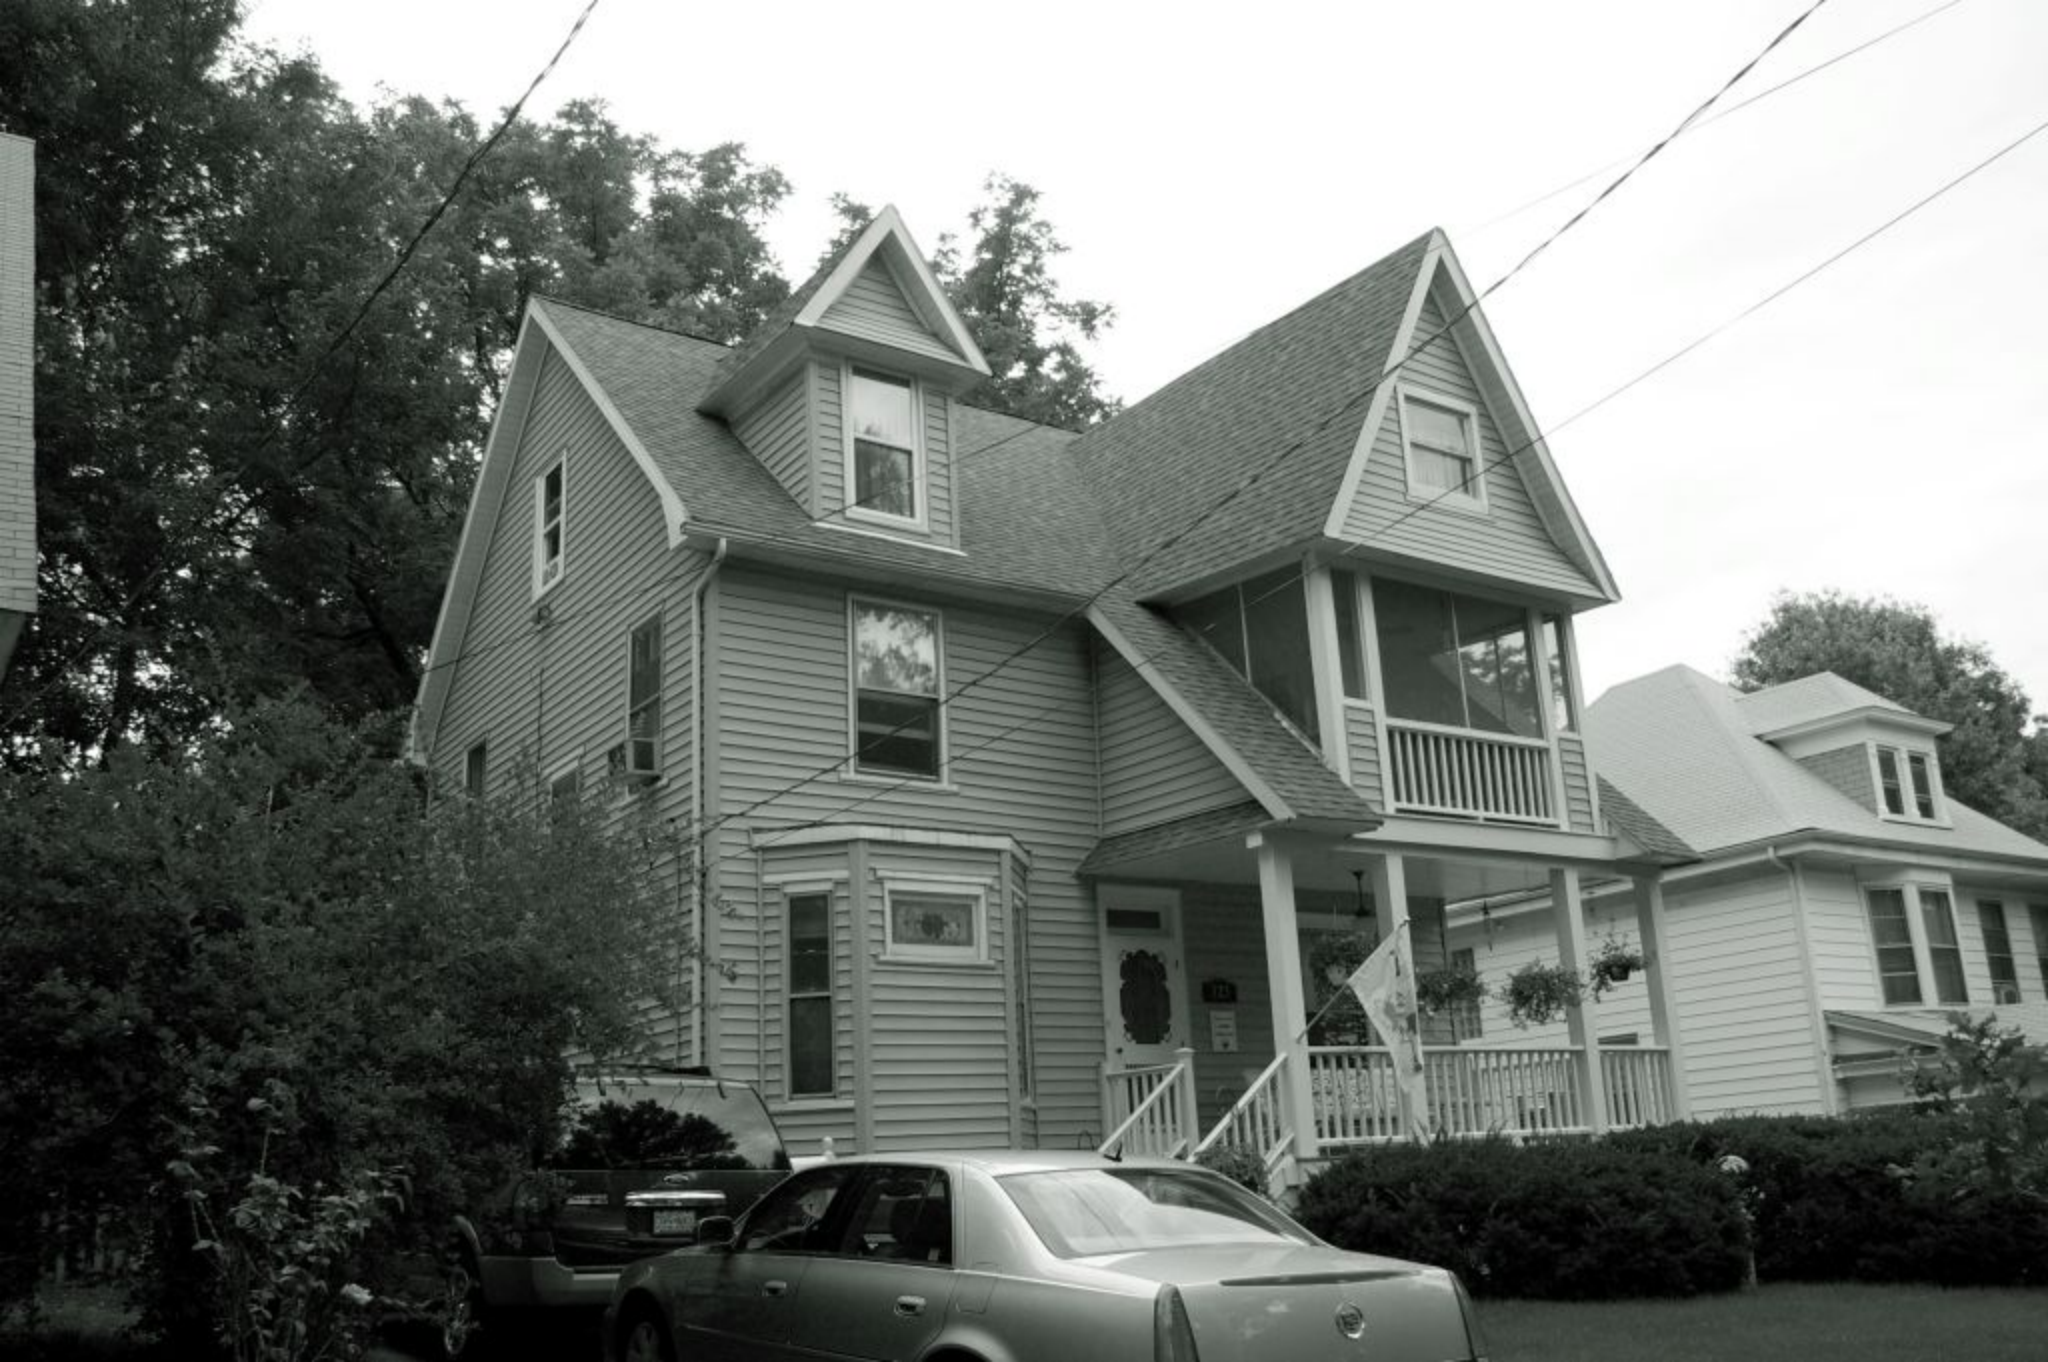
2009 Survey Update: Since the 1983 survey the wide aluminum siding has been replaced with vinyl siding and the wrought iron porch railings have been replaced with what appear to be historically proportioned vinyl railings. However, it still retains the original stained glass, and original one over one wood sashed windows (only the third floor multipaned fixed window has been replaced).

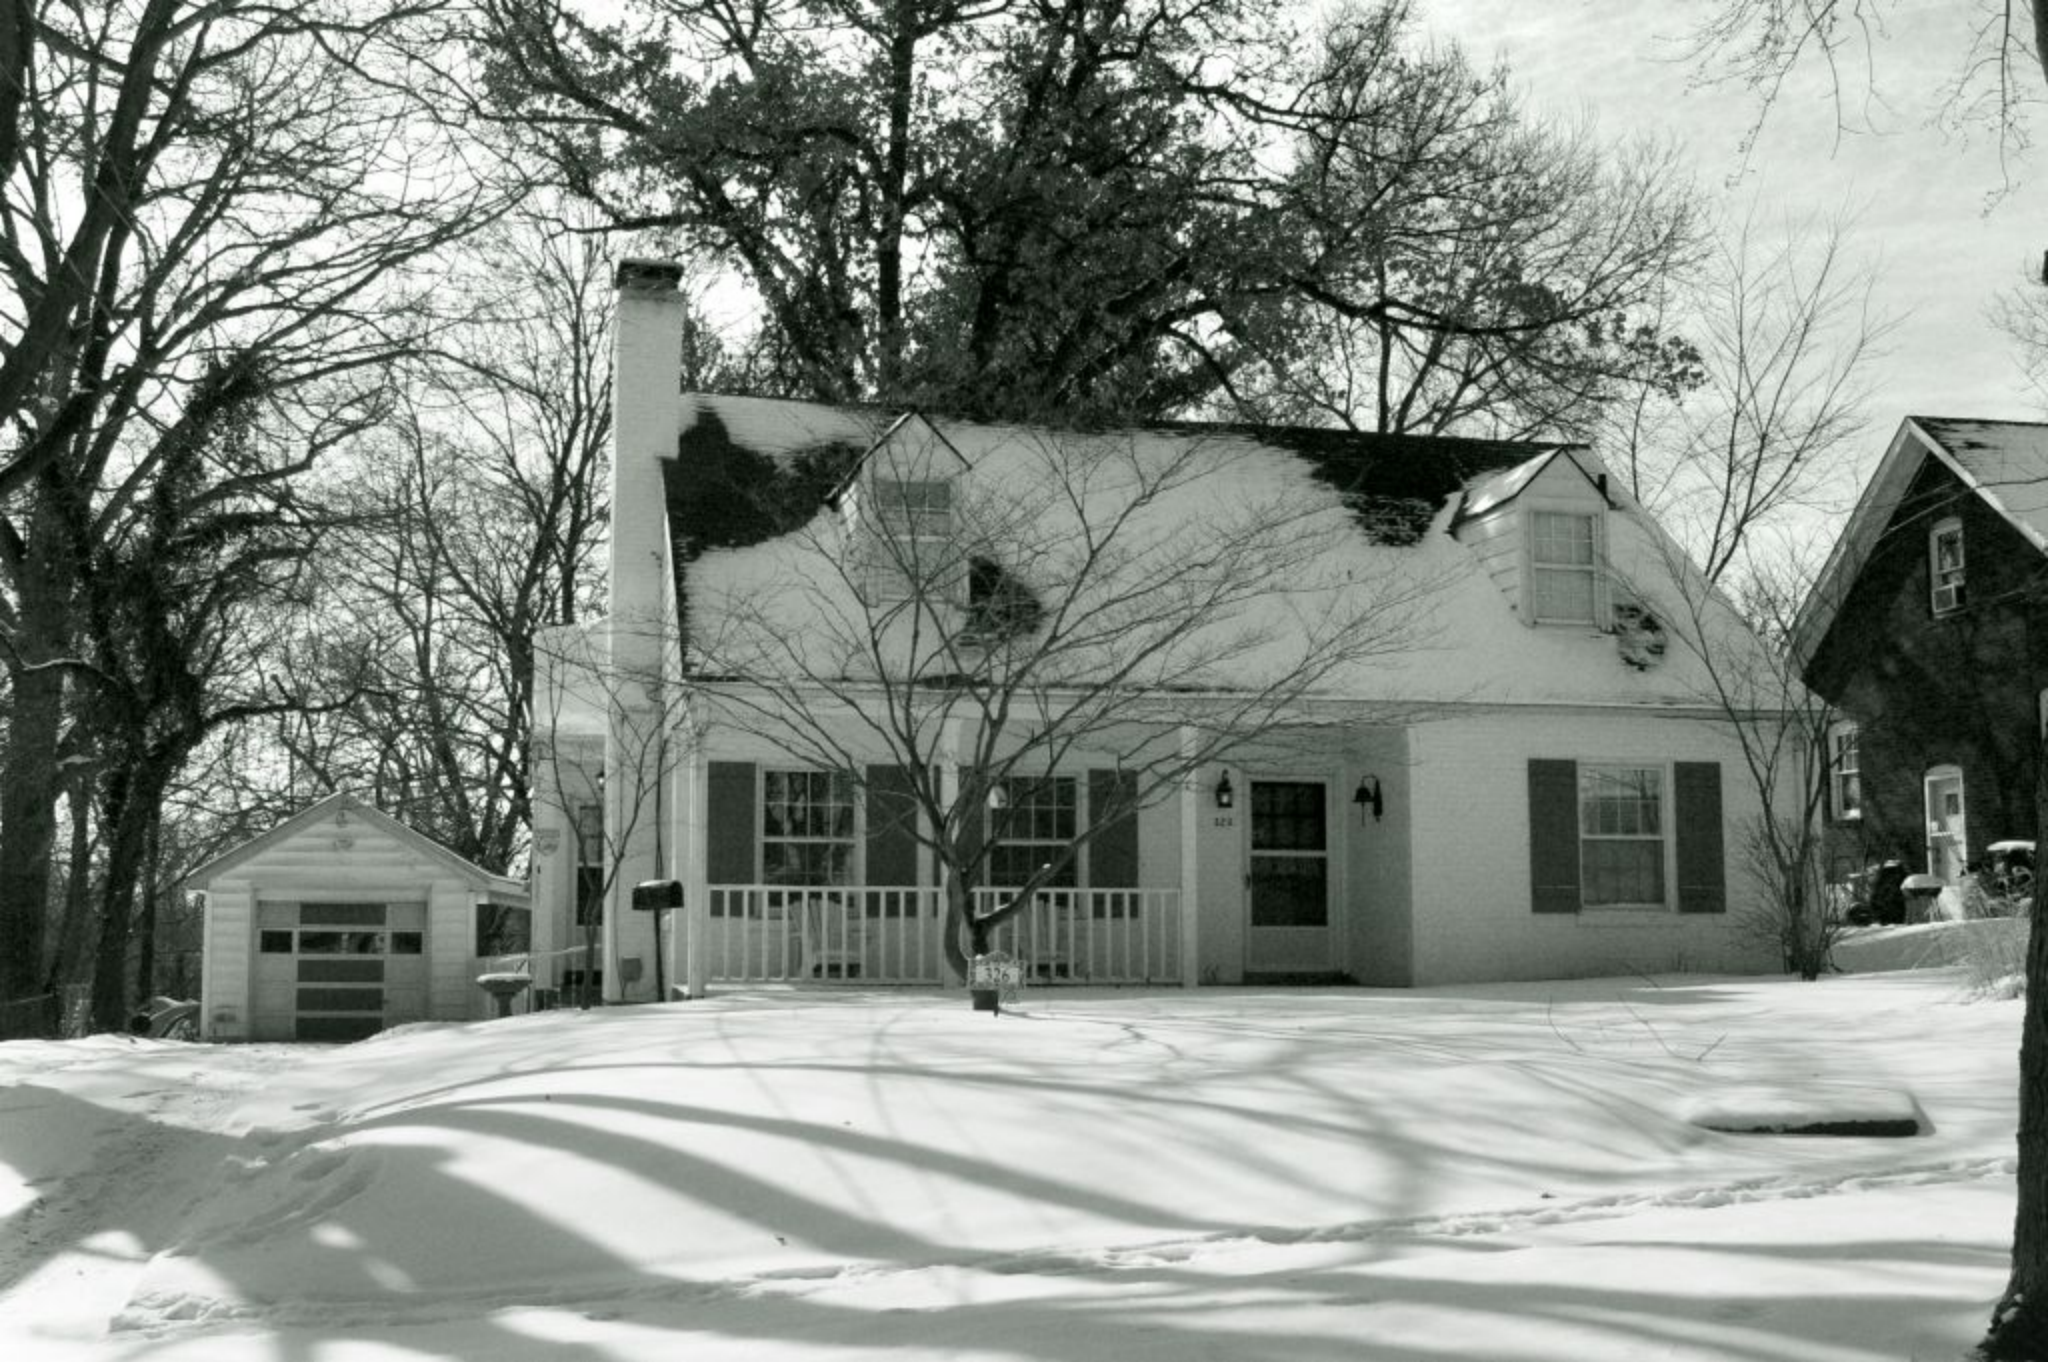
This side gabled, 1.5 story, painted brick Cape Cod house has two gabled dormers with 6 over 6 wood sashed windows on the facade. Below the gabled roof, there is a recessed porch, at grade, that spans 3 of the 4 first floor bays, with two 8 over 8 wood sashed windows with shutters and a half height, 9 light, wood door. The square posts supporting the roof have a decorative capital, and although they appear original, the railing may be a more recent replacement. On the west end of the facade there is another 8 over 8 wood sashed window with shutters. On the east elevation, there is a narrow, side gabled bay (actually a one story rear wing), recessed toward the rear, behind the brick end wall chimney. In this one story rear wing, there is a side entry door, also multipaned half light wood door, that faces the street and a short concrete stoop leading to the driveway. Besides the paint on the brick, the dormers and gable ends have been clad in aluminum siding and storm screens and doors have been installed.

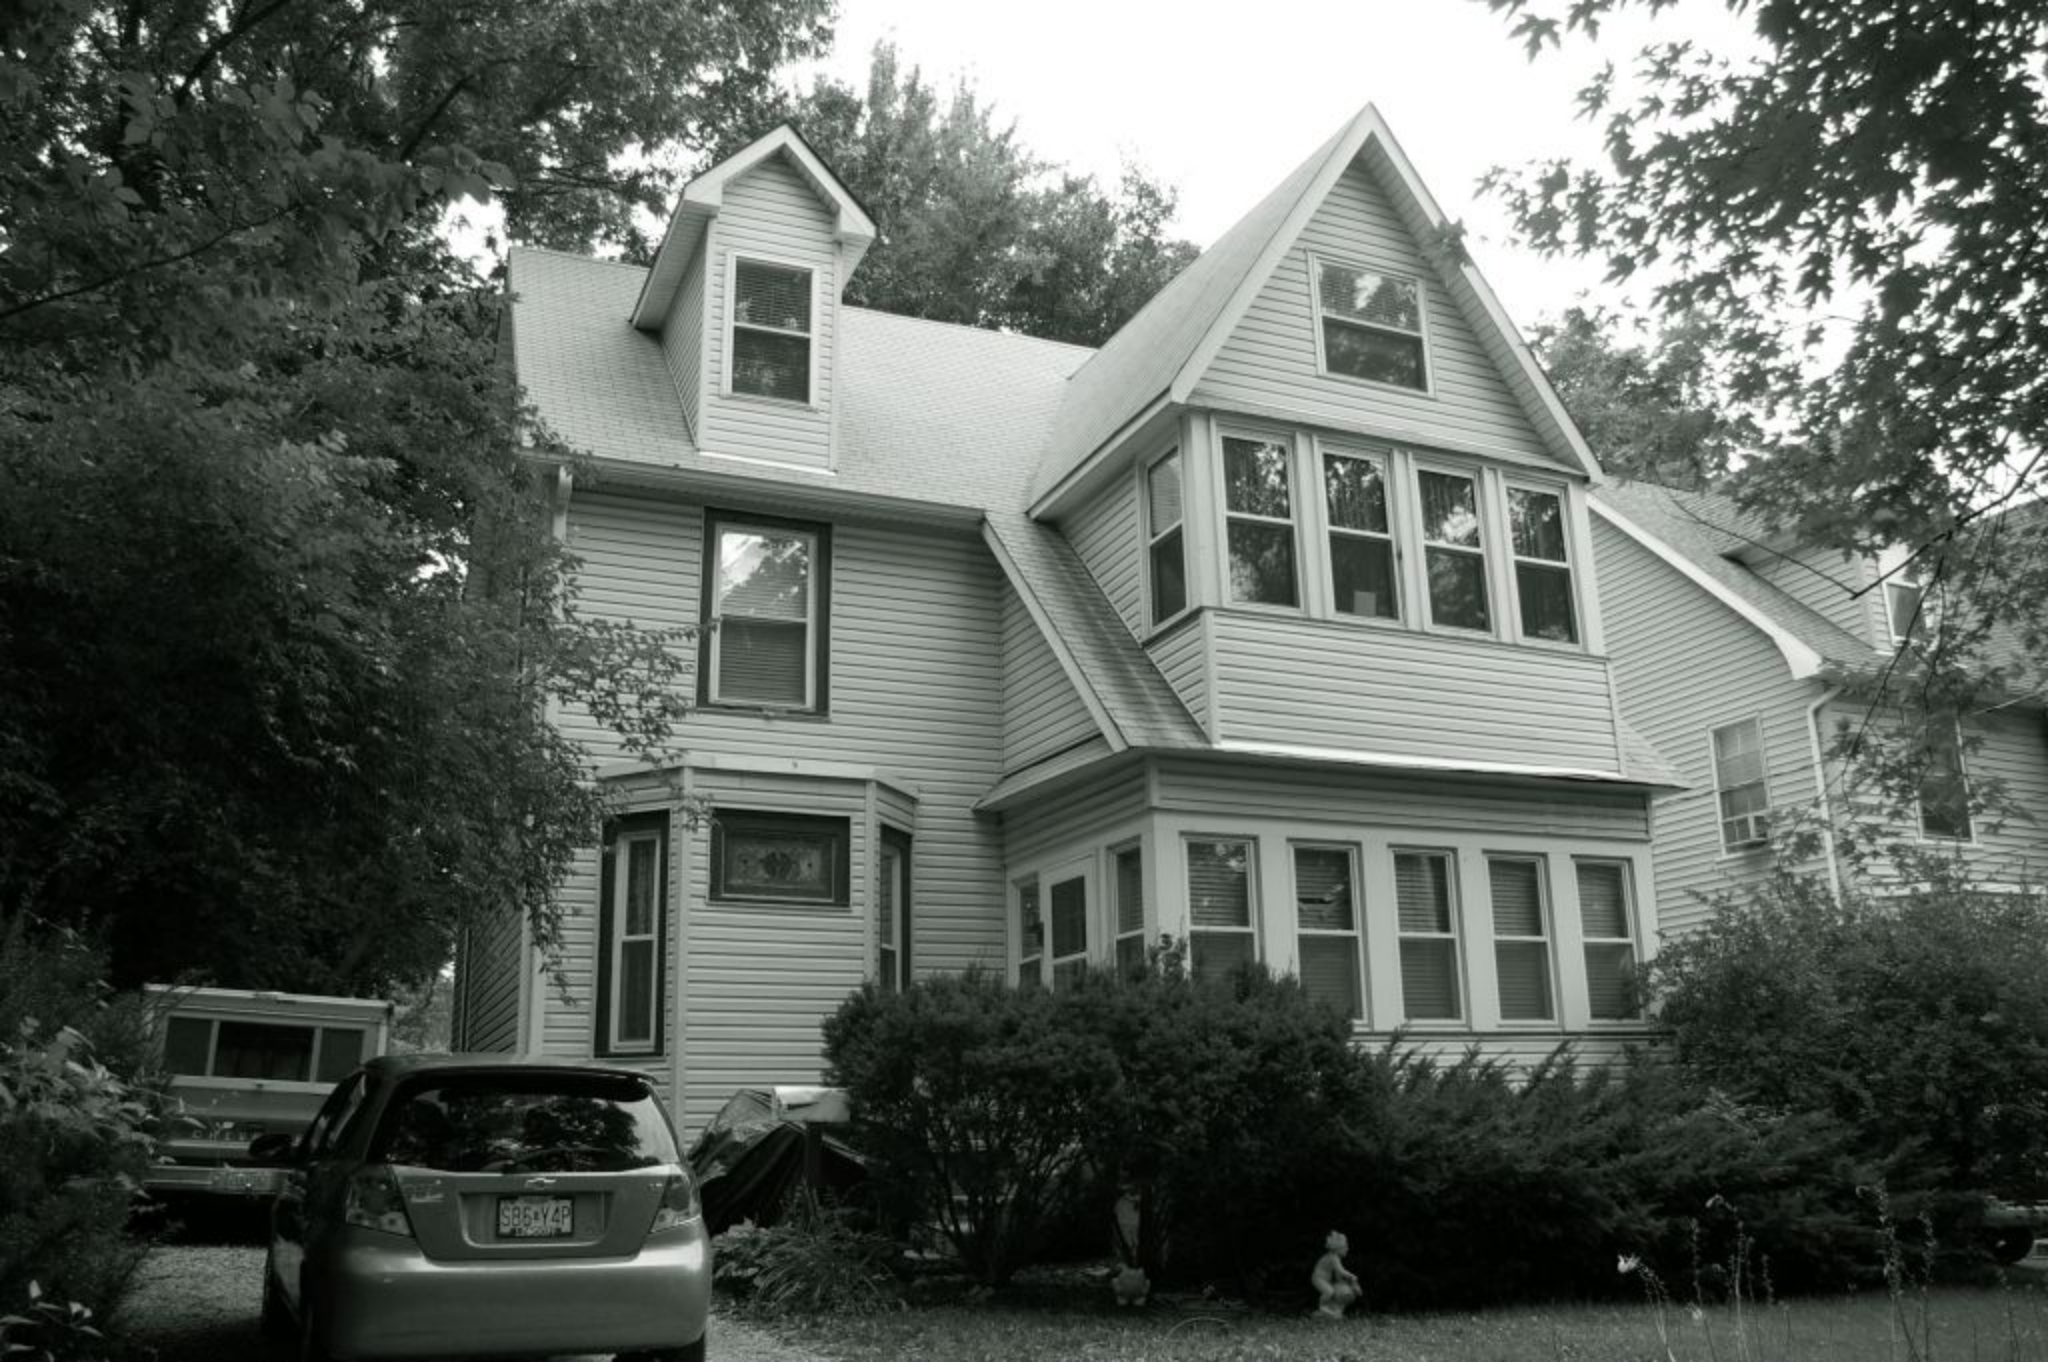
2009 Survey Update: Little has changed since the 1983 survey except for the replacement of the asbestos shingle siding (an alteration from the mid-twentieth century) with vinyl siding. The third floor window above the enclosed second floor porch has been replaced, and the house has had storms added protecting the original wood windows.

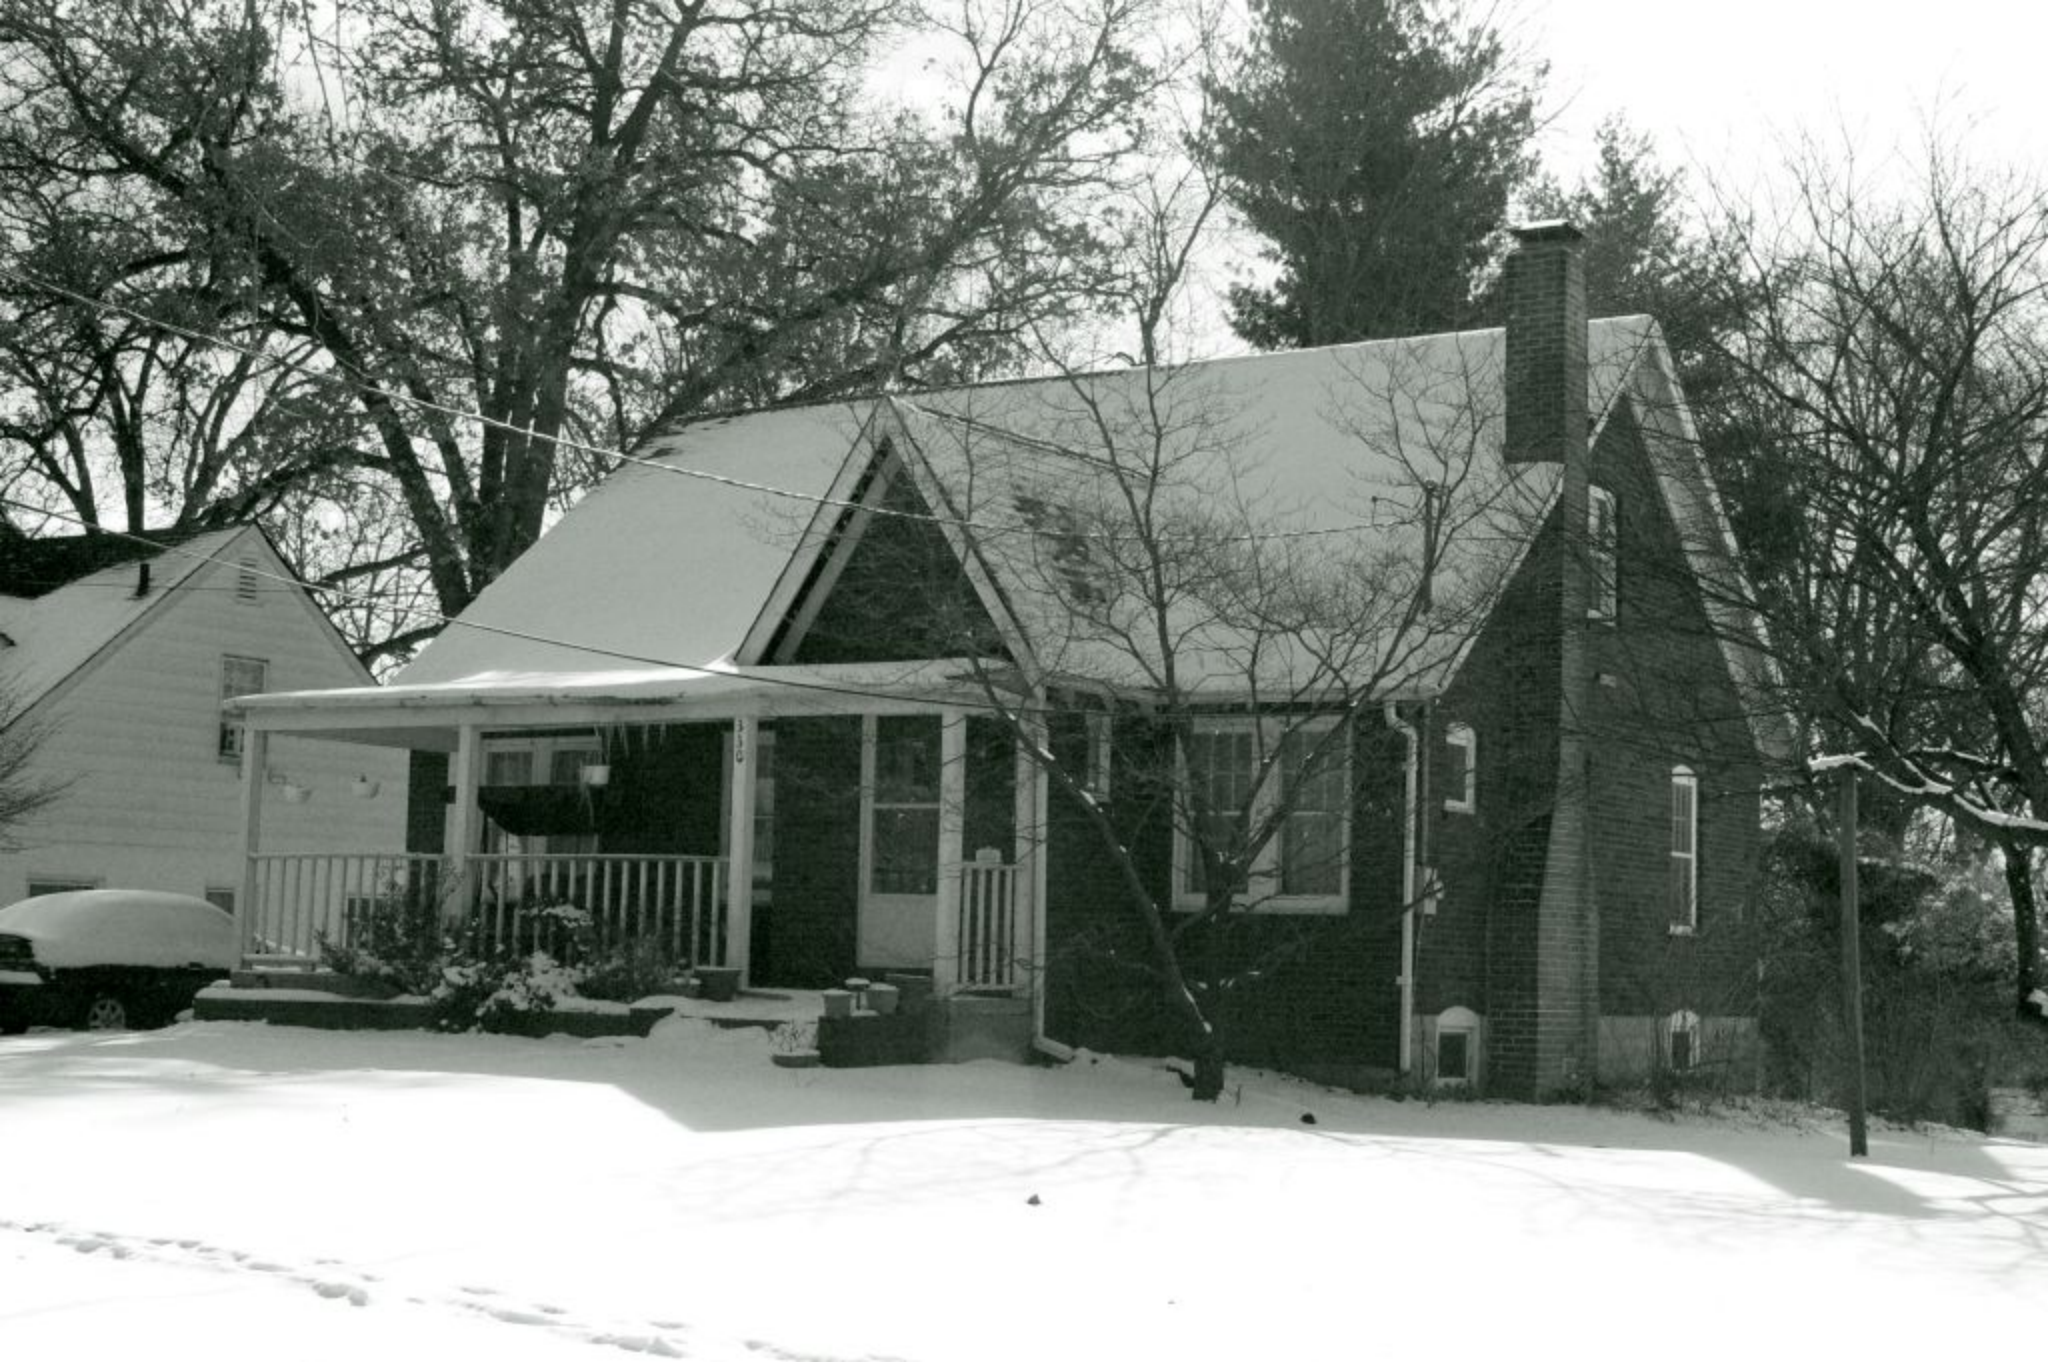
This side gabled, 1.5 story, brick house has a steeply pitched gabled one story vestibule nearly centered on the facade with a simple wood door and small fixed wood windows on each side. To the west and east end there are paired 6 over 1 wood sashed windows with another single, 6 over 1 wood sashed window just east of the vestibule. On the west elevation there is an end wall brick chimney that pierces through the roof eave and on the east side there is a side entry door. The windows and doors have storm windows. The more horizontal profile of the house is indicative of the transition to a more modern house design, one identified as Minimalist although the details on the house, such as the steeply pitched vestibule and wood plank door are strongly influenced by the Tudor Revival style and the open rafters and wider eaves are influenced by Craftsman designs. In front of the vestibule and extending to the east end of the facade is a shed roofed porch supported by simple wood posts resting on a low concrete porch floor (which appears very old), but the railings are a recent replacement. This porch appears to be a later addition, since it does not appear on the 1950 fire insurance map but its attachment to the main roof does cut into that roof, and is easily reversible if it is not original.
