ARCHITECTURAL/HISTORIC INVENTORY FORM

1. Survey No. SL-AS-036-001		2. Survey Name: Architectural Survey of Old Ferguson West	
3. County: St. Louis		4. Address: 1 Carson Rd.	
5. City: Ferguson	Vicinity: <input type="checkbox"/>	6. UTM:	7. Township/Range/Section
8. Historic name (if known):		9. Present/other name (if known): Whistle Stop	
10. Ownership: <input type="checkbox"/> Private <input checked="" type="checkbox"/> Public		11. Historic use (if known): TRANSPORTATION/rail-related	11. Current use: COMMERCE/restaurant & RECREATION/museum

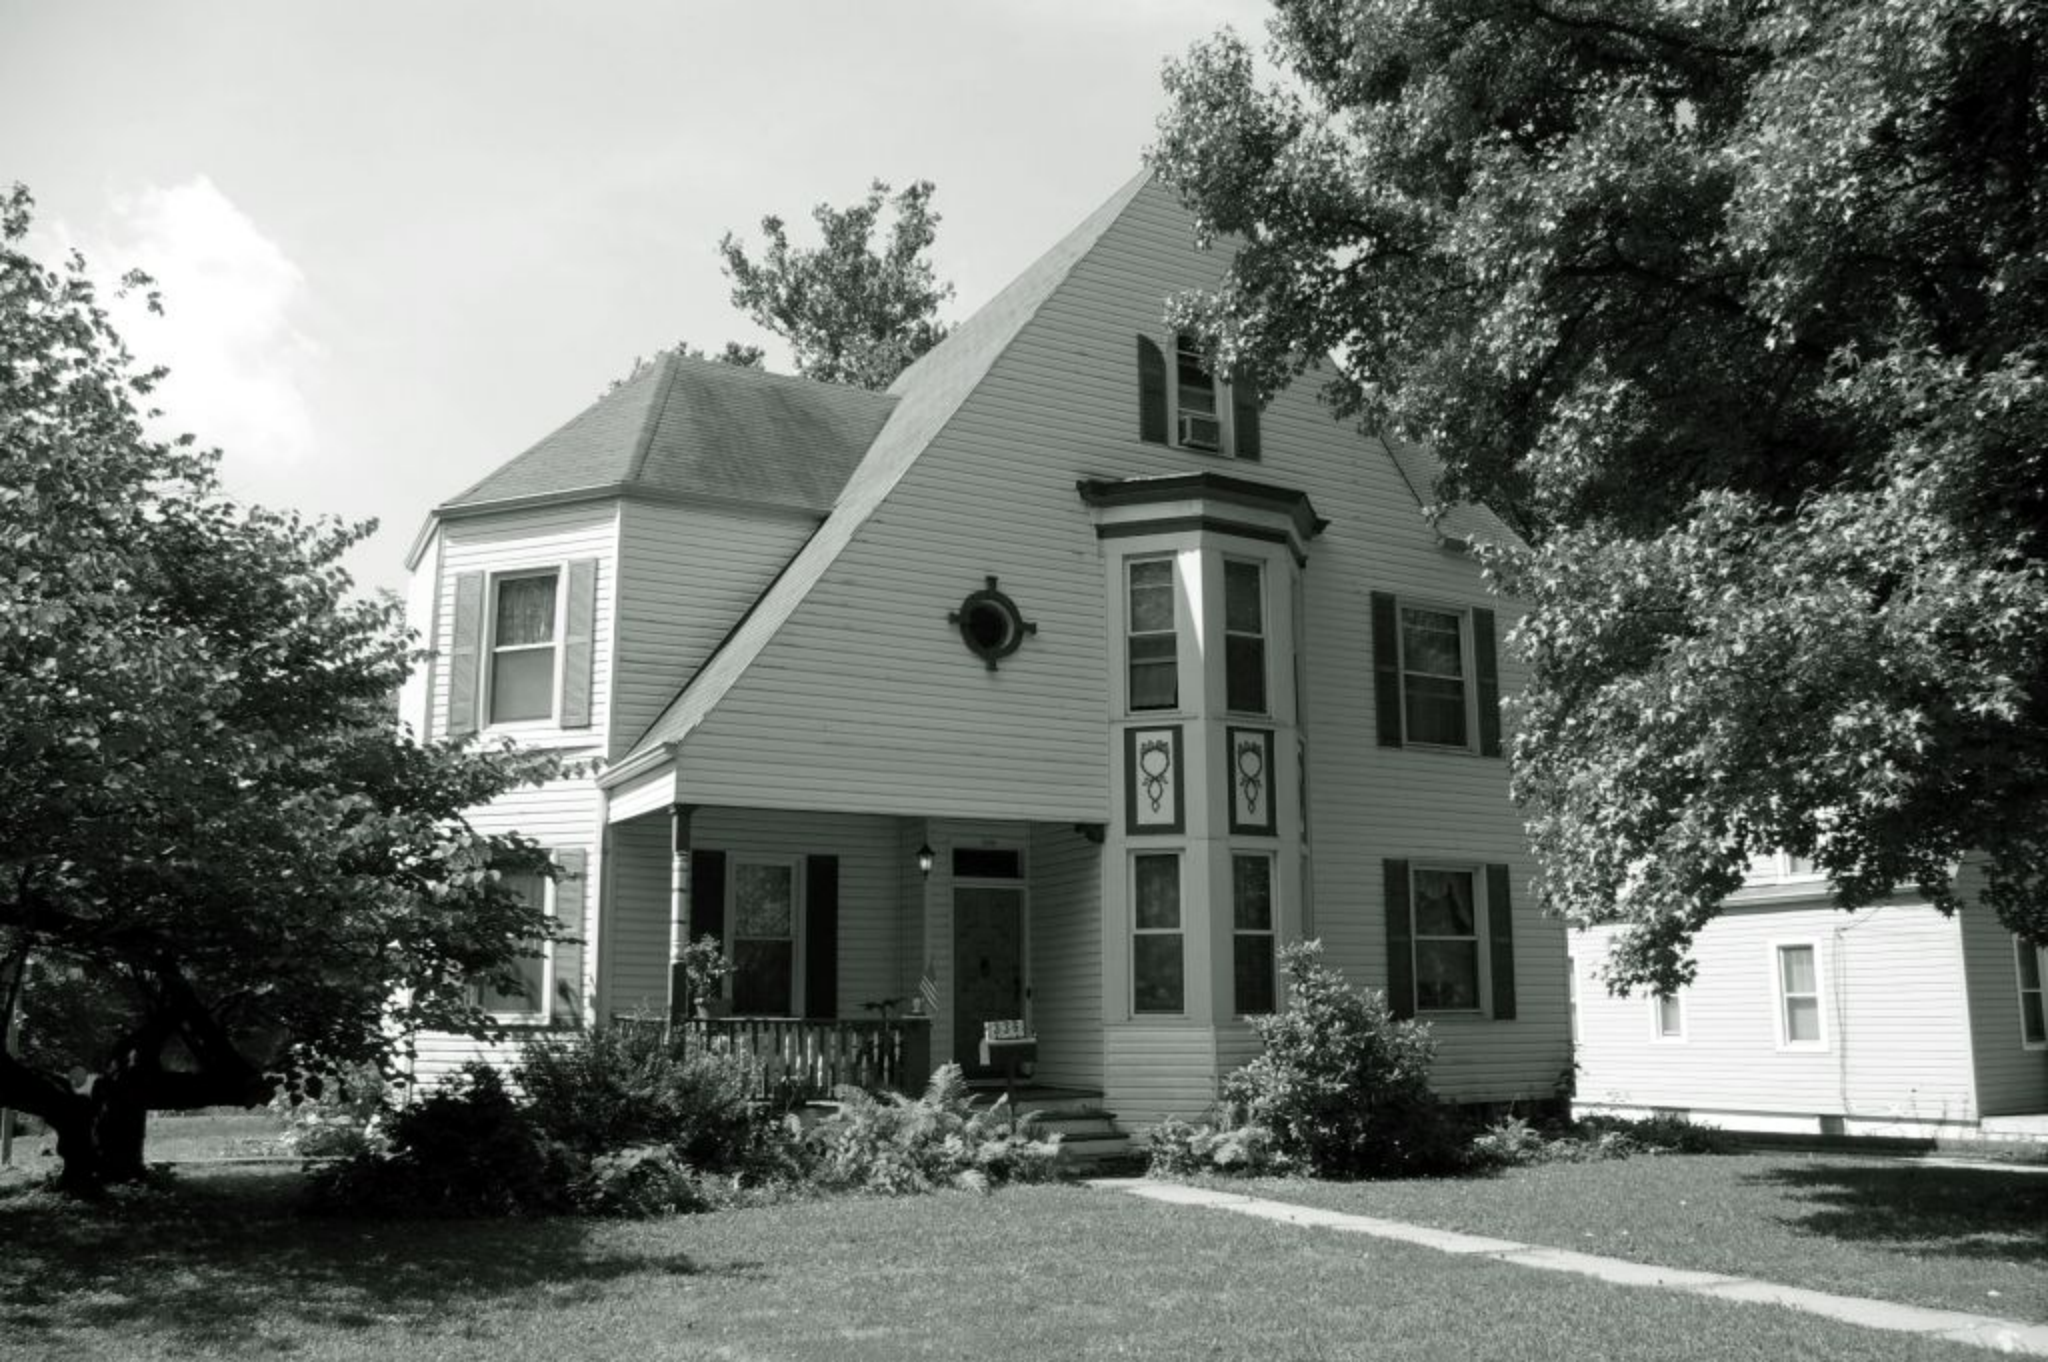
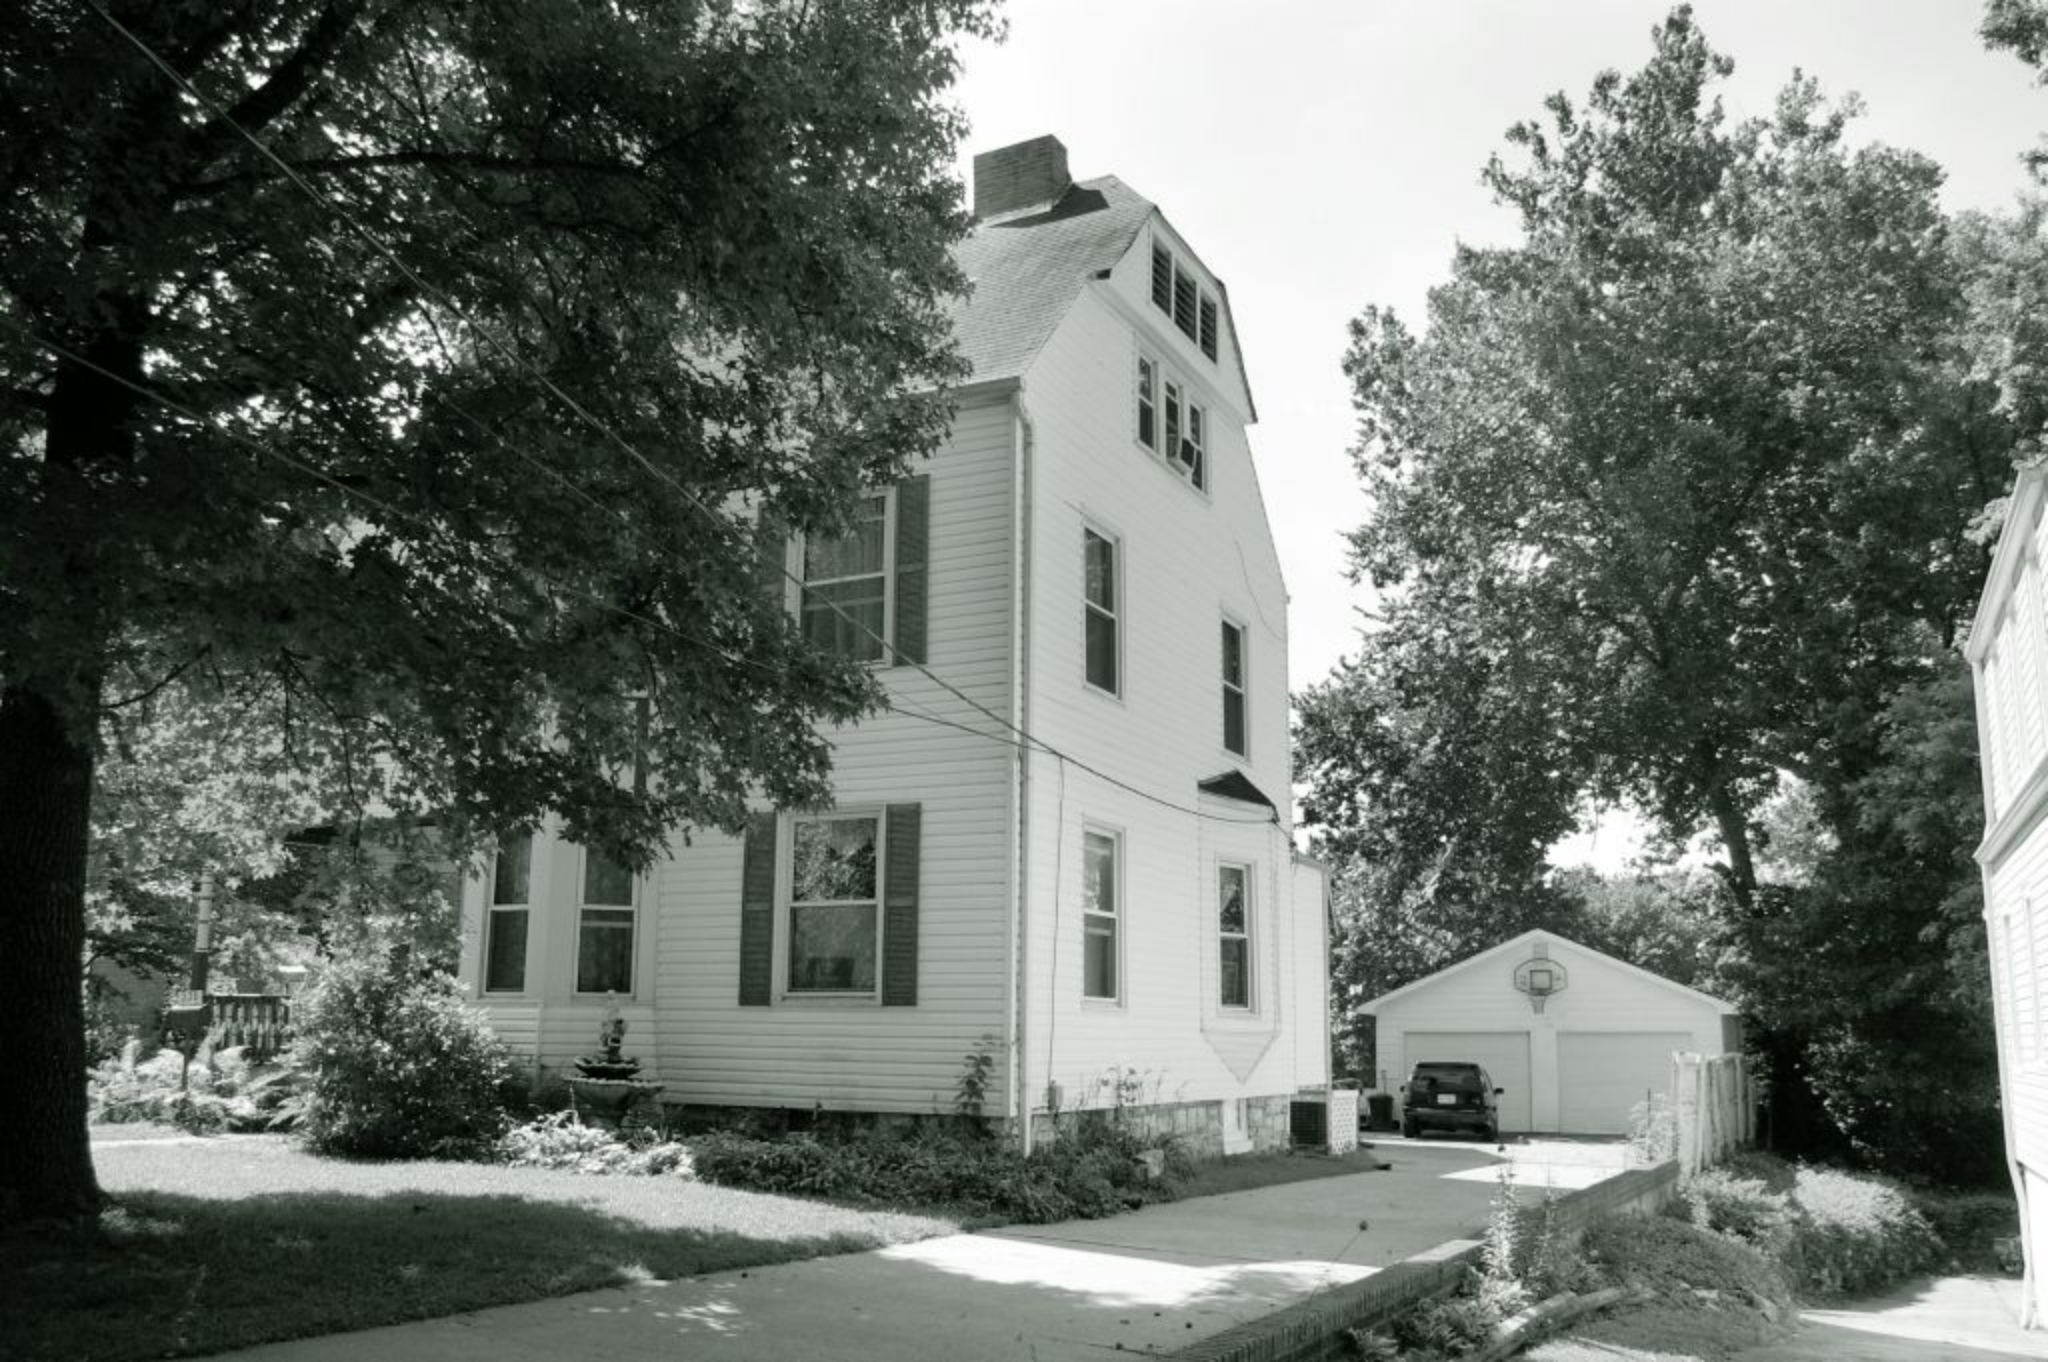
2009 Survey Update: At the southwest corner of the property is a two car, two bay, end gabled garage with replacement metal paneled overhead doors. The siding appears to be a wider wood lap siding. The garage was built much later than the house, but cannot be accurately dated since this portion of Ferguson is not included in the fire insurance maps but it appears from its detailing (two bays instead of two cars) and materials (wood lap siding) to pre-date 1955.

2009 Survey Update: Since the 1983 survey, the asbestos shingle siding has been replaced with vinyl siding, which unfortunately still covers most of the window trim. The front porch corner post may be original, but the railing is a sympathetic recreation of a more appropriate porch railing since it was a simple 2x4 railing in the 1983 survey photo. Shutters have been added to the facade as well. Otherwise, the house is unaltered from its 1983 appearance, but what is unclear is what the original wall covering was (given the house shape, it may have been shingles) and if other decorative details are missing, but it does retain its original wood sashed windows and other decorative details such as the canted bay and embossed garland panels and the porthole window and as such is still minimally contributing to the historic district.

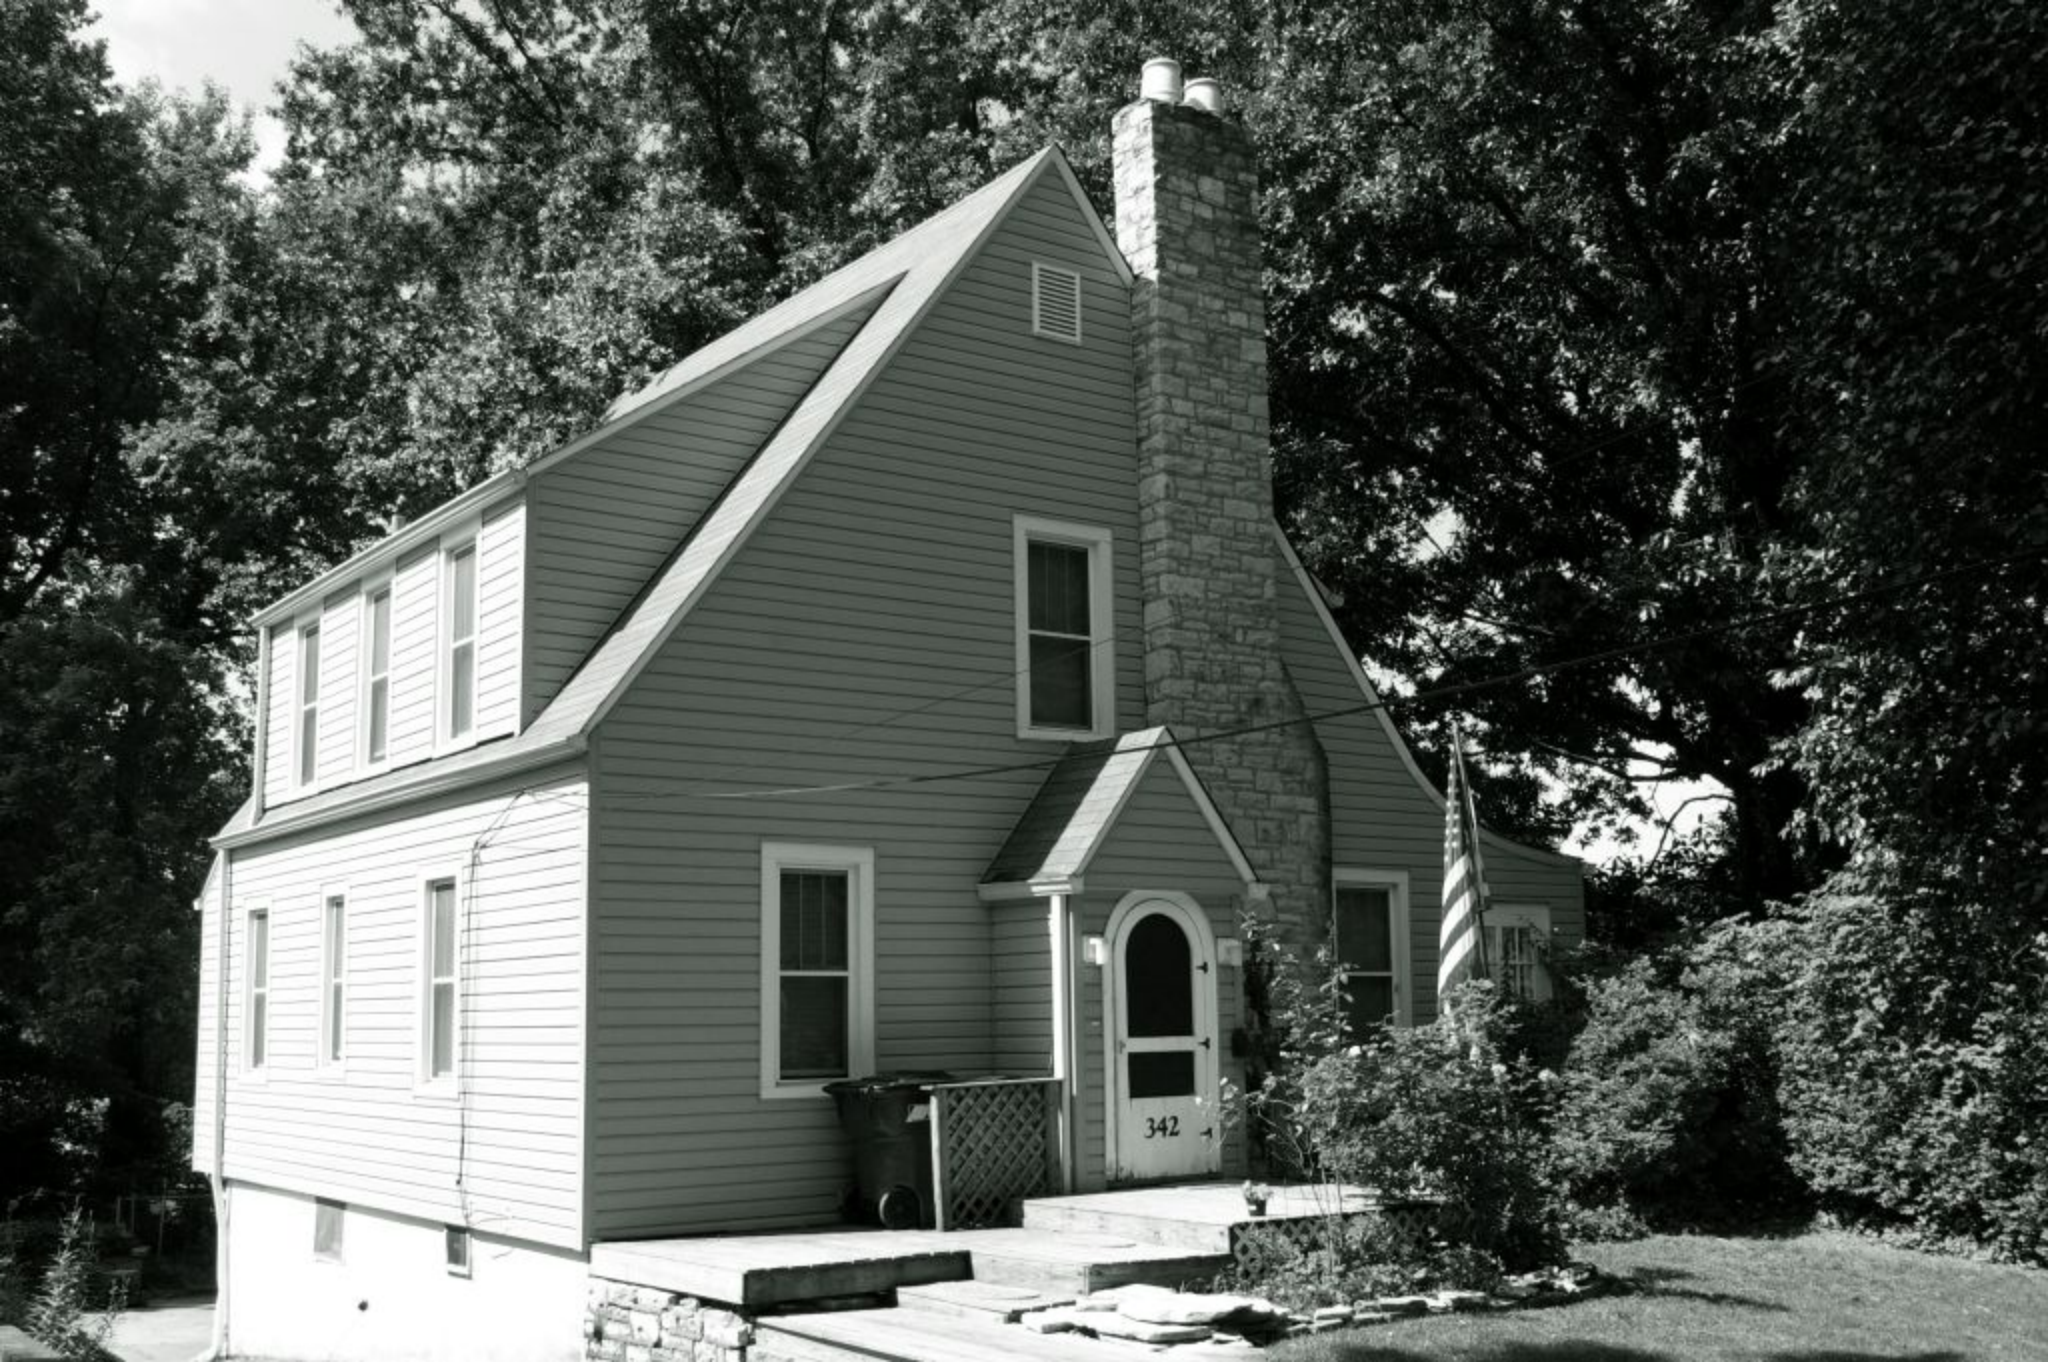
2009 Survey Update: Since the 1983 survey, the aluminum siding has been replaced with vinyl siding, but since this appears to be a frame Tudor Revival design, this does not drastically affect its historic appearance, but the loss of the half-timbering in the gable end of the entry vestibule is unfortunate. The front entry pad has been replaced or covered by a wood deck platform, but this is not visually intrusive since it is basically at grade. The building, despite not having been substantially altered since 1983 in no way resembles the sketch map with that survey, being basically a rectangular plan.

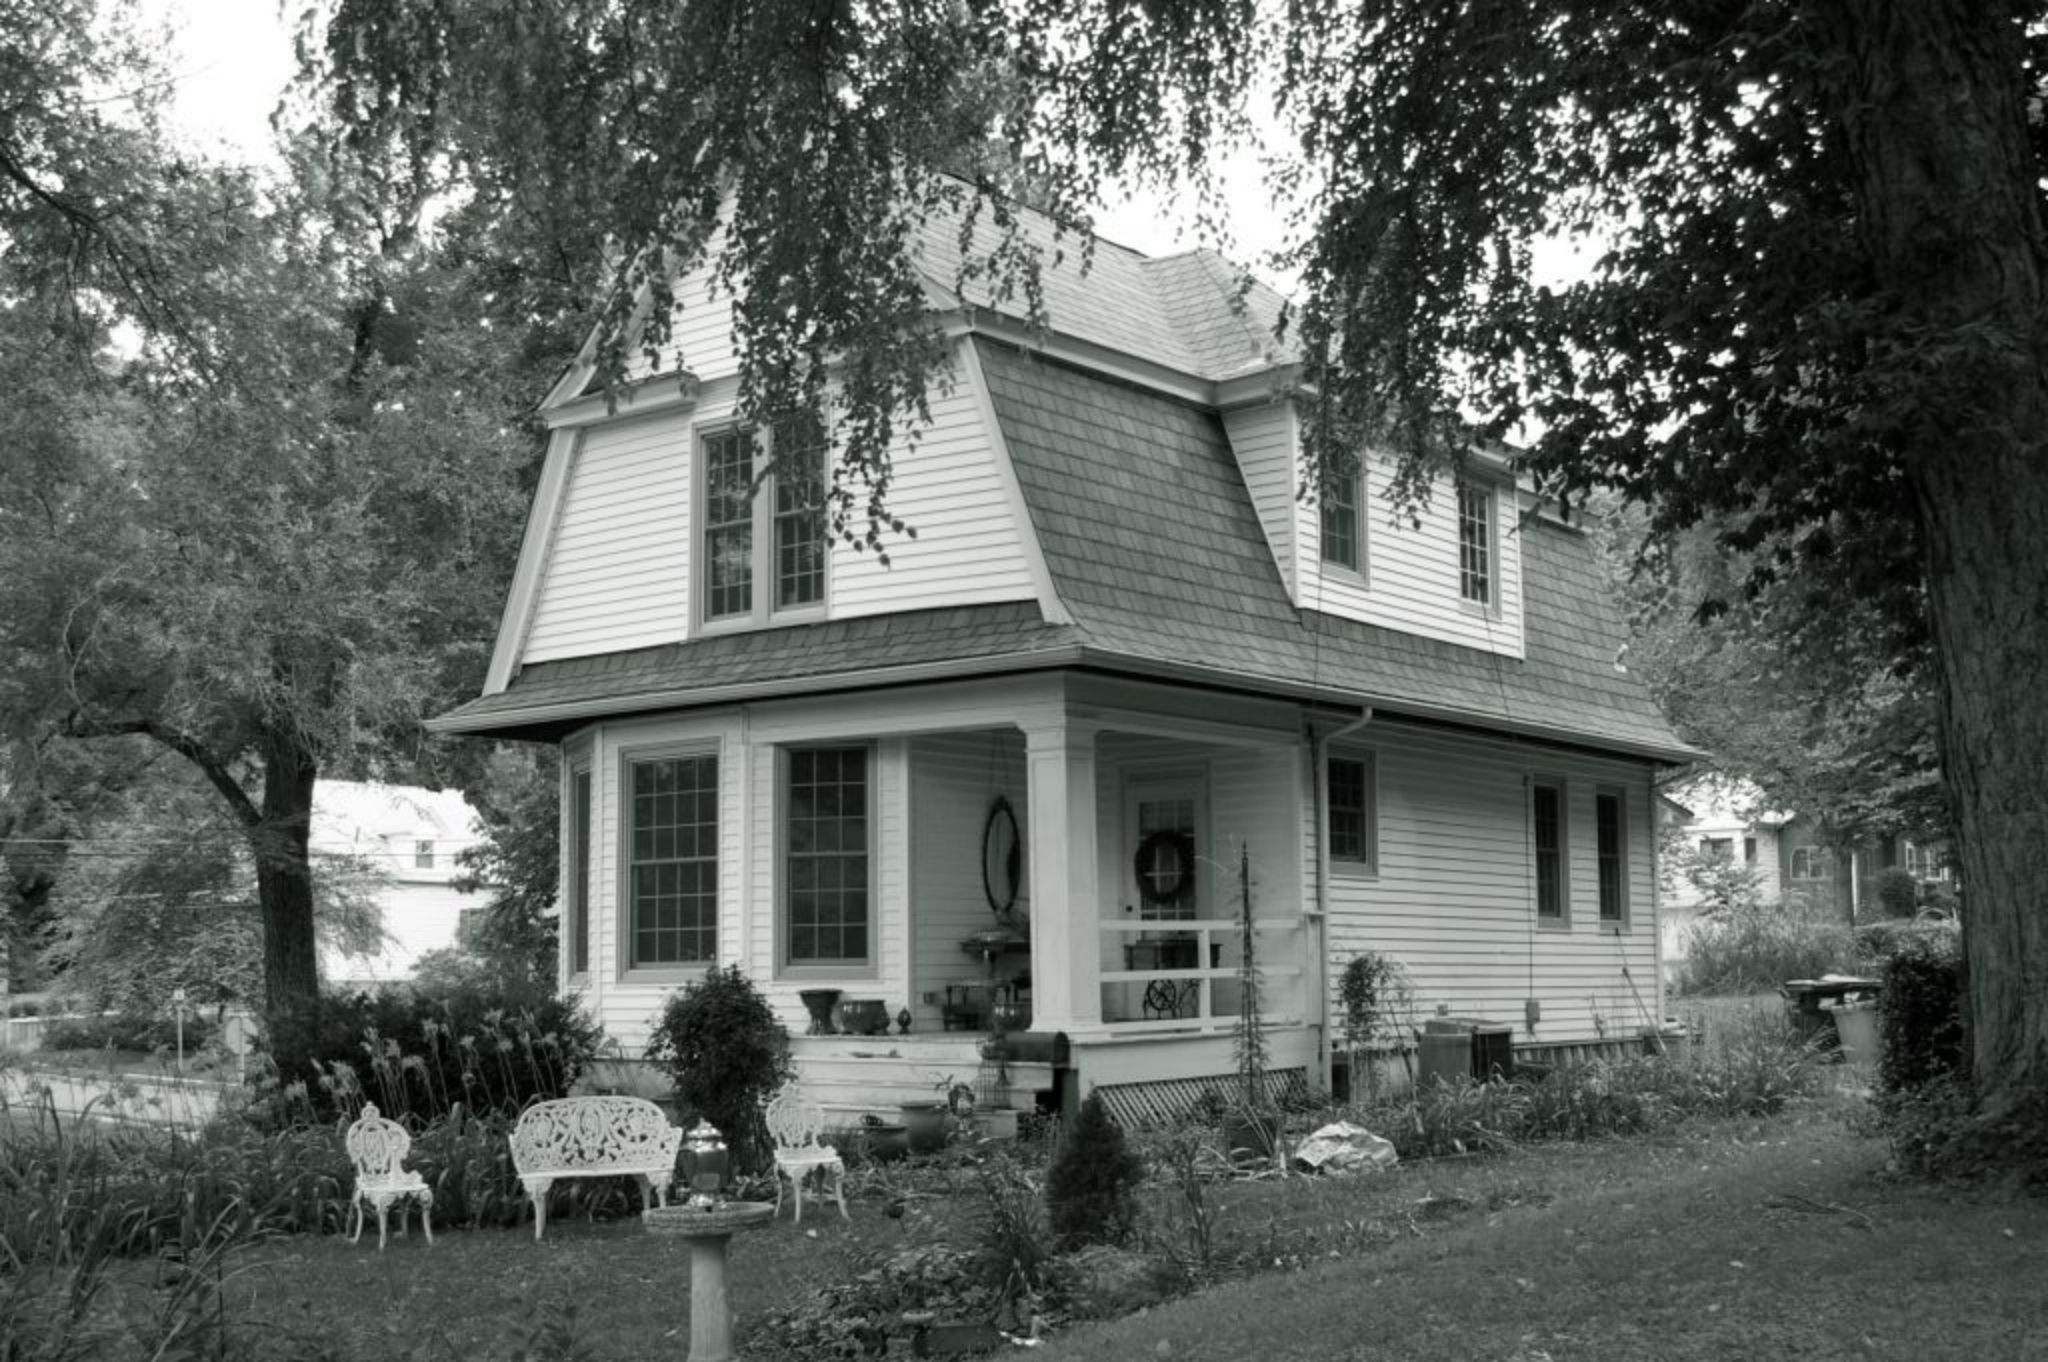
2009 Survey Update: Since the 1983 survey, the asbestos siding has been replaced with vinyl siding and the house has new aluminum or vinyl multipaned windows, which replaced the 1 over 1 windows, unfortunate, but at least on this style, consistent with the stylistic details found on many Dutch Colonial Revival houses. It retains the original corner, squared column with its capitol and decorative panels. The building, despite not having been substantially altered since 1983 in no way resembles the sketch map with that survey, being basically a rectangular plan but has a bay with a hipped dormer on top nearly centered on the west side of the house, making a stubby T-shaped plan.

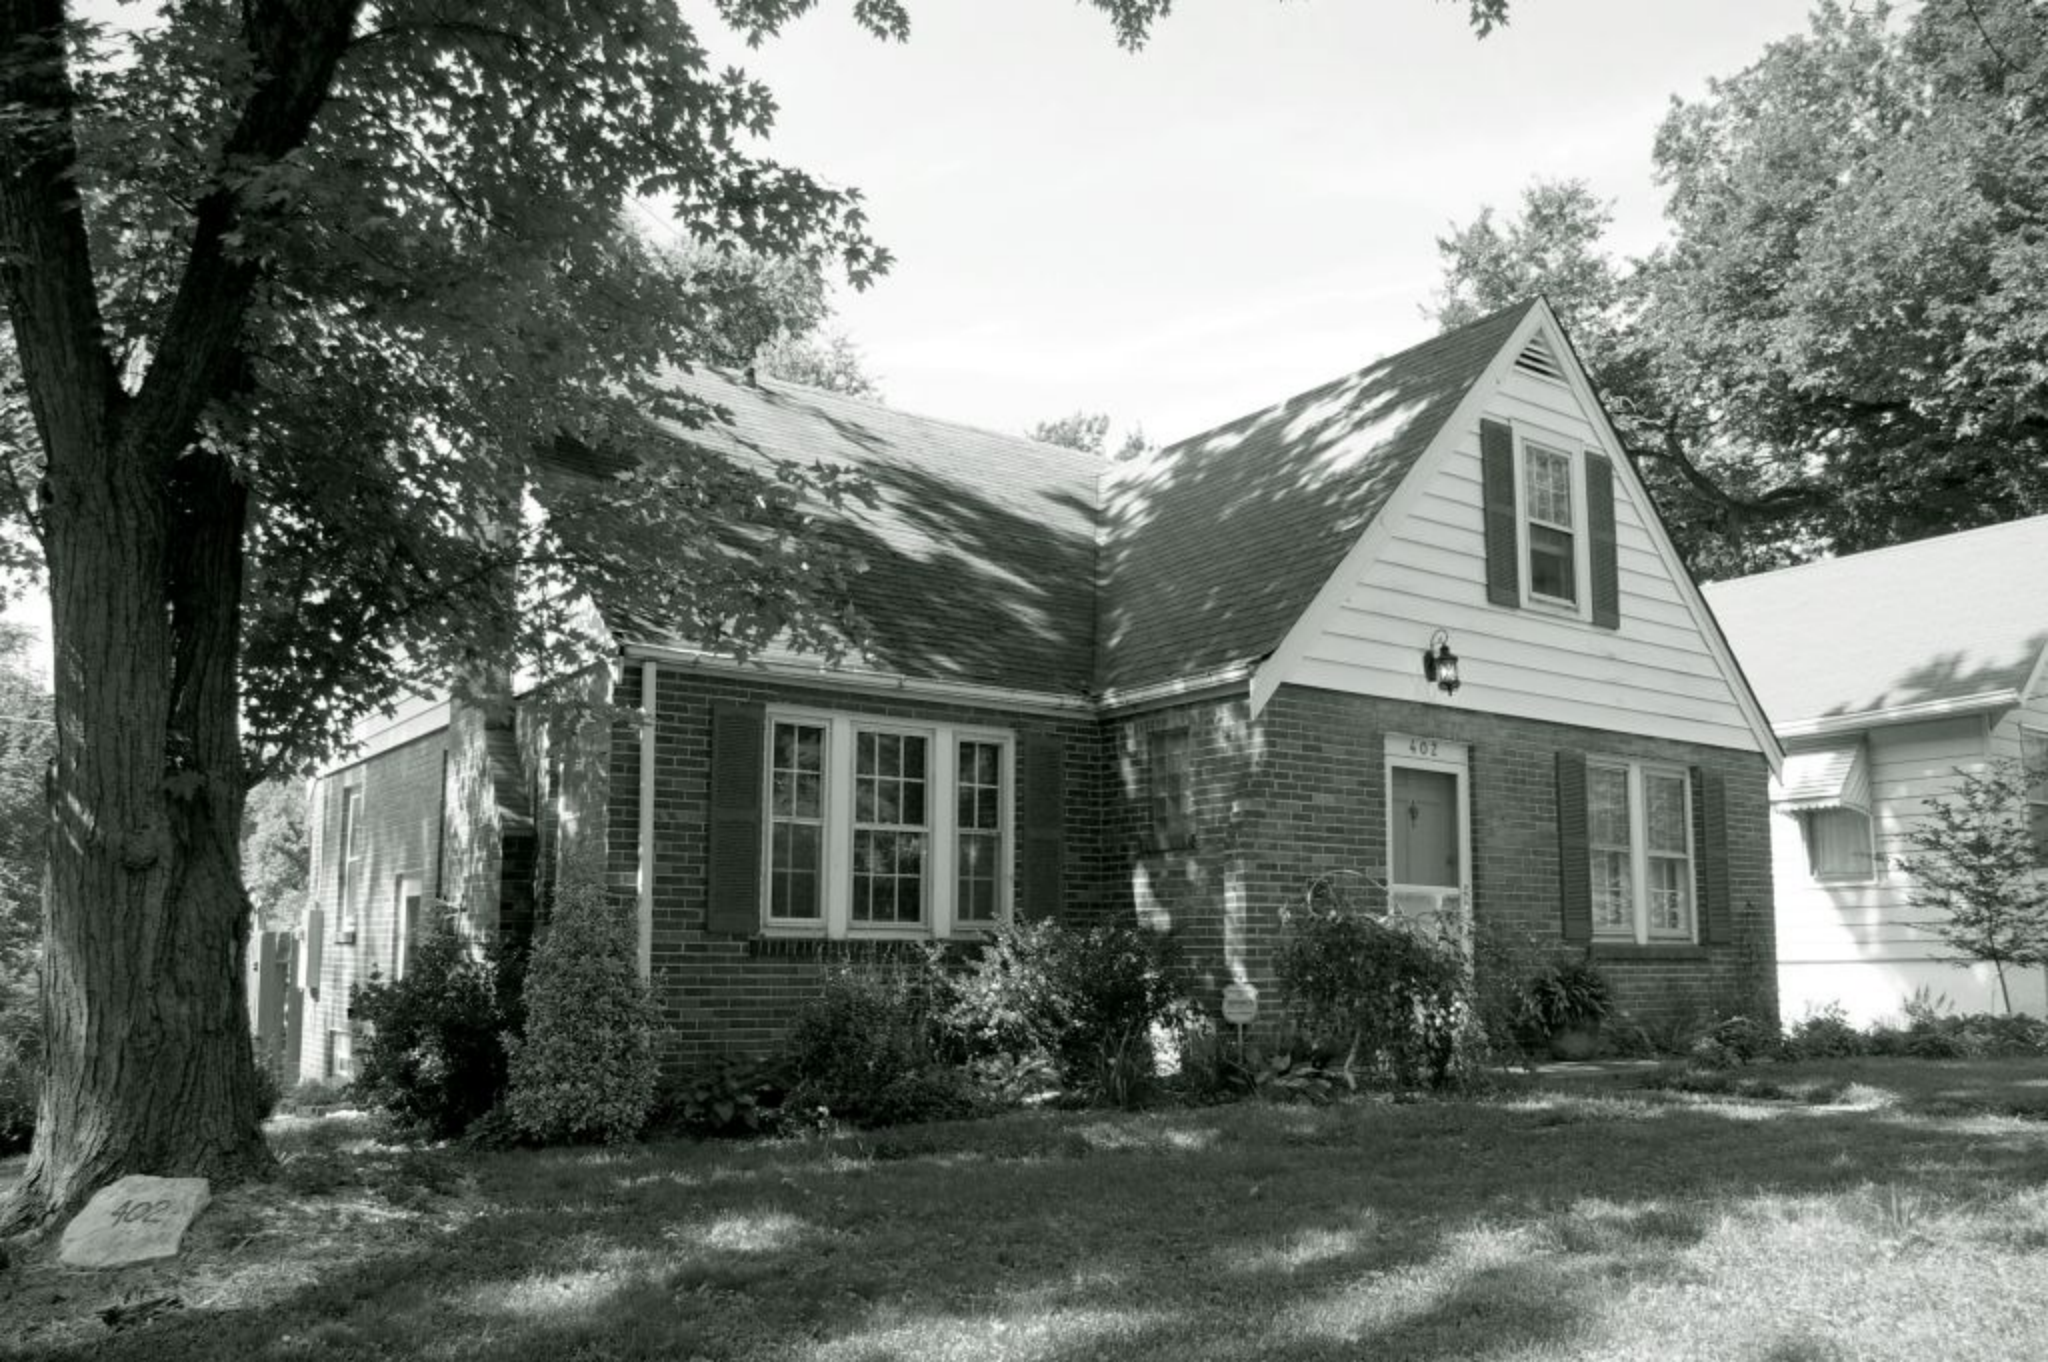
This Minimal Traditional design is 1.5 stories high with an L-shaped layout formed by the side gabled roof with the cross gabled bay that spans half of the facade. The gabled bay has the simple, wood paneled entry door with a simple concrete pad and the pendant light overhead, all positioned in the east half of that bay with paired, shuttered, 6 over 6 wood sashed windows in the other half. On the second floor, in the gable end, is another shuttered, 6 over 6 wood sashed window. On the interior wall of this bay there is a small glass block window. In the other bay of the facade there is a triple window unit, with 4 over 4 wood sashed windows flanking another 6 over 6 window, again with shutters. On the east elevation there is a brick, end wall chimney. The gable ends have been clad with aluminum and the house has aluminum storm windows and a storm door, but appears unaltered otherwise.

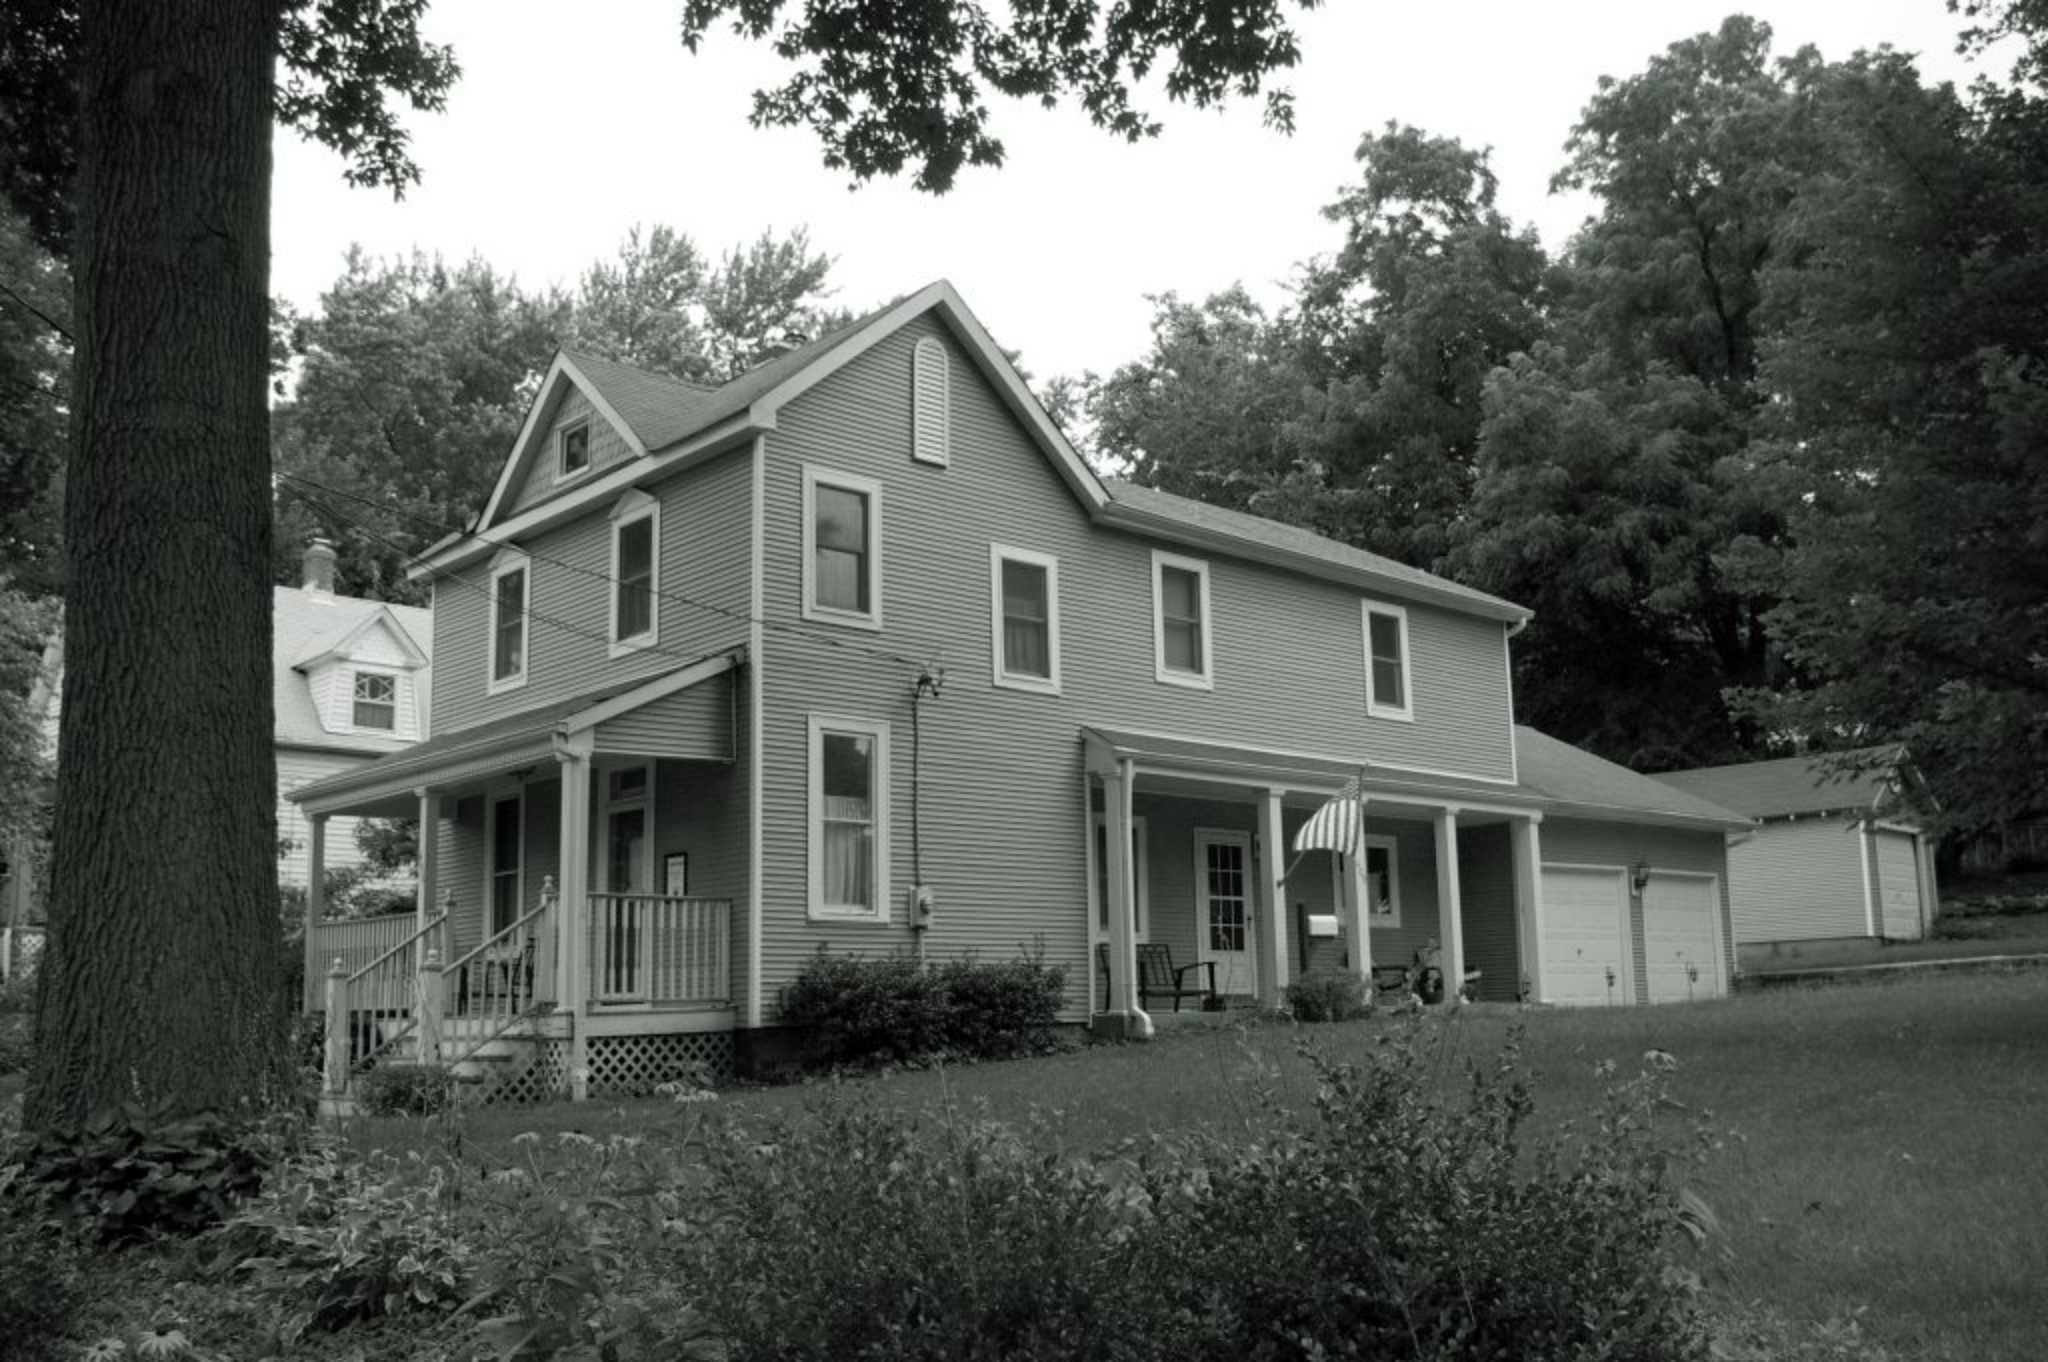
2009 Survey Update: Since the 1983 survey, a second floor addition has been added to the rear wing, utilizing the basic concept of I-house designs, with two windows on both levels and a centered doorway onto the shed roofed porch (the first floor elements were retained from the old rear wing) and the windows are proportioned to match those of the original house. Behind this rear wing, a side gabled two bay attached garage has been built. The entire building has been clad with vinyl siding and the front porch has a new, turned wood railing.

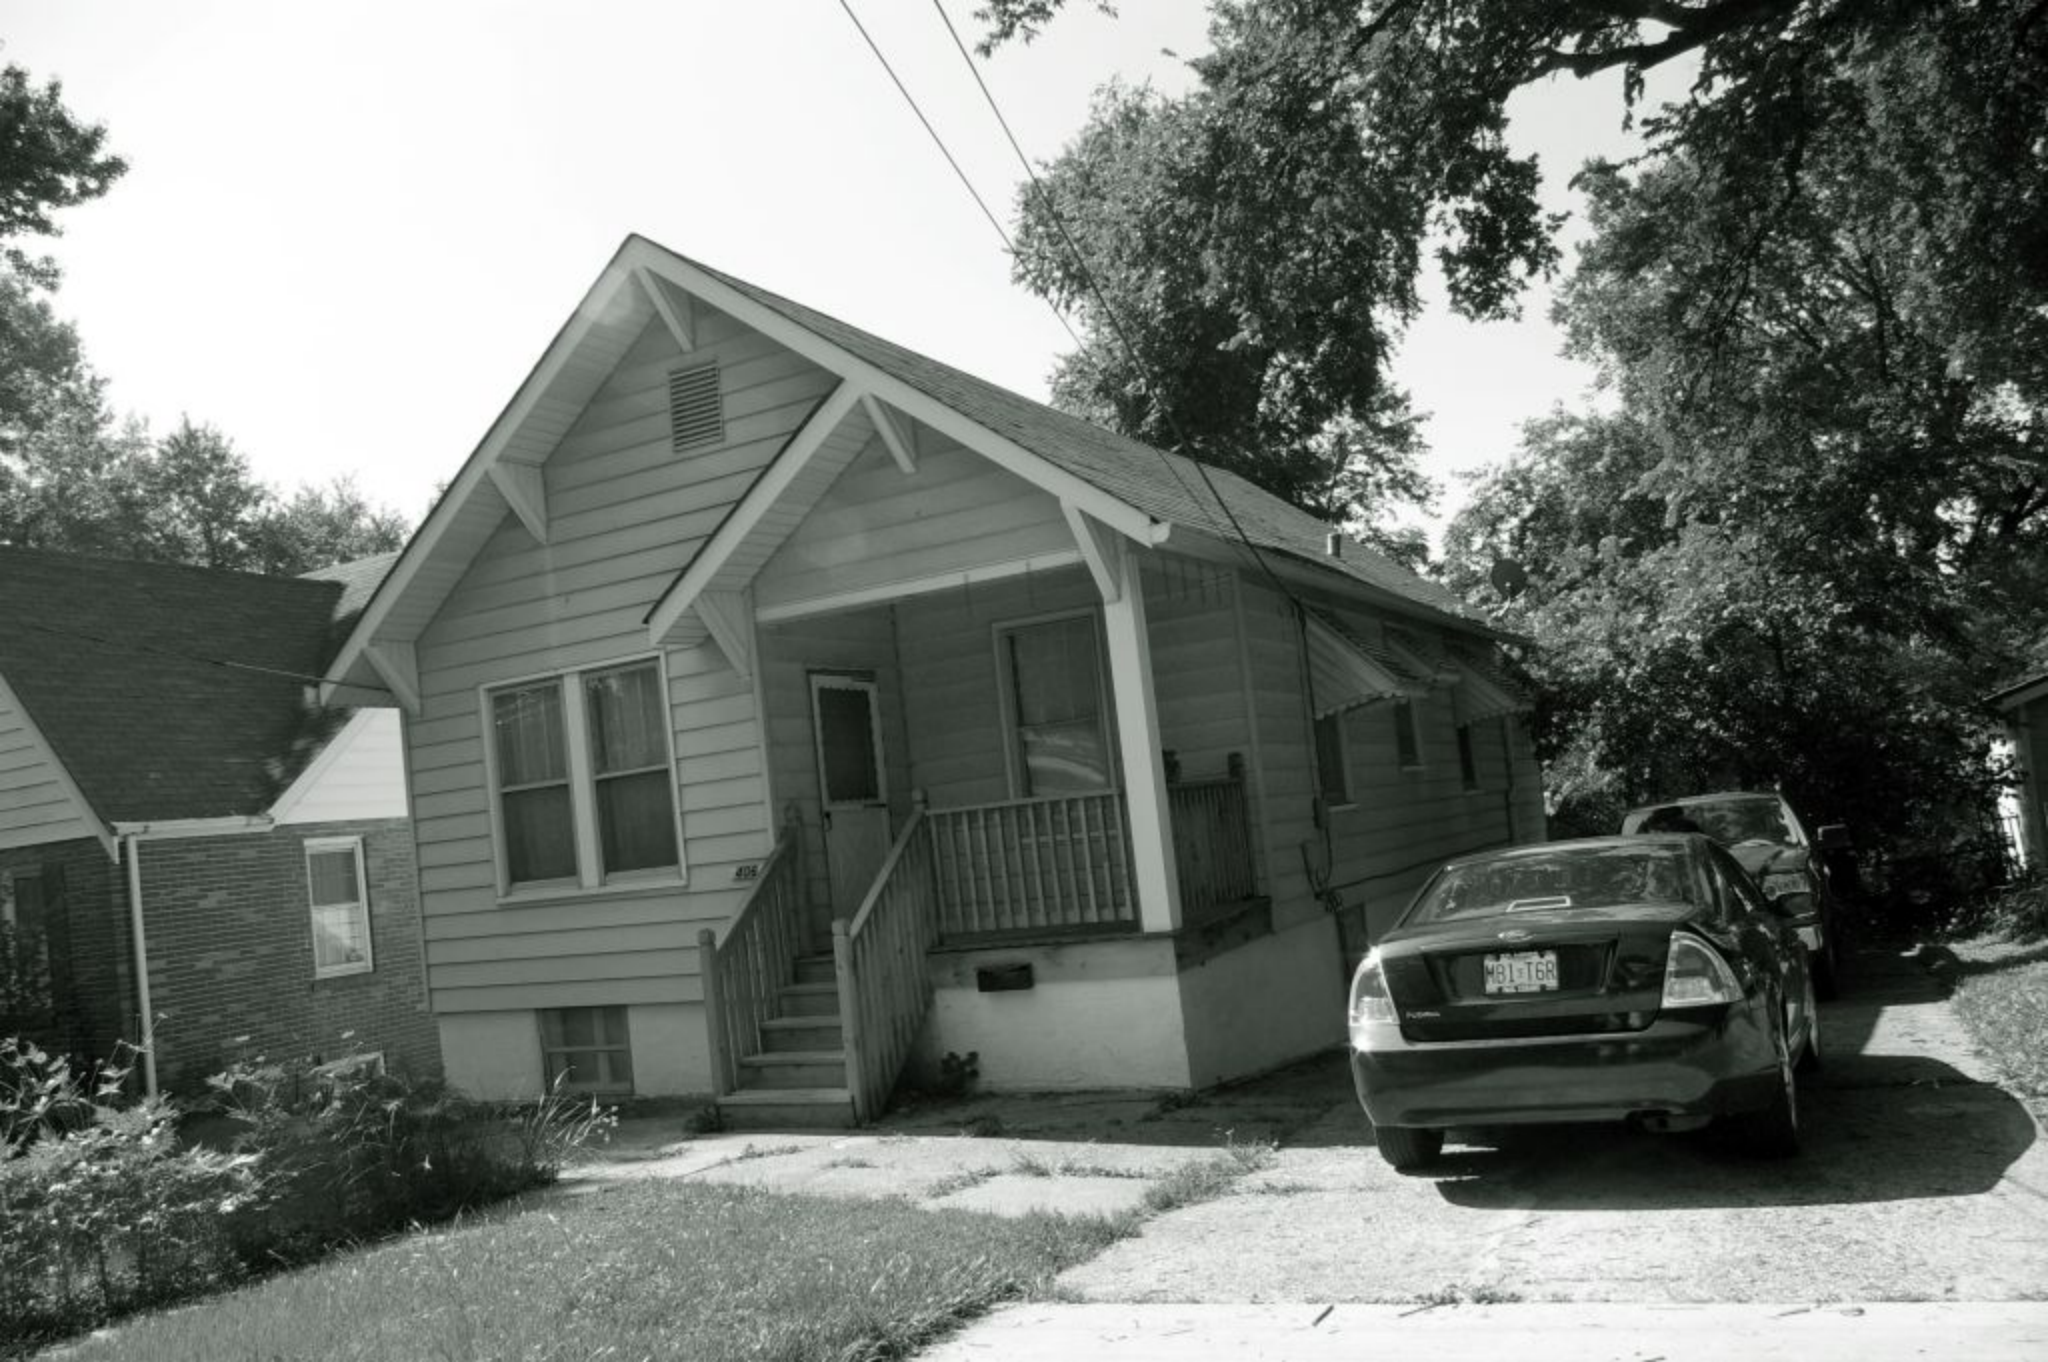
This one story, end gabled, Craftsman bungalow has wide eaves supported by a series of knee braces. The front porch is recessed into the facade, spanning the west half of the two bay facade with a square corner post supporting the roof. There is a secondary knee-braced roof that spans across the porch and shares the west side with the main roof. There are a series of wood steps leading up to the porch where there is a 3 over 1 wood sashed window facing the street with the entry door facing the side. On the other half of the facade there are paired 3 over 1 wood sashed windows with a basement window below. On the east elevation, there is an interior, brick chimney near the rear. The house has been sided with wide aluminum siding and the knee braces covered with siding as well. The basement windows have glass block and the porch has a new wood railing that is not painted yet. There are storm windows protecting the original windows and a storm door as well. This particular bungalow plan is seen in other areas of Ferguson as well, with its integrated corner porch.
