ARCHITECTURAL/HISTORIC INVENTORY FORM

1. Survey No. SL-AS-036-001		2. Survey Name: Architectural Survey of Old Ferguson West	
3. County: St. Louis		4. Address: 1 Carson Rd.	
5. City: Ferguson	Vicinity: <input type="checkbox"/>	6. UTM:	7. Township/Range/Section
8. Historic name (if known):		9. Present/other name (if known): Whistle Stop	
10. Ownership: <input type="checkbox"/> Private <input checked="" type="checkbox"/> Public		11. Historic use (if known): TRANSPORTATION/rail-related	11. Current use: COMMERCE/restaurant & RECREATION/museum

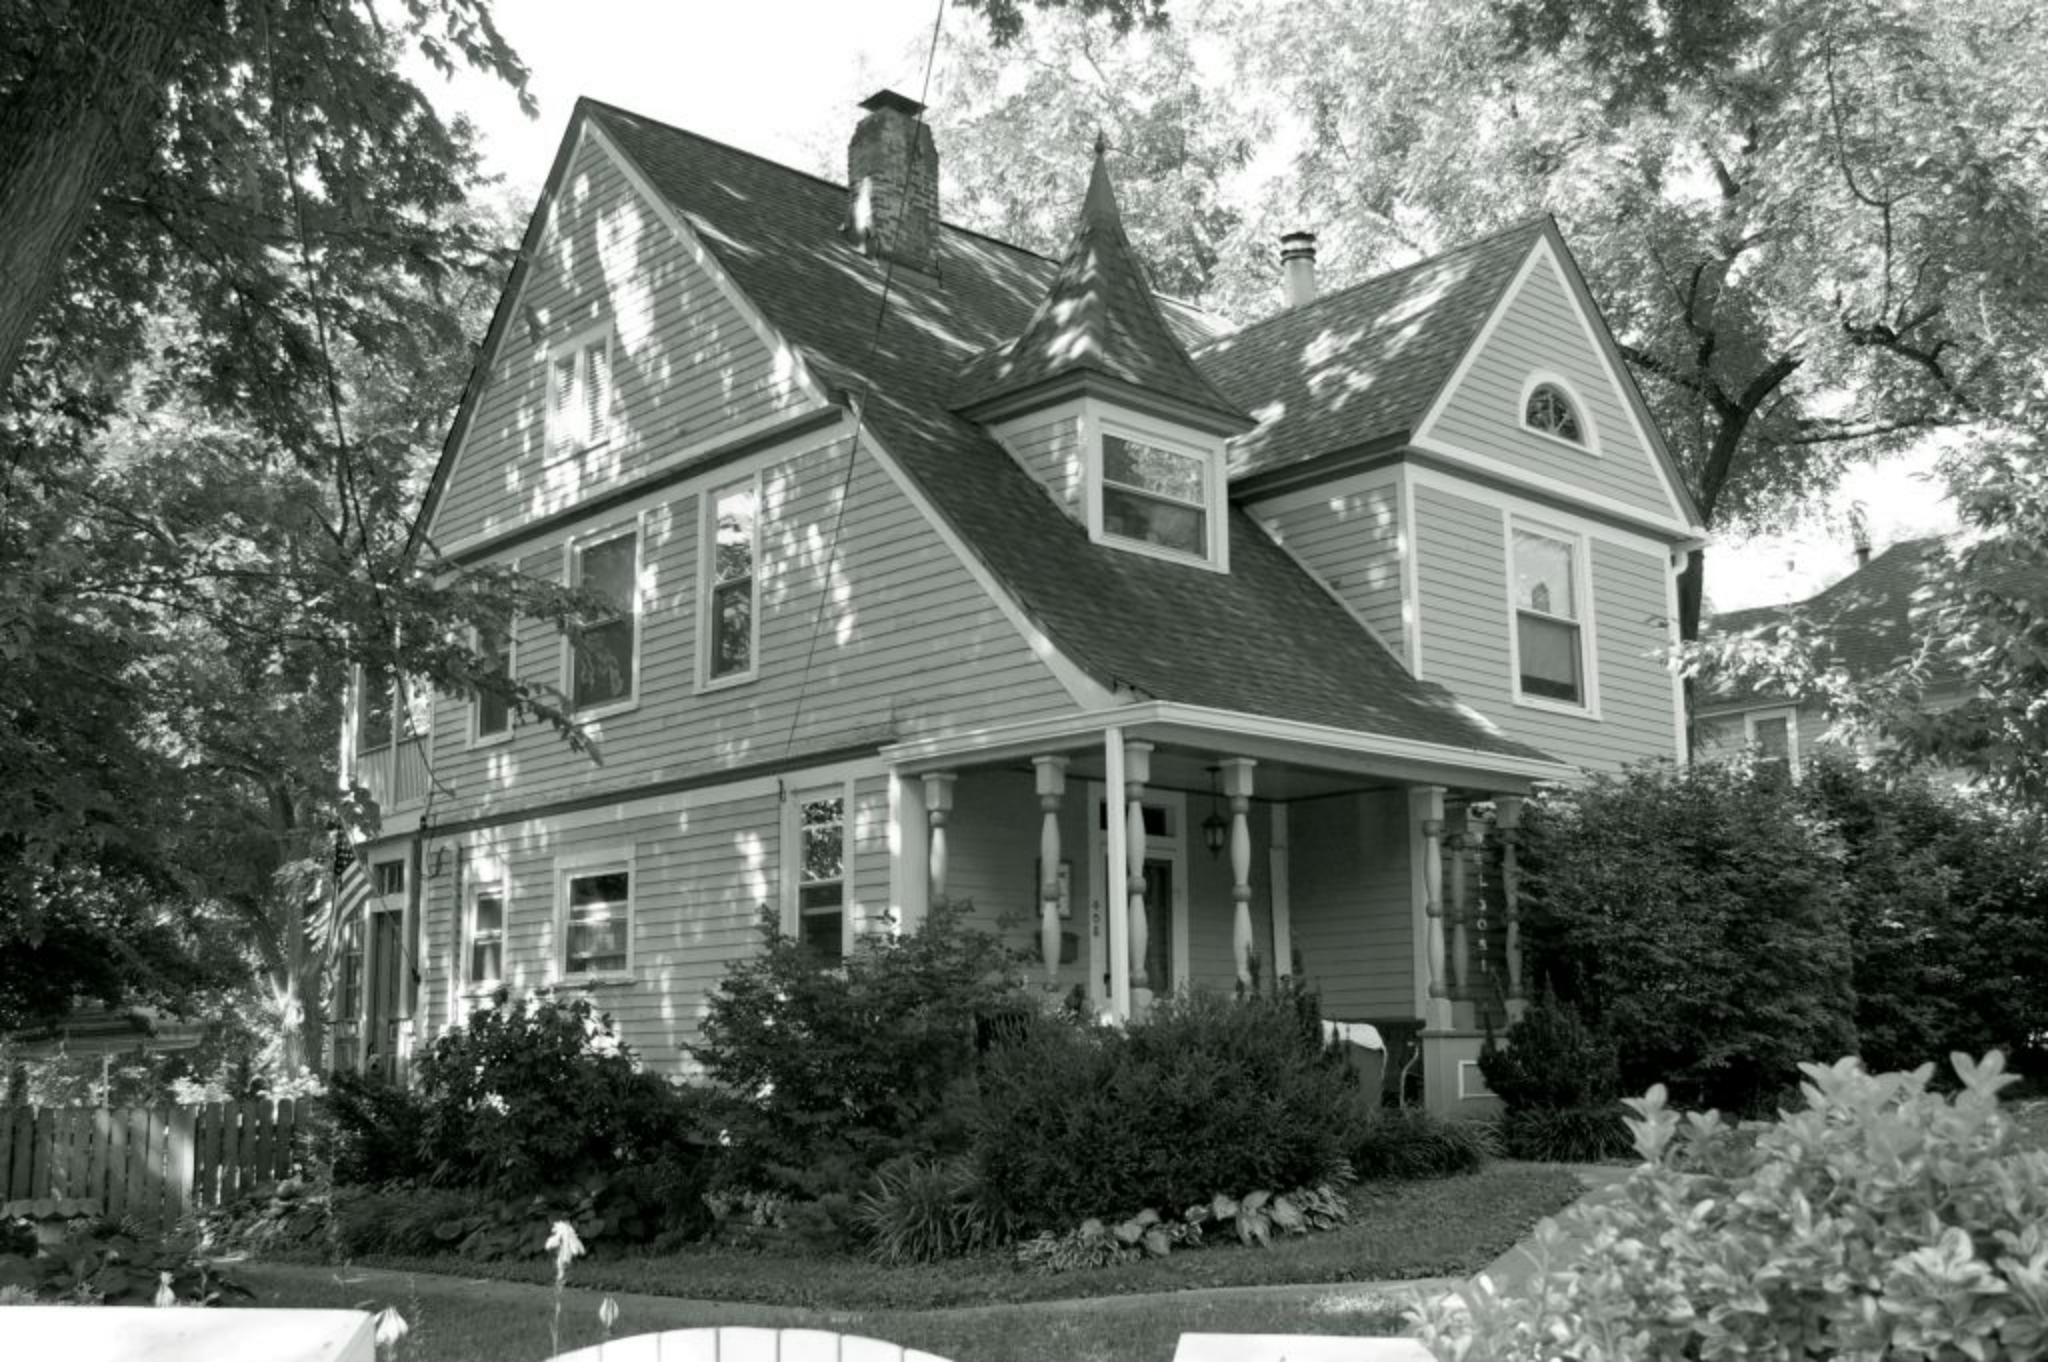
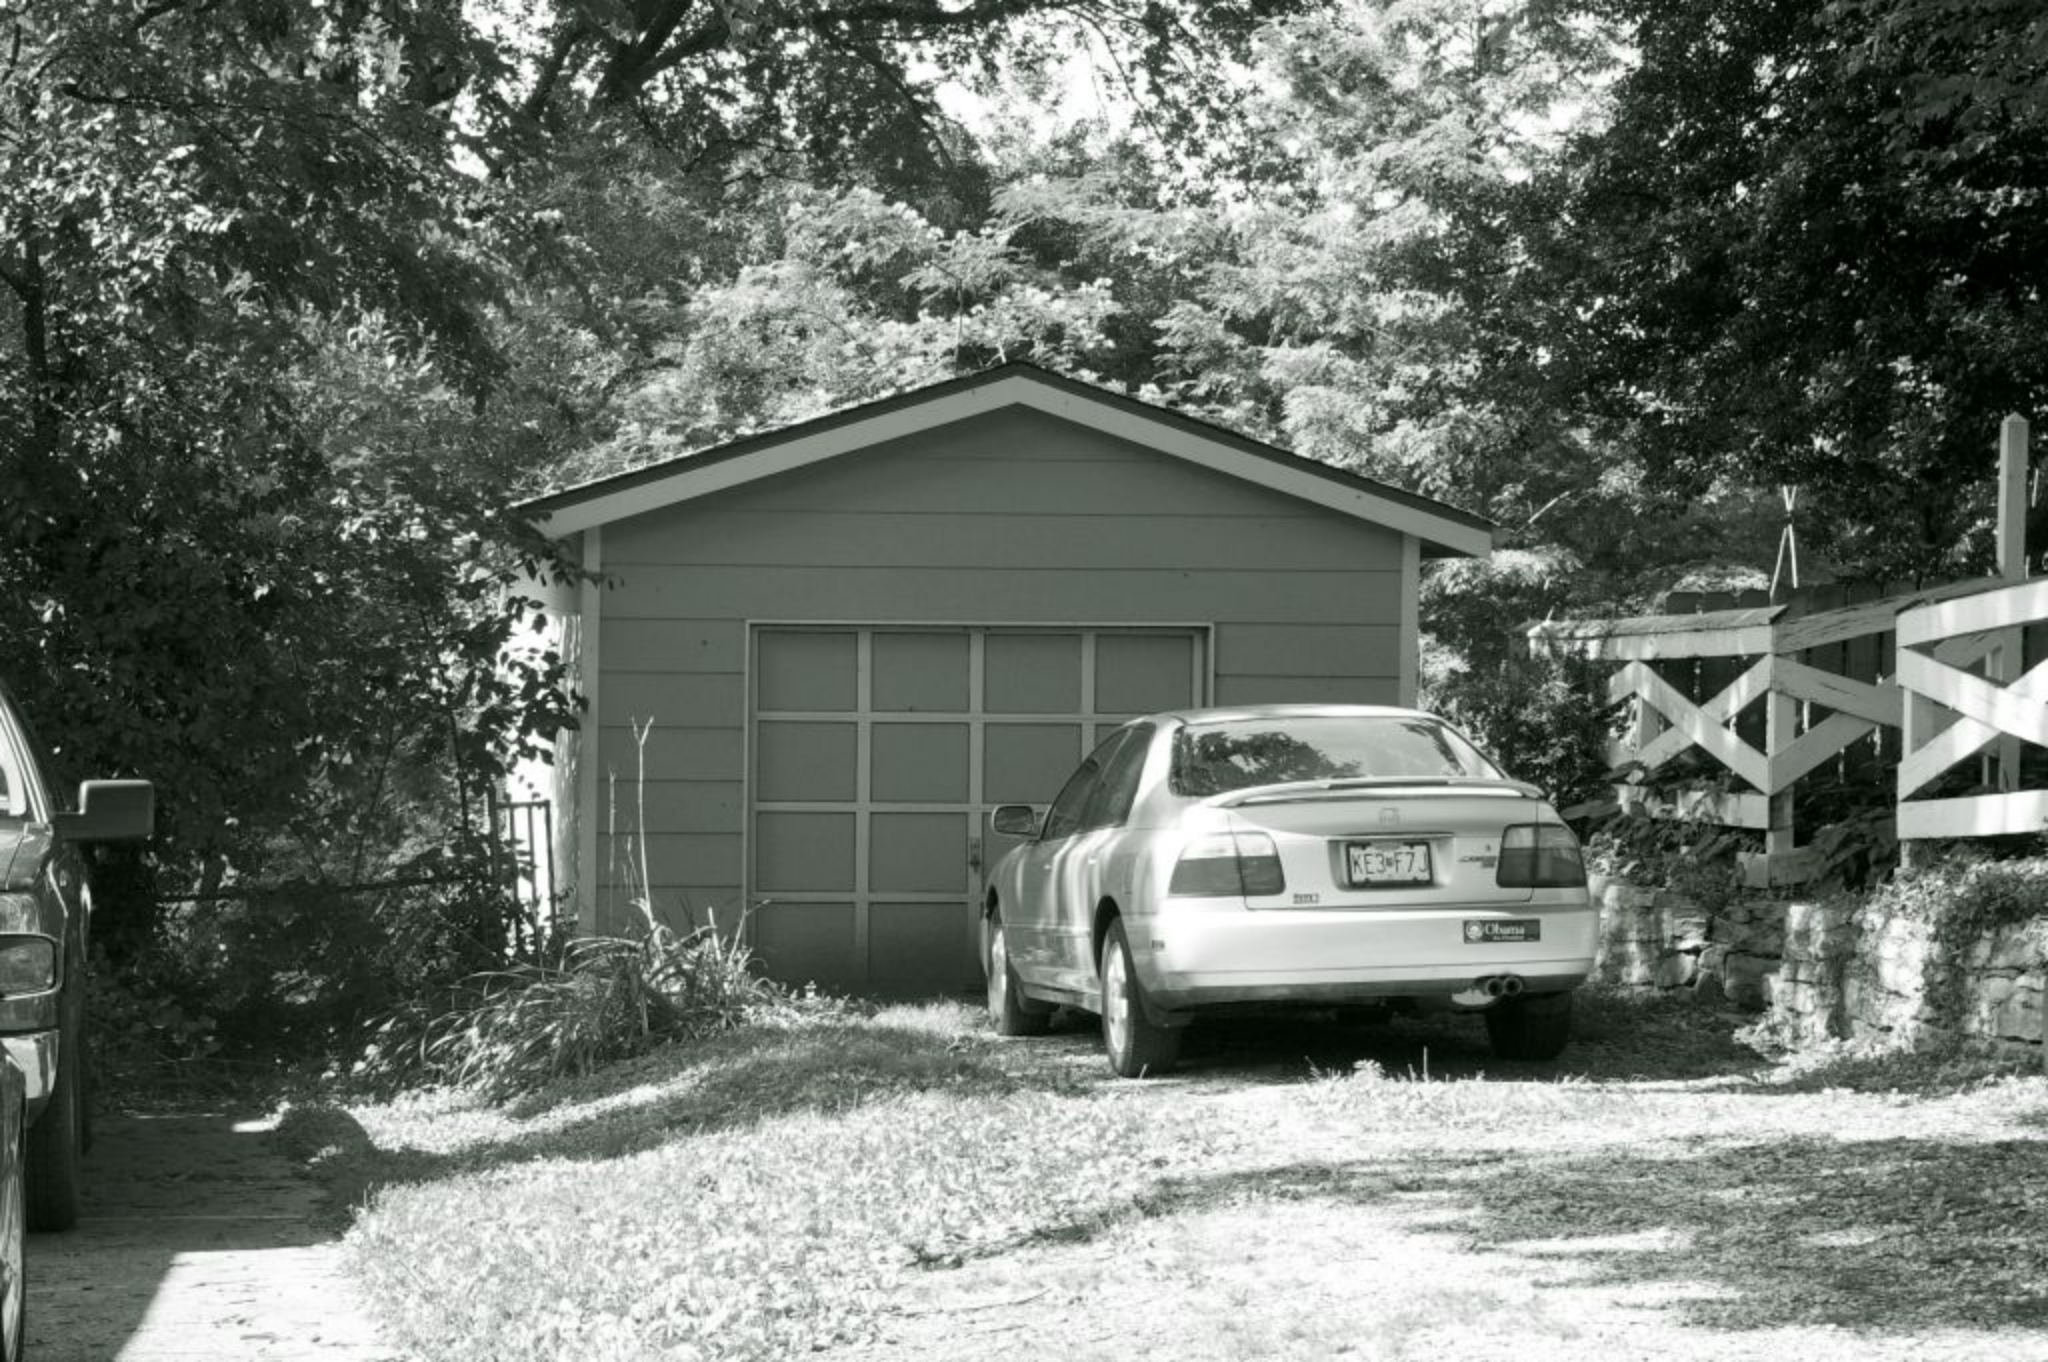
2009 Survey Update: The aluminum siding has been removed and the house is now clapboard. The porch has new turned posts on wood paneled knee walls. Some of the windows, have been replaced (most notably the 2 over 1 window in the fanciful, steeply pitched bellcast hipped dormer on the facade and a similar window on the east side. All windows have storms.

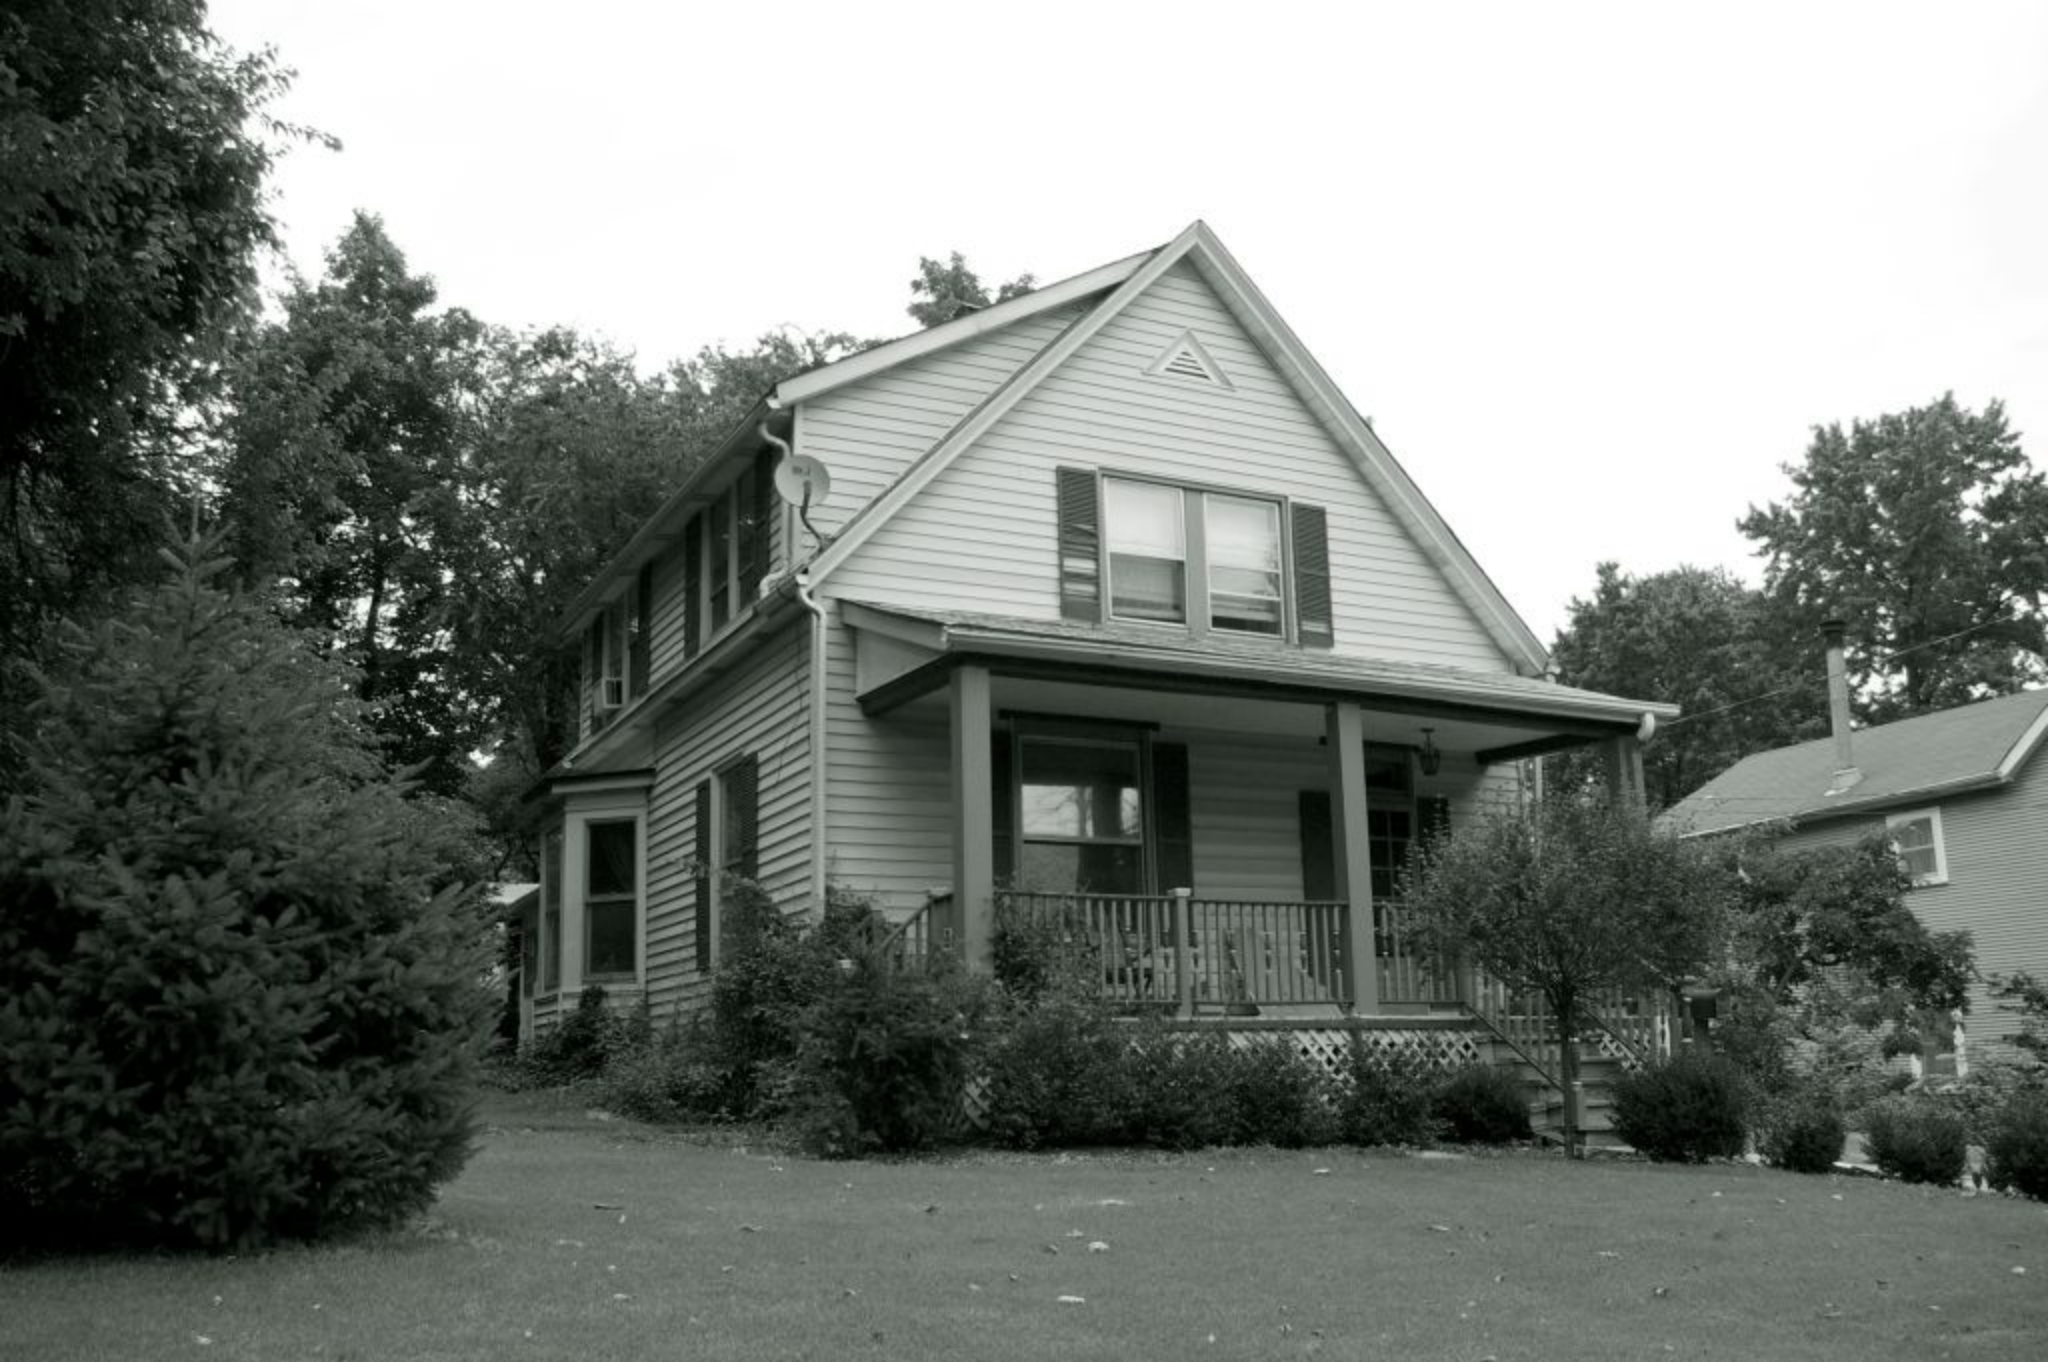
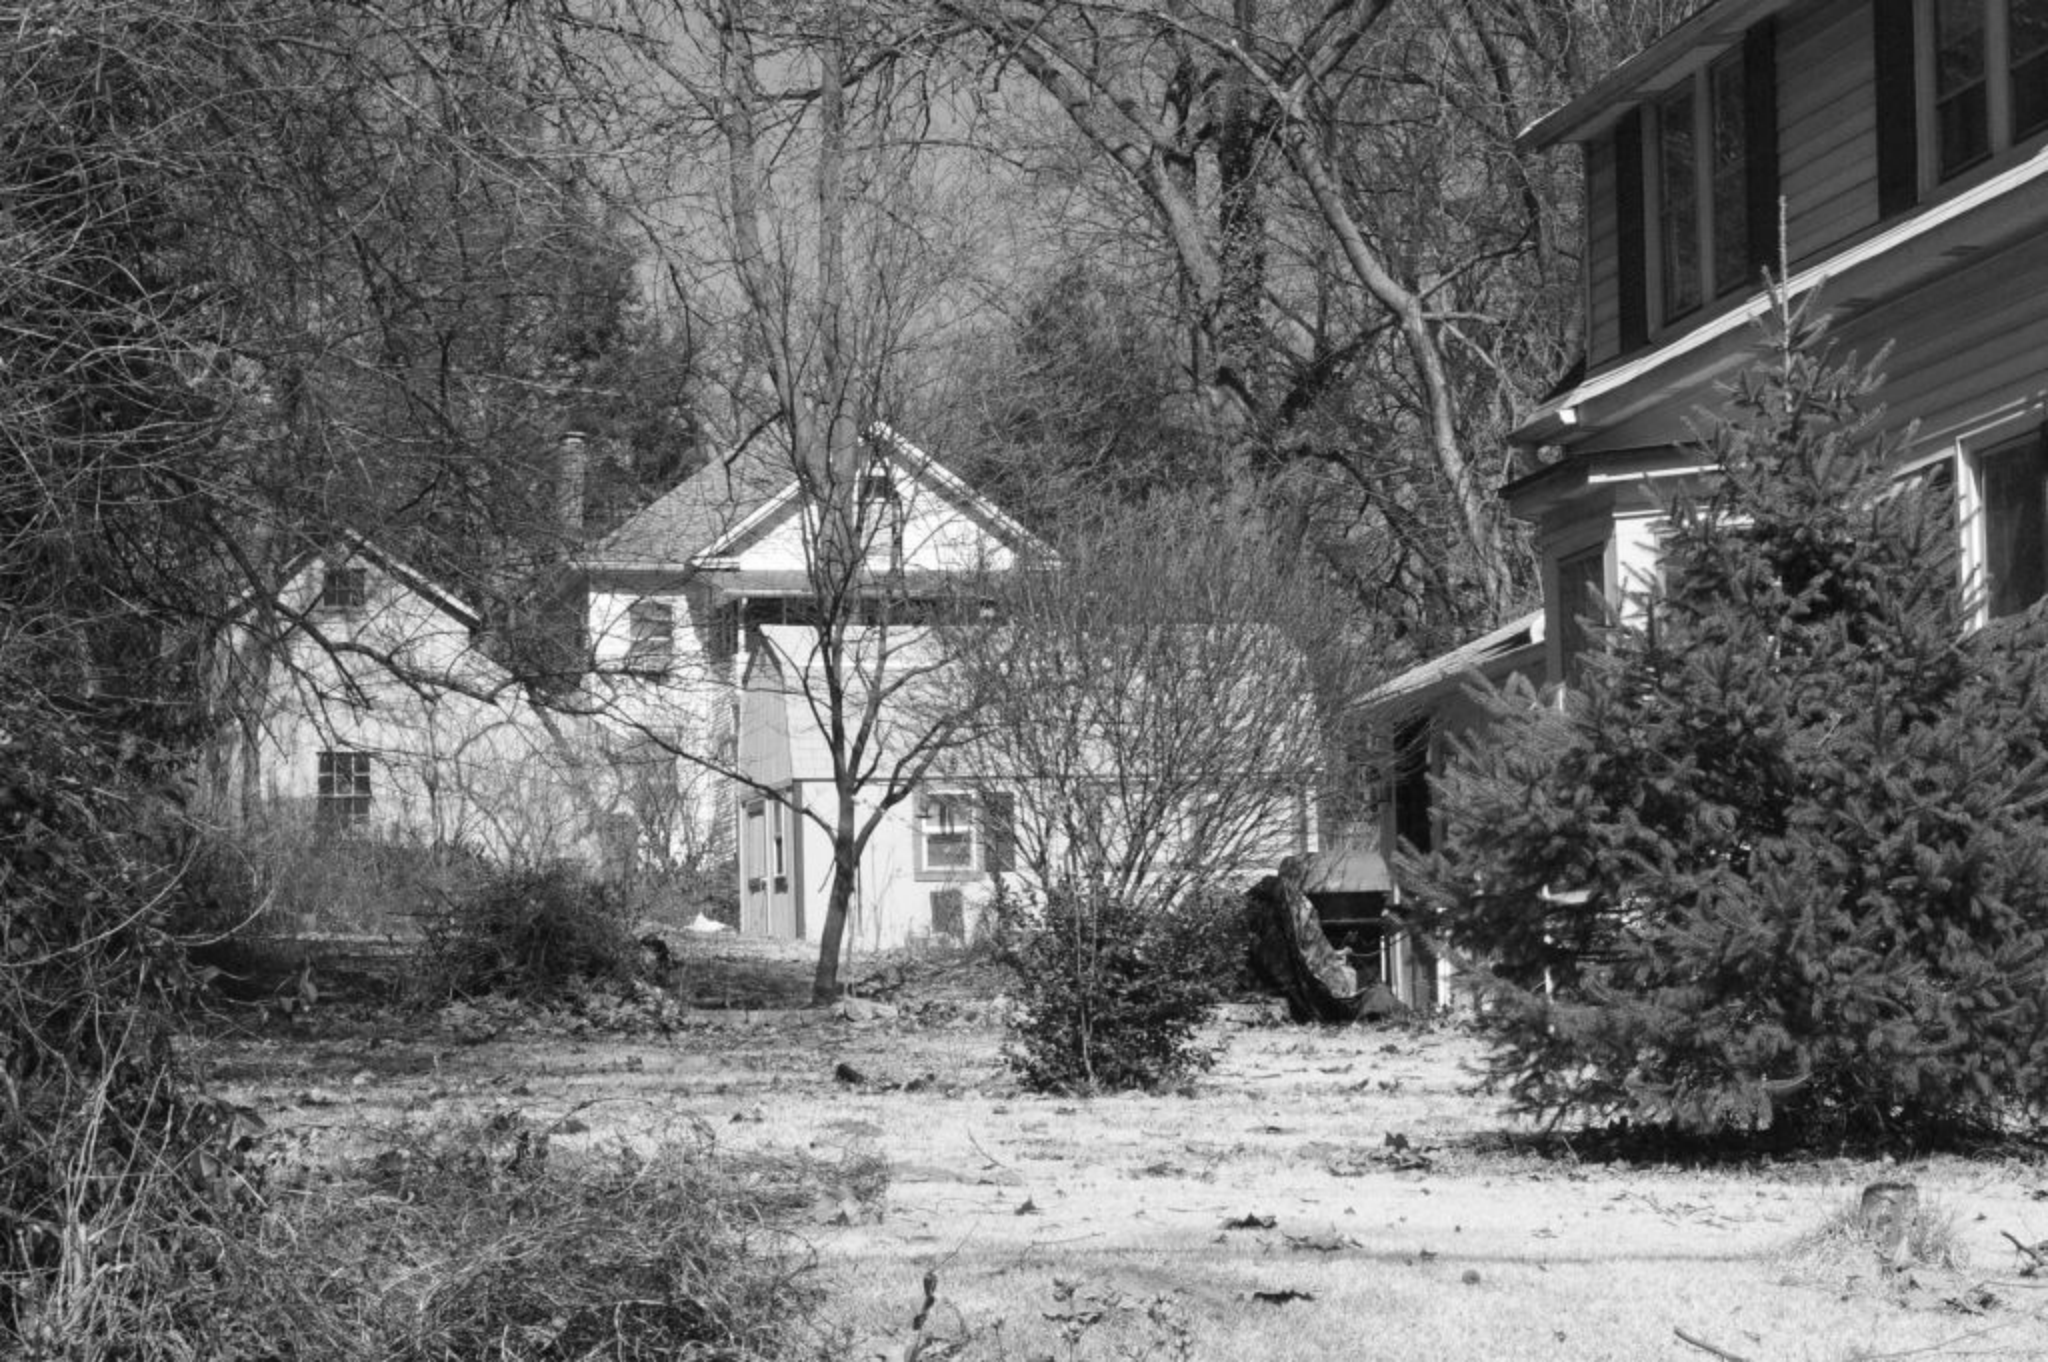
2009 Survey Update: The portion of the porch on the west end missing in the 1983 survey has been reconstructed and a new turned wood baluster railing installed. The aluminum siding has been replaced with vinyl siding, covering the fishscale shingles as well that were noted in the 1983 survey, but the house retains its original wood sashed windows, now covered with aluminum storm windows.

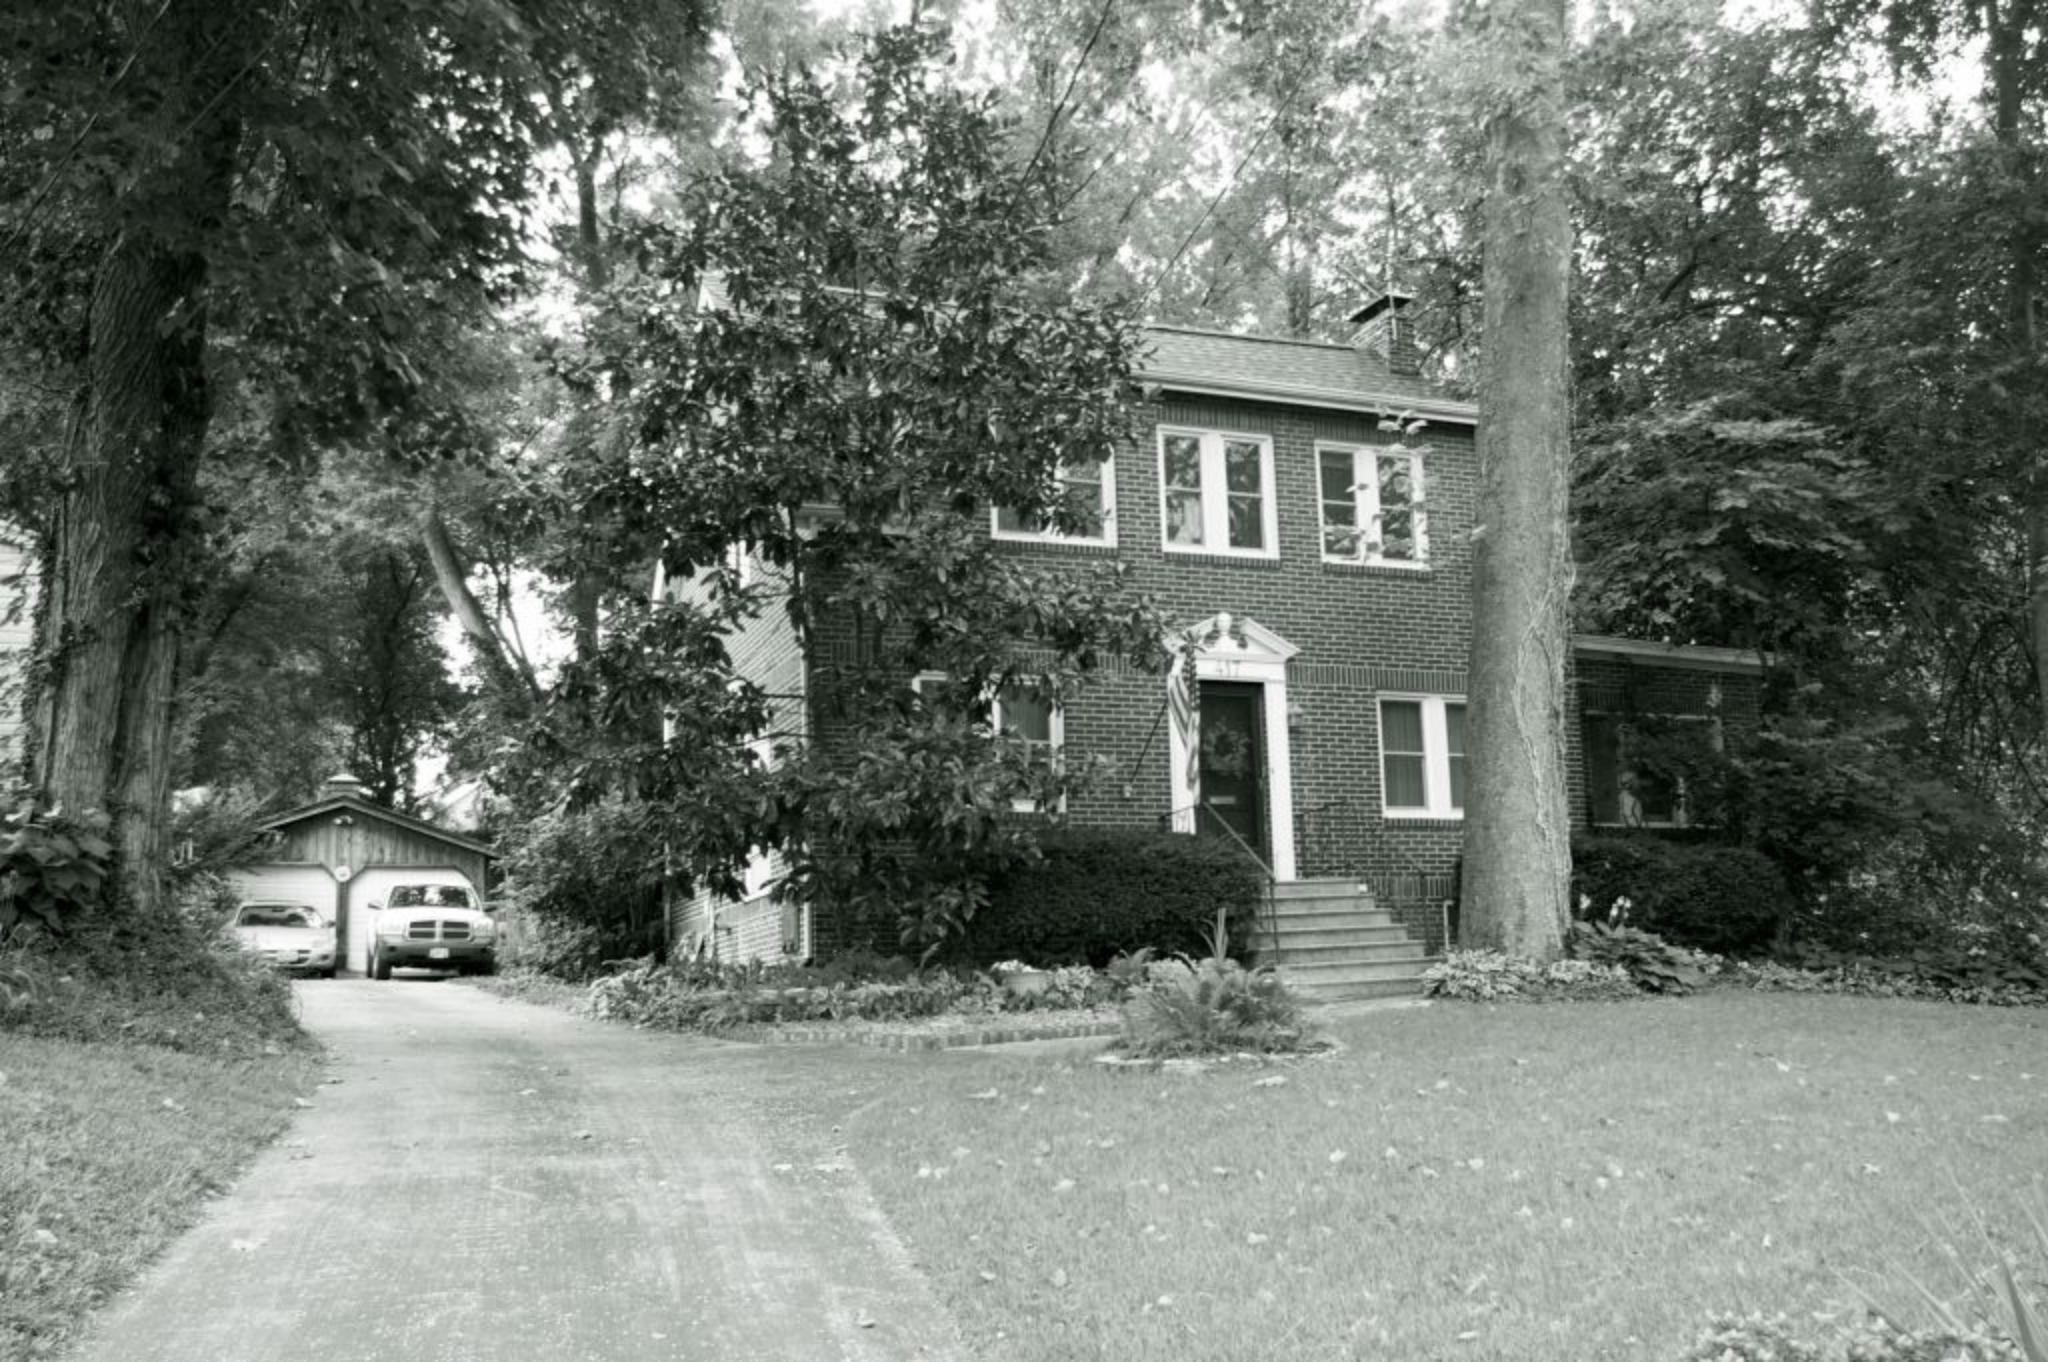
This two story, side gabled, brick house has a symmetrical facade on the main house with a broad shed wall dormer with three pairs of 1 over 1 sashed windows. On the first floor, there are paired 1 over 1 sashed windows on either side of the pedimented entry with its wood paneled door. The broken pediment integrates an urn, and to either side of the door are fluted pilasters. There is a concrete stoop with iron railings. To the east of the main facade is a flat-roofed, brick, sunroom with banks of three windows on the facade and two banks of three windows on the east elevation. The windows are 1 over 1 sashed windows, but on the facade, two of the windows are missing, boarded in from the interior. On the east elevation of the main building above the sunroom is a door onto the flat rooftop positioned in front of the end wall brick chimney. The windows appear to be wood, with aluminum storms.

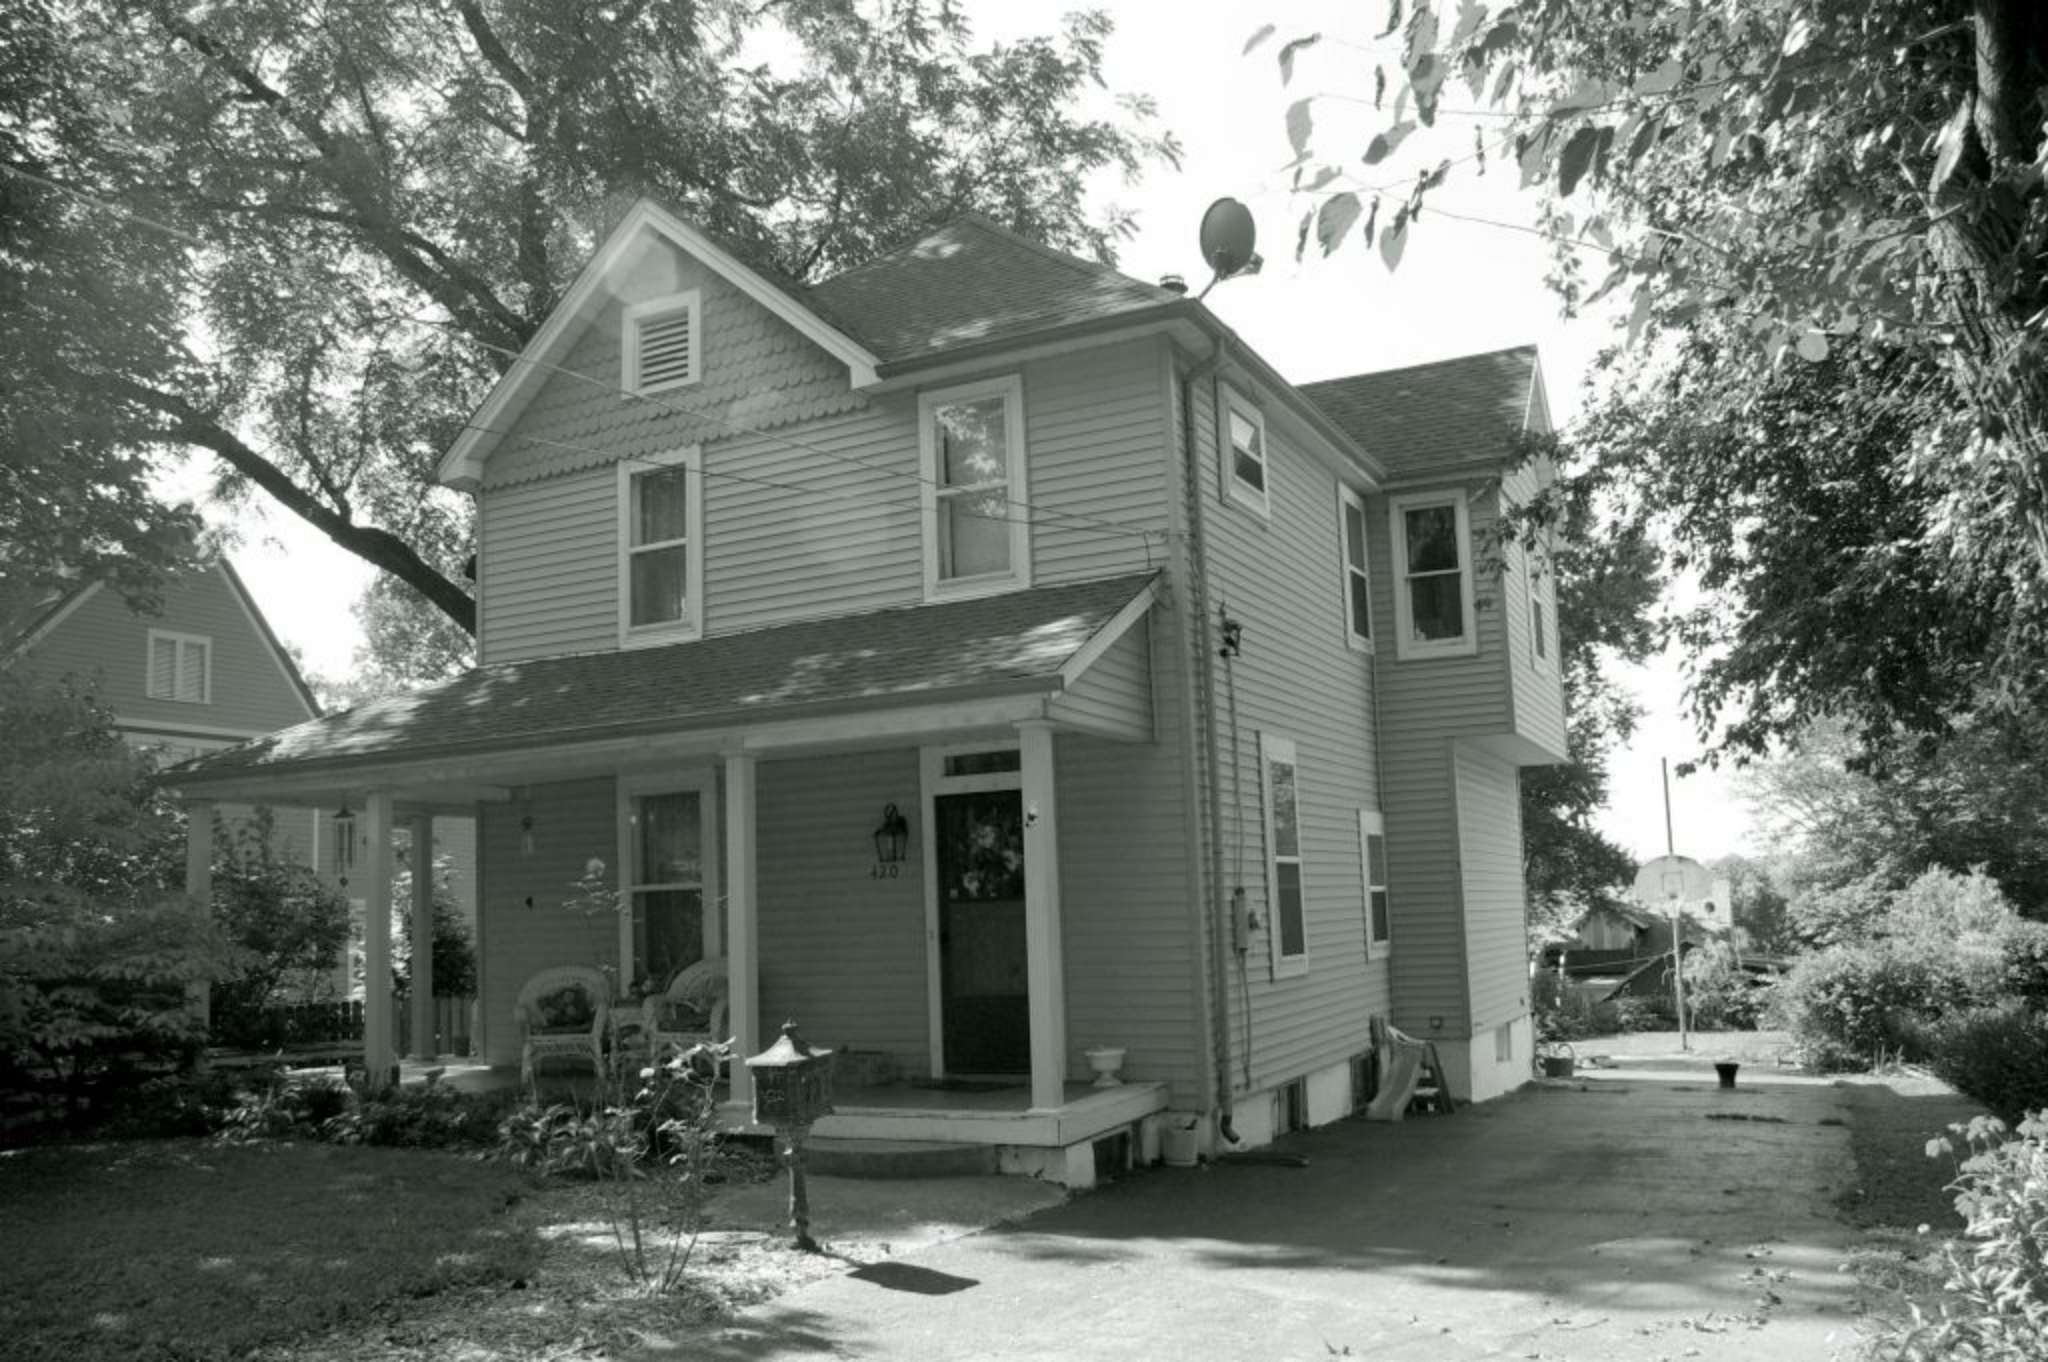
2009 Survey Update: Since the 1983 survey, the house has been resided with vinyl siding, but done well with the window casings still projecting away from the face of the wall. The original decorative wood half timbered treatment in the gable end has been covered with vinyl fishscale shingles. Although in keeping with the Folk Victorian style, it does alter the appearance to some degree. The house retains its original 1 over 1 wood sashed windows covered with aluminum storms.

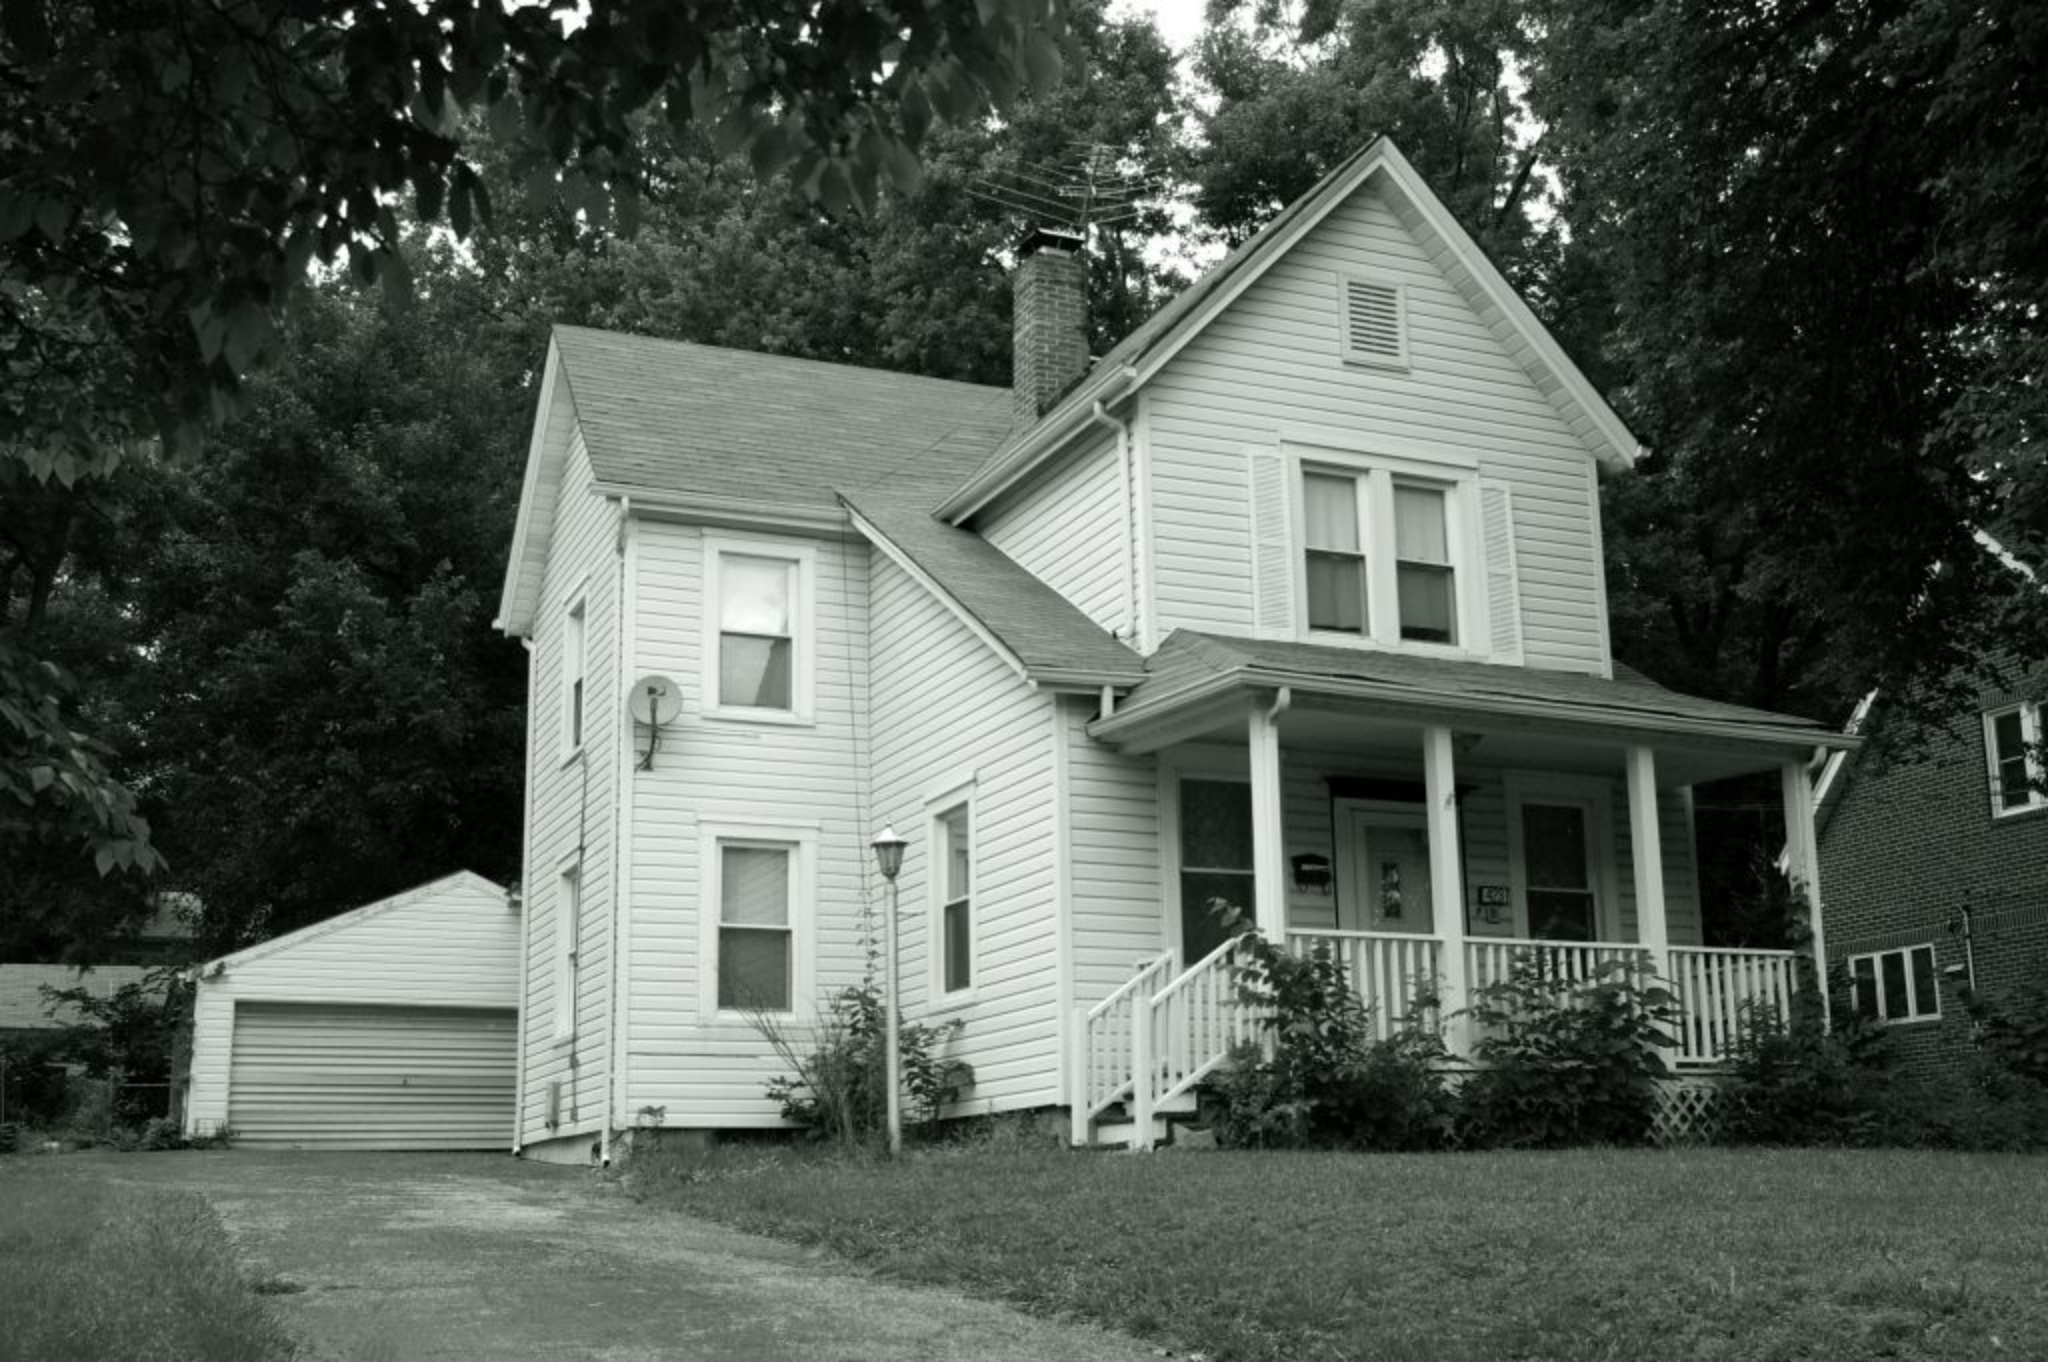
2009 Survey Update: Since the 1983 survey, the house has been sided with vinyl siding, replacing the asbestos shingles on the house in the 1983 survey, and probably more closely matching the historic appearance of the walls. The porch retains the simple square posts but has a new simple balustrade railing. The addition on the east side with its side shed roof pre-dates the 1983 survey. The front door has been replaced with a metal paneled door. The windows may be replacements, but they are still 1 over 1 sashed windows like the originals.
