ARCHITECTURAL/HISTORIC INVENTORY FORM

1. Survey No. SL-AS-036-001		2. Survey Name: Architectural Survey of Old Ferguson West	
3. County: St. Louis		4. Address: 1 Carson Rd.	
5. City: Ferguson	Vicinity: <input type="checkbox"/>	6. UTM:	7. Township/Range/Section
8. Historic name (if known):		9. Present/other name (if known): Whistle Stop	
10. Ownership: <input type="checkbox"/> Private <input checked="" type="checkbox"/> Public		11. Historic use (if known): TRANSPORTATION/rail-related	11. Current use: COMMERCE/restaurant & RECREATION/museum

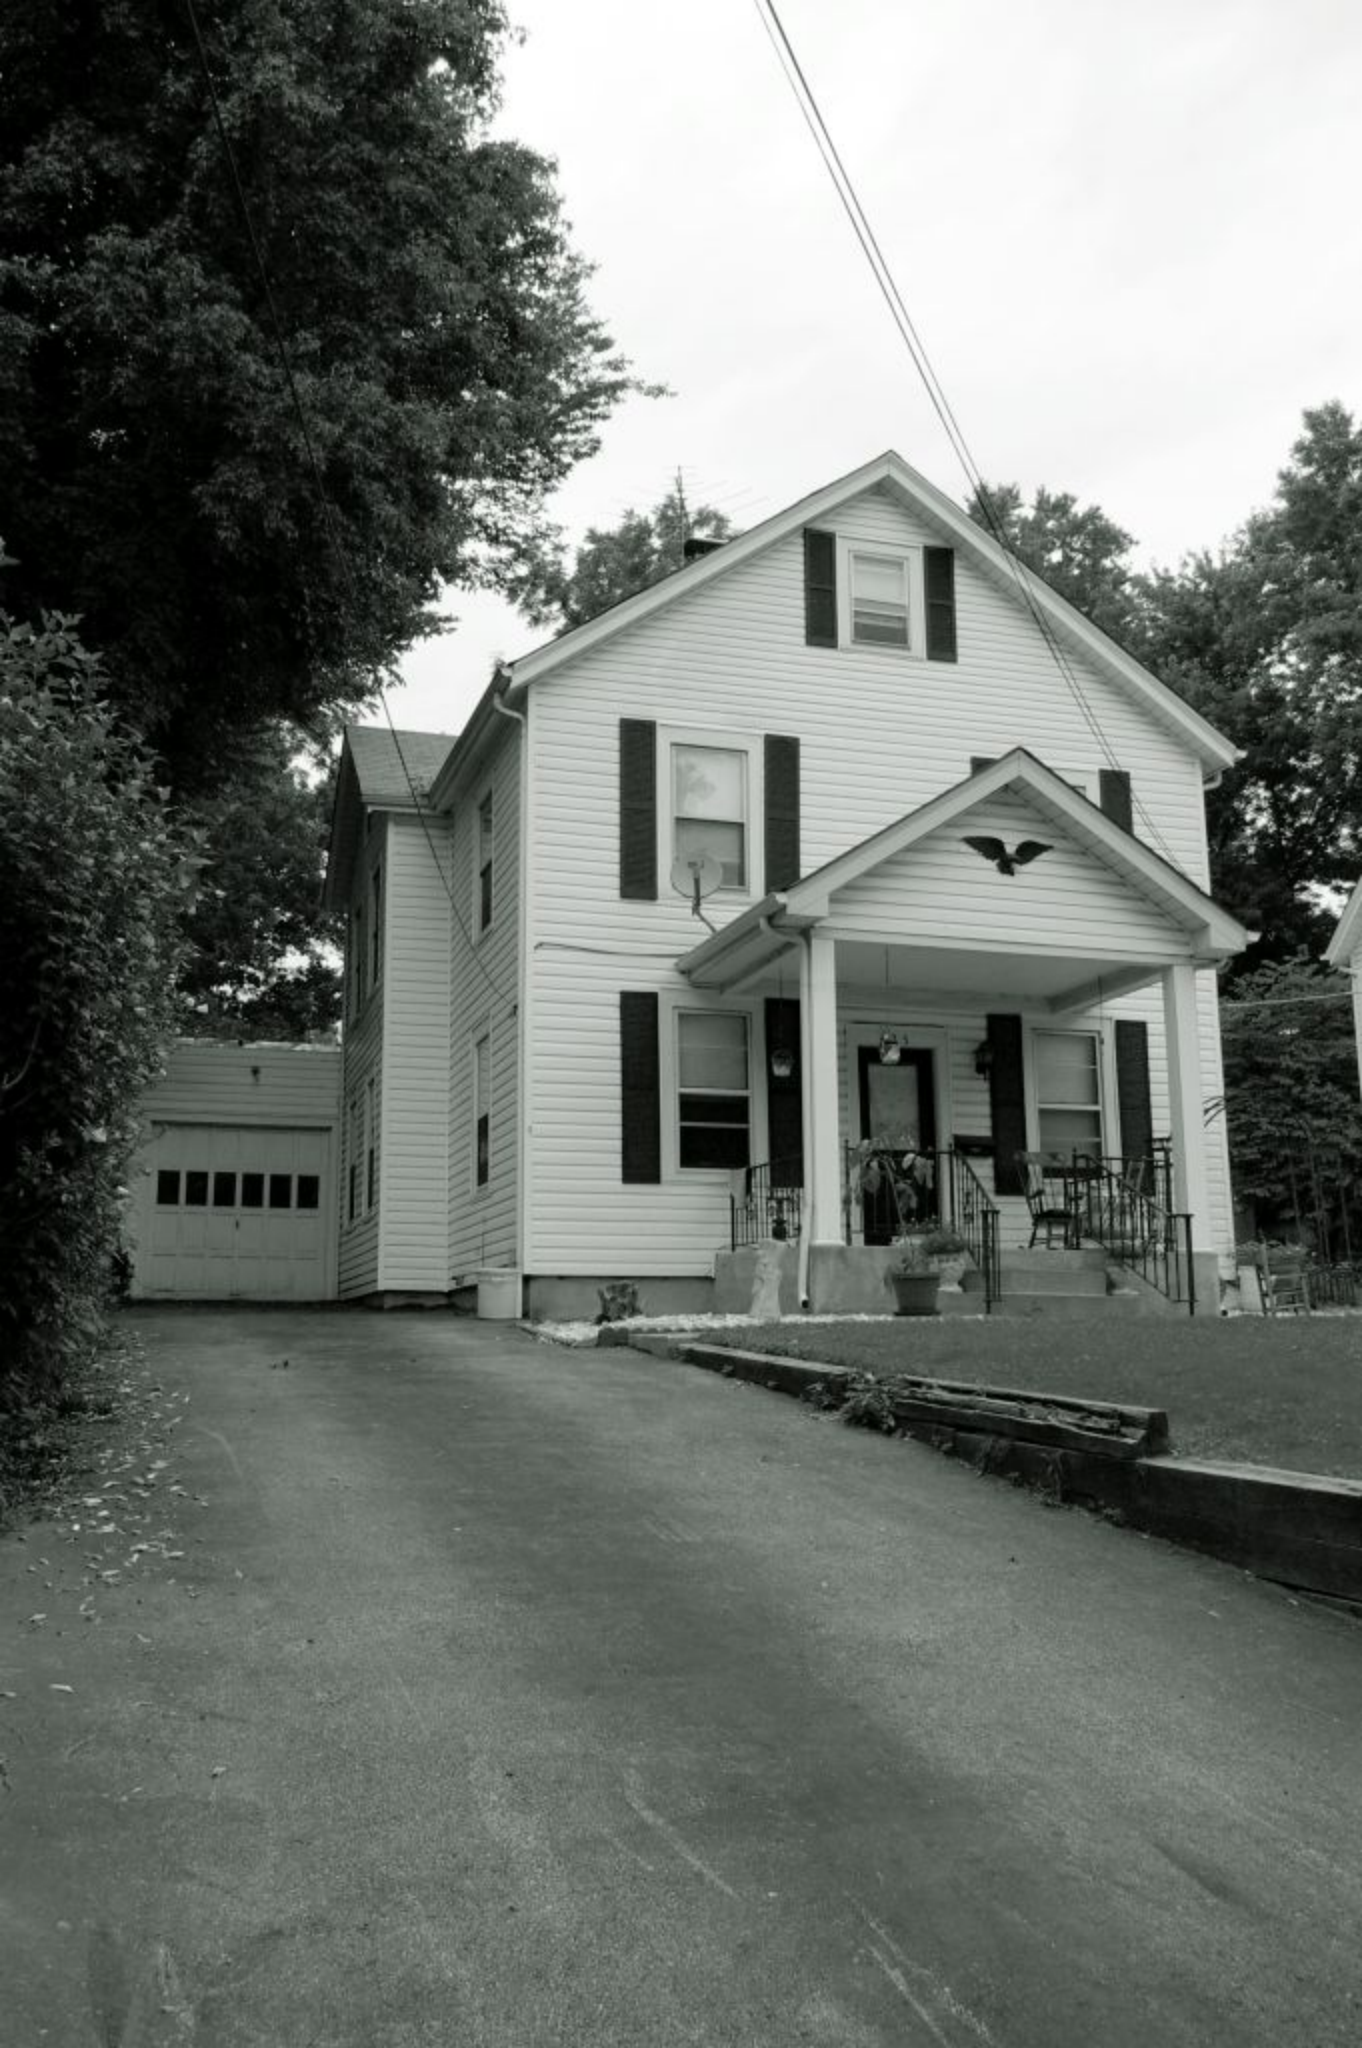
This end gabled, two story frame house has been re-sided with vinyl siding. On the facade it has 1 over 1 wood sashed windows on both levels of the outer bays that flank a simple paneled door under the deeply projecting gabled porch. The square porch posts have also been clad with fluted vinyl and are resting on a poured concrete porch floor and wrought iron railings. On the west elevation there is a two story cross gabled bay near the rear and behind it there is a one story, flat roofed garage, an early addition with its wood paneled overhead door. On the east elevation there is another addition near the rear, this one is a side shed roofed, one story wing. The house has two interior, brick chimneys at the ridge. Besides the vinyl siding, which also covers the soffits, the house has aluminum storm windows.

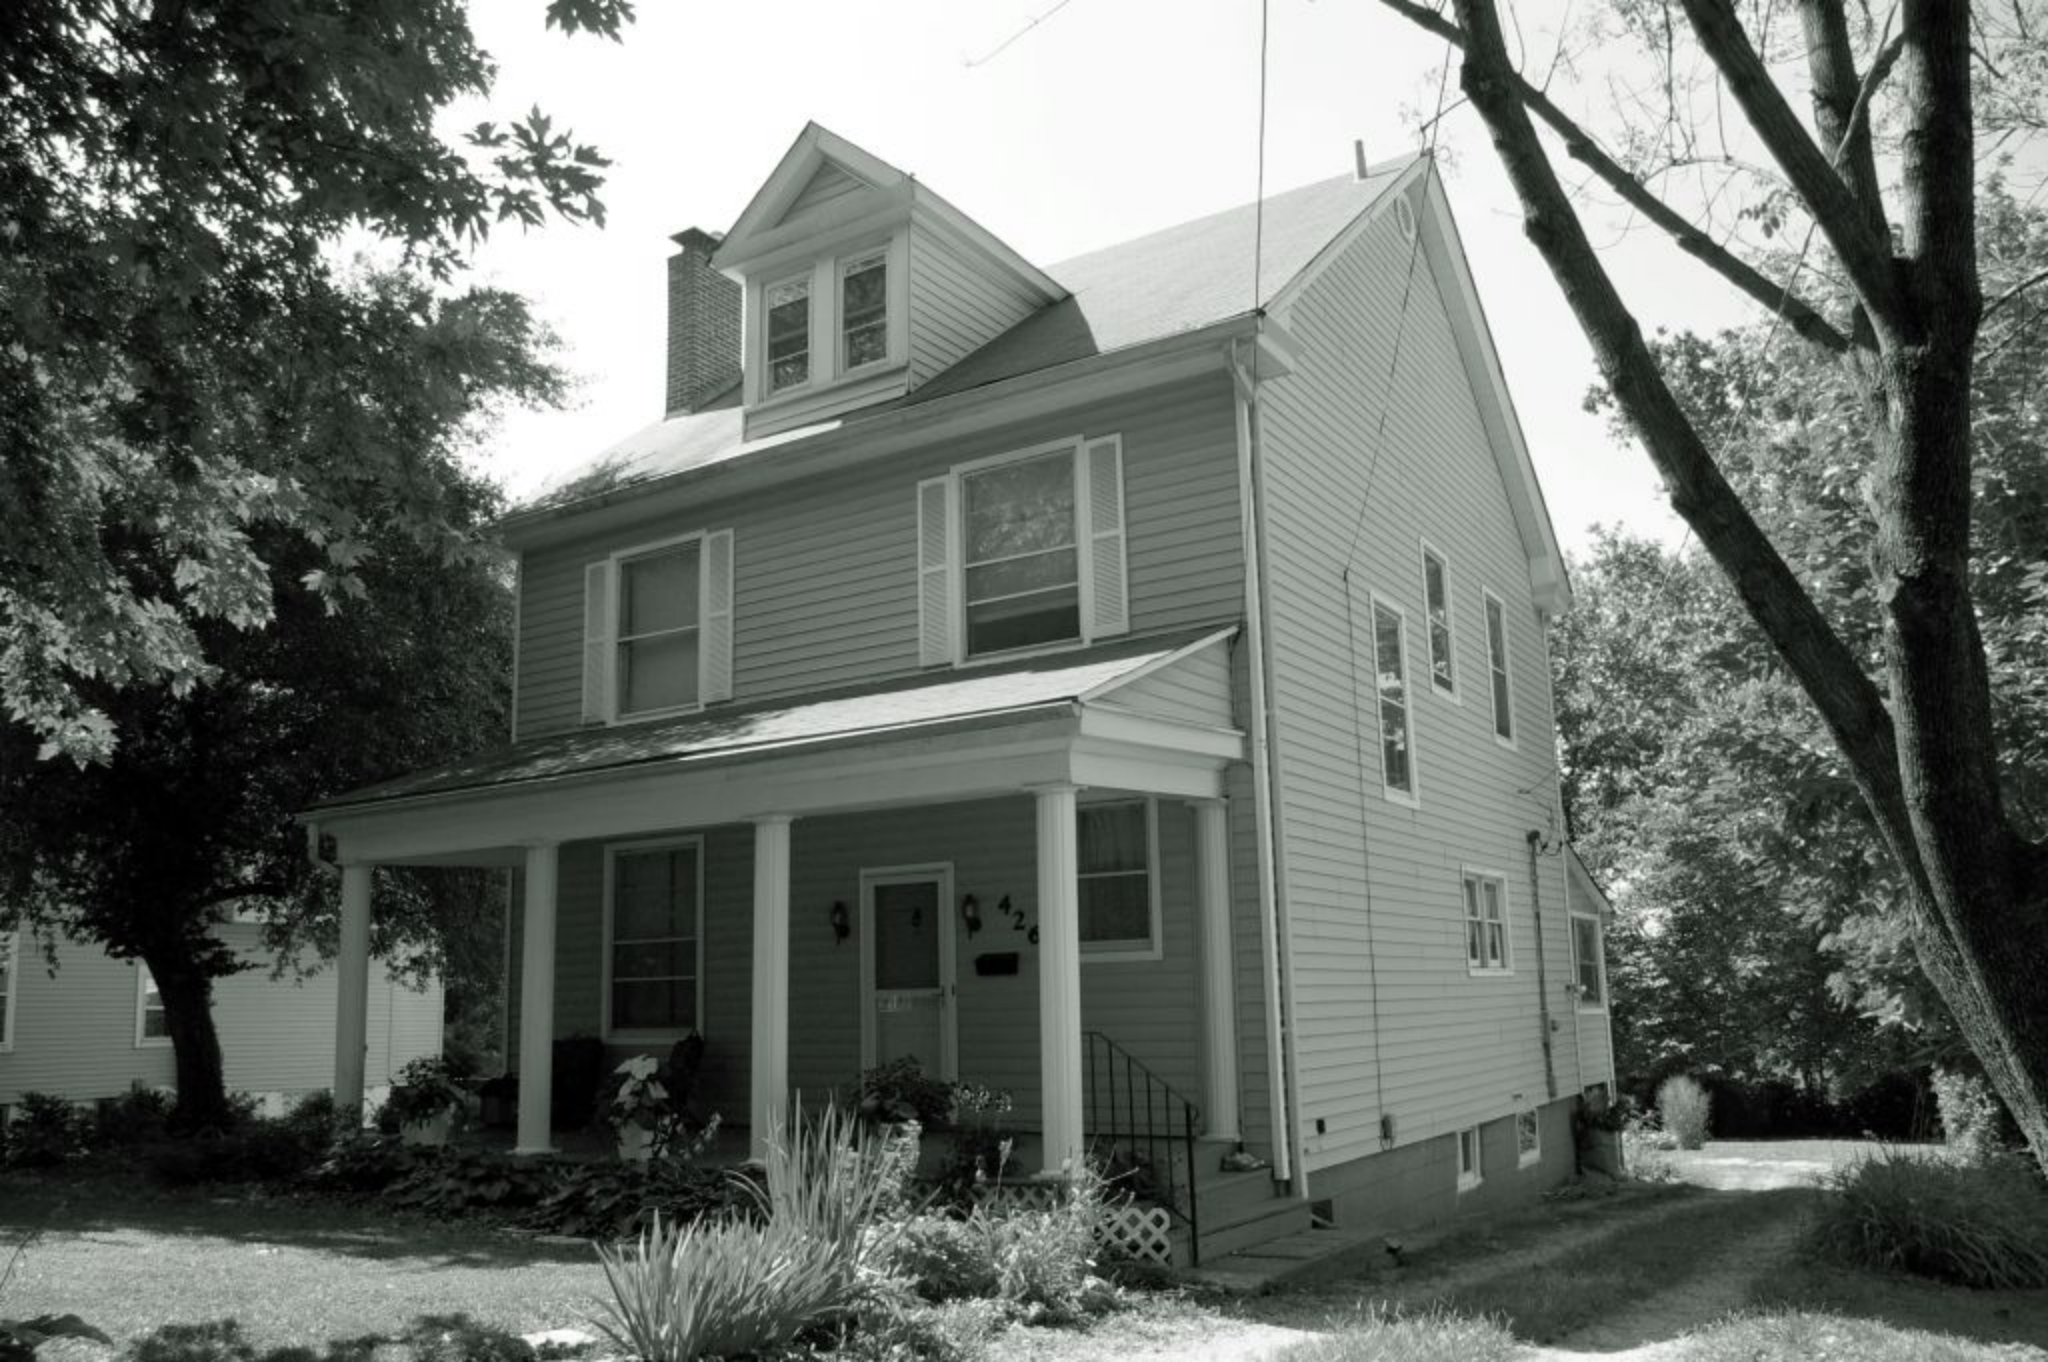
2009 Survey Update: Since the 1983 survey, the house has been resided with vinyl, covering the original clapboard as well as the original wood shingles in the gable ends. It still retains its original wood sashed windows and paneled wood door, but the columns may have been replaced with fluted vinyl columns, although they were simple round columns originally, it is difficult to be certain without closer inspection. It still retains its original wooden porch floor with side entry stairs, but a wrought iron railing has been added to the steps.

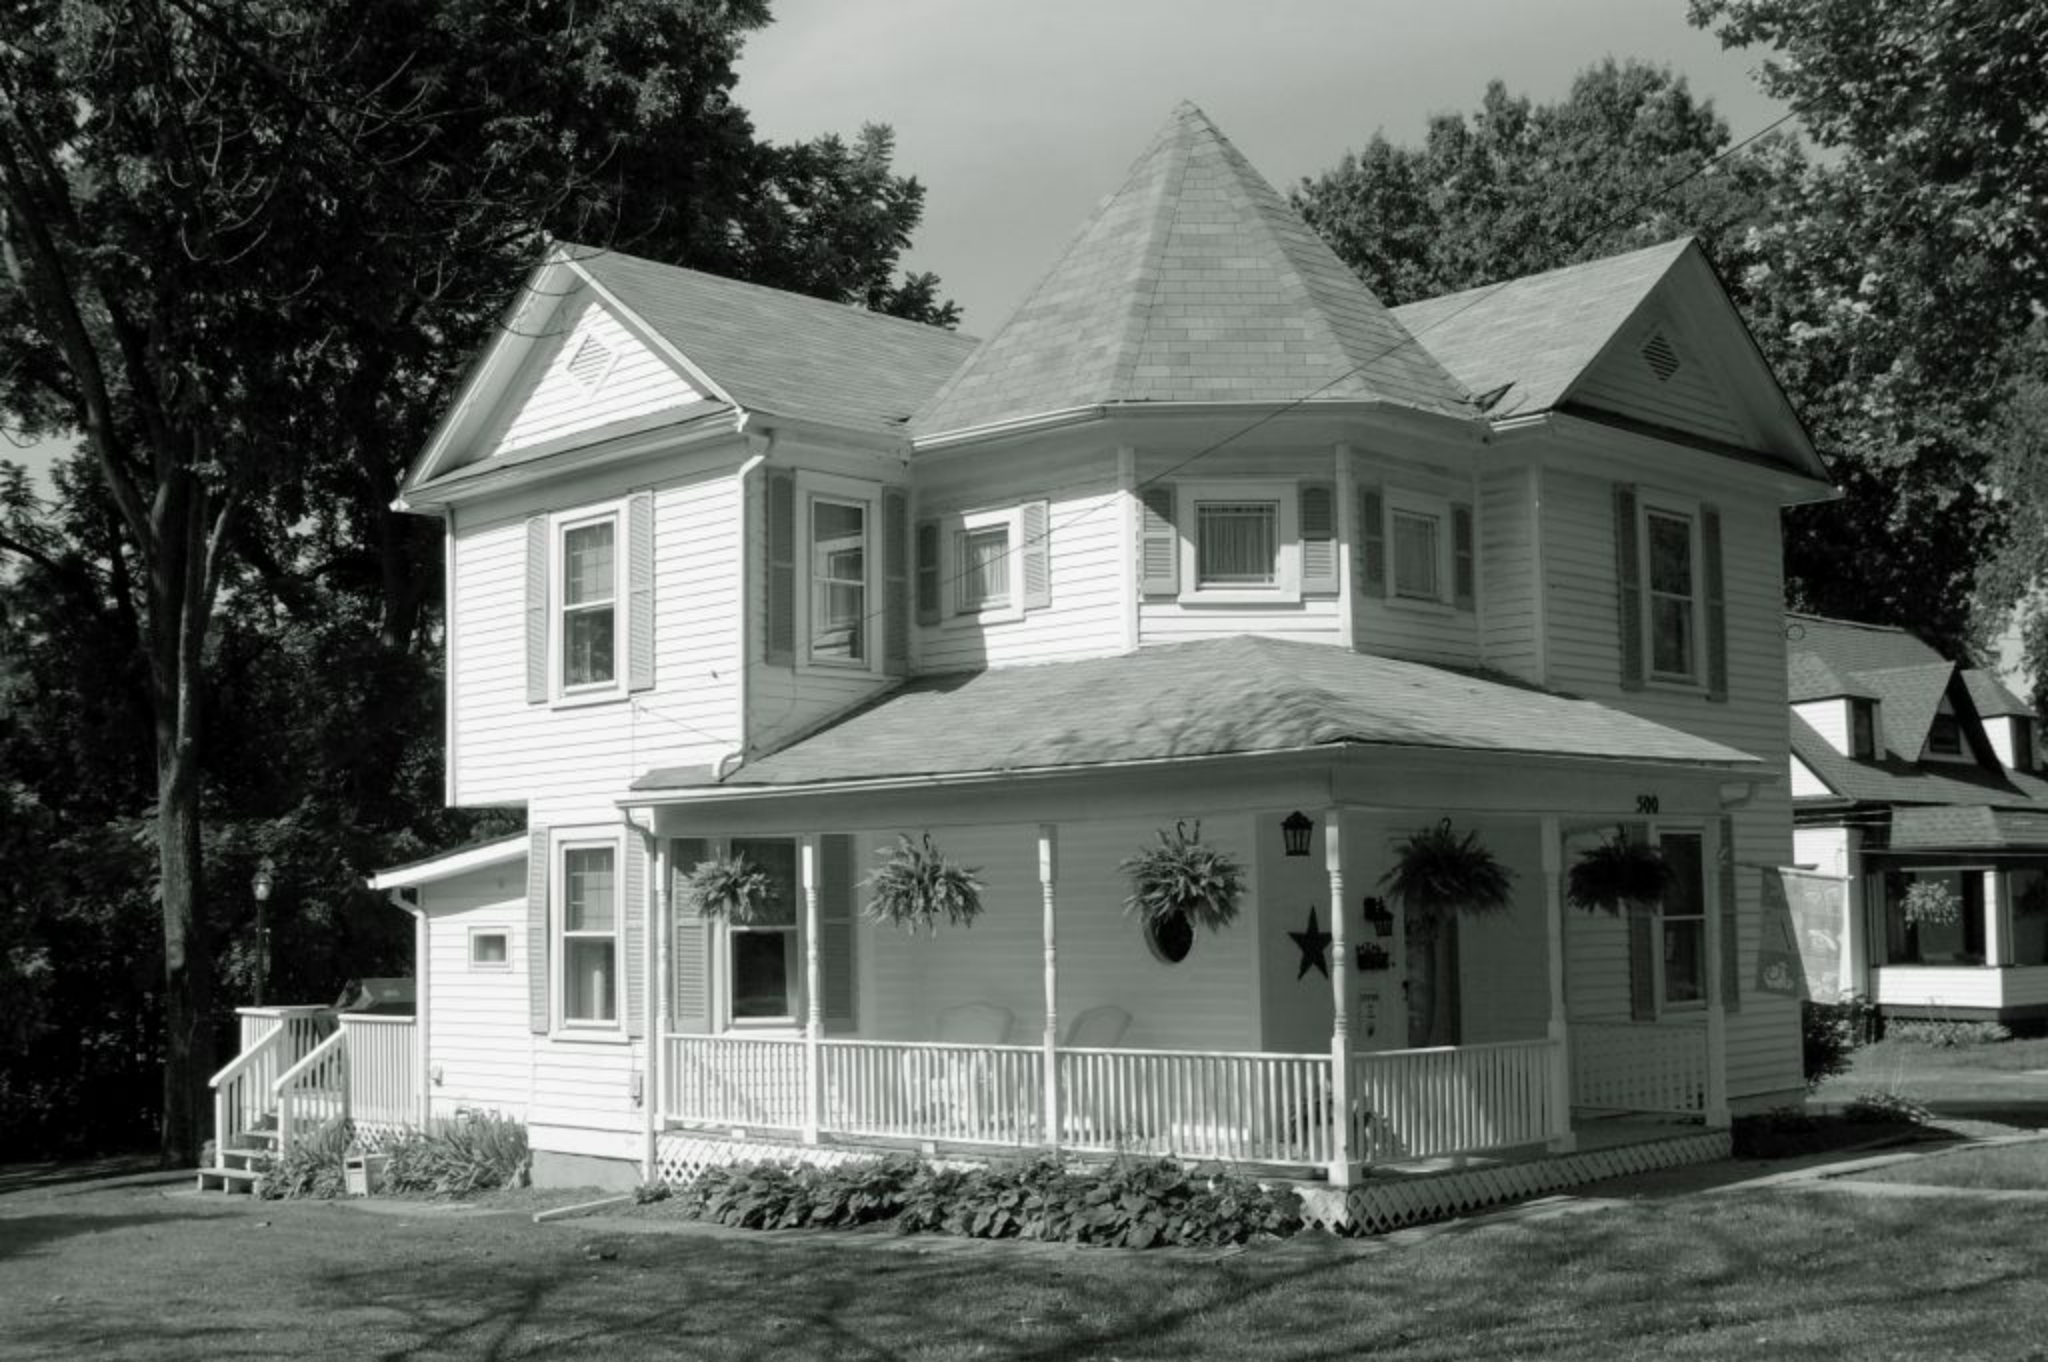
2009 Survey Update: Since the 1983 survey, the porch posts have been replaced with turned posts and a new balustrade, both more appropriate to this era home than the clustered square posts that were on the building in 1983. The front door has an oval light. This is one of the rare remaining homes in this neighborhood that retains its original clapboard siding and it also retains its original wood sashed windows, with aluminum storm windows and storm door. The rear porch has been enclosed or replaced with a shed roofed addition and a new deck added in the back.

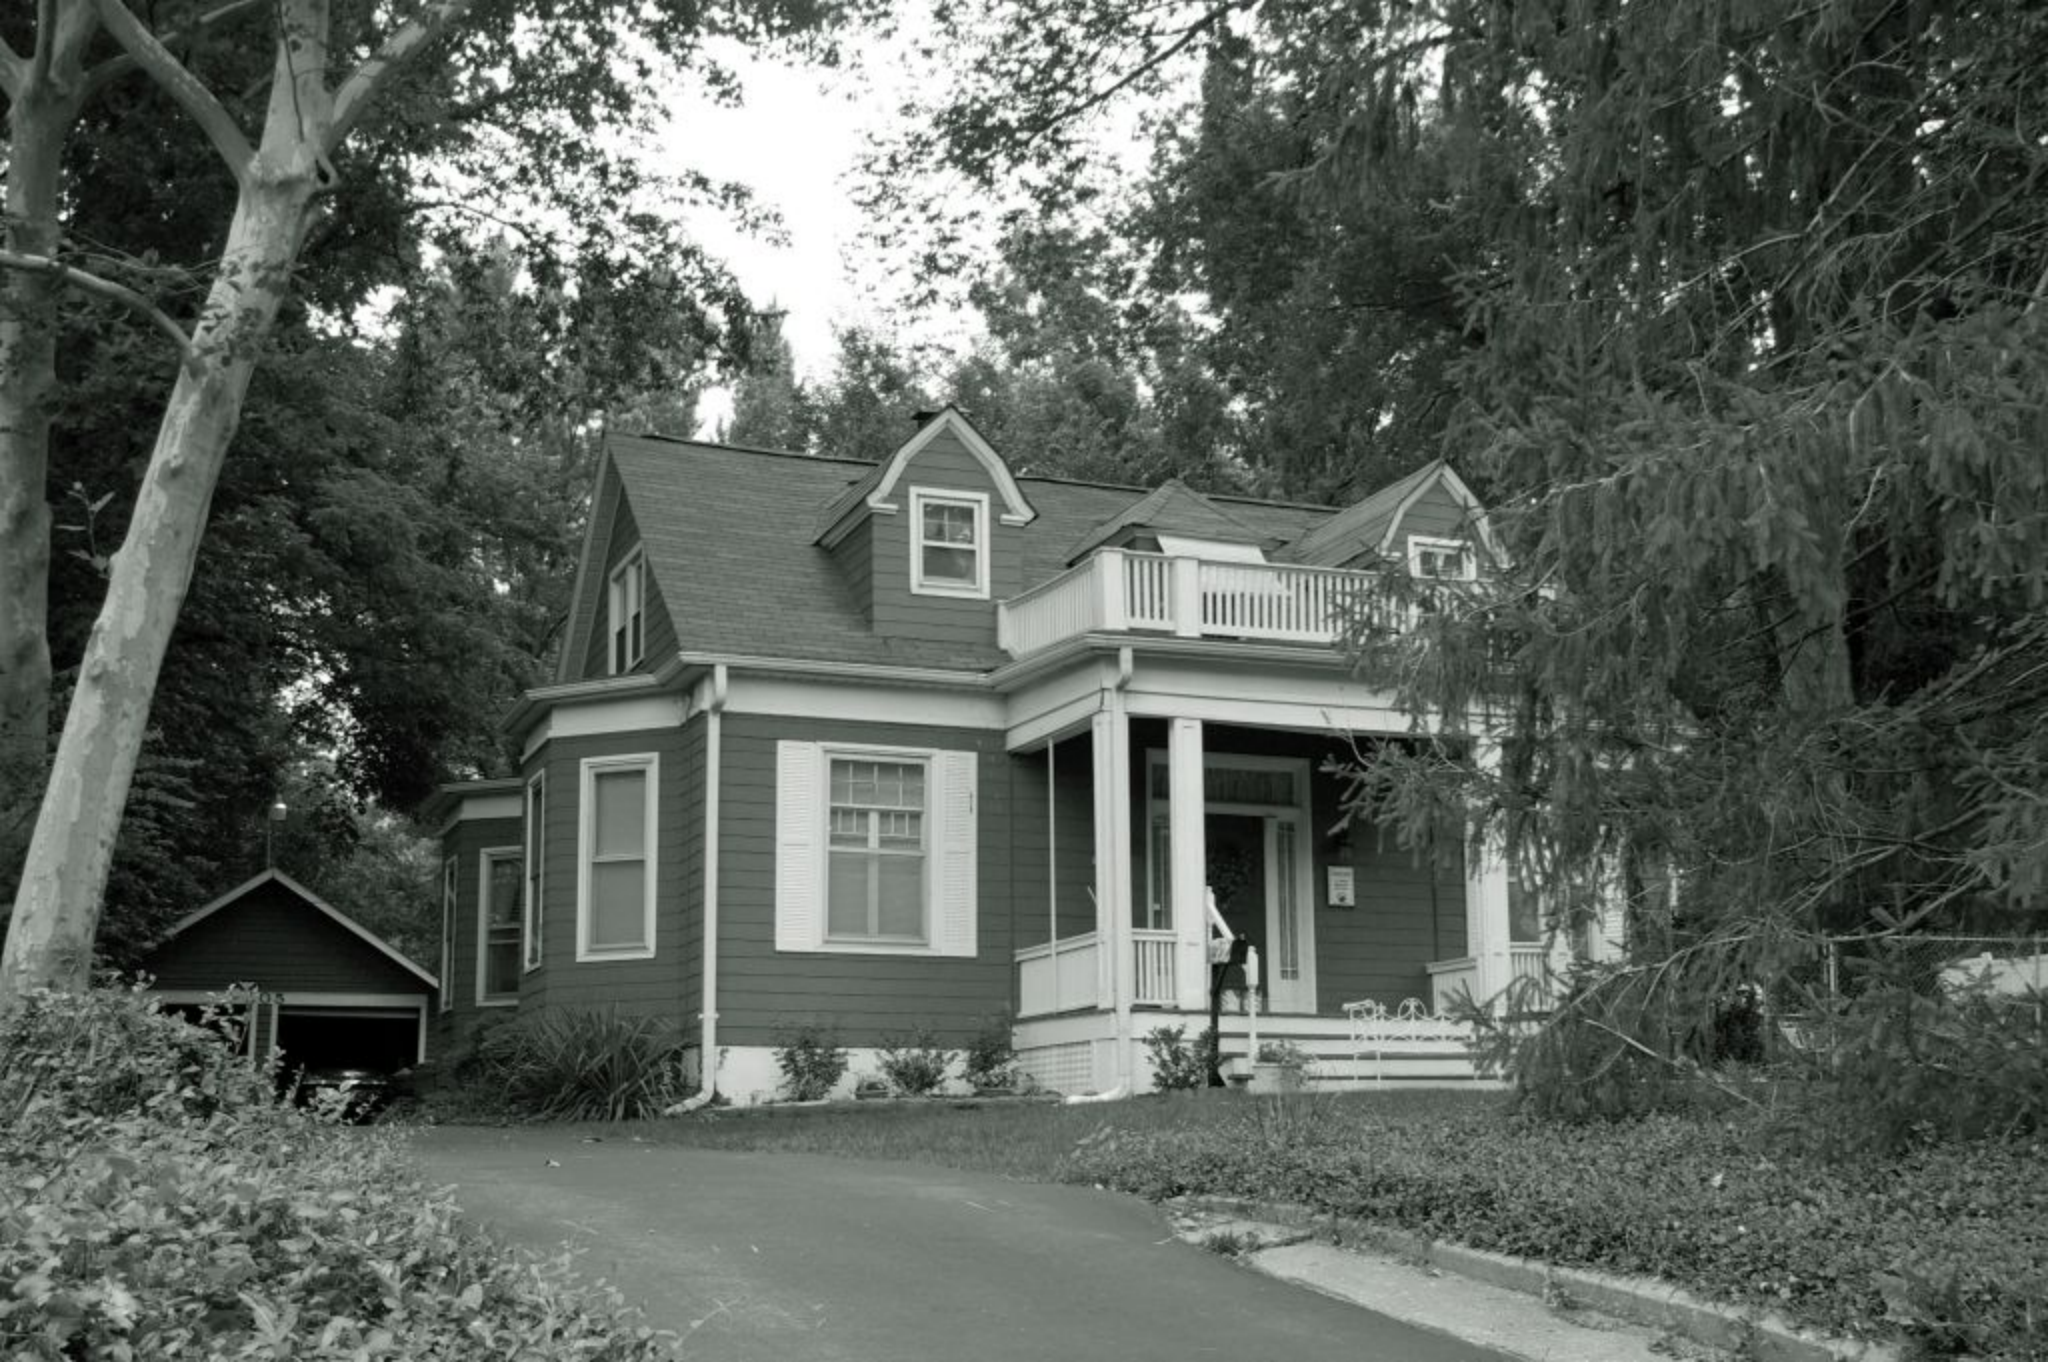
2009 Survey Update: The house retains its original wood lap siding, porch rails and clustered porch posts at each corner as well as the canted oriel windows on the side. The first floor facade windows are paired wooden casements with three lights in each casement, all capped by a four light transom. Unfortunately, the aluminum storm windows do not match the lines of these windows, obscuring this original detail.

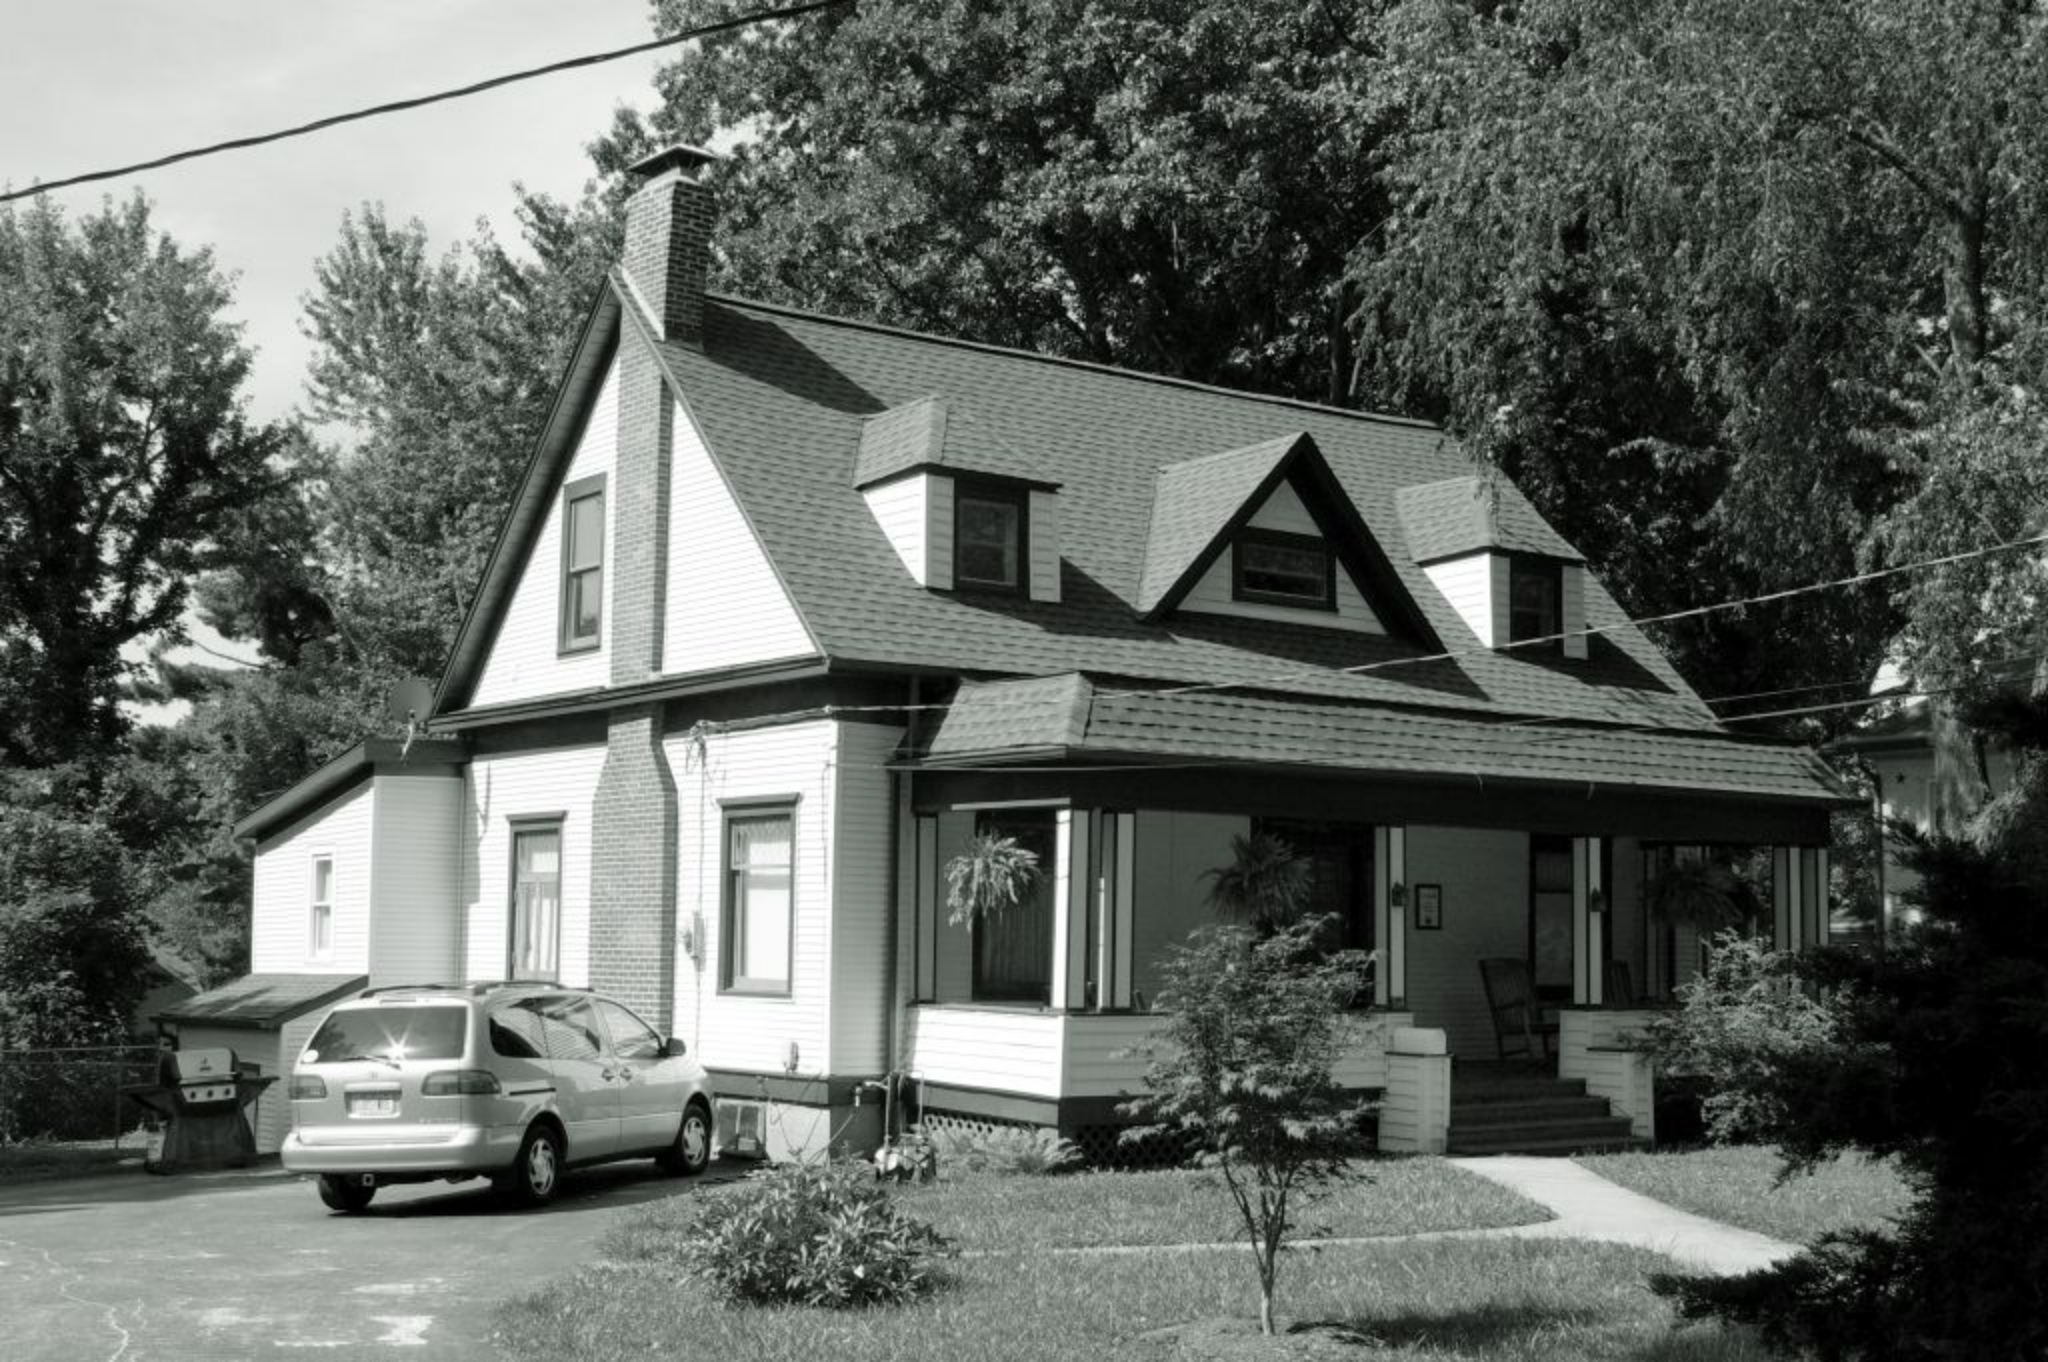
2009 Survey Update: Since the 1983 survey the screening on the porch has been removed, exposing the clustered square columns and revealing the original leaded glass sidelights and transom around the full light door. Most first floor window are an operable sashed window with a large single light on the bottom of what appears to be a diamond patterned transom. The original clapboard and wood shingles have been covered by vinyl siding.

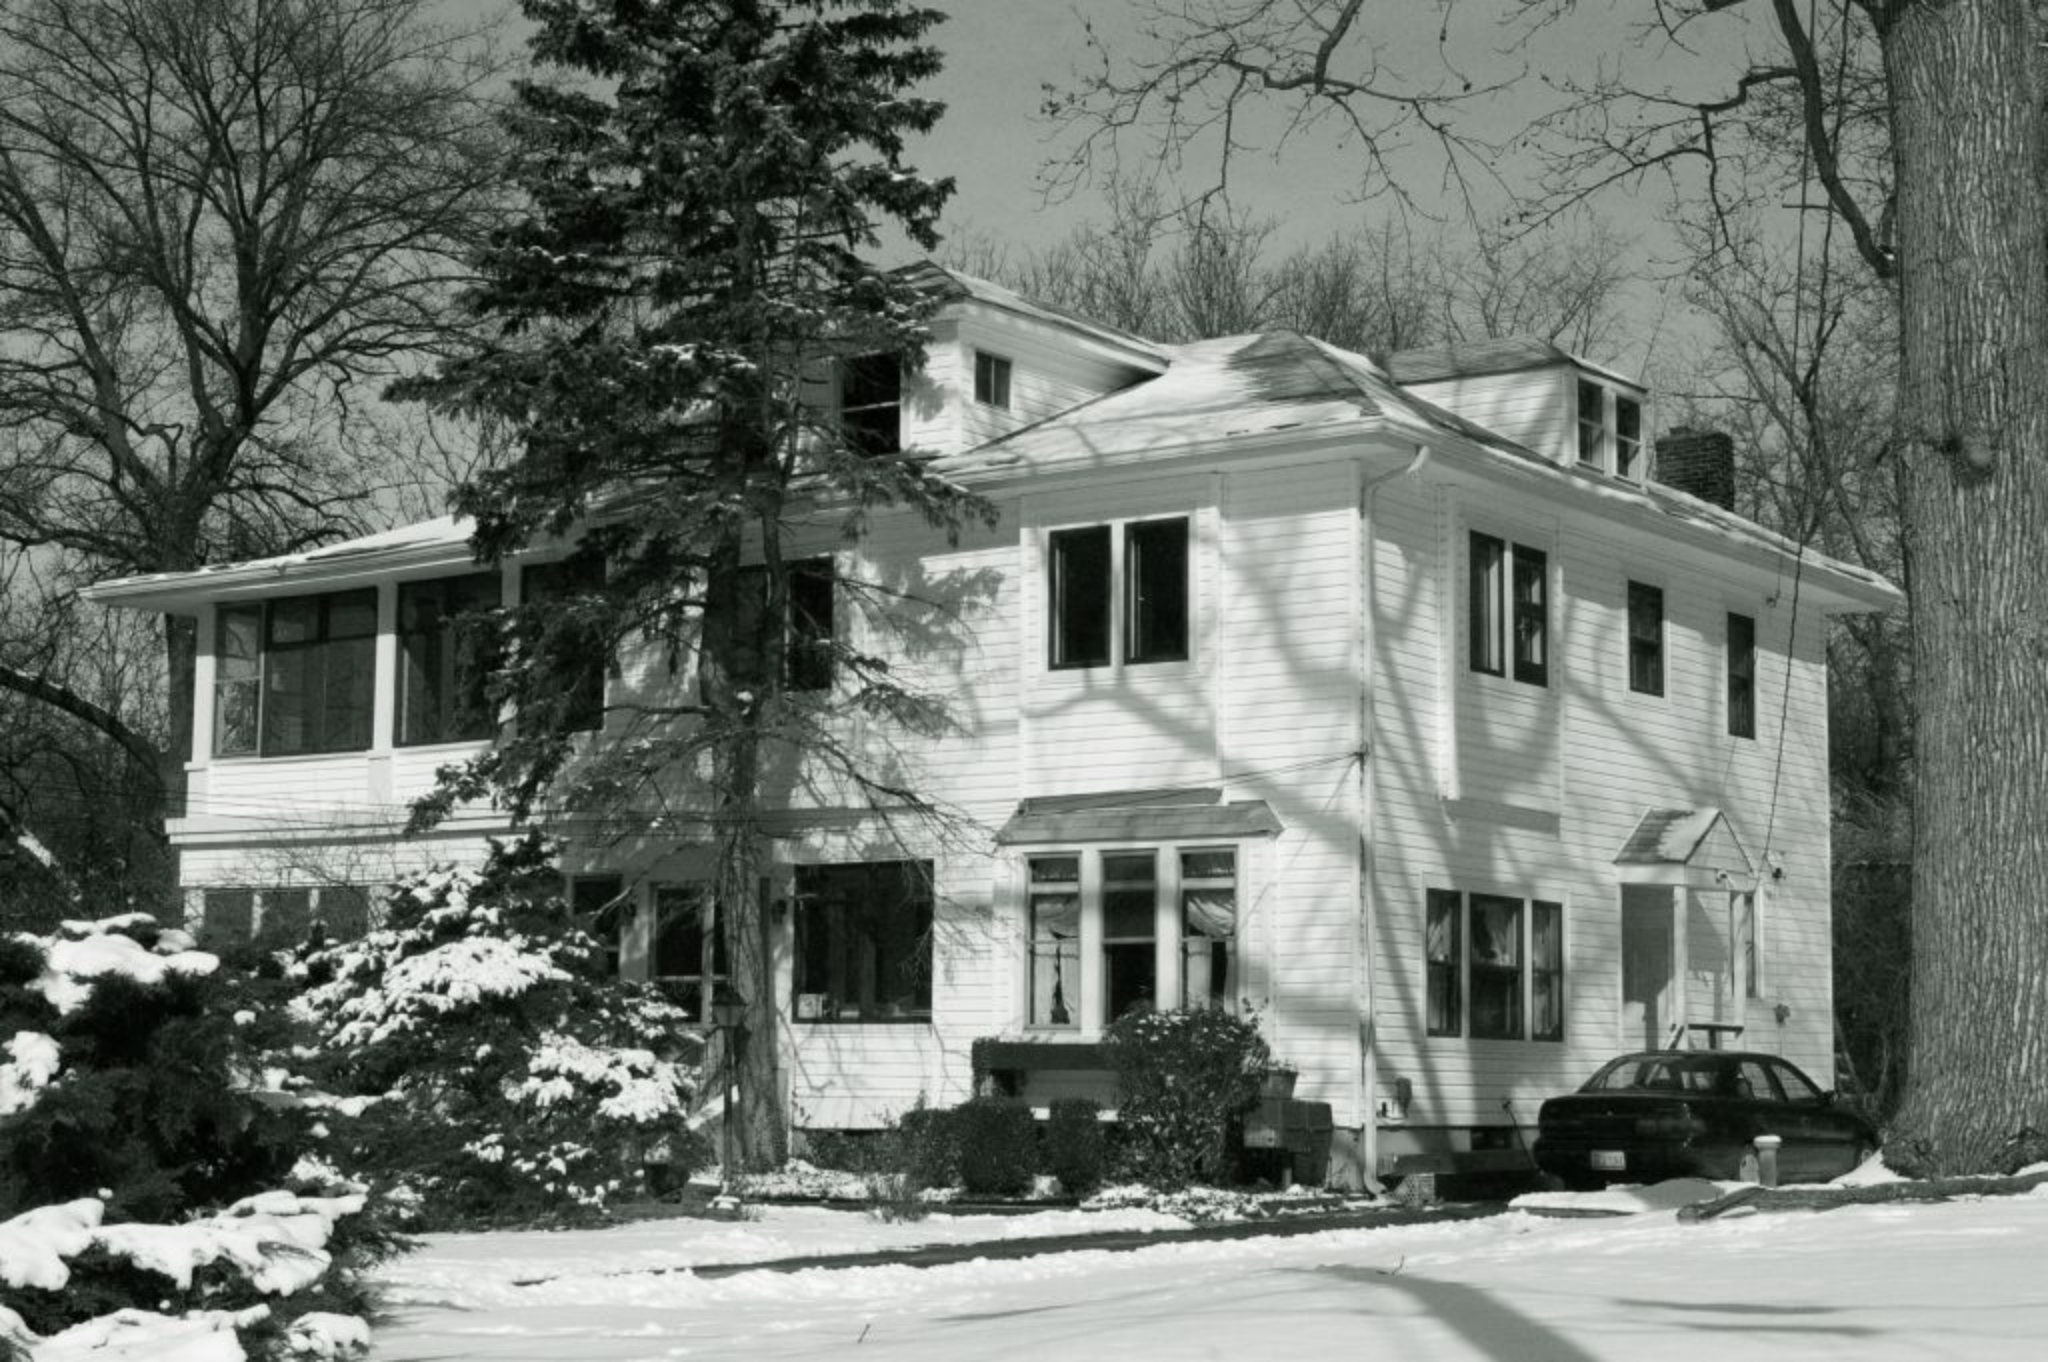
2009 Survey Update: Since the 1983 survey, the wide aluminum siding has been removed and the house was resided with vinyl siding, more closely approximating the original wall finishes. The windows are unusual, wood, single light casements, some with transoms and many with wooden storms now replacing the aluminum storm windows that obscured this original feature. The front hipped dormer has had the paired casement, multipaned windows replaced with sashed windows. The original doorway consists of a door with a single, wide sidelight under an arched roof.

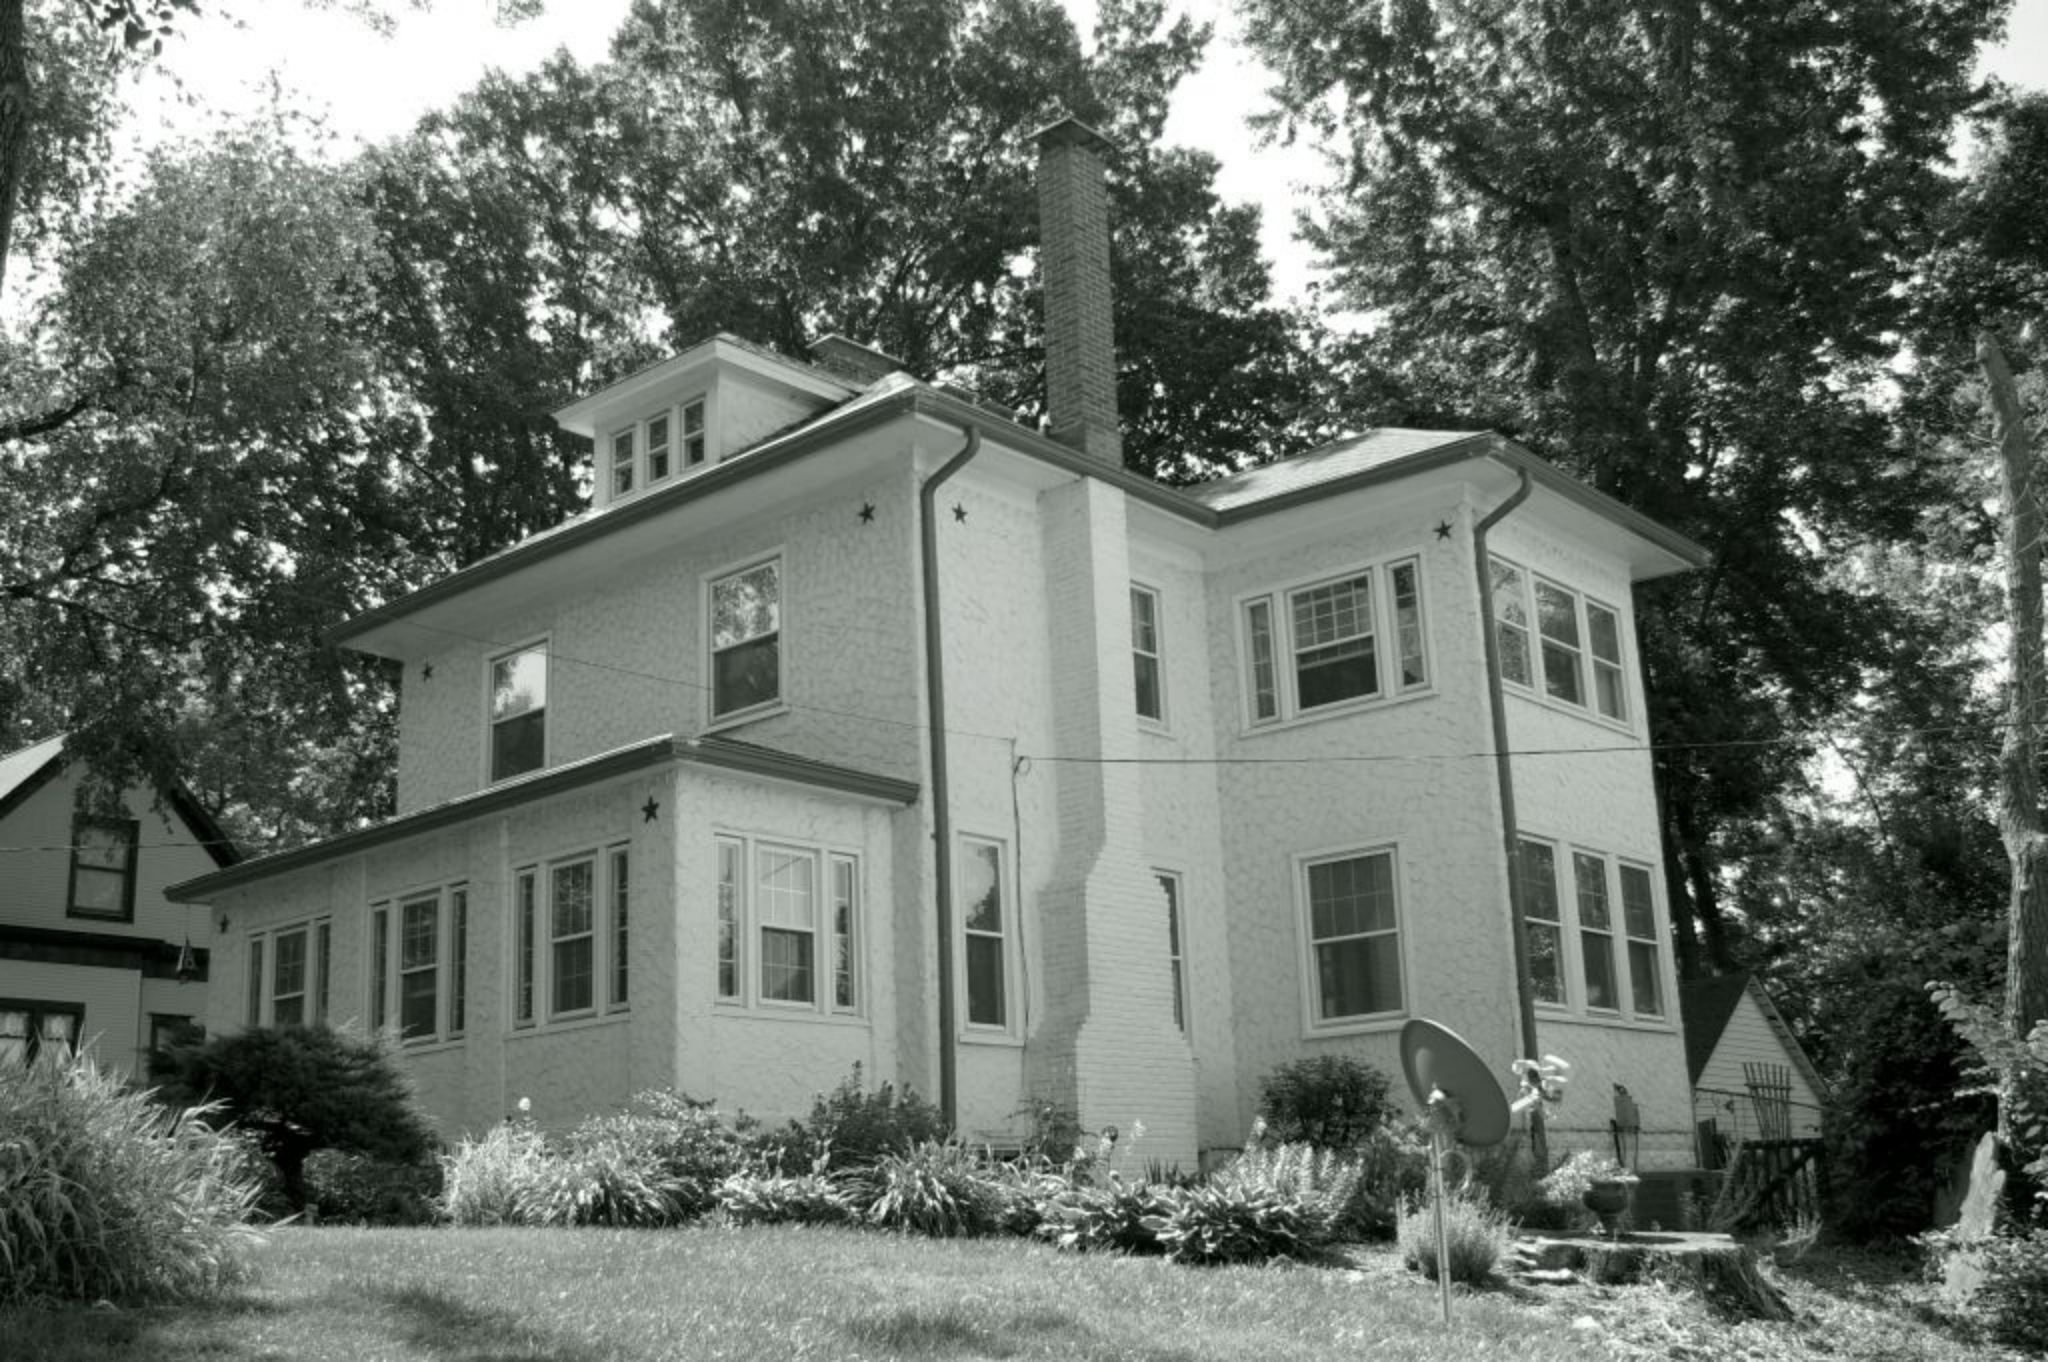
2009 Survey Update: The highly textured stucco house is a Commodius Box plan and since the 1983 survey it has had the windows replaced with vinyl windows, multipaned upper sashes, although the original windows were 1 over 1 windows. The enclosed front porch, which appears to be an original feature, originally had multipaned casement windows, and the replacement vinyl windows are multipaned, but there are now fixed narrow four light windows flanking a 6 over 6 sashed window. Despite the loss of the original window units, the house retains original form and distinctive stucco walls.
