ARCHITECTURAL/HISTORIC INVENTORY FORM

1. Survey No. SL-AS-036-001		2. Survey Name: Architectural Survey of Old Ferguson West	
3. County: St. Louis		4. Address: 1 Carson Rd.	
5. City: Ferguson	Vicinity: <input type="checkbox"/>	6. UTM:	7. Township/Range/Section
8. Historic name (if known):		9. Present/other name (if known): Whistle Stop	
10. Ownership: <input type="checkbox"/> Private <input checked="" type="checkbox"/> Public		11. Historic use (if known): TRANSPORTATION/rail-related	11. Current use: COMMERCE/restaurant & RECREATION/museum

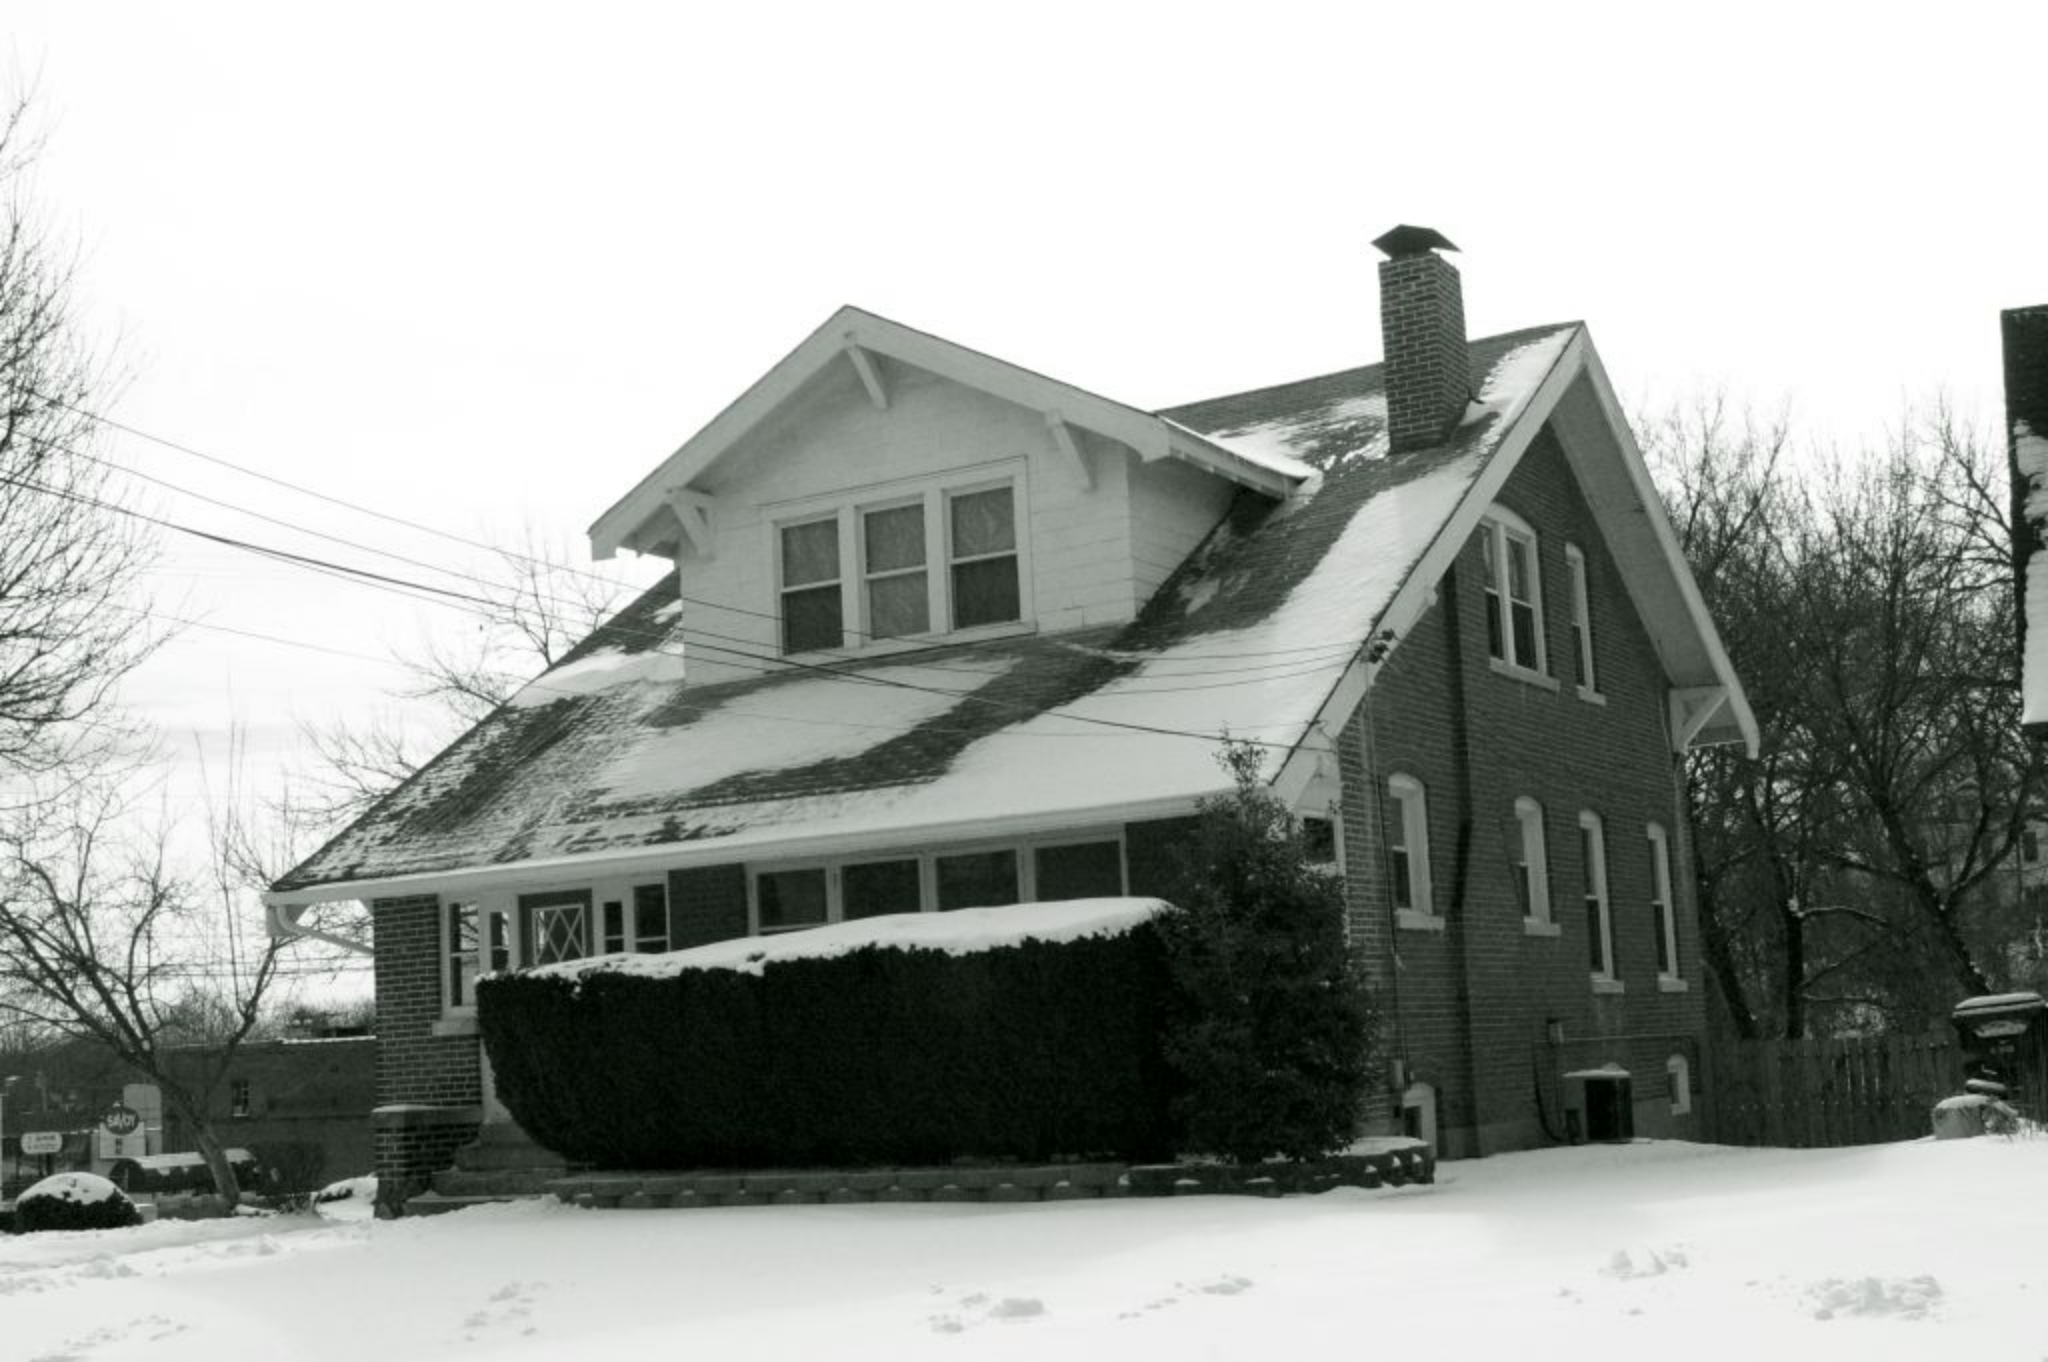
2009 Survey Update: Either the asbestos shingles in the gabled dormer on the facade have been removed, exposing the original wood shingles or that was a mistake in the 1983 survey since it is clearly clad with old wood shingles now. The porch and chimney top have been repointed, with nonmatching mortar. The enclosure on the full width porch is old, and most of it appears to be enclosed with wooden storm windows and doors, but originally this was an open porch based upon both the fire insurance maps and physical treatment of the porch. There is a basement level garage entered from the rear of the house.

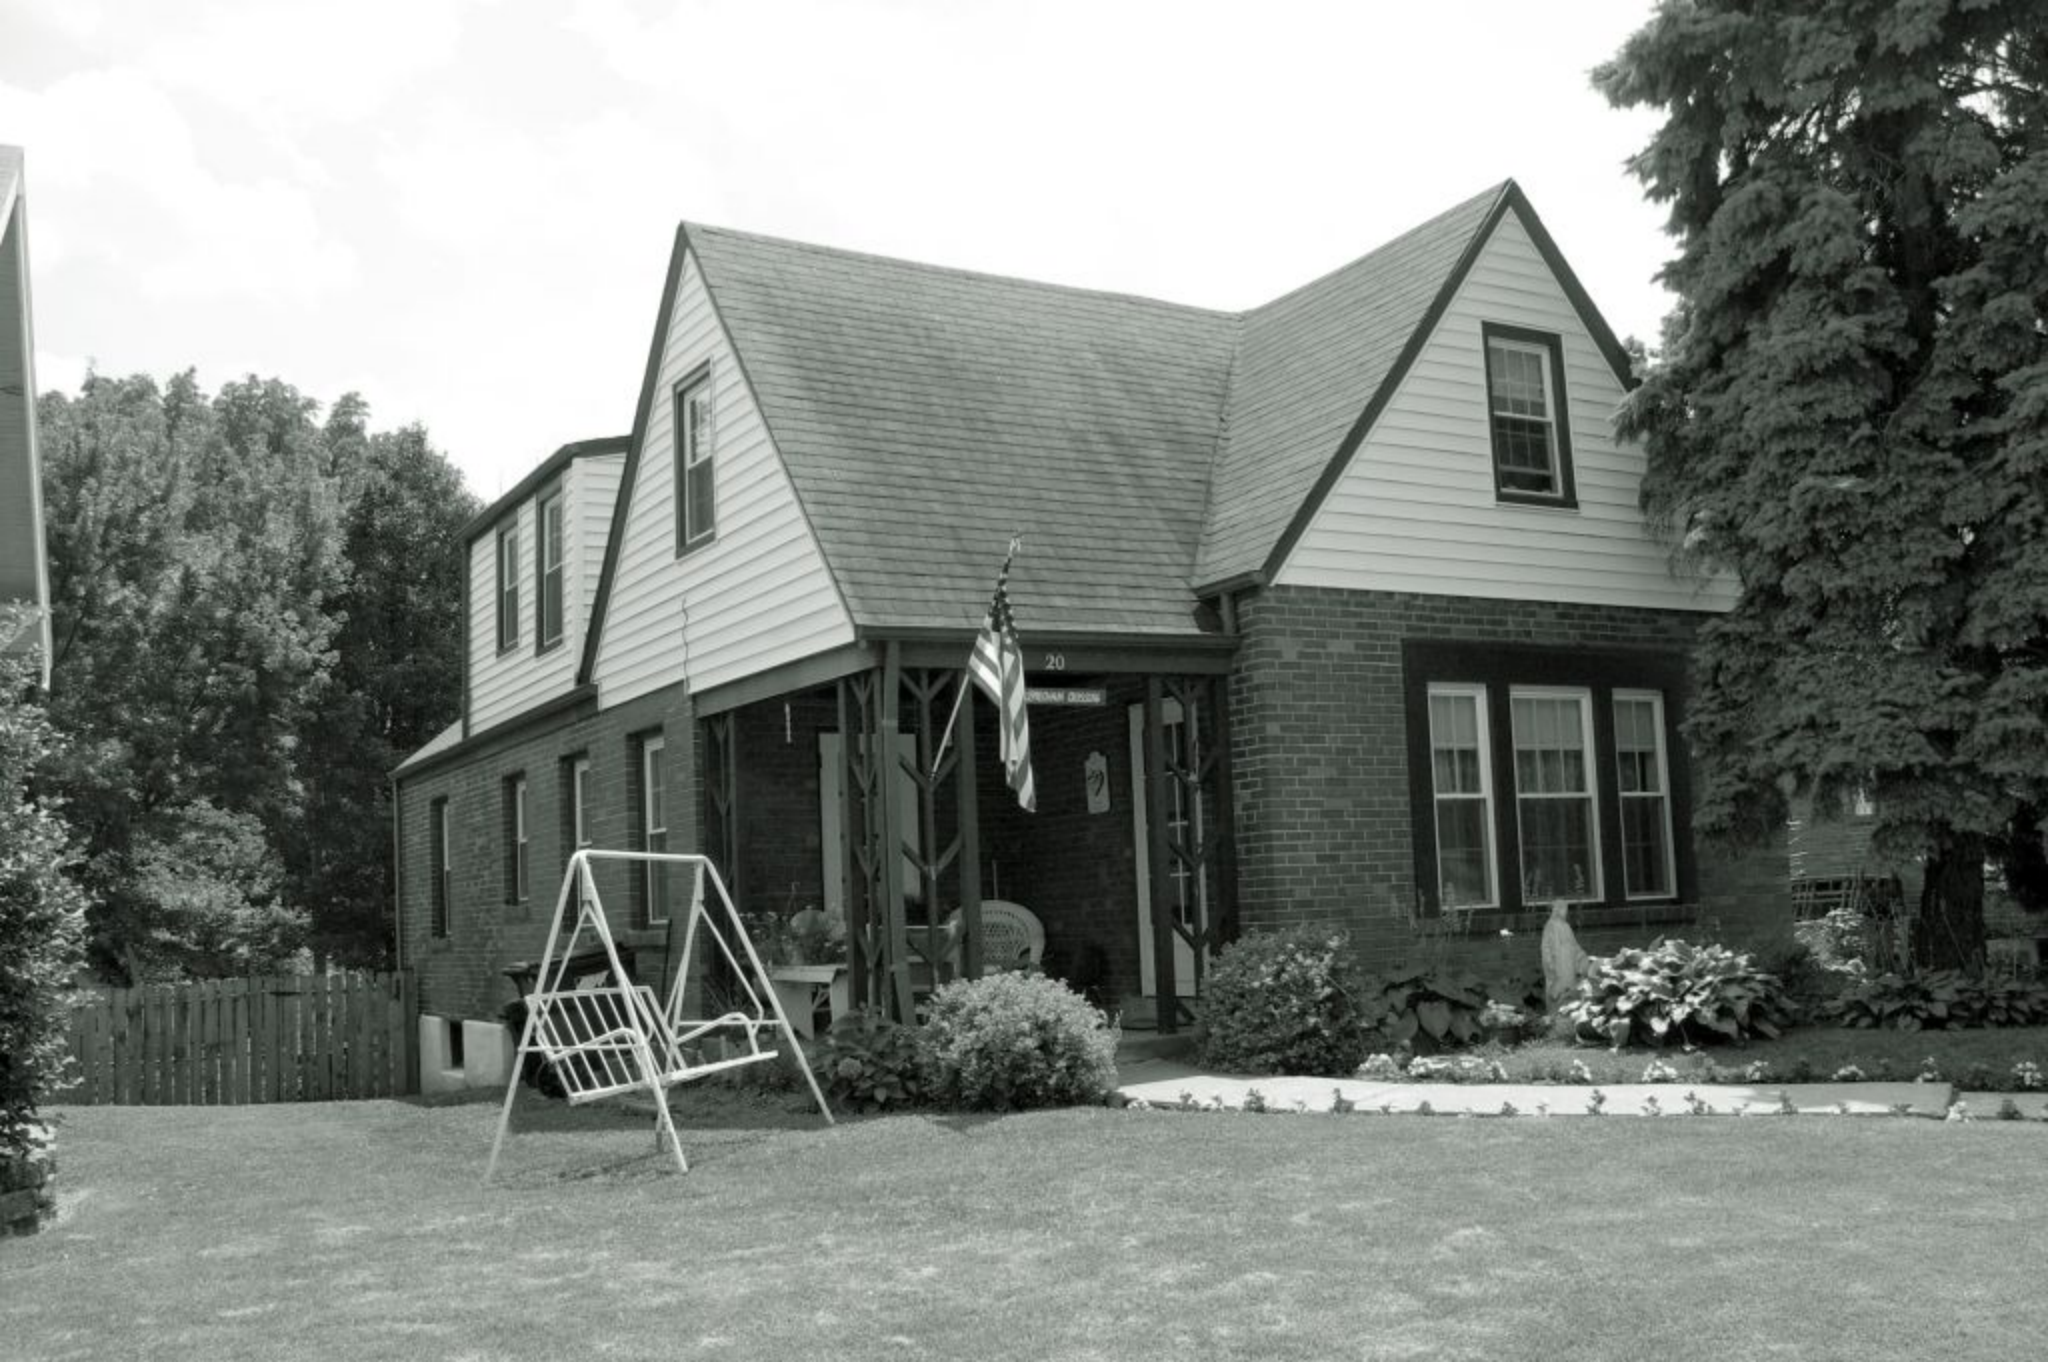
This 1.5 story, multicolored brick, side gabled house has a 1.5 story, cross gabled wing that extends across half of the facade. In this wing, the first floor has a prominent triple window unit framed heavily around the perimeter and consisting of a wider 6 over 6 sashed window flanked by narrower 4 over 4 sashed windows. Above, the gable end has another 6 over 6 sashed window. The open entry porch is recessed under the roof and spans the other half of the facade, with clustered, heavy timber wood supports at both facade corners. The floor of the porch is a concrete slab, slightly elevated off grade and the entry is a multipaned wood framed door that enters into the cross gabled wing, facing east. Behind the main side gable that spans the facade, the rear of the house has a broad intersecting gable, now with large shed roofed dormers. On the east side, the gable end above the open porch is a 6 over 6 sashed window. Behind the gable, there is a shed roofed dormer that appears to be a later addition. On the west elevation, there is an end wall brick chimney centered on the ridge of the gable and behind the chimney there is a broad shed roofed dormer, which appears to be a later addition. The dormers and gable ends have been reclad with vinyl siding, and the windows appear to have storm windows added to the original wood sashed windows. There is a garage in the basement accessed from the rear of the house.

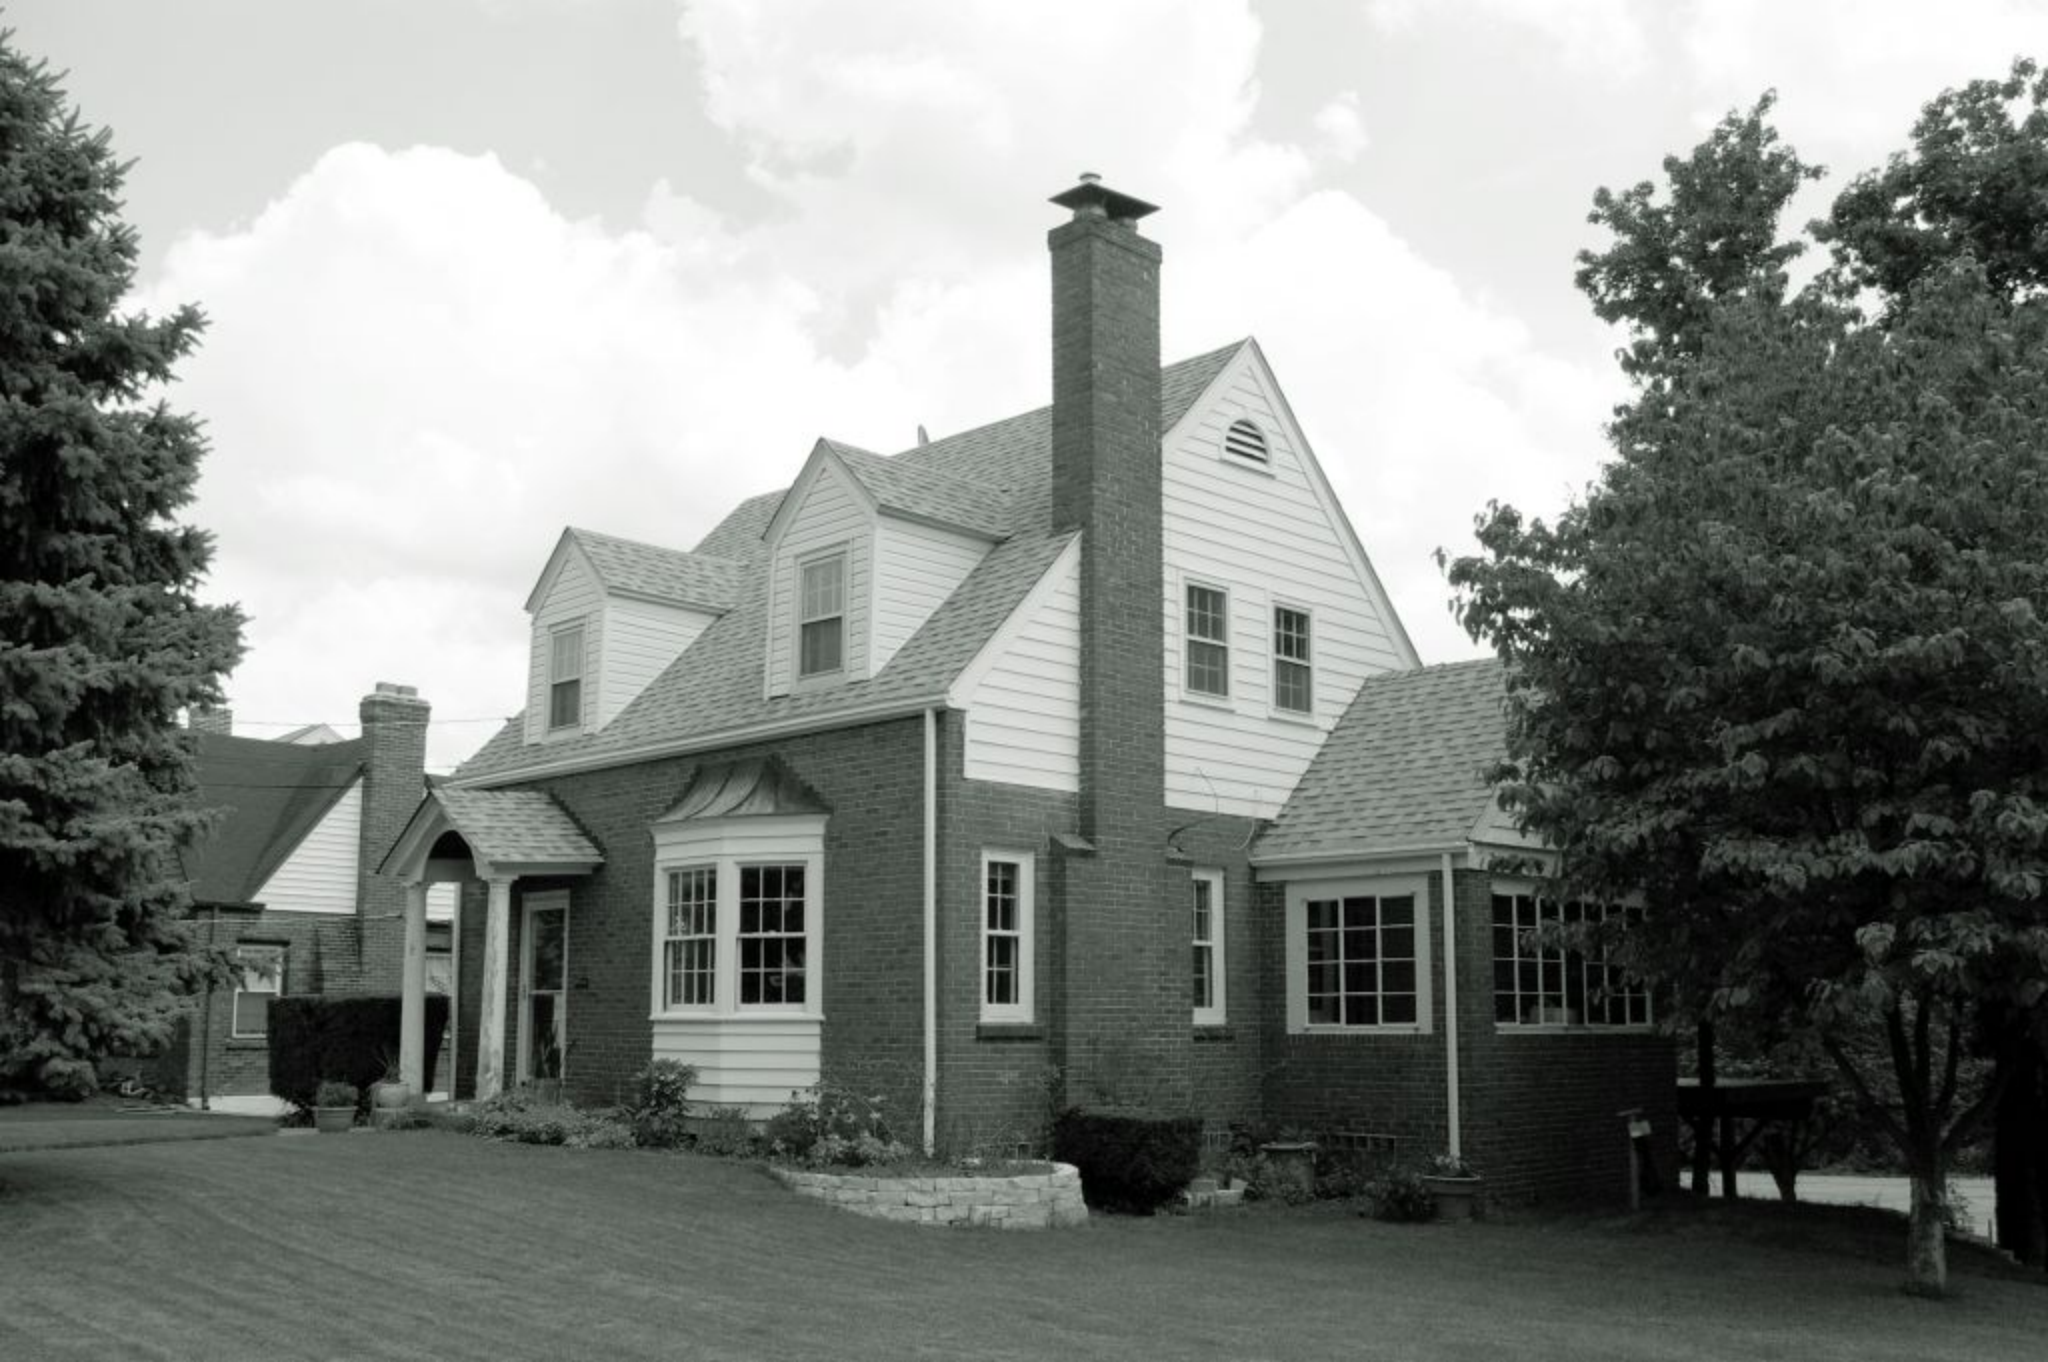
This 1.5 story Cape Cod brick house has a two bay facade with a small side gabled, one story sunroom wing on the west side, positioned near the rear of that elevation. Over the simple entry with its paneled door is a gabled roof which is arched underneath where its barrel vault shape has a small pendant lantern-style porch light (which is probably original to the house). This porch roof is supported by two wooden, Tuscan style columns which rest on the low concrete slab in front of the door. On the other bay of the facade is a canted bay window with wood paneling below the wooden sashed windows (multipaned in both sashes). This bay window has a standing seam, copper roof. There are two gabled dormers on the facade with 6 over 6 wood sashed windows. On the west side, there is a brick end wall chimney (which appears to have its original chimney pots below the newer metal cap), flanked on the first floor by 4 over 4 wood sashed windows. On the second floor behind the chimney are two 6 over 6 wood sashed windows and a small half-round attic vent. The sunroom has a multipaned steel caement window units, with 12 lights on the facade opening. On the east elevation there are multipaned wood sashed windows on both the first and second floor as well as another half-round attic vent. The gable ends of the house and sunroom all retain the original wood clapboard siding (as does the bay window), but the dormers have new vinyl siding. Some windows have wooden storm windows but others have aluminum storms and the bay window appears to have no storms or screens. There is a full light aluminum storm door on the entry door and a newer wood deck on the rear. The basement level garage is accessed via the driveway on the east side of the house and the door on the rear elevation.

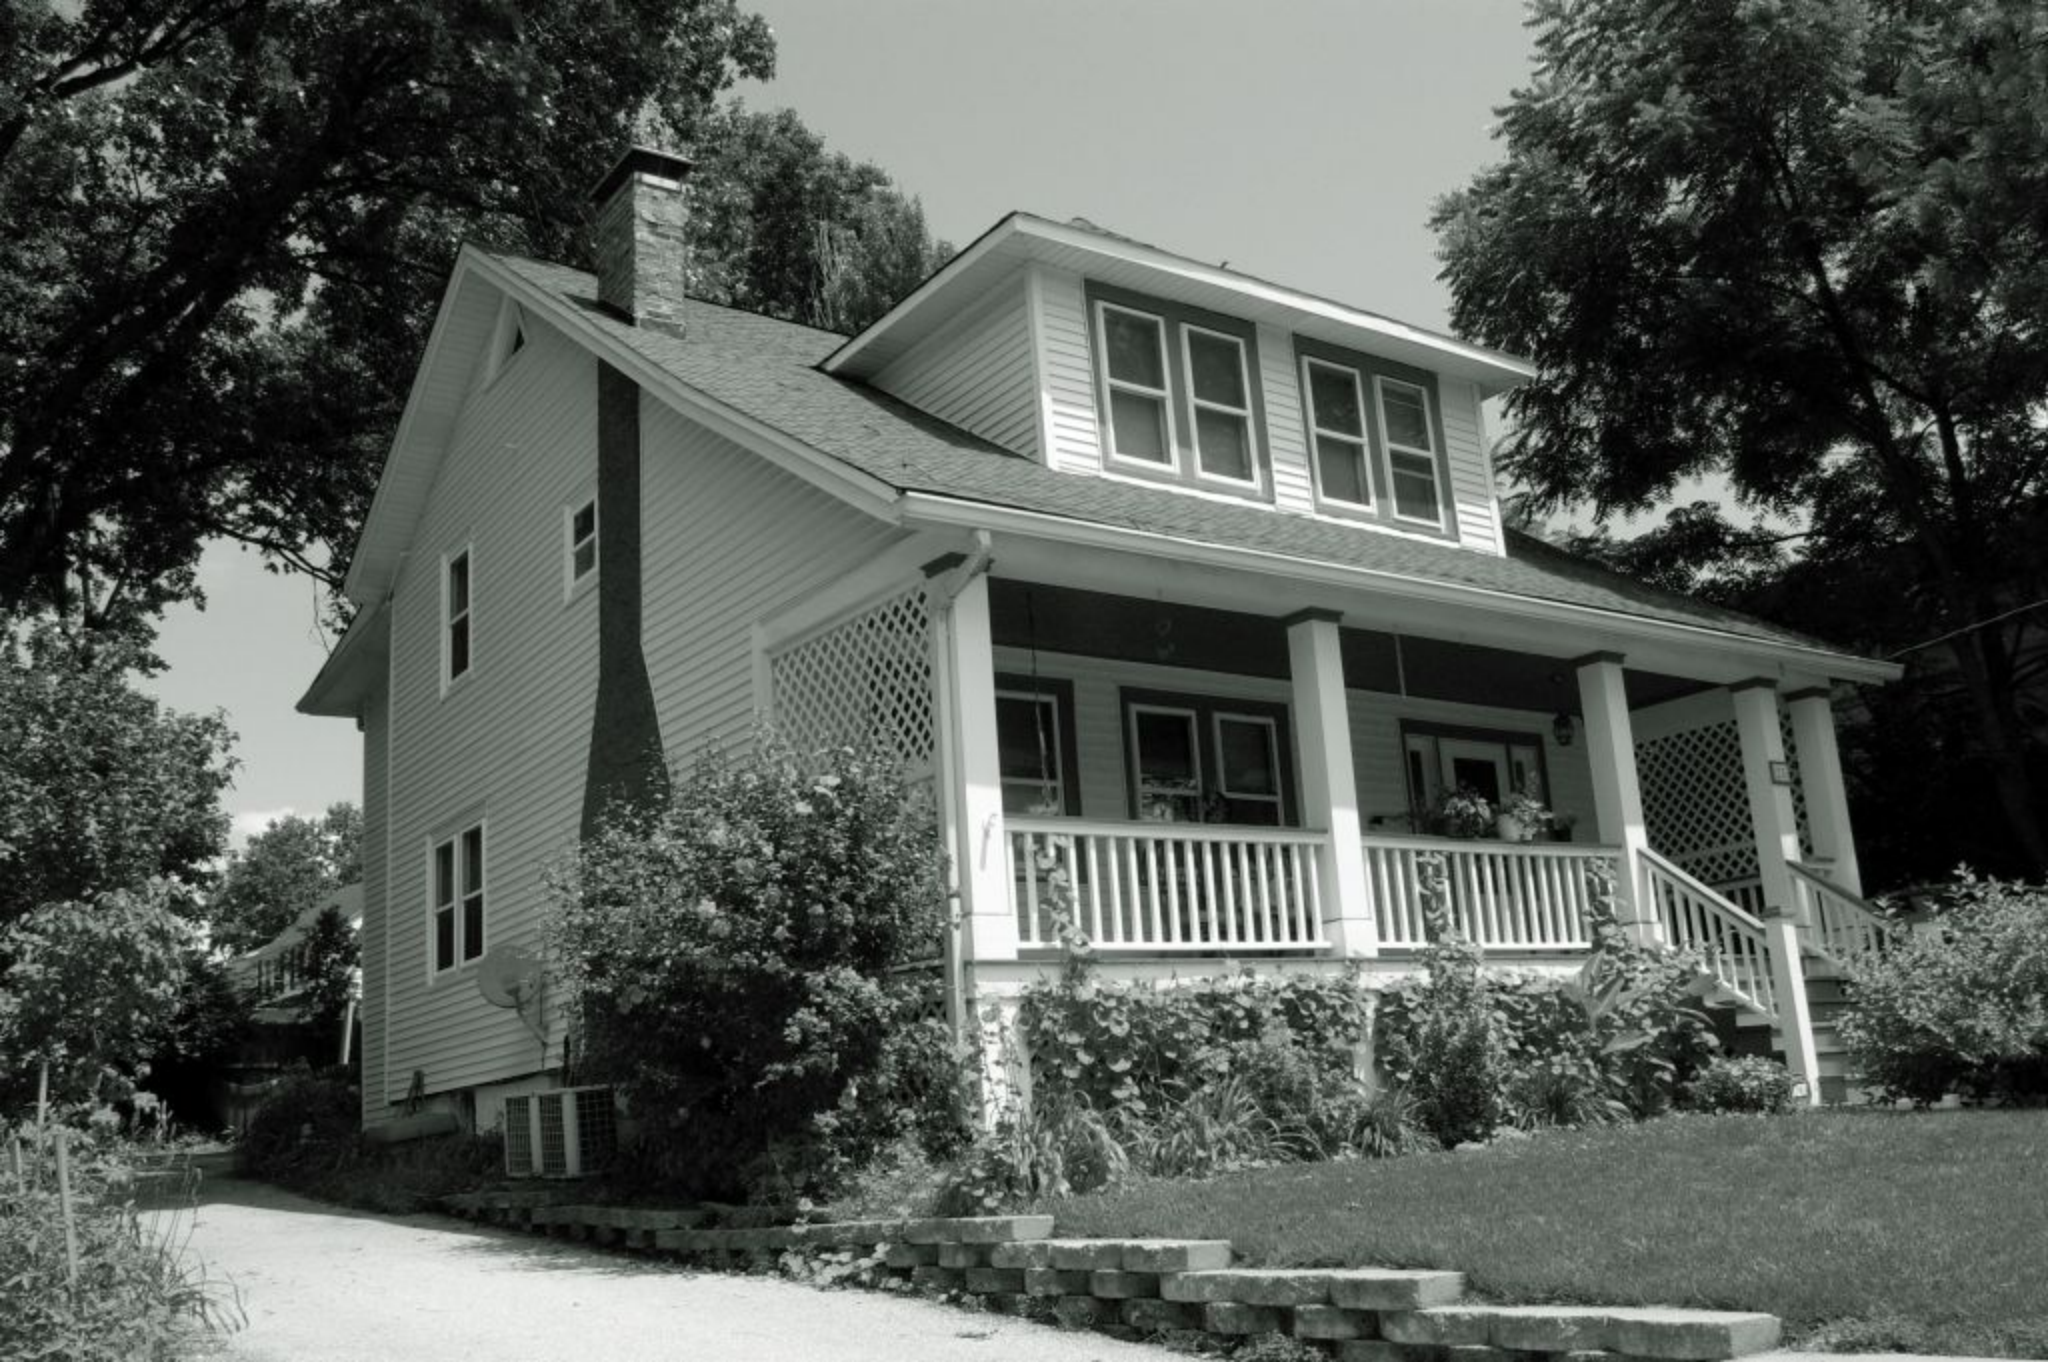
2009 Survey Update: The rear addition noted in the 1983 survey is shown as a 2 story open porch on the 1950 fire map (dating the addition to 1931-50), including the second floor that overhangs beyond the east elevation wall, but it has been an enclosed porch for many years, even prior to the 1983 survey. Since 1983, the asbestos siding has been replaced with vinyl siding which is probably closer to the original siding material, carefully retaining the original window trim, but the enclosure of the eaves with vinyl eliminated the brackets on the main roof. The nonhistoric porch railing balusters have been replaced with new square balusters (it is unclear whether the railing itself was replaced since it appears the same) and matching railings have been added to the steps.

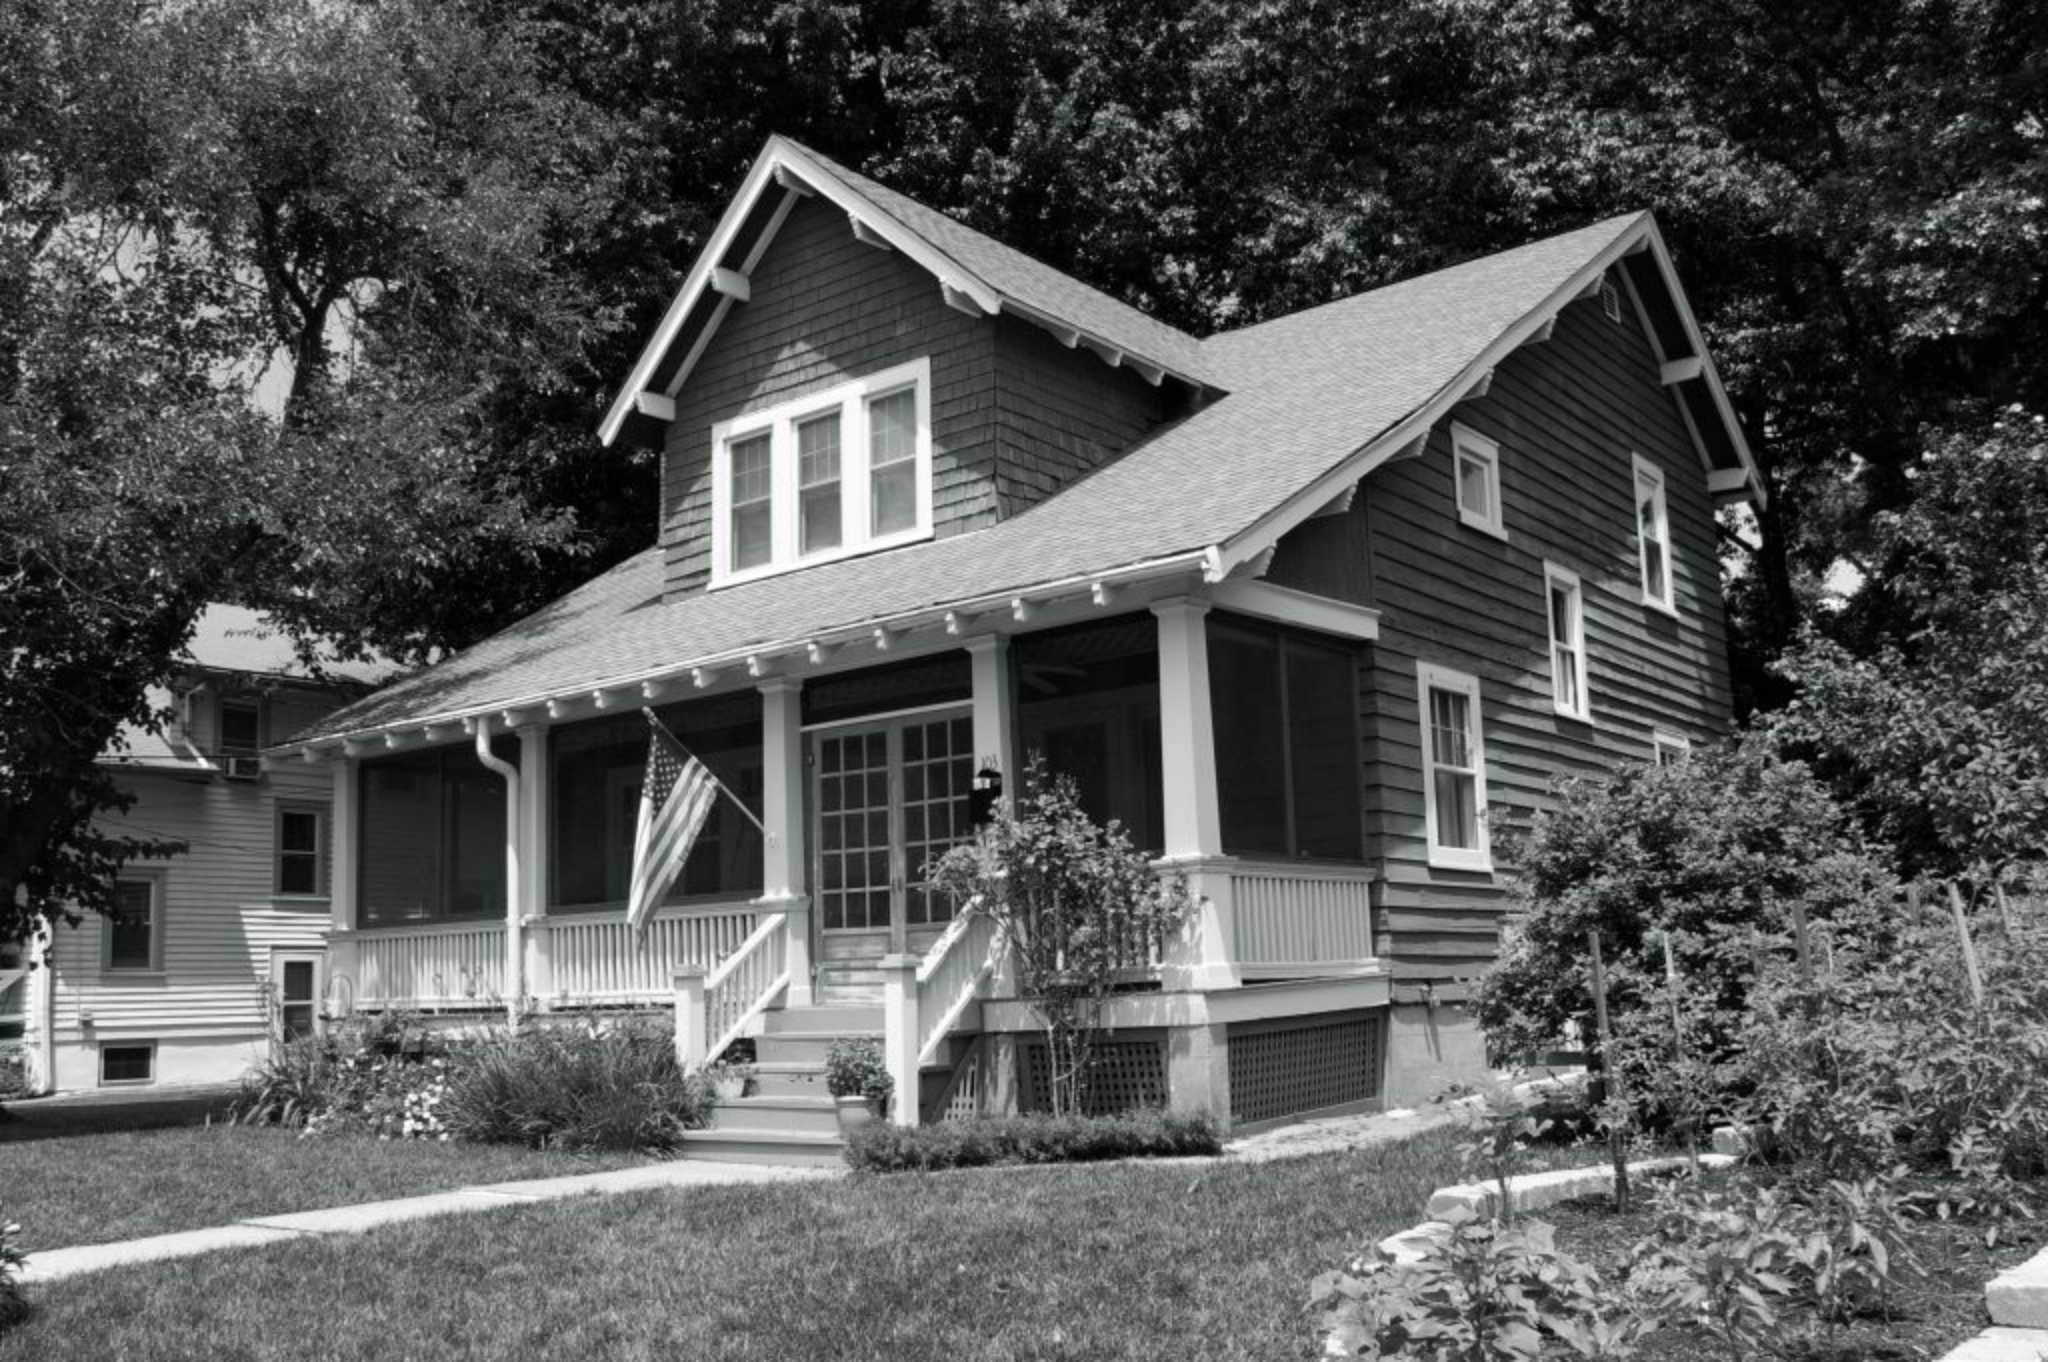
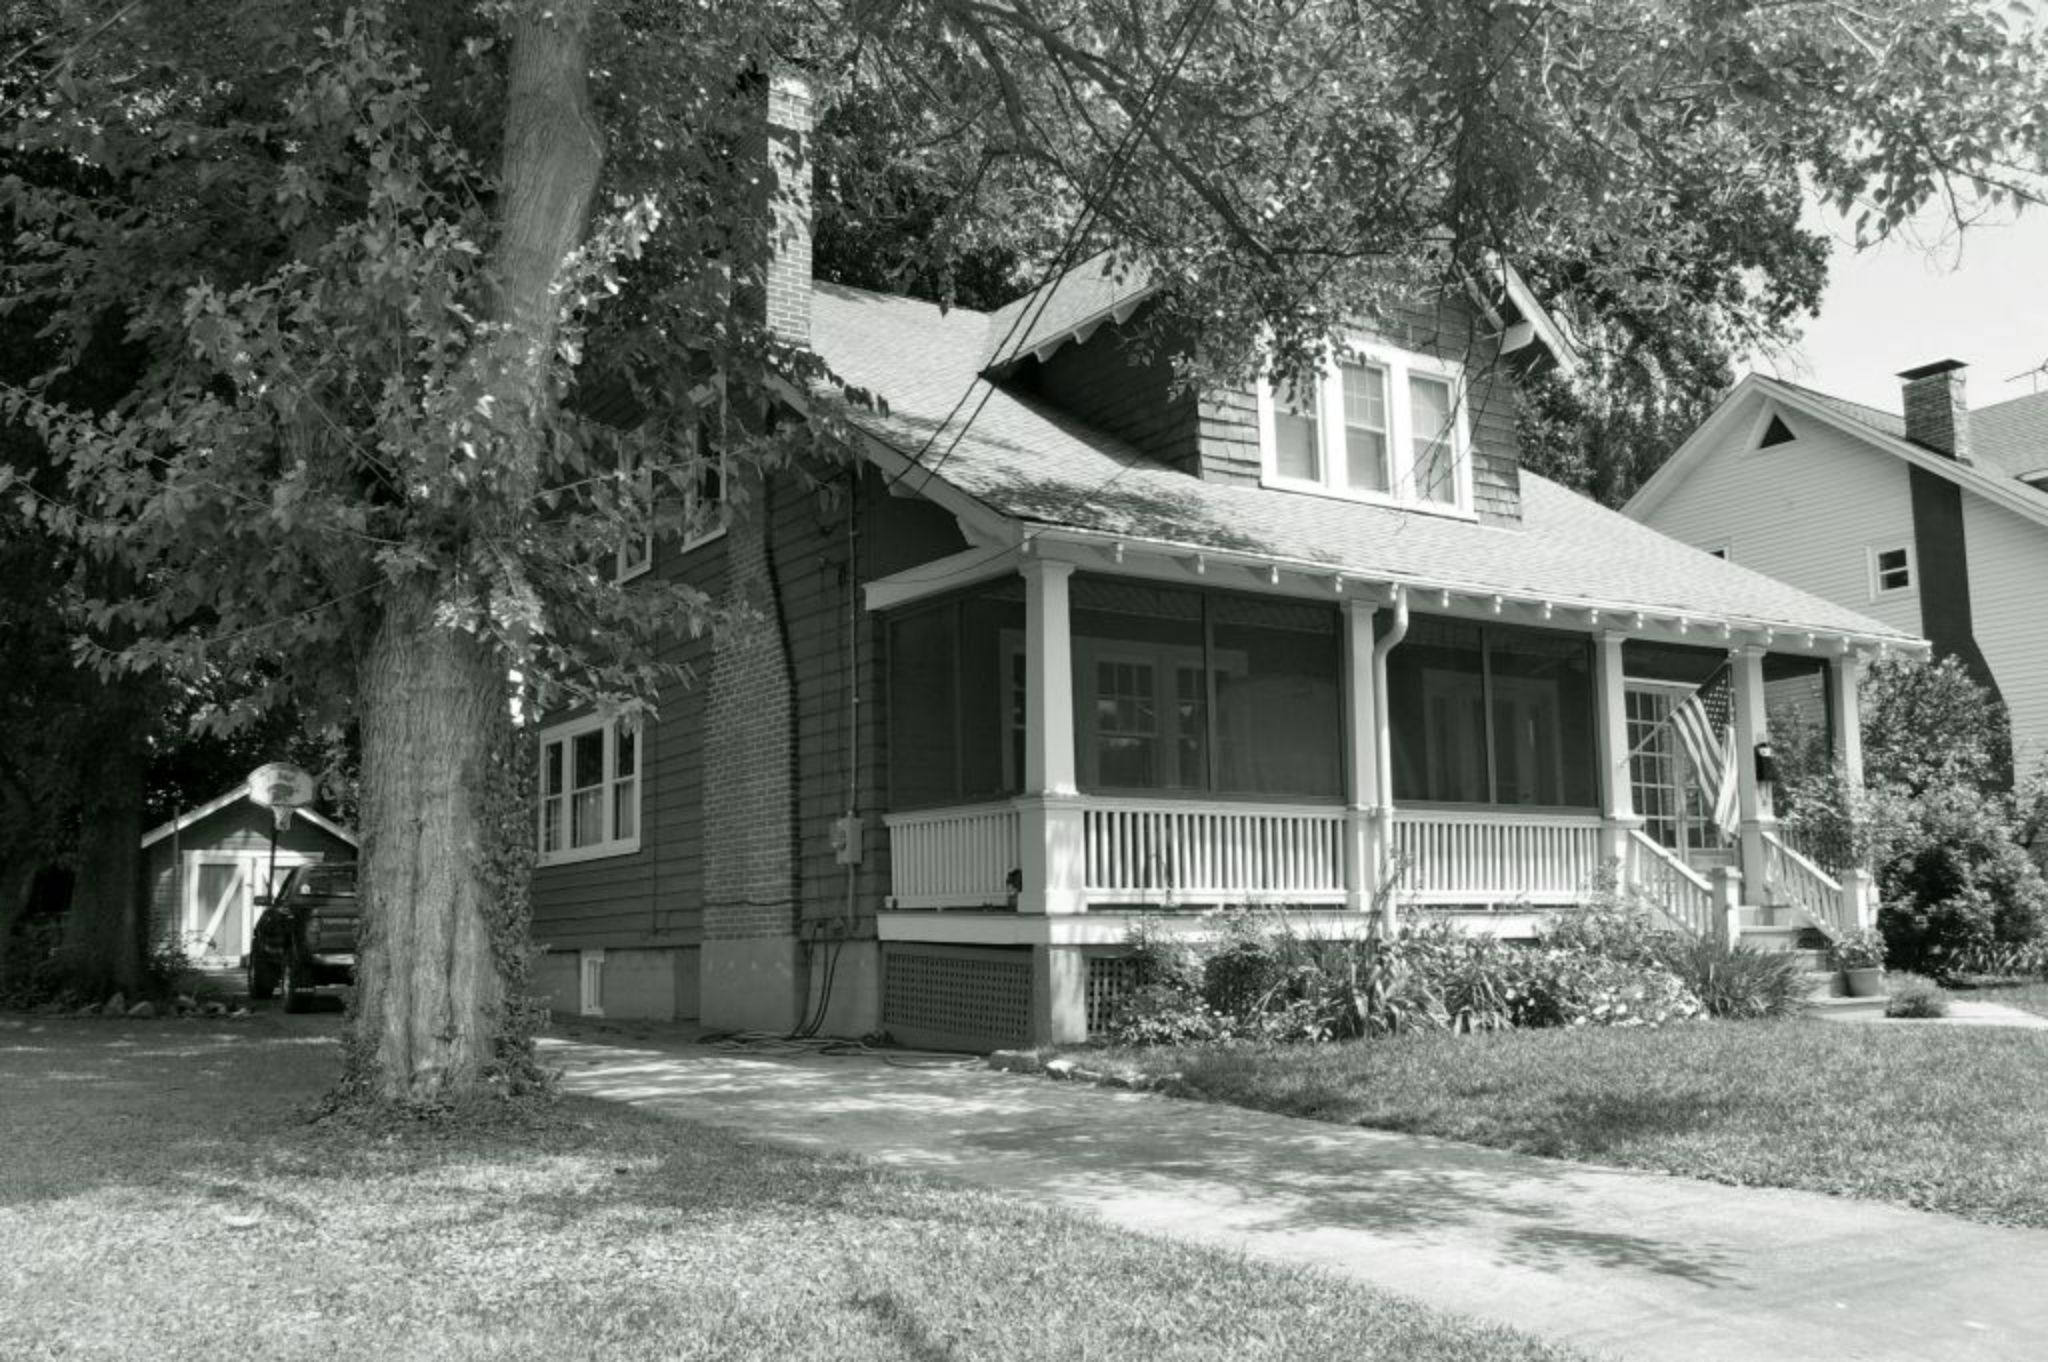
2009 Survey Update: Since the 1983 survey, the only change to this immaculately original Craftsman bungalow has been the very discreet installation of screening and accompanying doors on the porch with the screening installed on top of the railings and utilizing a screening material that does not substantially obscure visibility of the windows and entry on the porch.

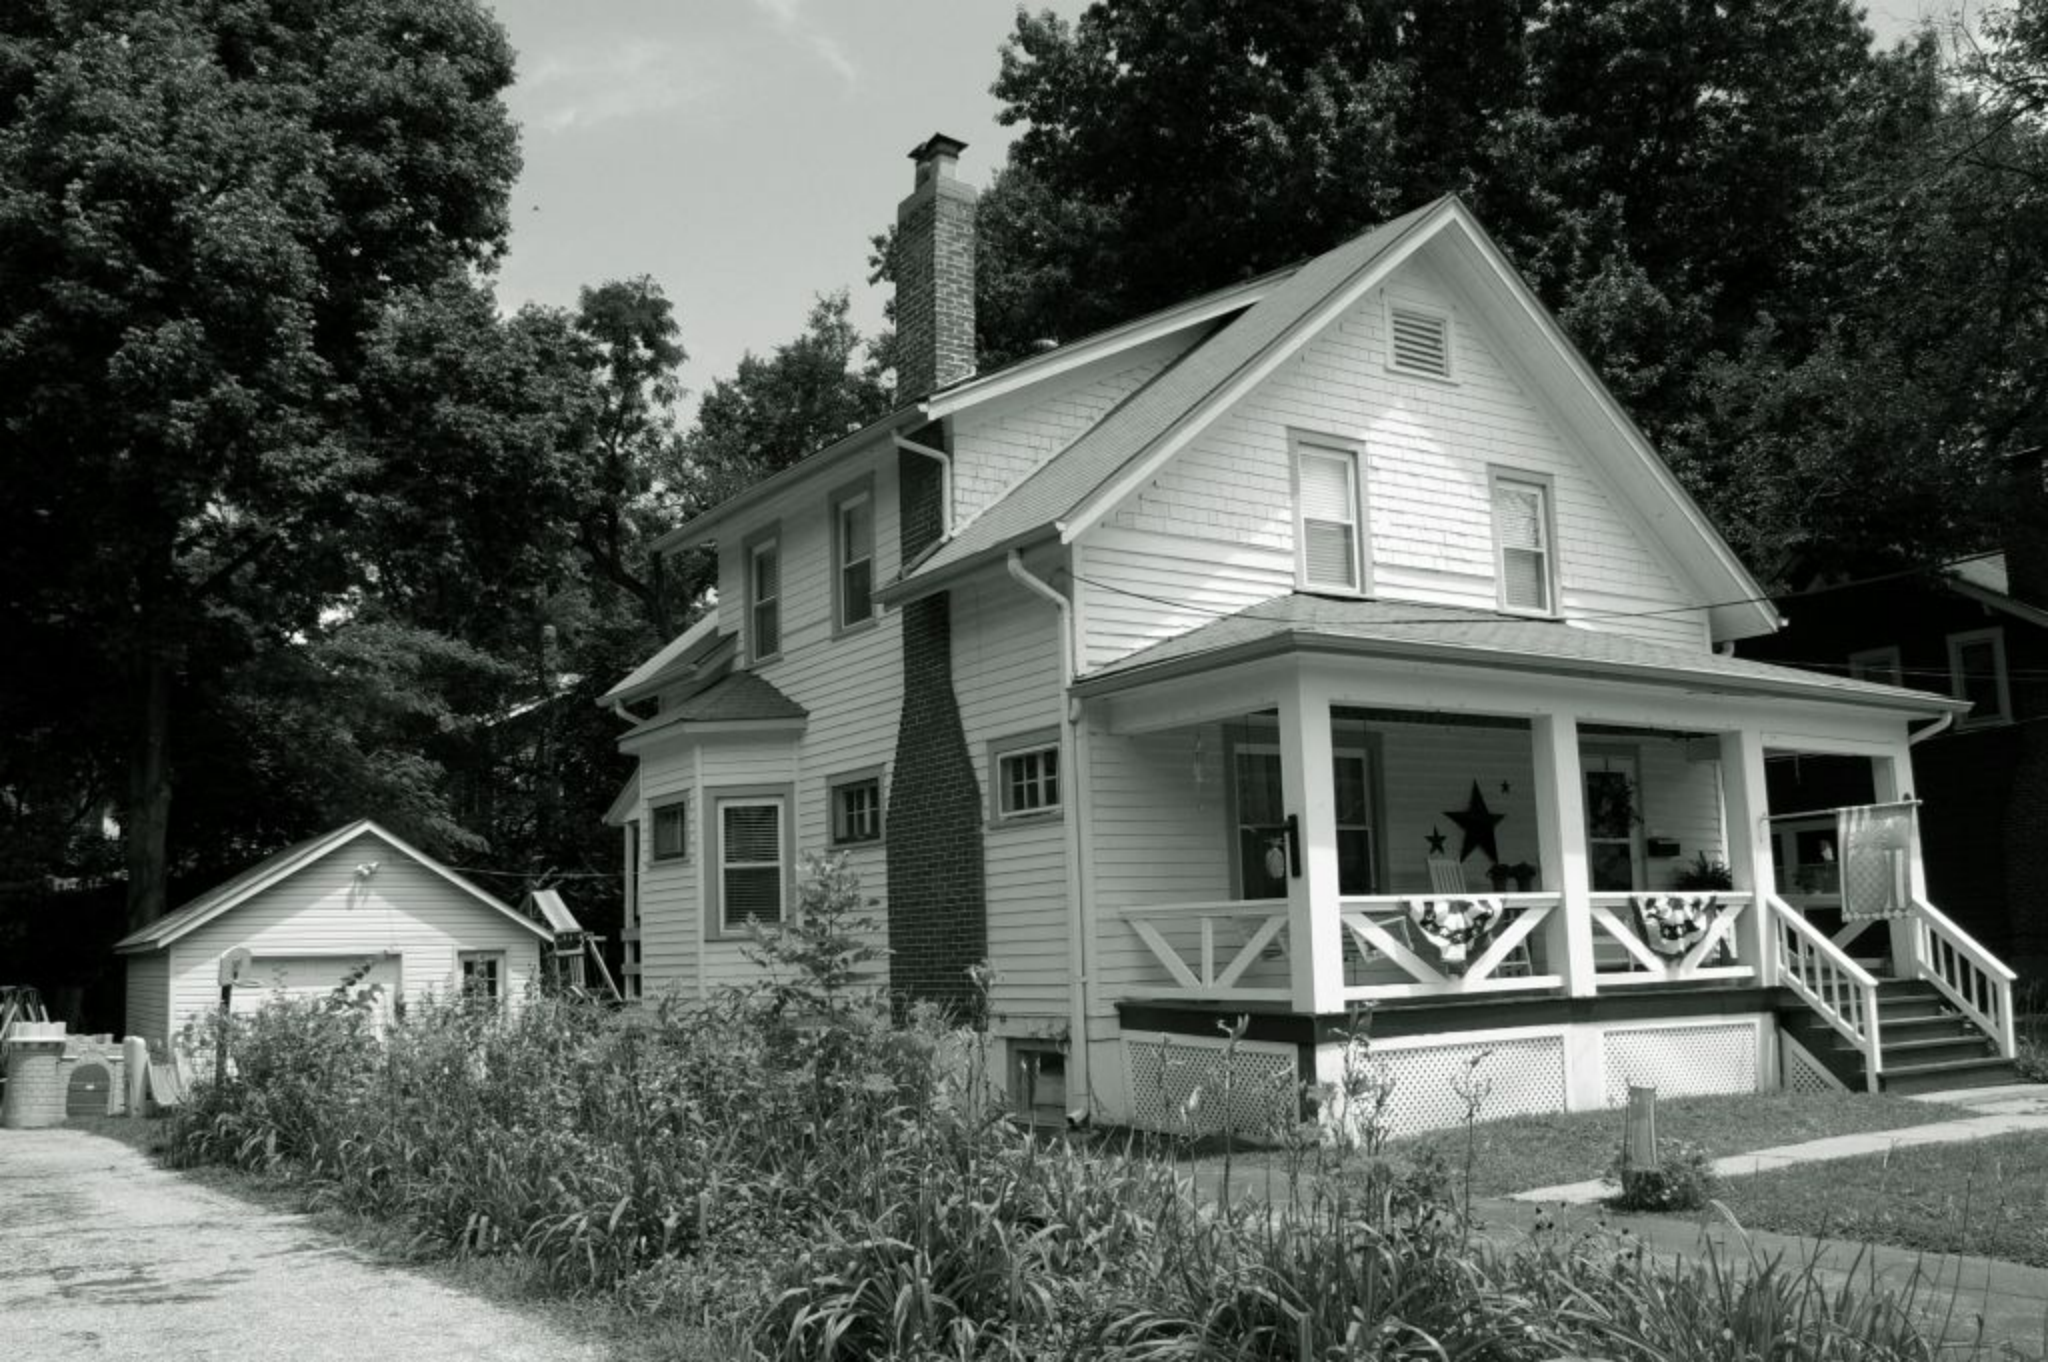
2009 Survey Update: Since the 1983 survey, the balusters in the railing (if not the entire railing) has been replaced with 2x4s, but the 1983 survey provides a very good photograph of the original balustrade pattern to guide in its reconstruction. The original 9 over 1 wood sashed windows have been replaced with vinyl 1 over 1 sashed windows, but the paired 4-light casement windows on the side and in the canted bay are still intact.
