ARCHITECTURAL/HISTORIC INVENTORY FORM

1. Survey No. SL-AS-036-001		2. Survey Name: Architectural Survey of Old Ferguson West	
3. County: St. Louis		4. Address: 1 Carson Rd.	
5. City: Ferguson	Vicinity: <input type="checkbox"/>	6. UTM:	7. Township/Range/Section
8. Historic name (if known):		9. Present/other name (if known): Whistle Stop	
10. Ownership: <input type="checkbox"/> Private <input checked="" type="checkbox"/> Public		11. Historic use (if known): TRANSPORTATION/rail-related	11. Current use: COMMERCE/restaurant & RECREATION/museum

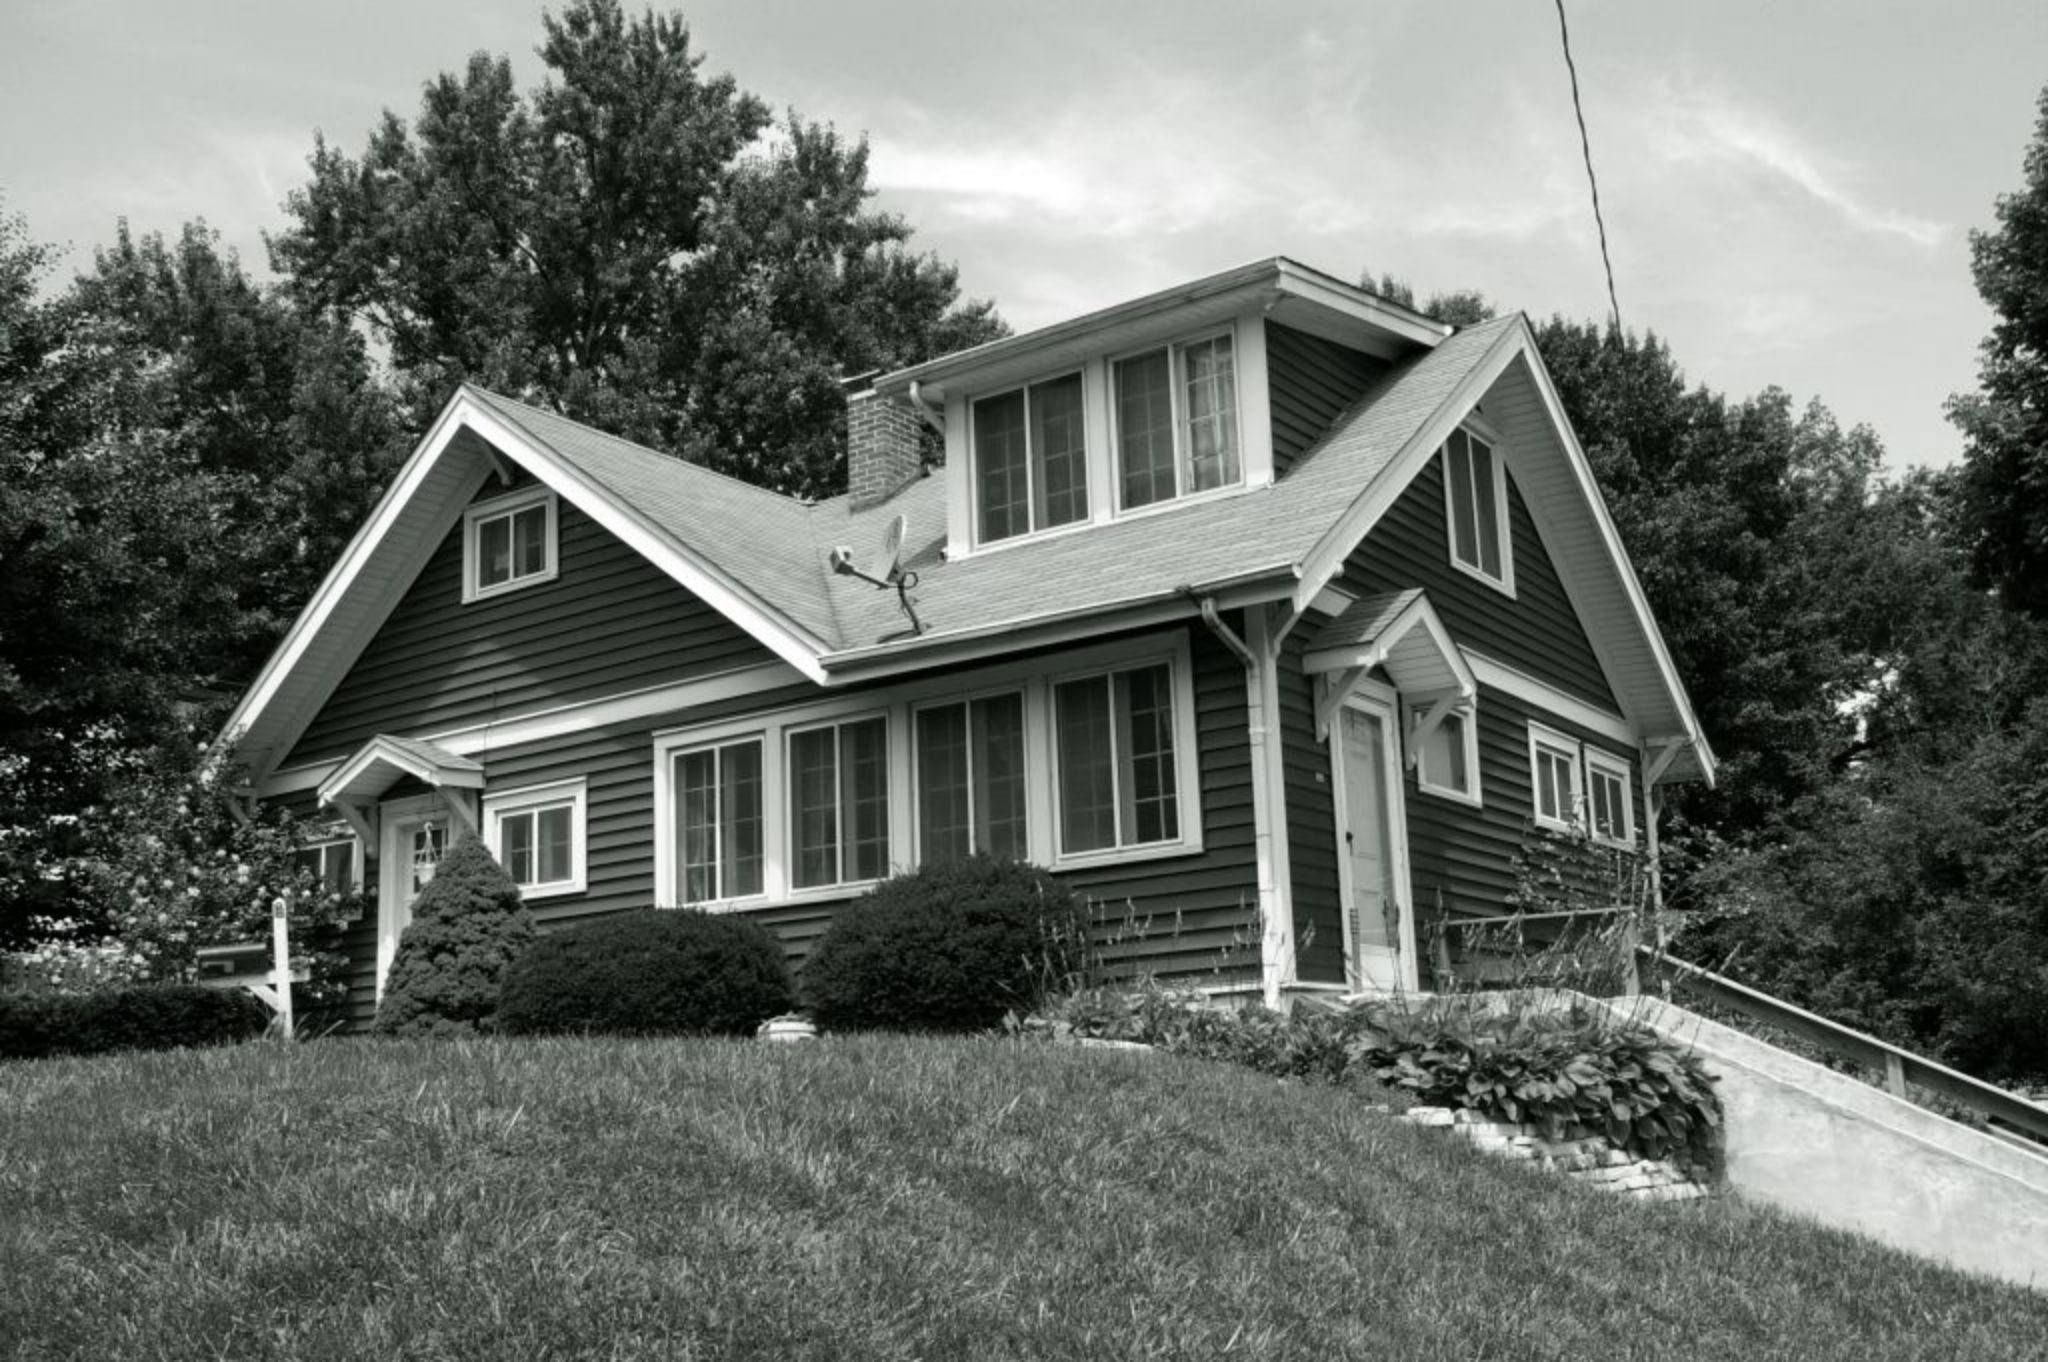
2009 Survey Update: The 1983 survey description of this Craftsman bungalow appears to have had a couple of minor errors. Since it described both pent roofs on the two separate entries as being the same, then it appears that the front one was not a shed roofed, but a gabled shape roof with knee braces like the east side, which is verified by the retention of both of these entries today. The other minor mistake appears to be the wood casement windows on either side of the front entry, they are in actuality also 4 light windows like those above, not 6 light casements since they are still intact. In 1983 the windows were covered with storm windows giving them the appearance of being sashed, but they are now covered by metal sliding storm windows that more closely match the lines of the casements. Since 1983 a retaining wall has been built extending from the east corner of the facade, possibly to create better access to the basement level garage that is original to the building.

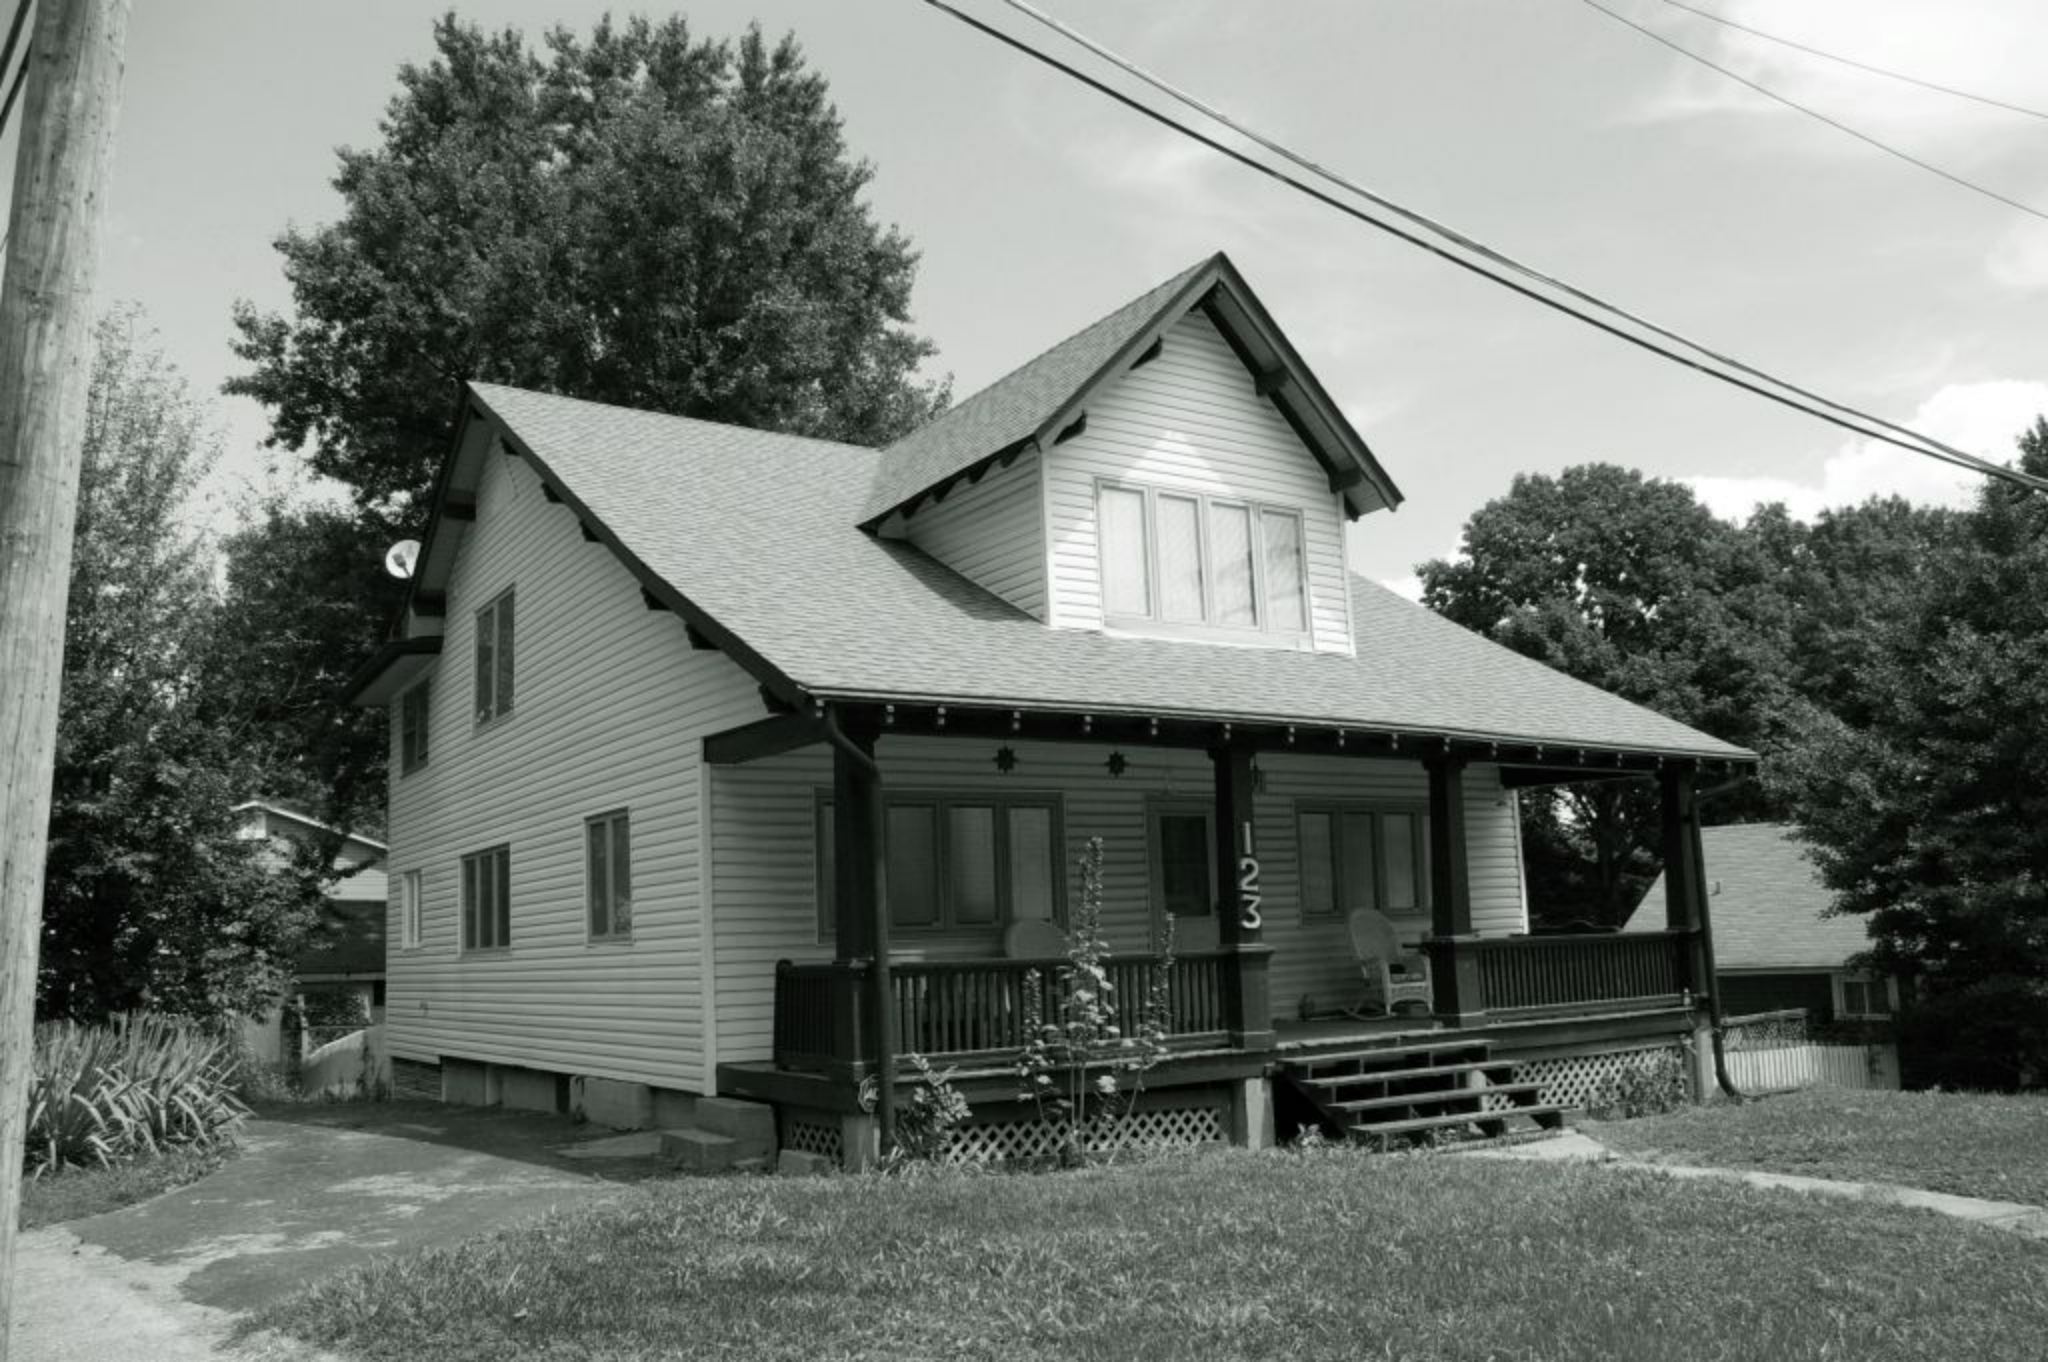
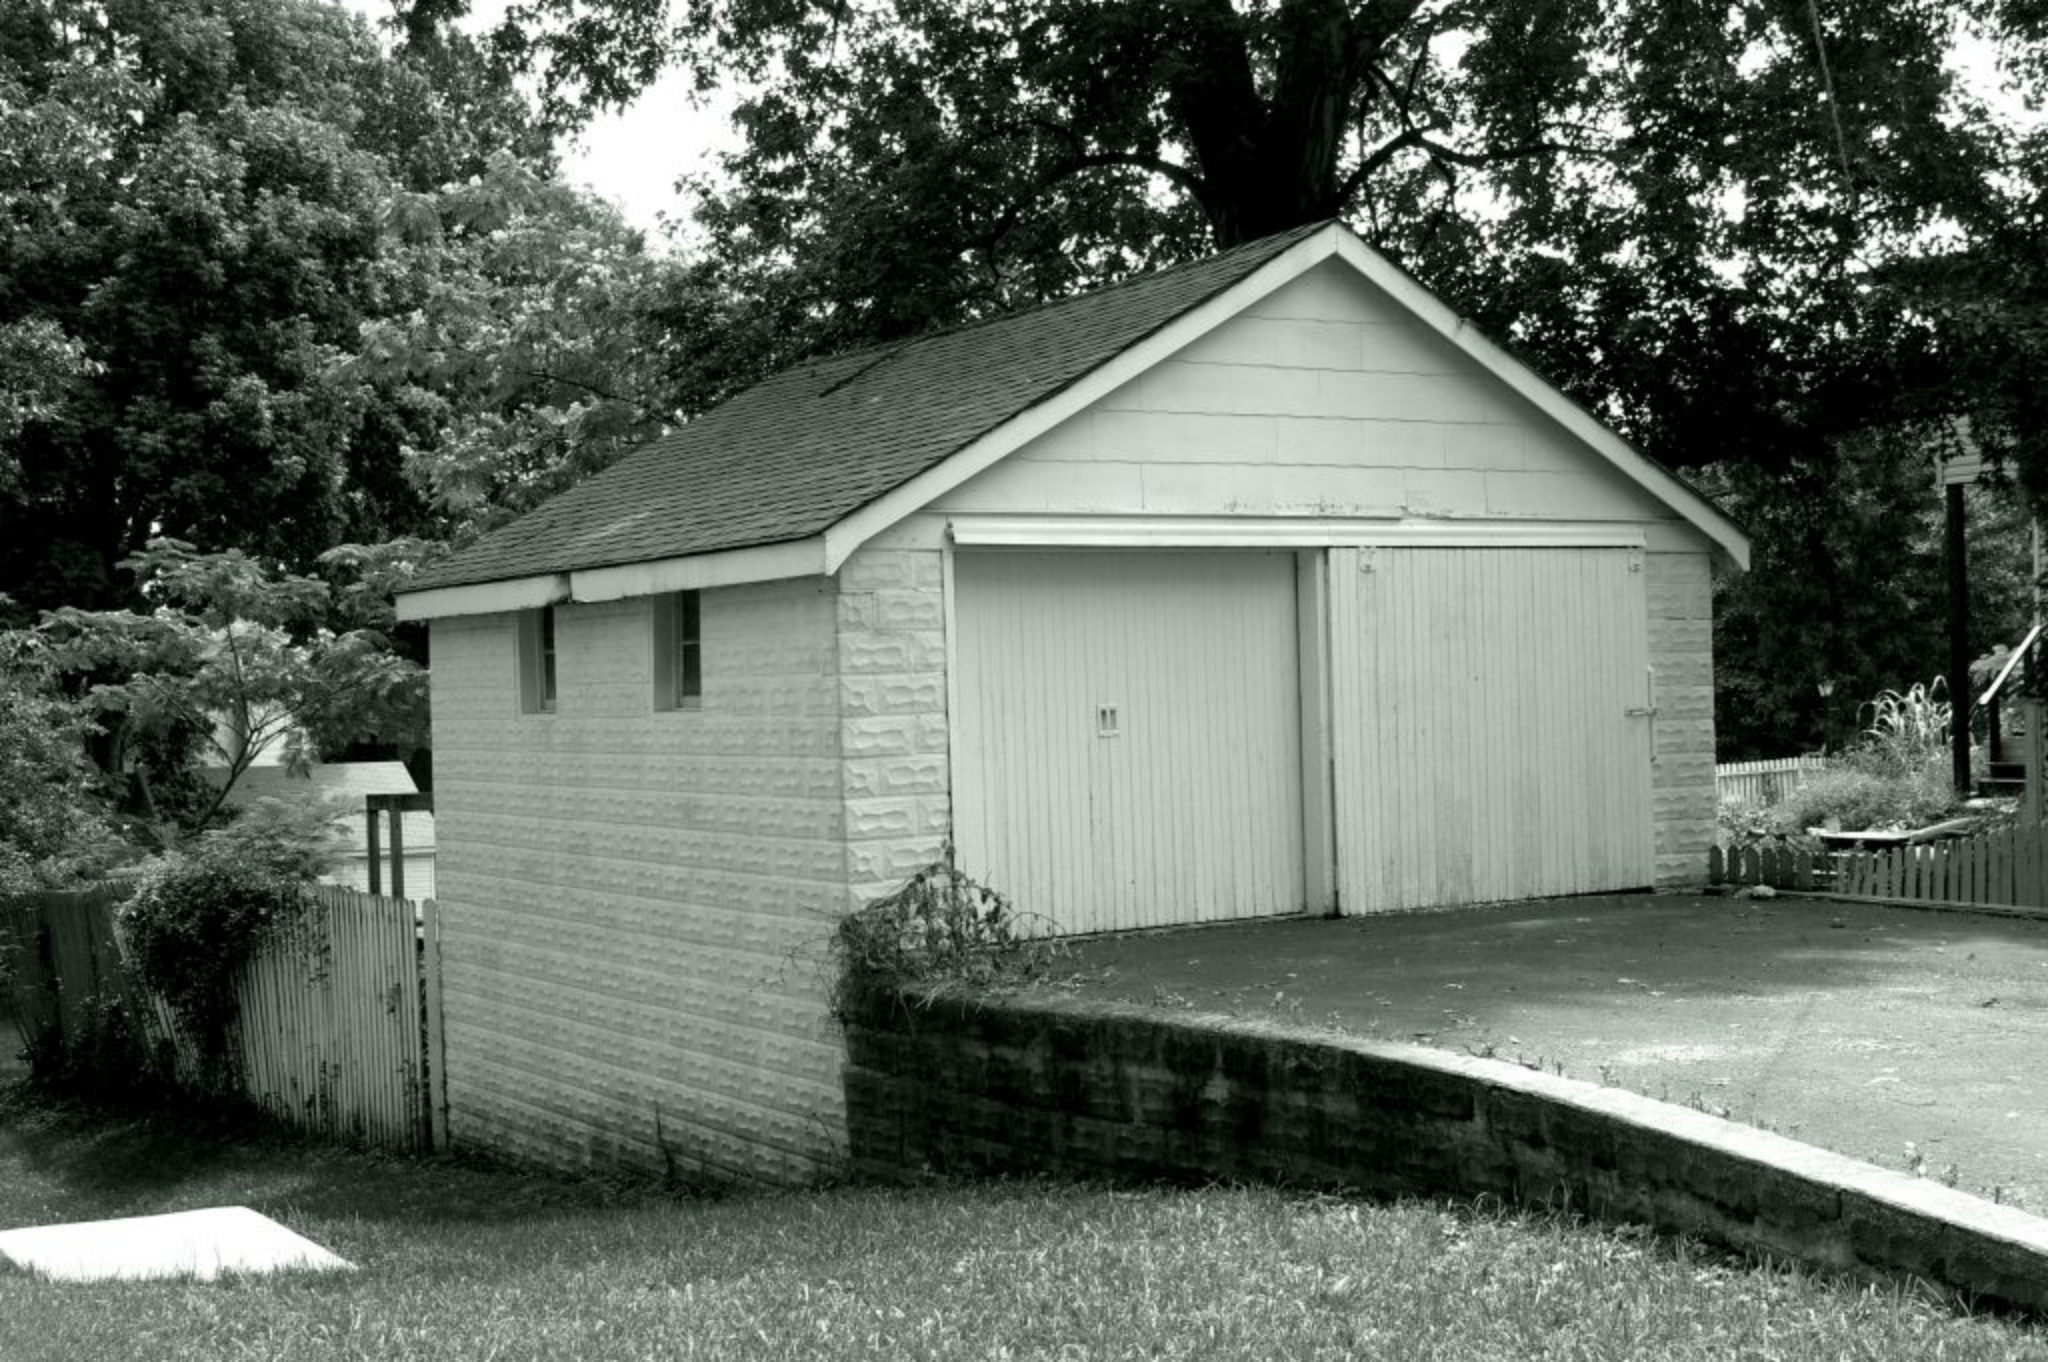
2009 Survey Update: Since the 1983 survey, the original 6 over 1 wood sashed windows have been replaced with metal casement windows and the asbestos and aluminum siding has been replaced with vinyl siding, which probably more closely approximates the original wall cladding given other Eppele Craftsman houses of this same plan are found in this neighborhood. However it still retains the birdsmouth rafter tails and exposed beams on the wide eaves, as well as the tapered square porch columns and porch railing.

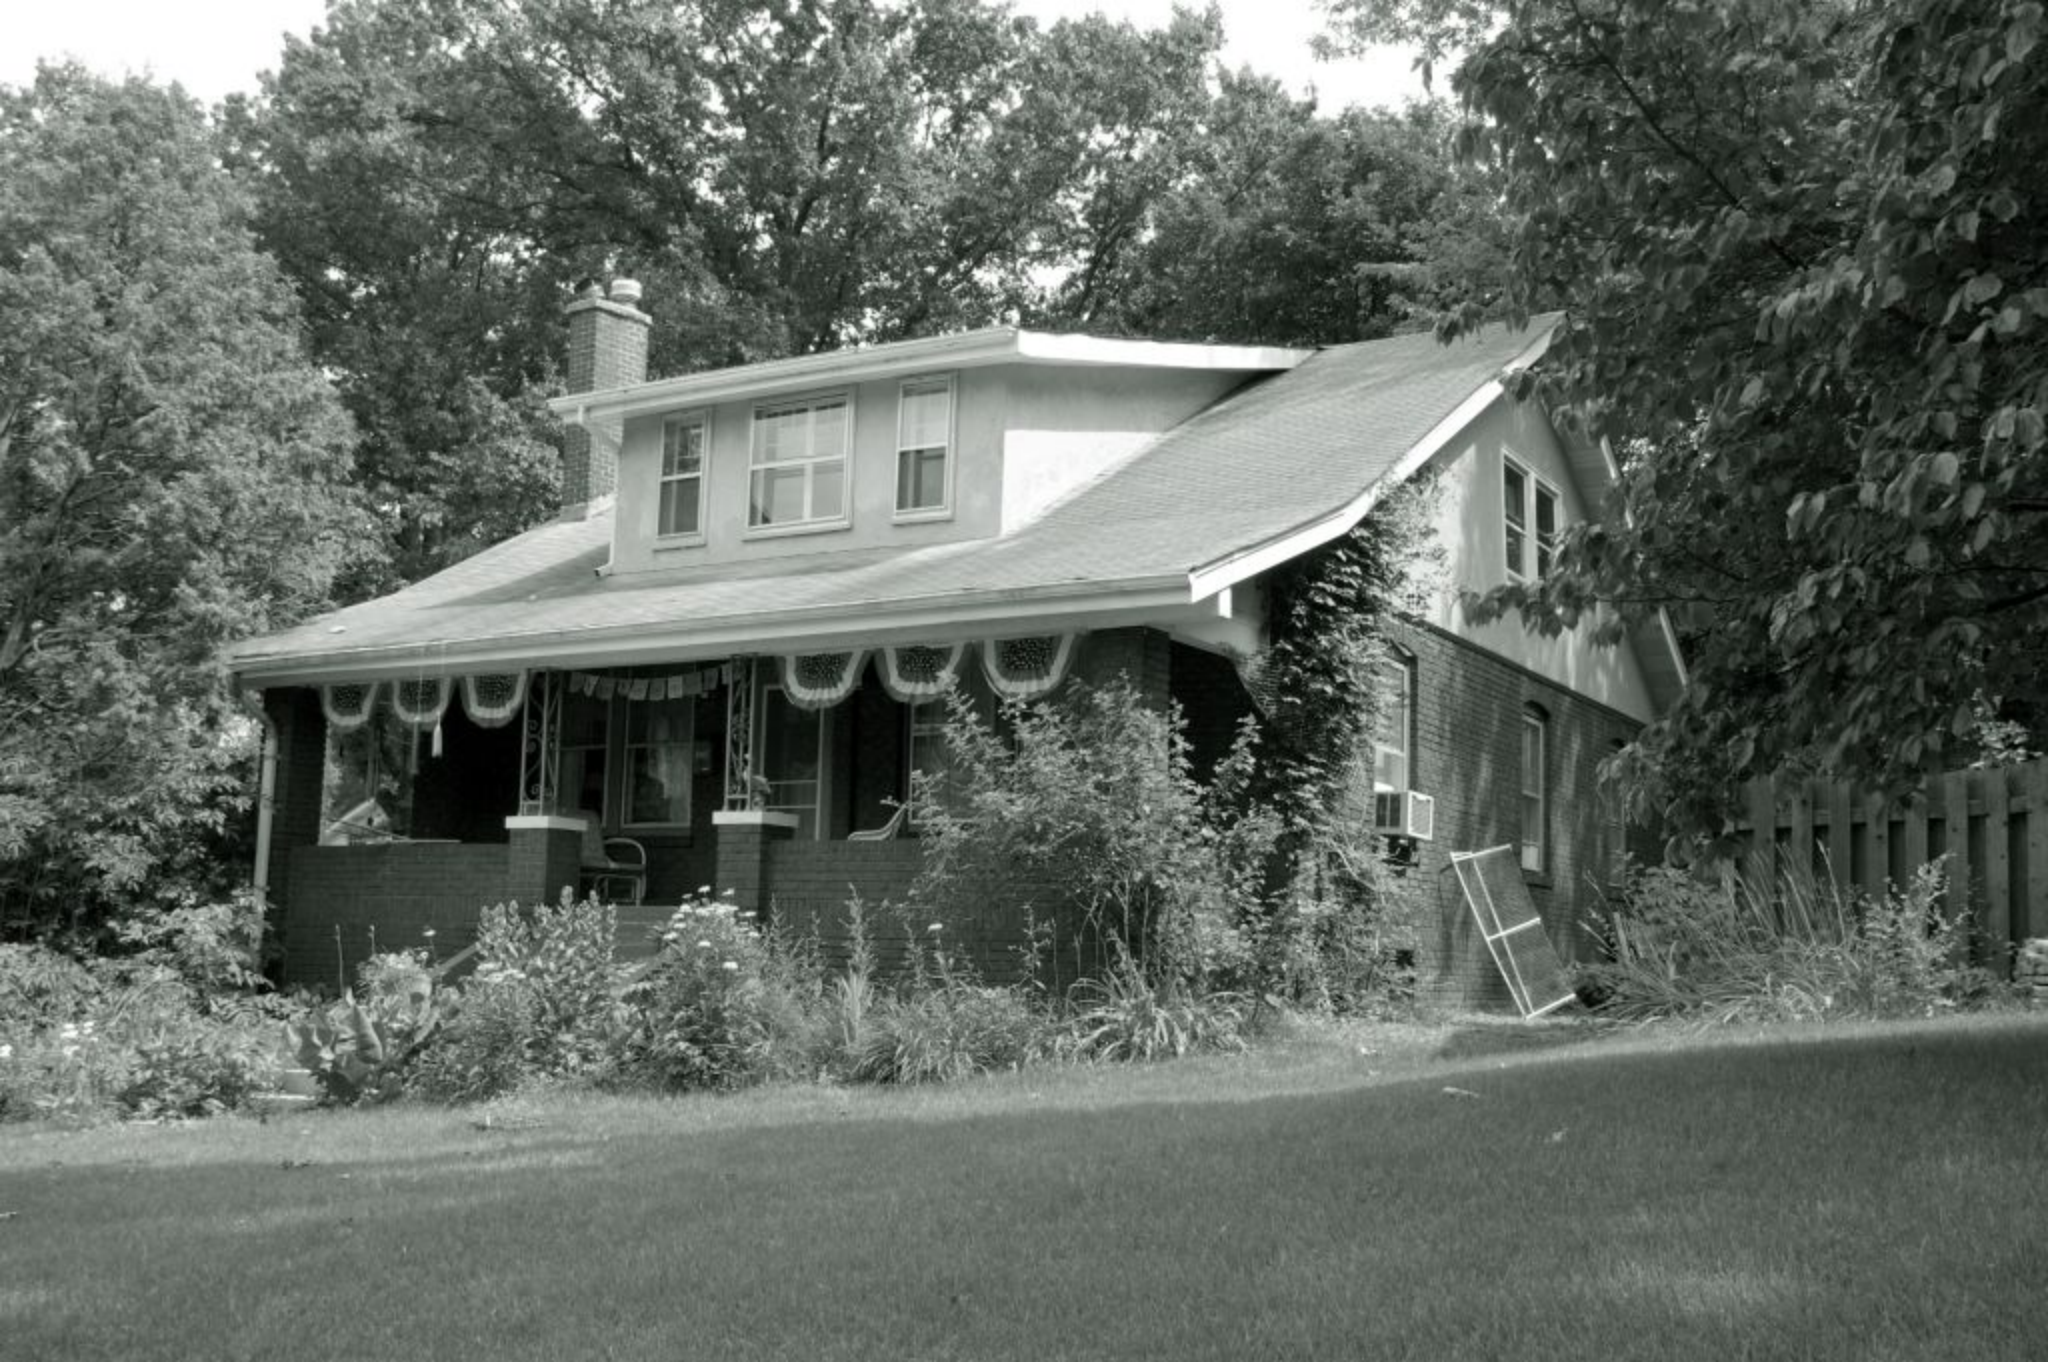
2009 Survey Update: Since the 1983 survey, the house has changed very little, except that the two brick columns with concrete capitals that flanked the front stairs have been replaced with wrought iron posts on top of the brick plinth bases. The house has storm windows. There was one minor mistake on the 1983 description, the sunporch is located on the southeast corner.

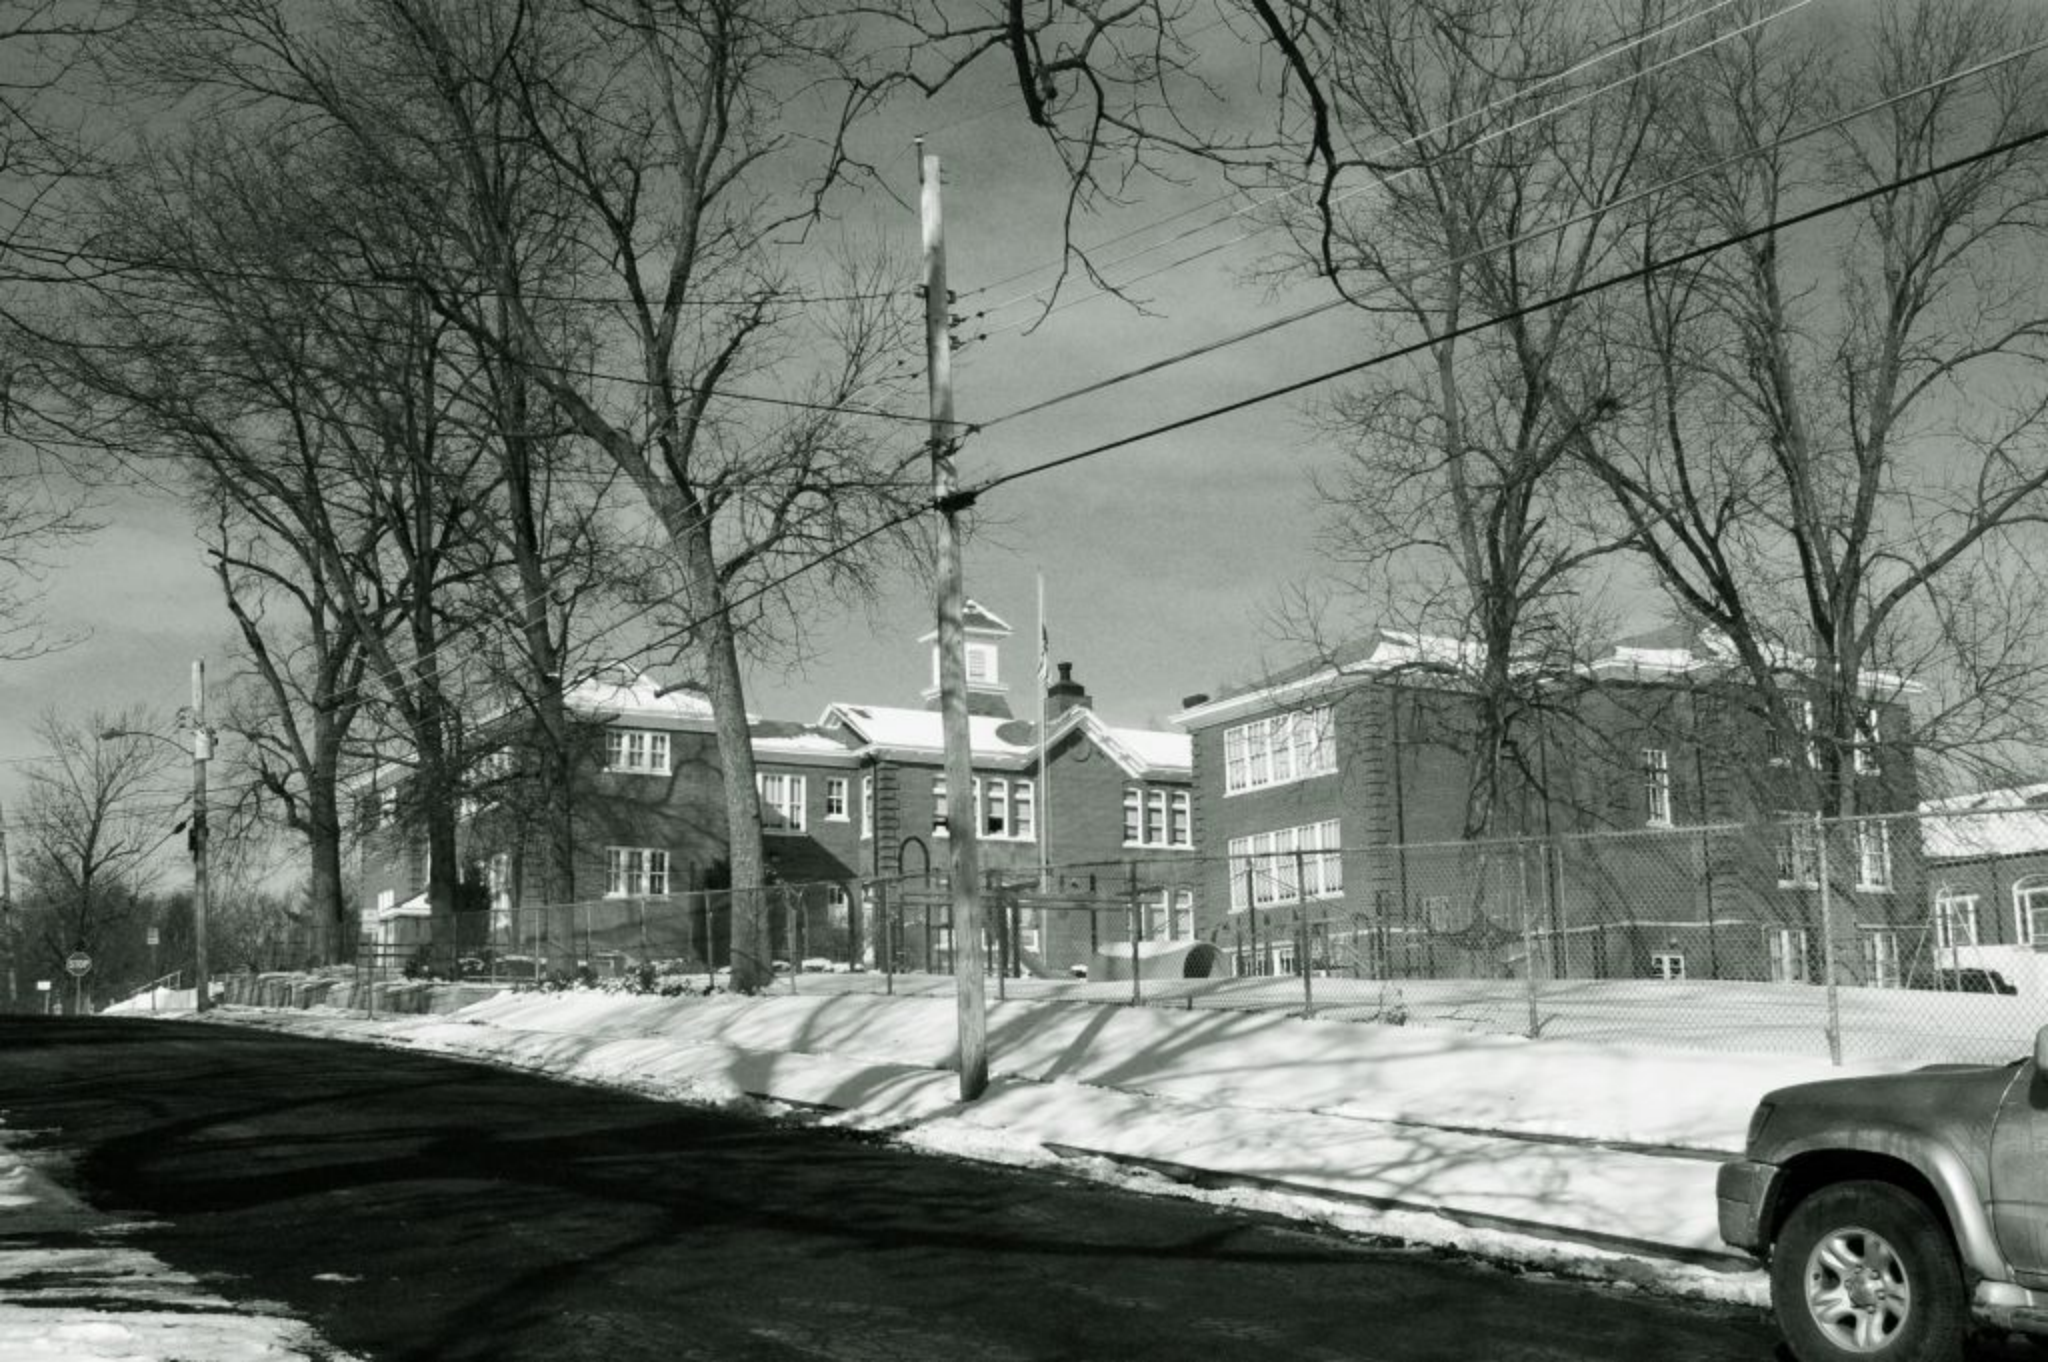
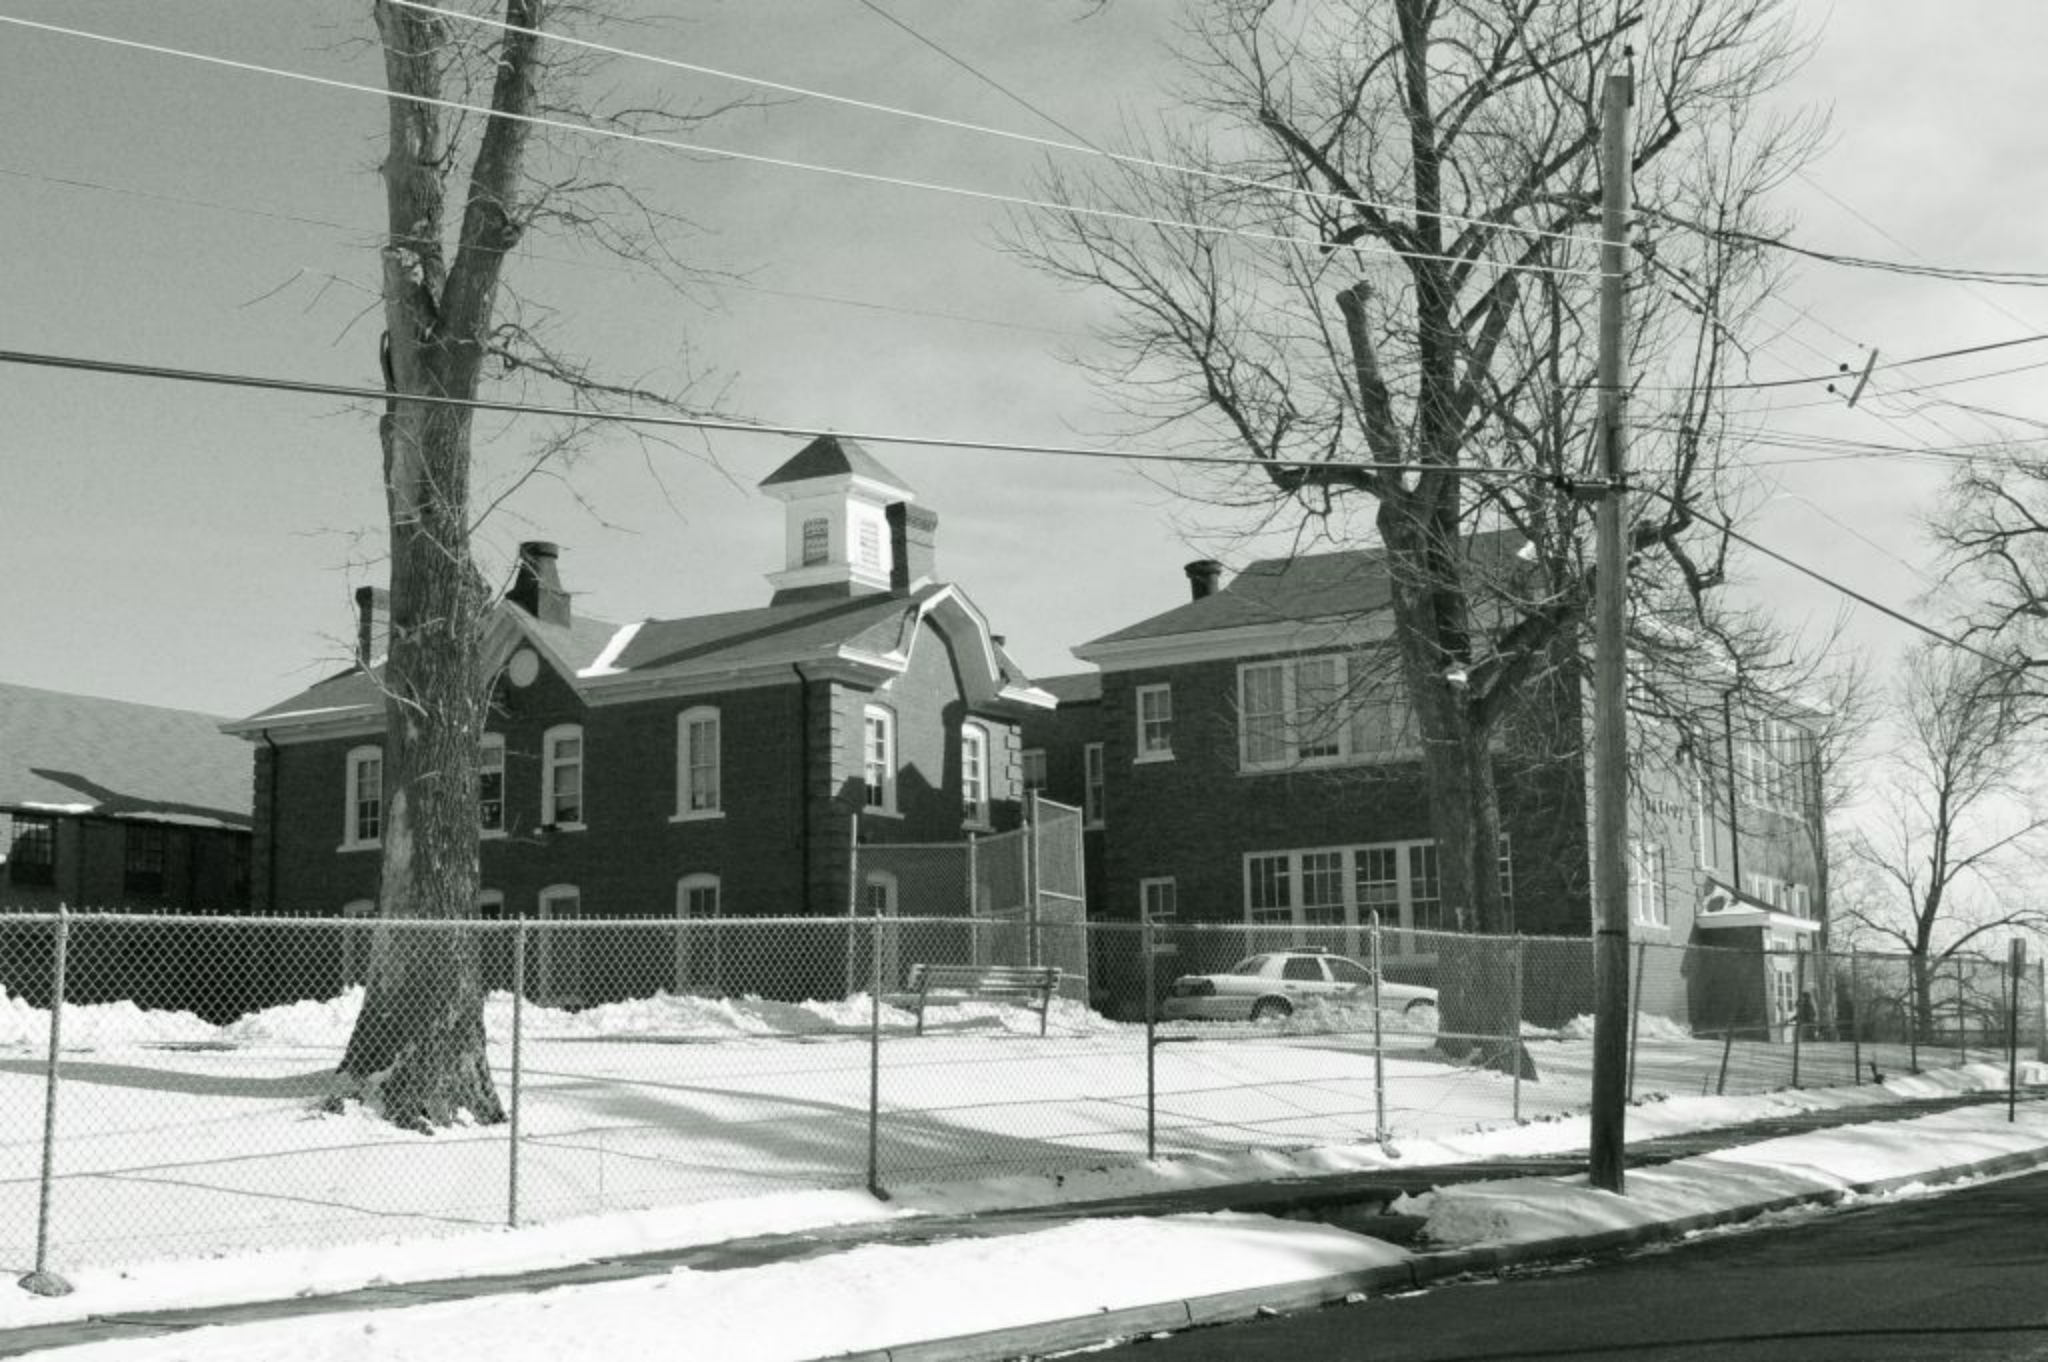
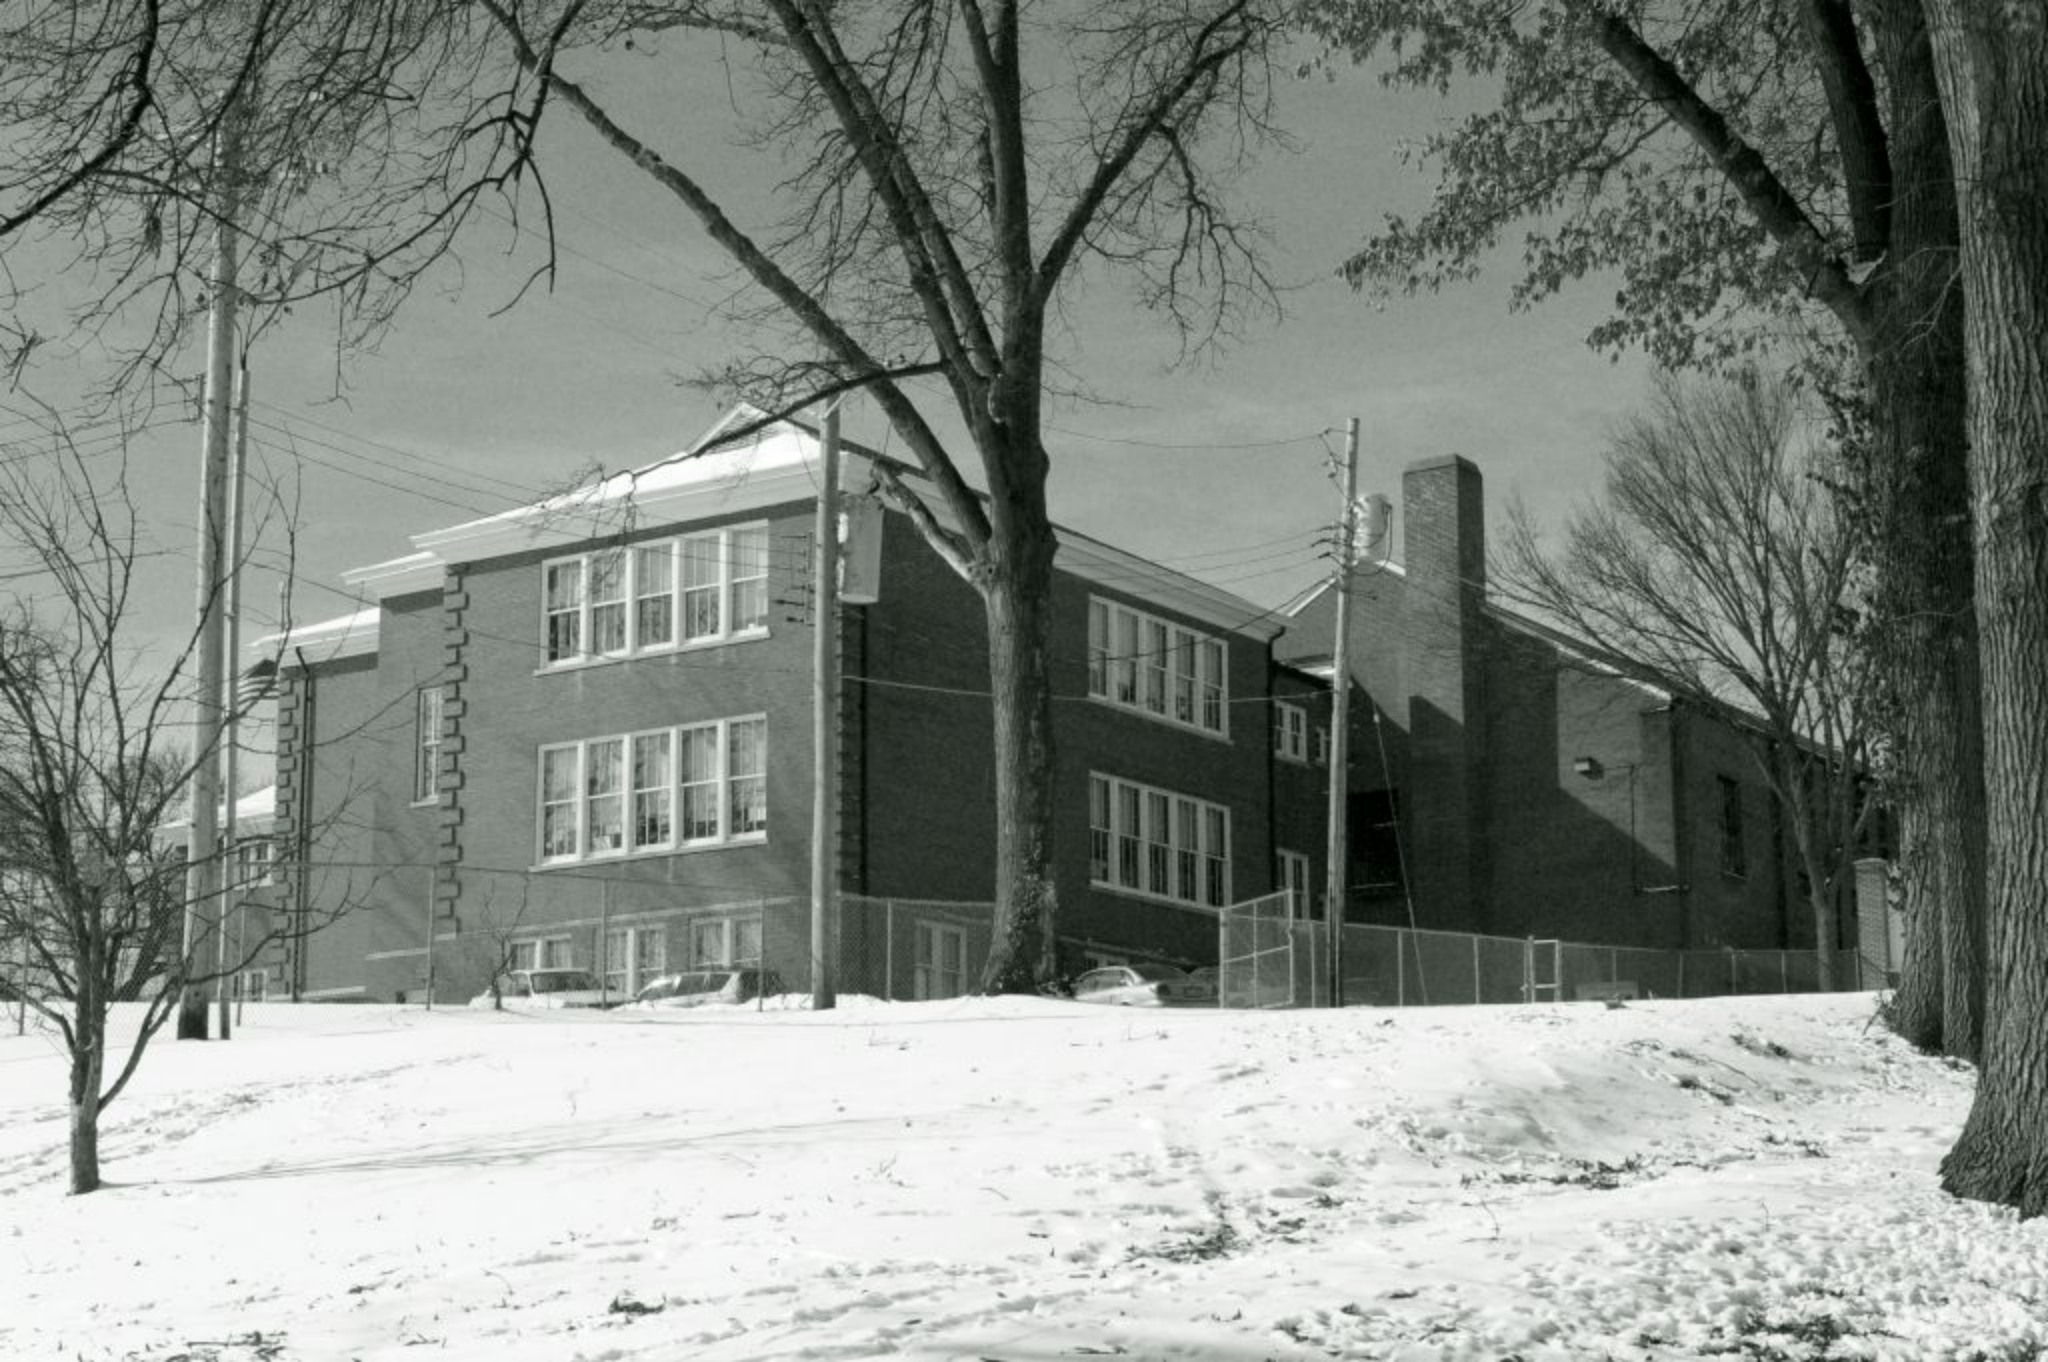
2009 Survey Update: The school does not appear to have changed substantially since it was listed on the National Register.
