ARCHITECTURAL/HISTORIC INVENTORY FORM

1. Survey No. SL-AS-036-001		2. Survey Name: Architectural Survey of Old Ferguson West	
3. County: St. Louis		4. Address: 1 Carson Rd.	
5. City: Ferguson	Vicinity: <input type="checkbox"/>	6. UTM:	7. Township/Range/Section
8. Historic name (if known):		9. Present/other name (if known): Whistle Stop	
10. Ownership: <input type="checkbox"/> Private <input checked="" type="checkbox"/> Public		11. Historic use (if known): TRANSPORTATION/rail-related	11. Current use: COMMERCE/restaurant & RECREATION/museum

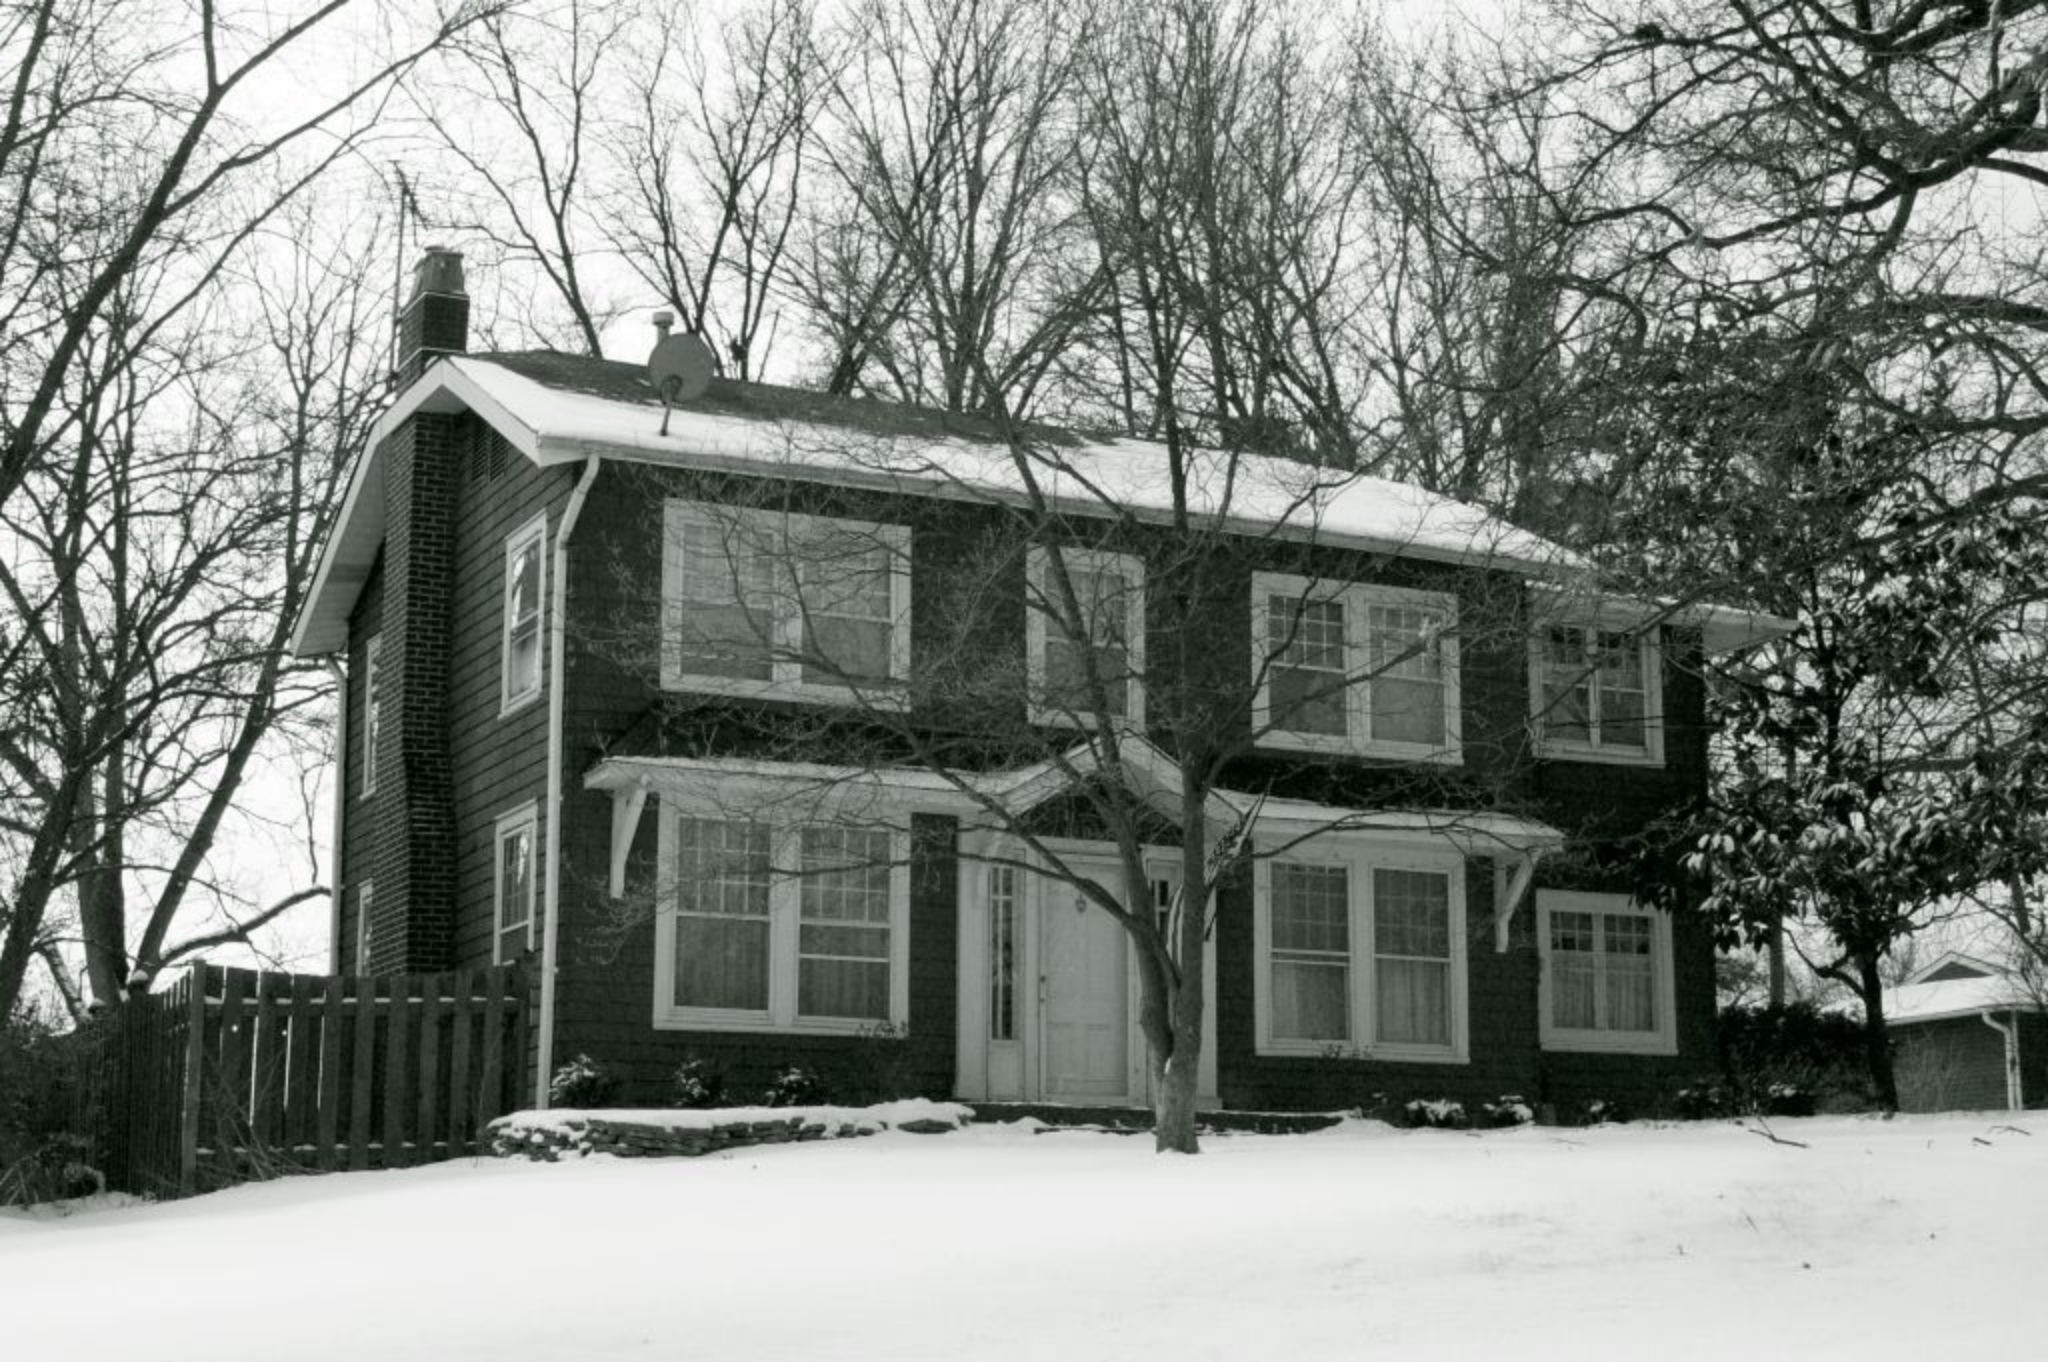
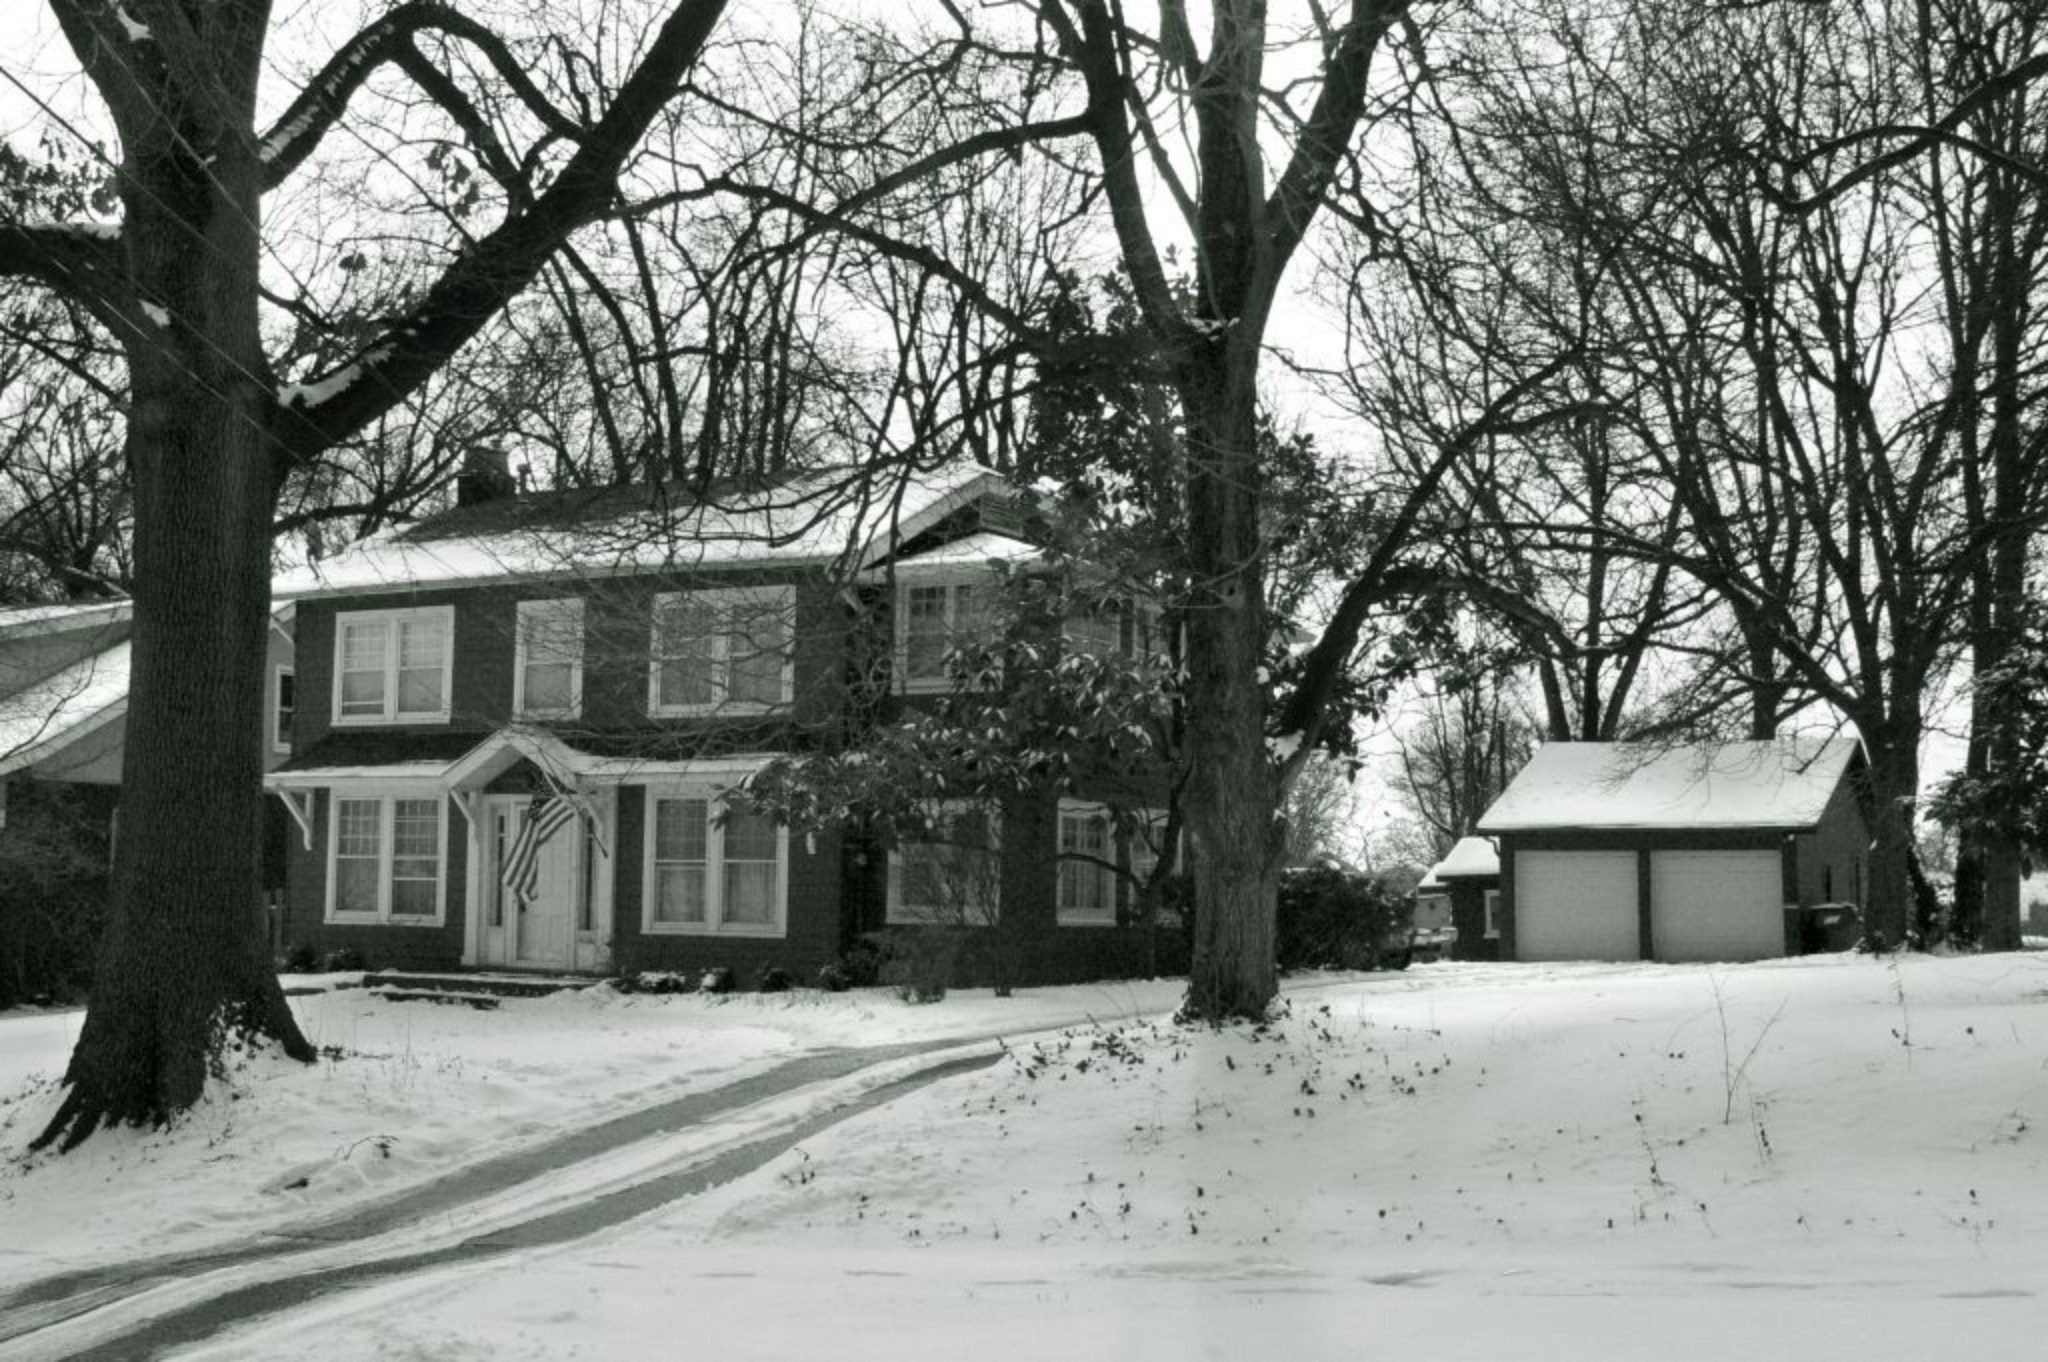
2009 Survey update: The two bay side gabled frame garage at the southwest part of the lot appears to have been built between 1931 and 1950 based upon the fire insurance maps since there was an earlier smaller garage on this site in 1931. It appears that there is a small side gabled addition to this garage, although the shape shown on the 1950 fire insurance map is not clear and it might be original to the garage's construction. The overhead doors have been replaced with newer metal overhead doors, but the wall cladding appears to be wood shingles, like the house.

2009 Survey Update: The house appears unaltered from the 1983 survey. The windows do have aluminum storm windows.

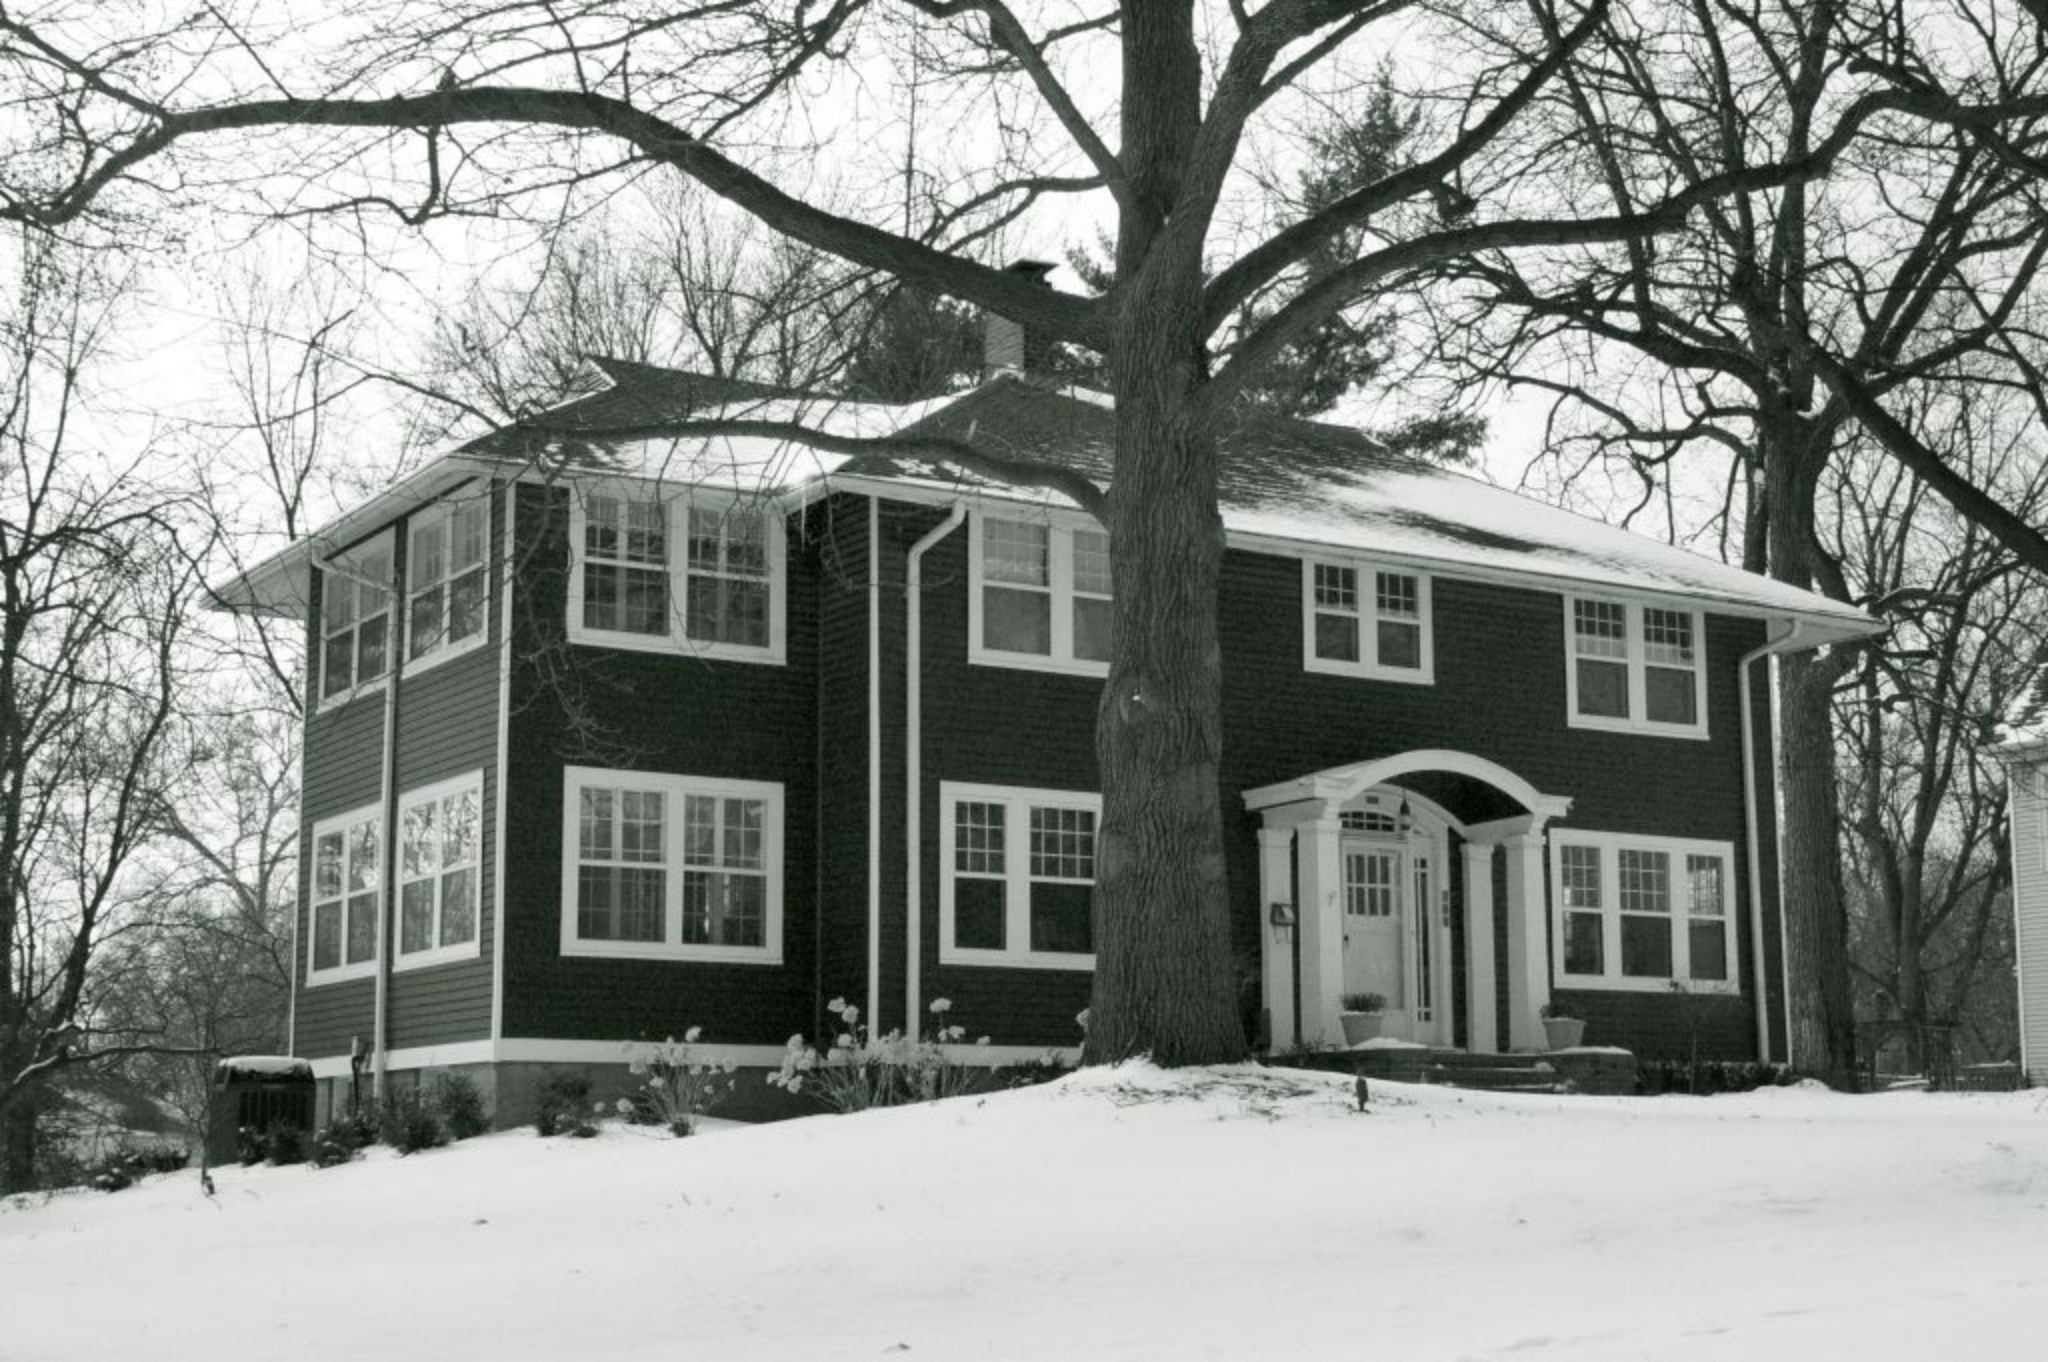
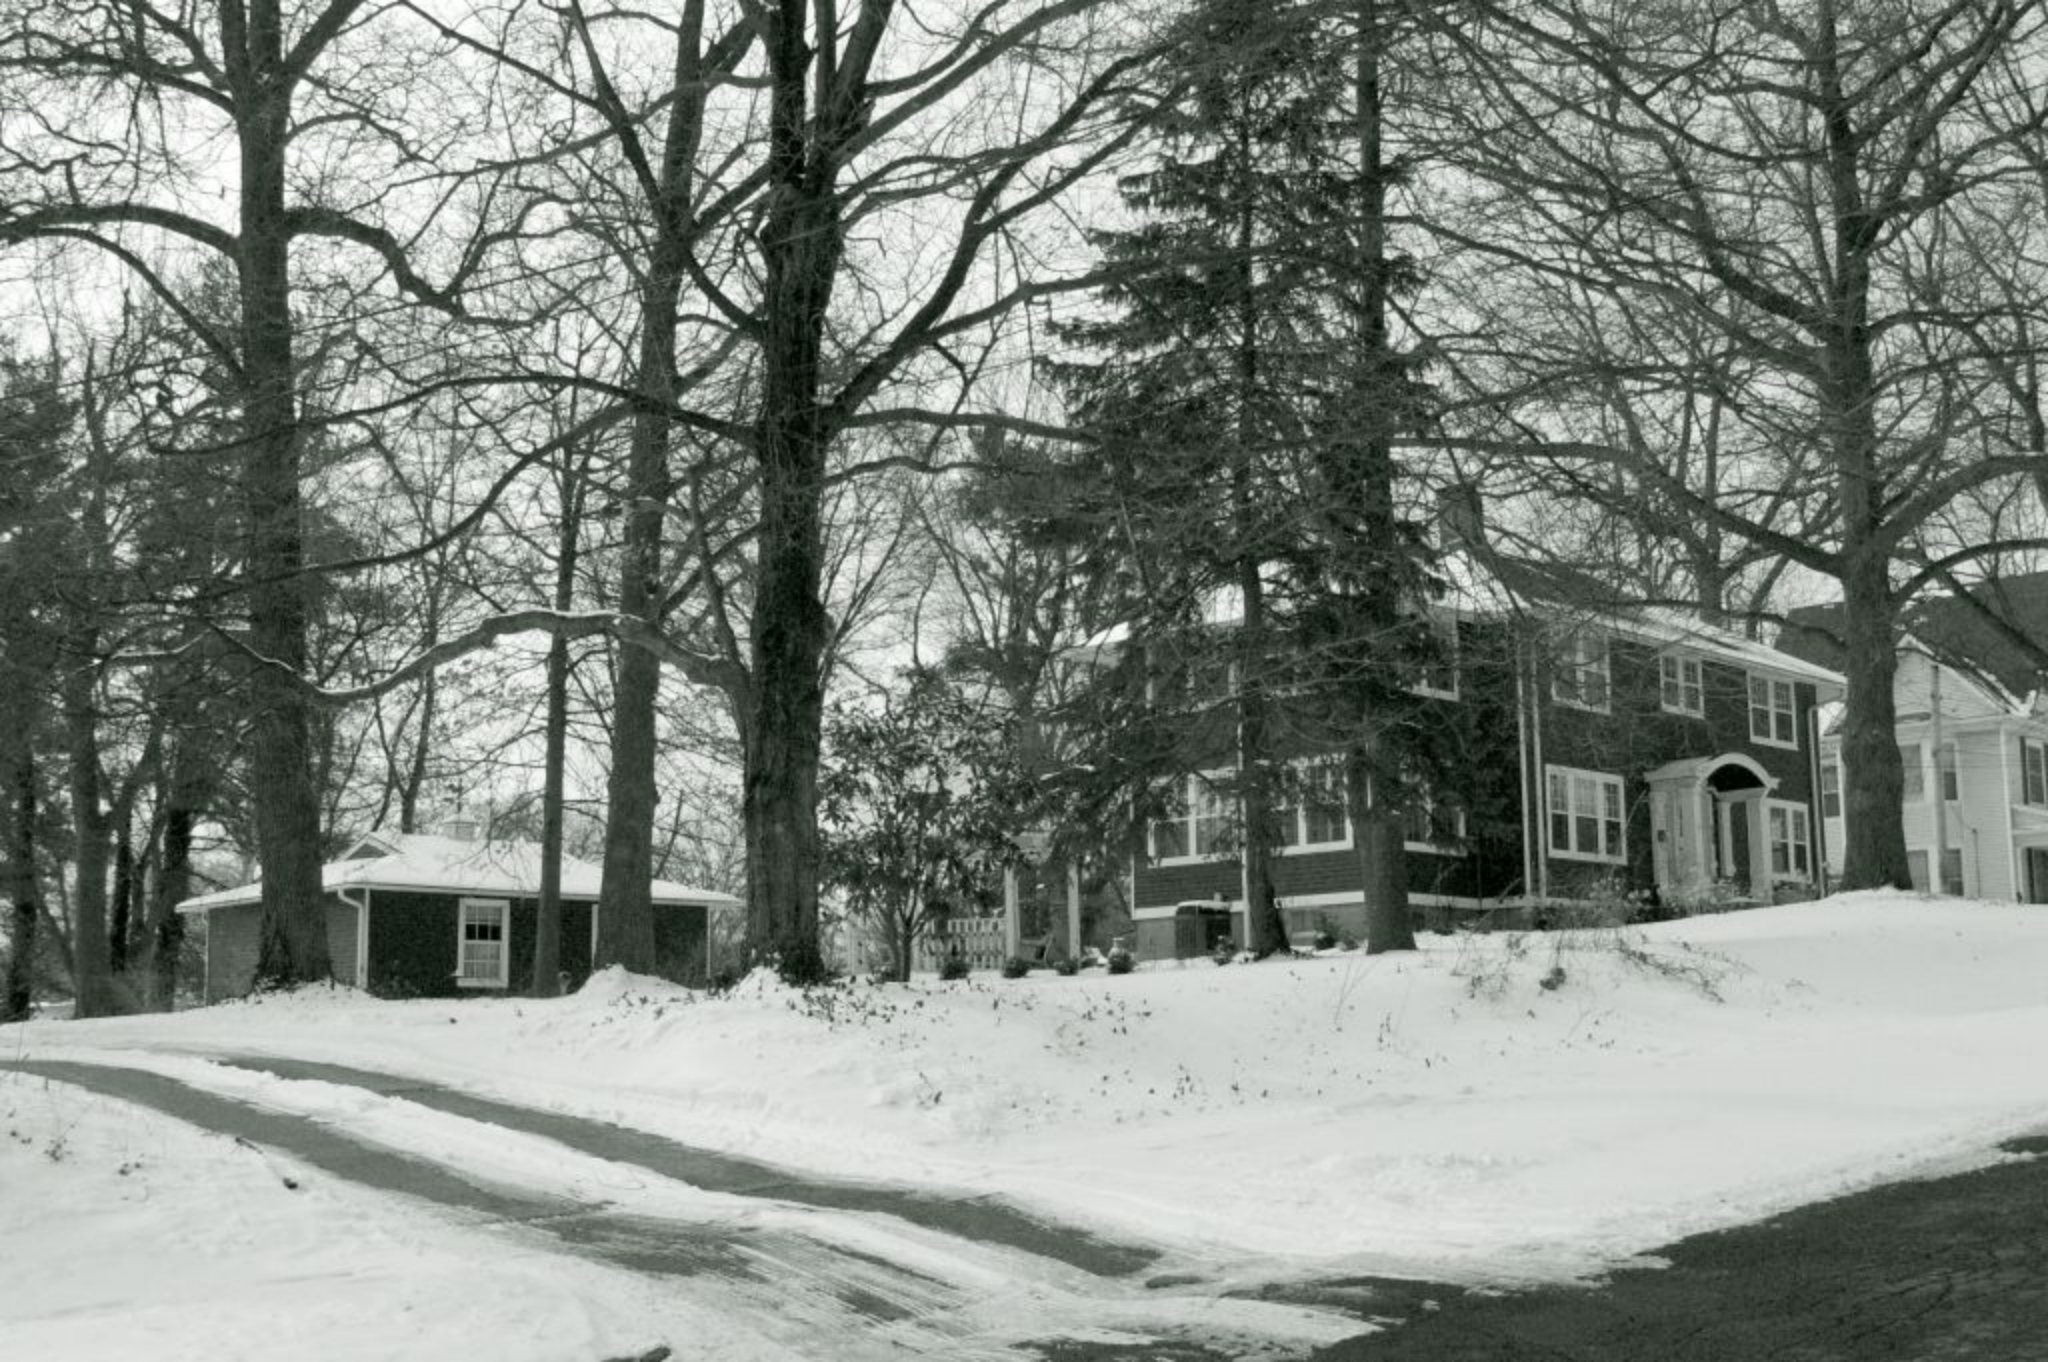
2009 Survey update: The house does not appear to have been altered since the 1983 survey, except for new aluminum storm windows, which on the side wing obscure the original wooden casement windows because the frames do not match, but have a sashed window design. Although the 1983 survey calls the two story east wing an addition, it is original to the house's construction.

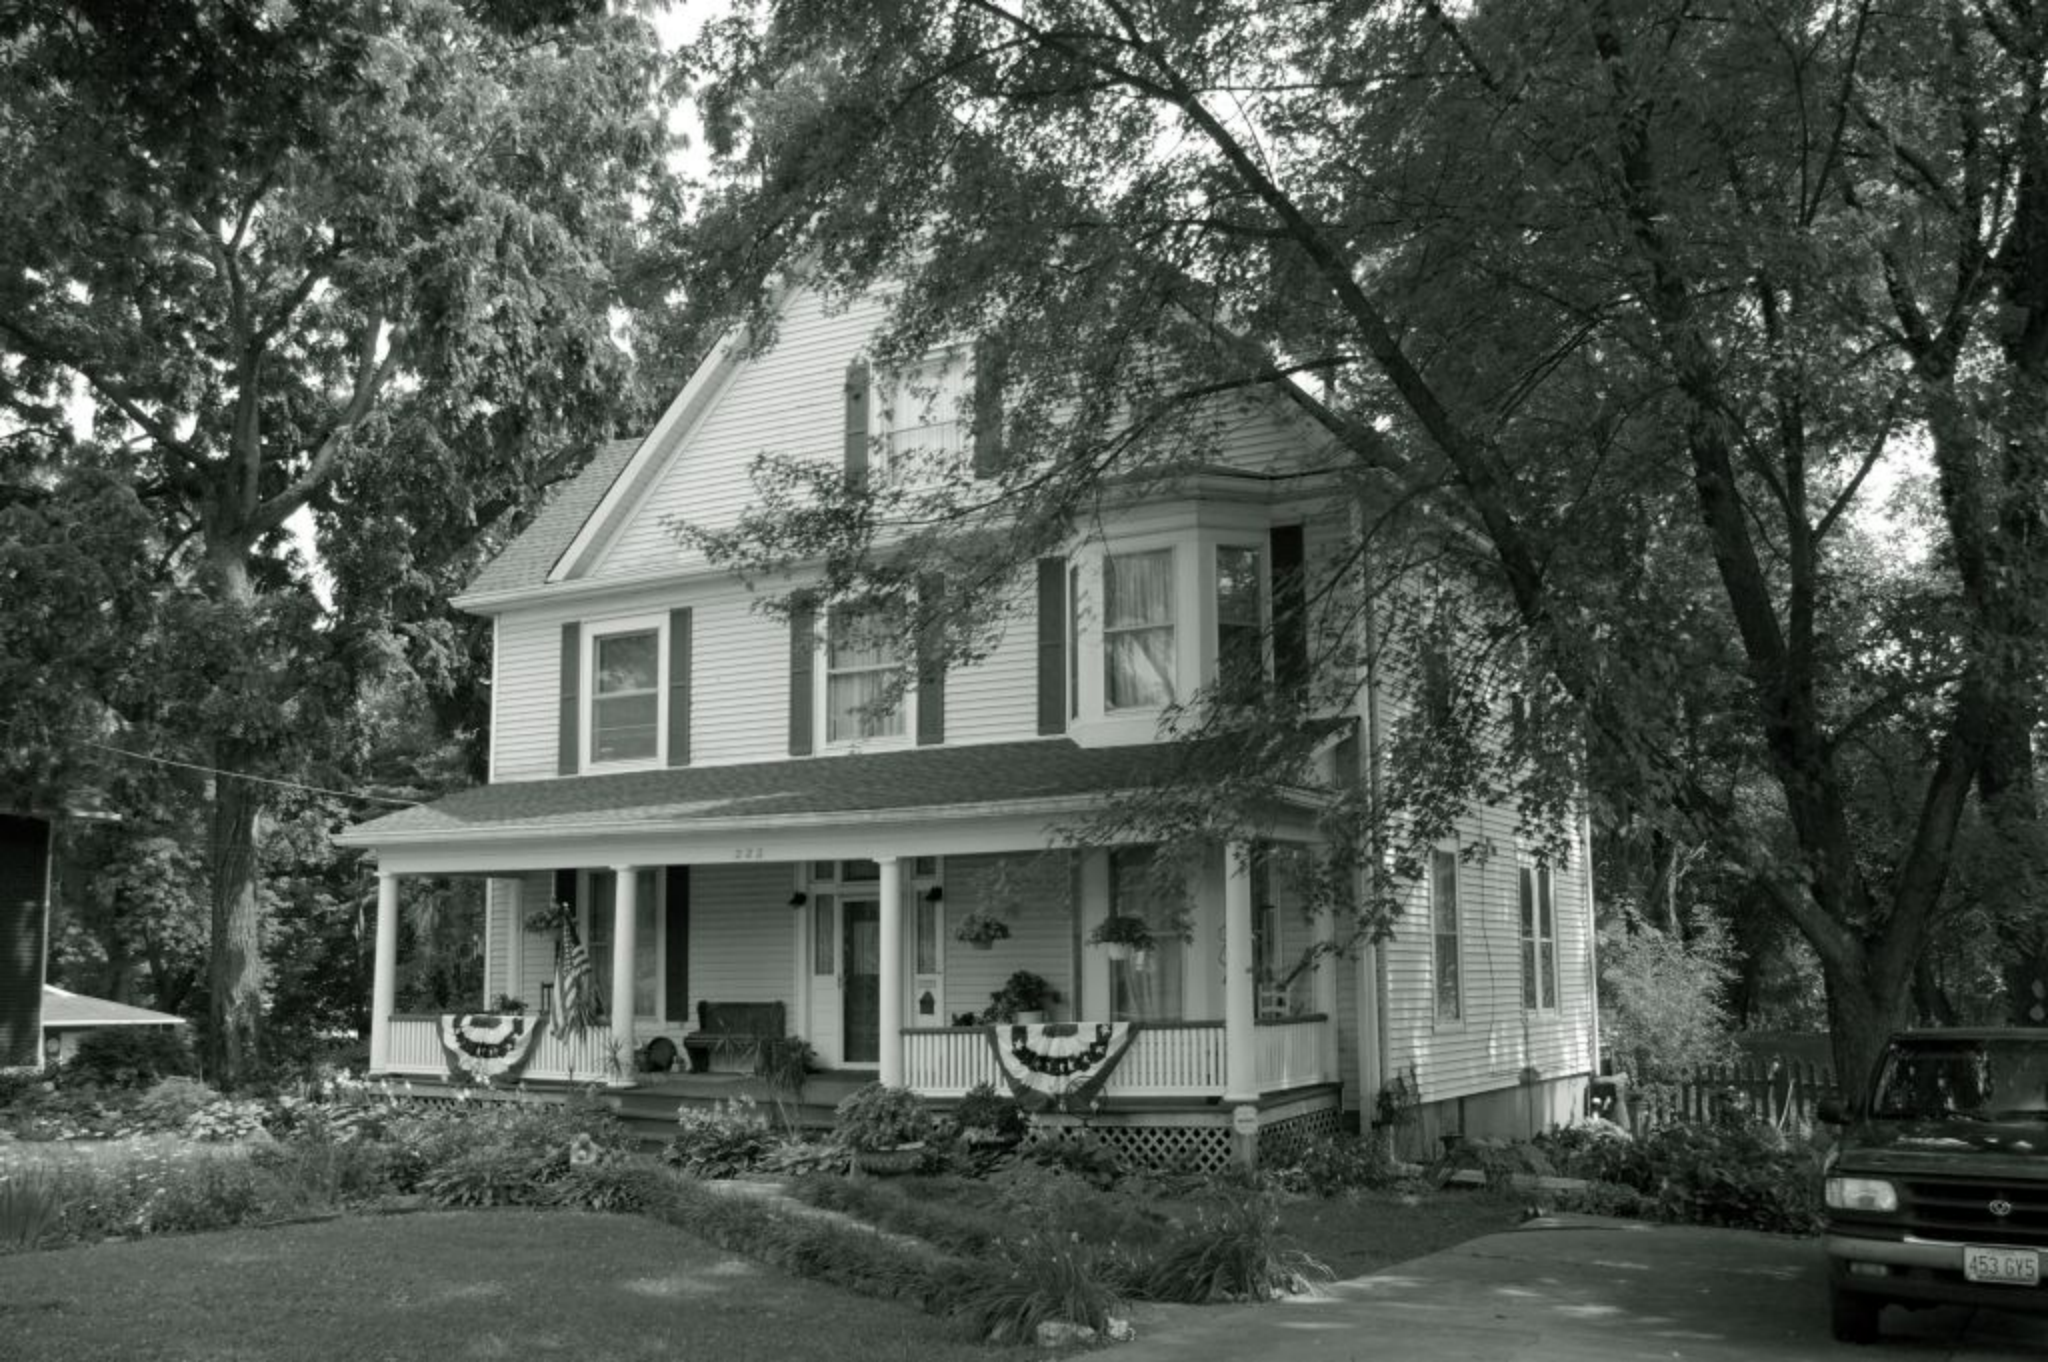
2009 Survey Update: Since the 1983 survey, the house has been reclad with vinyl siding. In the 1983 survey form it identified the siding as asphalt siding, but the photograph seems to indicate that it was clapboard and the vinyl siding closely approximates what was probably the original material (even if it had been asphalt siding, that would have been a later alteration since that product was not made until the late 1920s). The house still retains most of its original details, including the windows, porch railing and columns, but in recladding the house, the dentil molding was either covered or removed to clad the eaves. Fake shutters have been added and the attic window has been replaced with a 1 over 1 window.

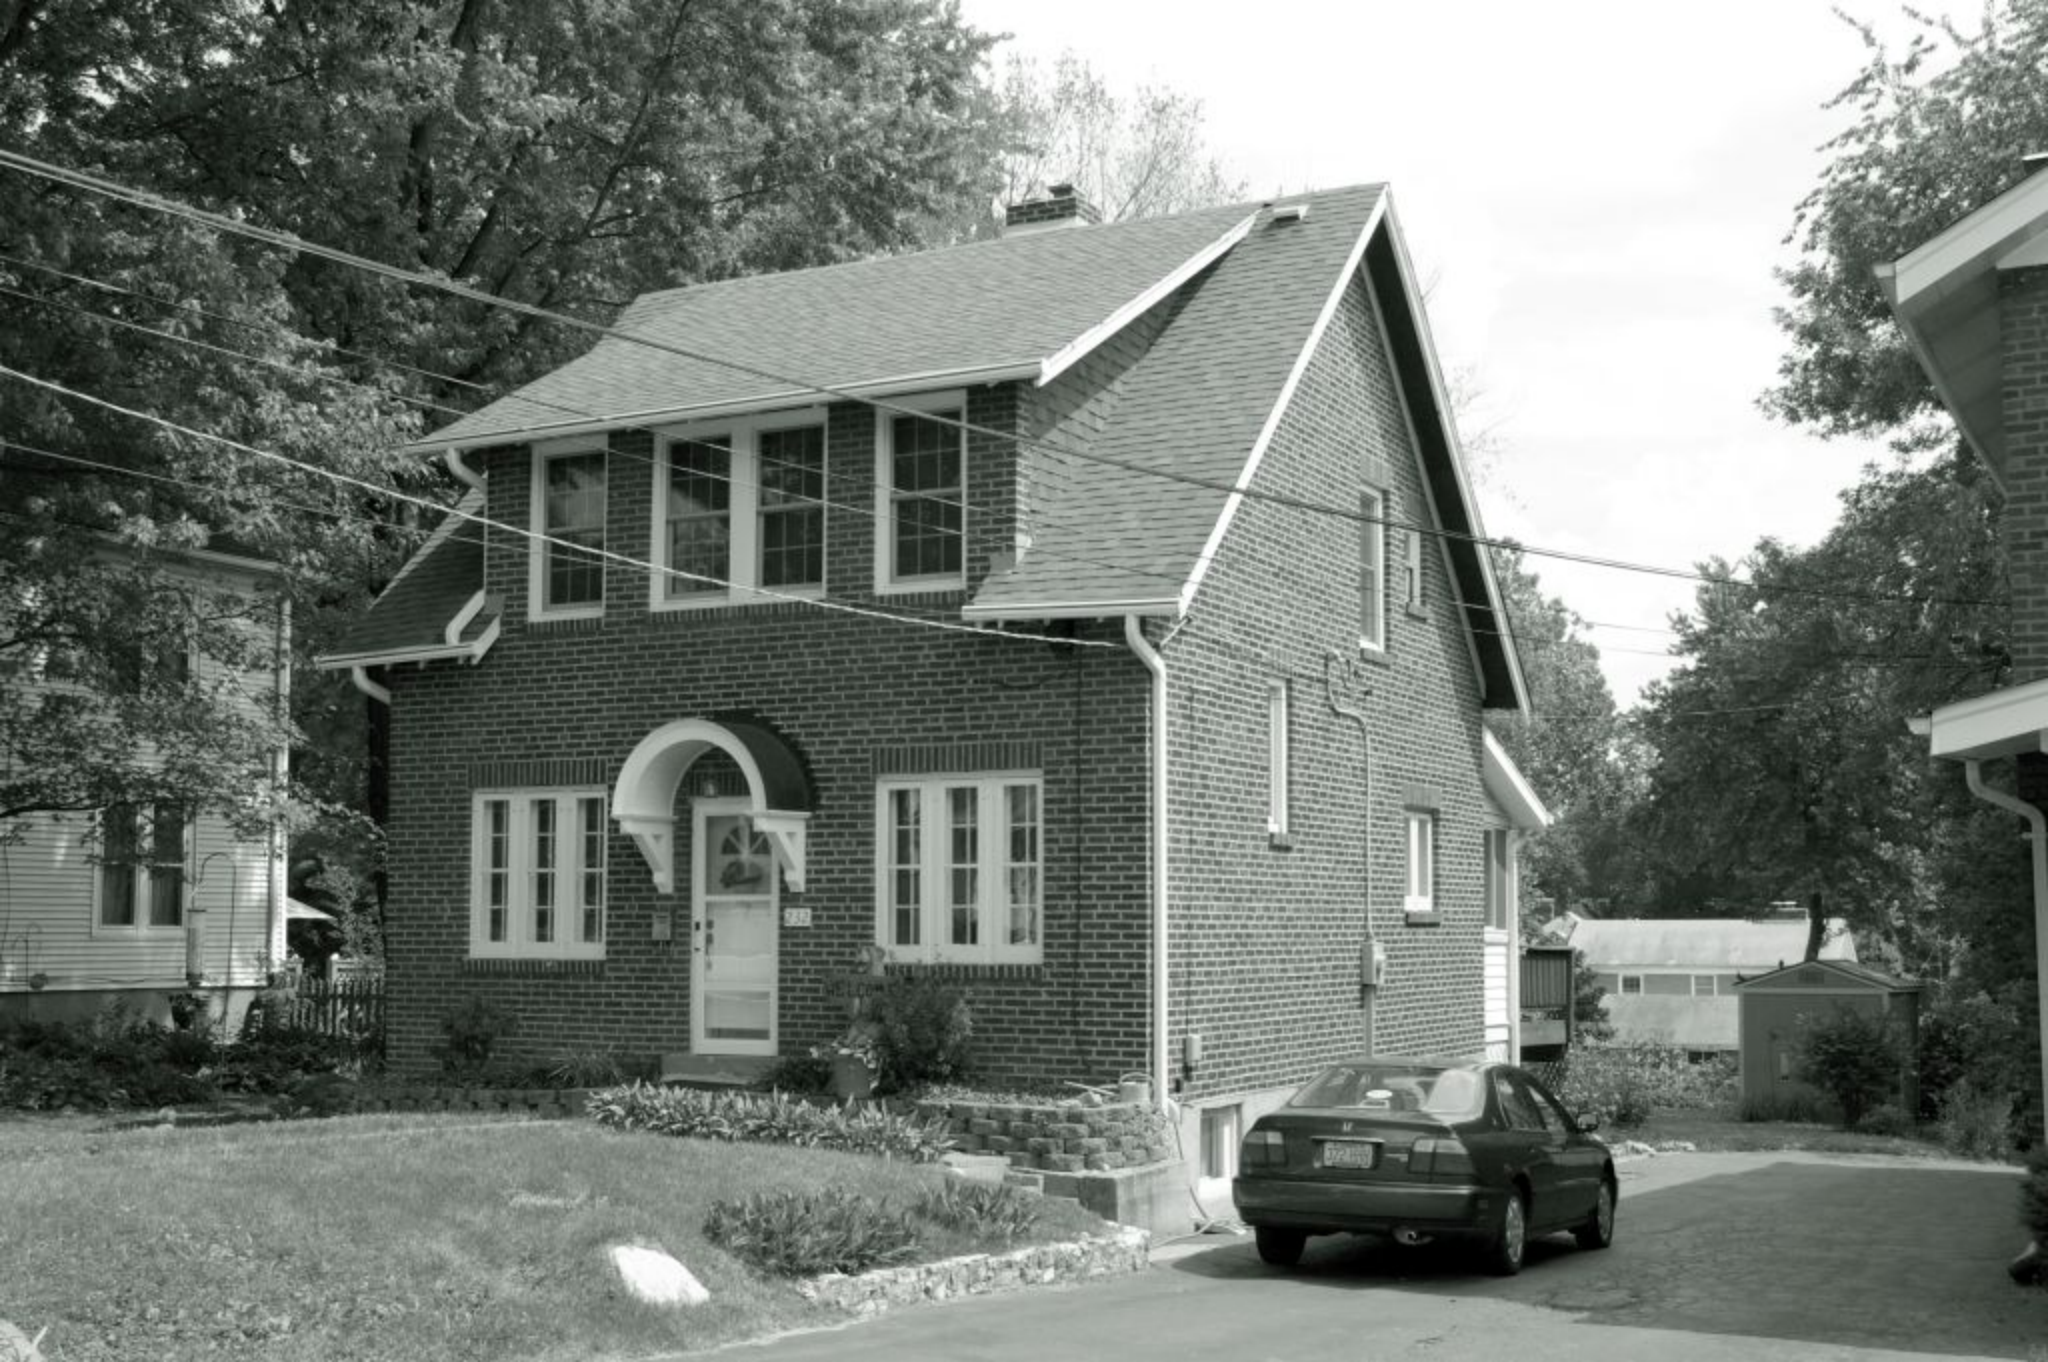
2009 Survey Update: This Colonial Revival house appears unaltered since the 1983 survey, except for the front door which has been replaced with a wood paneled door with a half round light near the top. It has an aluminum storm door, but it retains some of the original wooden storm windows on the casement windows. There is a wood deck added to the back.

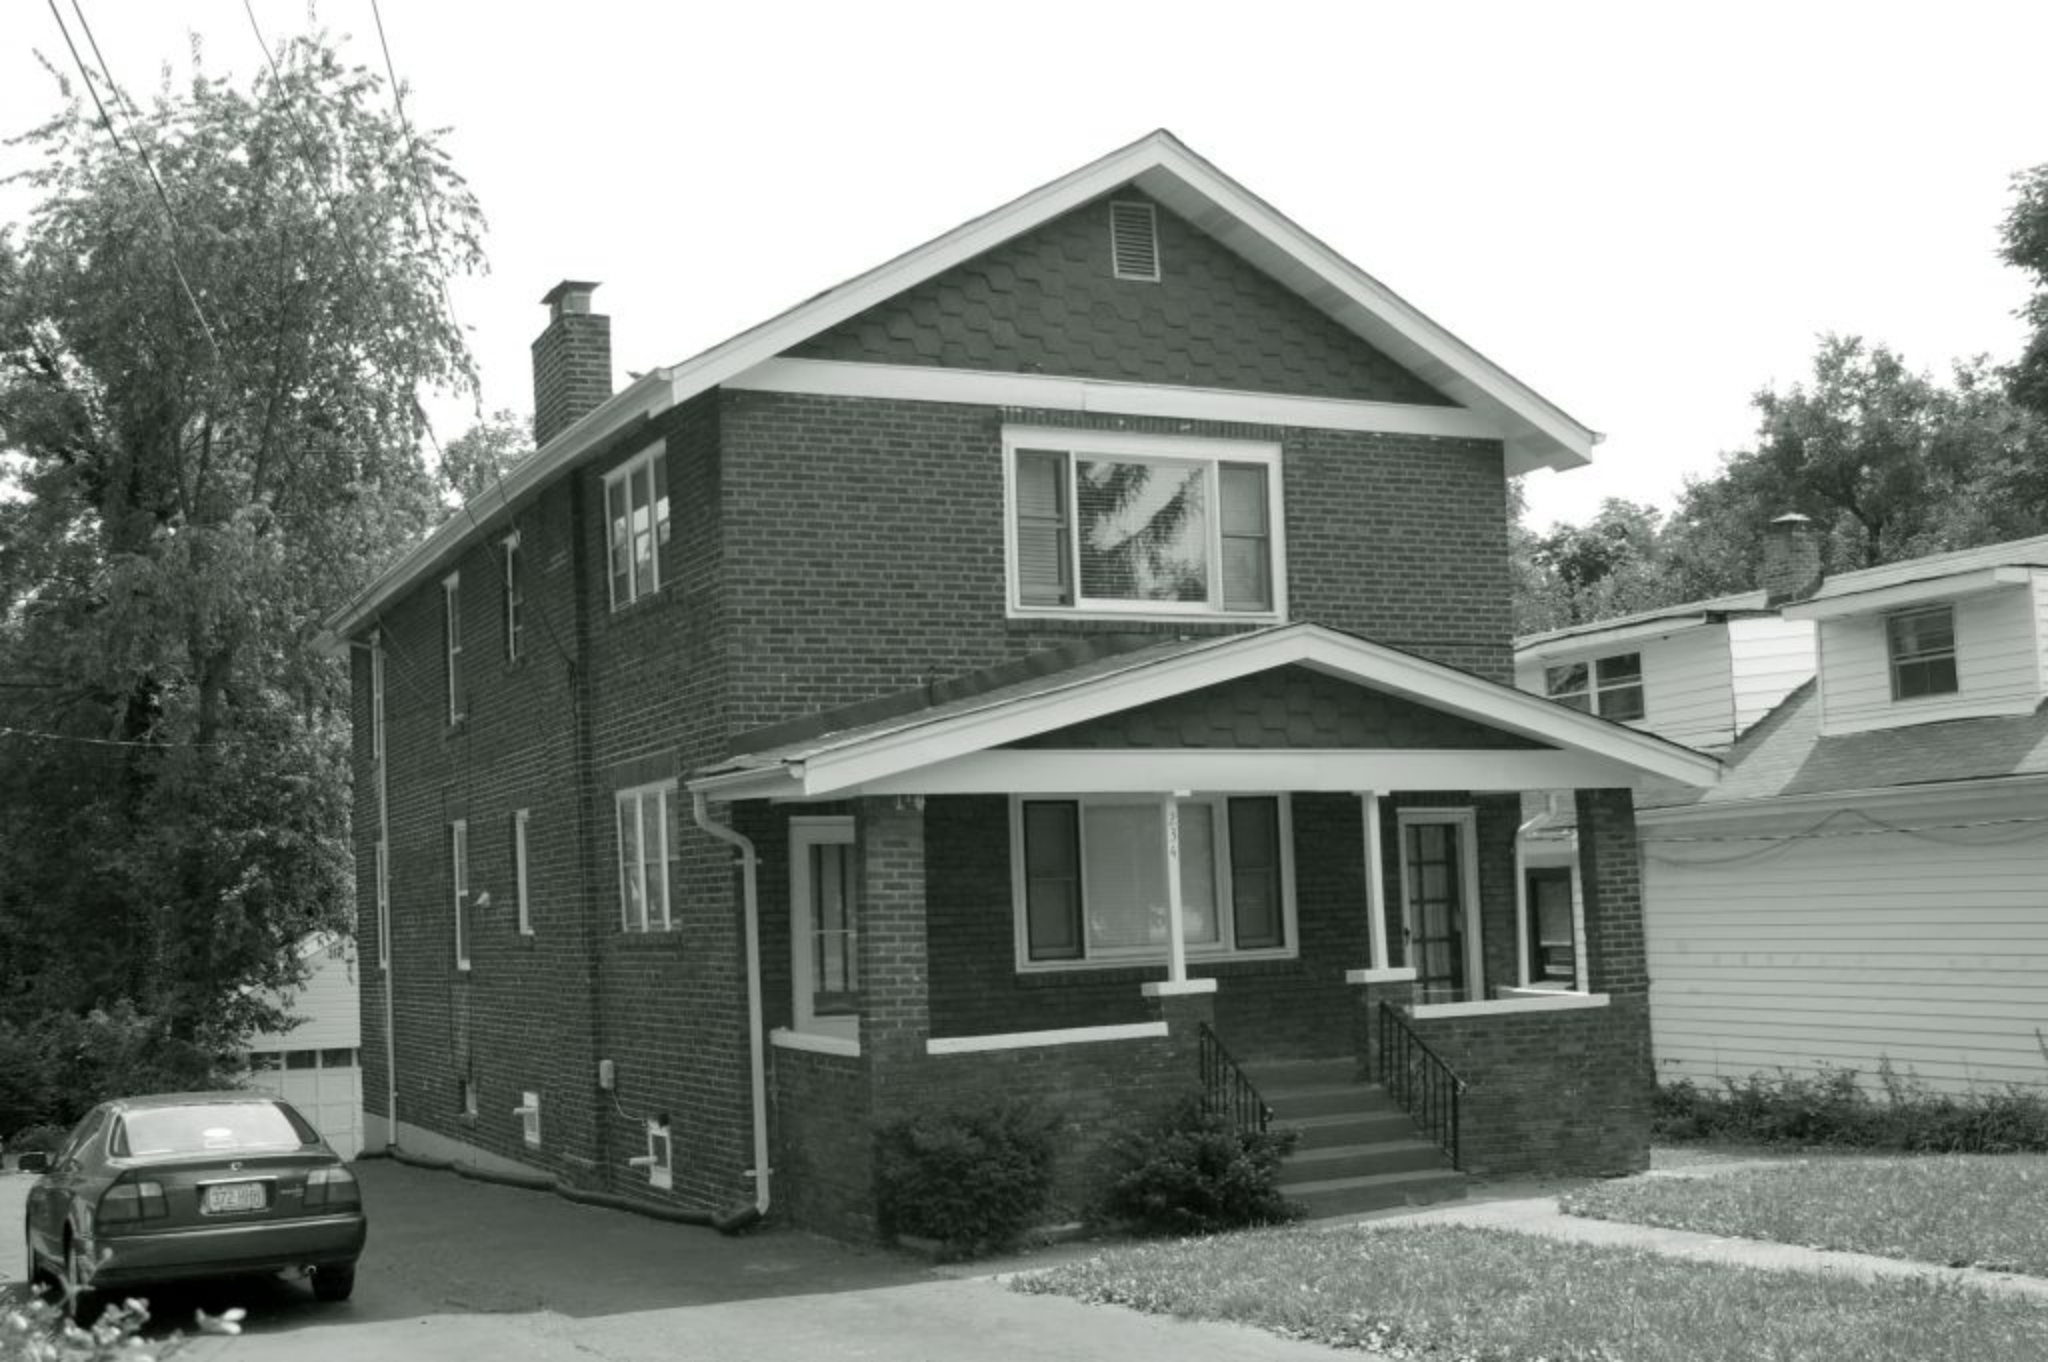
2009 Survey Update: Since the 1983 survey pipe columns have been added on top of the brick piers on either side of the sidewalk. The cluster of three sashed windows on both levels of the facade have had the windows replaced with two narrower sashed windows flanking a plate glass window. Other windows appear to still be 3 over 1 wood sashed windows. Although the 1983 survey identified the hexagonal shingles in the gable ends as wood, they are now asphalt, and likely the originals. One of the two front doors is a multipaned full light door while the other is a 3 vertical light door and it is not clear if either is a replacement or this was an original distinction between the two apartment units.

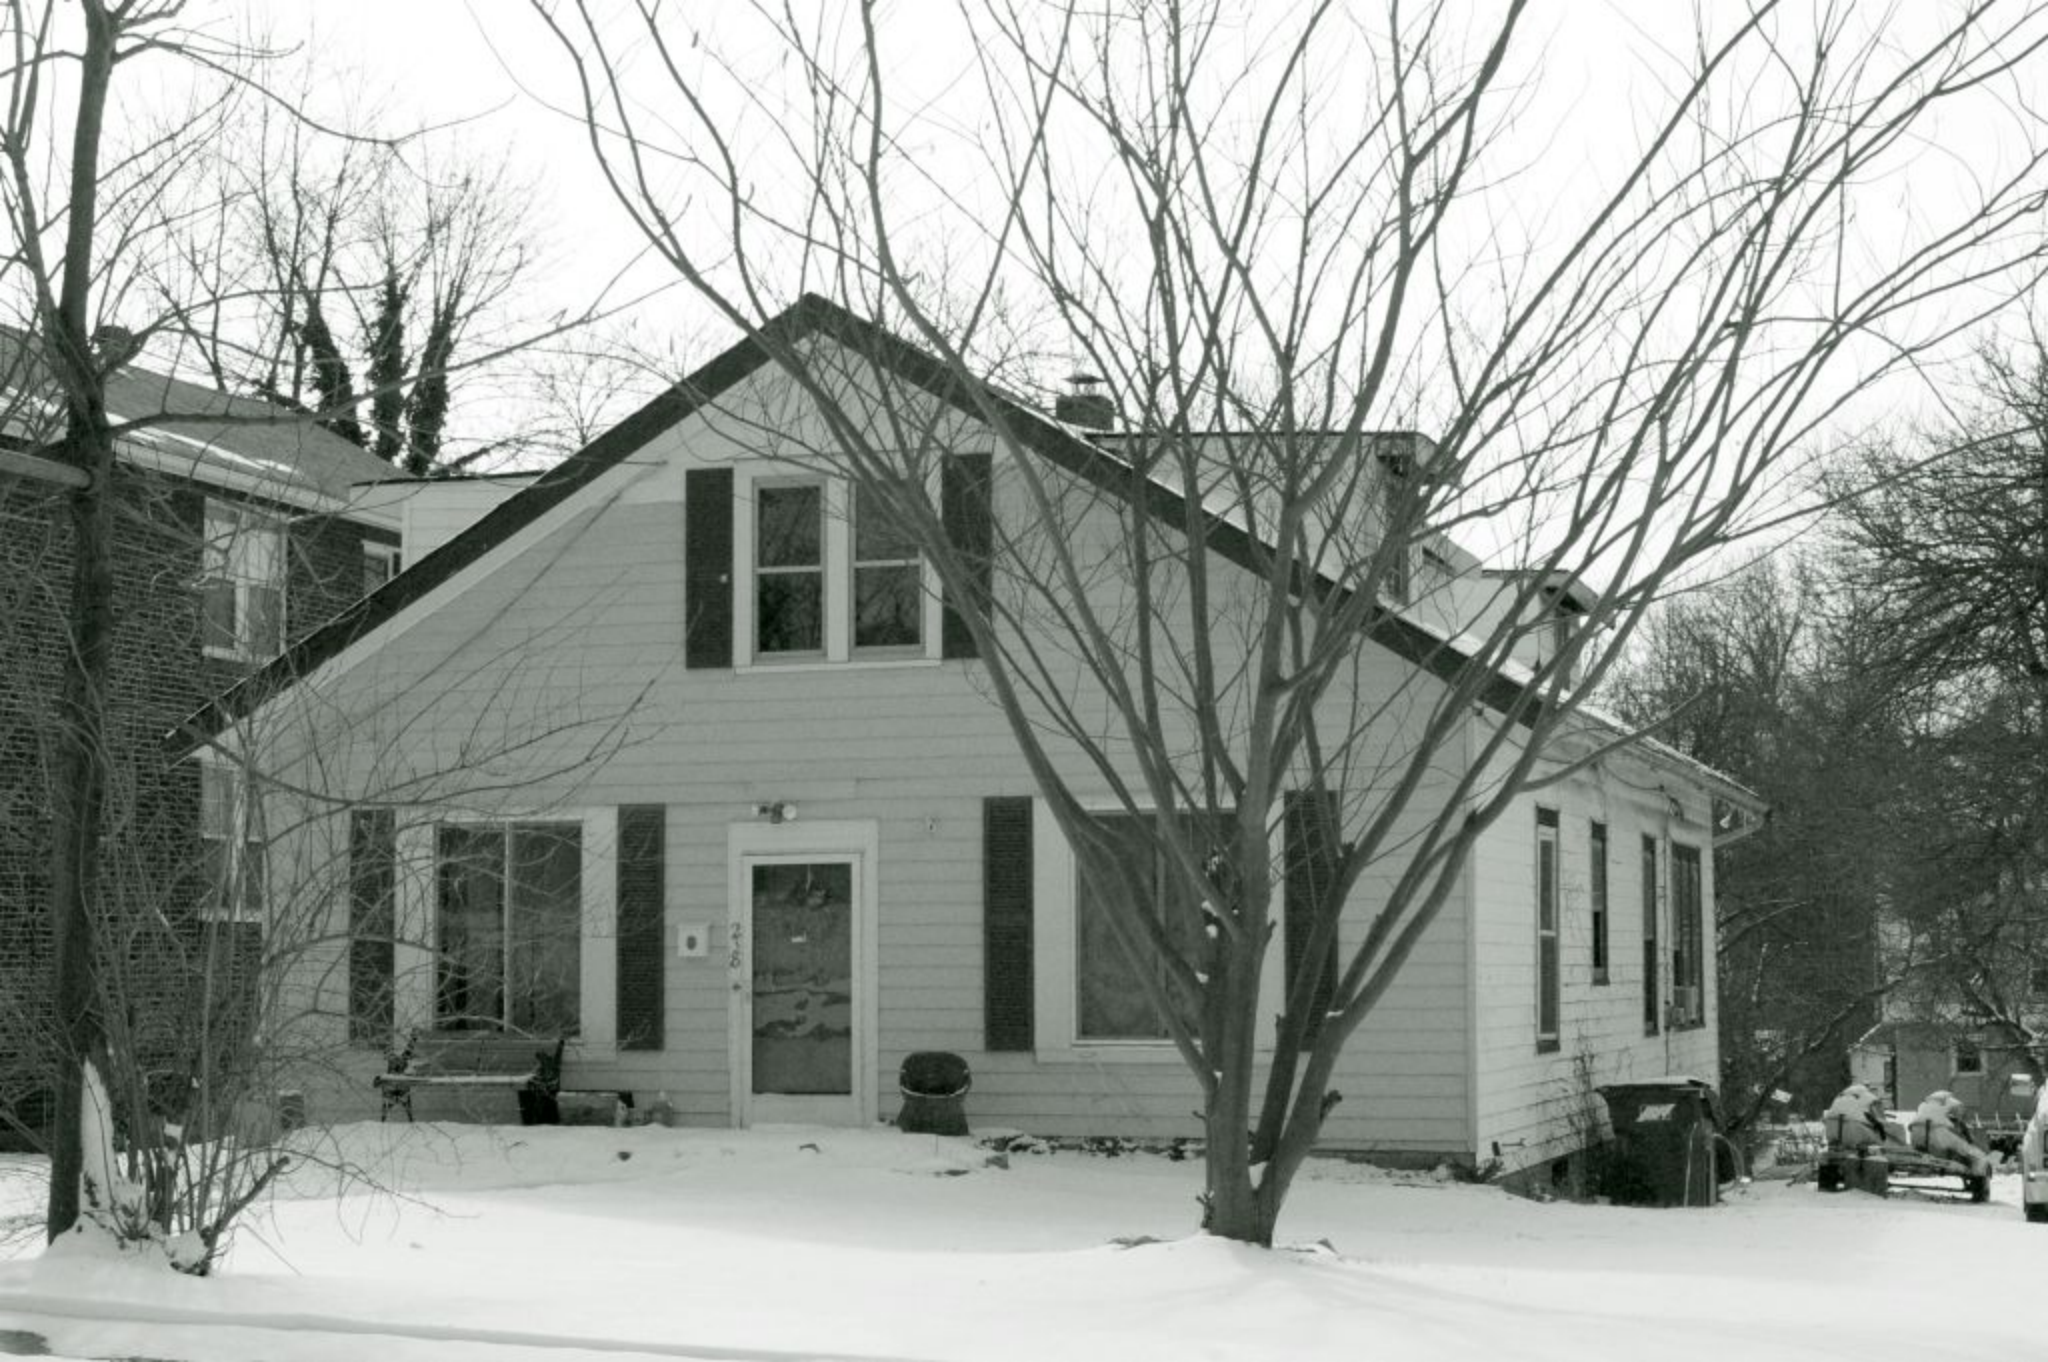
2009 Survey Update: Since the 1983 survey, the front porch has been eliminated and the distinctive door with its three lights in the upper third of the wood door has been replaced with a six panel metal door. The 3 over 1 windows have been replaced, mostly with 1 over 1 windows, but the first floor facade windows have large sliding 2 light windows and shutters have been added.
