ARCHITECTURAL/HISTORIC INVENTORY FORM

1. Survey No. SL-AS-036-001		2. Survey Name: Architectural Survey of Old Ferguson West	
3. County: St. Louis		4. Address: 1 Carson Rd.	
5. City: Ferguson	Vicinity: <input type="checkbox"/>	6. UTM:	7. Township/Range/Section
8. Historic name (if known):		9. Present/other name (if known): Whistle Stop	
10. Ownership: <input type="checkbox"/> Private <input checked="" type="checkbox"/> Public		11. Historic use (if known): TRANSPORTATION/rail-related	11. Current use: COMMERCE/restaurant & RECREATION/museum

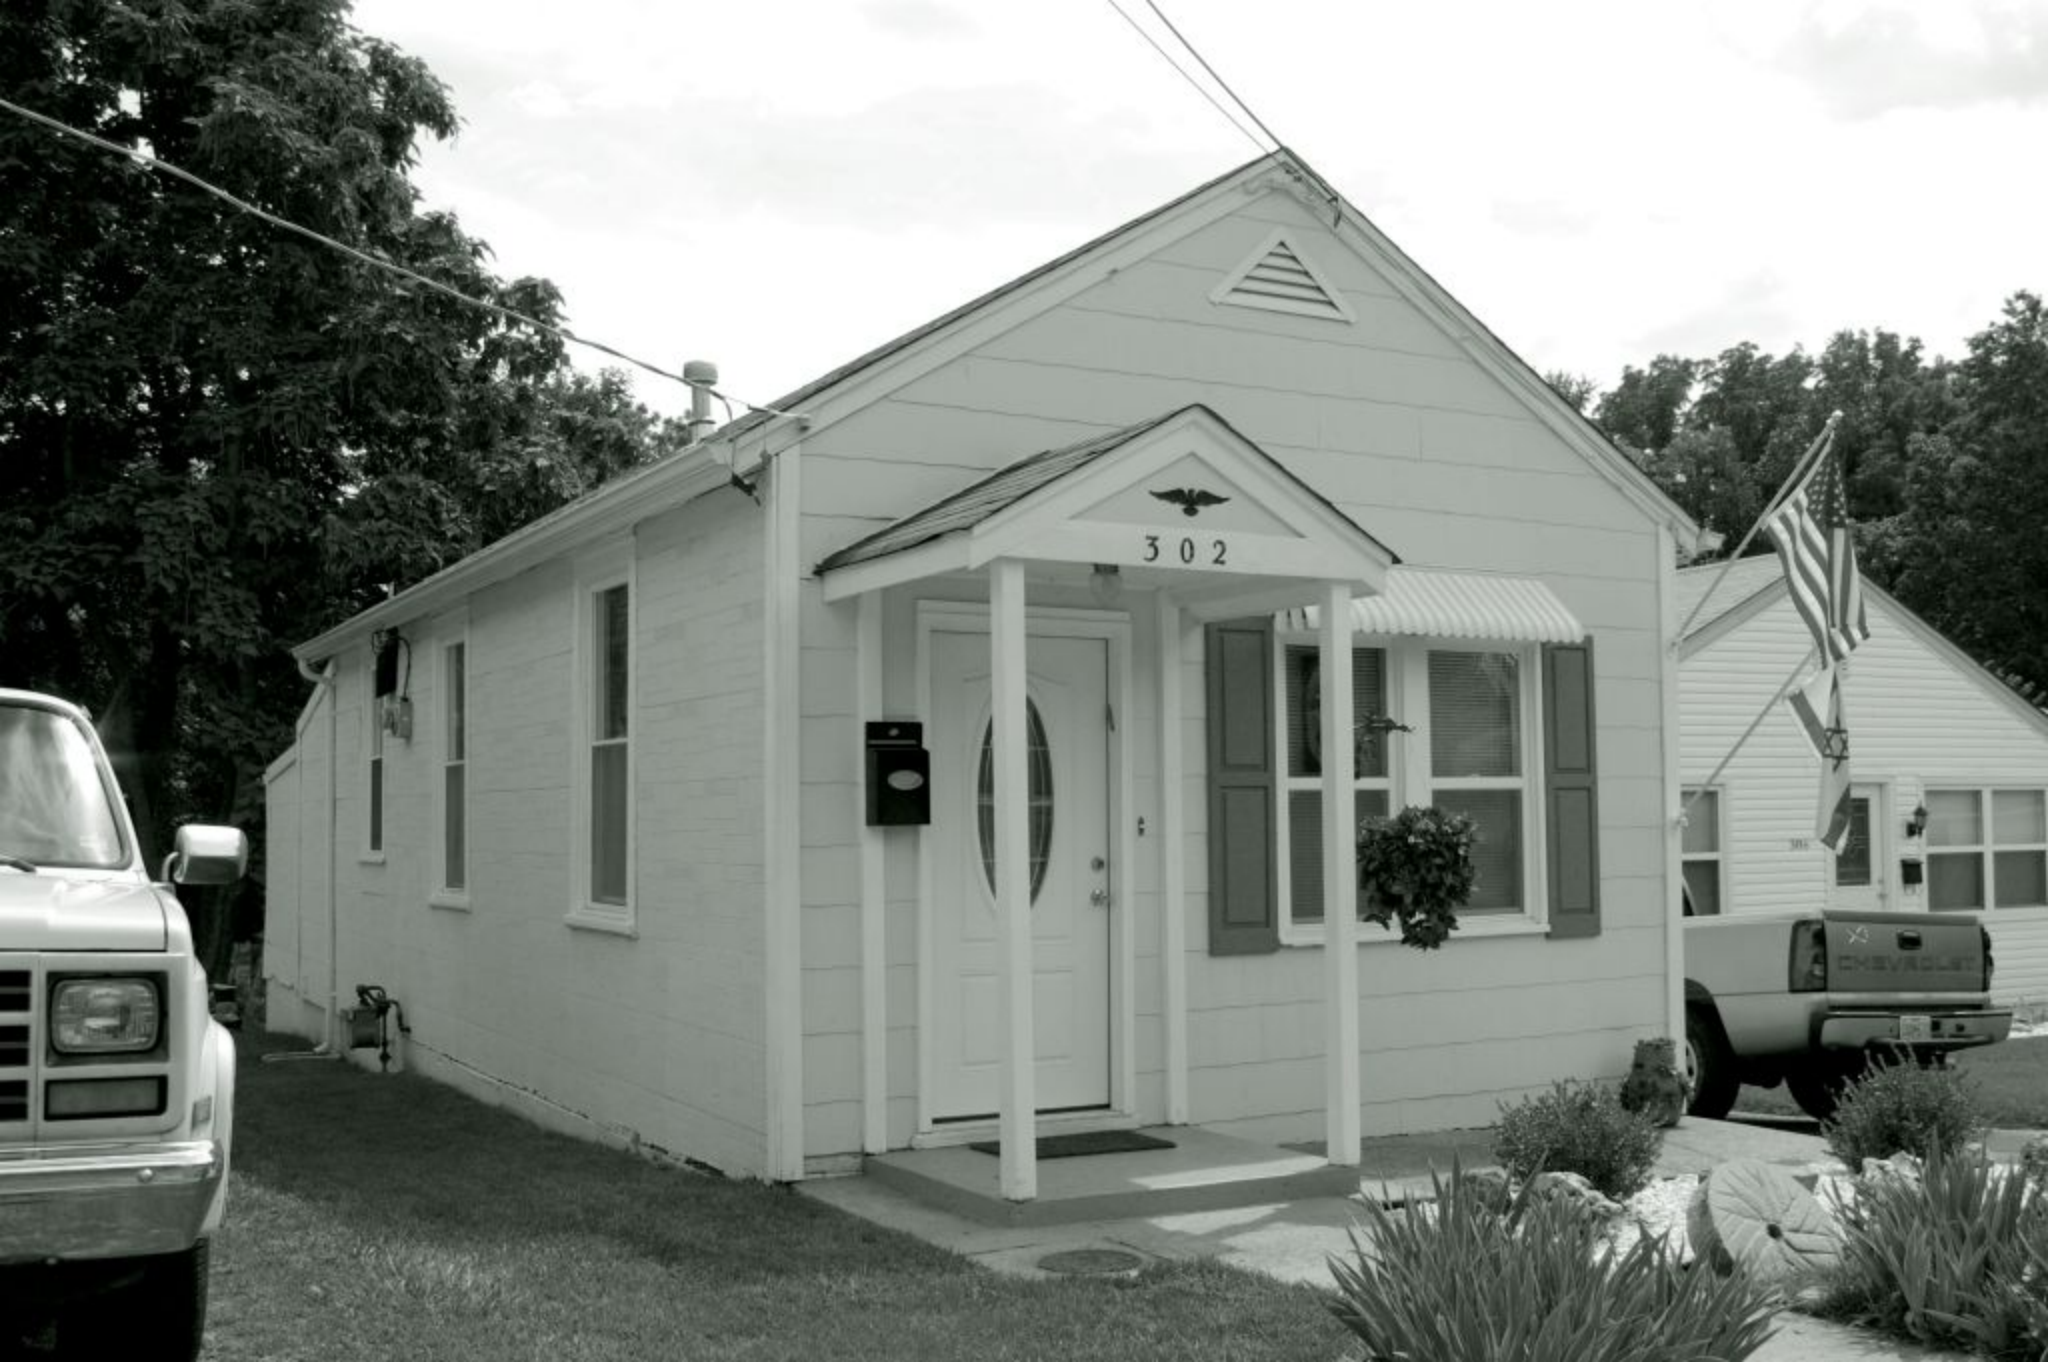
2009 Survey Update: Little has changed visually on this house since the 1983 survey (and probably since the early 1950s when the facade had asbestos siding added) although the original 1 over 1 wood sashed windows have been replaced with vinyl 1 over 1 windows. The front door has been replaced with a modern metal paneled door with an oval light and shutters have been added onto the front window unit.

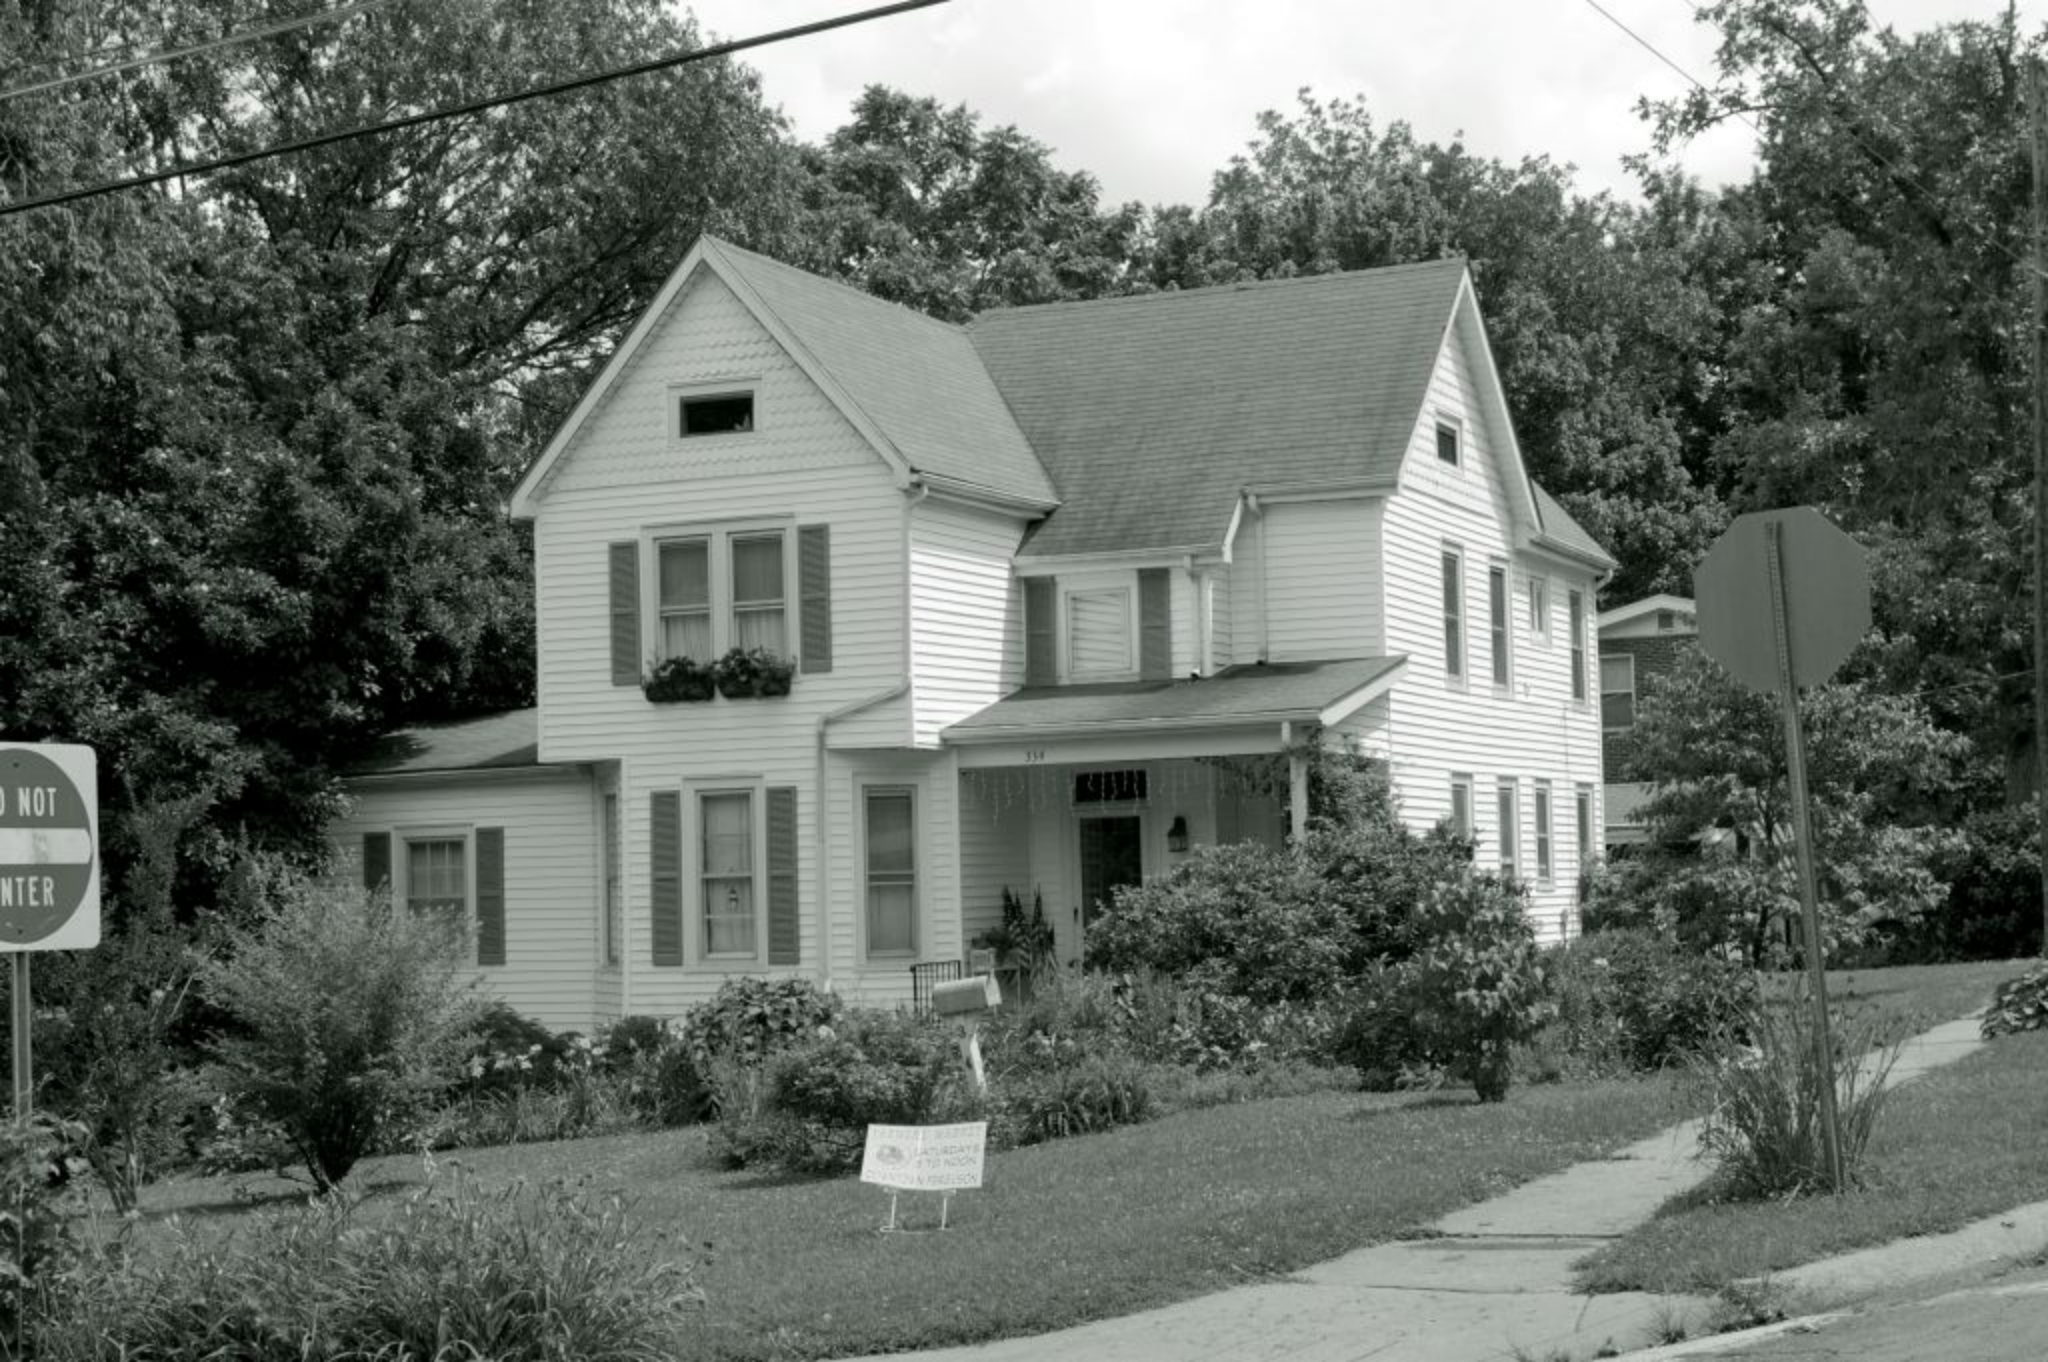
2009 Survey Update: Since the 1983 survey, the asbestos siding has been removed and replaced with vinyl siding, which most likely approximates the original siding more closely, but the shutters are a nonhistoric addition. The vinyl, fishscale shingles in the gable end may not represent original details, but is in keeping with the house, which has the form of a Folk Victorian house with crossed gables. The front porch was out of scale with the house, not original, and was oversized both visually and based upon the fire insurance map, and since the 1983 survey it has been replaced with a shed roofed porch that matches the historic proportions (based upon the fire insurance maps and physical details). It has a simple turned corner post. The house still retains its original wood sashed windows, but has newer storm windows.

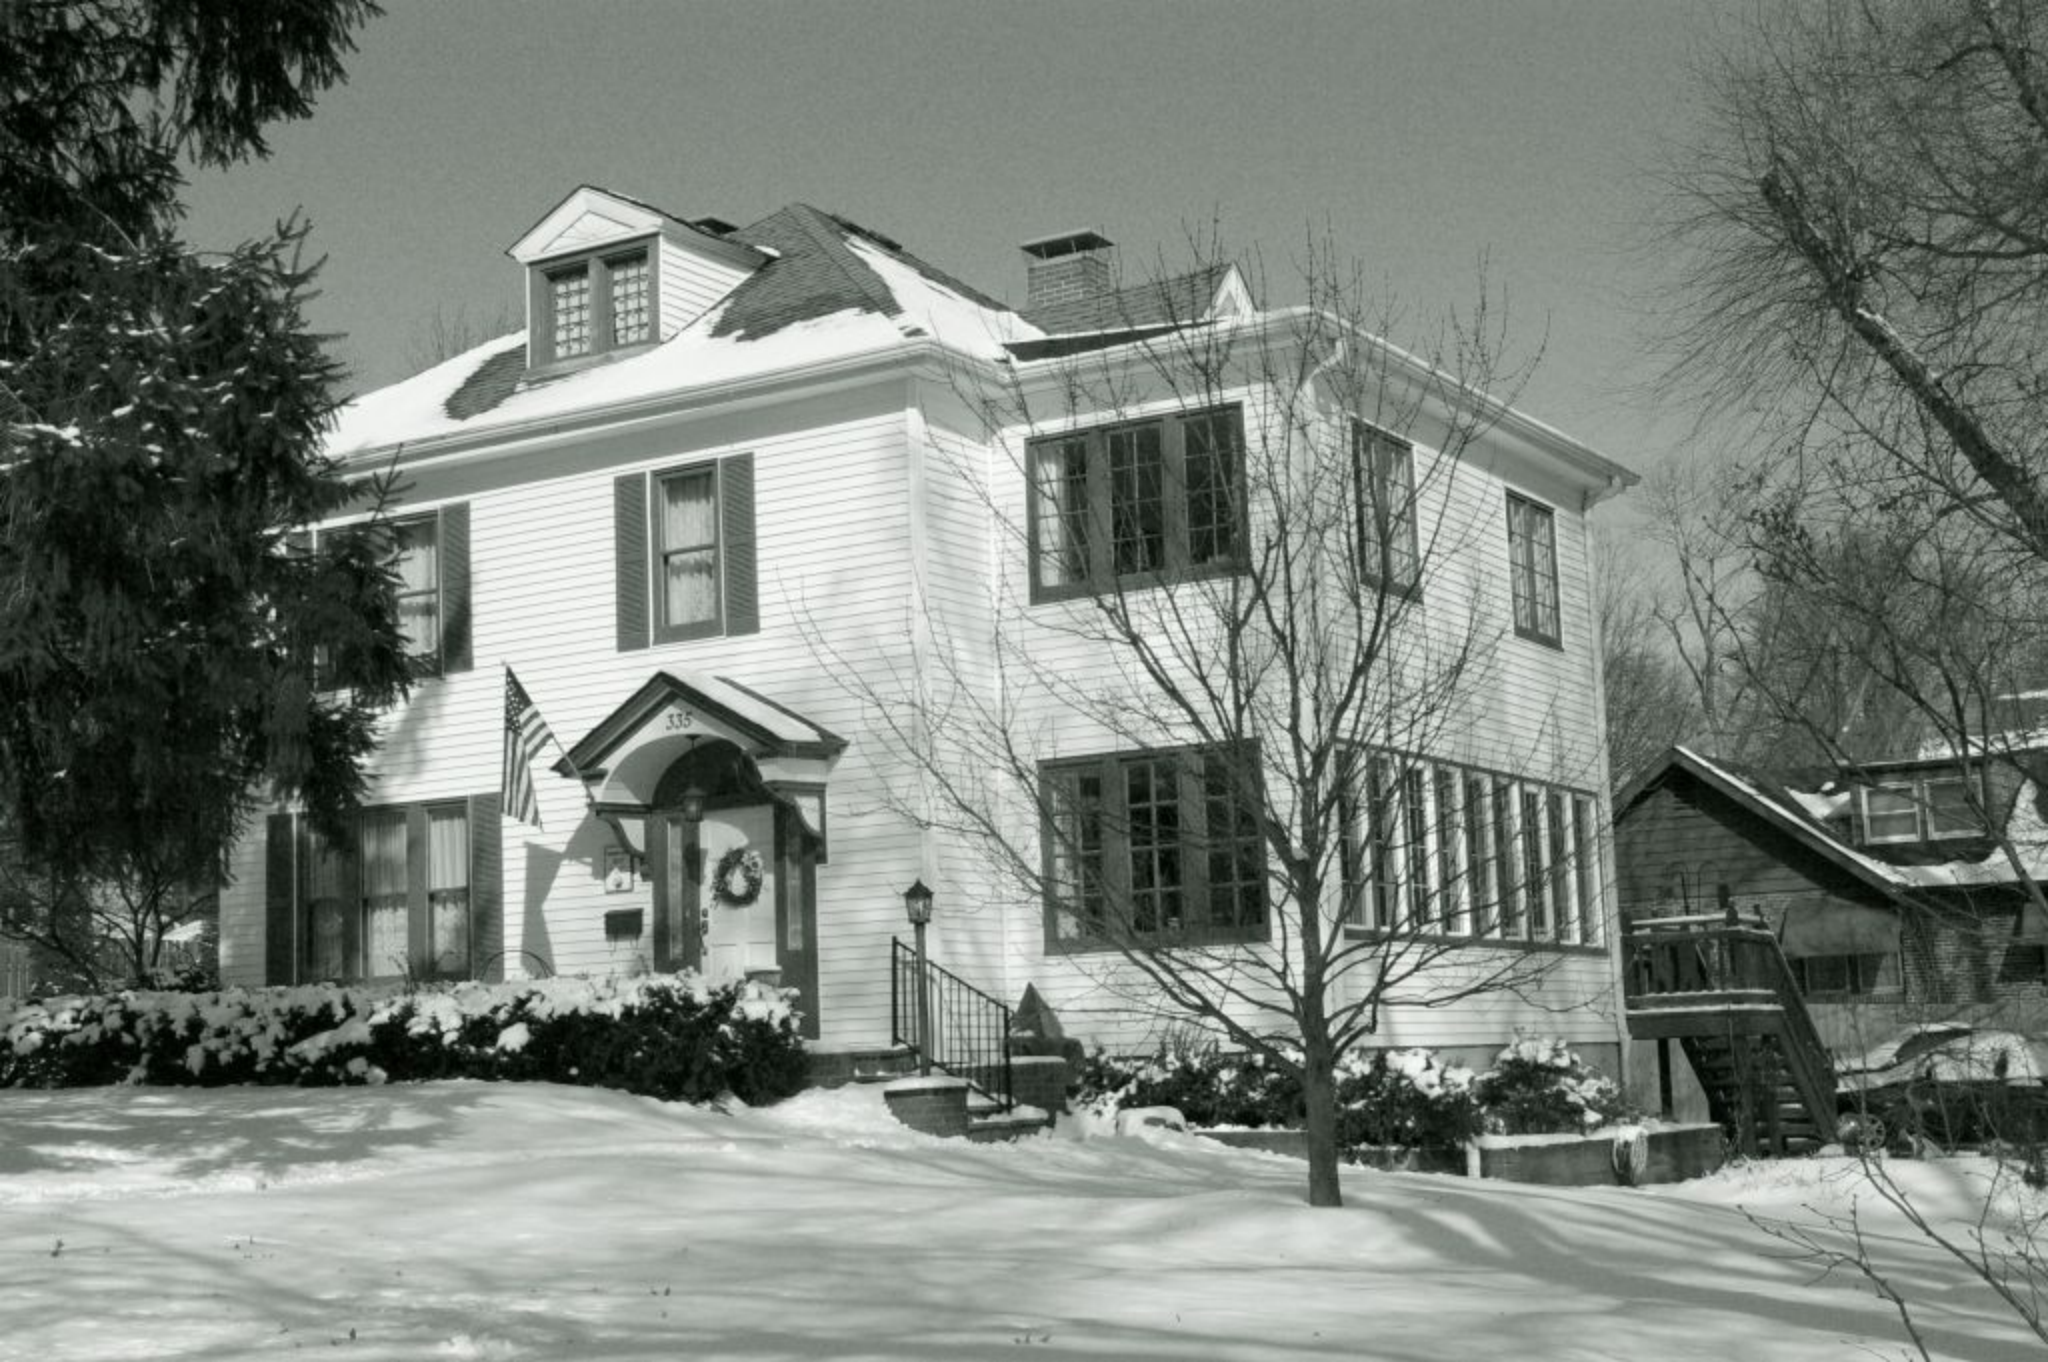
2009 Survey Update: Since the 1983 survey, it appears that the aluminum replacement siding has again been replaced, this time with vinyl siding, but the house retains its original wood sashed windows as well as the multipaned casement windows. It even seems to retain the original porch lantern and front entry door with its fanlight transom. On the back of the house, a wooden deck has been constructed.

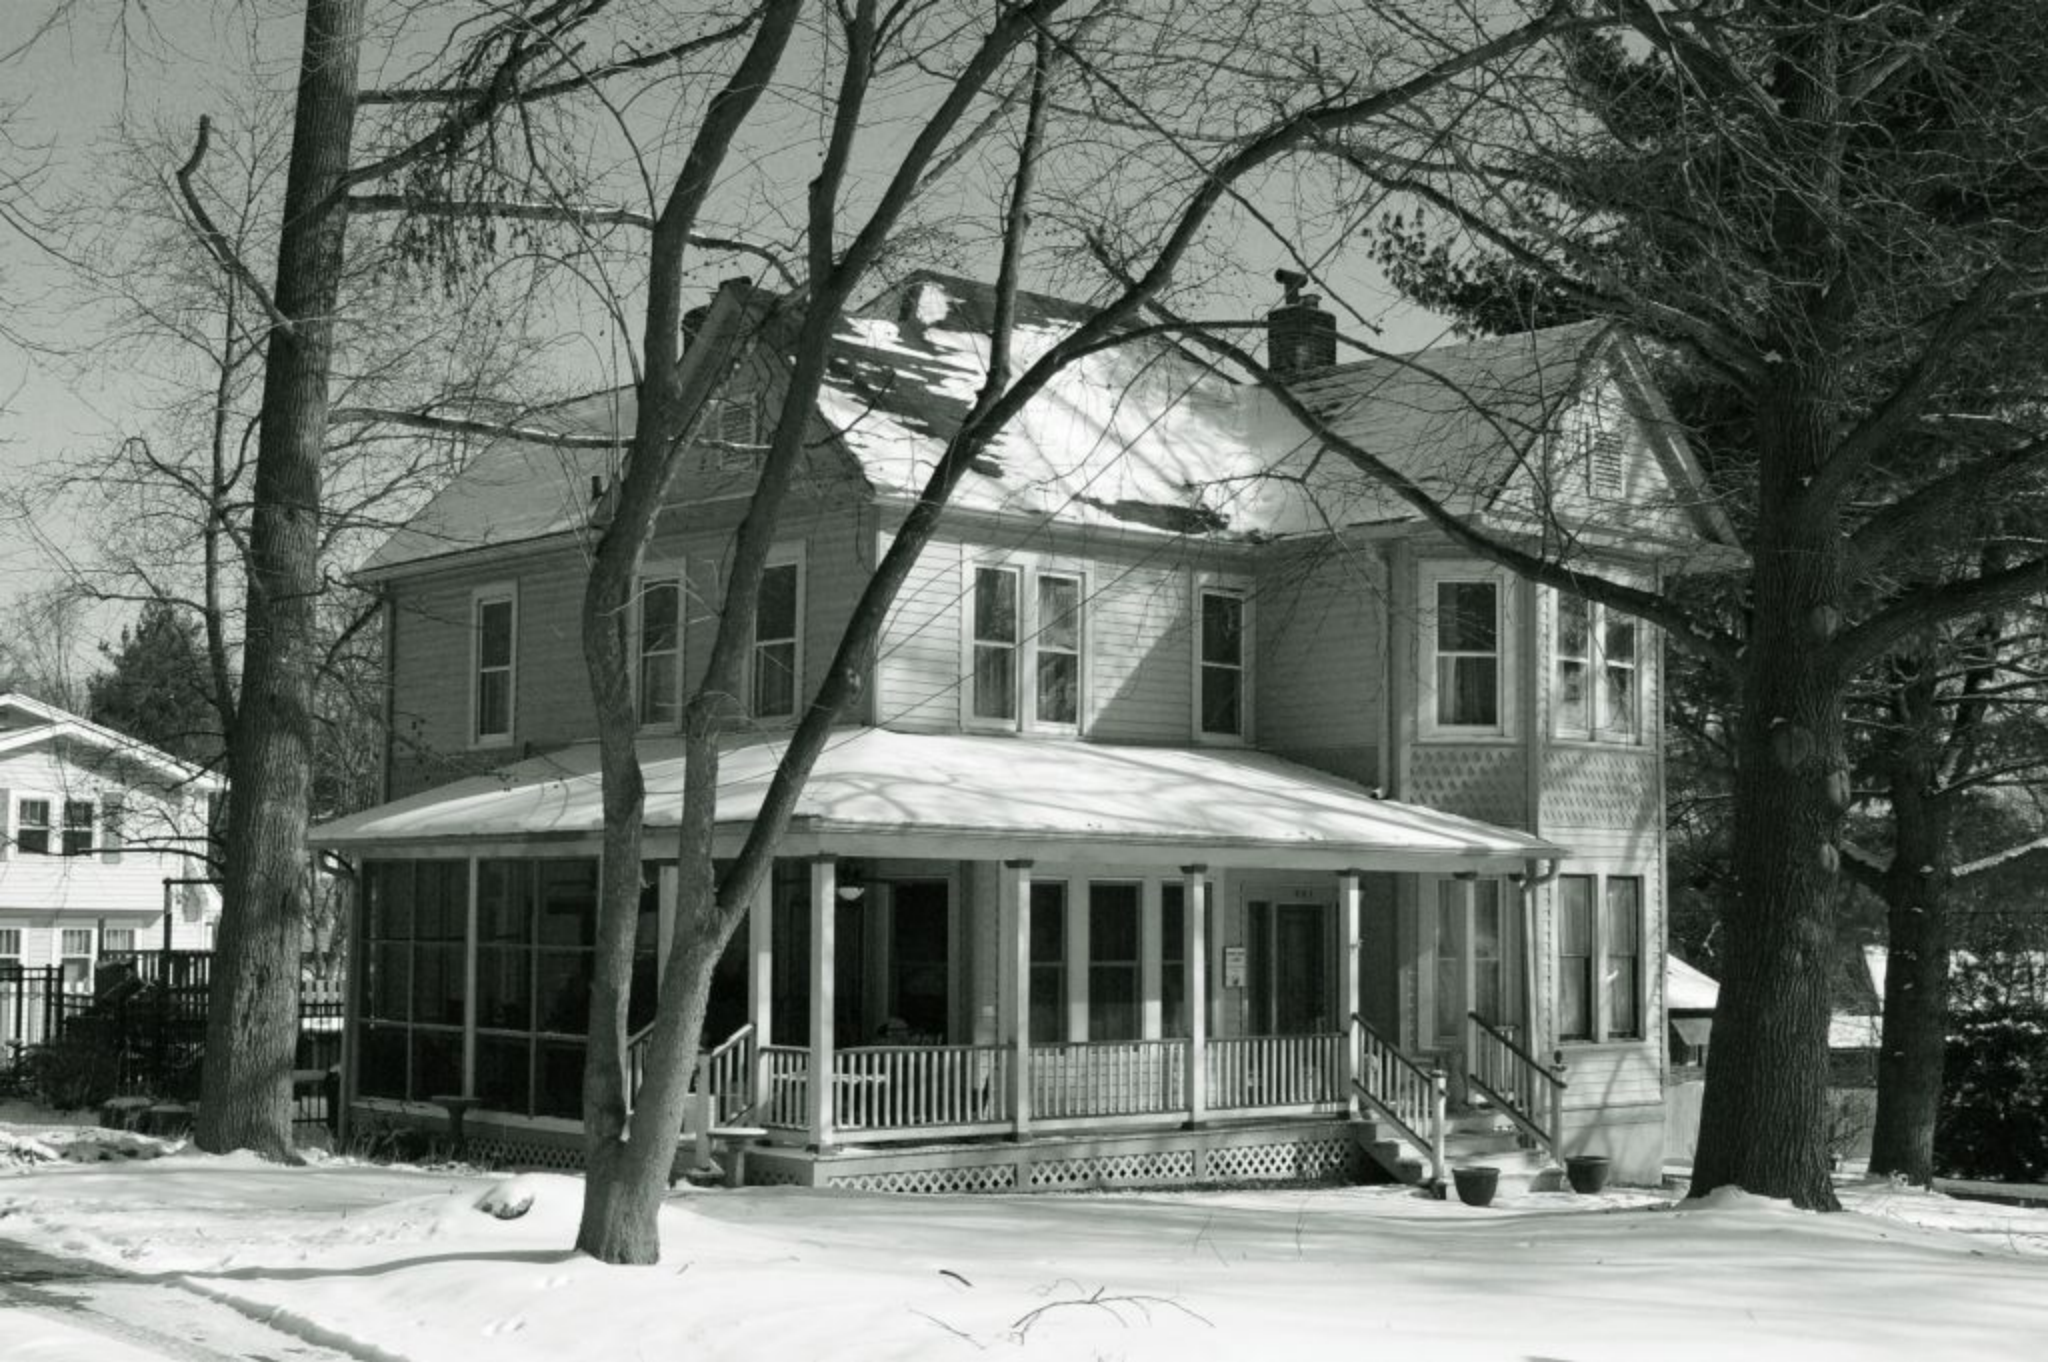
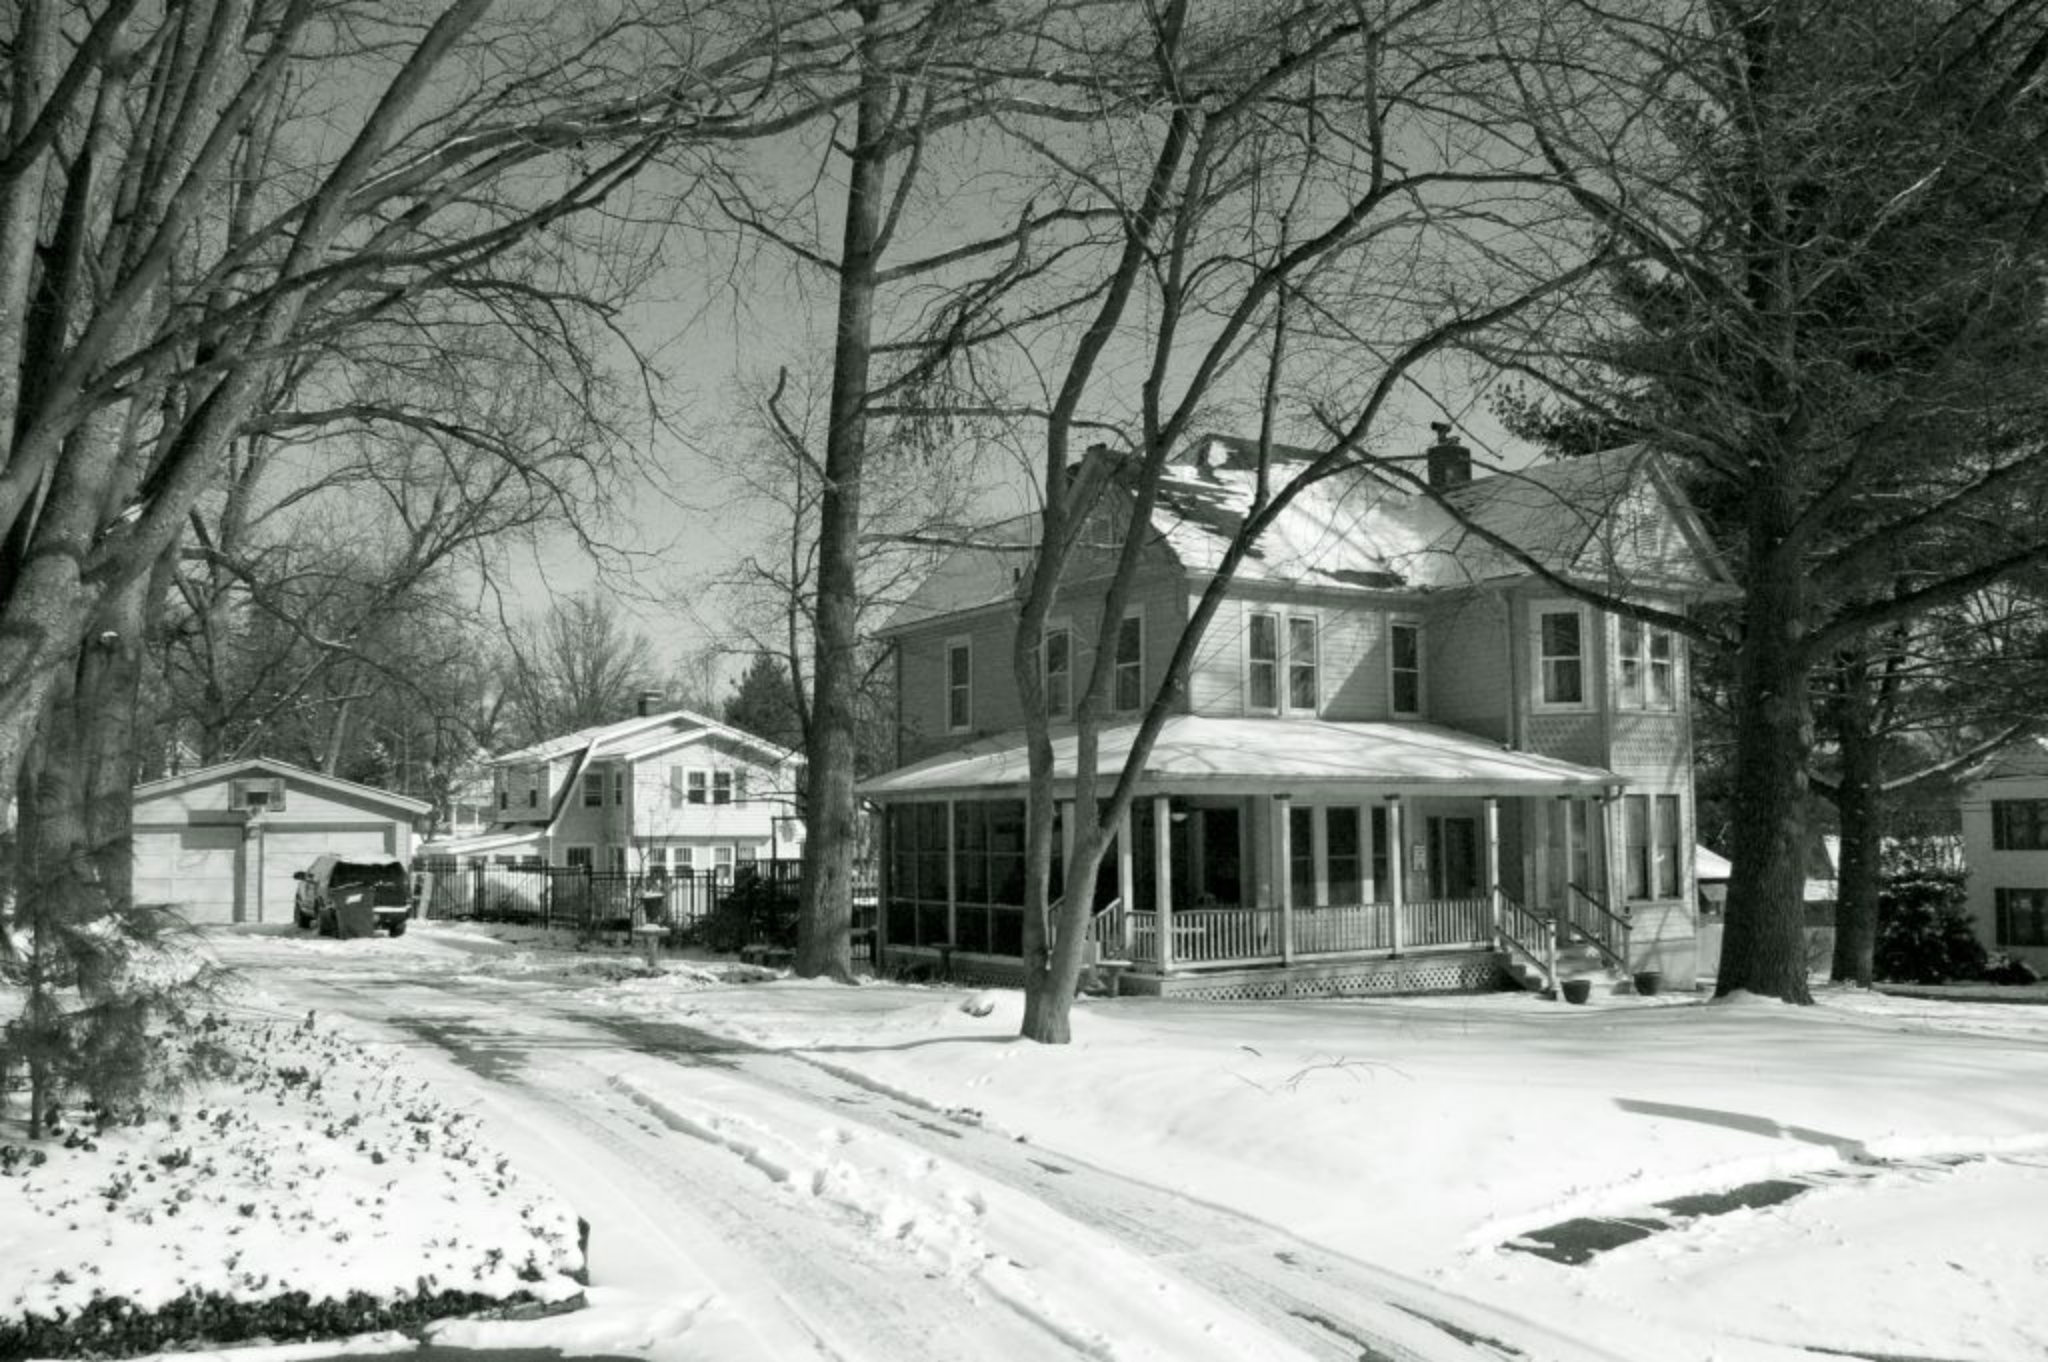
2009 Survey Update: Since the 1983 survey, the house has had the original clapboard and diamond pattern wood shingles covered with vinyl siding, carefully matching the diamond pattern wood shingles with vinyl diamond pattern. The nonhistoric porch enclosure has been removed and rebuilt, with a hipped roofed wrap around porch, screened on the west side. It has simple square posts with bases and caps and a wood porch railing, as well as latticework under the wood porch floor, all of these details are in keeping with the historic character of this Queen Anne house. The siding was carefully placed around the window frames, and the windows are still the original wood sashed windows, some of which have storm windows. It appears that the sidelights and front door may not be original but the large rectangular light in the door is certainly period appropriate, although the elaborate cut glass and leading are not commonly found on houses of this era.

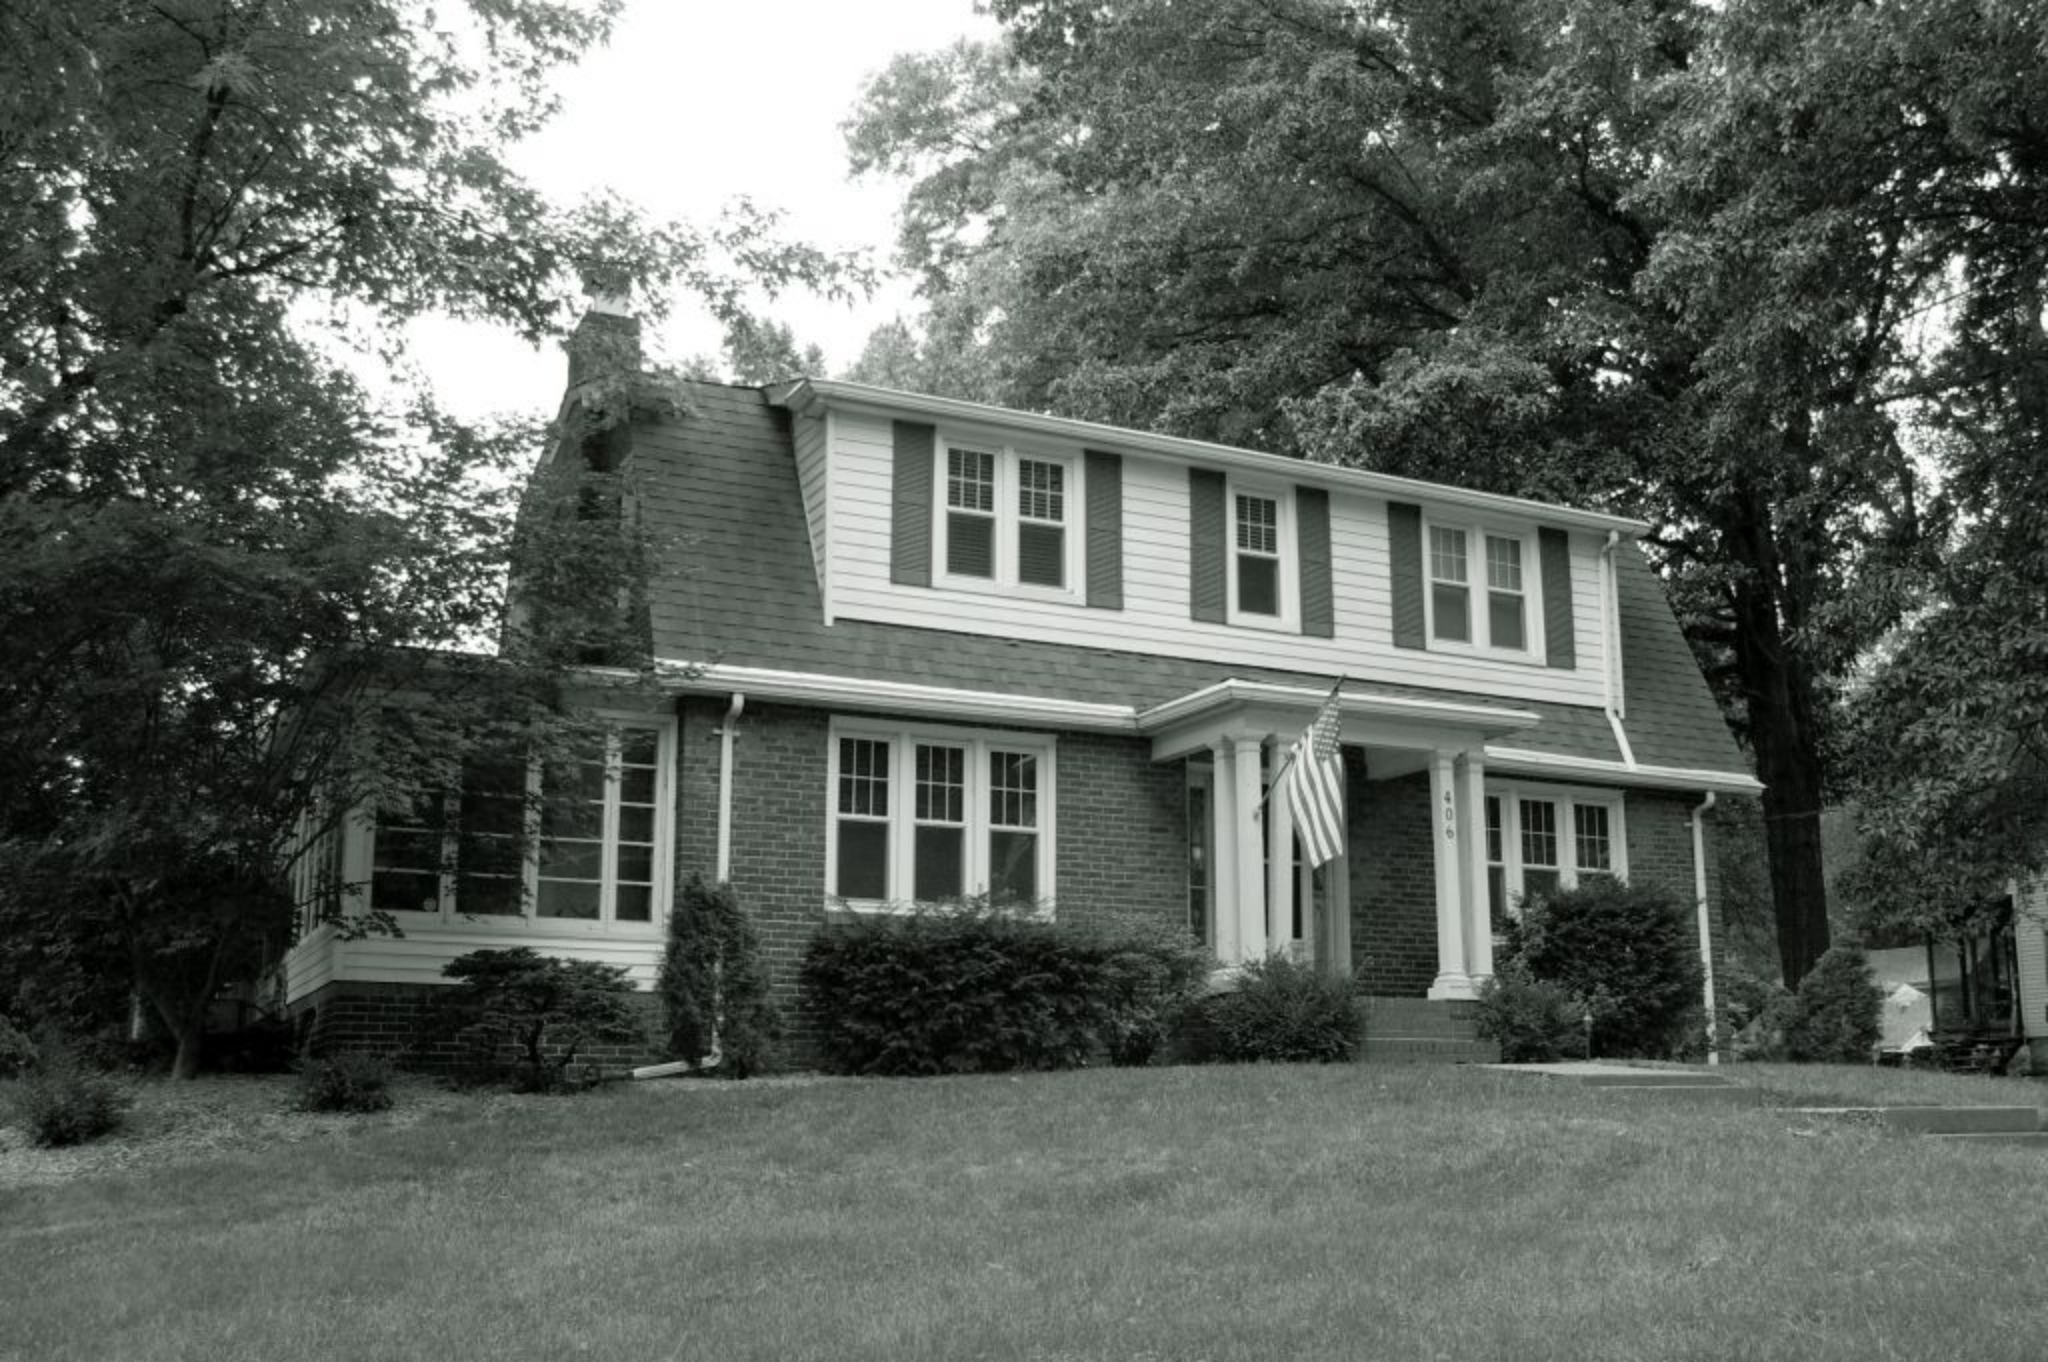
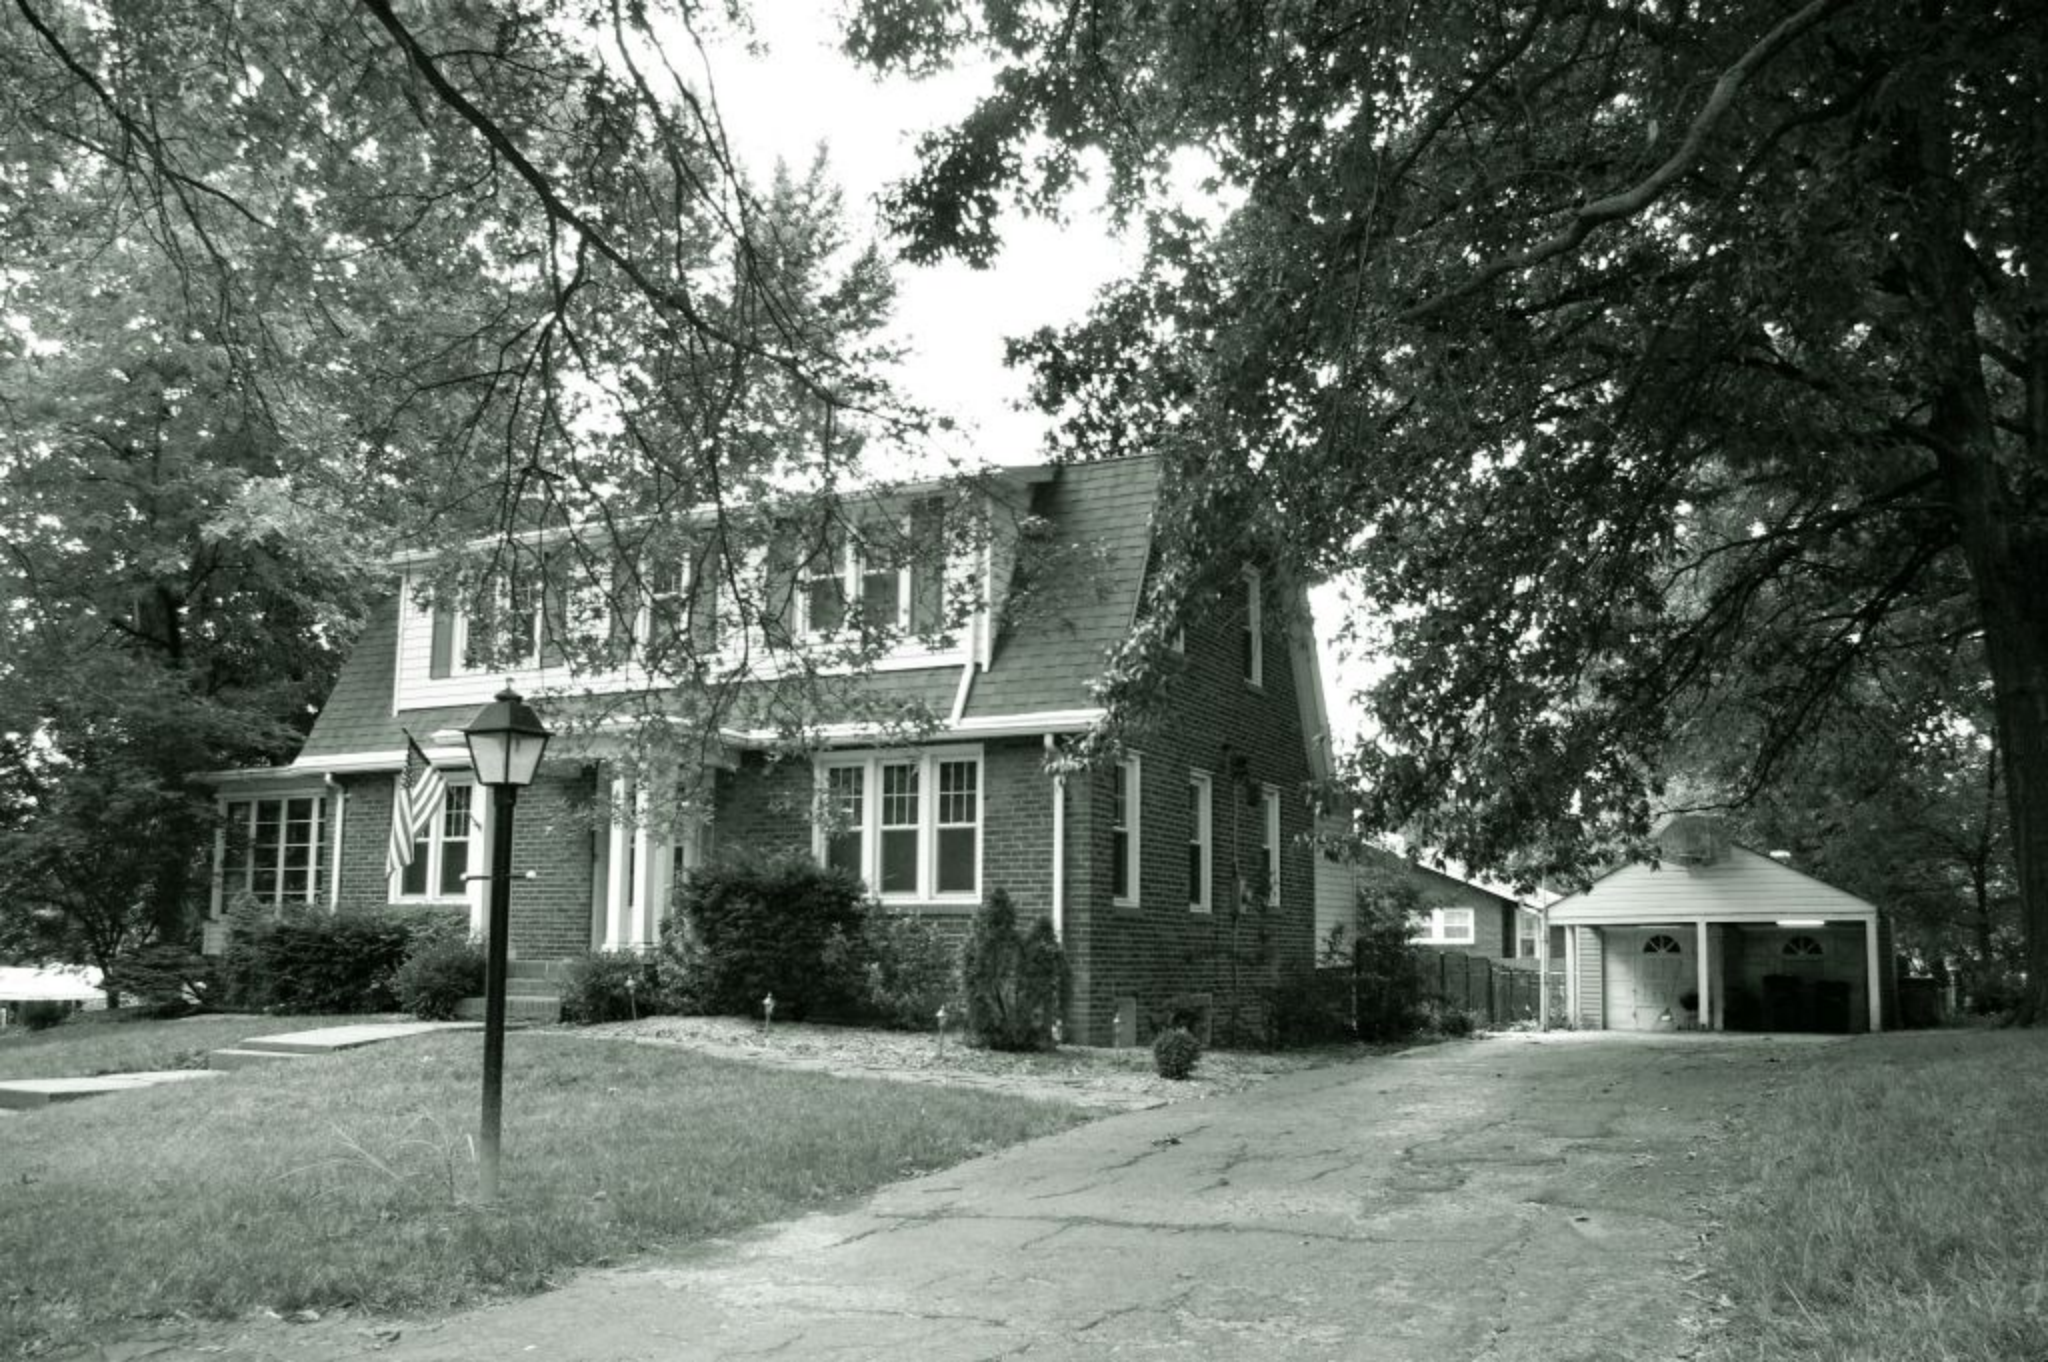
This 1.5 story, brick, Dutch Colonial Revival house has a broad shed roofed dormer on the facade. The main facade is divided into three bays, with clusters of three sashed 6 over 1 windows on each side of the flat roofed entry portico. It has 3 square columns clustered at each outer corner supporting the entablature below the roof and rest on a brick porch stoop and steps. There is a sidelighted entry door. Above, the shed dormer has paired 6 over 1 sashed windows flanking a single 6 over 1 sashed window. To the east, there is a one story, flat roofed sunroom that is enclosed by a series of wood casement windows with horizontal lights. Below the windows is a small section of aluminum siding above the brick foundation walls. There is an end wall chimney between the sunroom and main house. It appears that the sashed windows may have been replaced with vinyl windows.
