ARCHITECTURAL/HISTORIC INVENTORY FORM

1. Survey No. SL-AS-036-001		2. Survey Name: Architectural Survey of Old Ferguson West	
3. County: St. Louis		4. Address: 1 Carson Rd.	
5. City: Ferguson	Vicinity: <input type="checkbox"/>	6. UTM:	7. Township/Range/Section
8. Historic name (if known):		9. Present/other name (if known): Whistle Stop	
10. Ownership: <input type="checkbox"/> Private <input checked="" type="checkbox"/> Public		11. Historic use (if known): TRANSPORTATION/rail-related	11. Current use: COMMERCE/restaurant & RECREATION/museum

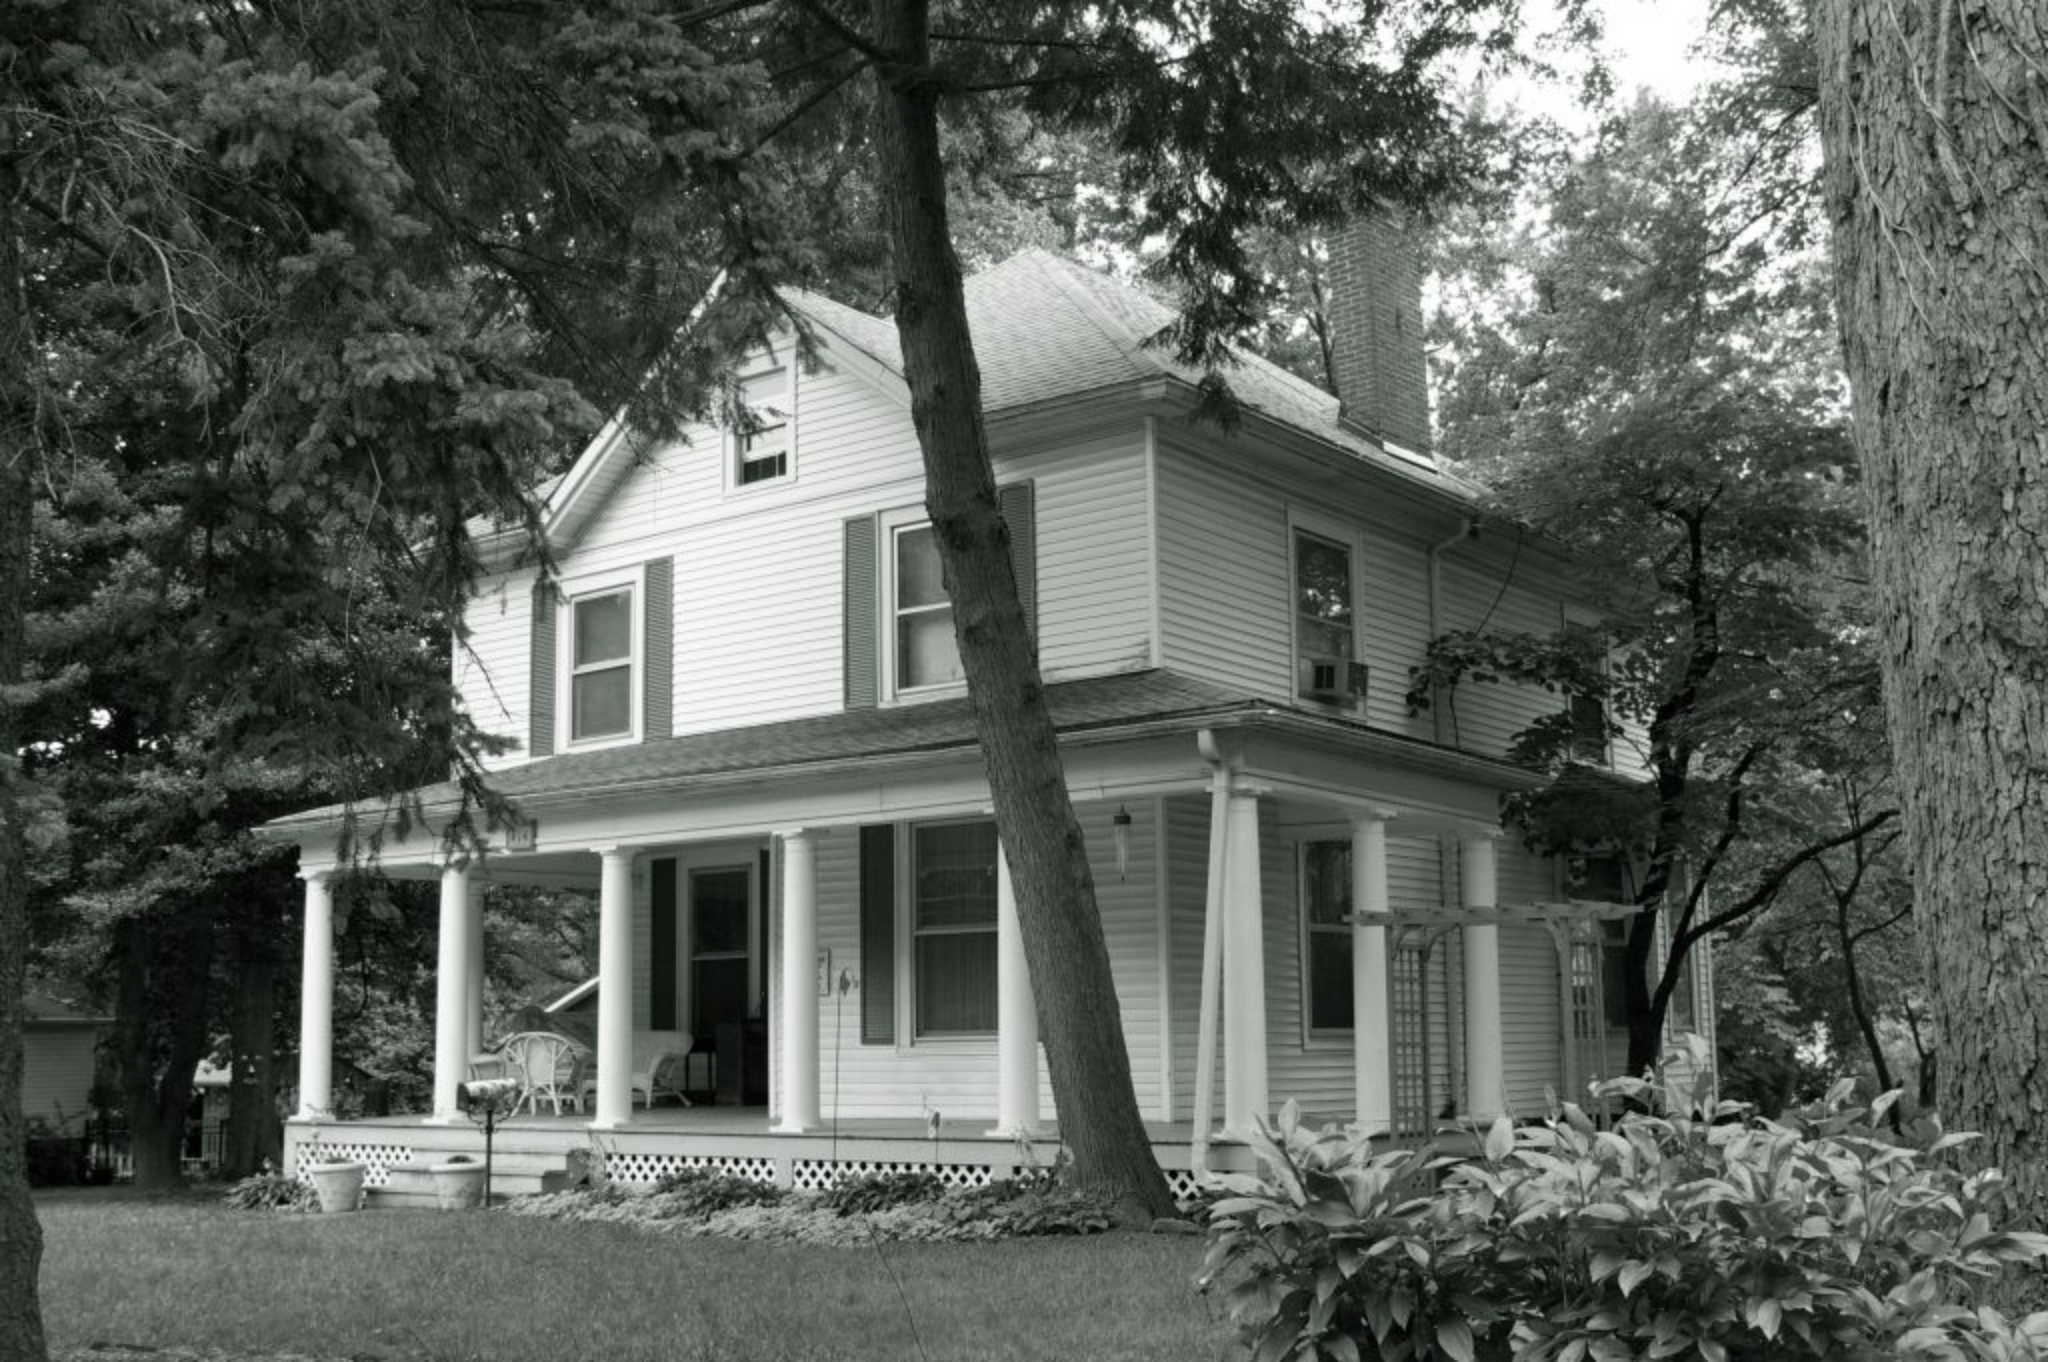
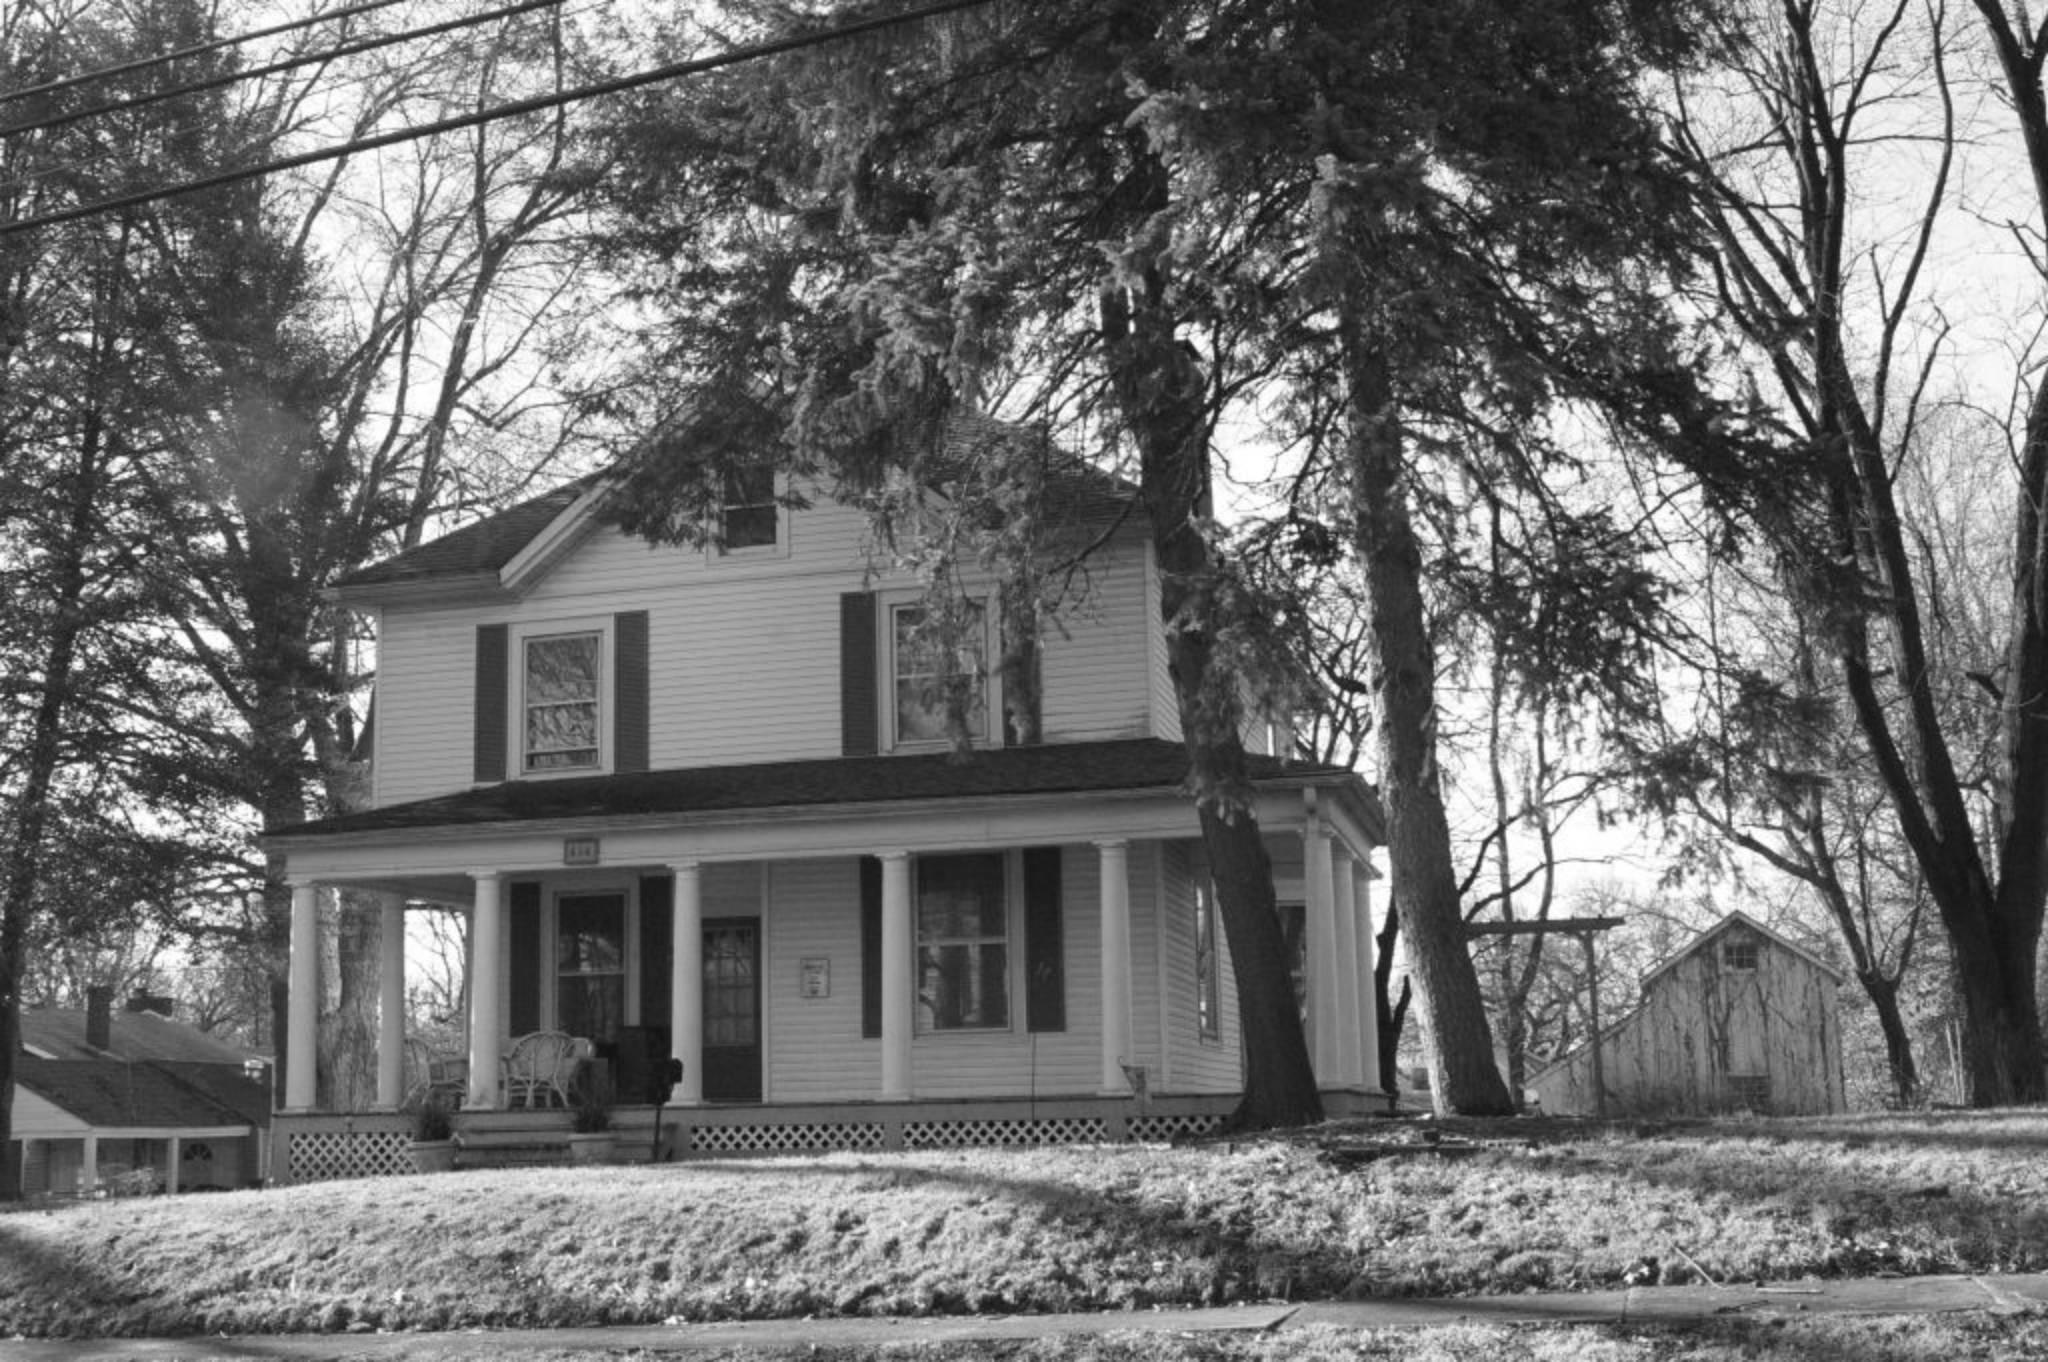
2009 Survey Update: Since the 1983 survey, the only alteration on the house has been cladding the house with vinyl siding, approximating the same width as the original clapboard.

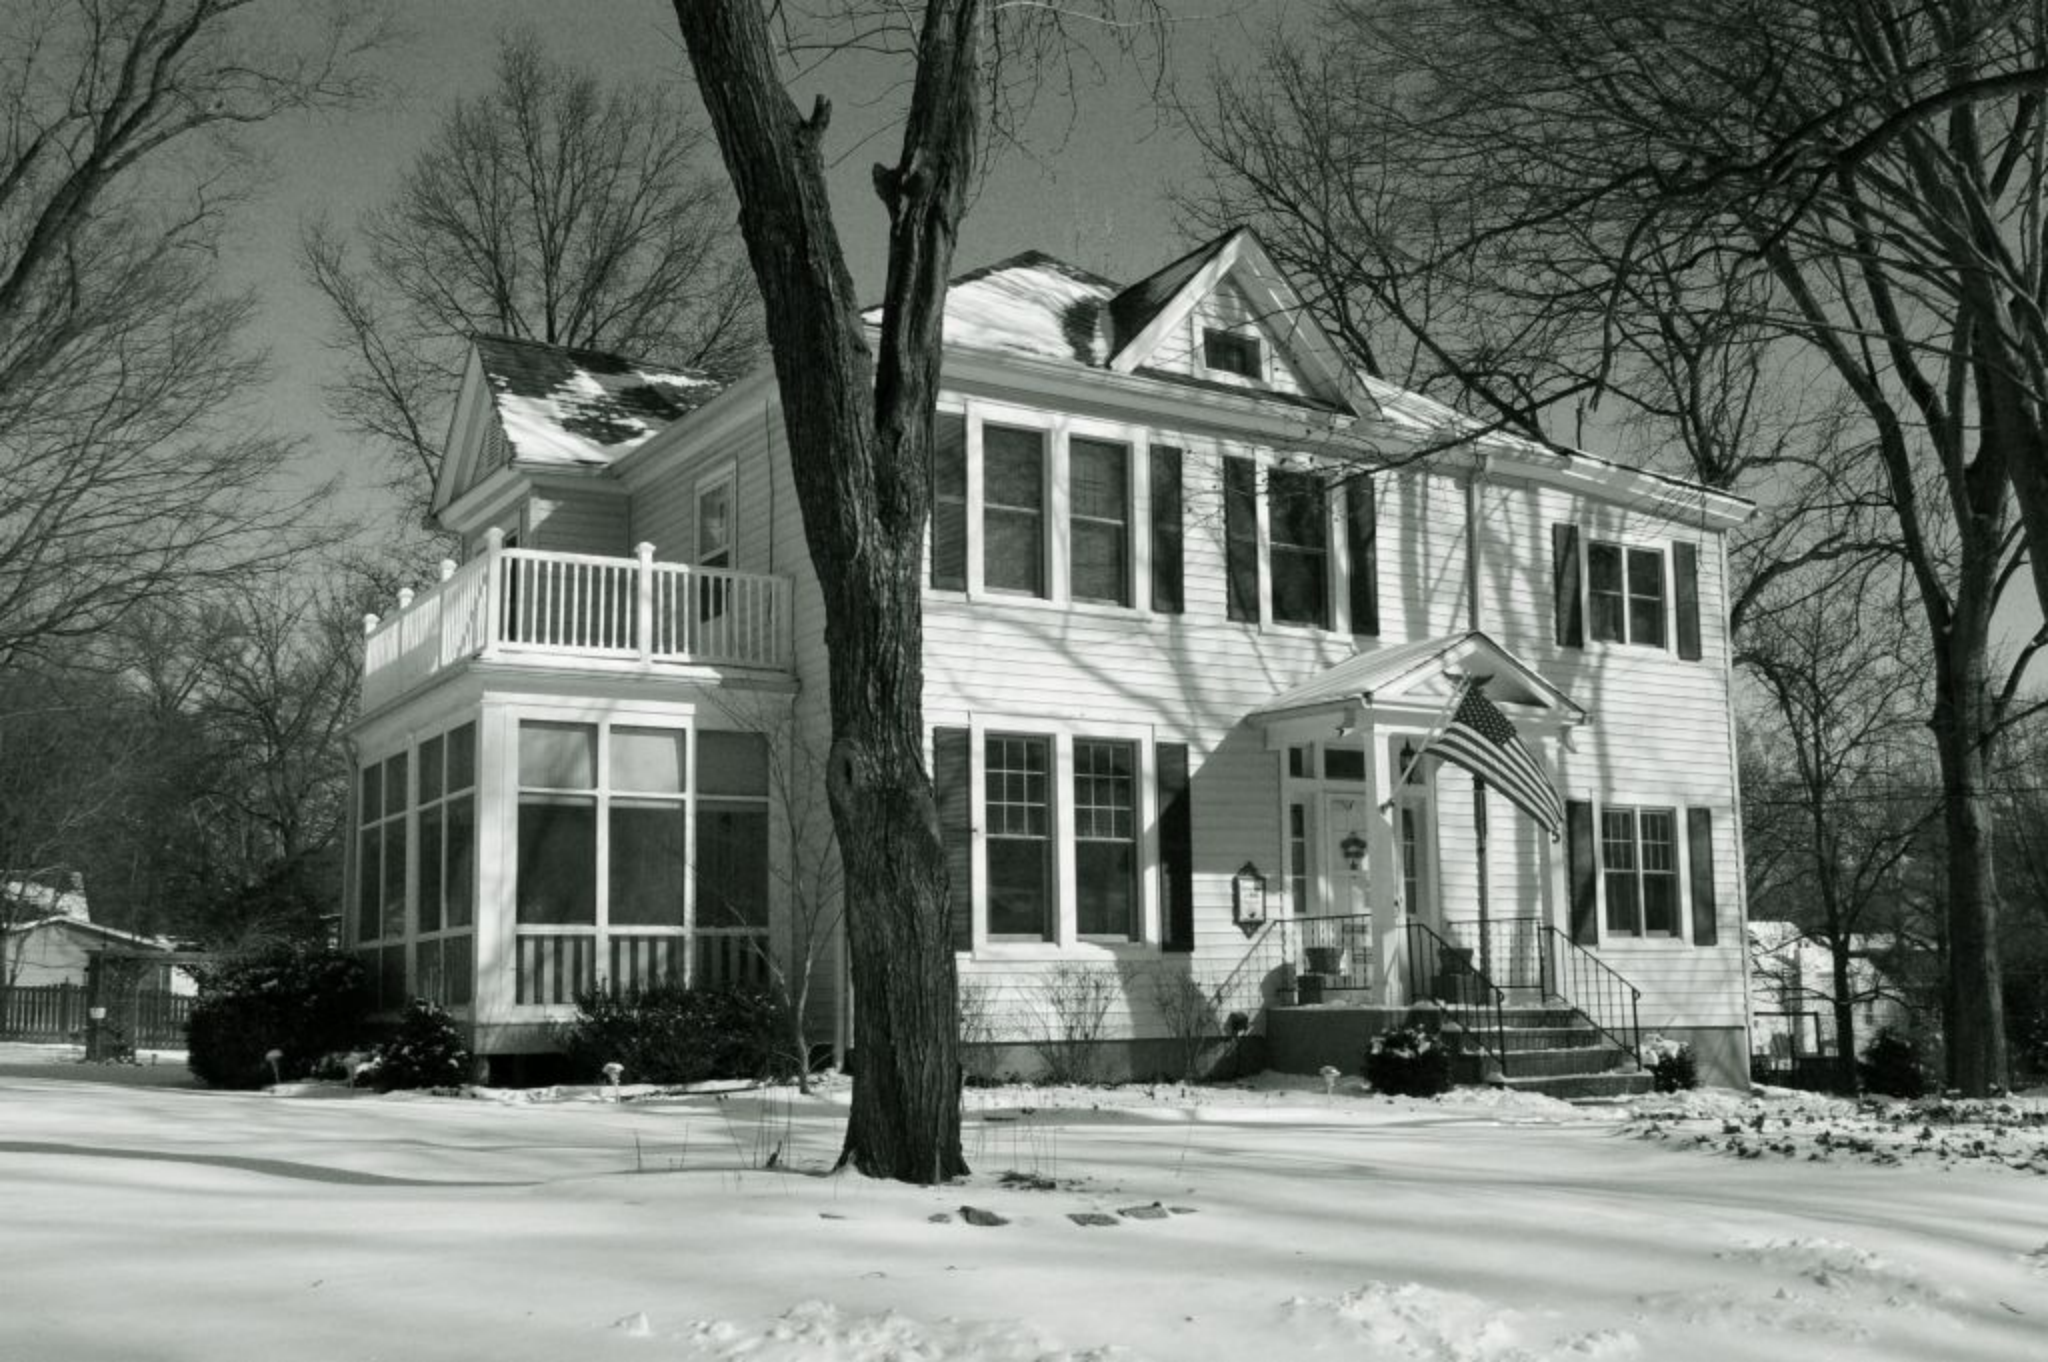
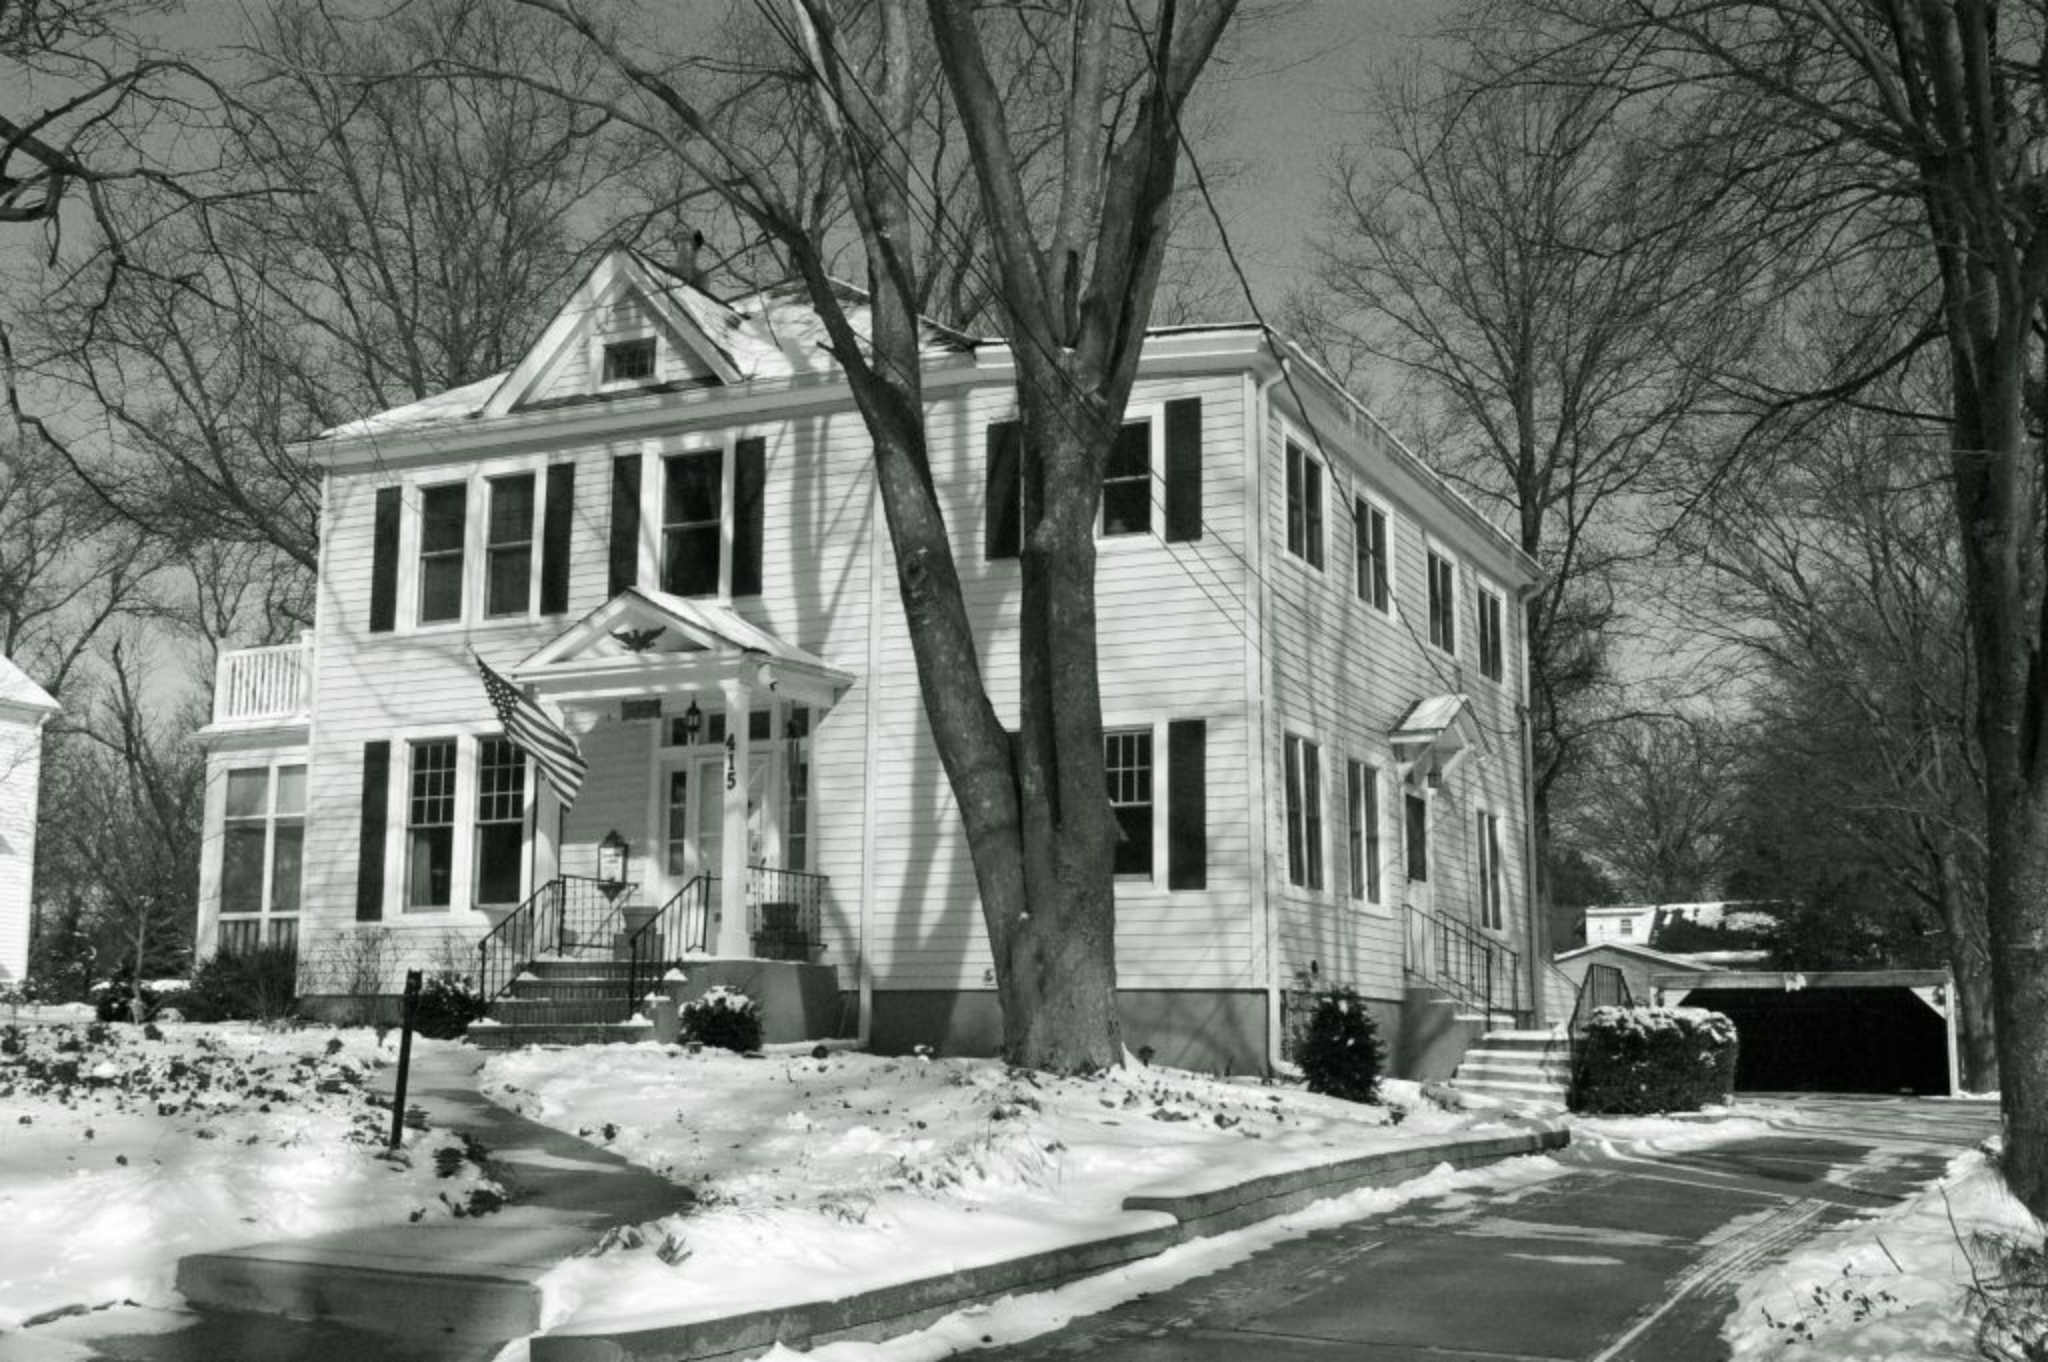
2009 Survey Update: Not noted on the 1983 survey, the main house has a hipped roof with a pediment dormer centered on the hipped roof section but there is a shallower hipped roof, full width, two story wing along the east side, which was originally a sunporch on the first floor. Since the 1983 survey was completed, the house has been reclad, replacing the aluminum siding with vinyl siding. Some or all of the windows have been replaced with vinyl windows, with multipaned upper sashes. Unfortunately, the sunporch originally had clustered casement windows, which are now sashed windows. Also, it appears that the railing on the roof of the screened porch has been replaced with a vinyl railing. Even with these alterations, the house retains its original composition, with the offset pediment dormer, the pedimented porch with its square corner columns, the sidelights and transom on the front entry, the small one story screened porch wing, and even the side entry with its bracketed gabled roof--all distinctively Colonial Revival details.

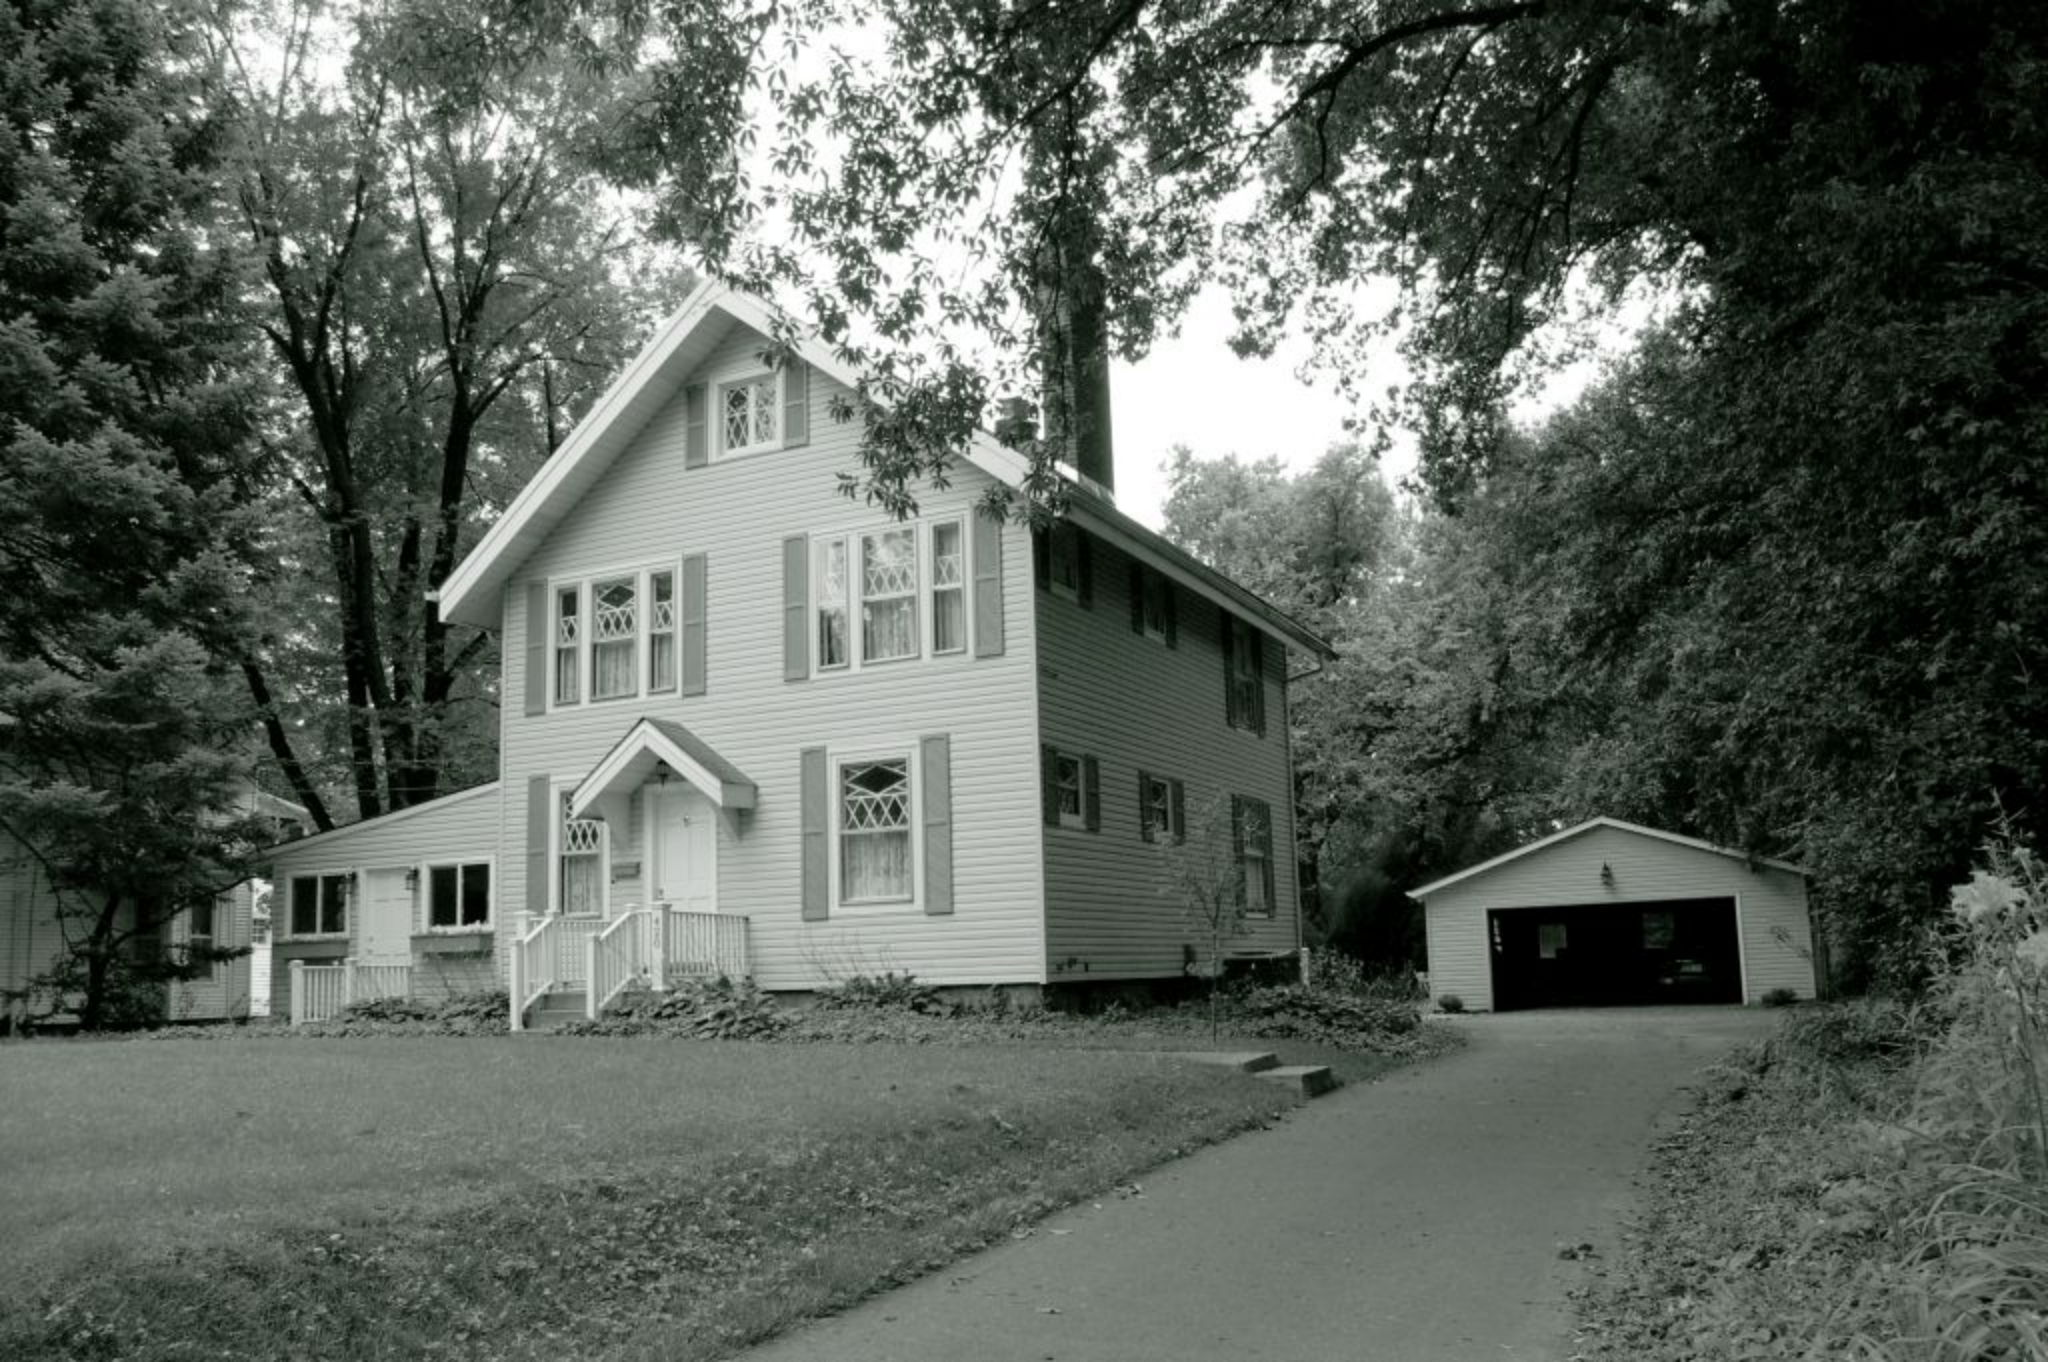
2009 Survey Update: Despite the opinion that the unusual diamond pattern in the wood sashed windows might not be original to the building, it is very likely that they are the one remaining Craftsman feature on this house that is not covered by vinyl. The house appears to have had open eaves, now enclosed, and it had knee braces supporting the gable roof over the porch, now covered. The stoop now has vinyl railings as well replacing the wrought iron ones that may have been original to the house. The asbestos siding has been replaced with vinyl siding.

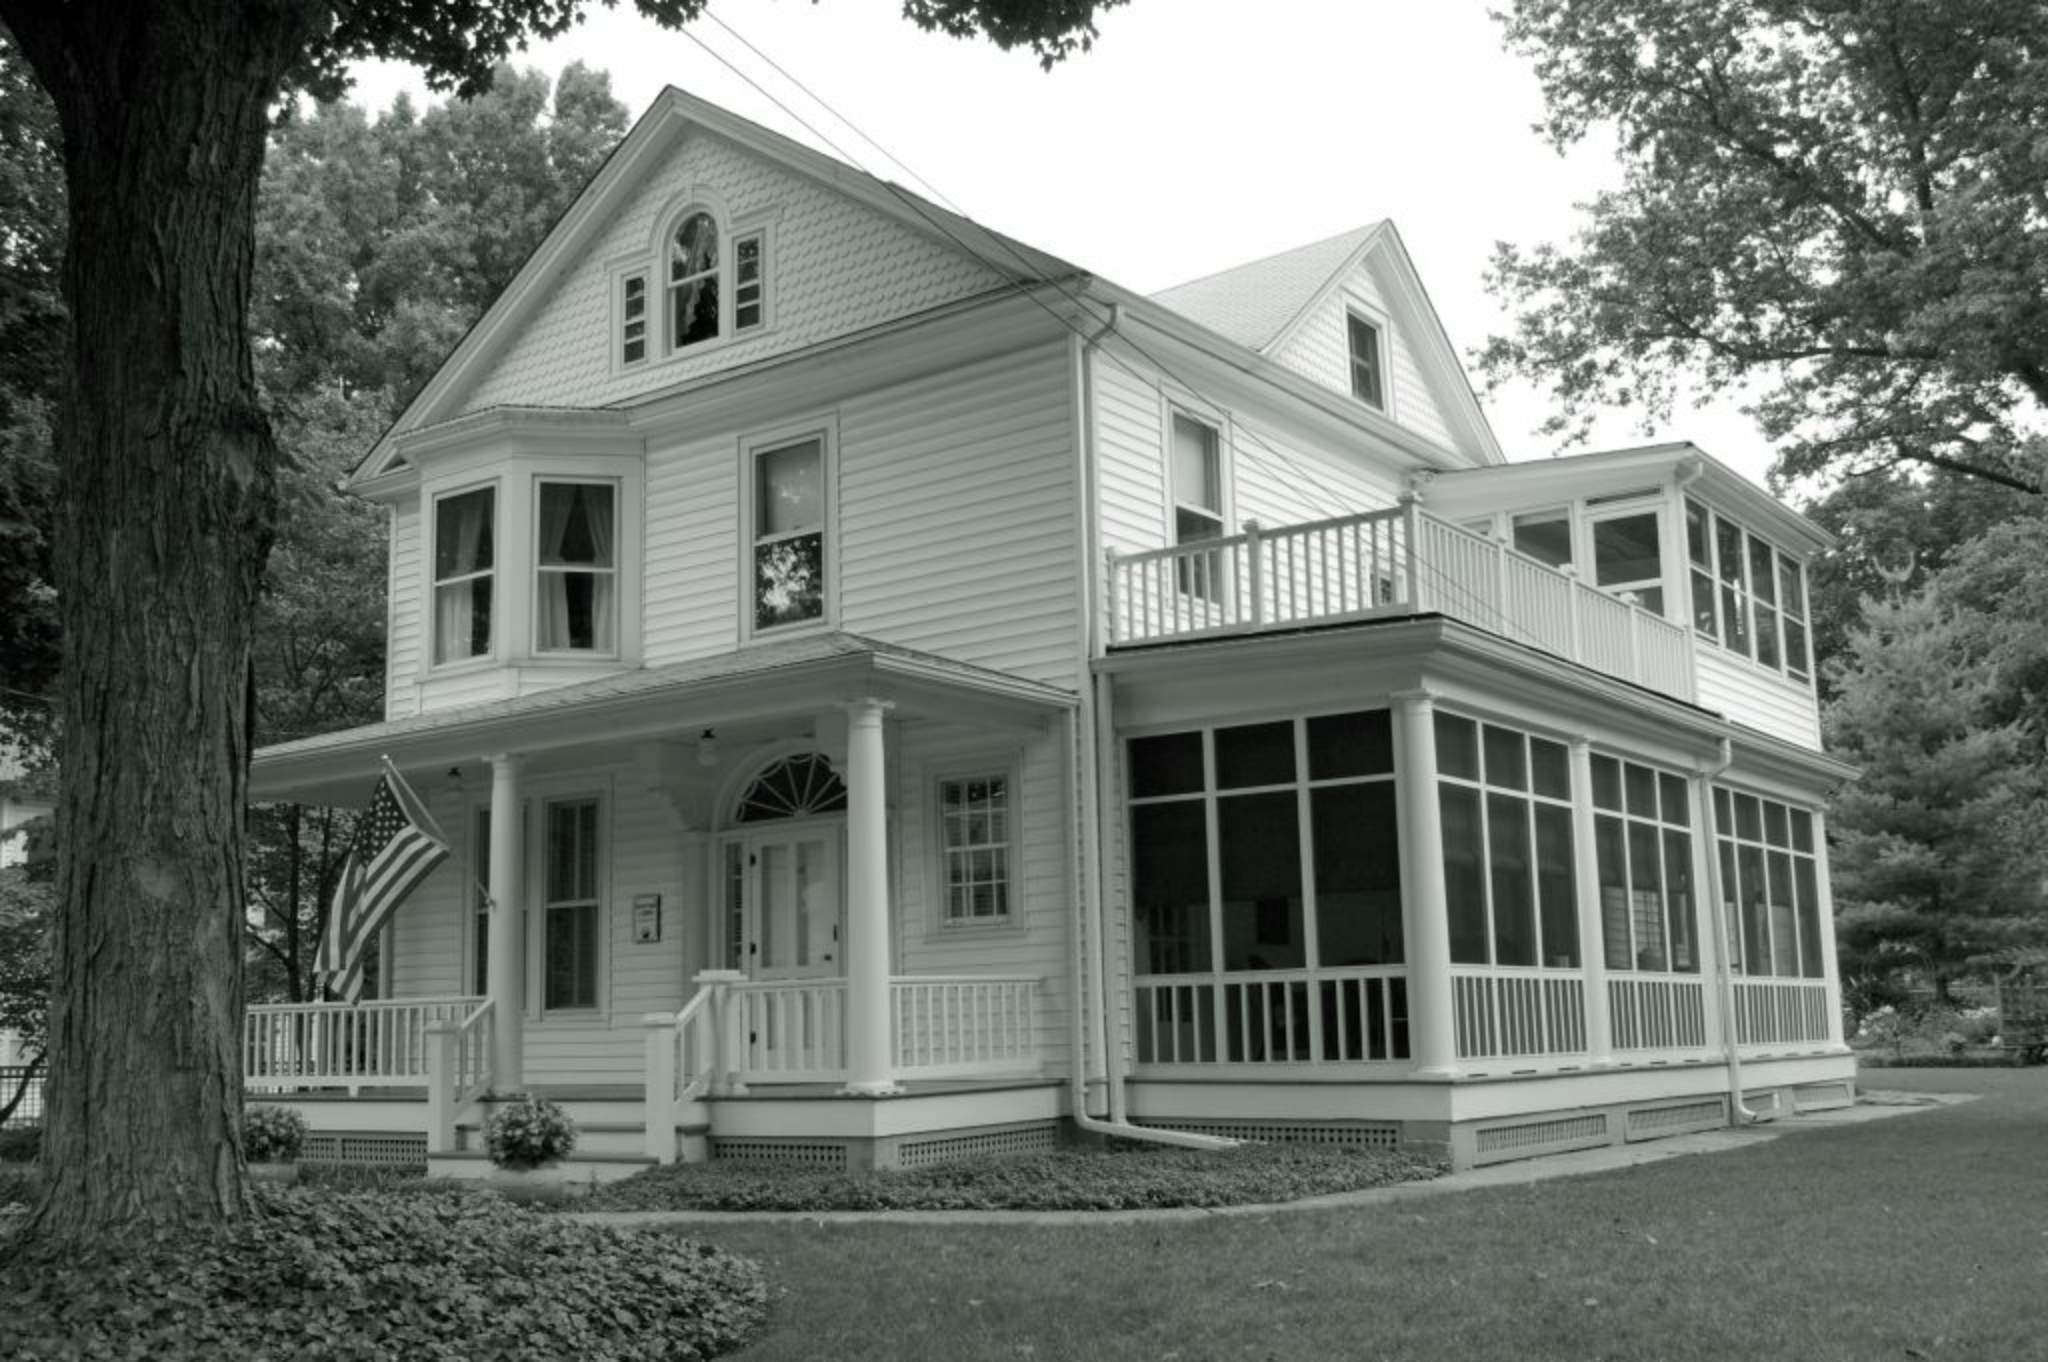
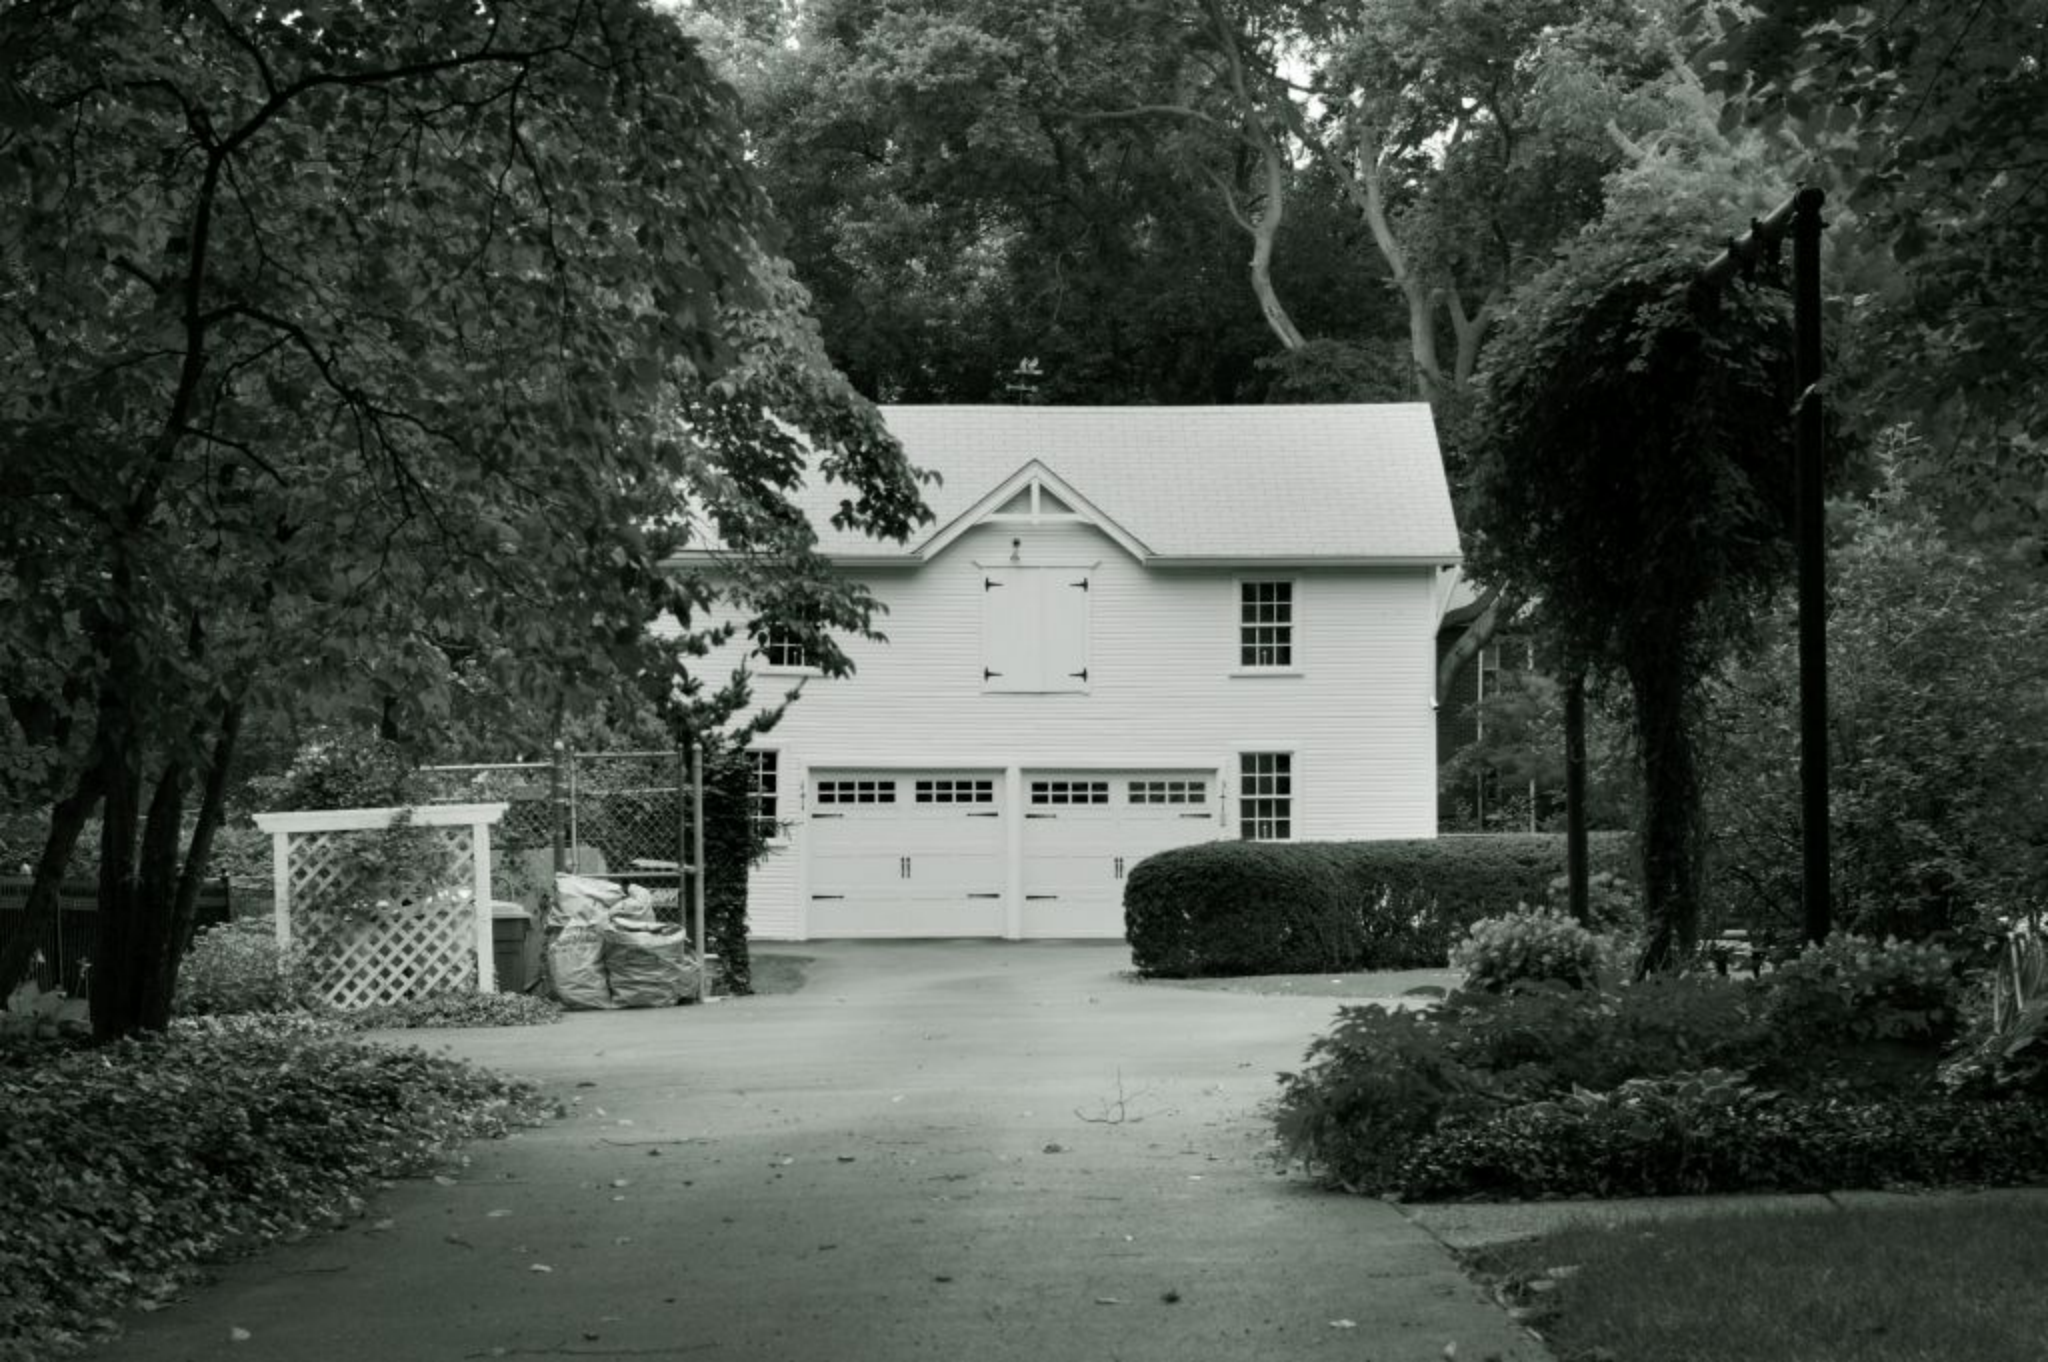
2009 Survey Update: Since the 1983 survey, the small gabled roof over the entry has been replaced with a shed roofed, full width porch supported by Doric columns. This front porch is based upon both the early historic photograph showing a full width porch (before the Colonial Revival alterations made in the early twentieth century to the house) and physical evidence, but utilized columns similar to those on the screened side porch since both the front entry and porch had been altered between 1913 and 1930 to re-style the house with Colonial Revival details and it seemed likely that the front porch was modified at that same time. The screened porch on the west side had columns that do not appear on the survey photo in 1983, because screening was positioned outside of the columns and now is positioned on top of the railing. There is now a balustrade on top of this screened porch. It retains its original windows and doors, but the house has been sided with vinyl siding.
