ARCHITECTURAL/HISTORIC INVENTORY FORM

1. Survey No. SL-AS-036-001		2. Survey Name: Architectural Survey of Old Ferguson West	
3. County: St. Louis		4. Address: 1 Carson Rd.	
5. City: Ferguson	Vicinity: <input type="checkbox"/>	6. UTM:	7. Township/Range/Section
8. Historic name (if known):		9. Present/other name (if known): Whistle Stop	
10. Ownership: <input type="checkbox"/> Private <input checked="" type="checkbox"/> Public		11. Historic use (if known): TRANSPORTATION/rail-related	11. Current use: COMMERCE/restaurant & RECREATION/museum

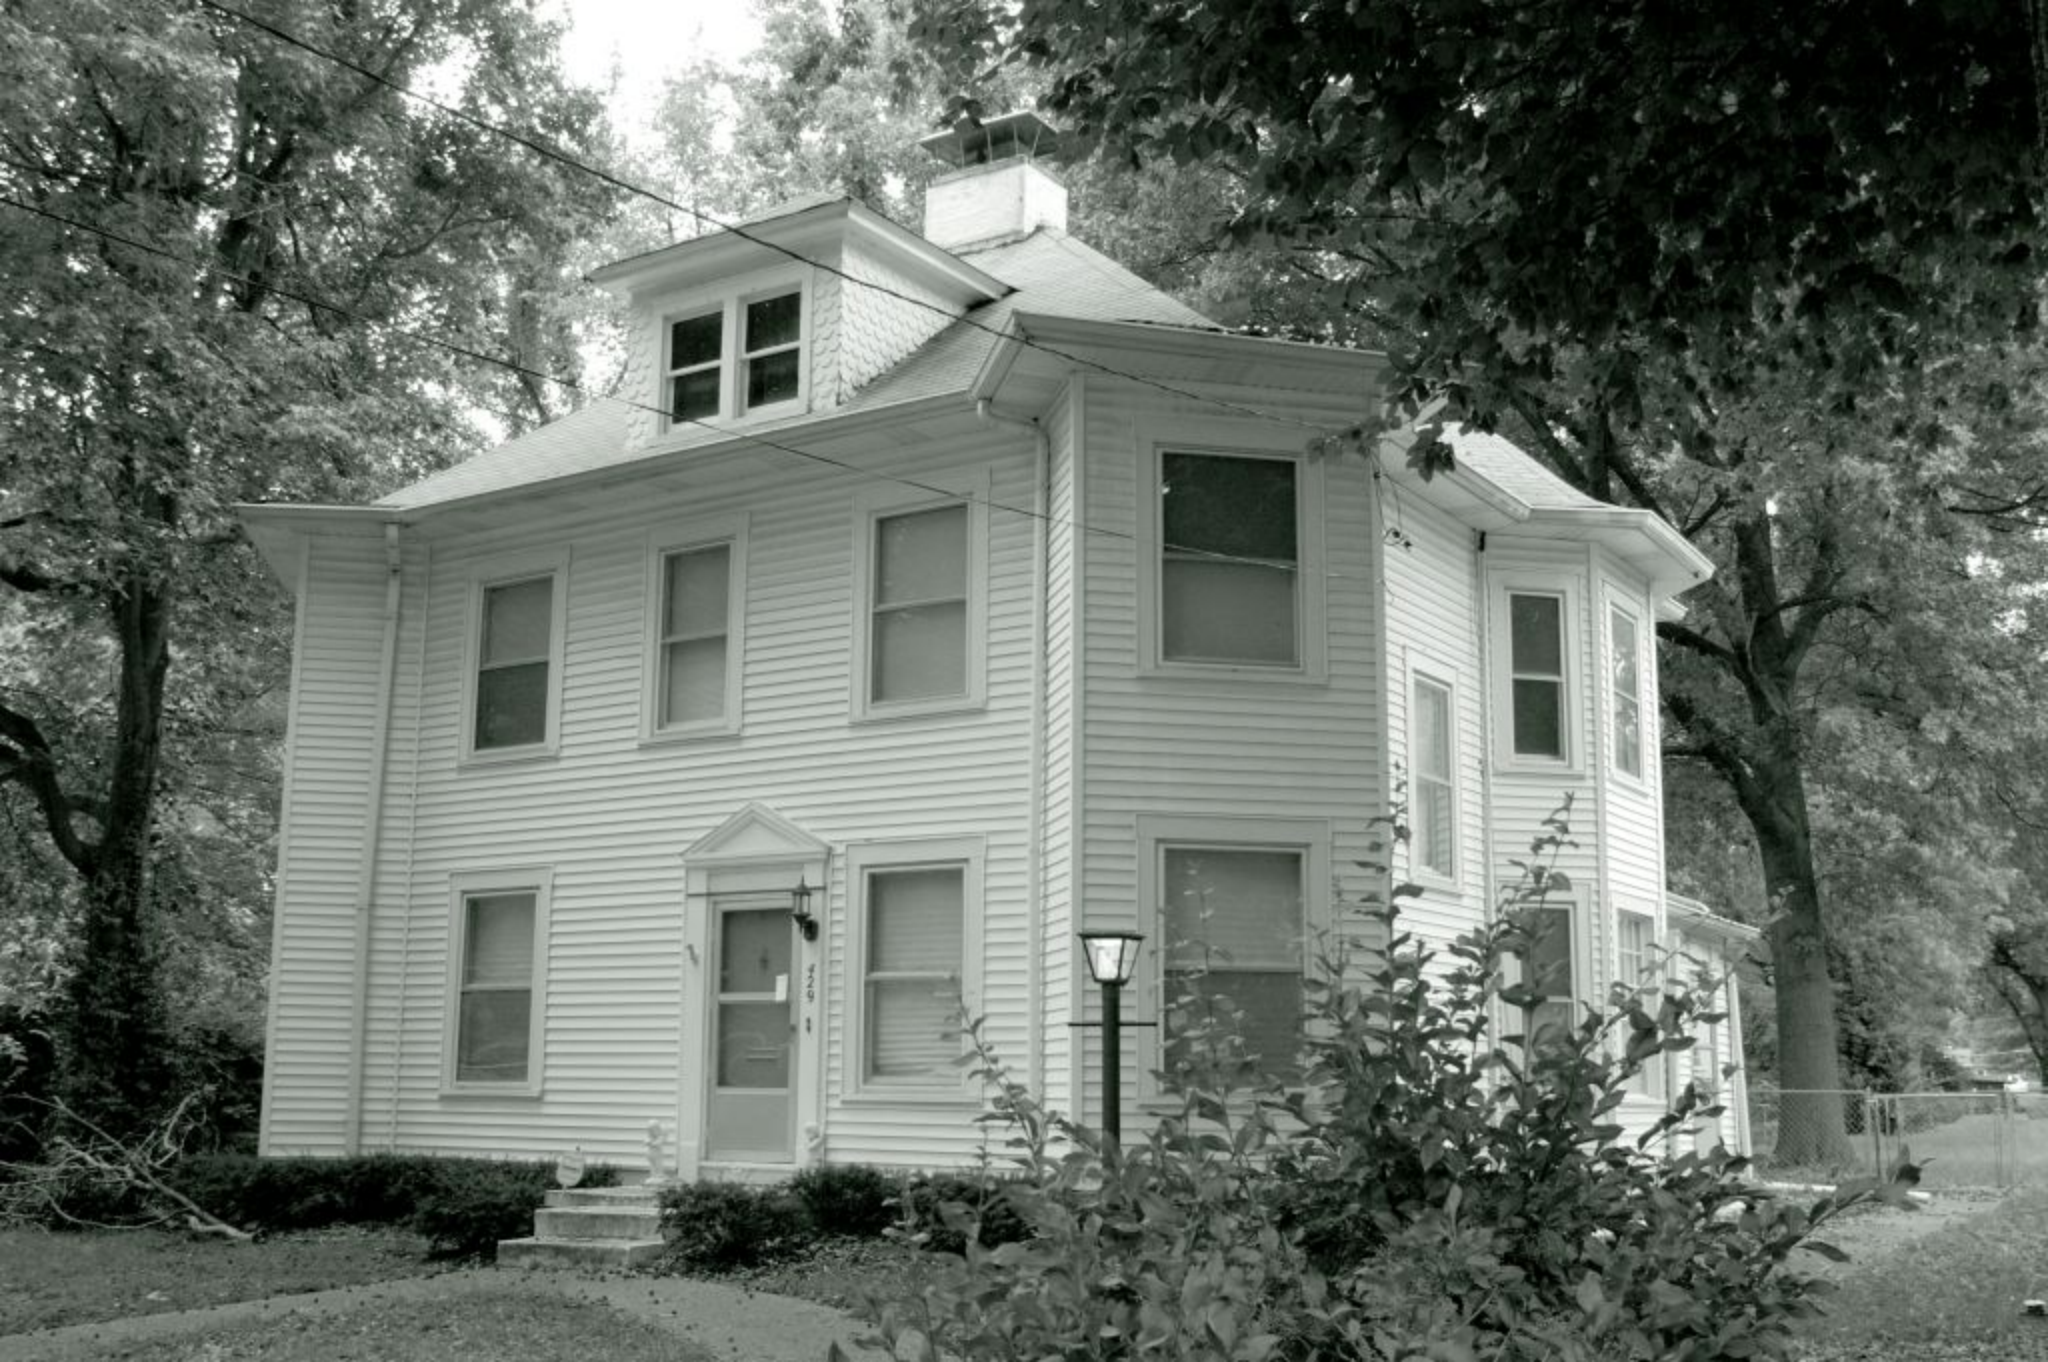
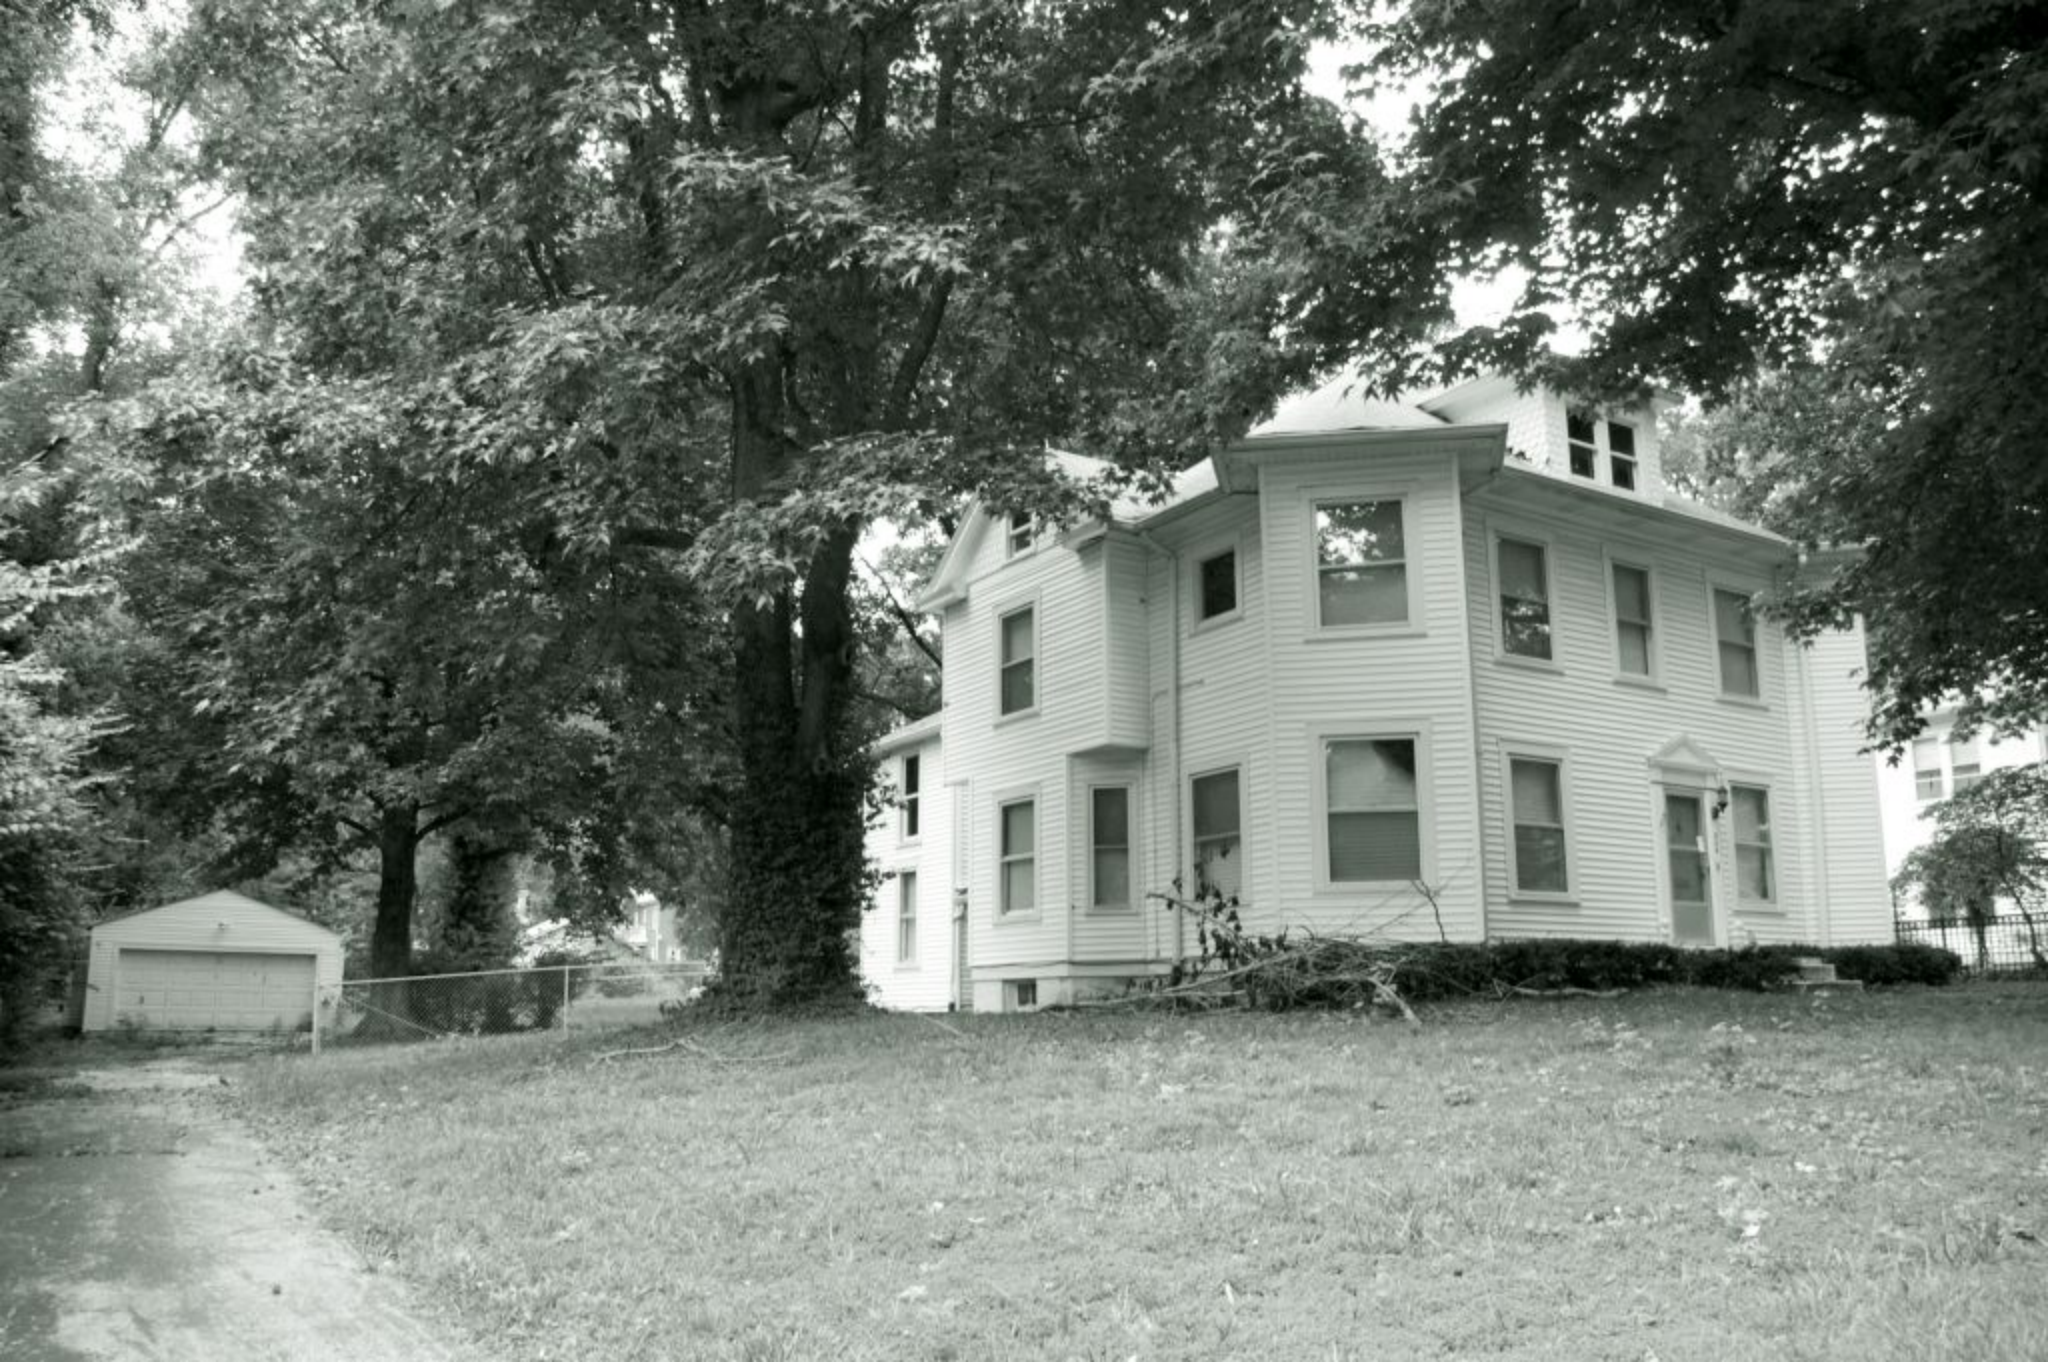
2009 Survey update: Since the 1983 survey, the clapboard siding has been covered with vinyl siding, maintaining the window frame exposure. The fishscale shingles on the hipped dormer are still wood but the fishscale shingles in the gabled bay on the side elevation appear to be vinyl.

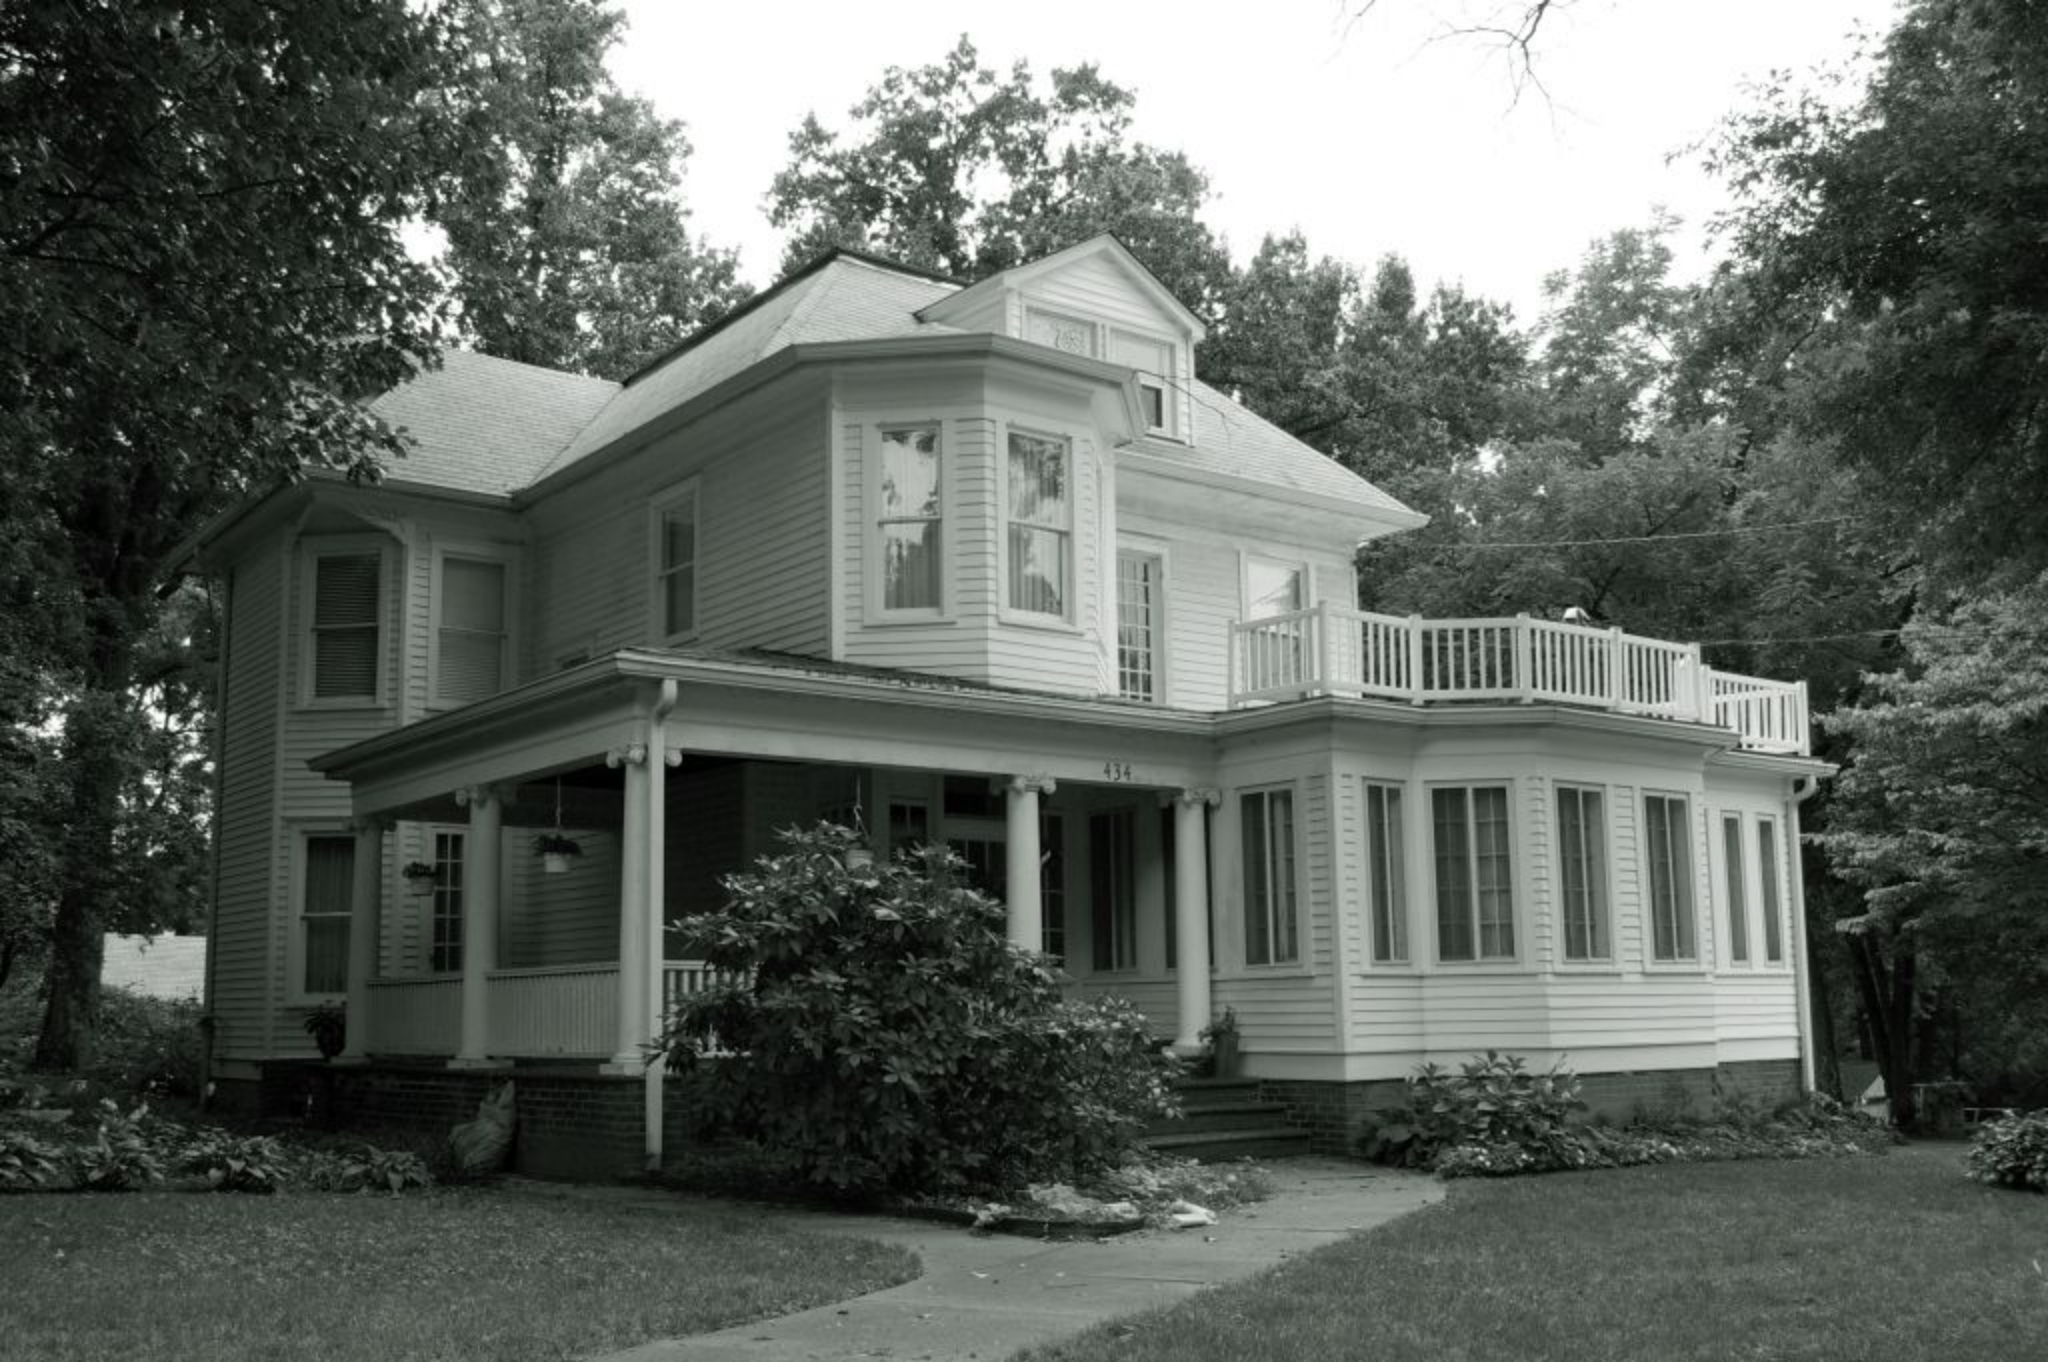
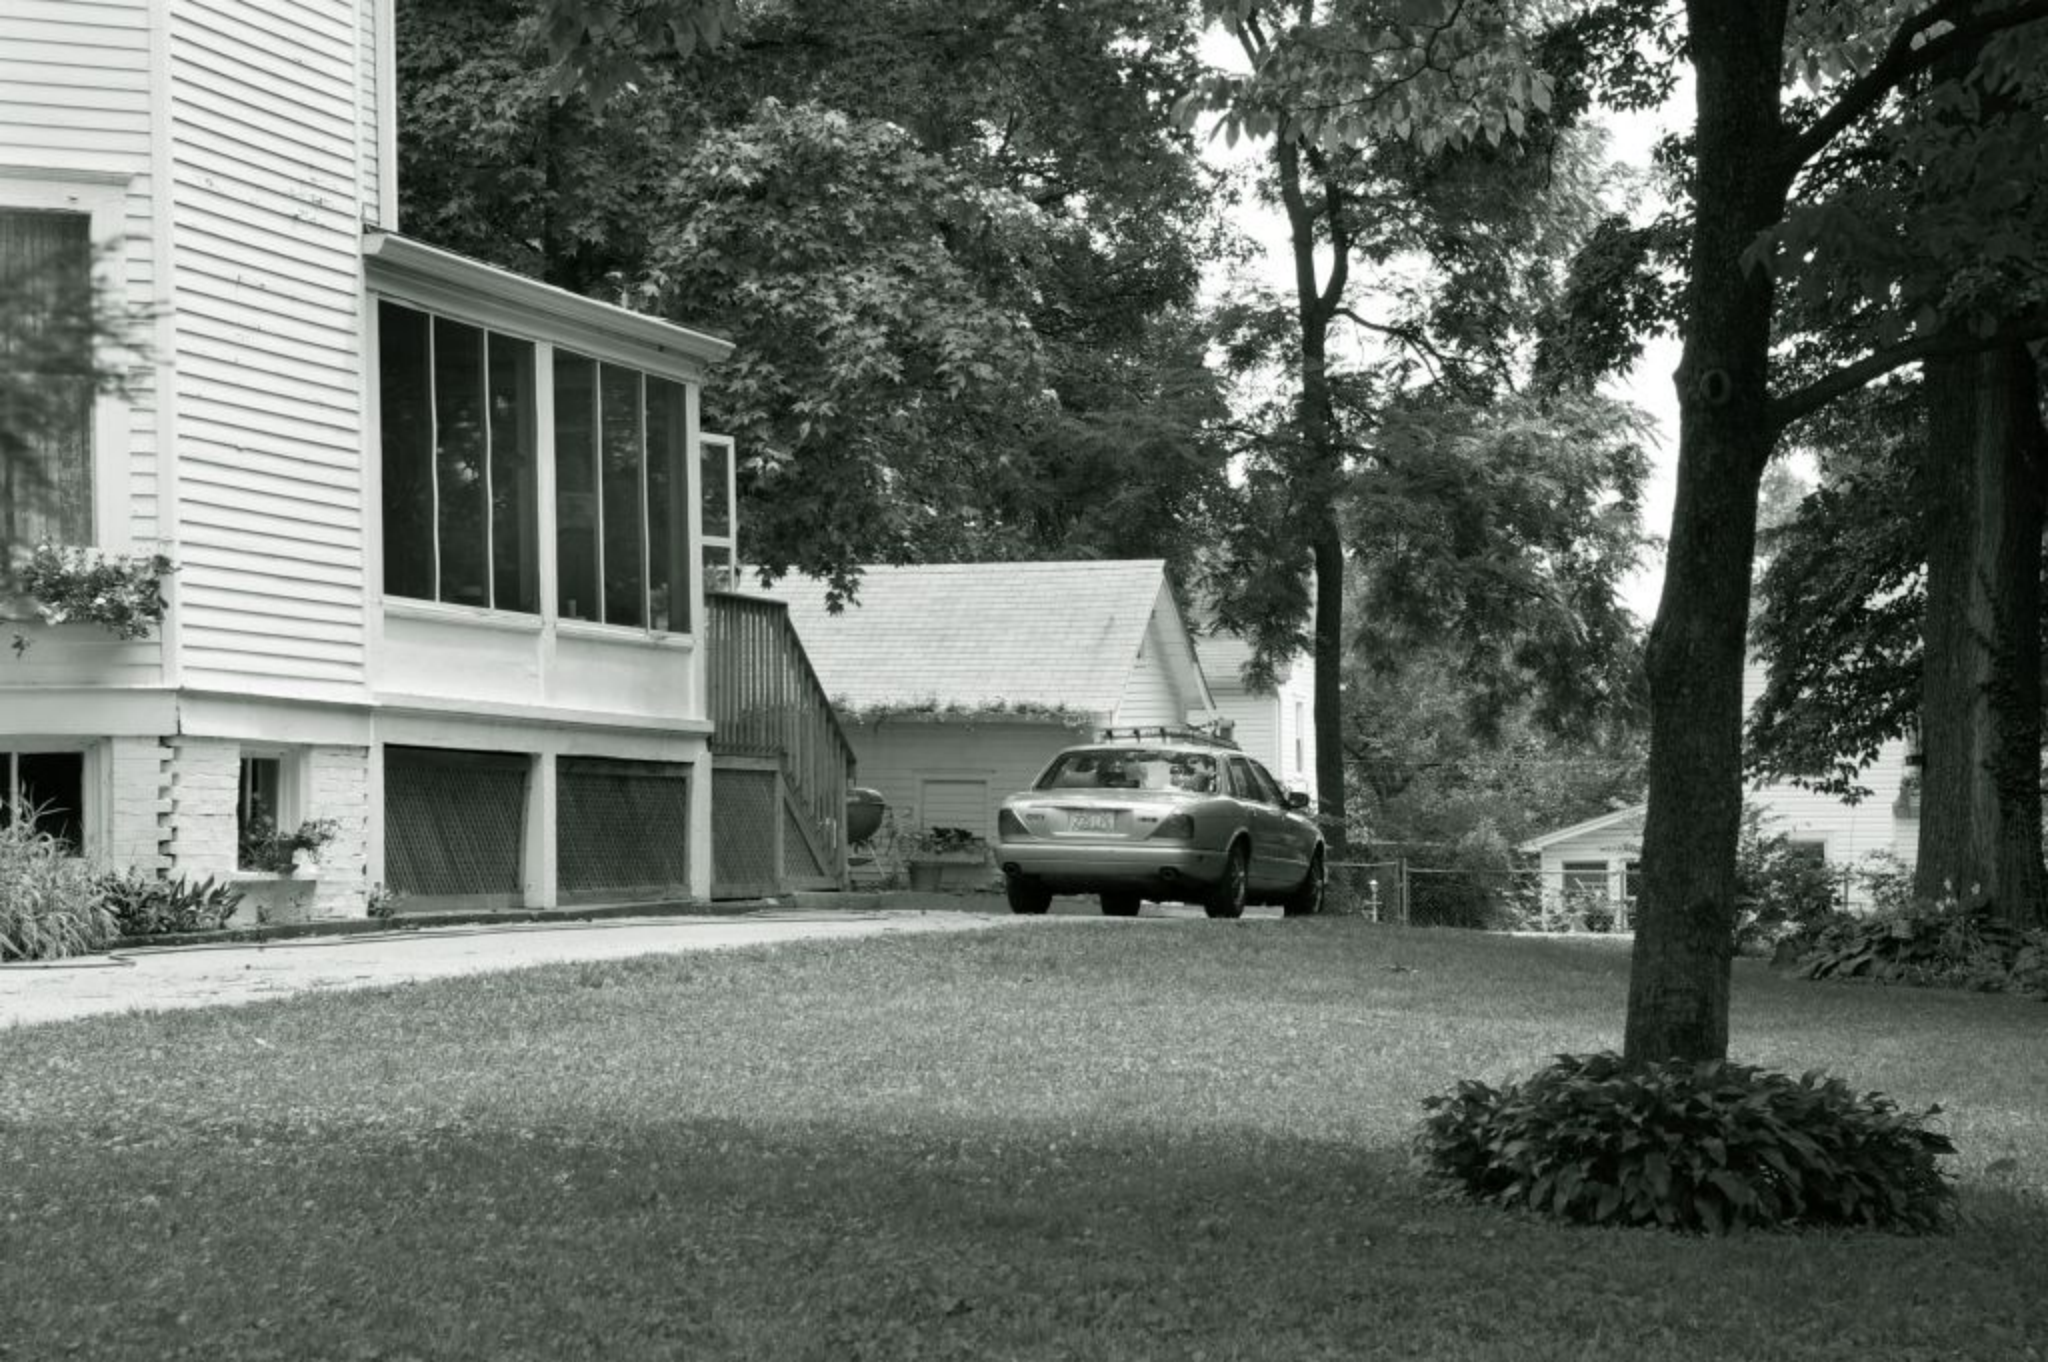
2009 Survey Update: Since the last survey, the wood shingle siding on the gabled dormer on the facade has been replaced with clapboard (or this was an error in the 1983 survey description since this clapboard matches the rest of the house). The solar collector and the diamond shape patterned sash window in the dormer have been replaced with 1 over 1 sashed windows. What was probably a missing rooftop balustrade on the sunroom on the facade has been rebuilt. The 1983 survey description incorrectly identified the columns as Corinthian when they are actually Ionic, visible in the 1983 survey photo and still intact today. Otherwise, the house has not changed except for the addition of some storm windows.

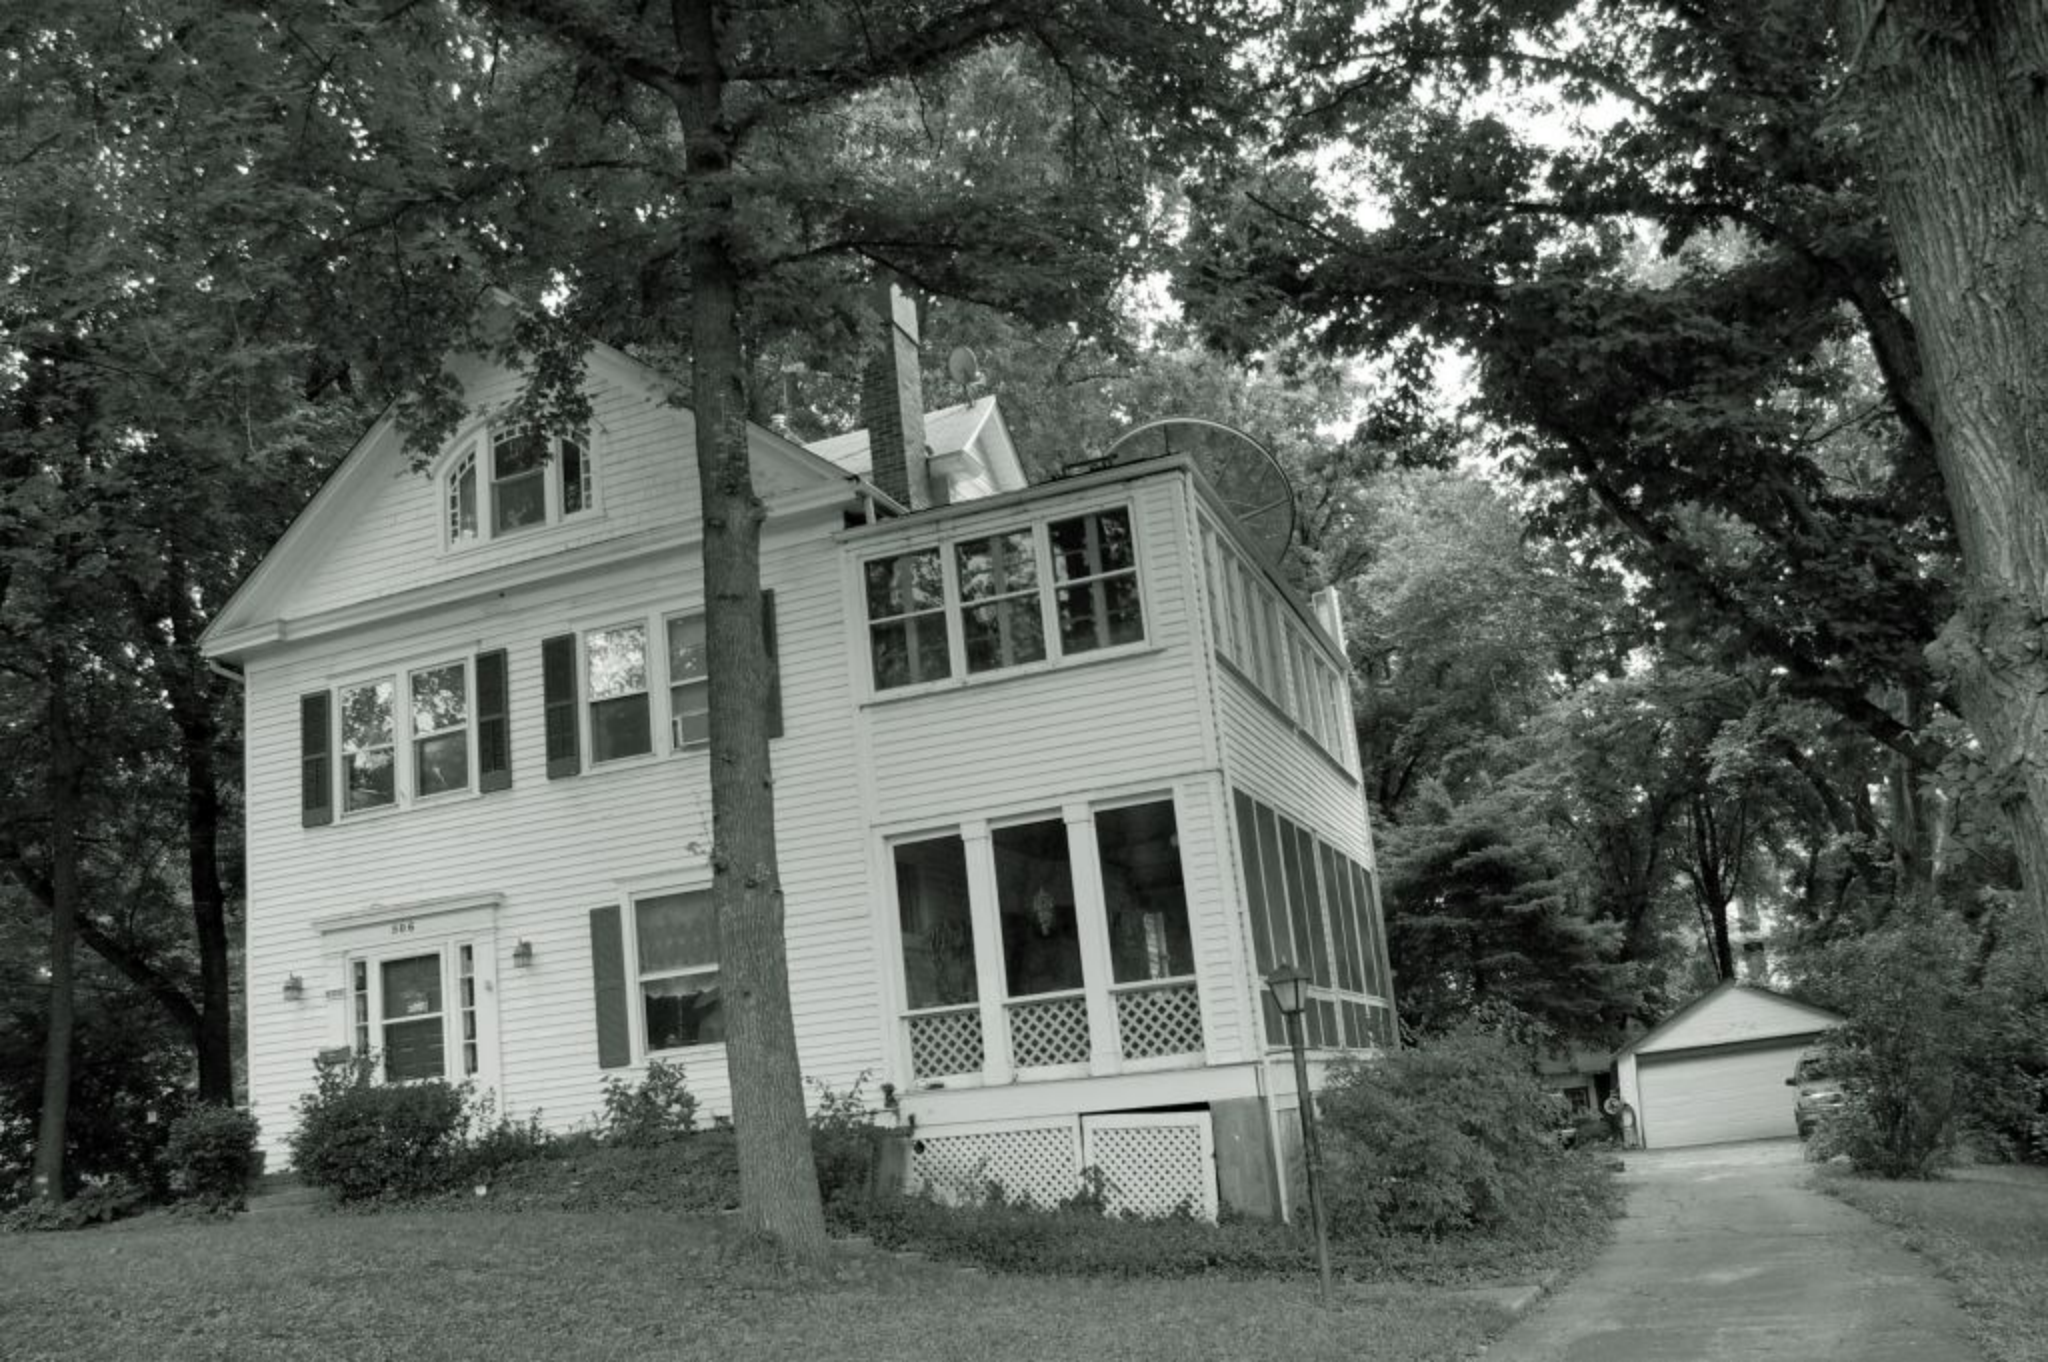
2009 Survey Update: There is a two car, detached, end gabled, frame garage with clapboard siding and a replacement overhead metal paneled door, located at the end of the driveway on the west side of the house. It appears to be leaning badly and the overhead door does not hang evenly in its opening. Although it is not mentioned in the 1983 survey it is shown on the sketch map.

2009 Survey Update: Little has changed on his house, except for the possible addition of the metal storm windows and storm door. The second floor sunroom's casement windows have wooden storm screens with a horizontal muntin. Although the third floor window on the facade is described as a Palladian window it is more appropriately described as a three part, segmental arched window opening with a sashed window with a fixed sidelights, still retaining the series of square panes outlining the arch.

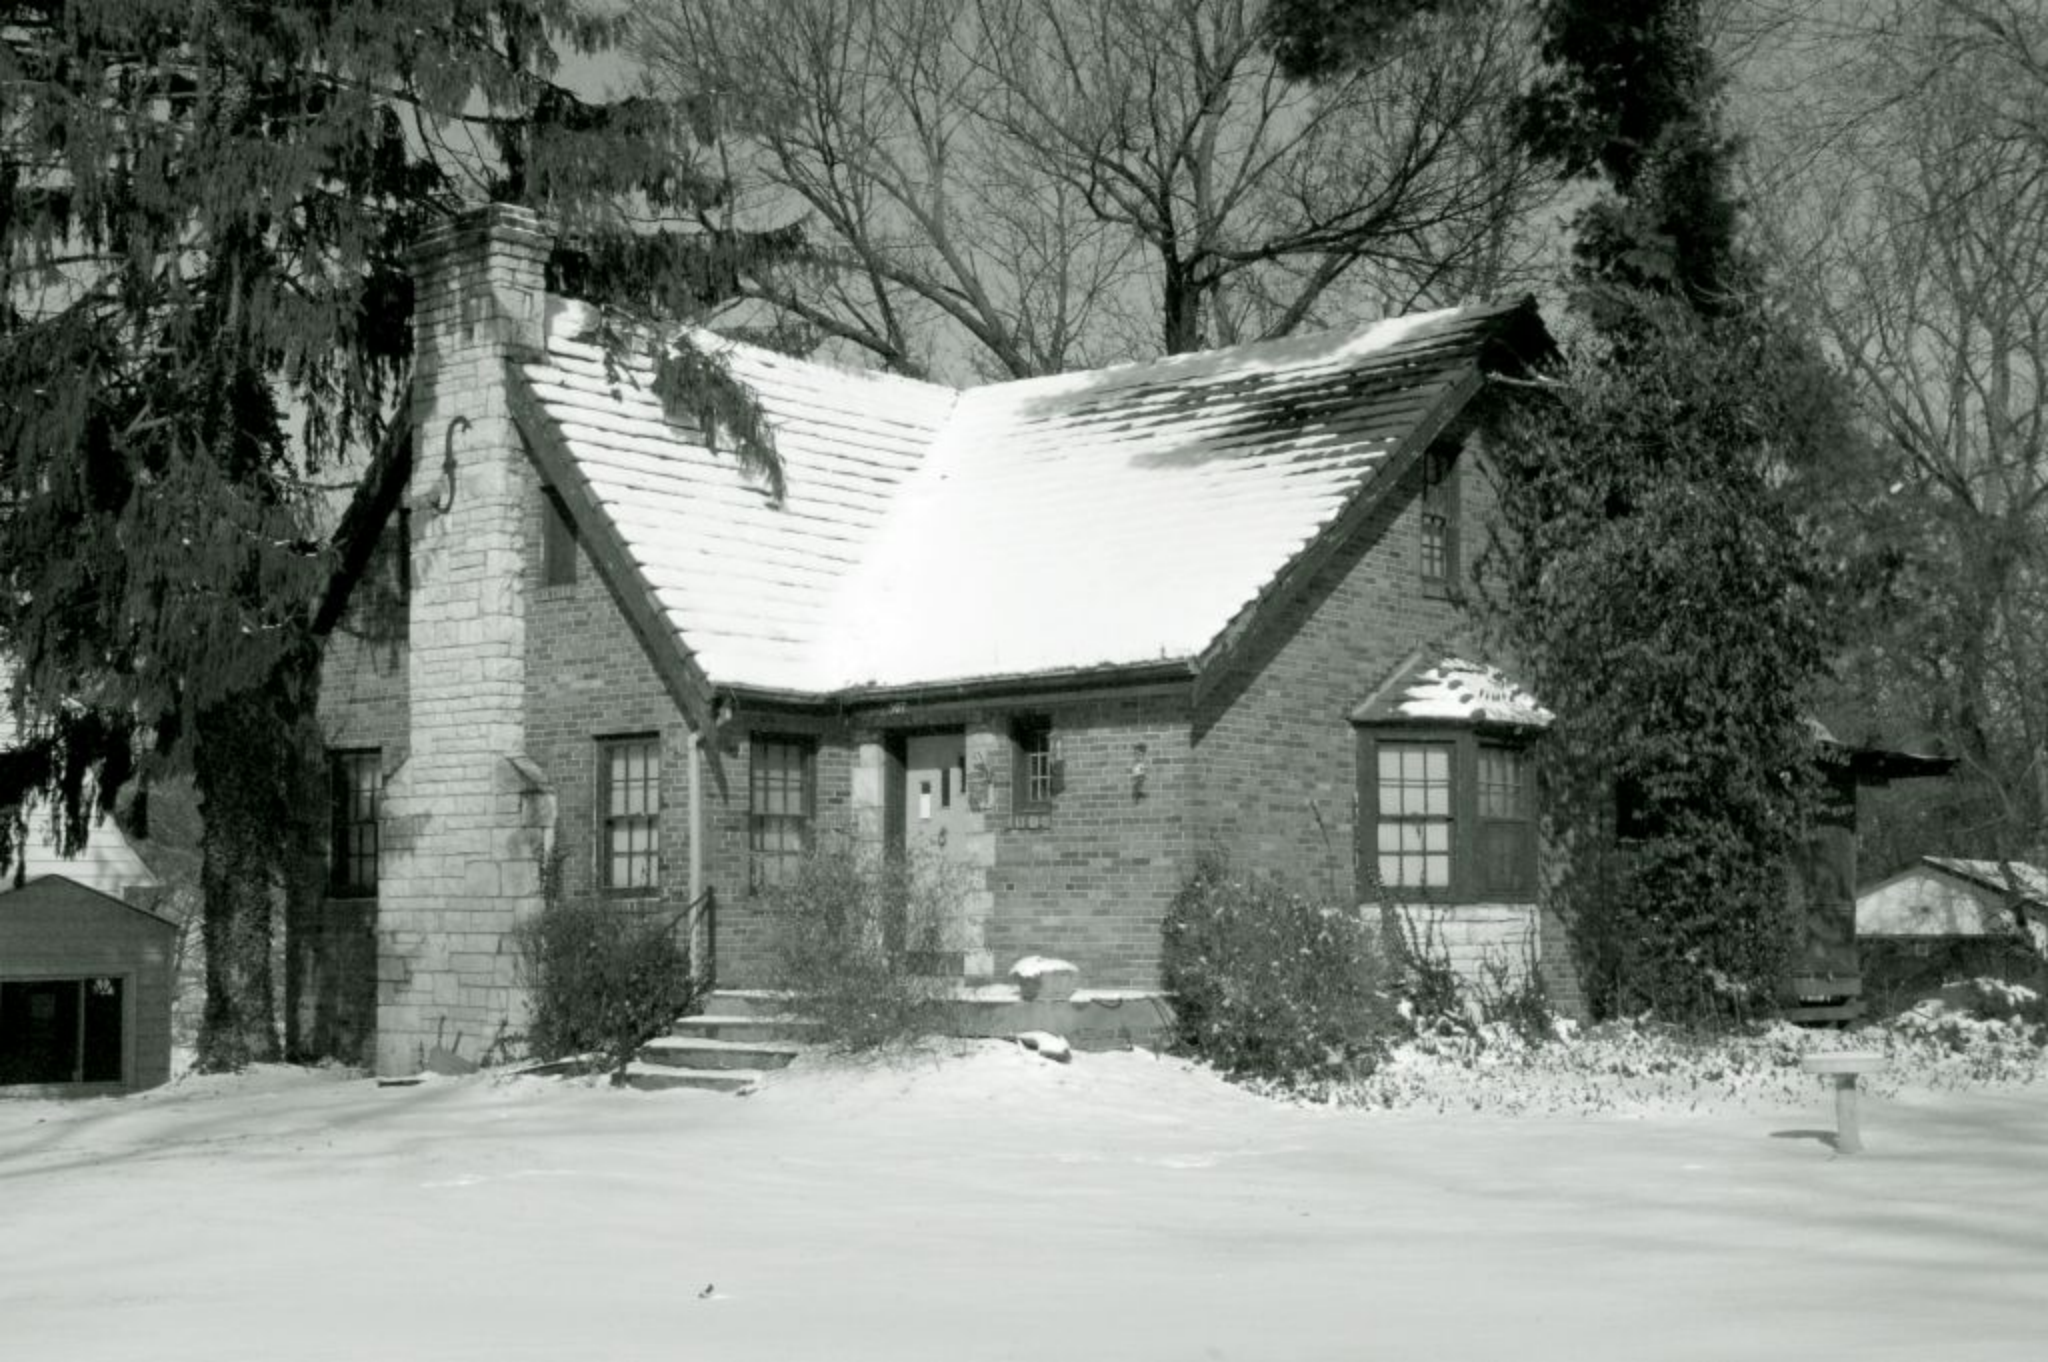
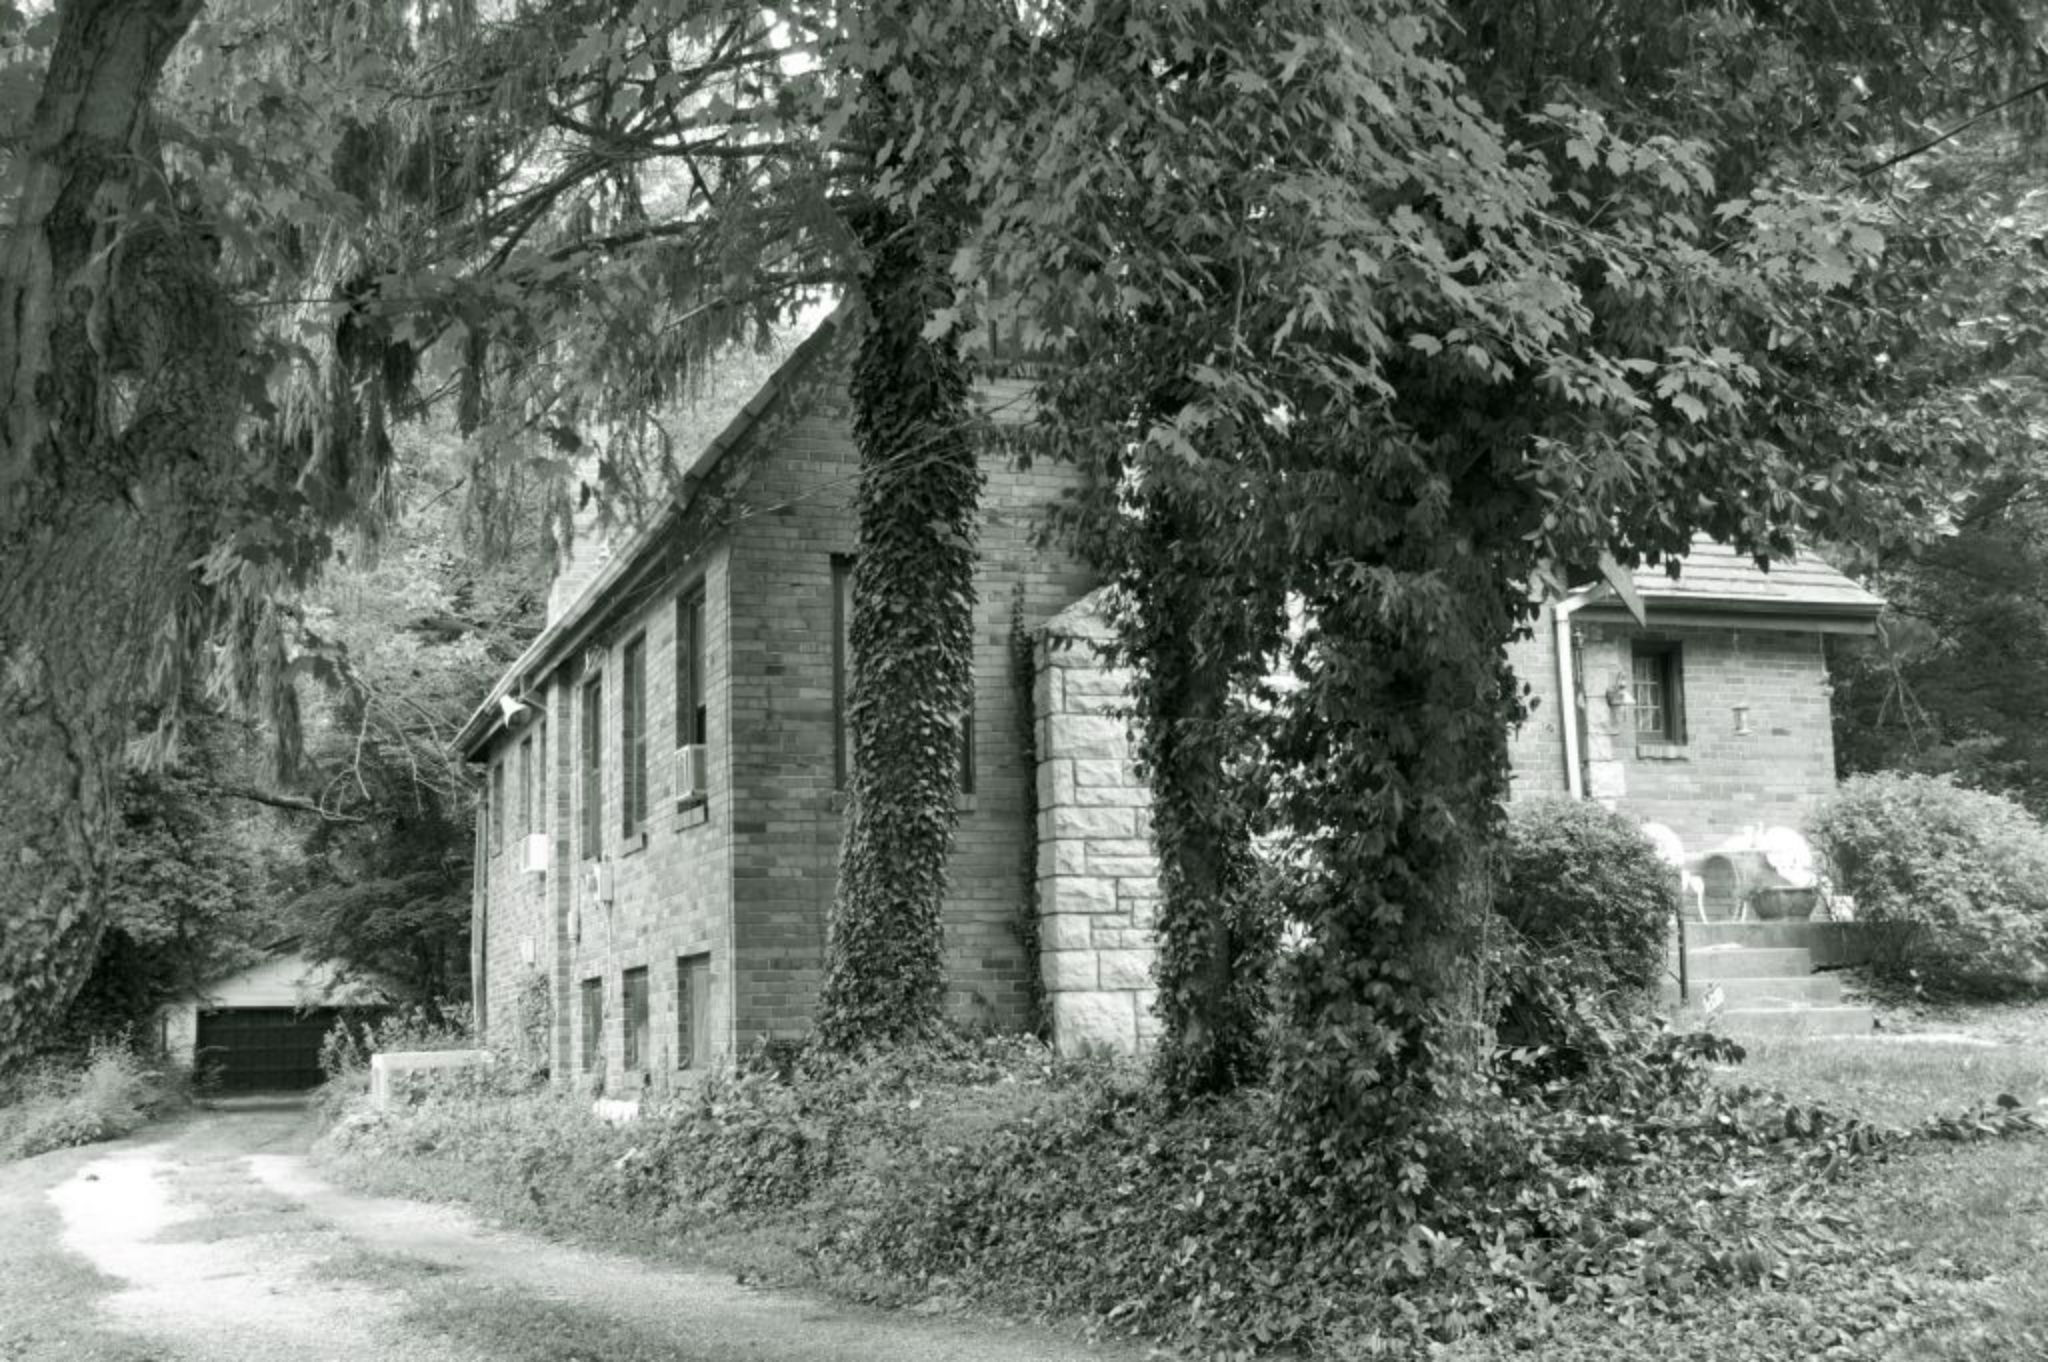
2009 Survey Update: Nothing has changed since the survey in 1983 except that some of the shrubs have been removed, making it easier to see the entry stoop.
