ARCHITECTURAL/HISTORIC INVENTORY FORM

1. Survey No. SL-AS-036-001		2. Survey Name: Architectural Survey of Old Ferguson West	
3. County: St. Louis		4. Address: 1 Carson Rd.	
5. City: Ferguson	Vicinity: <input type="checkbox"/>	6. UTM:	7. Township/Range/Section
8. Historic name (if known):		9. Present/other name (if known): Whistle Stop	
10. Ownership: <input type="checkbox"/> Private <input checked="" type="checkbox"/> Public		11. Historic use (if known): TRANSPORTATION/rail-related	11. Current use: COMMERCE/restaurant & RECREATION/museum

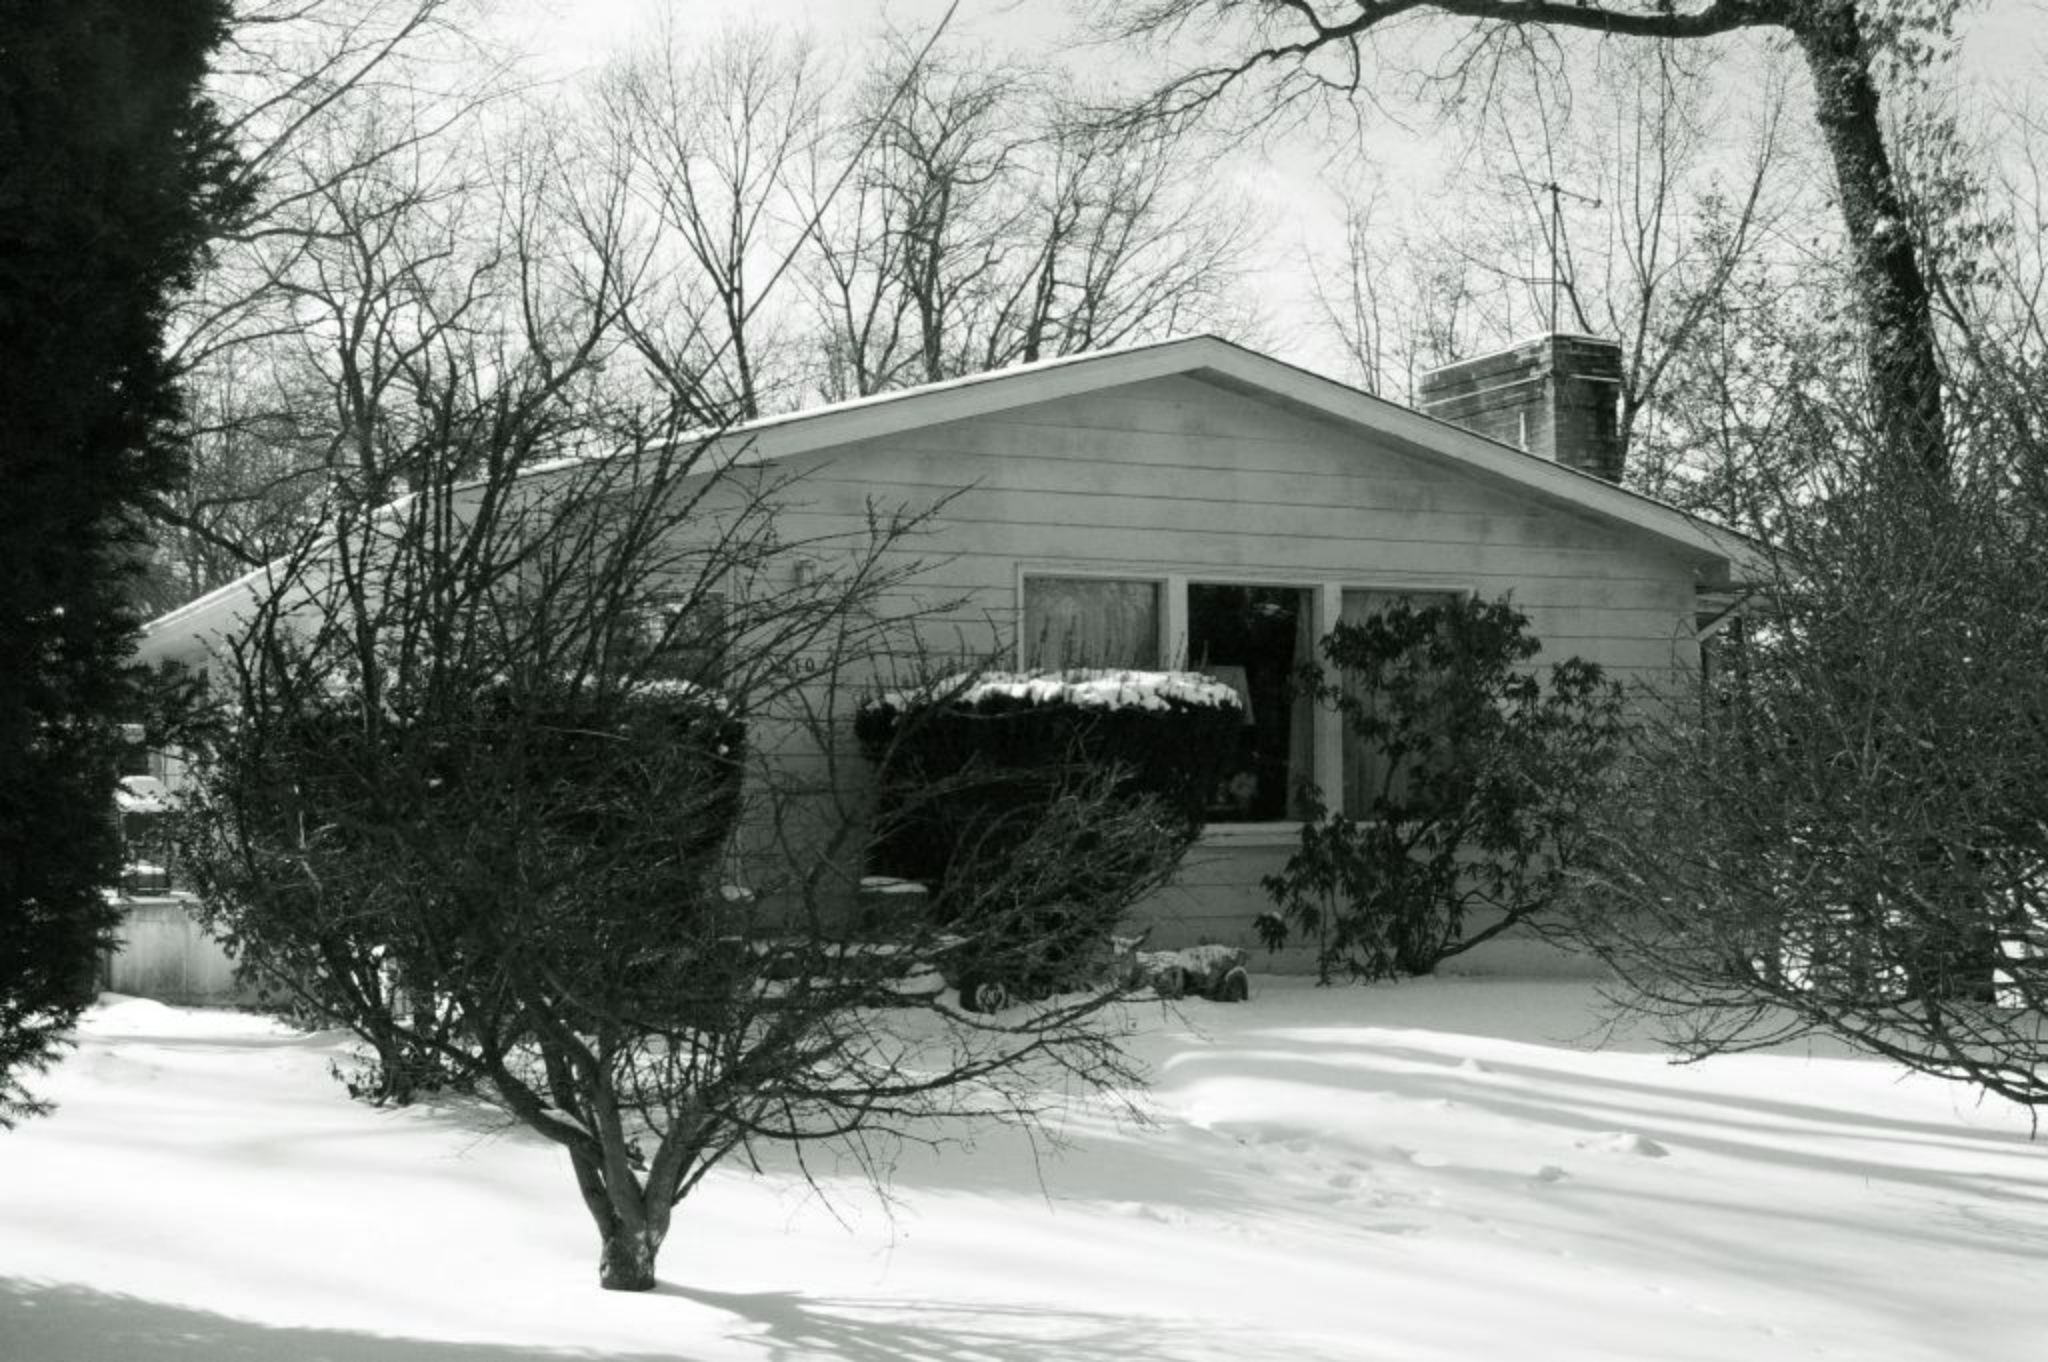
This wide eaved, frame house has wide aluminum siding that, given the age of the house, might actually be the original wall finish. The design is a Ranch style with the wider eaves and even a broad brick chimney on the west elevation, as well as the classic picture window facing the street. Since the gable end faces the street, the facade is very simple with a simple flat slab door with a small square light opening onto a brick topped, low entry stoop. To the west on the facade is a broad picture window, which currently has 3 panes of glass separated by wood mullions. While the window opening appears original, the fenestration does not (more likely one large plate glass window, or in some combination with sashed windows). On the east side, there are asymmetrically placed sashed windows as well as a series of 4 casement windows clustered together to form a multipaned window (each one has four horizontal lights). There is also a side entry door, again with the small square light and a taller concrete entry stoop with a metal railing (land is sloping downhill toward the rear of the property). The windows are 1 over 1 wood sashed windows, now covered with metal storm windows and the doors have storm doors as well. The basement level garage is entered from the back elevation.

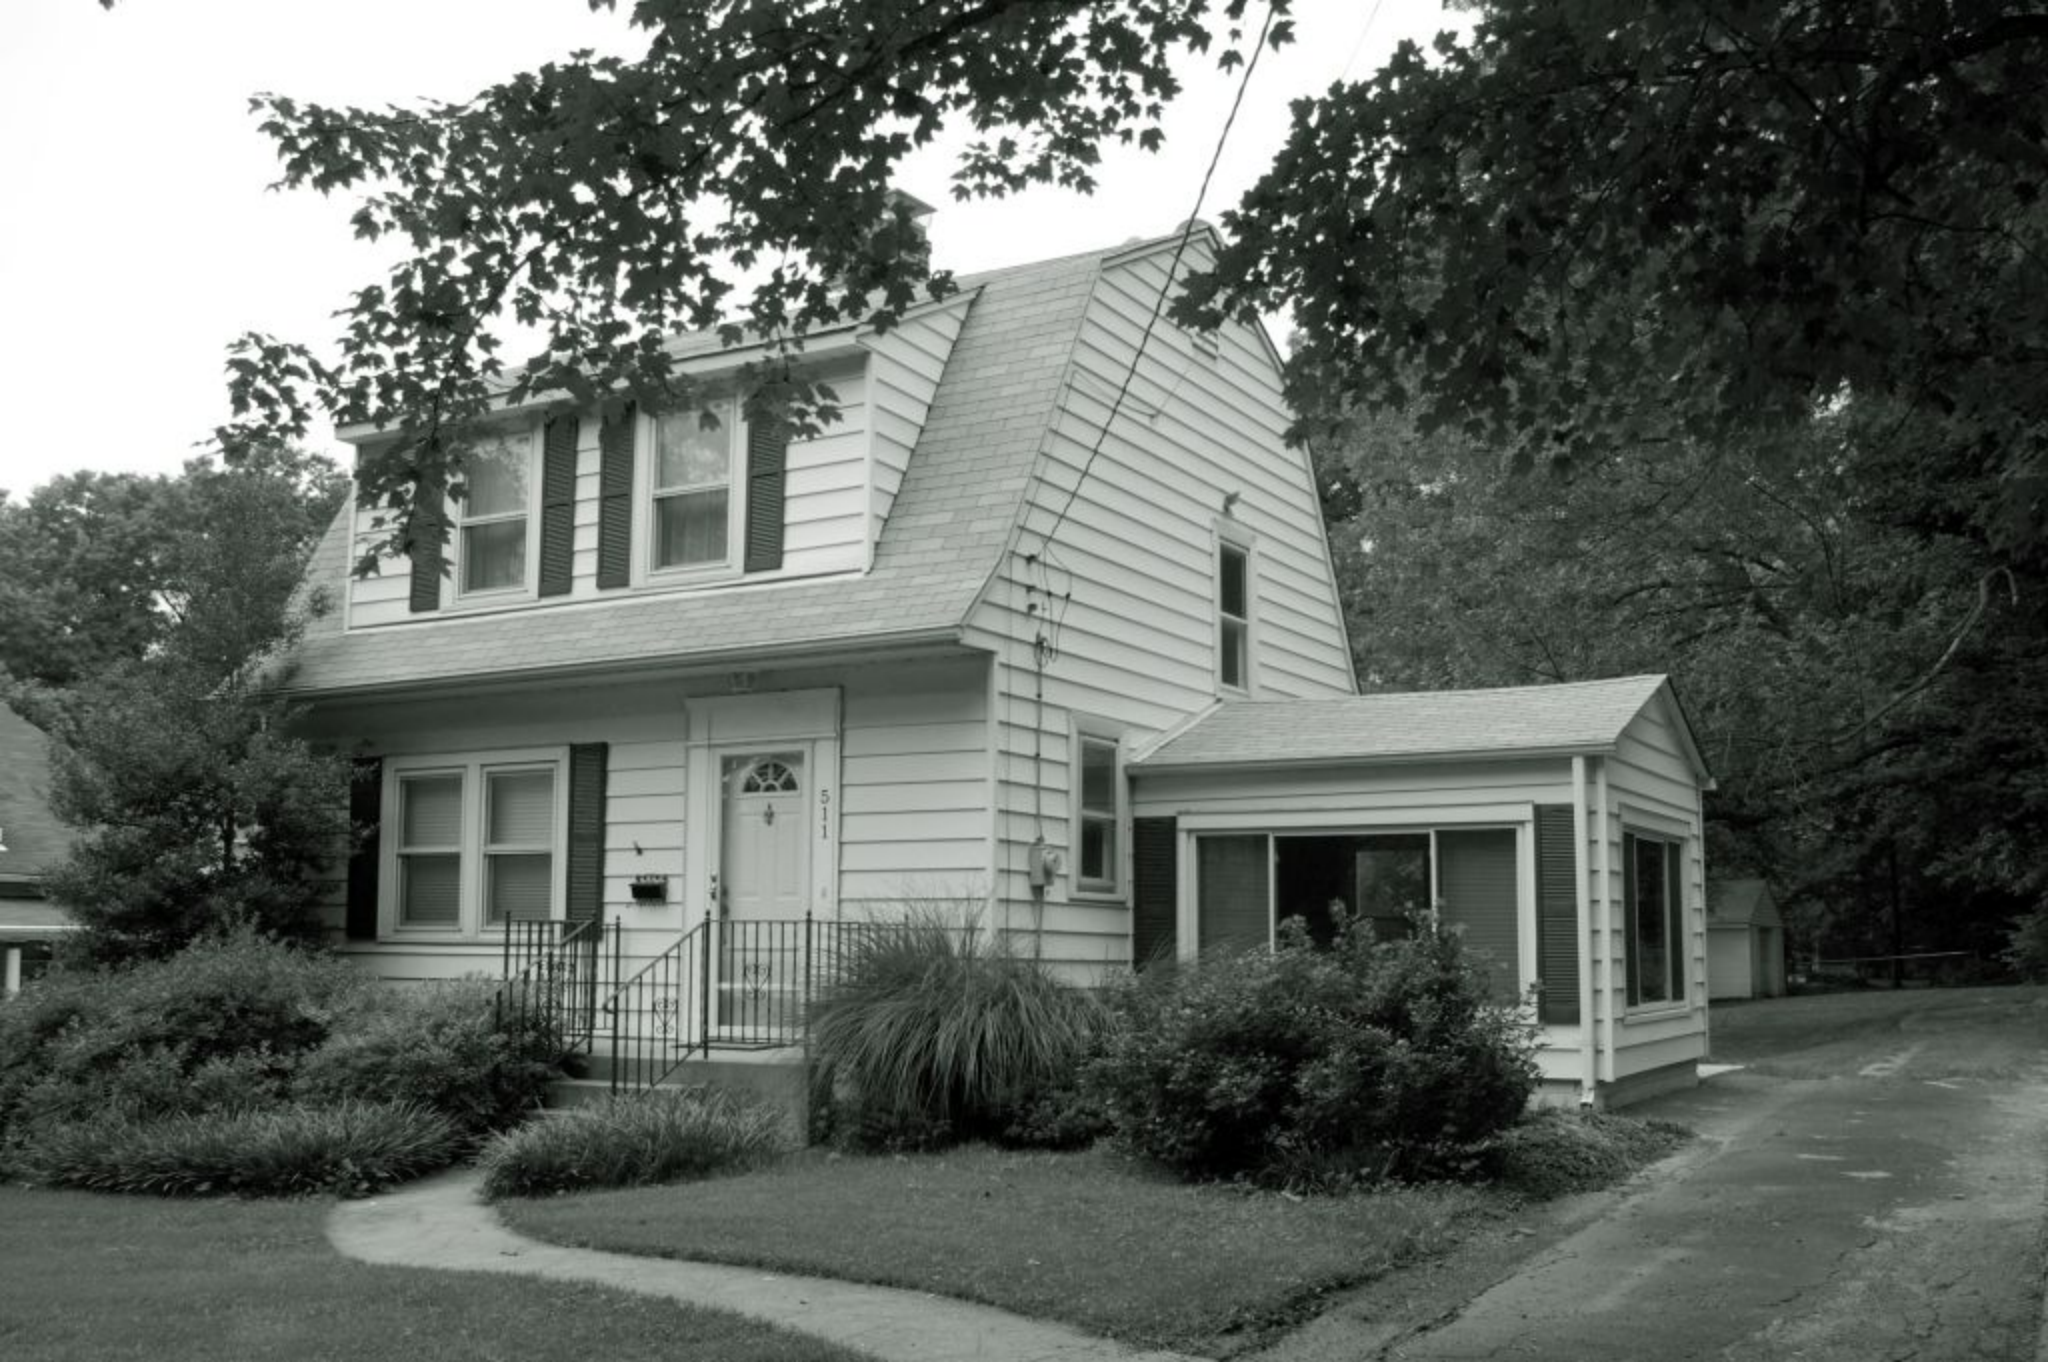
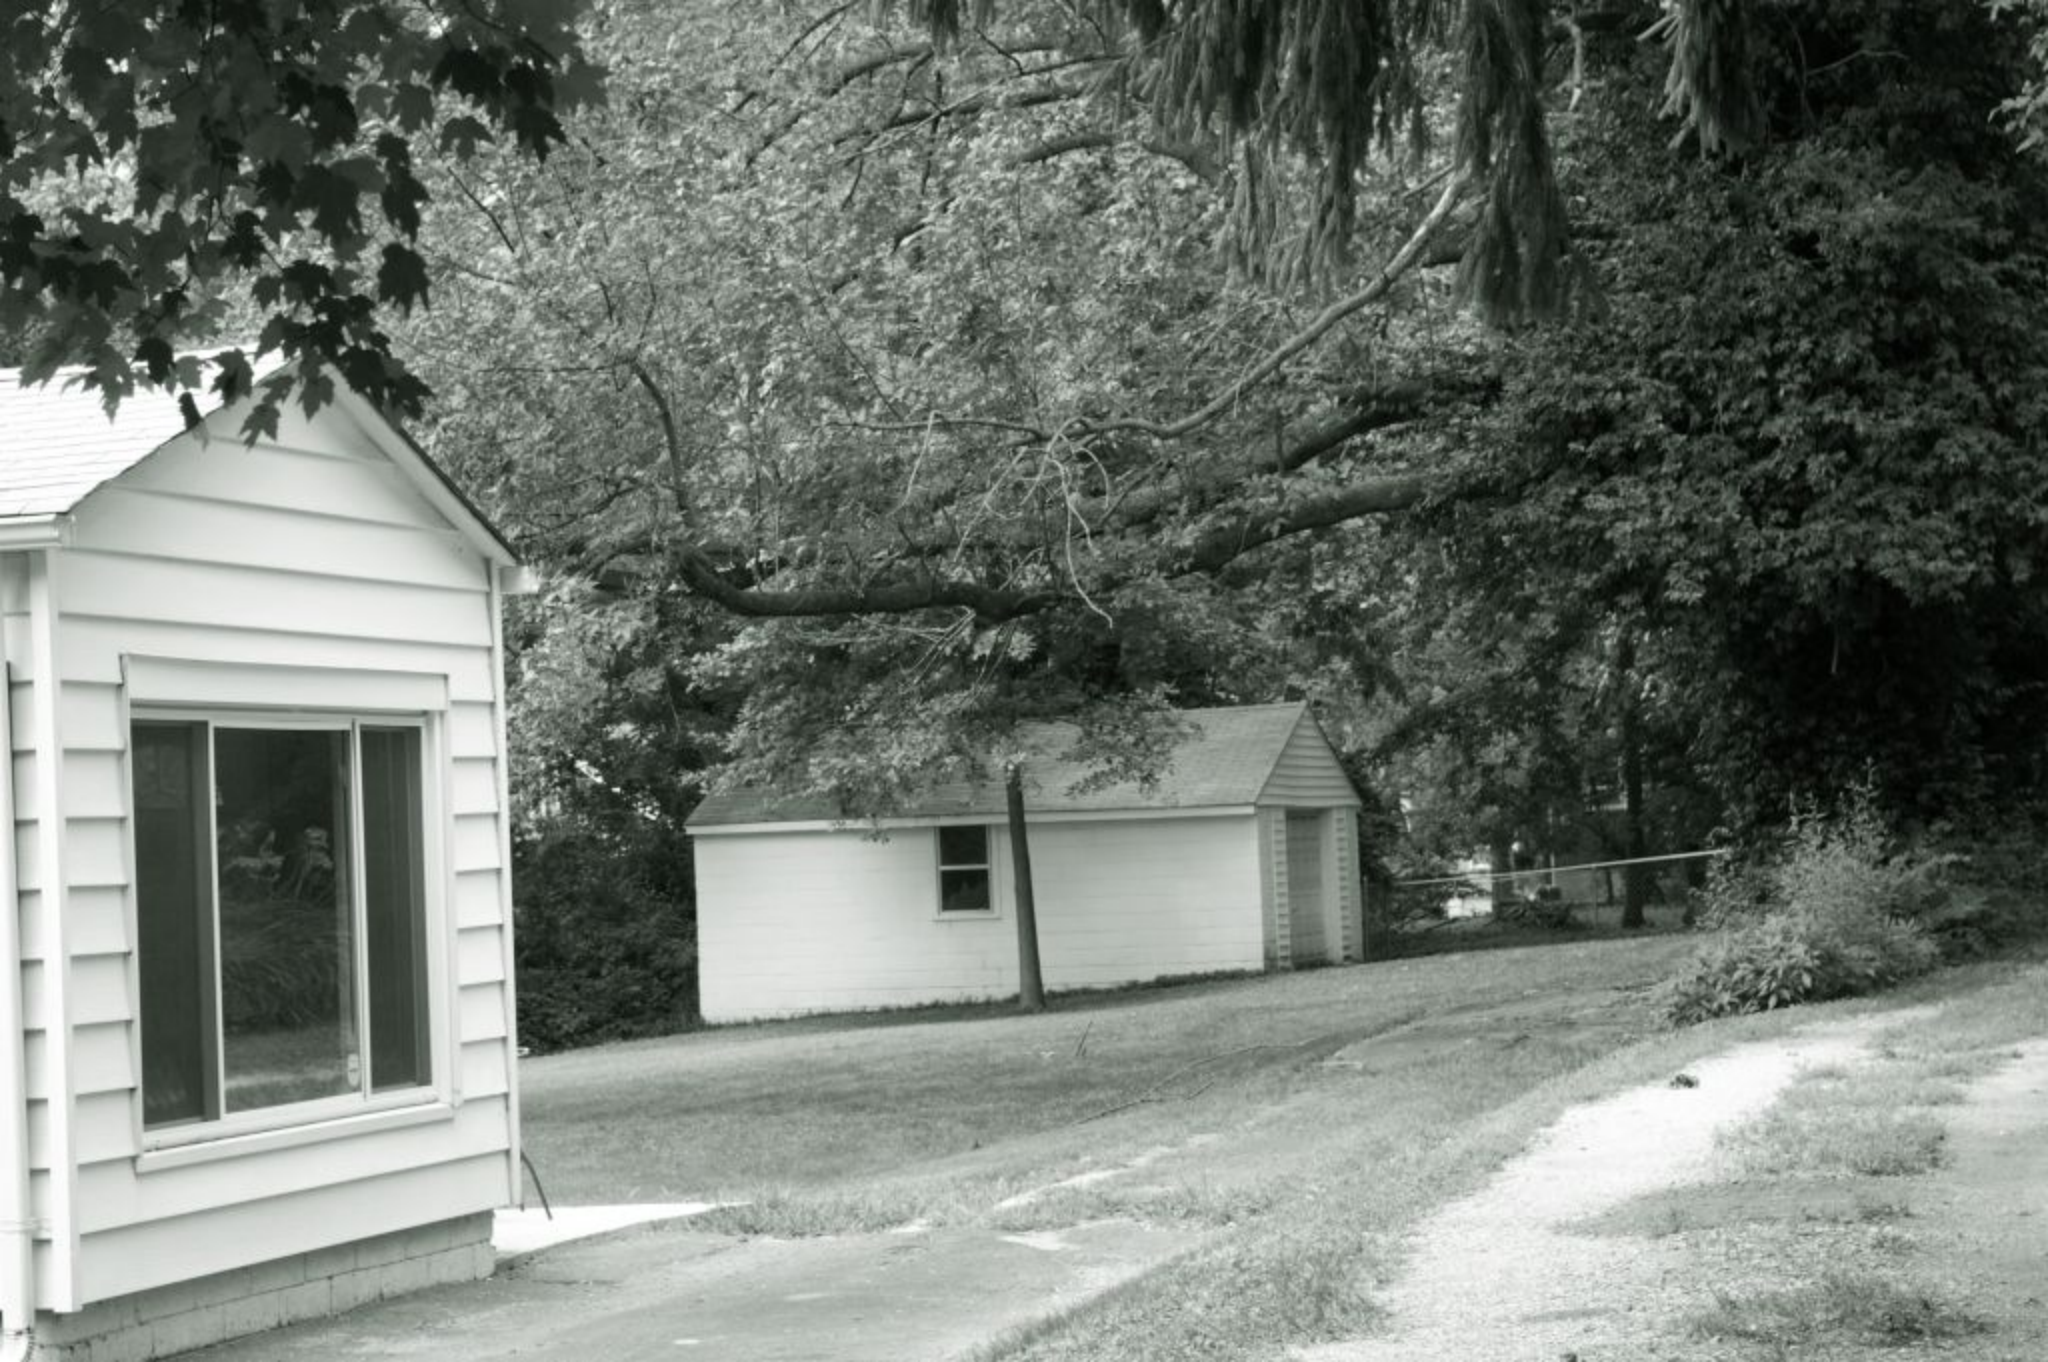
This Dutch Colonial Revival house has a broad shed dormer across the facade of the two bay frame house. The house has engaged flattened pilasters that extend into the simple entablature over the entry door and retains its wood paneled door with the half round fanlight in the door. In front of the door is a concrete entry stoop with wrought iron railings, which may be original. To the west of the entry bay are paired, 1 over 1 wood sashed windows with faux shutters. There are also shutters on the two 1 over 1 wood sashed windows in the dormer as well as on the west side sashed windows. On the east side of the house there is a one story, side gabled sunporch, a common feature on various Colonial Revival variant styles, including the Dutch Colonial Revival designs. However, in this instance, it appears that what may have been an open porch has been enclosed (or had the original windows replaced) with metal windows that consist of a plate glass window flanked by single light windows with screens (probably casement windows). The house has been sided with wide aluminum siding as well. The wood sashed windows have aluminum storm windows.

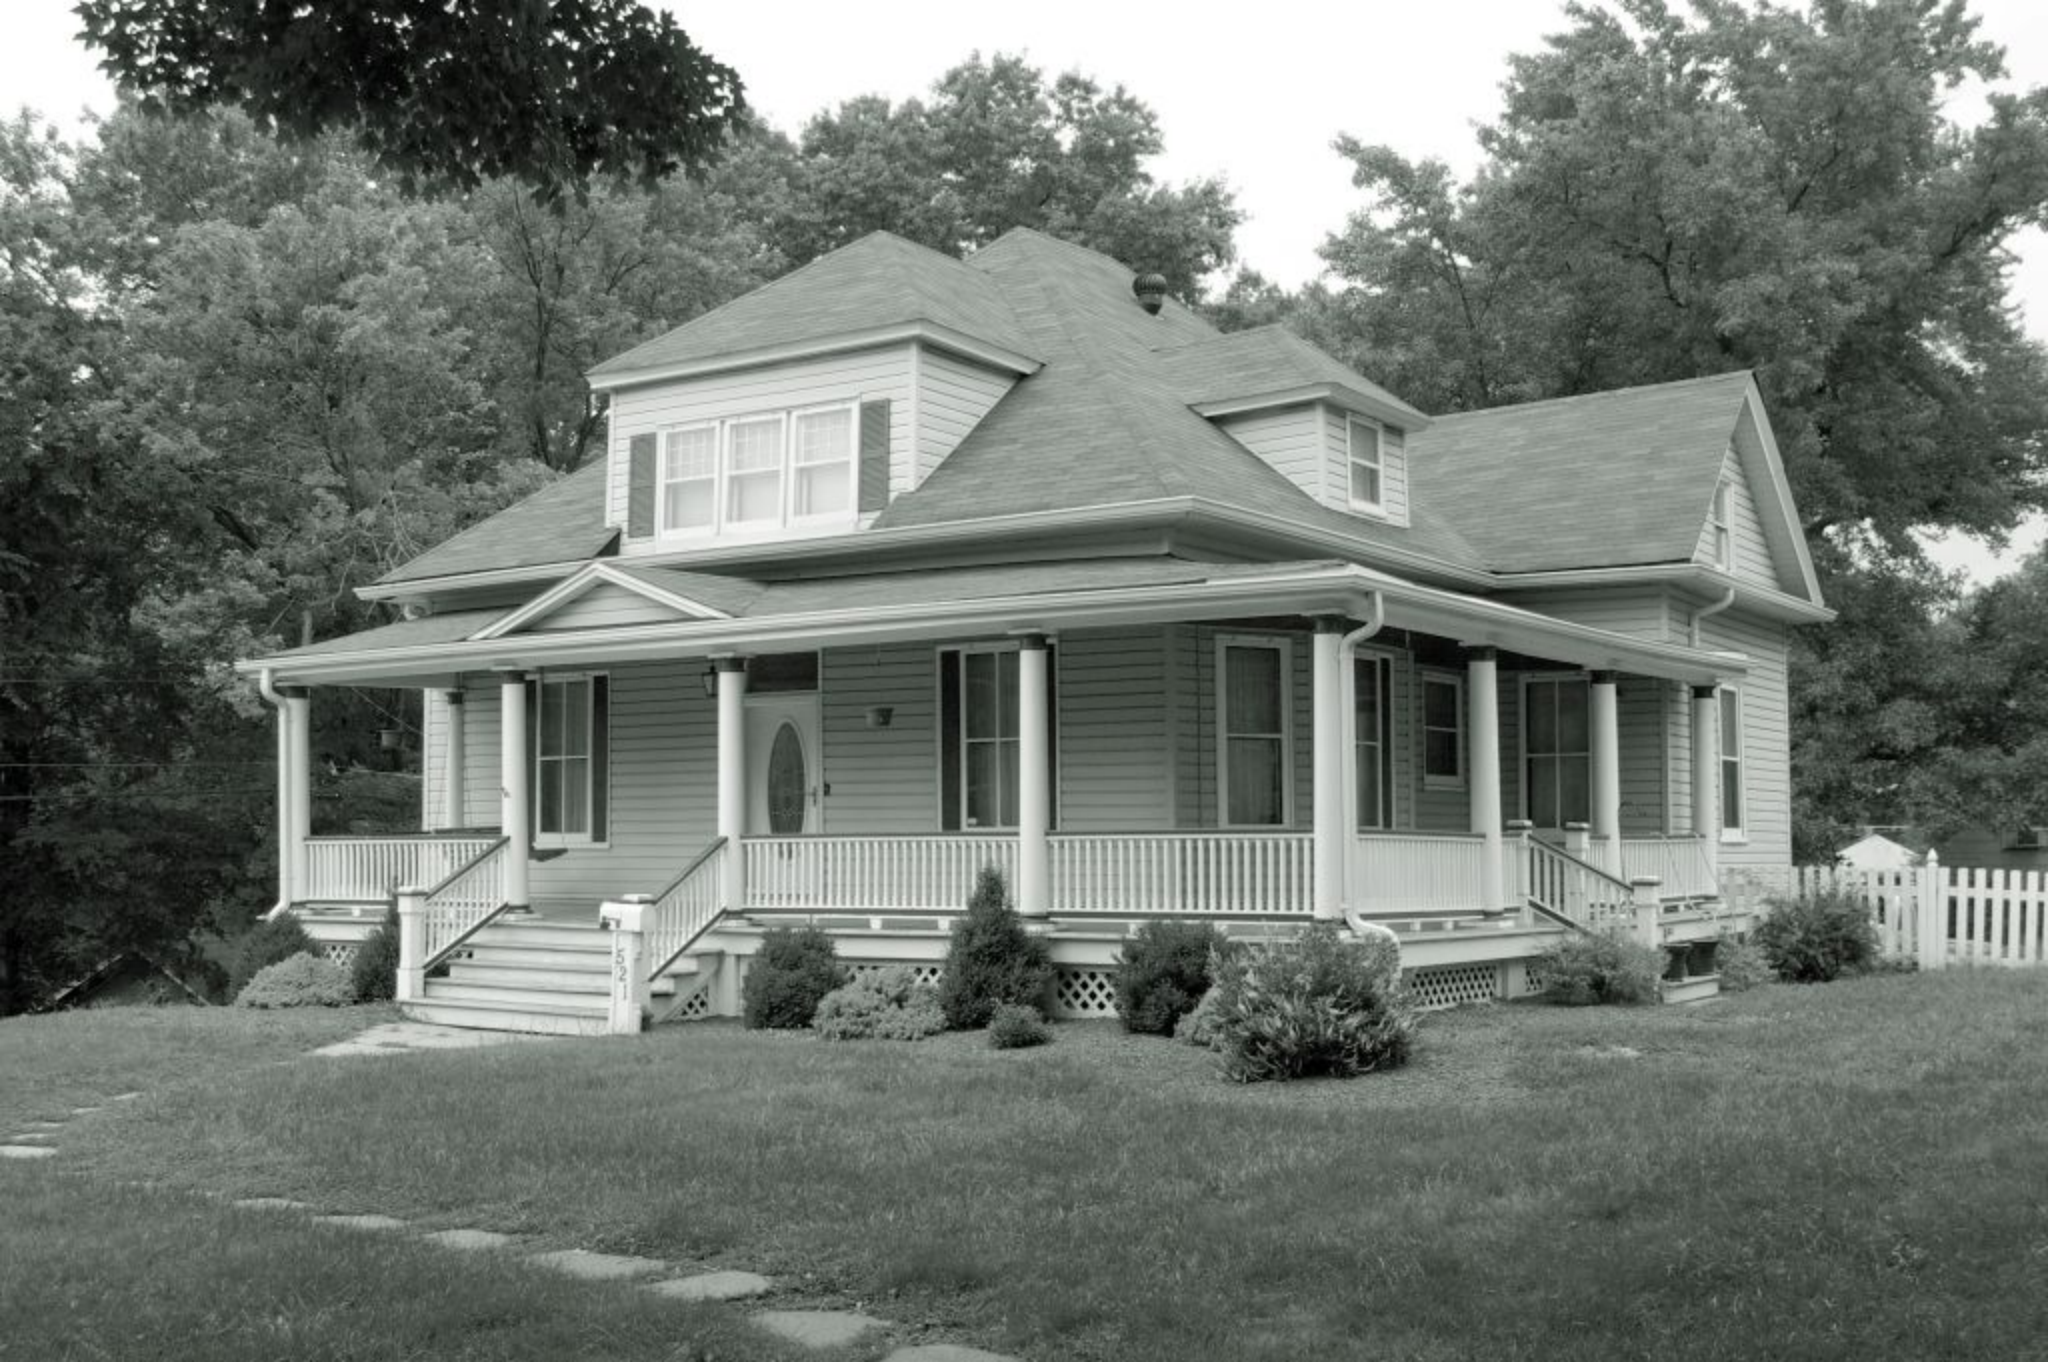
2009 Survey Update: Since the 1983 survey, the wood shingles siding has been replaced with vinyl siding but most of the windows appear to be the original wood sashed windows. Because of the overgrown shrubs in 1983, the description in the 1983 survey did not note that many of these windows (in the bay window and on less prominent openings) are in fact wood 1 over 1 wood sashed windows. Windows identified flanking the front door and on the face of the bay as 2 over 2 wood sashed windows have either had the sashed window units removed or were in fact single light fixed windows with 4 light wooden storm windows since the wooden storms are still intact on most of the house. On either side of the entry and in the bay, these same windows now have a framed sidelight-like feature which is boarded in and it is unclear if this represents a decrease in the dimension of the window width or a loss of some other feature such as sidelights. Since the last survey, the missing balustrade on the wrap-around porch has been rebuilt carefully articulated to match historic railing construction. The garage door on the basement level, facing Harvey, has been covered with large shutter panels and the horizontal fixed window opening above has been boarded over. The broad brick interior chimney is missing its cap.
