National Register of Historic Places
Registration Form

historic name Osage County Poorhouse

Osage County Poorhouse, Osage County, Missouri

Description

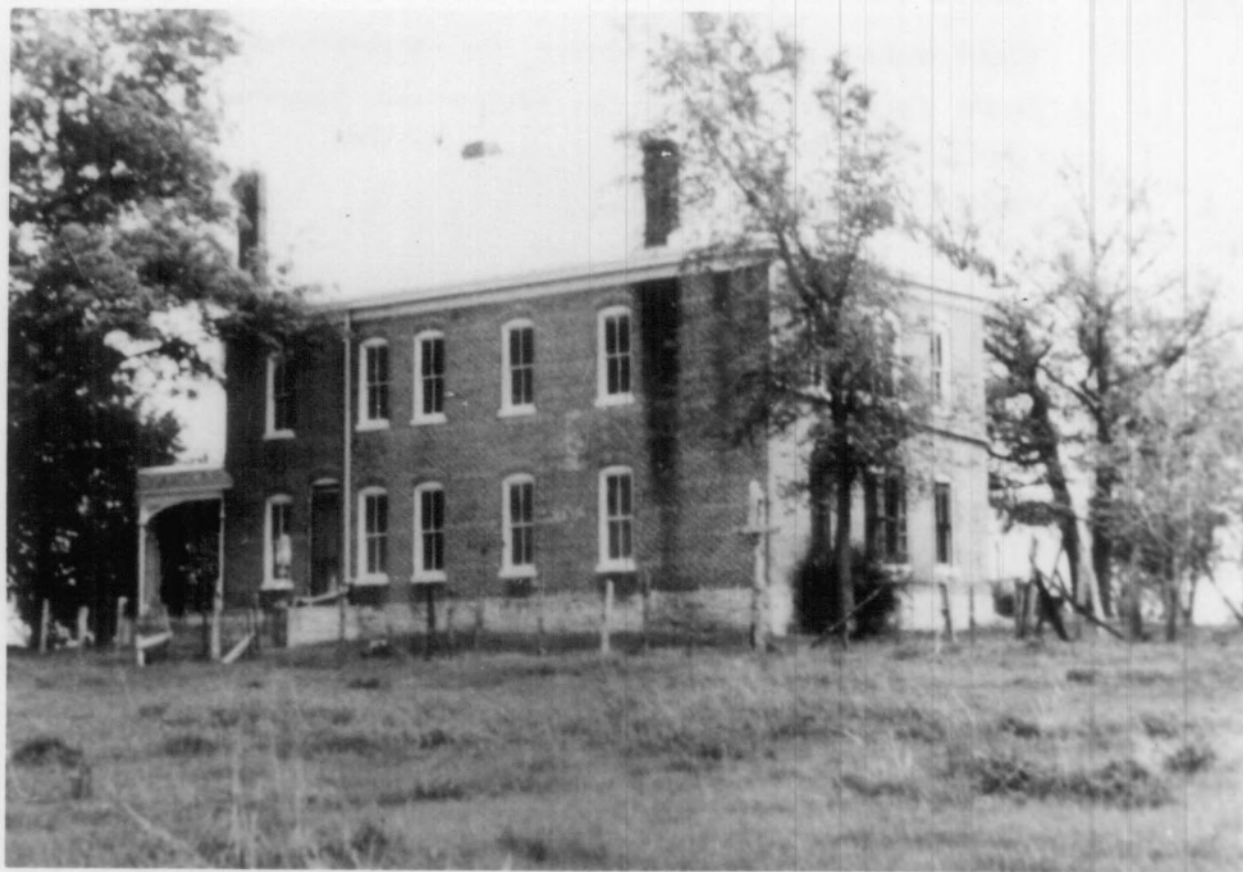
Photo #2 Osage County Poorhouse, Osage Co. Missouri, 1893

East view c. 1954, prior to renovation

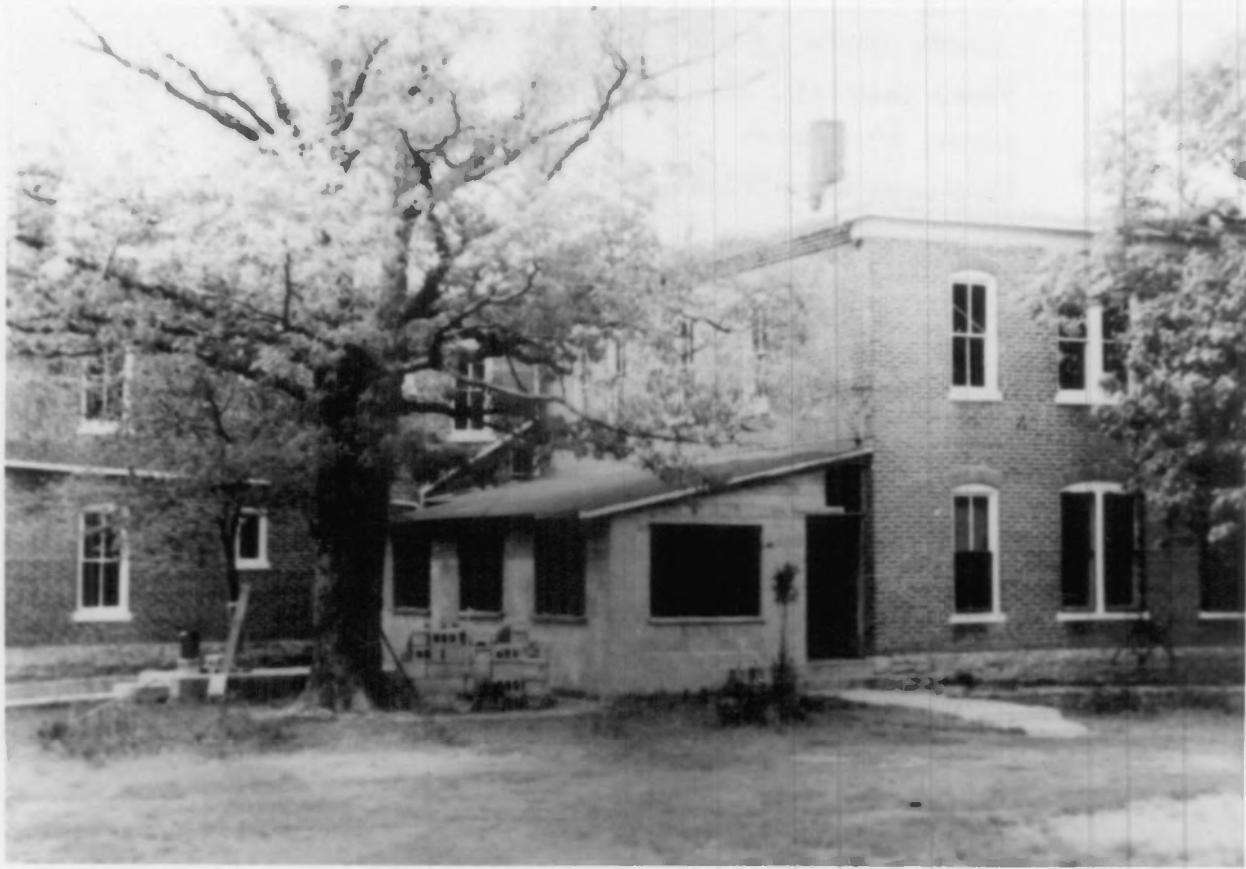
#4 Osage Co. Poorhouse, Osage Co. Missouri
Photographer Unknown
View from Southwest
c. 1954 before renovation
Courtesy Osage Co. Historical Society, Linn, Mo

Dr. Perry Kaullen purchased and renovated the facility in 1954 for use as a retirement home. This renovation significantly altered its interior and exterior the appearance. For many years the facility was known as the Linn Manor Rest Home. John Paul Quick of Belle, Missouri bought the property in 1992 and operated it as a dormitory for students of Linn Technical College. Mr. Quick is preparing for preservation-sensitive renovation of the poorhouse for use as a residential care facility. He plans to remove some of the building's non-contributing elements and to replace some of the original architectural details.

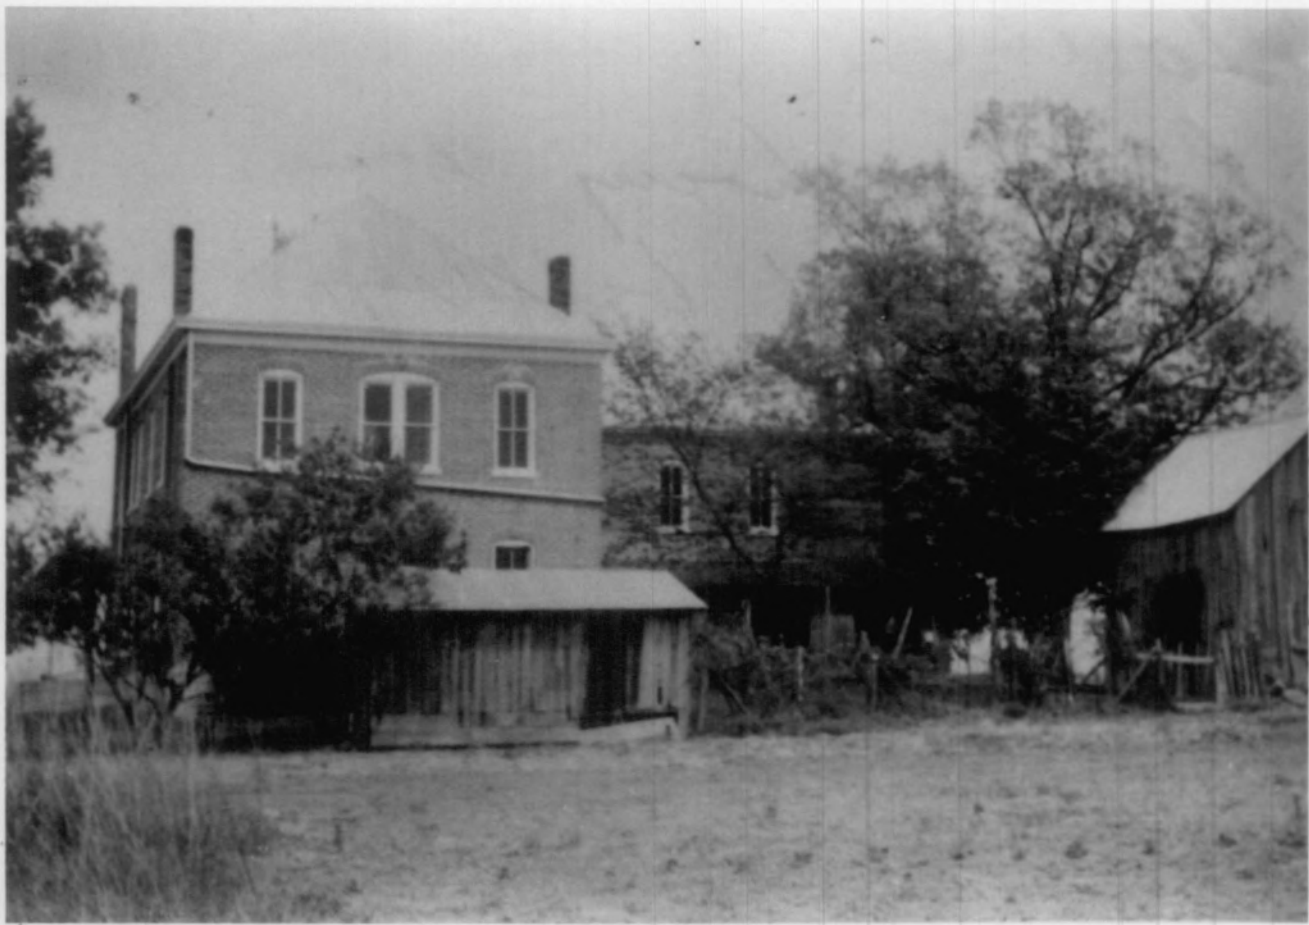
#5 Osage County Poorhouse, Osage Co. Missouri
Photographer Unknown
Courtesy Osage Co. Historical Society, Linn, Mo
c. 1954 View from Northwest
Before renovation

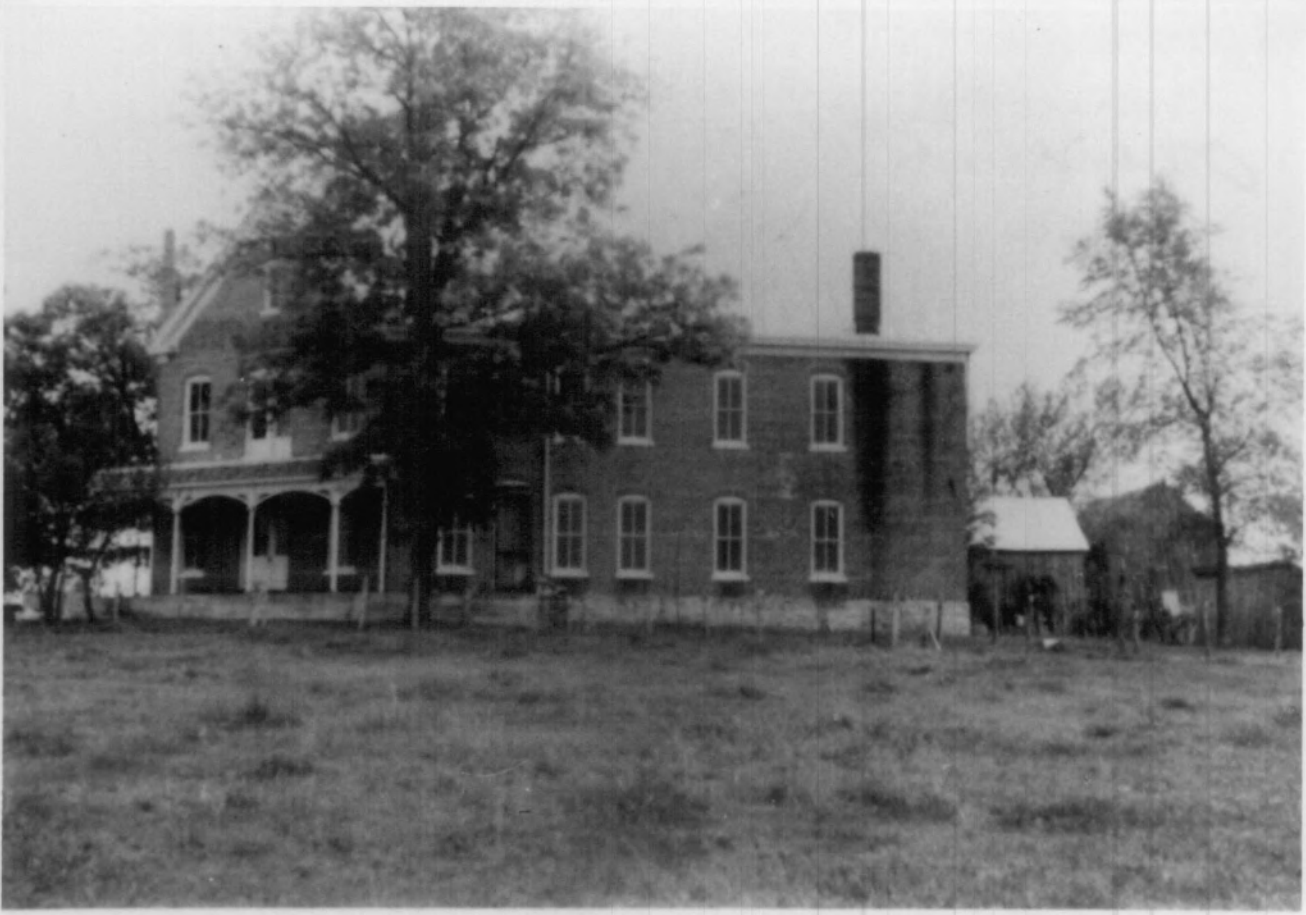
#6 Osage County Poorhouse, Osage Co. Missouri
Photo by Greg Olson, 1997
Photo Courtesy Greg Olson, Columbia, Missouri
Poorhouse from the East
