National Register of Historic Places  
Registration Form

historic name The Parkview

The Parkview Apartments

Apartment Buildings on the North End of The Paseo Boulevard in Kansas City, Missouri

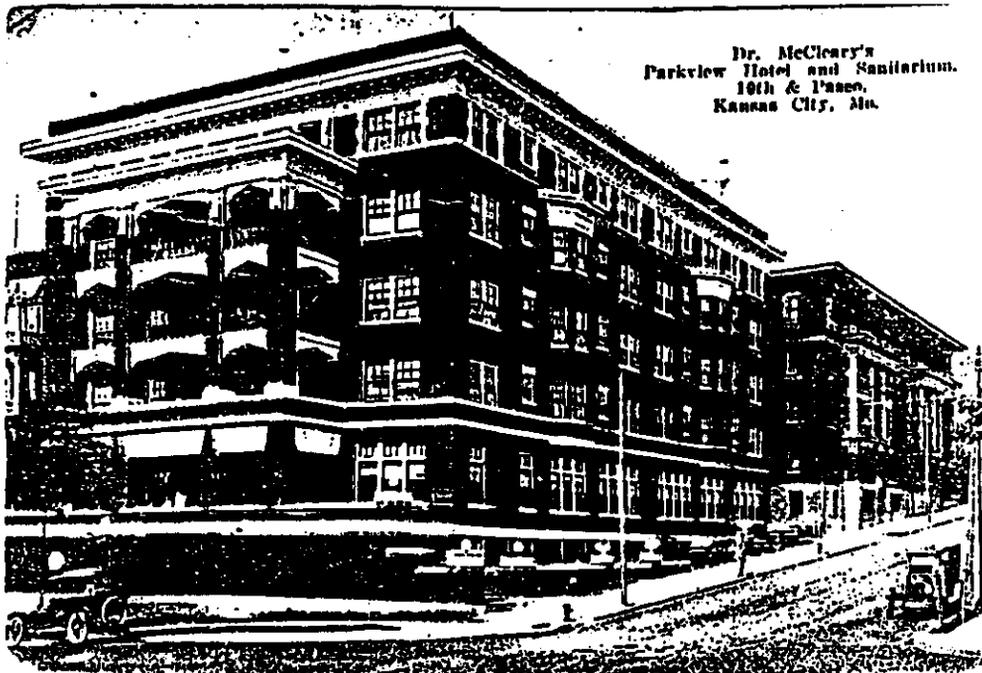
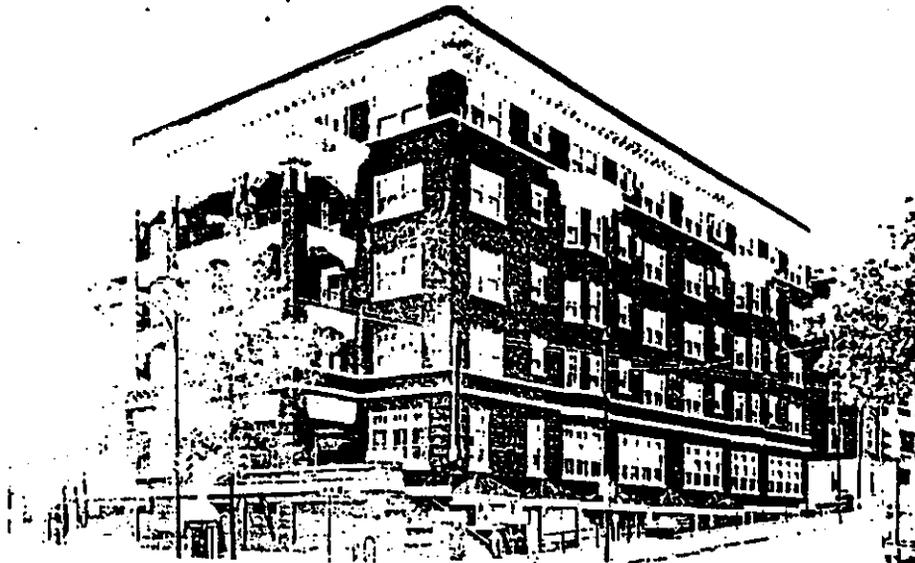
Figure 2: Photocopy of Historic Postcards of 1000 Paseo, dates unknown [SW] from Parkview Homes' marketing packet (former property owner)

PARKVIEW HOTEL - 1000 PASEO - KANSAS CITY, MISSOURI
