Architectural/Historic Inventory Survey Form

St. Joseph PENN Survey

Address: 603 South 14th Street Roll/Frame: 5/29, 9/19

Prepared by: The URBANA Group (Gallagher) Date: 12/91

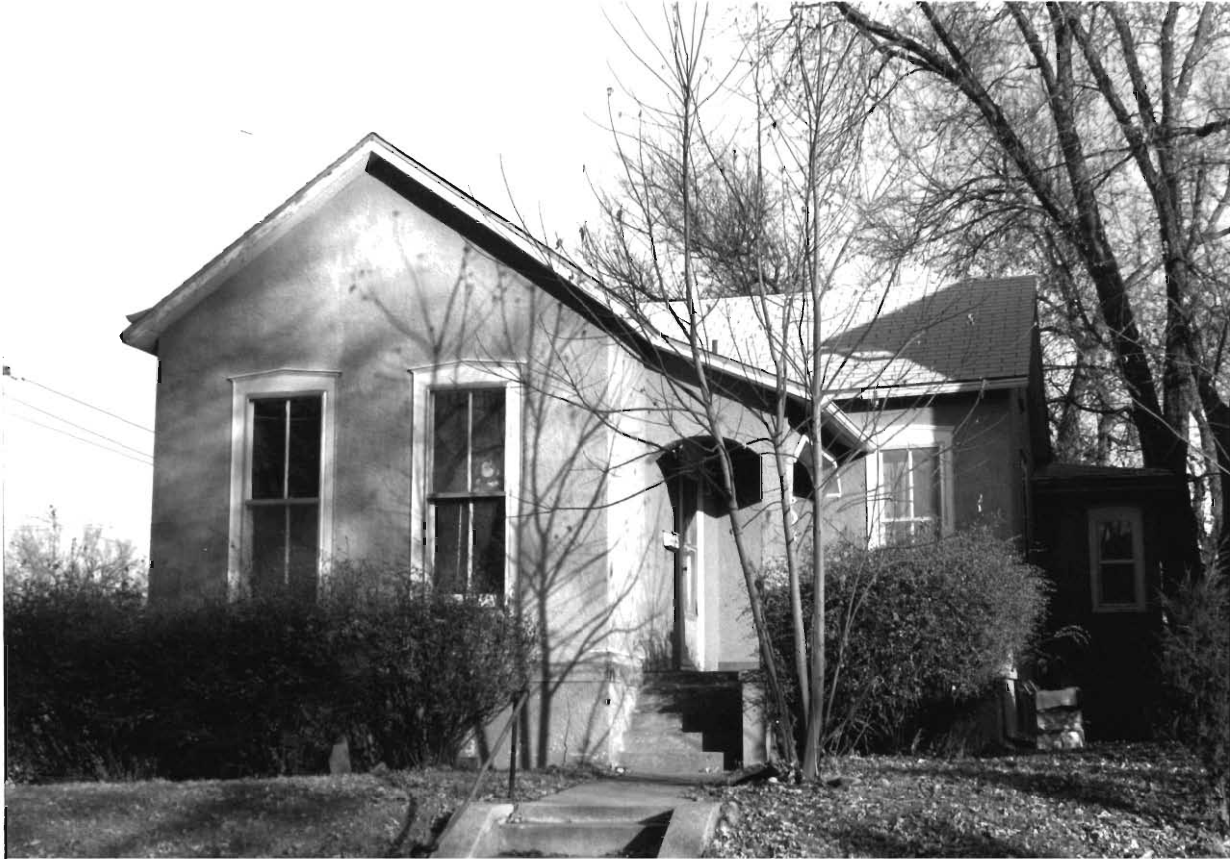
Exterior condition: Good Endangered/by what?: No

Three 2/2 windows face front--two of which are in gable front projection. All fenestration on front facade, north facade and one window on south side of building have wooden surrounds and pedimented drip molds. Boarded square window in south-facing gable. Stuccoed, masonry post supports extended eave of roof to accommodate porch in front reentrant angle. Segmentally arched porch entrance. Segmentally arched, wooden basement door allows access to basement from Messanie Street. Full-width, shed roof extension at rear with hipped roof extension on south side of building toward rear.

The building retains a high degree of integrity, and is significant as a representation of the continued use of a late 19th century dwelling updated with early 20th century exterior treatments and features.

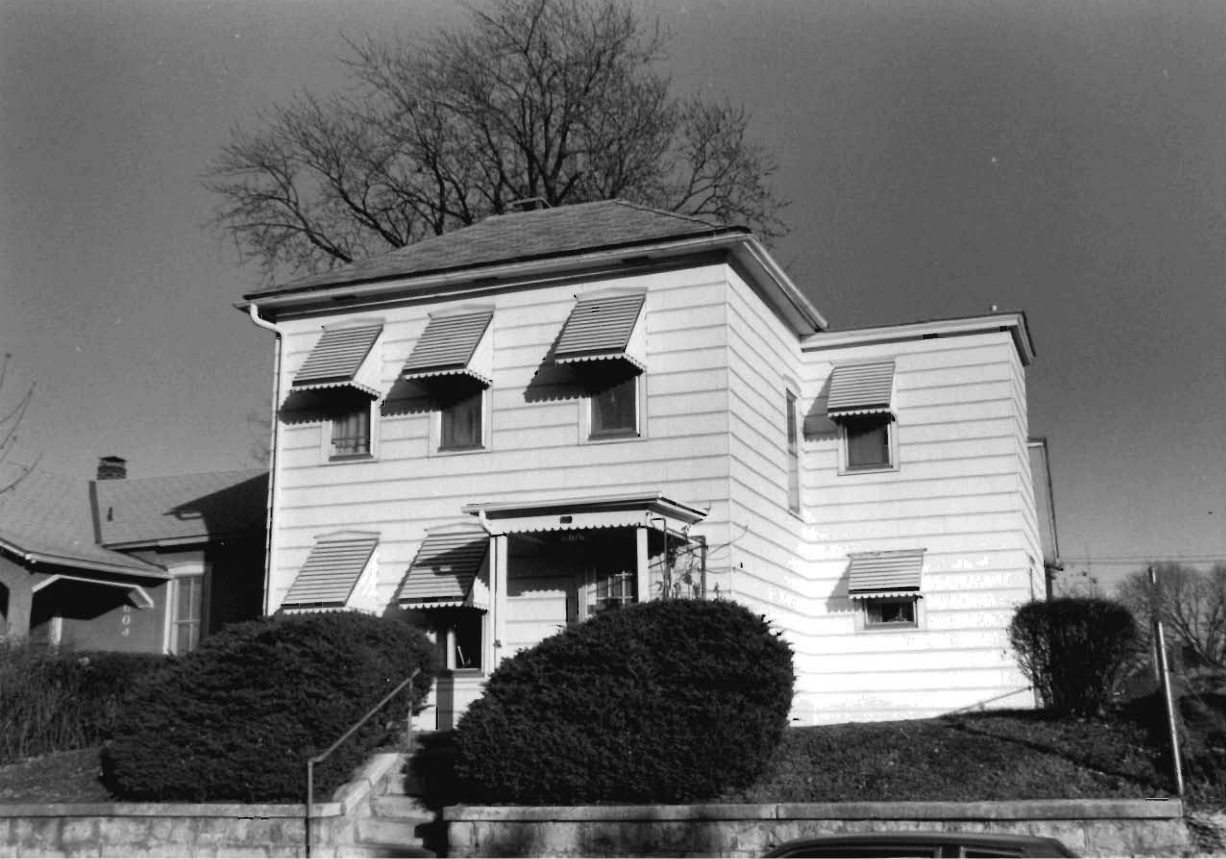
The building retains a fairly high degree of integrity despite its artificial siding, and is significant as an excellent representation of a Side Hall Plan house.

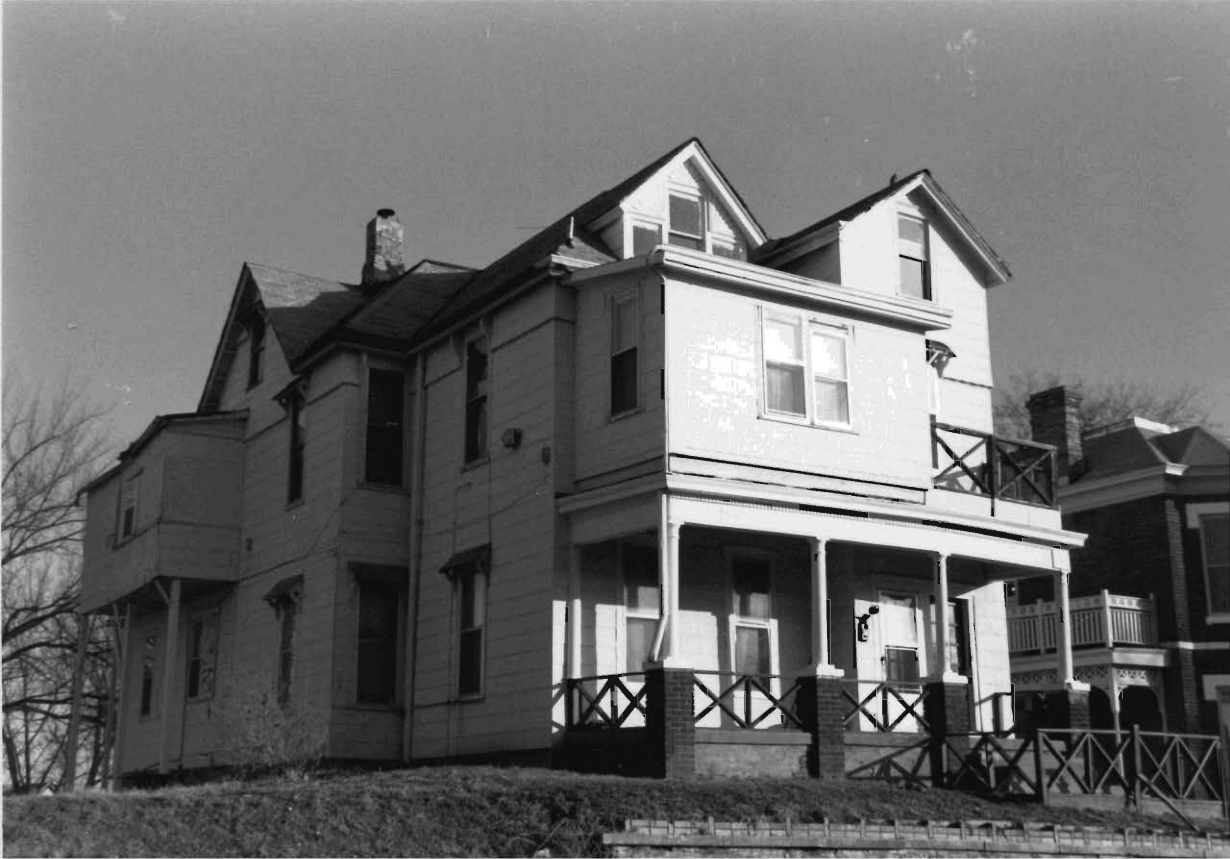
Description of Environment and Outbuildings: Elongated blocks, coursed limestone retaining wall continues across vacant lot to the north; poor condition. Appears to have concrete covering on parts, causing further deterioration of the stone. Buff brick pattern atop wall: soldier course pairs alternate with stretcher course pairs. Stairs break the wall toward the right (south) of the property, angling to the south entry doors under the porch.

Stylistic features and plan of building indicate construction c. 1885 which pre-dates building permit records. The building received an addition by J.L. Unangst in 1888; a stable was added to lot 8 in 1889. A building permit was granted to B. Skolnik in 1923 for fire damage repairs; two additional building permits for additions were also granted in 1923, and a third in 1924, all to Skolnik. A garage was built in 1925. Some of these additions could have been alterations to the facade porches, particularly to the second floor. In 1911, the building did have a full-facade porch and a three story tower.

The building retains a moderate degree of integrity, and through its plan and massing, is a significant representation of Queen Anne influenced architecture.

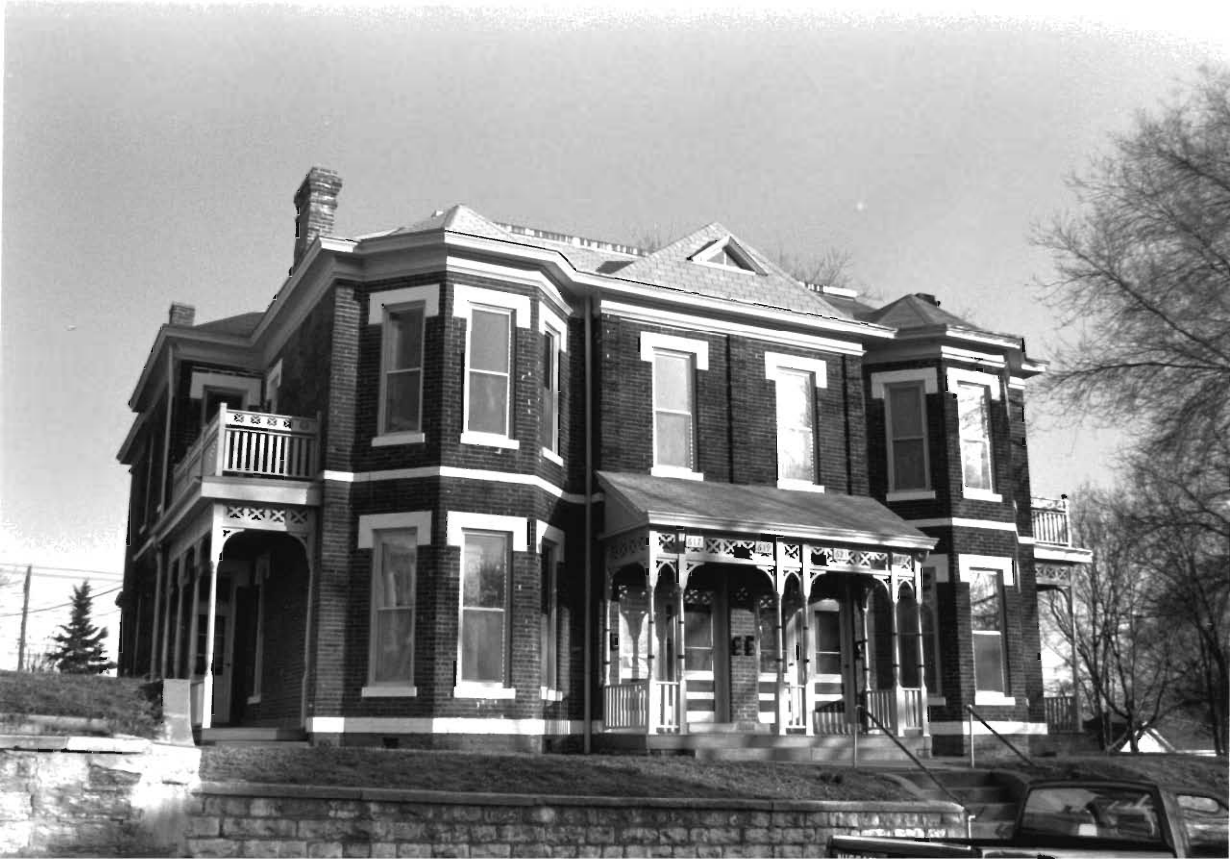
Running bond facade, with coursing changing to common bond on the side elevations (north and south) after the secondary end bay entries. Central hipped roof section slightly projects, and has four entrances with transoms paired in the center. Pairs are separated with paneled Doric pilasters. Shed roof porch with turned posts, cut-out patterned cornice, corner cut-out brackets, and wood slat balustrade on low wood floor; single concrete step. Rusticated (or banded) piers are at the ends and center of this section; two light triangular fixed windows in tiny gable roof dormer. Two 1/1 double hung sash between piers, this section. Hipped roof semi-hexagonal bays on either side with 1/1 sash. Raised brick (two courses stretcher brick) beltcourse at base of second floor; three course stretcher at watertable. Beltcourse wraps half of side elevations; watertable does not wrap. Windows have stone lintels with drops, painted white as is beltcourse. Side fenestration has soldier course flat arches, with the endmost bays on the south having double rowlock segmental arches.

Meets the property type definition for Multiple Family Residential, as defined in the Multiple Property Documentation form "Historic Resources of St. Joseph, Buchanan County, Missouri." The building retains a high degree of integrity and is significant as an outstanding example of that property type and as a representation of Queen Anne and Italianate stylistic influences.

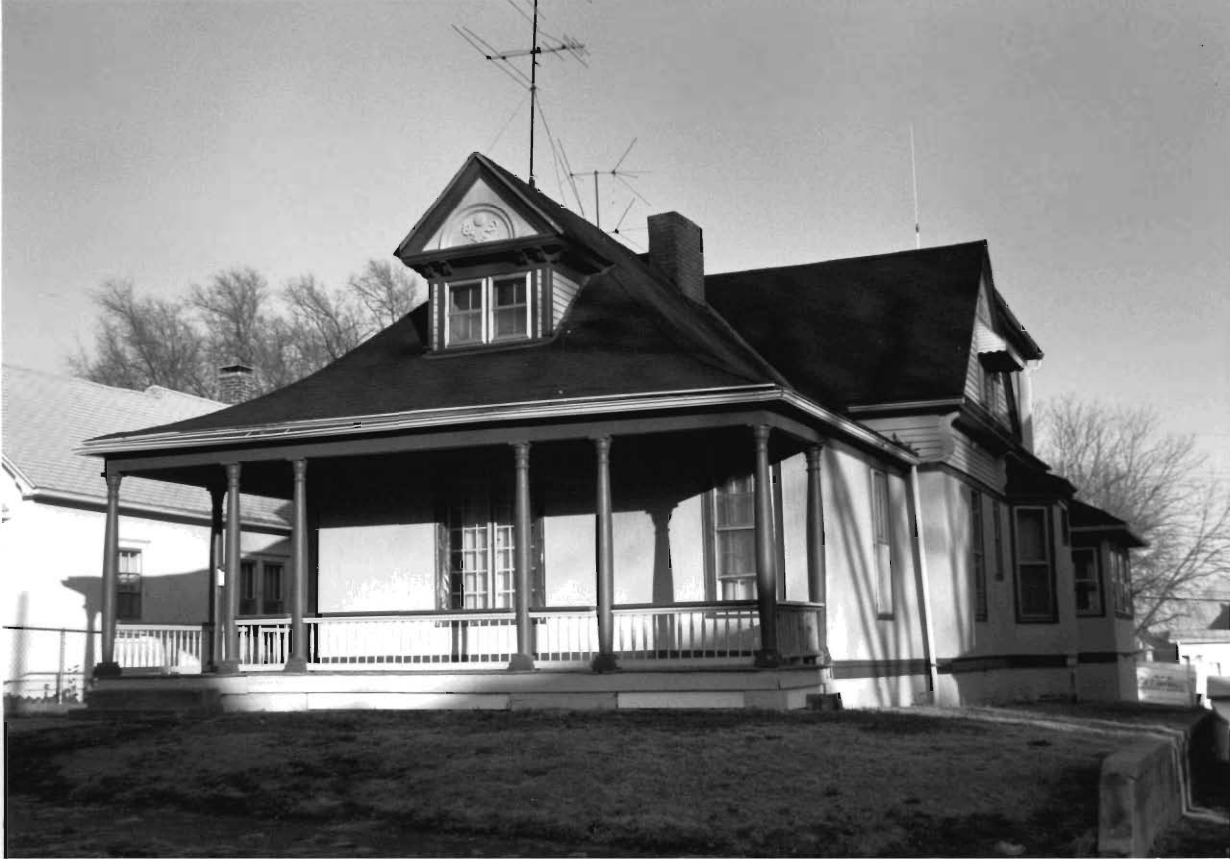
Entrance in recessed left bay of front projecting flared hip roof. Three light transom over door. Two 18 light fixed sash center with single 9/9 sash to the right. All are under full-facade porch created under flare of hip roof. Unusual columns with bulbous centers, paired on front with matching balustrade; low wood porch floor accessed by two concrete steps. (South end balustrade replaced.) Smooth wood beltcourse at watertable level. Small gable roof dormer projects off front hip ridge with squat pair of 2/2 sash, wide overhanging eave with paired curved modillions and decorative wood (?) round arched applique with a circle and vining patterns. Oval window with 4 "keystones" faces north in entrance. Side gable (cutaway) bay projects out of main hip block. 1/1 double hung sash. Clapboard cornice from under porch continues to elevation, visible at cutaway on gabled bay. Large solid corner "brackets" with incised scrolled pattern. Rear/north side porch with smaller versions of the main porch columns. Multi-light oval window with web pattern on north elevation. Pair of windows in side gable cut away bay with sunburst above.

Extremely varied roof line. Second floor stucco shed off central hip and side gables. Main hip turns to gable on south end with slight projection from front flared hip. No bay on south as on north. Clapboard first floor front cornice (under porch) continues on north, with curved "brackets" at edges of projection. Two small 1/1 sash in south gable with highly decorative peak with foliage and shells (plaster). A one story semi-hexagonal bay carries the second floor shed atop; squat stained glass fixed sash in center of bay. Rear full-facade shed roof porch, enclosed, forms into L to hip rear wing on south (three windows wide).

The building retains a high degree of integrity, and is significant as an excellent example of a Queen Anne cottage.

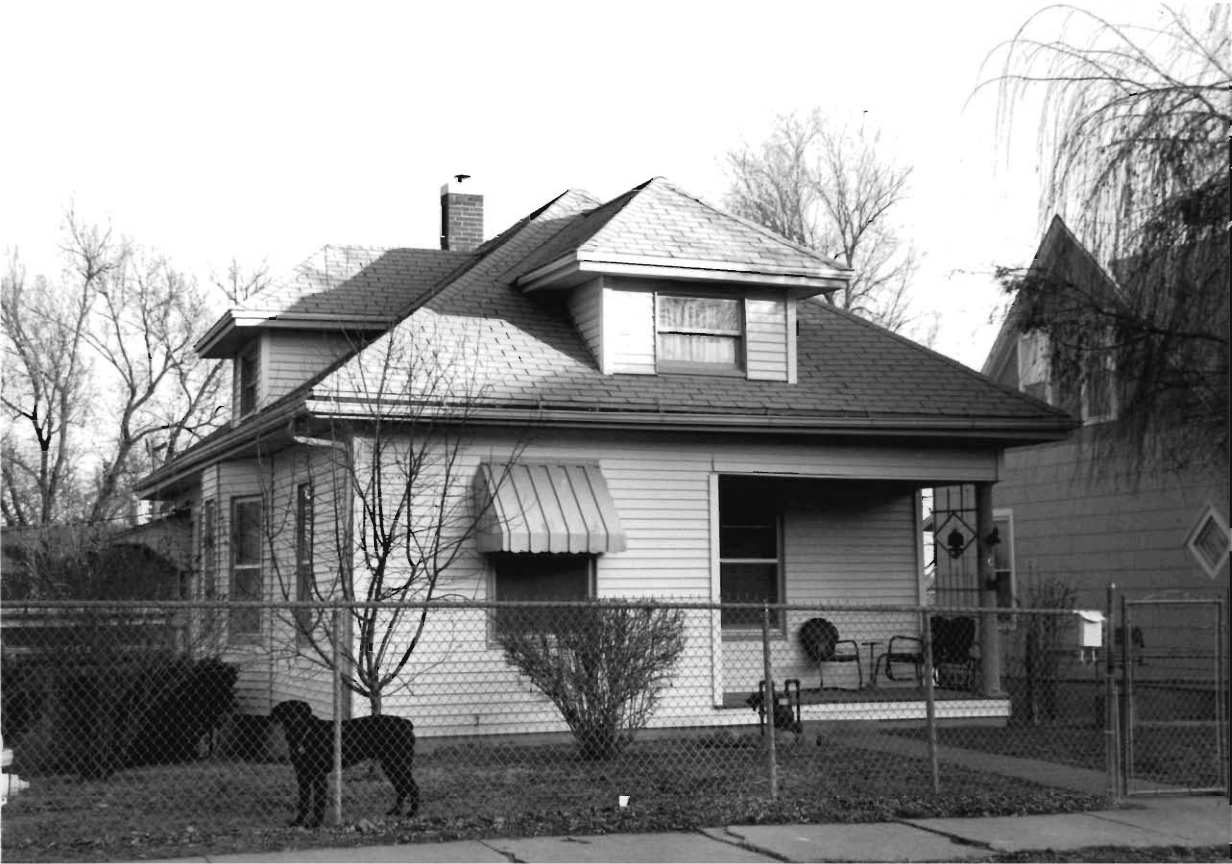
Building permit records indicate construction in 1917 for applicant J. W. Nidy. Permits further indicate that C. R. Murphy received a permit for remodelling in 1945 and that M. L. Boland received a permit for a garage in 1951. John Grippando, Jr., the current resident, received a permit to make repairs to this house in 1983.

The building retains a moderate degree of integrity due to artificial siding and modern patio doors added, but is a good example of early 20th century domestic vernacular architecture.

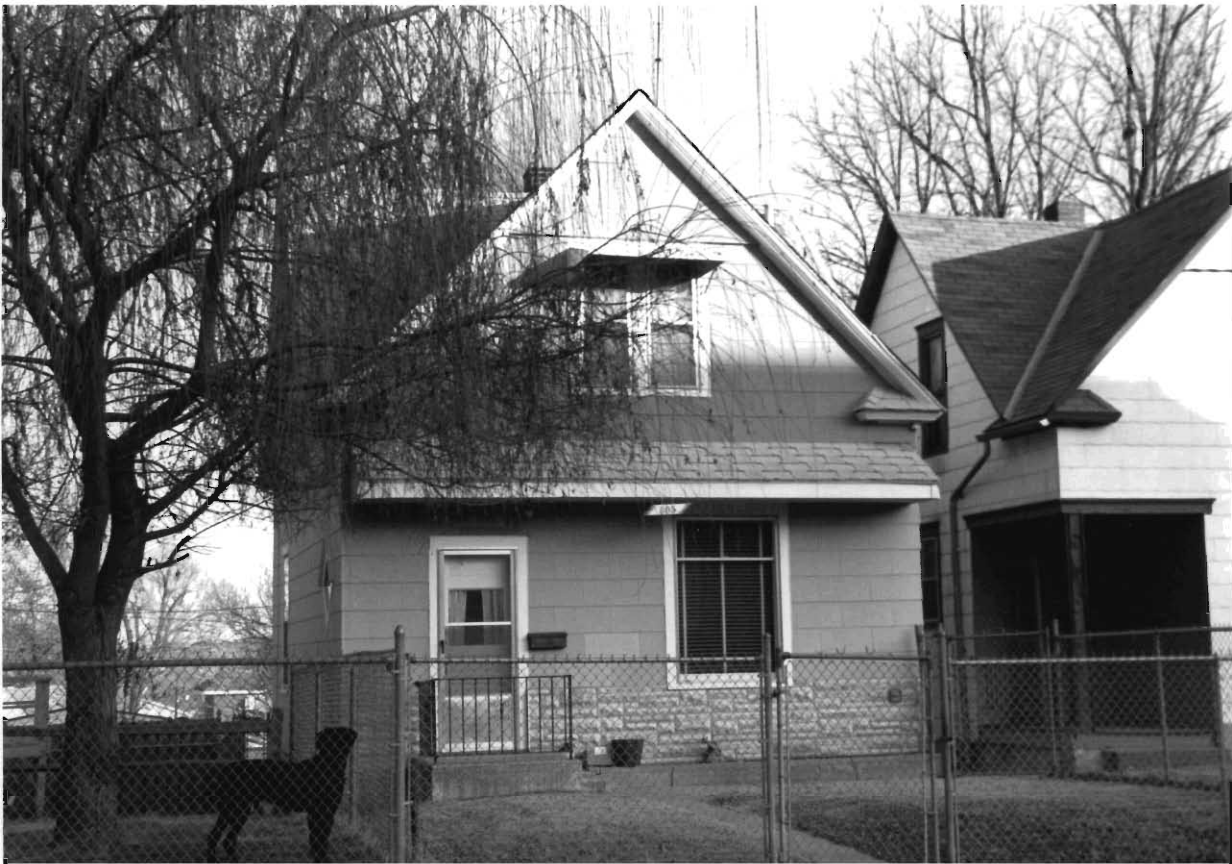
The house retains a moderate degree of integrity due to the front artificial siding and porch infill, however the building continues to significantly reflect early 20th century domestic vernacular architecture.

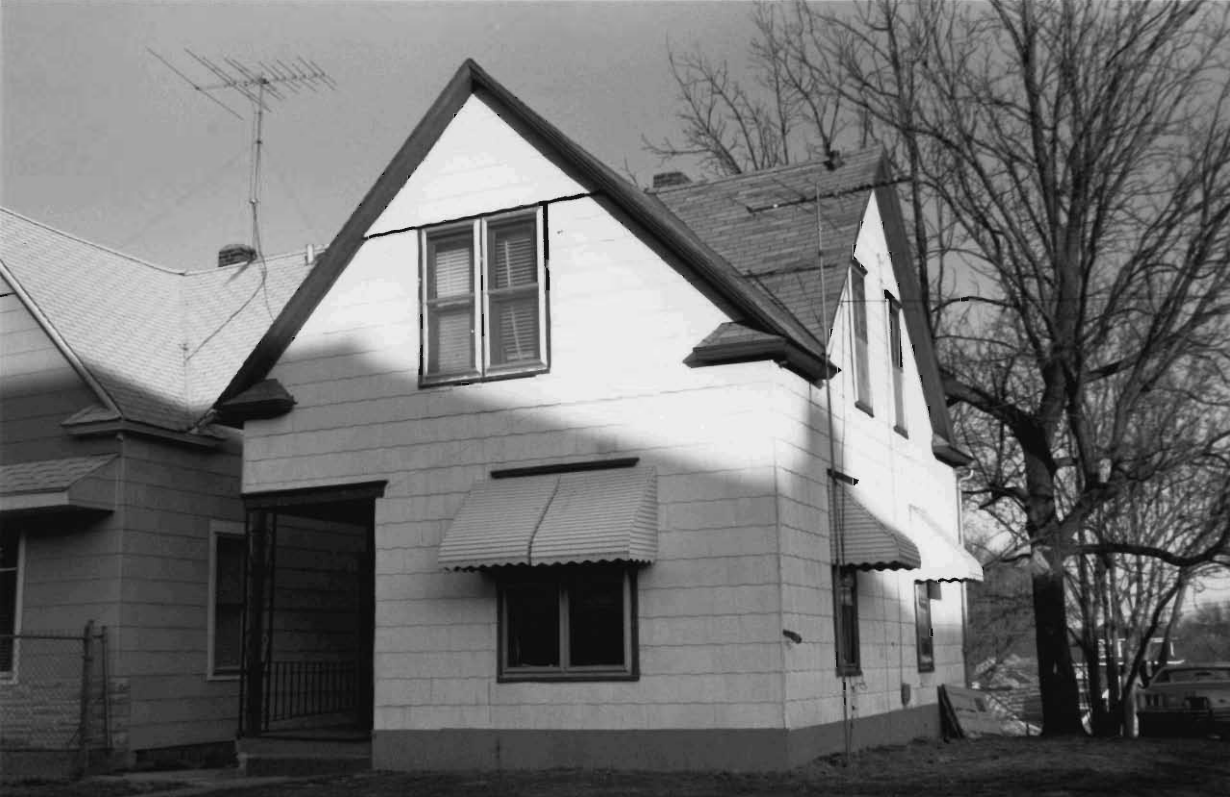
The building retains a fairly high degree of integrity with only a minor porch change and aluminum awnings added. The building is significant as a good example of a turn of the century vernacular residence.

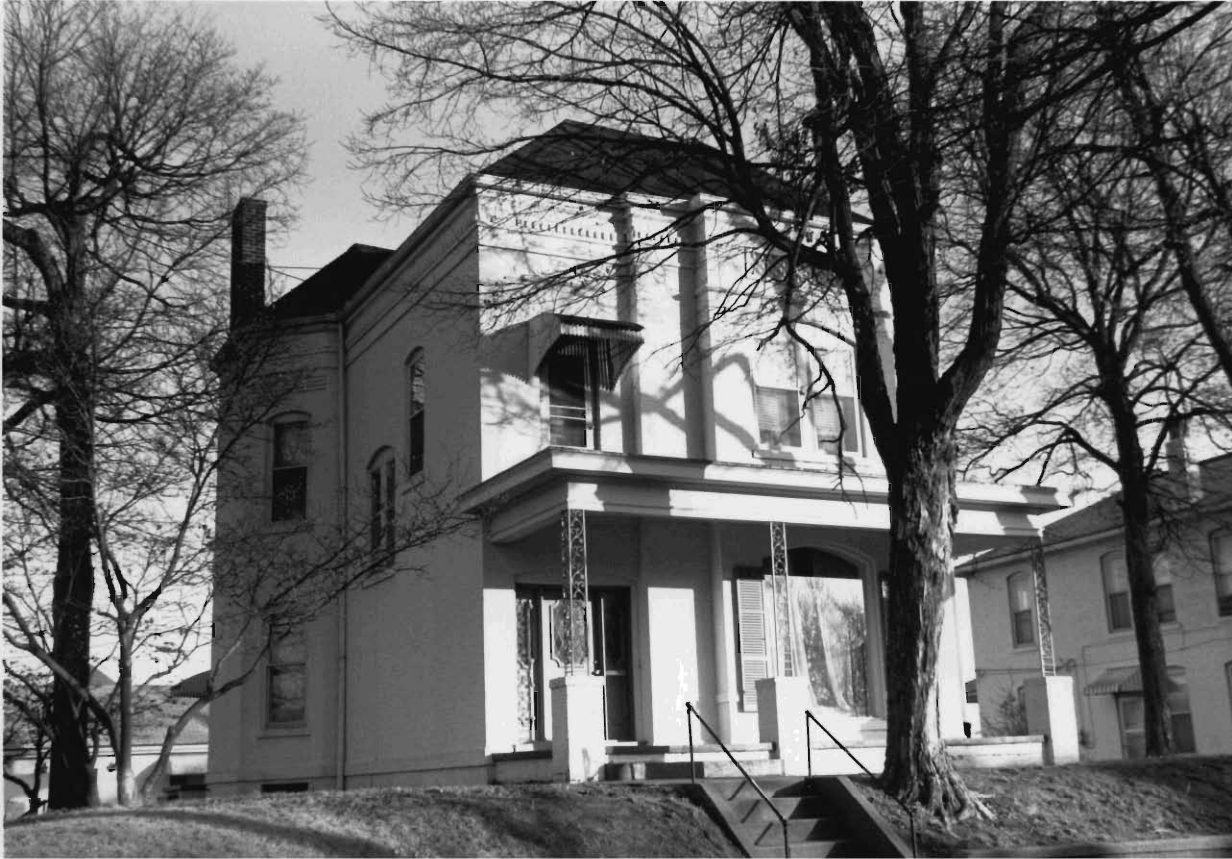
Brick painted ivory. Left bay modern entrance group of door with sidelights under a double rowlock segmental brick arch. Two slightly projecting pier-like features are to the right of the entrance before an enormous fixed segmentally arched sash, probably a replacement, with a tall soldier course segmental arch cut off by a low hip roof porch, probably an early 20th century alteration. Full-facade porch has modern iron supports on brick pedestals with rock-faced stone trim; no balustrade. A second floor door above that on first; no balustrade on top of porch roof though. A brick segmental arch can be seen beneath the aluminum awning; a projecting drip cap (stone?) is substantially above the door. A 1/1 sash pair is under a tall soldier course segmental brick arch as below on first floor. Sawtooth header brick panel above this pair, with stone beltcourse on this projecting section only. A denticulated cornice surrounds house except on this projection. Also a raised stretcher beltcourse at the cornice base.

The building retains a moderate degree of integrity with porch, door, and fenestration alterations. The building is a significant representation of Italianate influenced residential architecture.

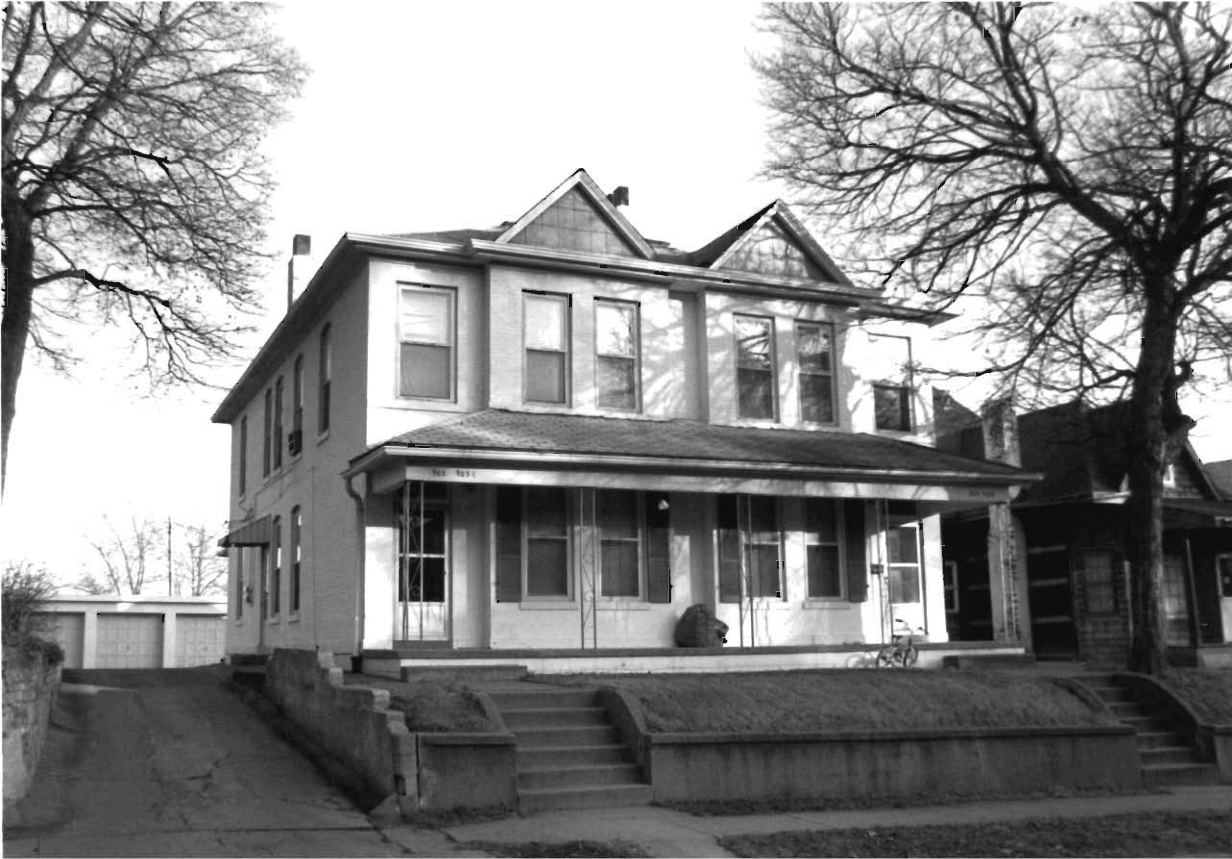
Despite the modern porch alterations, the building maintains a high degree of integrity, and is a significant representation of the Queen Anne stylistic influence used on multi-family buildings.

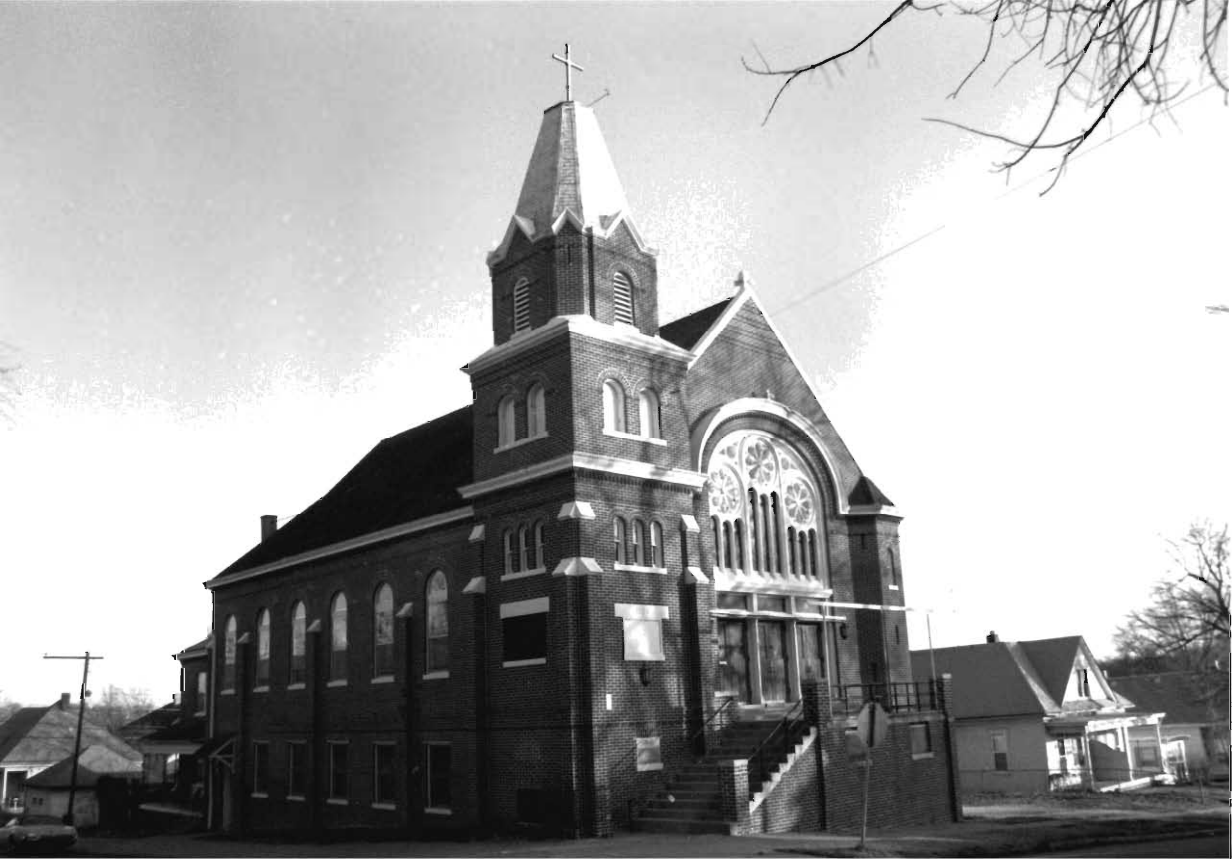
A concrete staircase, with stairs facing north and south, faced in brick with brick piers and posts, rises to a terrace at the entrance bay on the main (west) facade. Three sets of original doors with extensively stained and leaded lights with identical transoms above. Group of triple rosette windows on sets of three round arched windows, all matching the doors and transoms below, separated by delicate Ionic columnettes. Denticulated segmental arch above under continuous projecting (metal?) cornice. Three raised stretcher belt courses in gable peak above with large foliated finial. Third facade bay is to the right of the raised terrace. A semi-hexagonal roof aligns with the right gable edge over this lower semi-hexagonal bay extending to nearly fully exposed basement here. A single 1/1 round arched double rowlock window is in the upper level of this bay.

Detailing on the north elevation is similar to that of the main facade, as it is also street facing. "Buttresses" are at corners of the bell tower, and divide the rest of the elevation into 4 bays. Single stained rectangular sash with round arched transoms in first bay (east) with entrance below at exposed basement level; steep shed cover. Other bays are identical with two stained glass windows and two basement 1/1 windows with soldier flat arches. Stone lug sills.

The building retains a high degree of integrity despite sandblasting and improper repointing. It is an outstanding neighborhood church building and is significant as an excellent example of Late Gothic Revival architecture.

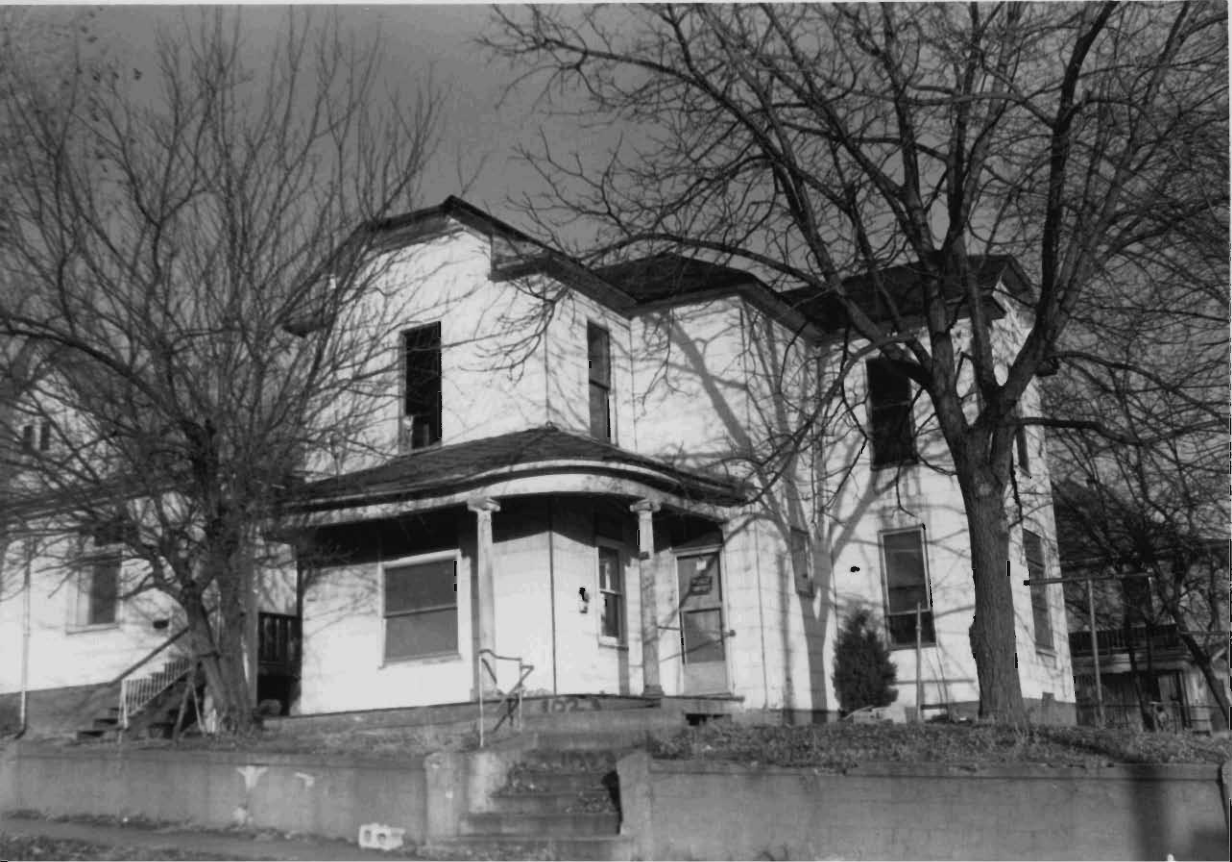
Exterior condition: Poor Endangered/by what?: Yes/Poor maintenance

The building retains a high degree of integrity, but it is currently endangered by vacancy and lack of maintenance. The building is a significant representation of Queen Anne influenced architecture.

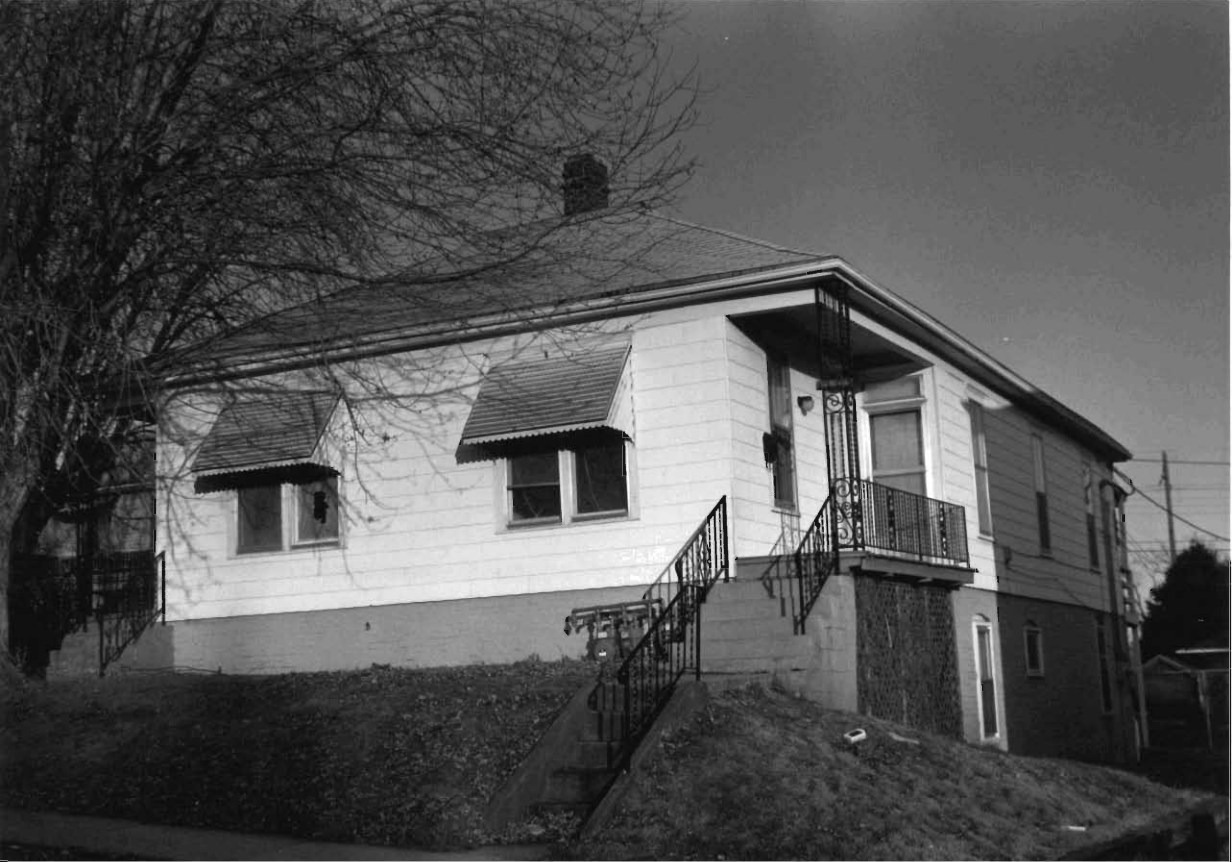
The building retains a moderate to low degree of integrity, with artificial siding, iron porch trim, and aluminum awnings altering the building's historic appearance. The building, therefore, retains only minimal significance as representing a late 19th century vernacular duplex building type.

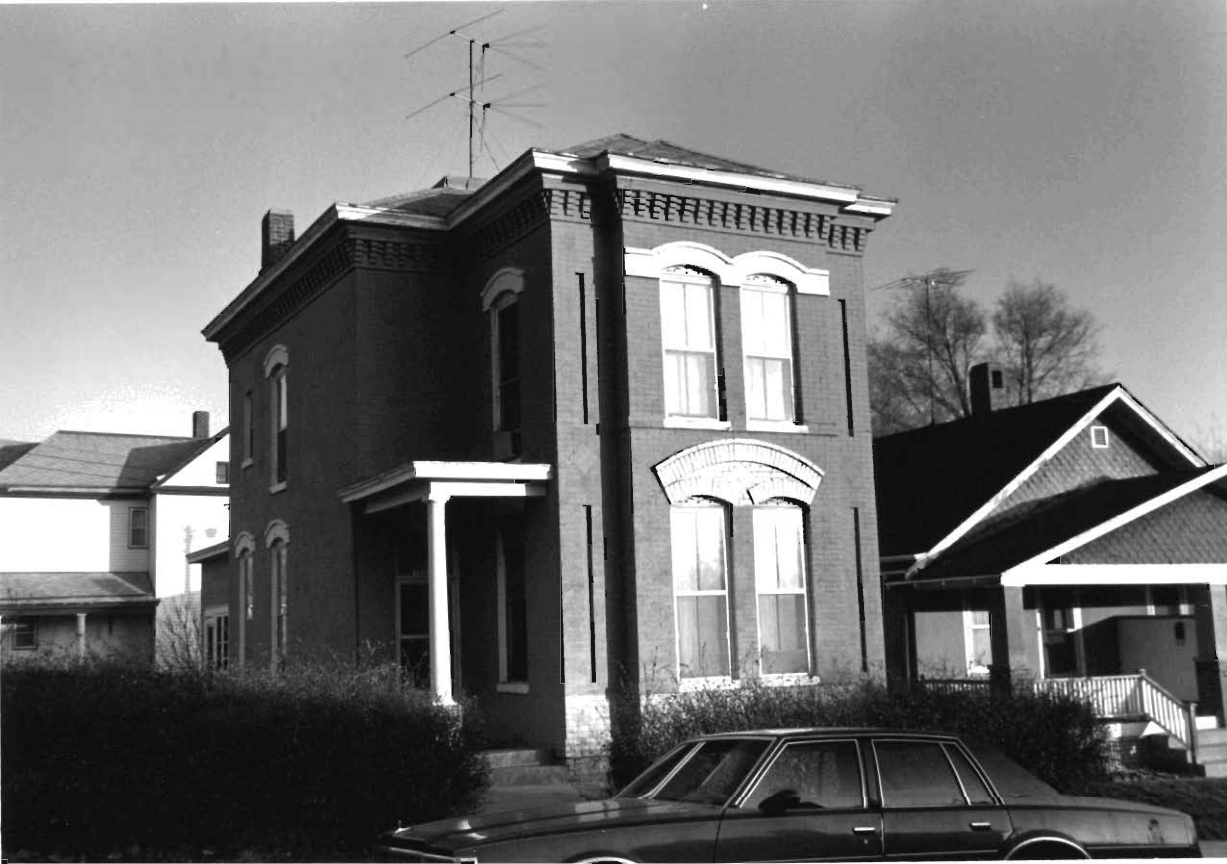
Left bay entrance with tall transom, incised window head, and soldier course segmental brick arch. Small hipped roof porch in this front reentrant angle: Doric columns on low concrete pedestals (replacements), and a poured concrete floor; one step up to access. Slight hip projection off front of "T" with pair 1/1 double hung sash first floor, each with soldier course segmental arches, then stretchers with a central diamond form, with a soldier course segmental arch with raised header trim to group this window pair. Raised stretcher beltcourse continuous from stone still. Trim at windows painted white. A similar window pair is above without taller segmental arch to group. Tall, thin rectangular incisions on first and second floor facade (west) on either side of this projection in main "T;" diamond pattern in brick between first and second floor incisions or recessed panels. Header "brackets" of four corbels, with raised stretcher beltcourse at base. Secondary double header rows between these "brackets." North elevation at Penn has same fenestration treatment as main facade (soldier segmental arches, header trim, and incised window heads). Rear reentrant with flat roof porch enclosed: north elevation door and four petite 1/1 (fixed; storm sash) and two toward the rear (east). Brick watertable of three stretcher courses. Continuous cornice.

One of the more finely detailed properties in this survey area. Retains a high degree of integrity, and is significant as an excellent example of Italianate influenced architecture surviving with its intact summer kitchen.

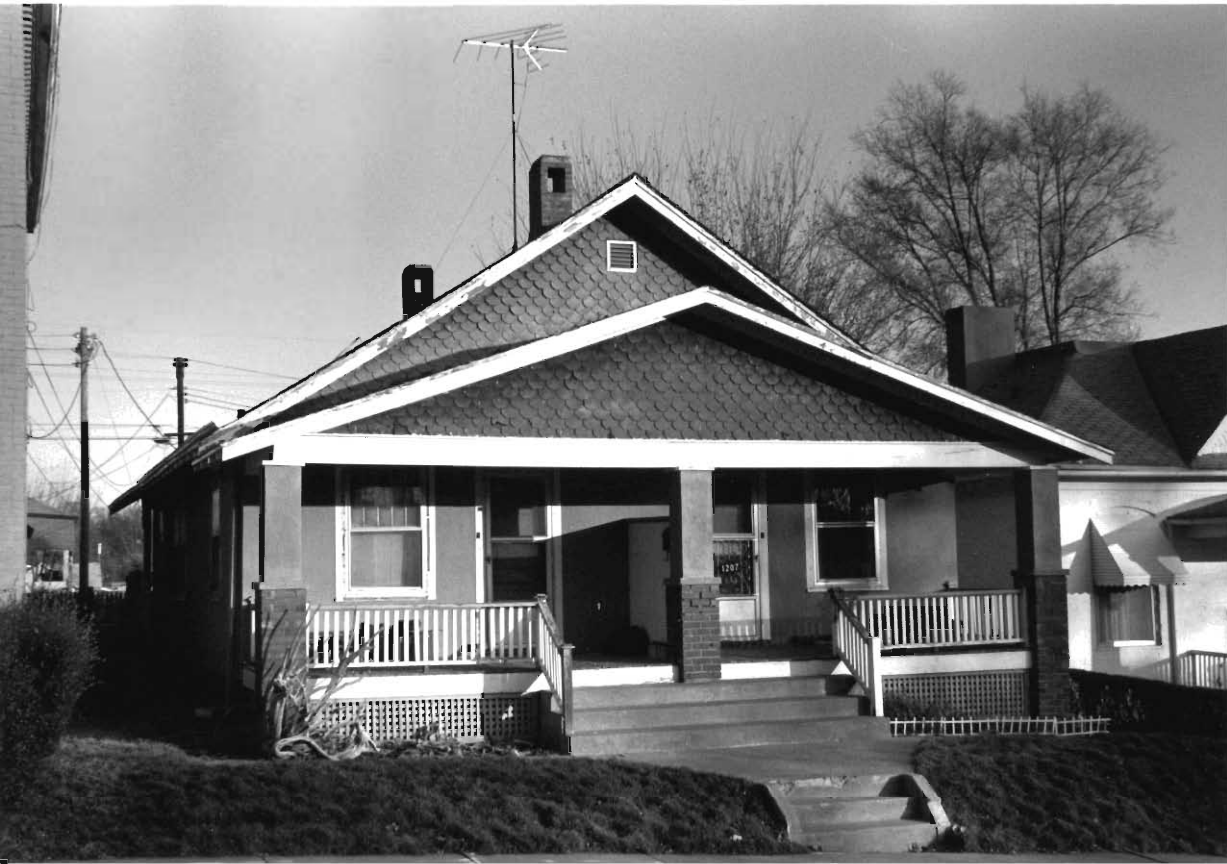
This building meets the property type definition for Popular Style Houses (Bungalow sub-type), as defined in the Multiple Property Documentation form "Historic Resources of St. Joseph, Buchanan County, Missouri." The building retains a high degree of integrity, and is significant as a representation of the Bungalow house type.

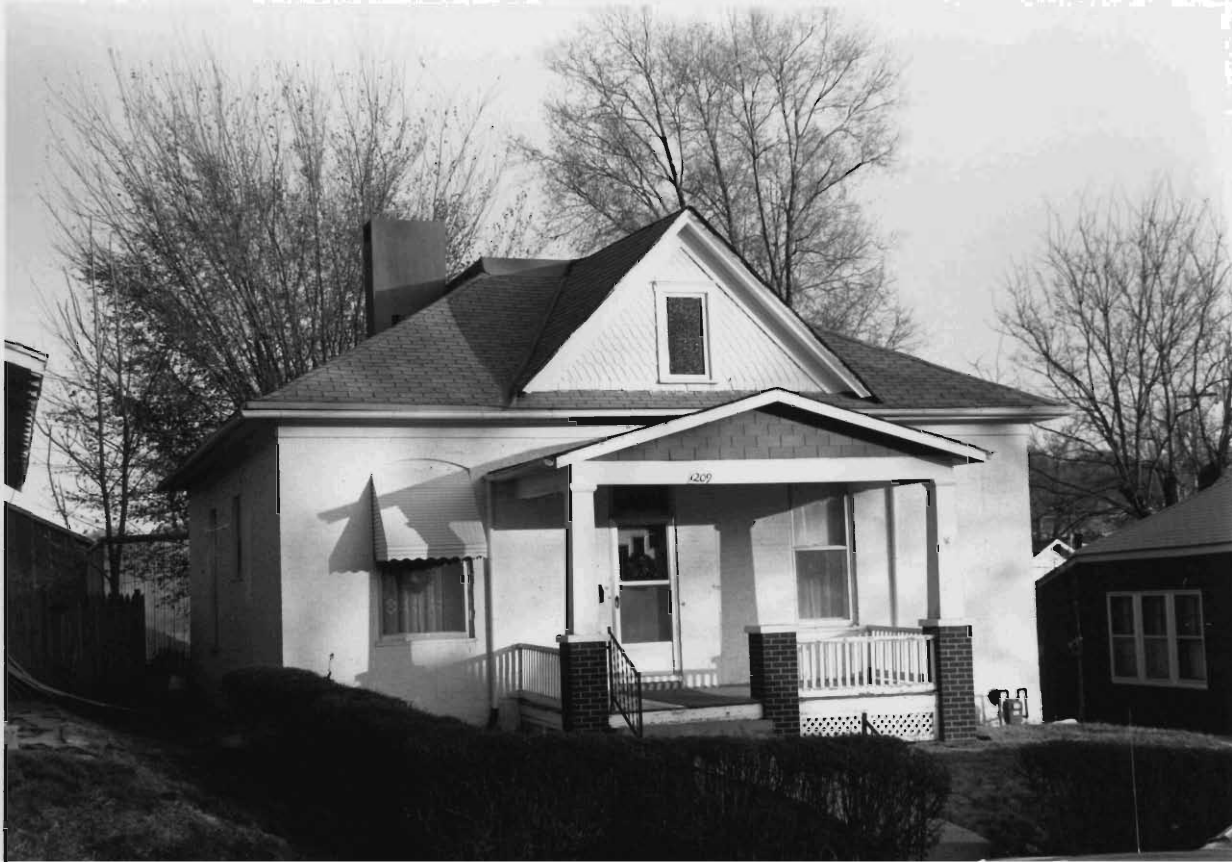
A modern replacement door is off-center to the left (north) with transom. 1/1 double hung sash to the right (south) under a central low gabled roof front porch: exposed rafters, smooth cornice, and tapered wood posts on brick pedestals with stone caps on this early 20th century porch. Large 1/1 sash with single rowlock segmental brick arch is to the left (north) outside of the porch; same to the right of the porch, as evidenced by the header course, but is now blocked; recession of original window or door pattern not maintained. Steep gable roof dormer with central fixed sash and fish scale, tear drop, and sawtooth shingles. Masonry chimney (concrete now) to left of truncated hip roof, rear. A second brick chimney is toward the rear/south.

The building retains a high degree of integrity, and is a significant representation of the Pyramid Cottage house type.

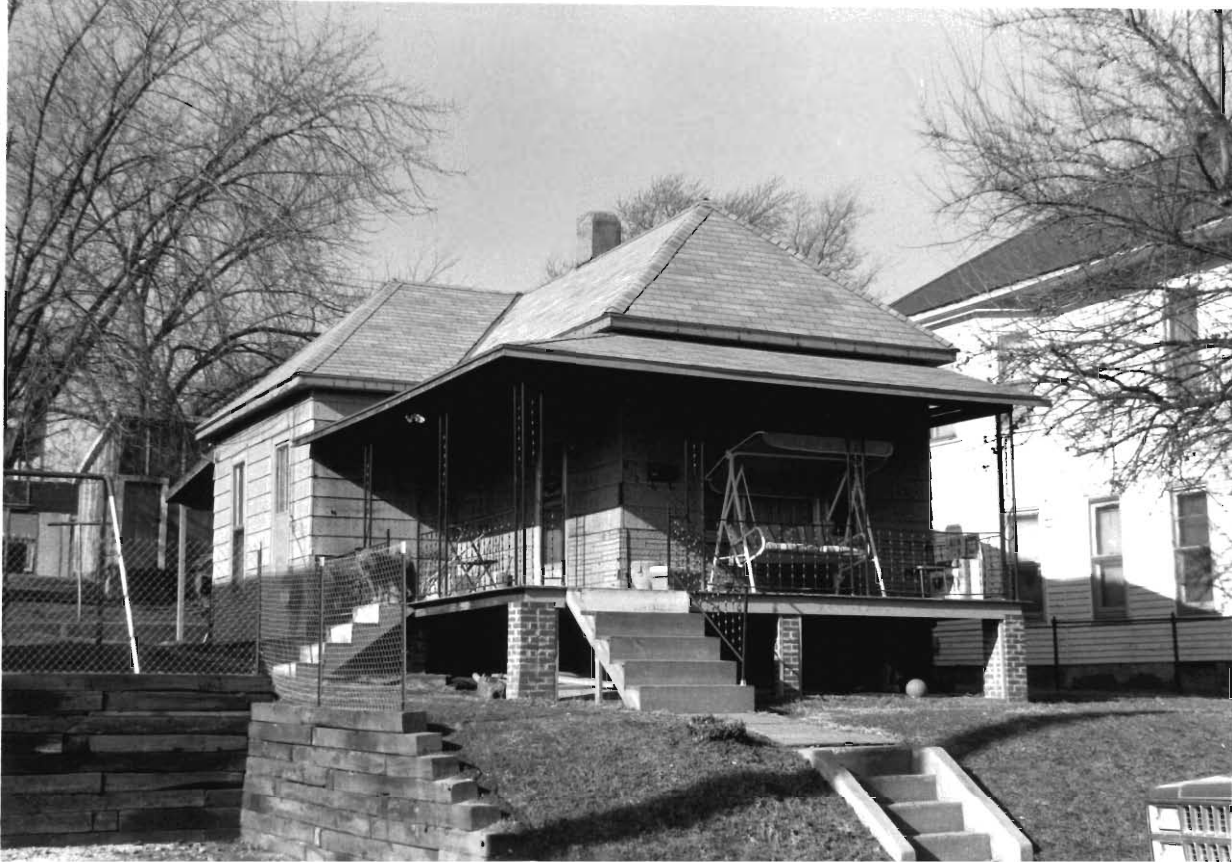
Entrance faces left (south) in front hip projection. Low hipped roof porch extends just out from under main hip on facade to wrap left (south). Modern iron replacement posts and railing. Steps from front and side (south). Front window group of fixed sash framed by narrow 1/1 double hung sash. Rear shed porch wing. Masonry chimney off center to the front on ridge.

The building retains a low degree of integrity, given modern alterations and siding. The building is only a marginal reflection of the original vernacular house type.

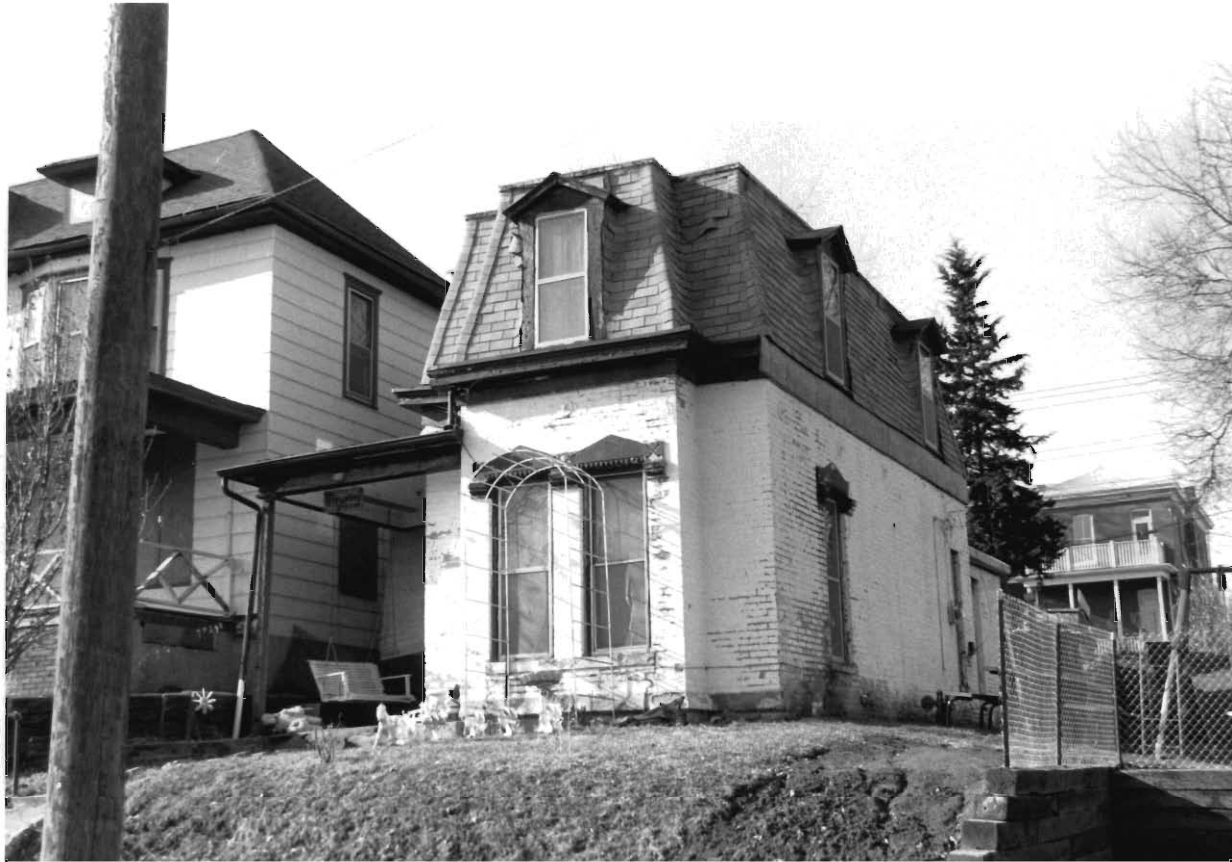
Left bay recessed and 1/1 double hung sash faces south under low hipped roof porch with concrete stoop and simple wood post. Projecting front with two 1/1 sash. Pedimented stone lintels with molded drops and sawtooth pattern. Smooth cornice. Projecting stone watertable. Gable roof dormers: one front and two side elevations. Star iron end braces front between two windows and above. Star end rods to north side also. Lower one story rear wing. Modern board covers substantially decayed cornice at gutter at base of the Mansard on the north elevation.

The building retains a fairly high degree of integrity clouded by lack of maintenance. It is significant as an excellent example of French Second Empire style used for a small dwelling.
