Architectural/Historic Inventory Survey Form

St. Joseph PENN Survey

Address: 603 South 14th Street Roll/Frame: 5/29, 9/19

Prepared by: The URBANA Group (Gallagher) Date: 12/91

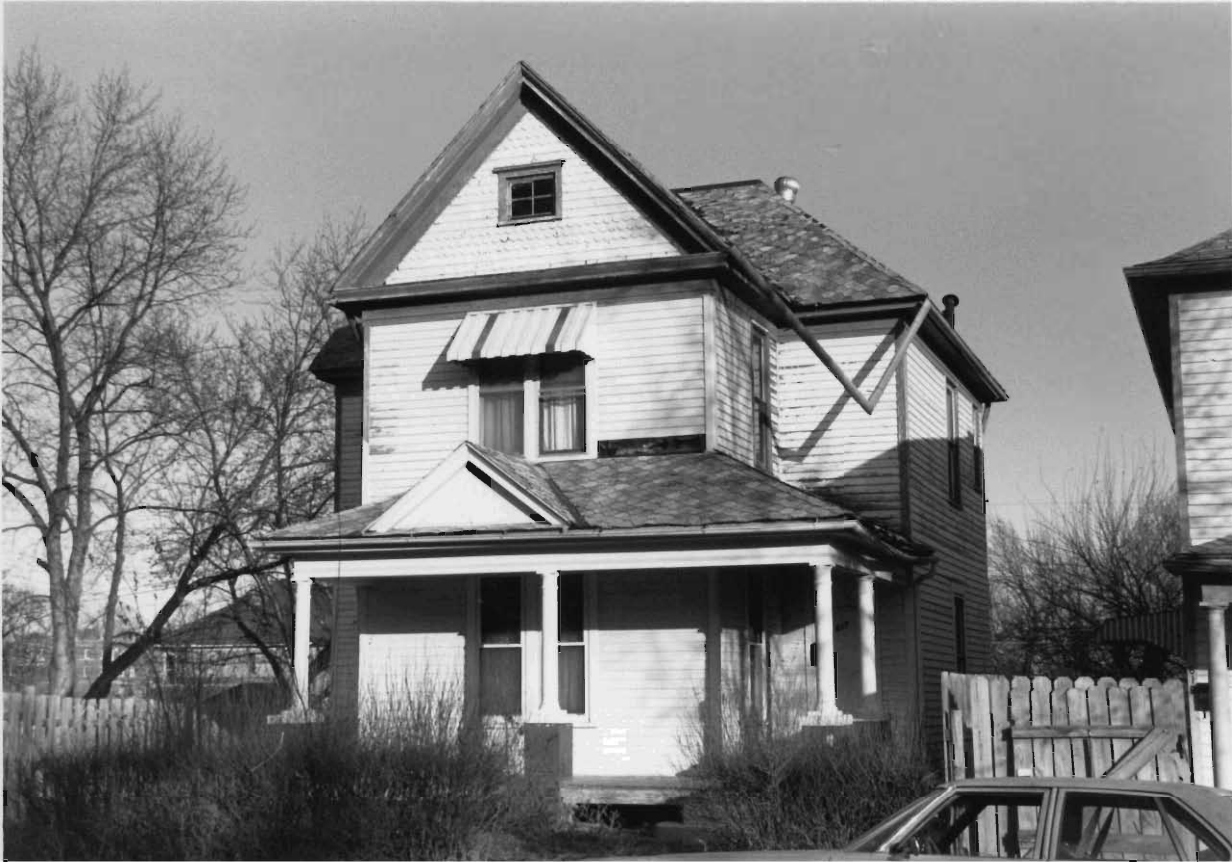
The building retains a fairly high degree of integrity, and is a good example of a slightly Queen Anne influenced turn of the century vernacular residence.

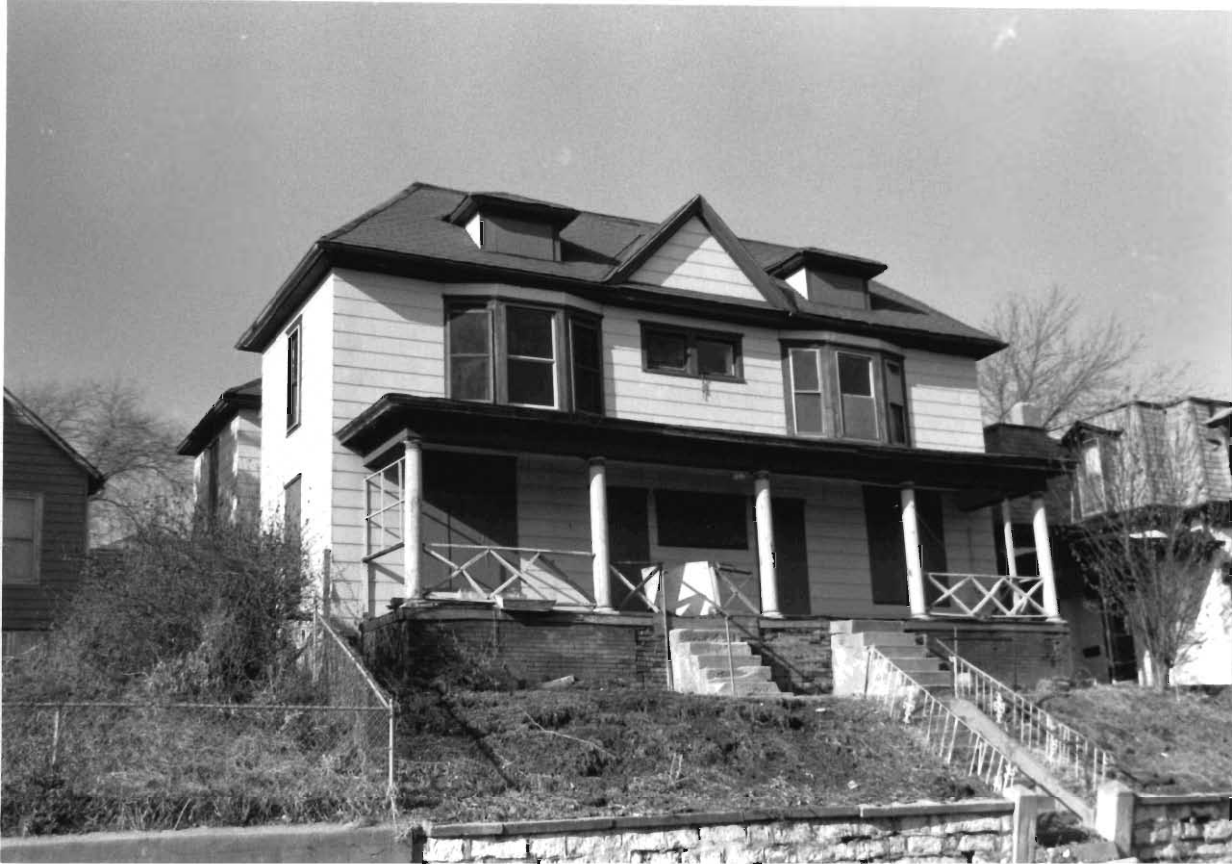
810-AC-008-091

While no historic district can be justified here, the demolition of this fine duplex would be a great loss to the neighborhood. The north/middle sections of this block, on either side of the street, have already suffered demolitions; further destruction will adversely effect the neighborhood cohesiveness which remains. Additionally, the building is a fine example of a turn of the century vernacular duplex and retains a fairly high degree of integrity.

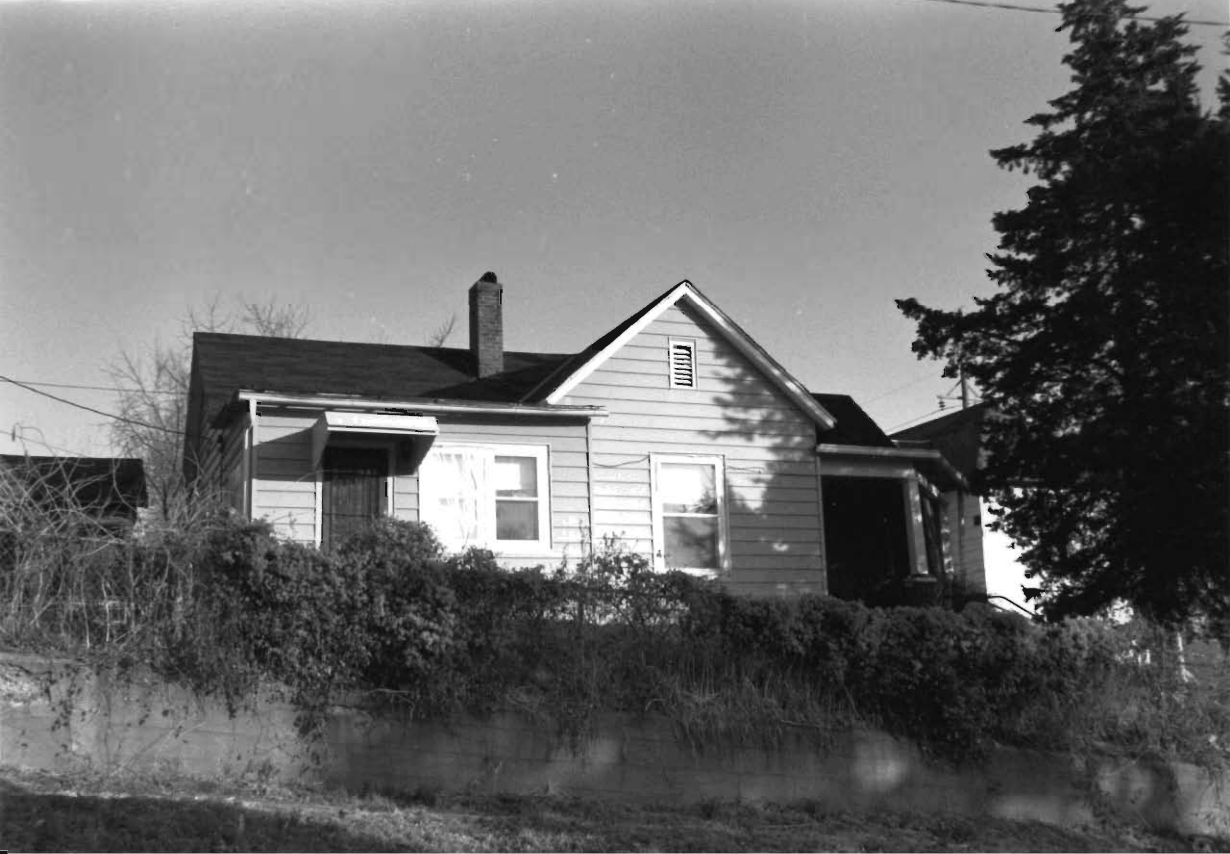
BL 45006 493

Description of Environment and Outbuildings: Frame, gable front garage accessible from the alley to the west. Vertical wood (at stud spacing) and asphalt wall treatment. Poor condition. House set on hill, with large setback from S. 15th St.; house appears more oriented to Locust St. A concrete retaining wall (incised with an elongated concrete block pattern) frames the property (1915).

The building retains a moderate degree of integrity, and is an example of a late 19th century vernacular house type.

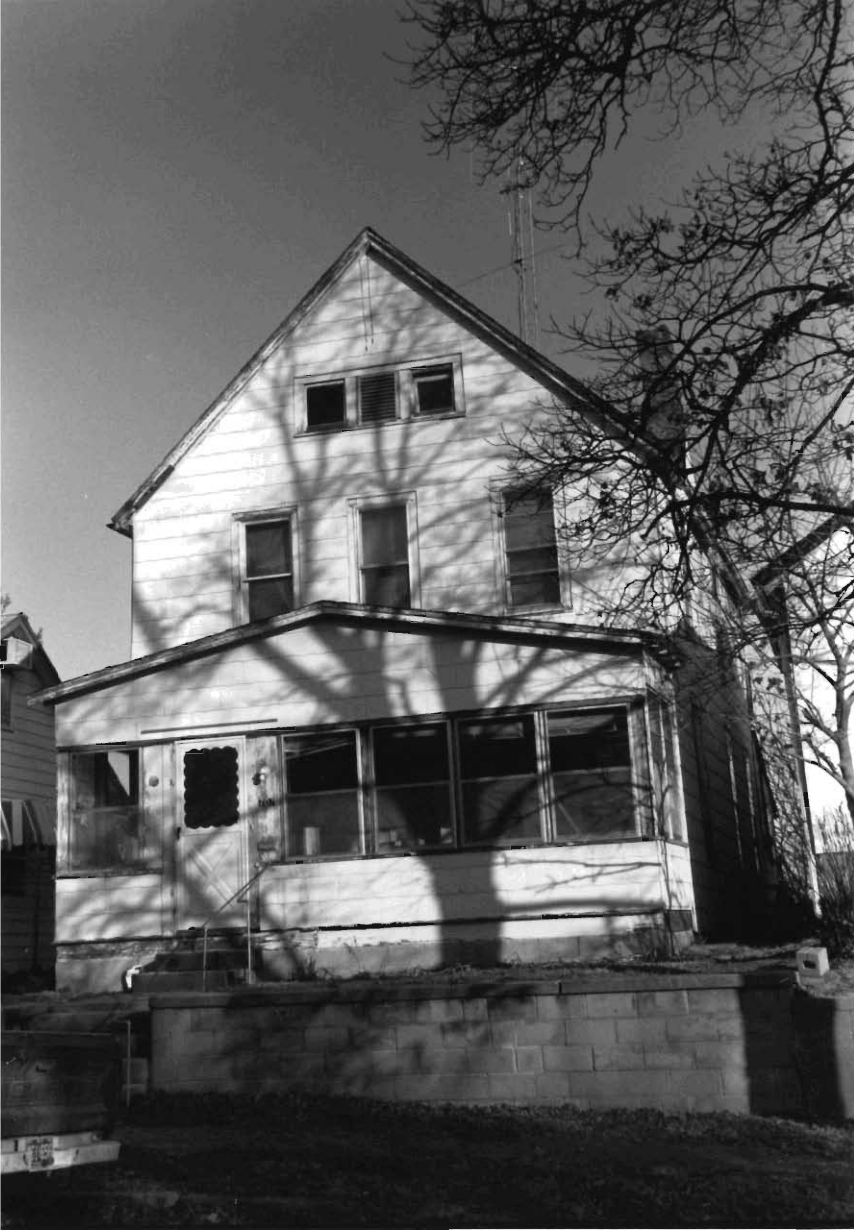
Enclosed low pitched gable front porch with door to left of center. Door on north elevation of building in hipped roof extension. Pediment drip molds above windows on second floor of front facade. Two stained glass windows on north side of building. Vent between two square windows in gable front. Interior end chimney at right of front facade. Shed roof wing at rear.

The building retains a moderate degree of integrity, and is a fair example of the Open Gable building type.

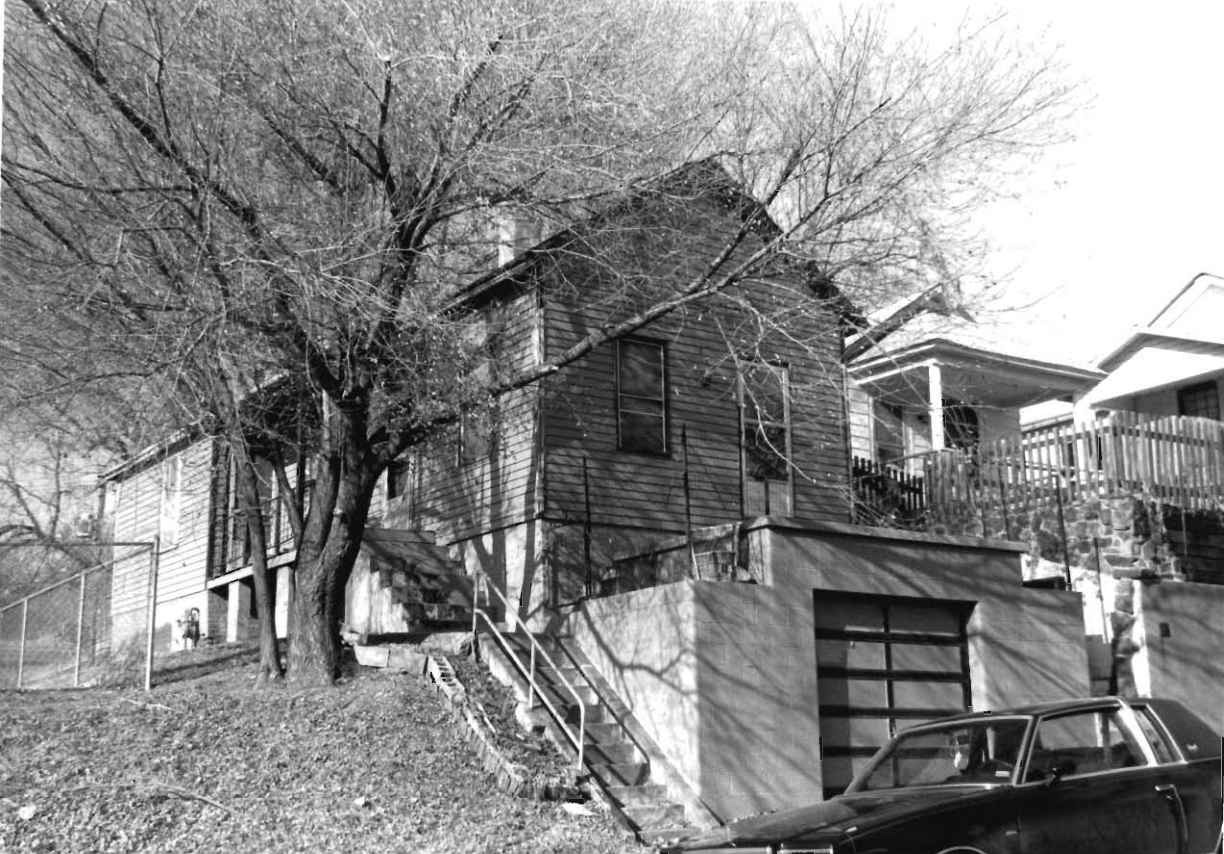
On gable front facing S. 15th, right bay door has missing step; left bay 1/1 double hung sash; no porch, presumably missing. Three sections to the rear, including a recessed section immediately to the back of the front block. Porch to south at recessed section, covered by main gable. Doors face south and front (east) on the south elevation. Simple wood posts; modern iron railing; wood porch floor. Exposed porch base with brick piers, painted.

The building retains a moderate degree of integrity, and is a good example of an early 20th century vernacular residential building type.

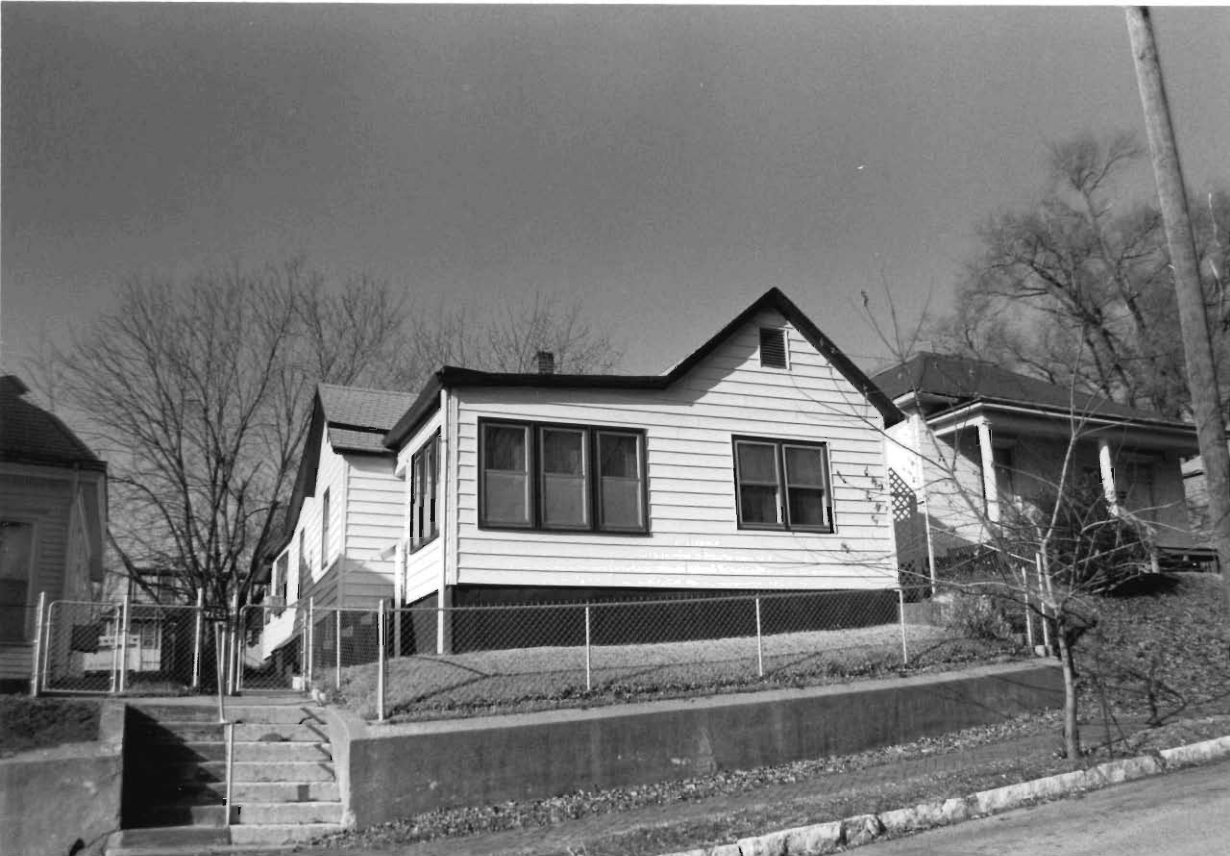
Maintenance of artificial siding (white) and painted trim (rust/brick color: "cornice," foundation, and window trim) has in effect altered this house.

The building retains a low degree of integrity and, therefore, reflects only minimally its original historic fabric and form.

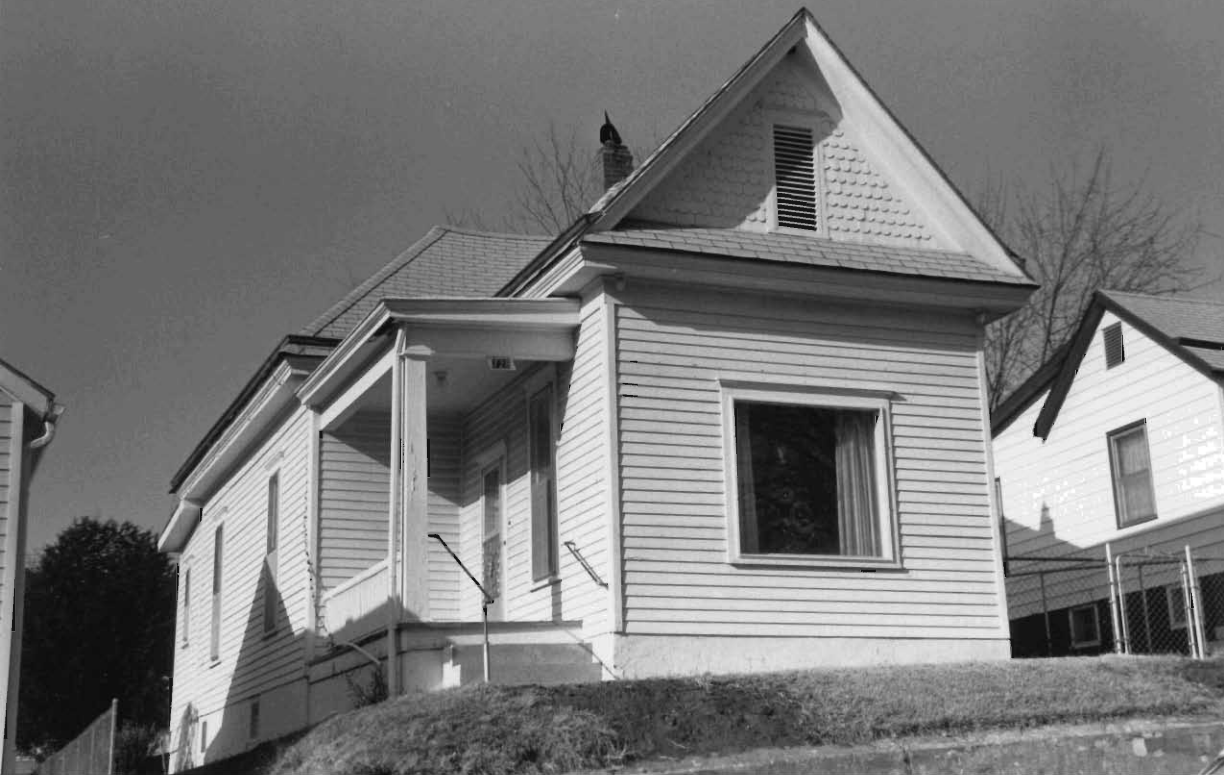
6N-15-008-055

Gable front T-bar to front, with broad fixed sash and full gable return. Fish scale shingles. Large attic vent in center of gable. Entrance faces south to left of gable with adjacent 1/1 double hung sash under shed roof porch with smooth cornice, wood post, wood slat balustrade, and poured concrete steps painted gray. Foundation faced with concrete and painted white. Gable front blind on north, with 1/1 in main hipped roof block facing front (east). Lower rear shed glassed in porch with multi-light windows.

A superbly maintained house with a high degree of integrity. Stands out as one of the best maintained houses in this survey area, certainly a shining star on both sides of the 700 block of S. 15th St. The building is a significant example of a late 19th century vernacular domestic building type.

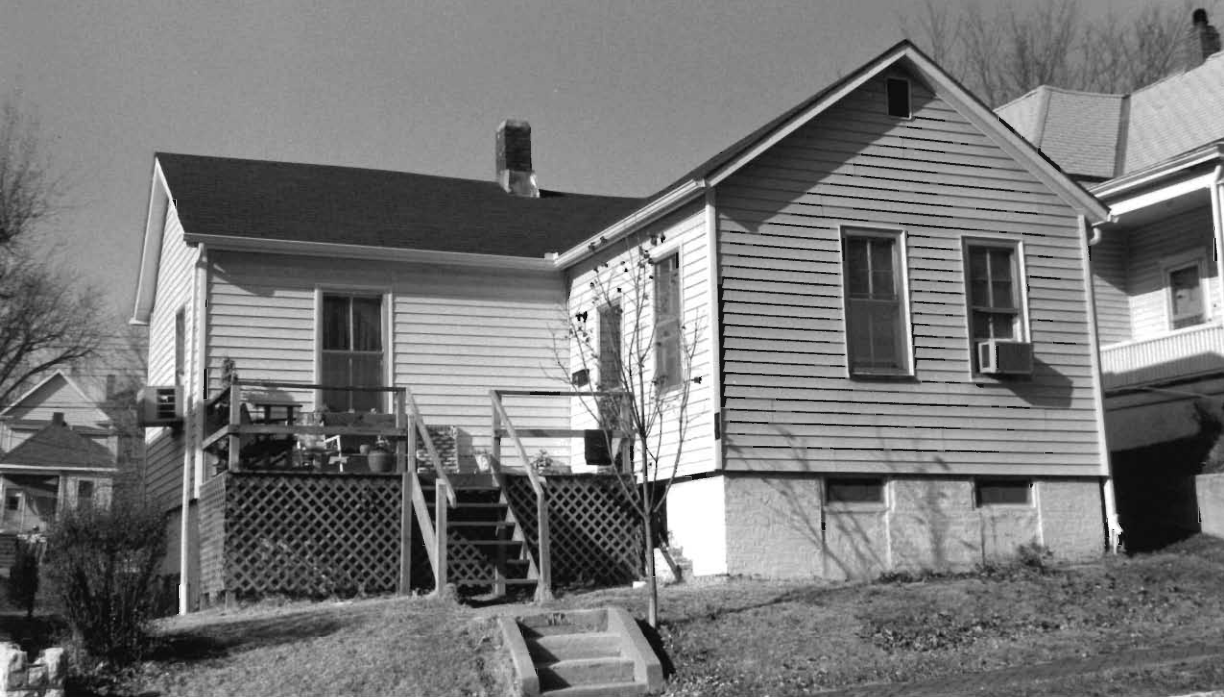
Probably 726 South 15th St. and this house were the same originally, but both have been altered. Entrance faces side (south) in right gable front with 4/4 double hung sash to right (front/east). 2/2 sash faces front in left bay. Two 4/4 sash in gable front. Porch altered as modern deck with wood open railing, lattice face, and no roof. Foundation painted white, remaining brick (not faced with concrete). Brick chimney off-center to the left. Small rear deck.

The building retains a moderate degree of integrity, and is a moderate example of the Gabled Ell building type.

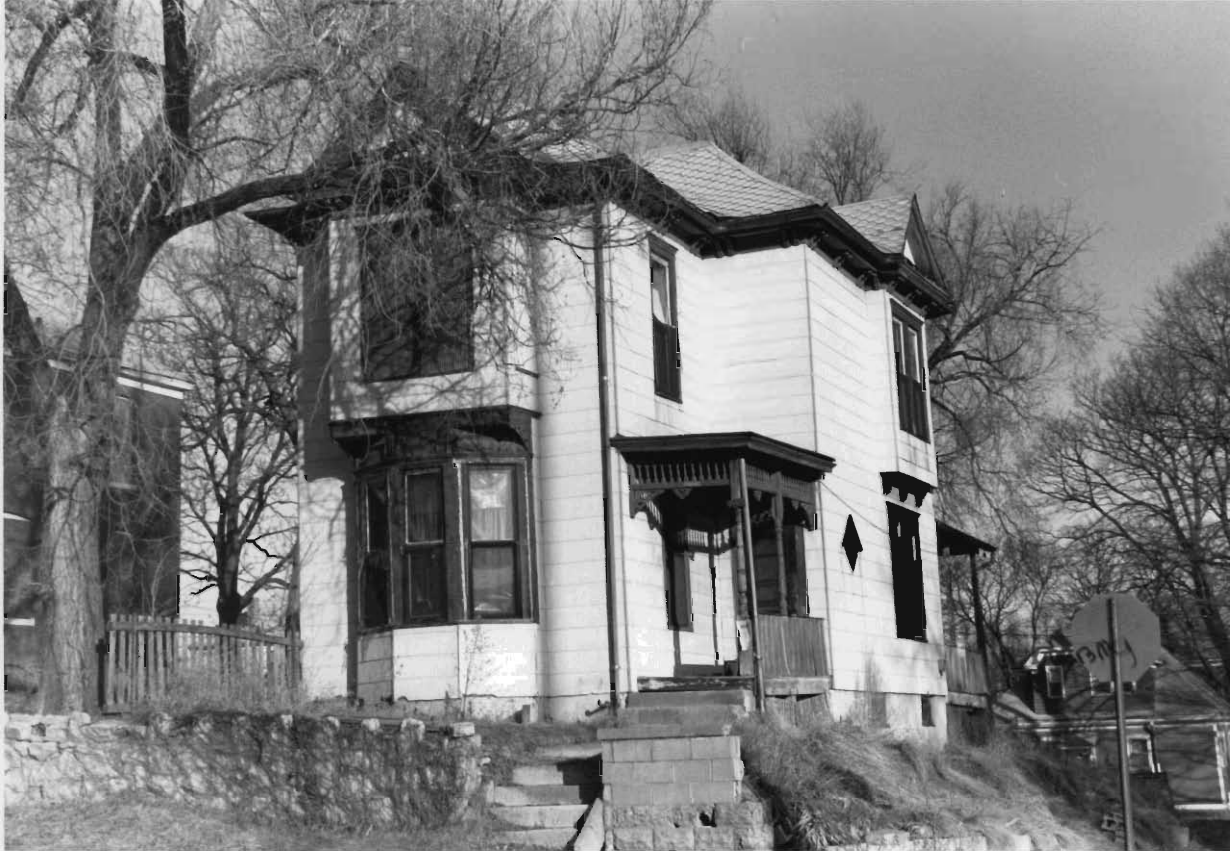
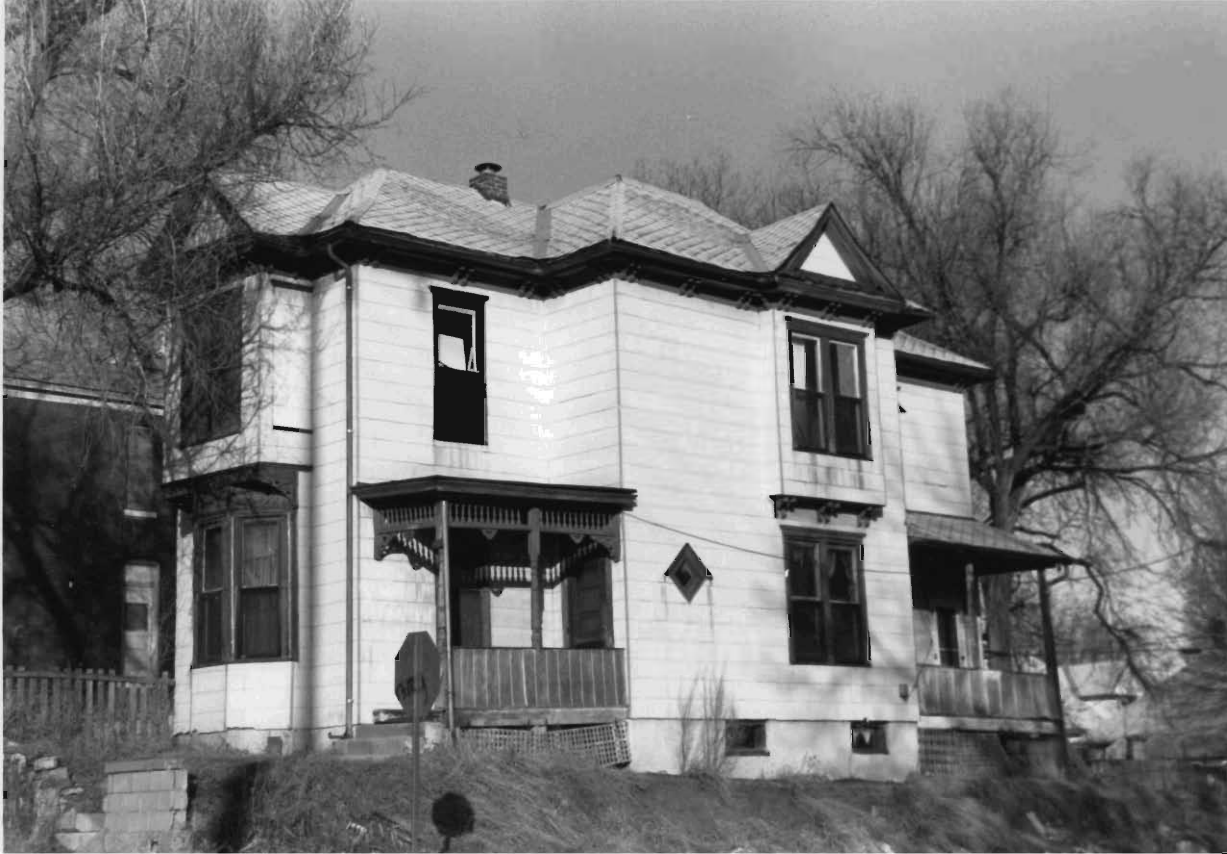
BN 45-608-058

Description of Environment and Outbuildings: Old wood picket fence on the north side. A crenelated random rock-faced stone wall is to the left (north) of the stairs, which are located toward the south of the front edge of the lot. The retaining wall to the right of the stairs at the southwest corner of the property was "repaired" with concrete block, and has further deteriorated. The wall wraps the property to the Patee St. (south) side. The shallow rear lot has a rubble-like retaining wall of concrete and limestone; decaying. Rear brick retaining wall. Appears that a house was once on Patee at the rear of this property, just west of the alley.

Retains a high degree of integrity and appears to be in fairly good condition structurally. Exhibits fine detailing and architectural elements. The middle of this block already suffers from demolitions. Demolition of this prominent corner building would be a great loss to the neighborhood. Part of an exceptional pair, with a finely detailed brick house also an Adolph Ehlers house to the north (727 s. 15th St.), also vacant. The building is a significant example of Italianate and Eastlake stylistic influences on vernacular domestic building types.

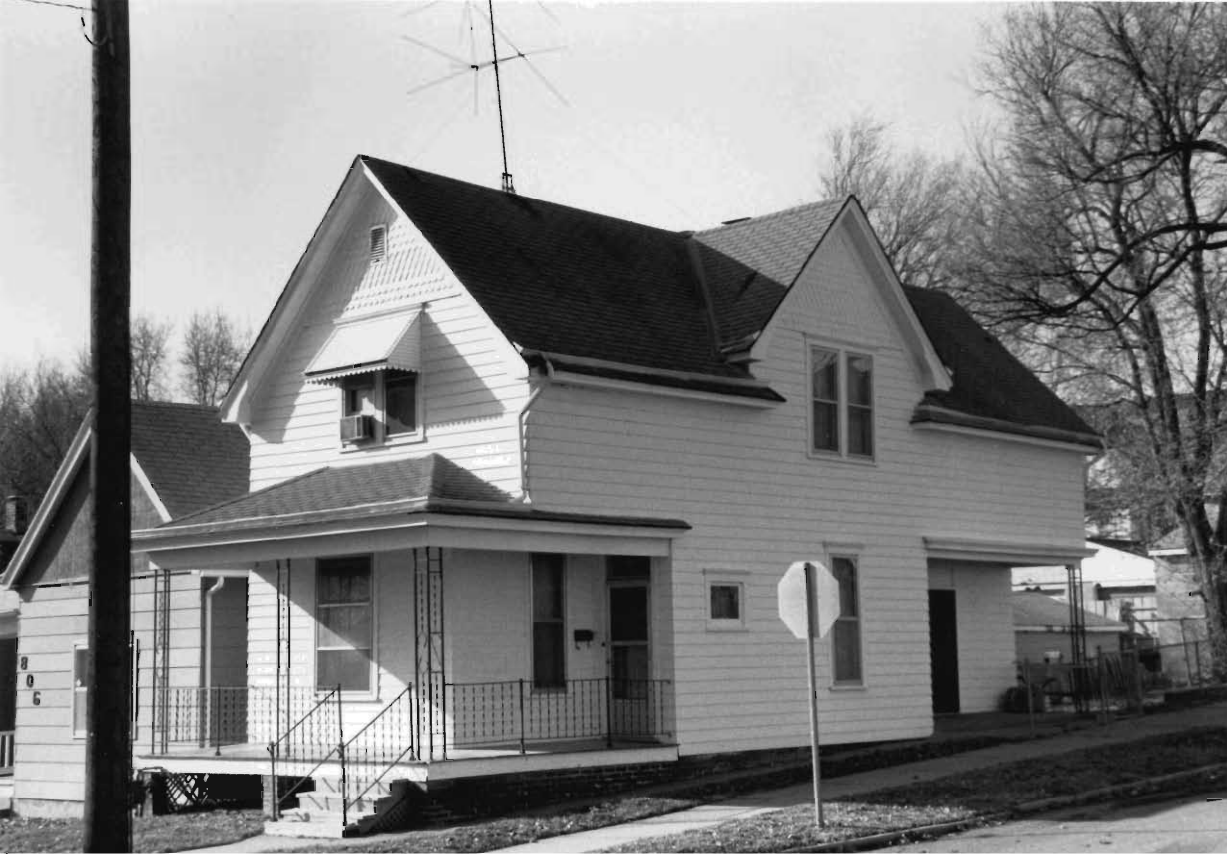
Gable front with entrance bay cut into right bay; door with transom. Fixed wide sash left with stained glass transom. Pair of narrow 1/1 double hung sash above on second floor. Several varieties of sawn shingles in gable peak; small vent. Small fixed entry window, leaded, faces north. Side gable with identical shingle treatment and pair 1/1 faces north. Secondary side entrance in recessed rear/north section, like that on front. Petite hipped roof wing, c. 6', with equally petite adjacent shed attachment.

The building retains a moderate degree of integrity with artificial siding and porch alterations. It remains, however, a moderate example of an early 20th century vernacular building type.

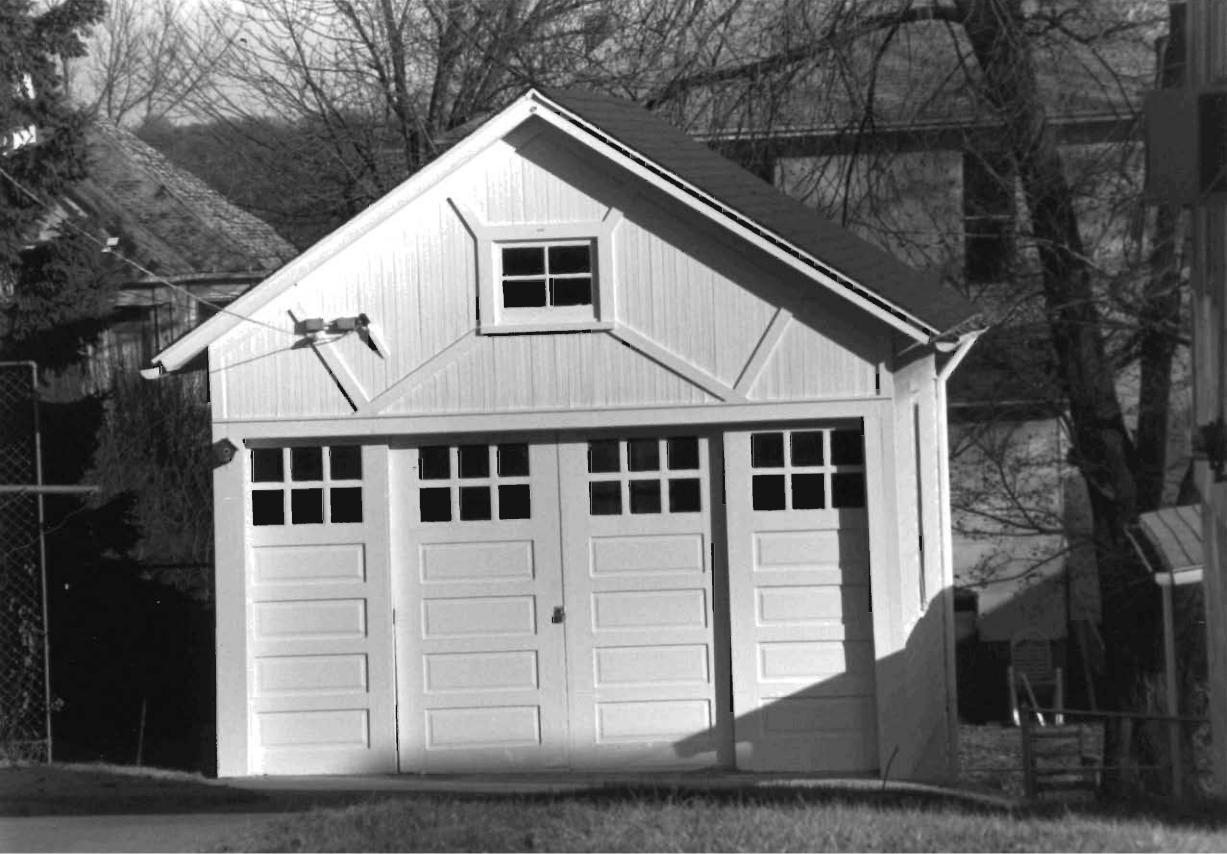
City directories indicate that James H. Welsh lived here in 1900, and at least through 1906. L.E. Wide lived here in 1926.

One of a series of similar dwellings along this block. Retains a fairly high degree of integrity, and is a good example of the Gabled Ell house type.

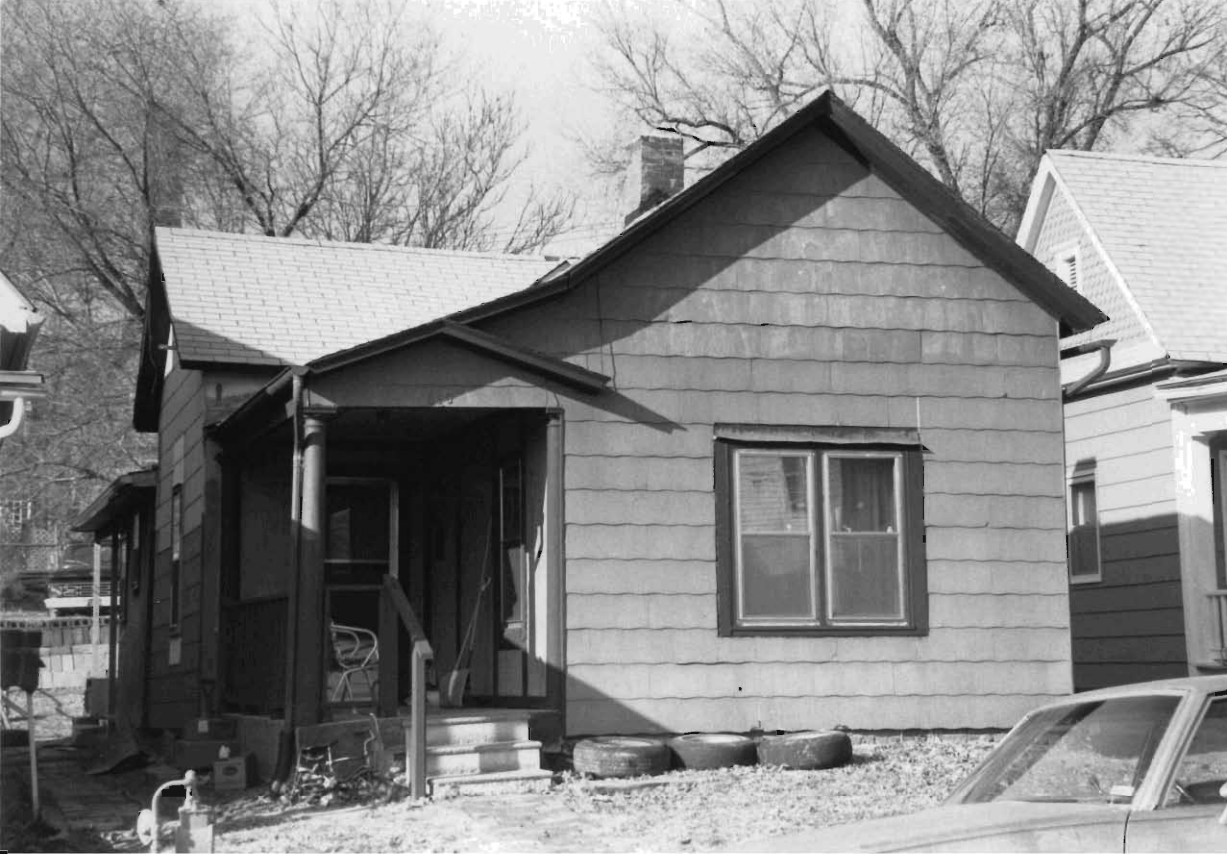
BN-AS-008-064

City directories indicate that Mrs. Wennie McKown lived here in 1900. David E. Nesser lived here in 1906. In 1926, W.T. Bohannon is listed as the occupant.

One of several Gabled Ell buildings on this block. Retains a moderate degree of integrity and is a moderate example of the Gabled Ell house type.

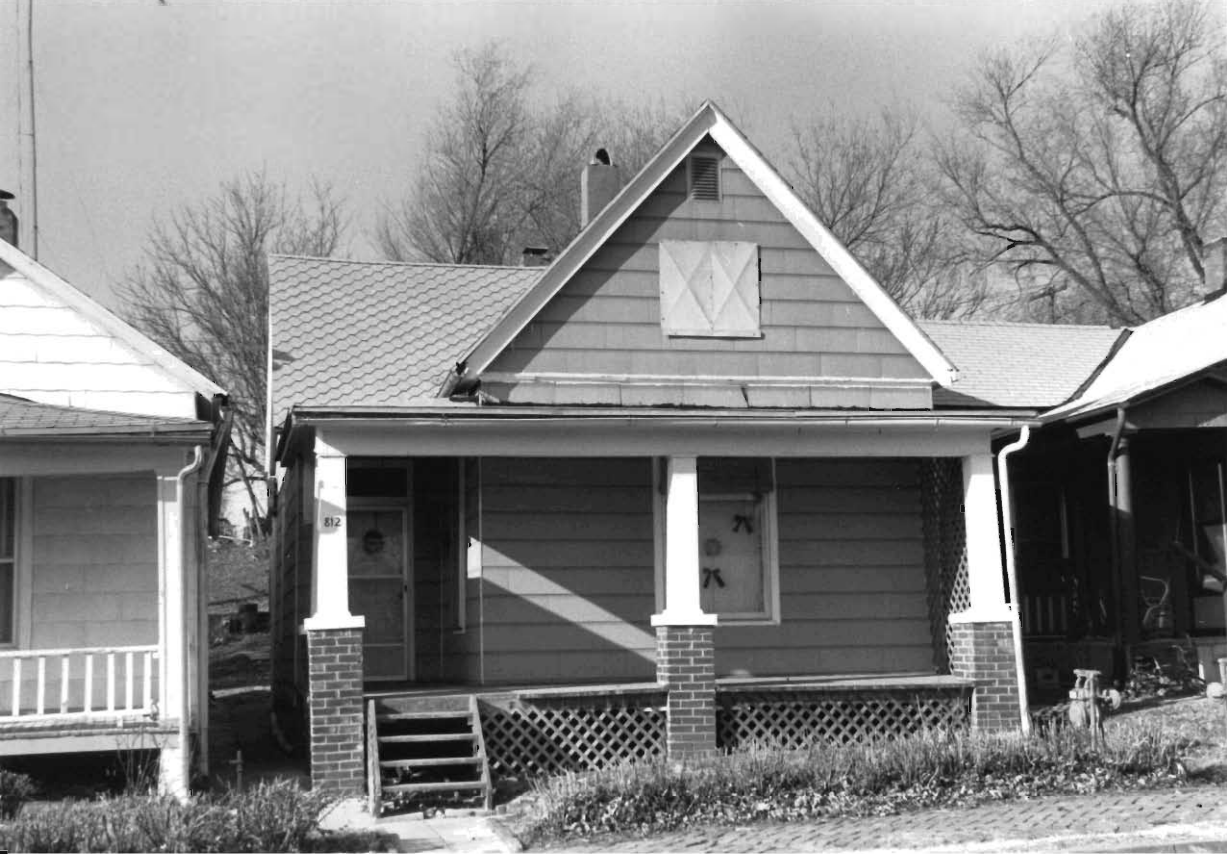
BN-AS-008-065

City directories indicate that David J. Mulholland was the occupant in 1900. The house was listed as vacant in 1906. J.J. Collins lived here in 1926.

One of a series of Gabled Ell house types on this block. Retains a high degree of integrity and is a good example of the Gabled Ell building type.

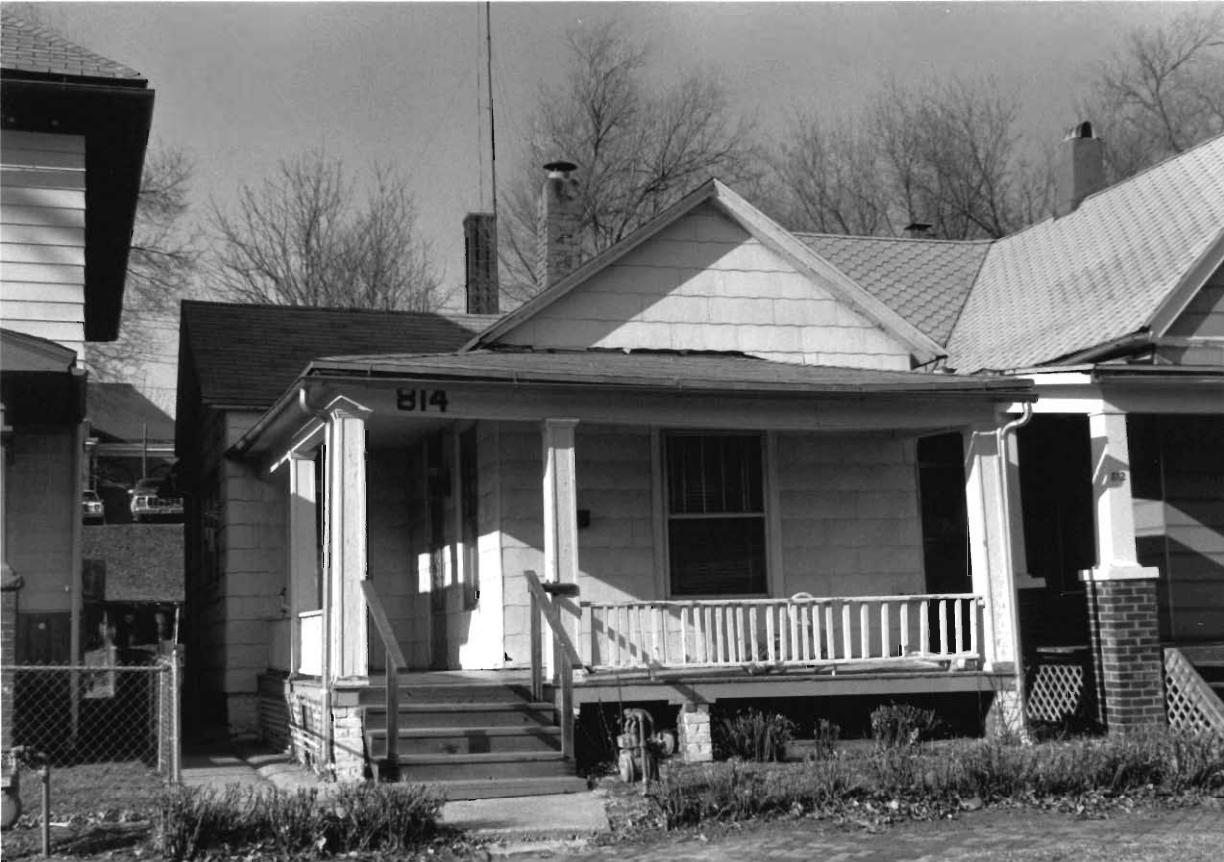
BU 45-008-066

City directories list H. Shroyer as the occupant of the house in 1926.

The building retains a moderate degree of integrity, and is a good example of the Pyramidal Cottage building type.

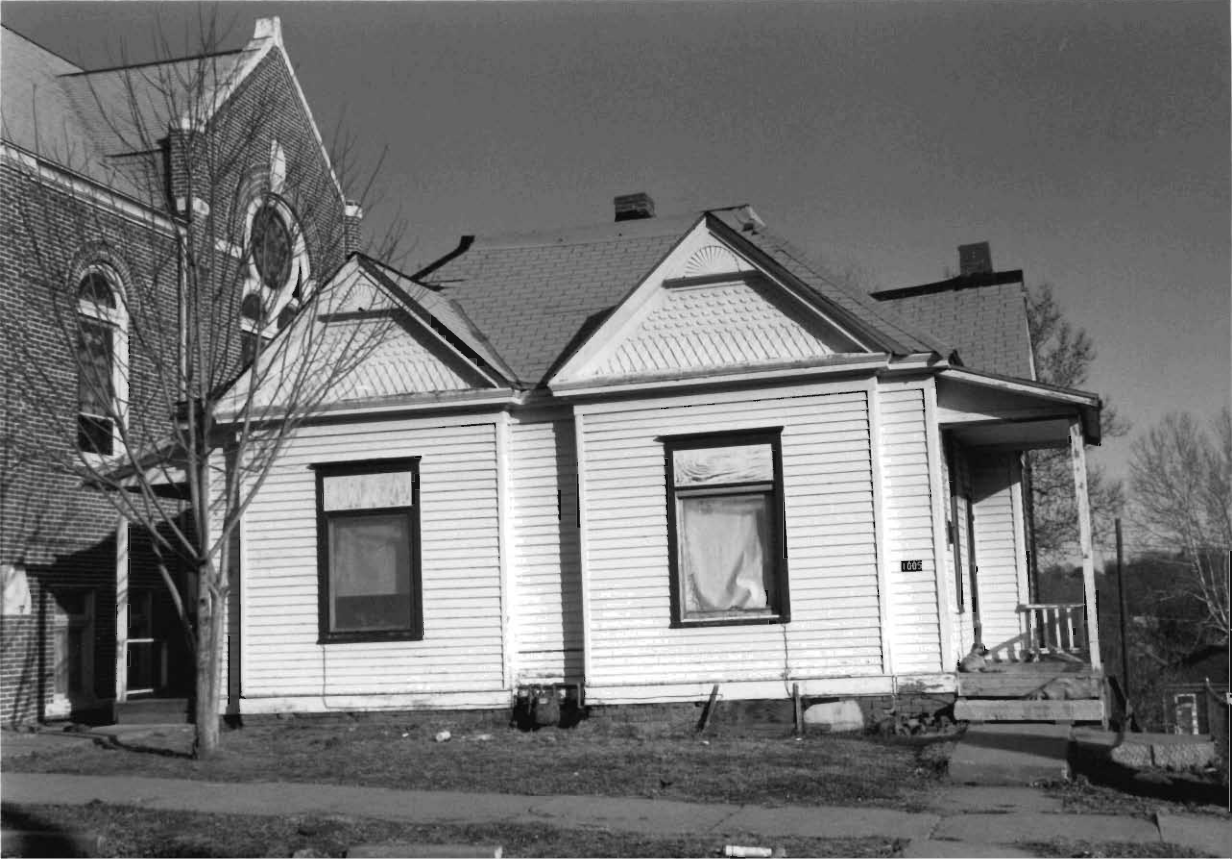
BN-A-006-003

Soffits substantially deteriorated on south elevation (see photo 1/8). This building is in dire need of proper maintenance, before it meets the unfortunate fate of its neighbor to the south.

One of four, soon to be three, nearly identical doubles on this block (either side of the street). An exceptional grouping of turn-of-the-century duplexes. The building retains a high degree of integrity, and is a significant representation of a late 19th century vernacular duplex.

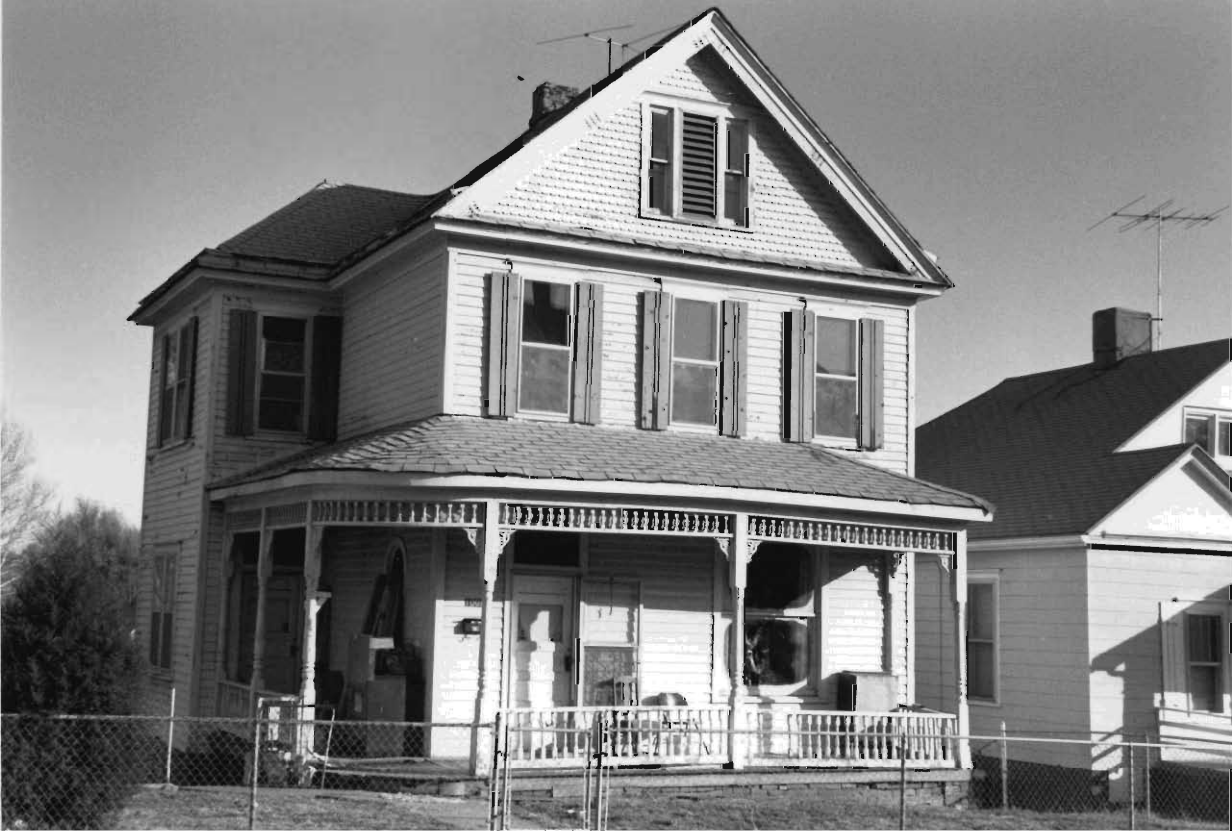
Exterior condition: Very poor Endangered/by what?: Too late; being demolished

An extremely unfortunate loss within this survey area. From what remains of this building, it would appear to have had the finest detailing of the four similar duplexes on this block. The second floor of the building was apparently dumped into the front yard. No work to clear the debris occurred during the week of field work.

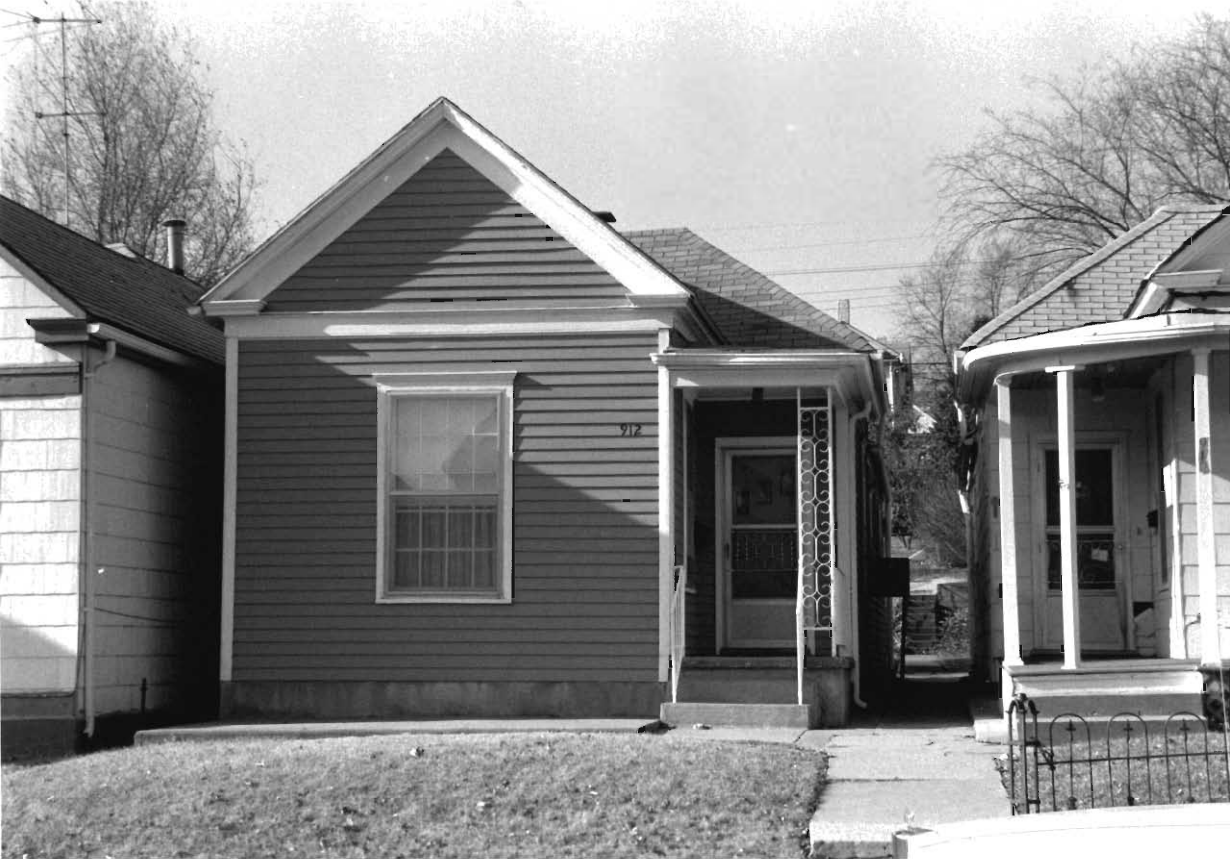
The building retains a high degree of integrity and is in excellent condition. It is significant as a well-preserved example of a turn of the century vernacular residential building type.

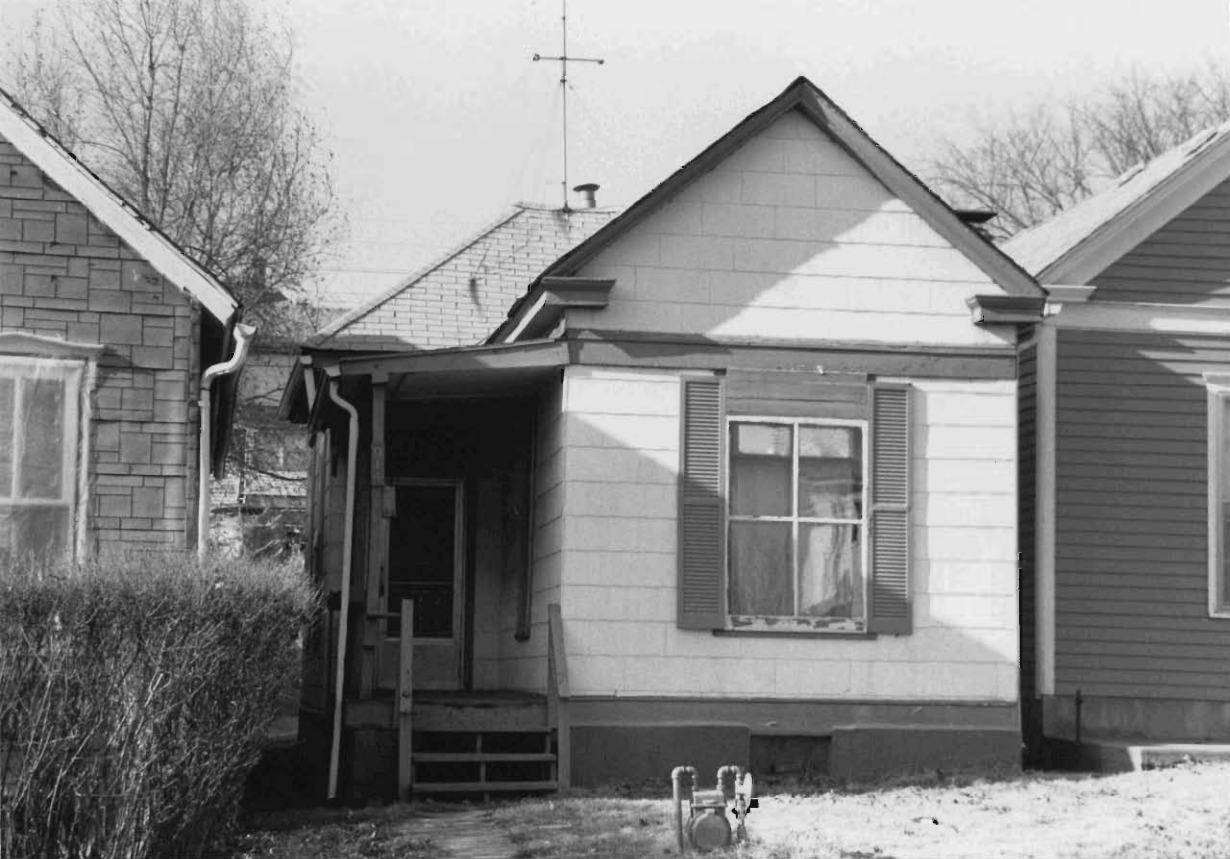
Entrance left bay in main hip section; blind transom presumed boarded. Gable front pavilion right with returns; smooth cornice band along gable with wide four light fixed sash and blocked transom; shutter added. Shed porch in reentrant angle with plain wood posts and rails. Modern parged concrete foundation. One original turned post remains at facade on porch. Elevation windows with plain drip molds. Rear lower one story shed porch is full-width.

The building retains a fairly high degree of integrity, and is significant as a good representation of a turn of the century vernacular residential building type.

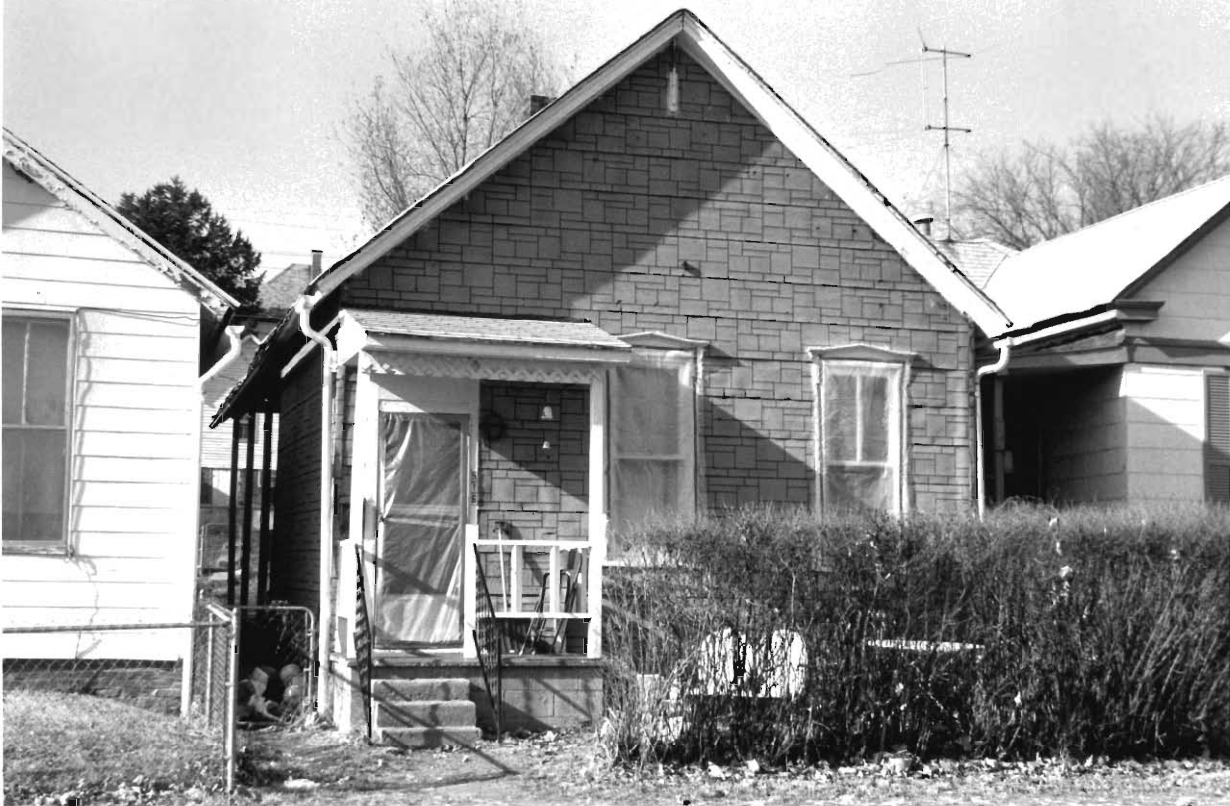
The building retains a moderate degree of integrity, and is significant as a representation of a turn of the century vernacular residential building type.
