Architectural/Historic Inventory Survey Form

St. Joseph PENN Survey

Address: 603 South 14th Street Roll/Frame: 5/29, 9/19

Prepared by: The URBANA Group (Gallagher) Date: 12/91

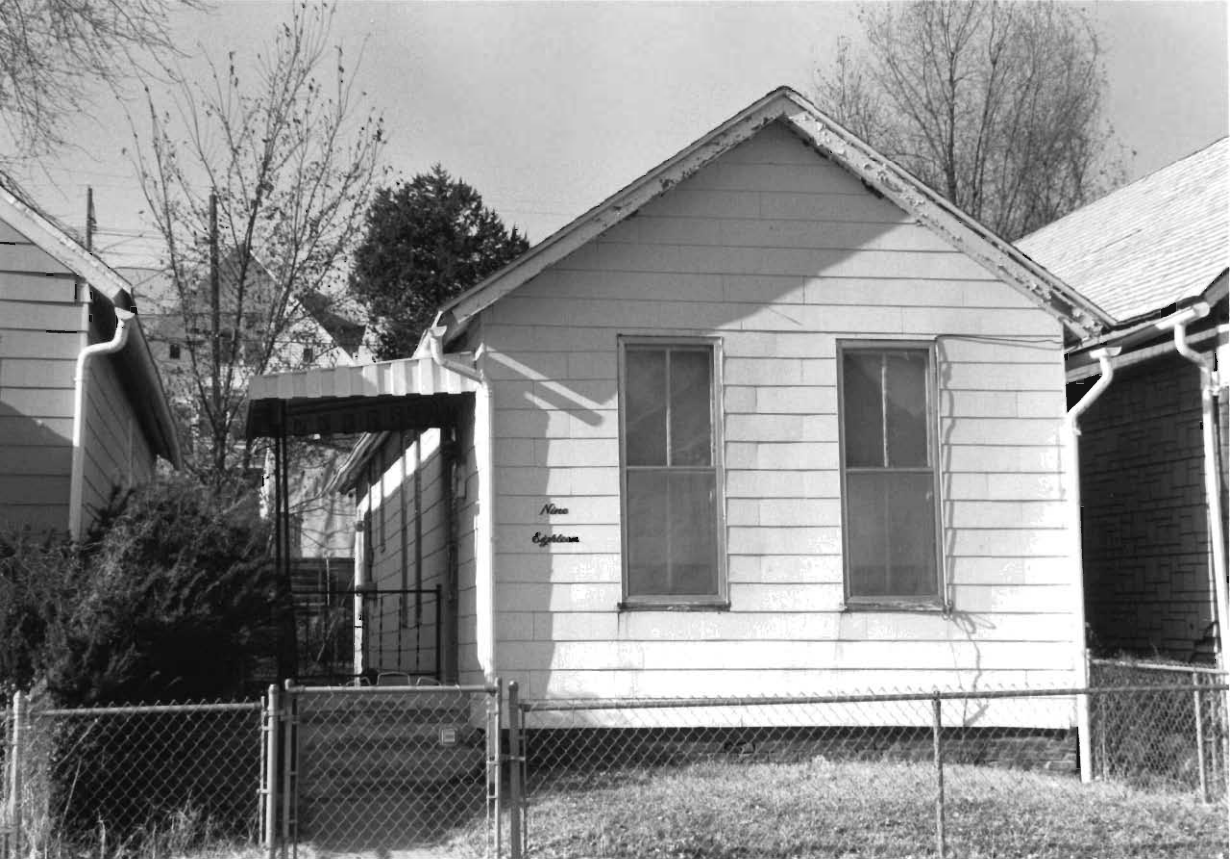
The building retains a moderate degree of integrity. It is one of a series of eight basically rectangular vernacular buildings on the middle and south end of this block. While this example has been artificially sided, it contributes in form and character to this interesting grouping, and is a significant representation of a late 19th century vernacular residential building type.

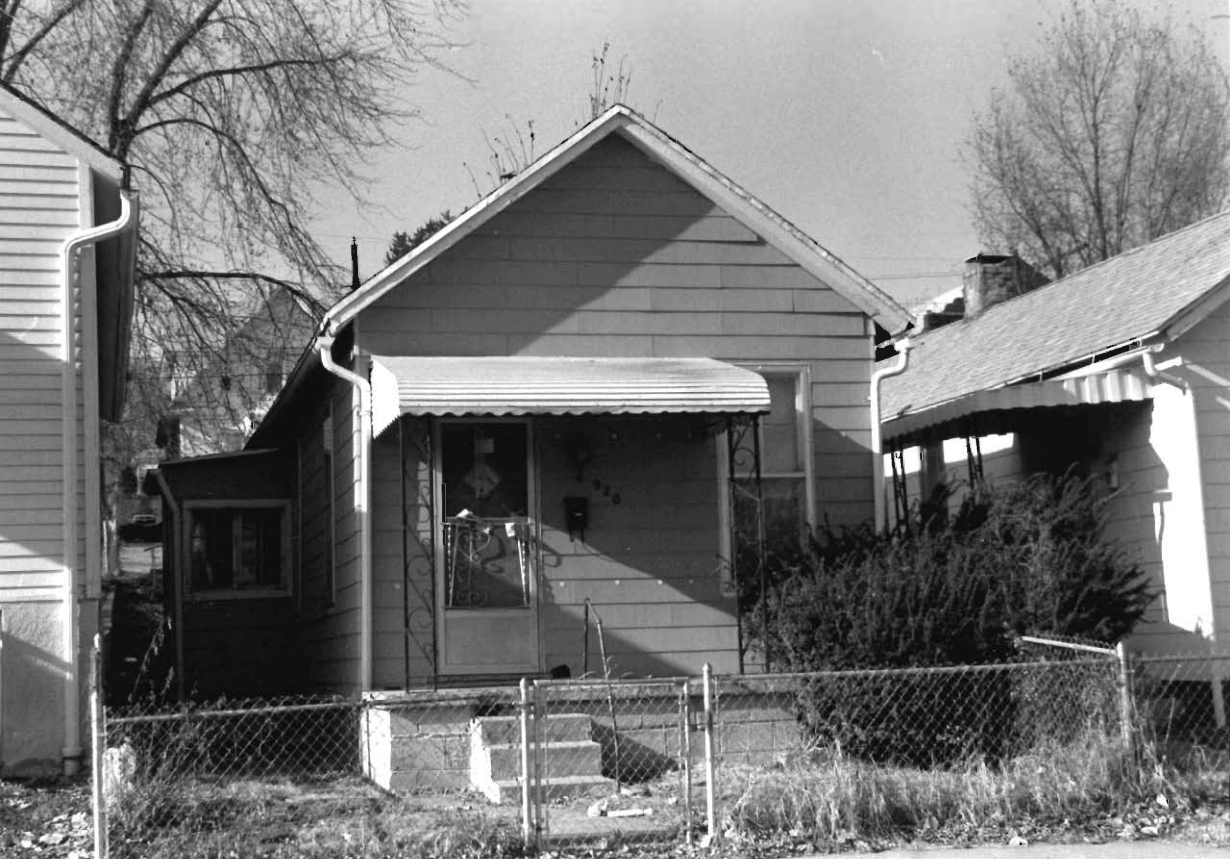
The building retains a moderate degree of integrity. It is significant as a representation of a vernacular domestic building type, one of a cluster of such dwellings on this block.

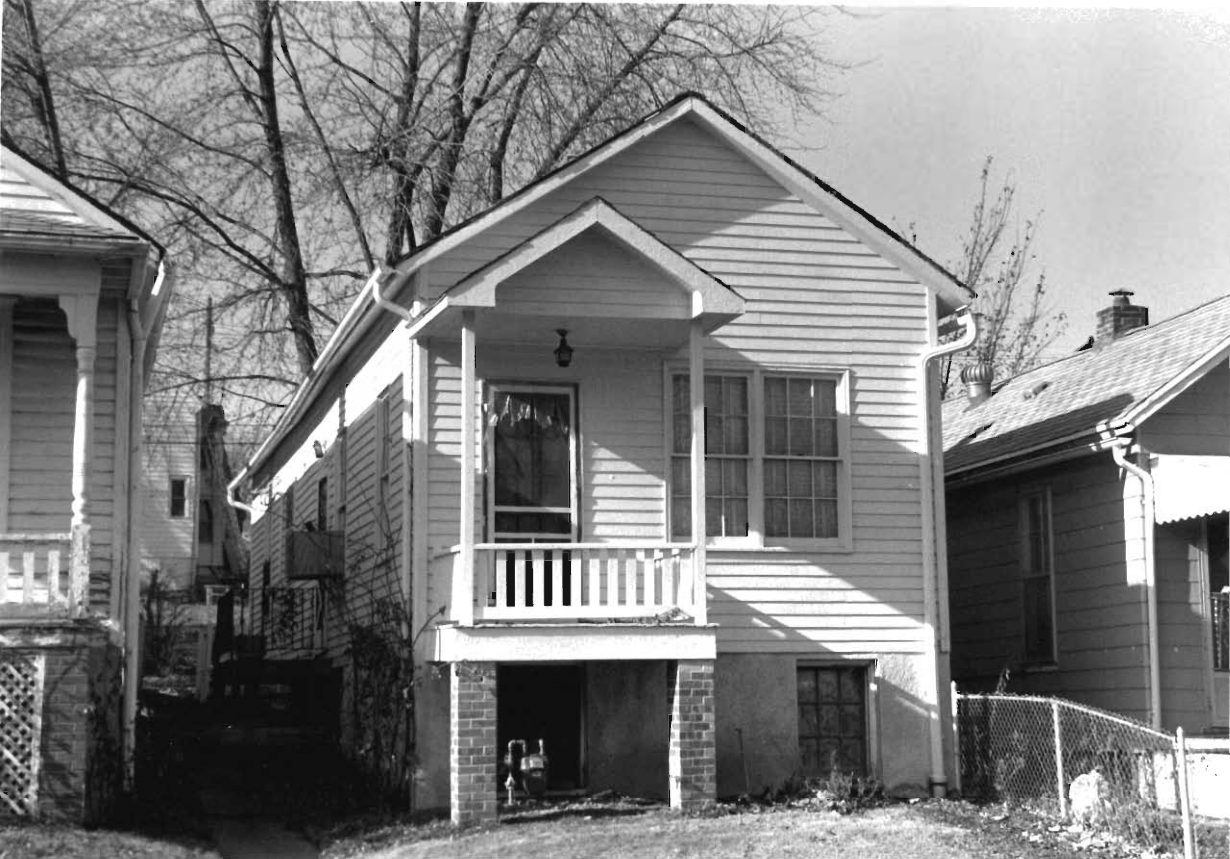
The building retains a high degree of integrity. It is significant as an excellent example of the shotgun variation vernacular residential building type, and particularly significant with its adjacent companion to the south.

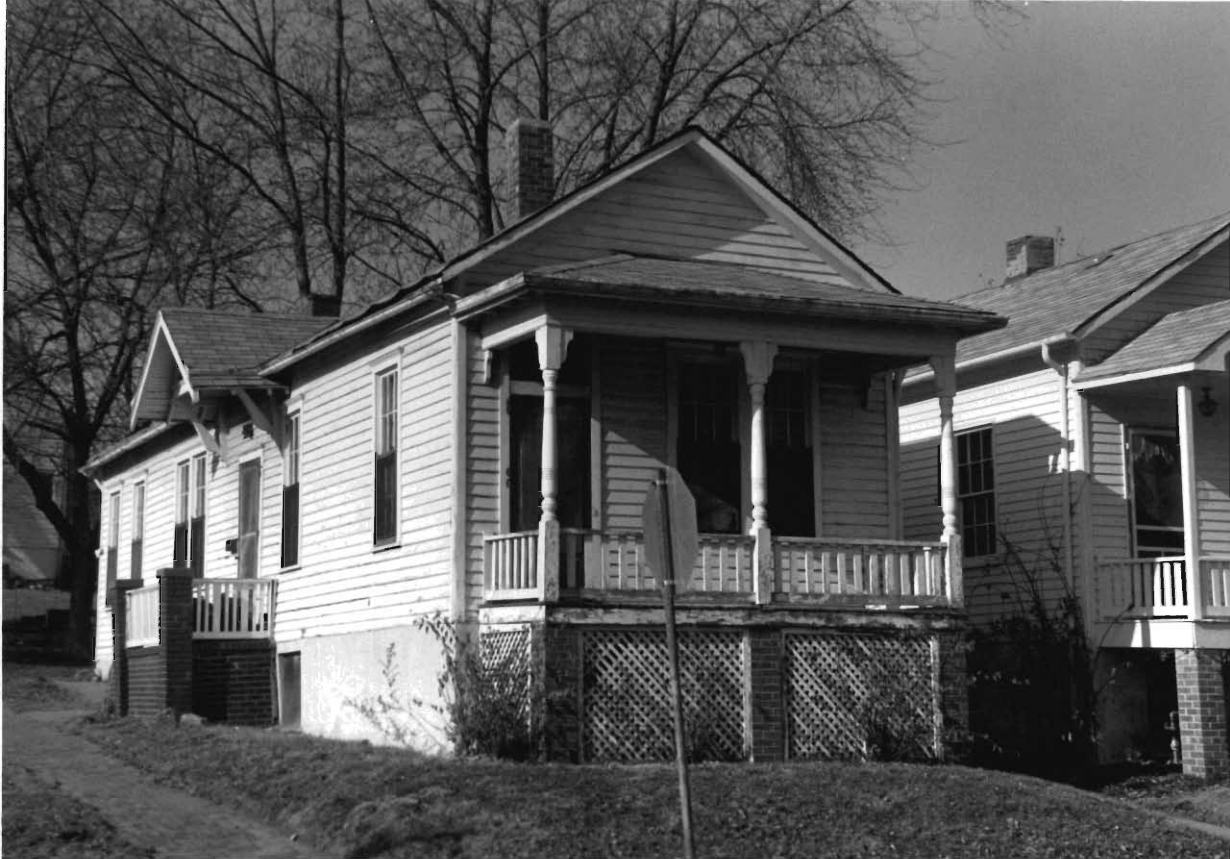
The building retains a high degree of integrity. It is significant as an excellent example of the shotgun vernacular residential building type, and particularly significant with its companion to the north.

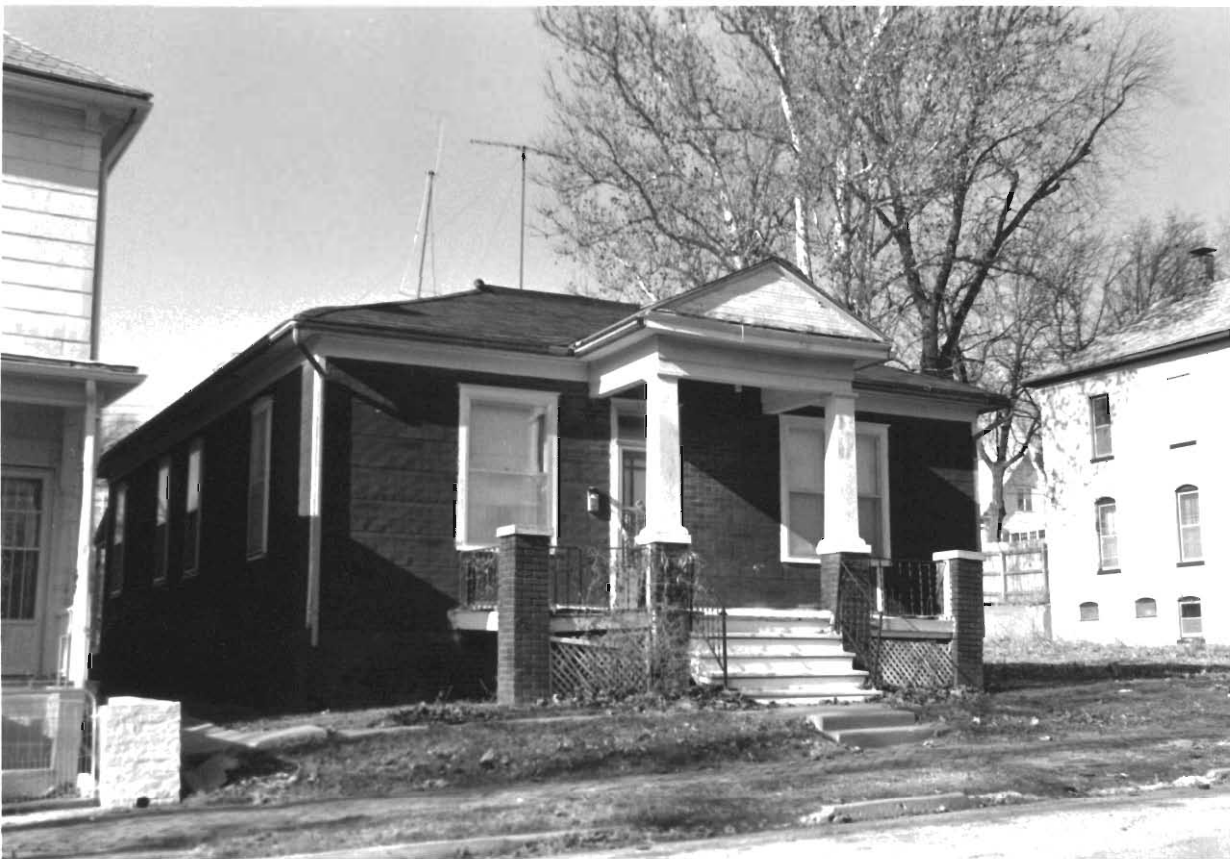
Entrance off-center to the left (south) with a multi-light oak door, transom, and simple drip mold. Wide 1/1 double hung sash left with narrower pair 1/1 sash to the right with drip molds. Central entry porch (does not align with off-centered door; justified left) with gable front, tapered wood posts on wire-cut brick pedestals, and smooth frieze and cornice. Wood porch floor, in poor condition. Two porch bases extend out from the gable cover, creating a terrace. Old lattice base, but modern iron rail. Smooth cornice band surrounds house. Elevation windows have low pedimented drip molds. Rear lower one story shed porch creates fifth side bay. 2/2 elevation windows. Insul-brick badly deteriorated on north elevation, toward front.

The building retains a fairly high degree of integrity, remaining an interesting example of a late 19th century vernacular house type.

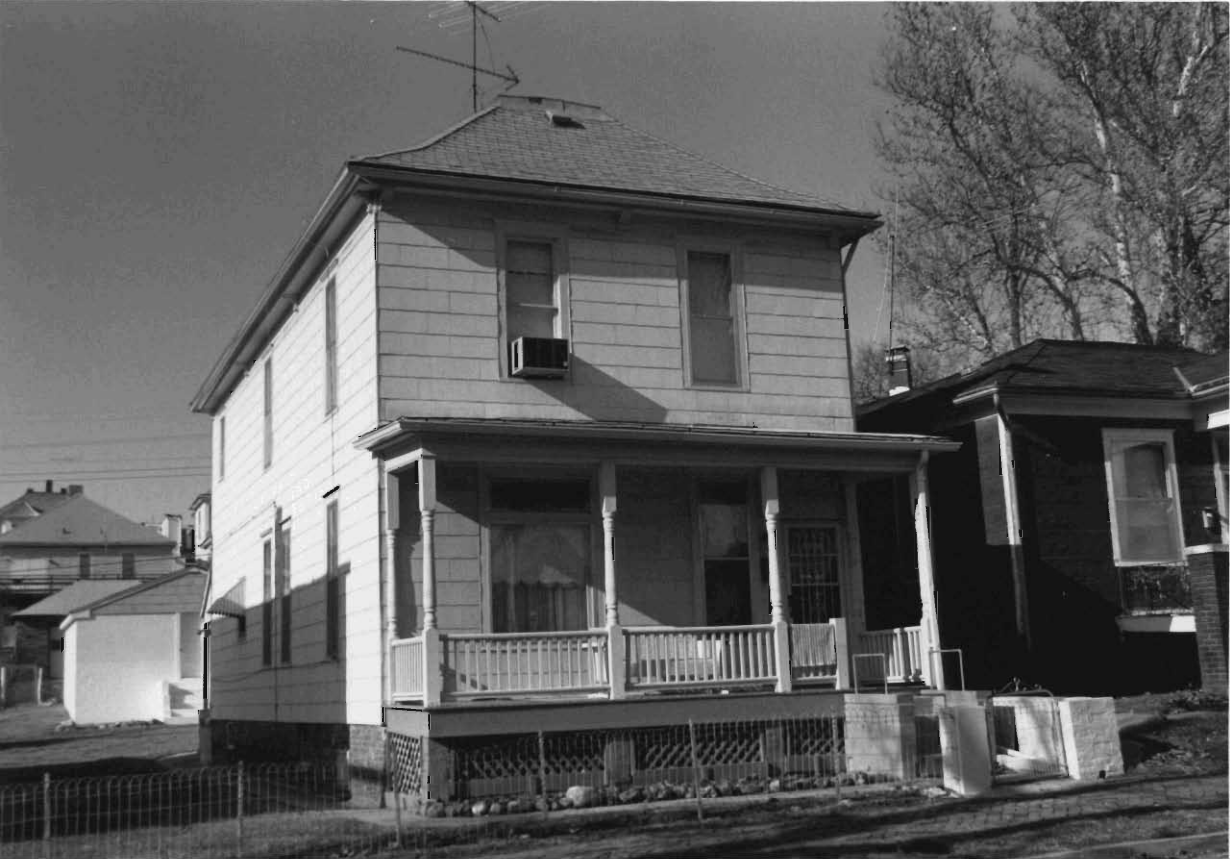
Front entrance in right bay of facade with modern iron storm door. Bay window with lead and stained glass transom in left bay. Hip roof with flared eaves and central brick chimney. Full facade front porch with turned posts and plain wooden balustrade. Wooden porch floor with lattice underneath. Concrete steps with concrete block cheek pieces lead to porch. Rear porch with shed roof visible at rear. Irregularly spaced windows on north and south side.

The building retains a high degree of integrity, and is a good example of a late 19th century vernacular domestic house type.

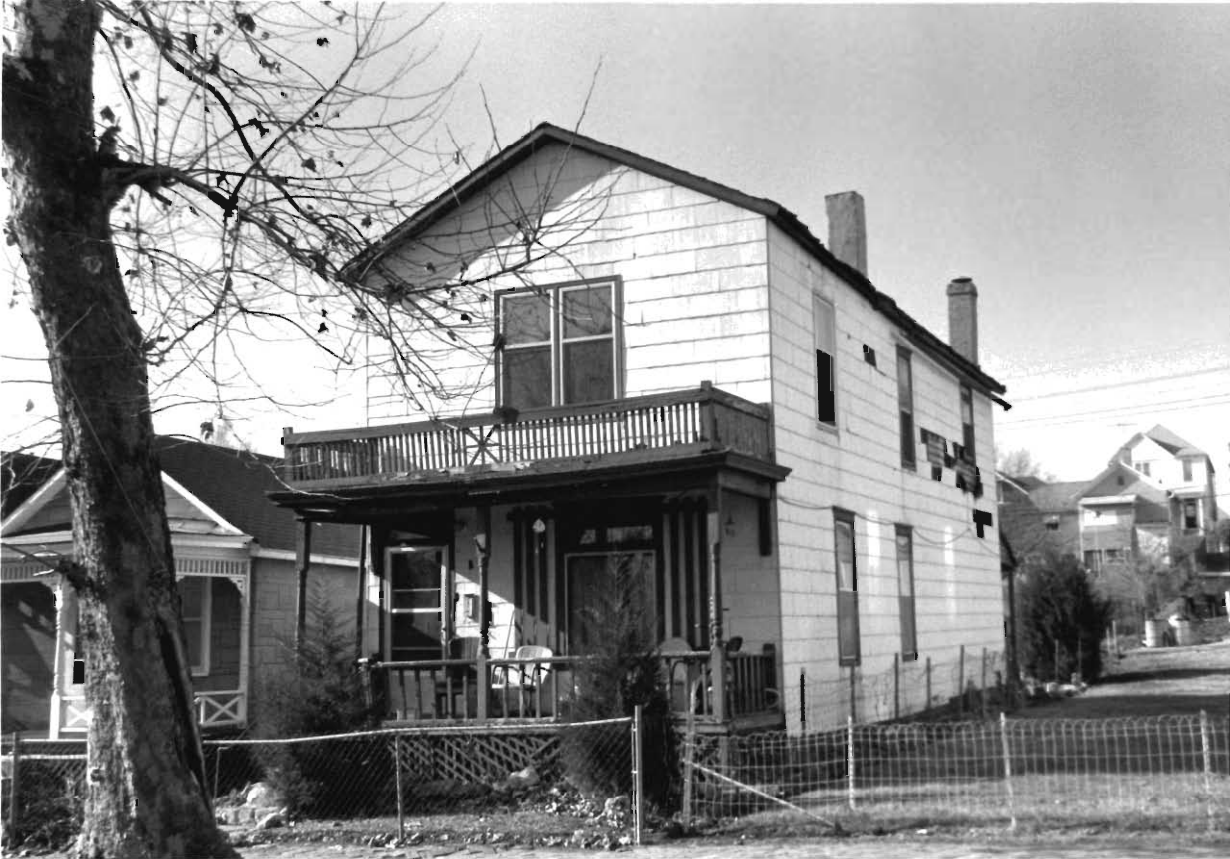
The building retains a high degree of integrity, but is in fair condition. It is a good example of a turn of the century vernacular domestic building type.

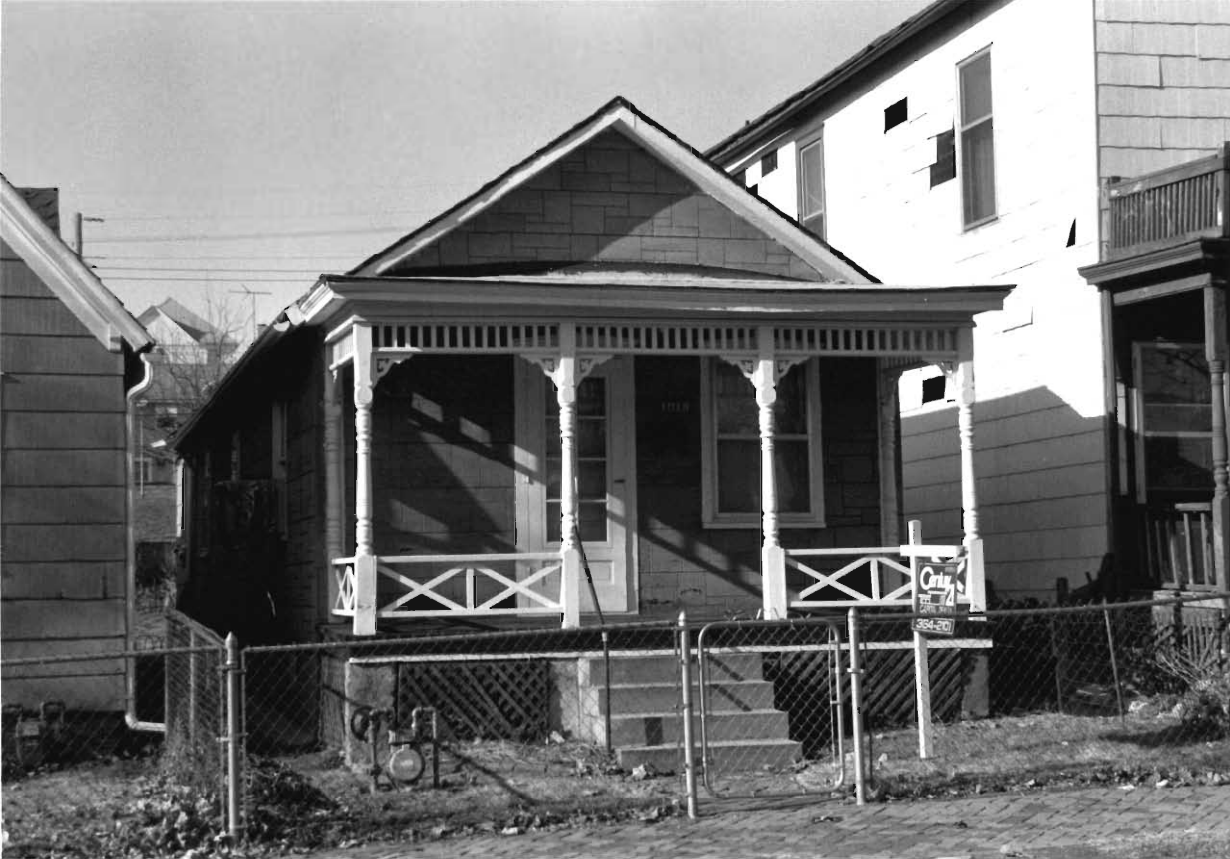
Entrance off-center to the left (south) with three light paneled door and historic storm door. Wide 2/2 double hung sash right. All fenestration with low pedimented drip molds. Full-facade hip porch (low) with wood slat cornice, turned posts, and cross brace wood open railing. Astro-turf covered porch floor. Old lattice porch base. Concrete faced foundation (but brick patterning is visible on the front.) Full-width rear porch enclosed with storm sash and wide wood.

The building retains a high degree of integrity, and is one of several significant examples of the shotgun house type on this street.

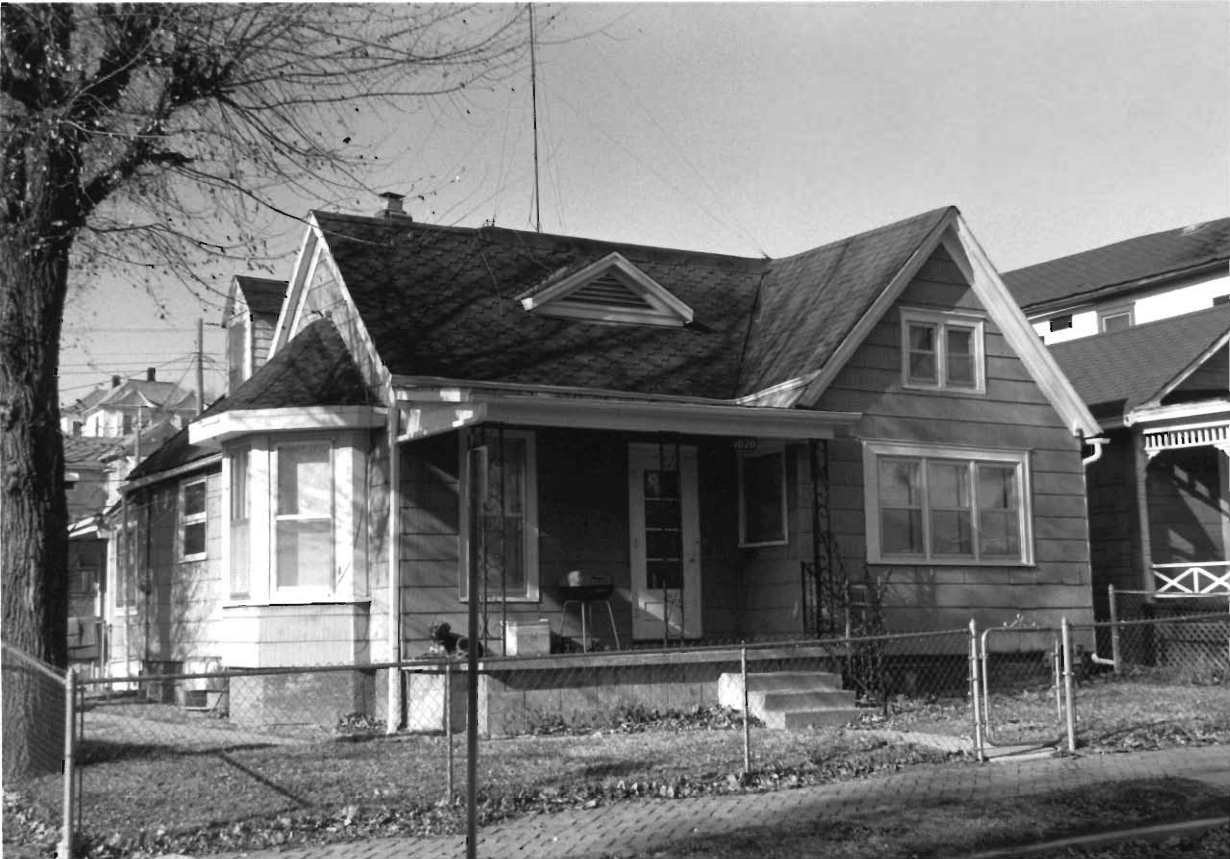
The building retains a moderate degree of integrity with modern porch alterations and artificial siding. It remains, however, a good example of a late 19th century vernacular domestic building type.

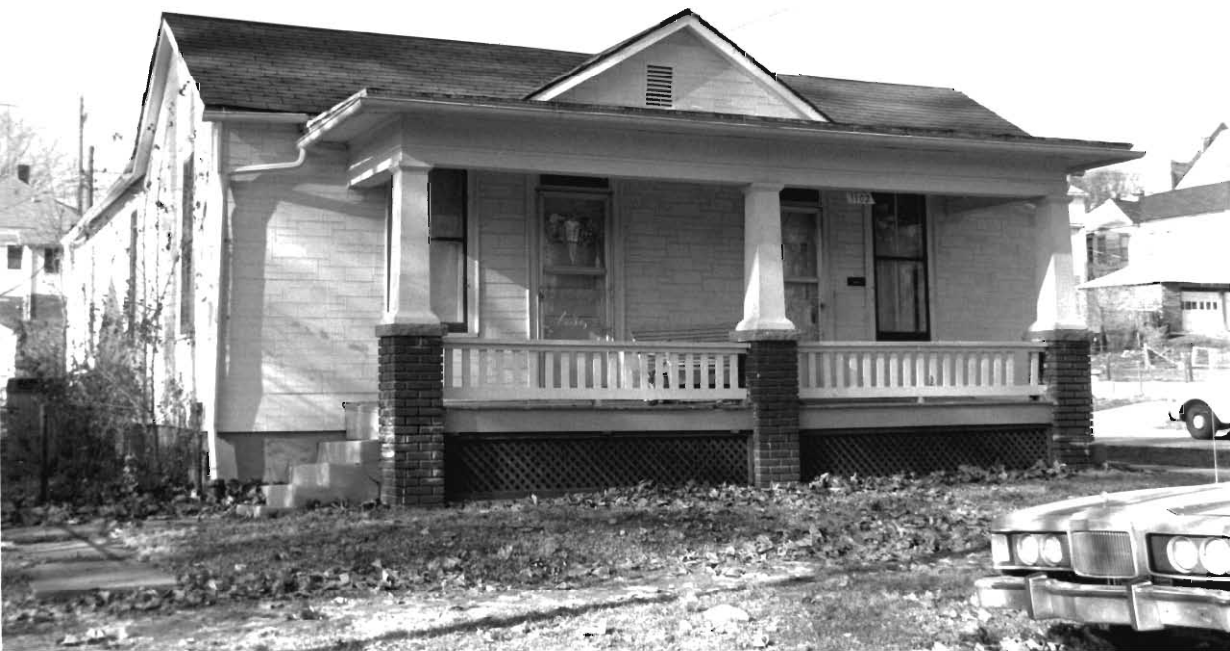
The building retains a high degree of integrity, and is significant as an example of a late 19th century conversion of single family to duplex. The building has a very unusual plan, with the two rear Shotgun-like wings creating a rear U-plan.

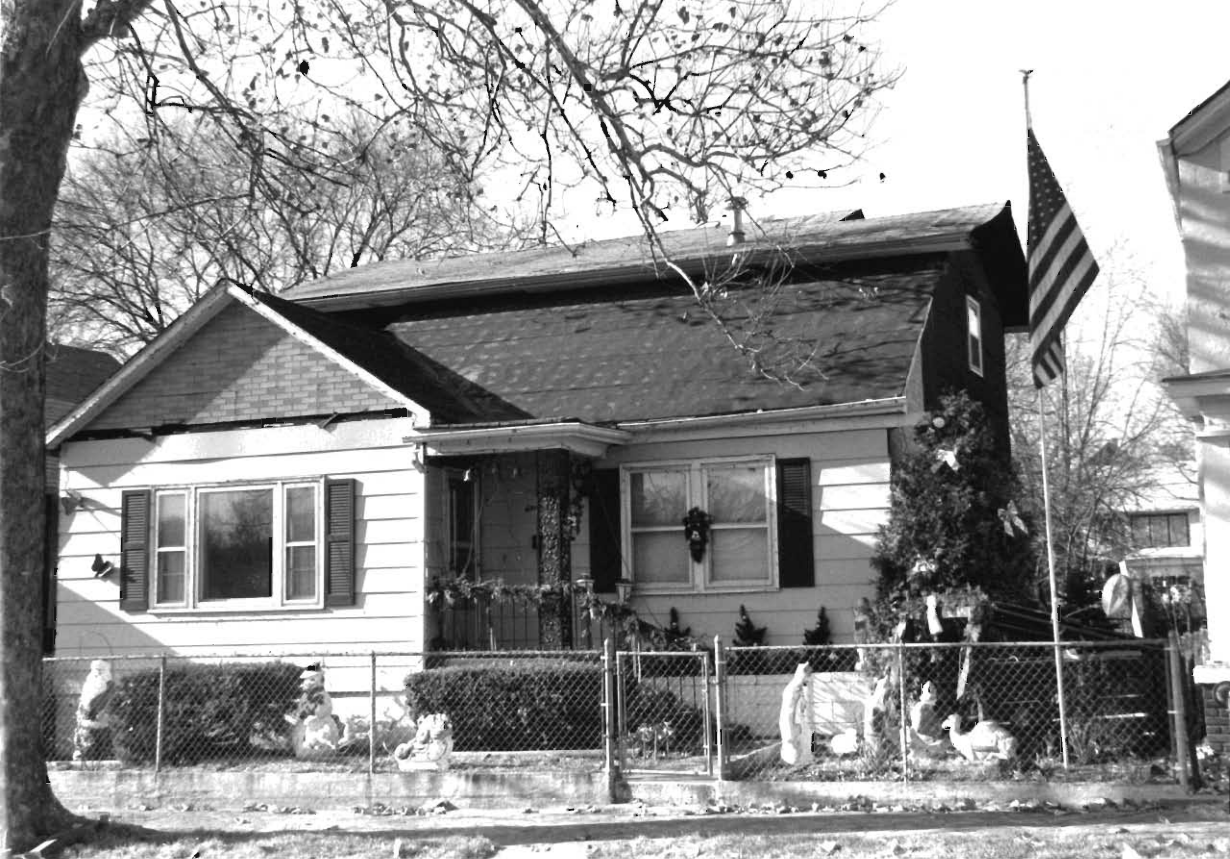
The building retains a moderate degree of integrity, with artificial siding and porch additions and alterations. However, it continues to be a good example of the Gabled Ell building type, with its form substantially intact.

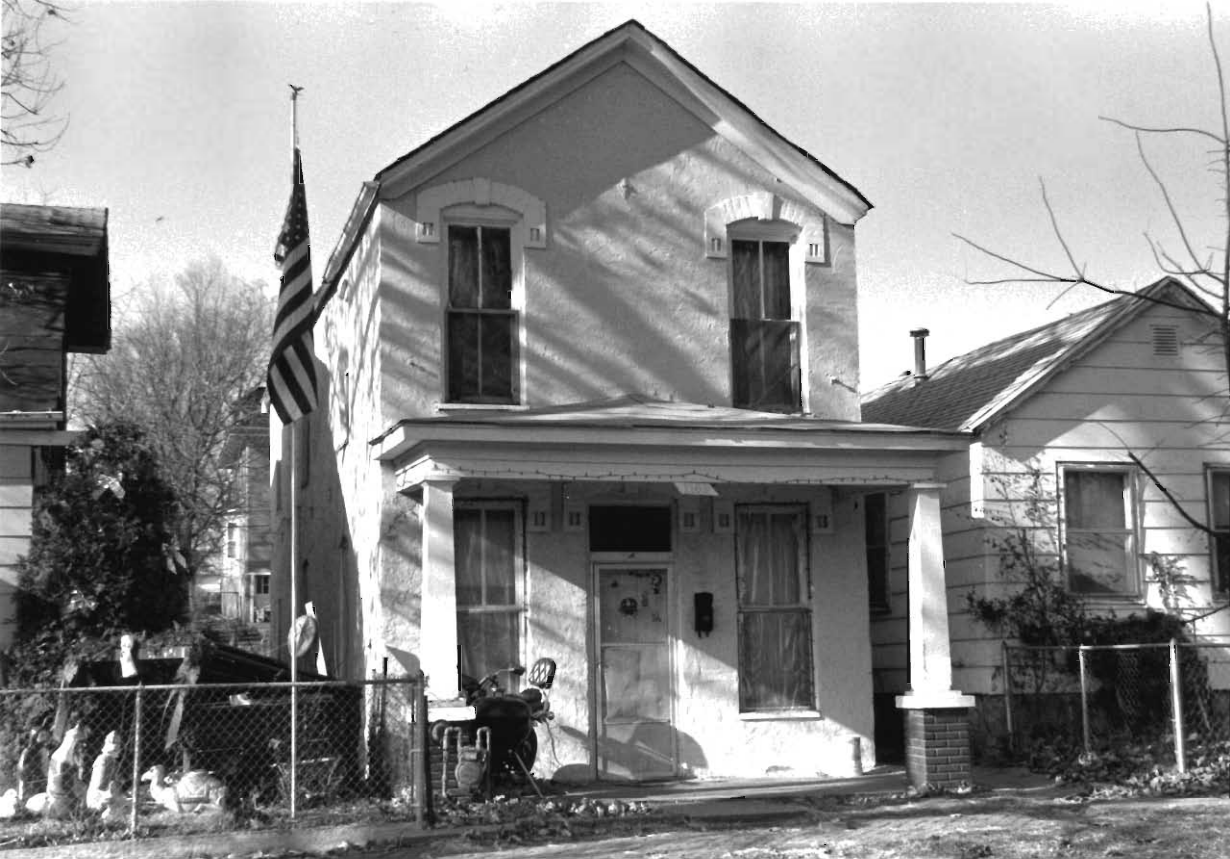
The building retains a high degree of integrity, and is significant as an excellent example of Italianate influence on a basically vernacular residence.

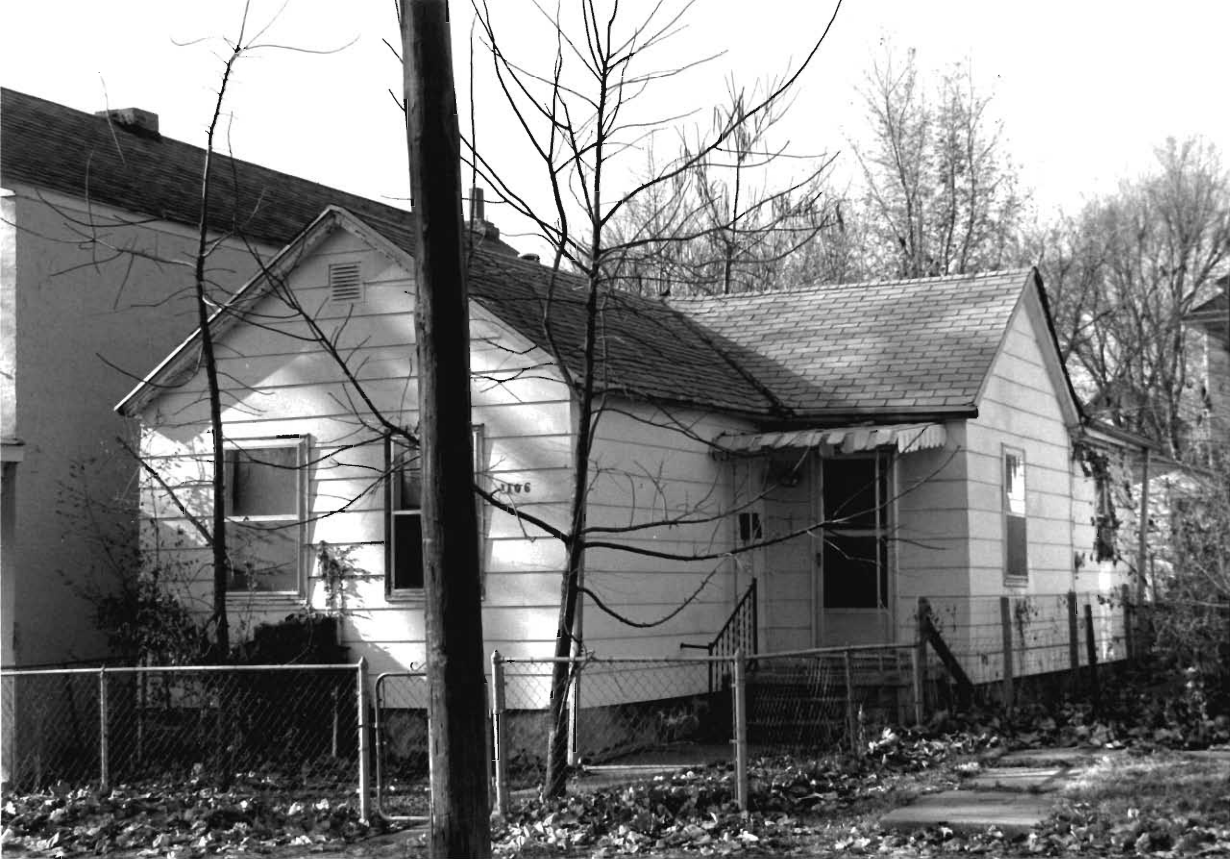
Substantially altered exterior with elevations and a portion of the facade (east) masked with tar paper and replacement windows inserted. Two story side gable section is an addition/alteration with left bay one story gable projection (original) to the front. Recessed shed section on the right bay extends from side gable edge above on second. Small 1/1 double hung sash flank plate glass windows in the gable projection. Painted Insul-brick in gable peak. Entrance faces north in reentrant angle. Pair 1/1 sash in right bay. Small entrance porch with flat roof; iron posts and railing. Insul-brick on first floor of north elevation.

The building retains a very low degree of integrity, due to the second floor addition, artificial siding, and fenestration and door changes. The building, therefore, no longer reflects the sense of time and place of a historic building.

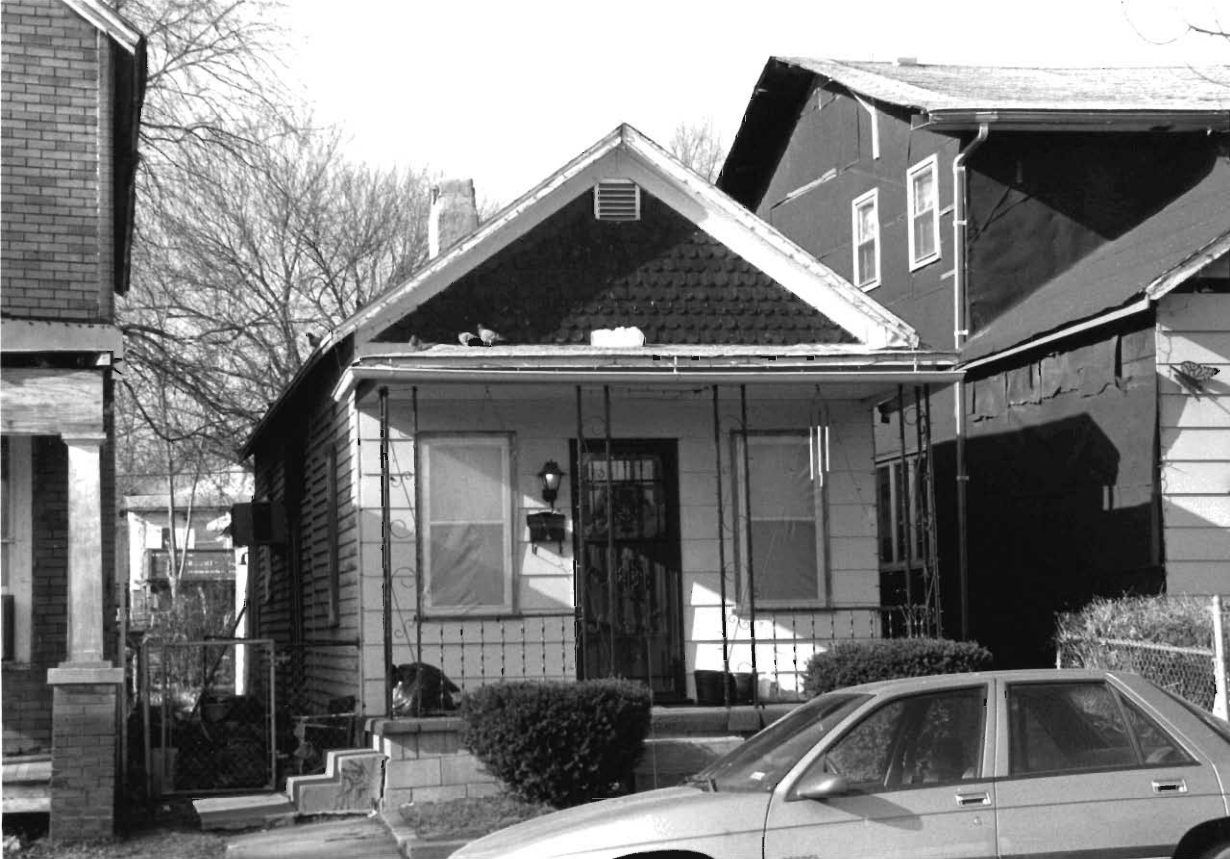
The building retains a moderate degree of integrity, given the artificial siding and porch alterations, however, it still remains a good example of the Shotgun building type.

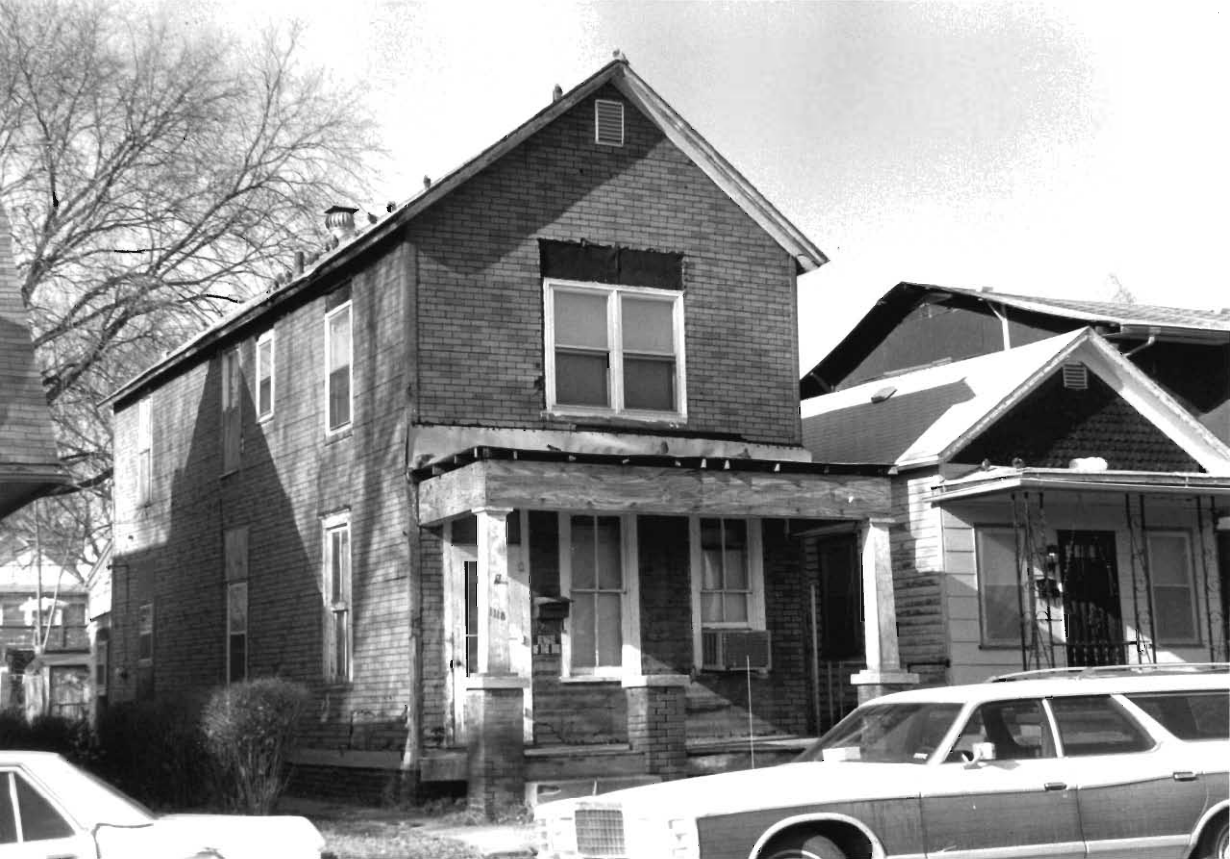
Left bay entrance with boarded transom. 2/2 double hung sash on second and third bays. Full-facade porch altered with flat roof and wide frieze board. Wood Doric posts on brick pedestals with stone caps appear original to the porch. Wood porch floor; no balustrade. Pair 1/1 sash centered on second floor with drip molds removed; tarred "lintel" space. Small attic vent above. Regularly spaced elevation windows. Some 2/2 sash have drip molds intact on elevation; others have replacement 1/1 with drip molds removed. Rear shed lower one story porch wing. Blown-in insulation holes evident, north elevation.

The building retains a moderate degree of integrity with some modern alterations. It remains, however, a good example of a turn of the century vernacular house type.

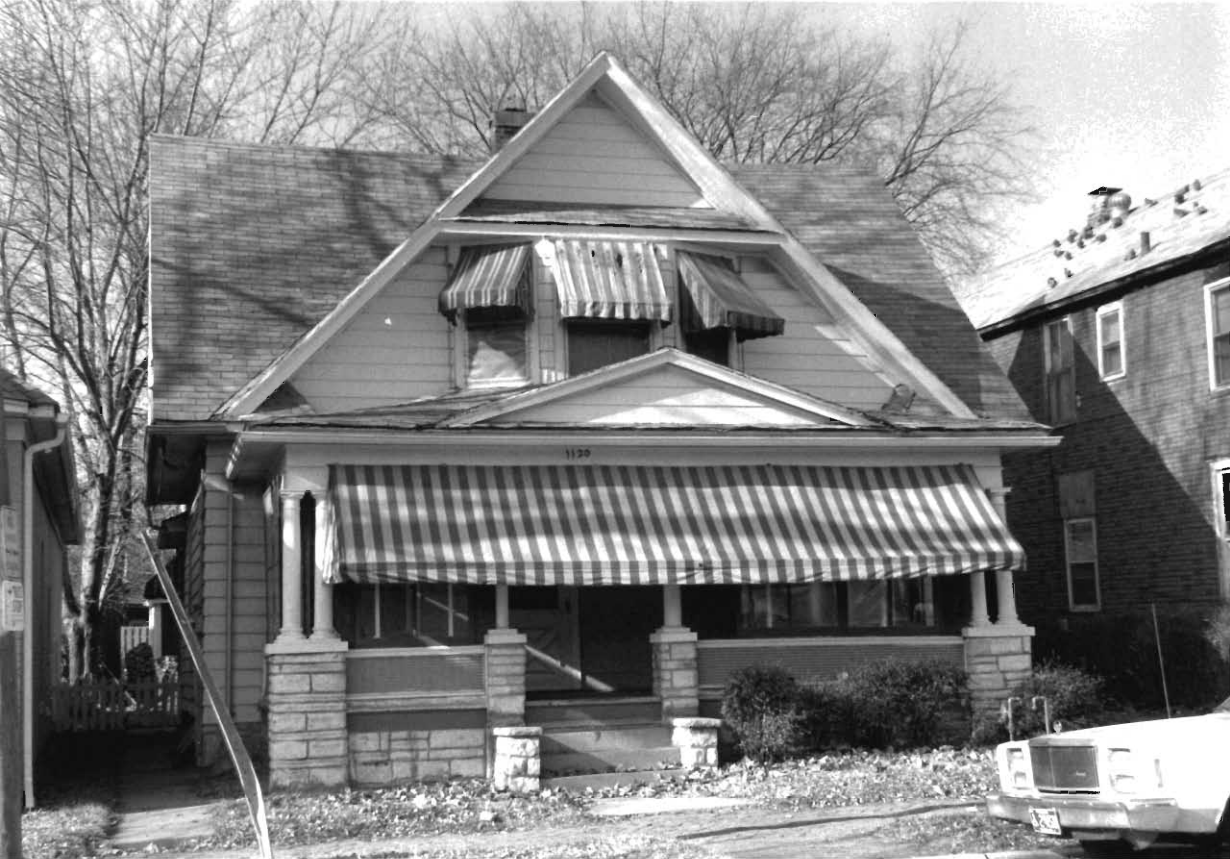
The building retains a fairly high degree of integrity, and is a good example of early 20th century residential architecture.

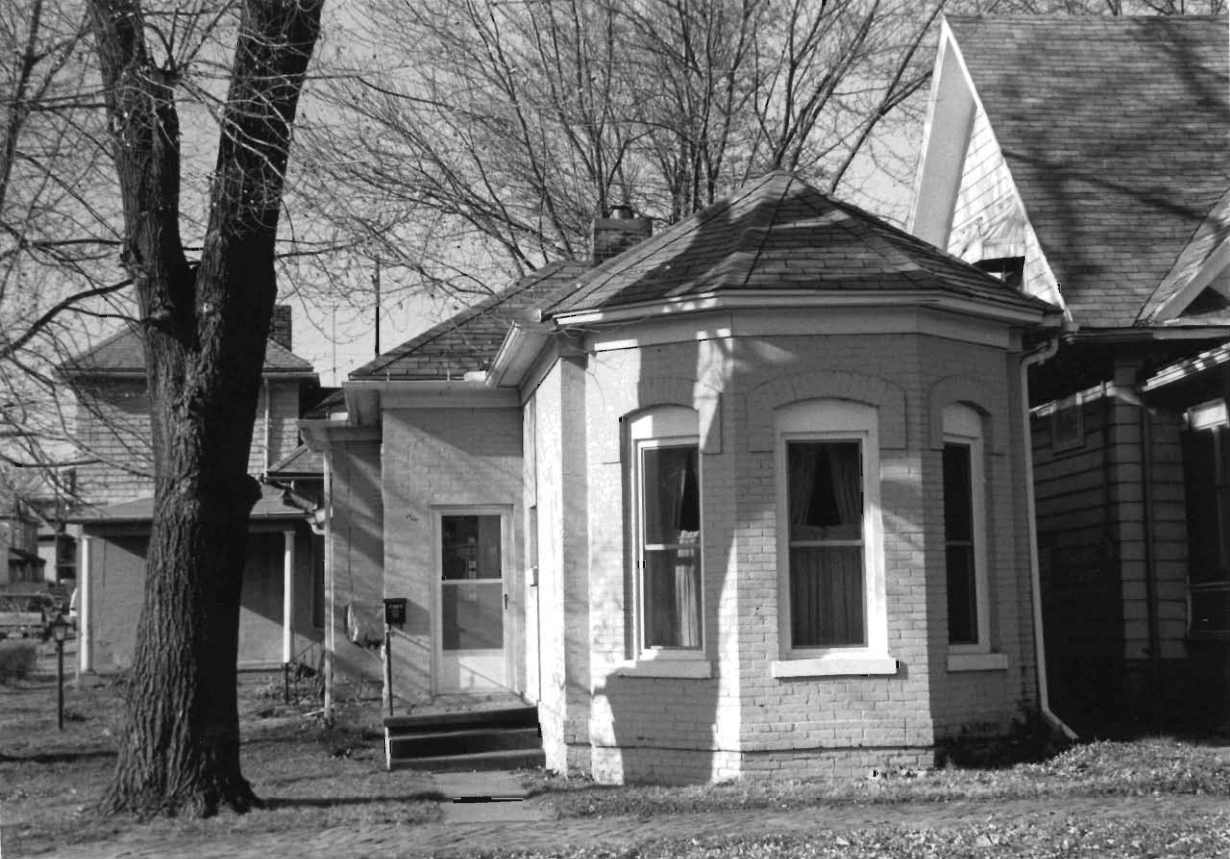
The building retains a high degree of integrity. It is a good example of late 19th century residential architecture and may be particularly significant given the related building on the lot which faces Penn St. The relationship of the two buildings merits further research.

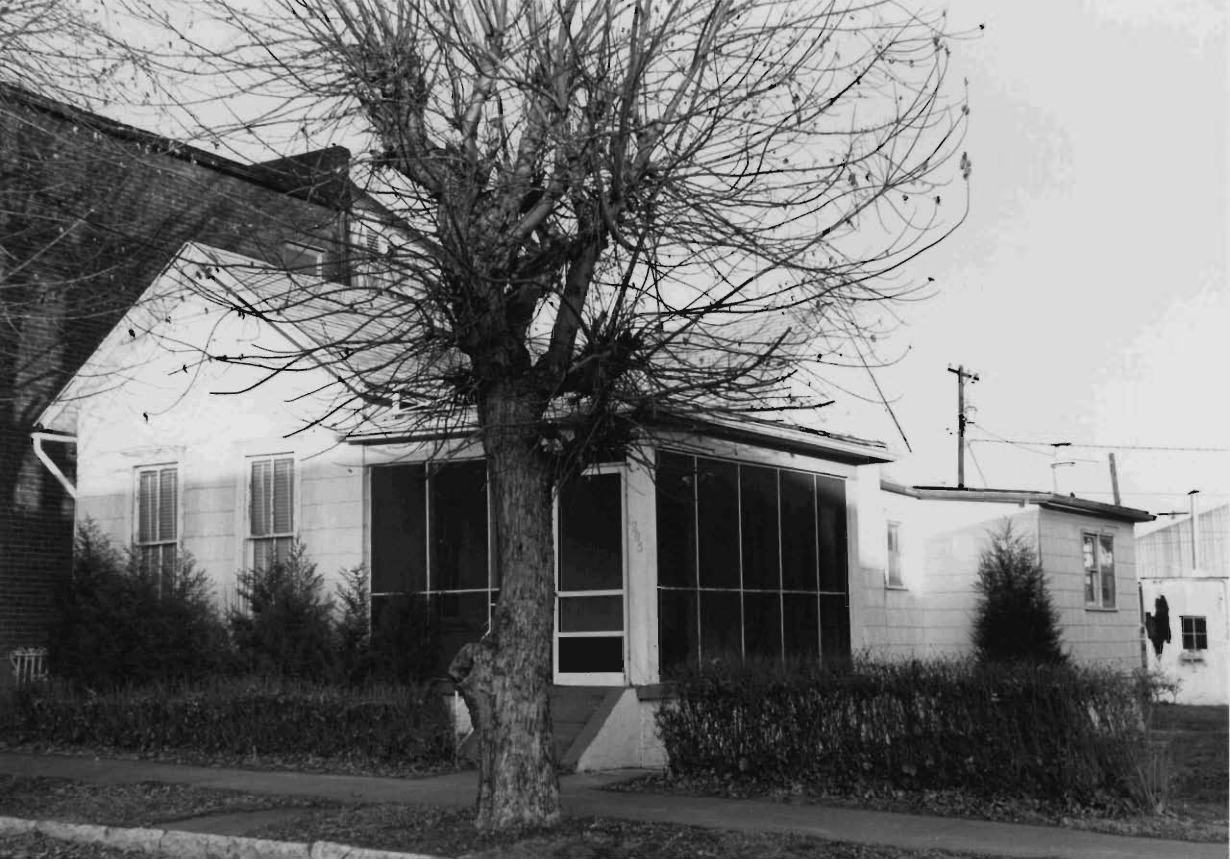
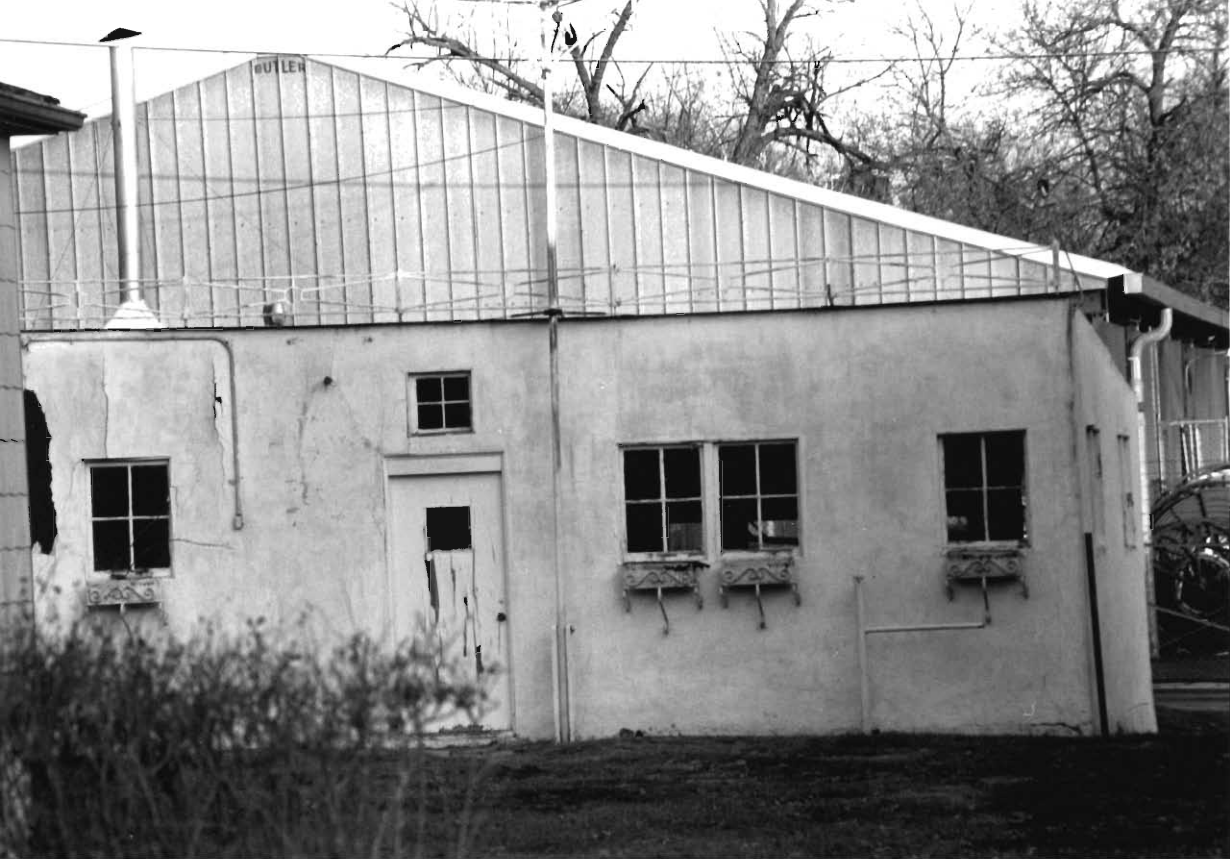
Gable front left with two 2/2 double hung sash; plain surround and drip molds. Brick chimney toward rear on this ridge. Entrance faces front (west), concealed by black screened in porch (full-height screens). Hip roof of porch extends beyond facade plane with right door; low delicate cross brace open railing on top of roof decorative only; no access to use as a terrace.) Rear hip wing lower one story. Enclosed rear porch. Rear stairs to door missing.

The building retains a fairly high degree of integrity, and is a good example of late 19th century vernacular residential architecture.

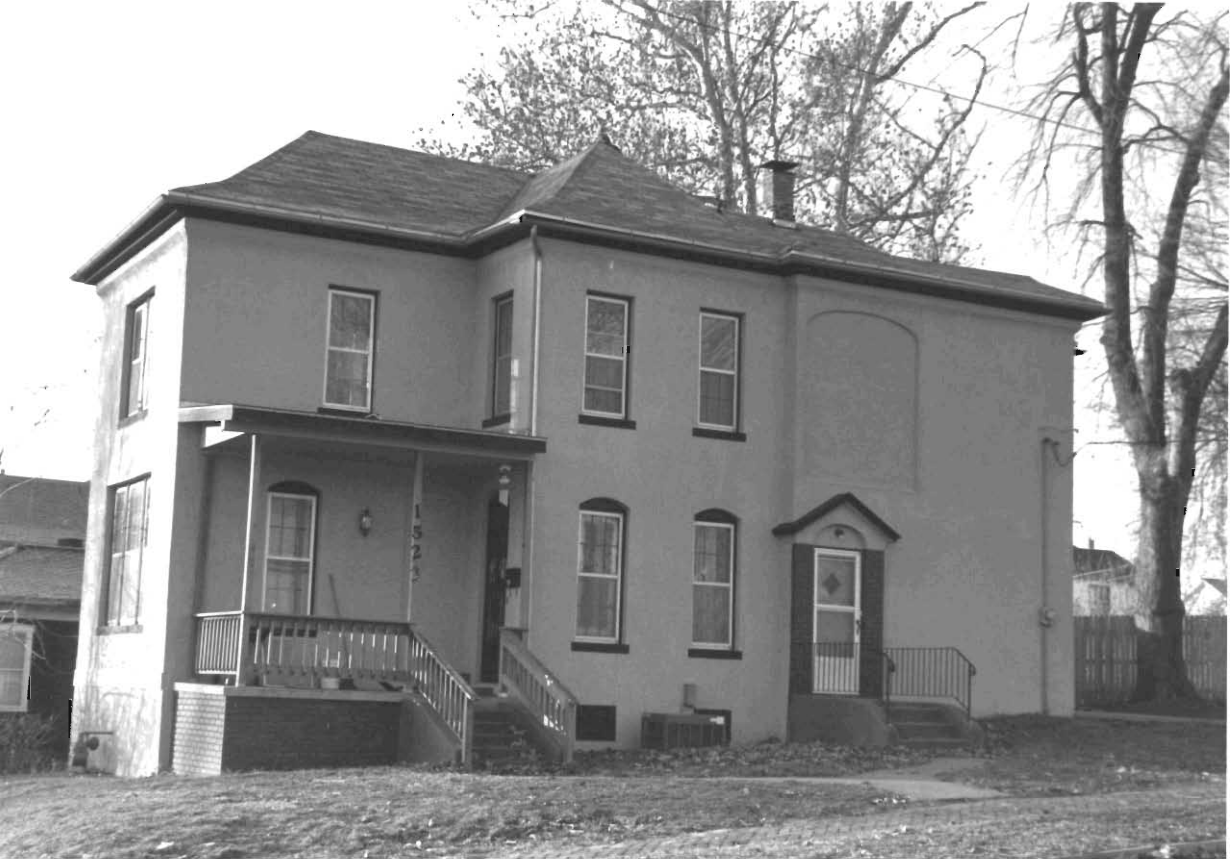
The building retains a moderate degree of integrity, and is a good example of a late 19th century large scale vernacular house type.
