Architectural/Historic Inventory Survey Form

St. Joseph PENN Survey

Address: 603 South 14th Street Roll/Frame: 5/29, 9/19

Prepared by: The URBANA Group (Gallagher) Date: 12/91

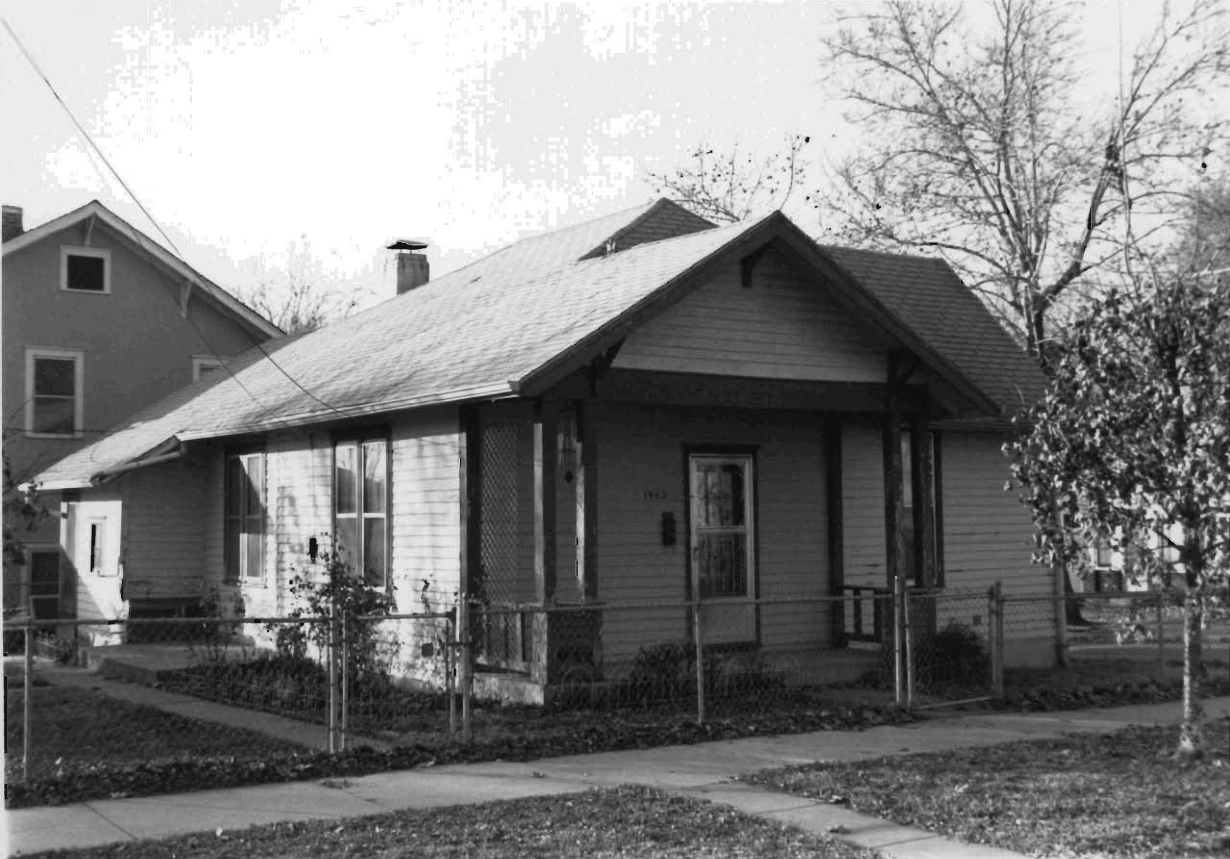
The building retains a fairly high degree of integrity, and is a good example of an early 20th century vernacular house type.

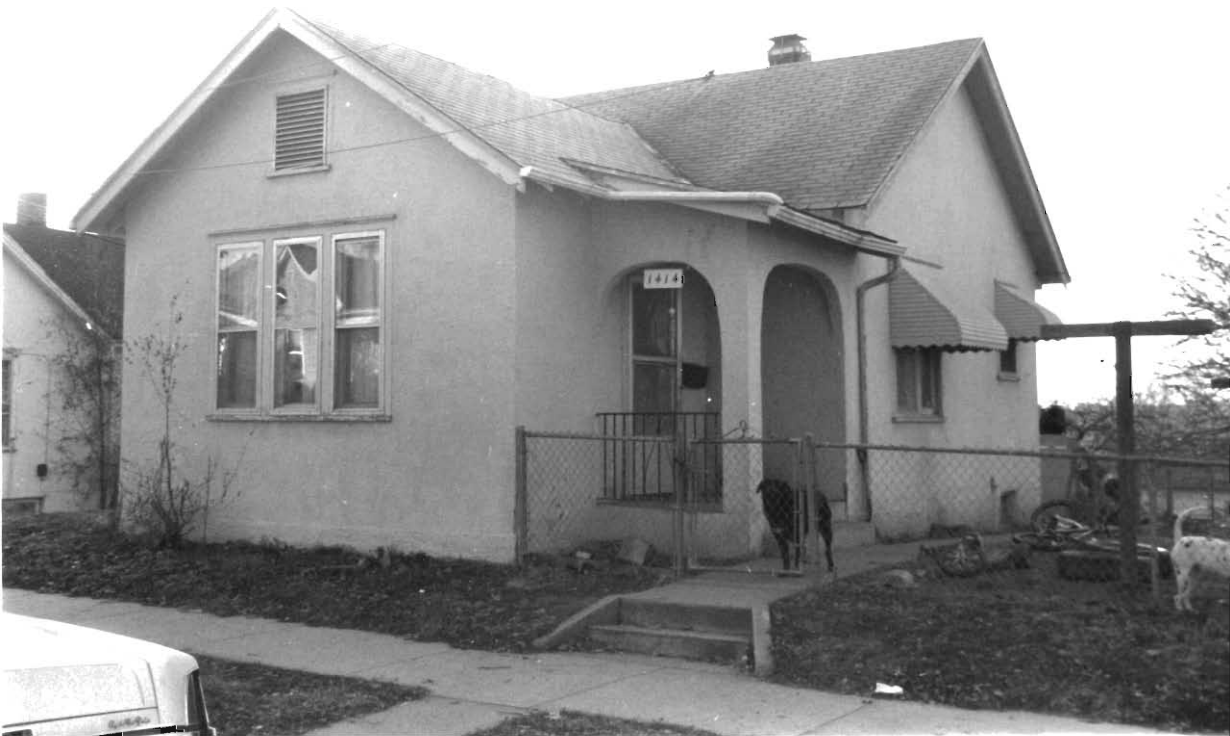
The building retains a high degree of integrity, and is a good example of an early 20th century house type.

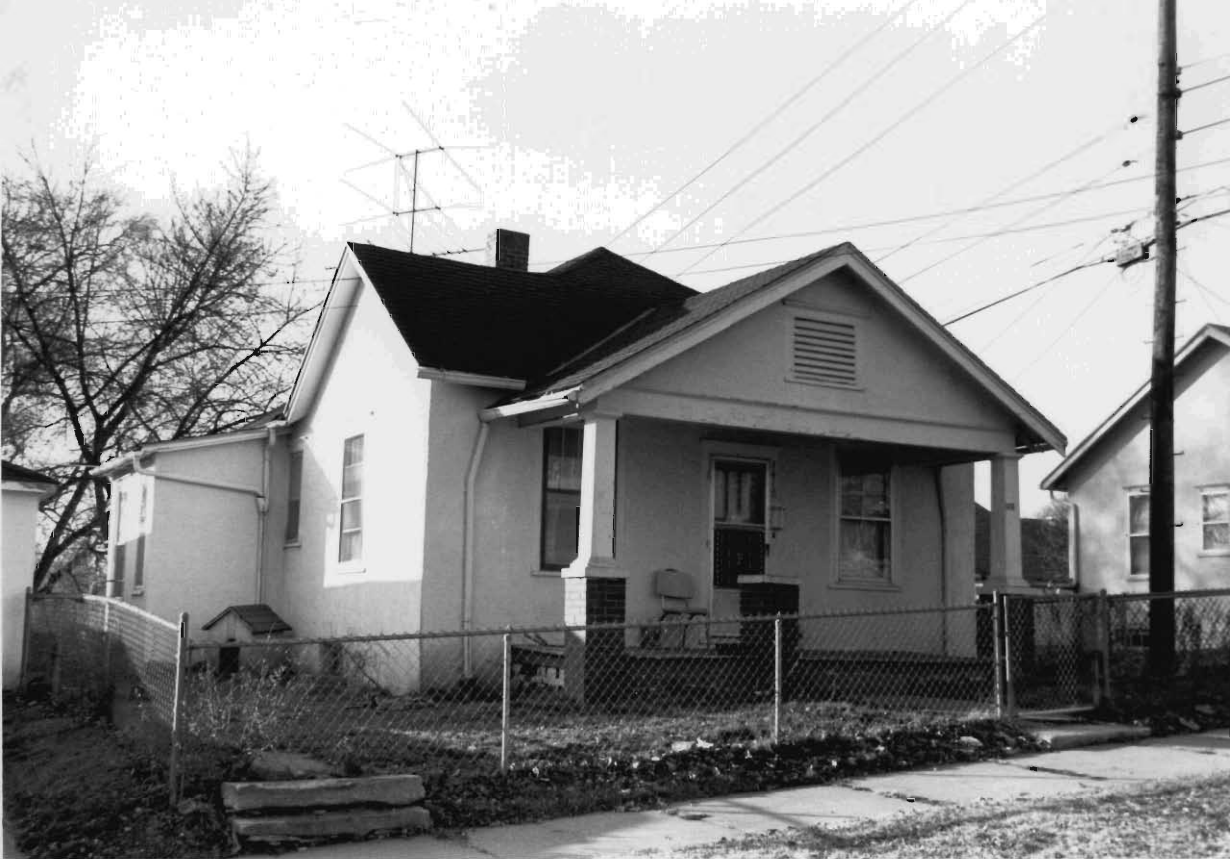
The building retains a high degree of integrity, and is a good example of an early 20th century vernacular house type.

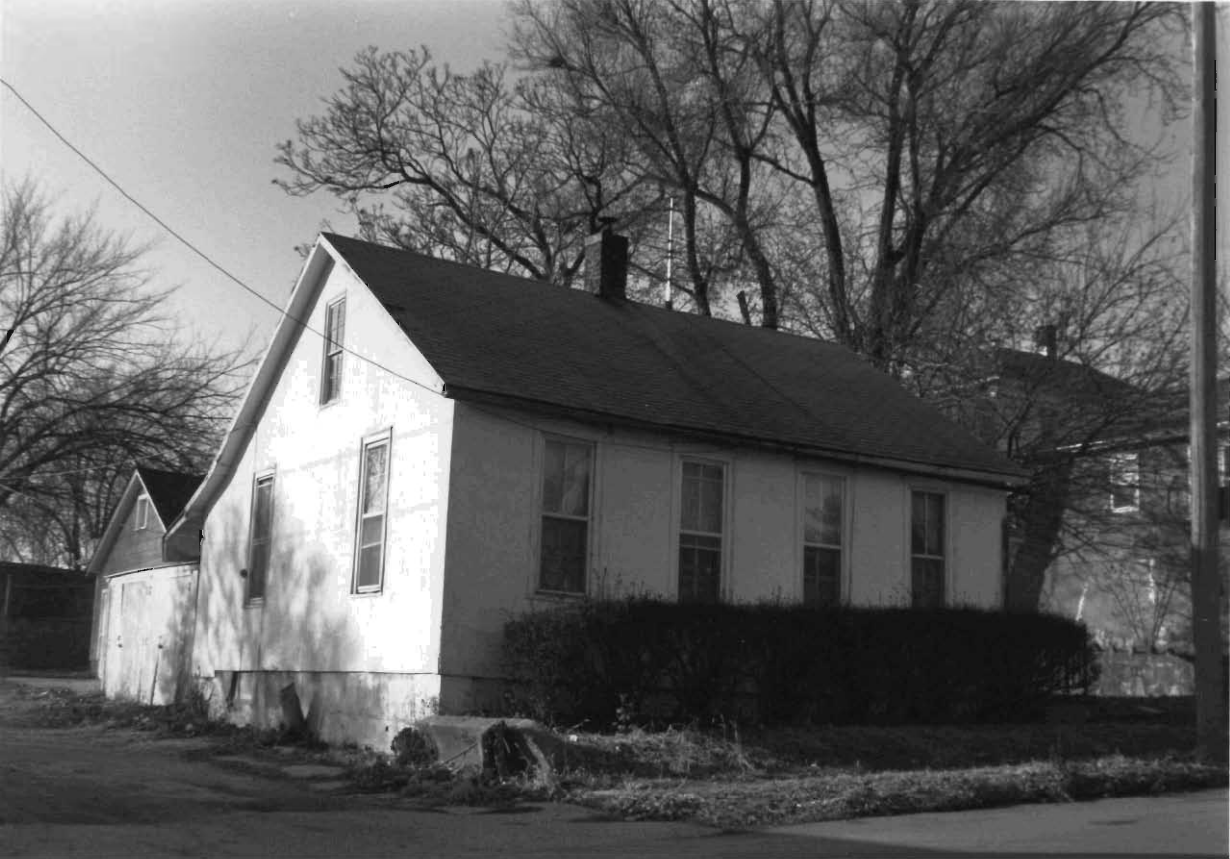
The building retains a good degree of integrity, and is a good example of a late 19th century vernacular house type.

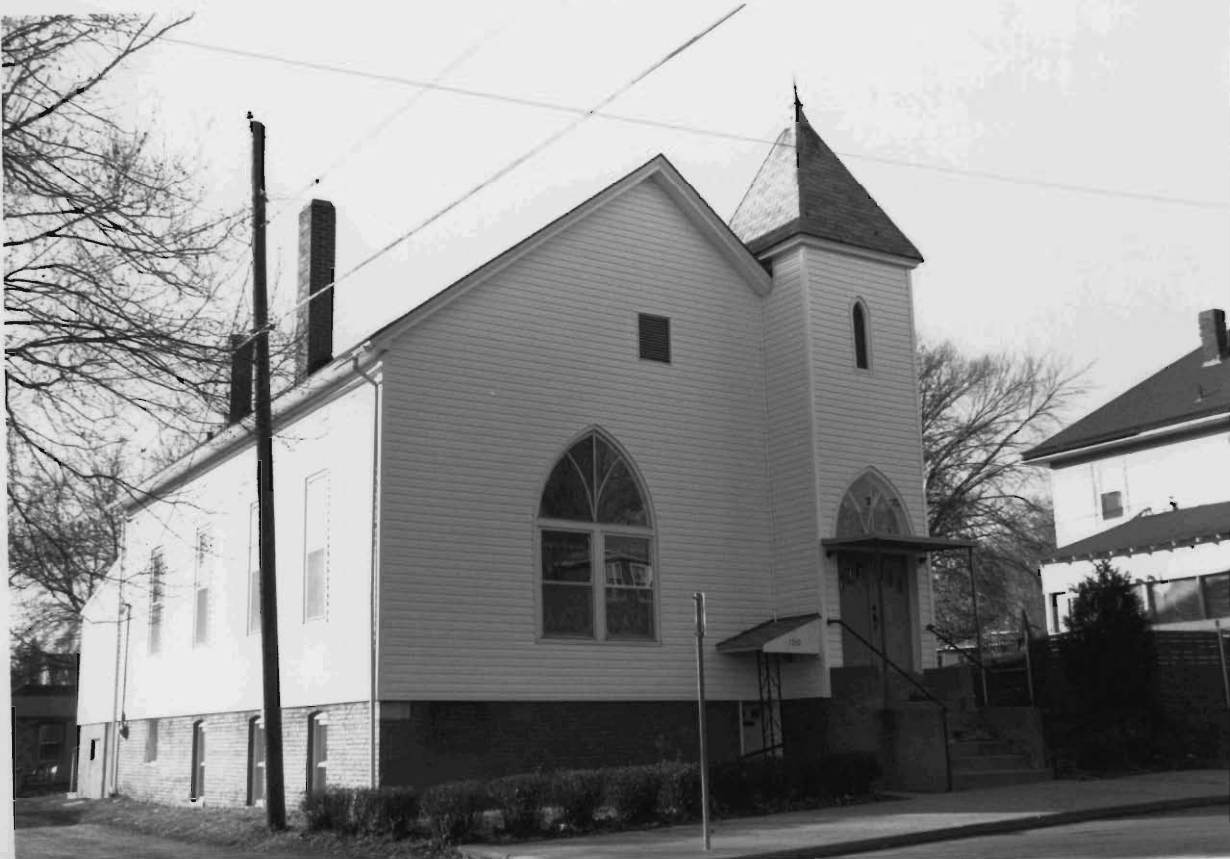
The building retains a moderate degree of integrity, and is a moderate example of a Gothic Revival neighborhood church.

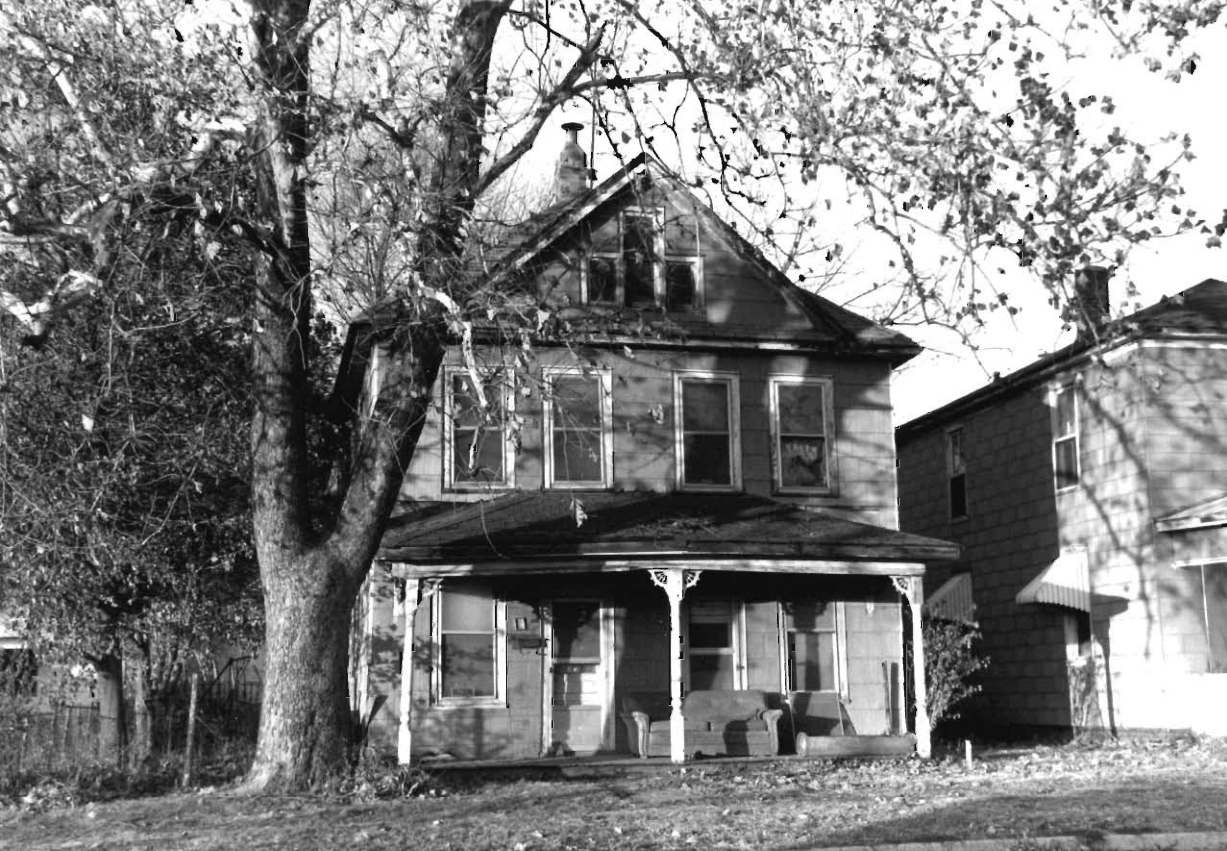
Exterior condition: Deteriorated Endangered/by what?: Yes; neglect, vacancy; bordering industry

Description of Environment and Outbuildings: A deteriorated metal shed roof garage and storage building is to the rear of the property. A parking lot connected with 1401 and 1403 Mitchell is to the west. The other remaining residential property is adjacent to the east. Across the street is a broad semi-truck parking lot.

Entrances with large light paneled doors and transoms are central with 1/1 double hung sash in the end bays. Nearly full-facade hipped roof porch is deteriorated. Turned posts rest on low wood floor near ground level. Steamboat style side brackets. Four 1/1 sash are on the second floor with wood surrounds and drip molds. Gable wall dormer has full return. Short fixed sash flank a central 1/1 double hung sash. Regularly spaced elevation fenestration with first and second floor doors at the rear of the east elevation; stairs to access second floor door are completely deteriorated and unusable.

The building retains a fairly high degree of integrity given its current poor condition. It is a good example of a turn of the century vernacular house type.

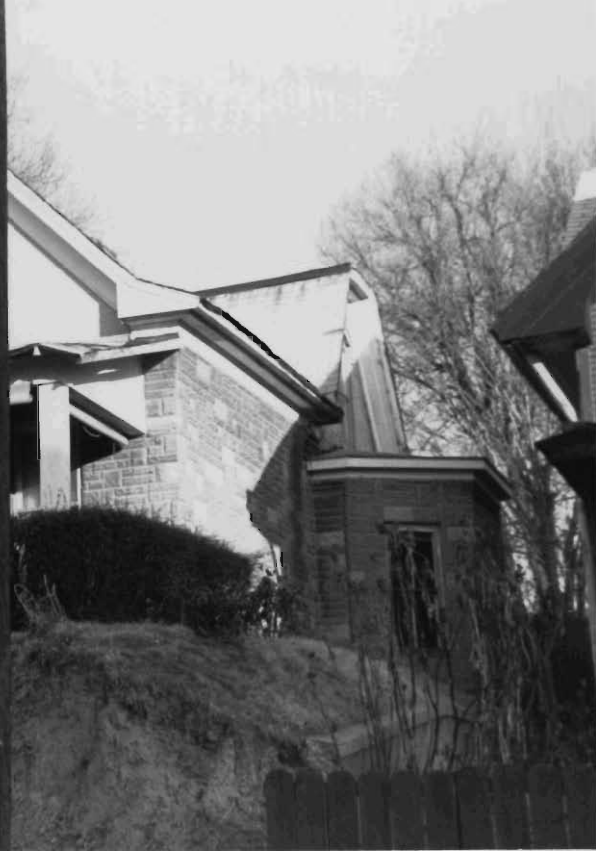
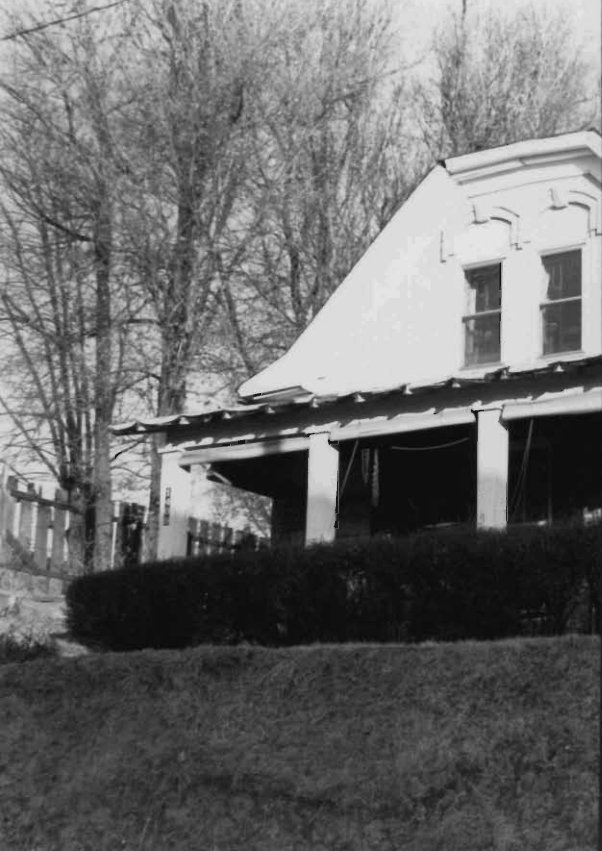
BN-15008-156

Similar in plan and detailing to 1401, but altered with artificial siding. The first floor has a "stone-look" artificial siding, but the upper floor remains brick. Left bay entrance, with two 2/2 double hung sash in the second and third facade (south) bays. Shed porch nearly full-facade with wood posts on brick pedestals, an early 20th century alteration. Above in the upper story, as on 1401 Olive, is the original window treatment of a single rowlock segmental brick arch with a drip mold, drops, and central keystone. Replacement sash here, however, resulted in partial wood infill here. Lower rear wing. Semi-octagonal bay with 2/2 double hung sash on right (east; mirroring the plan of 1401) with a two-sided steep Mansard-like wall dormer above with an original window (single 2/2 with segmental arch). A brick chimney toward the rear of the house has been cut off.

The building retains a fairly high degree of integrity. It is a significant example of French Second Empire influenced architecture, particularly with the adjacent dwelling of similar design.

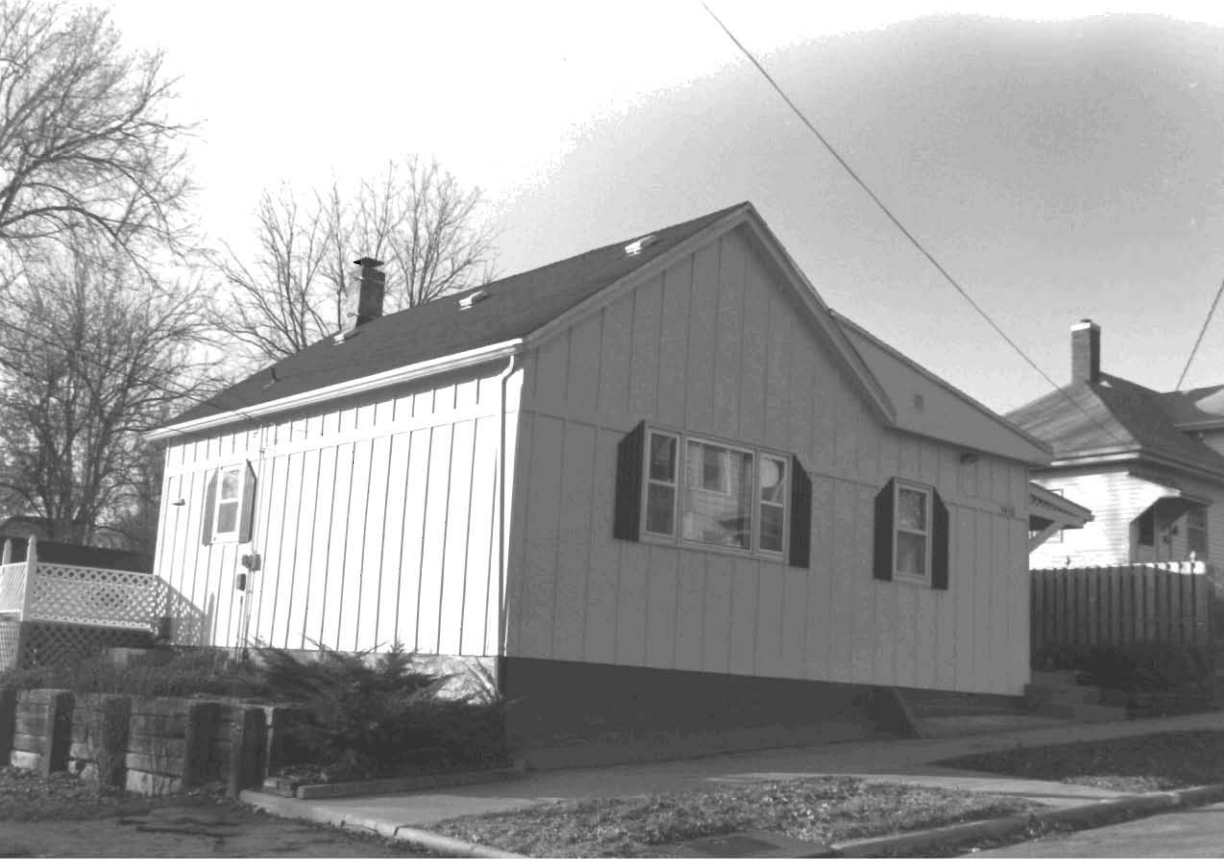
Completely altered. Refaced concrete foundation. Modern replacement window sash. Vertical wood siding. Rear deck.

The building retains a low degree of integrity, and conveys only a minimal sense of time and place through its form.

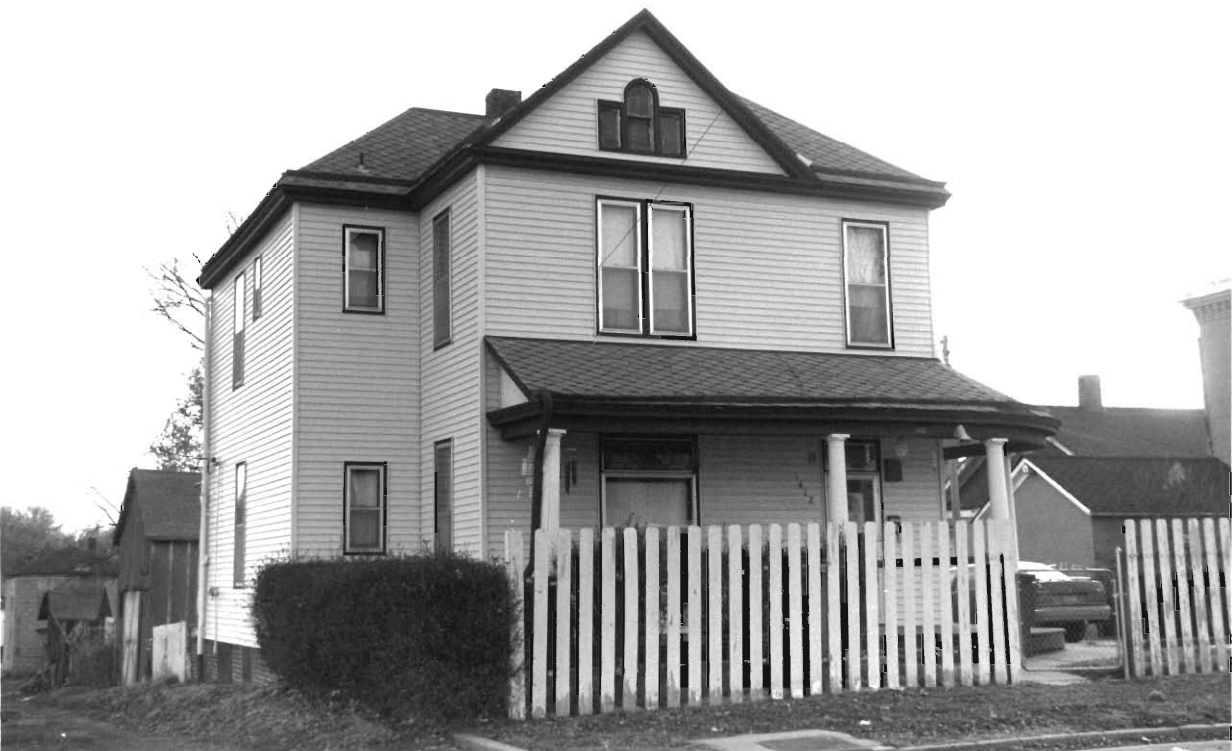
BN A-006-175

Front door in deeply recessed right bay of facade near front reentrant angle. Another entrance in right bay of front block. Front porch extends across gable front and along the west side to the recessed right bay. Five Doric columns on brick pedestals support hip porch roof with rounded northwest corner. Wooden porch floor. Full returns and Palladian windows in front and west-facing gables. Transoms above doors and leaded, stained glass transom over first-floor window in left bay of gable front. Narrow plain wooden surrounds on windows and doors. Chimney at apex of roof toward rear of building. Rear wooden porch on brick supports with hipped roof and awning on west side.

The building retains a fairly high degree of integrity despite artificial siding. It is a good example of a late 19th century Queen Anne influenced residence, and is significant with Tanner's other dwelling and summer kitchen at 1203 S. 14th Street.

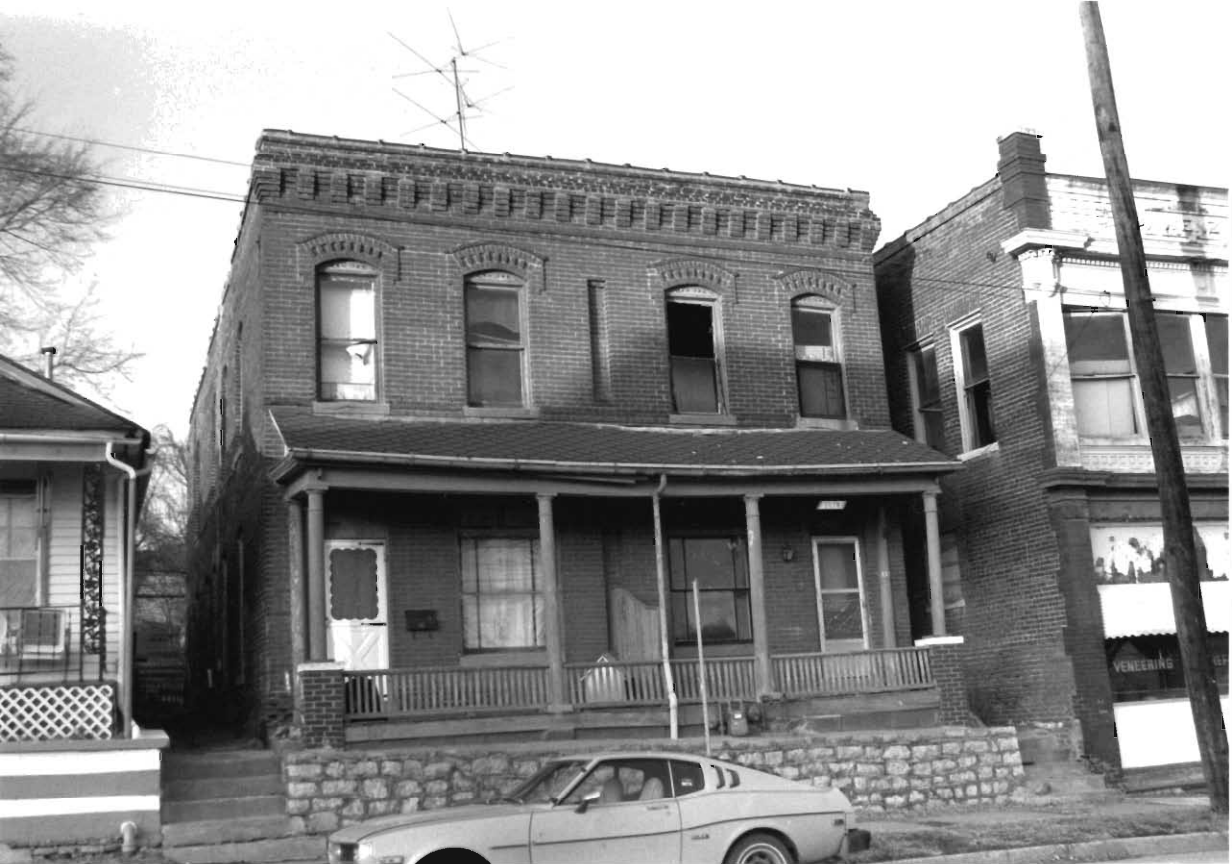
BUAS 106-129

An exceptionally detailed duplex in great need of maintenance. At least one downstairs space is occupied, but second floor spaces (whether separate units or still in duplex form) appear inhabitable given the condition of the upper floor windows, many of which are missing. Combines with adjacent commercial buildings to make an exceptional and significant turn of the century grouping within this survey area.

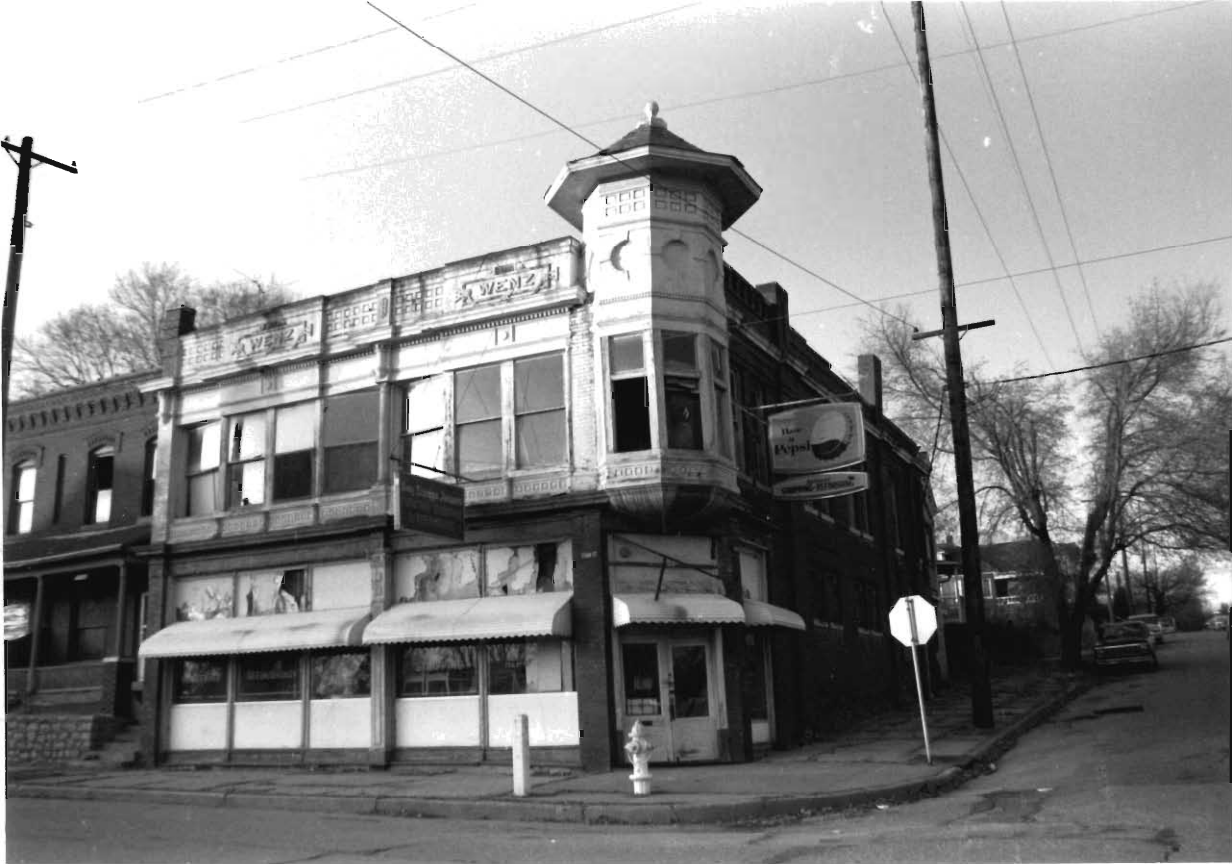
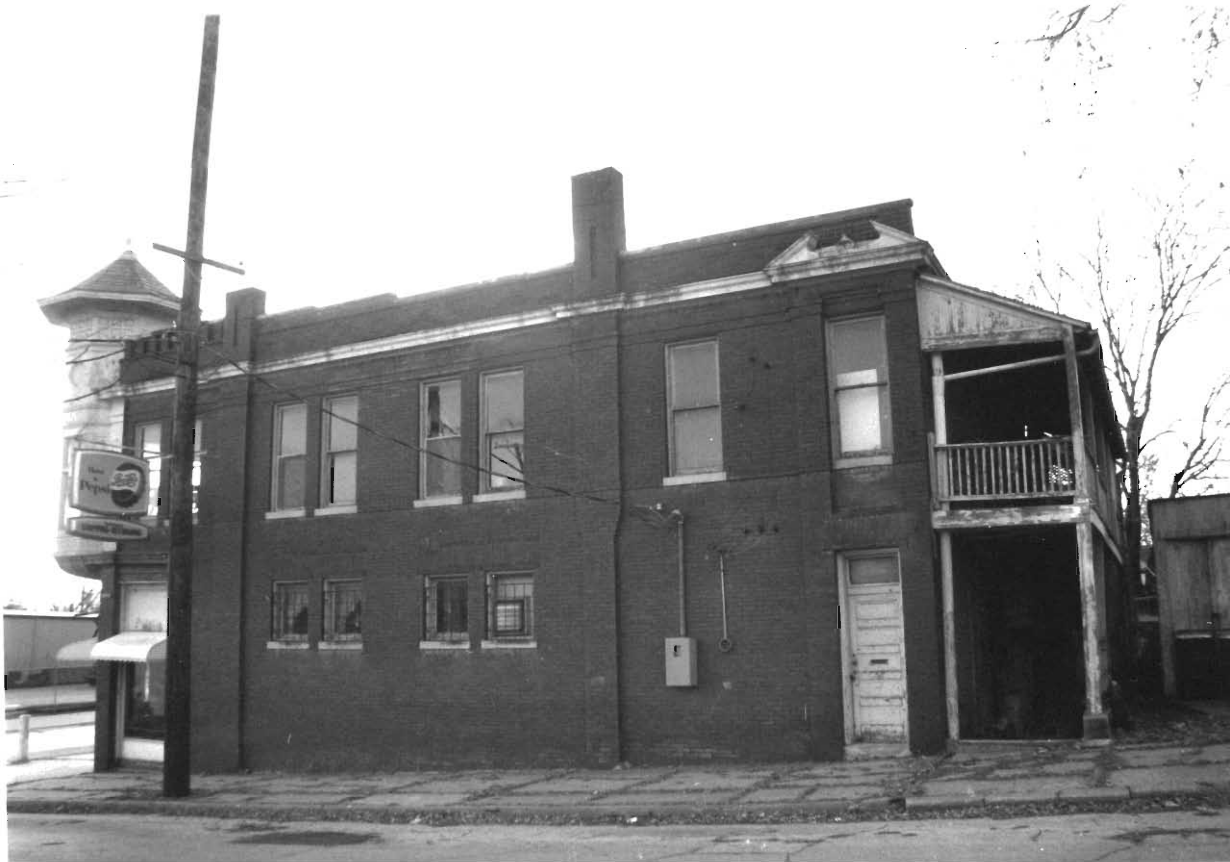
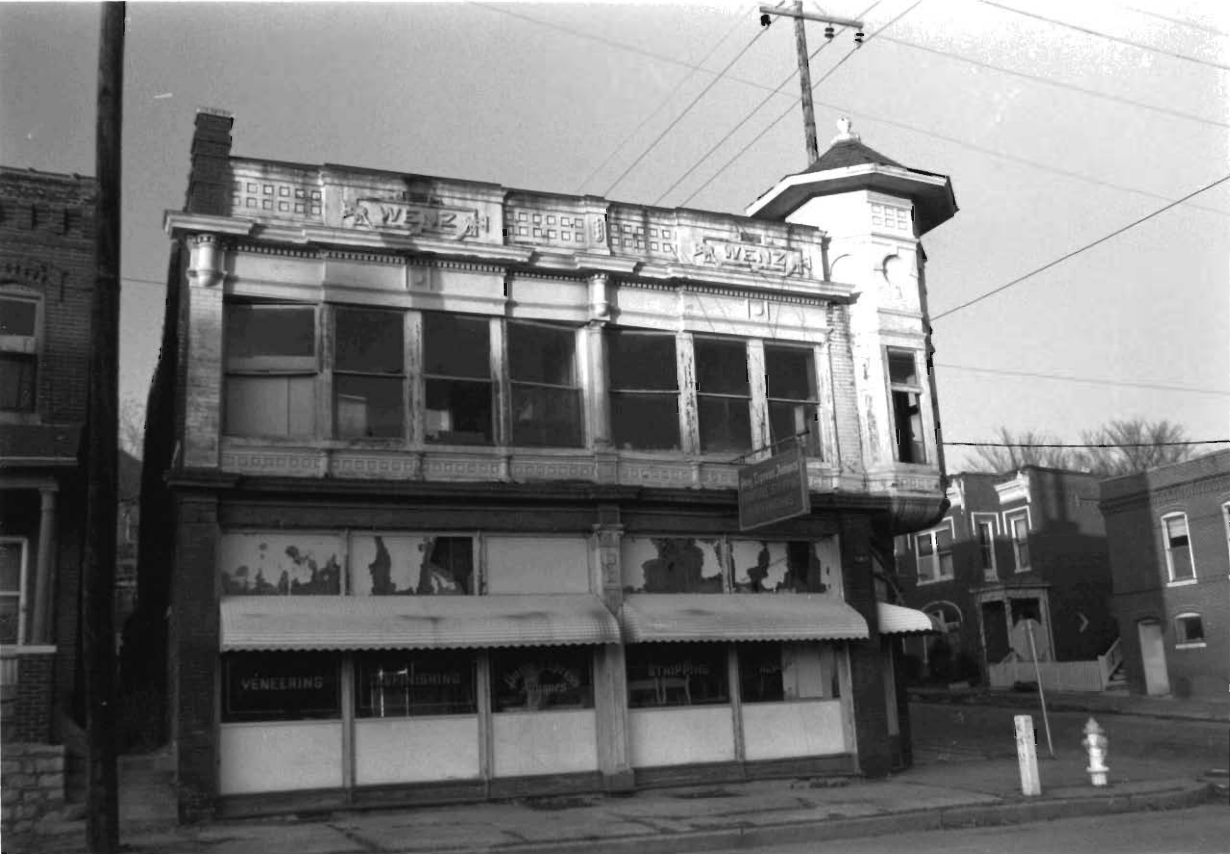
Exceptional Queen Anne corner commercial building. Red brick end piers on first floor with off-center to right (east) Corinthian iron pilaster creating two bays. Low wood bulkheads. Wood panels above these, a later (modern?) infill, with shorter fixed sash above with secondary transoms covered by a curved aluminum awning on each bay. Three window units left; two right. Broad transoms above awning; mostly broken with wood panels behind. Thin round wood "columns" separate these window panels through to the top transom. A metal cornice is above these bays projecting more at the corners and at the pilasters.

Entrance on the chamfered southeast corner with double large light doors, aluminum awning, and tall boarded transom. Elaborate 1-1/2 story hexagonal metal Oriel above with missing double hung sash; square transom above. Same square patterning and denticulated cornice as to the left on the Penn St. facade (south) Four boarded oculus windows with four keystones on each. Square cornice as to left, but taller with hexagonal hip roof with ball finial.

An exceptional commercial building in dire need of property maintenance/repairs before its integrity is effected. A significant example of Queen Anne style architecture used on a commercial building.

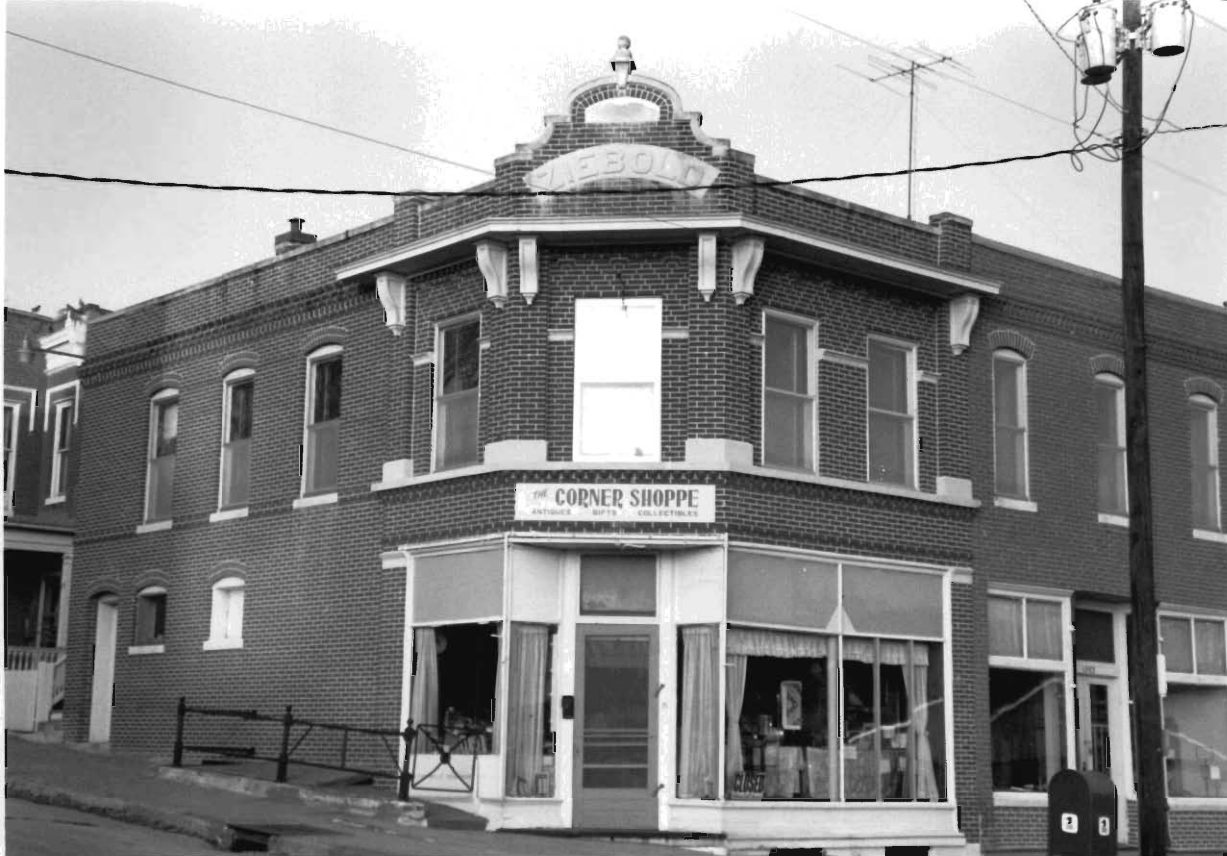
BN-AS 608-181

The building has been altered by sandblasting, but otherwise retains a very high degree of integrity. It is a significant contribution to a Penn St./S. 15th grouping of commercial buildings and a related residence.

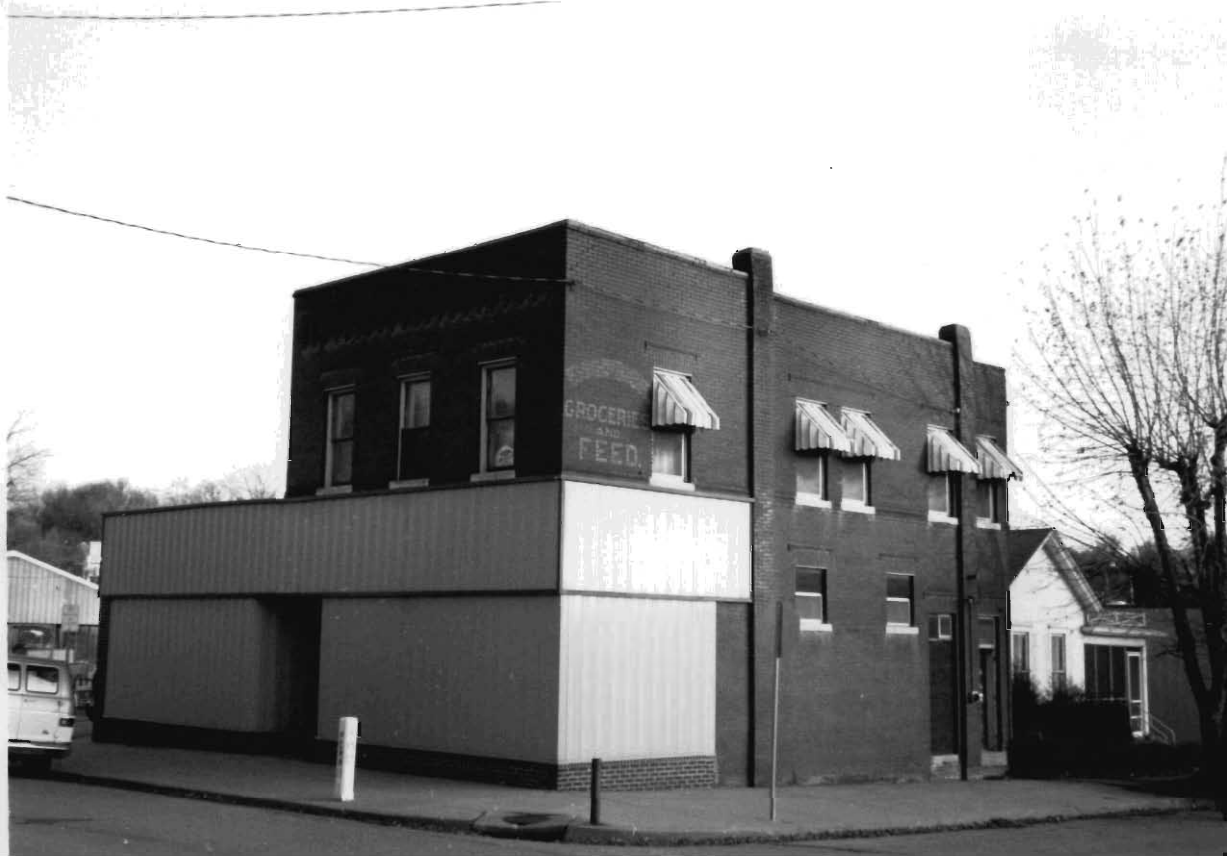
Overall, the building retains a moderate degree of integrity, with the entire second floor intact, and part of the west elevation intact; the first floor facade is altered, but this may be just a facing. The building is historically significant as it relates to this Penn Street commercial grouping.

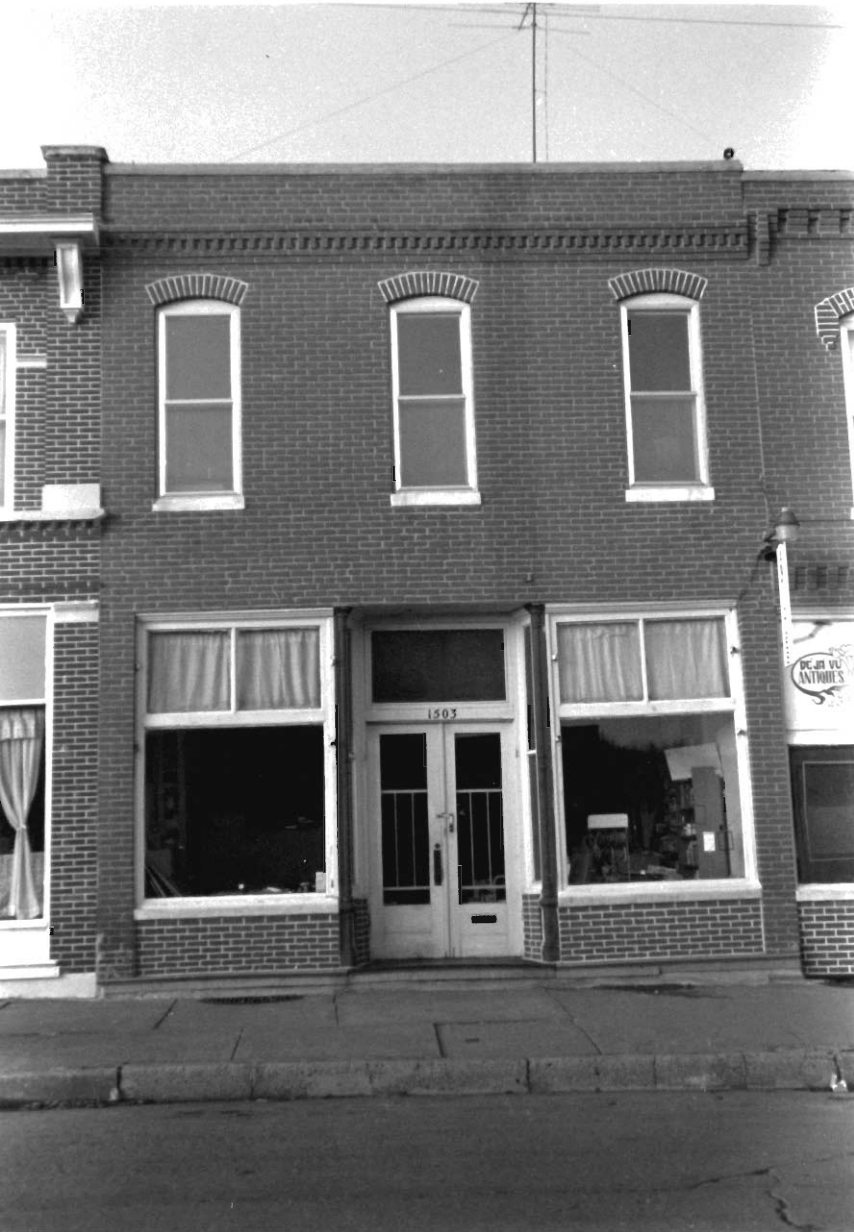
1503

Altered by sandblasting and improper tuckpointing.

The building retains a high degree of integrity, and is a significant contribution to a Penn St./S. 15th St. grouping of commercial buildings and a related residence.

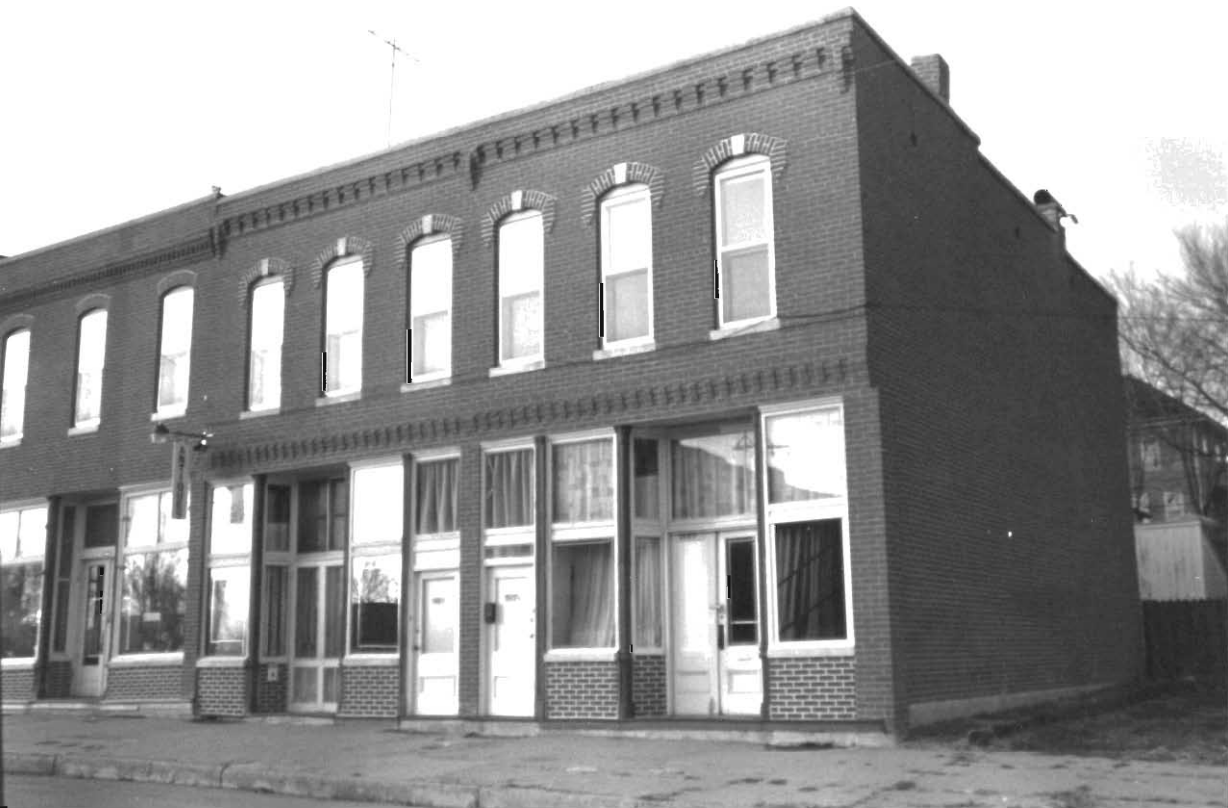
Altered by sandblasting and improper tuckpointing.

The building retains a high degree of integrity, and is a significant example of turn of the century commercial architecture which contributes to a Penn St./S. 15th St. grouping of commercial buildings and a related residence.

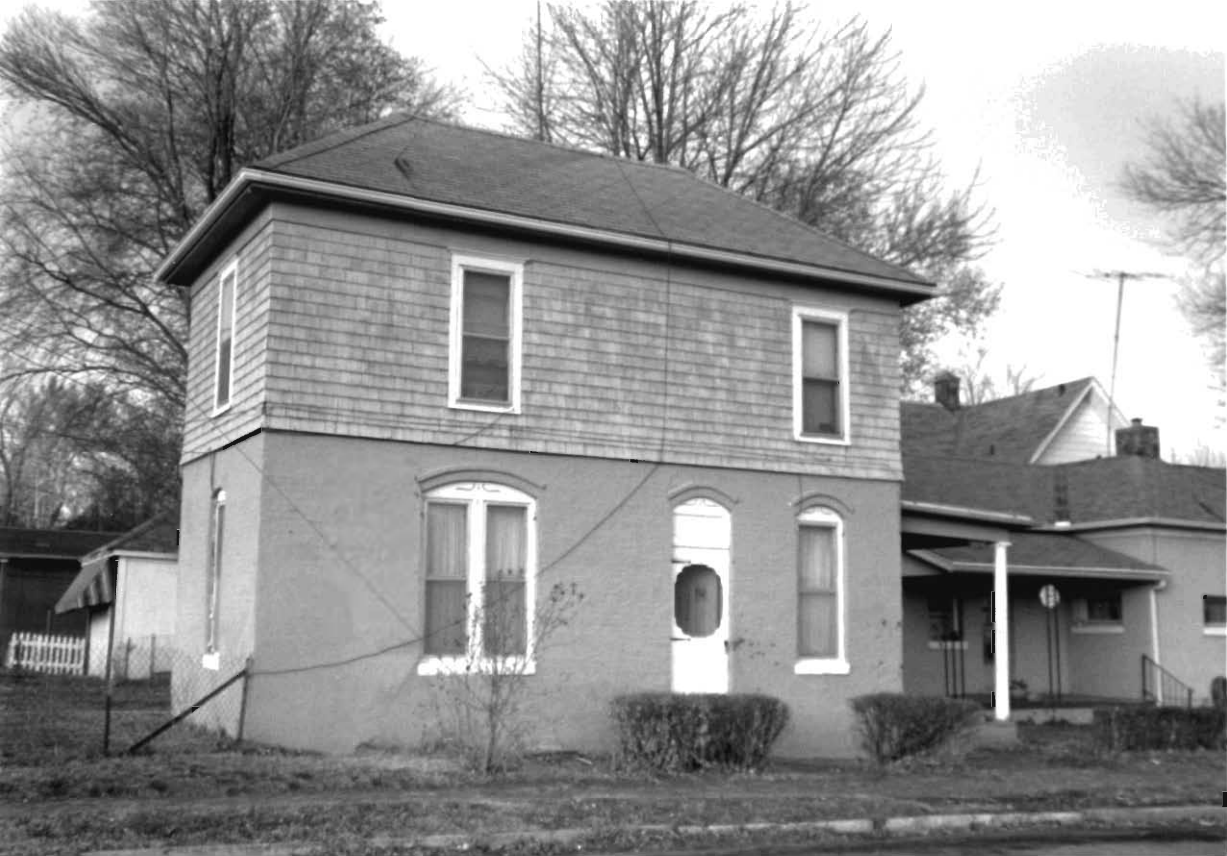
PA 1500-135

The building retains a very high degree of integrity. It is a good example of a mid-late 19th century vernacular dwelling, and is particularly interesting with its contemporary to the east on this lot.

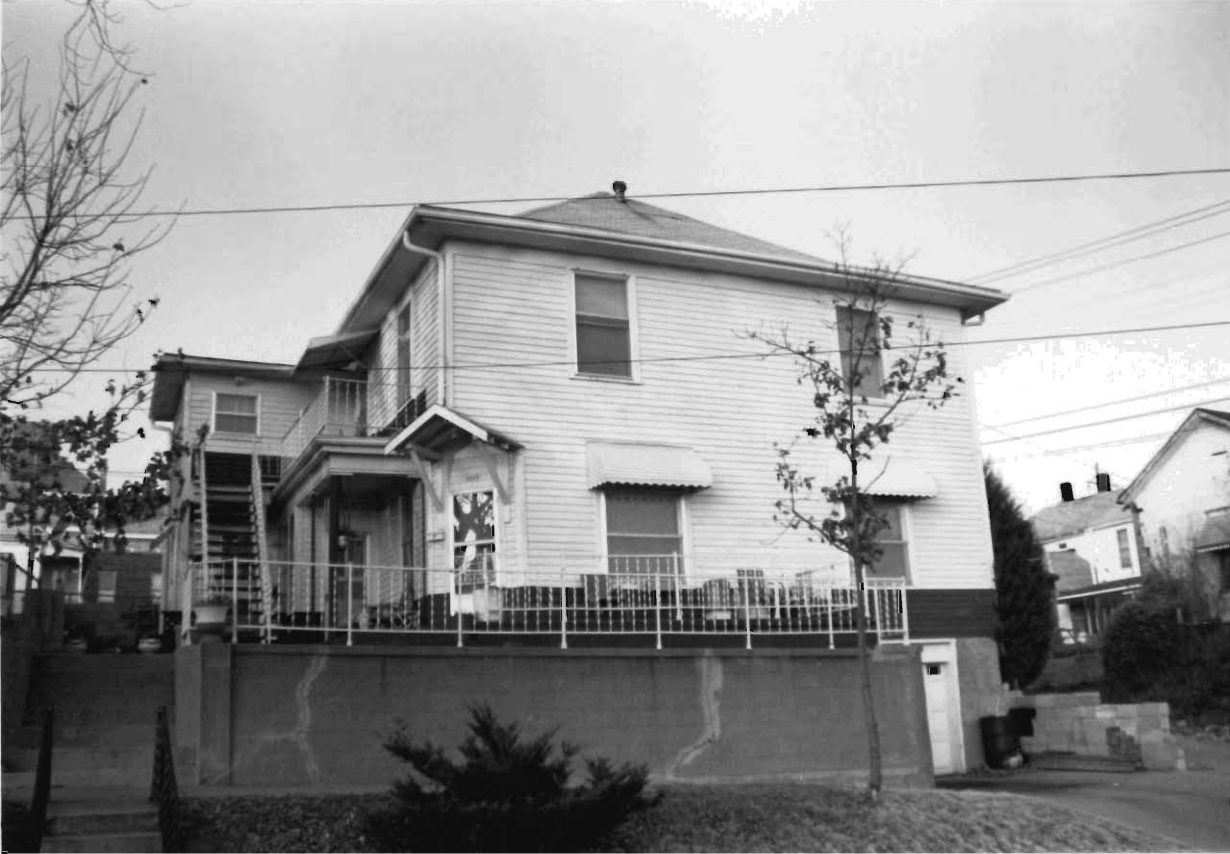
The building retains a fair degree of integrity, and is a fair example of a turn of the century vernacular house type.

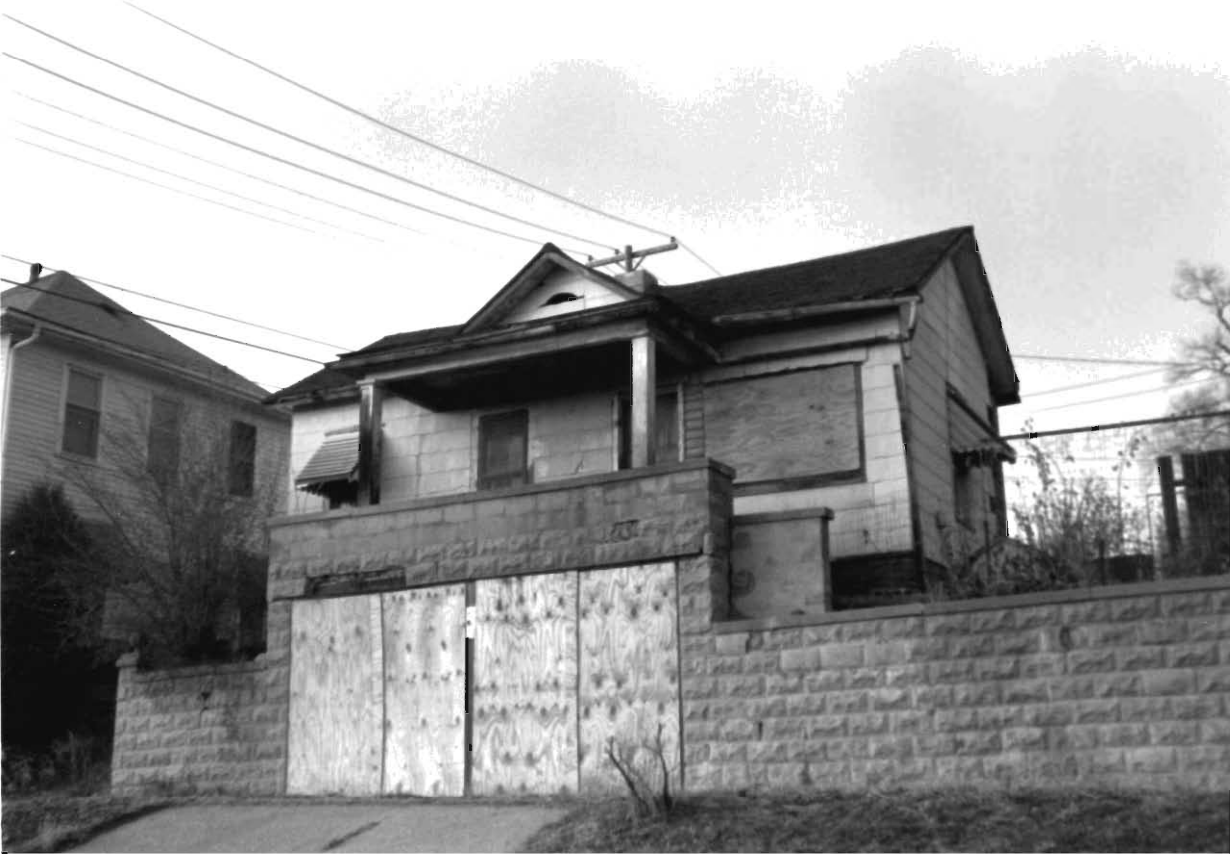
BN A5008-167

Exterior condition: Extremely bad Endangered/by what?: Yes; "red tagged"

The building retains a moderate degree of integrity given its current condition, but is a good example of an early 20th century vernacular house type.
