Architectural/Historic Inventory Survey Form

St. Joseph PENN Survey

Address: 603 South 14th Street Roll/Frame: 5/29, 9/19

Prepared by: The URBANA Group (Gallagher) Date: 12/91

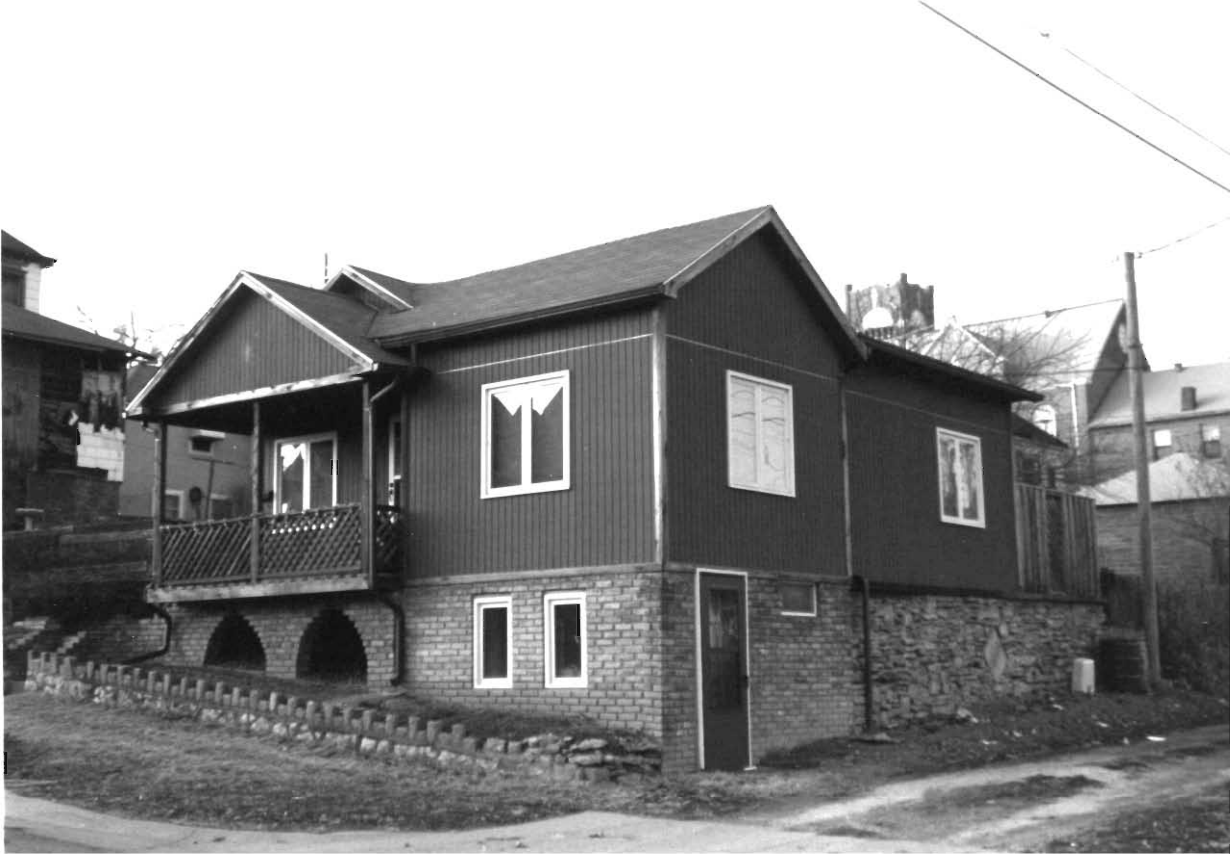
Completely altered with modern fenestration (casement and patio doors). Foundation appears to be faced with modern brick. Modern lattice porch "wall." Modern wood vertical siding. Low front retaining wall--random limestone with crenelation made of red sandstone pavers. Stacked limestone former retaining wall (?) now serves as foundation for rear addition and deck. Not recognizable as a historic house.

The building retains a low degree of integrity, and no longer appears as a historic building.
