Reconnaissance Survey of the Depot District and Old Town Neighborhoods

Kirksville, Adair County, Missouri

Owen & Eastlake Ltd

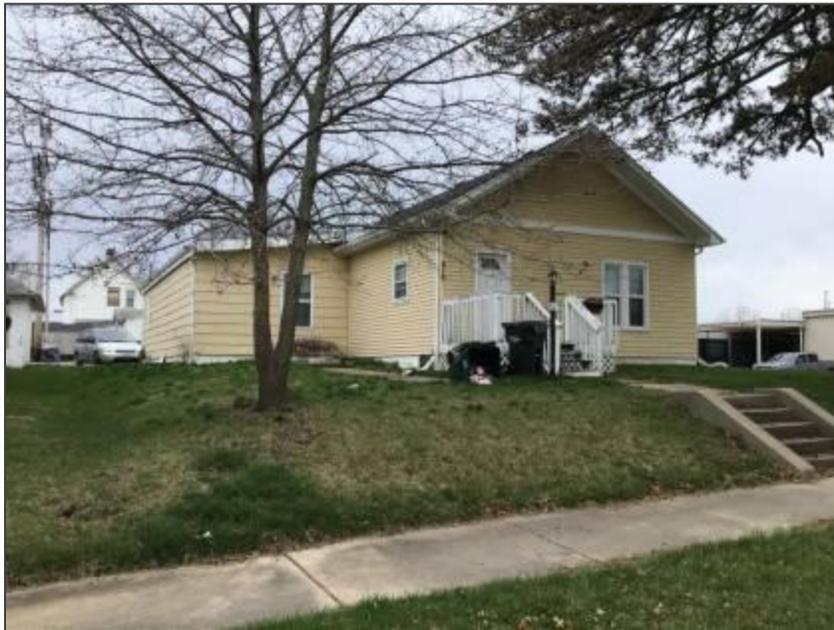
The gable front type is a simple housing form found in many regions of the United States. This type arose as a folk housing form earlier in the nineteenth century and remained popular as railroads brought mass production and standardization to the building industry. In Kirksville, earlier subtypes include simple one-story gable-front houses or two-story examples. Kirksville examples commonly have a front porch with a shed, hipped, or gabled roof. Kirksville also has examples with a recessed front porch incorporated into the main roofline. In Kirksville, before about 1905, smaller one-story examples of this house type either had little or no stylistic detail, or had modest classically-inspired or Victorian/Queen Anne detailing. Larger two-story examples were larger and more expensive homes, and were often adorned with more detail. After 1910, the one-story version of this house in Kirksville often takes on forms and detailing of the Craftsman style, including lower roof pitches, overhangs, exposed rafter tails, and knee braces. A small gable-fronted Craftsman bungalow, usually with a gabled front porch, is probably the most common pre-1930 Kirksville housing type, appearing all over the city's older residential areas.

Figure 17. A gable front house at 615 North Elson Street.

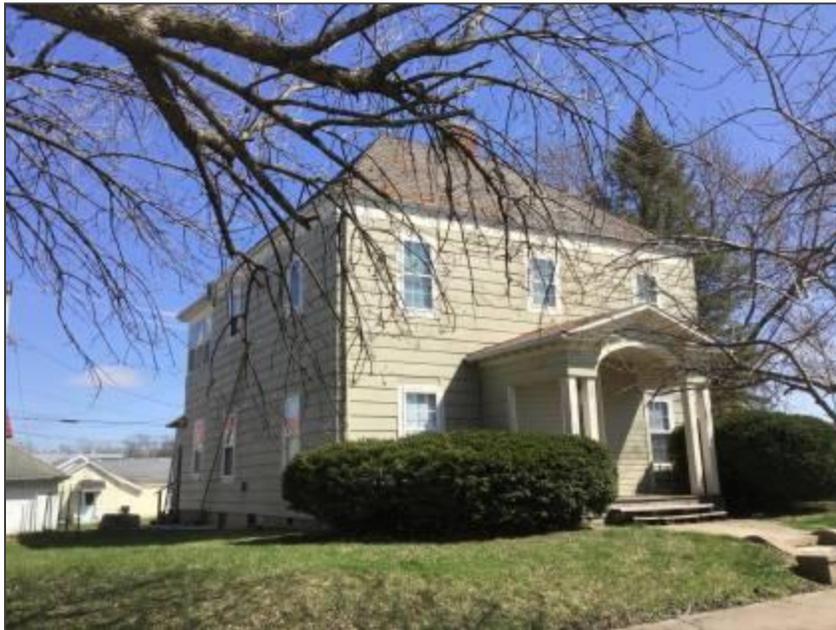
In a more narrow sense, this simple folk housing form is a one-story house with a side-gabled roof and an entrance in the center of the facade. The houses are two rooms in width, and the main gabled portion is one room deep, often with a shed-roof rear wing addition. The type originated as a traditional English housing form and was common in the southeastern United States during the pre-industrial era. The “central passage” term is also used in this study to denote any one or two-story house with a central front entrance that is at least two rooms wide, and that does not fit into any of the other major housing types/categories listed in this study. Kirksville has some simple examples of early vernacular examples of the more narrowly-defined central passage type, as well as many later examples of houses that fall into the wider category.

Figure 18. A center passage form house with Colonial Revival porch.

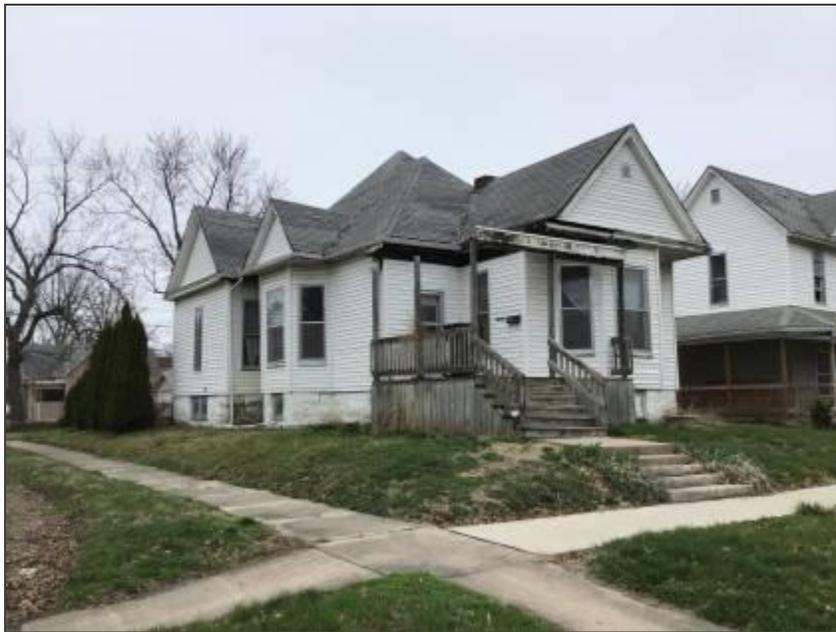
Queen Anne represents both an architectural style and an approach to house planning and layout. The style and form are inspired by Medieval architecture and emphasize complexity and asymmetry. The house facades often feature elements such as three-sided bays, turrets/towers, and varied window shapes and sizes. Ornament consists of contrasting textures and shapes, including use of both wood siding and shingles, as well as shaped claddings like fishscale shingles. Other ornament includes porch ornaments like spindles, scroll-saw tracery, and turned posts. Examples can be one or two stories tall. Kirksville has a number of typical asymmetrical examples with turrets, bays, and gables projecting out from a central hipped roof. The city also has a number of distinctive examples that have symmetrical facades with multiple three-sided bay windows and diagonal angles at the corners, giving an octagon-like effect.

Figure 19. A Queen Anne form house at 501 East Washington Street.

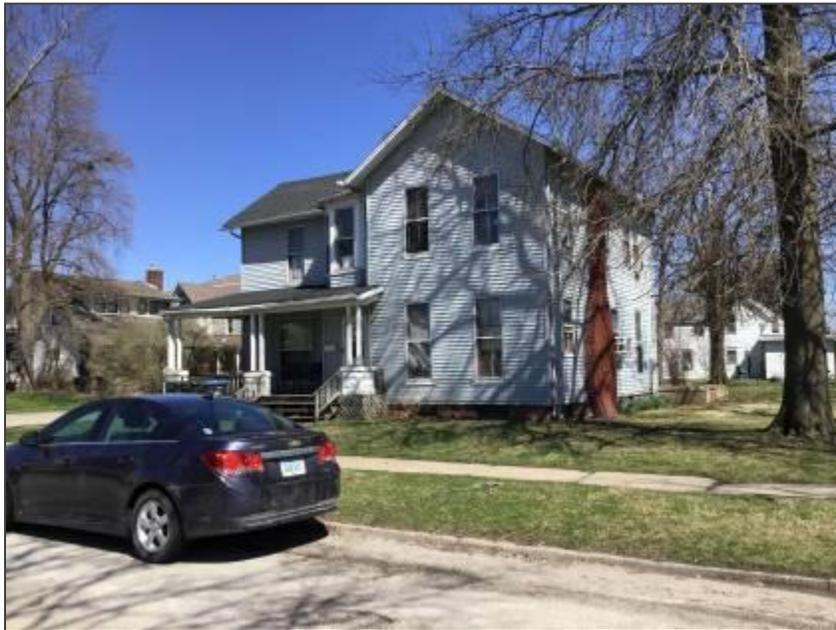
This type of house is typically two stories in height, and has a wider section of roof, often hipped or cross-gabled, at the rear, and a narrower section of gabled roof on the front. The facade is then composed of the main gabled section and a recessed area on one side. A porch is often placed in front of the recessed area. These houses are common in densely developed cities in the Midwest. The format was used by builders at the end of the nineteenth century and in the early twentieth. Stylistically, these houses may be plain folk-style examples or reflect a range of historical styles from Italianate to Queen Anne to Colonial Revival. Kirksville examples tend to be plain in design or reflect Queen Anne, Neoclassical, or Colonial Revival stylistic influence. In Kirksville, this format becomes less common after about 1910, supplanted by newer housing formats like the American Foursquare.

Figure 20. Gabled-ell form house at 301 South Florence Street.

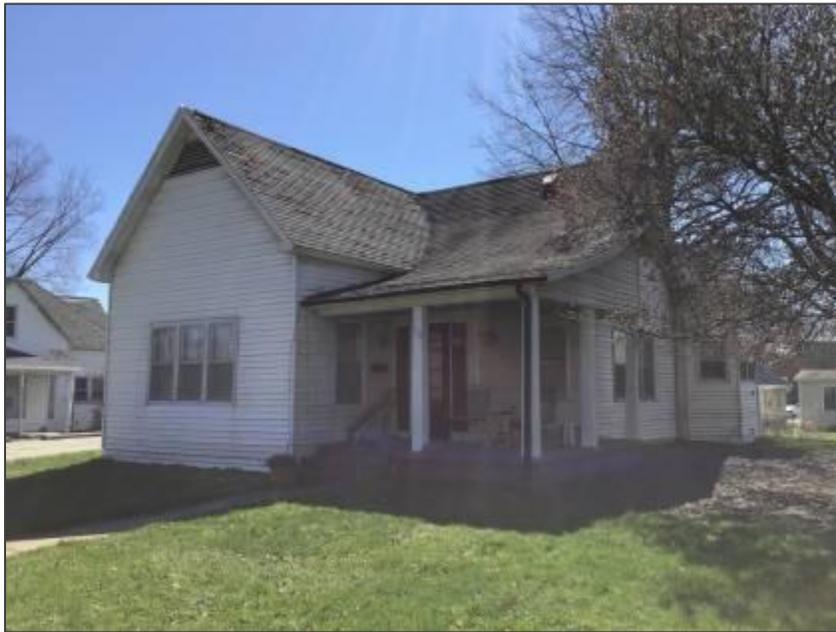
Like the gable front housing form, the gable and wing type also had origins in pre-industrial times and appears in many locations throughout the United States. The form consists of a typical gable-front house that also has a side-gabled wing, placed to the right or left. This is one of the most common housing types for pre-1910 Kirksville, with examples seen throughout the project survey area. Kirksville examples commonly have a front porch with a gabled, hipped, or shed roof. Examples tend to have little or no stylistic detail, or have somewhat sparse elements of Victorian/Queen Anne detailing, which often takes the form of porch features such as spindles or turned posts. However, Kirksville also has several examples of this housing form with more elaborate high-style Queen Anne or Carpenter Gothic detailing. Pre-1915 Kirksville housing features both one-story and two-story examples of the form, although the one-story format seems especially common. In Kirksville after about 1915, it appears that the one-story version of this small house type was largely replaced by the gable-front Craftsman bungalow as the favored small house type.

Figure 21. Gable and wing form house at 701 East Harrison Street.

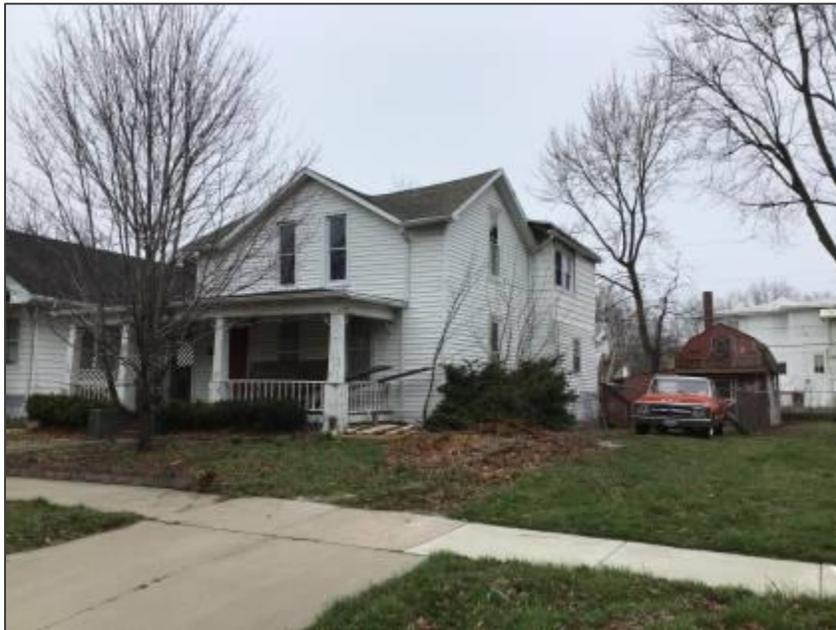
This type is related to the gable and wing type, and consists of a side-gabled house with a symmetrically-placed front-facing gable, and a central entrance under the gable. The gable can either be a simple roof gable or can be part of a projecting central front wing. Like the front gable and gable and wing types, it has origins in pre-industrial folk housing. This type was mostly built before 1920 in Kirksville and is not as common as the much-favored gable and wing format. There are two major Kirksville variants of this type. The first variant is a full two-story side-gabled house with a gable and entrance in the center of the facade. The second common variant is a house with a full first story and a shorter second story partially or fully accommodated under the roofline. The central roof gable provides additional space for the partial second story. Examples of both subtypes are plain or have modest Victorian/Queen Anne detail. The one-story version of this format was largely supplanted after 1915 in Kirksville by the gable-front Craftsman bungalow.

Figure 22. Center gable form house with Craftsman porch details.

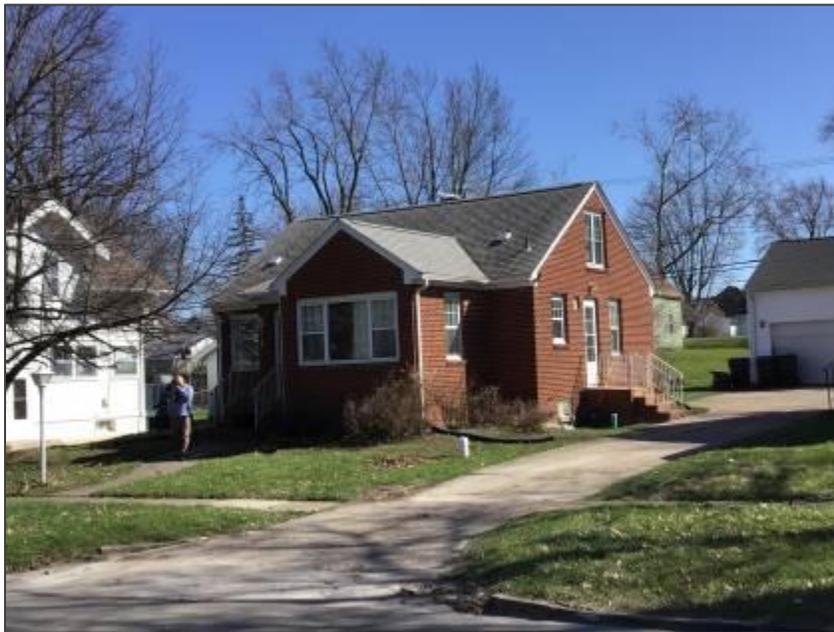
This type of house originated with the need for budget-cutting in house construction during the lean years of the 1930s and World War II. These houses are typically simplified and stripped-down versions of the Colonial Revival and Tudor Revival houses popular in the 1920s. The homes usually feature relatively low roof pitches, and the roof designs tend to lack the broad overhangs seen in earlier Craftsman and Prairie housing stock. These features give the Minimal Traditional style a somewhat clipped, boxy appearance. The houses are usually side-gabled or cross-gabled in format, although Kirksville also has a few hipped-roof versions. These houses are usually plain with very little stylistic ornament, although a few simple details such as Colonial porch columns are sometimes included. Kirksville examples of this style typically date from 1945 into the 1950s, and are similar to examples found in other areas of the United States that experienced postwar-era development. The format was a slightly more traditional alternative to the Modernist-inspired postwar Ranch house.

Figure 23. Minimal traditional form house at 904 East Washington Street.

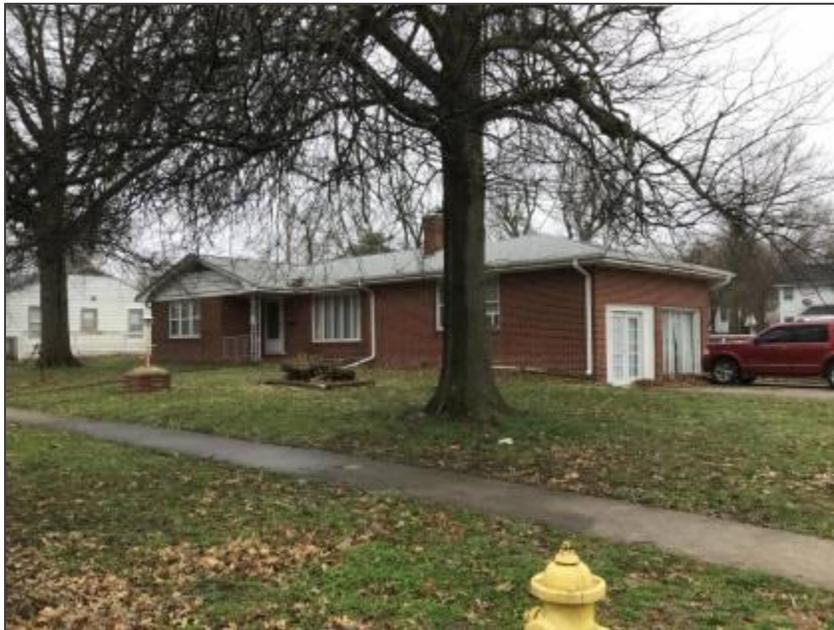
The ranch house is a one-story home characterized by plain design with little ornament, low rooflines of hipped, side gabled, or cross-gabled design, and a low, horizontal, sprawling format. The ranch house evolved in the 1930s from a combination of Modernist influences and western vernacular house types. Its simplicity, informal character, and ease of construction made it a favorite housing type for postwar real estate developers. A modest number of ranch houses are found in the survey area, and many were infill houses that occupied vacant lots left over in older residential subdivisions after World War II. Kirksville's ranch house examples in the survey area are fairly typical of ranch house construction in the postwar Midwest. Both brick and wood frame ranches exist in Kirksville. Although most examples are plain and fairly utilitarian in design, sometimes a few Colonial Revival or Mediterranean features were incorporated into the exteriors.

Figure 24. Ranch house form at 907 East Washington Street.

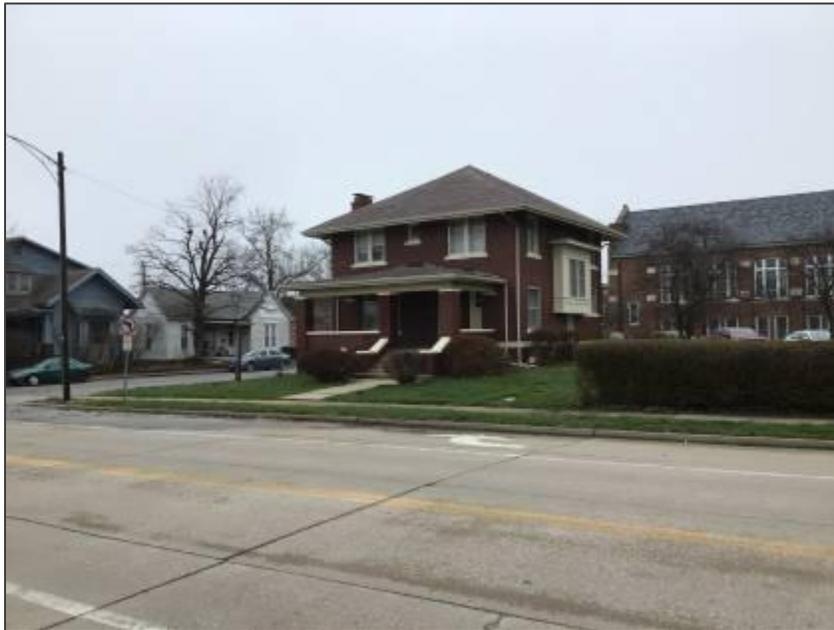
This housing type is common all across the United States in areas that saw development from about 1900–20. Examples of the type are two-story houses with box-like proportions, low horizontal lines, overhanging roofs with dormers, broad one-story hipped-roof front porches, and largely symmetrical facades. The foursquare form was influenced by the simplicity and horizontality of Frank Lloyd Wright’s early Prairie-style architecture, and this housing format is considered distinctly American due to its Wrightian origins. Examples in Kirksville sometimes have little or no ornament, or a few subtle Craftsman details, in sympathy with Wright’s emphasis on simplicity. However, Kirksville examples also exist that have more stylistic detailing, often taking the form of cornice brackets and various designs of porch supports.

Figure 25. An American Foursquare at 301 East Jefferson Street.

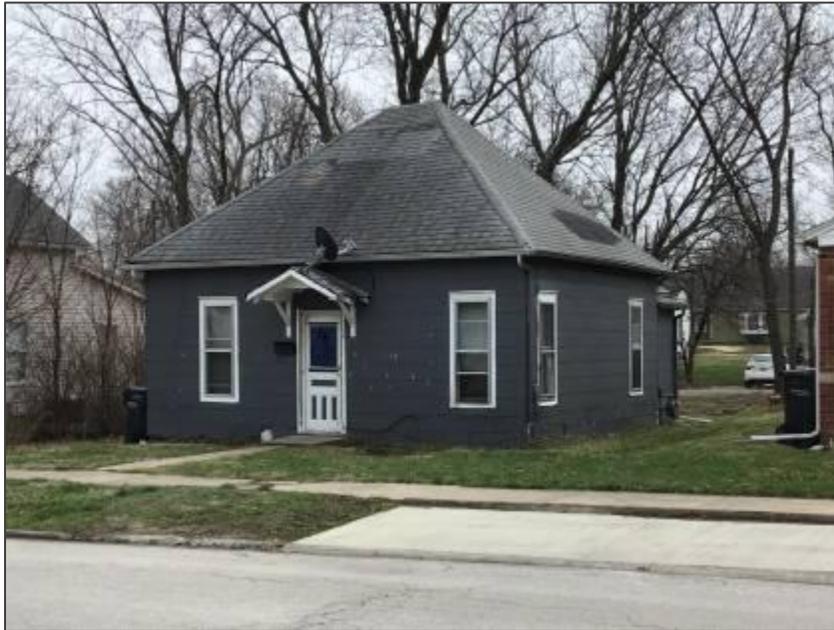
The pyramid-roof housing format usually involves a small house with nearly square proportions, allowing for the roof to take a pyramidal or near-pyramidal form. This is in contrast to the more conventional hipped roof that would cover a house with a longer rectangular shape. This house form originated in the pre-industrial era, but persisted into the twentieth century. The form is most common in the American south and is not seen as much in the northeast and upper Midwest. Its presence in Kirksville may indicate some degree of southern influence in the city's pre-1910 residential architecture. Most Kirksville examples are very small cottages of simple design with little or no stylistic detail and were built before 1920. A few examples were built ca. 1910–30, and they often reflect influence of the prevailing bungalow/Craftsman aesthetic of that era. The pyramid roof form exists in Kirksville but is much less common than the dominant gable front and gable and wing formats seen throughout the city's older residential areas.

Figure 26. Pyramidal roof form at 714 East McPherson Street.

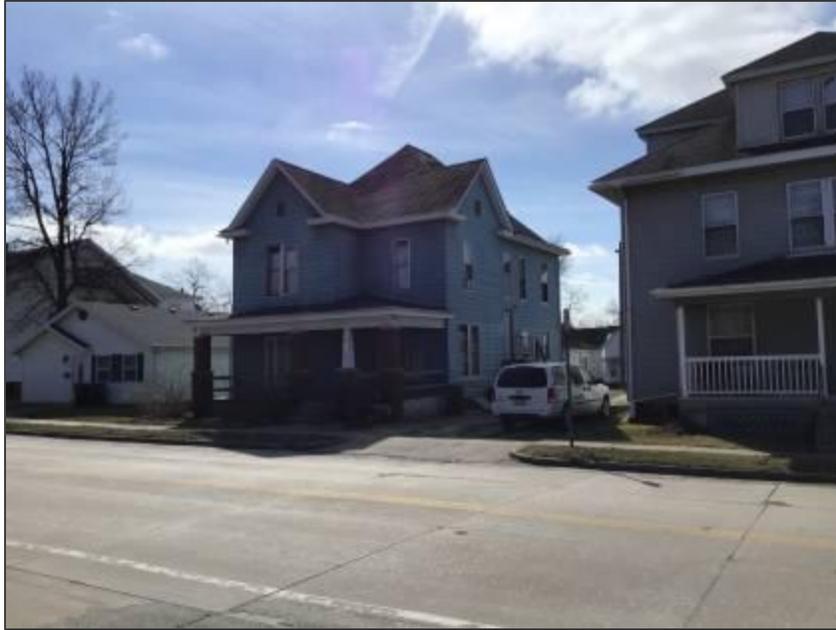
Changes to this style often result in the wrap-around porch being removed. Porch supports and columns are also often switched out, although some high-style examples remain. High-style examples would have turned wood supports, although in some instances classical columns are present.

Figure 32. This Queen Anne style at 308 Jefferson Street has a subsequently added Craftsman porch.

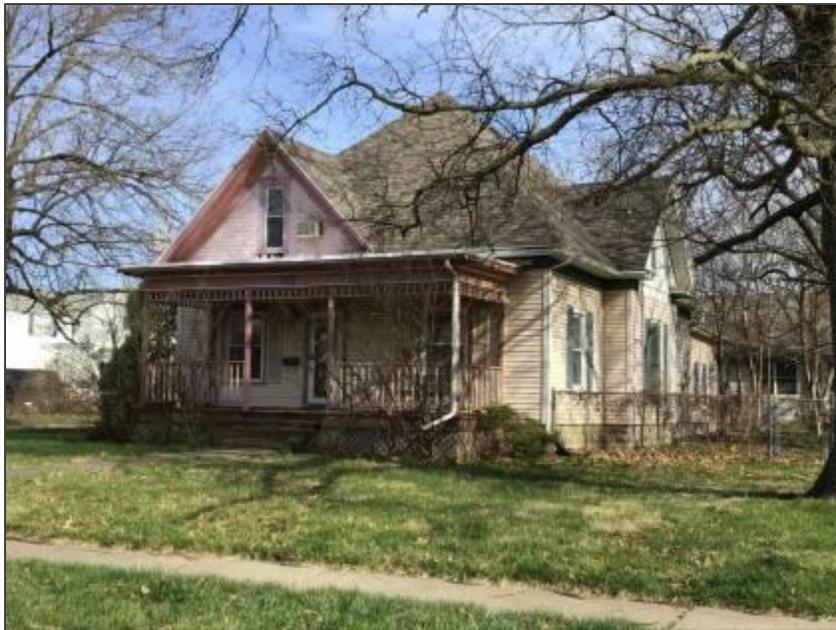
Figure 33. This high-style Queen Anne at 701 E. Harrison Street features an irregular shape and hip and gable roof. The porch features turned wood posts and spindlework.

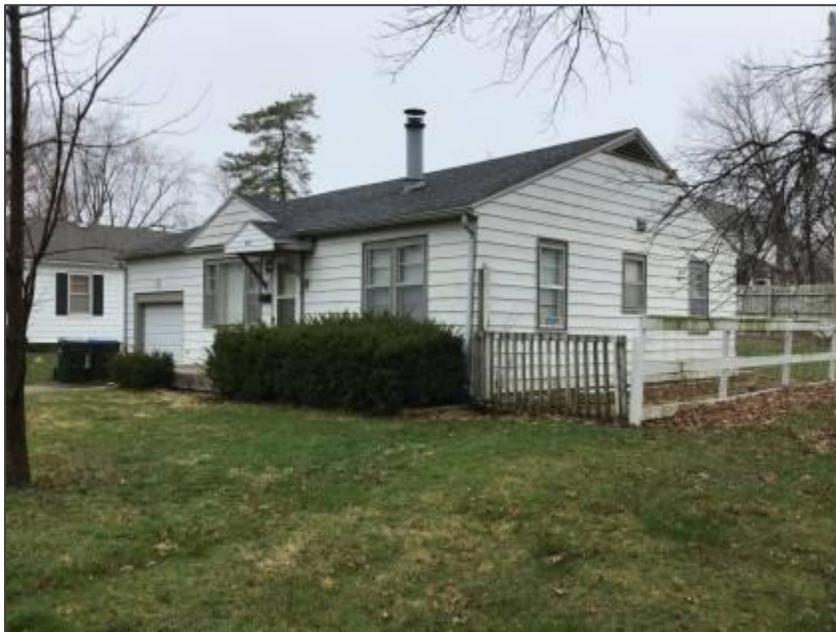
Minimal Traditional house forms are based on Federal Home Administration small house designs from the 1930s. The form was popular from 1935–50. Predominant designs include the Cape Cod and gable and wing forms. The houses sometimes have Colonial-inspired elements and forms, but do not have enough Colonial detailing to be classified as examples of the Colonial Revival style. In Kirksville survey area the Minimal Traditional house was used as the major infill design during the 1940s and 1950s. In Kirksville houses of this vintage often have horizontal two-over-two windows. Porch supports are decorative metal and the porch deck is often poured concrete. The design was aimed at easing production and cost. In some examples the design is based on four-foot increments to allow for less cutting of sheet material.

Figure 34. Minimal Traditional design located at 903 E. Washington Street.

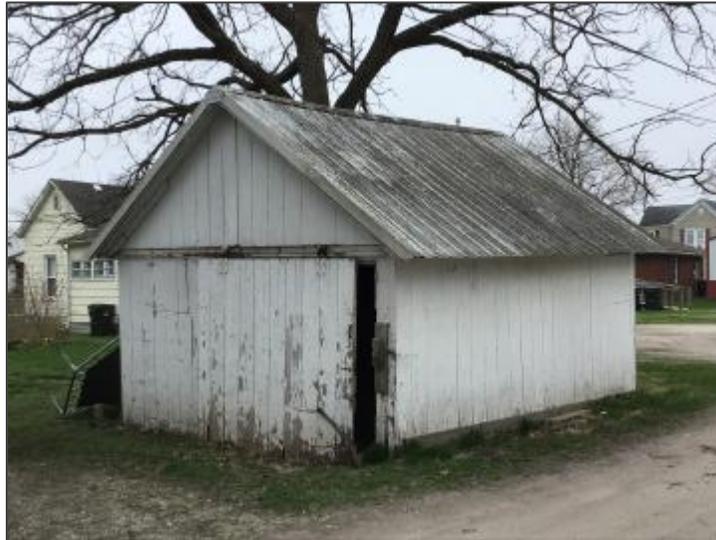
Kirksville garages fall into three broad categories. Some garages are based on agricultural buildings and feature vertical, barn-type siding, with or without windows.

Figure 54. Pre-1925 vertical sided garage at 615 East Jefferson Street.

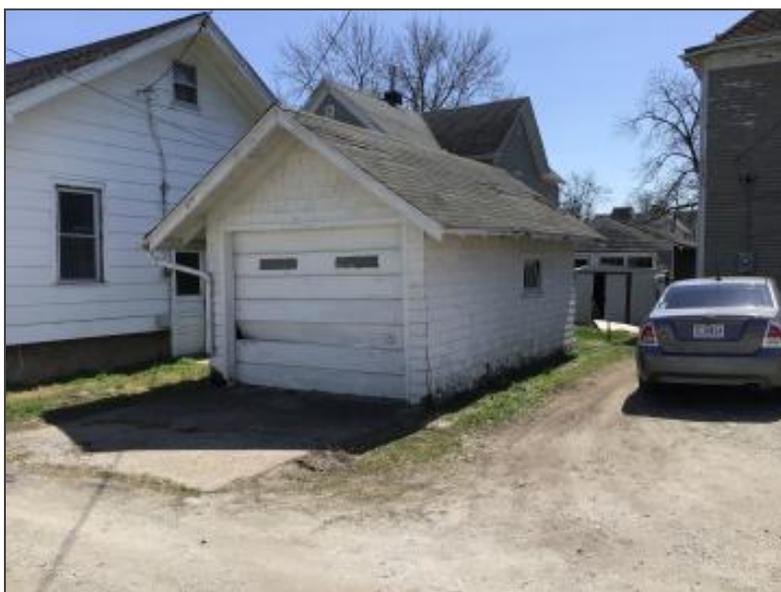
Figure 55. Garage at 210 South Davis Street with exposed rafter tails.
