**National Register of Historic Places
Registration Form**

historic name Richland Christian Church

Richland Christian Church
Callaway County, MO

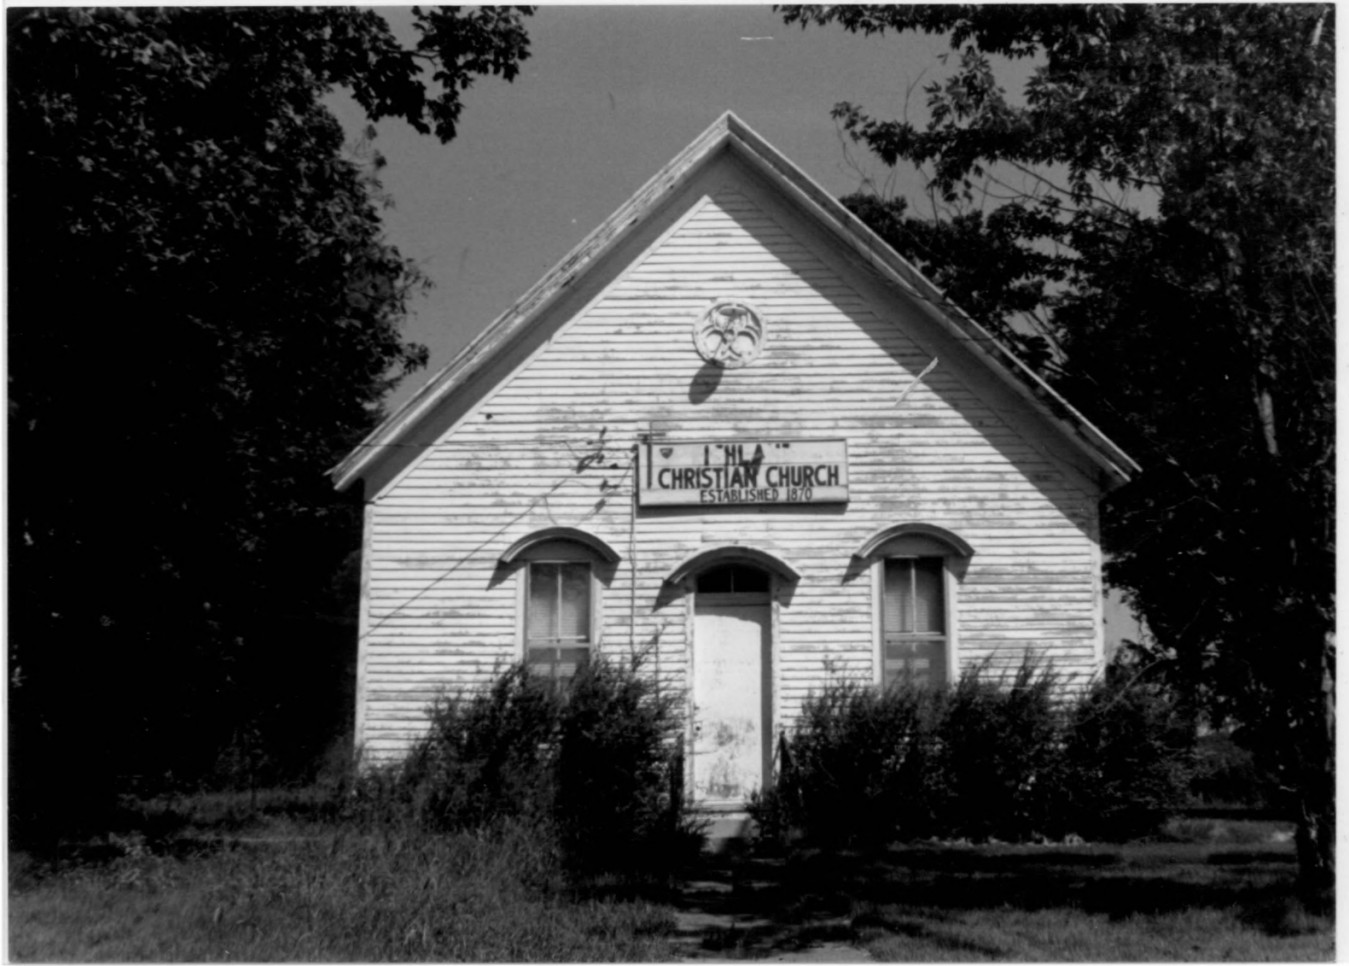
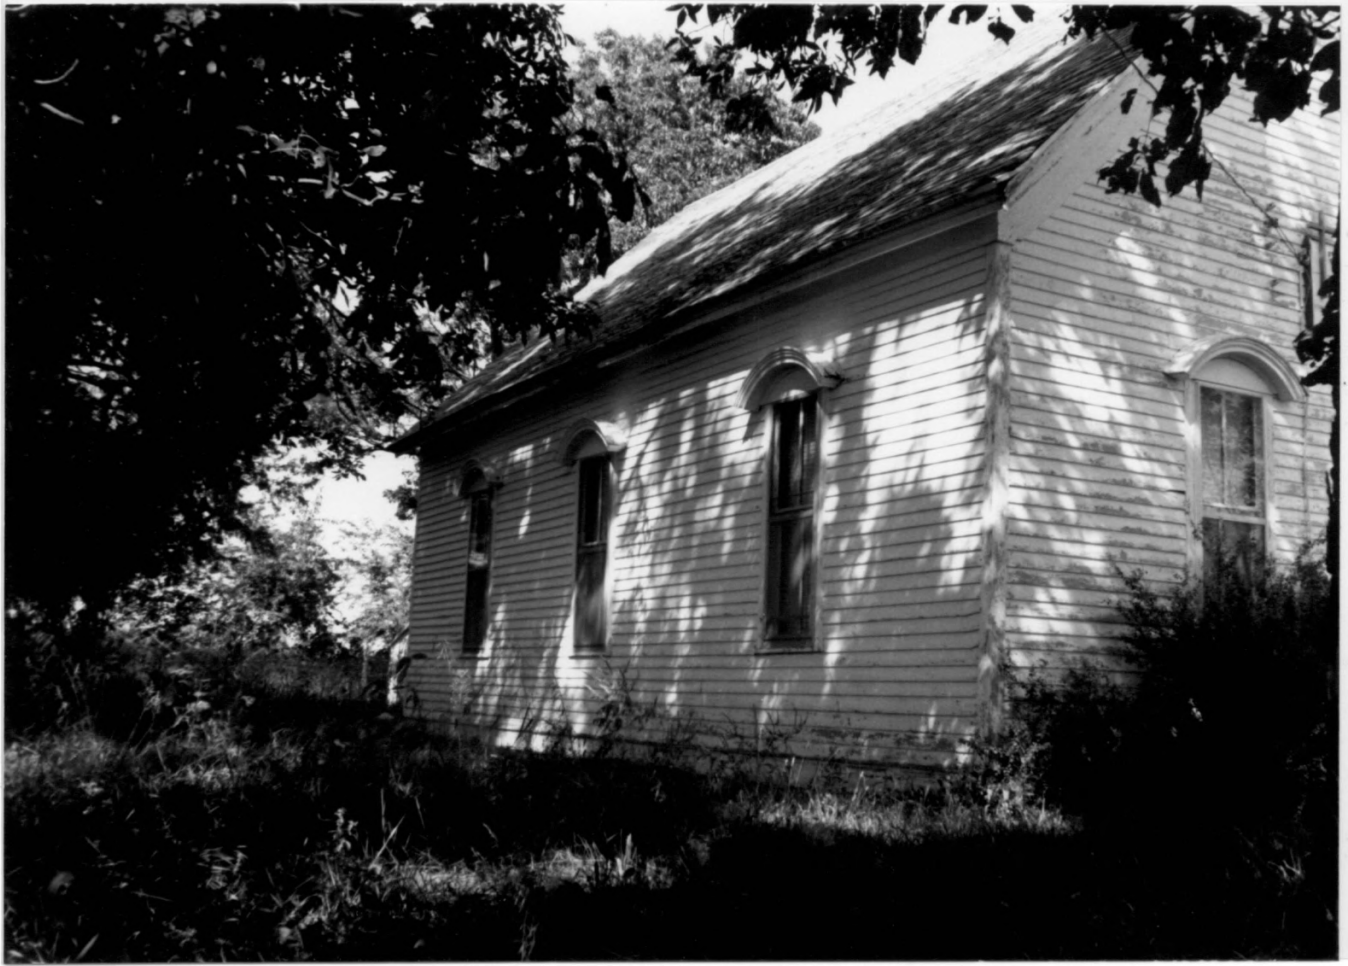
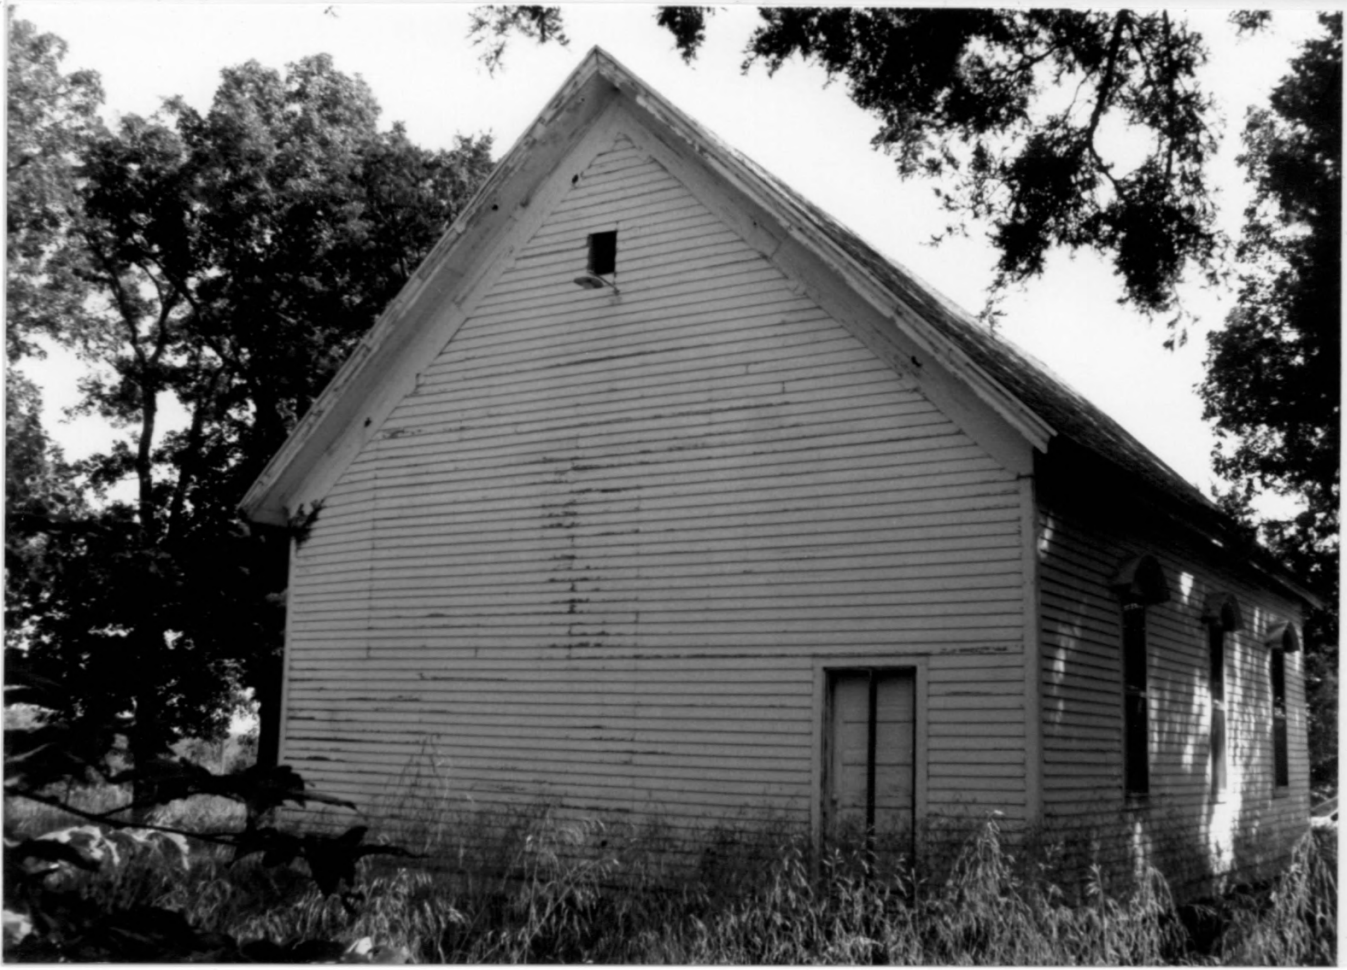
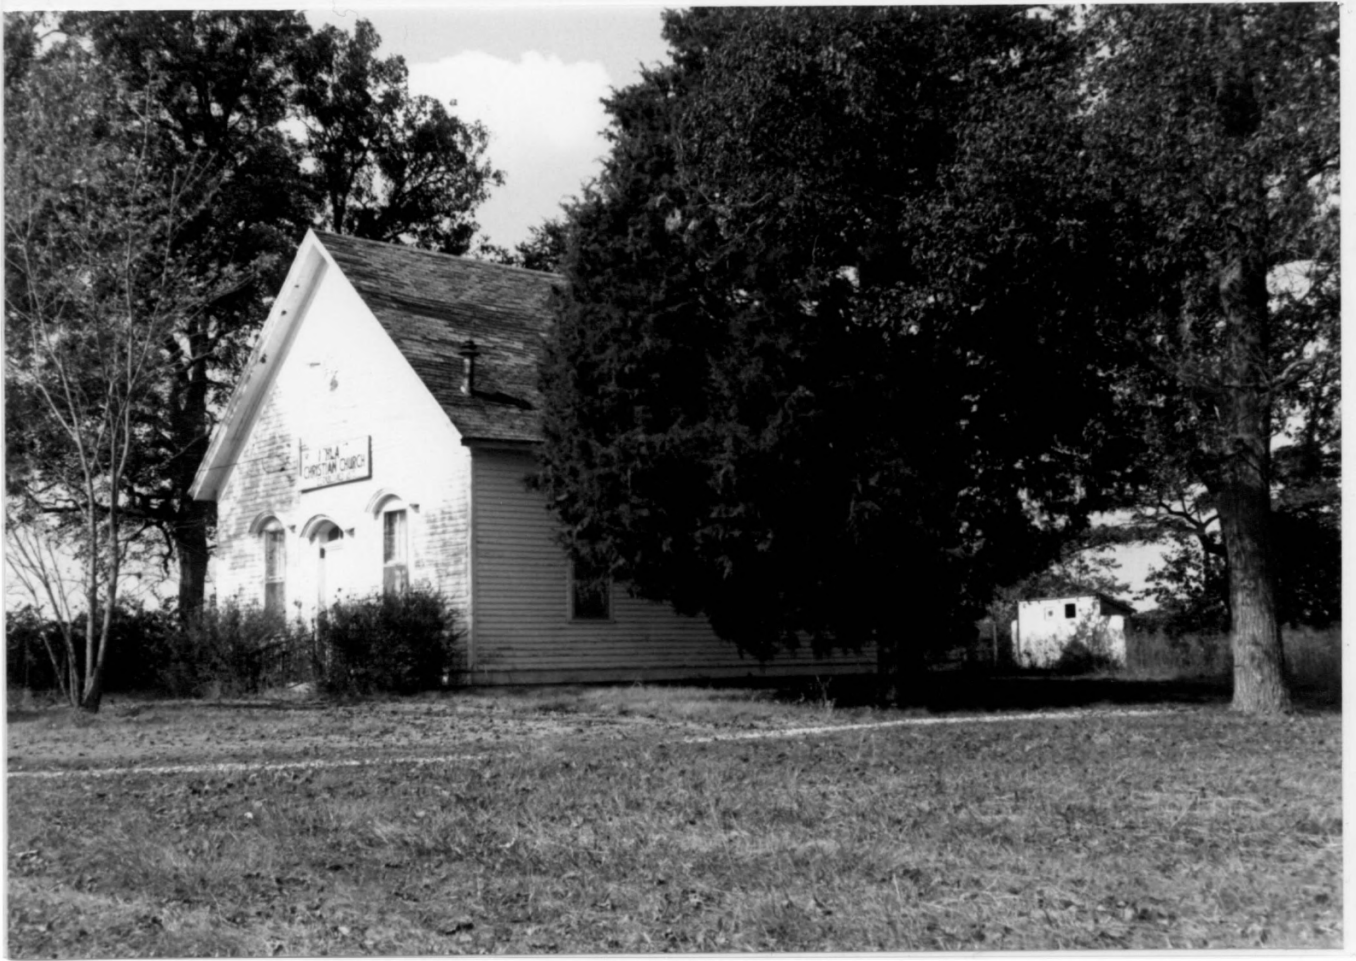
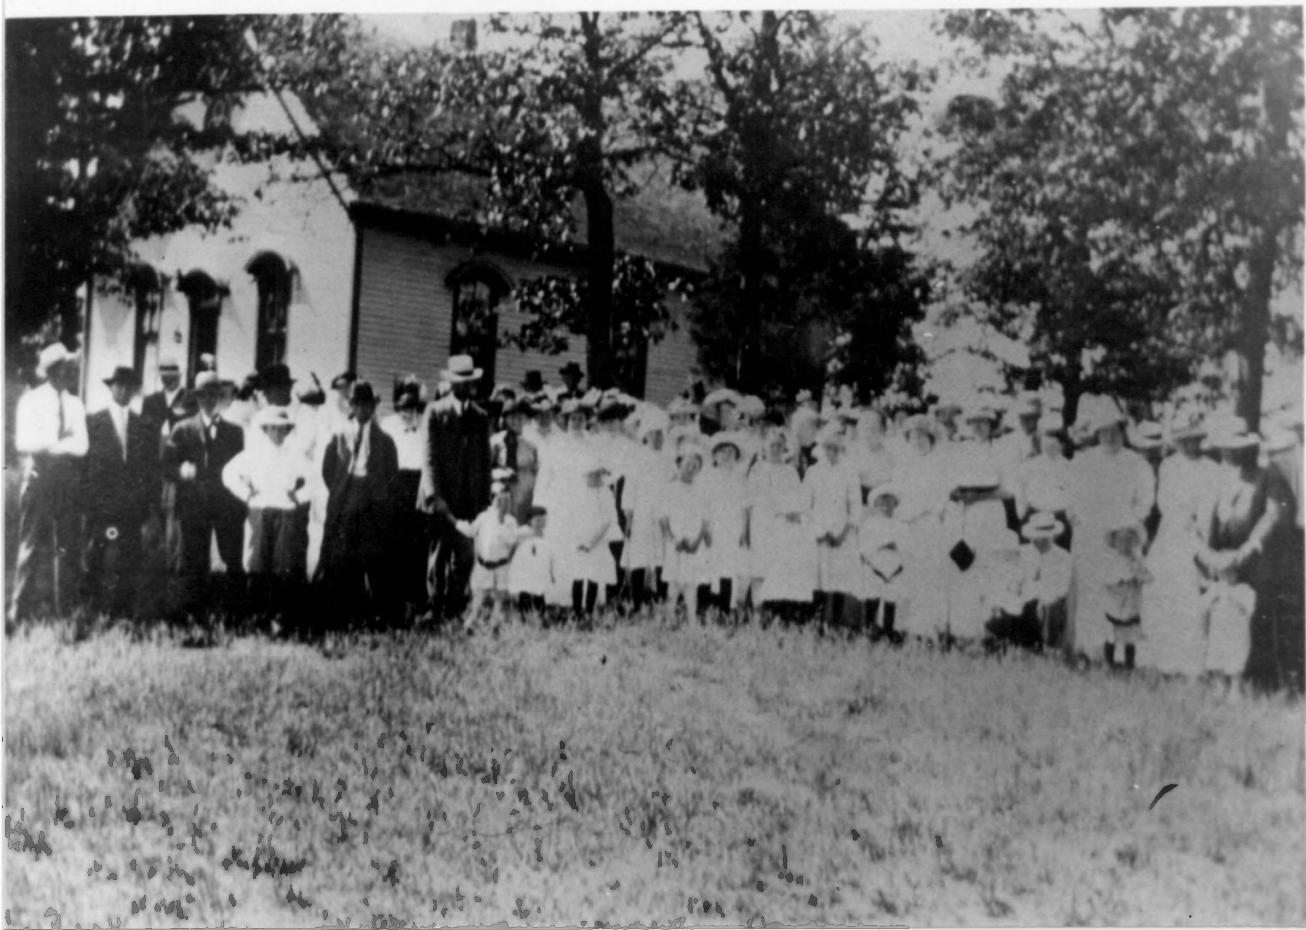
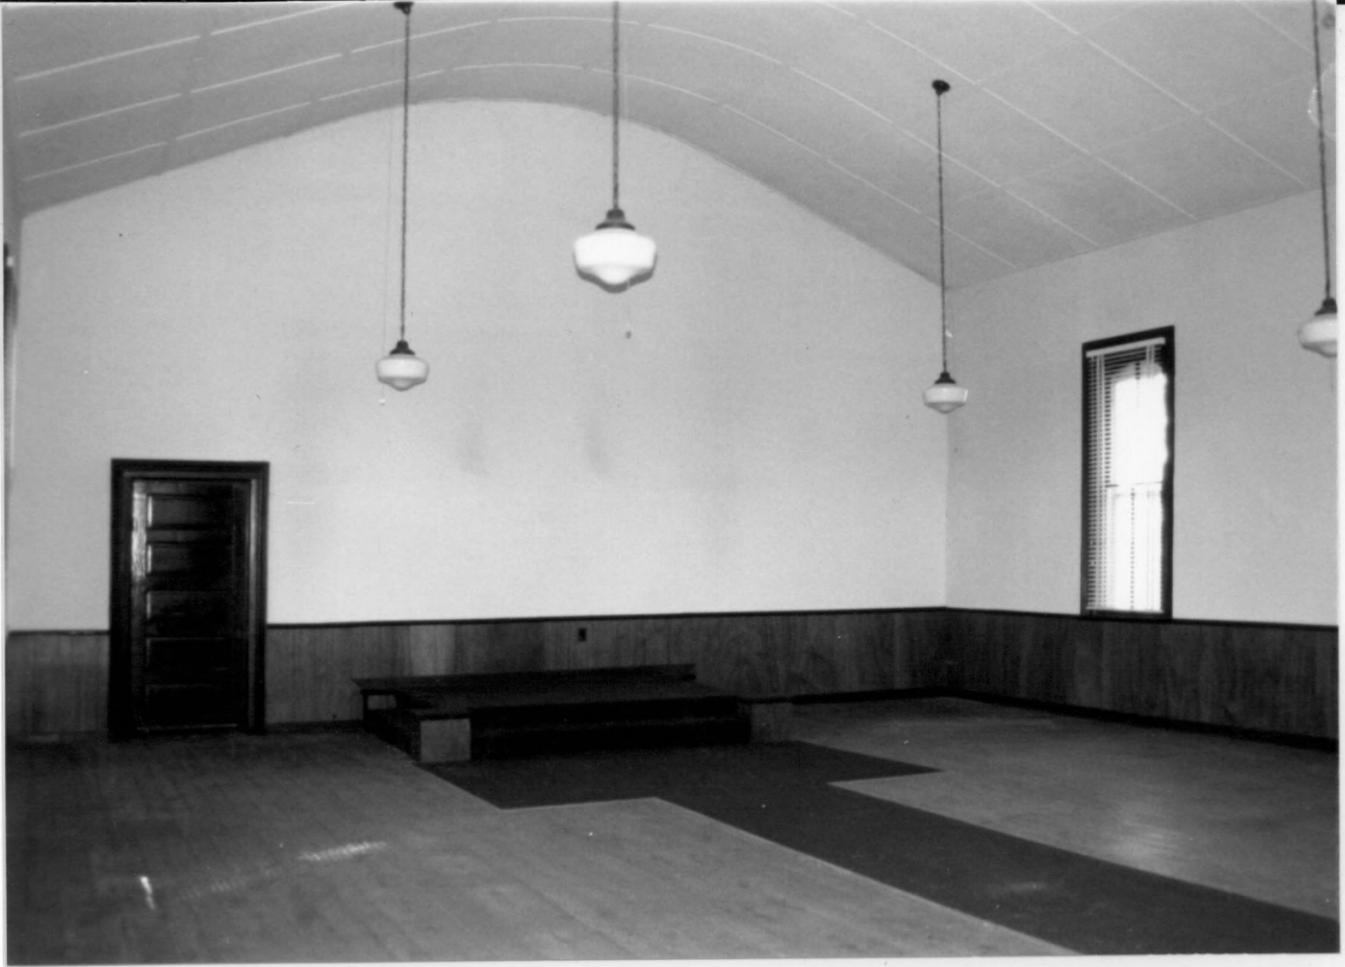
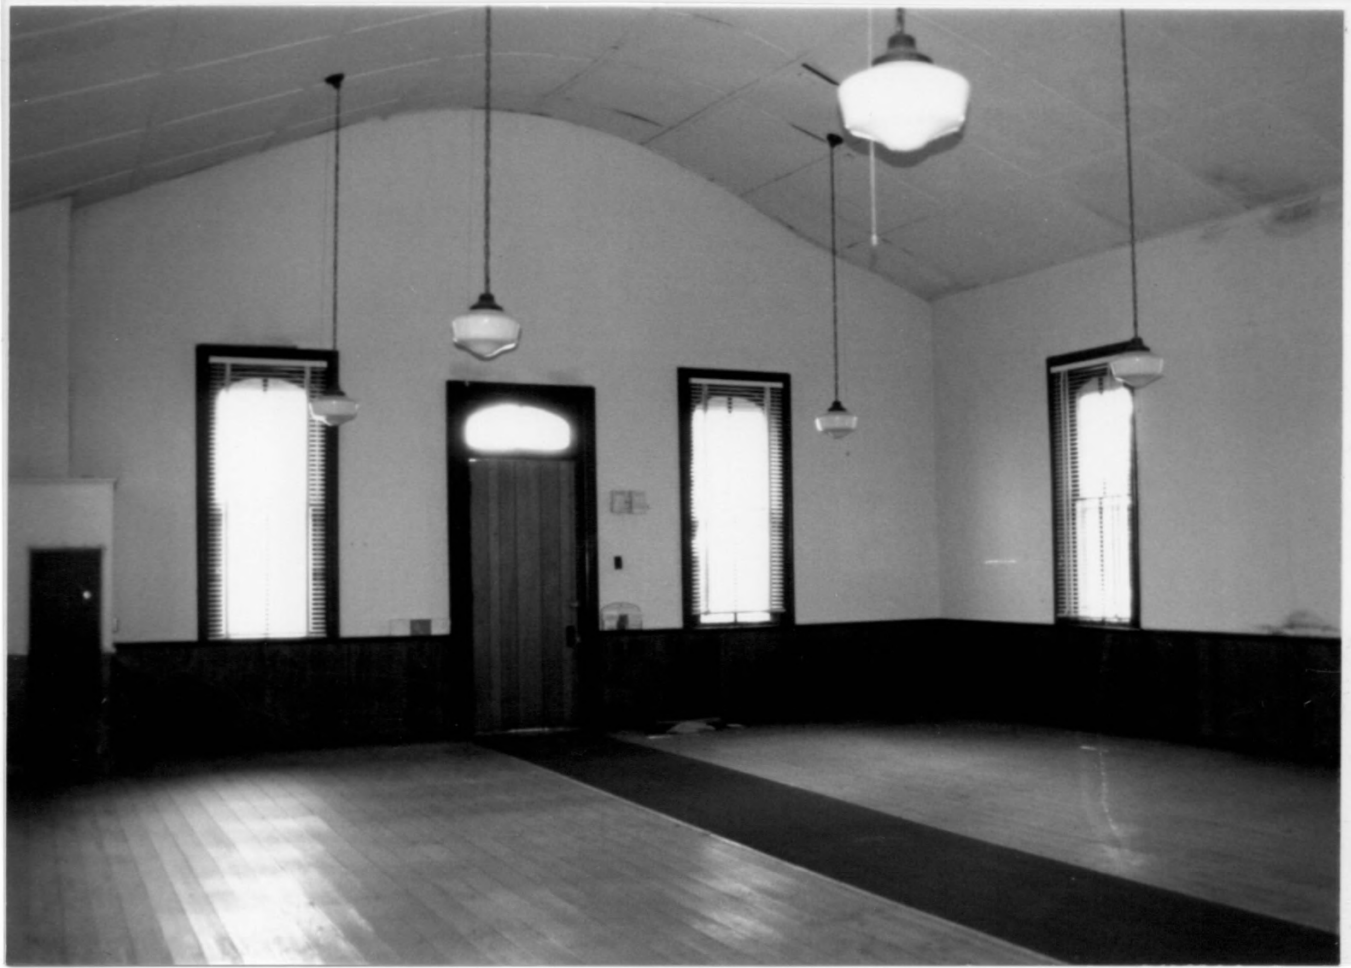
- #1. Primary (south) façade, facing north.
- #2. East elevation, facing west-southwest.
- #3. West and south elevations, facing northeast.
- #4. North and west elevations, facing southeast.
- #5. South and east elevations with outhouse, facing northwest.
- #6. South and east elevations with Sunday school classes, facing northwest (circa 1913).
- #7. Interior view, facing northeast.
- #8. Interior view, facing southwest.
