MISSOURI DEPARTMENT OF NATURAL RESOURCES
STATE HISTORIC PRESERVATION OFFICE, P.O. Box 176, Jefferson City, MO 65102
ARCHITECTURAL/HISTORIC INVENTORY FORM

1. Survey No. BO-AS-011-0087		2. Survey name: North Central Columbia Survey Phase II	
3. County: Boone		4. Address (Street No.) 902	Street (name) N. Seventh Street
5. City: Columbia	Vicinity: <input type="checkbox"/>	6. Geographical Reference:	7. Township/Range/Section: T: R: S:
8. Historic name (if known):		9. Present/other name (if known):	
10. Ownership: <input checked="" type="checkbox"/> Private <input type="checkbox"/> Public		11a. Historic use (if known): Domestic/single dwelling	11b. Current use: Domestic/single dwelling

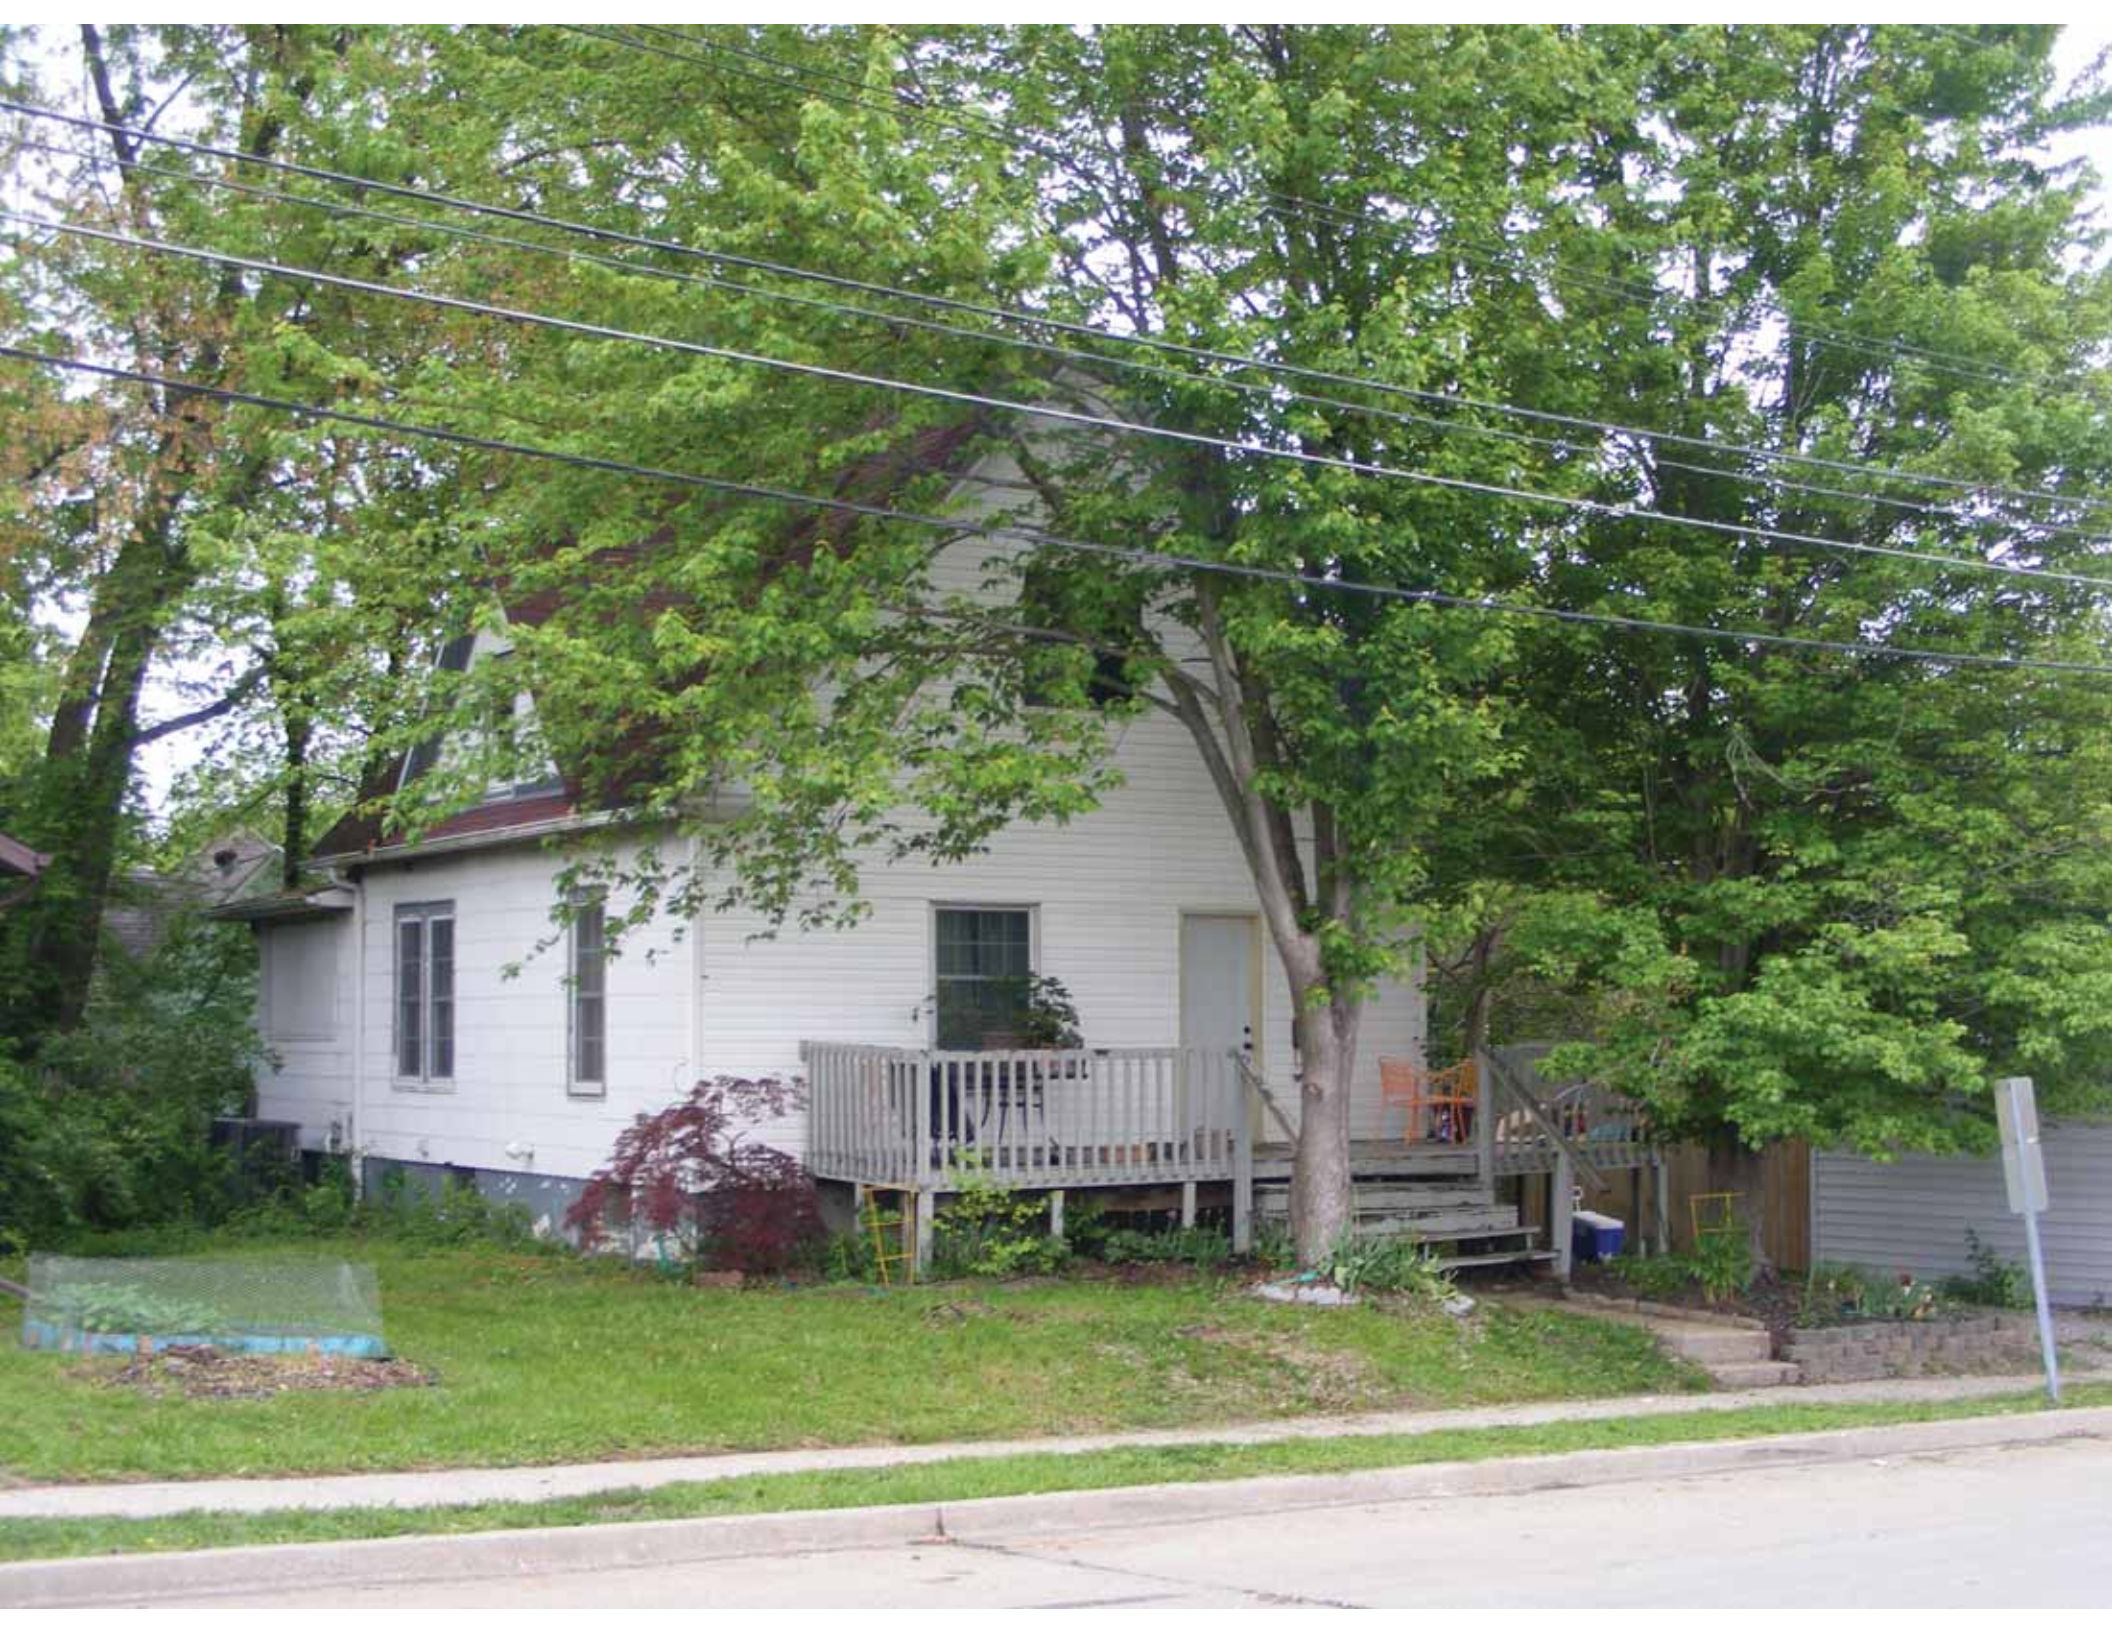
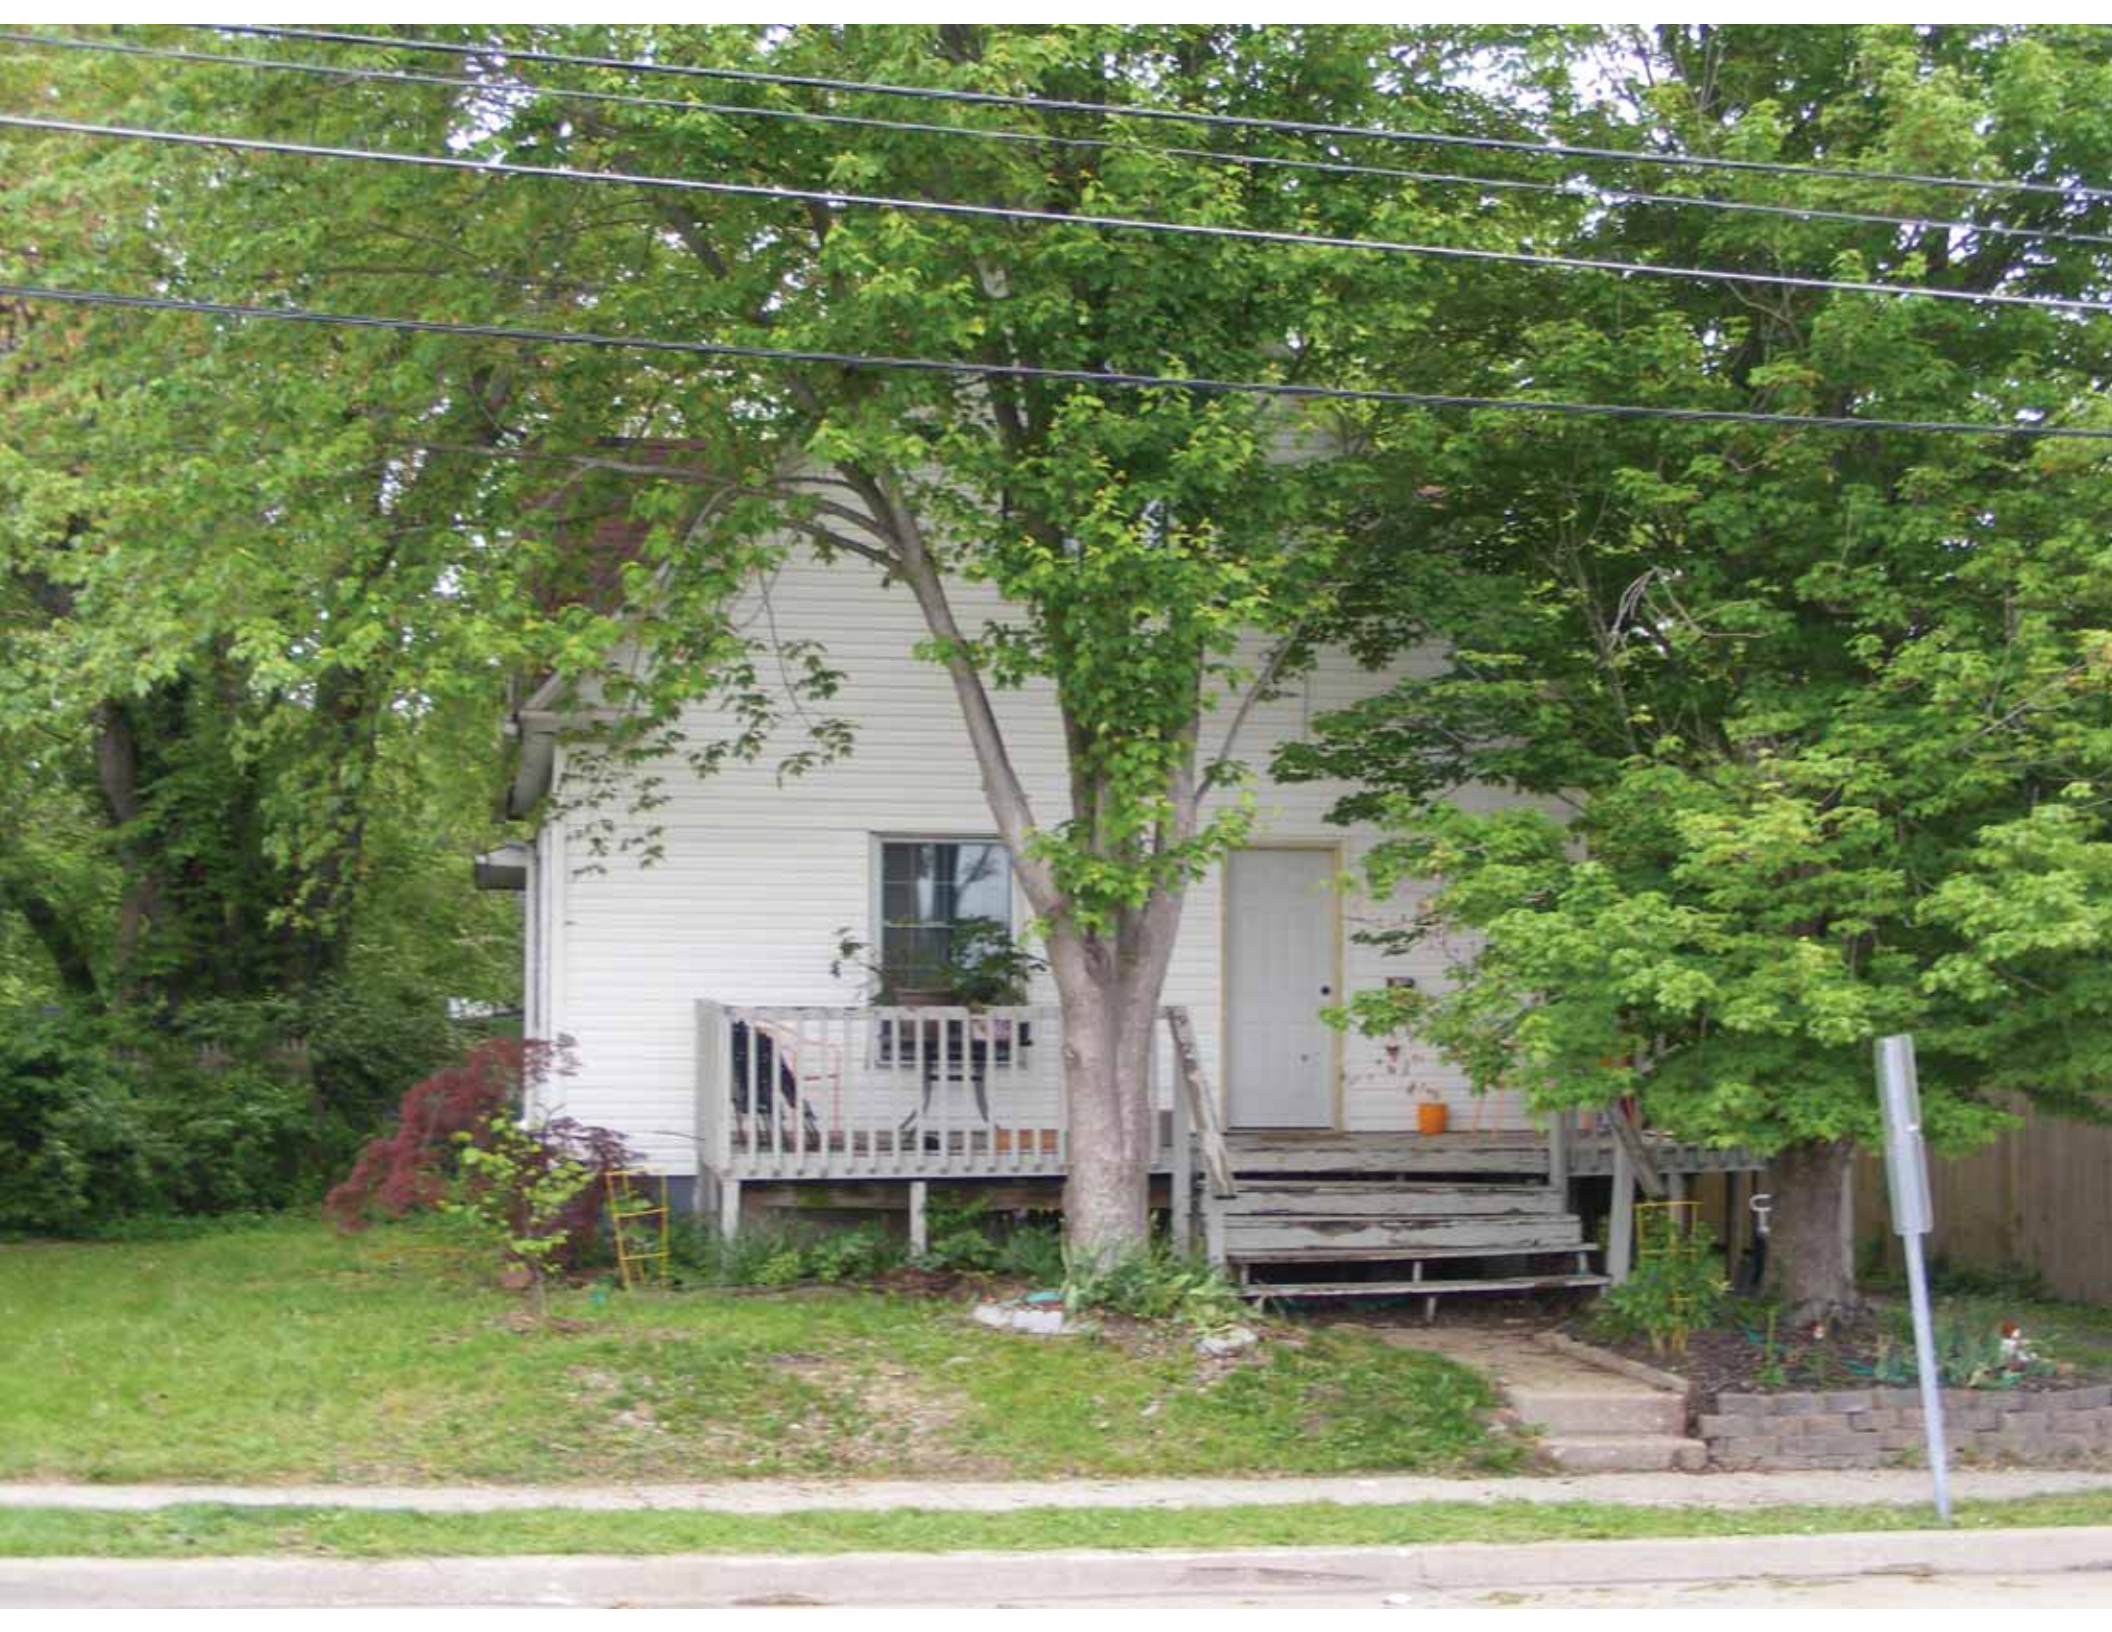
The altered dwelling has an asphalt-shingled roof, exterior synthetic (façade) and asbestos shingle (side elevations) siding, and a concrete raised foundation. The primary (west) elevation is fronted by a wide open frame stoop with a wood balustrade. The stoop wraps to the south elevation. The west elevation holds a c. 2019 paneled door offset by a replacement double-hung window. The upper façade elevation holds a one-over-one replacement window. The north elevation has a gabled wall dormer with a single double-hung window. The lower north elevation retains paired and single original four-over-four windows. The dwelling has a rear shed wing. The south elevation has an upper projecting window bay with replacement fixed sash windows. A staircase leading to the façade stoop spans much of the south elevation.

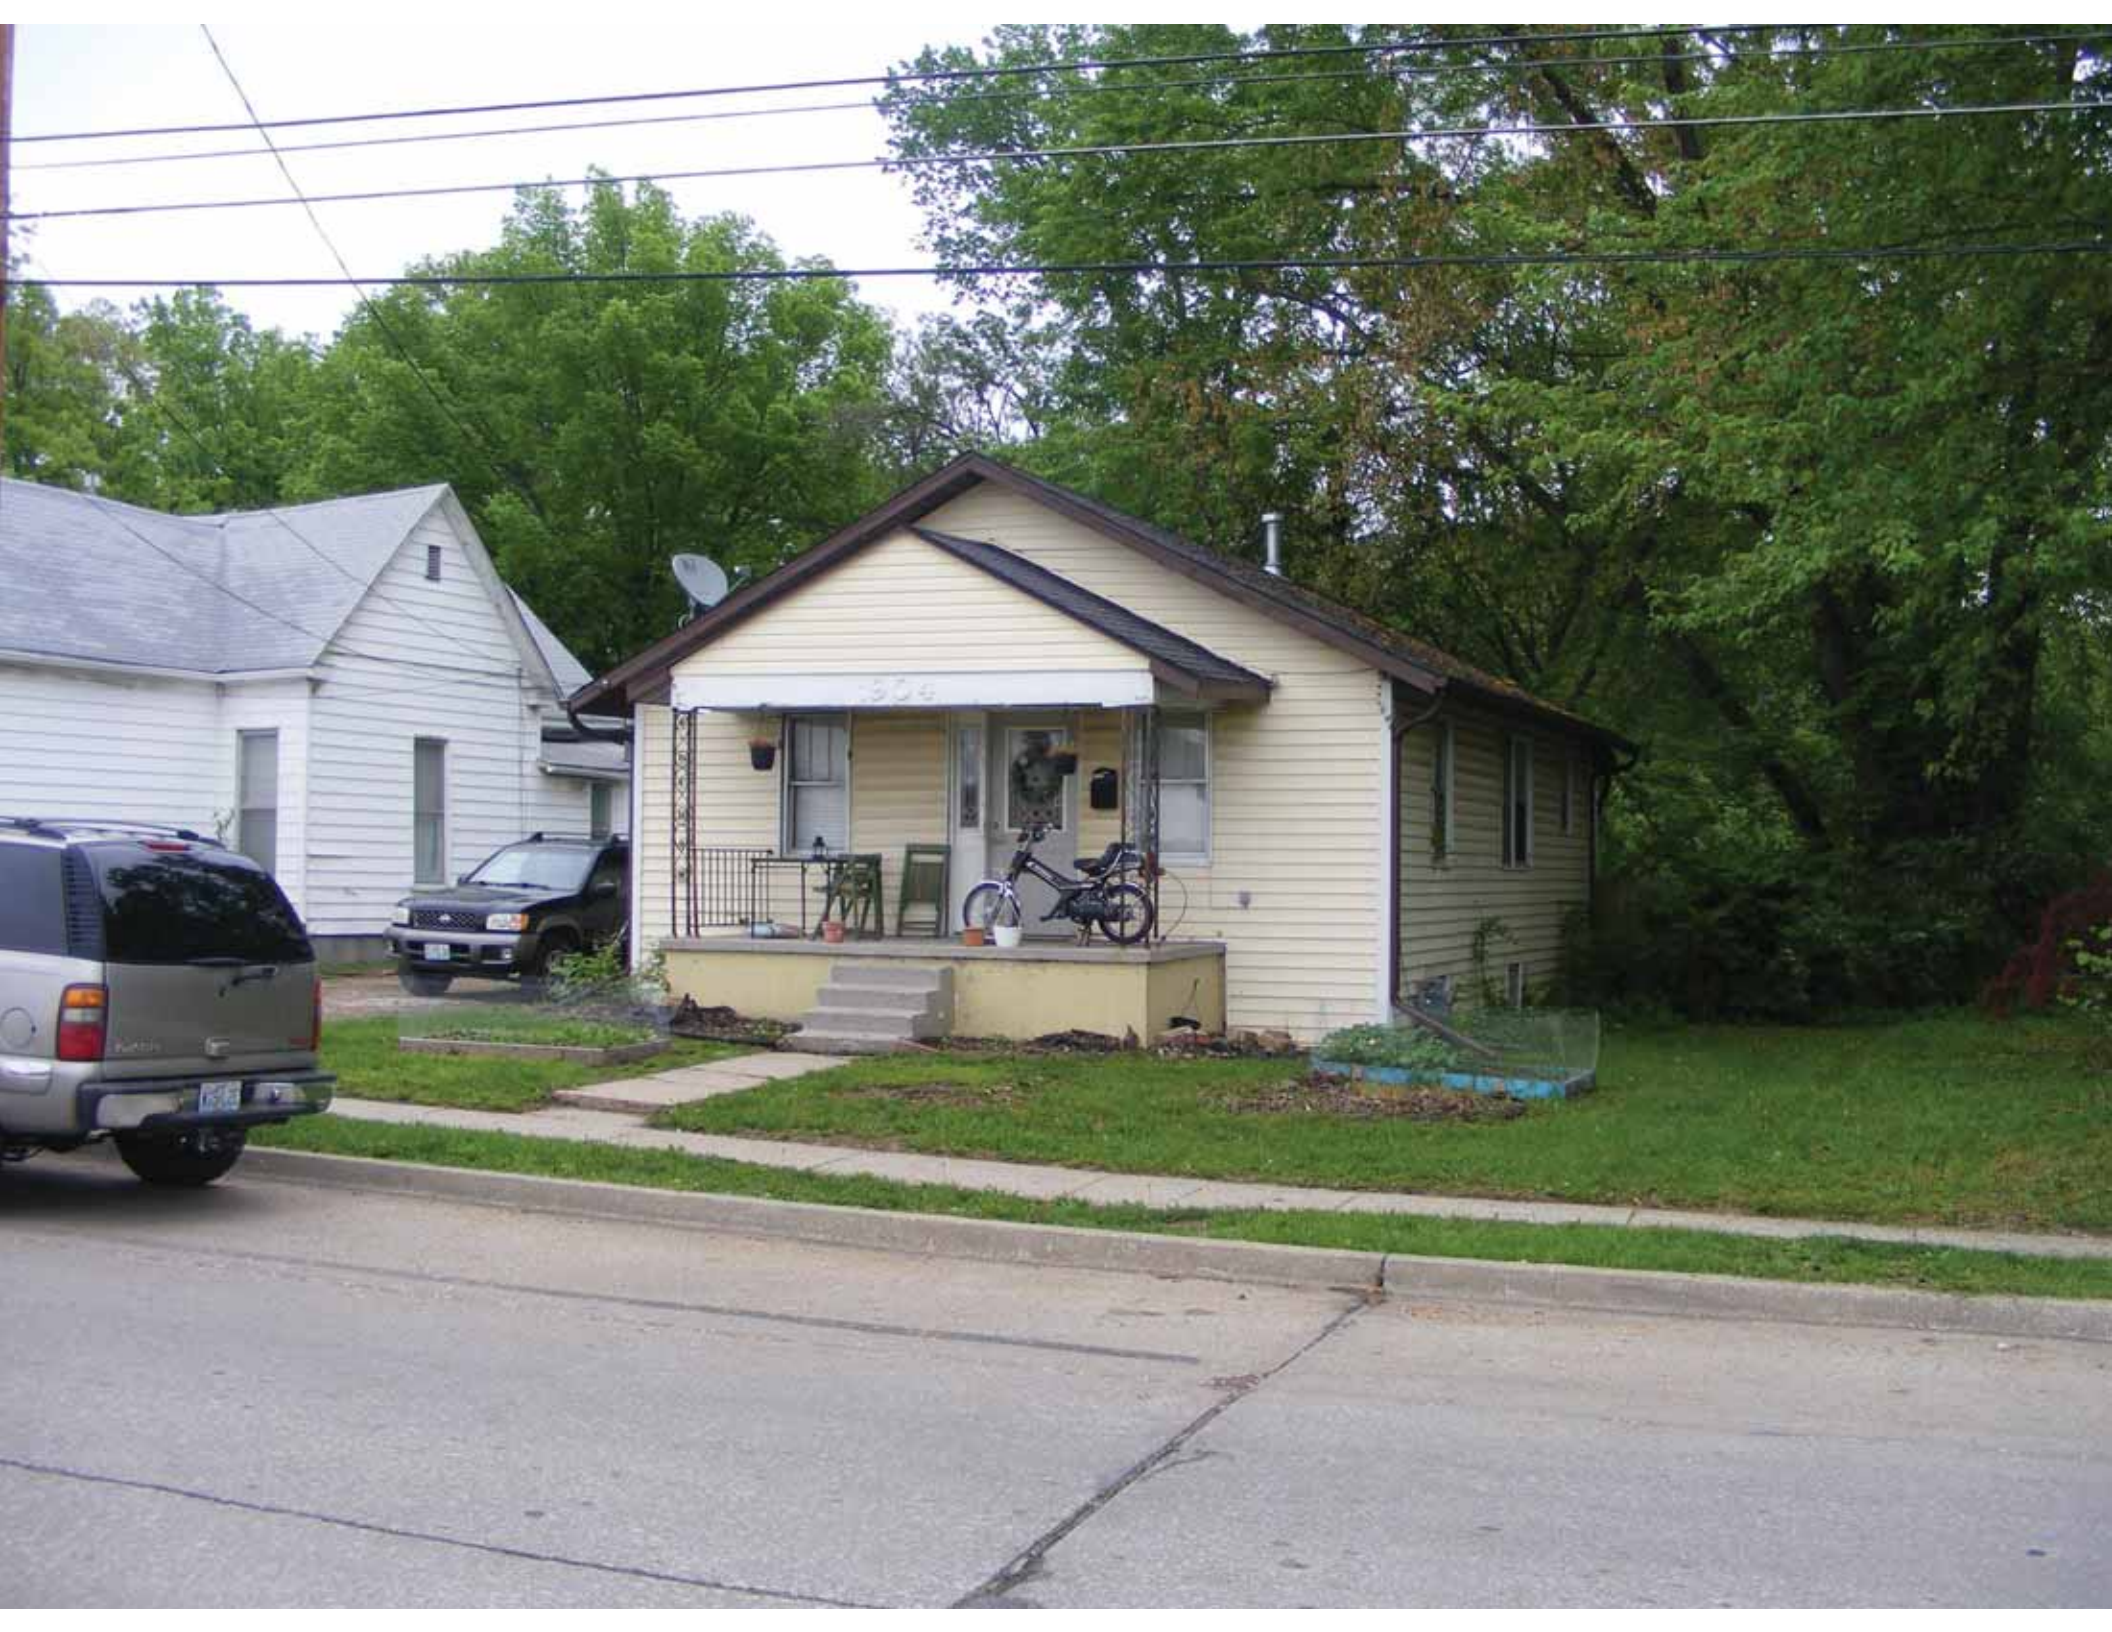
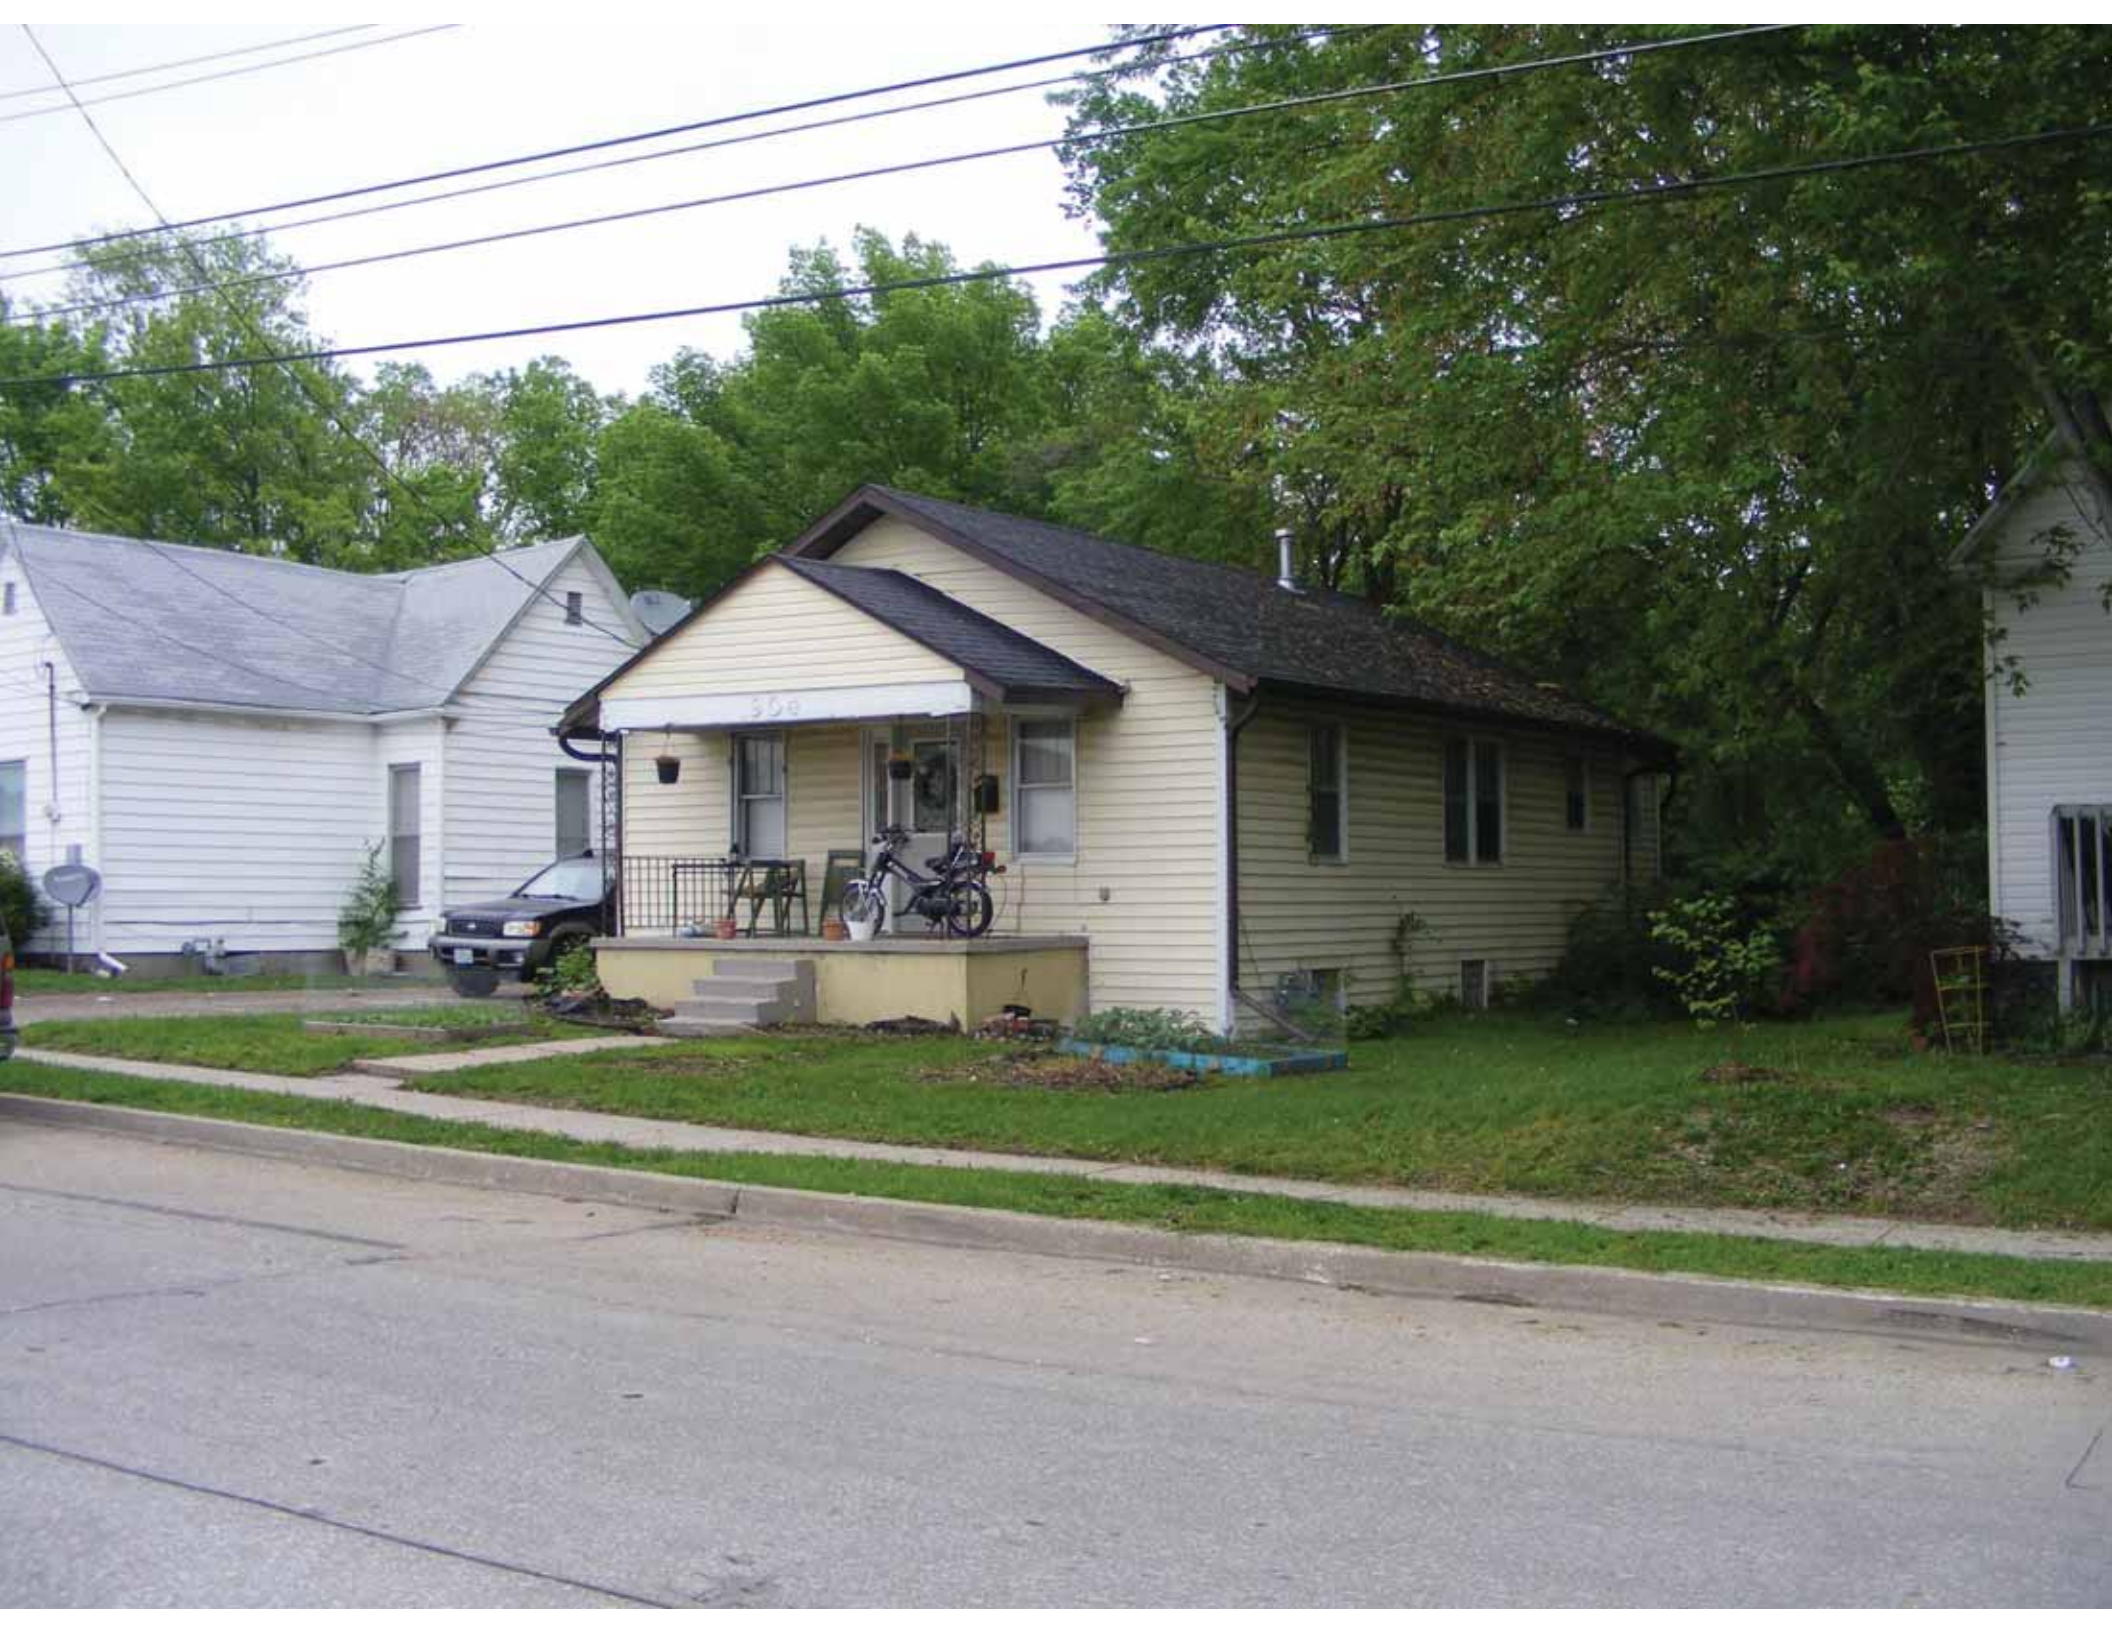
The gable-front plan dwelling has an asphalt-shingled roof, exterior synthetic siding and a covered foundation. The primary (west) elevation holds a gabled porch supported by wrought iron columns resting on a concrete stoop. A metal balustrade flanks the north end of the porch. Within the porch bay is a single-light storm door (which obscures the primary door) offset by a single-light sidelight (replacement) above an original wood panel. Original three-over-one windows flank the entry bay.

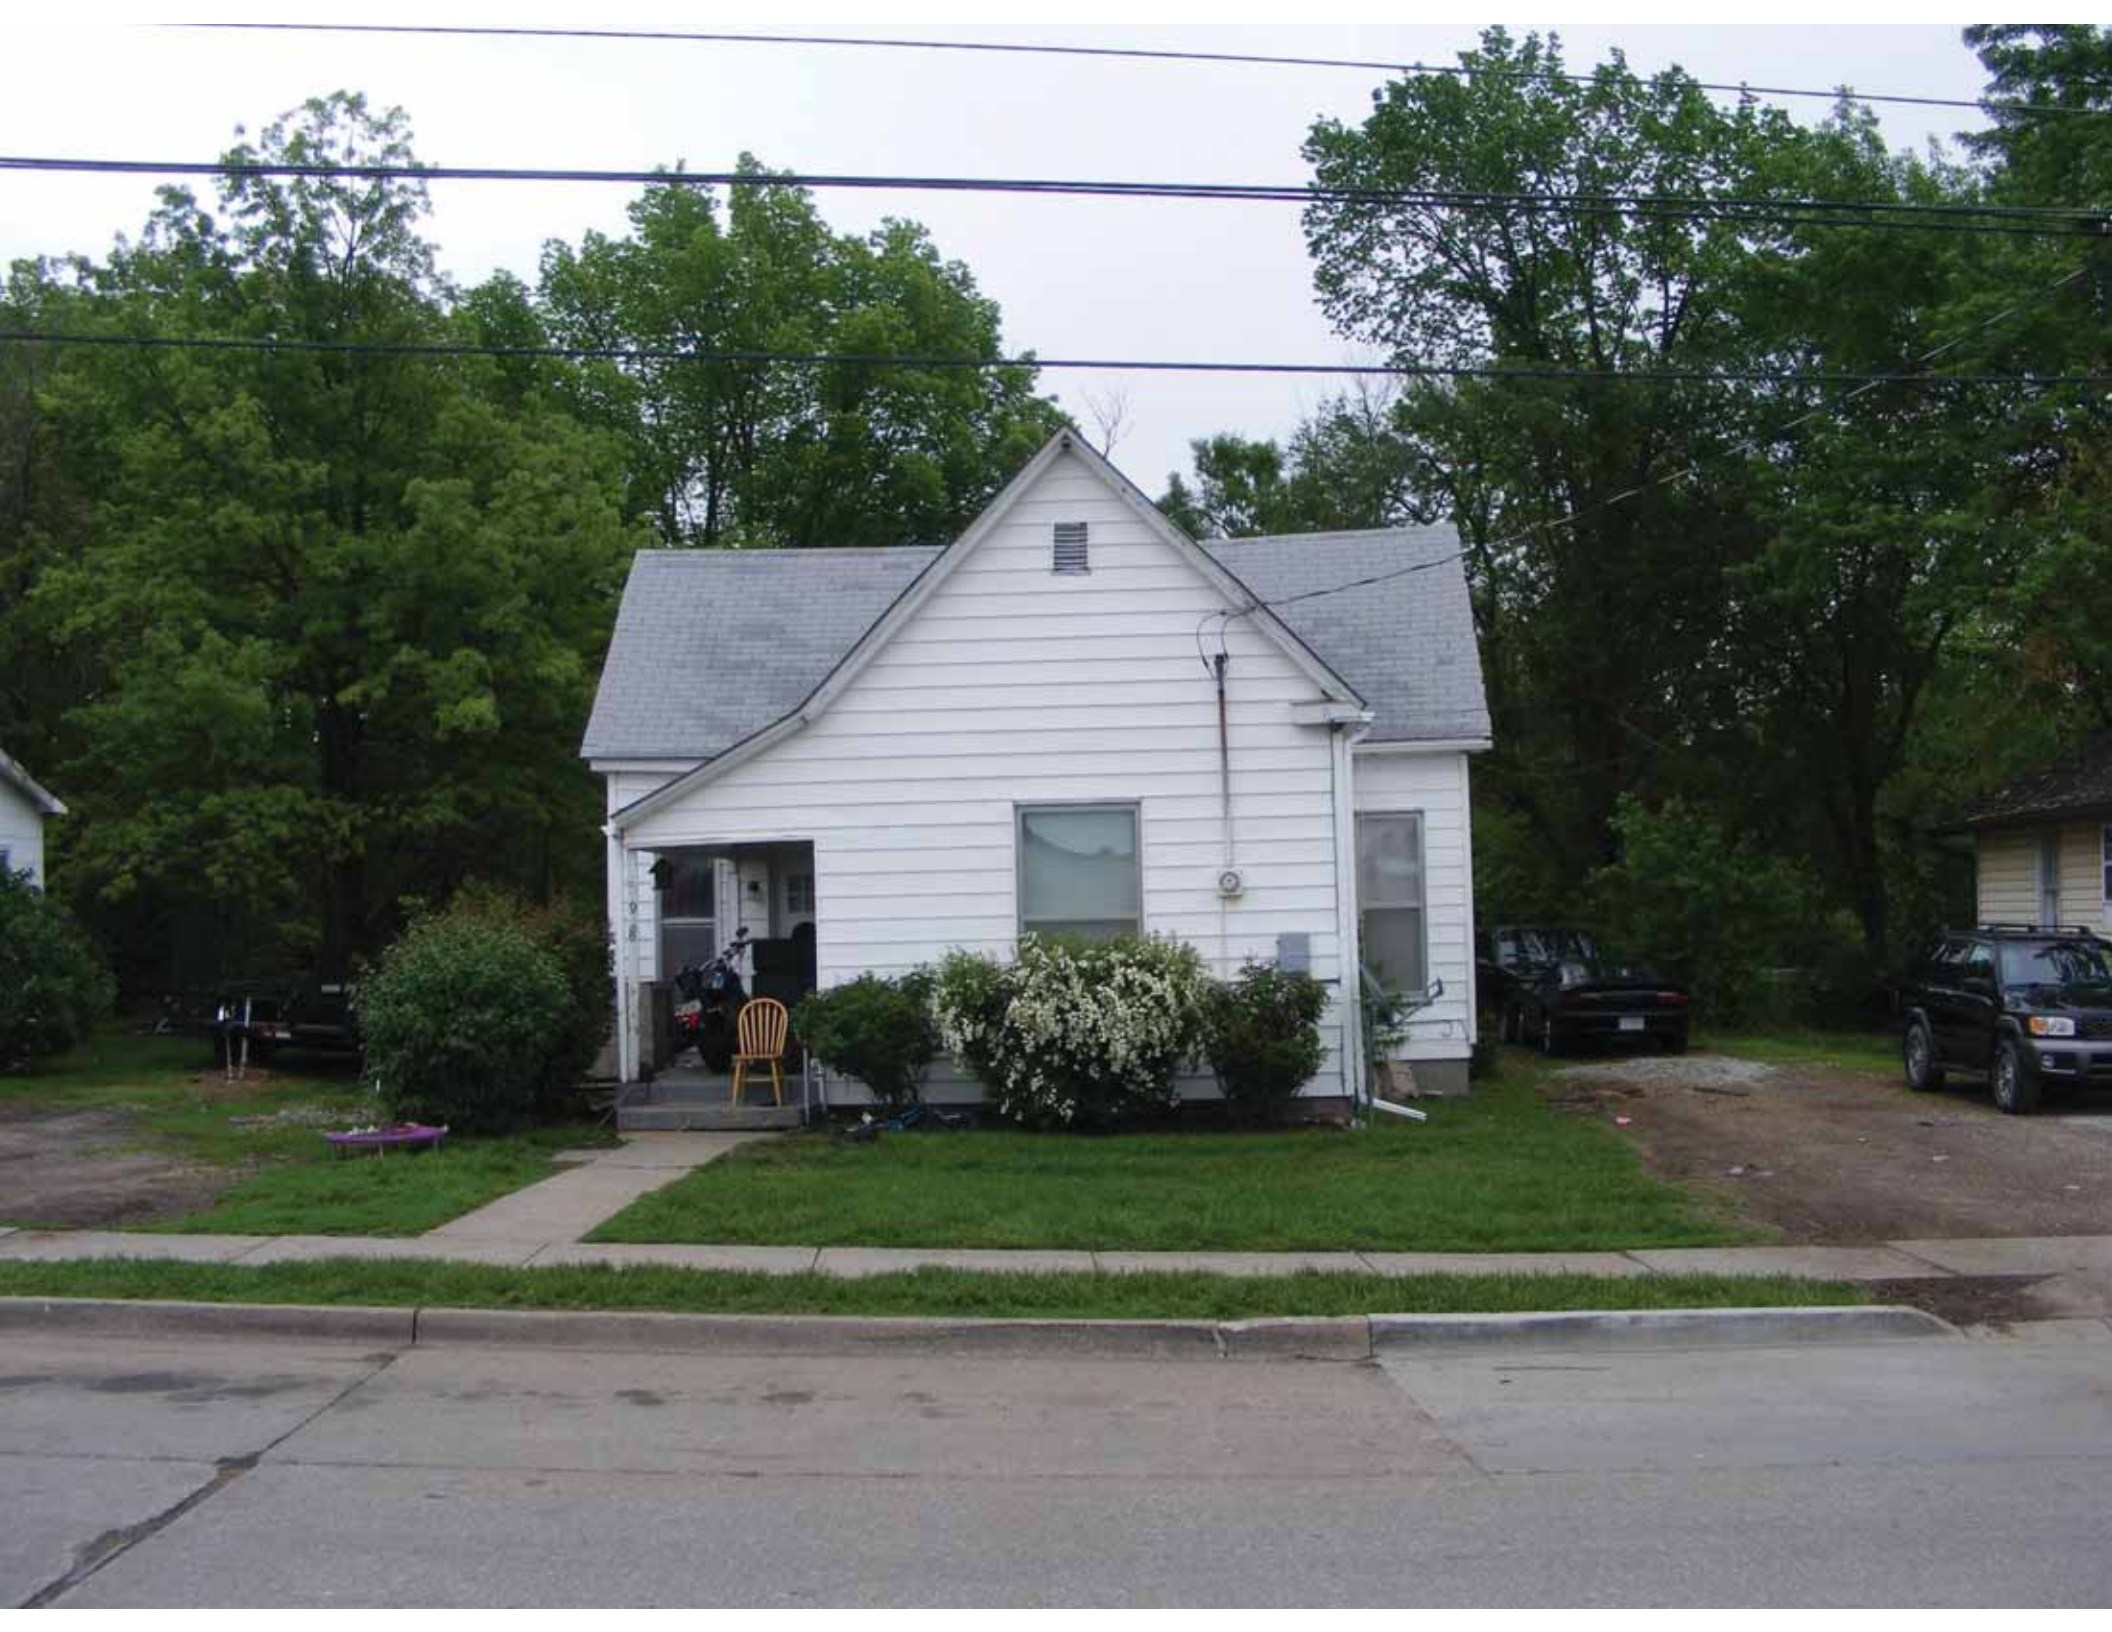
The dwelling is a cross-gabled plan with an asphalt-shingled roof, exterior synthetic siding and a concrete foundation. The front facing gable is centered on a rear cross gabled wing. The west wall of the front wing holds a one-over-one wide window. The gable has a return on the south and flares to create an integral porch north of the front gabled wing. The porch is supported by wood columns. Within the porch by are a six-light paneled door (west elevation) and one-over-one window (north wall). The dwelling has a rear one-story wing. Gable fields have louvered vents.
