MISSOURI DEPARTMENT OF NATURAL RESOURCES
STATE HISTORIC PRESERVATION OFFICE, P.O. Box 176, Jefferson City, MO 65102
ARCHITECTURAL/HISTORIC INVENTORY FORM

1. Survey No. BO-AS-011-0087		2. Survey name: North Central Columbia Survey Phase II	
3. County: Boone		4. Address (Street No.) 902	Street (name) N. Seventh Street
5. City: Columbia	Vicinity: <input type="checkbox"/>	6. Geographical Reference:	7. Township/Range/Section: T: R: S:
8. Historic name (if known):		9. Present/other name (if known):	
10. Ownership: <input checked="" type="checkbox"/> Private <input type="checkbox"/> Public		11a. Historic use (if known): Domestic/single dwelling	11b. Current use: Domestic/single dwelling

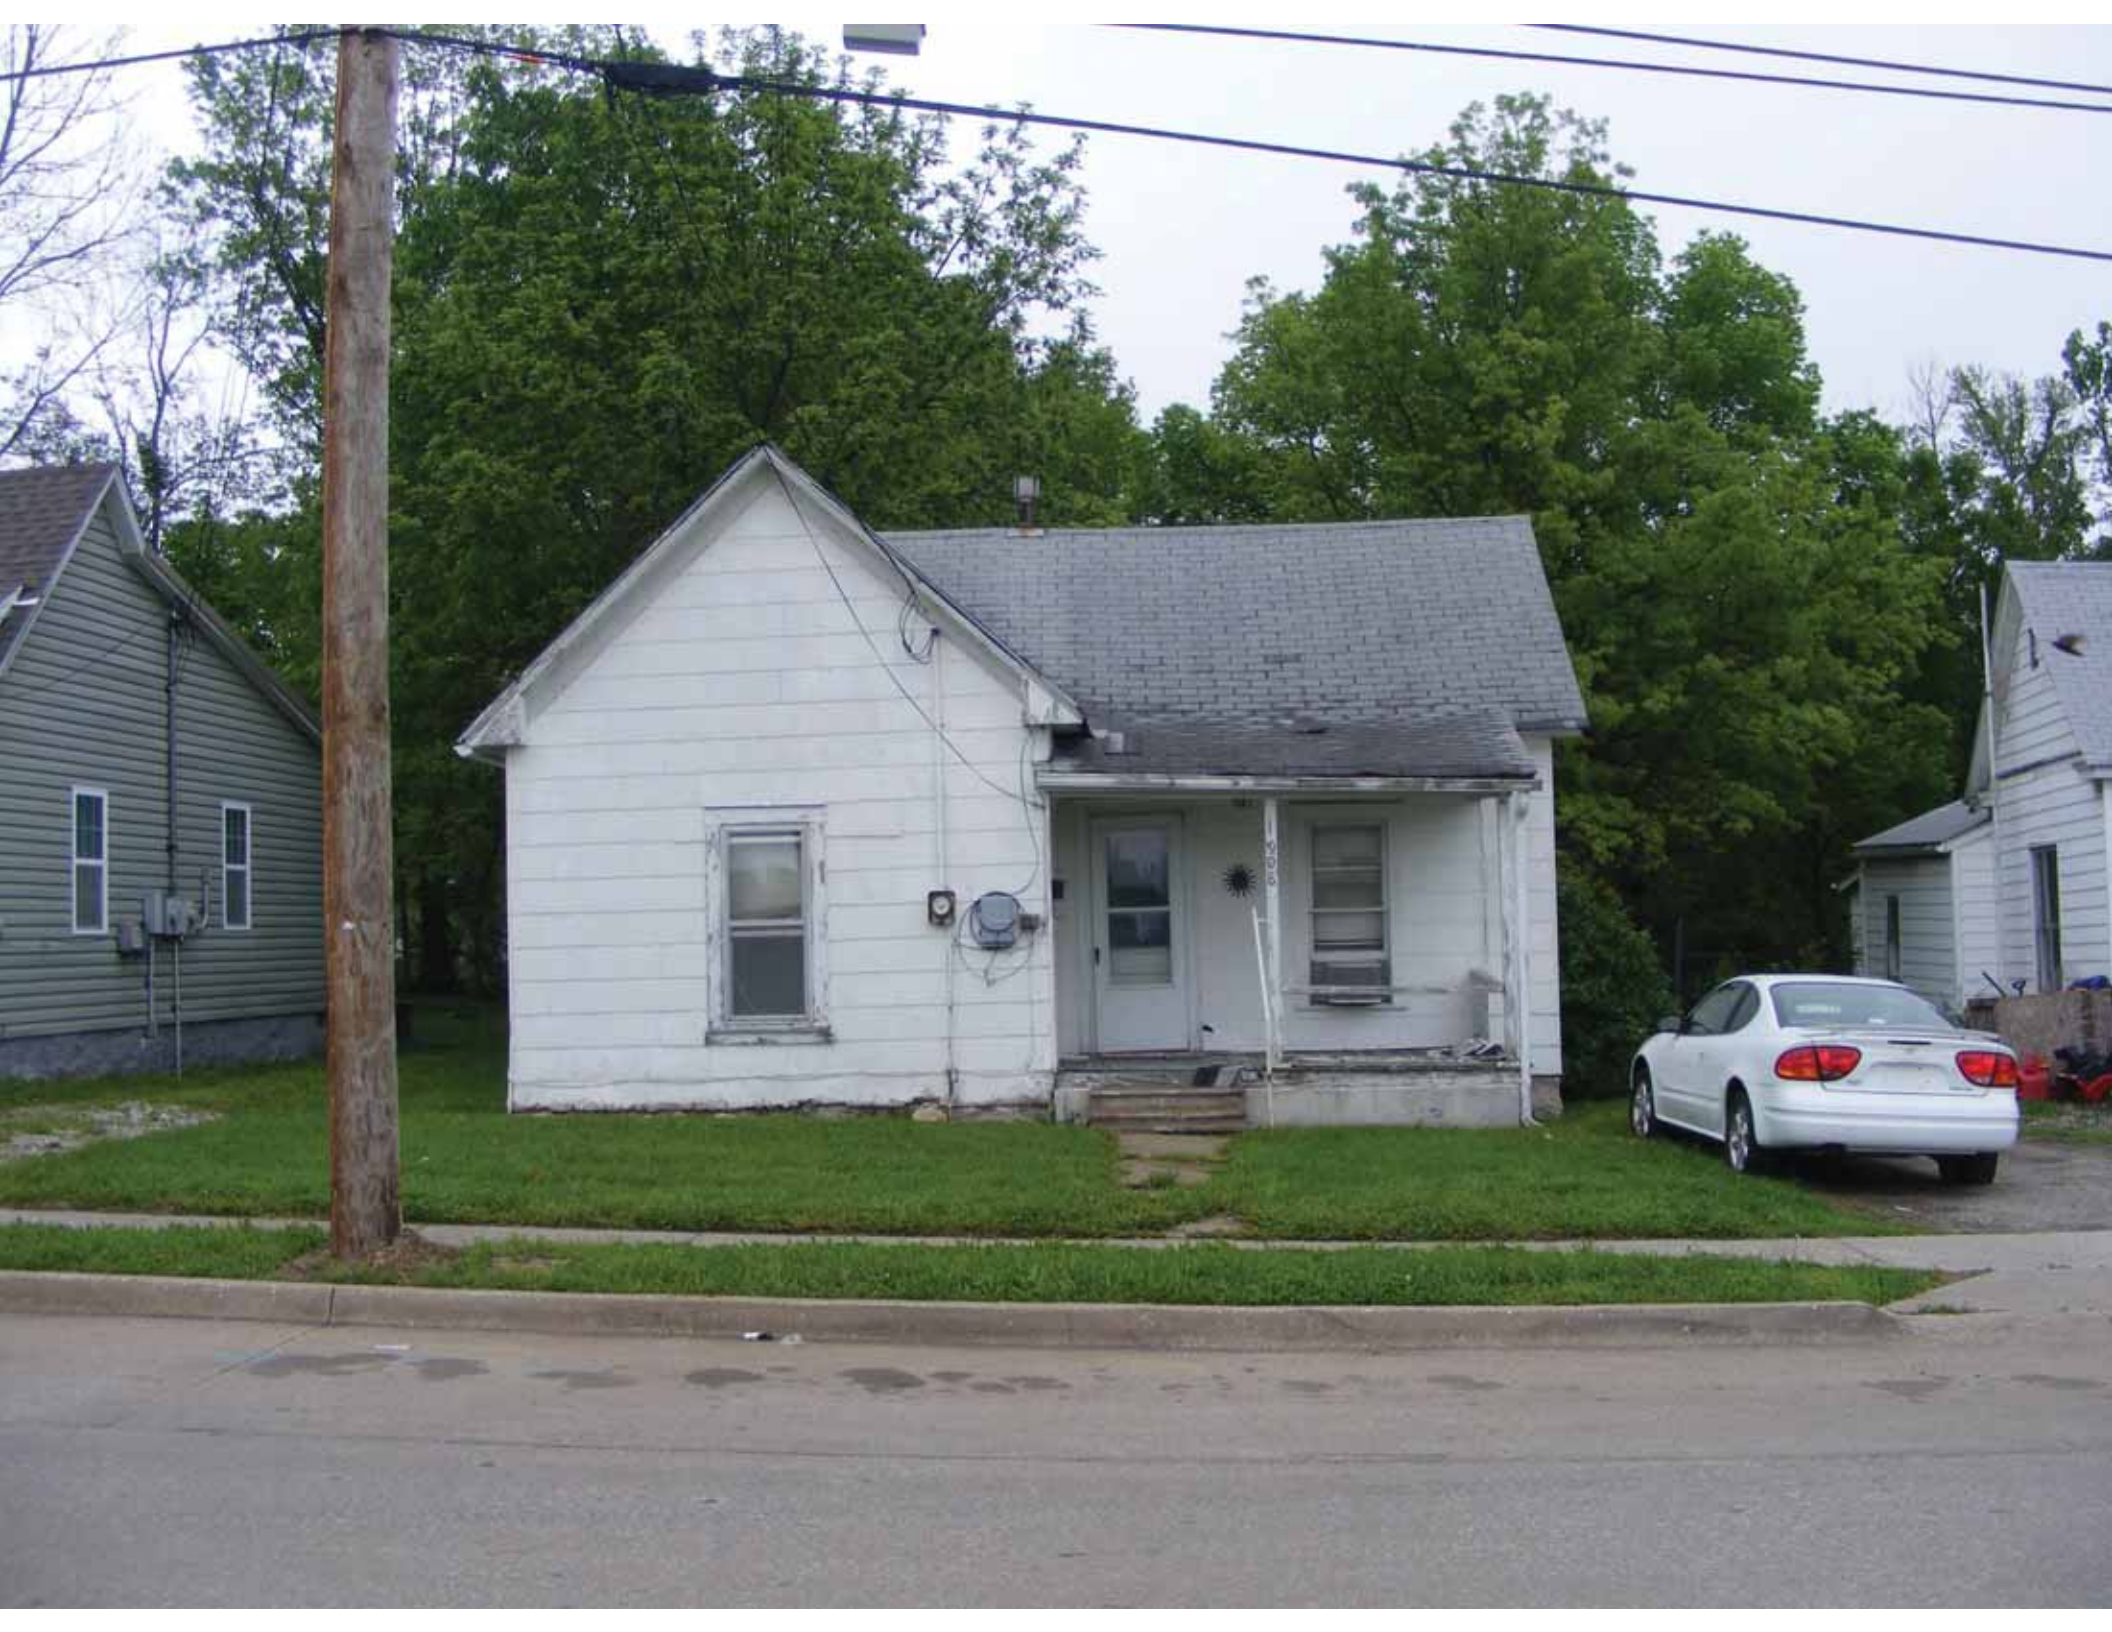
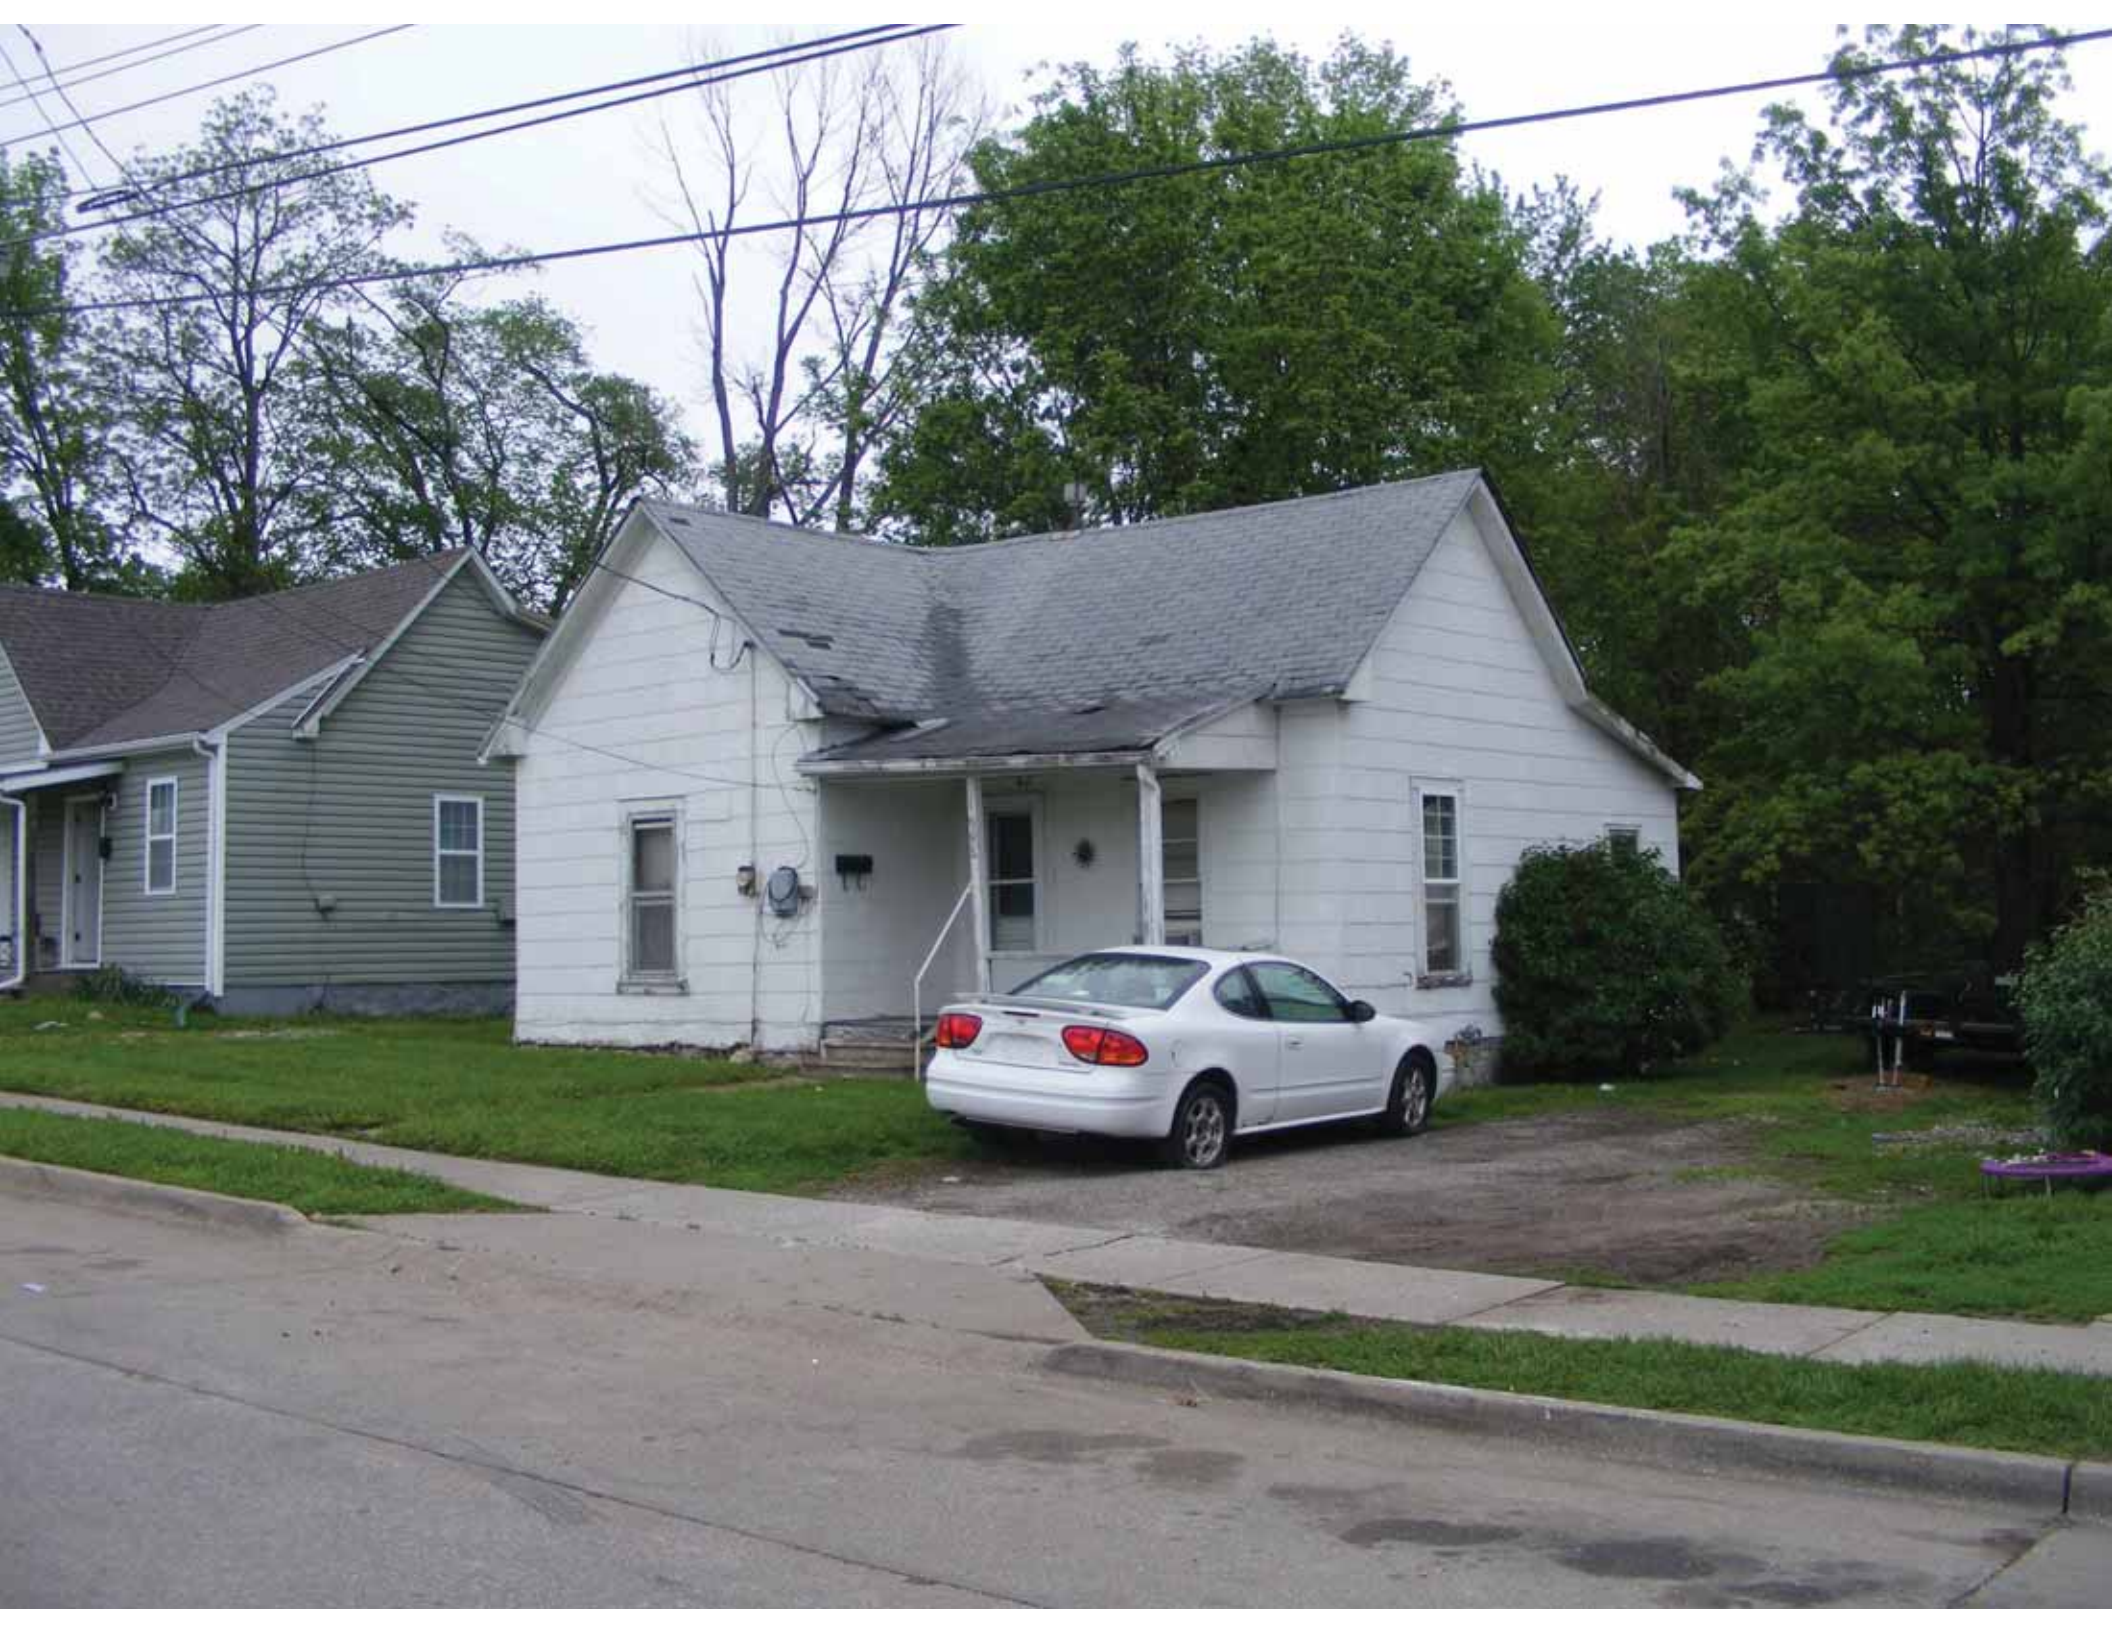
The dwelling has an asphalt-shingled roof, exterior asbestos shingle siding and a limestone foundation covered with concrete. The primary (west) elevation has an off-center shed porch supported by square wood columns. A single metal pole handrail extends along the porch steps. Within the porch bay is a single-light paneled door (original) offset by a one-over-one window. The front gabled wing north of the porch has covered gabled returns and a one-over-one window. Remaining windows are of similar configuration. The south elevation has a four-over-four window. The dwelling has a rear shed wing.

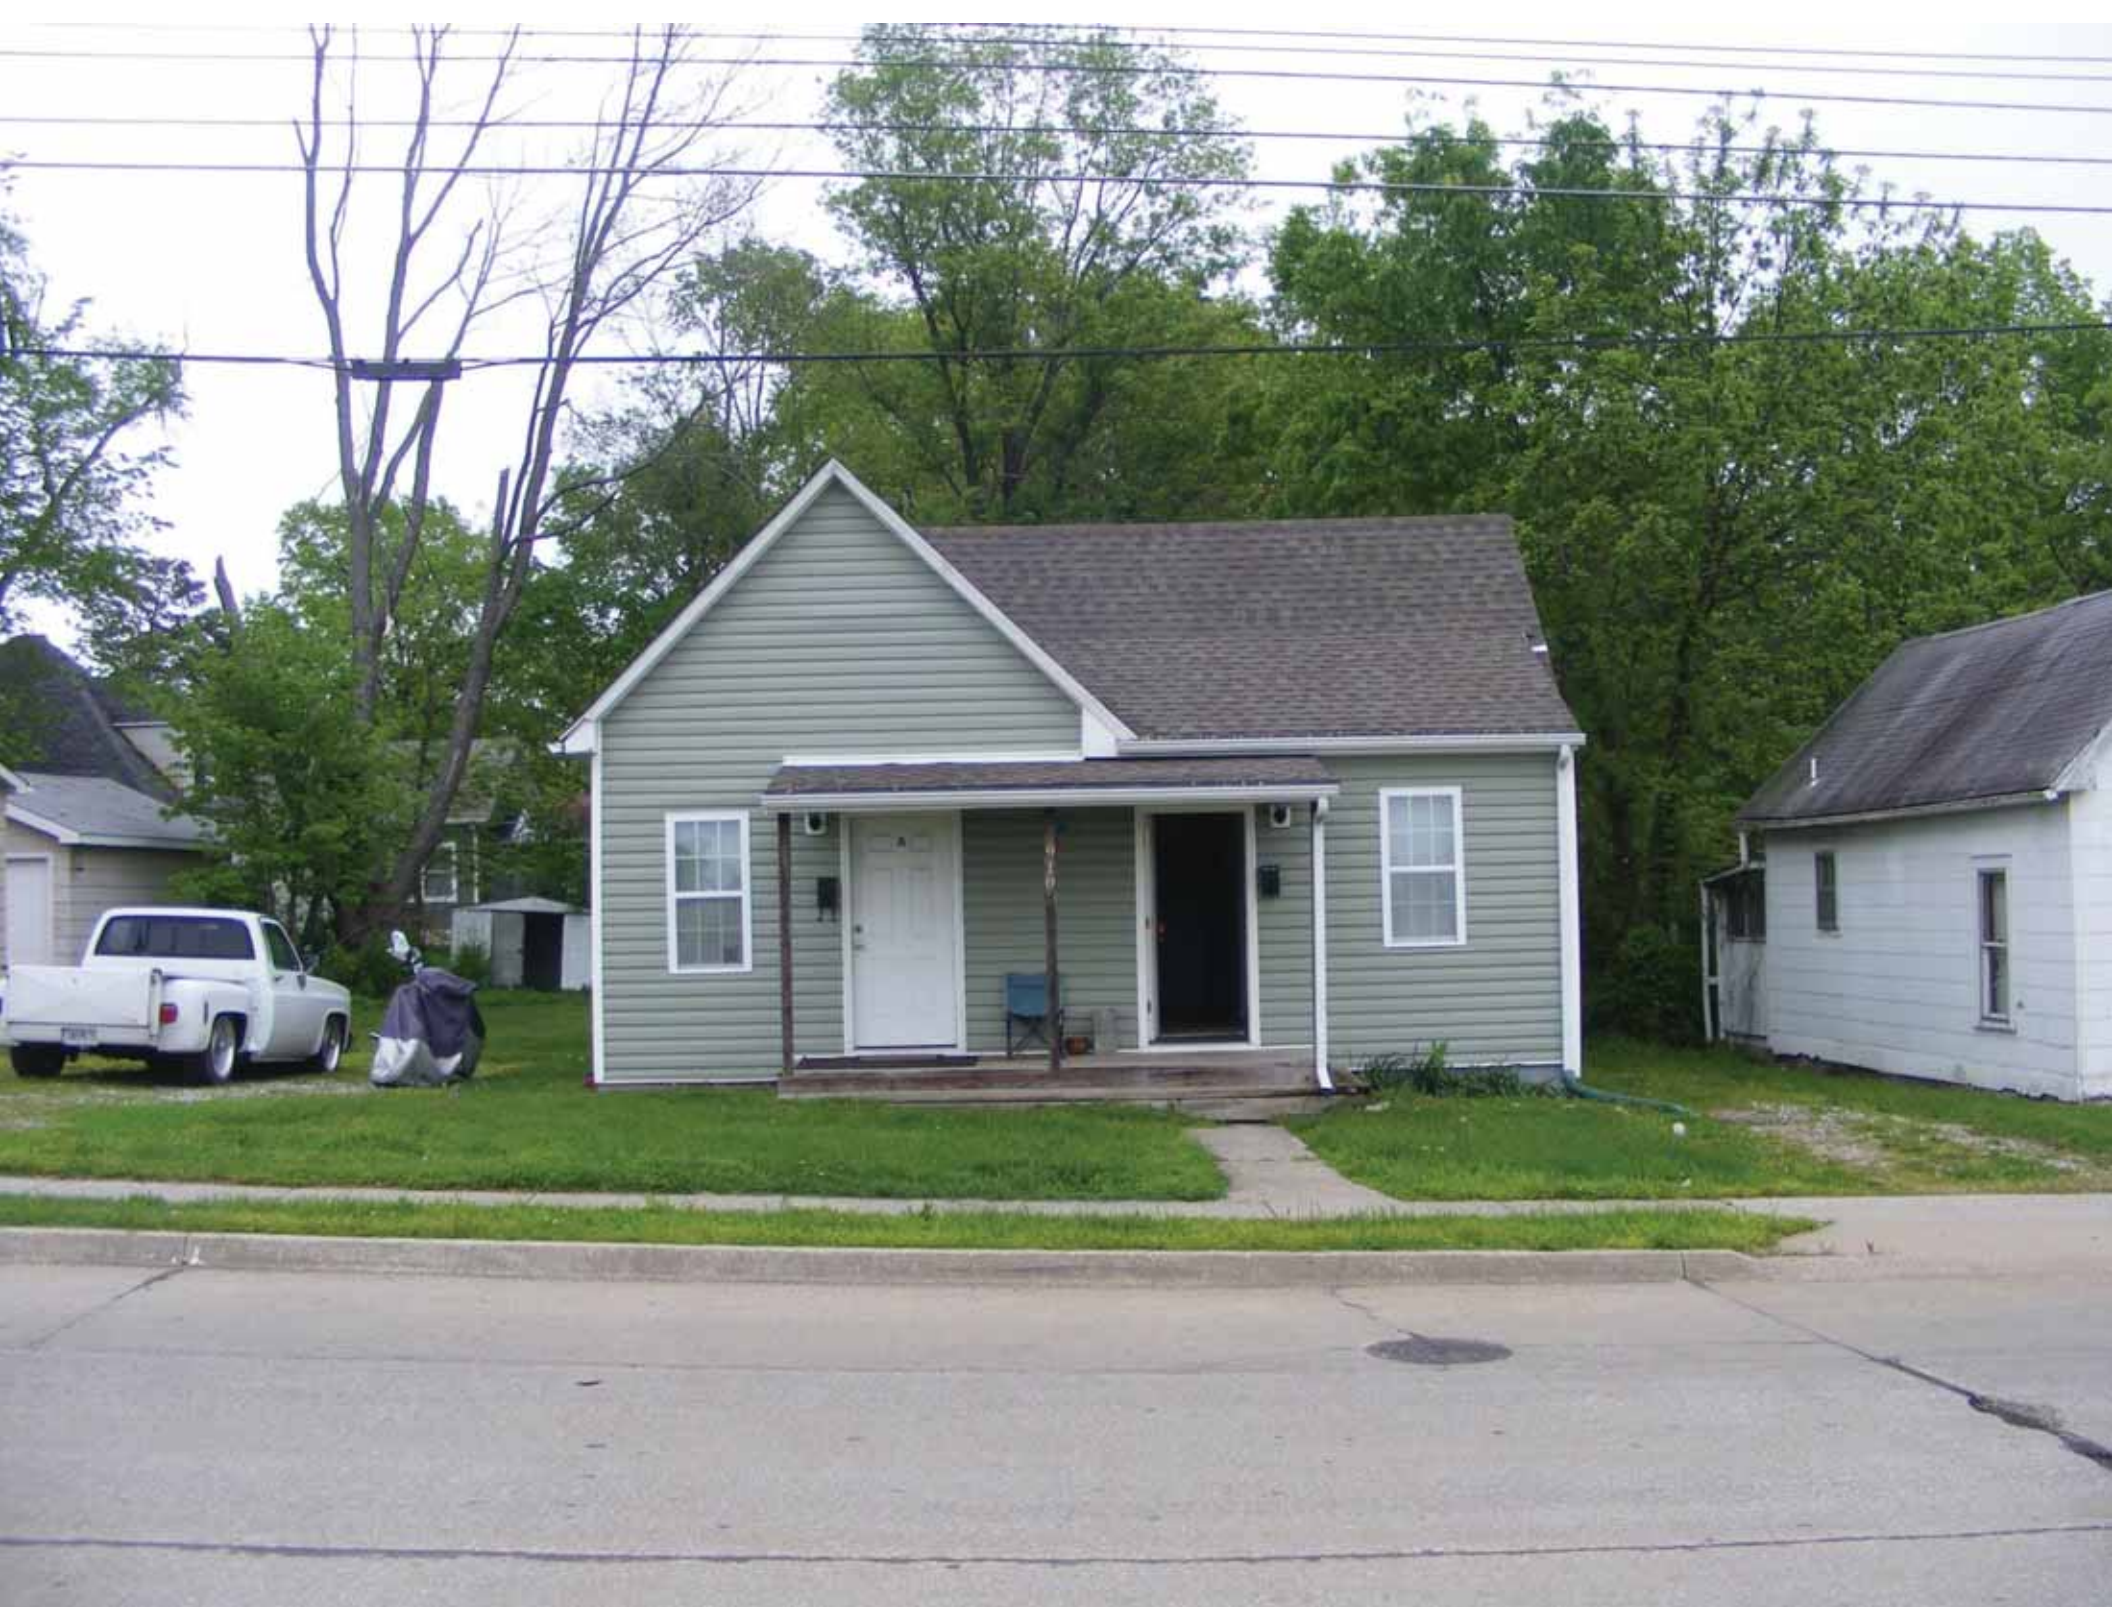
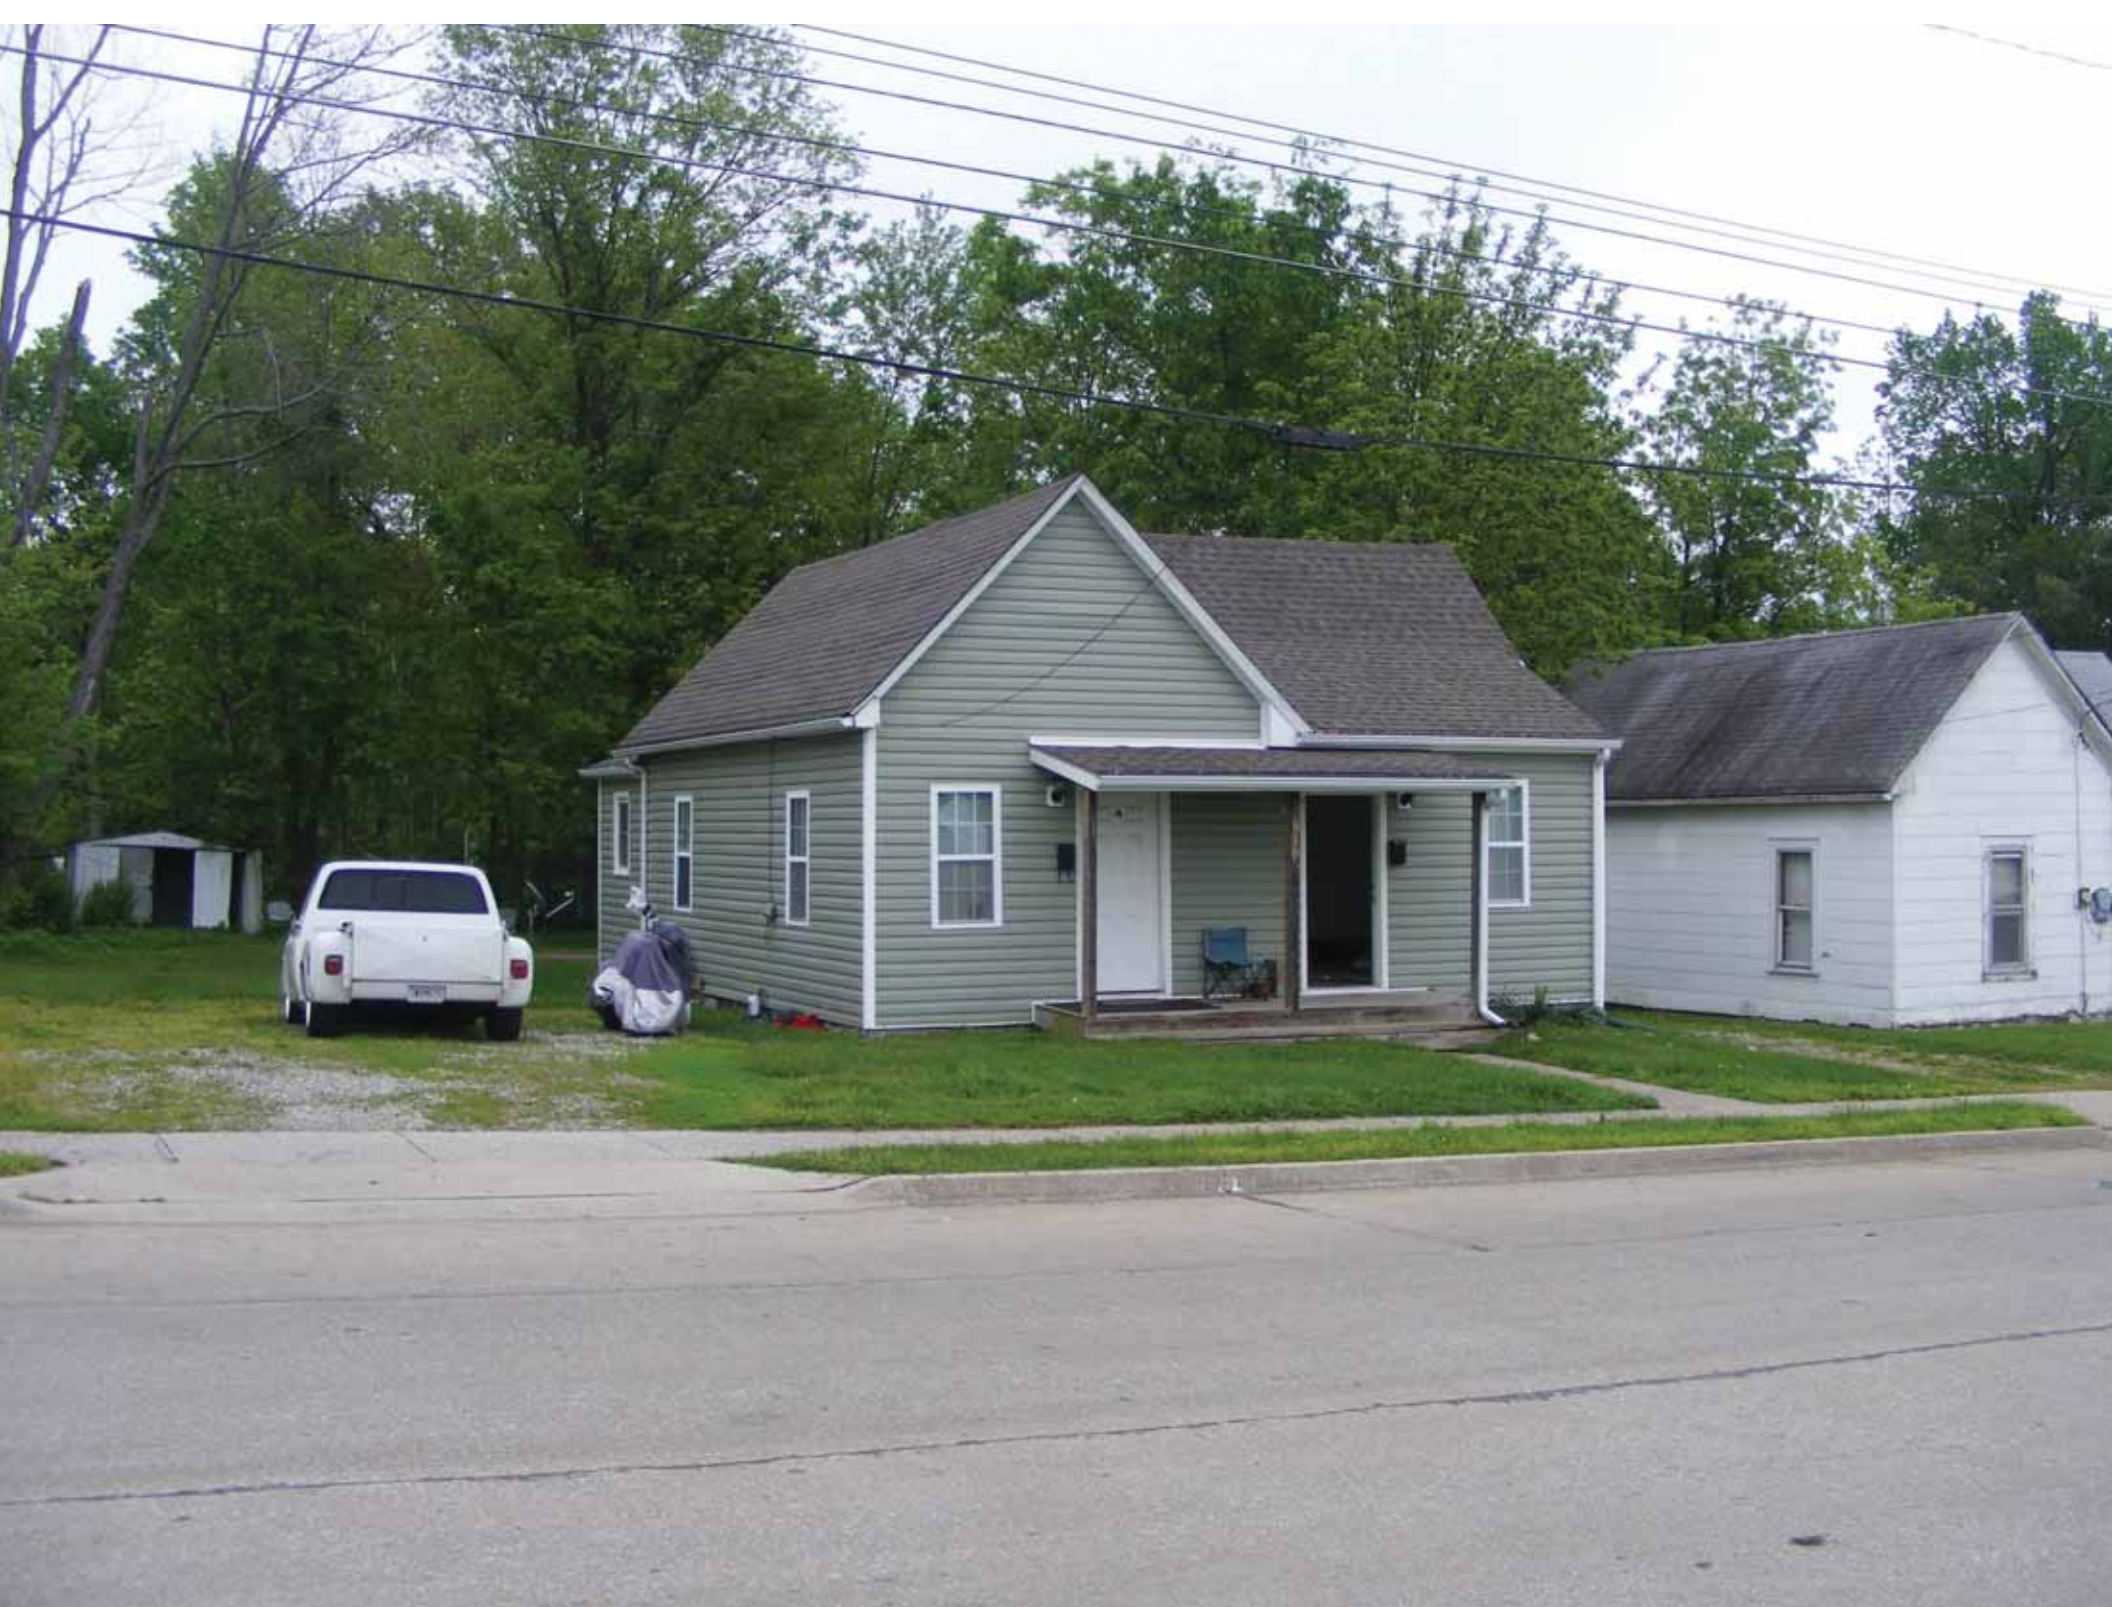
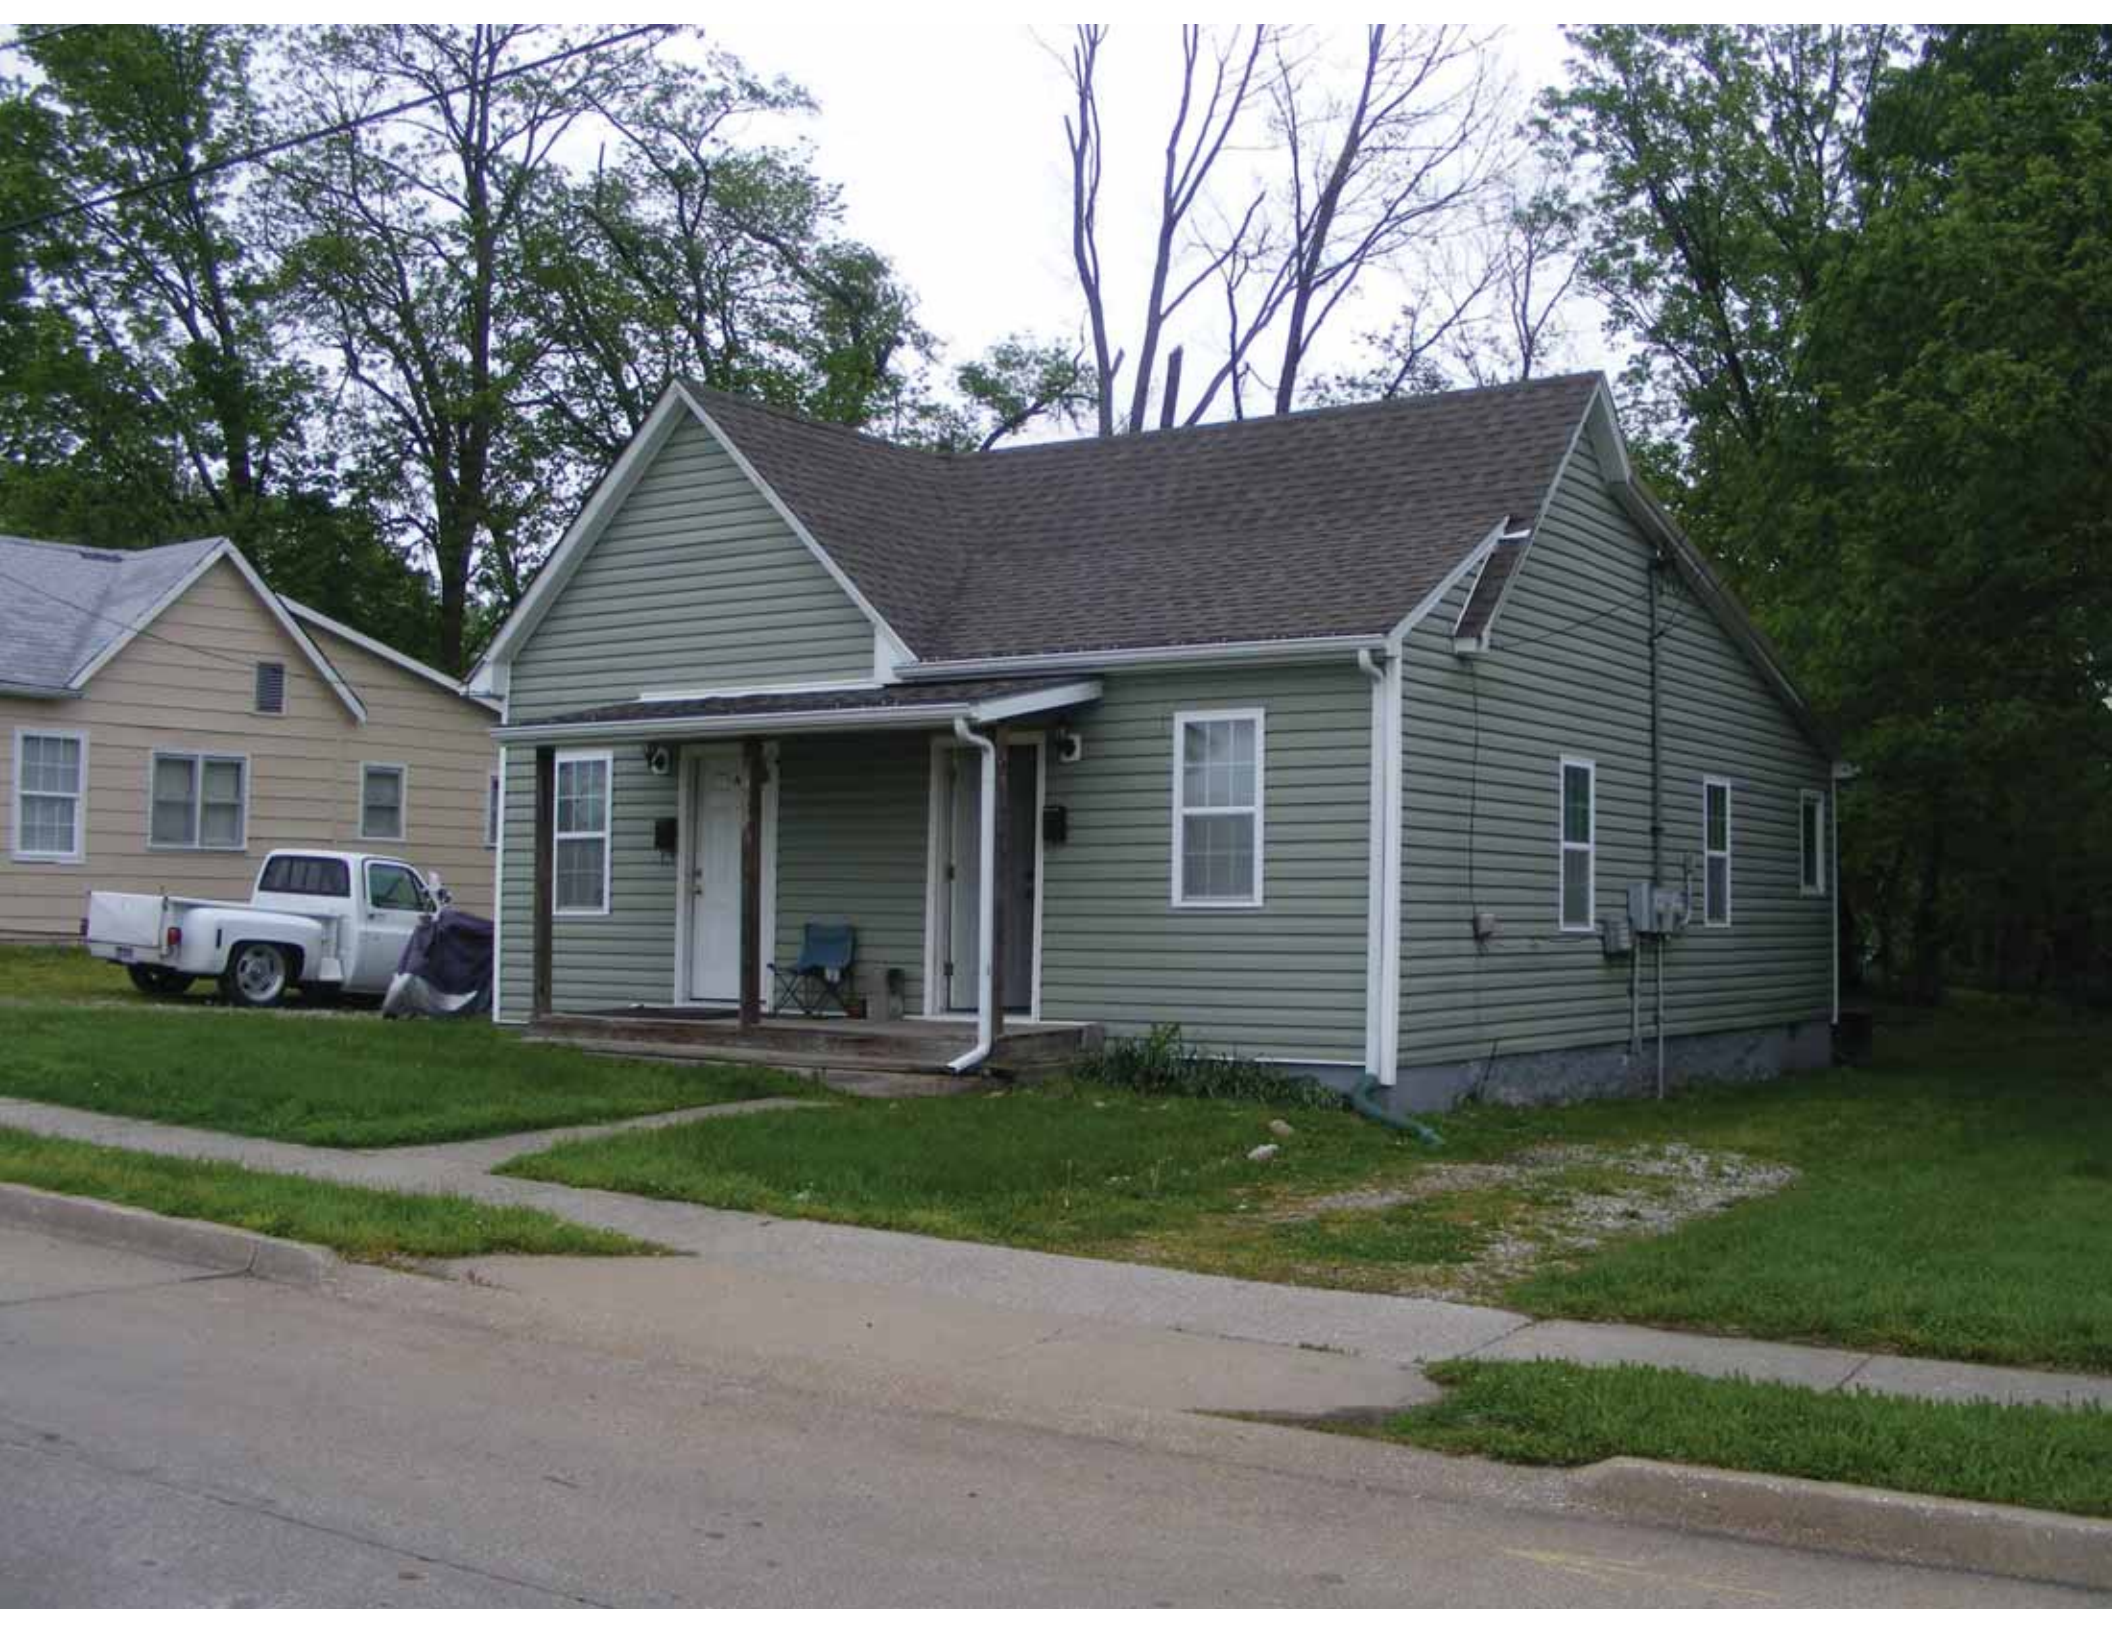
The dwelling, originally a single-family house, has been modified to support two-family housing. The dwelling has an asphalt-shingled roof, exterior vinyl siding and a concrete foundation. The primary (west) elevation has a central shed contemporary porch supported by three slender wood columns. Within the porch bay are two contemporary paneled doors. The porch is flanked by six-over-six replacement windows. The dwelling has a rear shed wing.
