MISSOURI DEPARTMENT OF NATURAL RESOURCES
STATE HISTORIC PRESERVATION OFFICE, P.O. Box 176, Jefferson City, MO 65102
ARCHITECTURAL/HISTORIC INVENTORY FORM

1. Survey No. BO-AS-011-0087		2. Survey name: North Central Columbia Survey Phase II	
3. County: Boone		4. Address (Street No.) 902	Street (name) N. Seventh Street
5. City: Columbia	Vicinity: <input type="checkbox"/>	6. Geographical Reference:	7. Township/Range/Section: T: R: S:
8. Historic name (if known):		9. Present/other name (if known):	
10. Ownership: <input checked="" type="checkbox"/> Private <input type="checkbox"/> Public		11a. Historic use (if known): Domestic/single dwelling	11b. Current use: Domestic/single dwelling

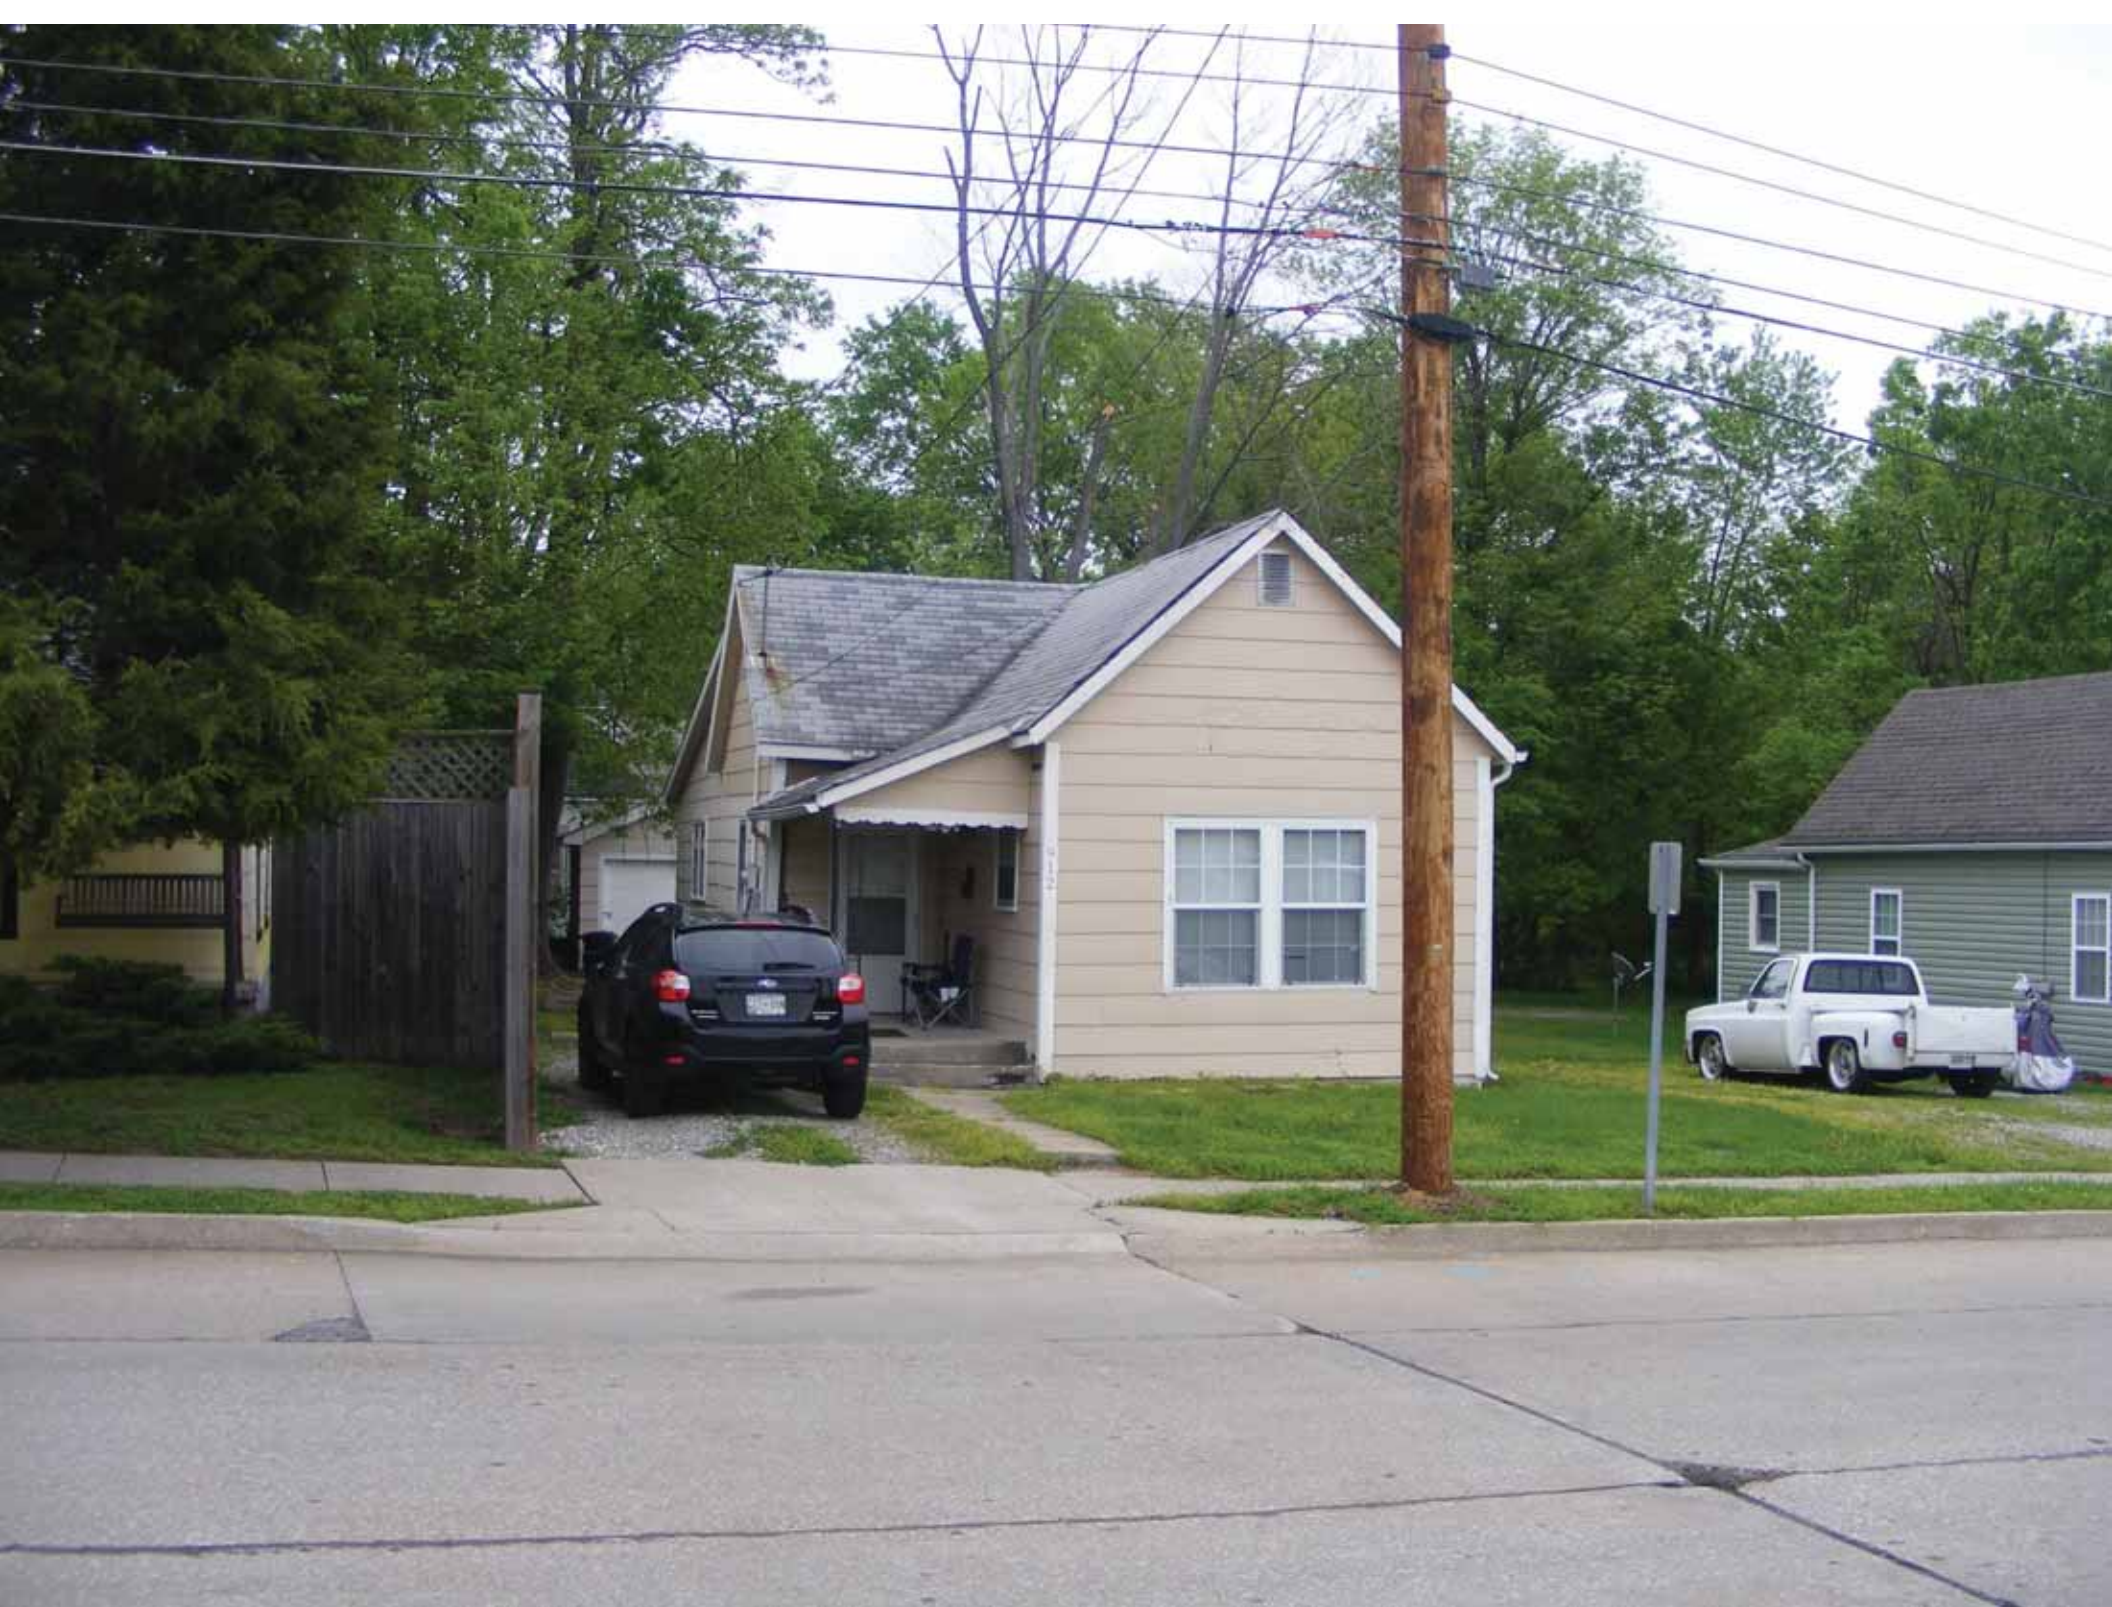
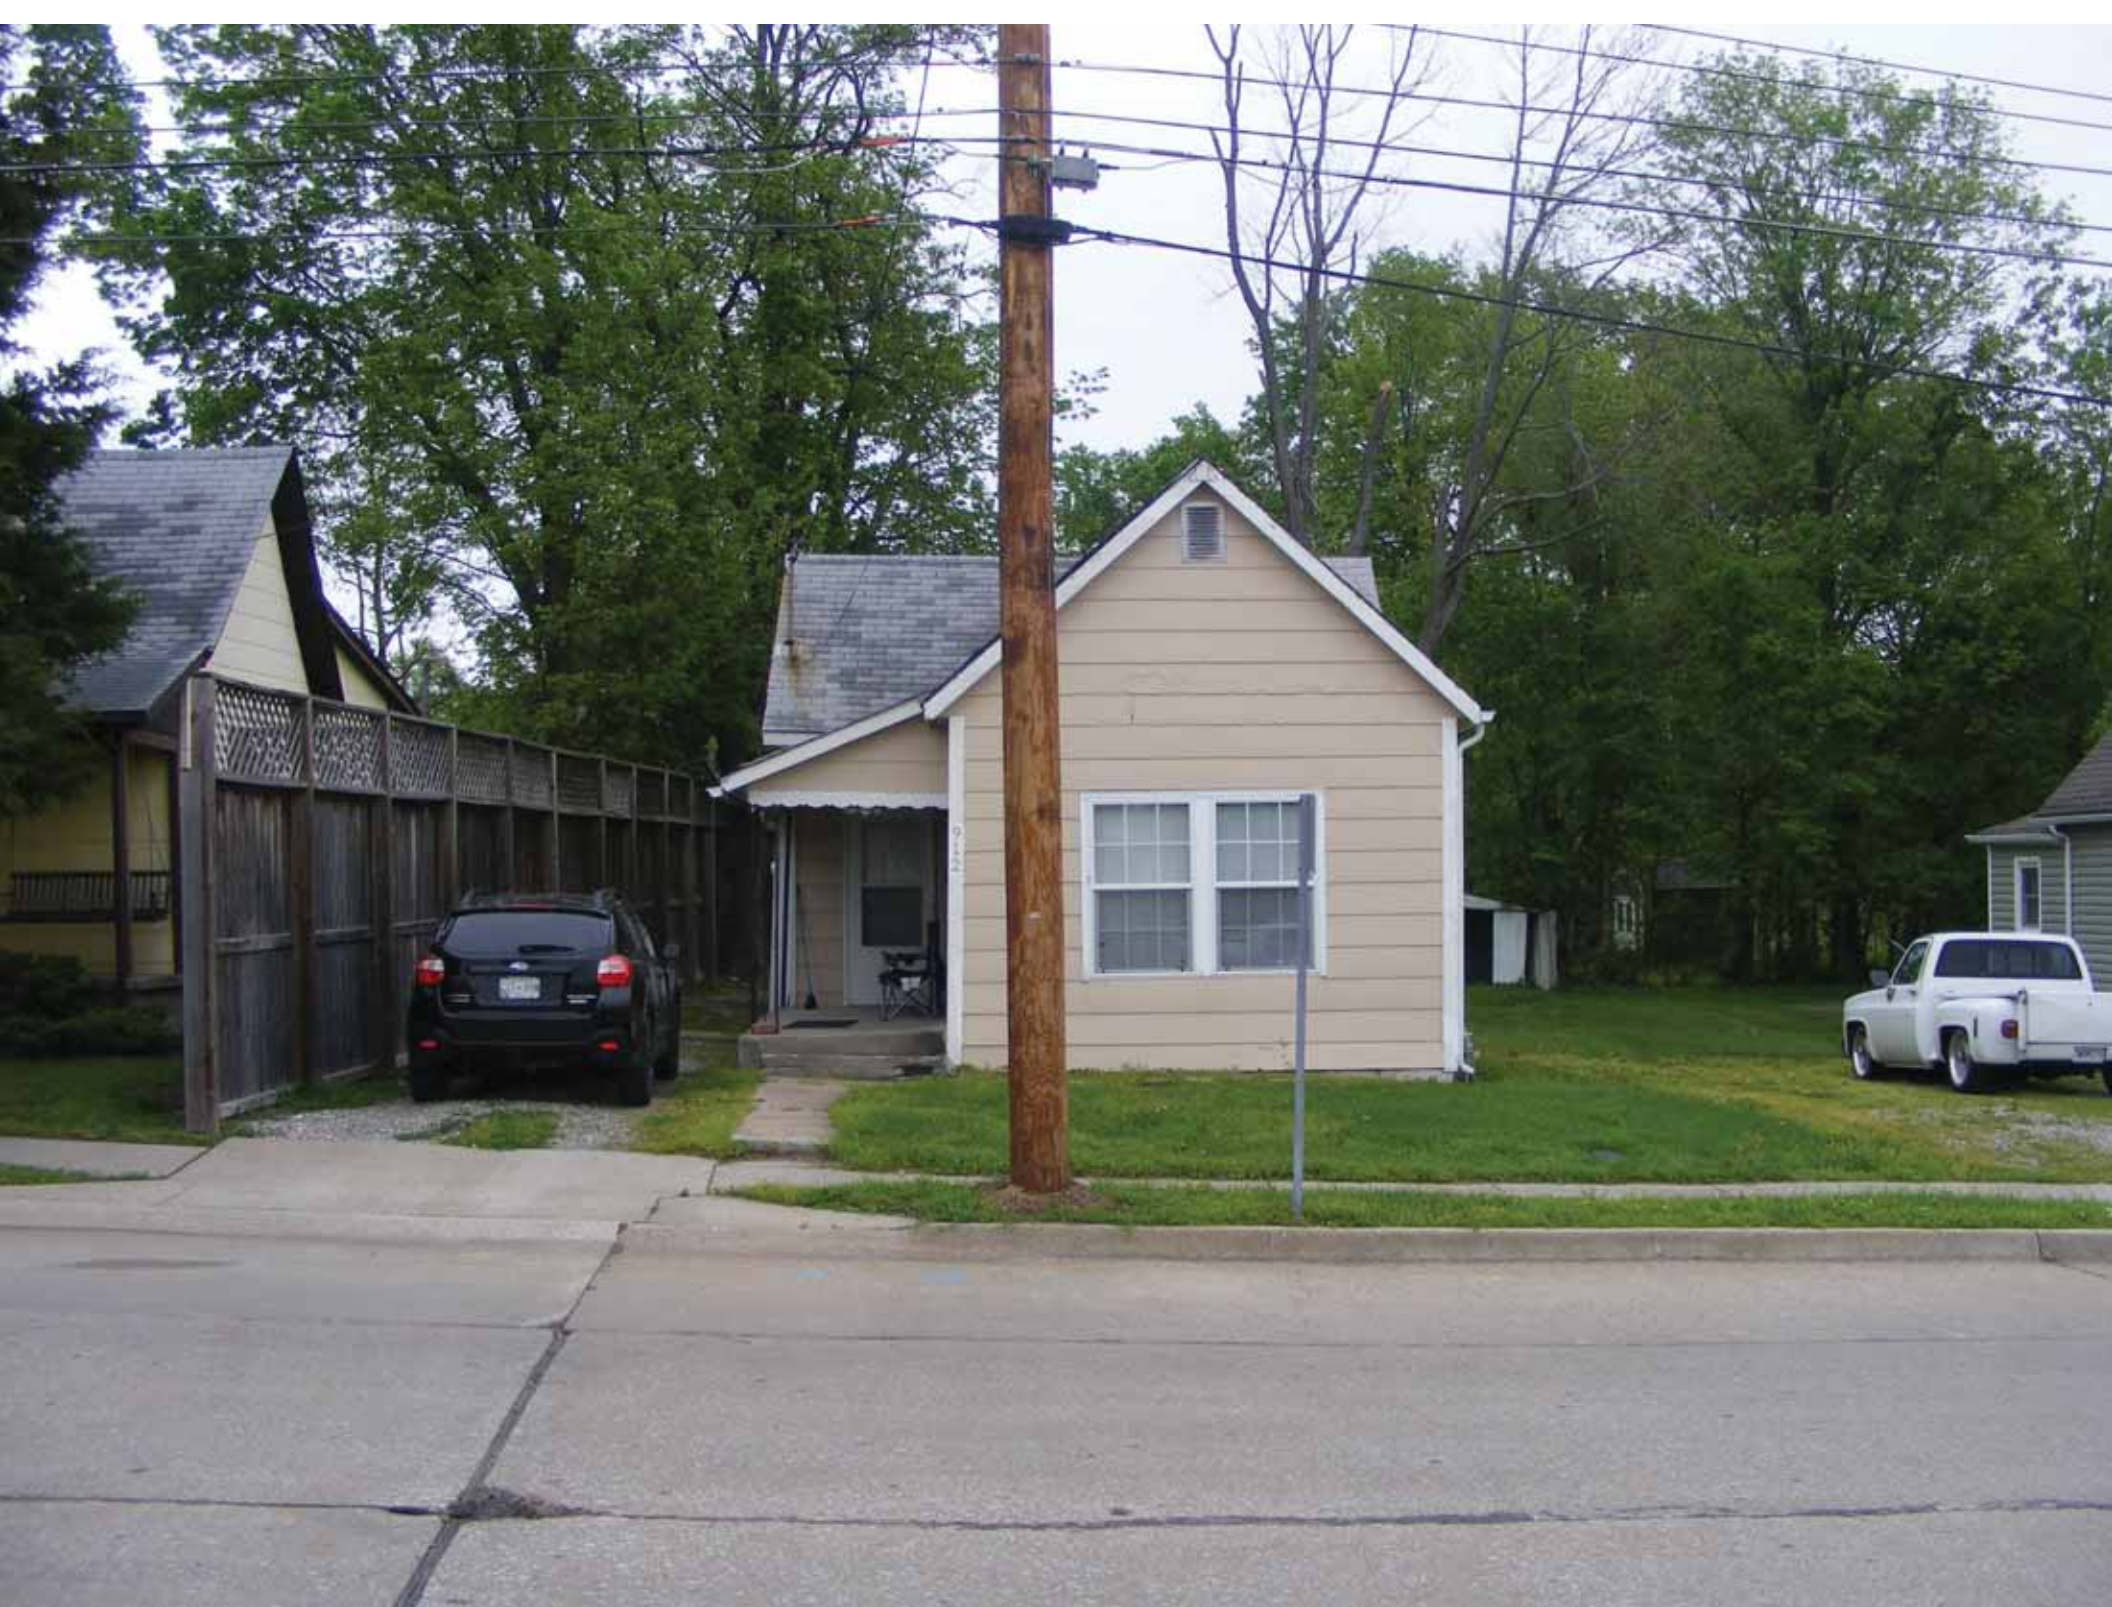
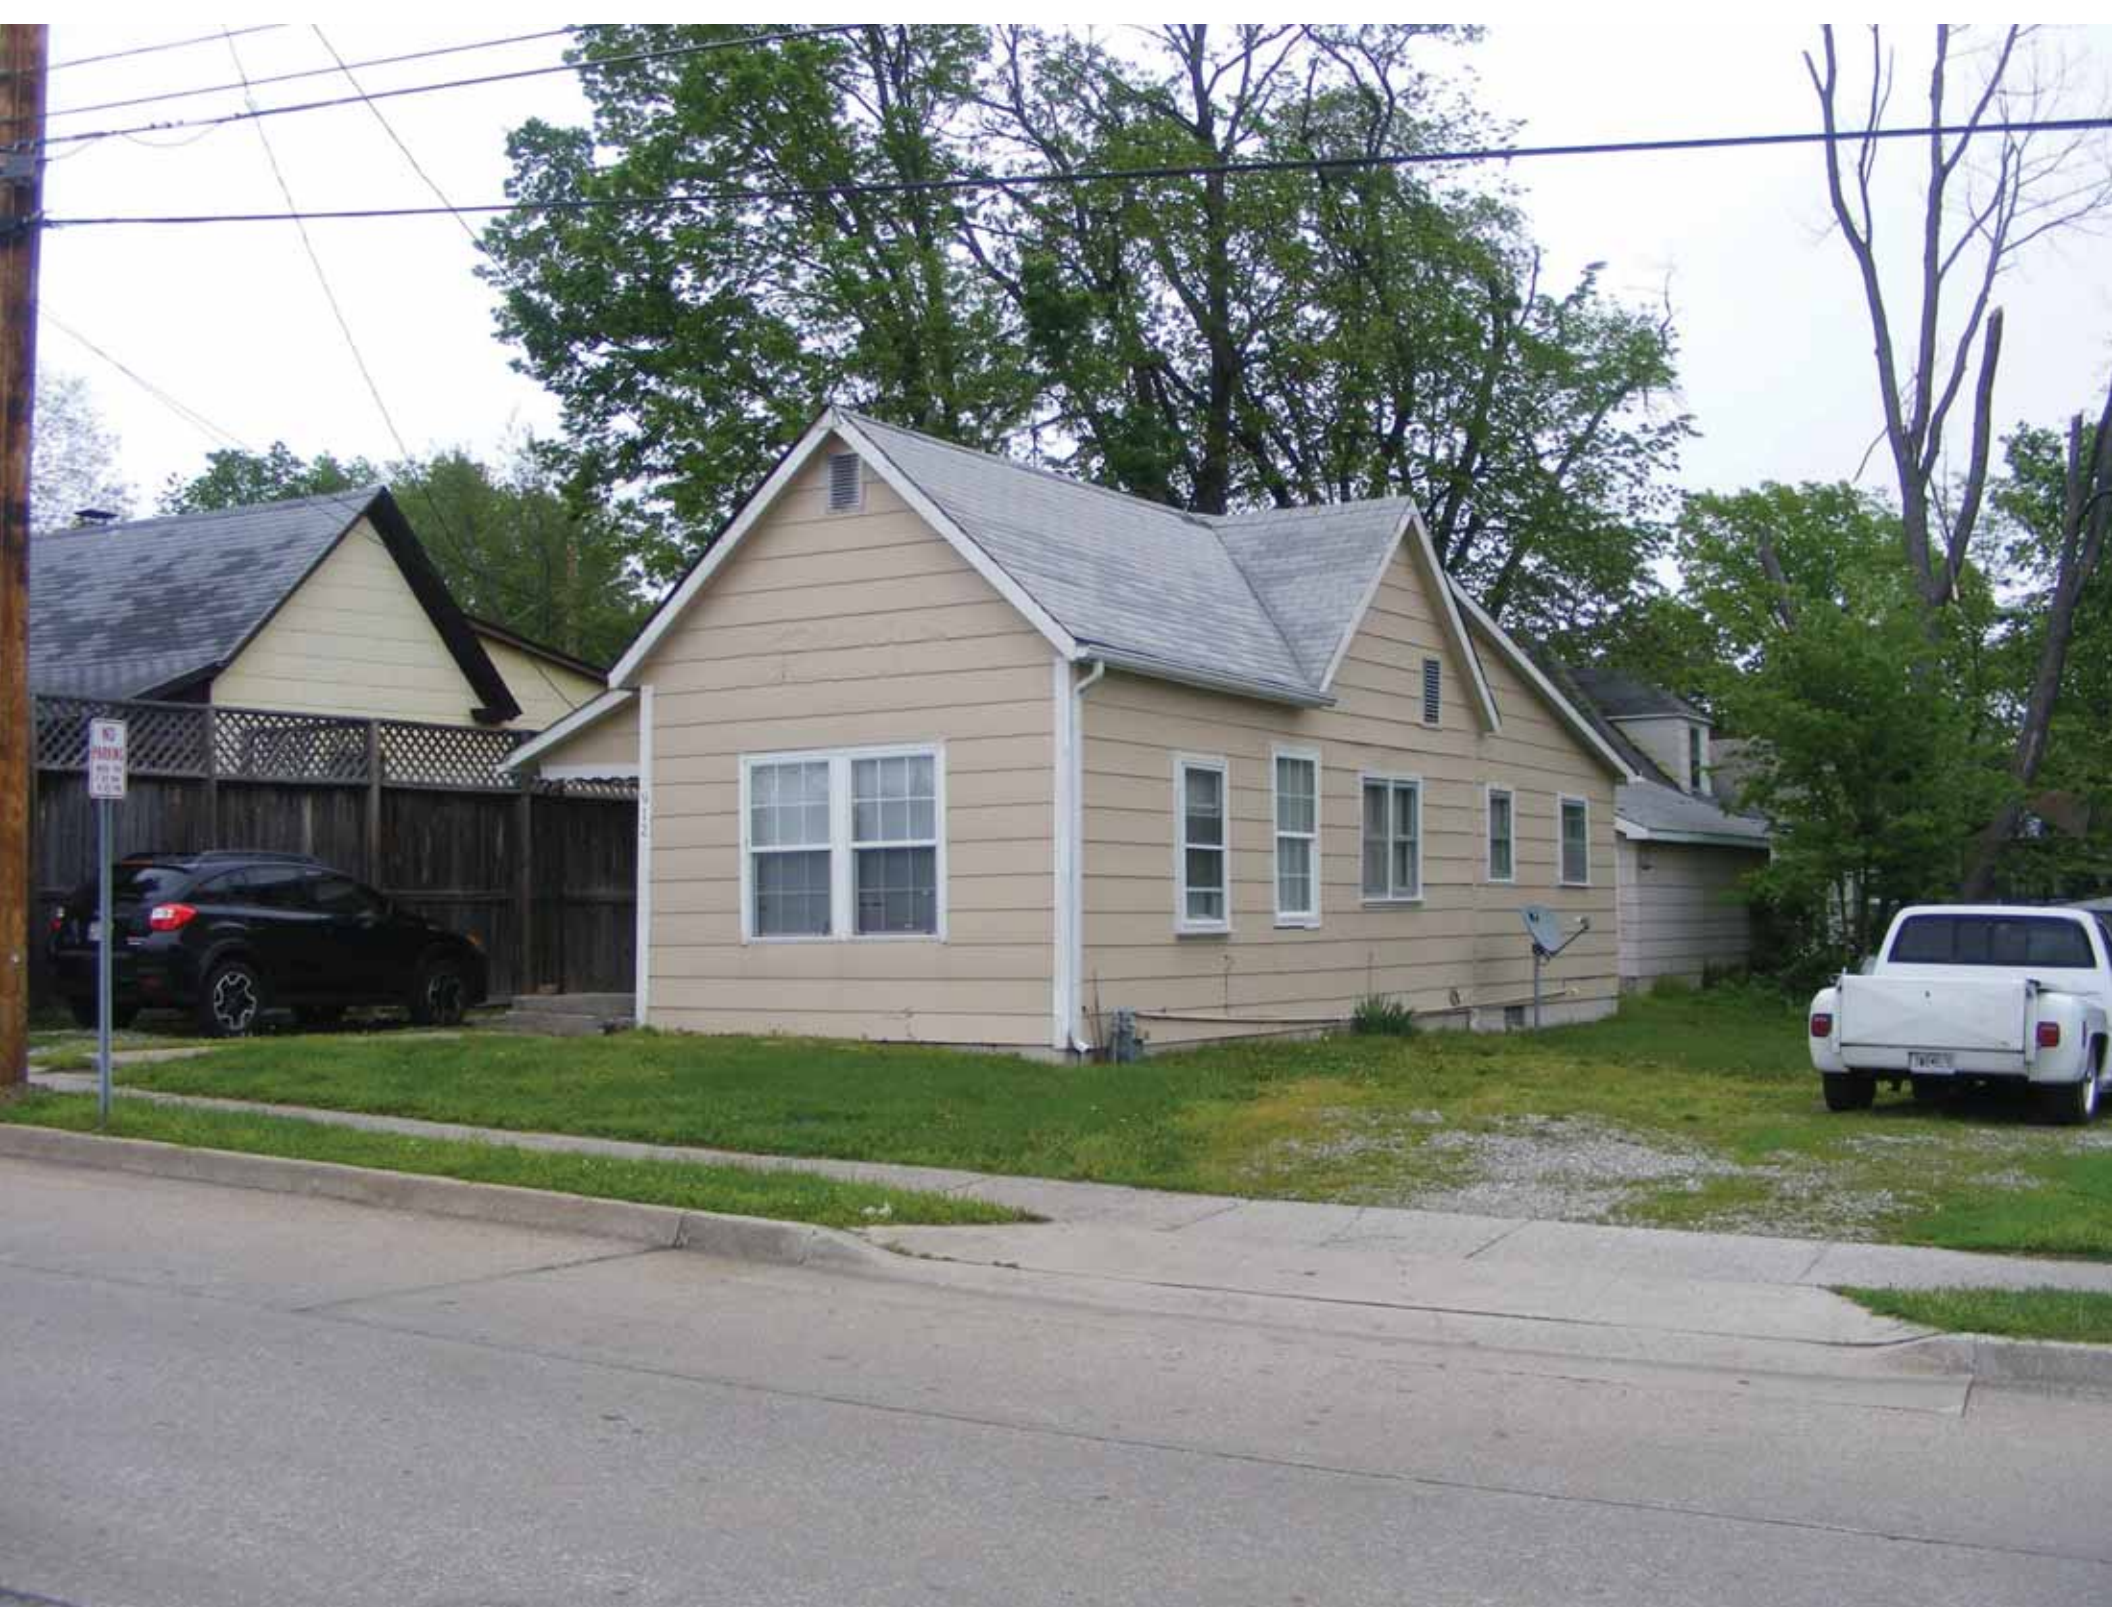
The cross-gable plan dwelling has an asphalt-shingled roof, exterior asbestos siding and a concrete foundation. The front facing gabled wing holds paired replacement six-over-six windows. Remaining windows are one-over-one. The gable field has a louvered vent. Offsetting the gabled wing on the north is a shed porch supported by wrought iron columns. The porch roof is trimmed with a scalloped edge. Within the porch bay is a paneled door (west wall). A one-over-one small window is situated on the north wall within the porch bay. The dwelling has a rear shed wing.
