MISSOURI DEPARTMENT OF NATURAL RESOURCES
STATE HISTORIC PRESERVATION OFFICE, P.O. Box 176, Jefferson City, MO 65102
ARCHITECTURAL/HISTORIC INVENTORY FORM

1. Survey No. BO-AS-011-0087		2. Survey name: North Central Columbia Survey Phase II	
3. County: Boone		4. Address (Street No.) 902	Street (name) N. Seventh Street
5. City: Columbia	Vicinity: <input type="checkbox"/>	6. Geographical Reference:	7. Township/Range/Section: T: R: S:
8. Historic name (if known):		9. Present/other name (if known):	
10. Ownership: <input checked="" type="checkbox"/> Private <input type="checkbox"/> Public		11a. Historic use (if known): Domestic/single dwelling	11b. Current use: Domestic/single dwelling

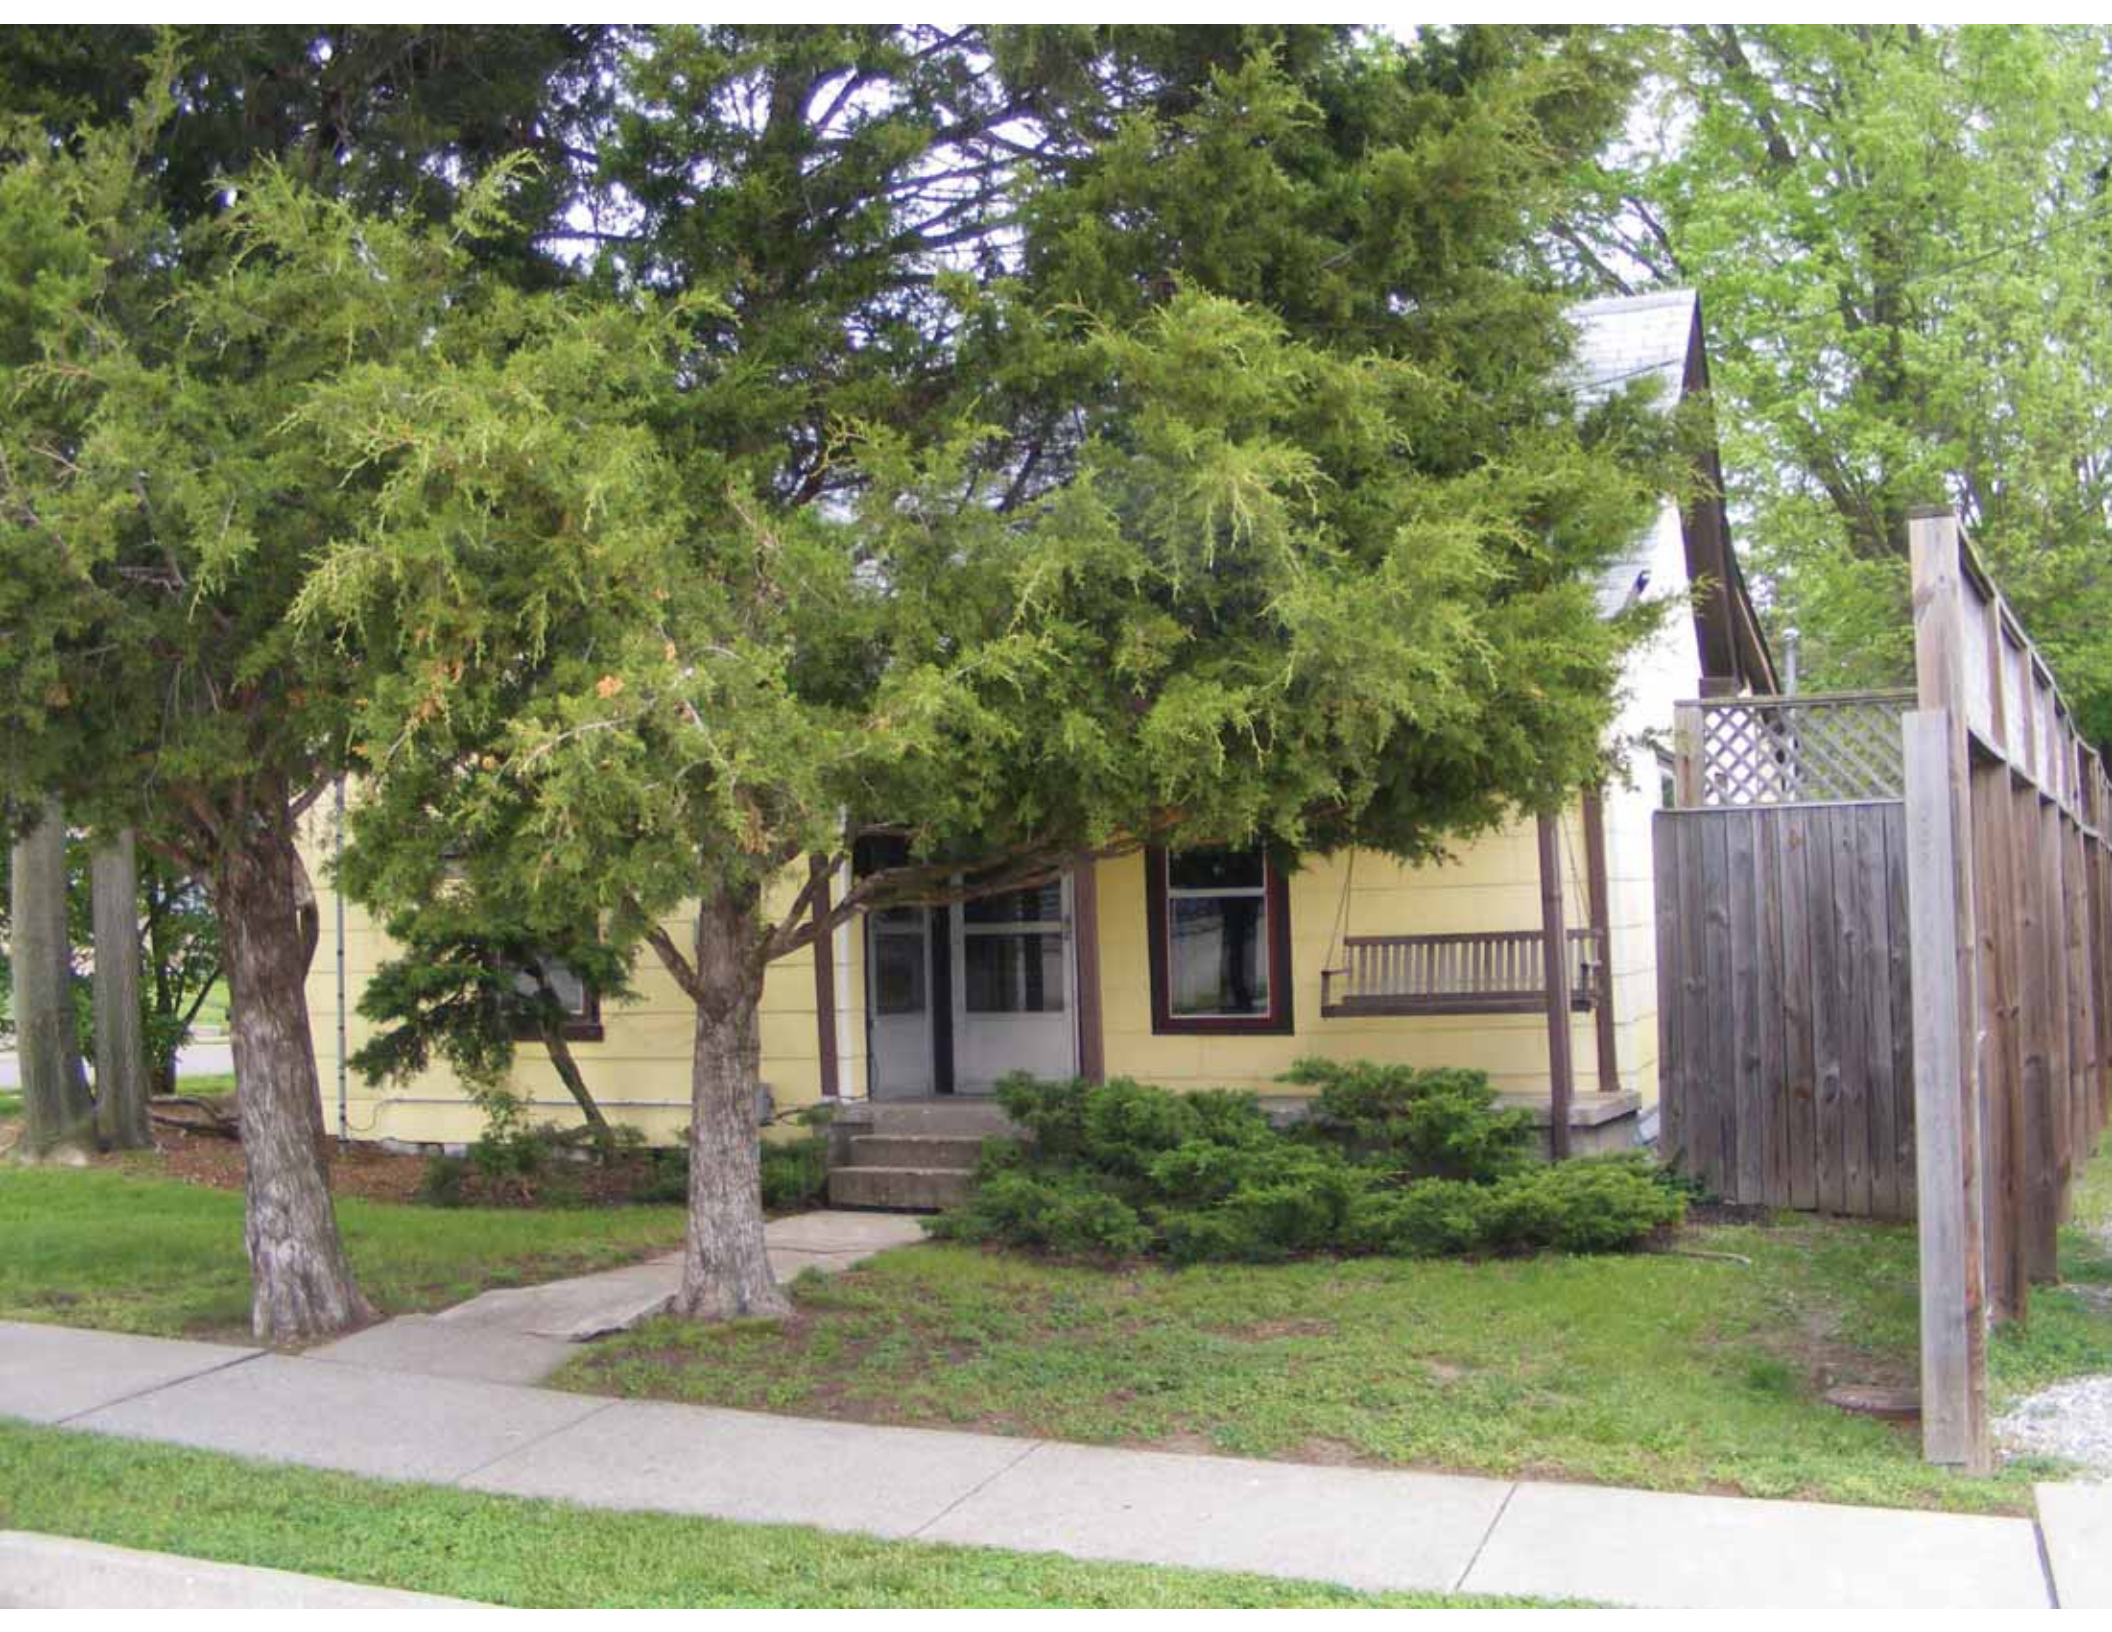
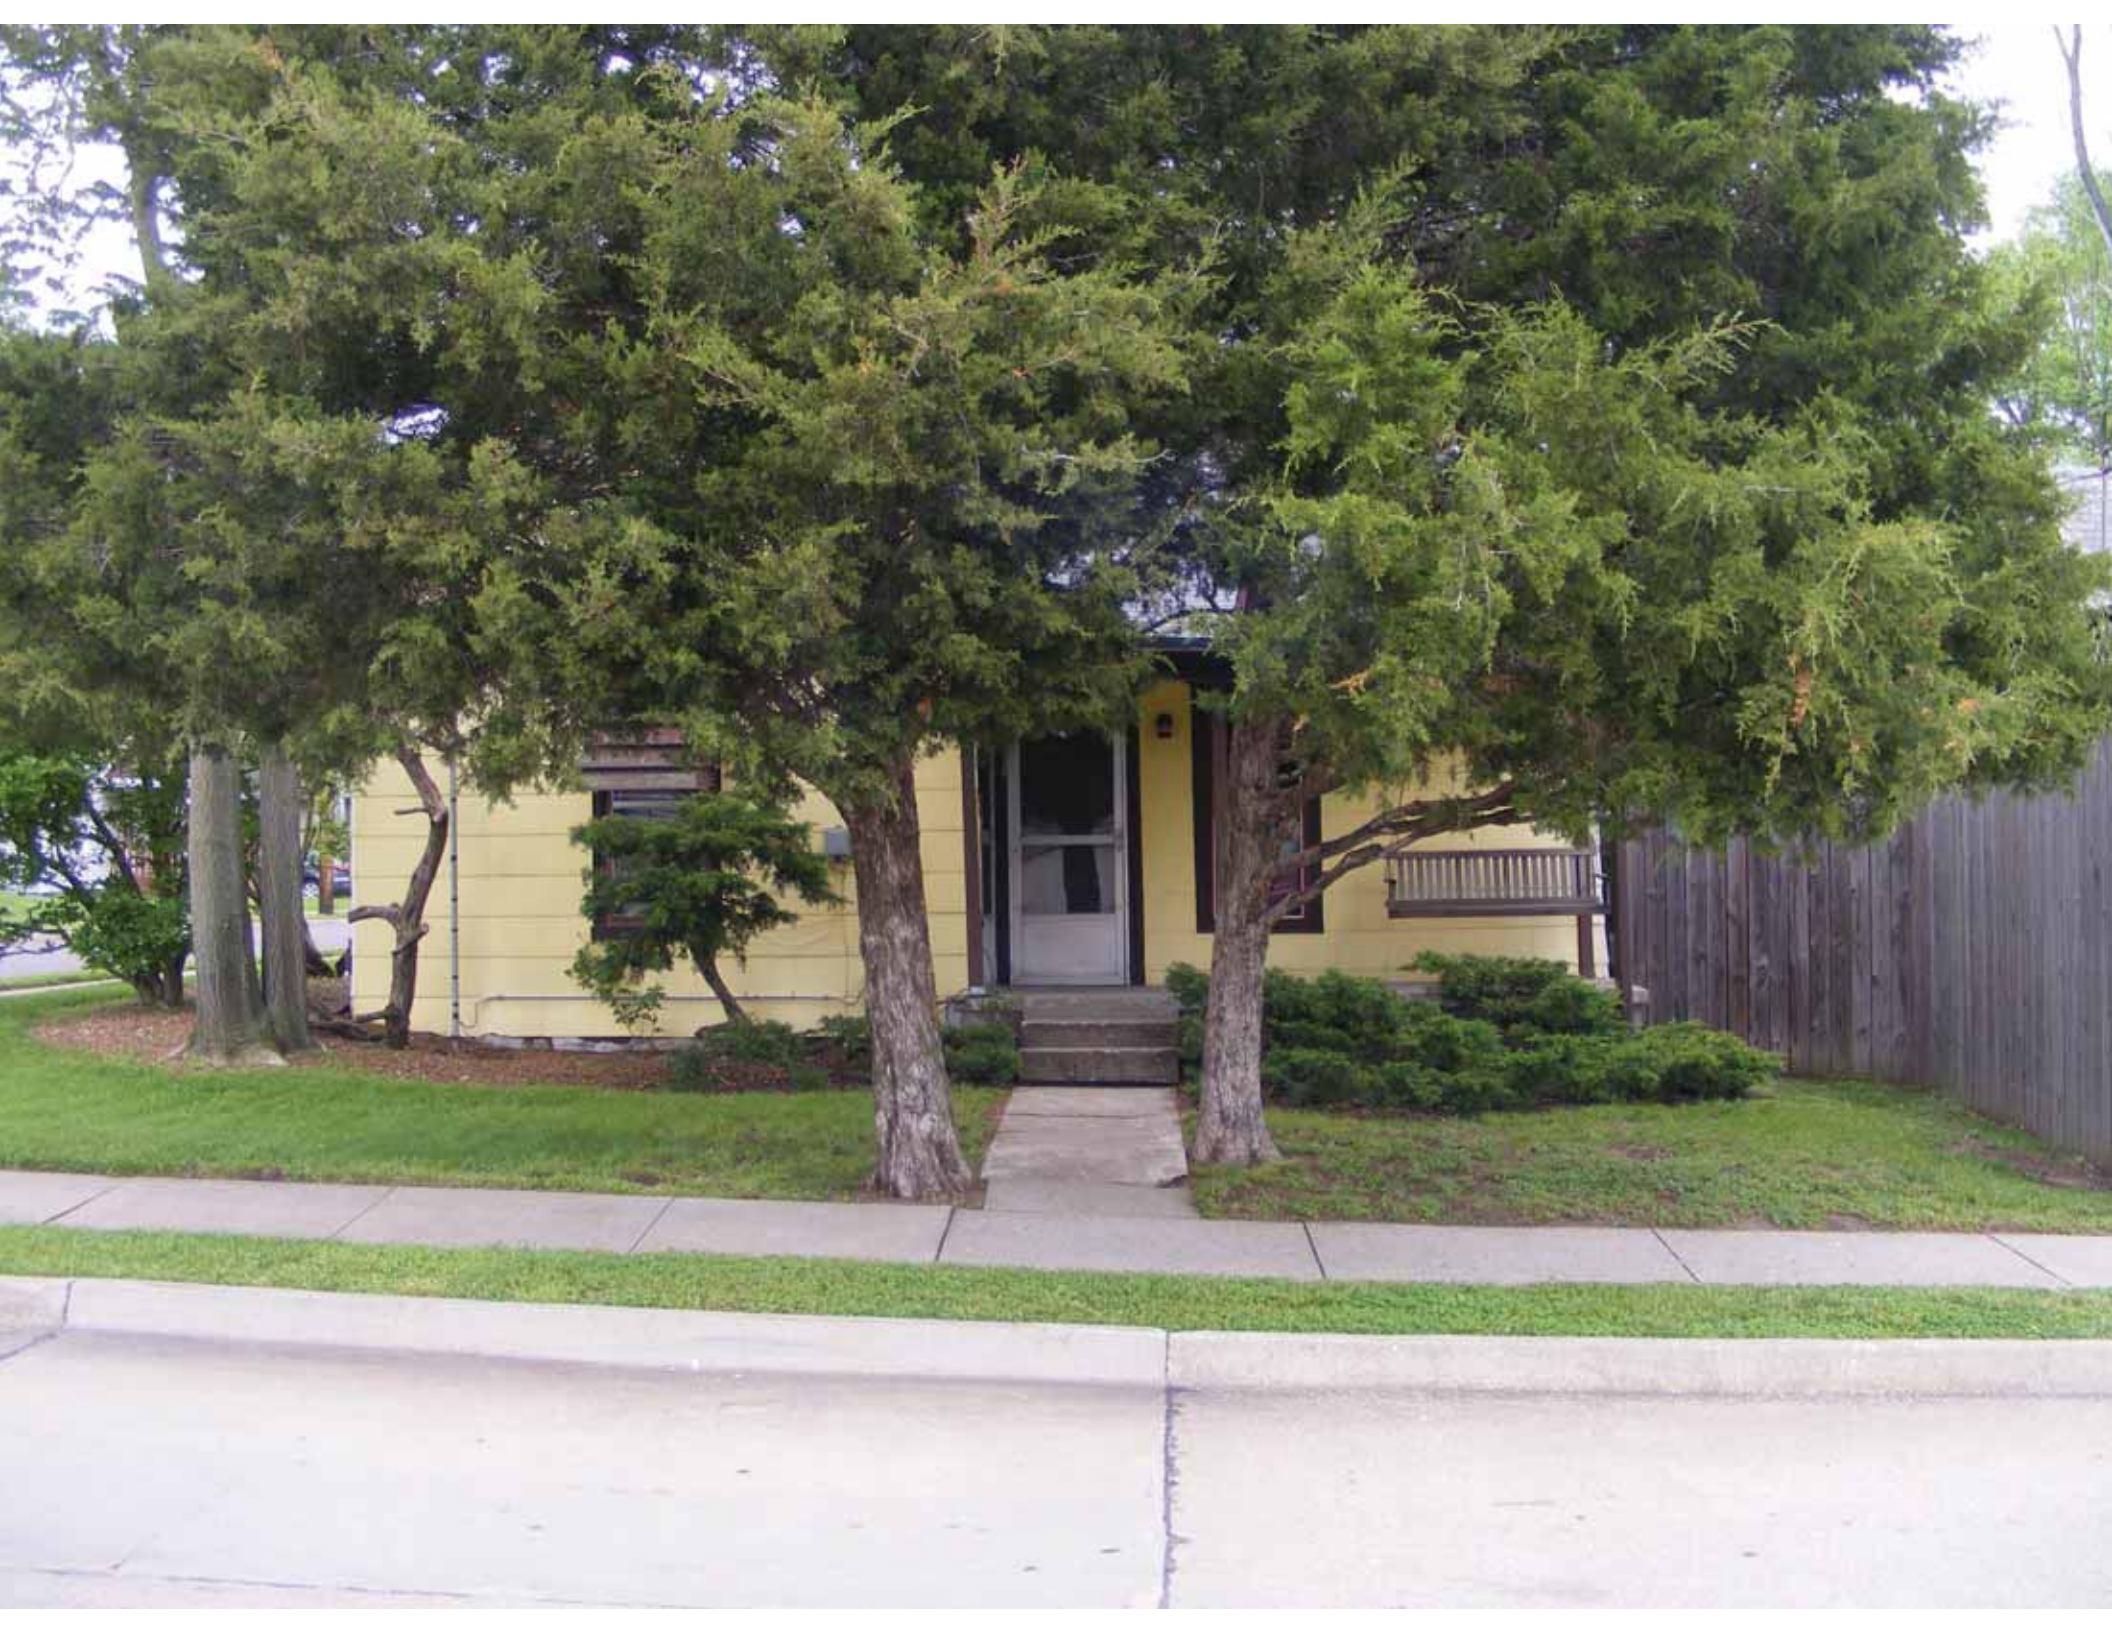
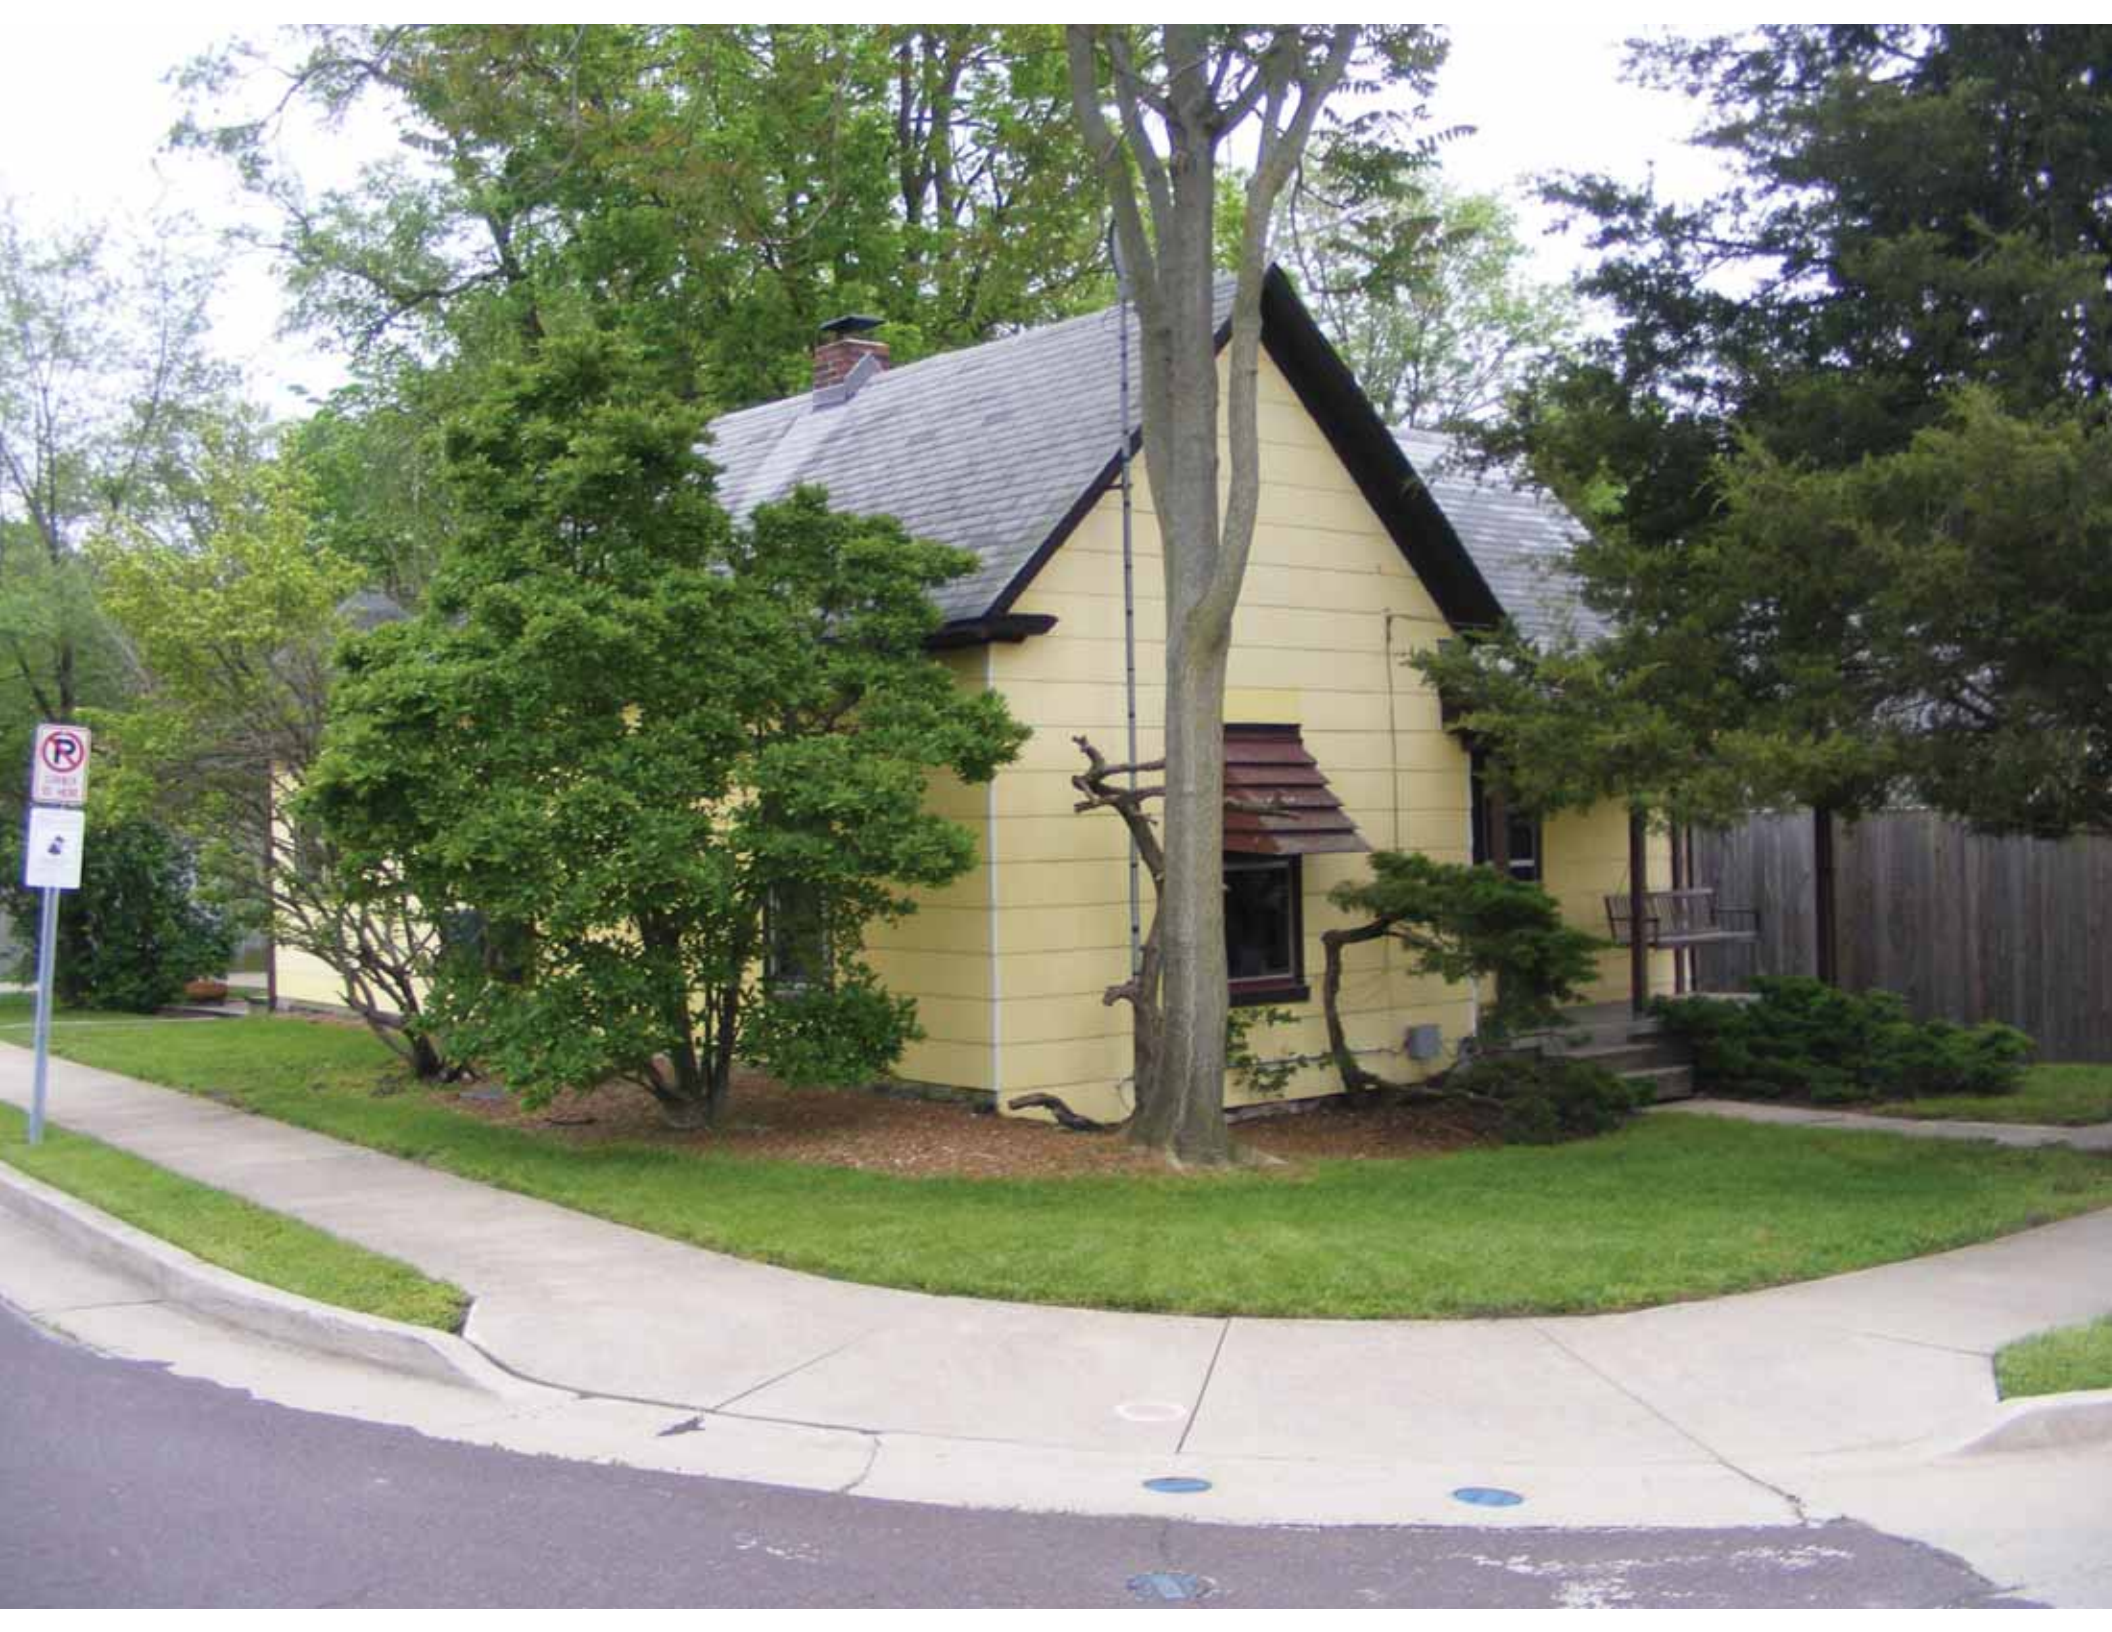
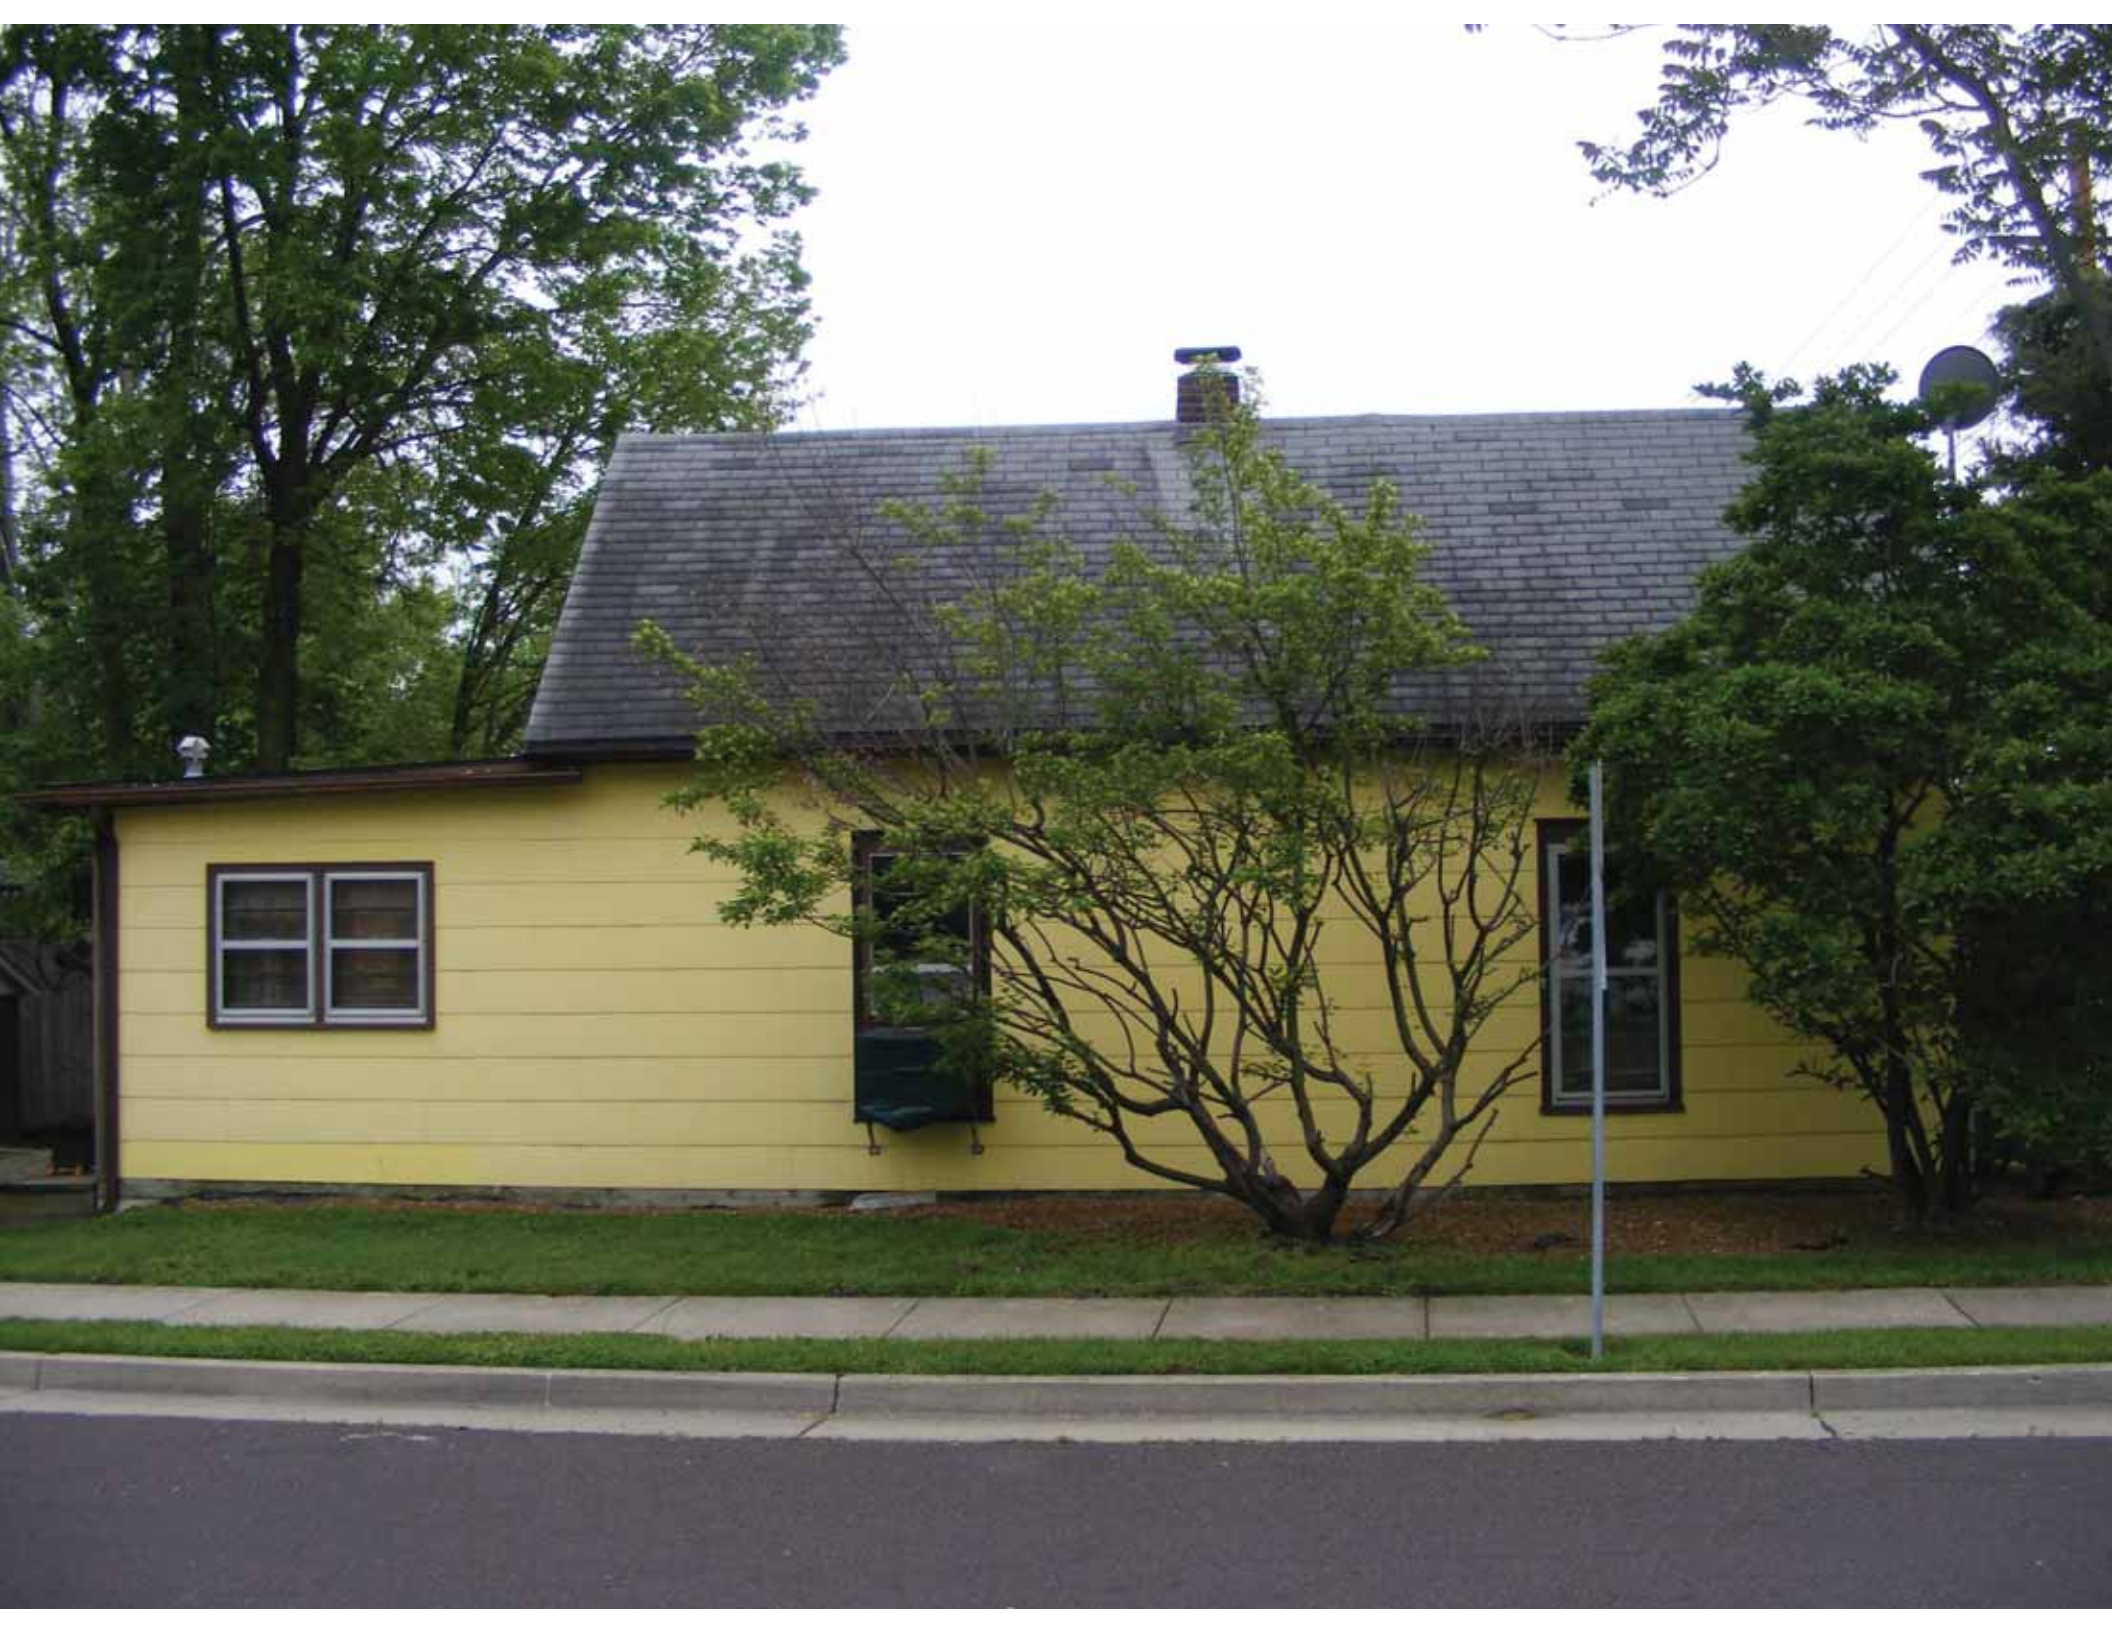
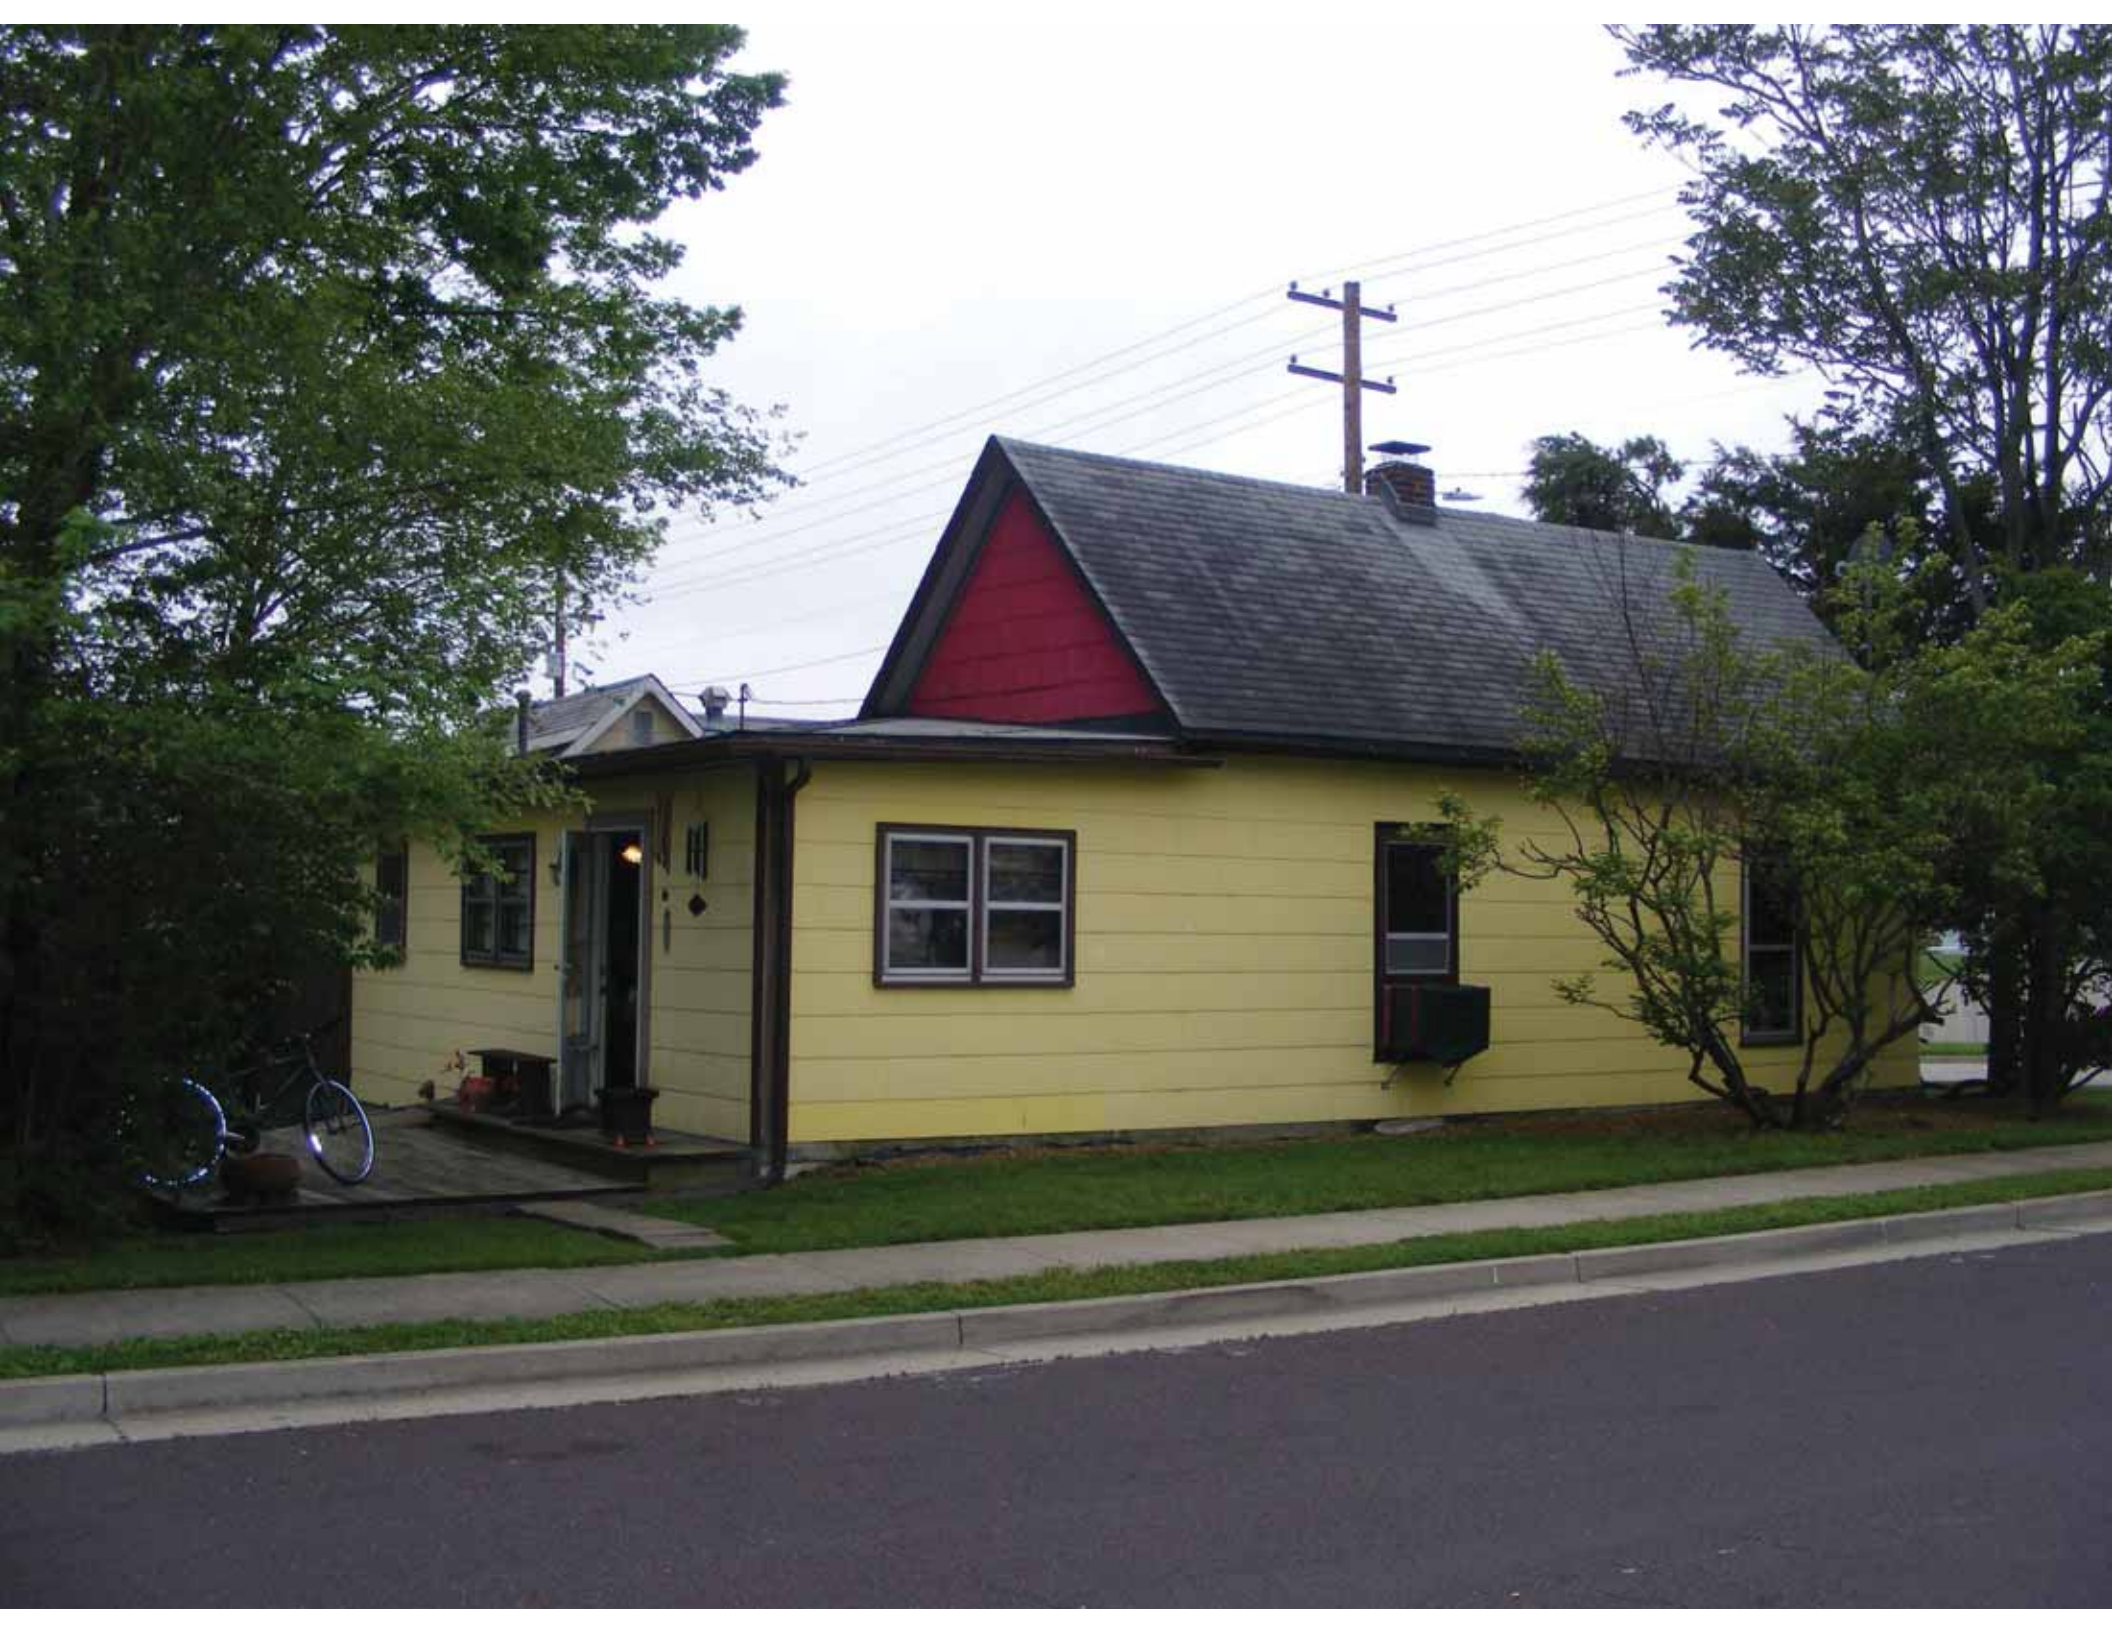
The cross gable plan dwelling has an asphalt shingled roof with gable returns, exterior asbestos shingle siding and a limestone and concrete foundation. The primary (west) elevation has a half-width shed porch supported by square columns. Within the porch bay are single doors on the south and west walls. The west door is offset by a one-over-one window. The dwelling has an interior central brick chimney and a rear shed wing.

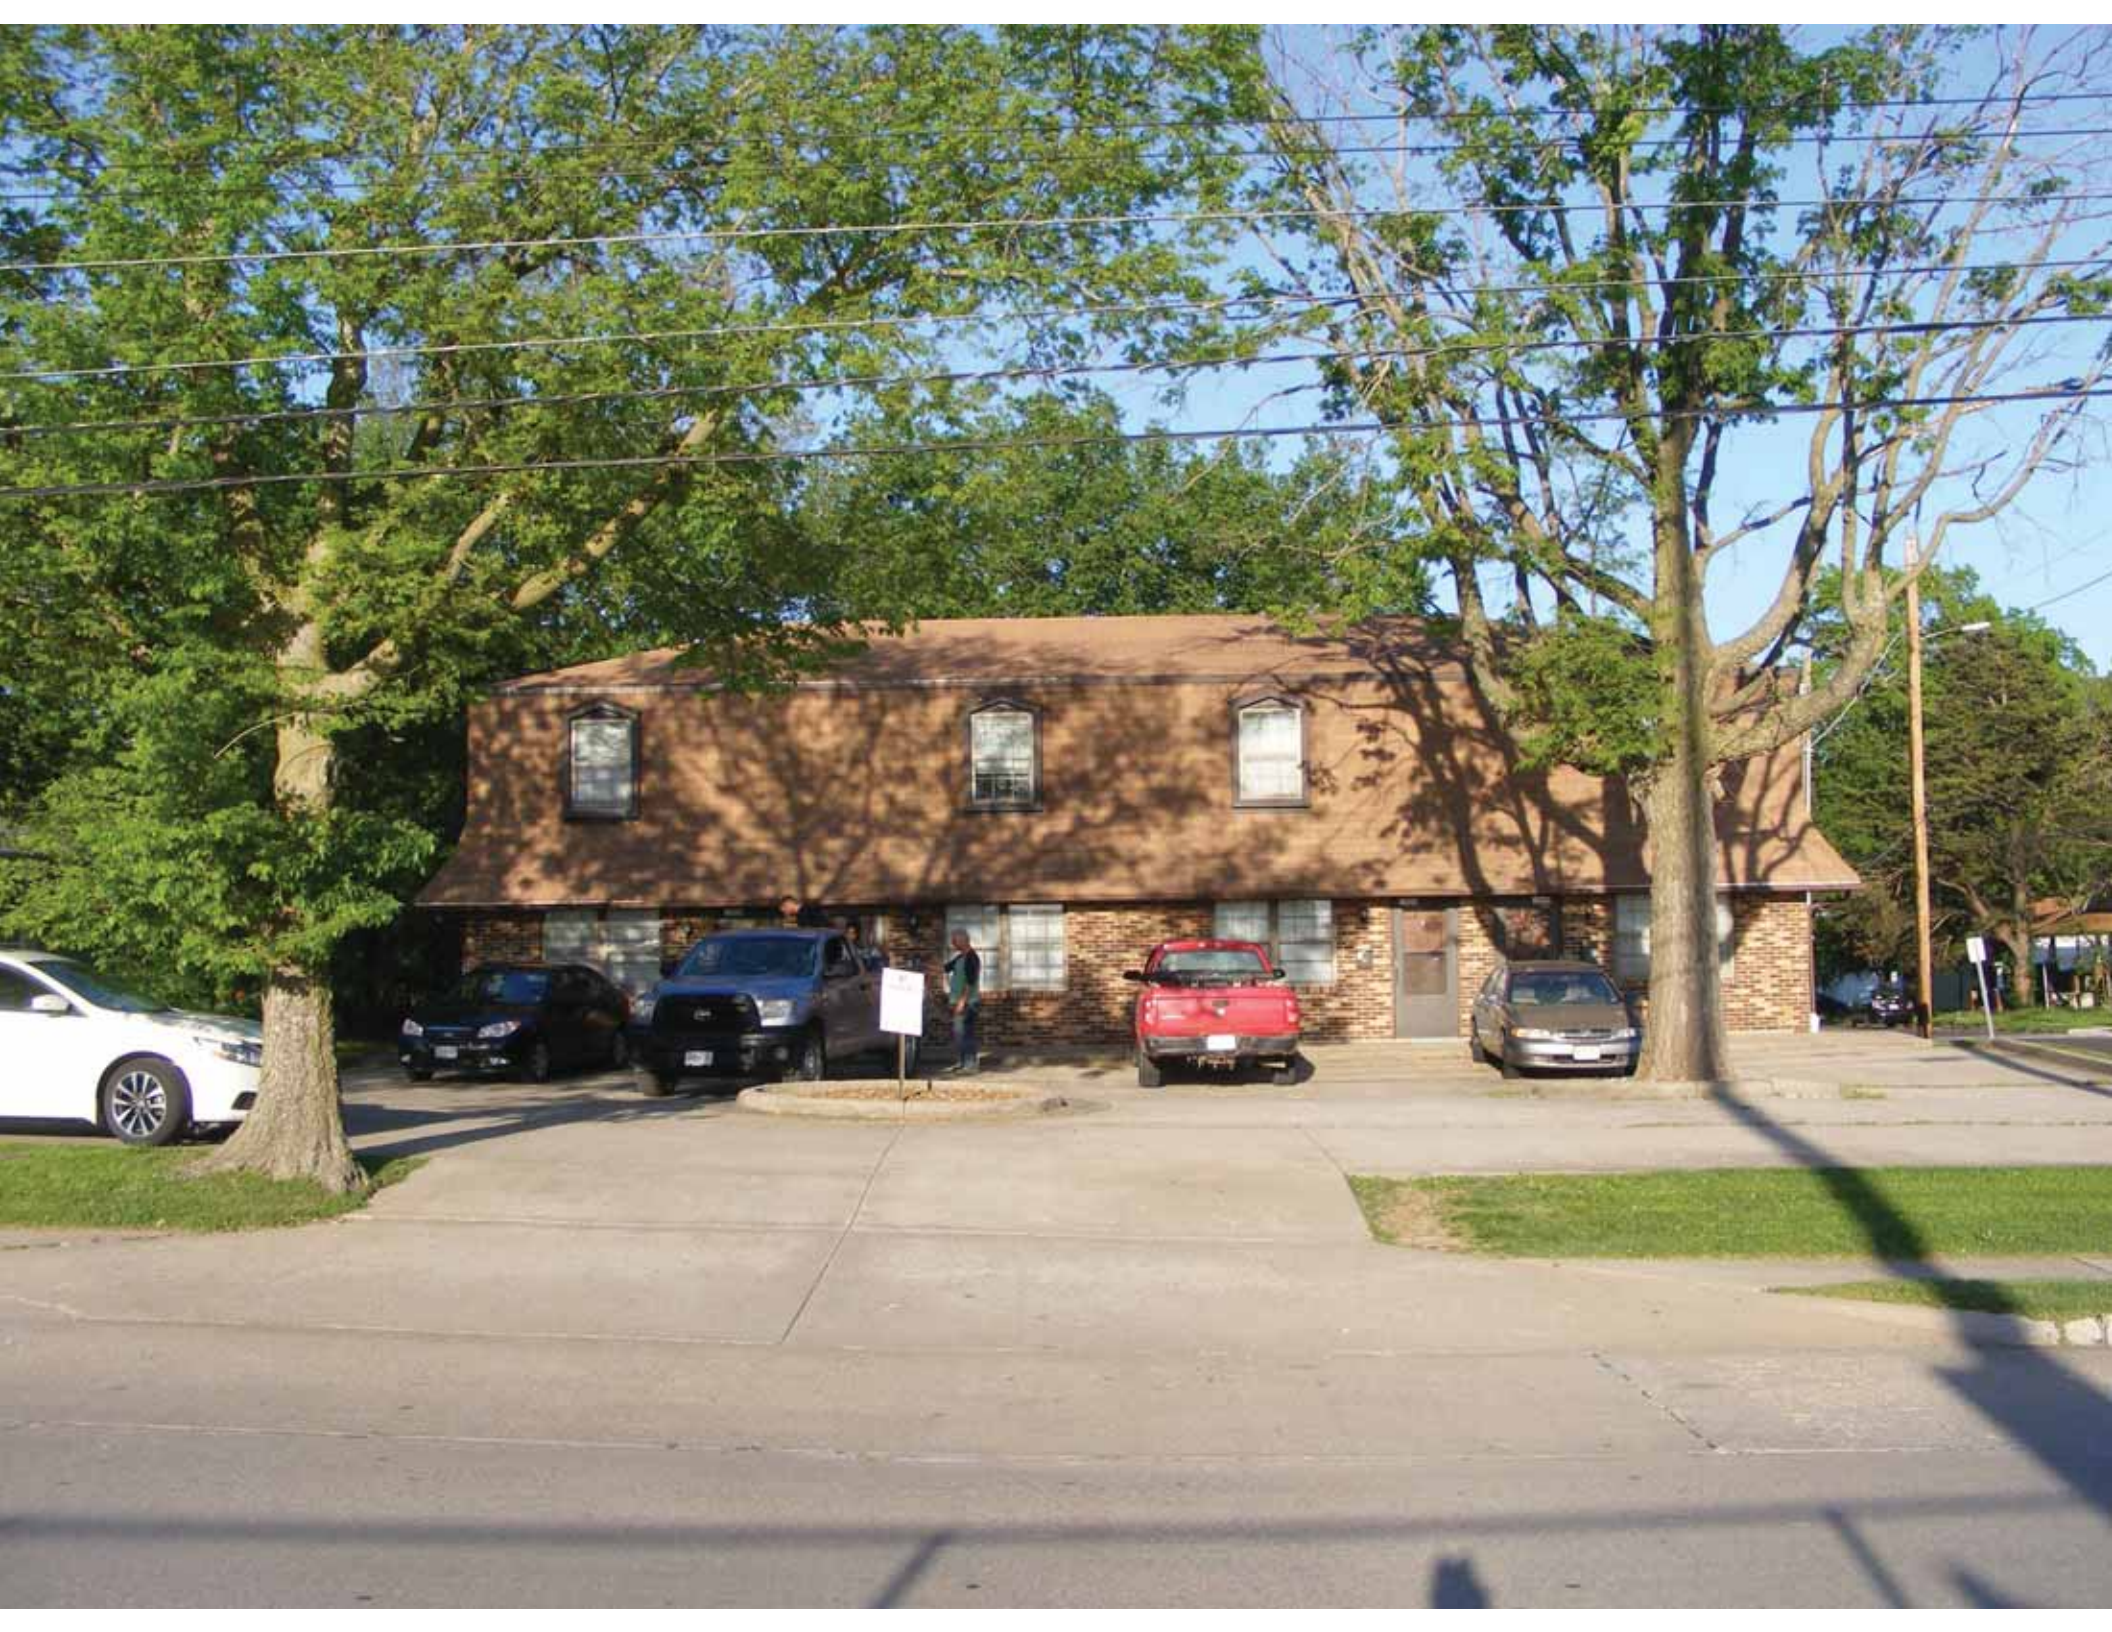
The two-story apartment building is a Mansard style building with an asphalt-shingled flared mansard roof, exterior brick and vertical board siding and a concrete slab foundation. The lower façade (west elevation) holds eight solid paneled doors, each of which is offset by paired six-over-six windows with brick sills. The doors are set in pairs, providing entries for eight housing units. The upper story (within the mansard) features four symmetrically placed six-over-six windows with gabled hoods and wood framing.
