MISSOURI DEPARTMENT OF NATURAL RESOURCES
STATE HISTORIC PRESERVATION OFFICE, P.O. Box 176, Jefferson City, MO 65102
ARCHITECTURAL/HISTORIC INVENTORY FORM

1. Survey No. BO-AS-011-0087		2. Survey name: North Central Columbia Survey Phase II	
3. County: Boone		4. Address (Street No.) 902	Street (name) N. Seventh Street
5. City: Columbia	Vicinity: <input type="checkbox"/>	6. Geographical Reference:	7. Township/Range/Section: T: R: S:
8. Historic name (if known):		9. Present/other name (if known):	
10. Ownership: <input checked="" type="checkbox"/> Private <input type="checkbox"/> Public		11a. Historic use (if known): Domestic/single dwelling	11b. Current use: Domestic/single dwelling

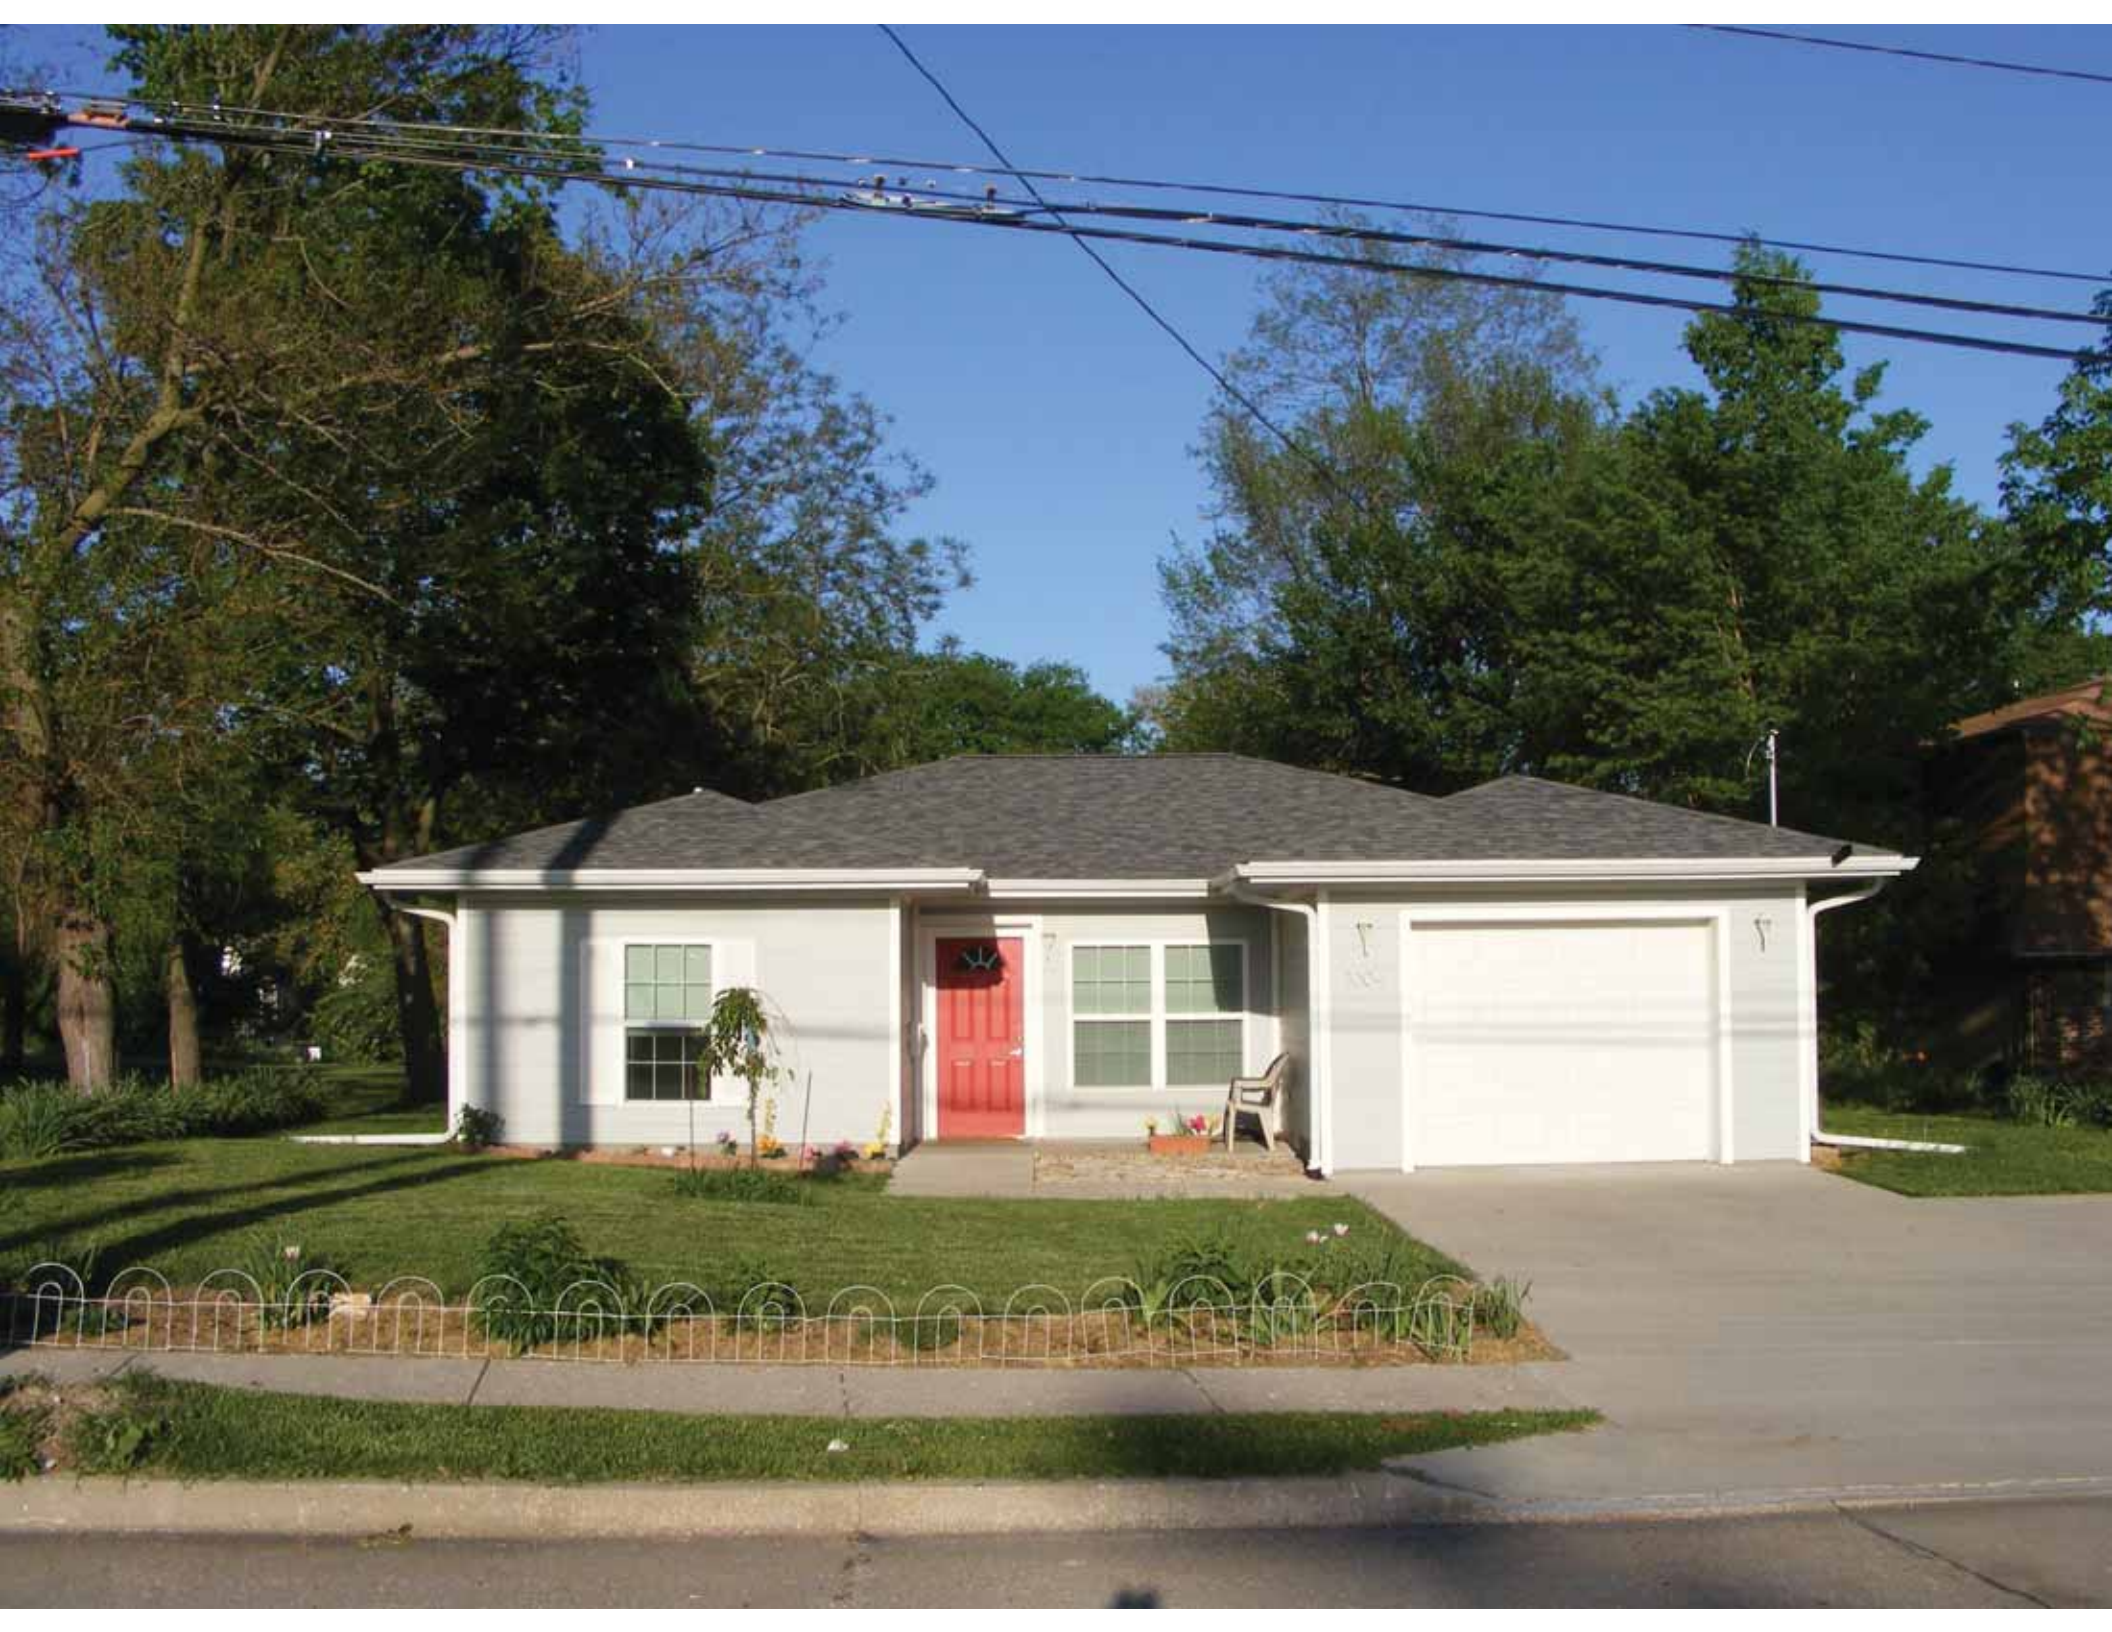
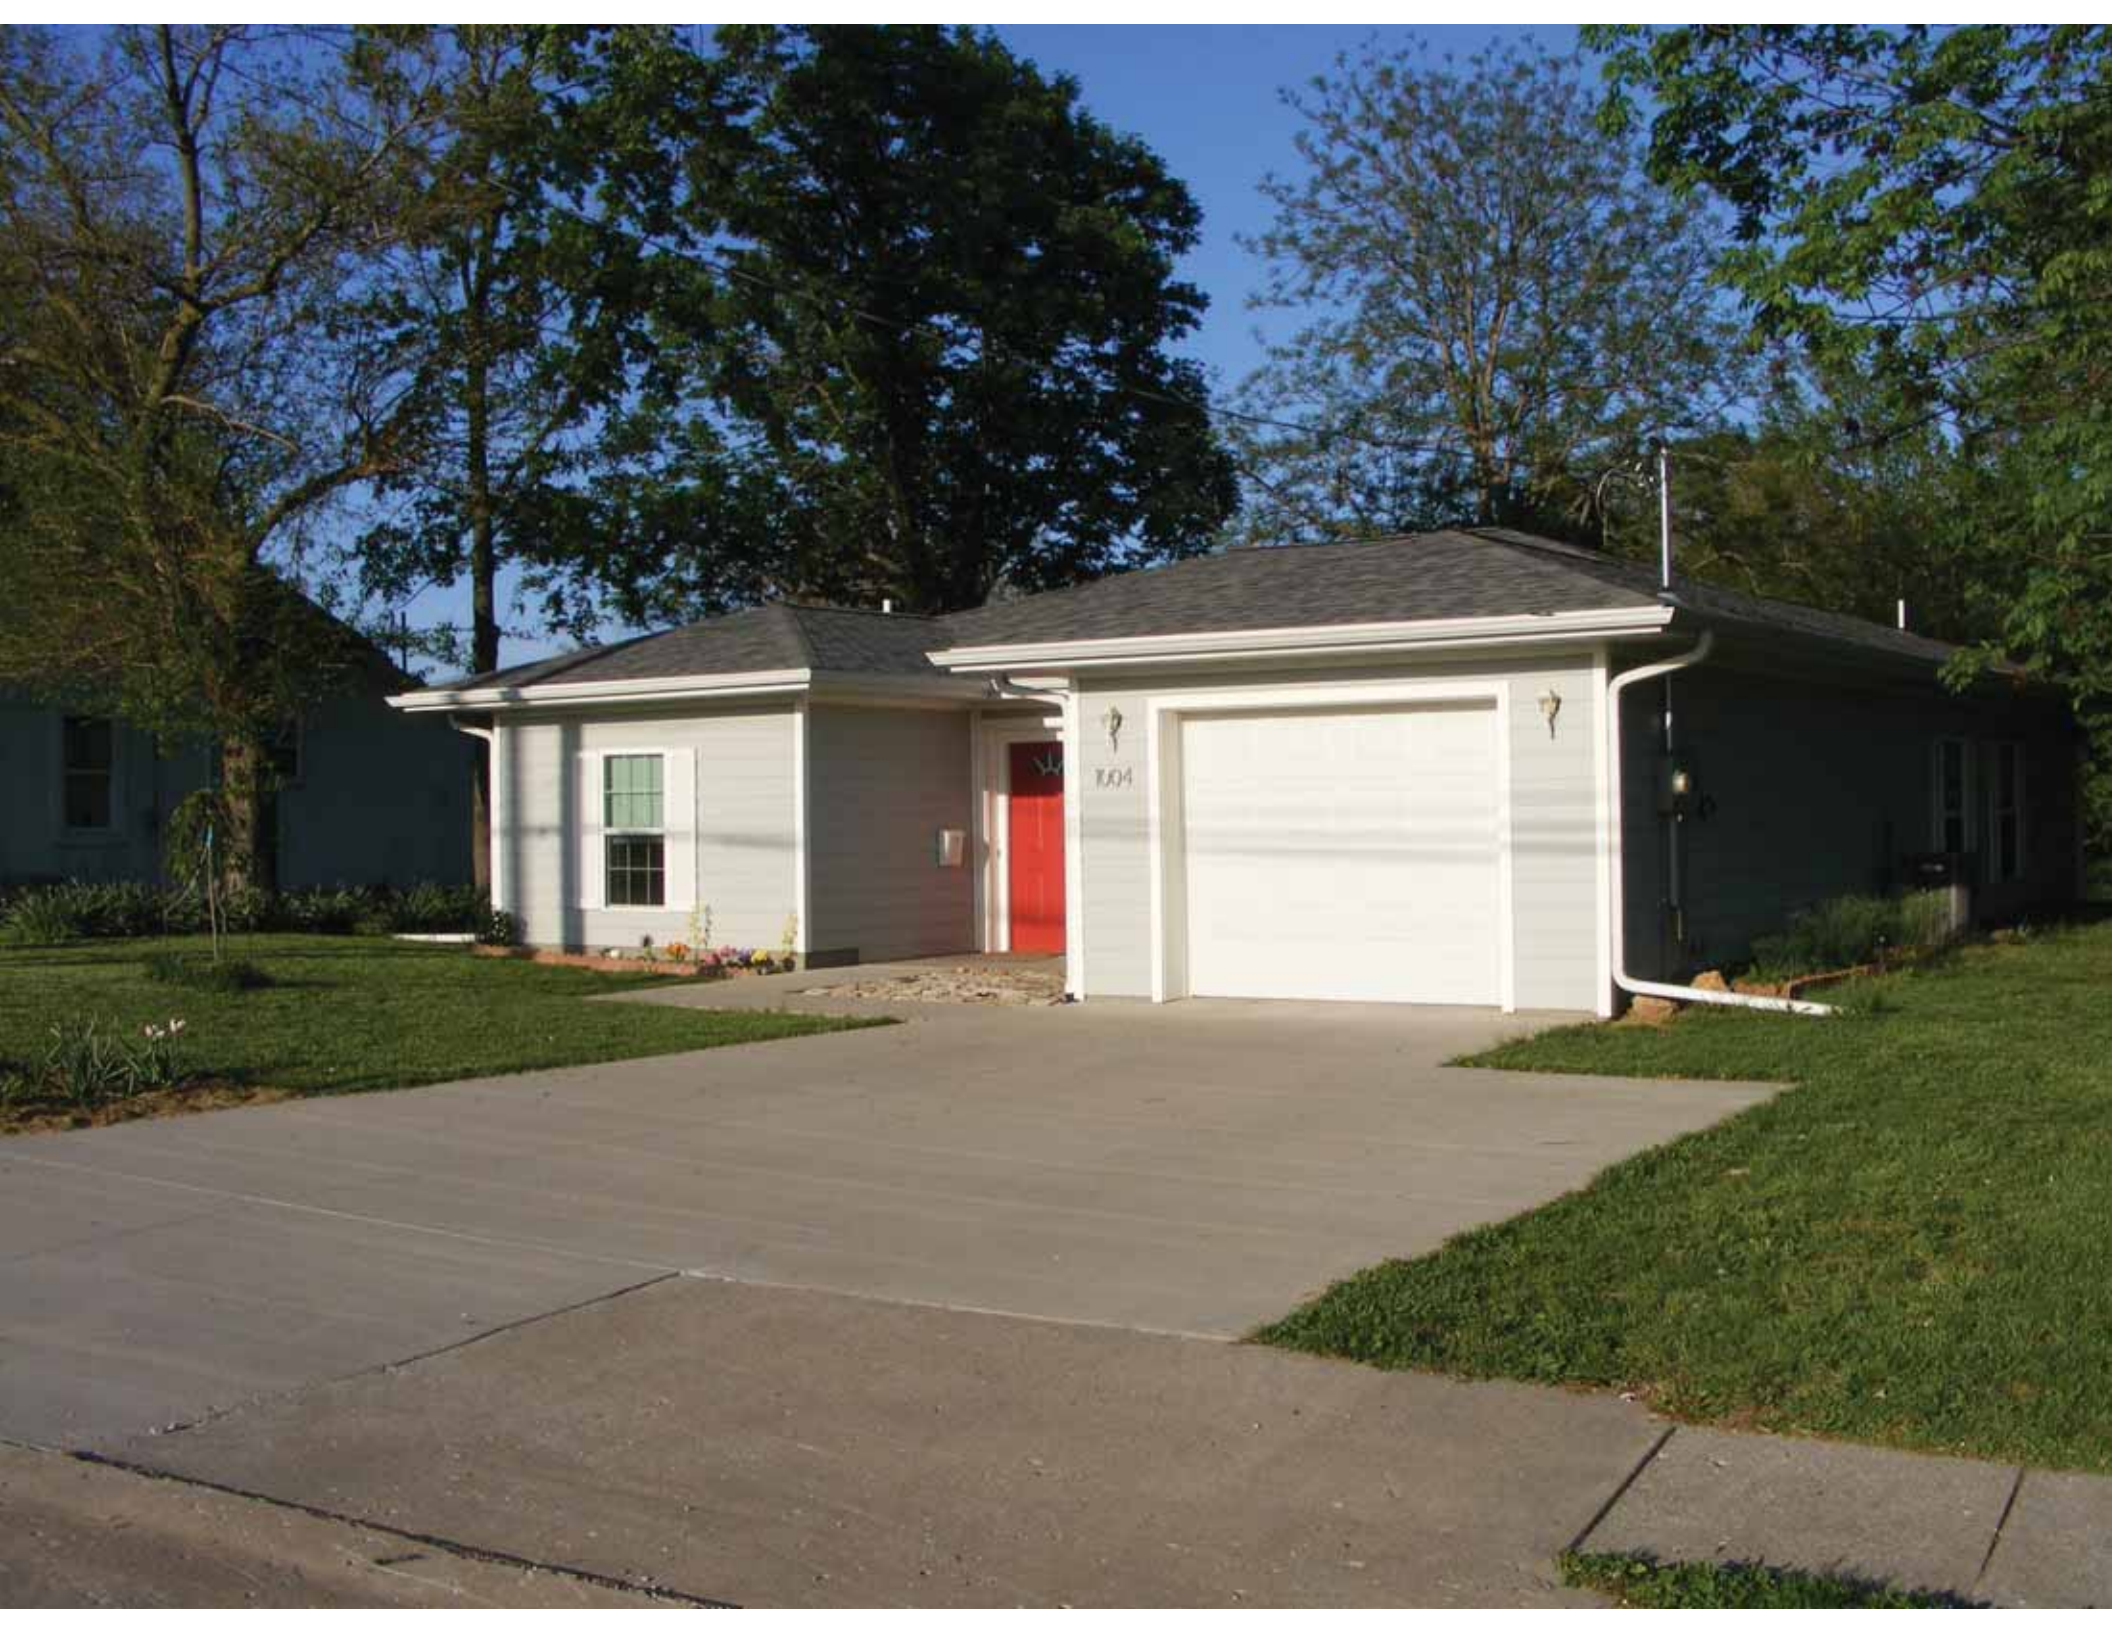
The dwelling has an asphalt-shingled roof, exterior wide board (possibly pressed wood) siding and a concrete foundation. The dwelling has two pyramidal front wings at either end (north and south) of the façade (west elevation). The south wing holds an overhead track door leading to an attached garage. The north wing has a six-over-six window with faux shutters on the west elevation. The wings project, creating a recessed primary cross-hipped wing that supports a paneled door with a fanlight offset by paired six-over-six windows. Within the setback created by the projecting pyramidal wings is a concrete patio. There is no fenestration on the north elevation. The south elevation has two double-hung windows

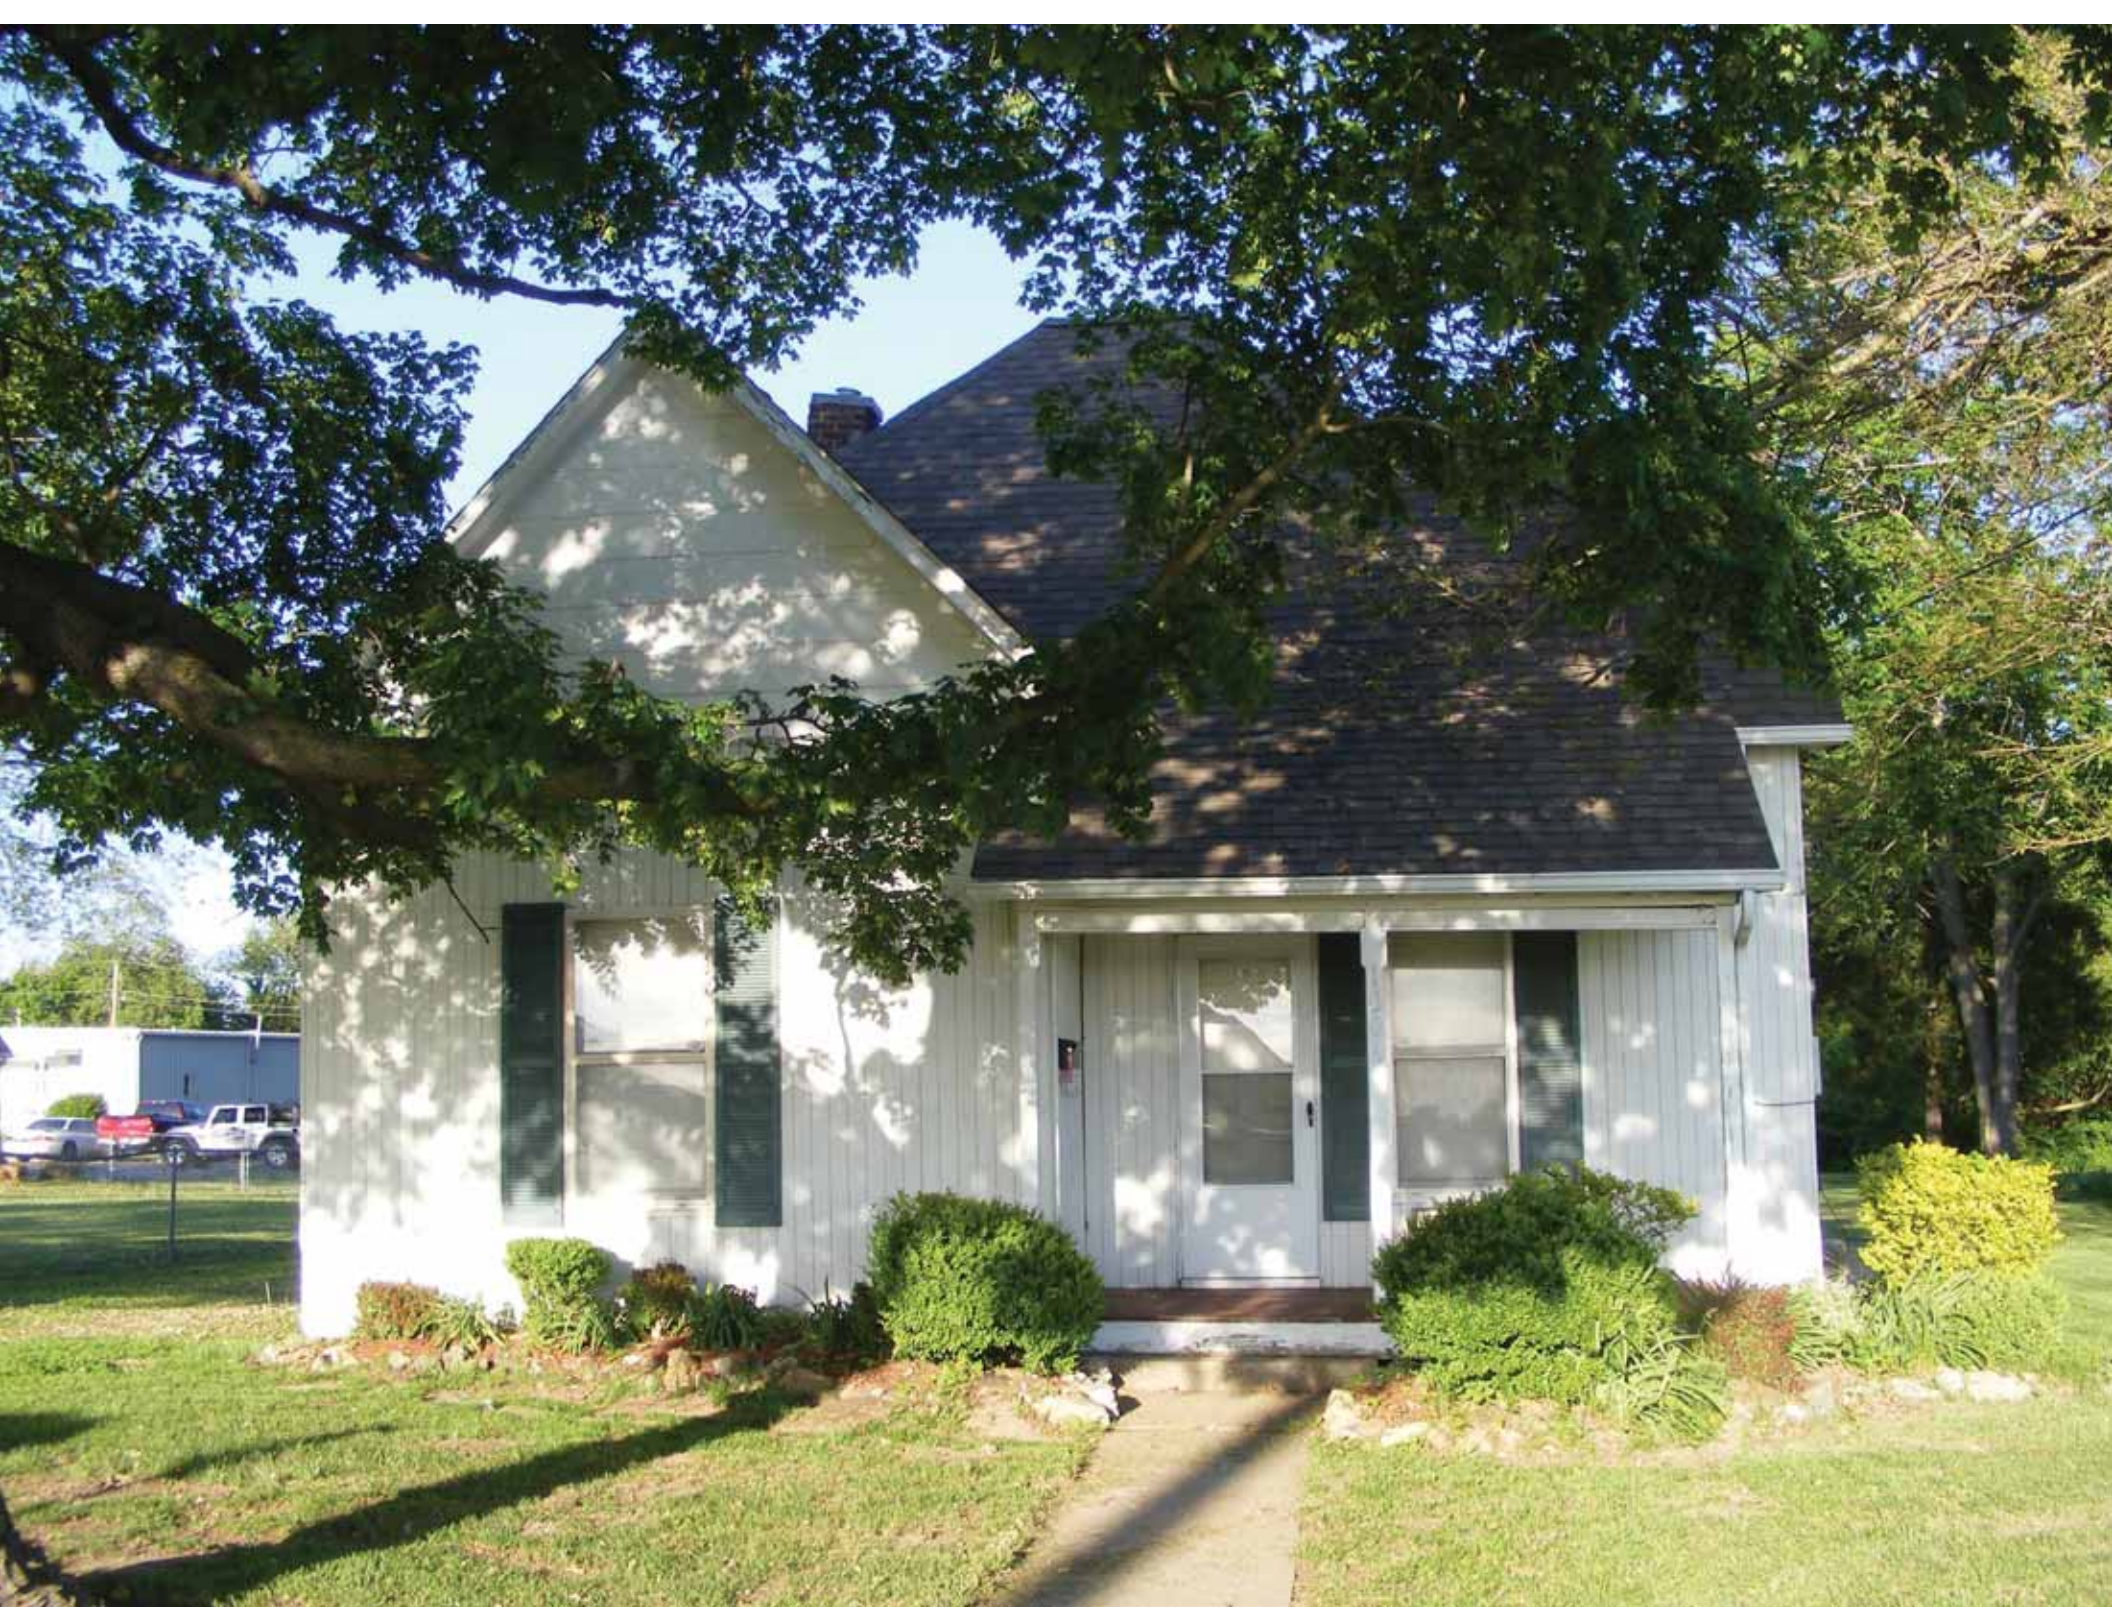
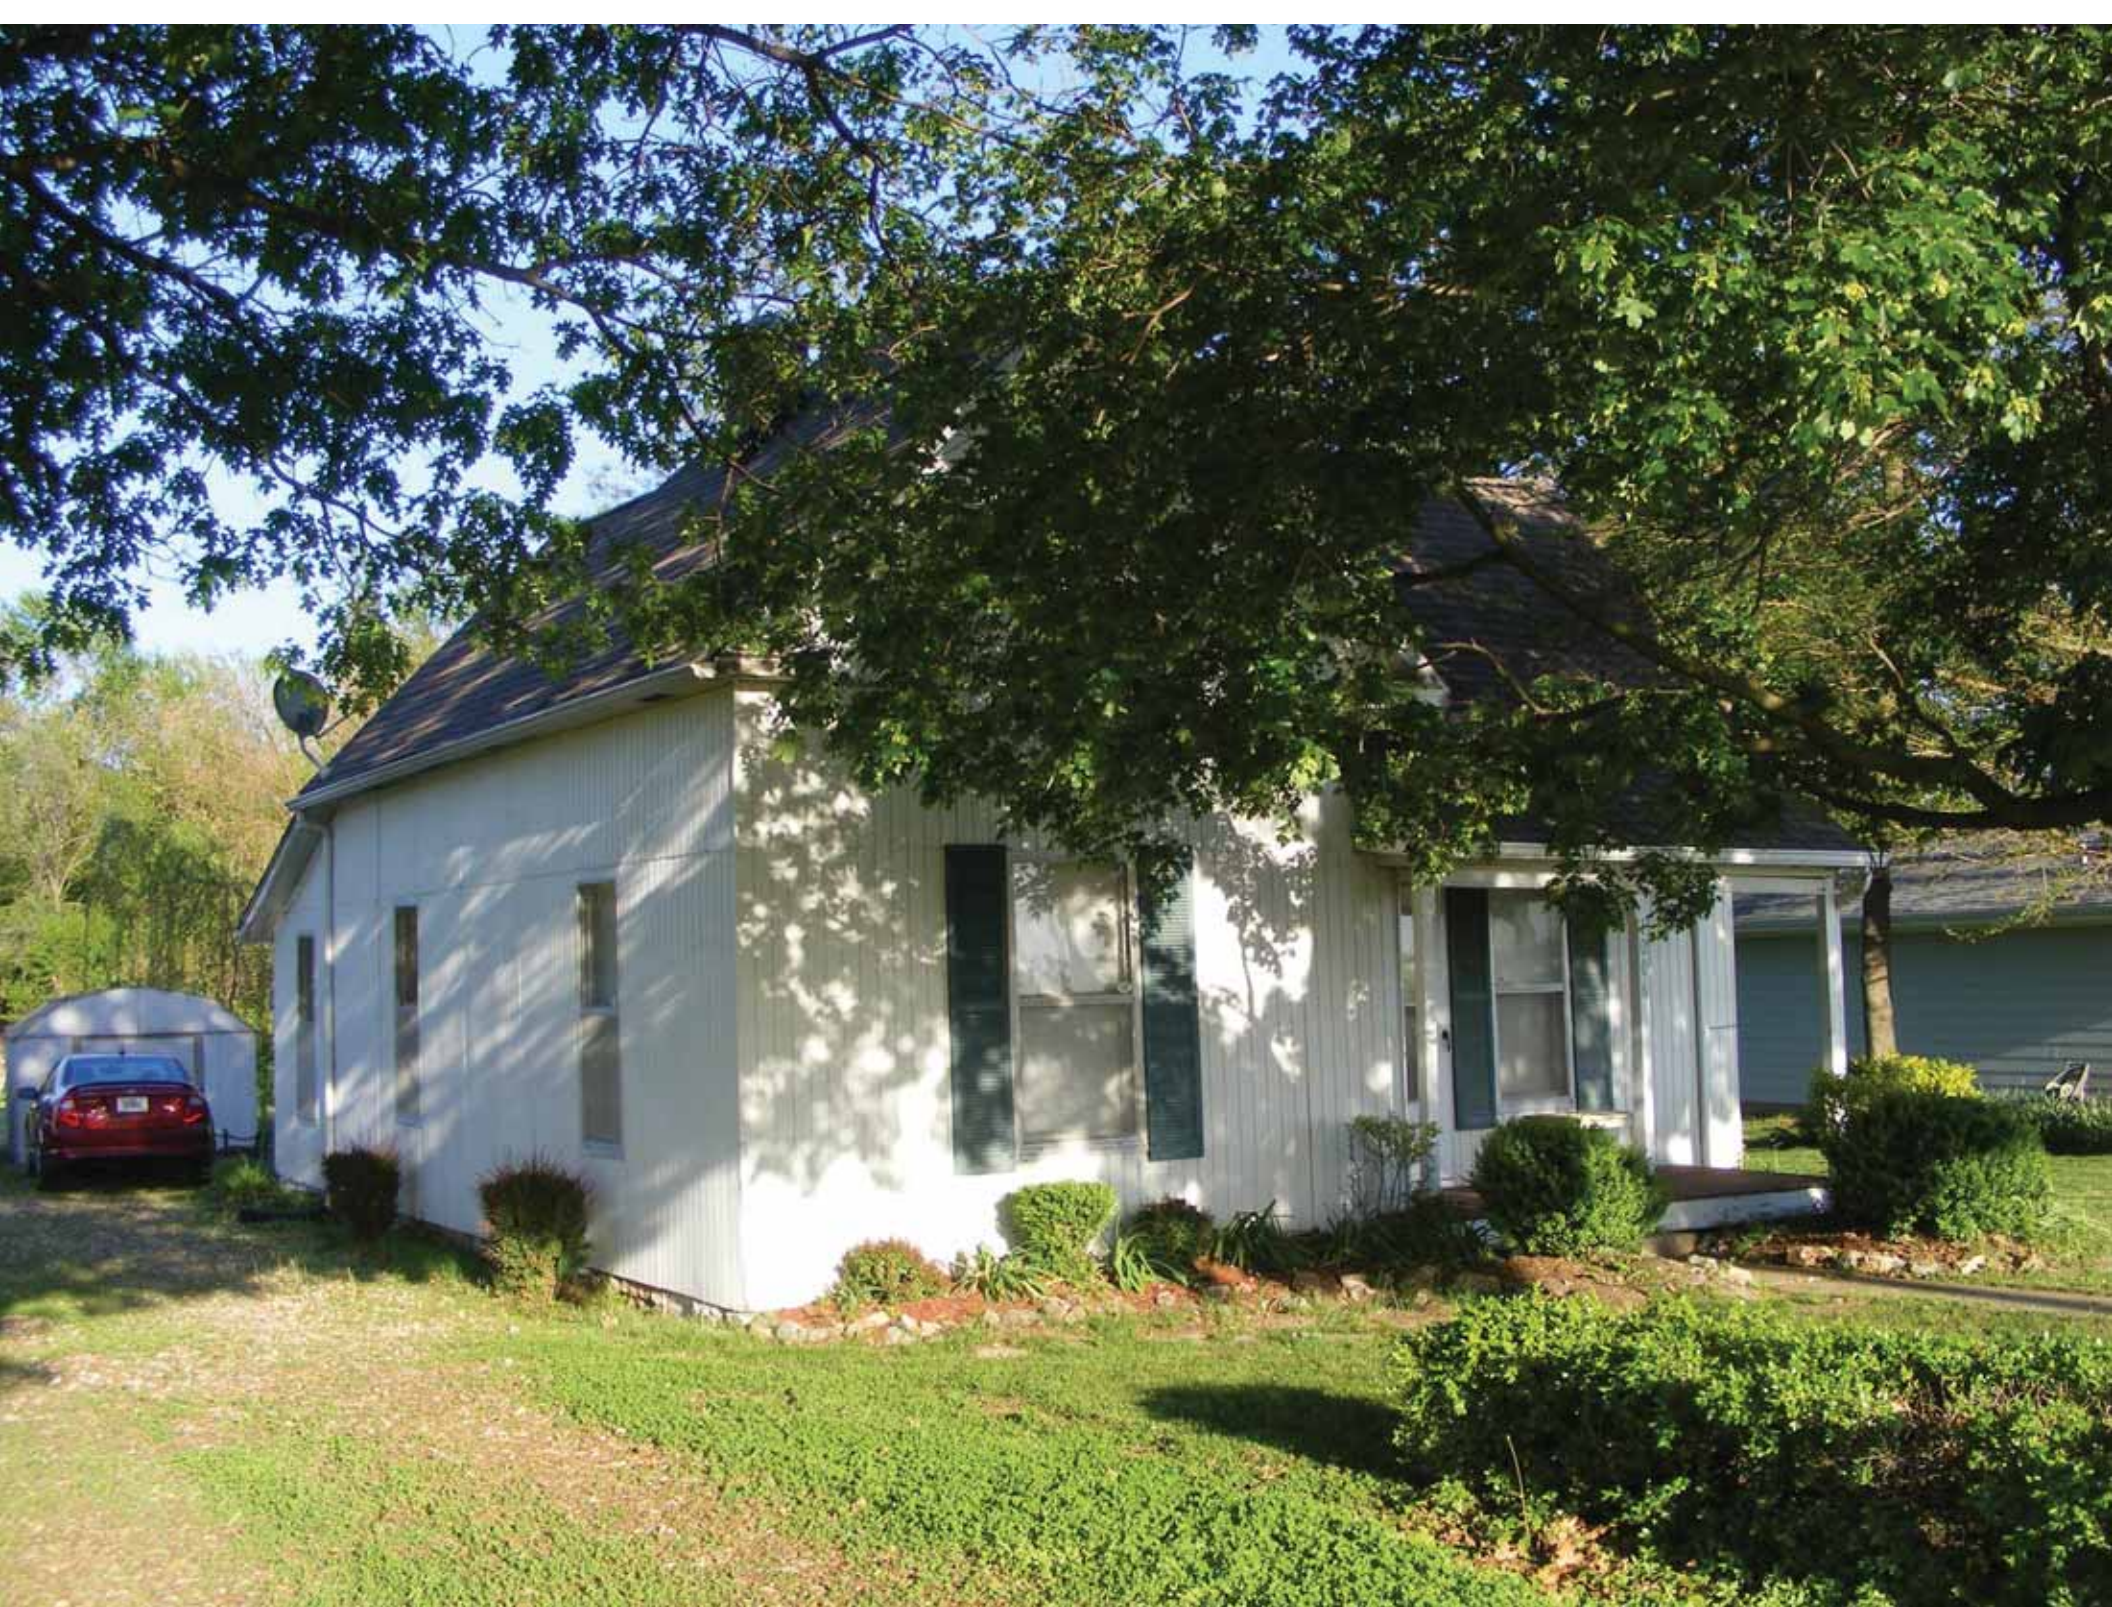
The dwelling has a hipped and gabled asphalt-shingled roof, exterior vertical board siding and a stone foundation. Gable fields are filled with asbestos shingles. Windows are original one-over-one. A front gabled wing at the north end of the dwelling holds a single one-over-one window. Offsetting the wing on the façade is a shed porch supported by chamfered columns. Within the porch bay is a paneled door offset by a one-over-one window. Façade windows have faux shutters. The dwelling has a rear shed wing and interior brick chimney.

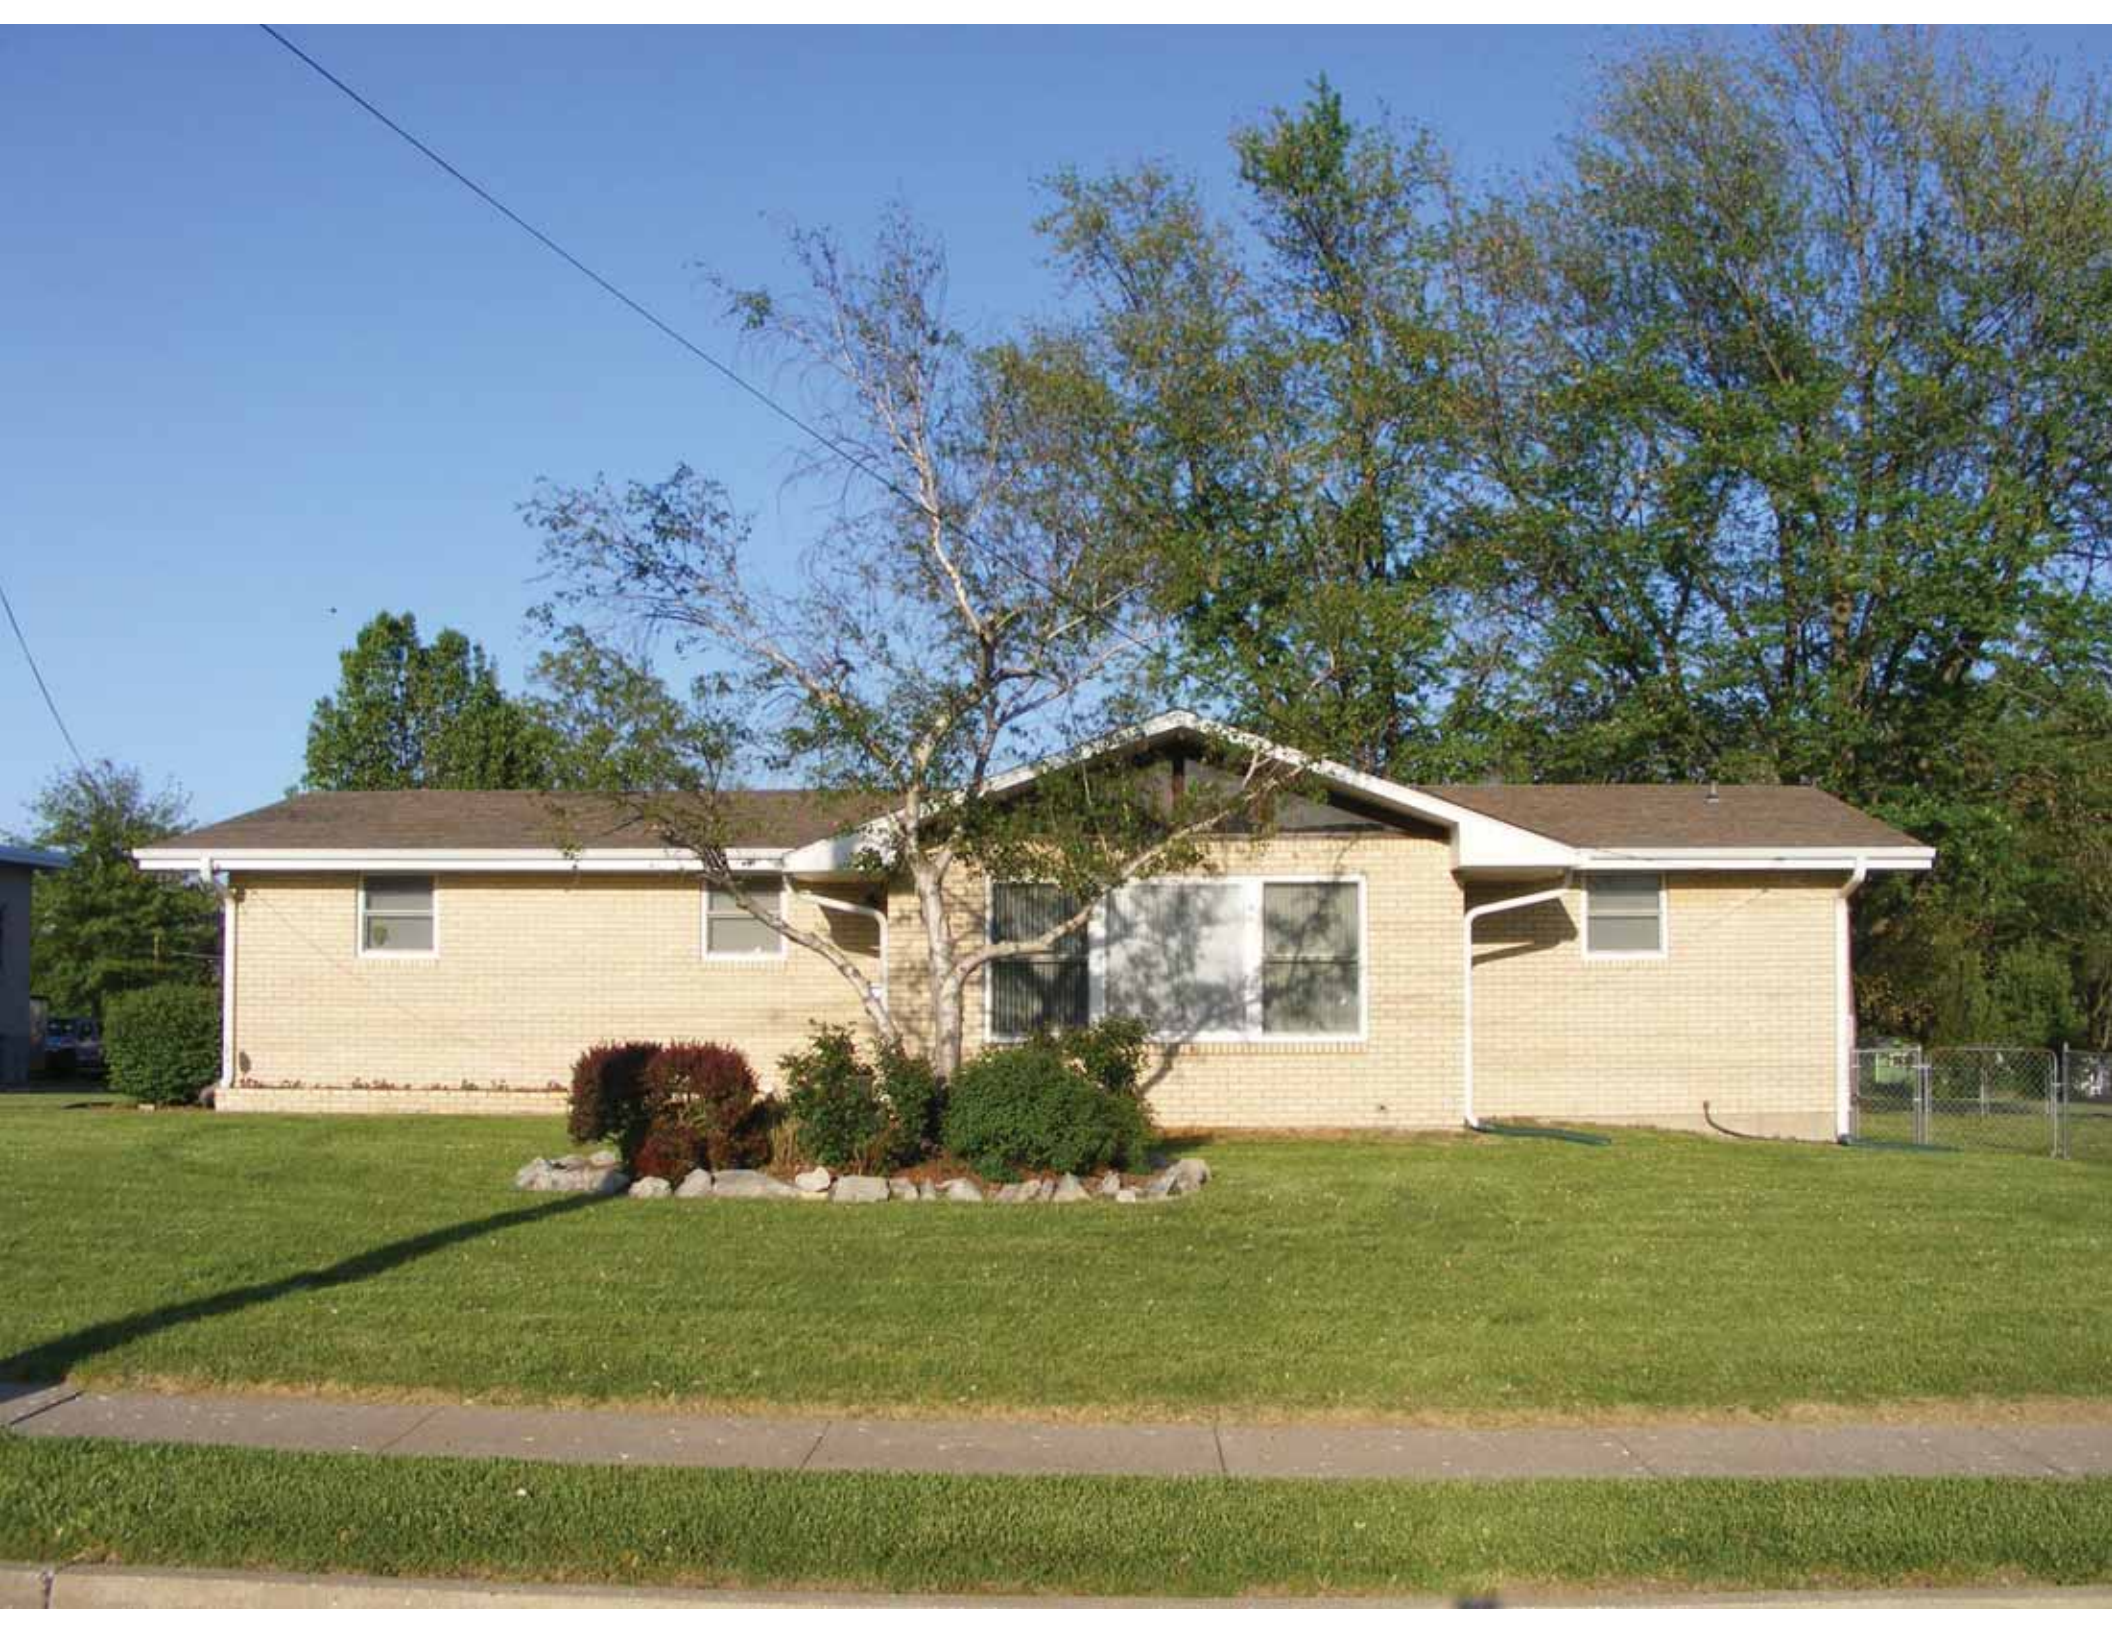
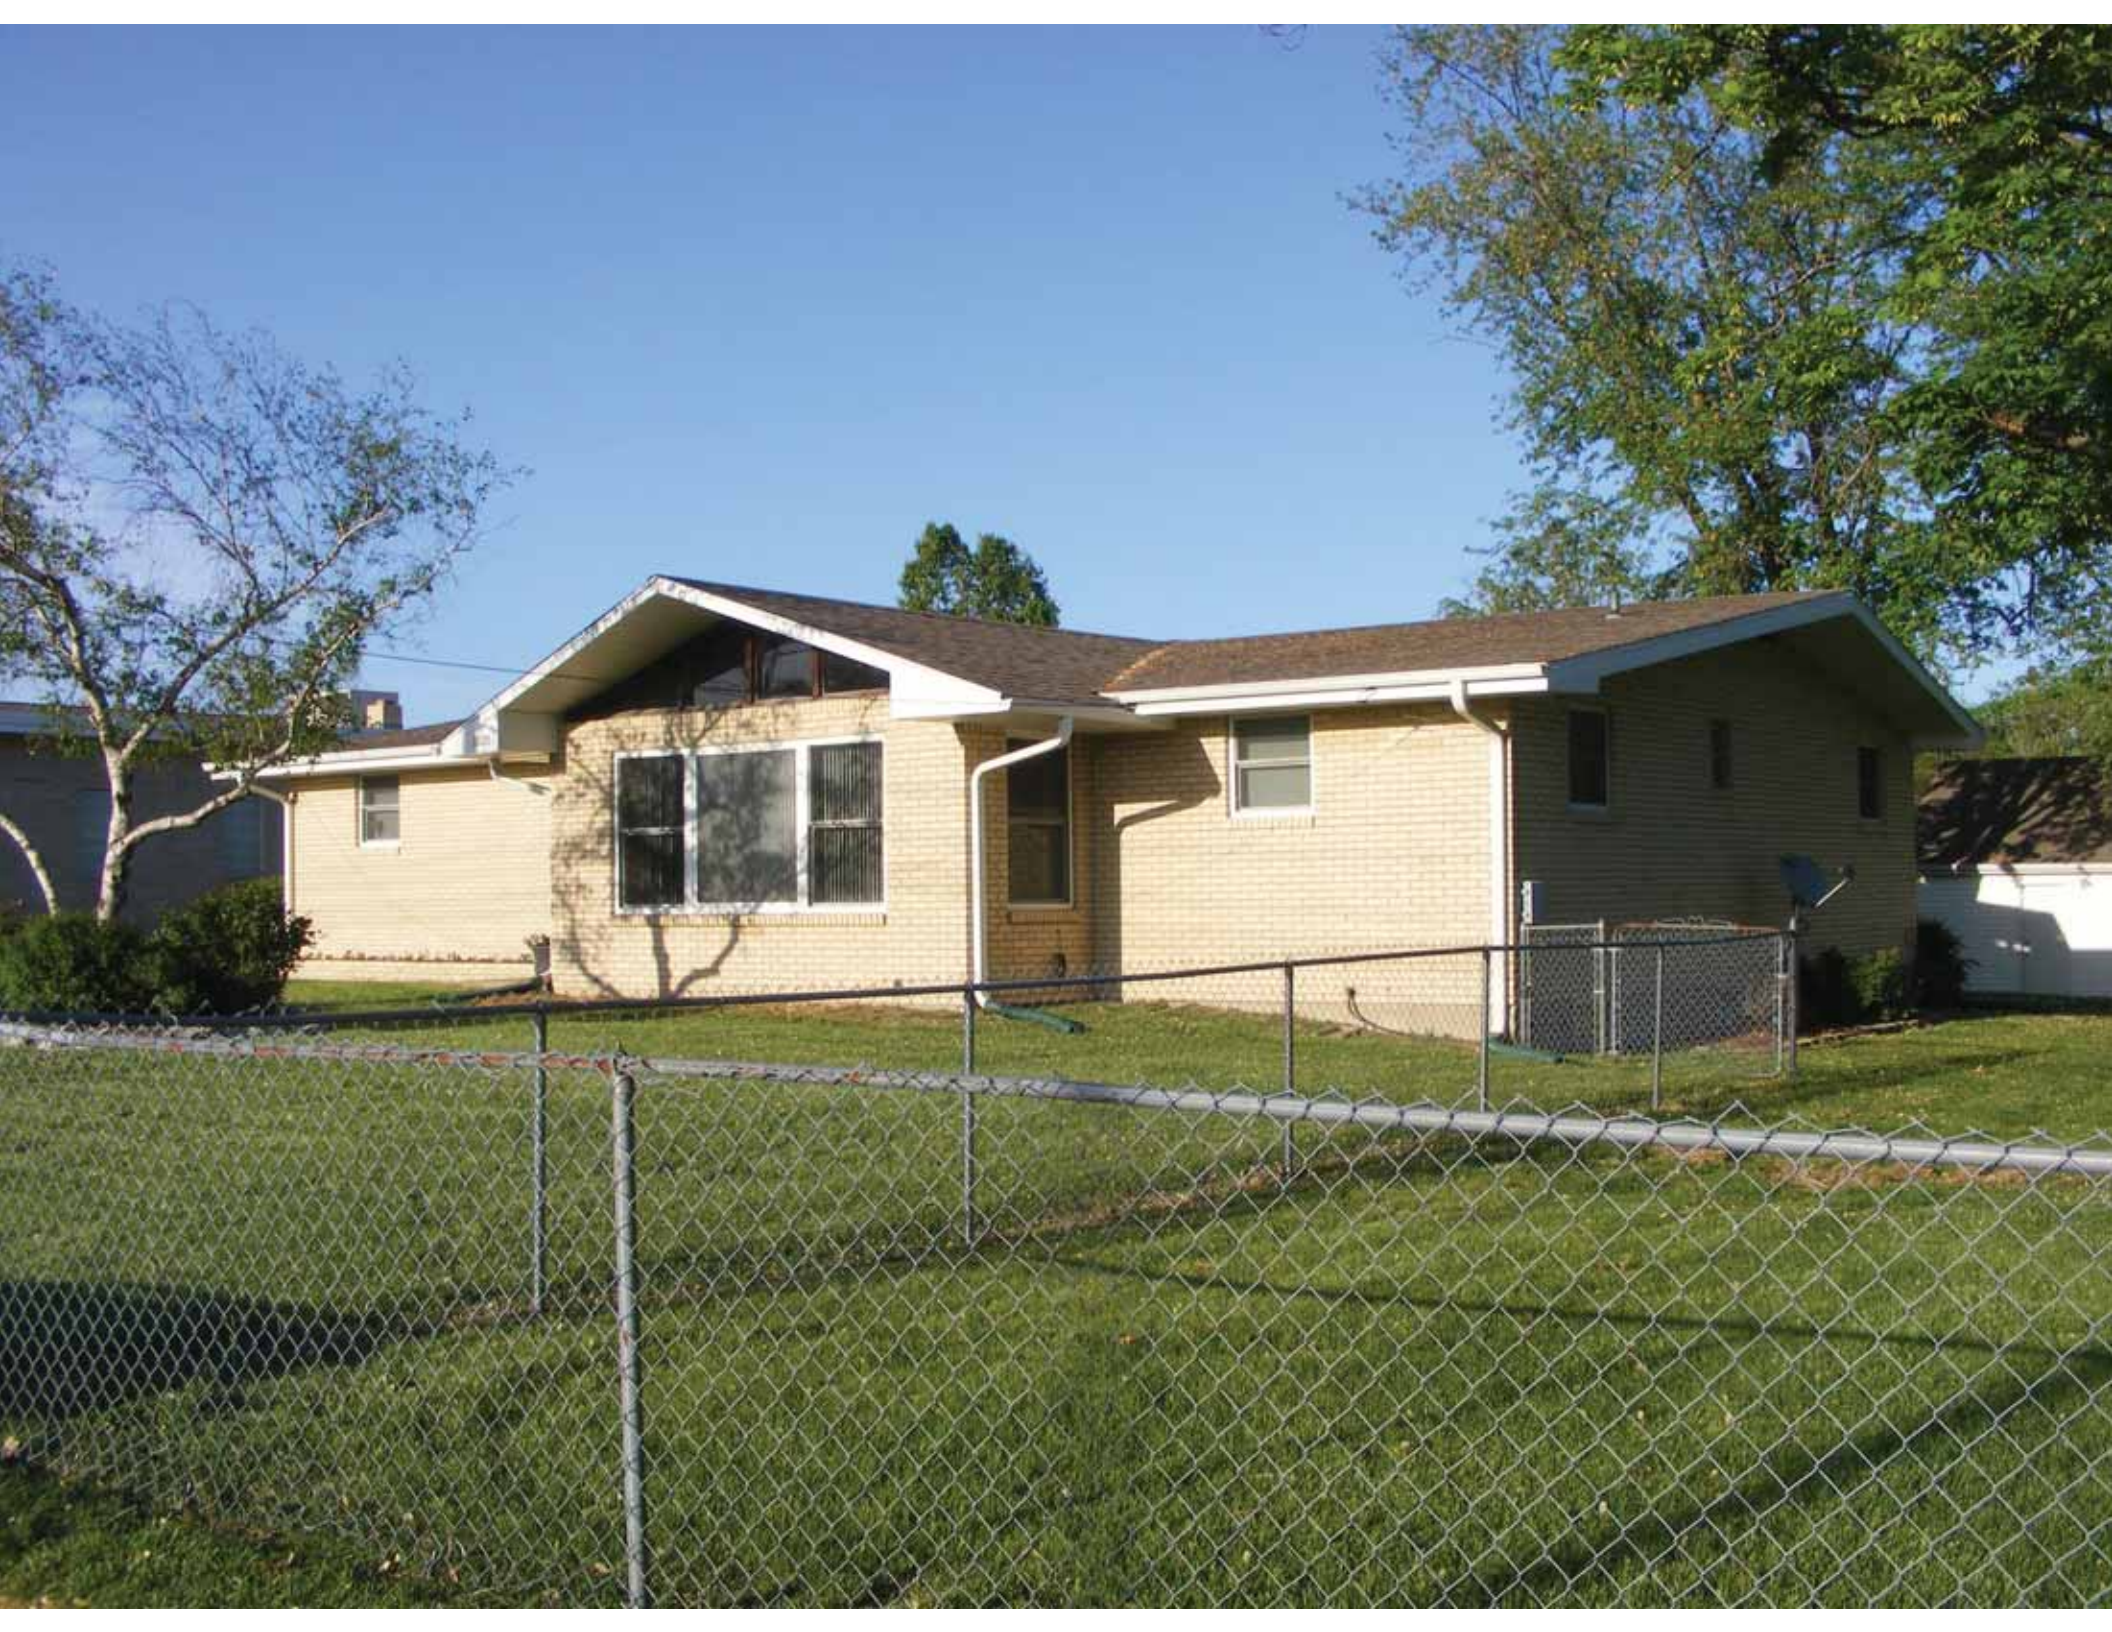
The dwelling has a low gabled asphalt-shingled roof, exterior blonde brick veneer and a concrete foundation. A low matching brick planter flanks the façade wall (west elevation) at the north end, adjacent to a concrete pad that fronts the primary door on the projecting gable's north wall. The entry bay is filled with an original upper light wood paneled door. The projecting gable's west elevation features a large picture style window consisting of a central fixed light flanked by one-over-one windows. Above the picture style window, the gable holds a large triangular light with four vertical pieces of wood dividing the glass. The south wall of the gabled wing has a one-over-one window. The remaining façade wall has smaller one-over-one windows at the upper wall near the north and south ends of the elevation. Windows have original brick sills. There is a carport extension on the rear elevation.
