MISSOURI DEPARTMENT OF NATURAL RESOURCES
STATE HISTORIC PRESERVATION OFFICE, P.O. Box 176, Jefferson City, MO 65102
ARCHITECTURAL/HISTORIC INVENTORY FORM

1. Survey No. BO-AS-011-0087		2. Survey name: North Central Columbia Survey Phase II	
3. County: Boone		4. Address (Street No.) 902	Street (name) N. Seventh Street
5. City: Columbia	Vicinity: <input type="checkbox"/>	6. Geographical Reference:	7. Township/Range/Section: T: R: S:
8. Historic name (if known):		9. Present/other name (if known):	
10. Ownership: <input checked="" type="checkbox"/> Private <input type="checkbox"/> Public		11a. Historic use (if known): Domestic/single dwelling	11b. Current use: Domestic/single dwelling

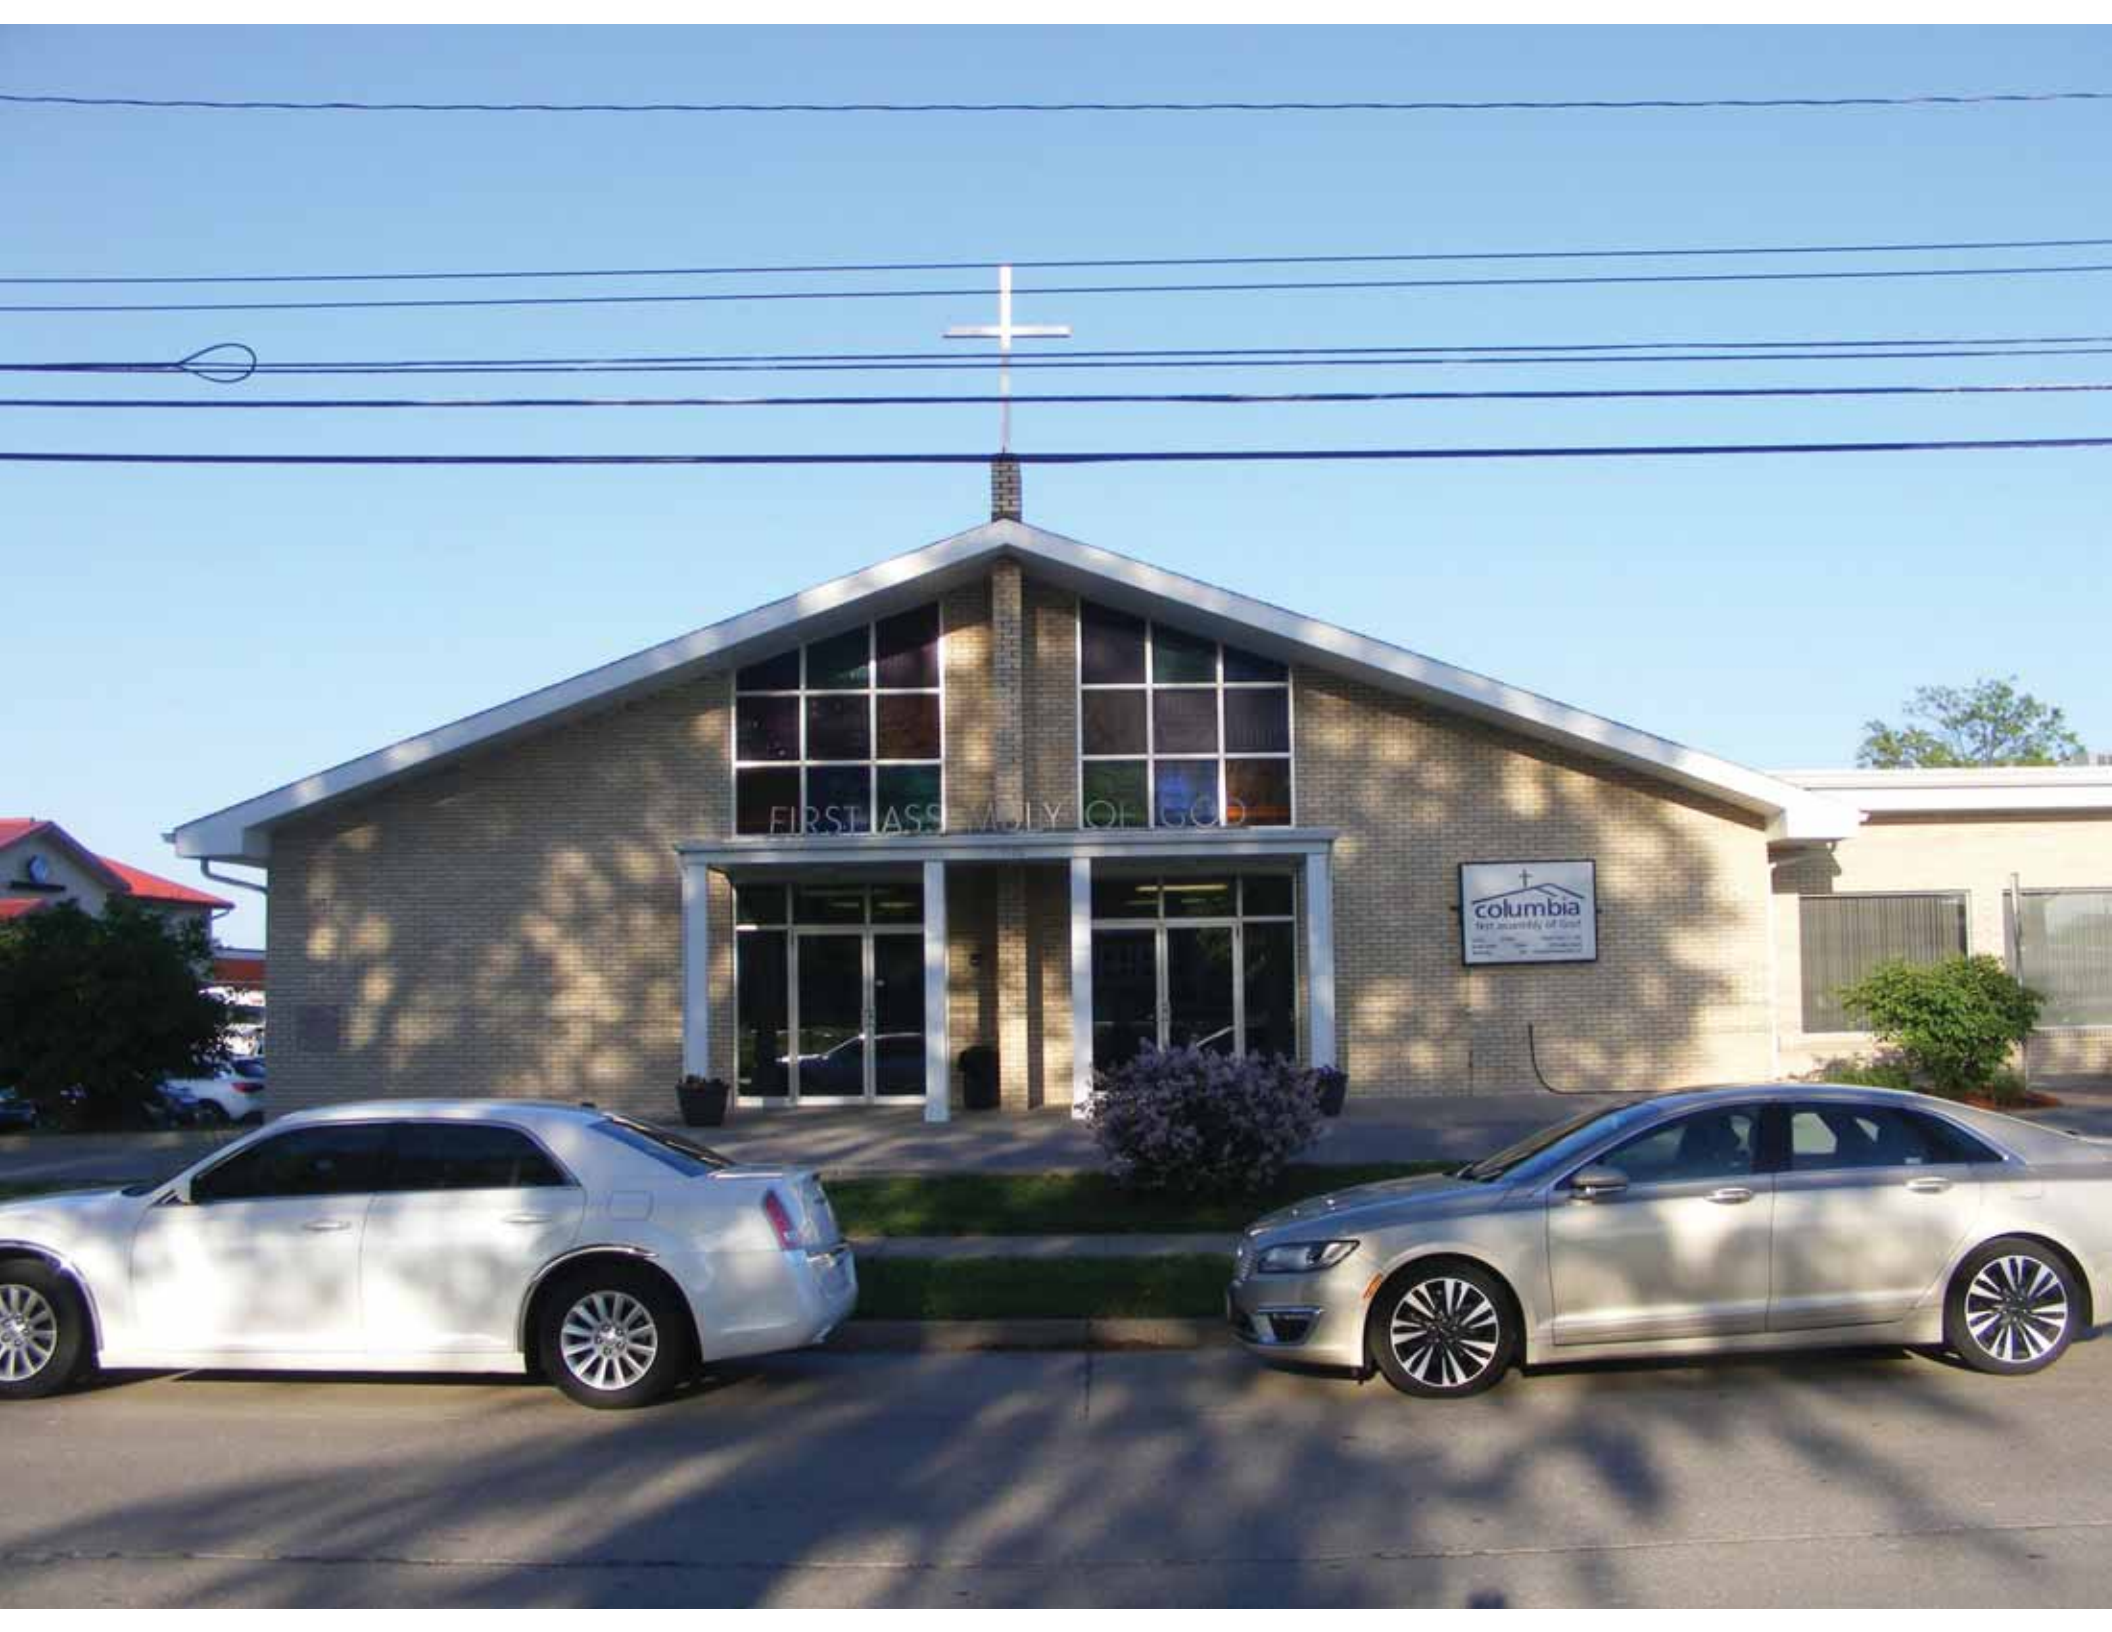
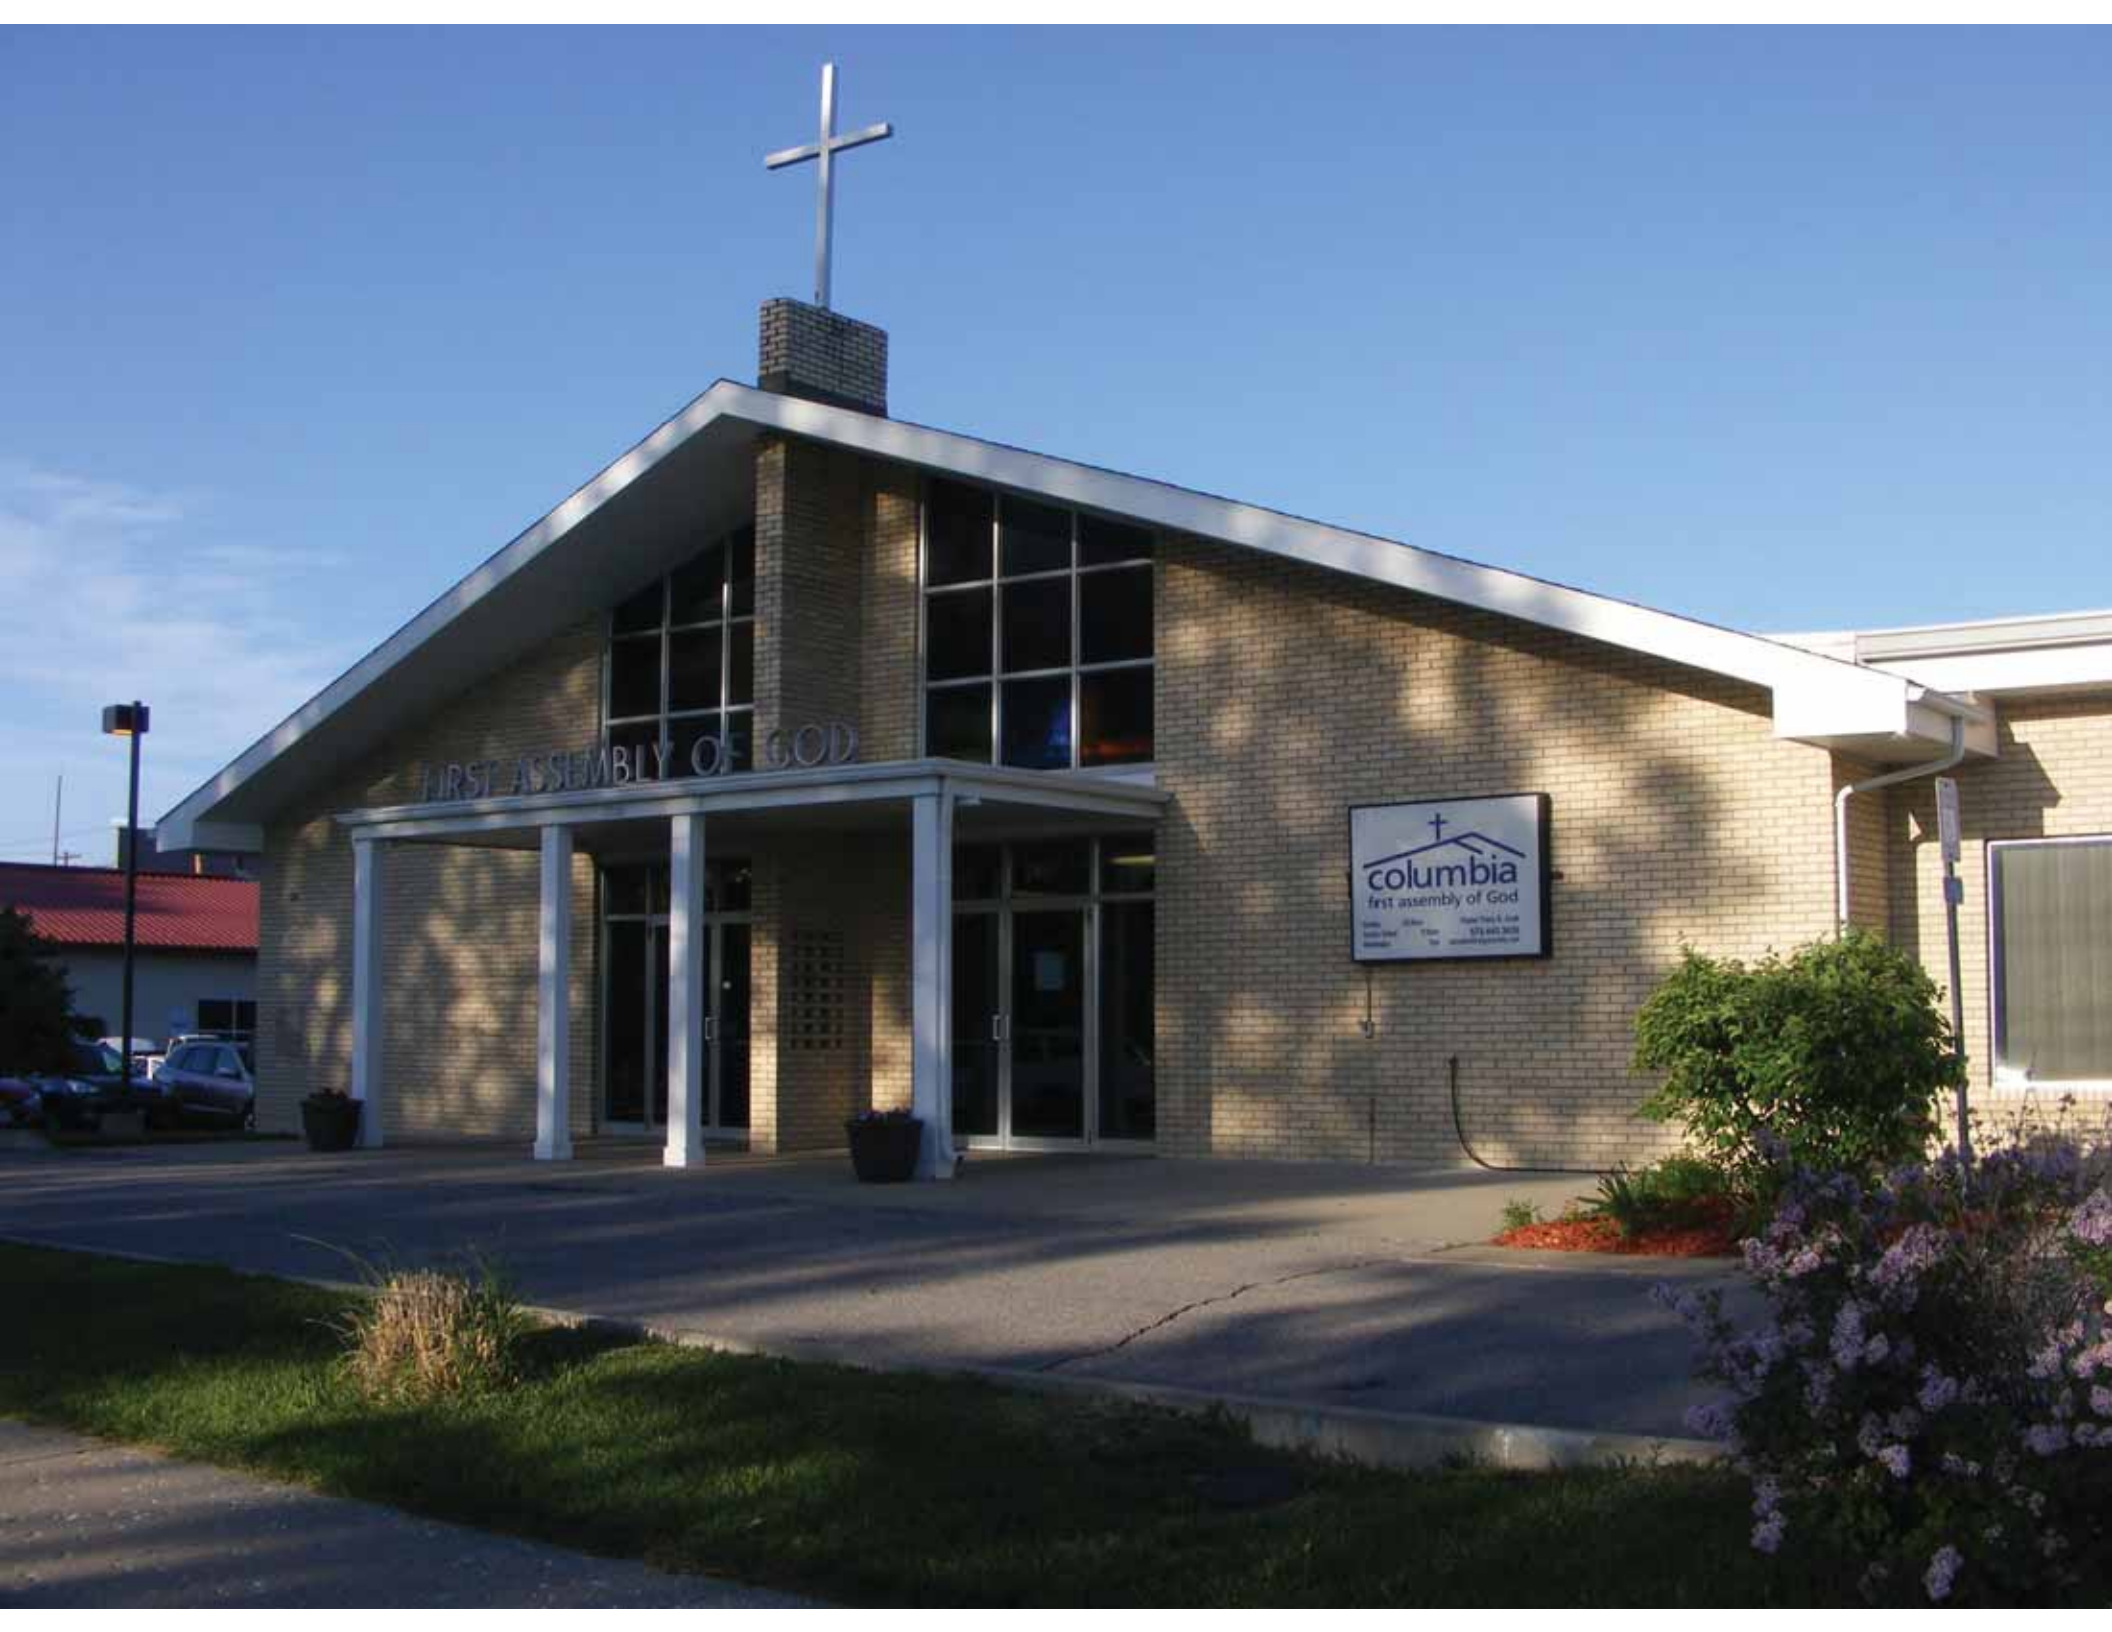
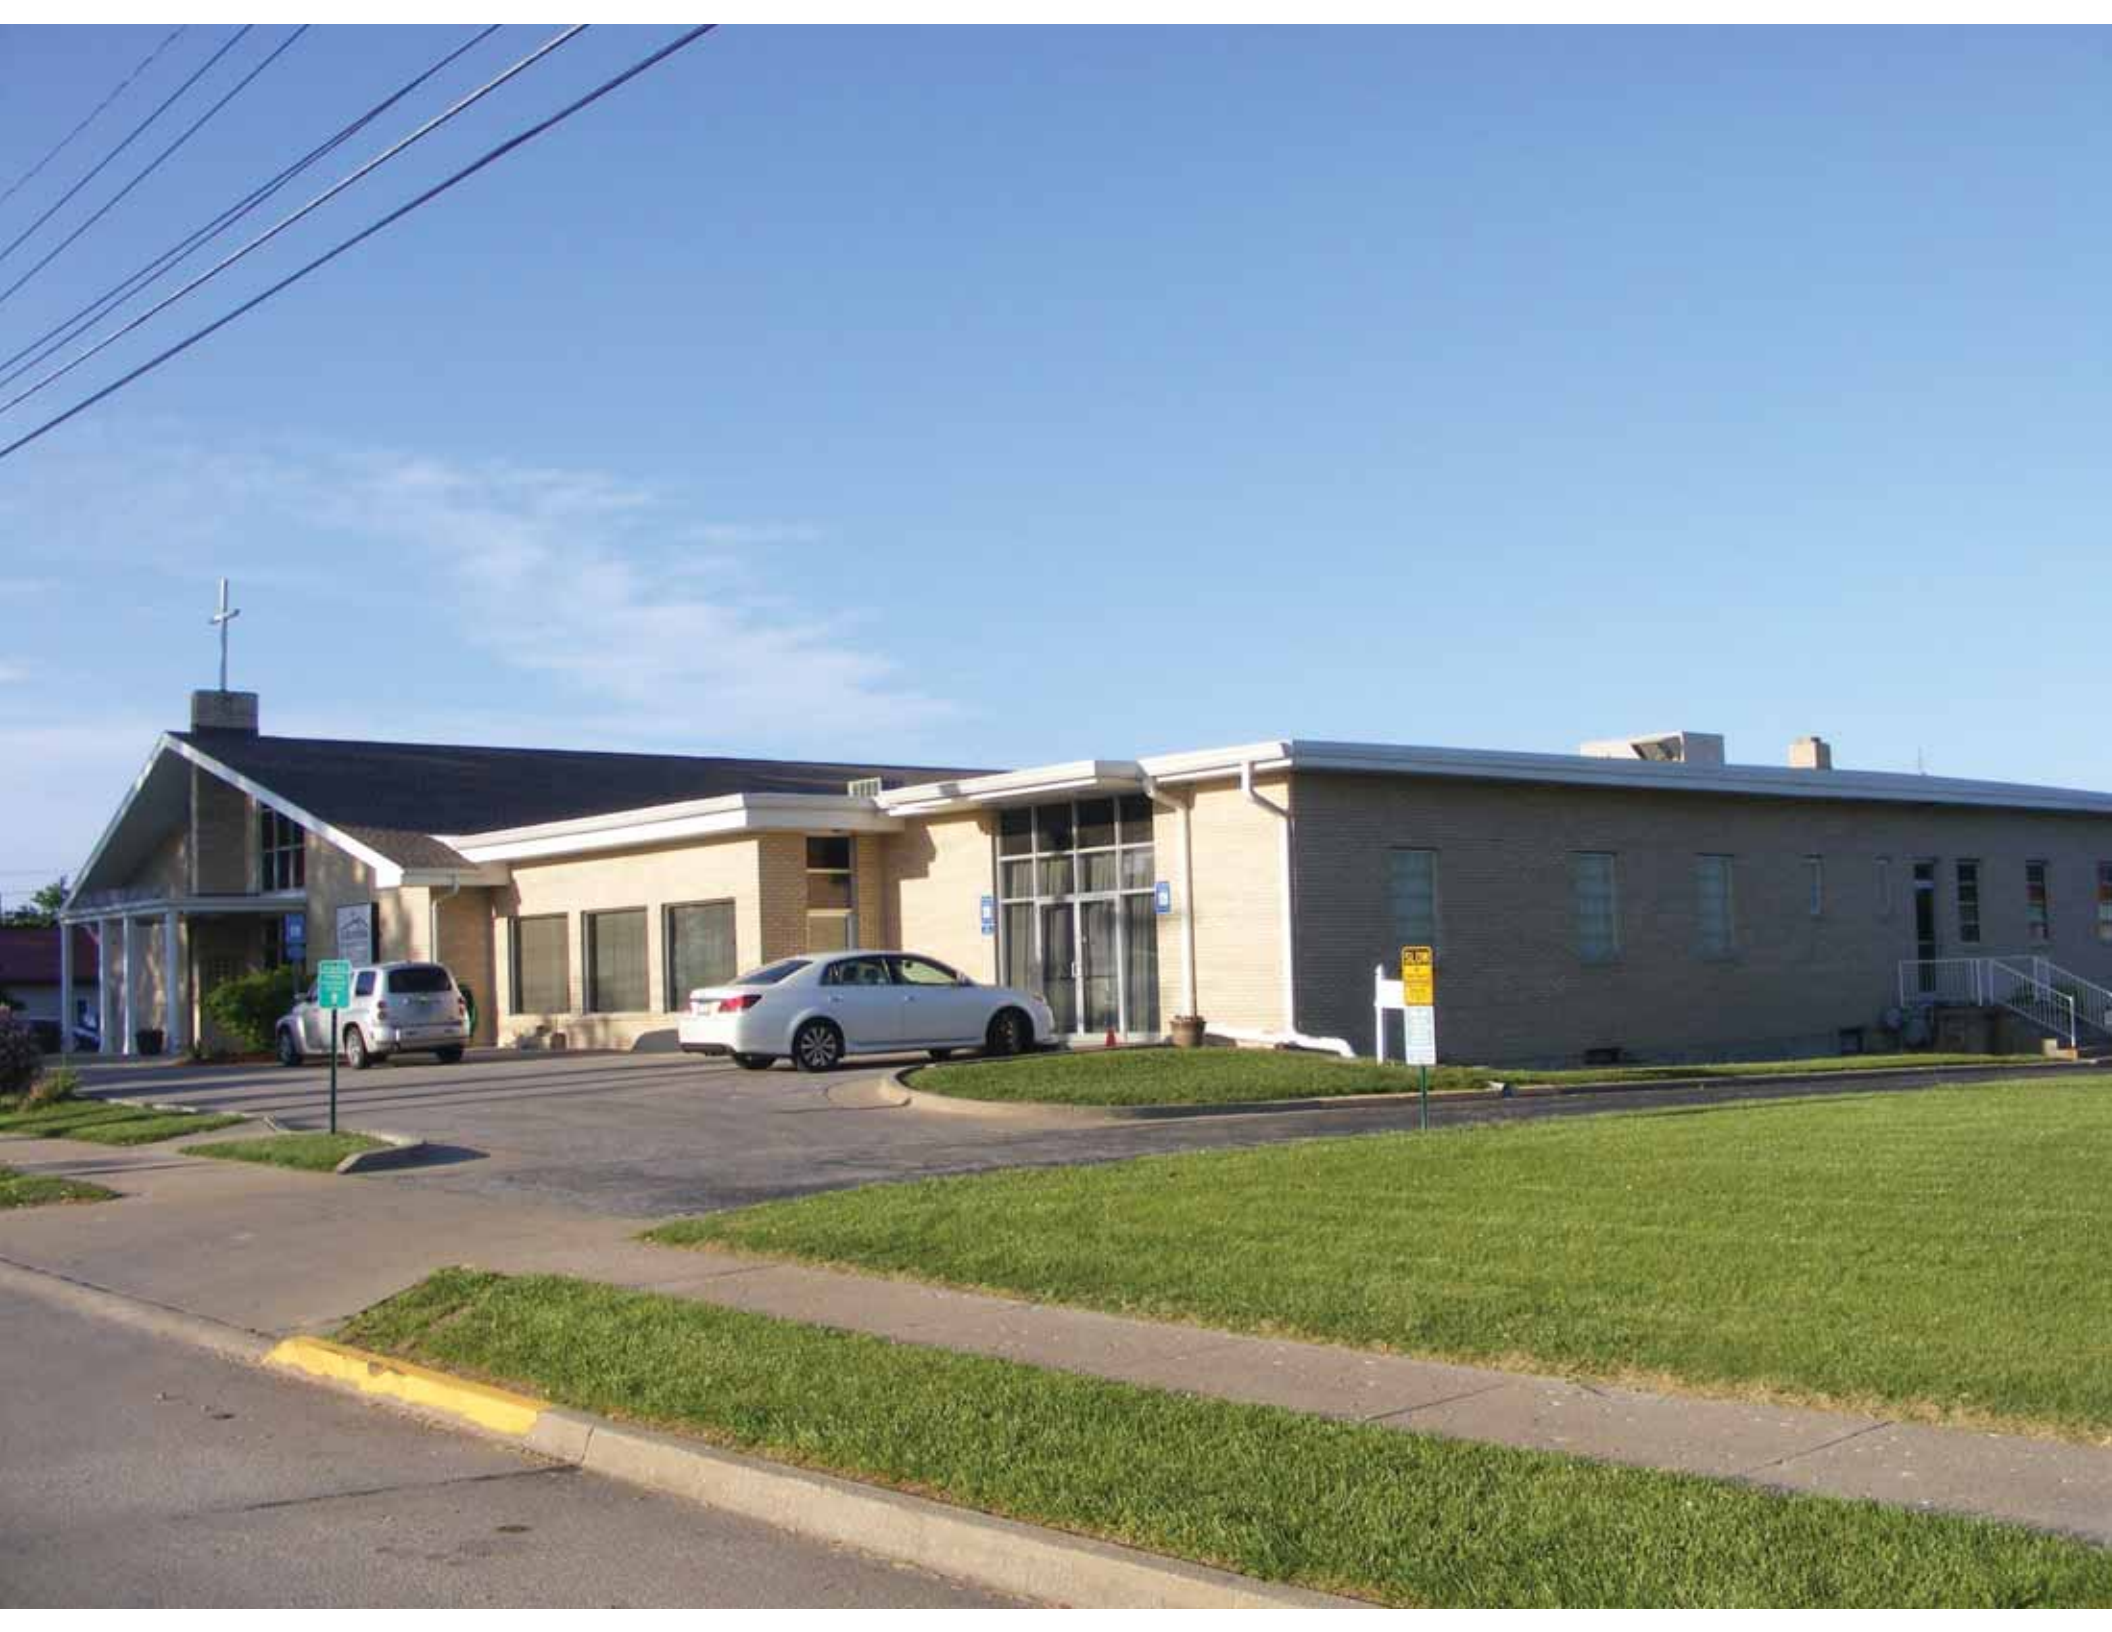
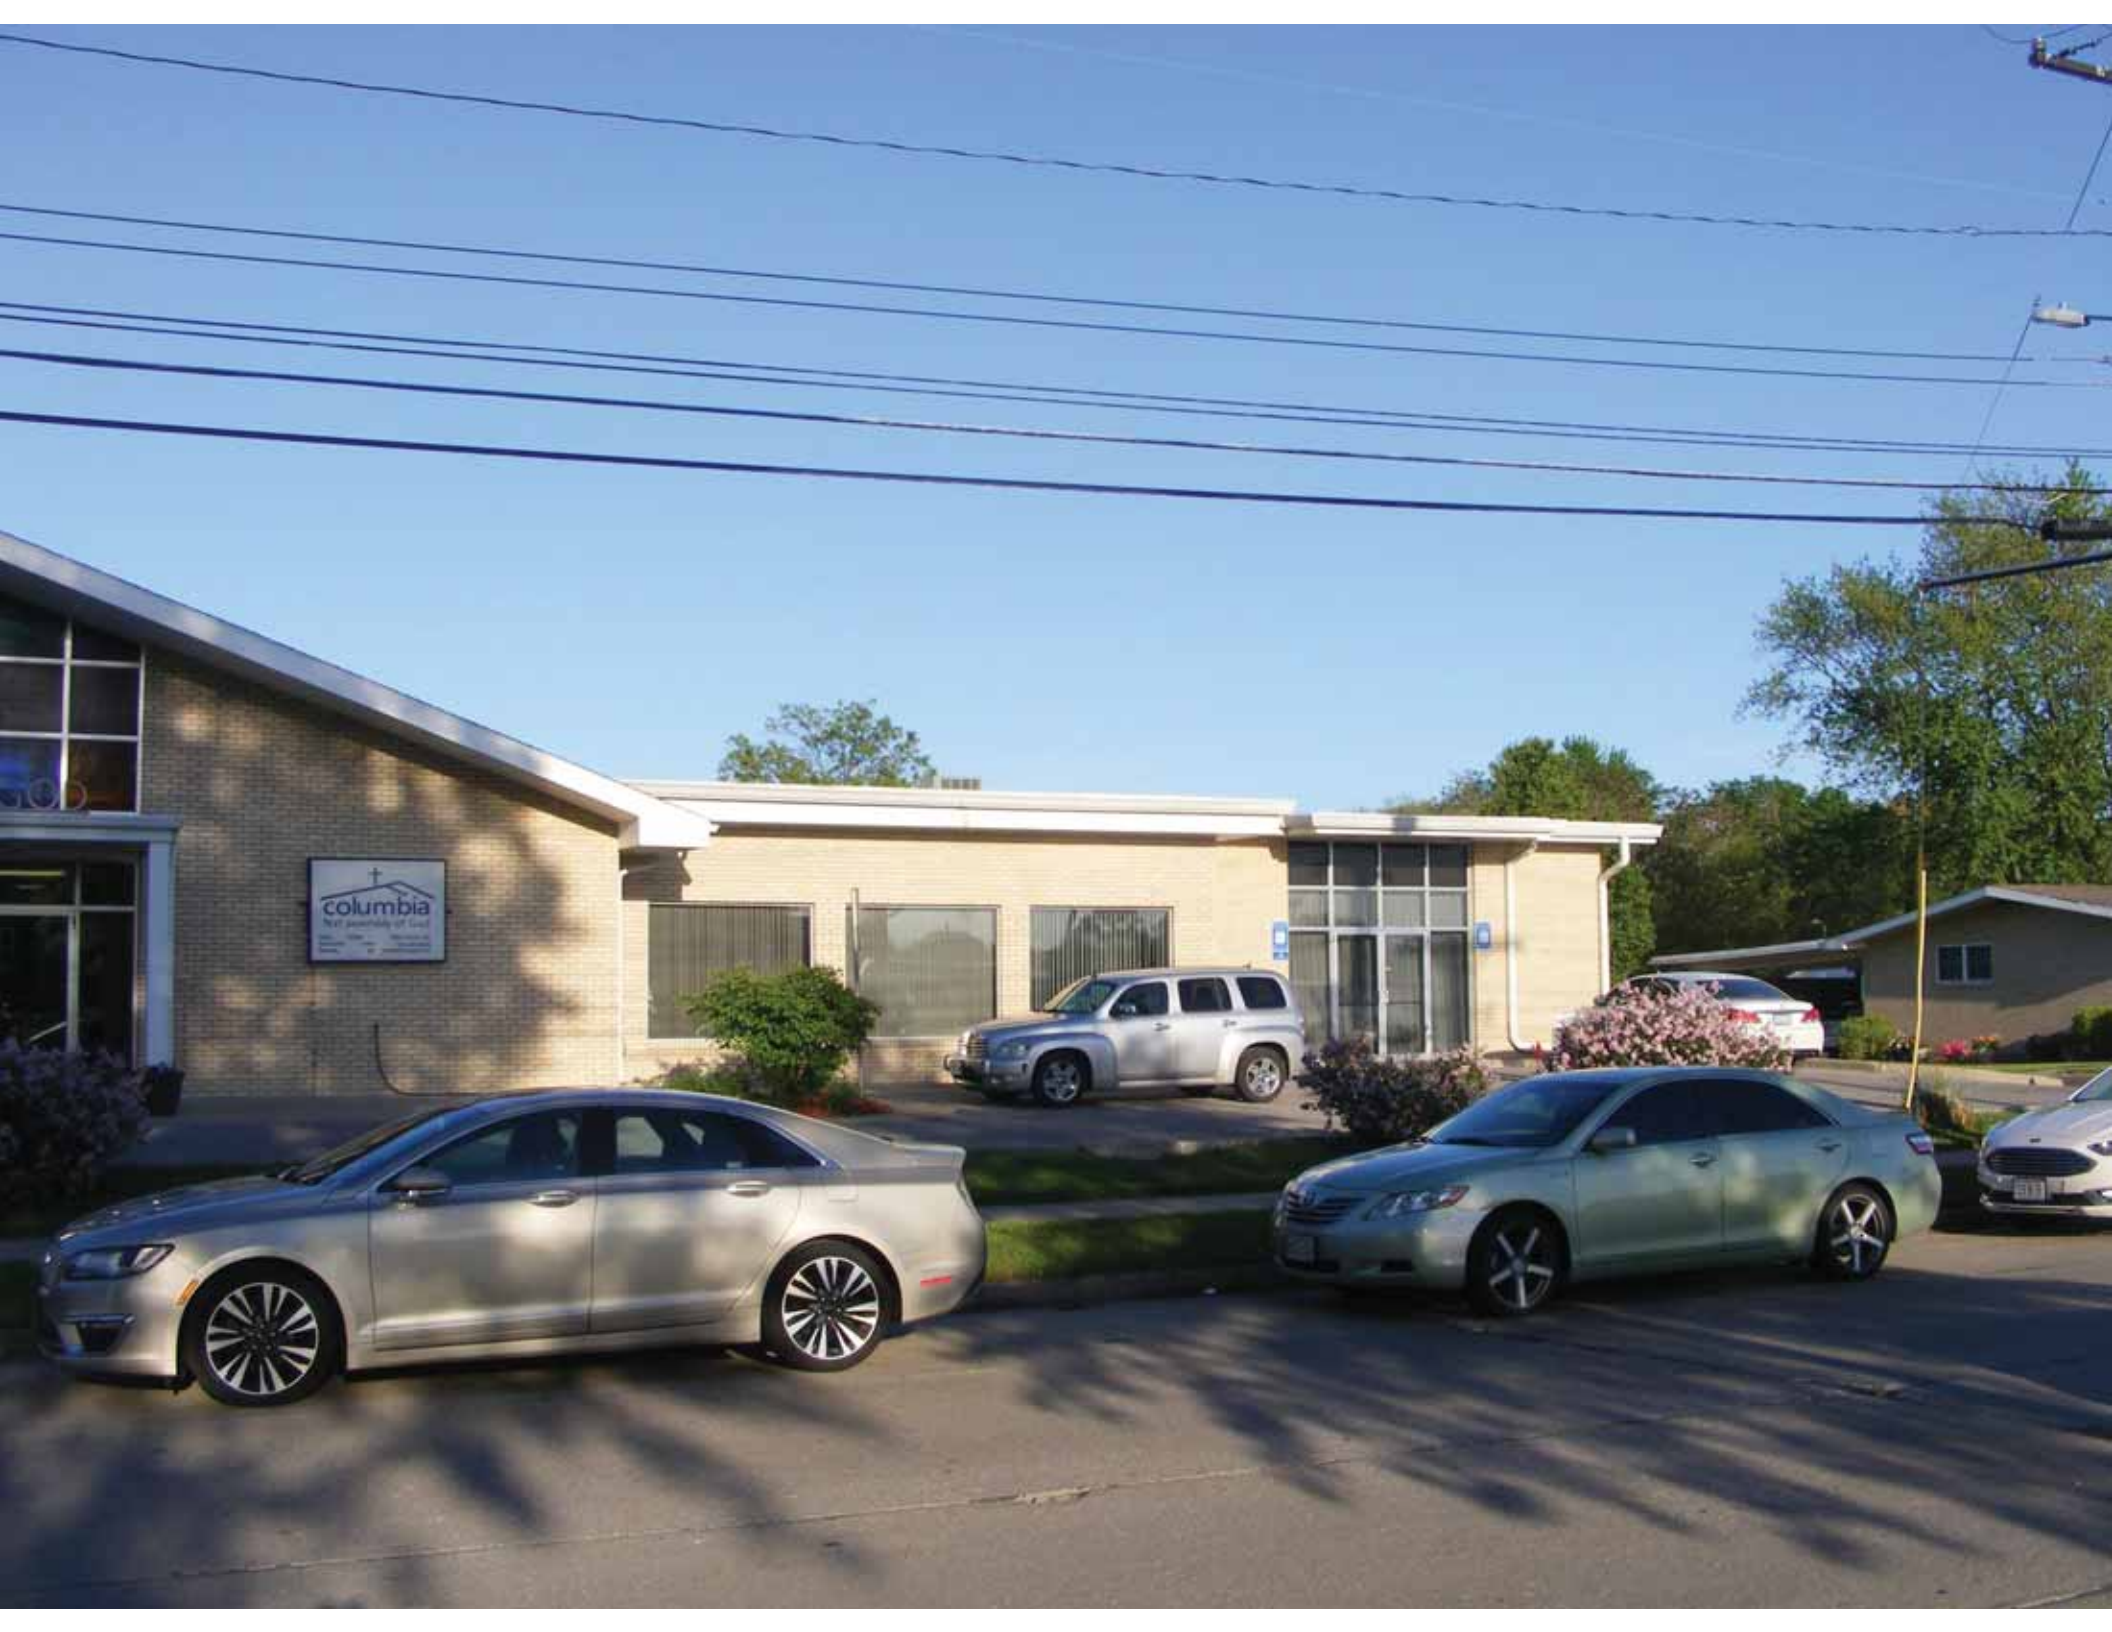
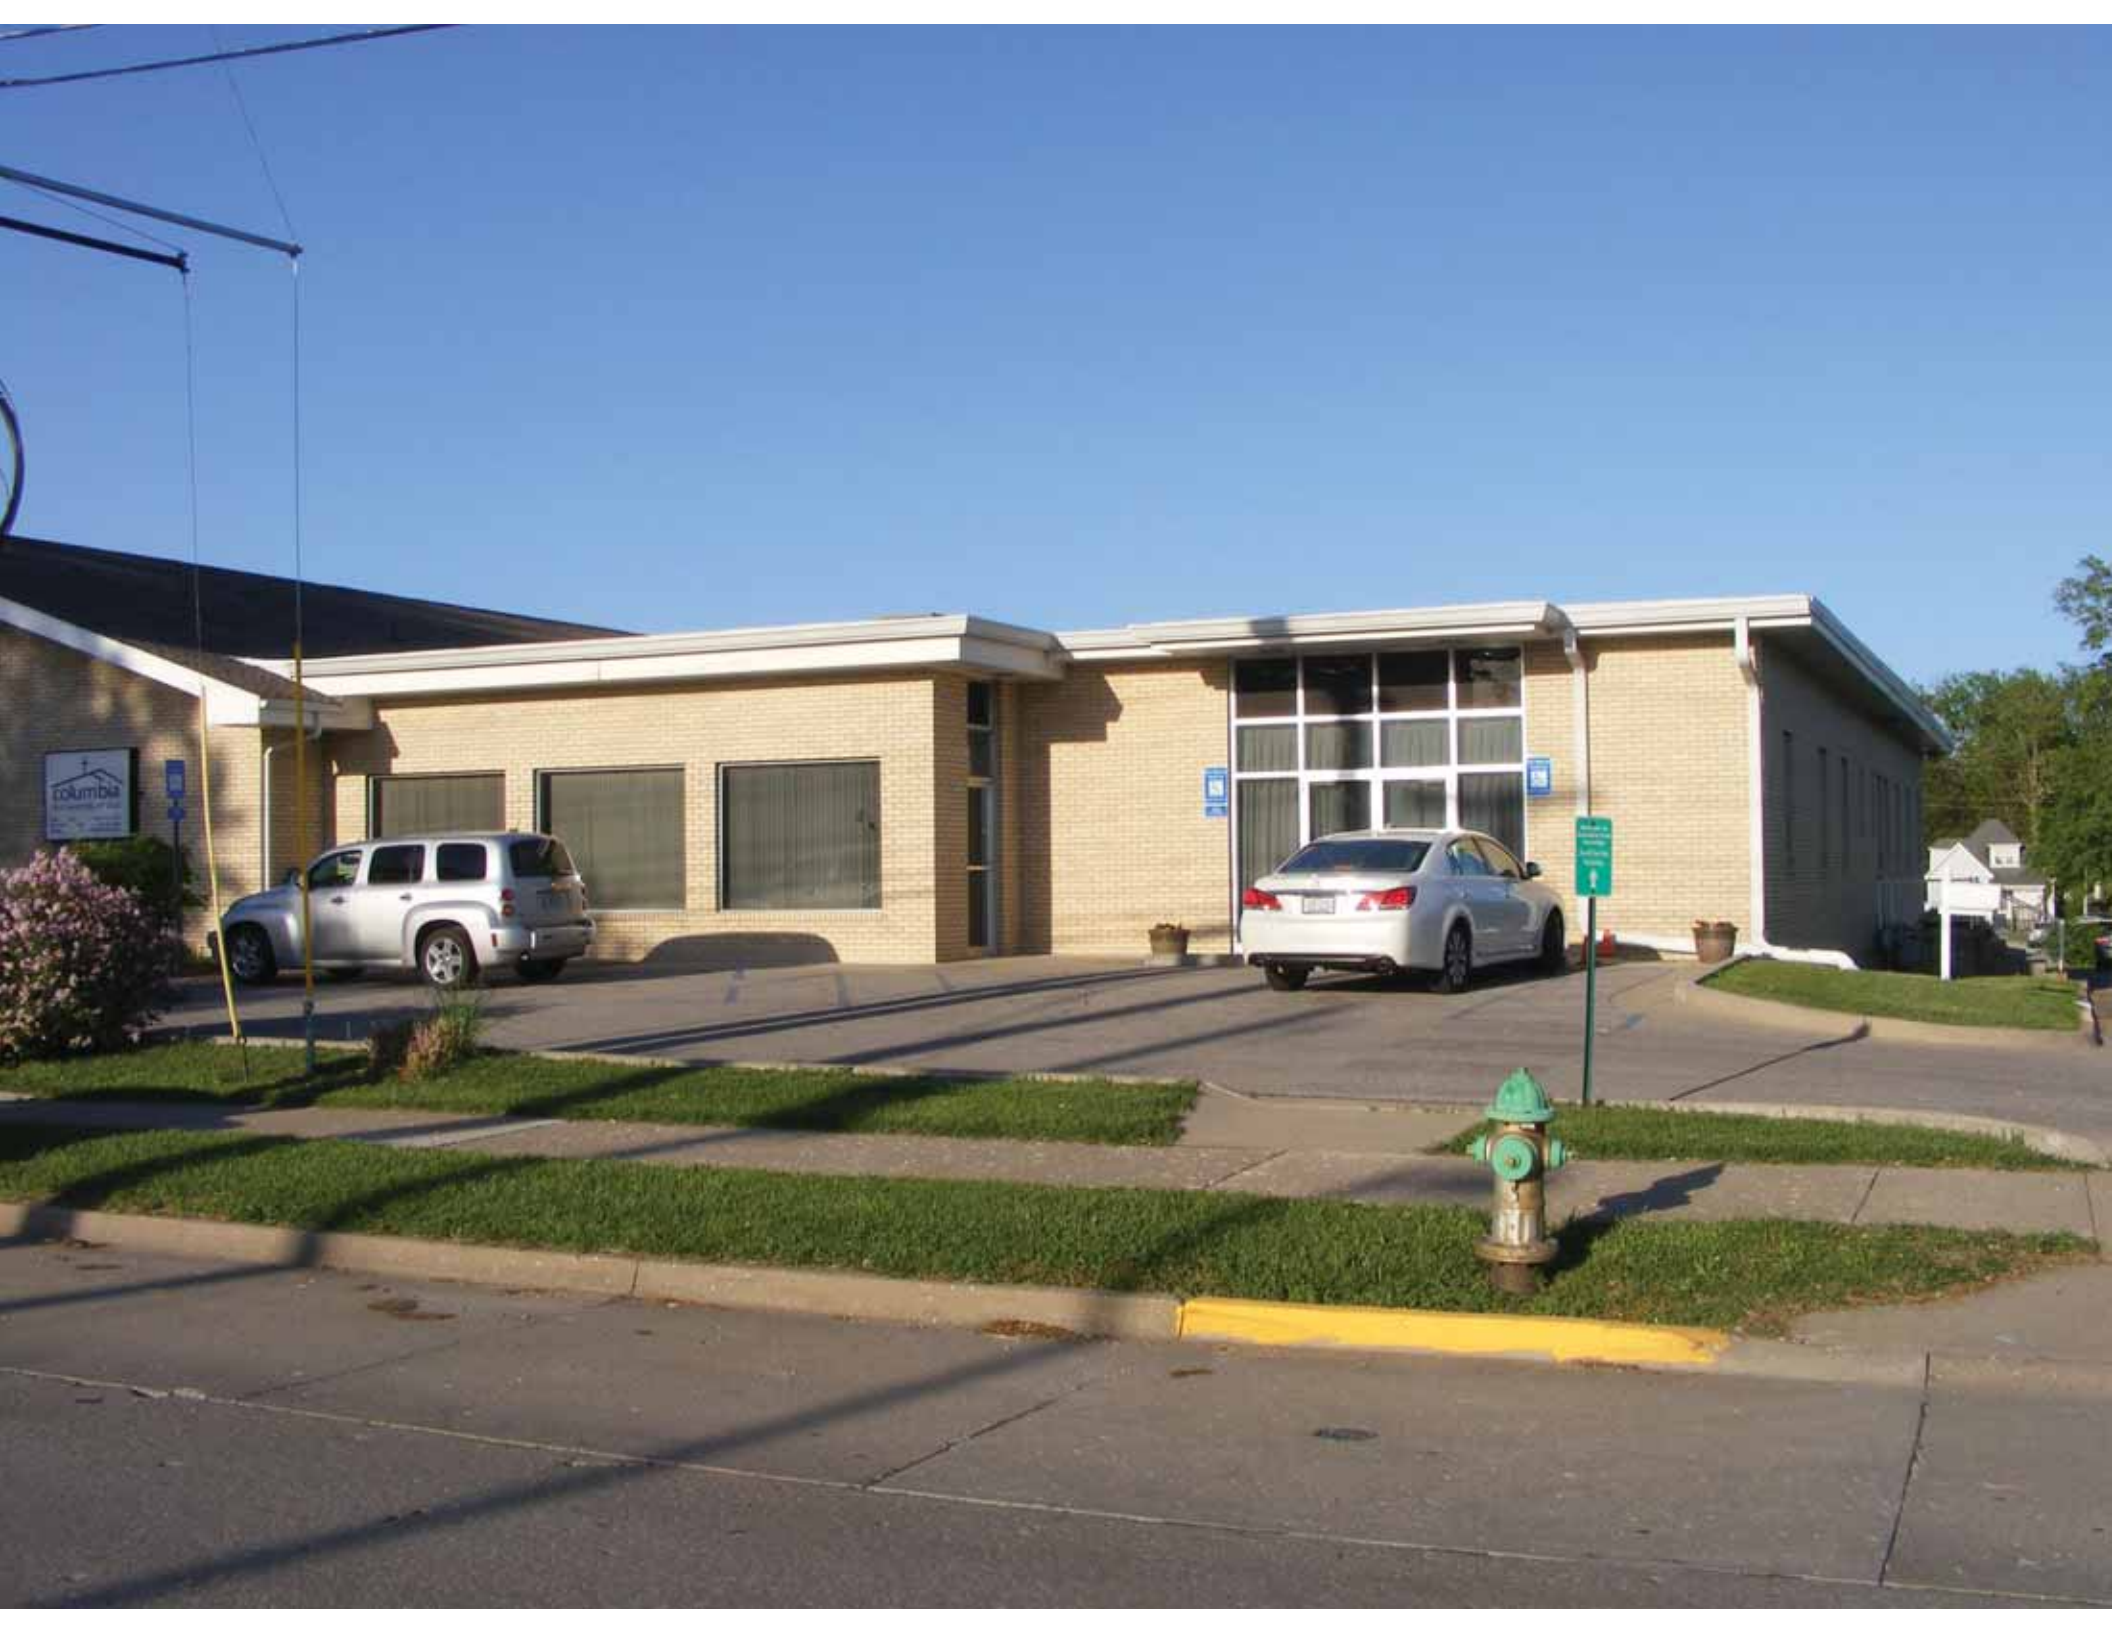
The building is composed of the sanctuary (north wing) and two flat wing additions attached to the south wall of the sanctuary. The façade of the sanctuary has a central brick projection that serves as a steeple, capped above the roofline with a cross. The projecting brick divides two large nine-light steel sash windows (colored glass) on either side of the upper gable wall. A flat roof portico is centered below the upper façade windows, supported by four square columns. Large aluminum letters on top of the portico indicate the church's name (First Assembly of God). The portico covers two bays, each of which holds paired glass and aluminum doors with a surround of fixed light panels. The north elevation holds a solid door (west) offset by four large four-light (fixed sash) windows. The two wings on the south elevation are staggered – with the southernmost wing set back the furthest. The central wing's west wall holds three large single-sash windows. The exposed south wall of the central wing features a single glass and aluminum door set below a stacked two-light transom. The west wall of the south wing features a central bay composed of paired glass and aluminum doors with a glass and aluminum surround. The south elevation has a central glass door below a single-light transom. The entry bay is flanked by four individual windows on either side. Visible at the roofline is a rear brick chimney (south wing).
