MISSOURI DEPARTMENT OF NATURAL RESOURCES
STATE HISTORIC PRESERVATION OFFICE, P.O. Box 176, Jefferson City, MO 65102
ARCHITECTURAL/HISTORIC INVENTORY FORM

1. Survey No. BO-AS-011-0087		2. Survey name: North Central Columbia Survey Phase II	
3. County: Boone		4. Address (Street No.) 902	Street (name) N. Seventh Street
5. City: Columbia	Vicinity: <input type="checkbox"/>	6. Geographical Reference:	7. Township/Range/Section: T: R: S:
8. Historic name (if known):		9. Present/other name (if known):	
10. Ownership: <input checked="" type="checkbox"/> Private <input type="checkbox"/> Public		11a. Historic use (if known): Domestic/single dwelling	11b. Current use: Domestic/single dwelling

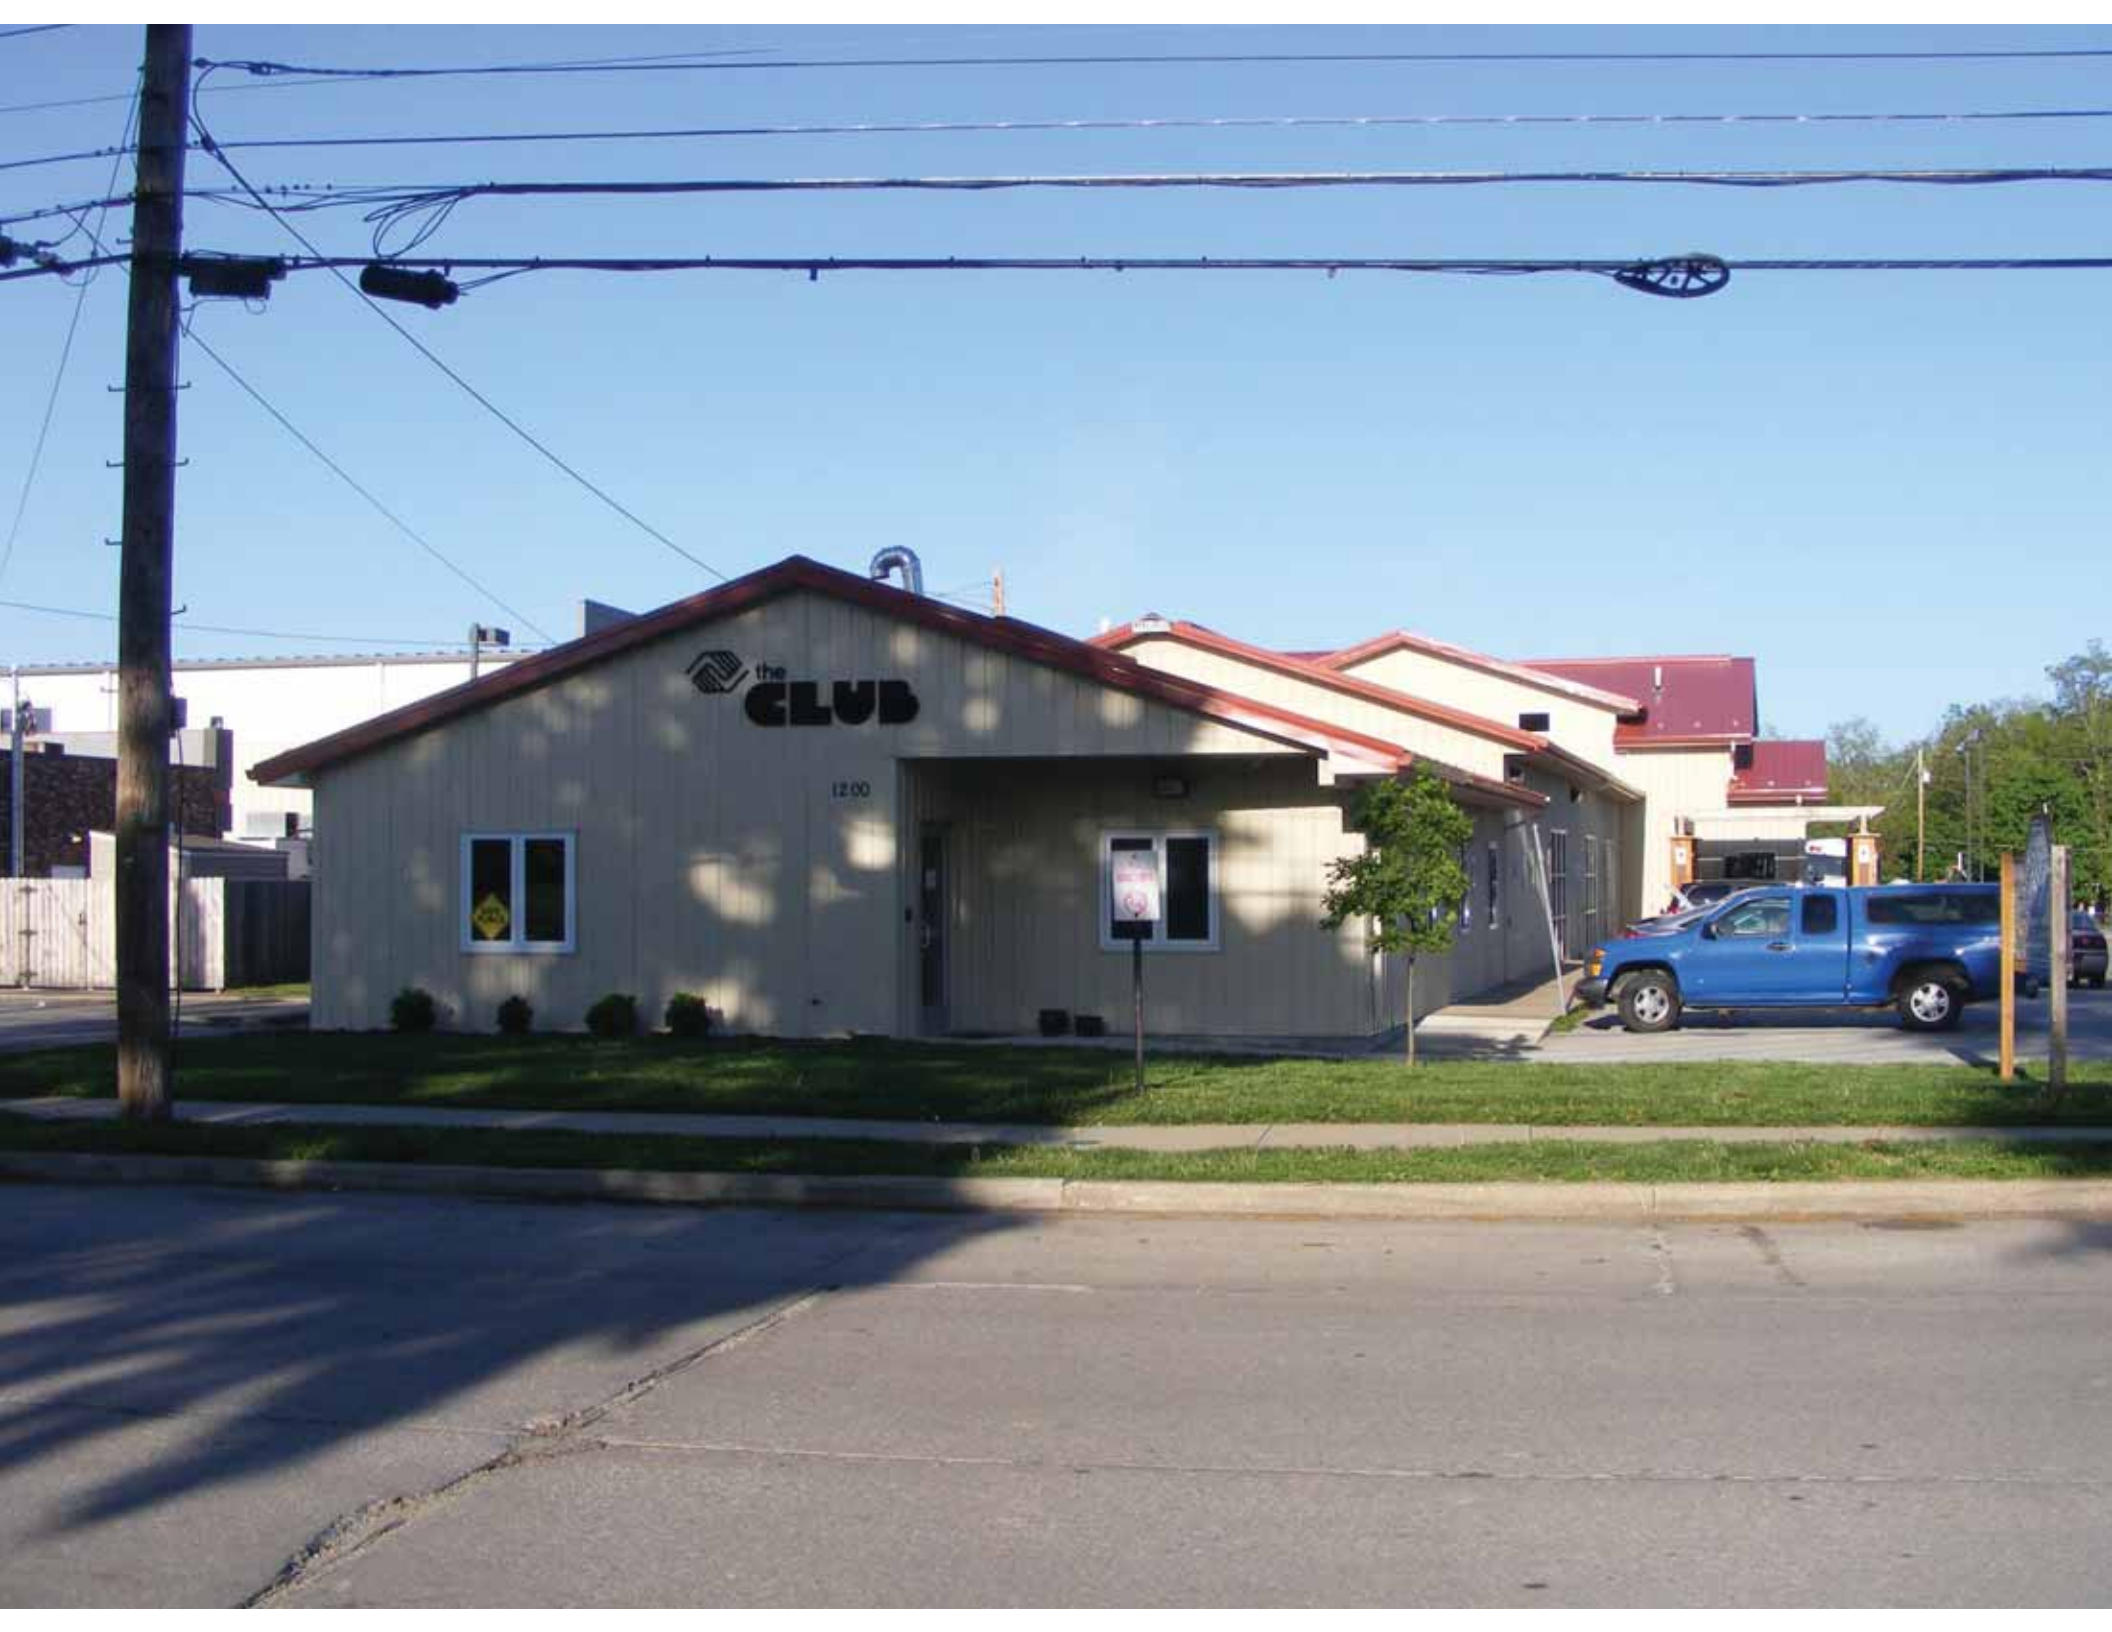
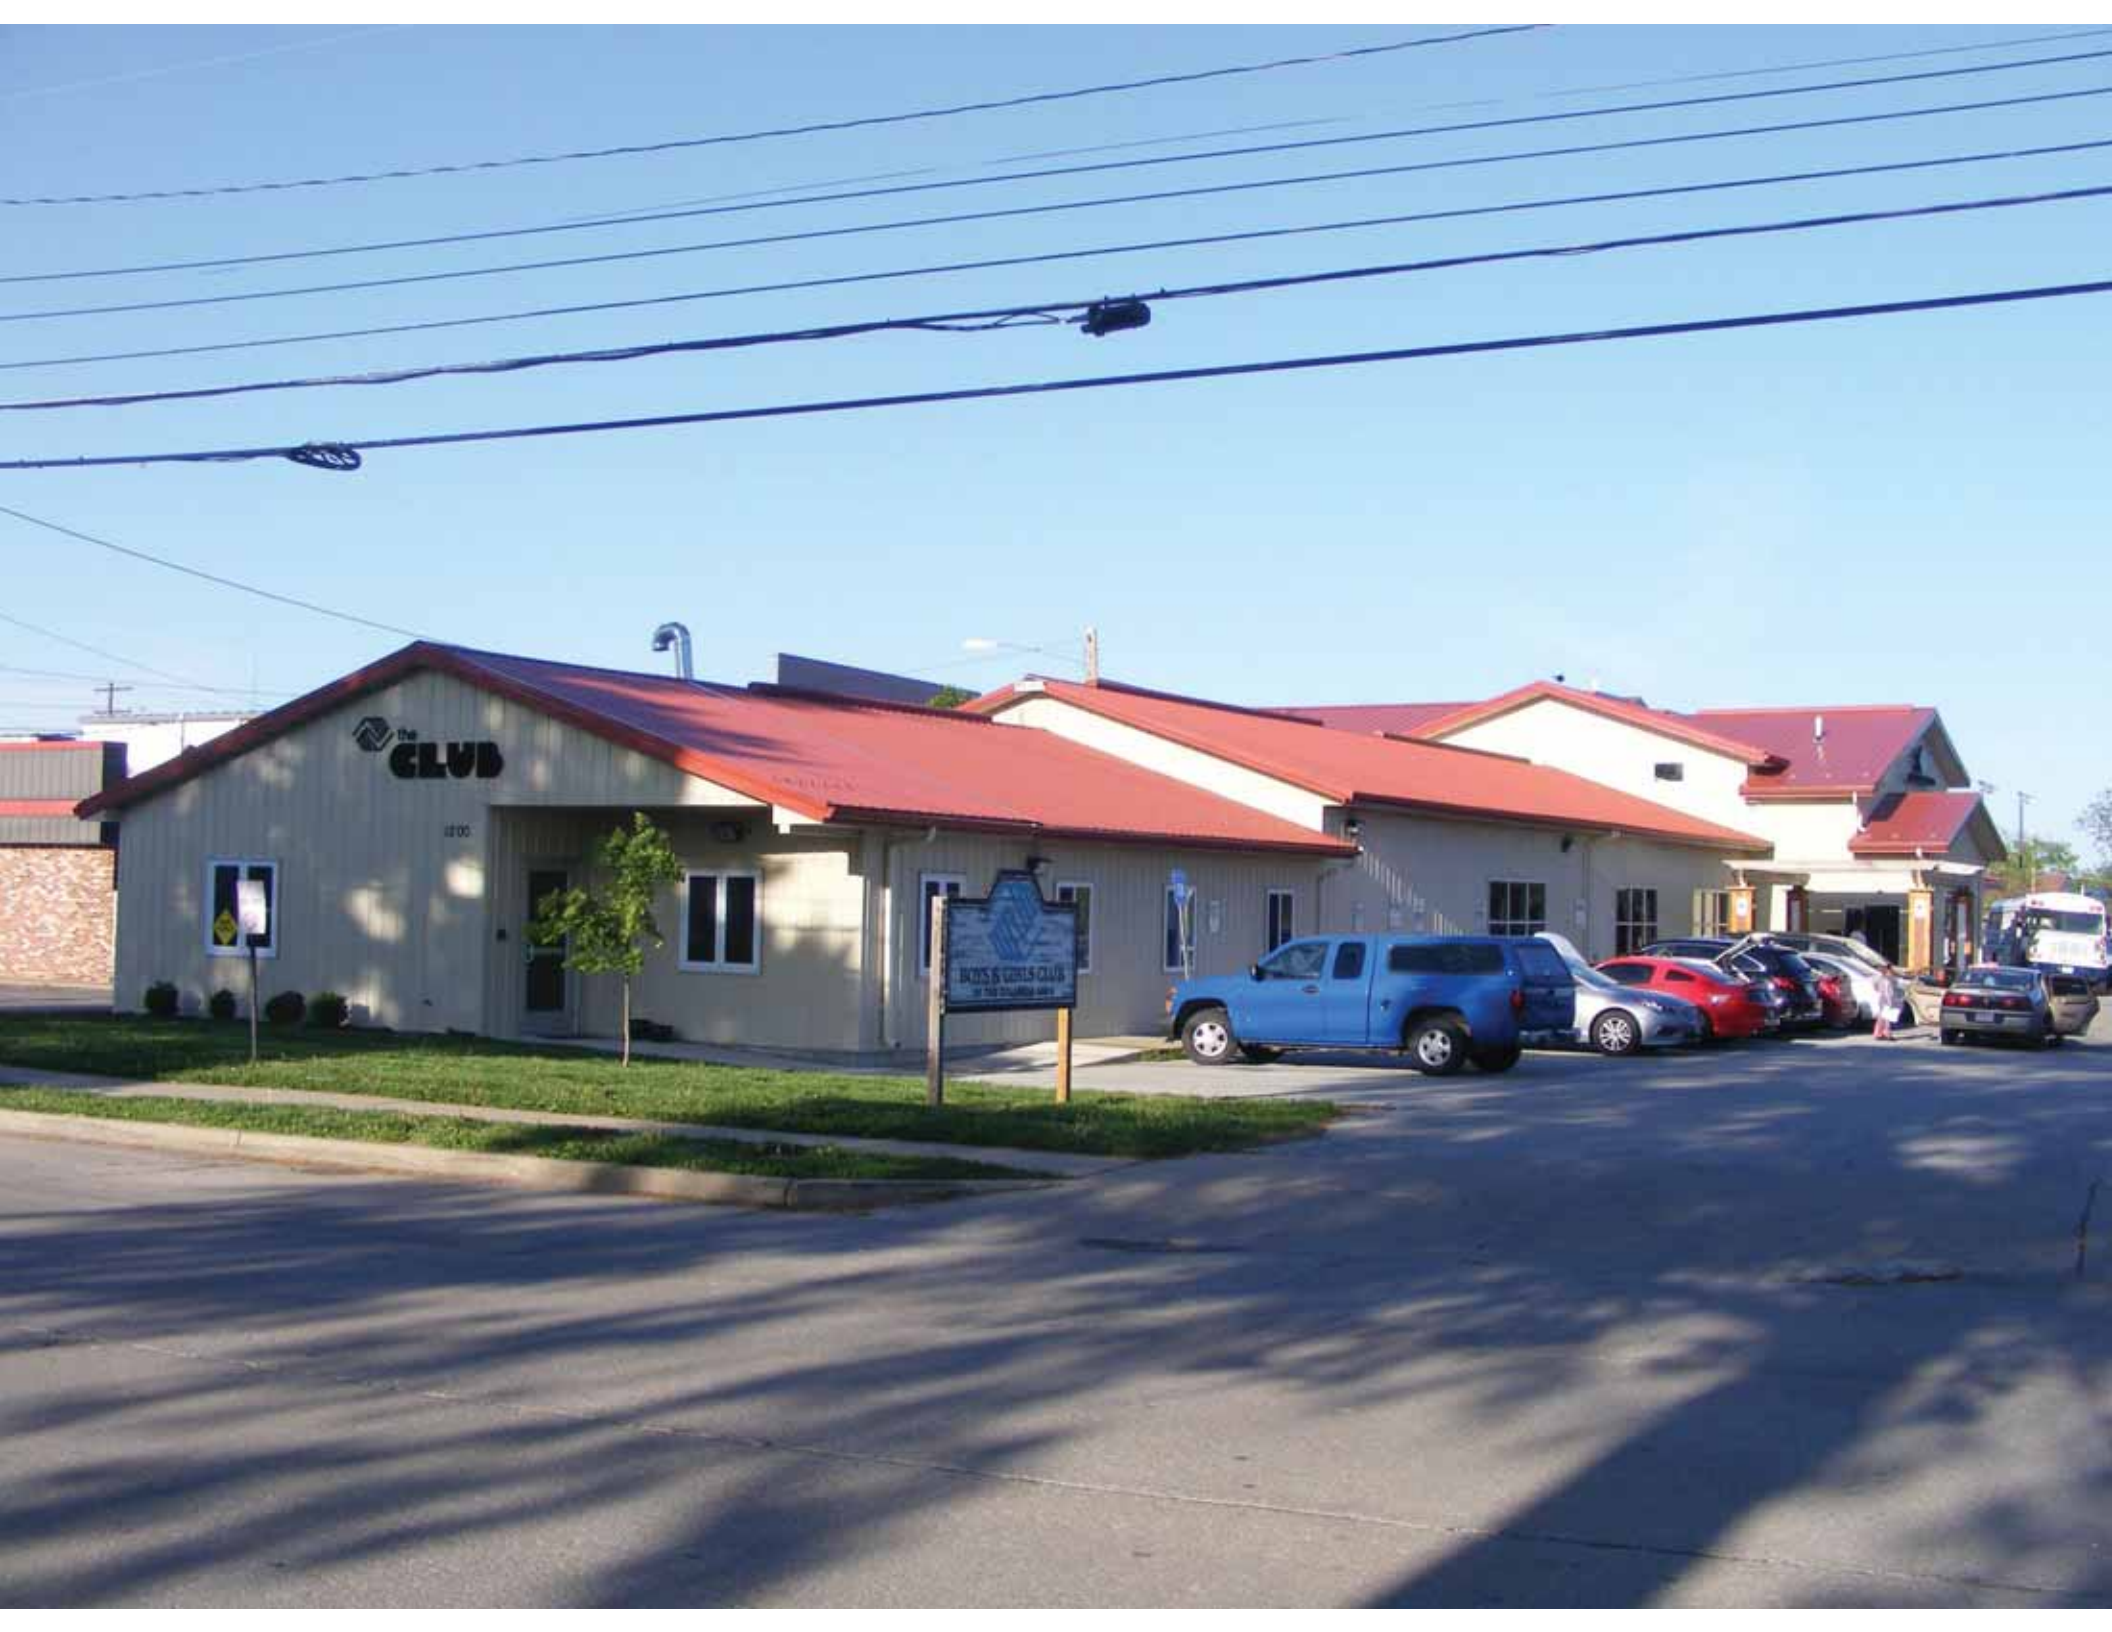
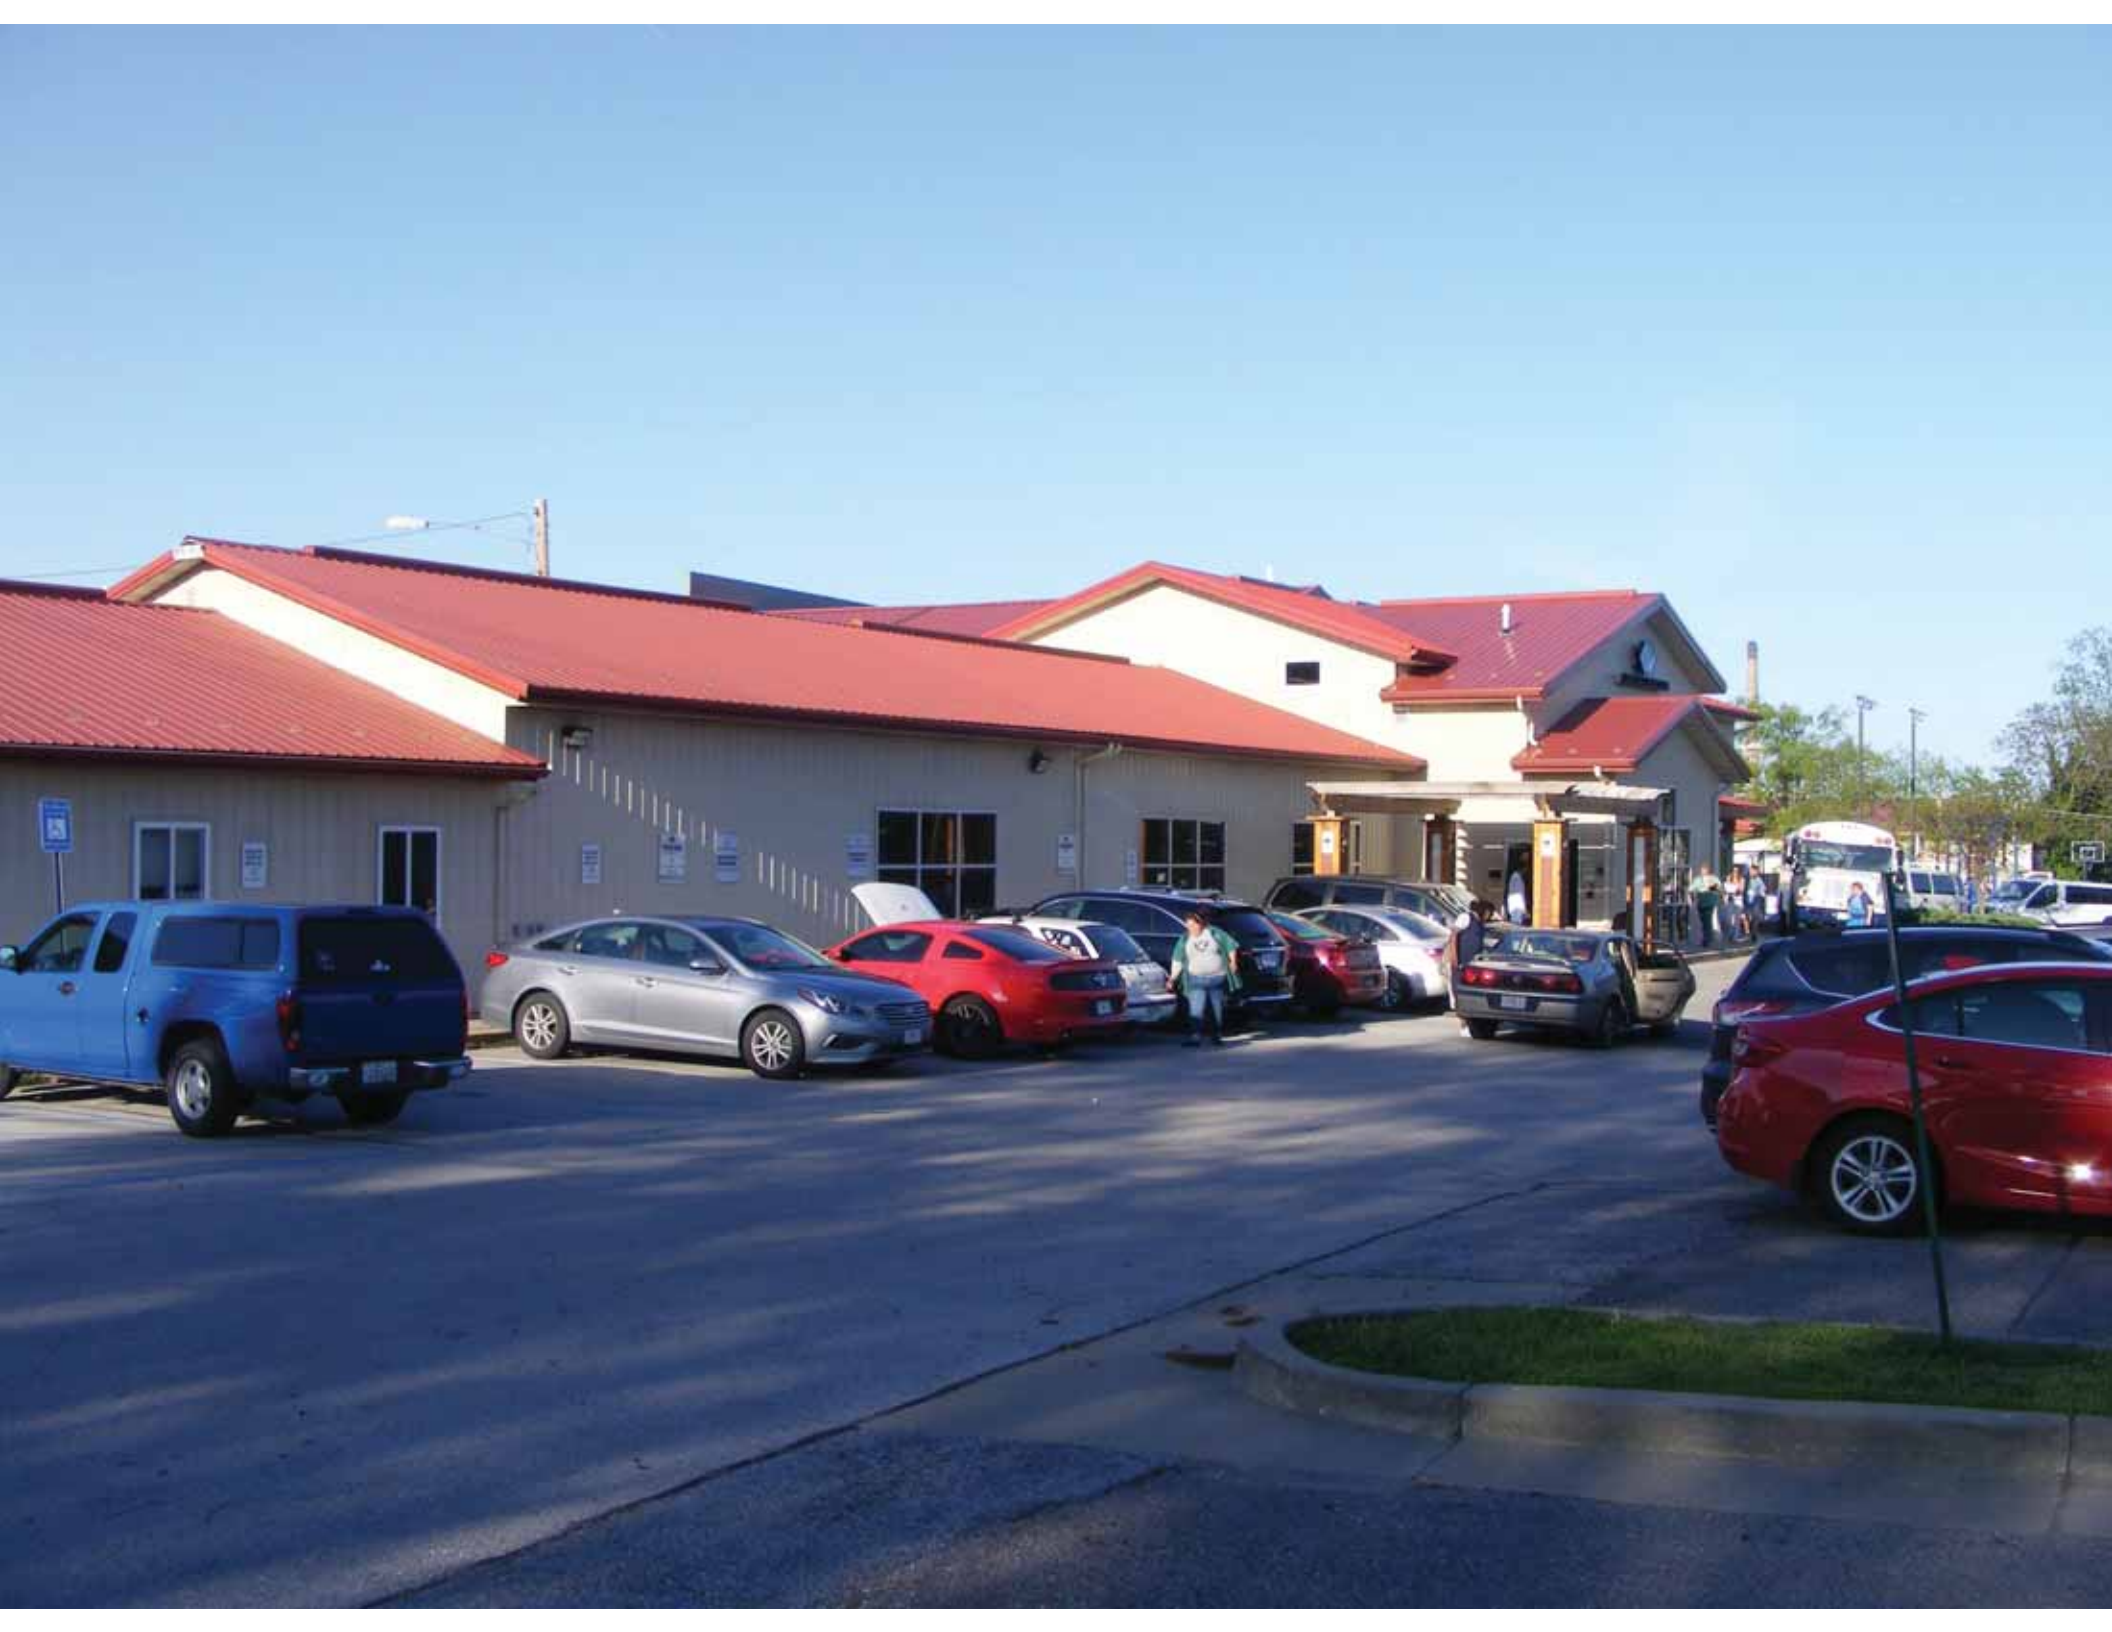
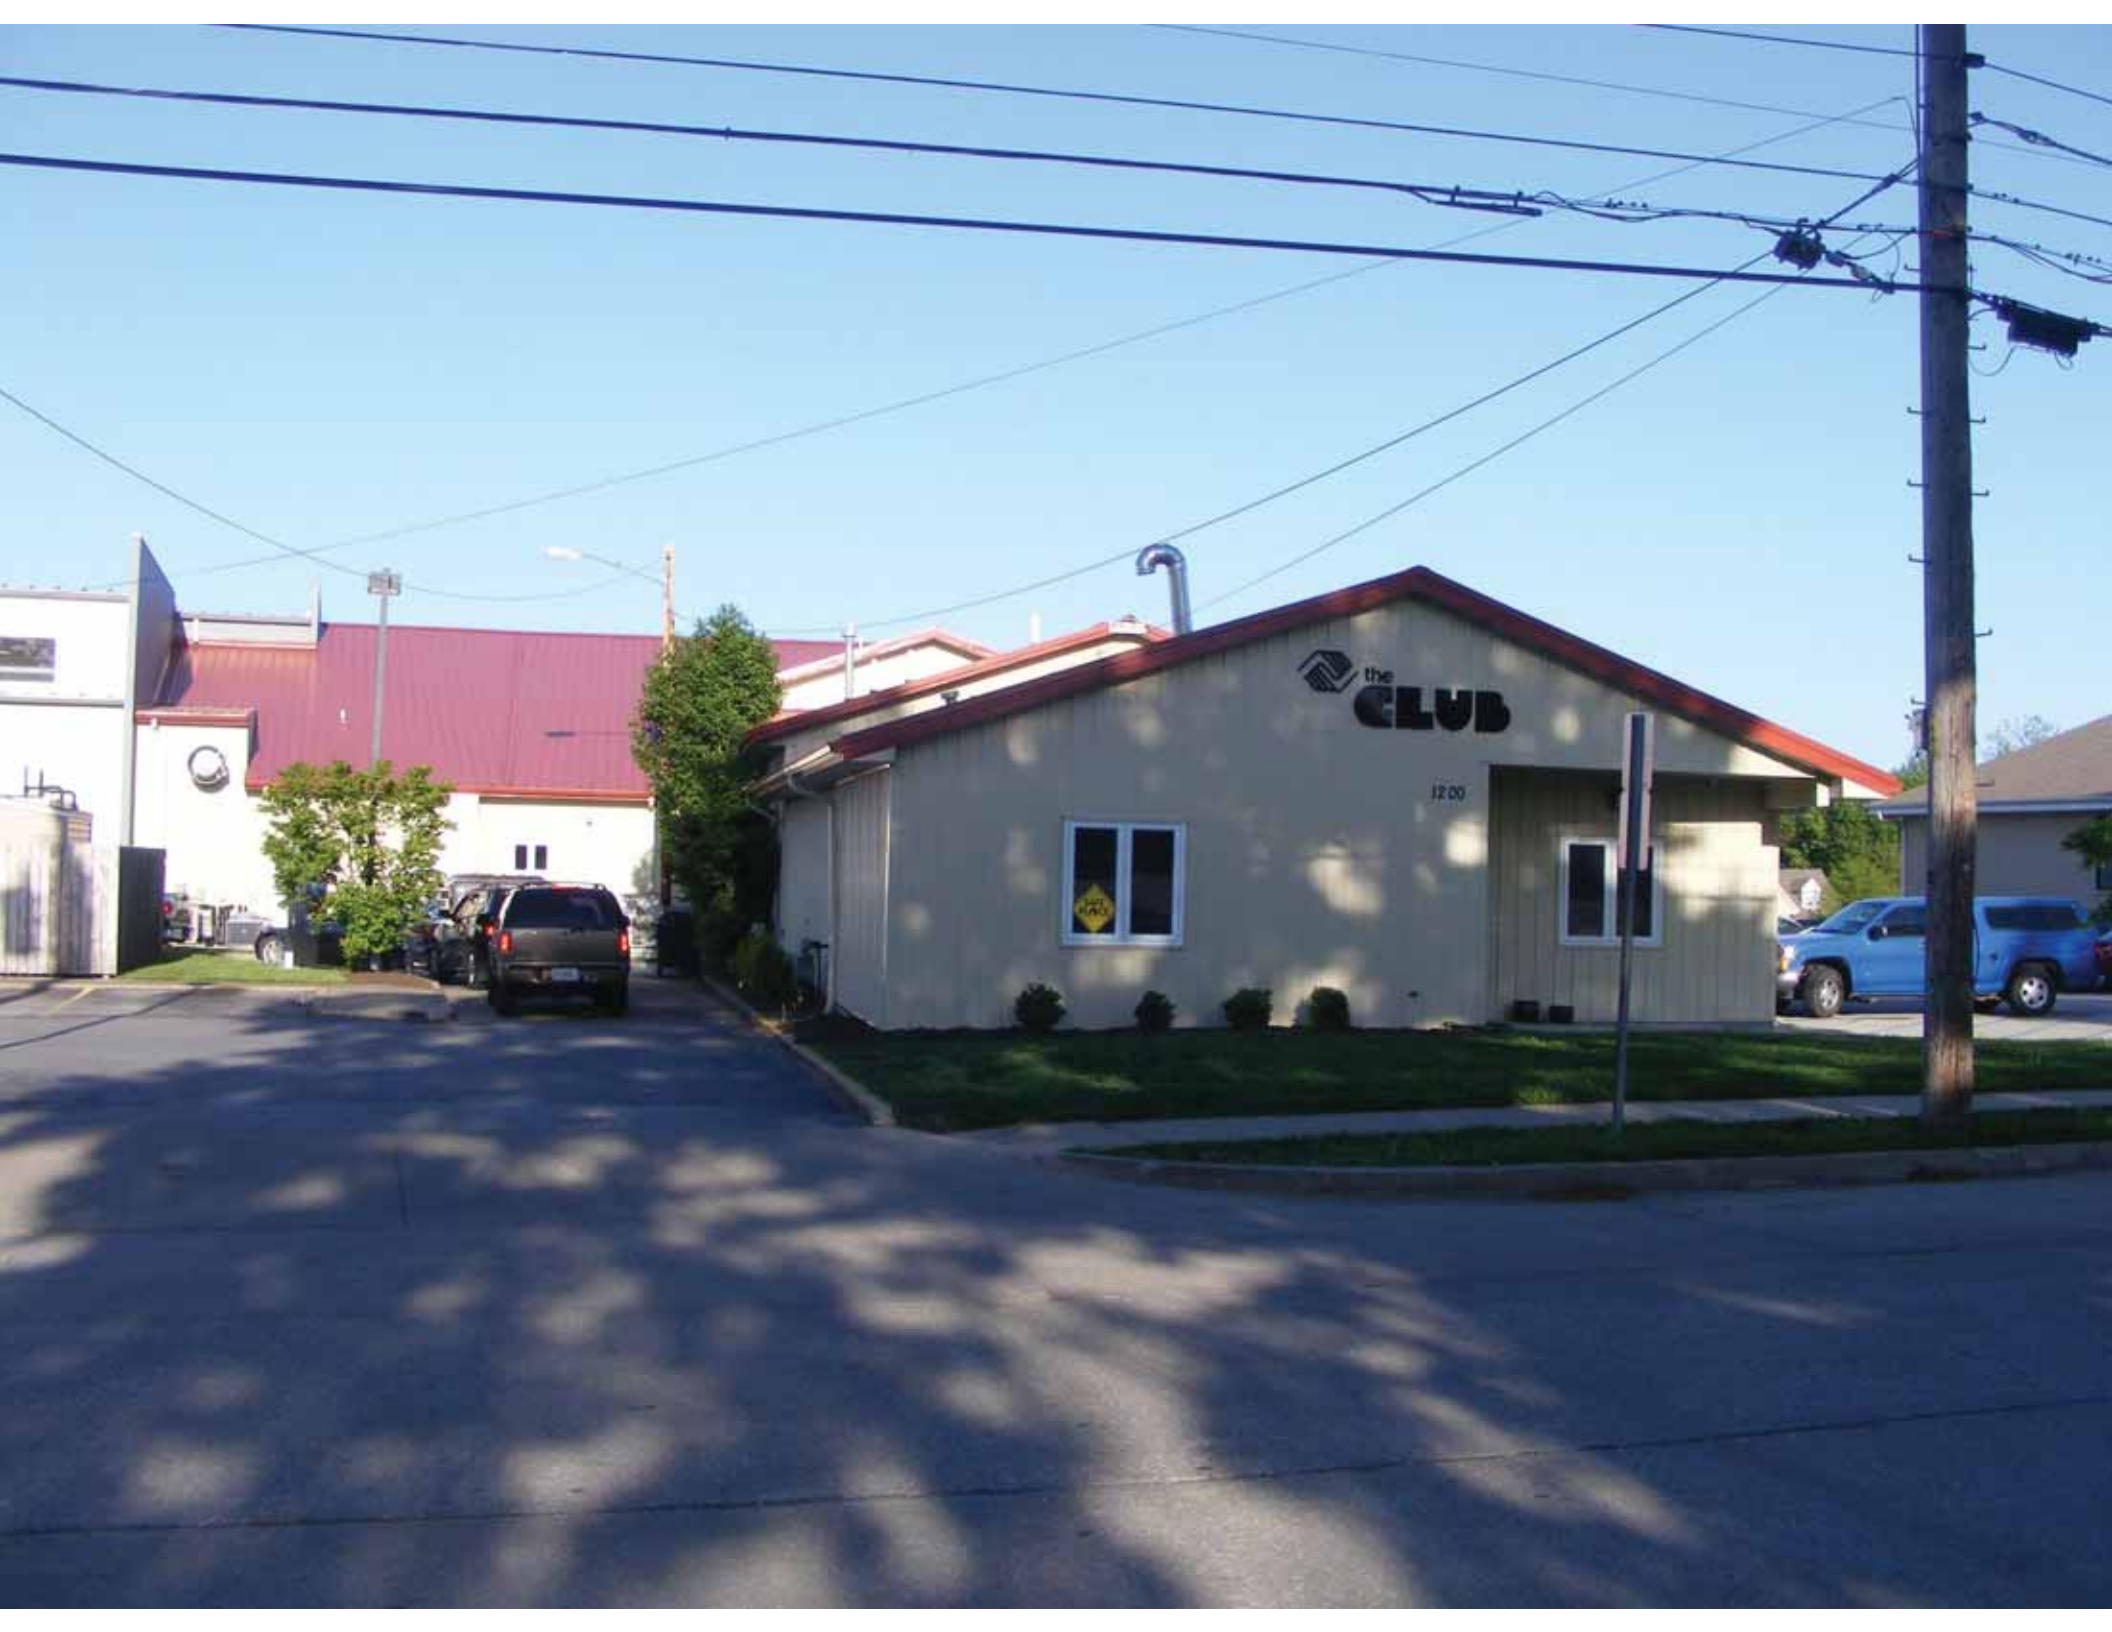
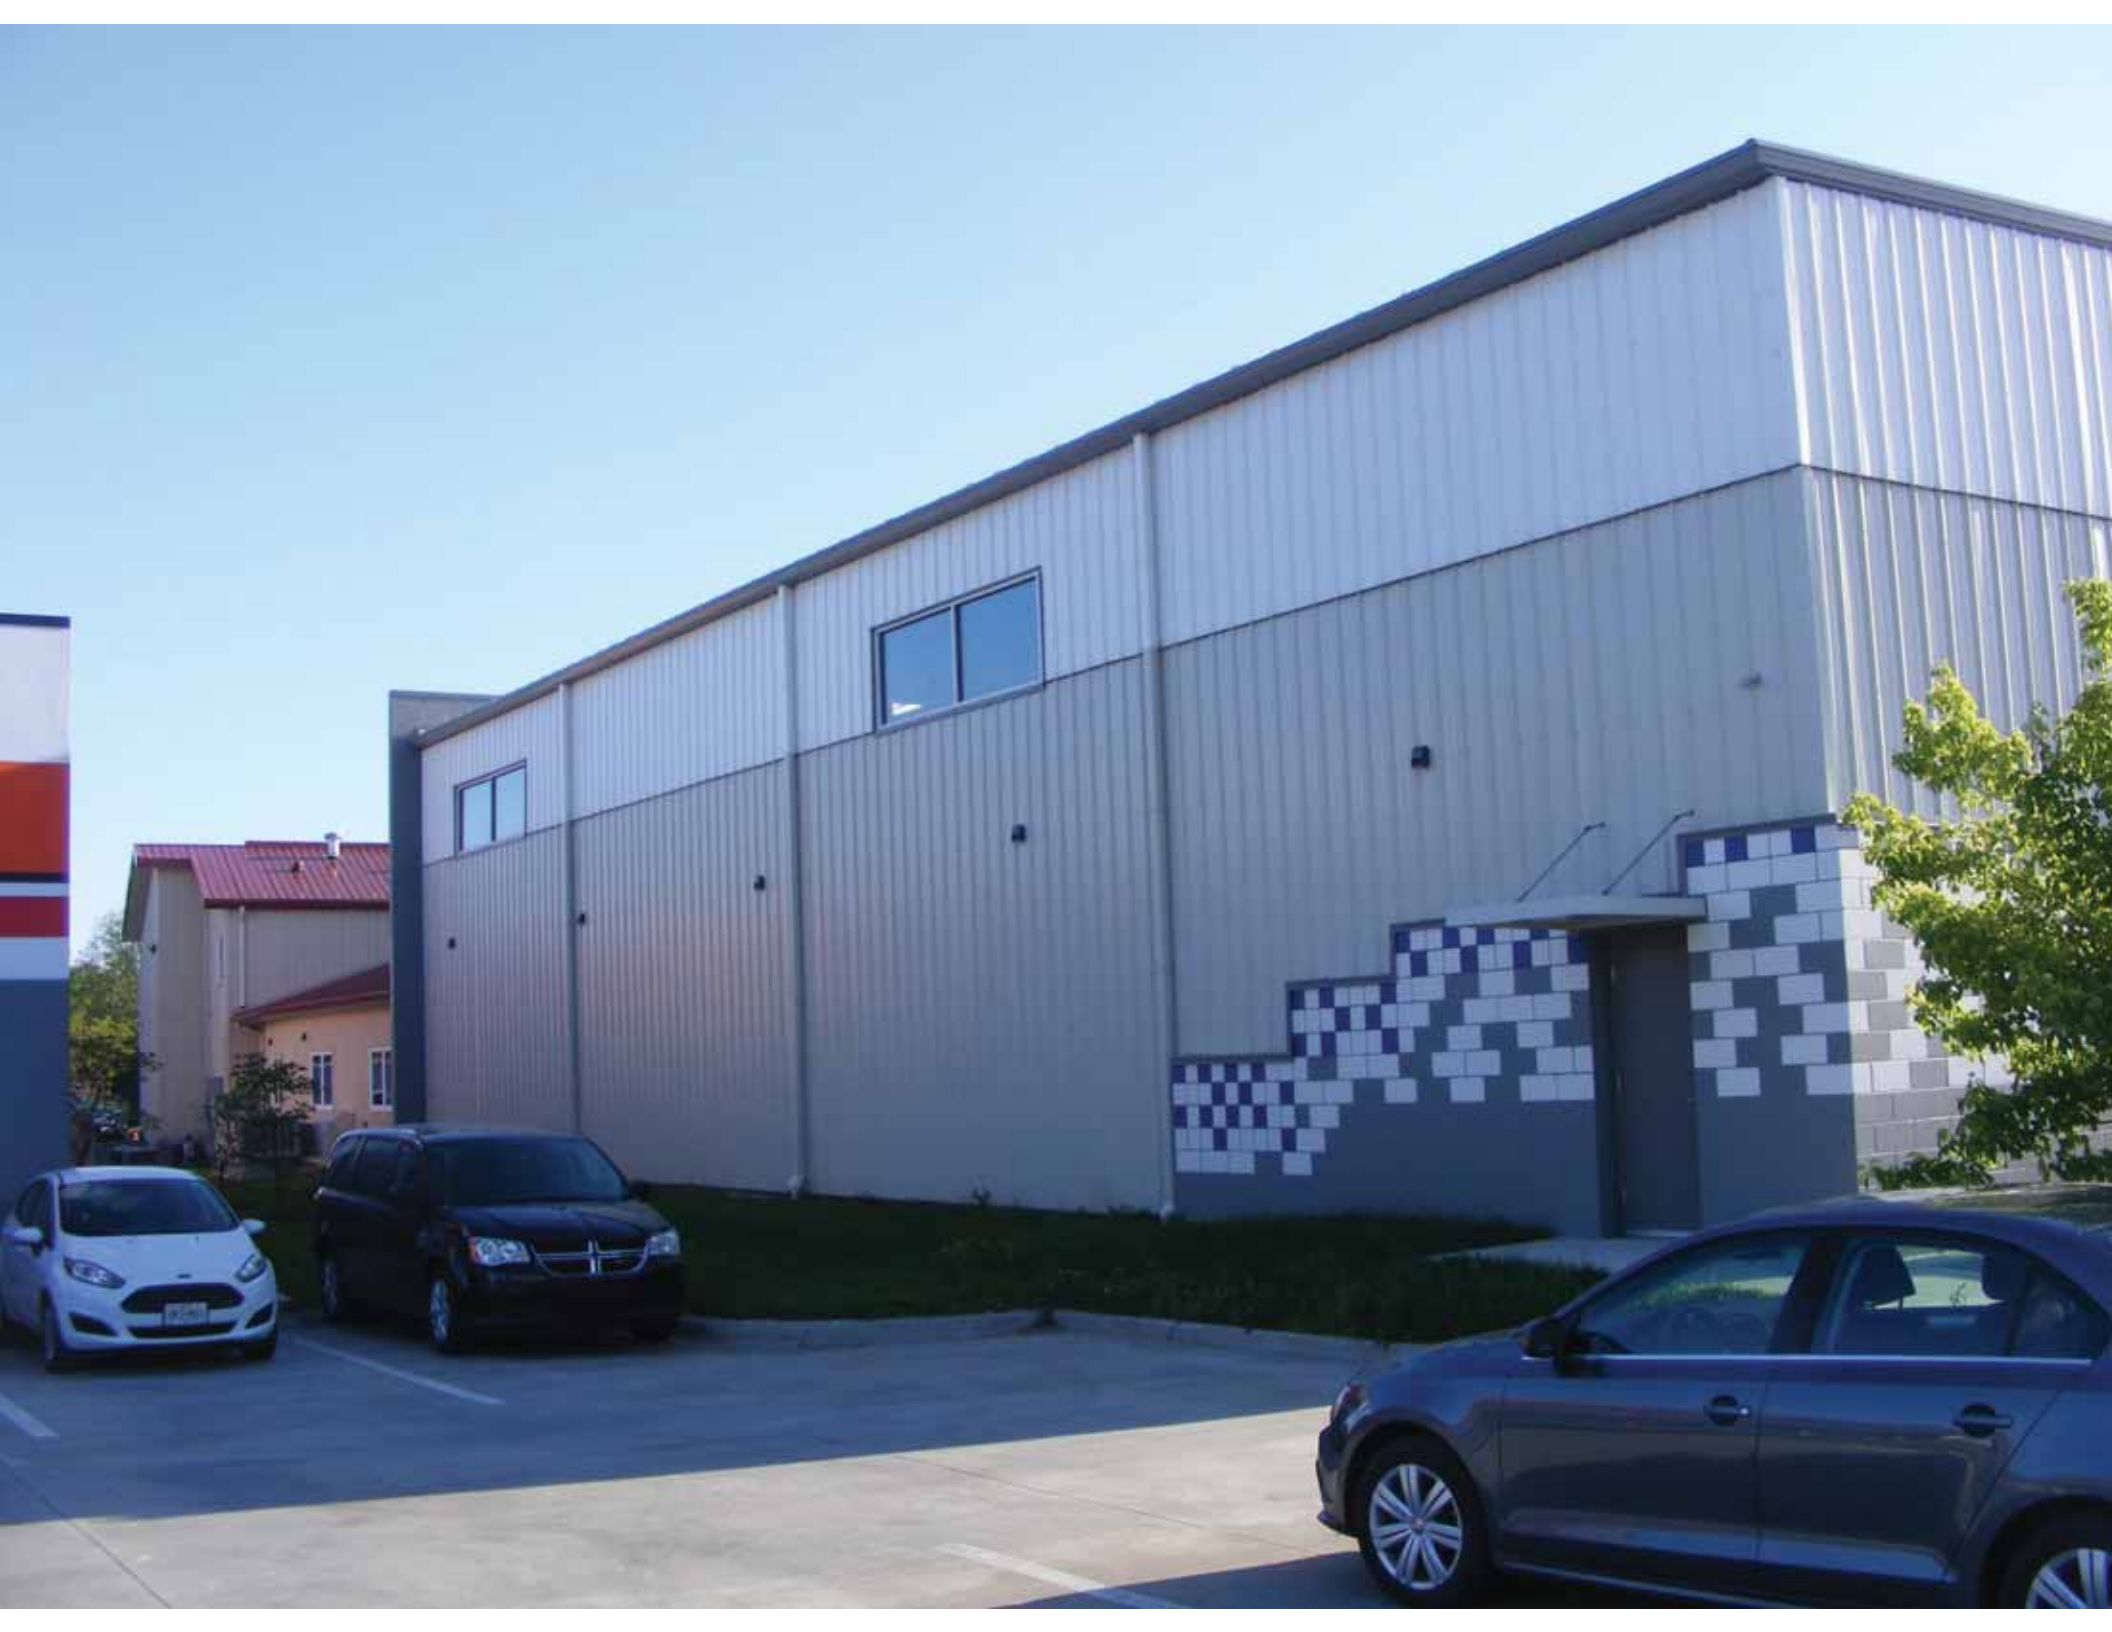
This large complex of connected building wings appears to have been constructed from c. 1990-2010. The older wing faces S. Seventh Street. The building complex is constructed of prefabricated panels. Wings have metal clad gable roofs. The west elevation facing Seventh Street has an incised entry area at the southwest corner. Within the recess is a single door facing south and a window (two-light) facing west. The remaining west wall holds a two-light window. Similar windows span the wing's south elevation. The wing immediately east holds two large multi-light windows on the south elevation. Another wing, further east, appears to serve as lodging, resembling a two-story motel with front (south elevation) gabled portico. Entry faces south and access (for photography purposes) was limited. Attached to the north wall of the lodging wing is a prefabricated wing with large multi-light windows on the east elevation. A gymnasium is attached to the north wall of the connector wing. The gymnasium's north wall faces U.S. Business Loop 70. Windows are on the upper elevation walls, two-light design. Walls are clad with vertical synthetic siding that is cut away to expose decorative painted block walls (north, west and east elevations). A solid door is situated on the east elevation at the north end.

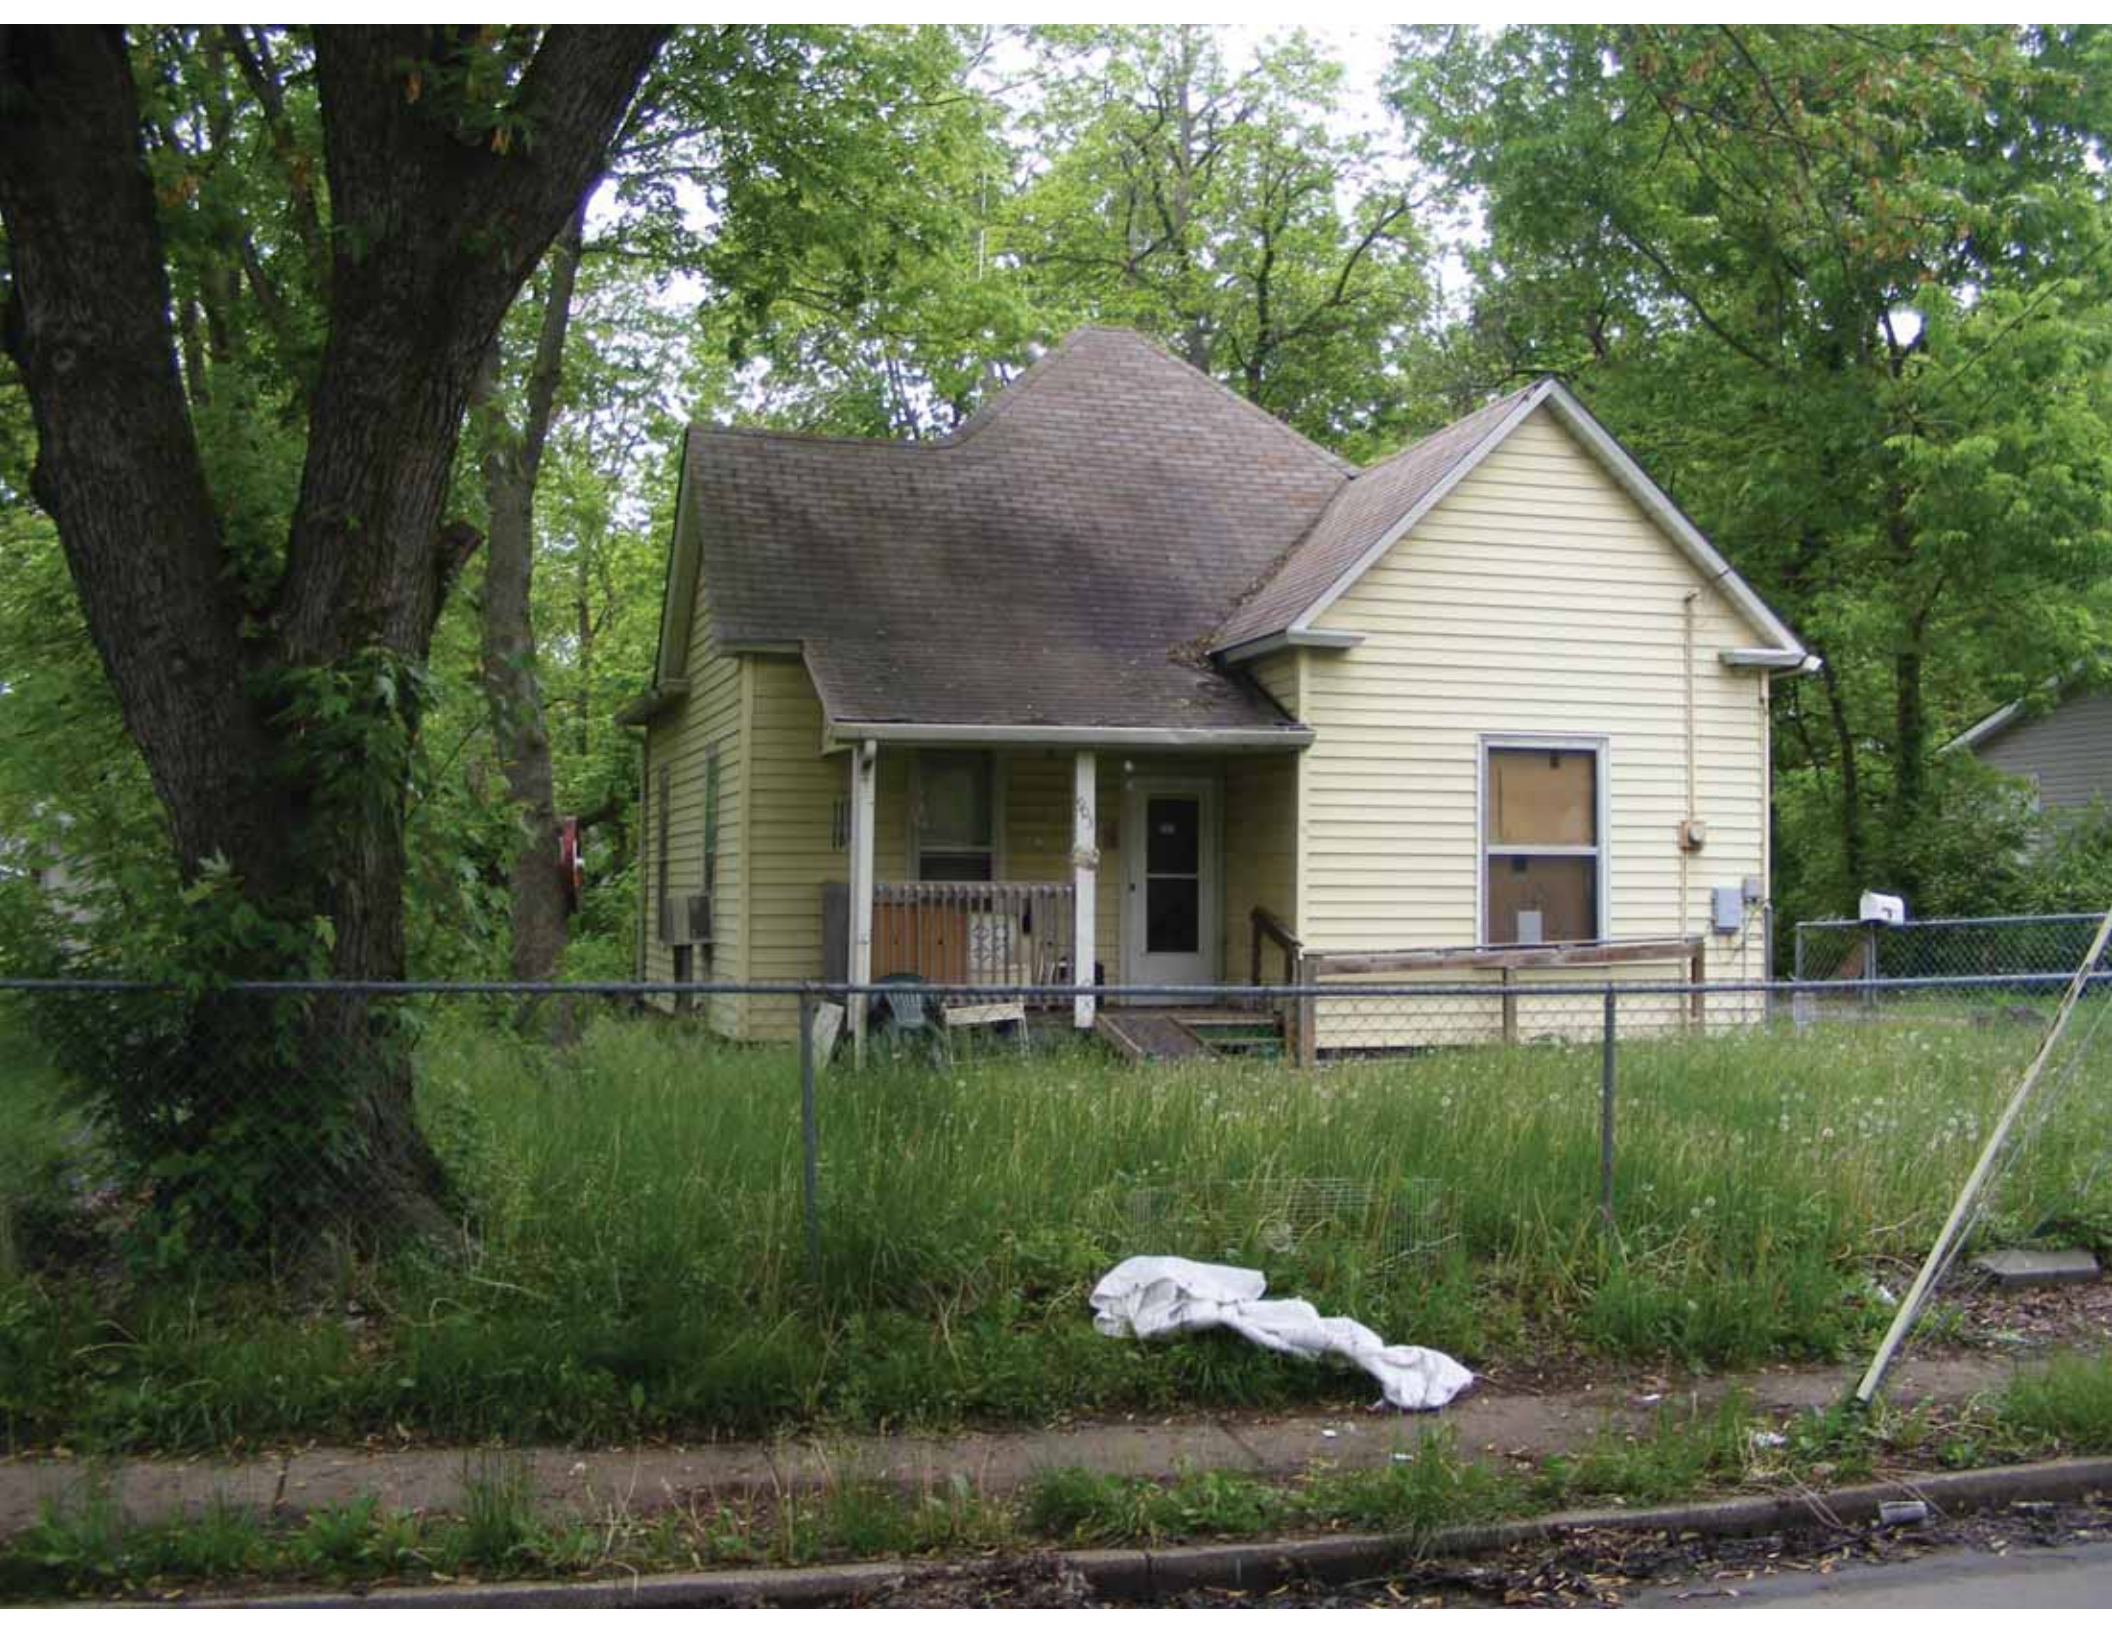
The property is a single-story frame dwelling with a gabled hip roof clad with asphalt shingles, exterior vinyl siding and a covered foundation. The primary facing gable is situated at the north end of the façade and has gable returns. Centered on this portion of the façade is a one-over-one window. The remaining façade is set back, created a shed porch supported by two square columns resting on a frame porch. The entry bay is offset on the right (north). To the south of the door is a one-over-one window. Side elevations hold single and paired one-over-one windows. There is an interior metal flue near the north end of the roofline. Eaves are enclosed.
