MISSOURI DEPARTMENT OF NATURAL RESOURCES
STATE HISTORIC PRESERVATION OFFICE, P.O. Box 176, Jefferson City, MO 65102
ARCHITECTURAL/HISTORIC INVENTORY FORM

1. Survey No. BO-AS-011-0087		2. Survey name: North Central Columbia Survey Phase II	
3. County: Boone		4. Address (Street No.) 902	Street (name) N. Seventh Street
5. City: Columbia	Vicinity: <input type="checkbox"/>	6. Geographical Reference:	7. Township/Range/Section: T: R: S:
8. Historic name (if known):		9. Present/other name (if known):	
10. Ownership: <input checked="" type="checkbox"/> Private <input type="checkbox"/> Public		11a. Historic use (if known): Domestic/single dwelling	11b. Current use: Domestic/single dwelling

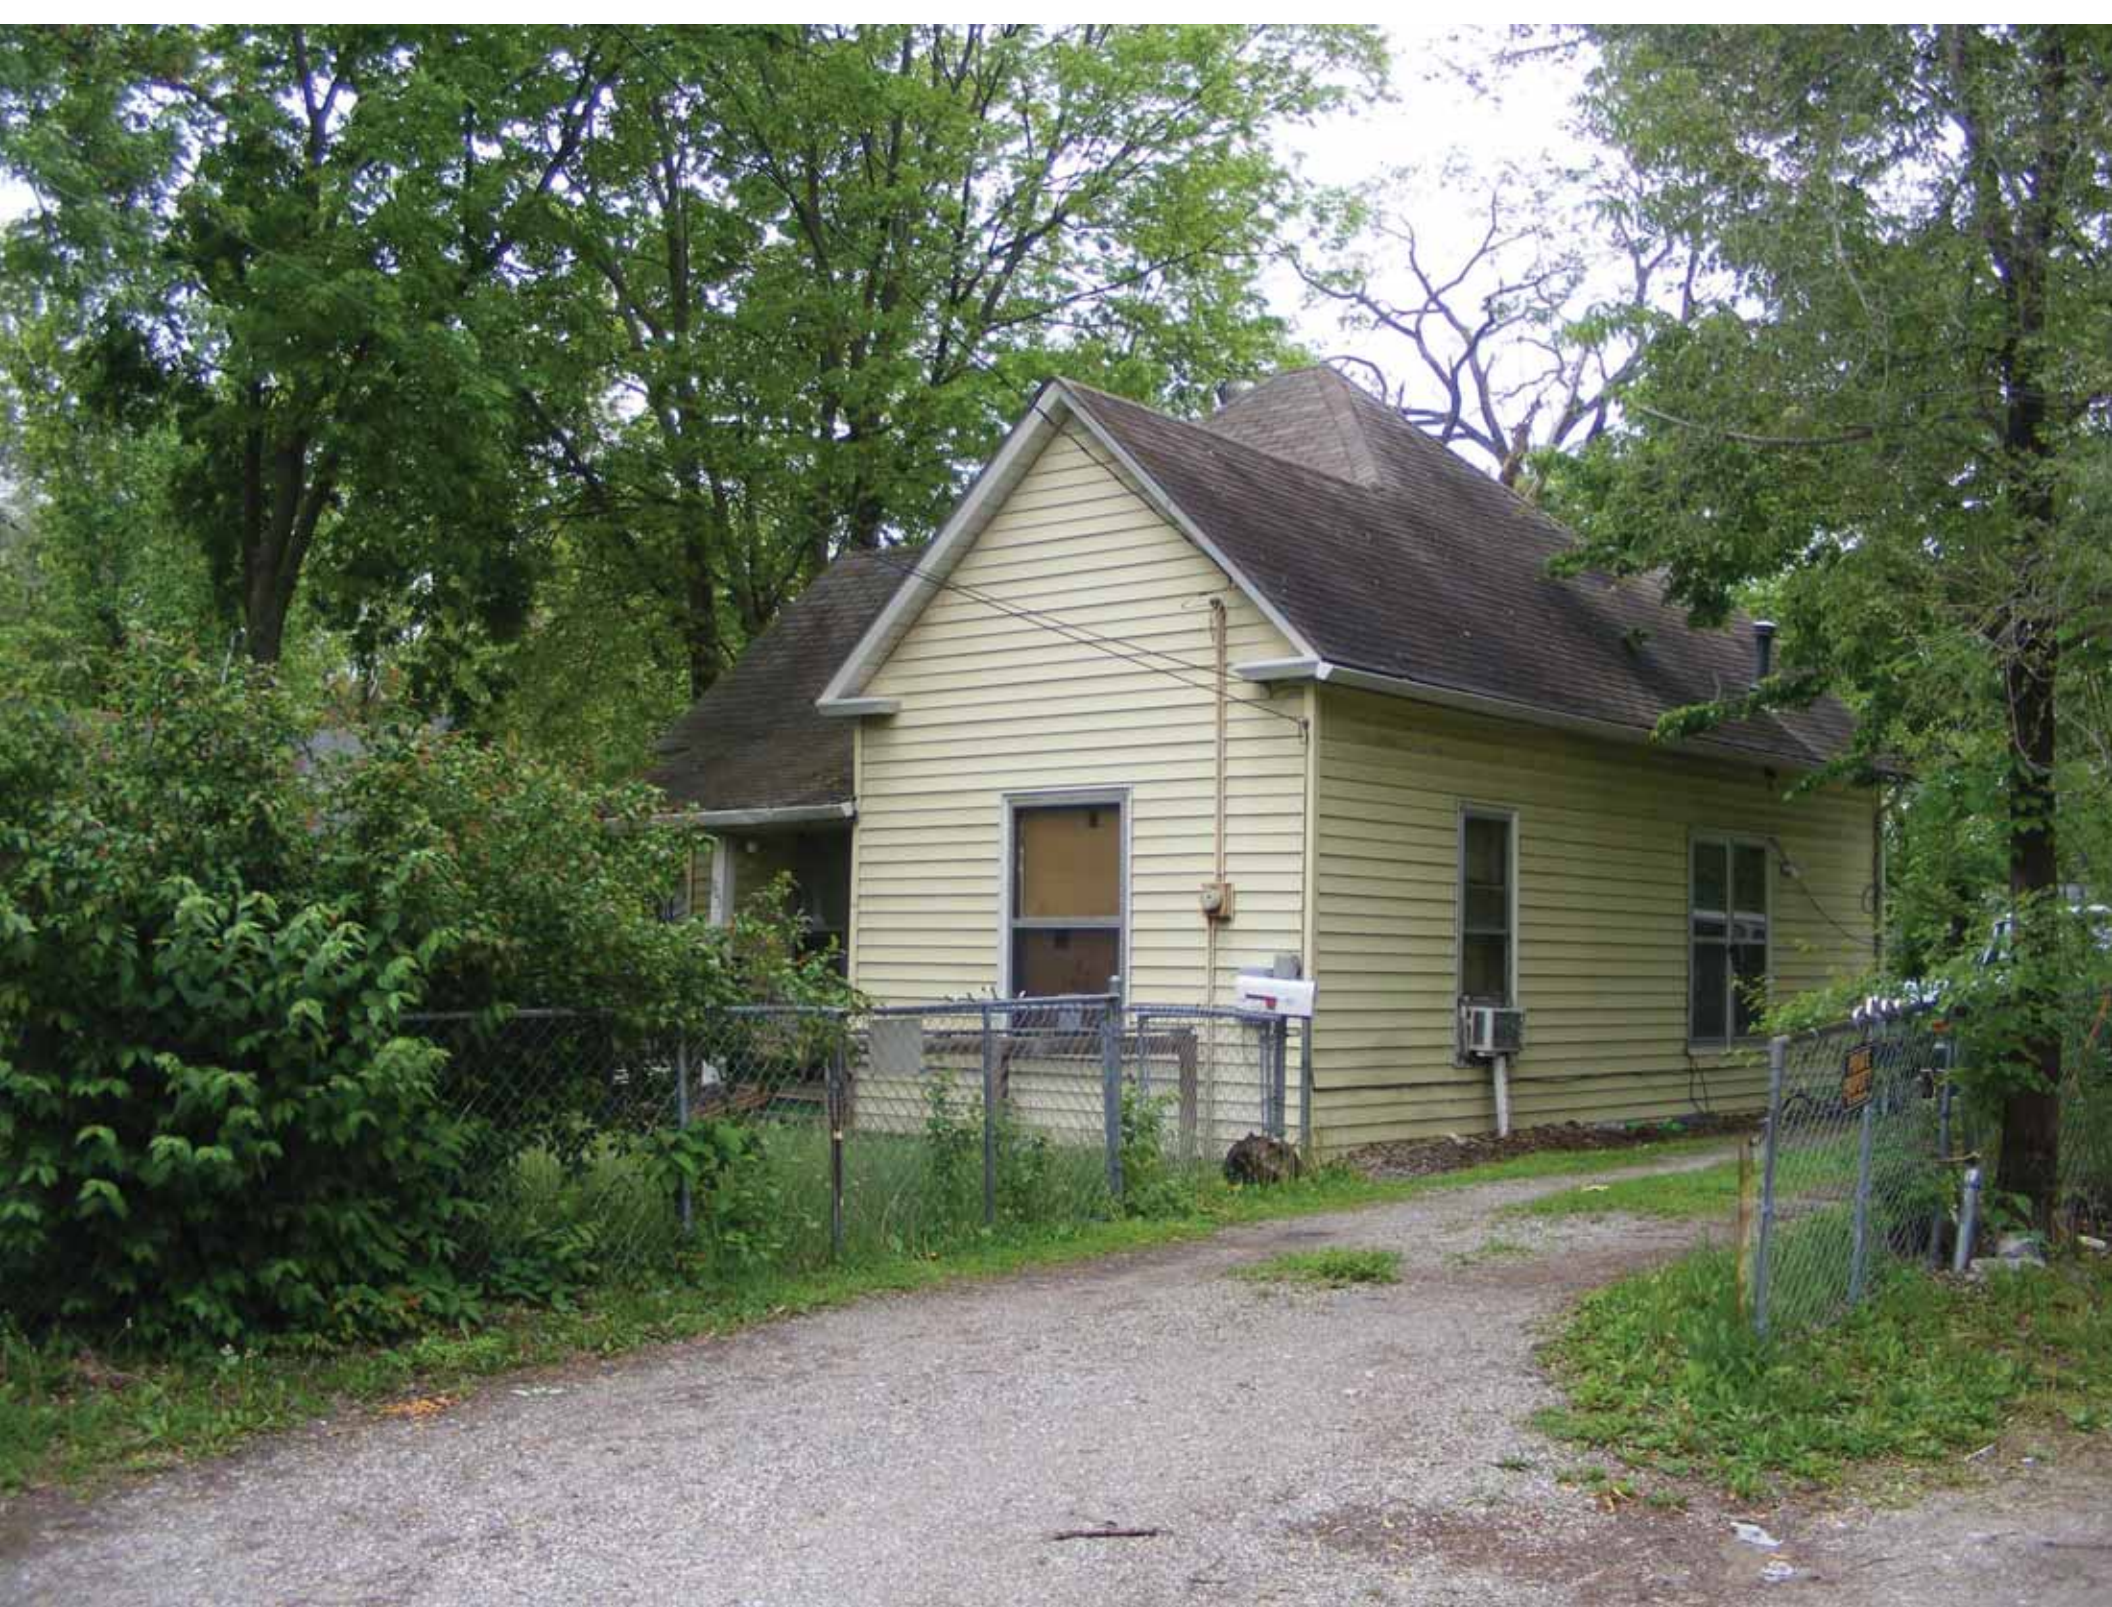
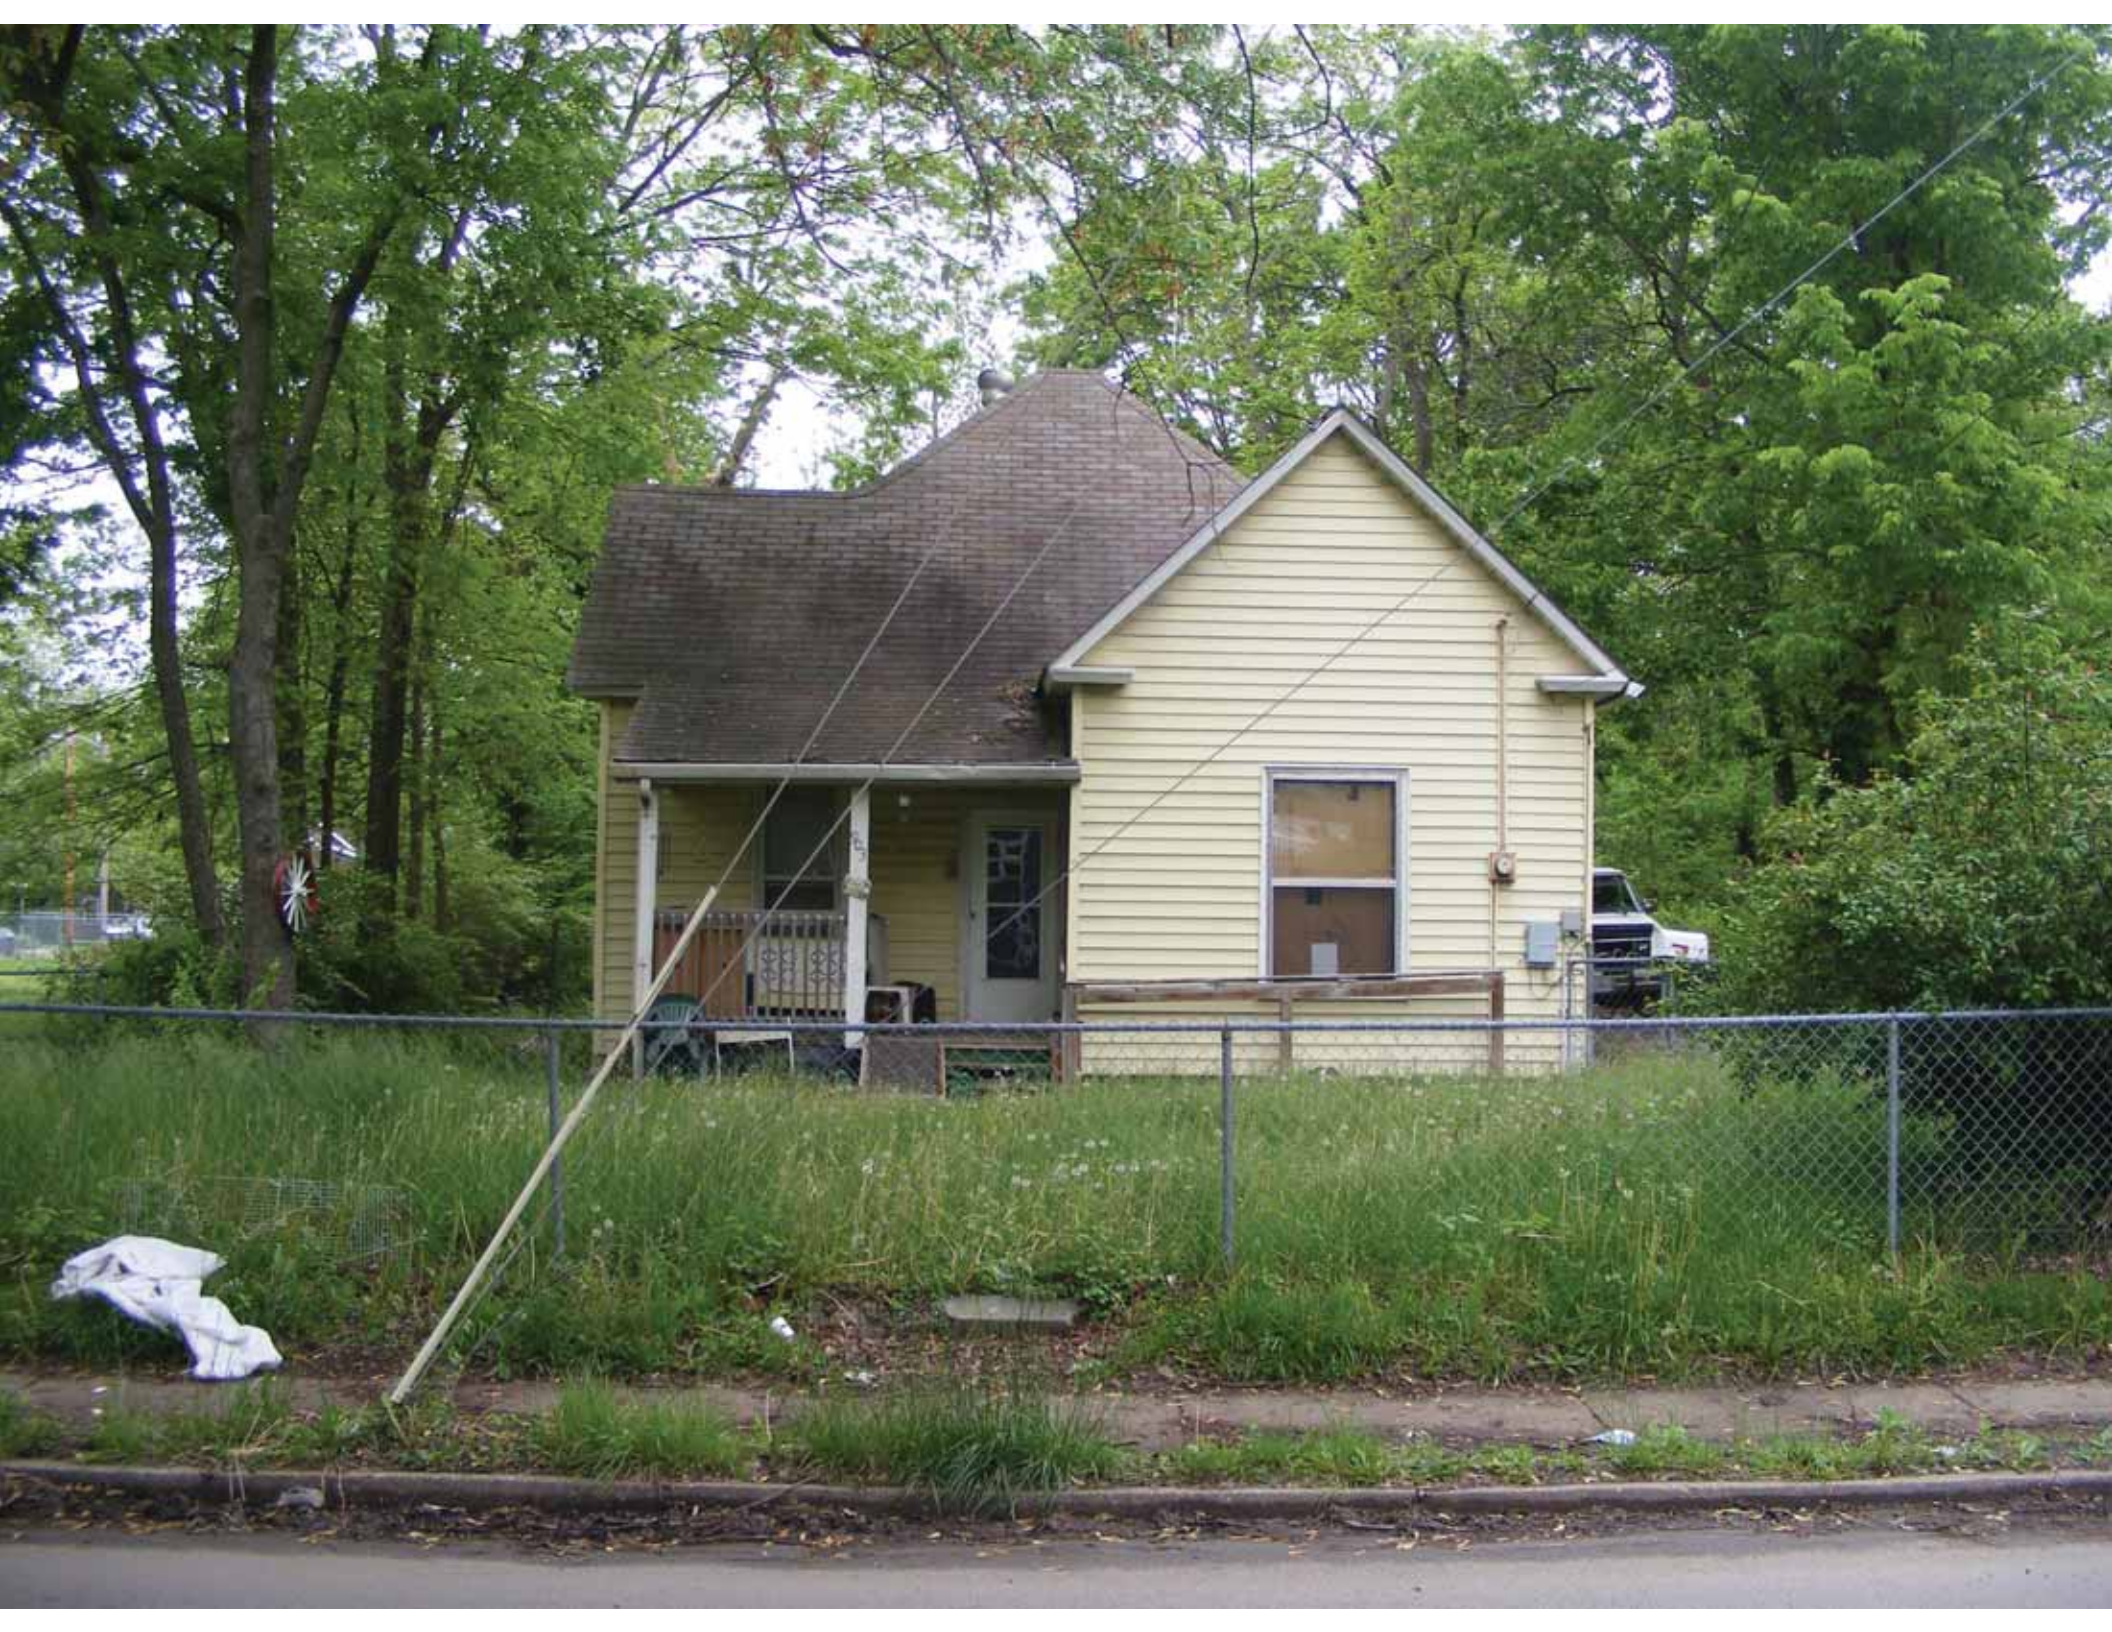
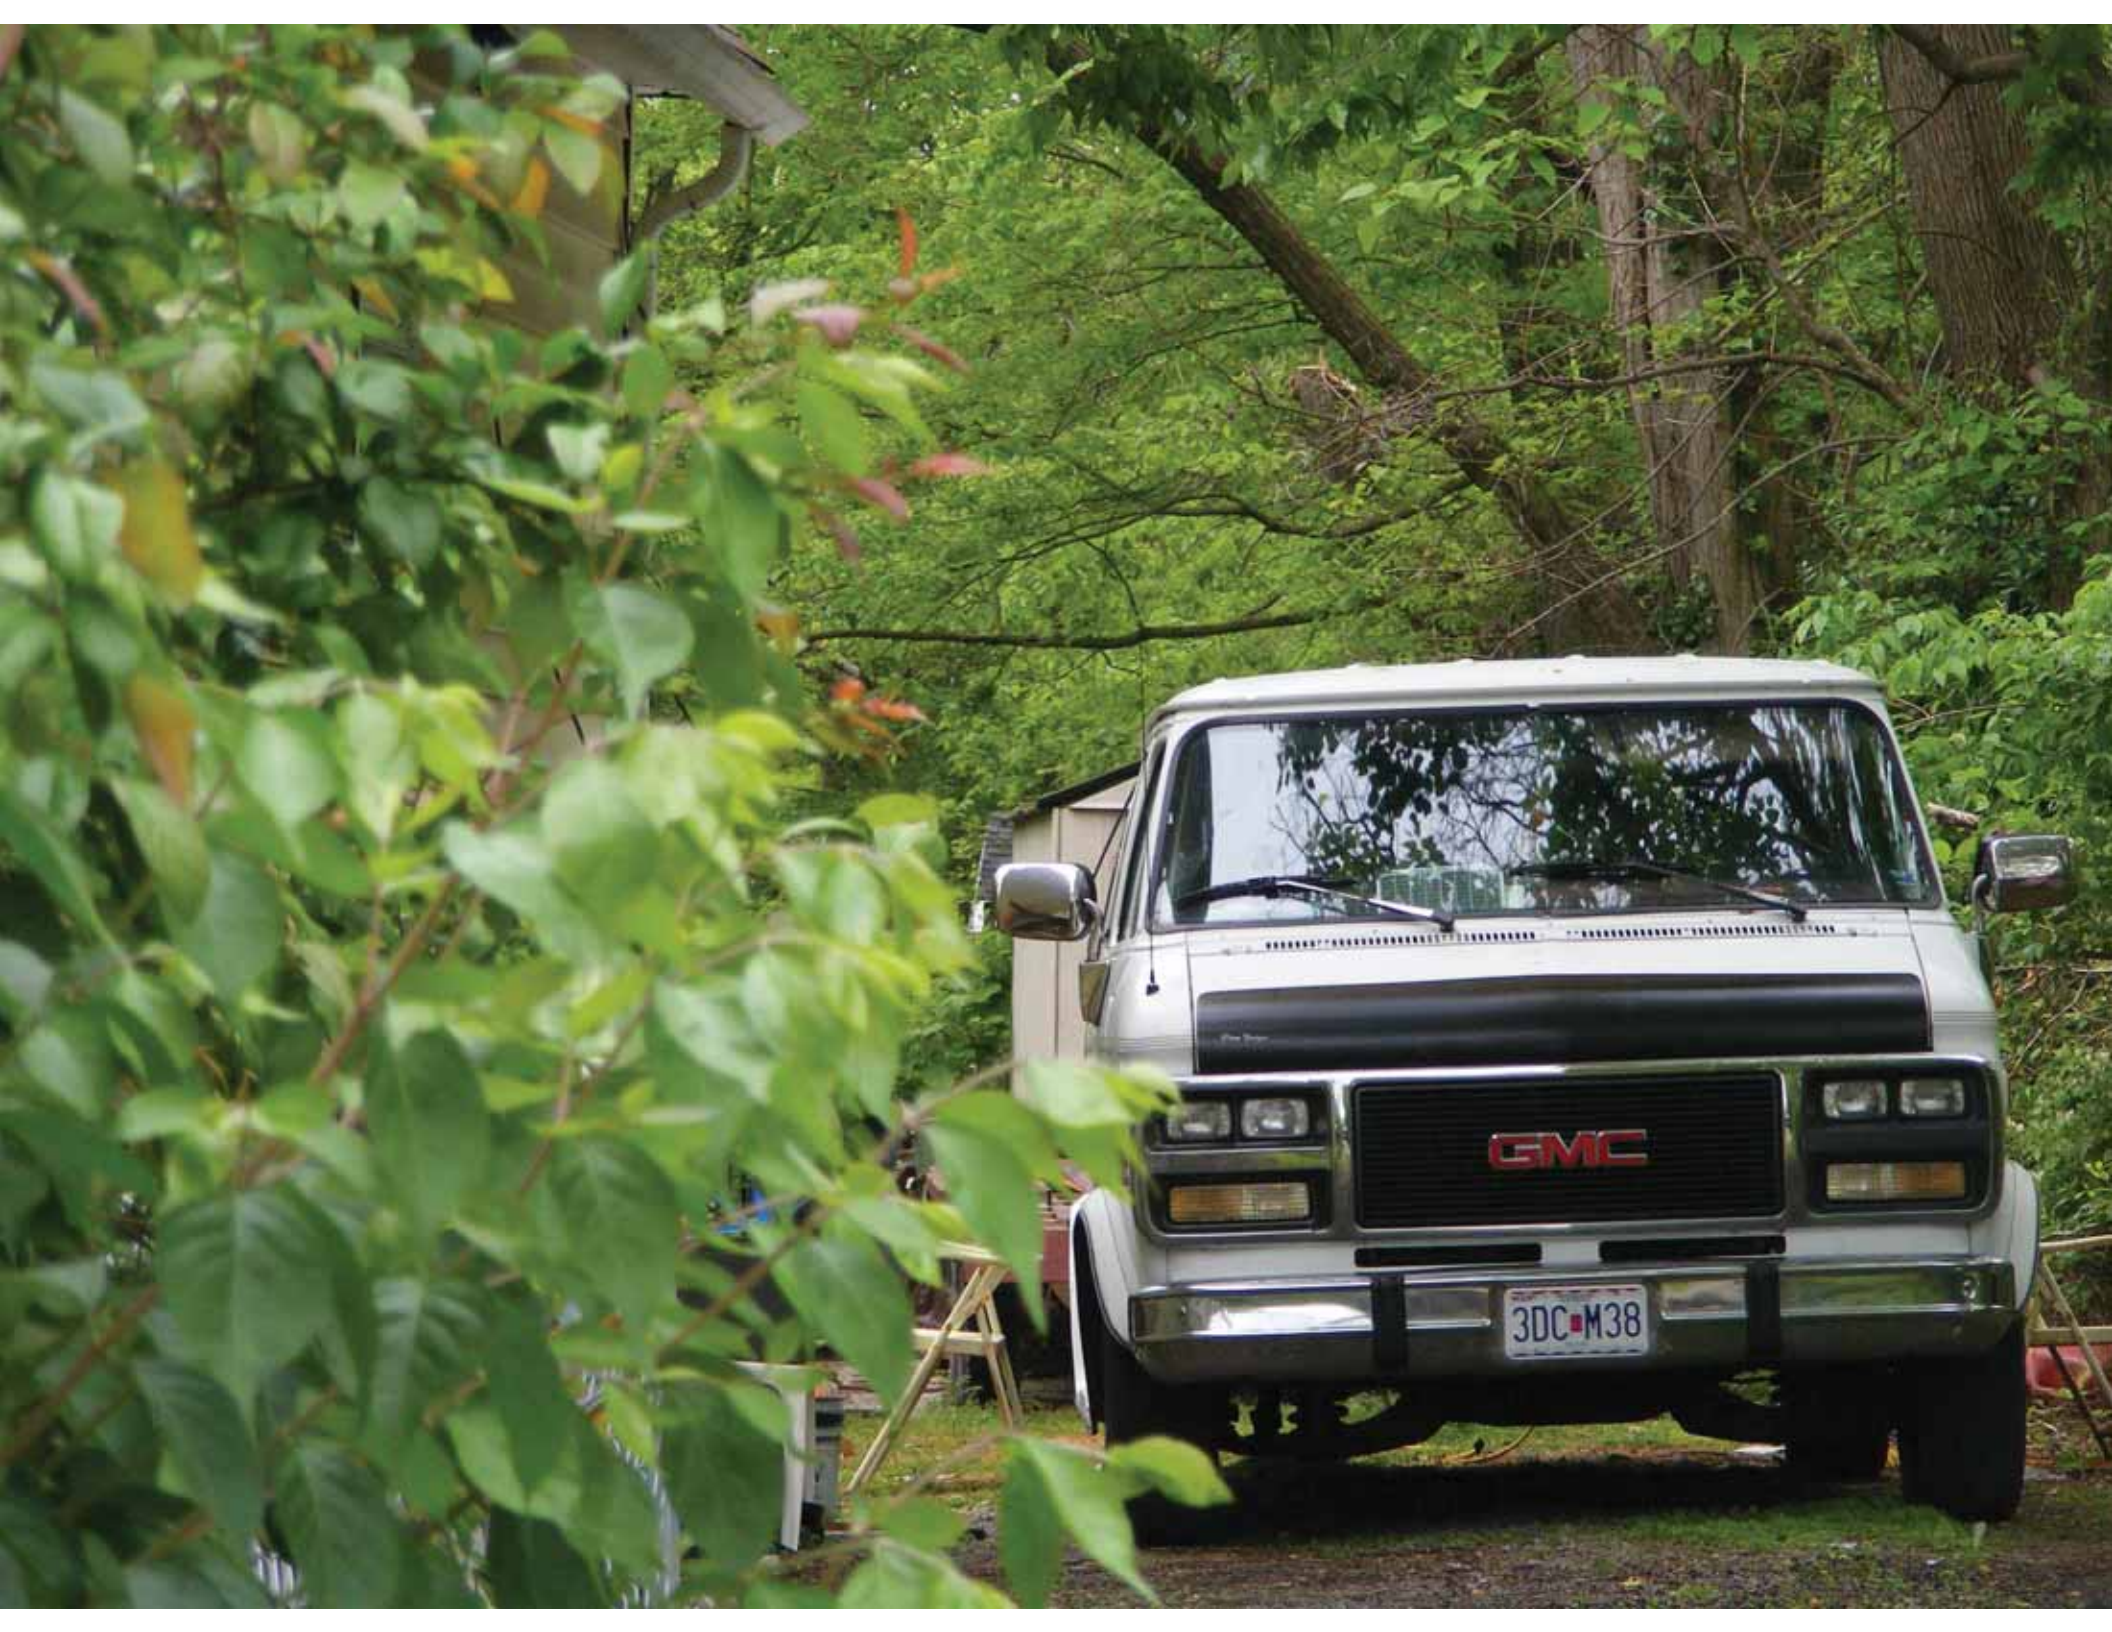
The property is a single-story frame dwelling with a gabled hip roof clad with asphalt shingles, exterior vinyl siding and a covered foundation. The primary facing gable is situated at the north end of the façade and has gable returns. Centered on this portion of the façade is a one-over-one window. The remaining façade is set back, created a shed porch supported by two square columns resting on a frame porch. The entry bay is offset on the right (north). To the south of the door is a one-over-one window. Side elevations hold single and paired one-over-one windows. There is an interior metal flue near the north end of the roofline. Eaves are enclosed.

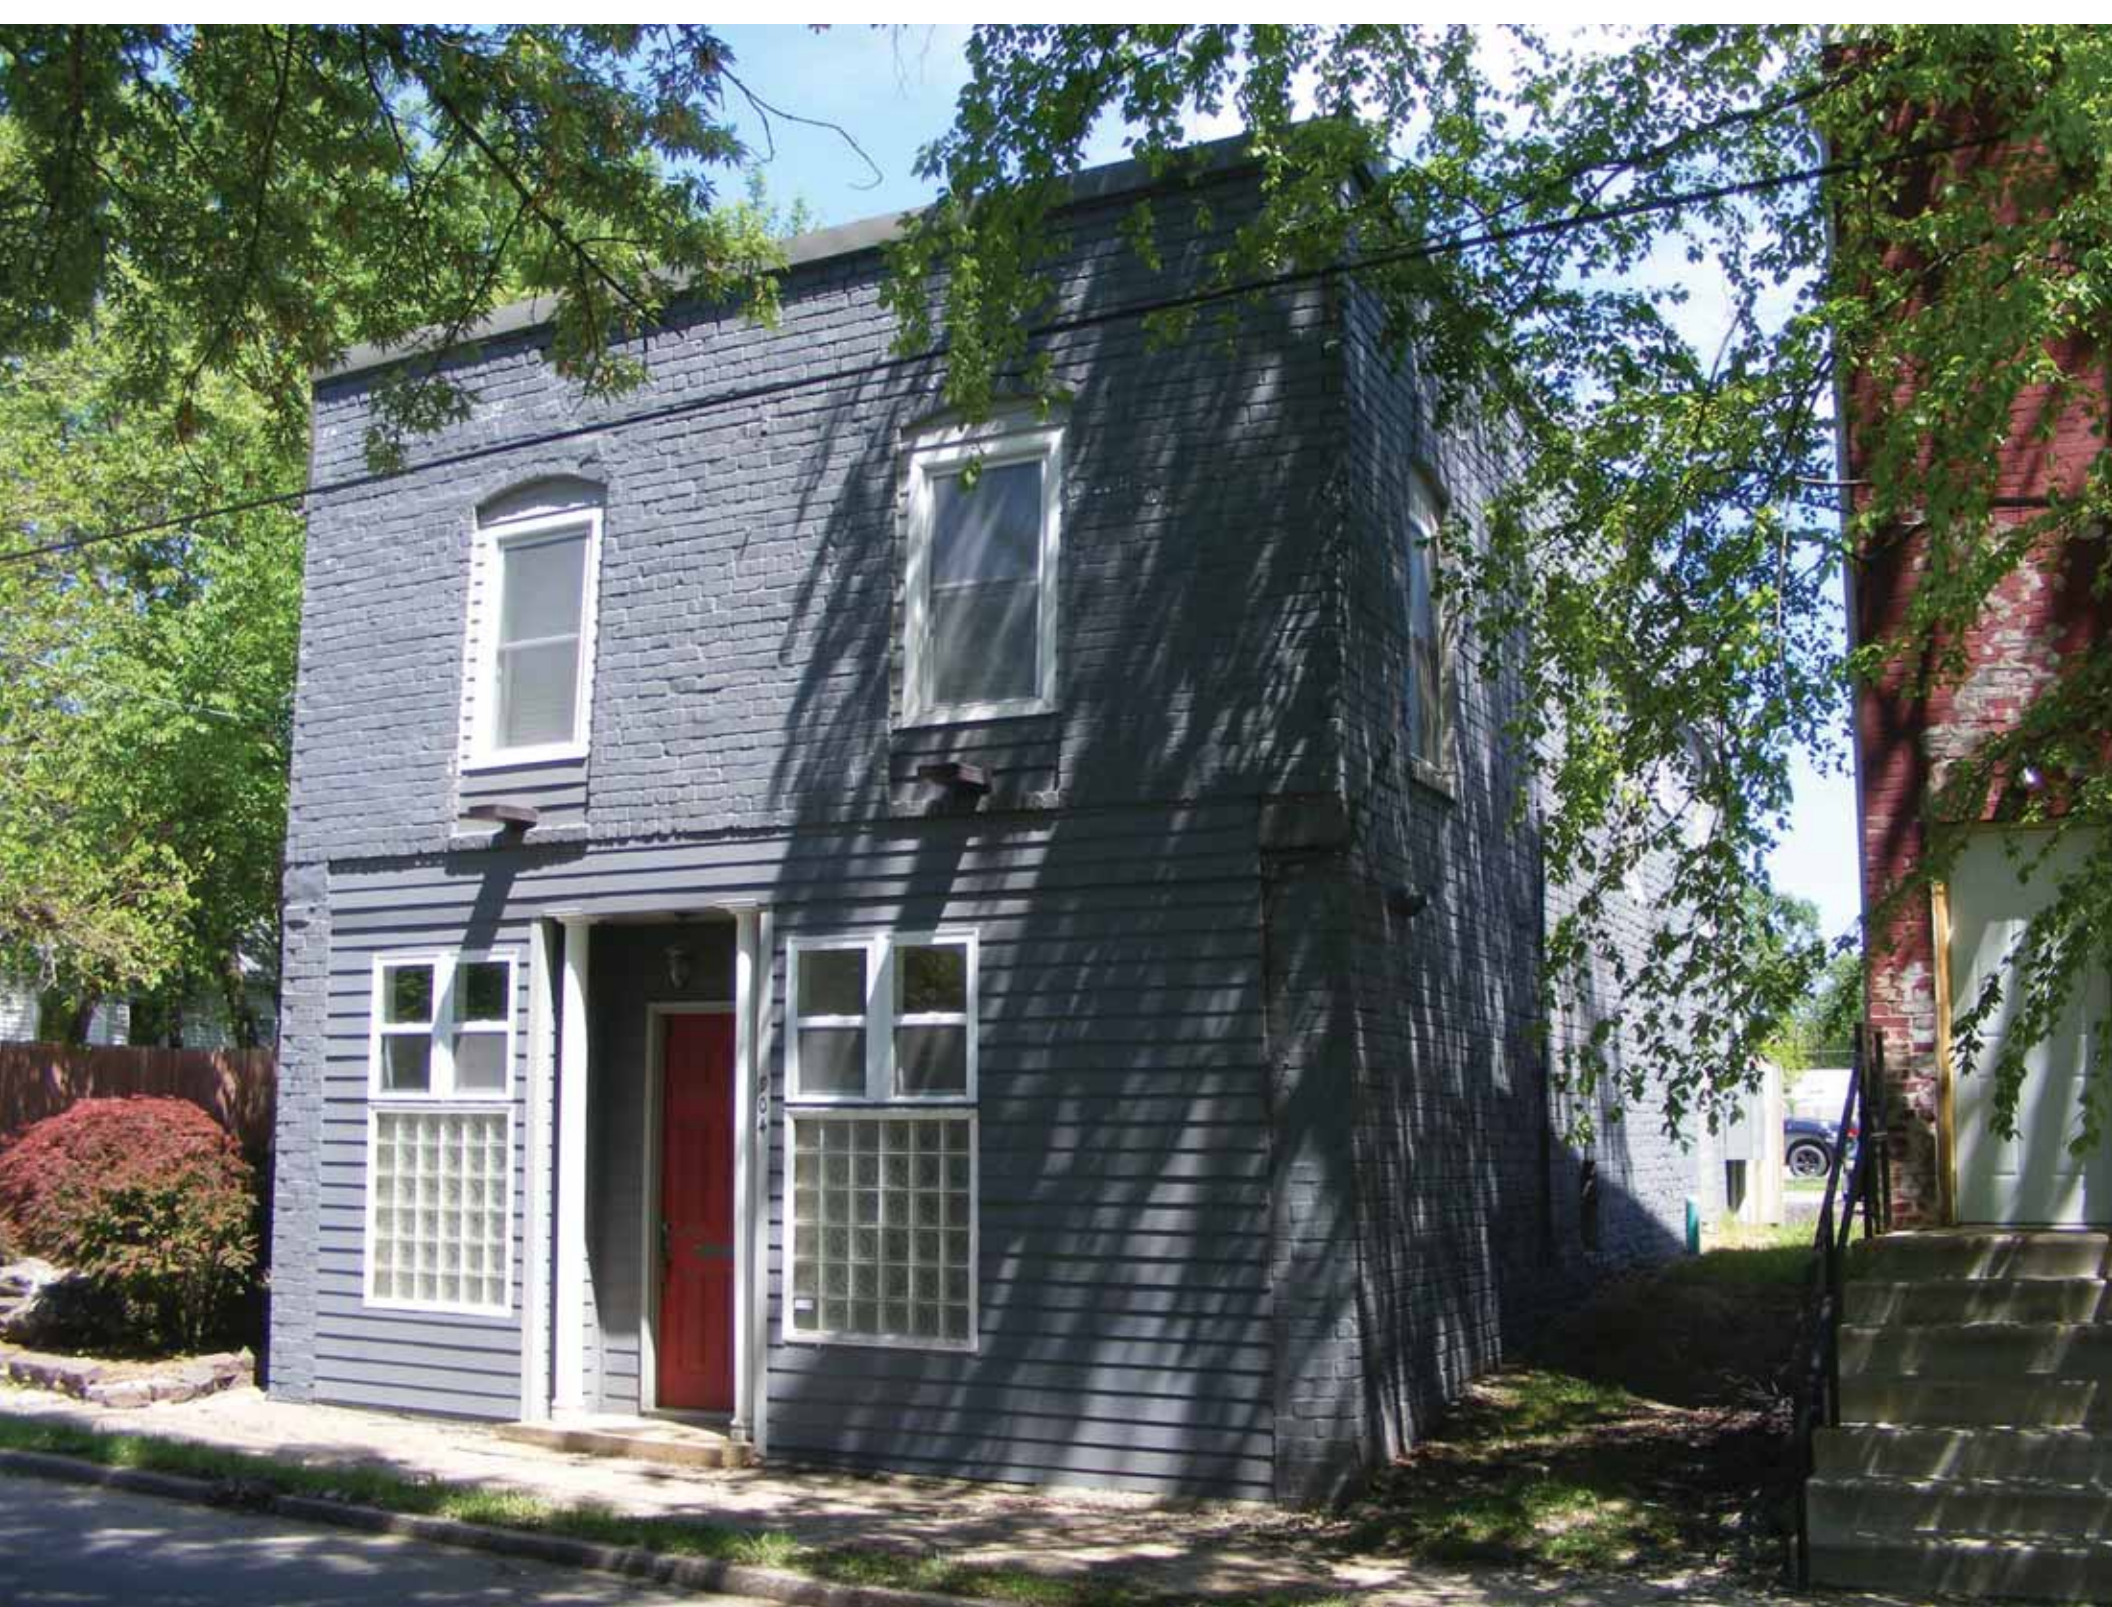
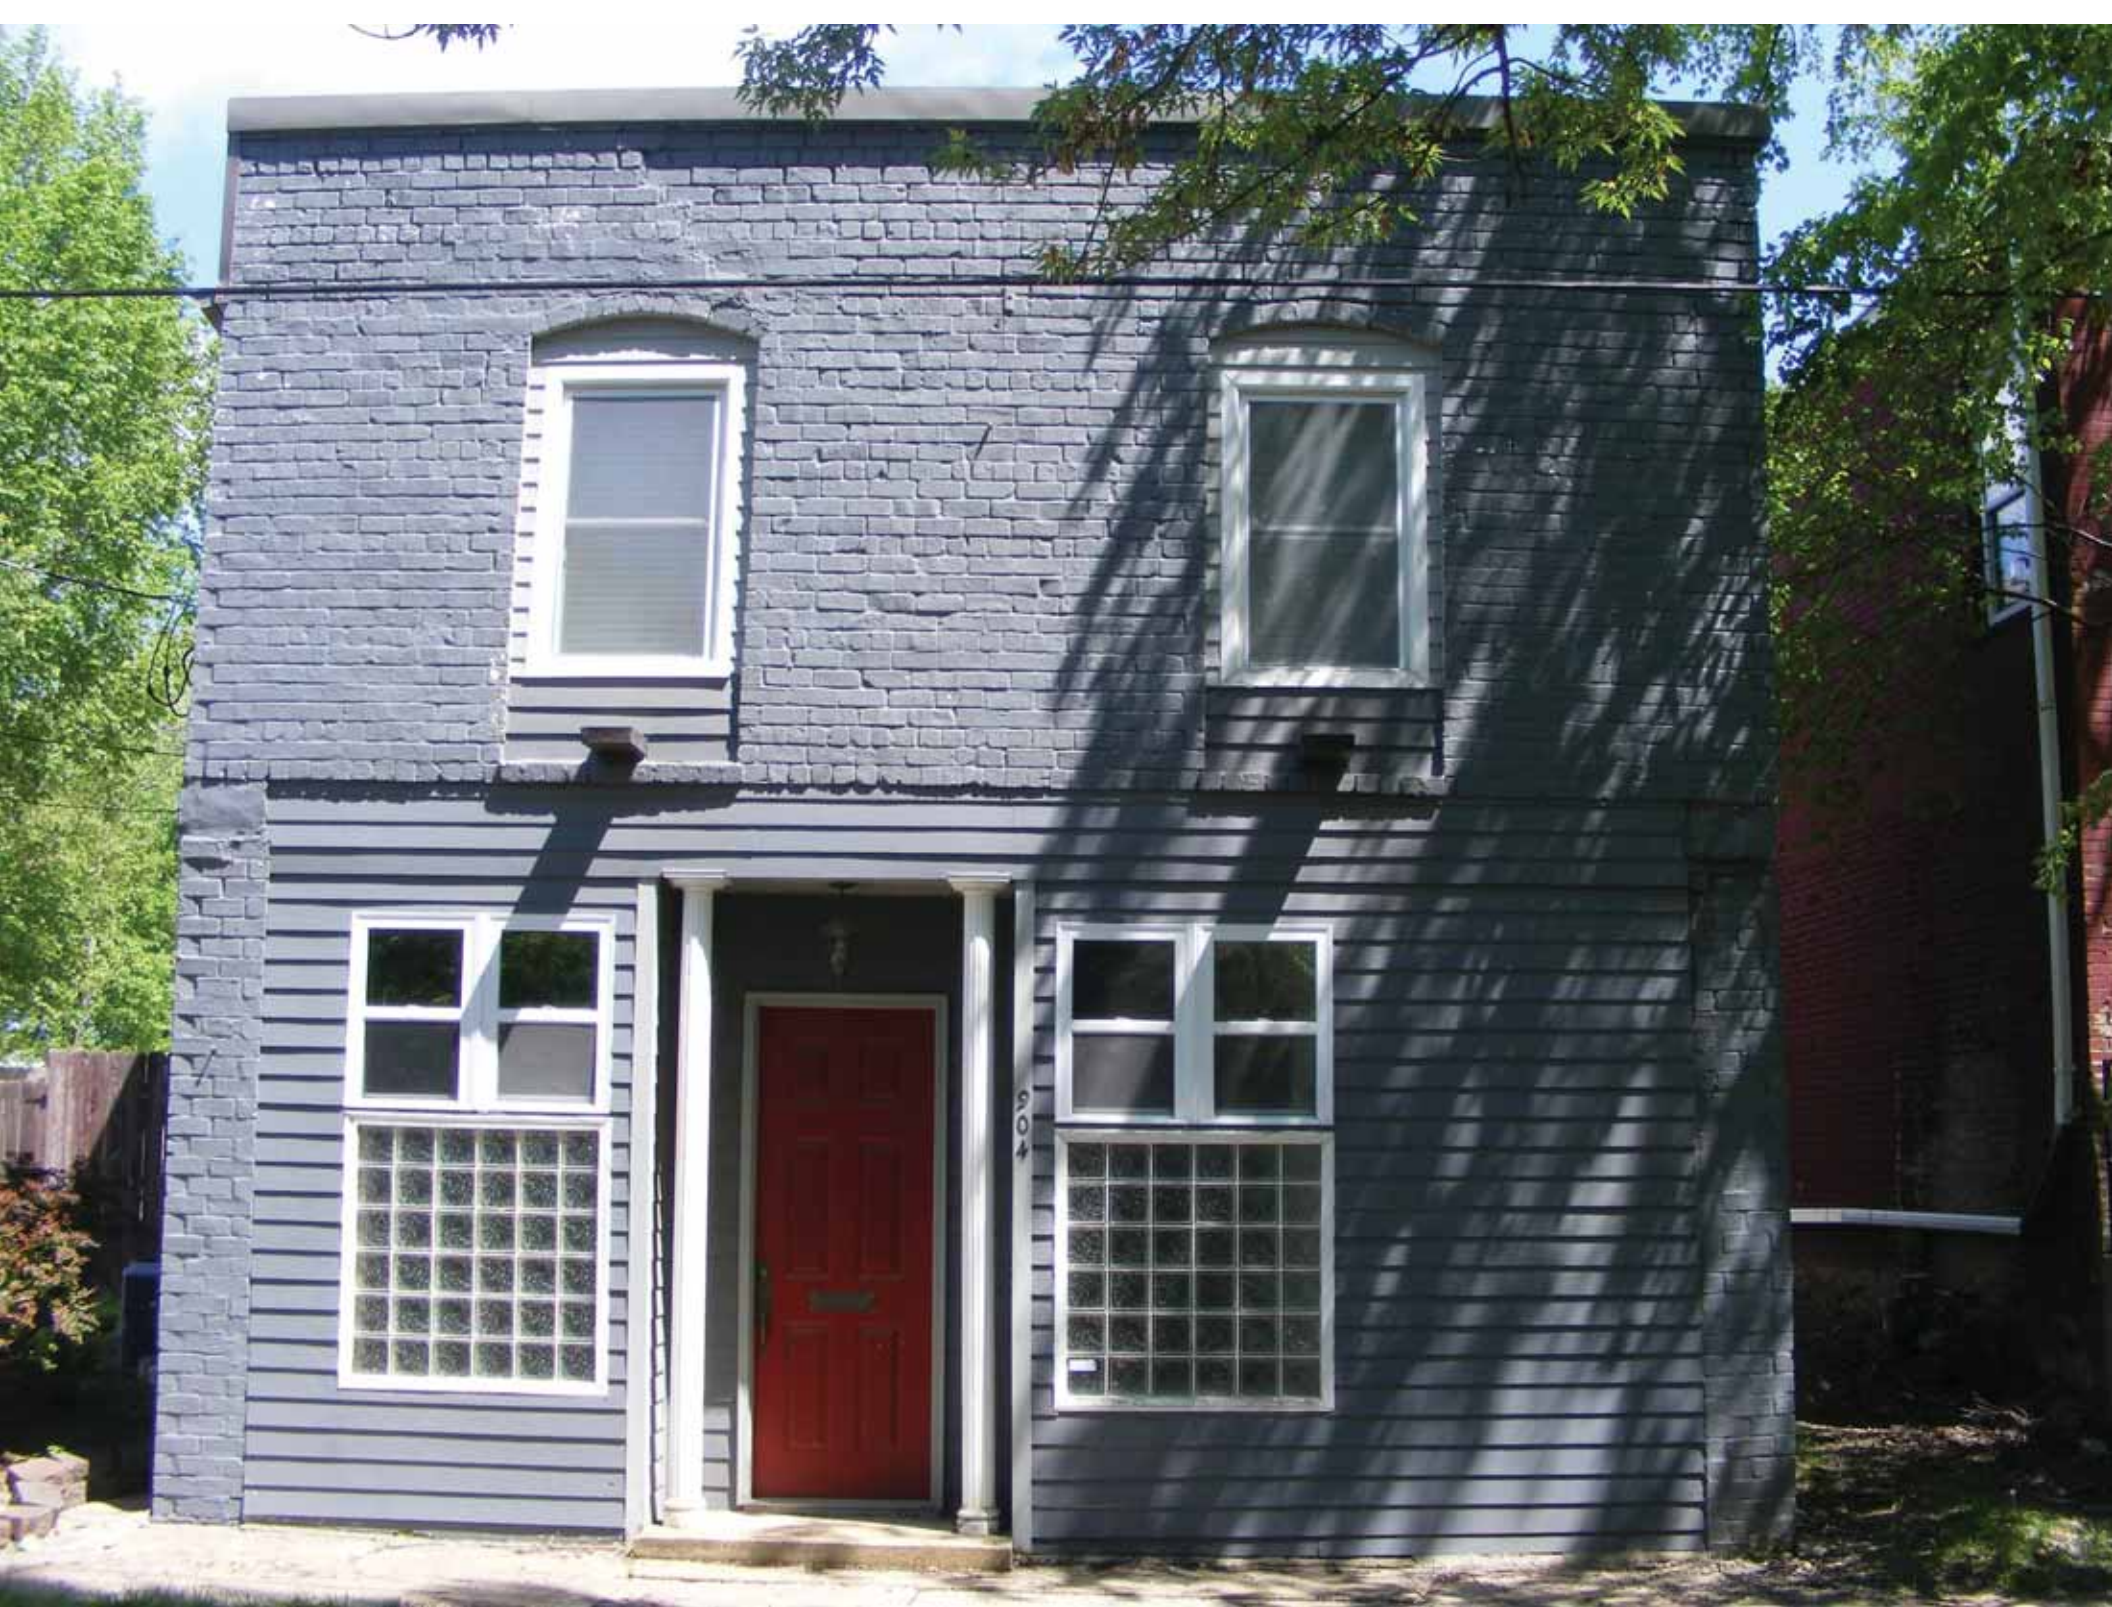
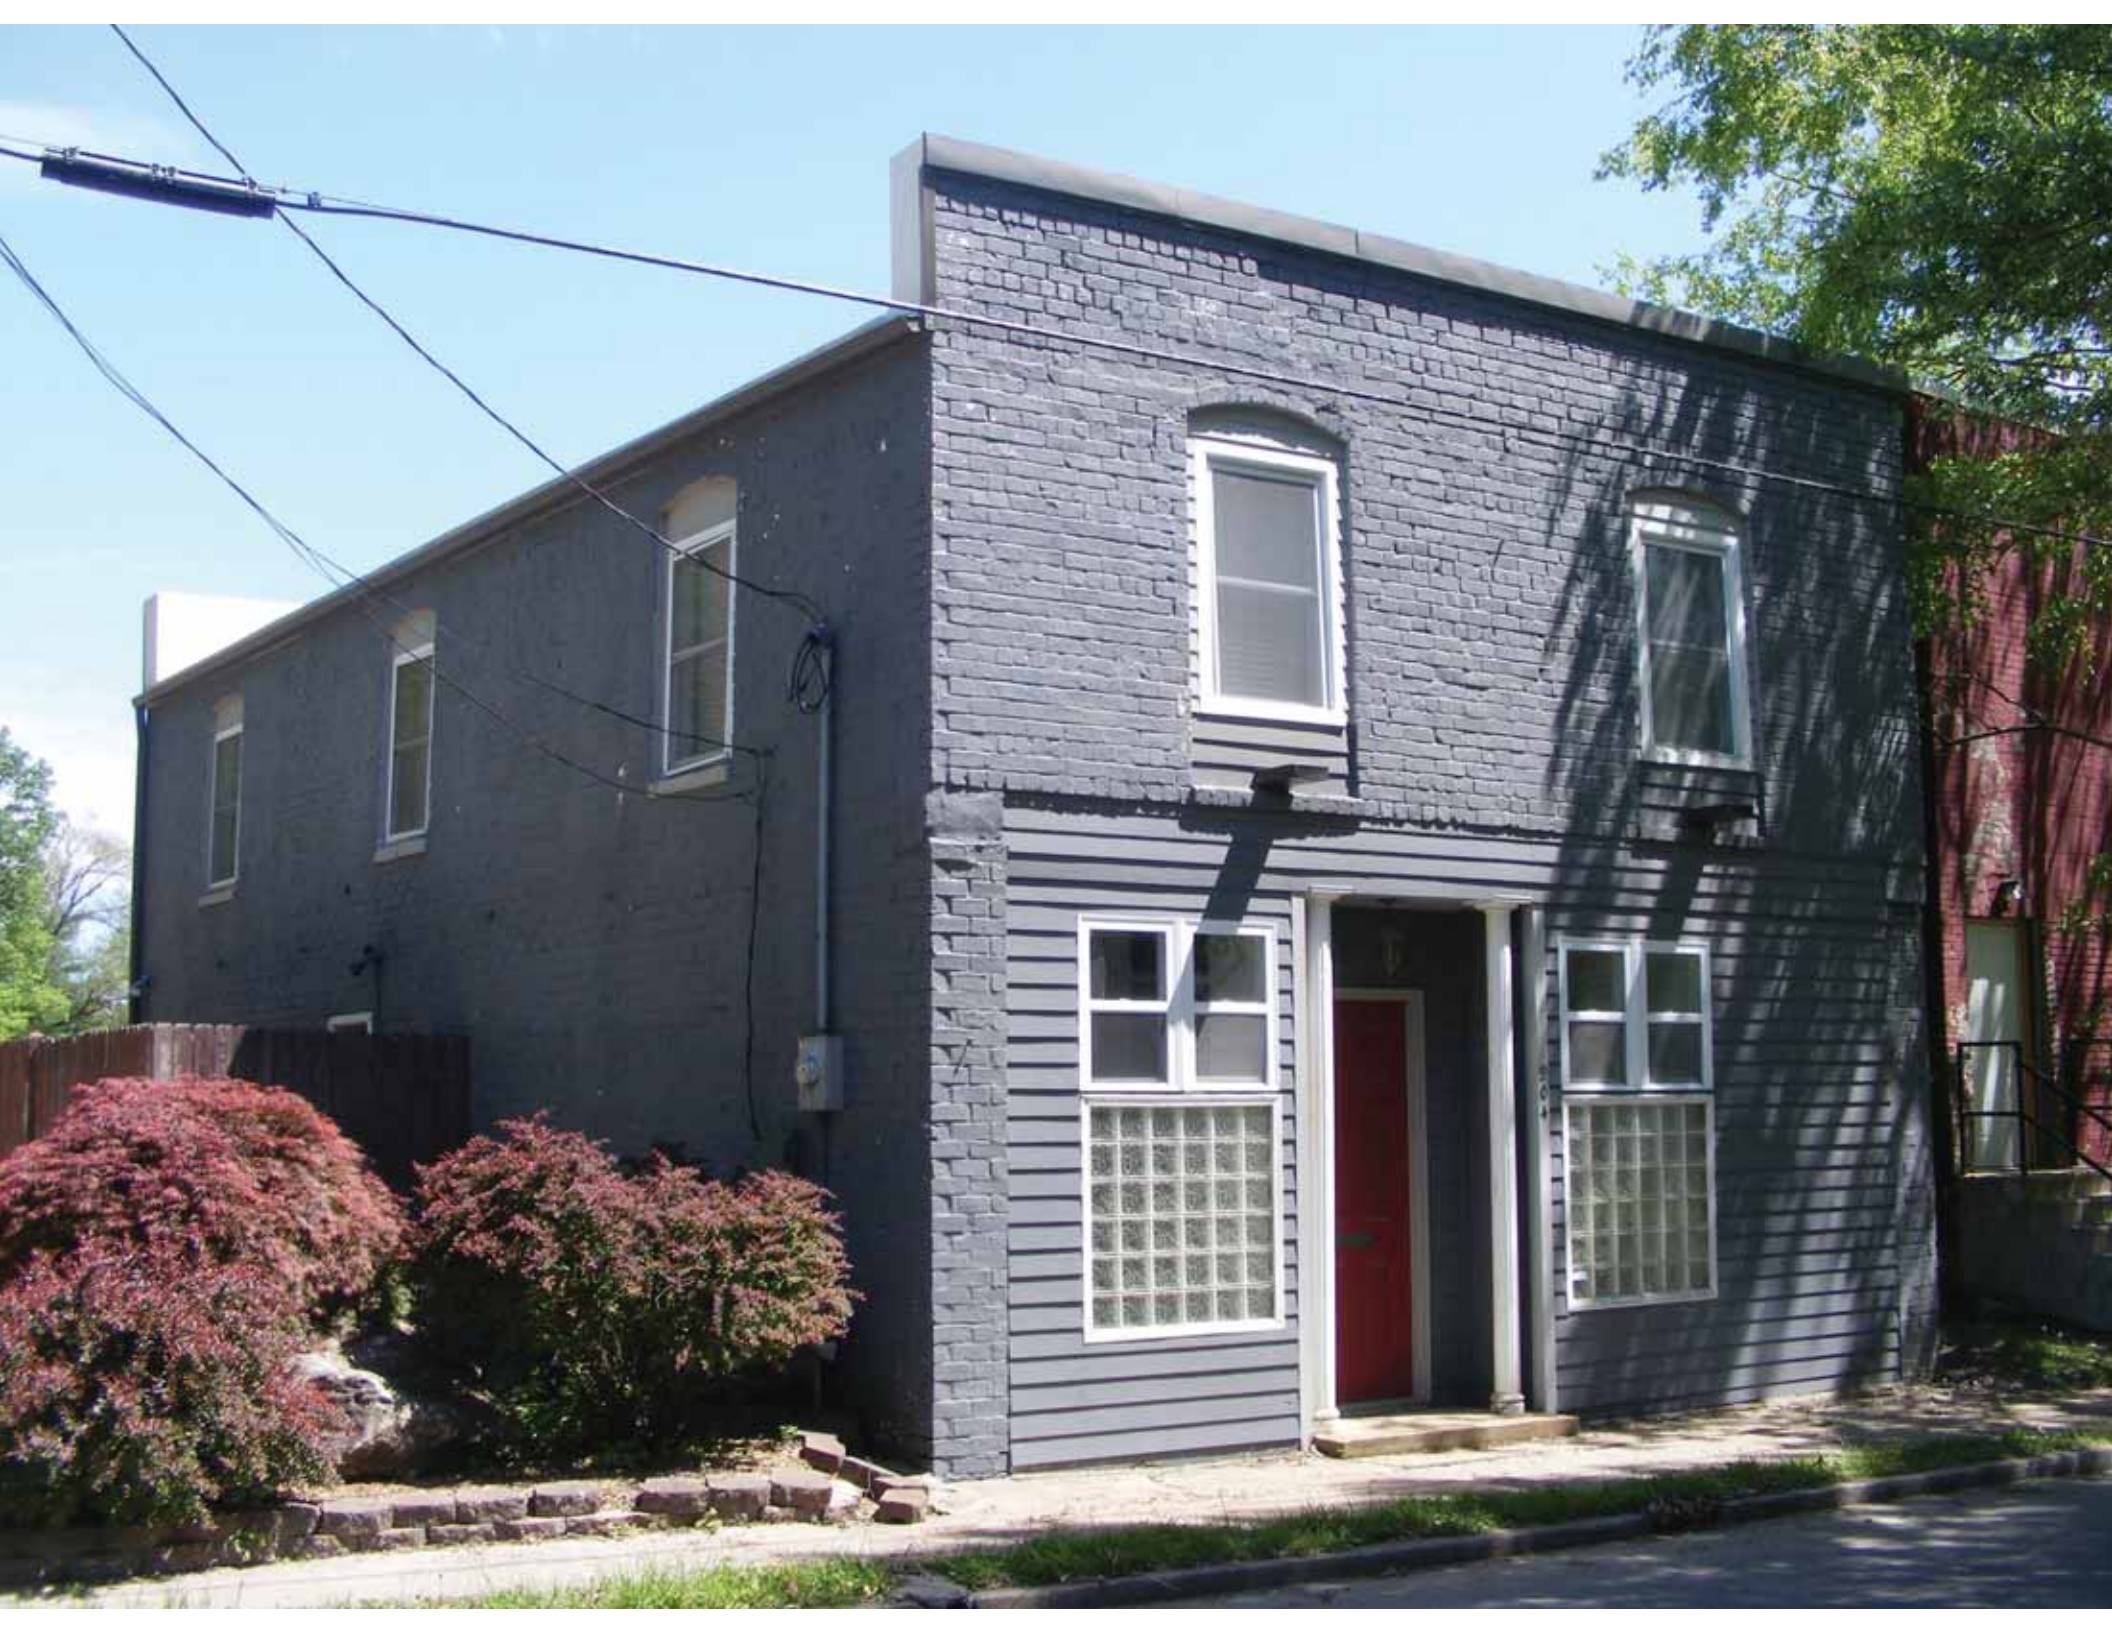
The property is a two-story brick building originally used for commercial purposes. The façade (west elevation) has a false front capped with concrete coping. The rear (east elevation) also rises above the roofline. Corners of the façade have a woven brick appearance, which is original. The lower façade holds a central recessed entry bay with a paneled replacement door (c. 2010). The bay is flanked by non-original c. 2010 fluted columns. Flanking the central recess are altered windows composed of lower glass block lights (possibly original) capped by paired c. 2010 one-over-one small windows. The lower façade is clad with synthetic siding (vinyl). The upper façade has original arched window bays with brick sills. These two bays are placed symmetrically and each holds a replacement c. 2010 one-over-one window with vinyl infill. The upper side elevations (north and south walls) have similar window configurations – original bays infilled with replacement windows. The aforementioned privacy fence (see #40, above) obscures a secondary entry on the lower elevation of the north wall. There is no fenestration on the lower level of the south elevation.
