MISSOURI DEPARTMENT OF NATURAL RESOURCES
STATE HISTORIC PRESERVATION OFFICE, P.O. Box 176, Jefferson City, MO 65102
ARCHITECTURAL/HISTORIC INVENTORY FORM

1. Survey No. BO-AS-011-0087		2. Survey name: North Central Columbia Survey Phase II	
3. County: Boone		4. Address (Street No.) 902	Street (name) N. Seventh Street
5. City: Columbia	Vicinity: <input type="checkbox"/>	6. Geographical Reference:	7. Township/Range/Section: T: R: S:
8. Historic name (if known):		9. Present/other name (if known):	
10. Ownership: <input checked="" type="checkbox"/> Private <input type="checkbox"/> Public		11a. Historic use (if known): Domestic/single dwelling	11b. Current use: Domestic/single dwelling

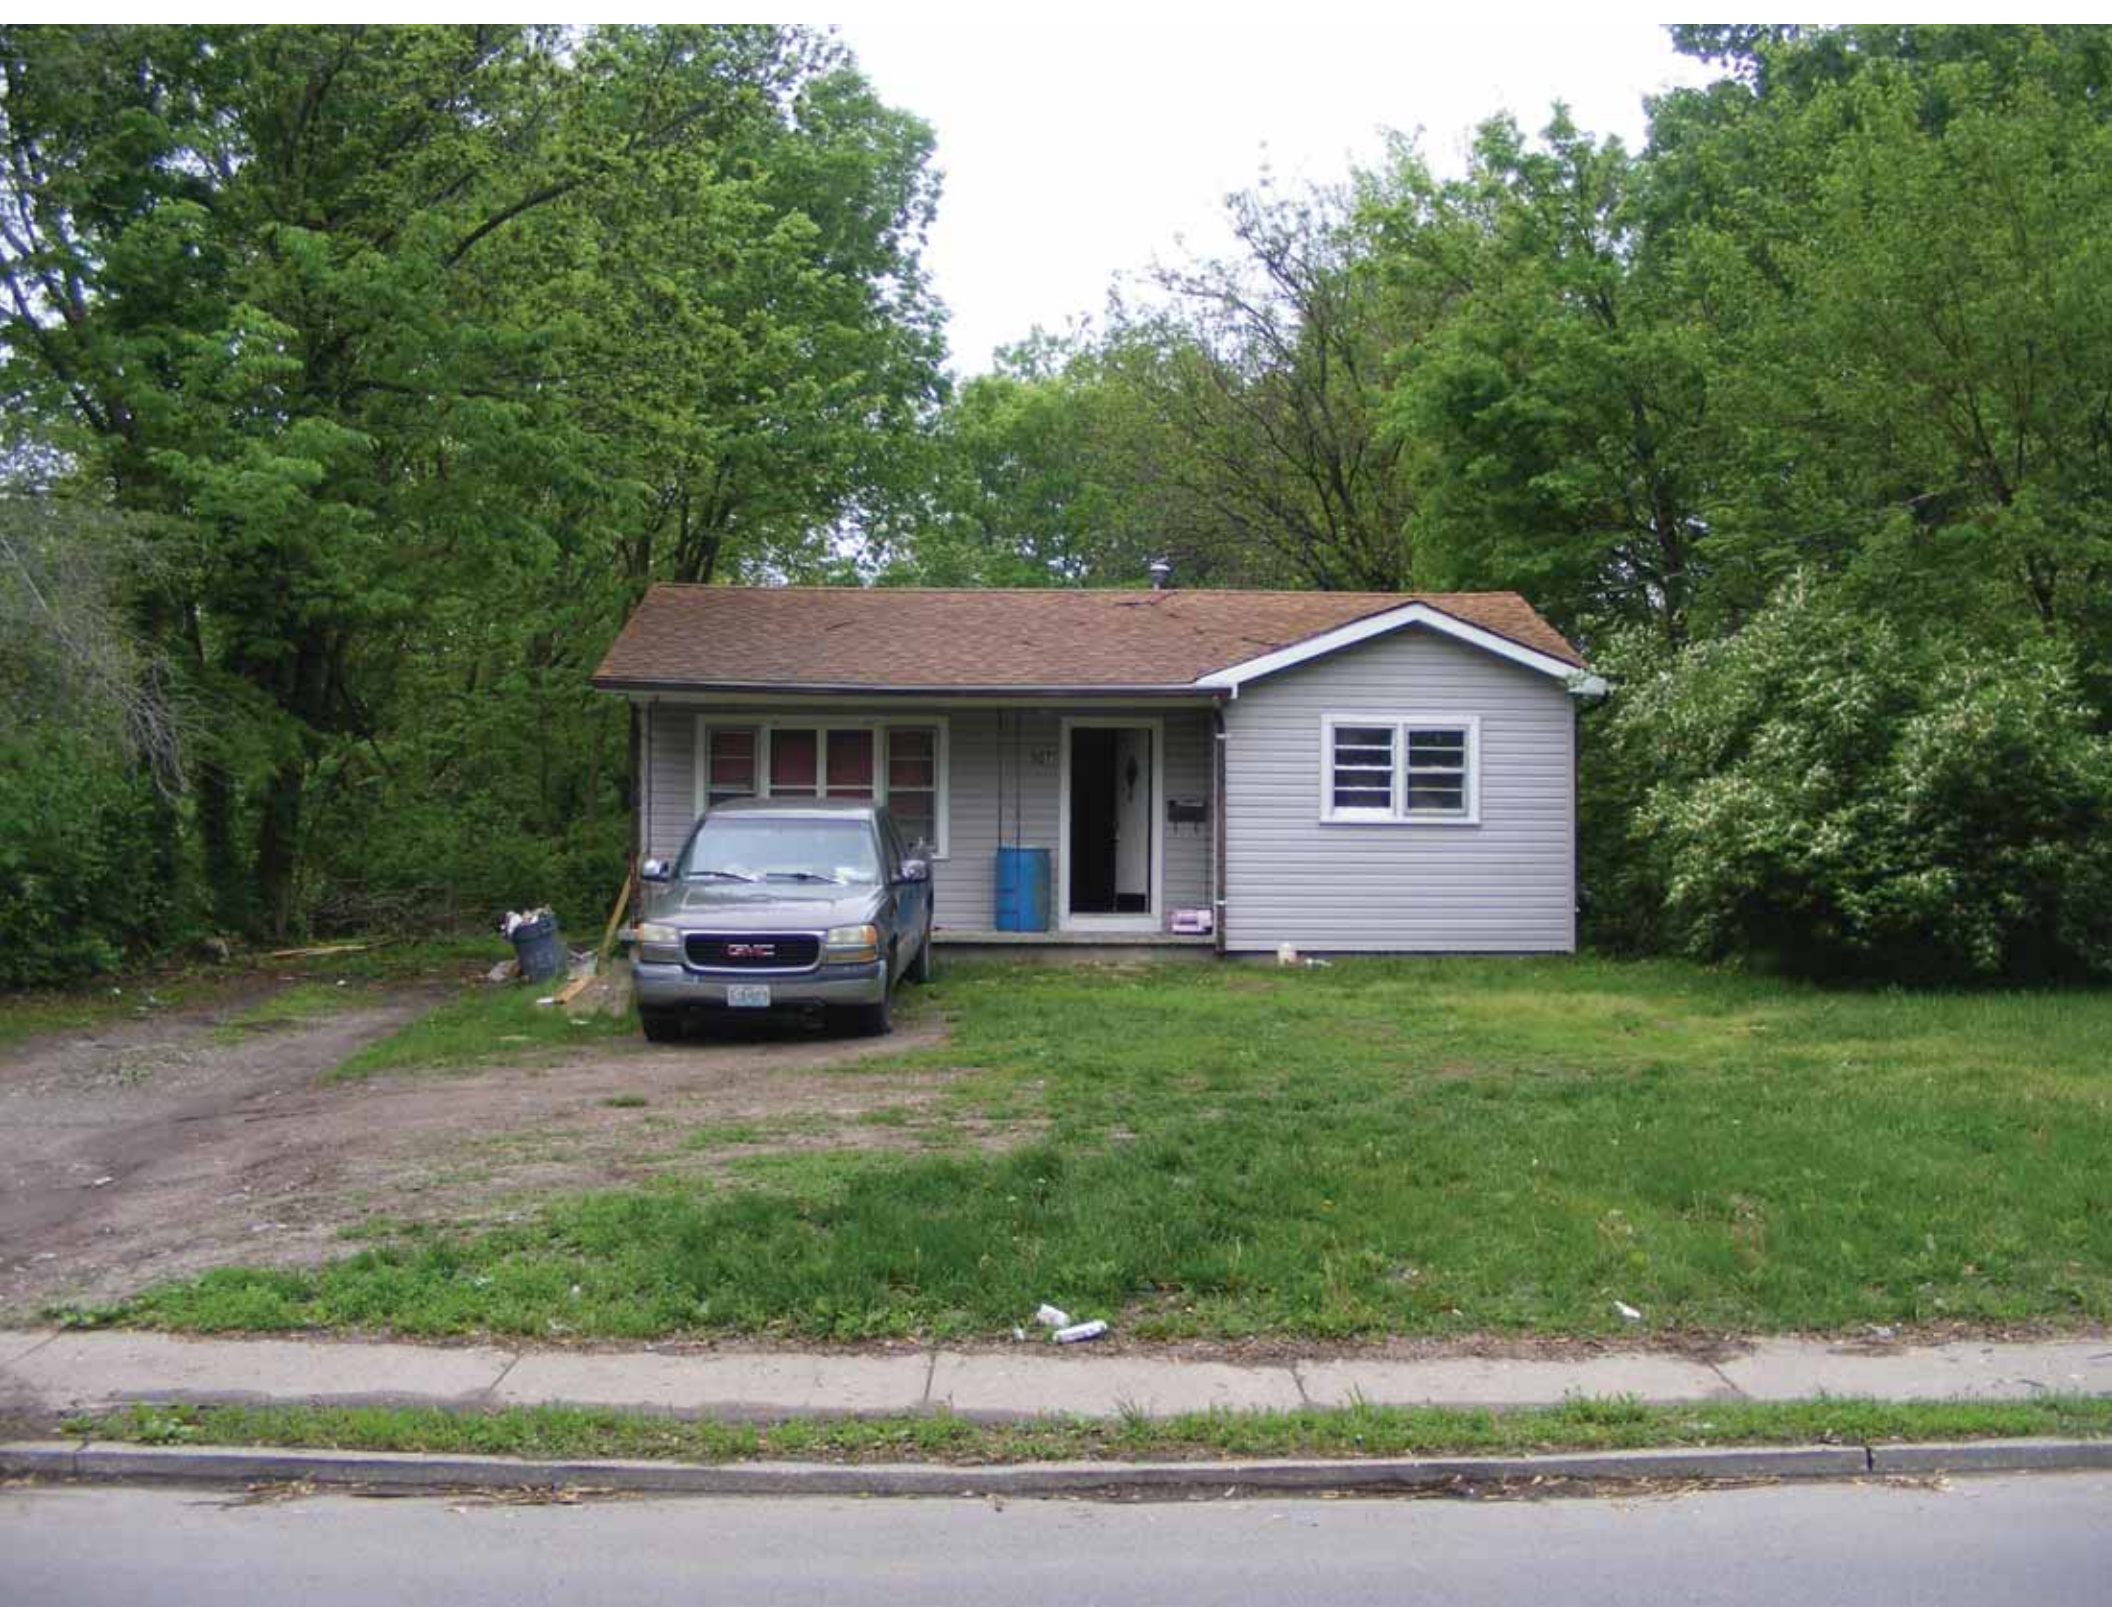
The single-story dwelling has a gable and wing plan. The front facing gable is situated at the north end of the dwelling. The house has an asphalt-shingled roof, exterior vinyl siding and a poured concrete foundation. The porch is off-center, created by the projecting gable wing on the north end. The porch is supported by original wrought iron columns. Within the porch bay is an off-center entry bay (north end) filled with an original door with an upper diamond light. Offsetting the entry on the south is a picture window. The window has original four-light side lights. The central fixed bay has been altered to hold paired one-over-one replacement lights. The front facing gable wall holds paired original two-over-two horizontal sash windows. At the central roofline ridge is an interior metal flue.

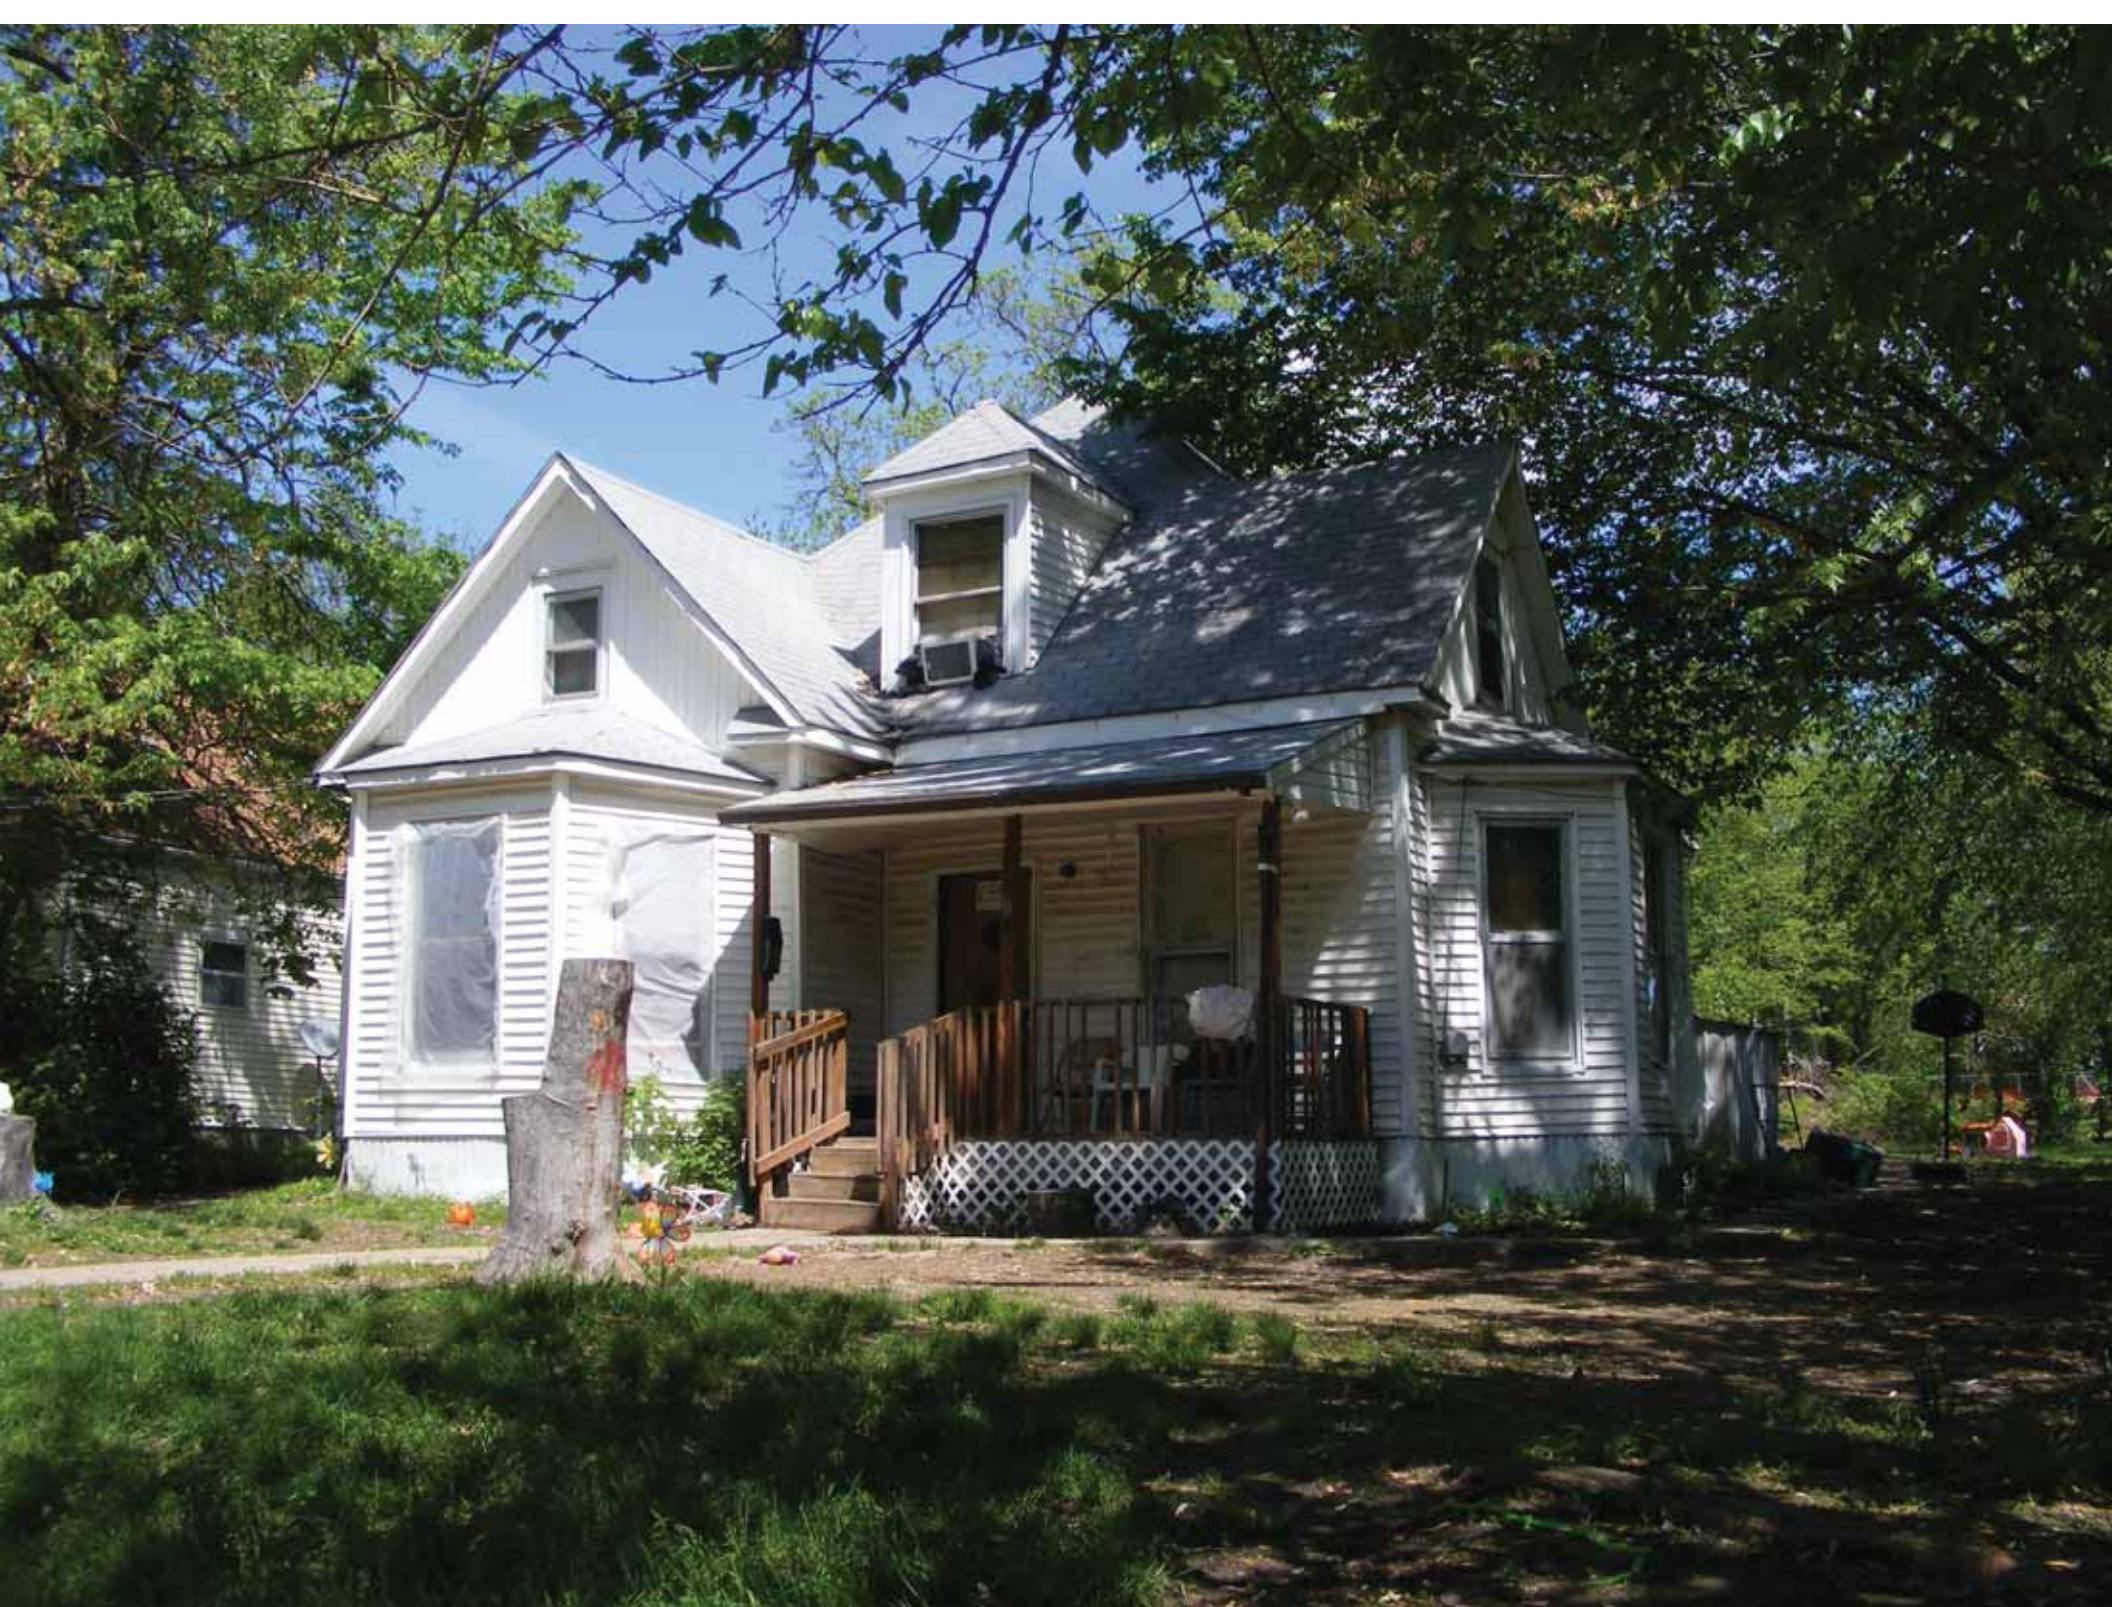
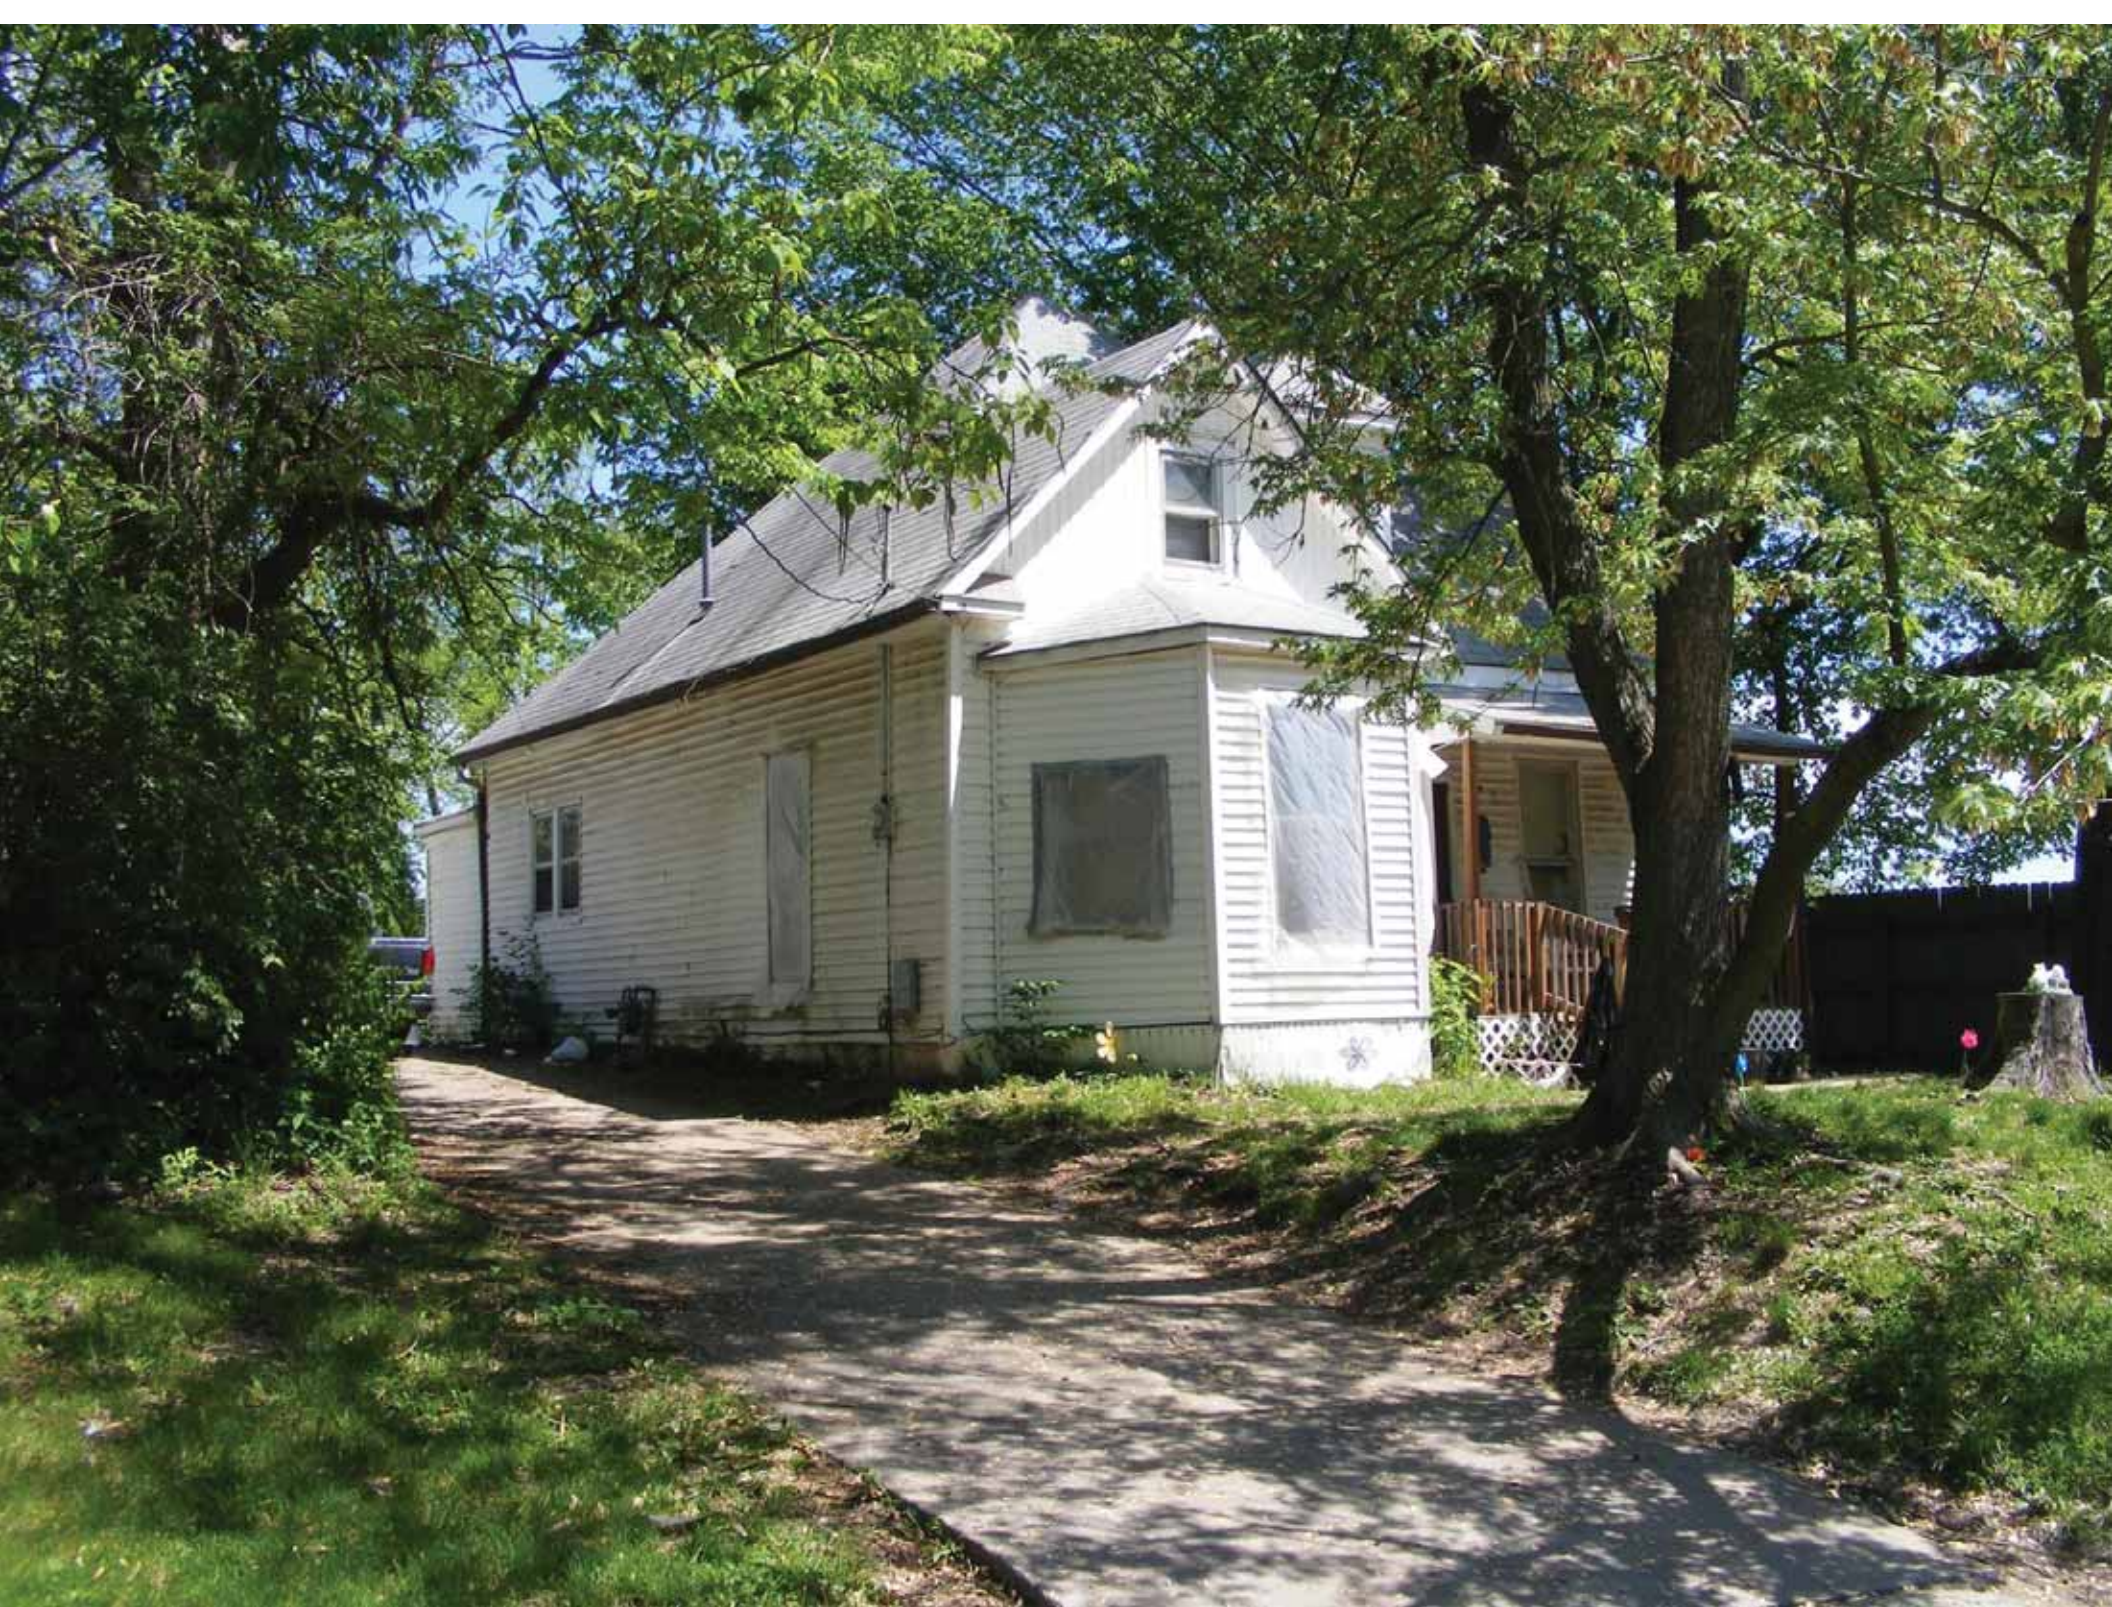
The 1.5-story frame dwelling has an asphalt shingled gabled and hipped roof, exterior vinyl siding and a foundation covered by vertical vinyl siding. A projecting gabled wing with an angled three-sided bay is situated at the north end of the façade. The three sided projection has a single window on each wall. Windows are one-over-one, covered with plastic. The bay is hipped and above the hip is a front facing gable with vertical vinyl siding. A small one-over-one window is in the gable field. The gable has returns. Offsetting the projecting bay on the south, the façade holds an original shed porch supported by replacement wood columns. A non-original (c. 2000) frame balustrade surrounds the porch and flanks the steps. Lattice (c. 2000) is set below the porch. The porch bay has an off-center entry bay (north end) filled with a replacement c. 1960 wood door with upper diamond light. The door is offset on the south by a one-over-one window. Above the porch is a hipped dormer with a one-over-one window. The south elevation has a projecting window bay similar to that on the façade. These windows are not covered with plastic. The north elevation has a covered (with plastic) one-over-one window and paired one-over-one windows. A single-story wing is situated on the rear (east) elevation.

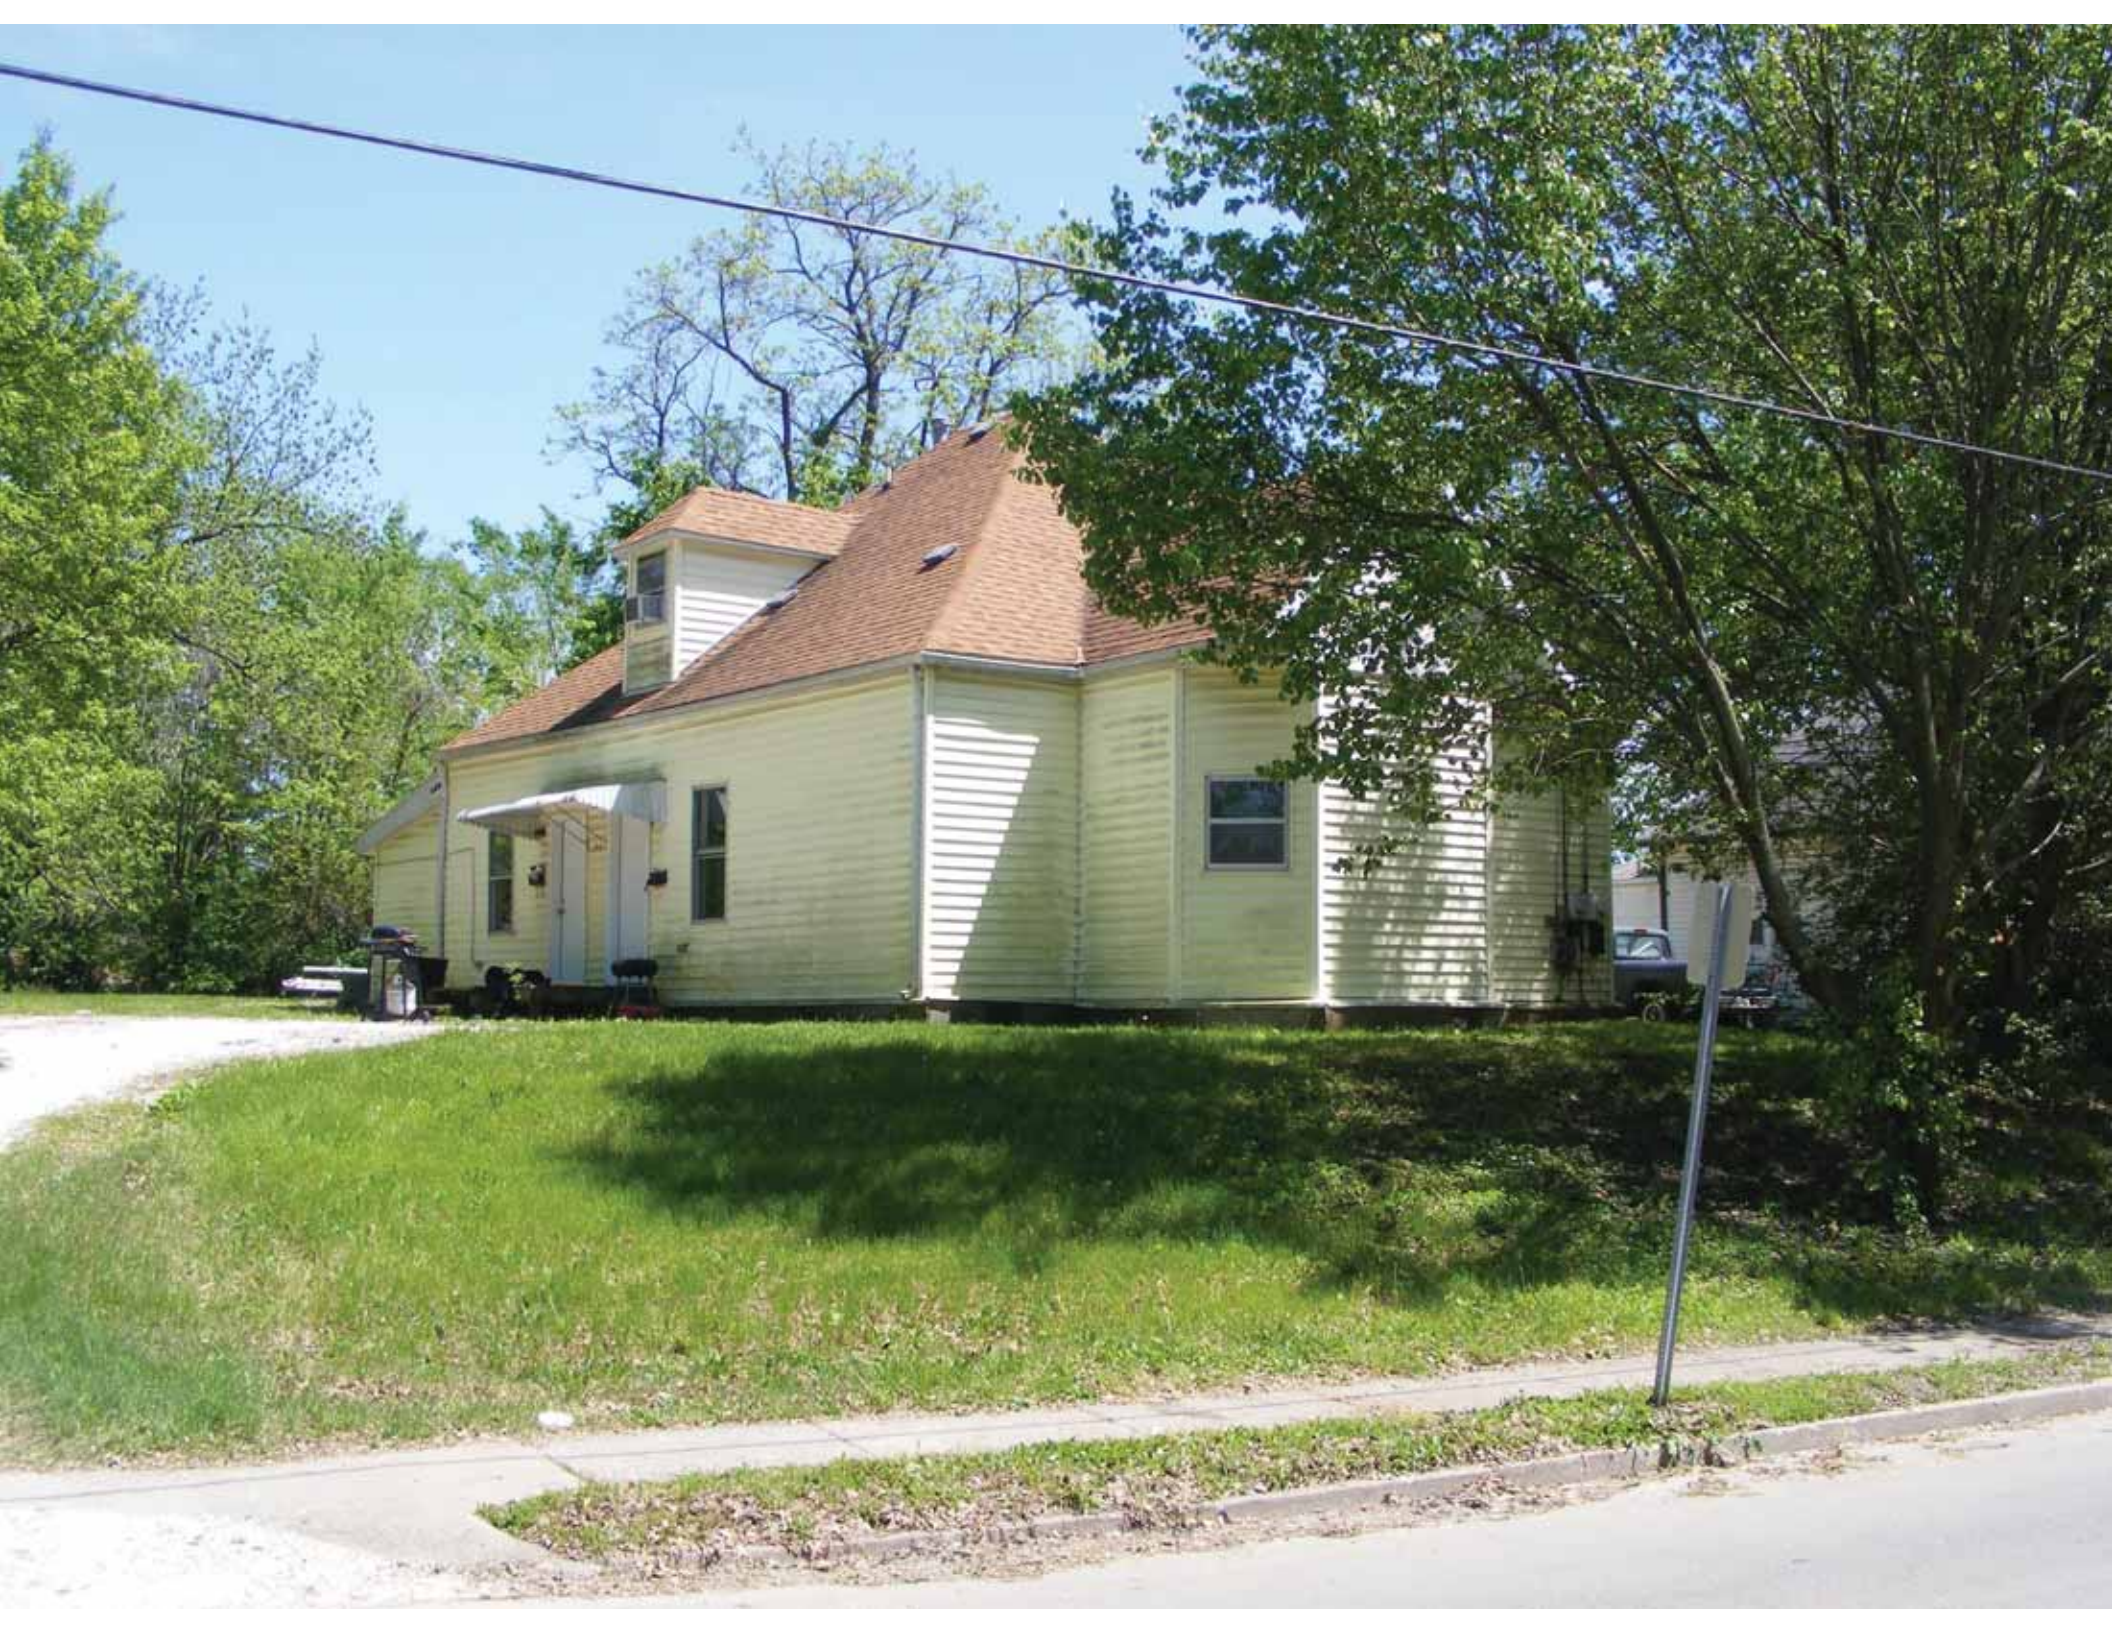
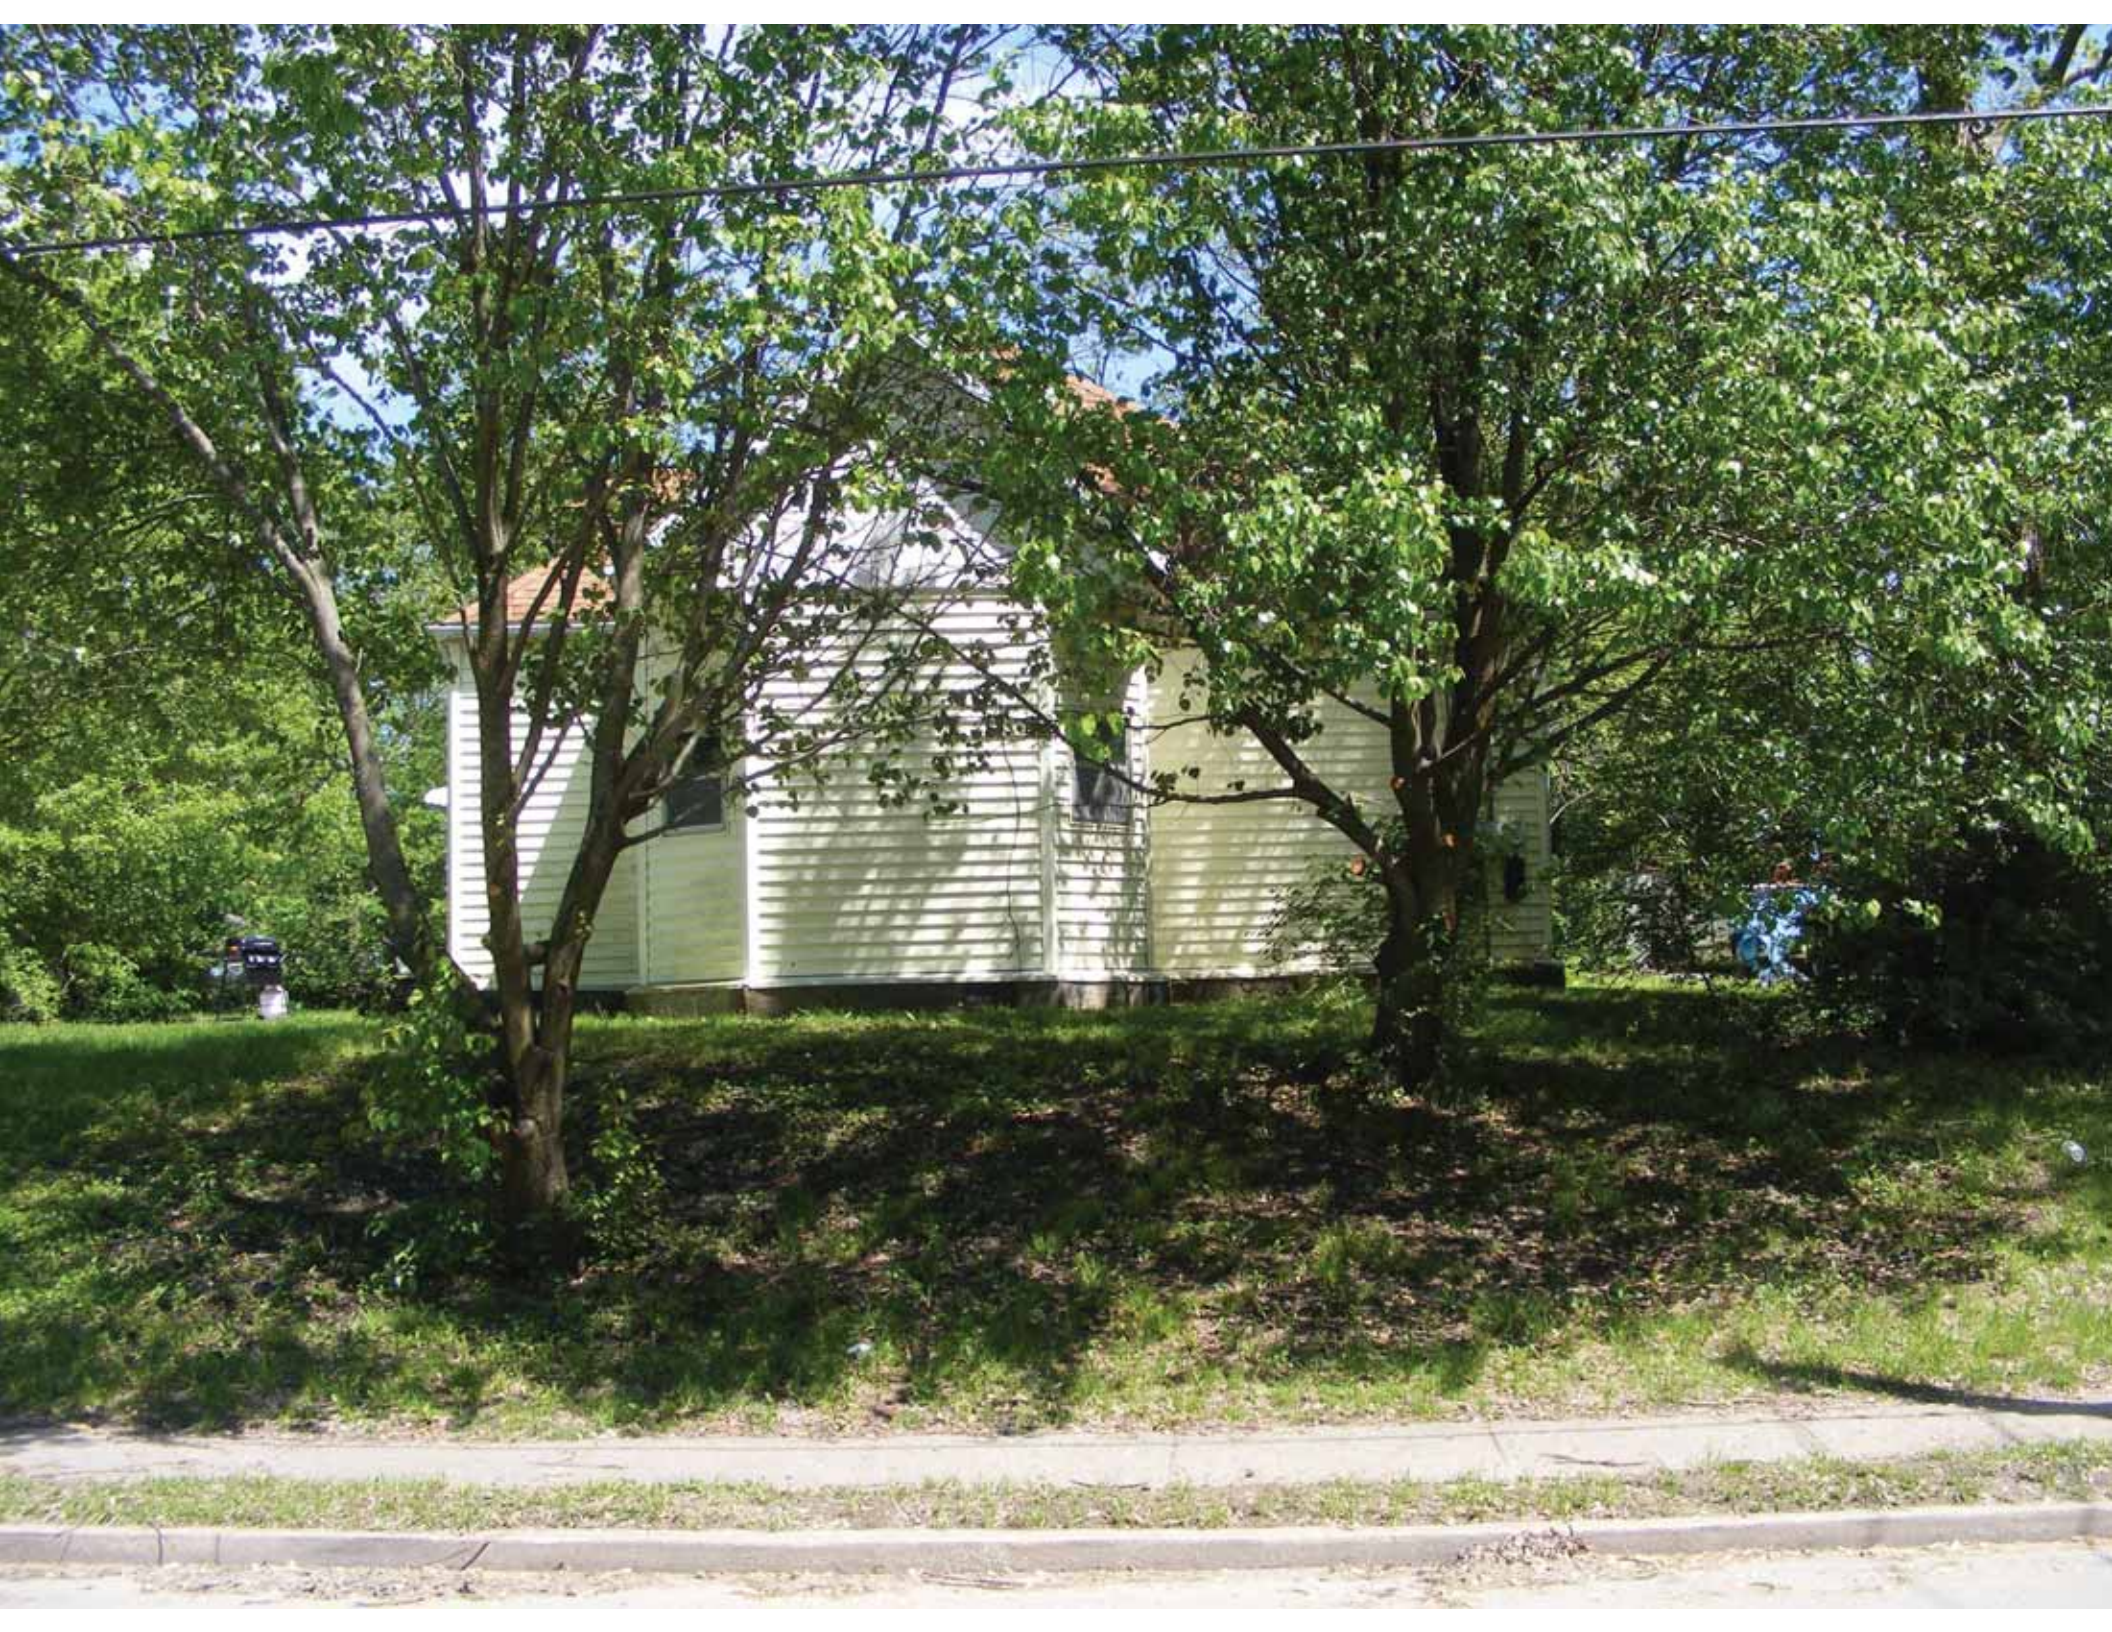
The dwelling has a high hipped asphalt shingled roof, exterior vinyl siding and a poured concrete foundation. The primary (north) elevation has a central wood stoop (c. 2000). Two doors are accessible via the stoop. The entry bays are filled with c. 1980 solid wood doors. Above the doors is a shared c. 1960 metal awning with metal brace supports. The doors are flanked by one-over-one c. 2000 replacement windows. Above the entries, the roofline supports a hipped dormer with a one-over-one replacement window. The east elevation has a shed one-story wing with no fenestration on the north elevation. The west elevation (facing N. Eighth Street) holds a single-story gabled original wing. The wing has angled corner walls, creating a five-sided projecting wing. The shorter beveled walls (two) each hold a small one-over-one replacement window. The west elevation has no other fenestration.
