MISSOURI DEPARTMENT OF NATURAL RESOURCES
STATE HISTORIC PRESERVATION OFFICE, P.O. Box 176, Jefferson City, MO 65102
ARCHITECTURAL/HISTORIC INVENTORY FORM

1. Survey No. BO-AS-011-0087		2. Survey name: North Central Columbia Survey Phase II	
3. County: Boone		4. Address (Street No.) 902	Street (name) N. Seventh Street
5. City: Columbia	Vicinity: <input type="checkbox"/>	6. Geographical Reference:	7. Township/Range/Section: T: R: S:
8. Historic name (if known):		9. Present/other name (if known):	
10. Ownership: <input checked="" type="checkbox"/> Private <input type="checkbox"/> Public		11a. Historic use (if known): Domestic/single dwelling	11b. Current use: Domestic/single dwelling

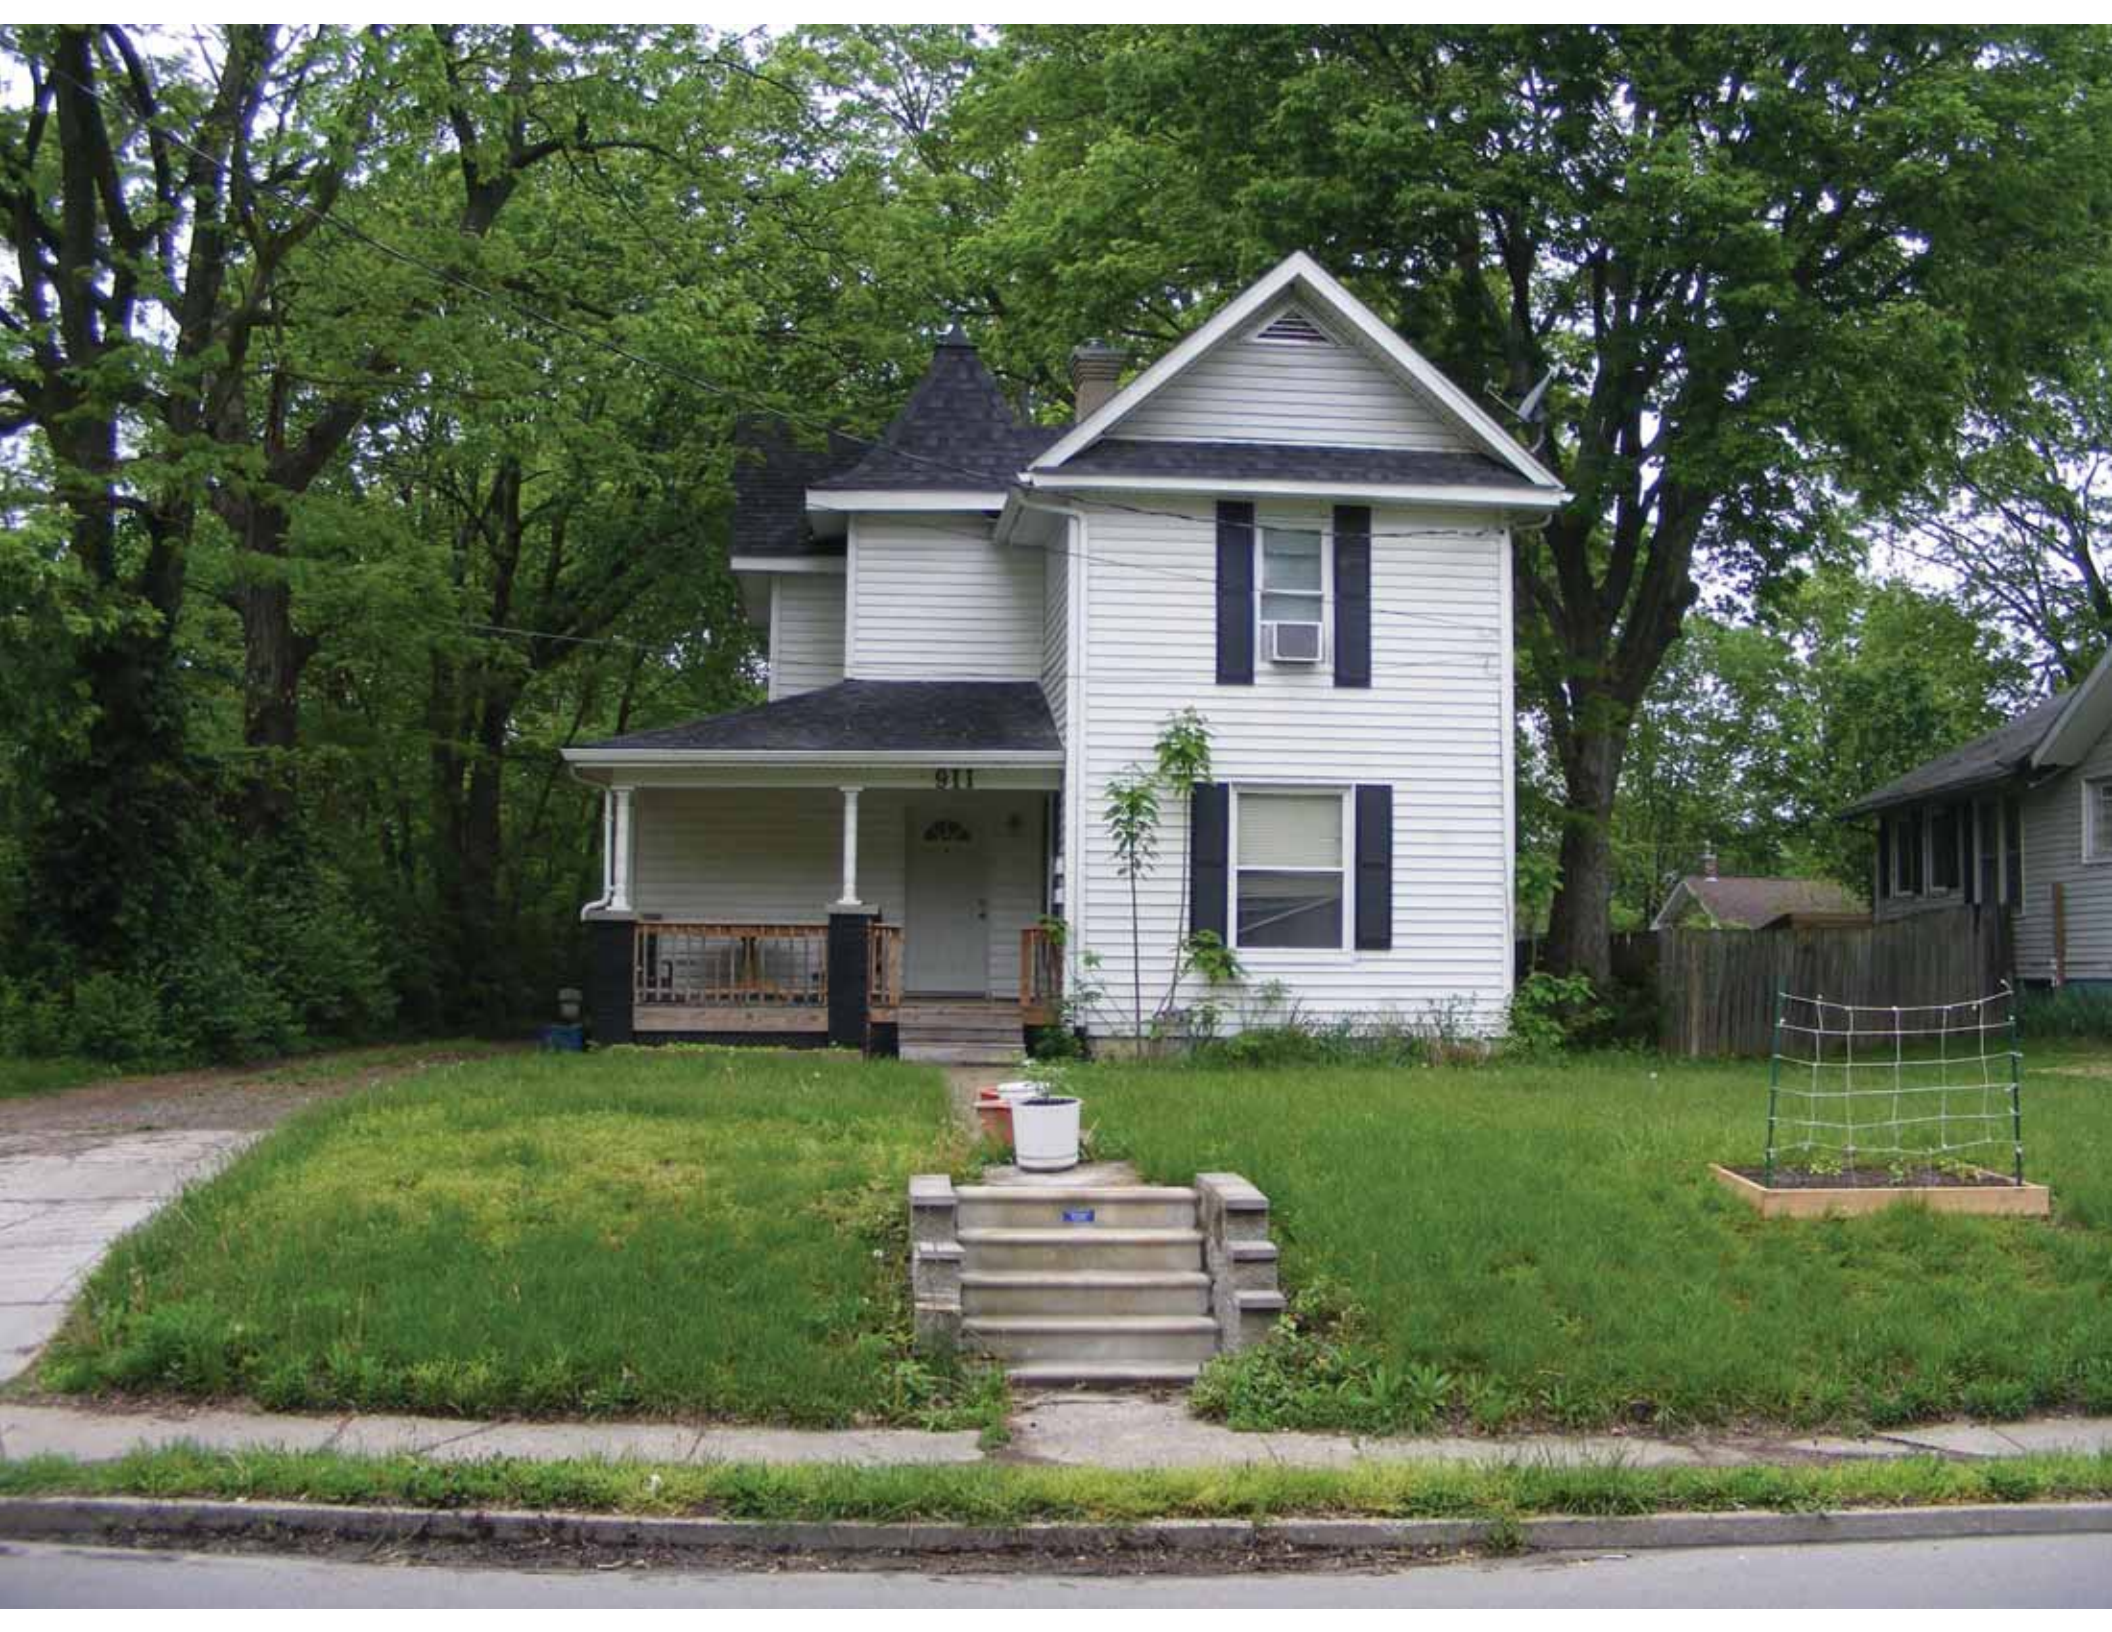
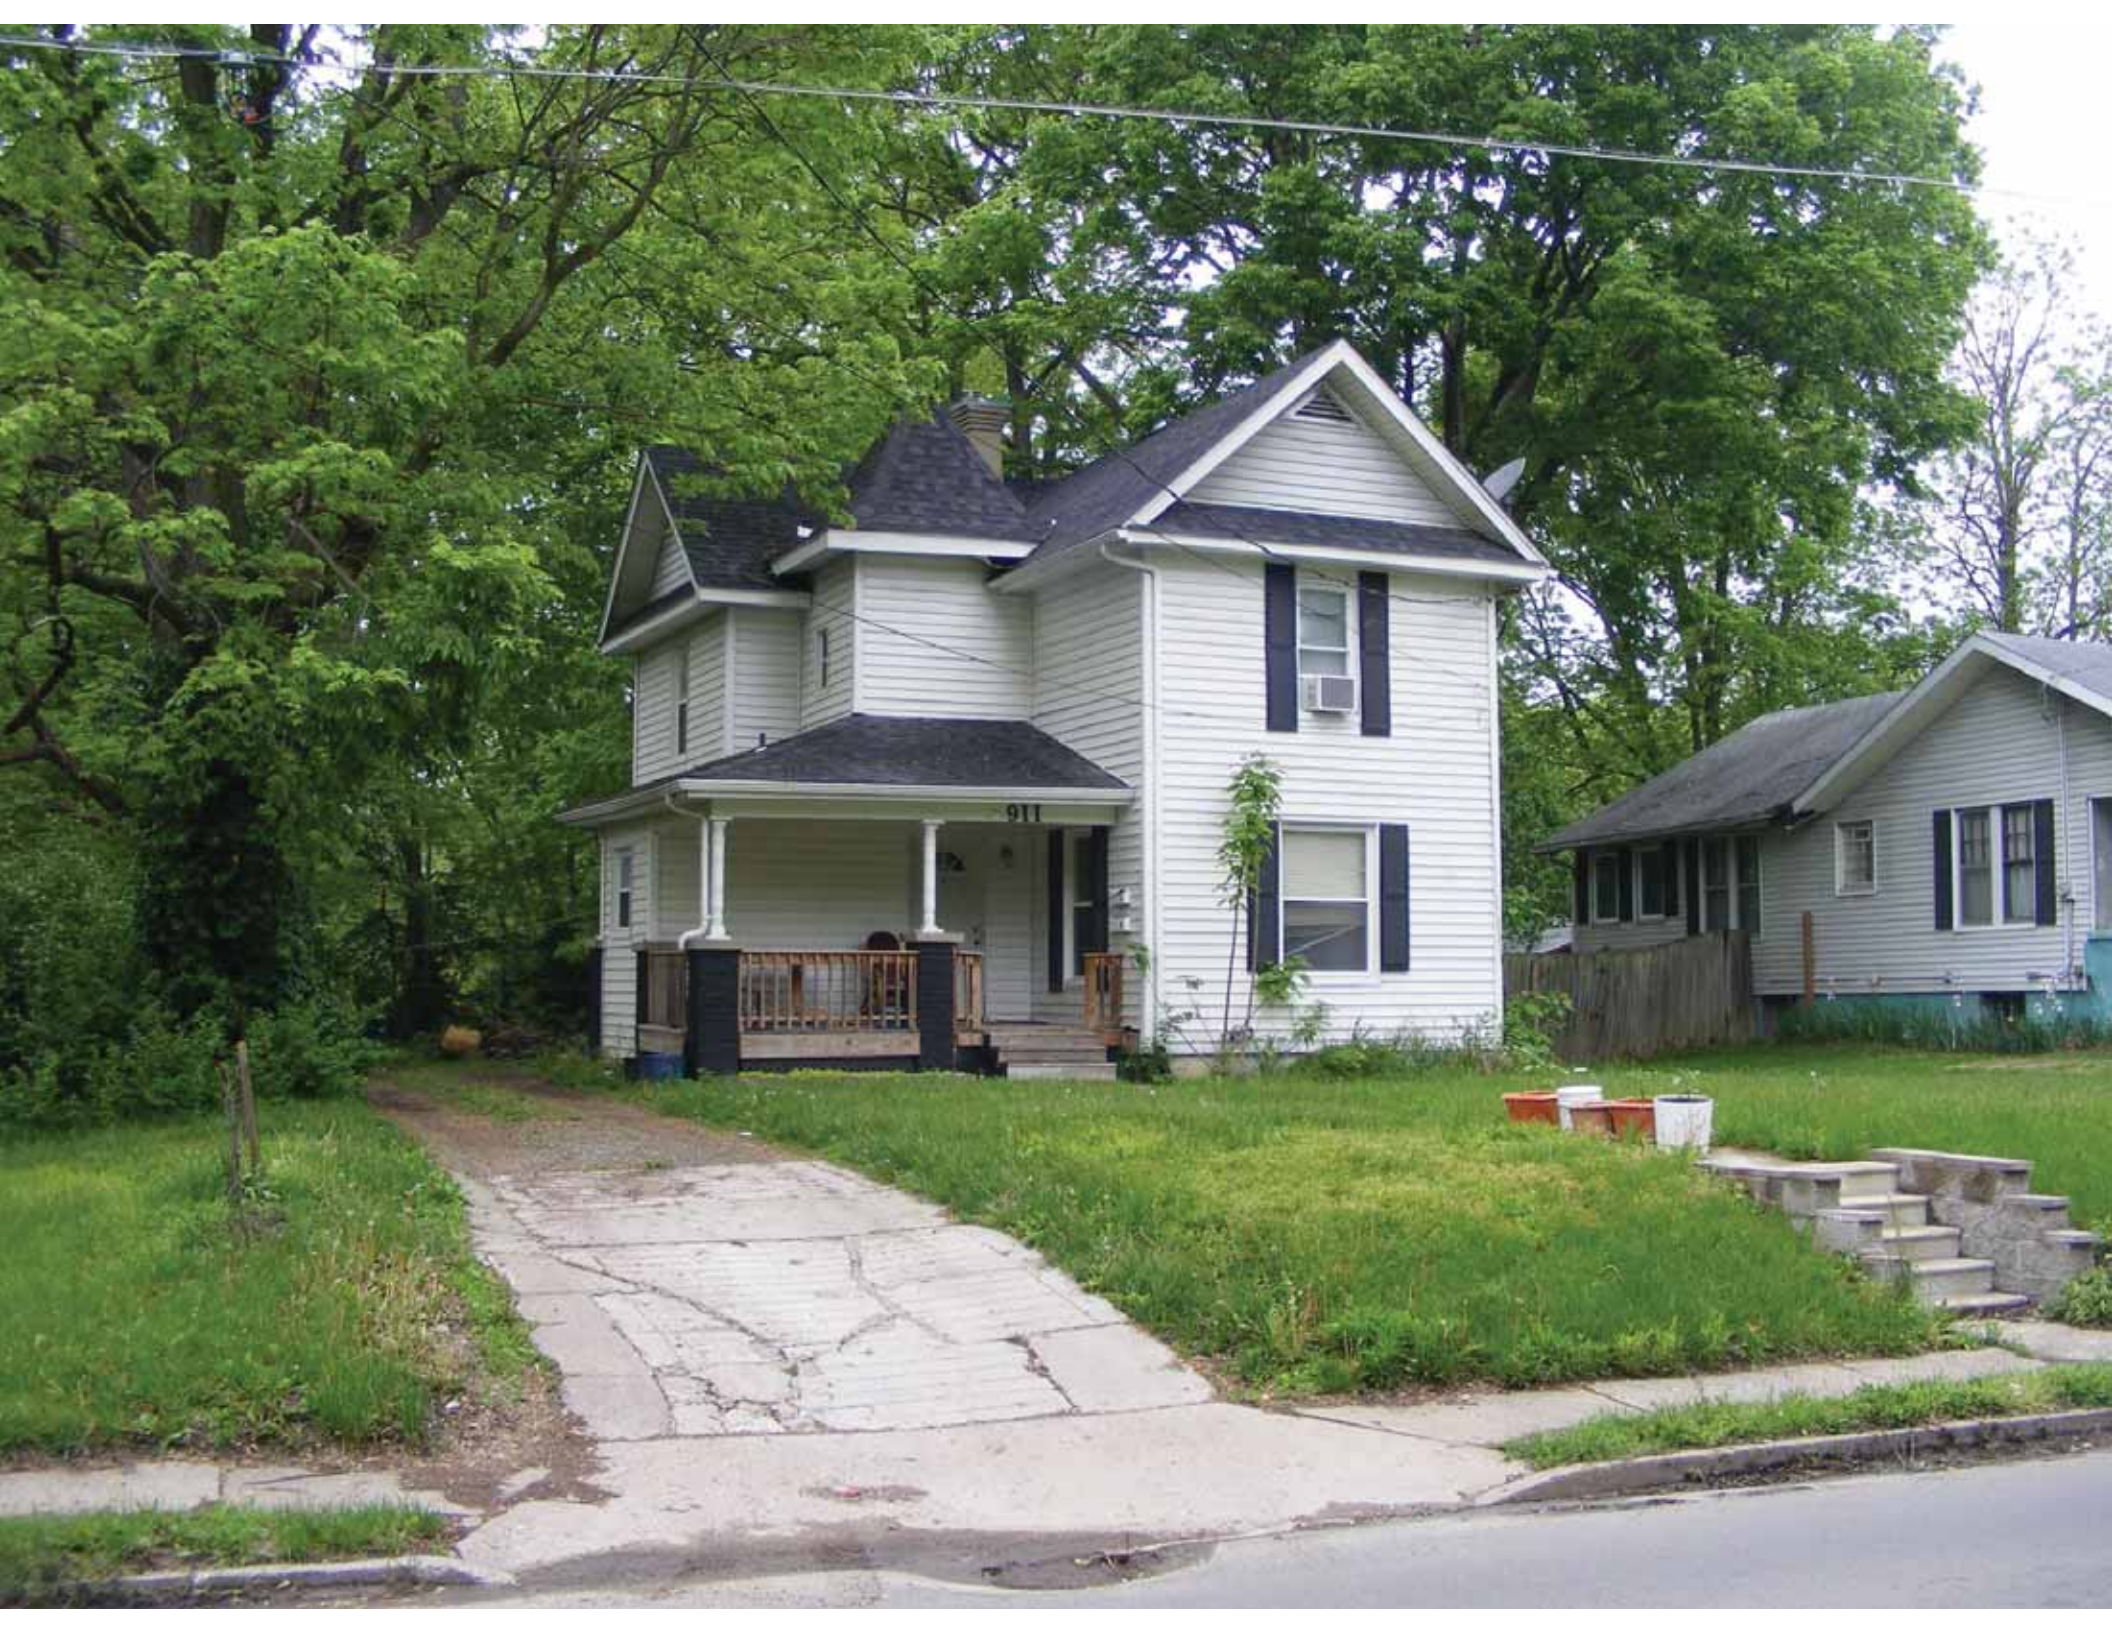
The dwelling, constructed as a single-family property is currently a two-family residence. The dwelling has an asphalt-shingled front-gabled roof, exterior synthetic siding, enclosed eaves and a concrete foundation. Gables are pedimented and have upper triangular vents. A central brick chimney rises above the roofline. Centered between front and side gabled wings is a central tower with a belcast hipped roof. The primary elevation has a hipped single-story half-width porch supported by scored columns resting on brick piers. The porch has a c. 1990 frame balustrade. The primary entry is filled with a replacement c. 1990 replacement door with an upper fanlight. Windows are double-hung with faux shutters. The porch appears to have originally wrapped the façade but has been enclosed on the south end. The rear elevation supports frame steps leading to a second-floor entry.

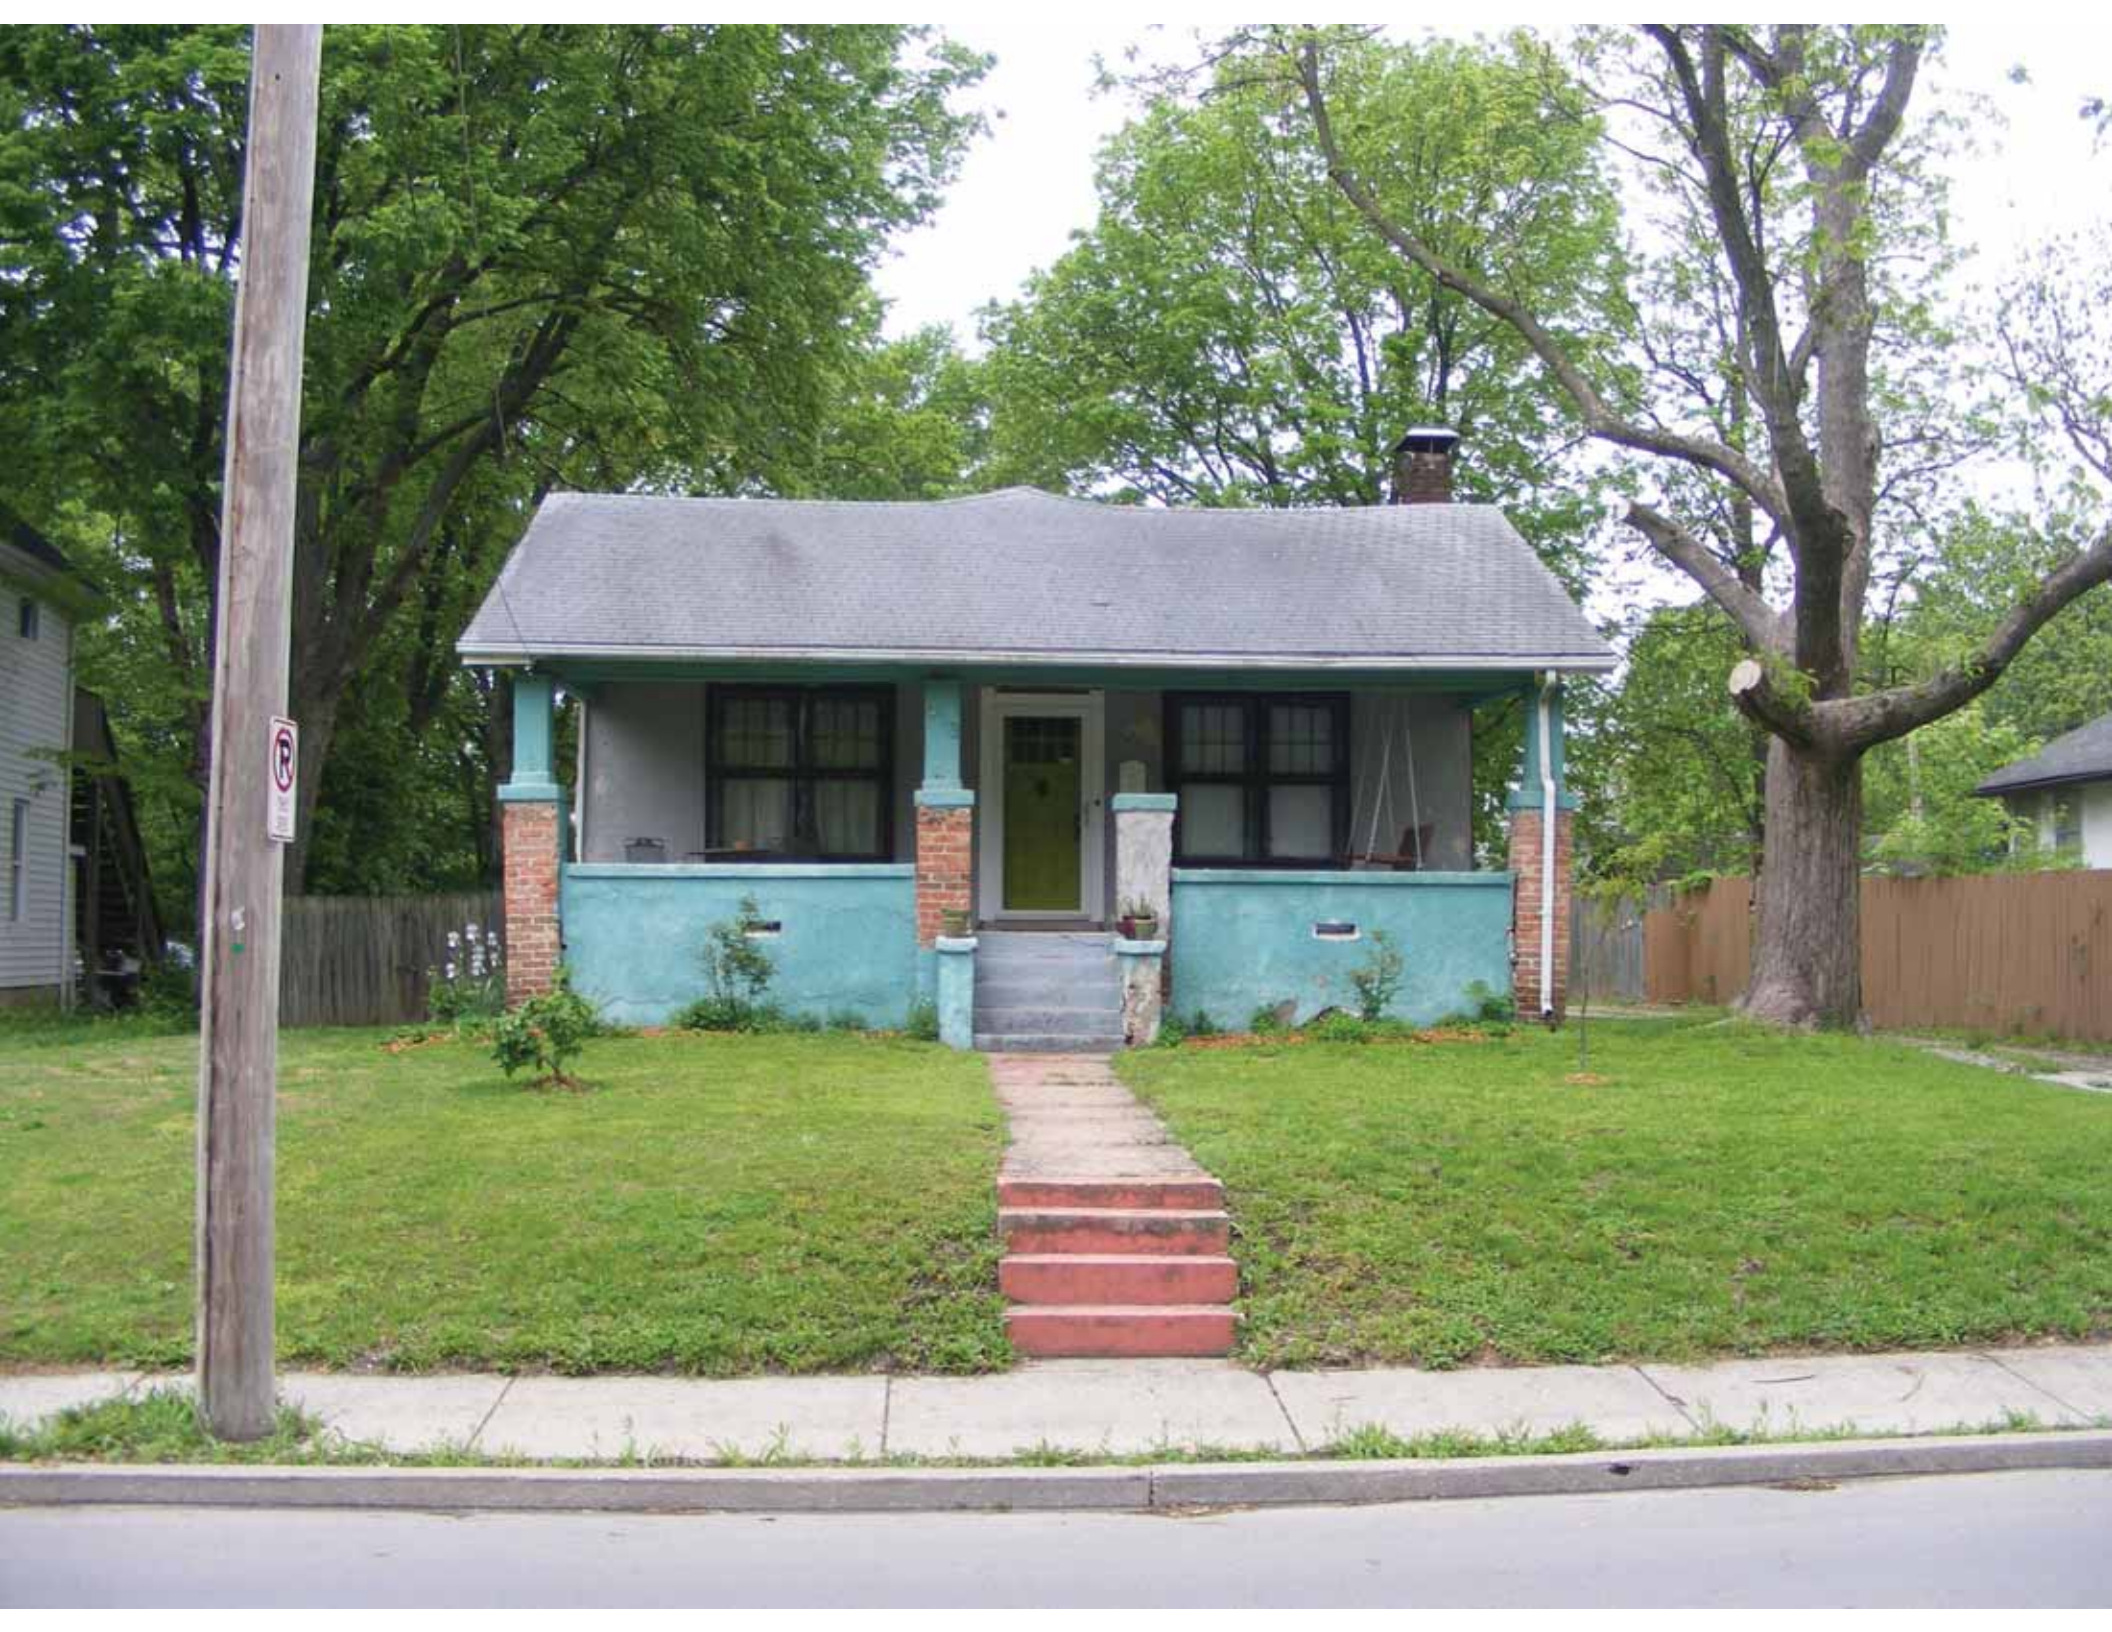
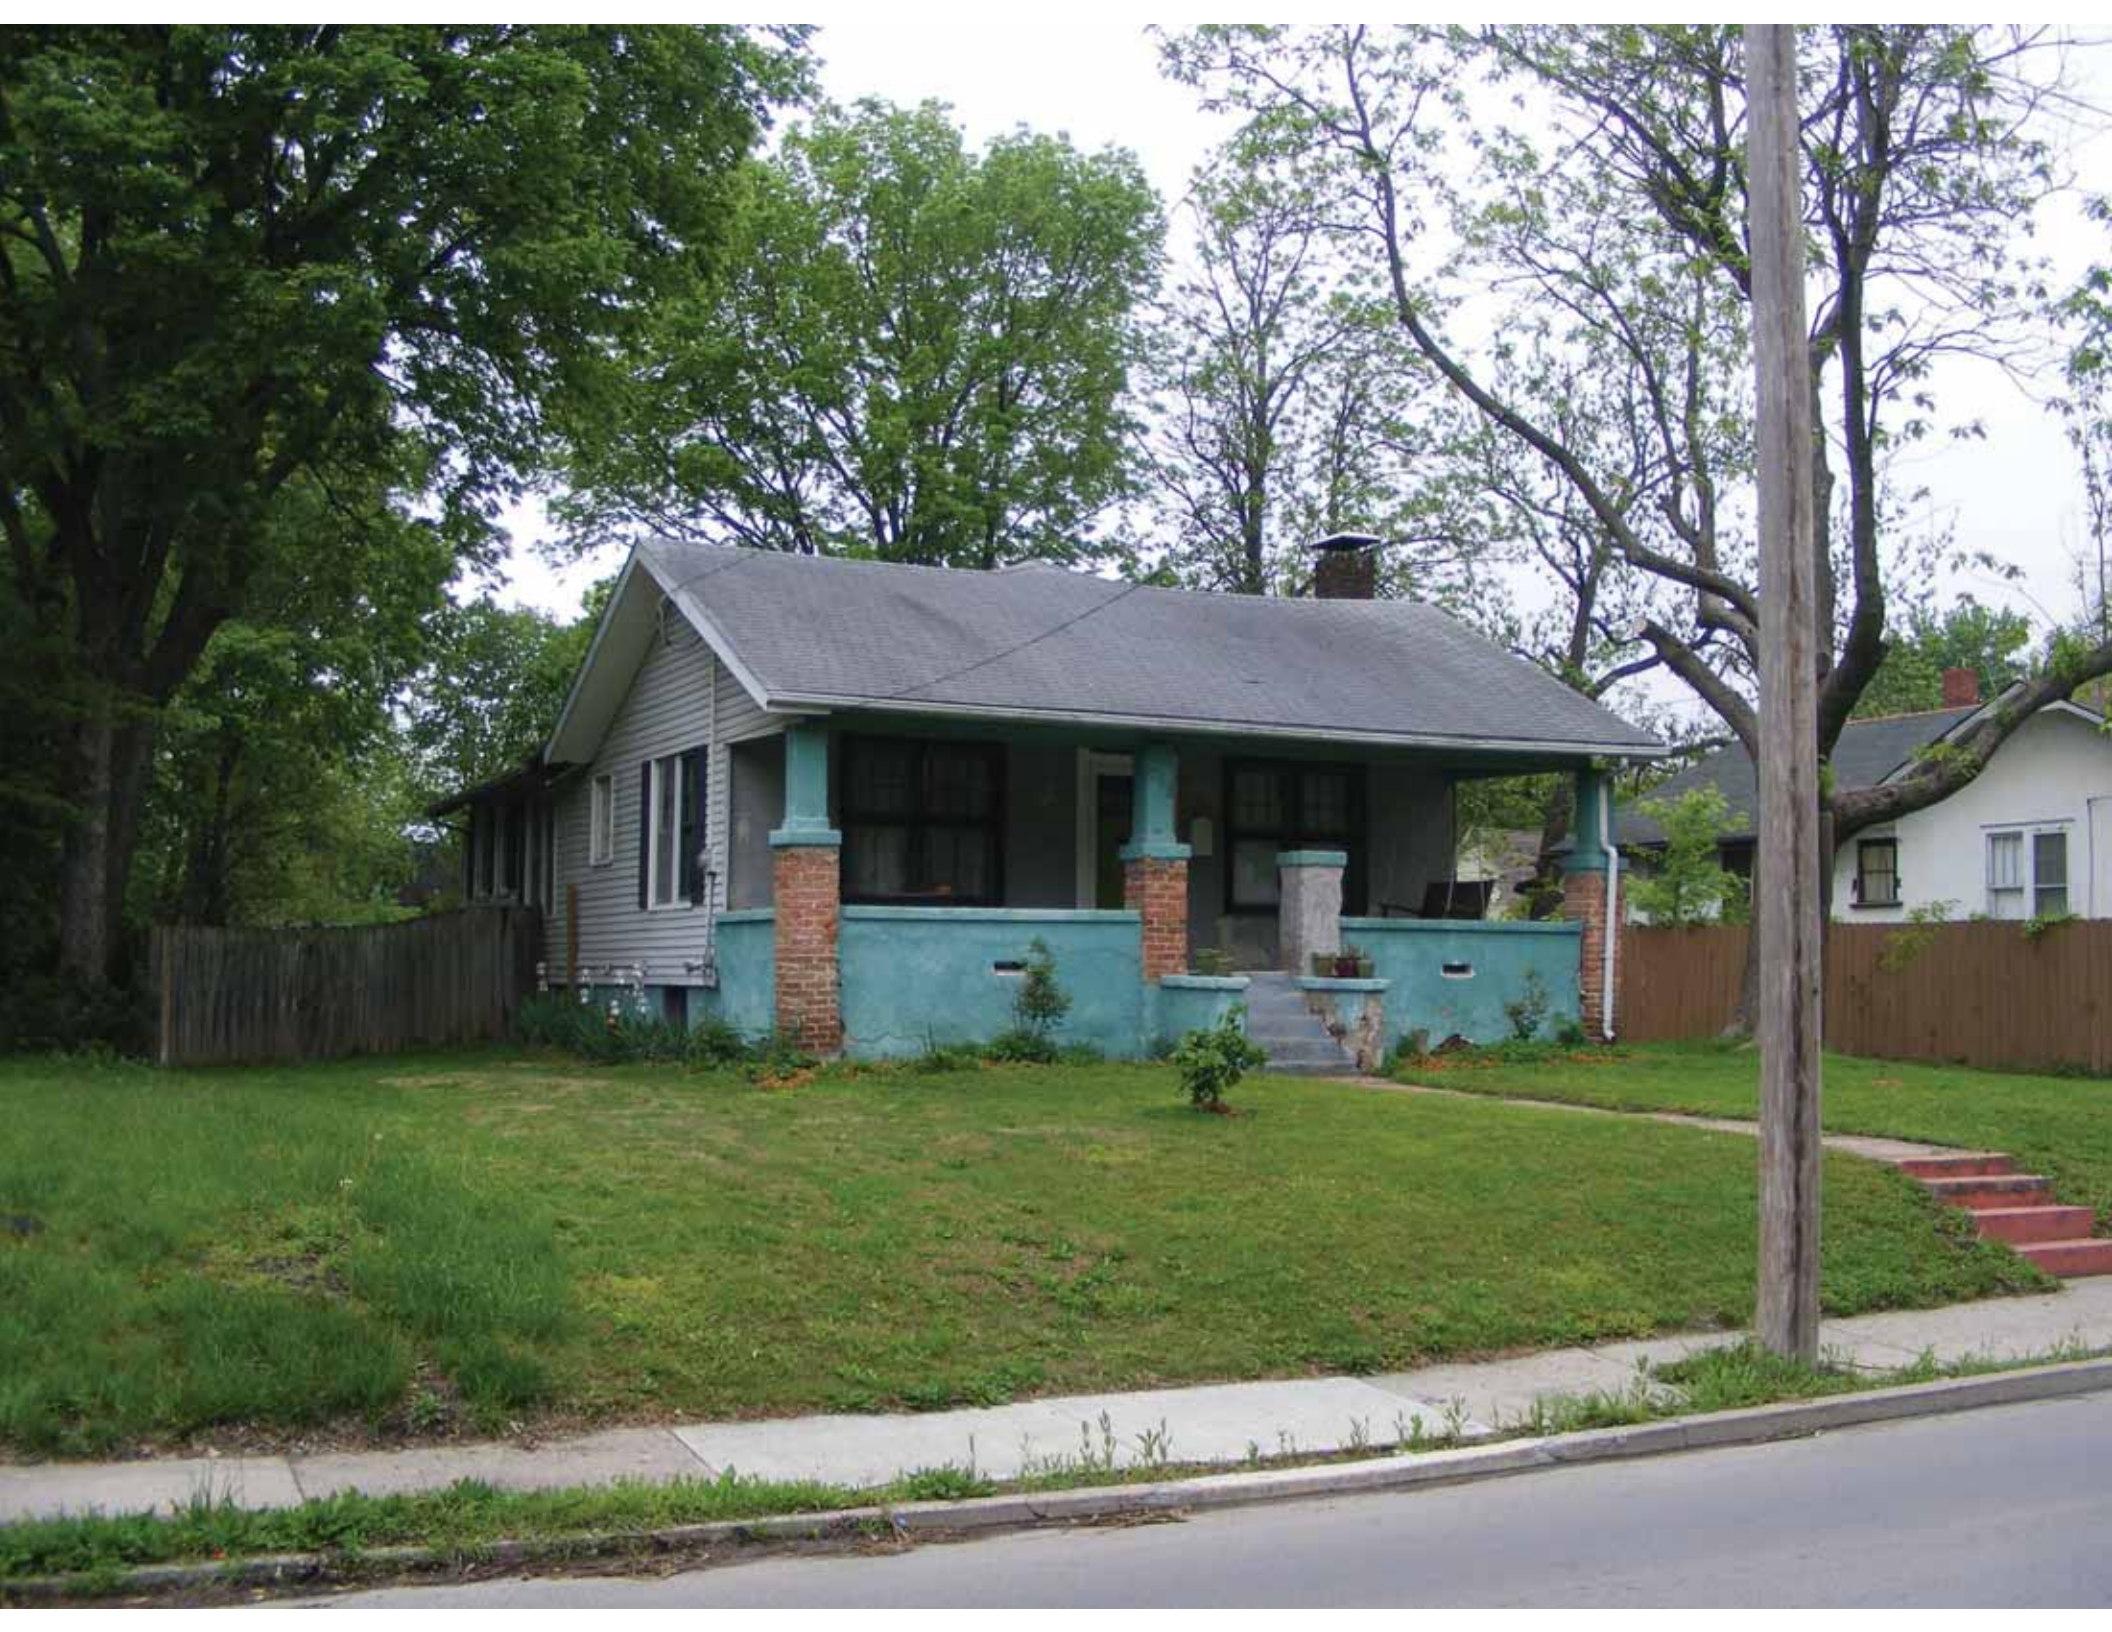
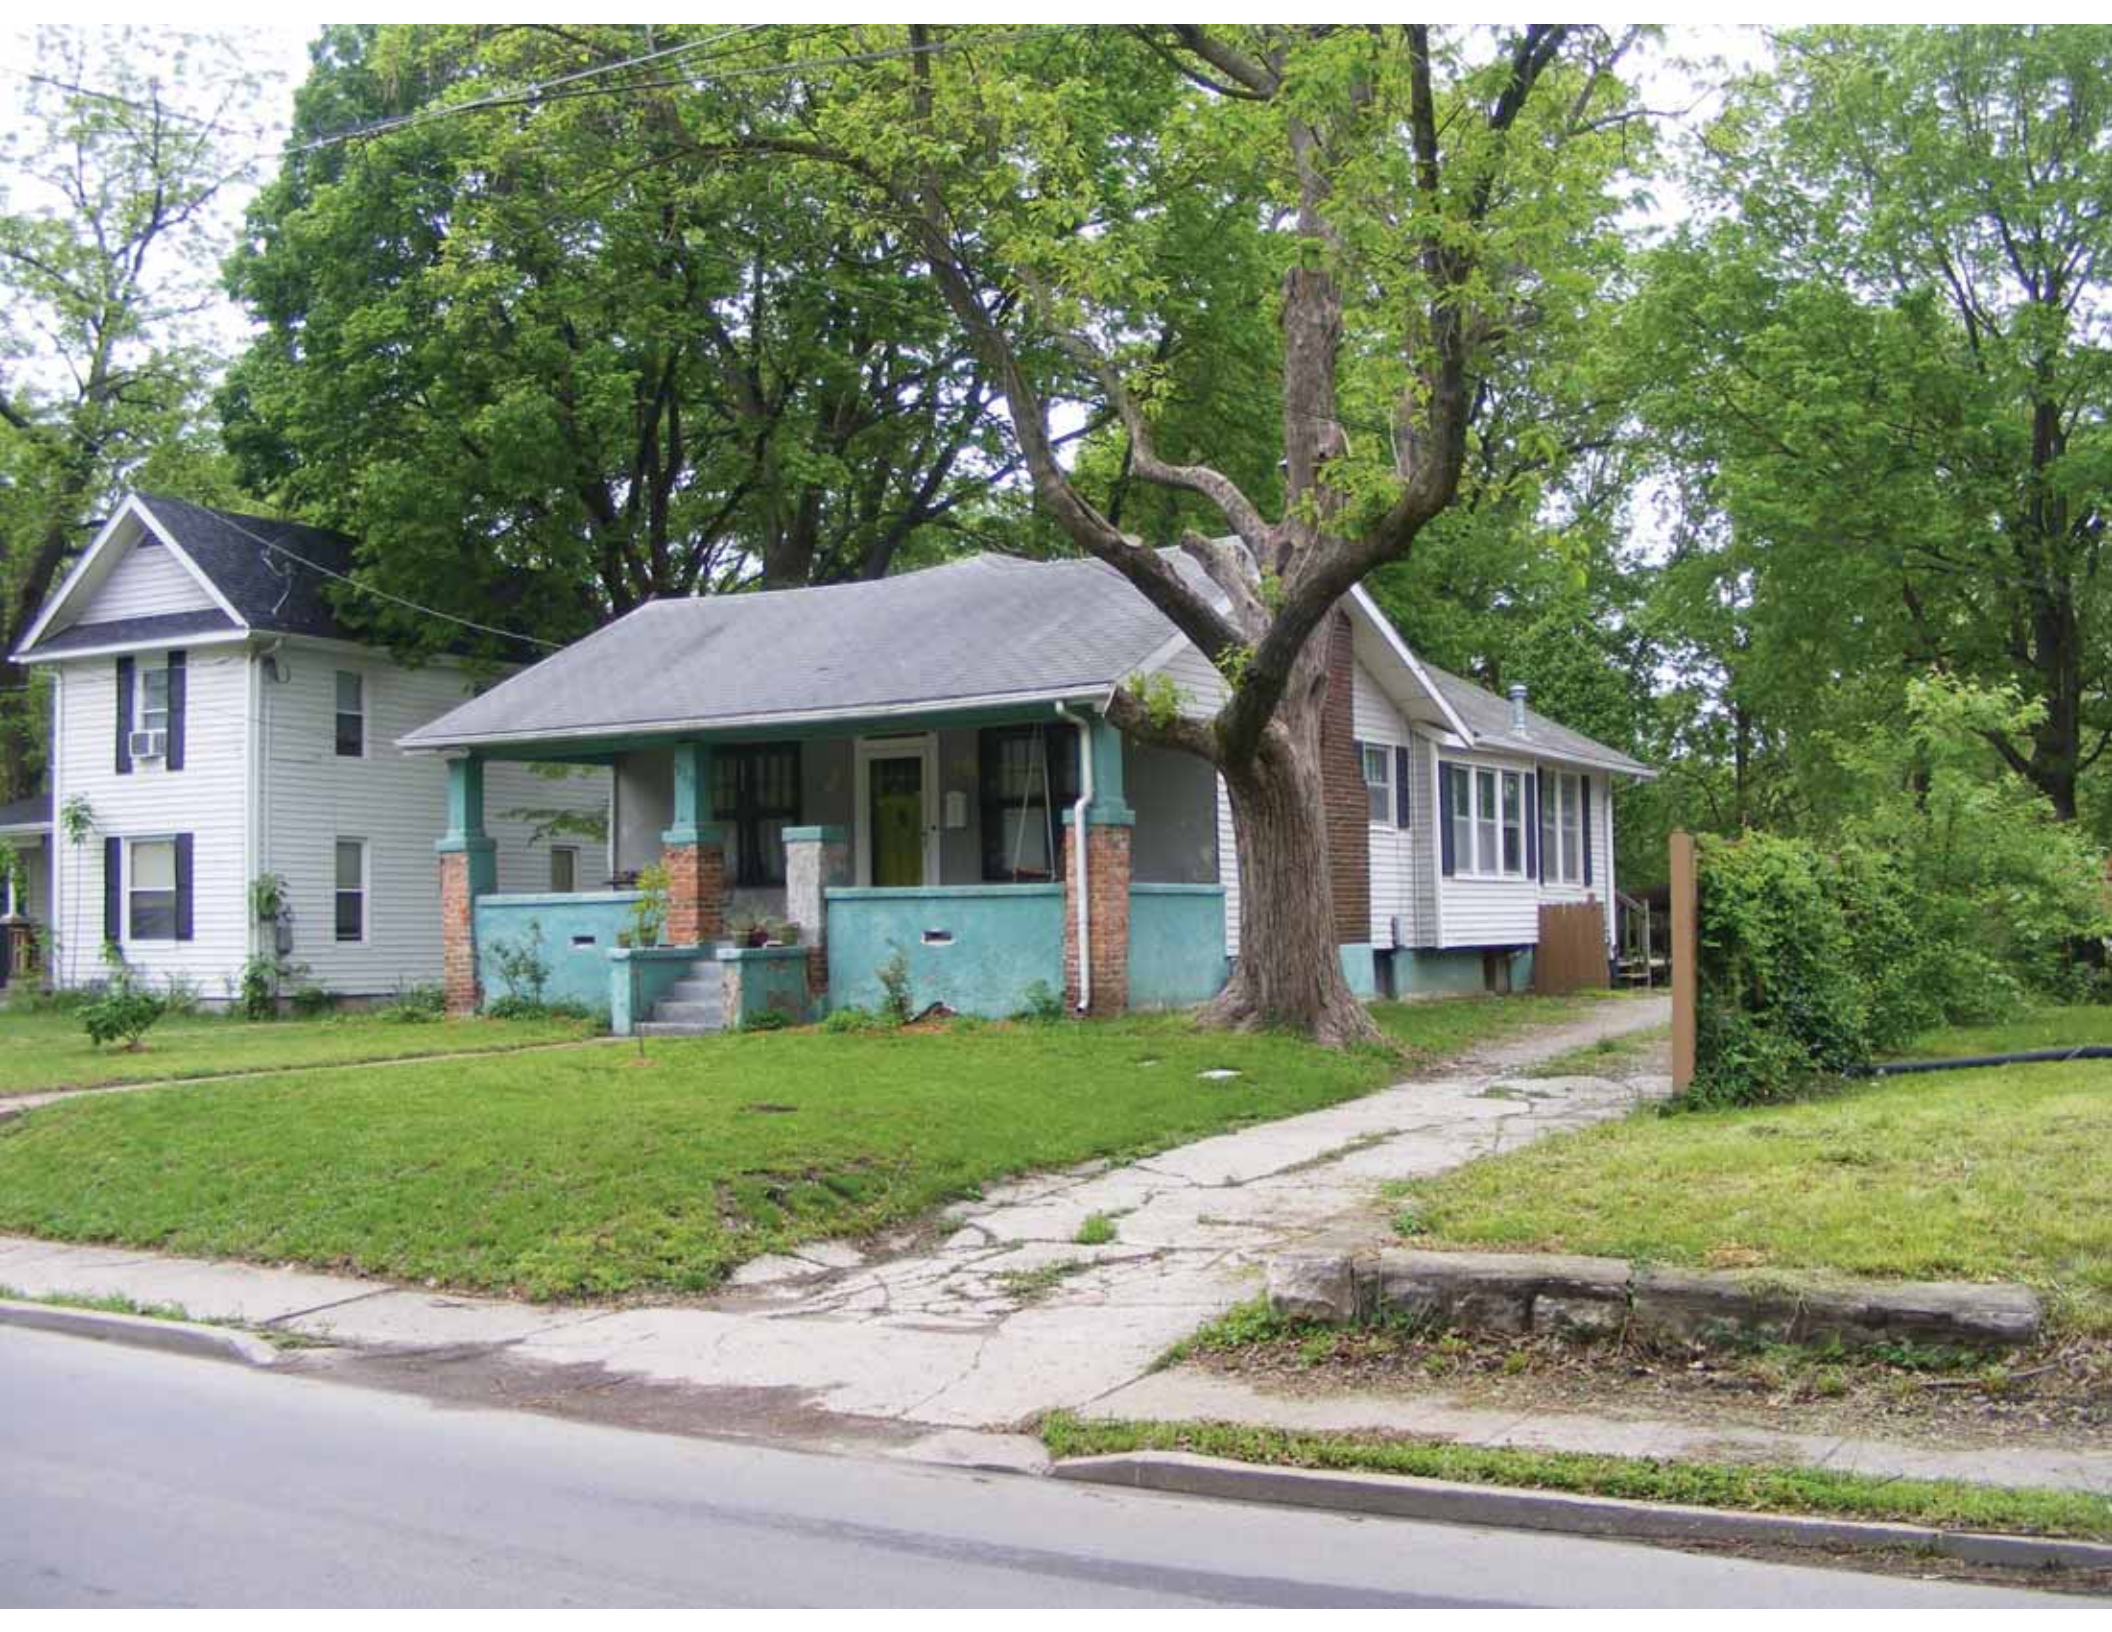
The single-family dwelling at 903 N. Eighth Street has an asphalt-shingled end-gable roof, rear gabled wing (with small front hip) and full-width façade porch supported by tapered columns on brick piers. The porch is surrounded by an original concrete low wall that extends between the brick piers. The dwelling has exterior vinyl siding on all elevations except the façade which is covered with stucco. The entry is centered in the porch bay and holds an original Craftsman style six-light door. The entry bay is flanked by paired original six-over-one windows. Eaves are enclosed. At the north end of the dwelling is an exterior brick chimney. The dwelling appears to be identical in plan to 917 N. Eighth Street.
