MISSOURI DEPARTMENT OF NATURAL RESOURCES
STATE HISTORIC PRESERVATION OFFICE, P.O. Box 176, Jefferson City, MO 65102
ARCHITECTURAL/HISTORIC INVENTORY FORM

1. Survey No. BO-AS-011-0087		2. Survey name: North Central Columbia Survey Phase II	
3. County: Boone		4. Address (Street No.) 902	Street (name) N. Seventh Street
5. City: Columbia	Vicinity: <input type="checkbox"/>	6. Geographical Reference:	7. Township/Range/Section: T: R: S:
8. Historic name (if known):		9. Present/other name (if known):	
10. Ownership: <input checked="" type="checkbox"/> Private <input type="checkbox"/> Public		11a. Historic use (if known): Domestic/single dwelling	11b. Current use: Domestic/single dwelling

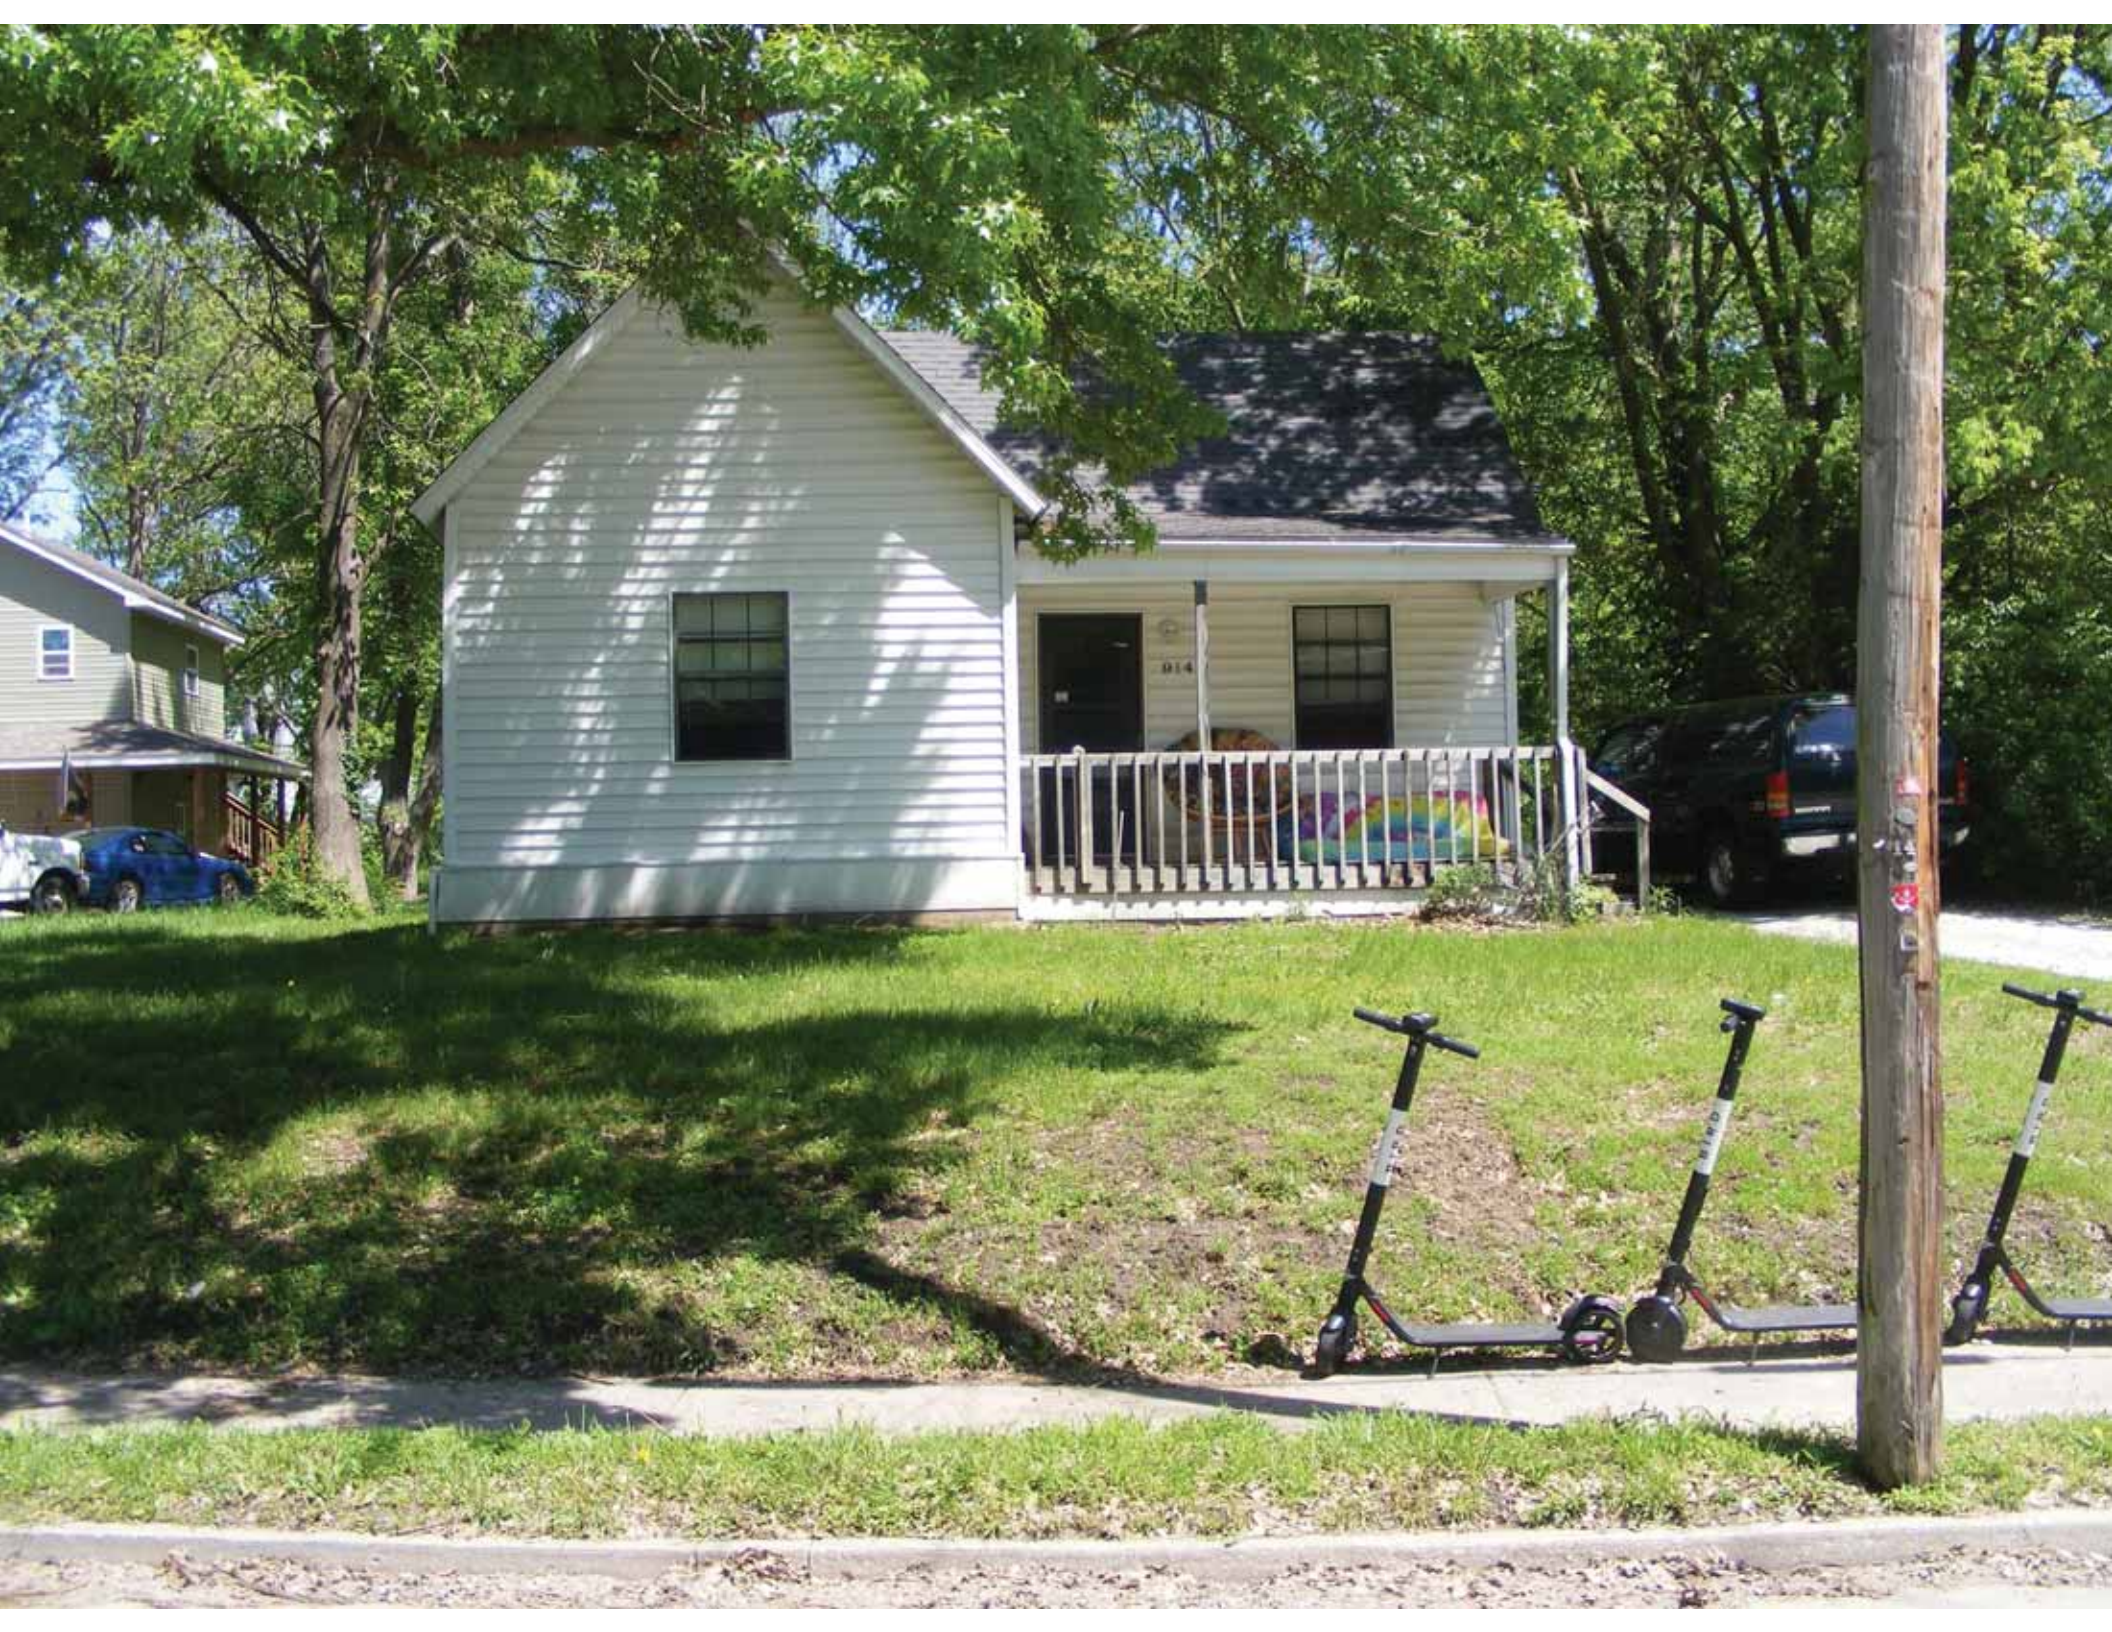
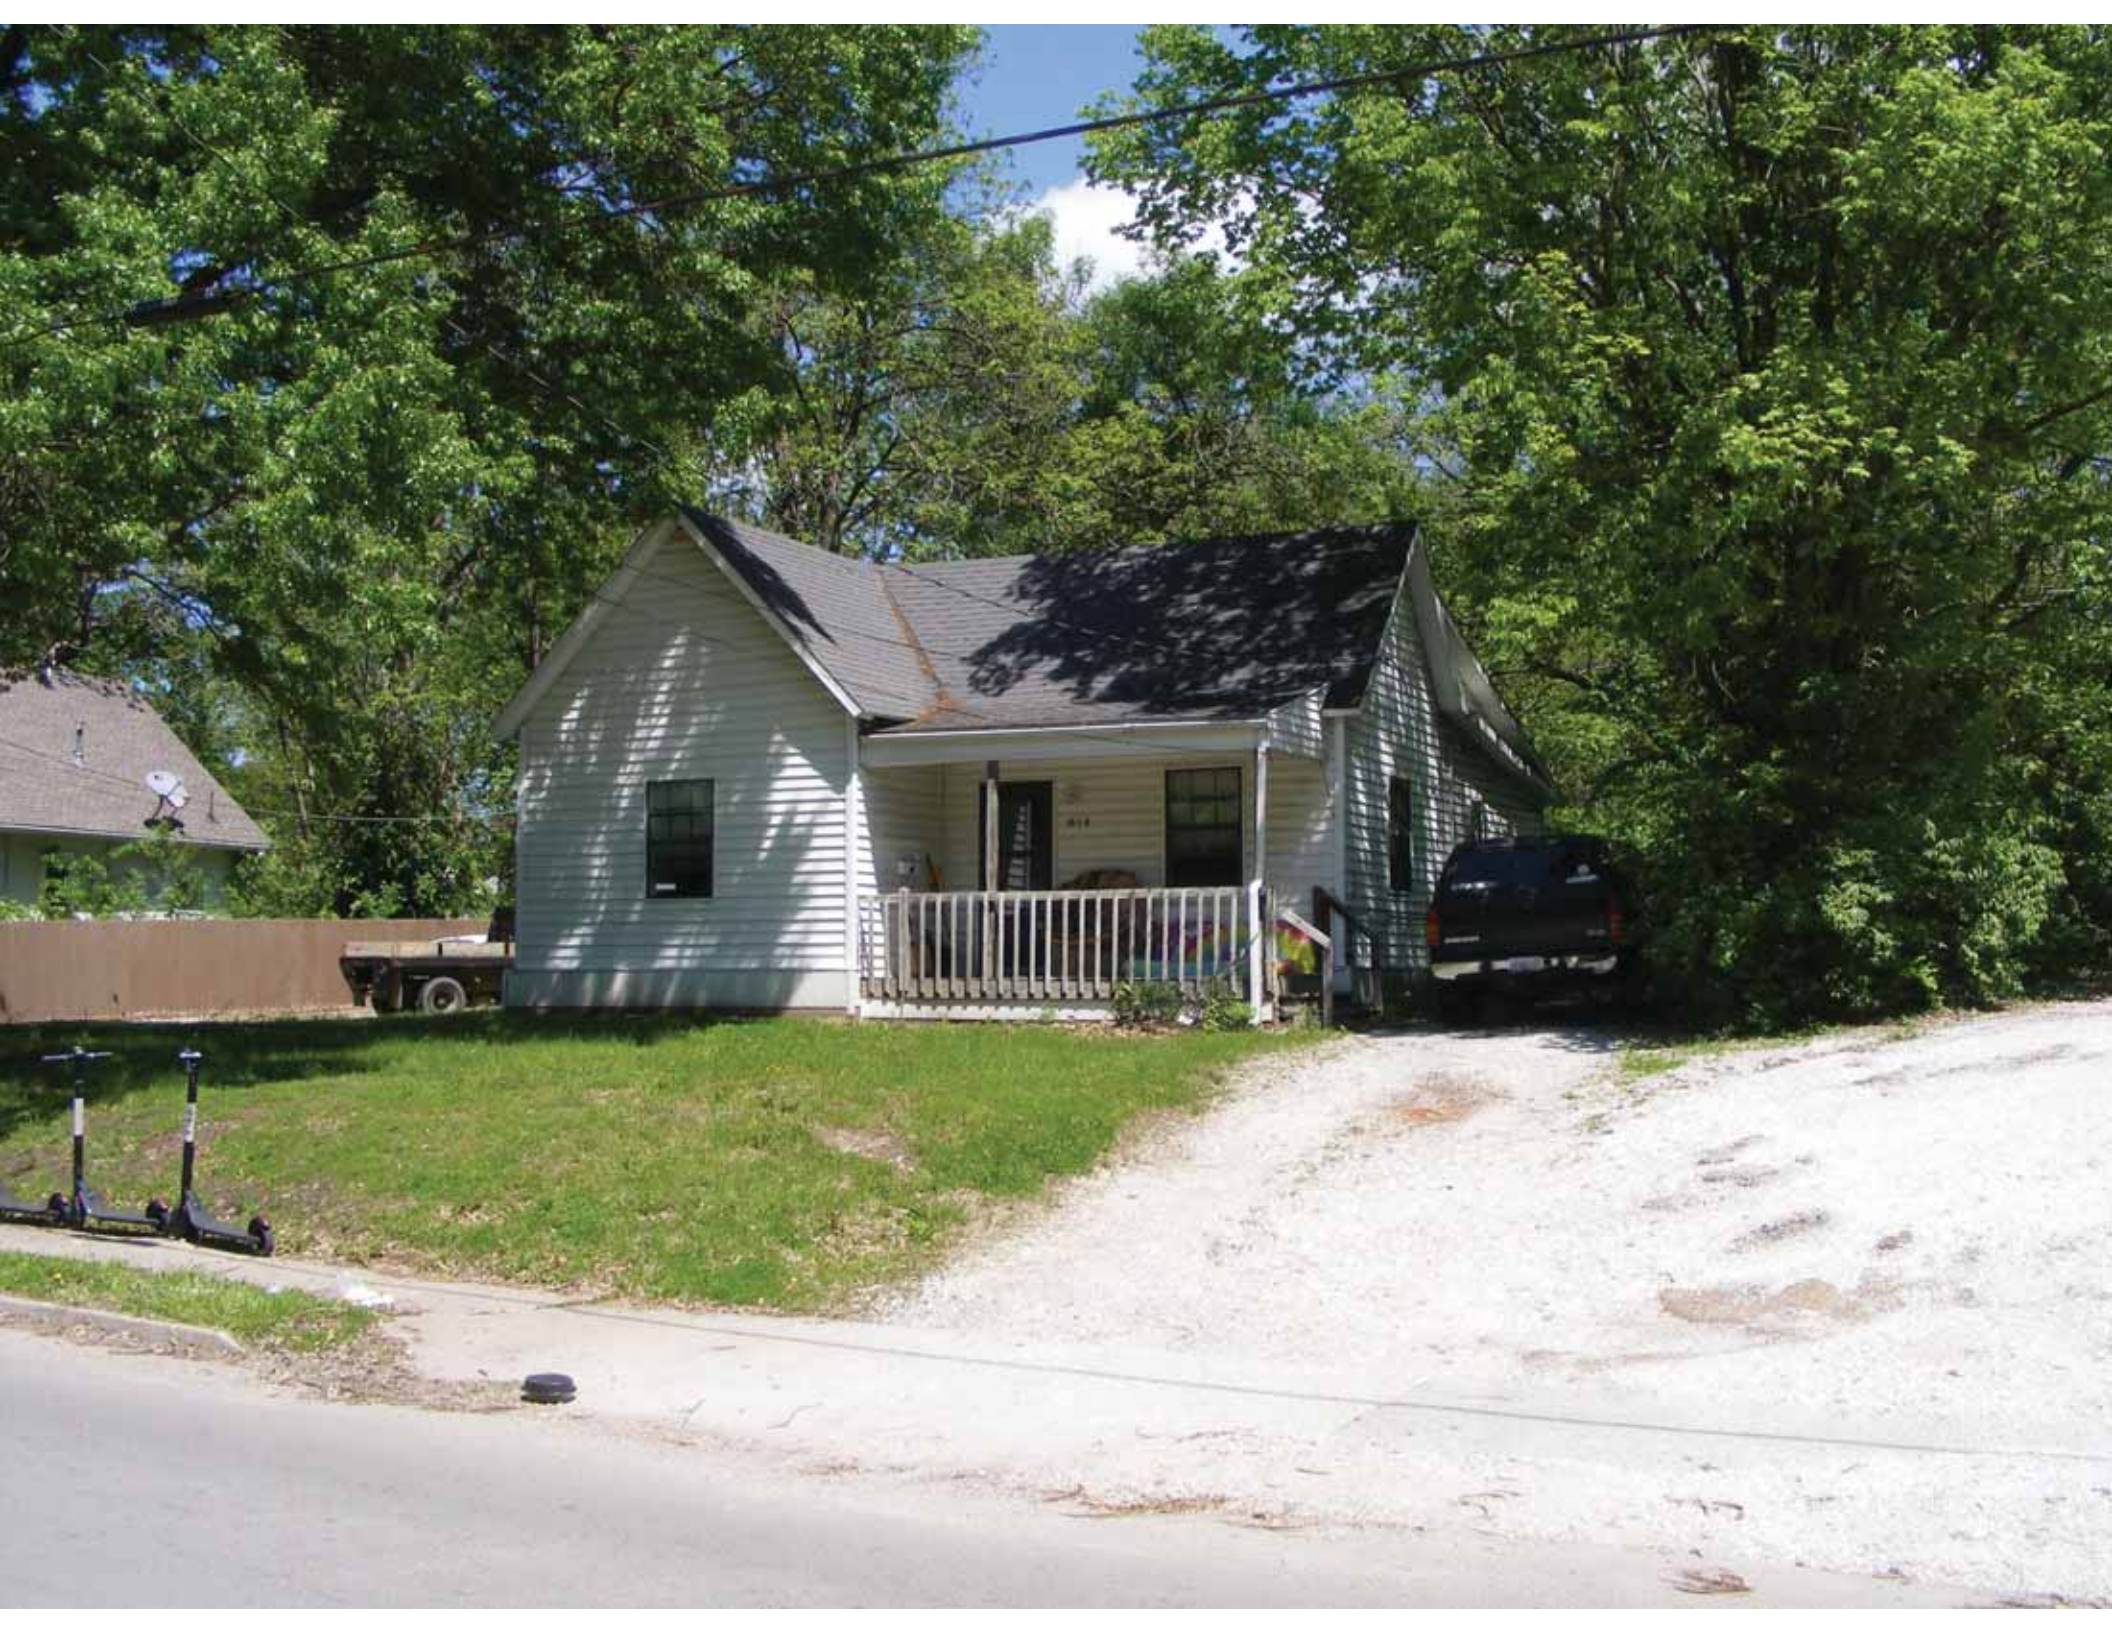
The single-story dwelling has an asphalt-shingled cross-gabled roof and rear shed wing. The dwelling is clad with vinyl siding and has a concrete foundation. The porch is situated within the area created by the front facing gabled wing. The half-width shed porch has replacement square columns and a non-original frame balustrade. Within the porch bay is a single door with a replacement storm door offset by a replacement six-over-six window. The window within the front facing gable is of similar configuration. Eaves are enclosed.

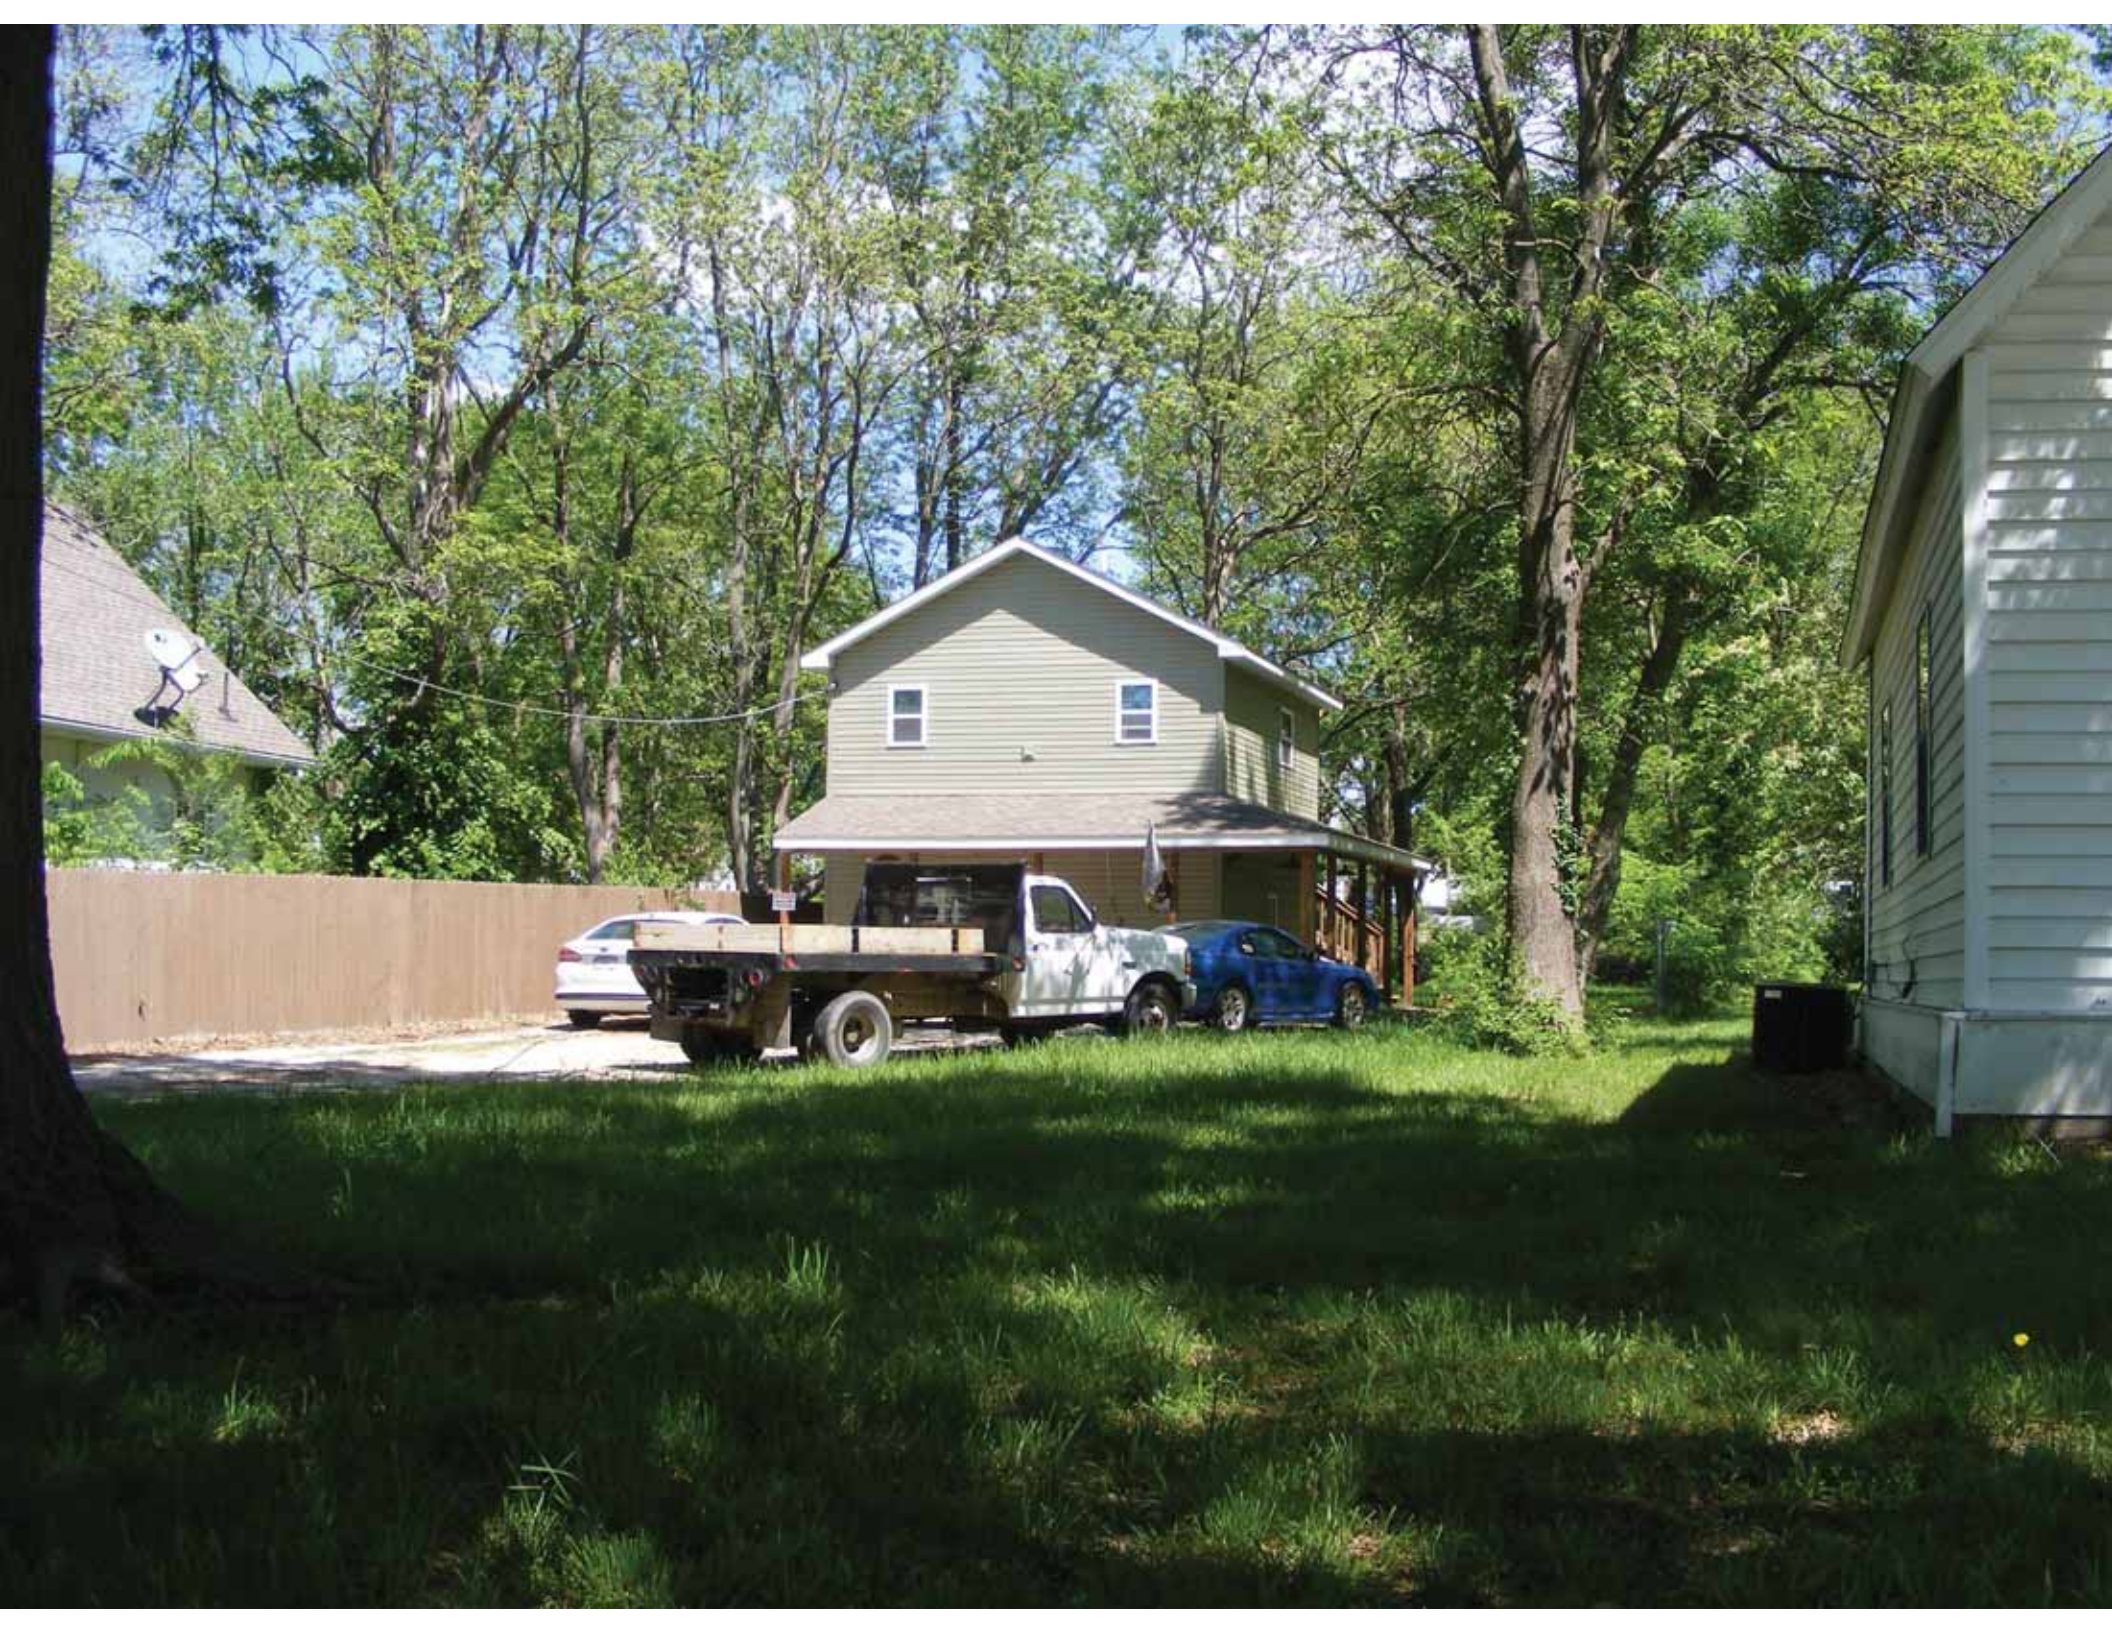
The dwelling is a two-story dwelling with an asphalt-shingled gable roof, exterior vinyl siding and a covered foundation. The dwelling has a single-story hipped wrap-around porch supported by square wood columns. The elevation facing Eighth Street (west) holds a single door with an upper light offset by a small one-over-one window. Remaining windows are of similar configuration. There is a second entry on the south elevation, within the wrap-around porch.
