MISSOURI DEPARTMENT OF NATURAL RESOURCES
STATE HISTORIC PRESERVATION OFFICE, P.O. Box 176, Jefferson City, MO 65102
ARCHITECTURAL/HISTORIC INVENTORY FORM

1. Survey No. BO-AS-011-0087		2. Survey name: North Central Columbia Survey Phase II	
3. County: Boone		4. Address (Street No.) 902	Street (name) N. Seventh Street
5. City: Columbia	Vicinity: <input type="checkbox"/>	6. Geographical Reference:	7. Township/Range/Section: T: R: S:
8. Historic name (if known):		9. Present/other name (if known):	
10. Ownership: <input checked="" type="checkbox"/> Private <input type="checkbox"/> Public		11a. Historic use (if known): Domestic/single dwelling	11b. Current use: Domestic/single dwelling

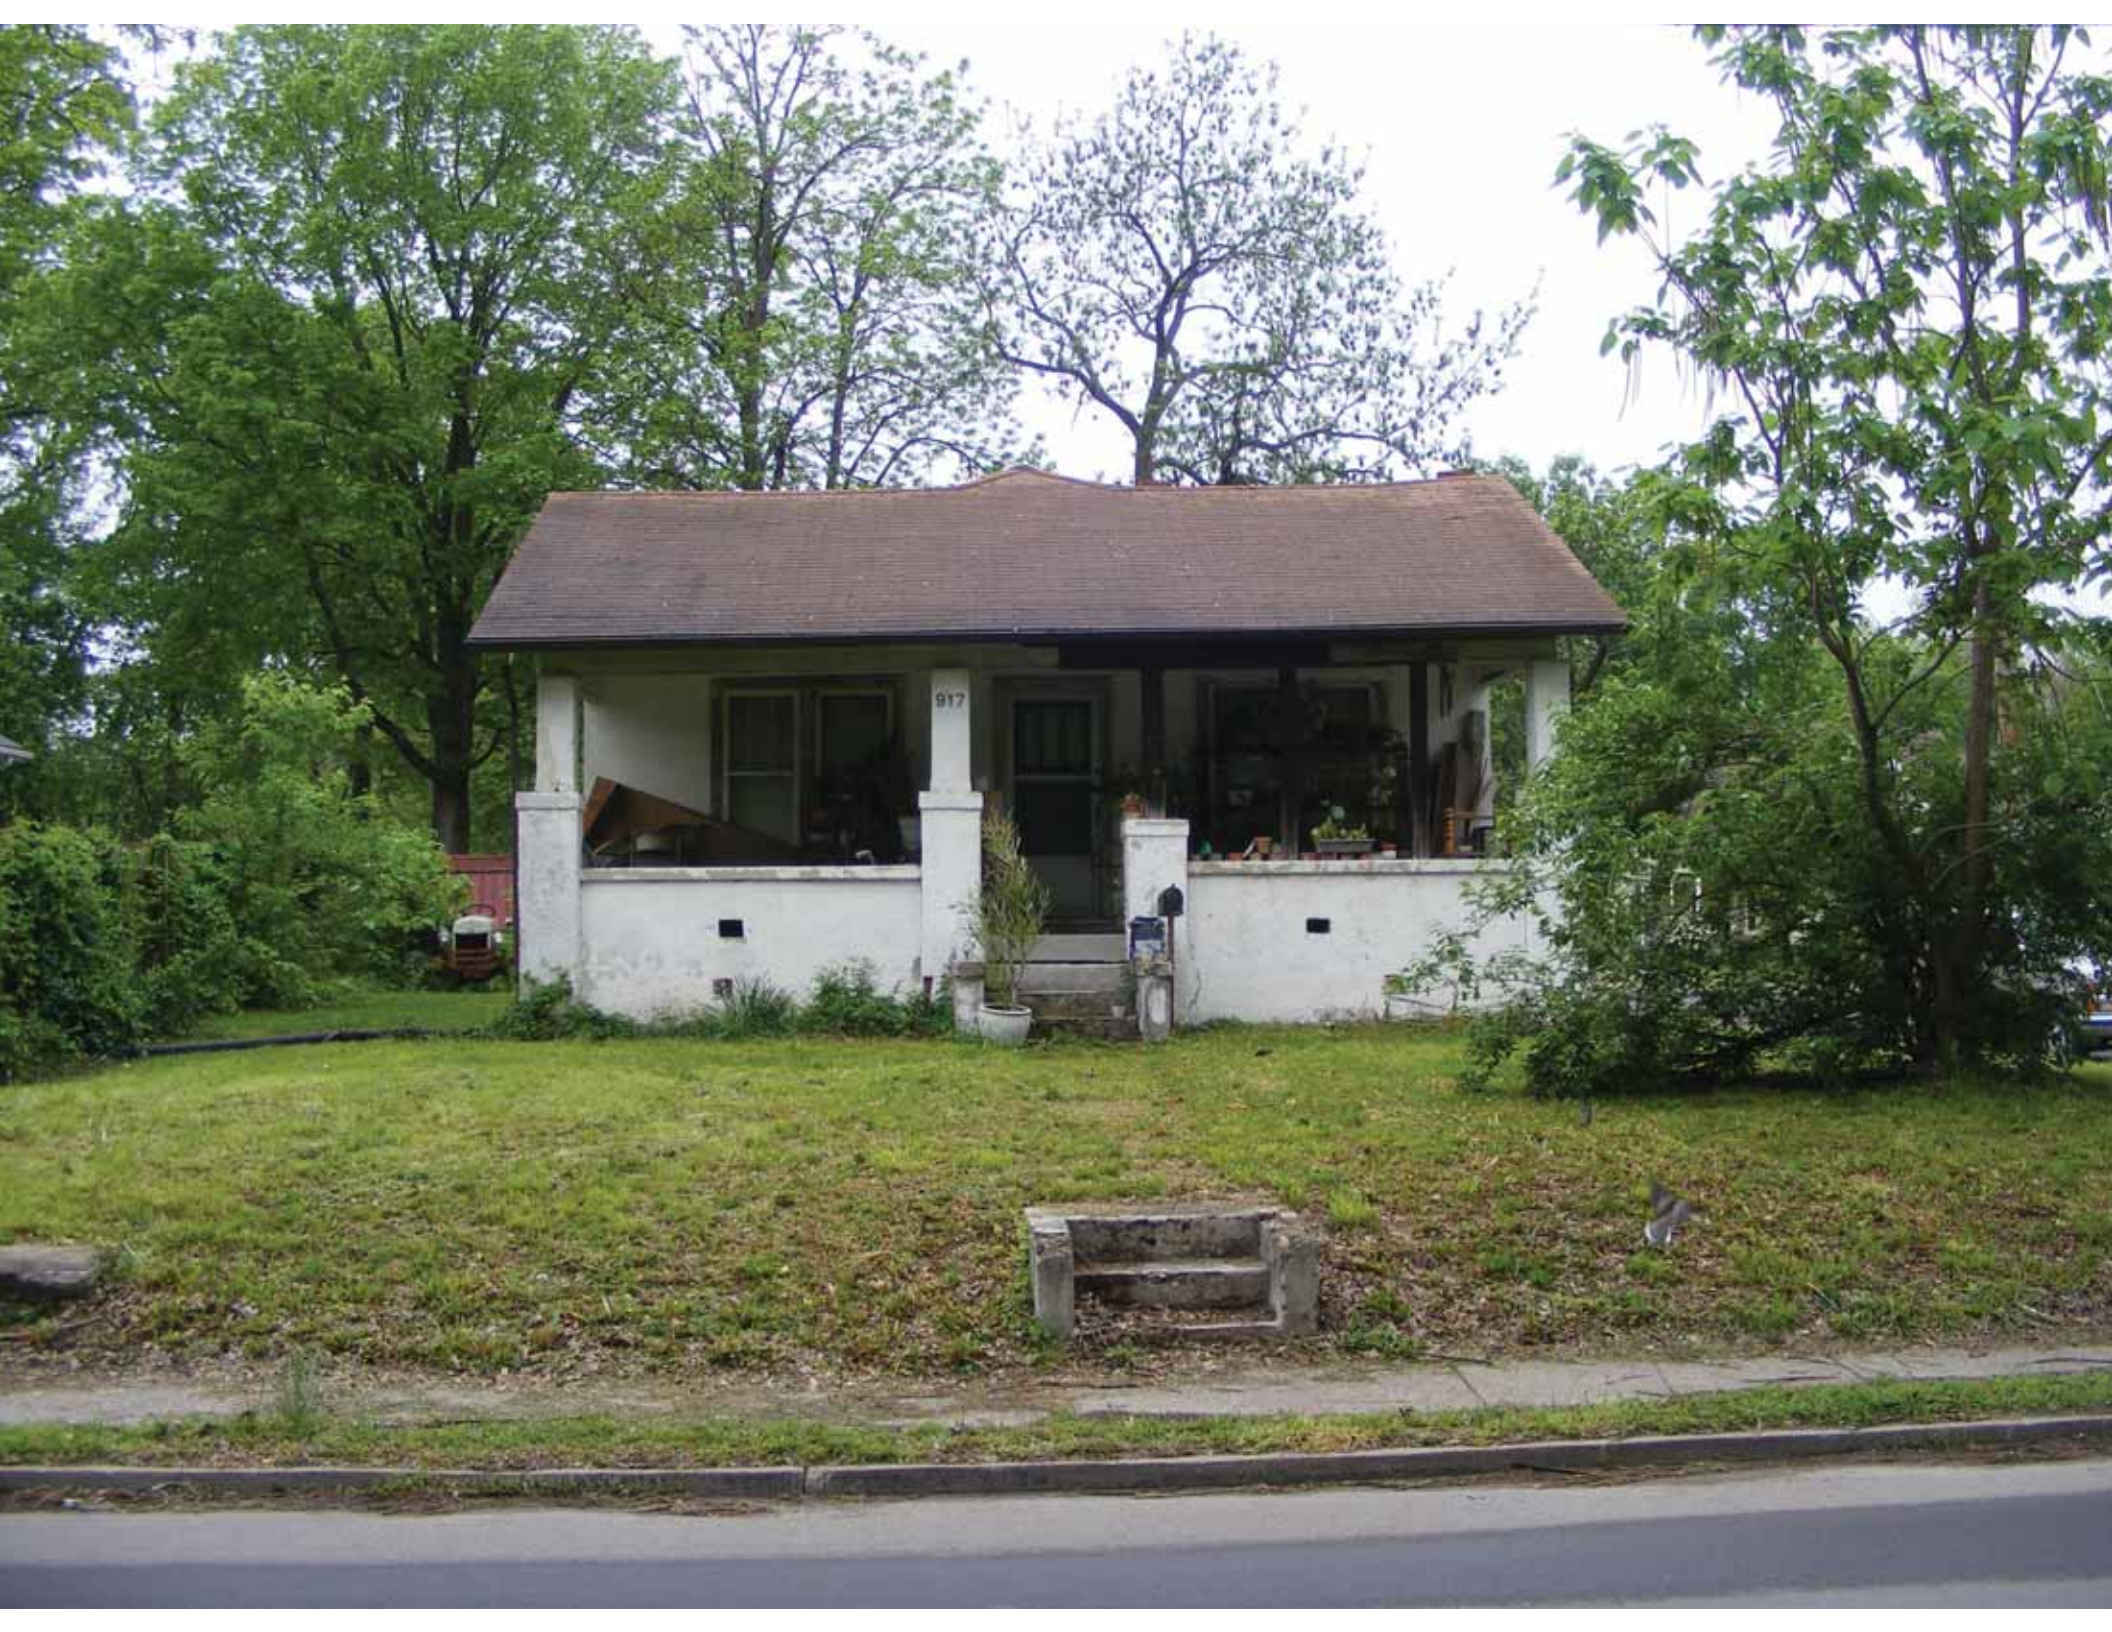
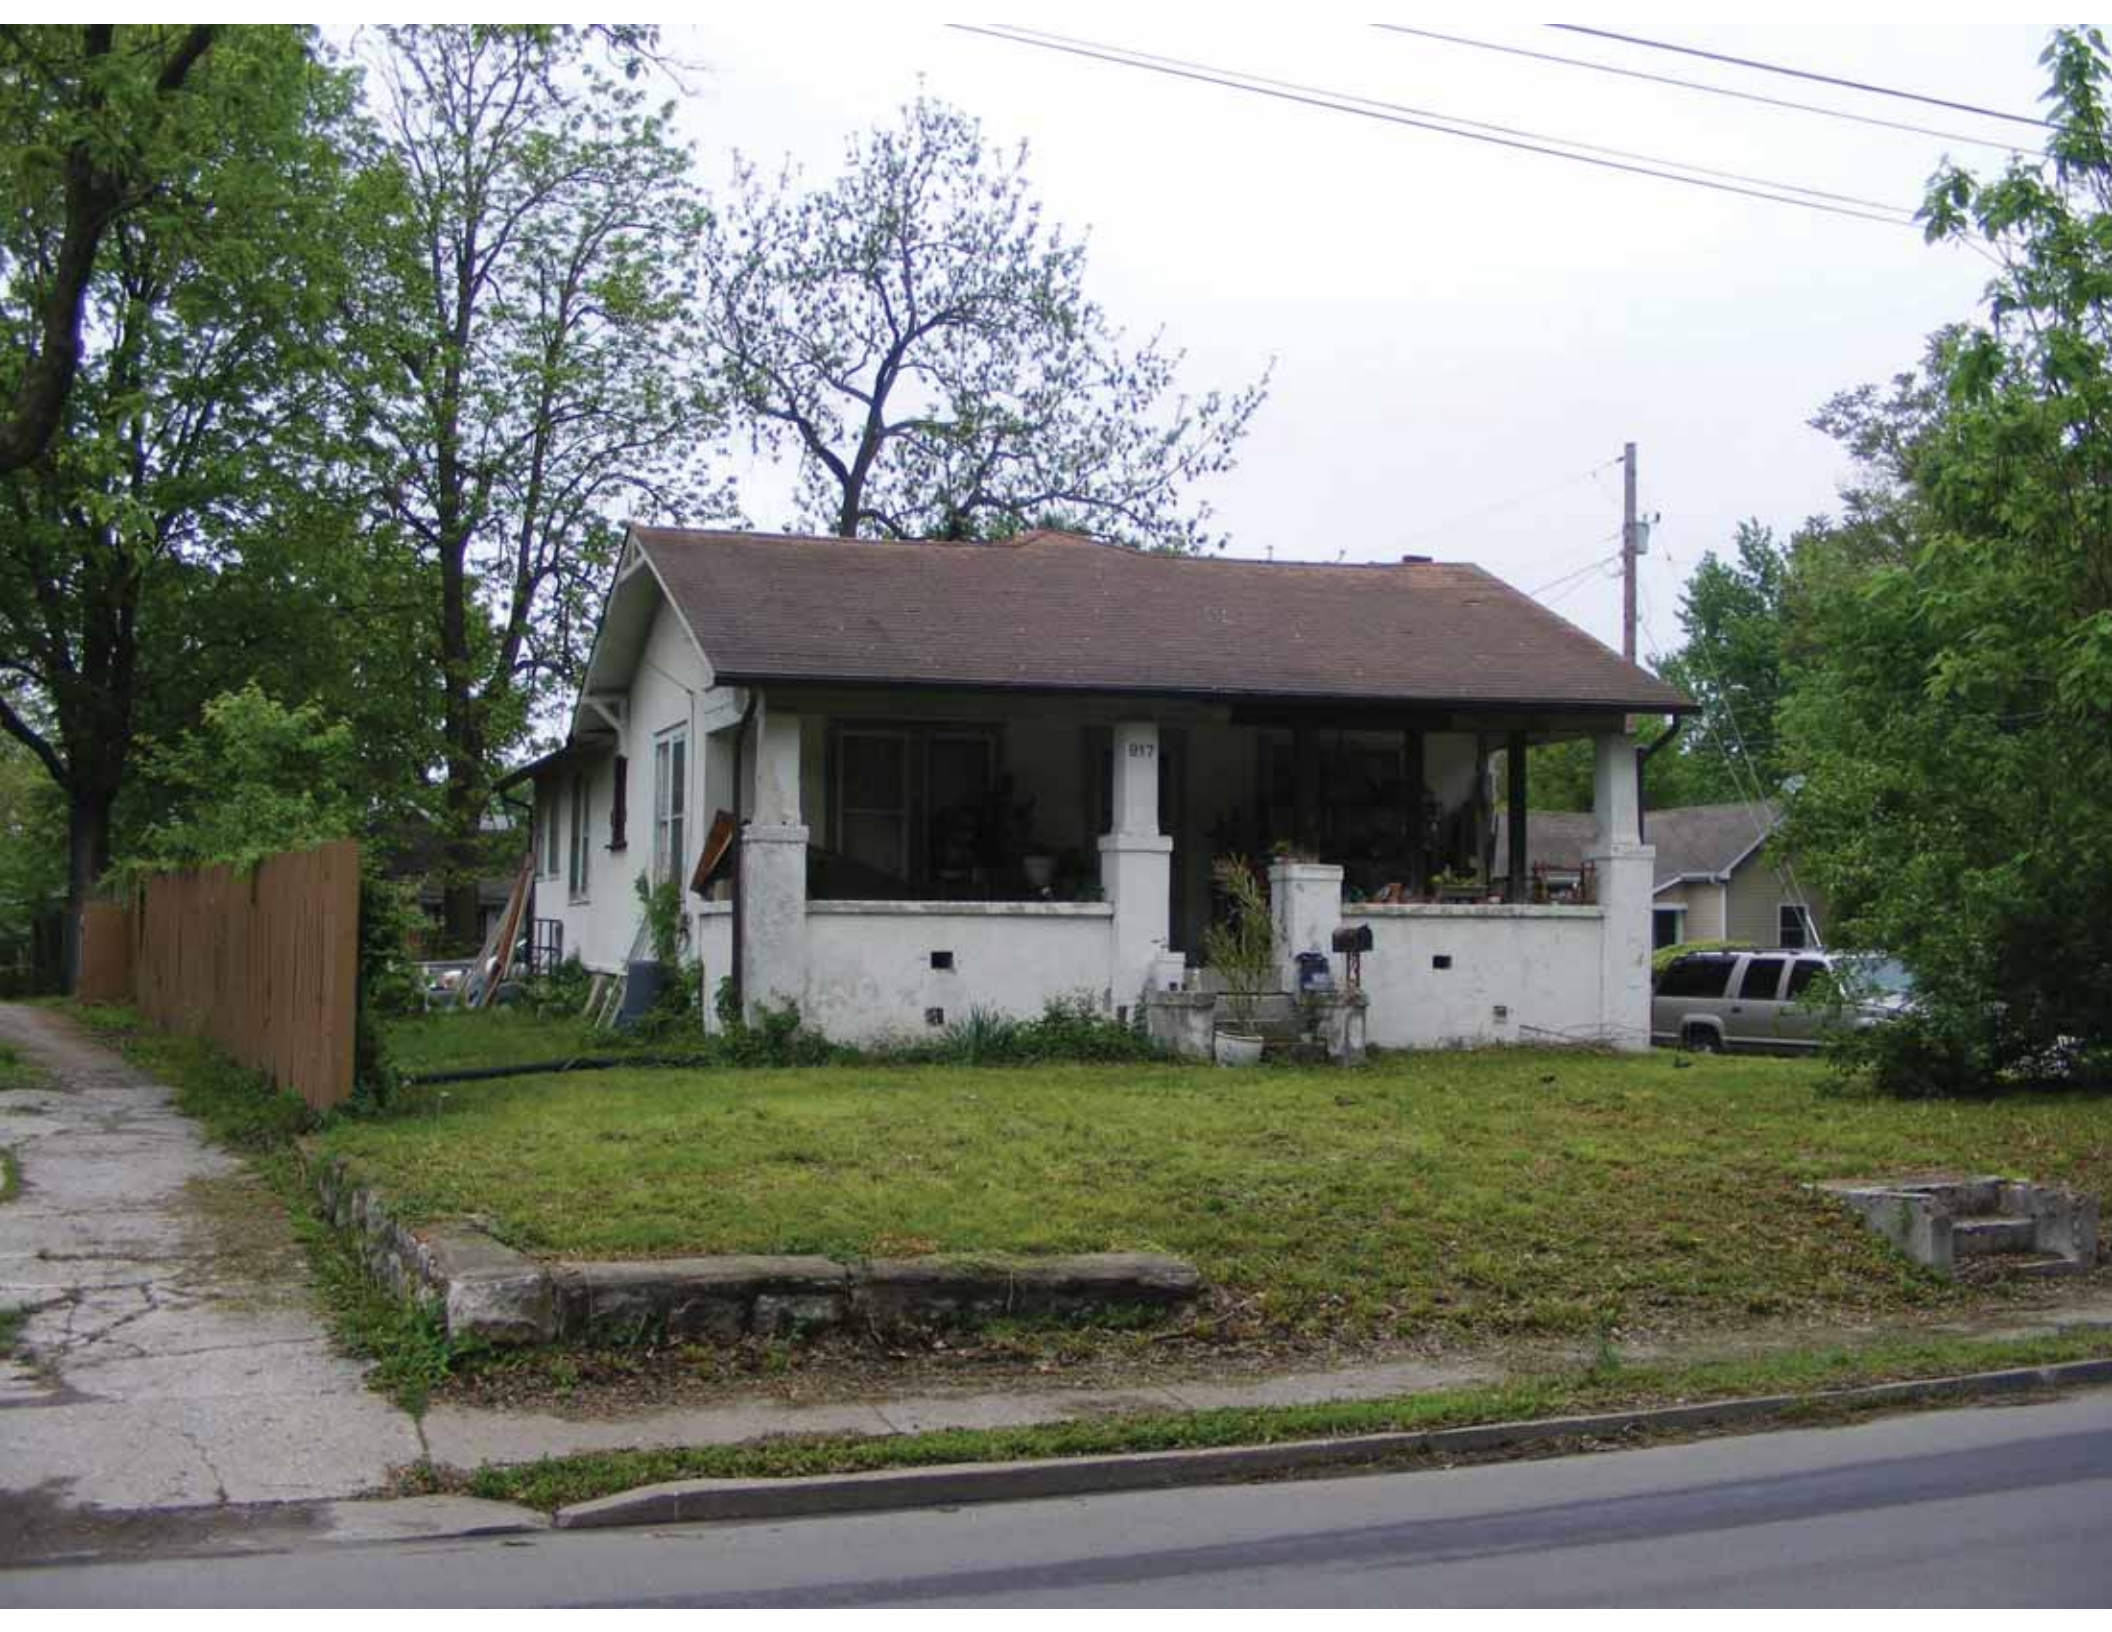
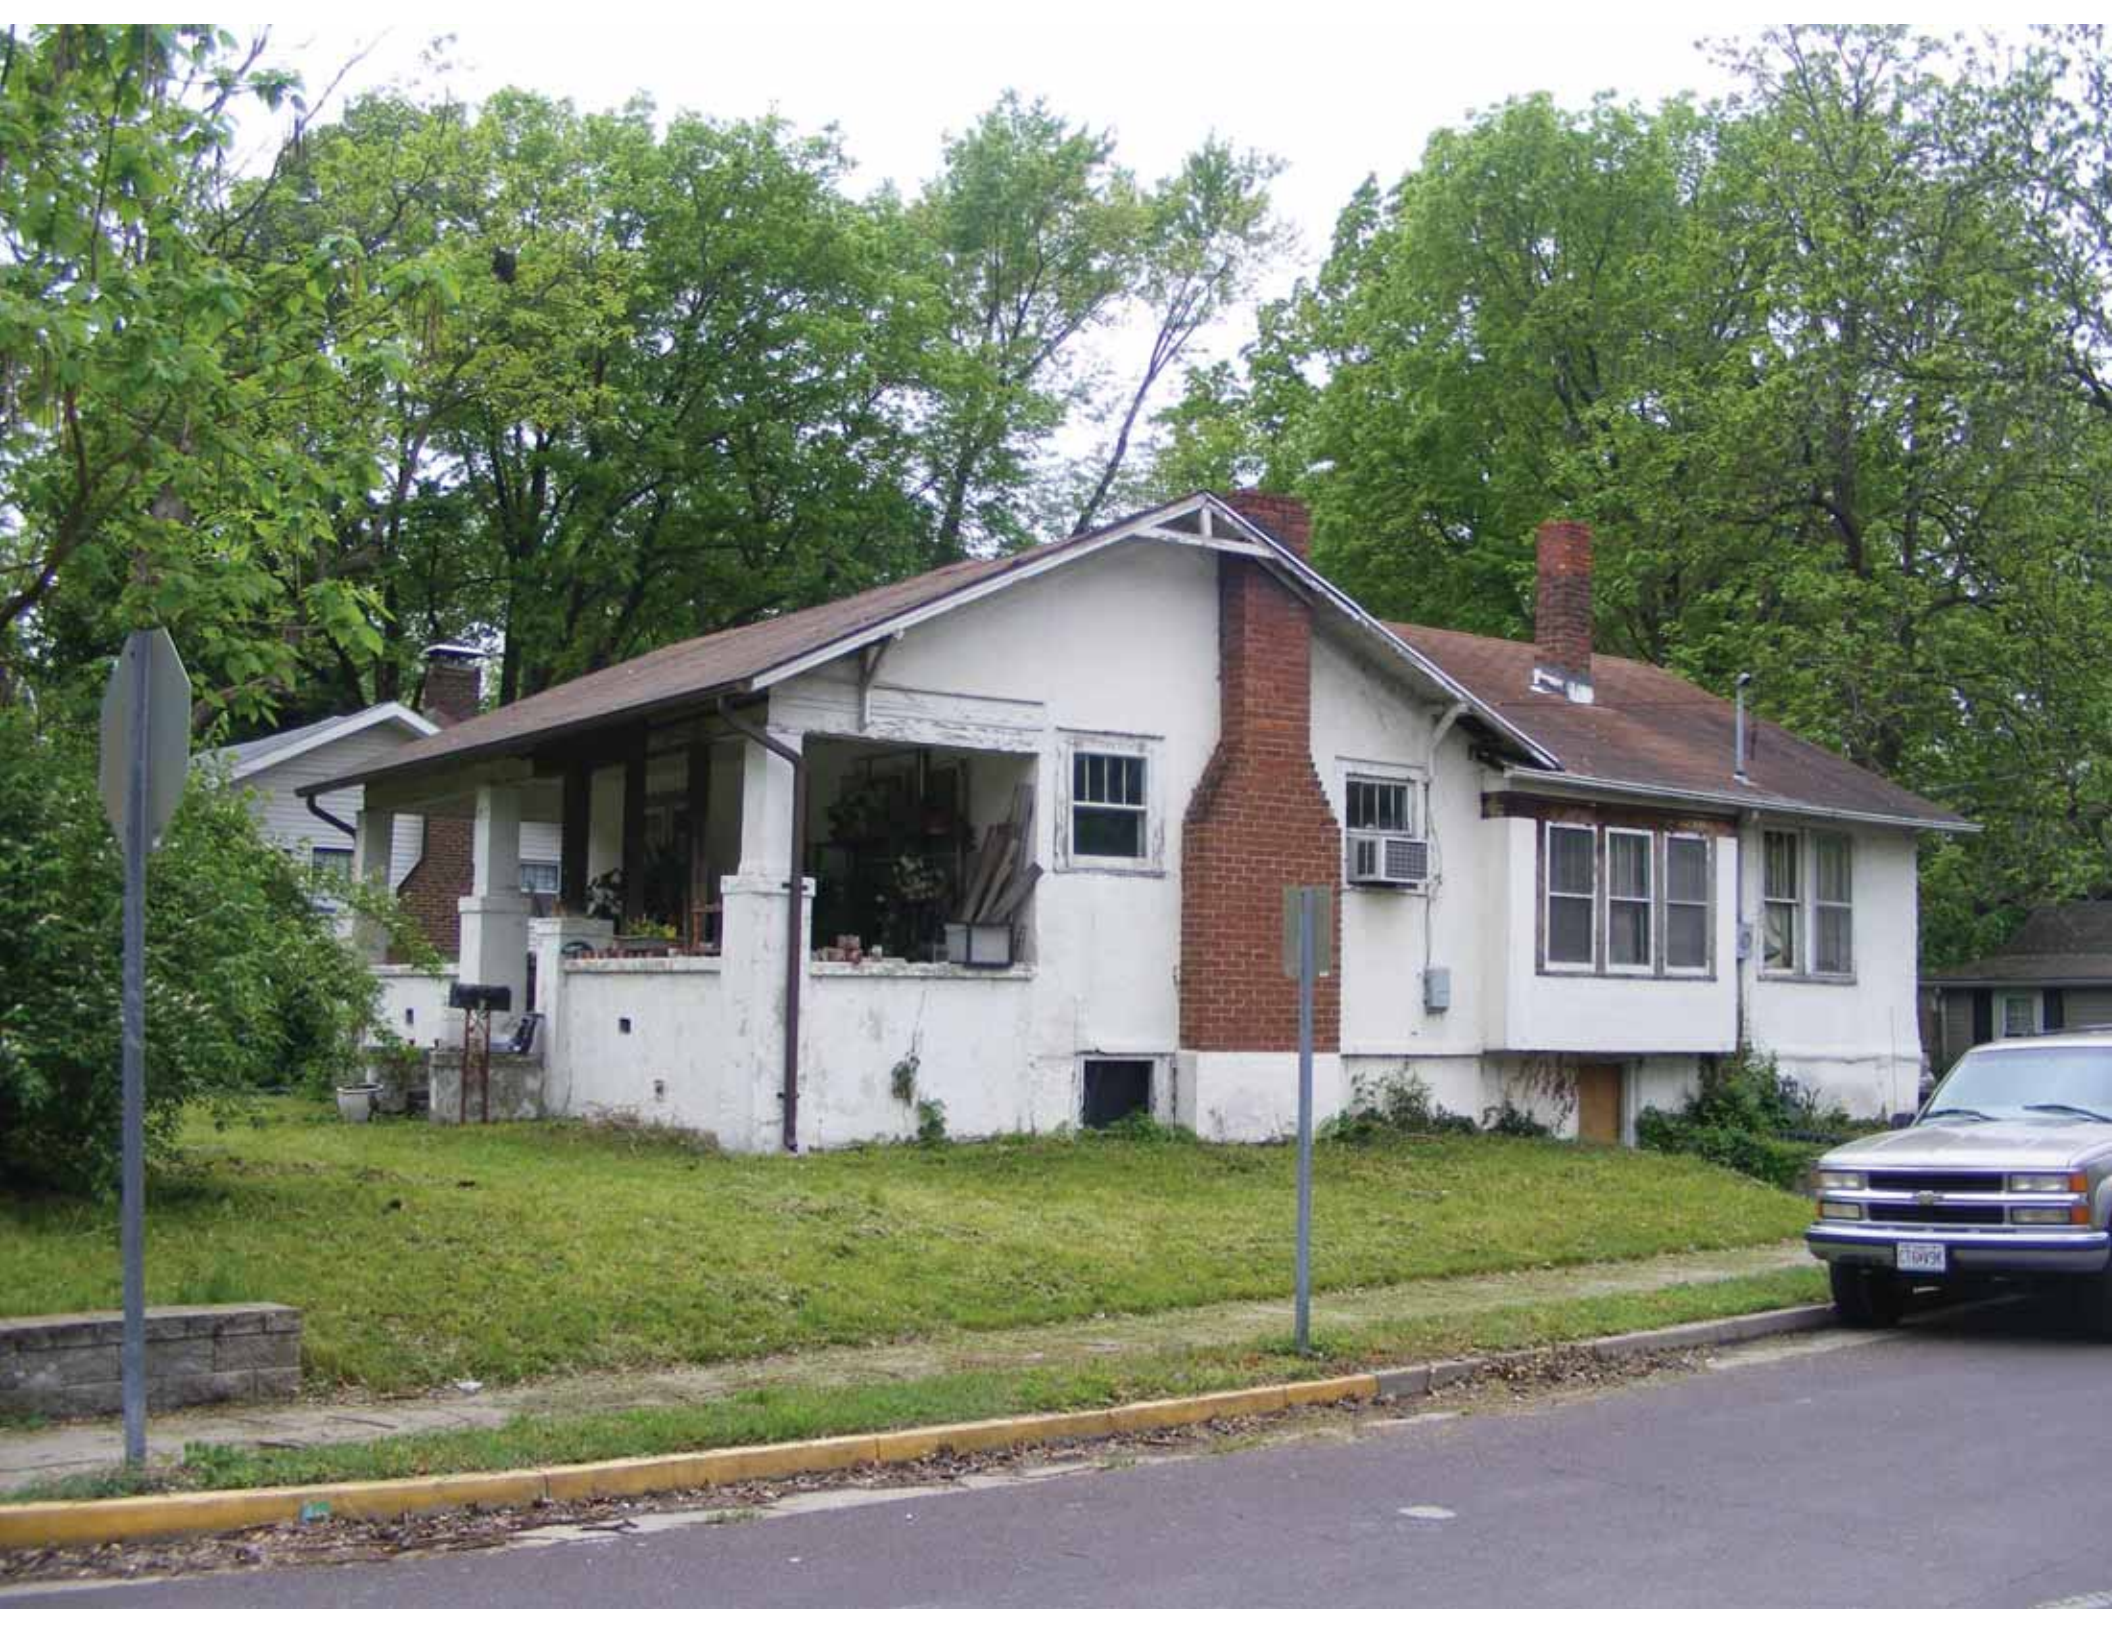
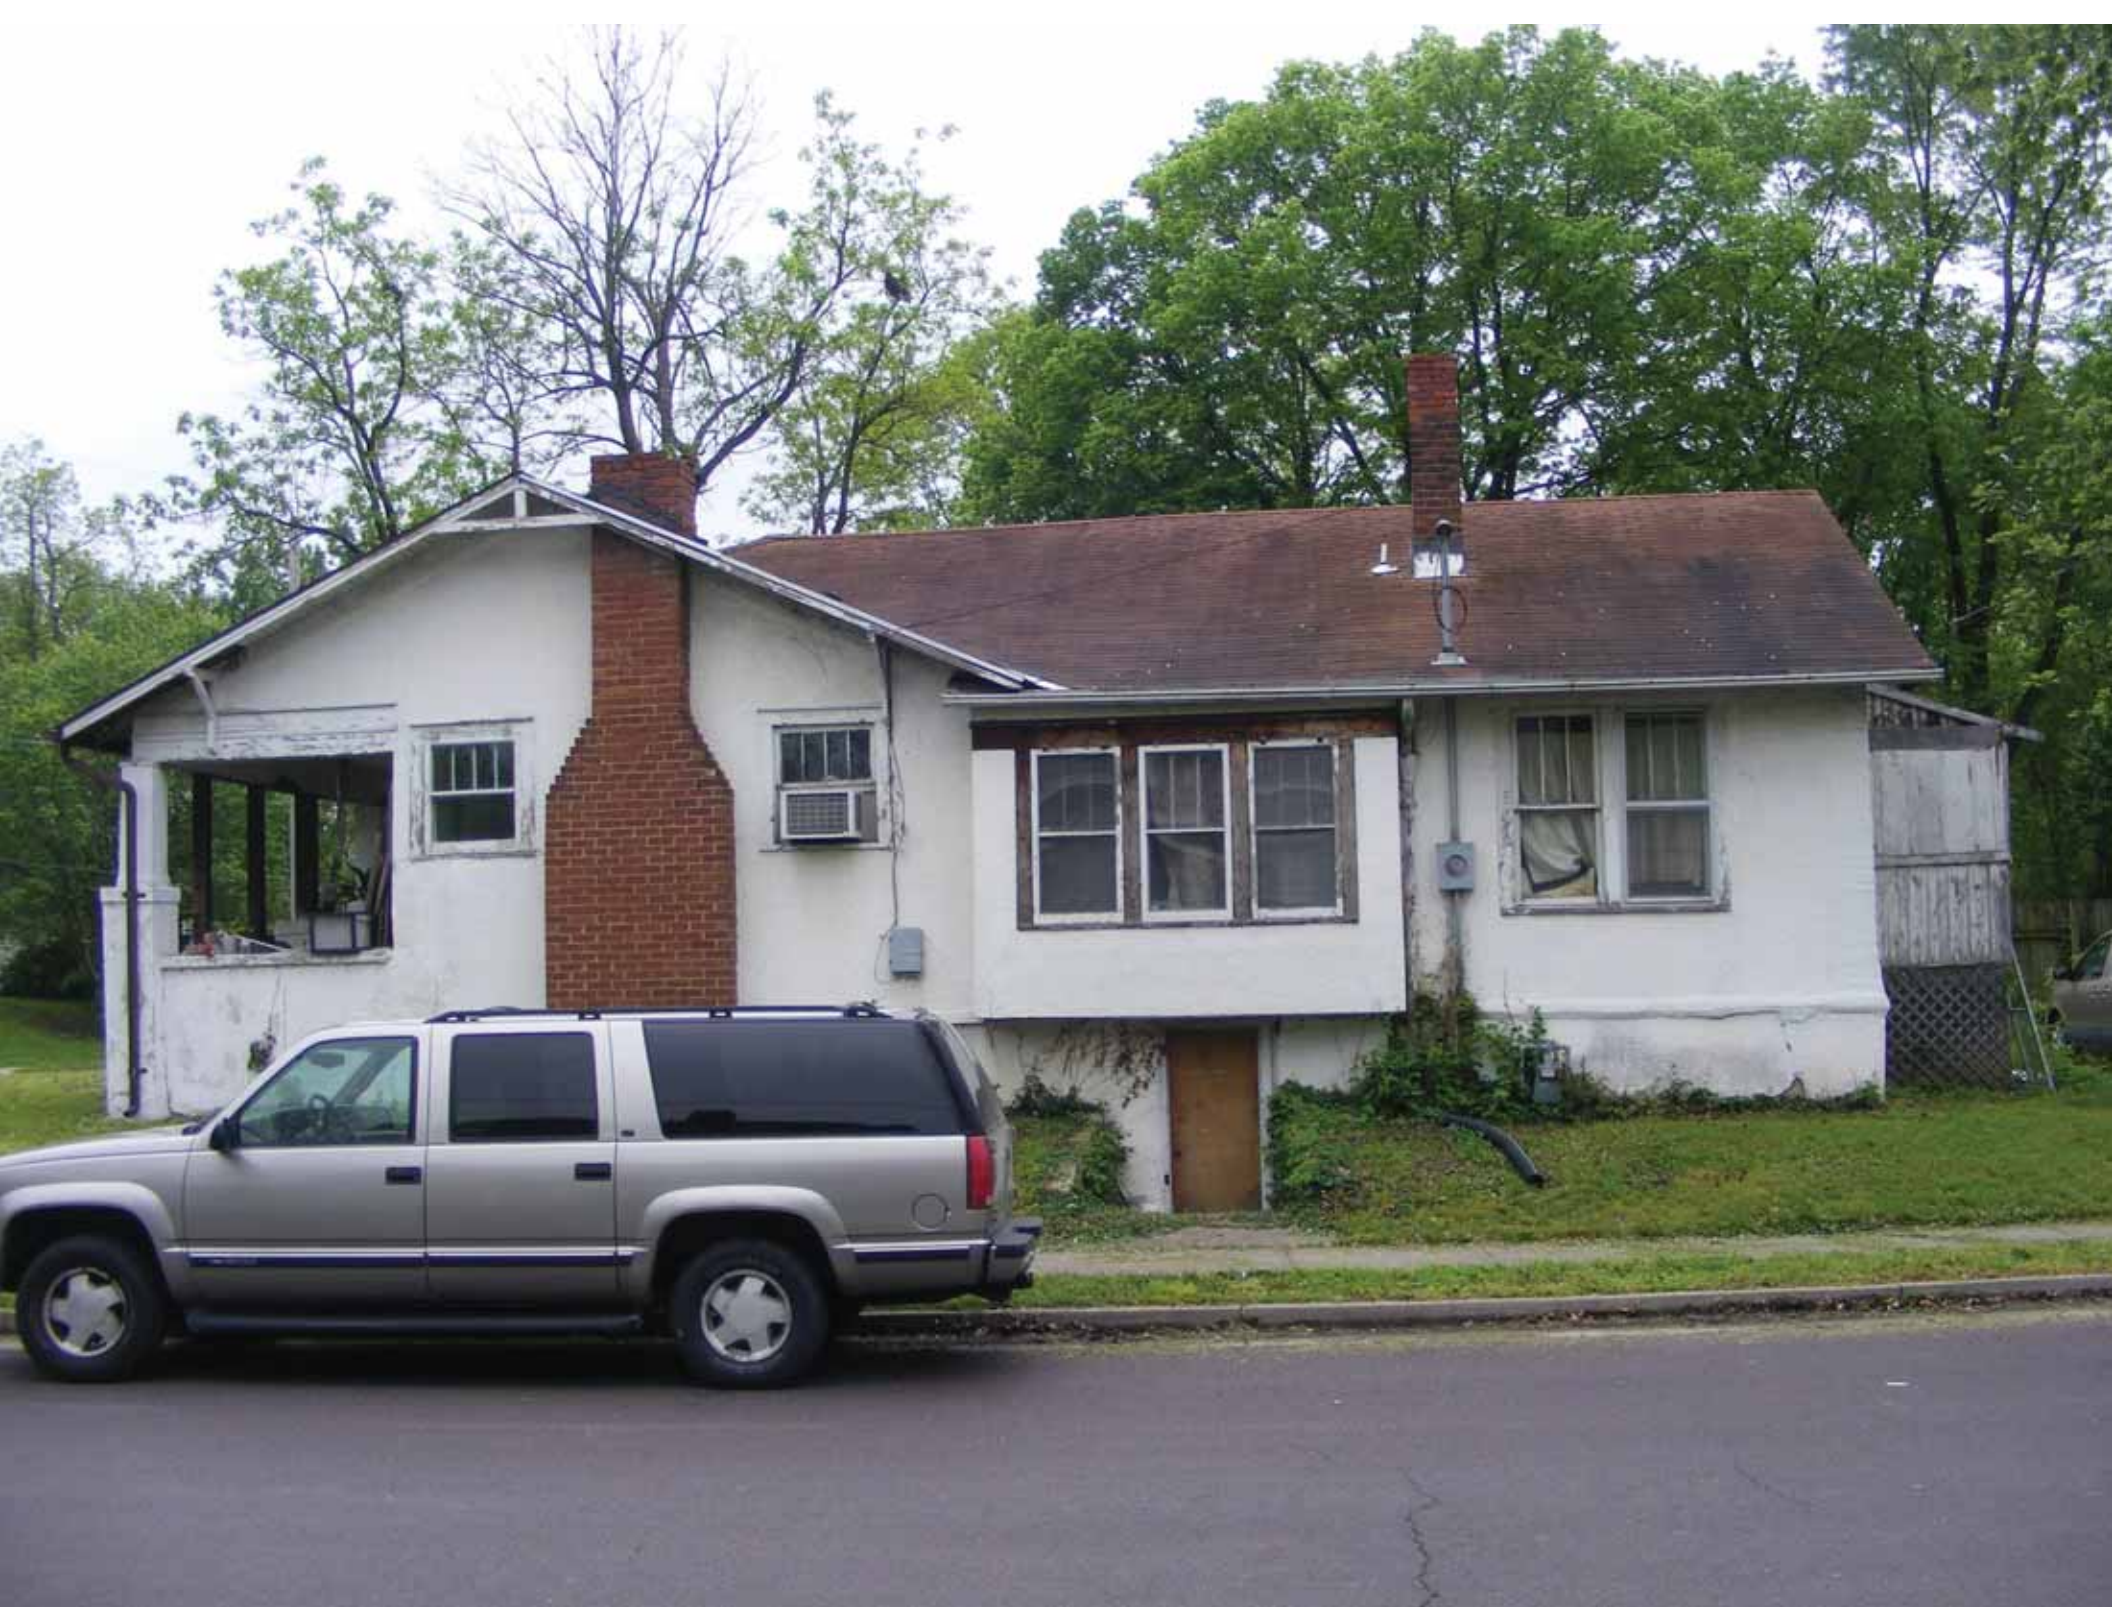
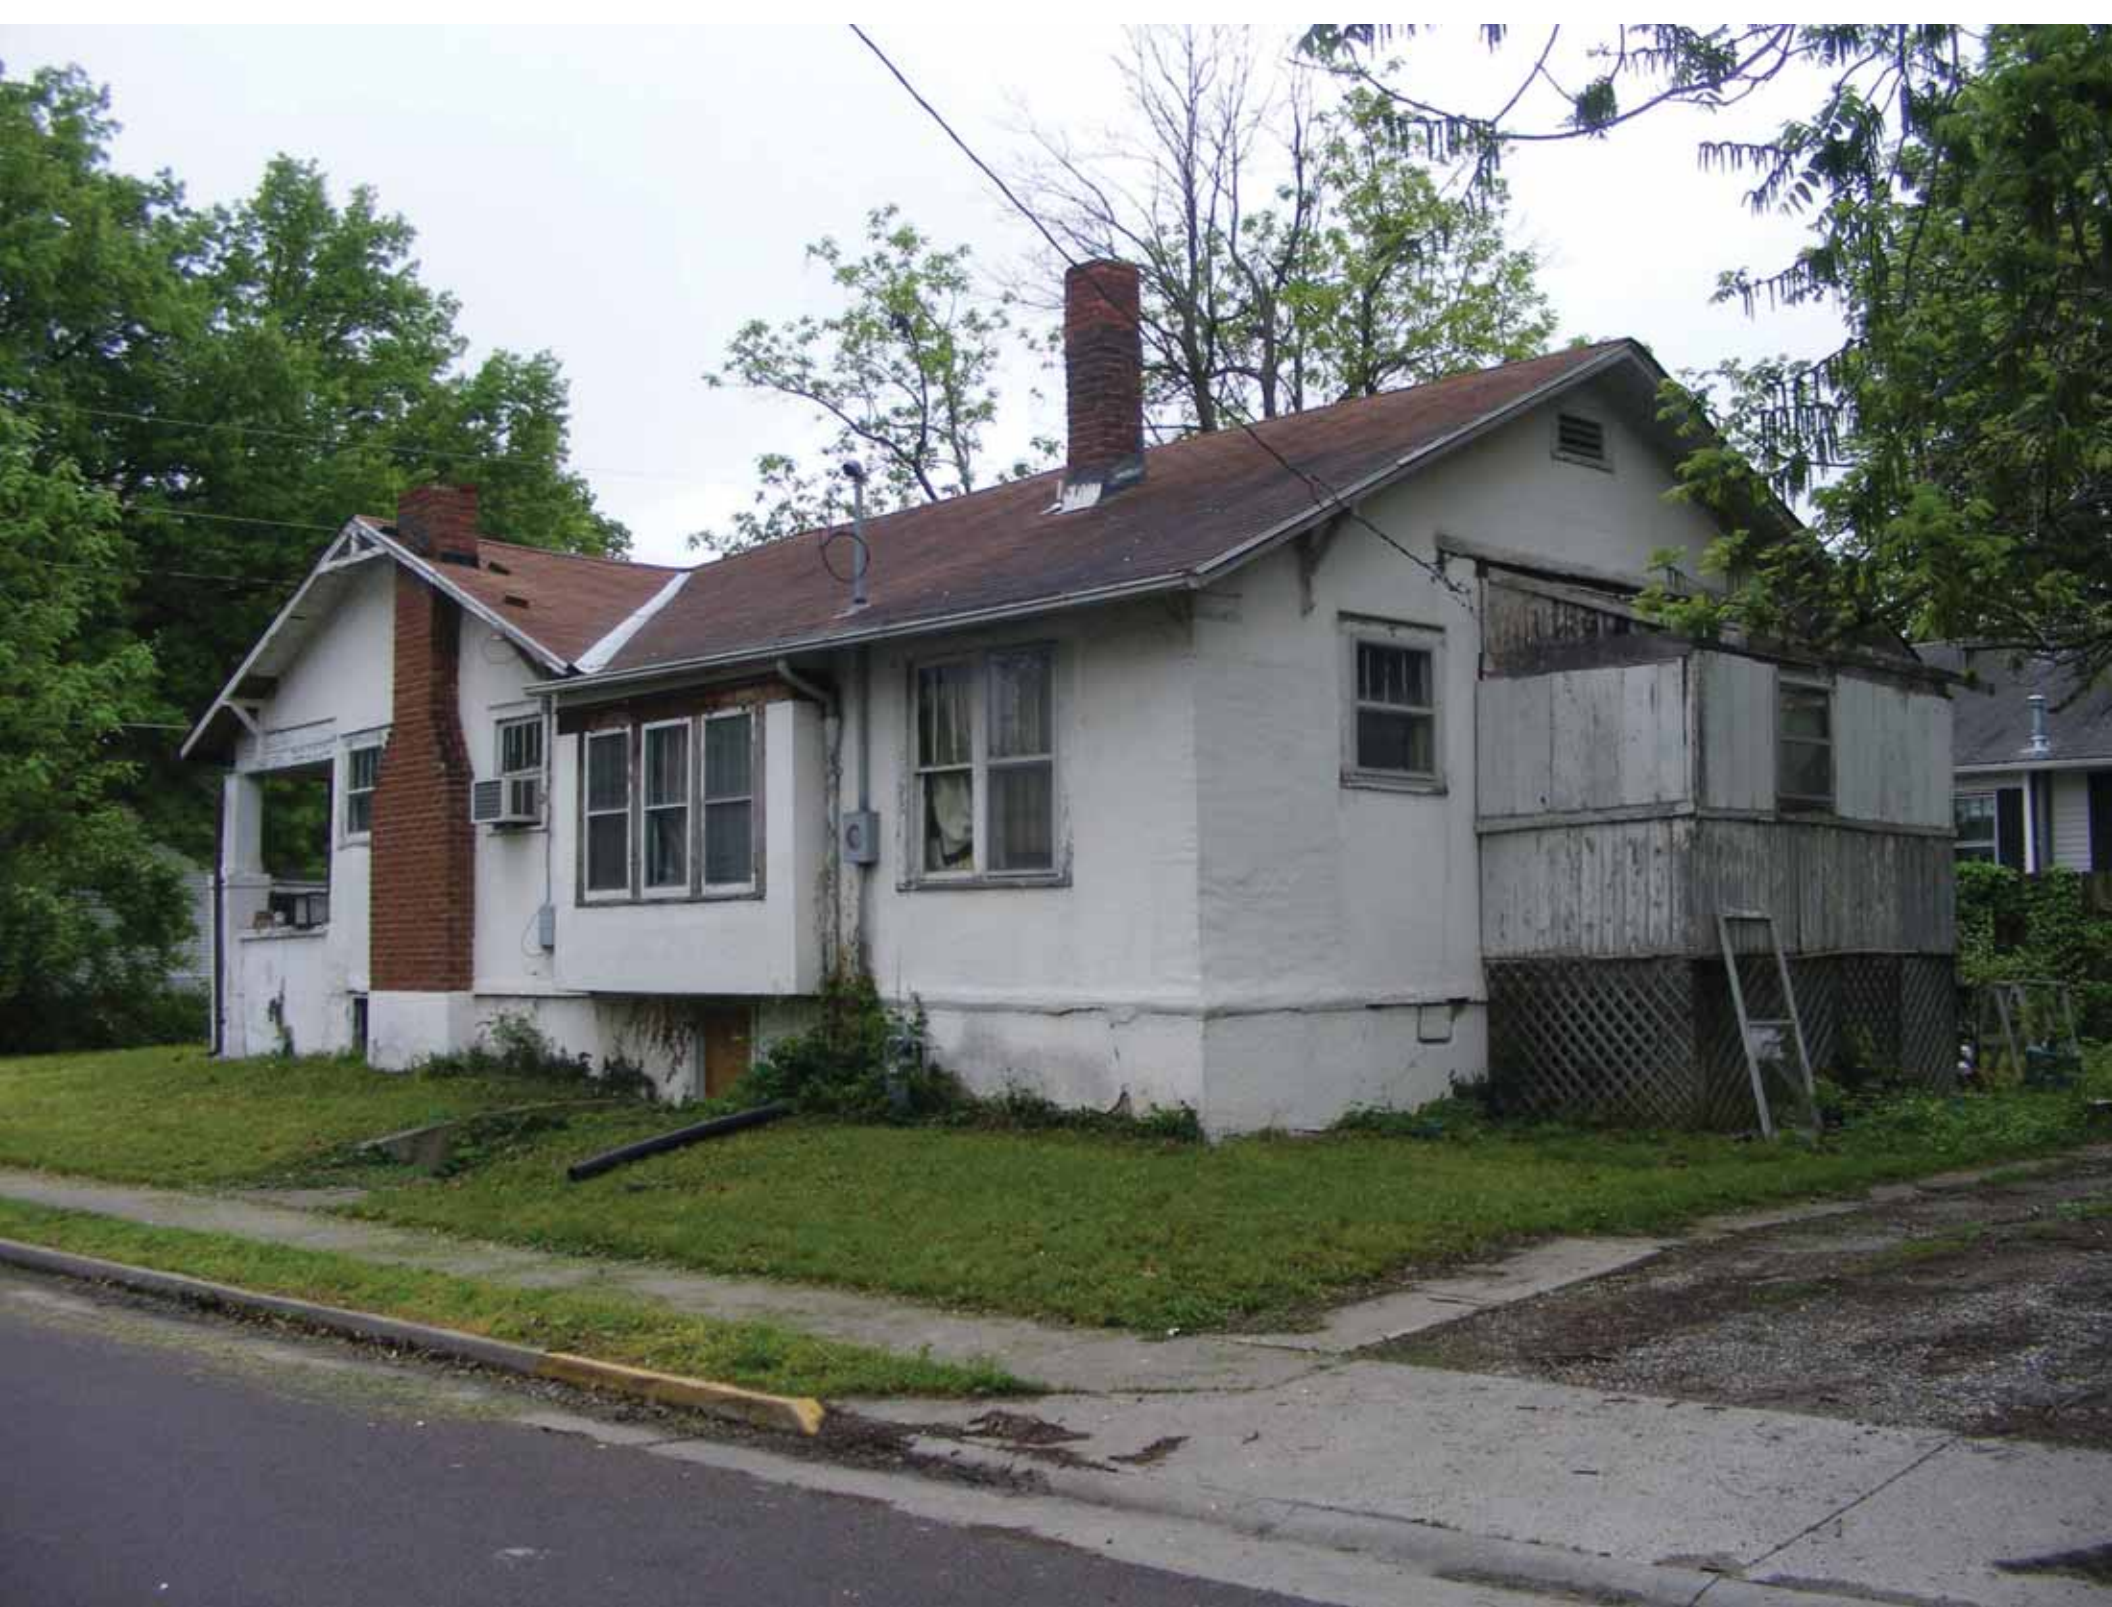
The single-family dwelling at 903 N. Eighth Street has an asphalt-shingled end-gable roof, rear gabled wing (with front small hip) and full-width façade porch supported by tapered columns on stucco clad piers. The porch is also supported on the north end by frame square wood columns. The porch is surrounded by an original concrete low wall that extends between the piers. The dwelling has exterior stucco on all elevations. The entry is centered in the porch bay and holds an original Craftsman style three-light door. The entry bay is flanked by paired original three-over-one windows. Other windows are of three- and four-over-one configuration. Eaves have knee brace brackets below the roofline overhang. At the north end of the dwelling is an exterior brick chimney. There is a second interior brick chimney in the rear gabled wing. The dwelling appears to be identical in plan to 913 N. Eighth Street.

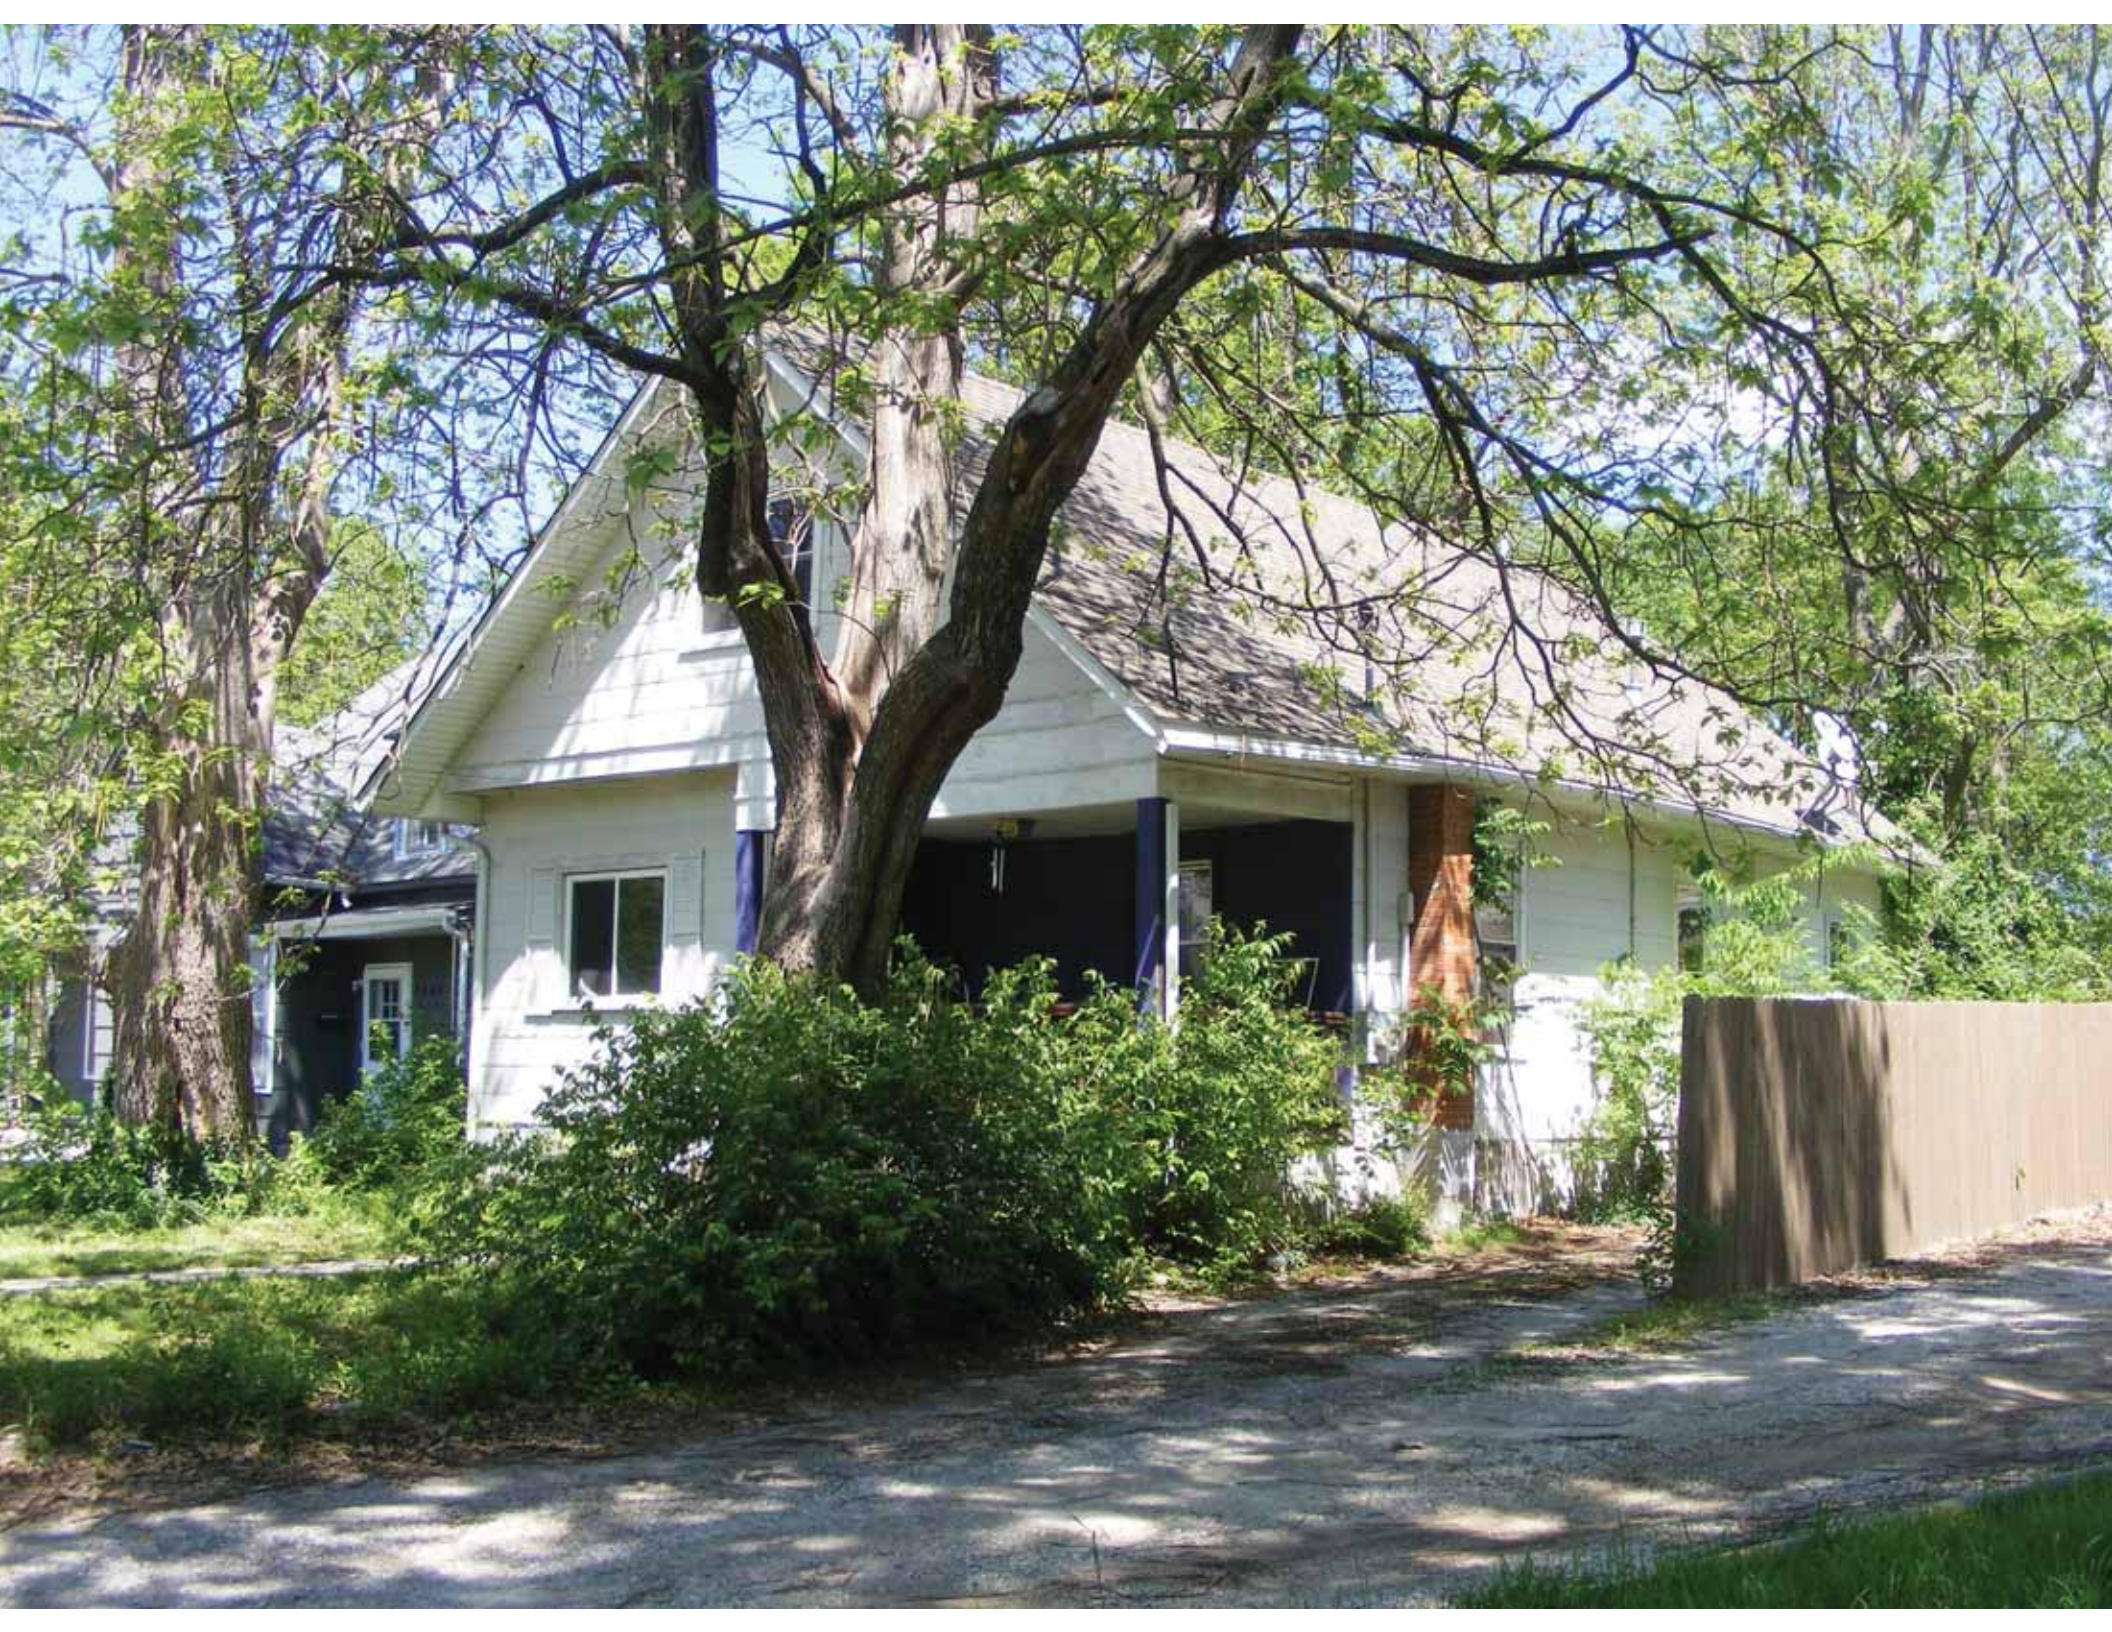
The gable-front single-family dwelling has an asphalt-shingled roof, exterior asbestos shingle siding and a concrete foundation. The primary (east) elevation has been altered with enclosure of the south end of the primary open porch, which is supported by two square wood columns. A two-light sliding window is set within the east elevation of the enclosed area and the primary entry is on the north elevation of the enclosed porch. The original elevation within the porch bay holds an original six-over-one window. The porch has a non-original frame balustrade. The front facing gable holds paired one-over-one windows. Most windows are of this configuration. An exterior end brick chimney on the north elevation has been removed above the roofline.
