MISSOURI DEPARTMENT OF NATURAL RESOURCES
STATE HISTORIC PRESERVATION OFFICE, P.O. Box 176, Jefferson City, MO 65102
ARCHITECTURAL/HISTORIC INVENTORY FORM

1. Survey No. BO-AS-011-0087		2. Survey name: North Central Columbia Survey Phase II	
3. County: Boone		4. Address (Street No.) 902	Street (name) N. Seventh Street
5. City: Columbia	Vicinity: <input type="checkbox"/>	6. Geographical Reference:	7. Township/Range/Section: T: R: S:
8. Historic name (if known):		9. Present/other name (if known):	
10. Ownership: <input checked="" type="checkbox"/> Private <input type="checkbox"/> Public		11a. Historic use (if known): Domestic/single dwelling	11b. Current use: Domestic/single dwelling

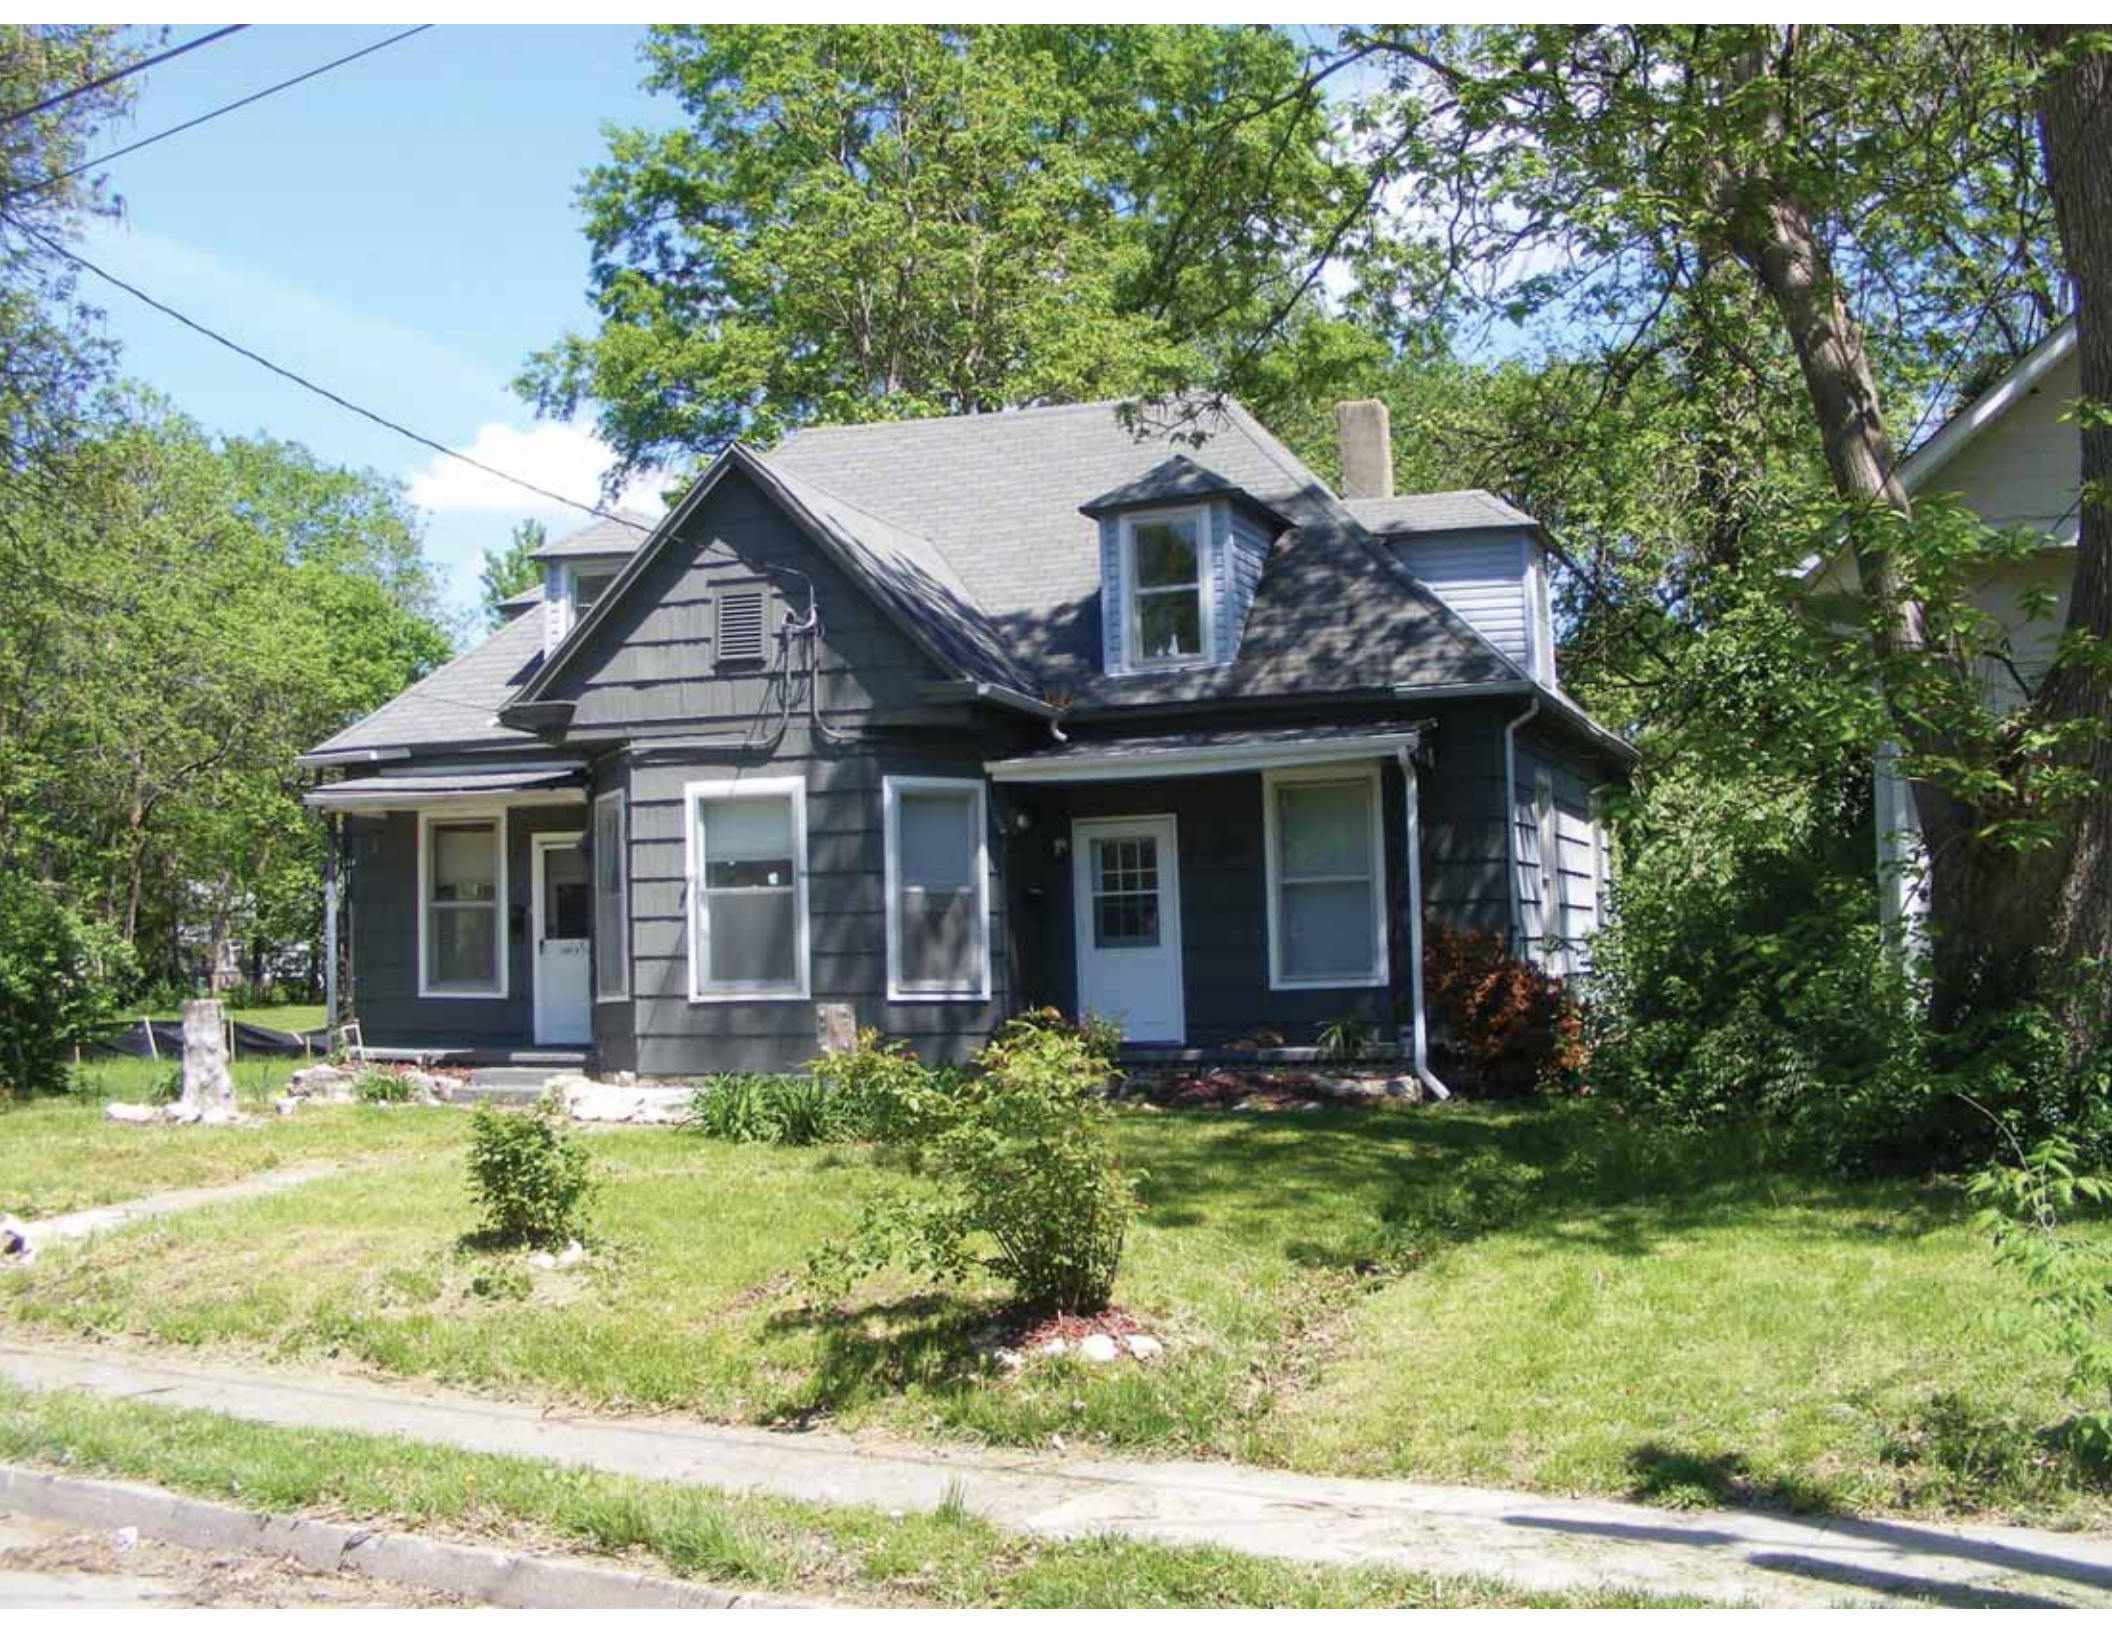
The dwelling has a steeply pitched hipped roof clad with asphalt shingles, exterior asbestos siding (lower floor) and vinyl clad hipped dormers. The foundation is stone. At the center of the façade is an original projecting one-story gabled wing with gable returns. The gable field holds a louvered vent. The three walls of the projecting wing each hold a single double-hung (one-over-one) window. Flanking the central projecting bay, the façade features small shed porches on either side (north and south). Each small porch is supported by a single wrought iron replacement column. Within the porch bays are single-light original (north) and six-light (replacement) doors. The doors are each offset by a single window (1/1). Hipped dormers are situated on all elevations. Each dormer holds a one-over-one window. Two interior chimneys on the rear roofline are sheathed with concrete. The rear roofline is shed.

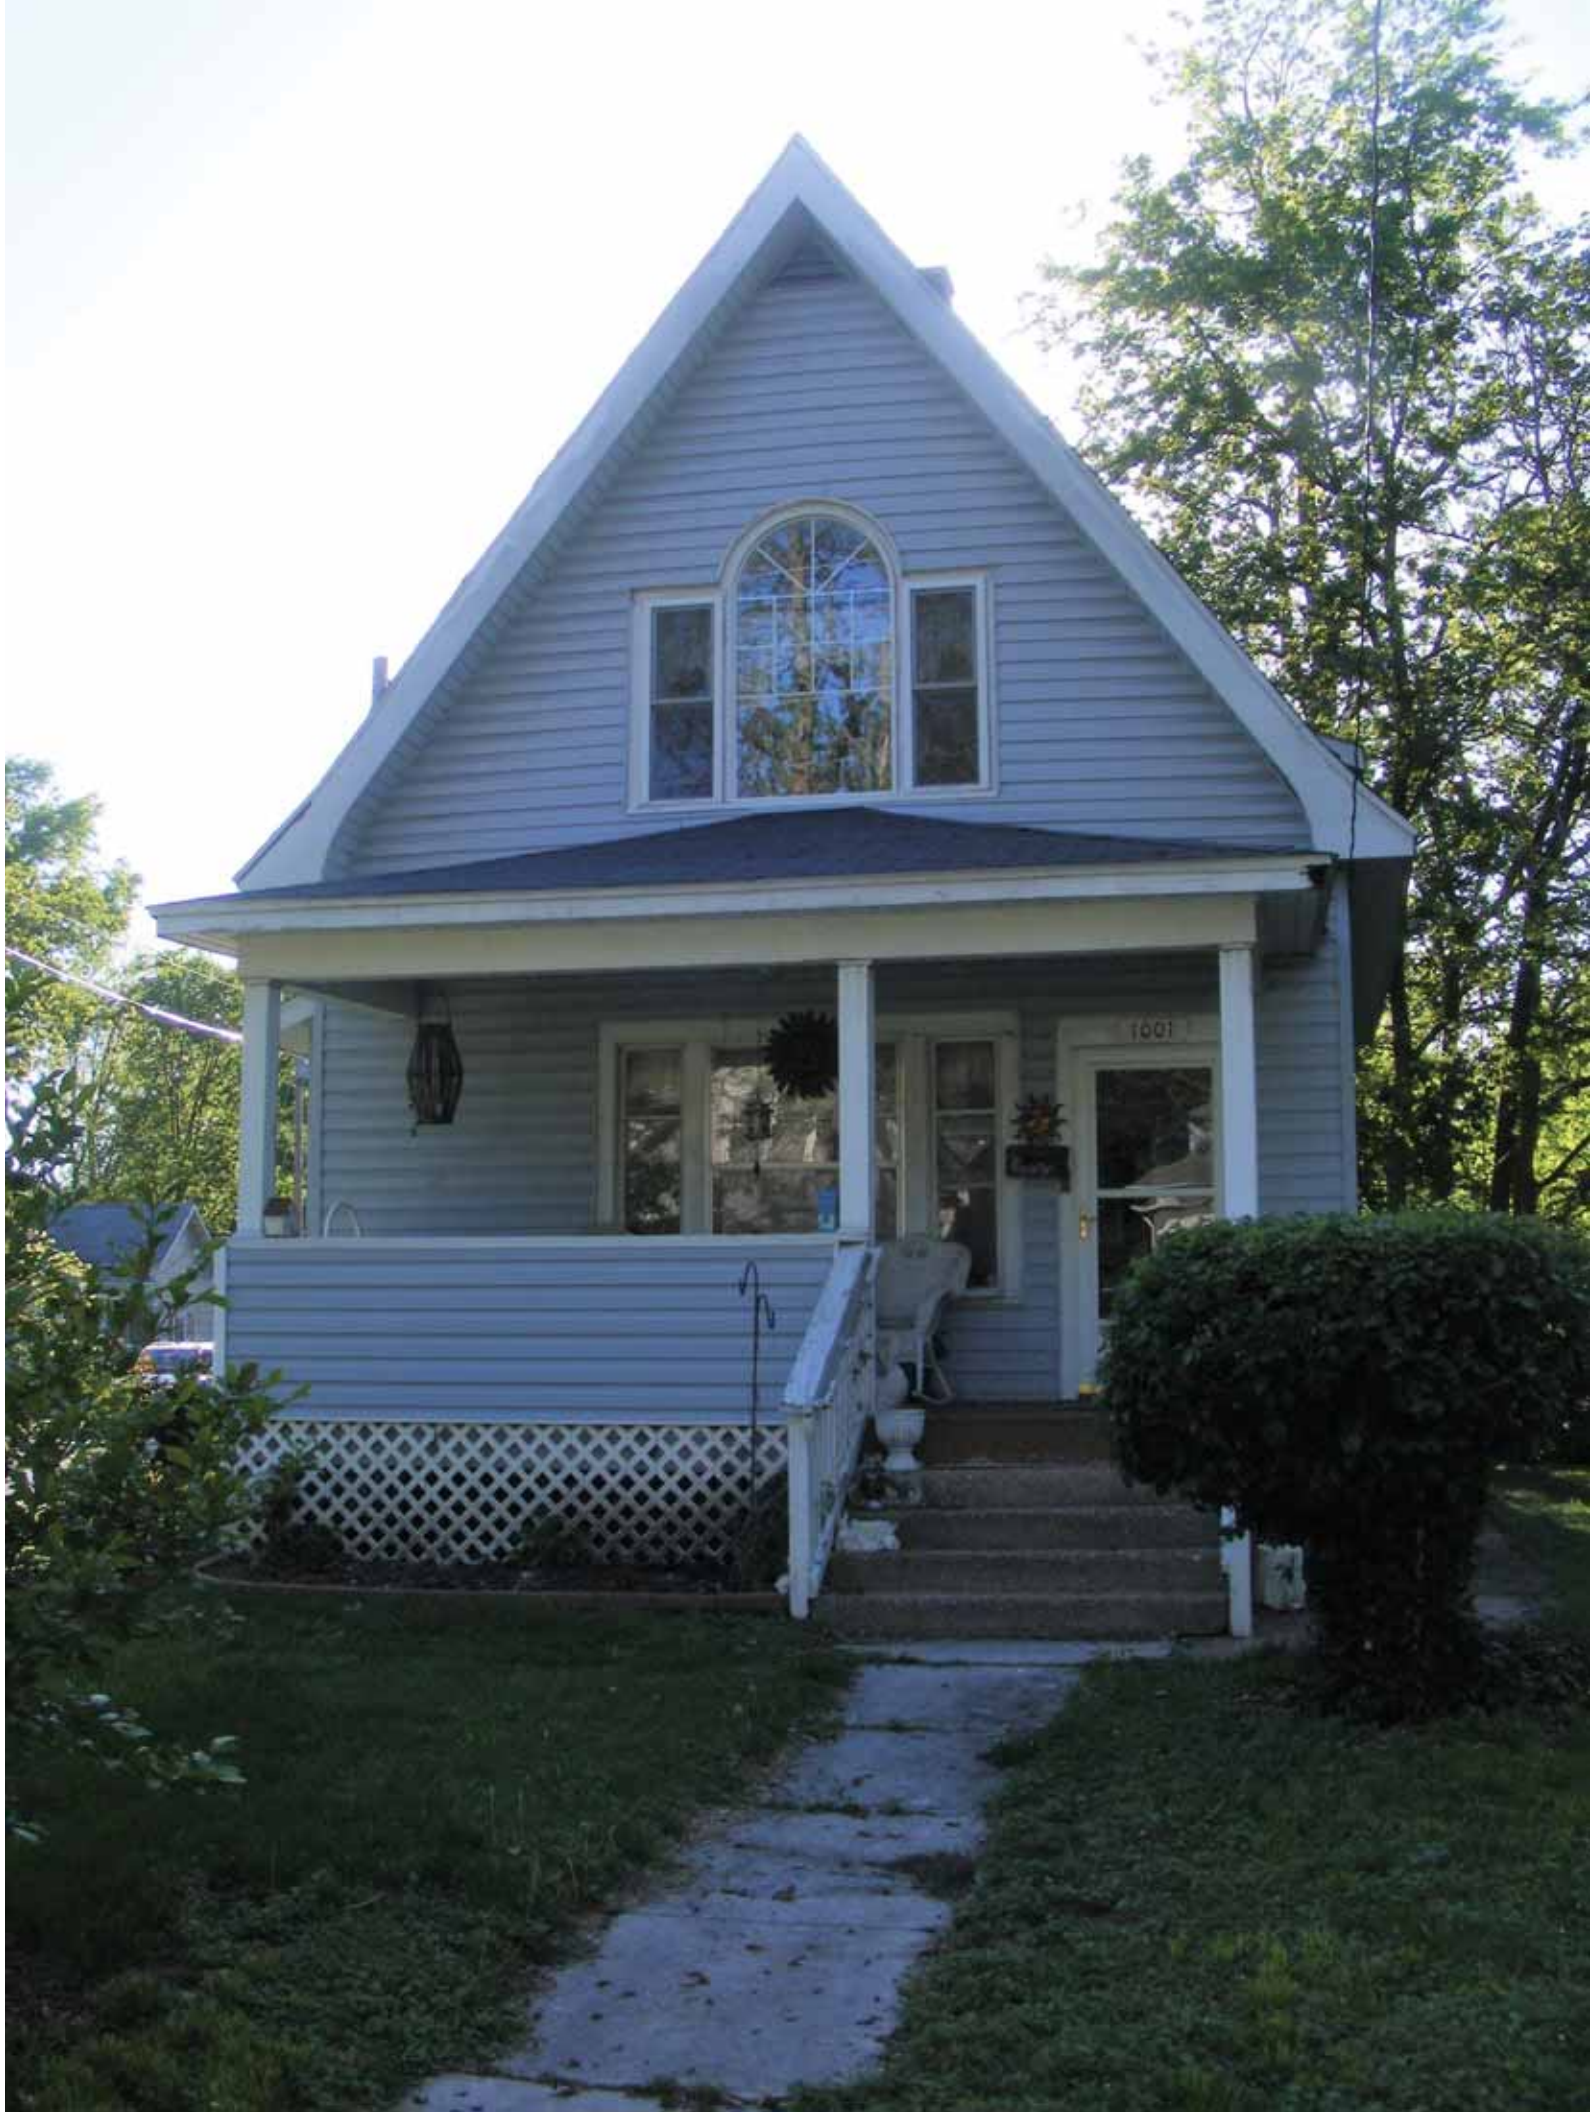
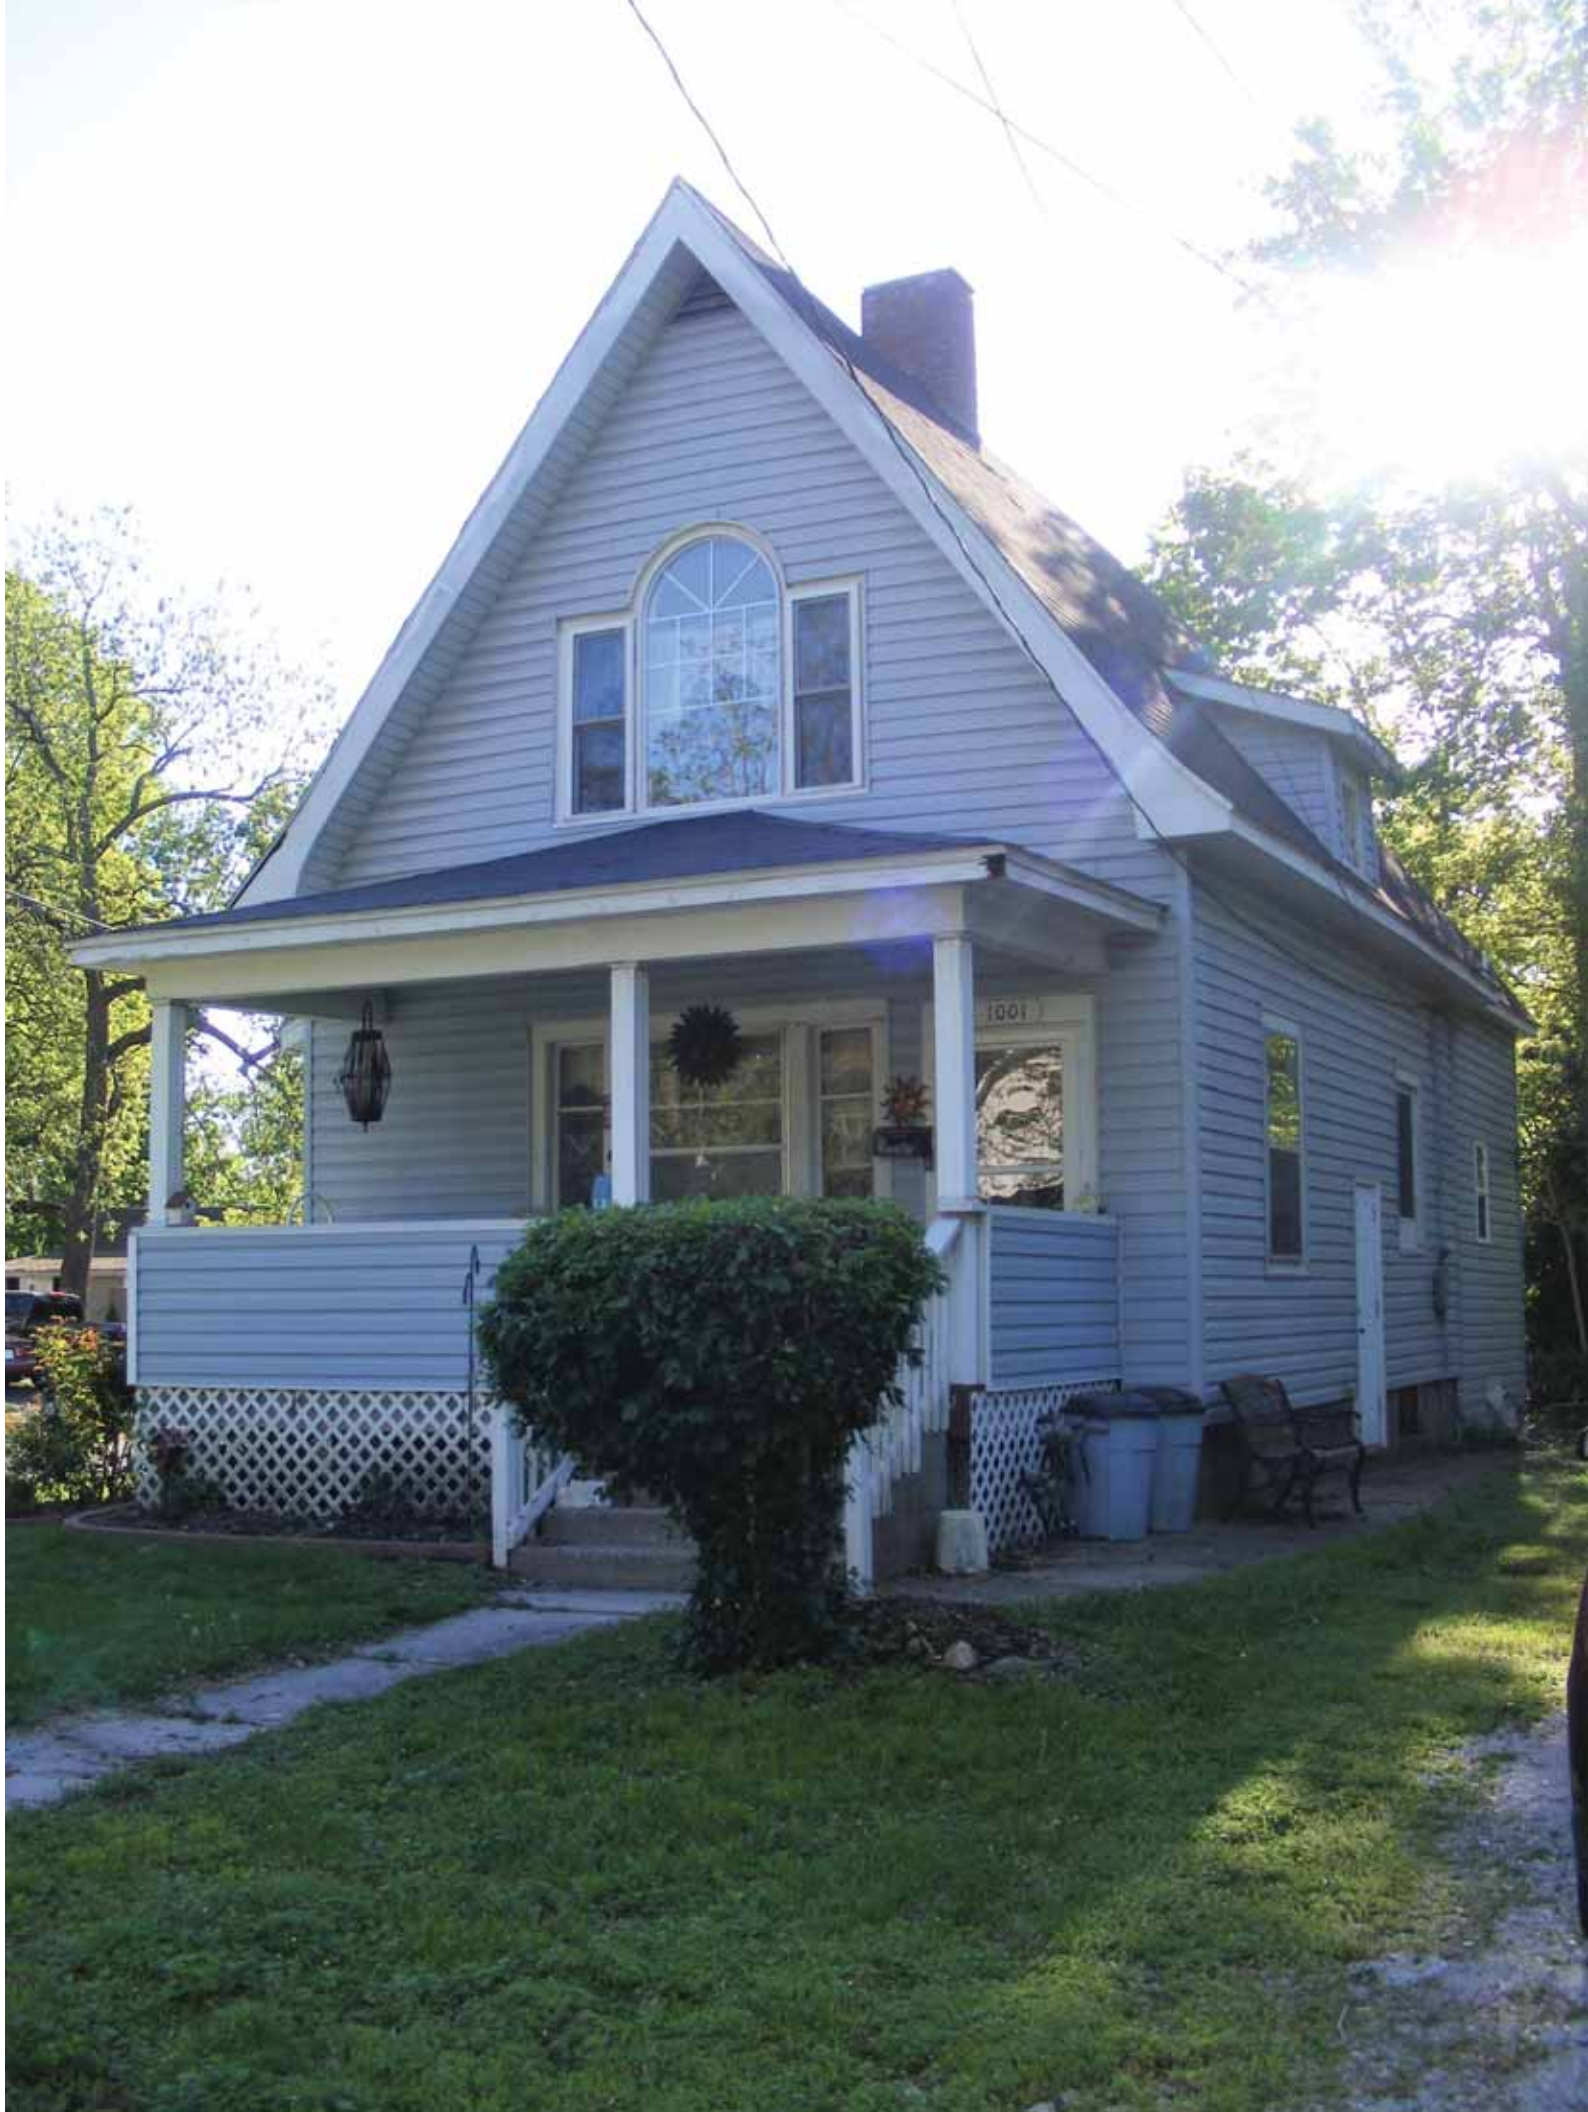
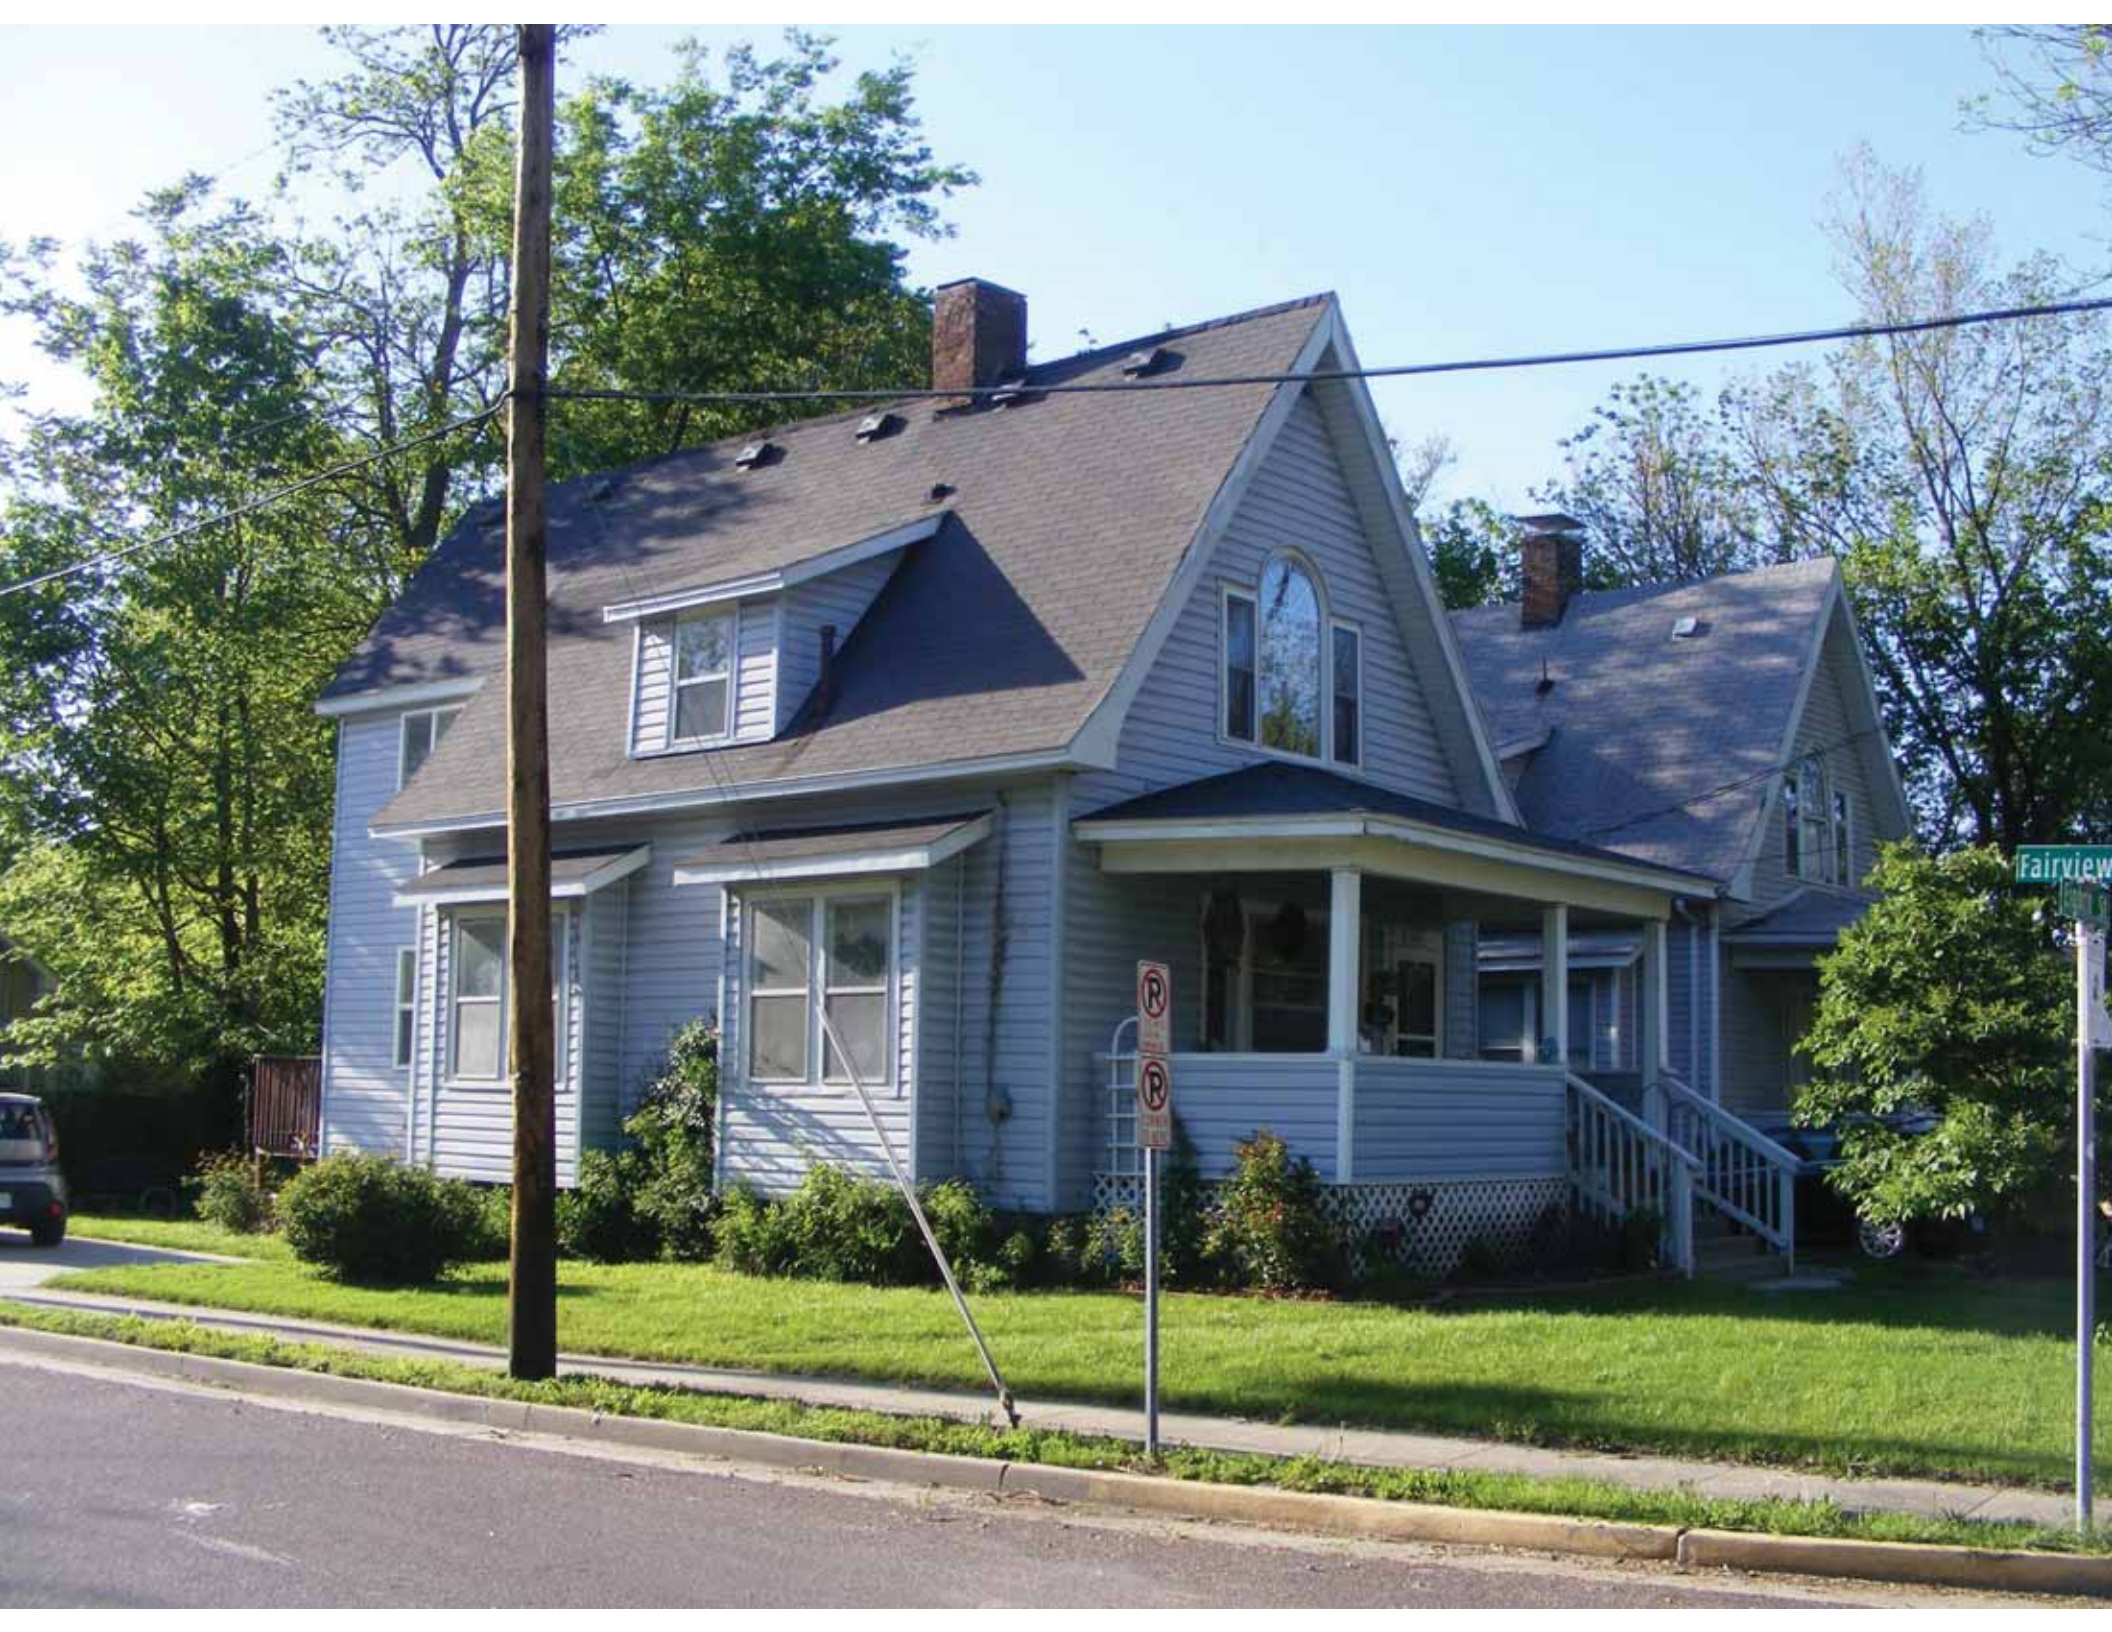
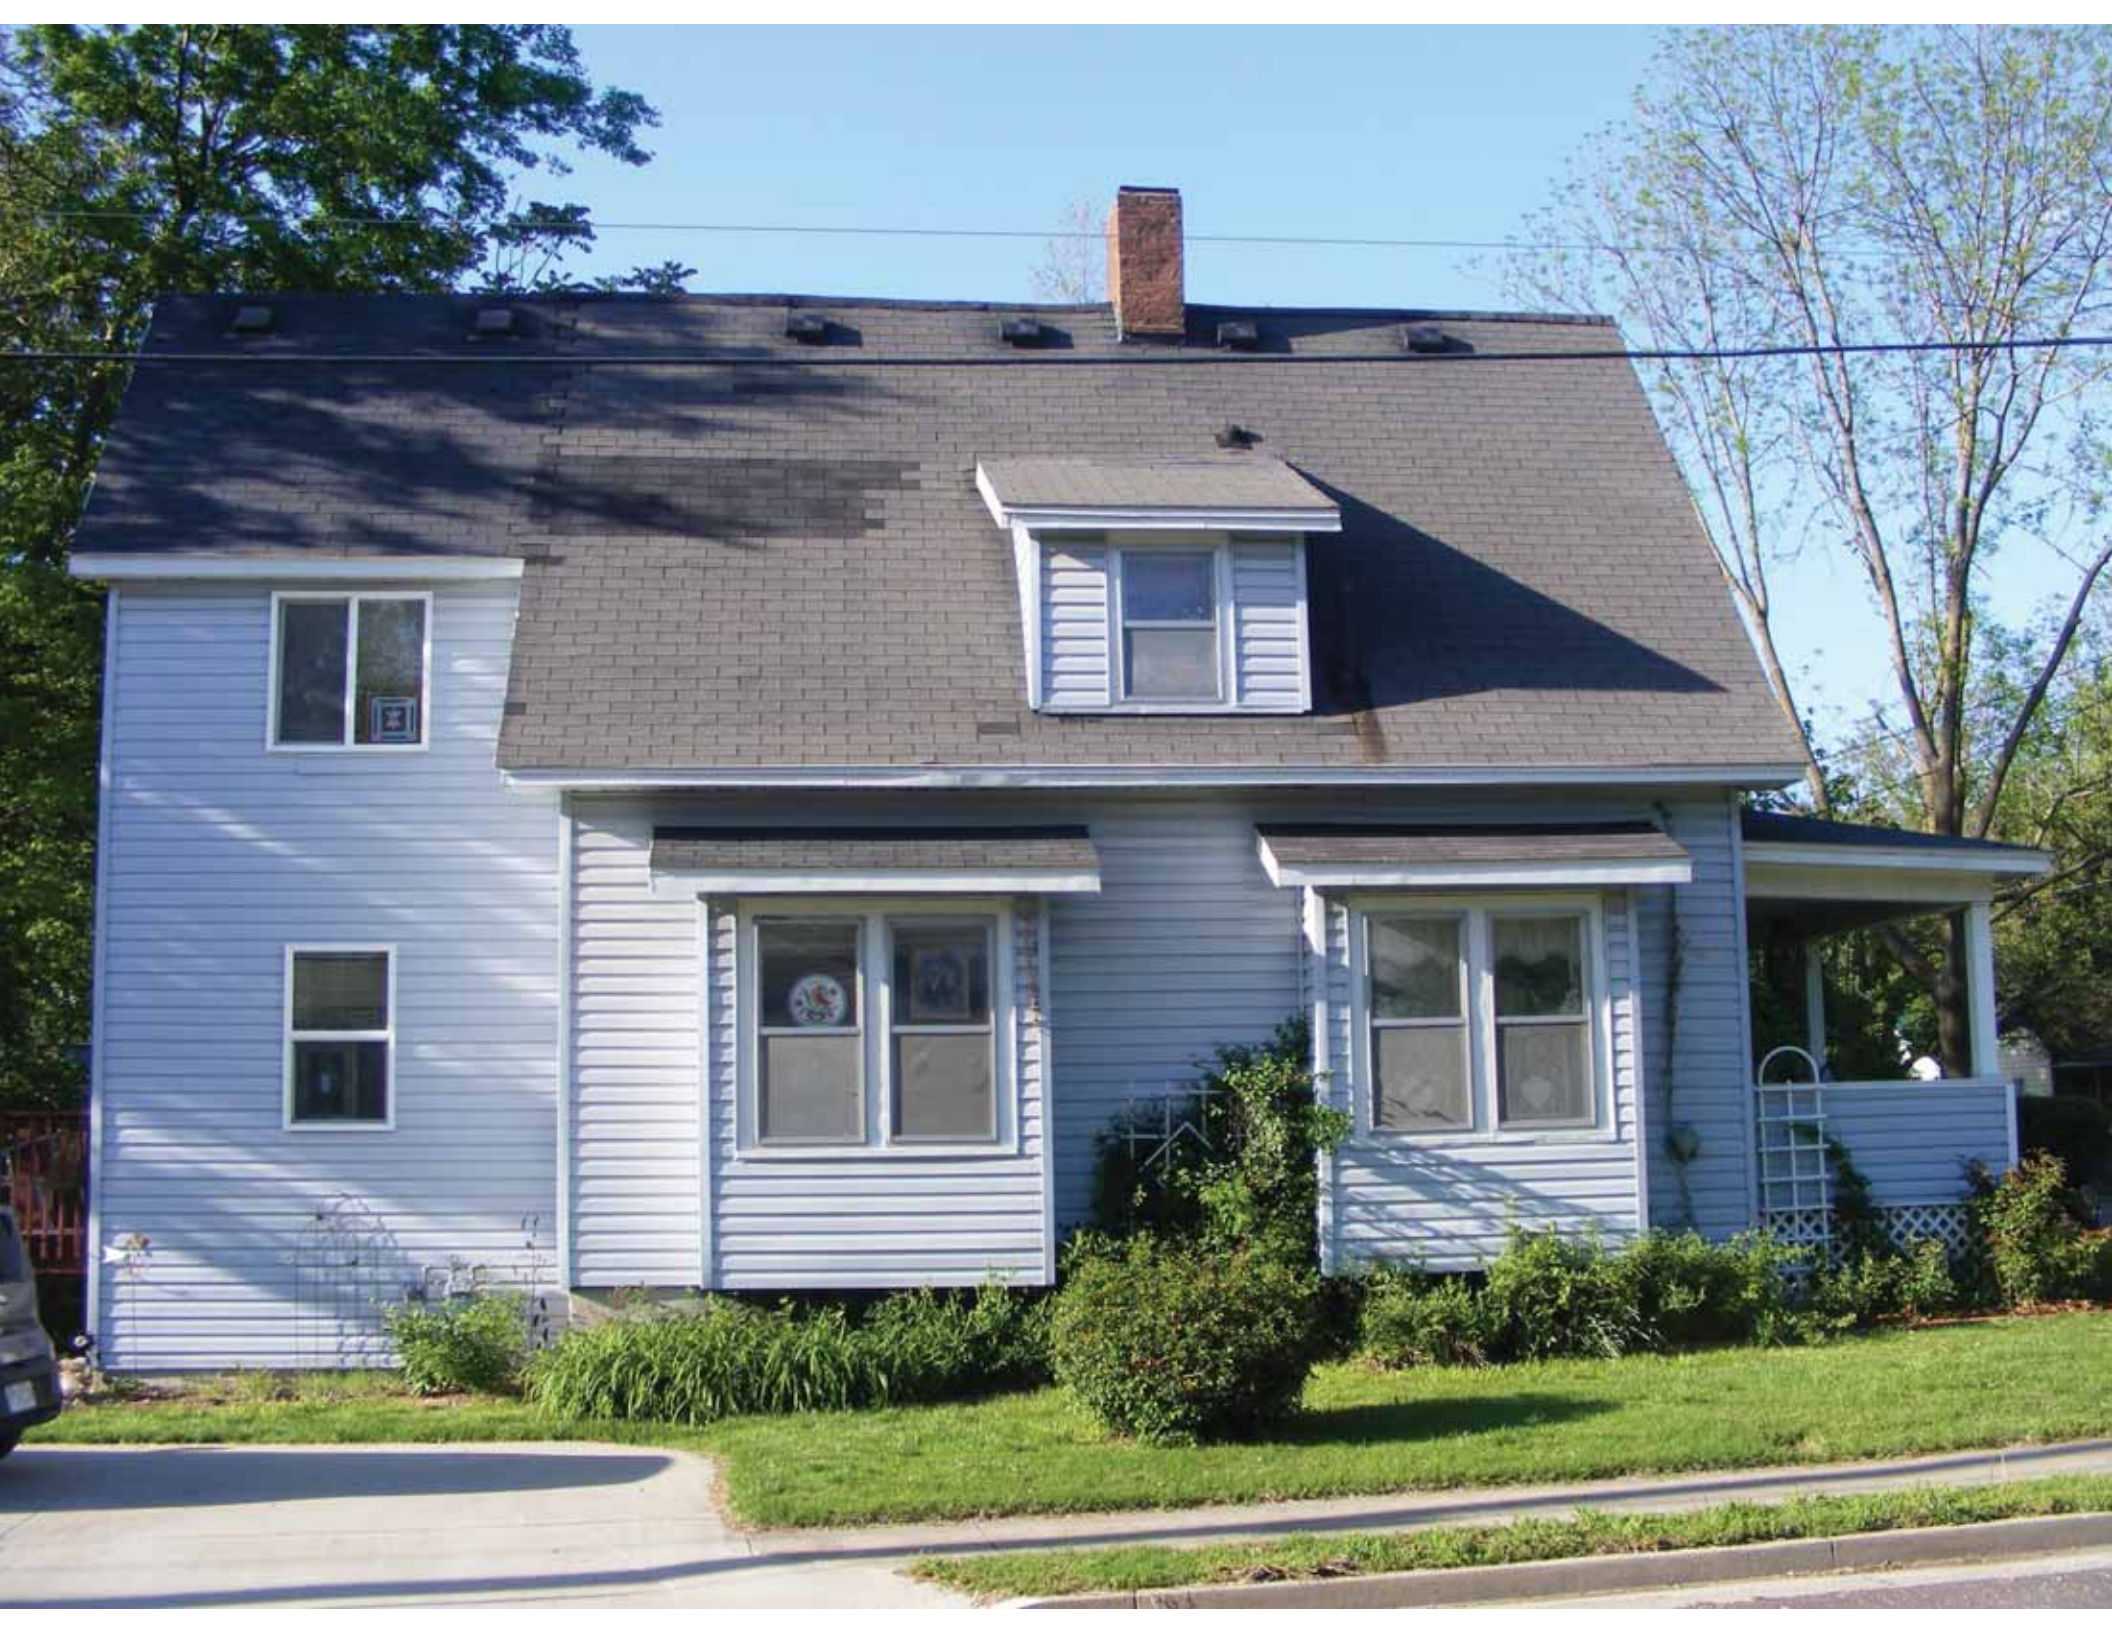
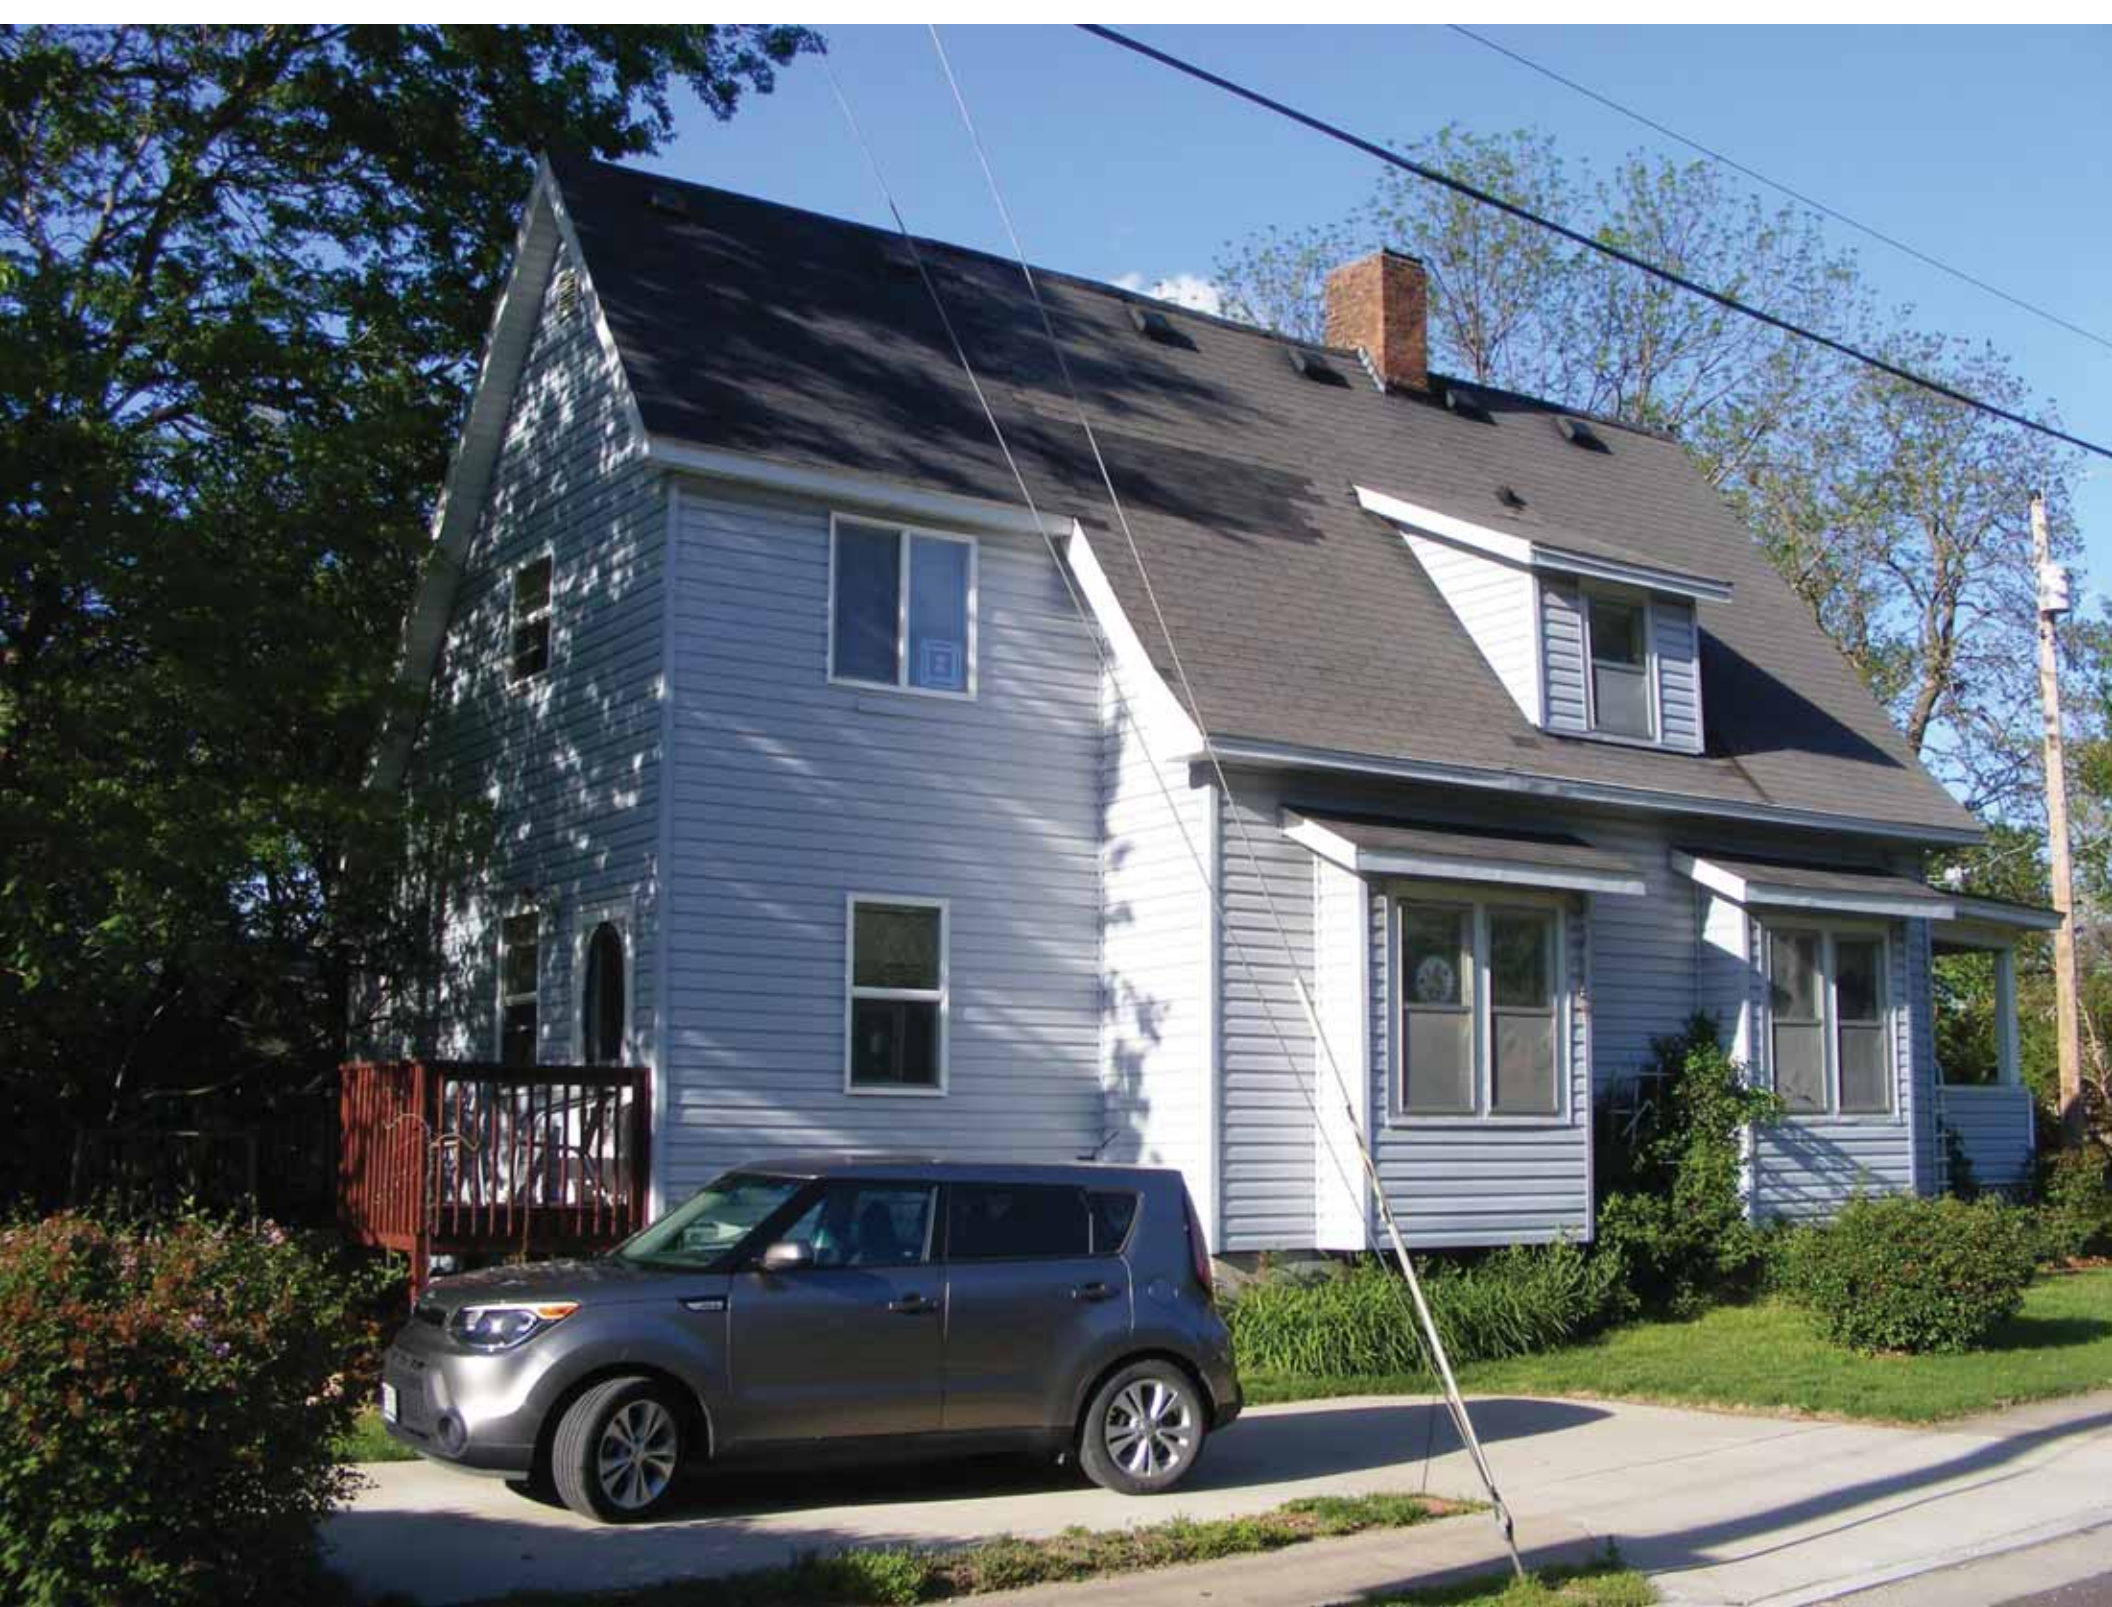
The two-story dwelling has a steeply pitched front gable roof clad with asphalt shingles. The dwelling has exterior vinyl siding and a concrete foundation. The primary (east) elevation has a single-story hipped three-quarters width porch supported by wood columns. A high enclosed balustrade clad with vinyl siding surrounds the porch. Porch steps are off center on the north end and have frame handrails. Within the porch bay is a single door offset by a tripartite window. The bay has a central wide two-light window flanked by slender two-sash lights that appear to be double-hung. Some windows are original one-over-one; others are replacement such as an upper story sliding window on the south elevation and upper Palladian window above the porch. Fenestration bays are original. Shed dormers are situated on the roofline slopes of the north and south elevations. The dwelling has a rear deck (contemporary) and central interior brick chimney. This dwelling appears identical in plan to the house at 1003 N. Eighth Street.
