MISSOURI DEPARTMENT OF NATURAL RESOURCES
STATE HISTORIC PRESERVATION OFFICE, P.O. Box 176, Jefferson City, MO 65102
ARCHITECTURAL/HISTORIC INVENTORY FORM

1. Survey No. BO-AS-011-0087		2. Survey name: North Central Columbia Survey Phase II	
3. County: Boone		4. Address (Street No.) 902	Street (name) N. Seventh Street
5. City: Columbia	Vicinity: <input type="checkbox"/>	6. Geographical Reference:	7. Township/Range/Section: T: R: S:
8. Historic name (if known):		9. Present/other name (if known):	
10. Ownership: <input checked="" type="checkbox"/> Private <input type="checkbox"/> Public		11a. Historic use (if known): Domestic/single dwelling	11b. Current use: Domestic/single dwelling

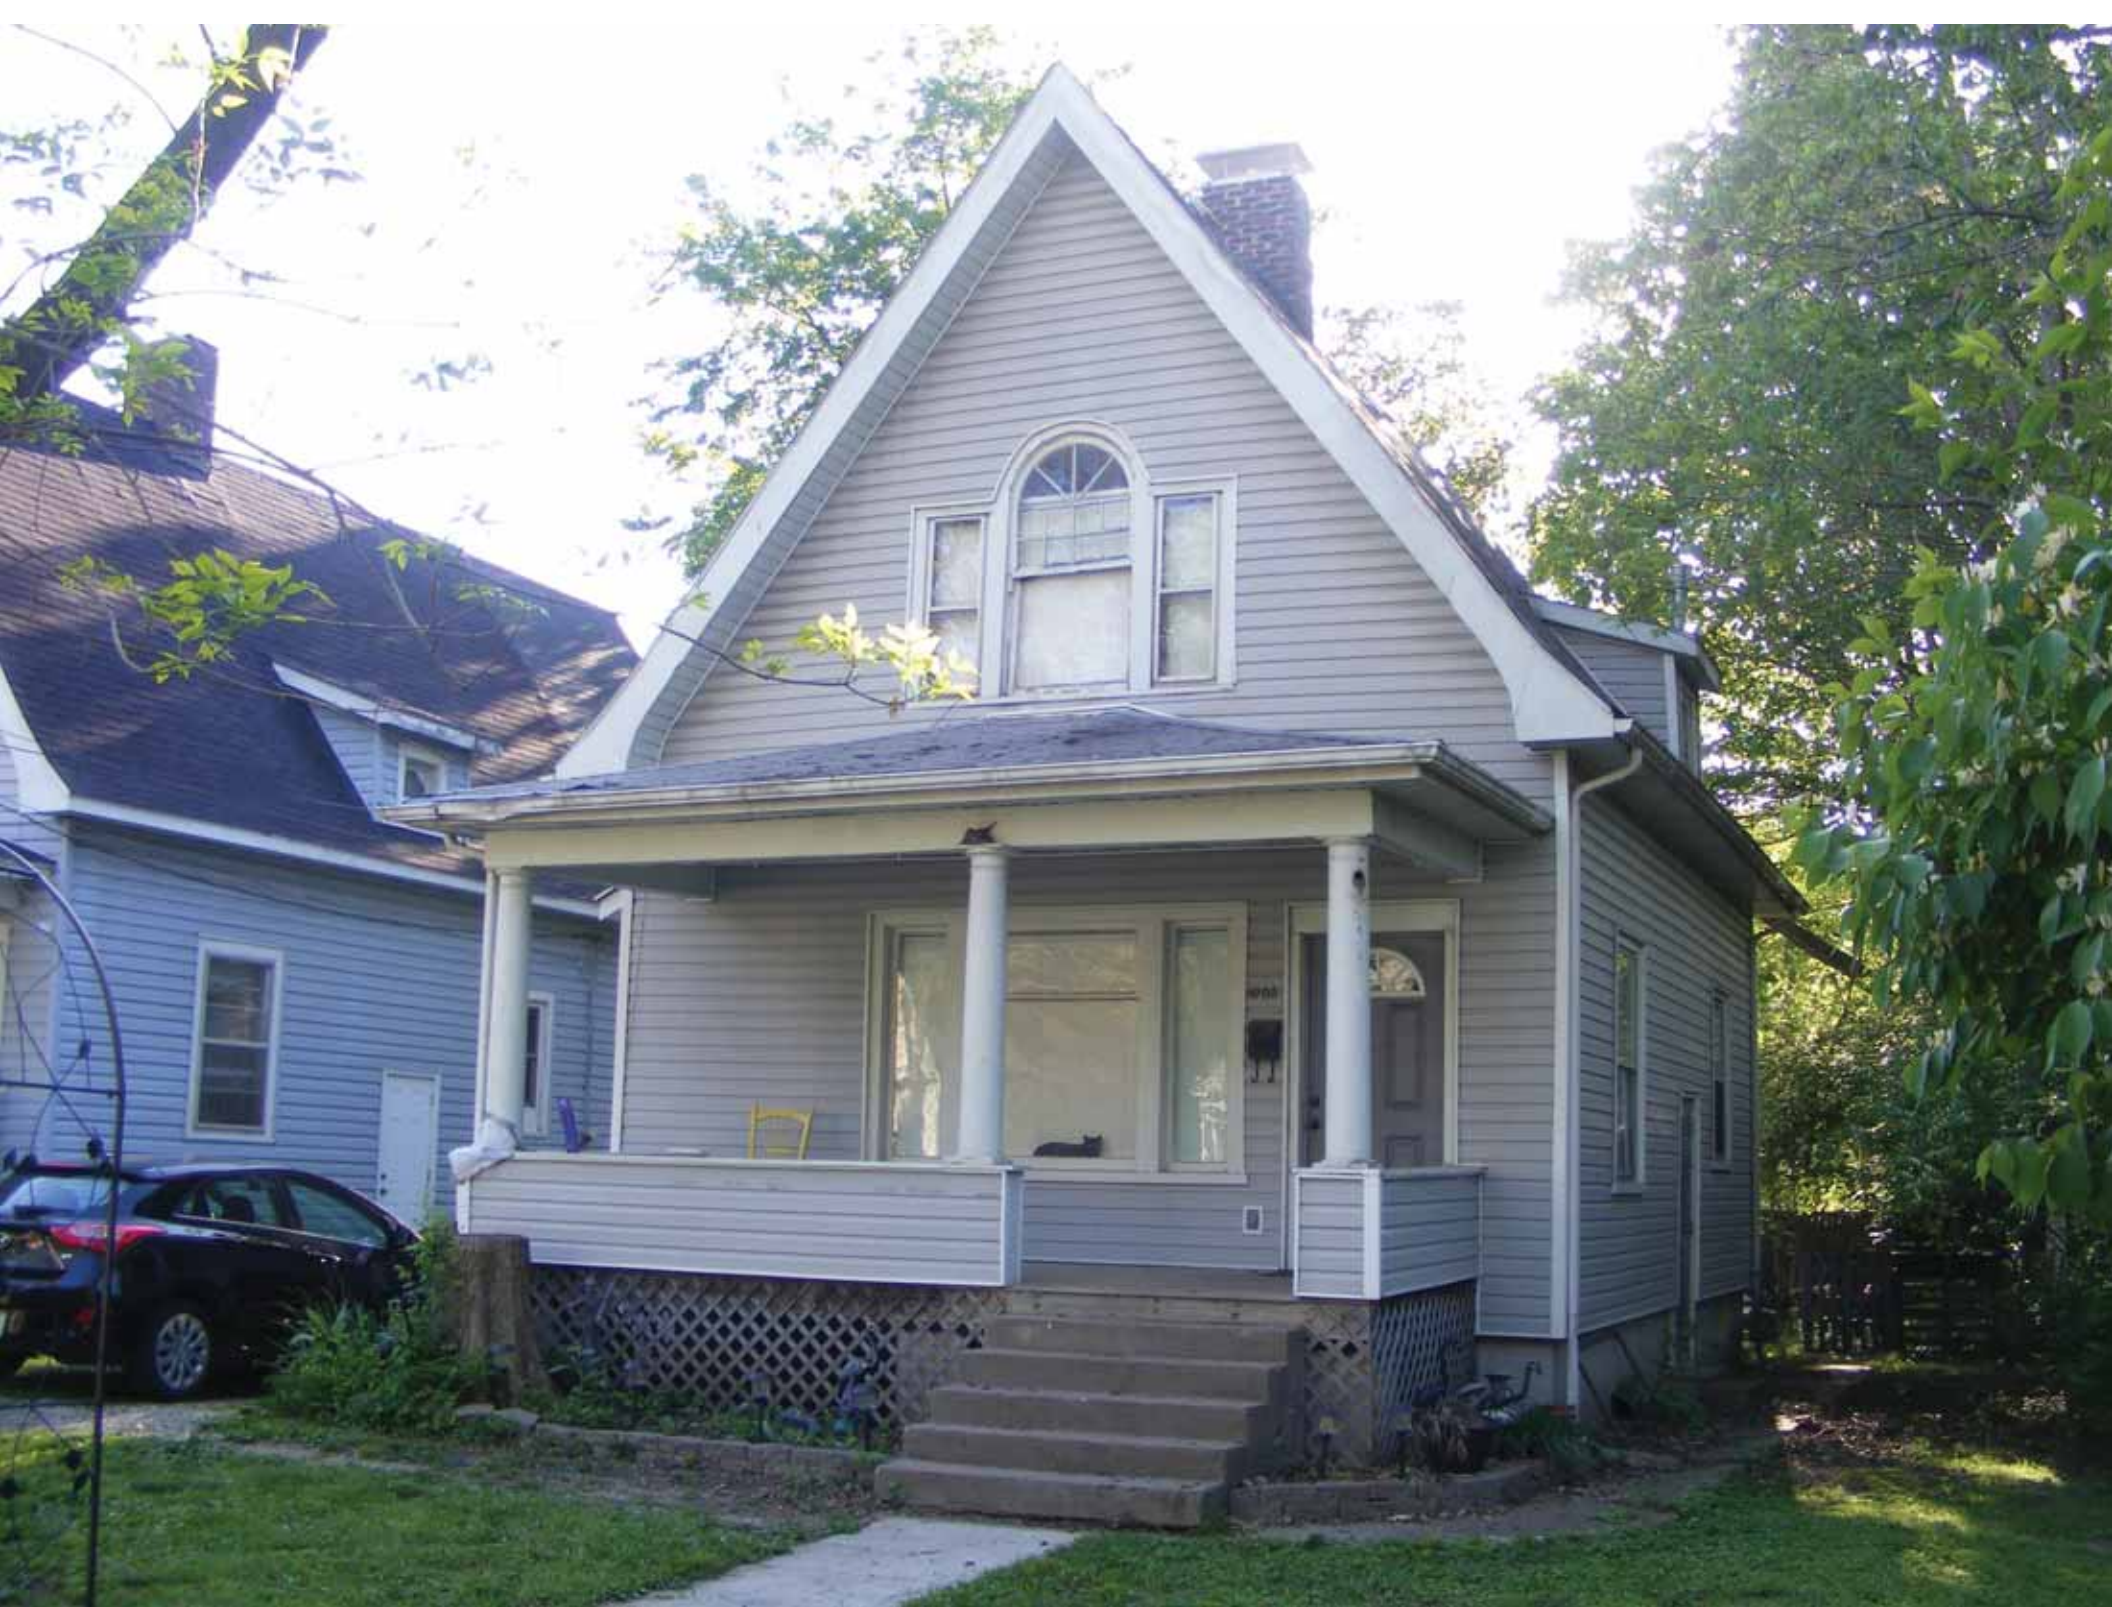
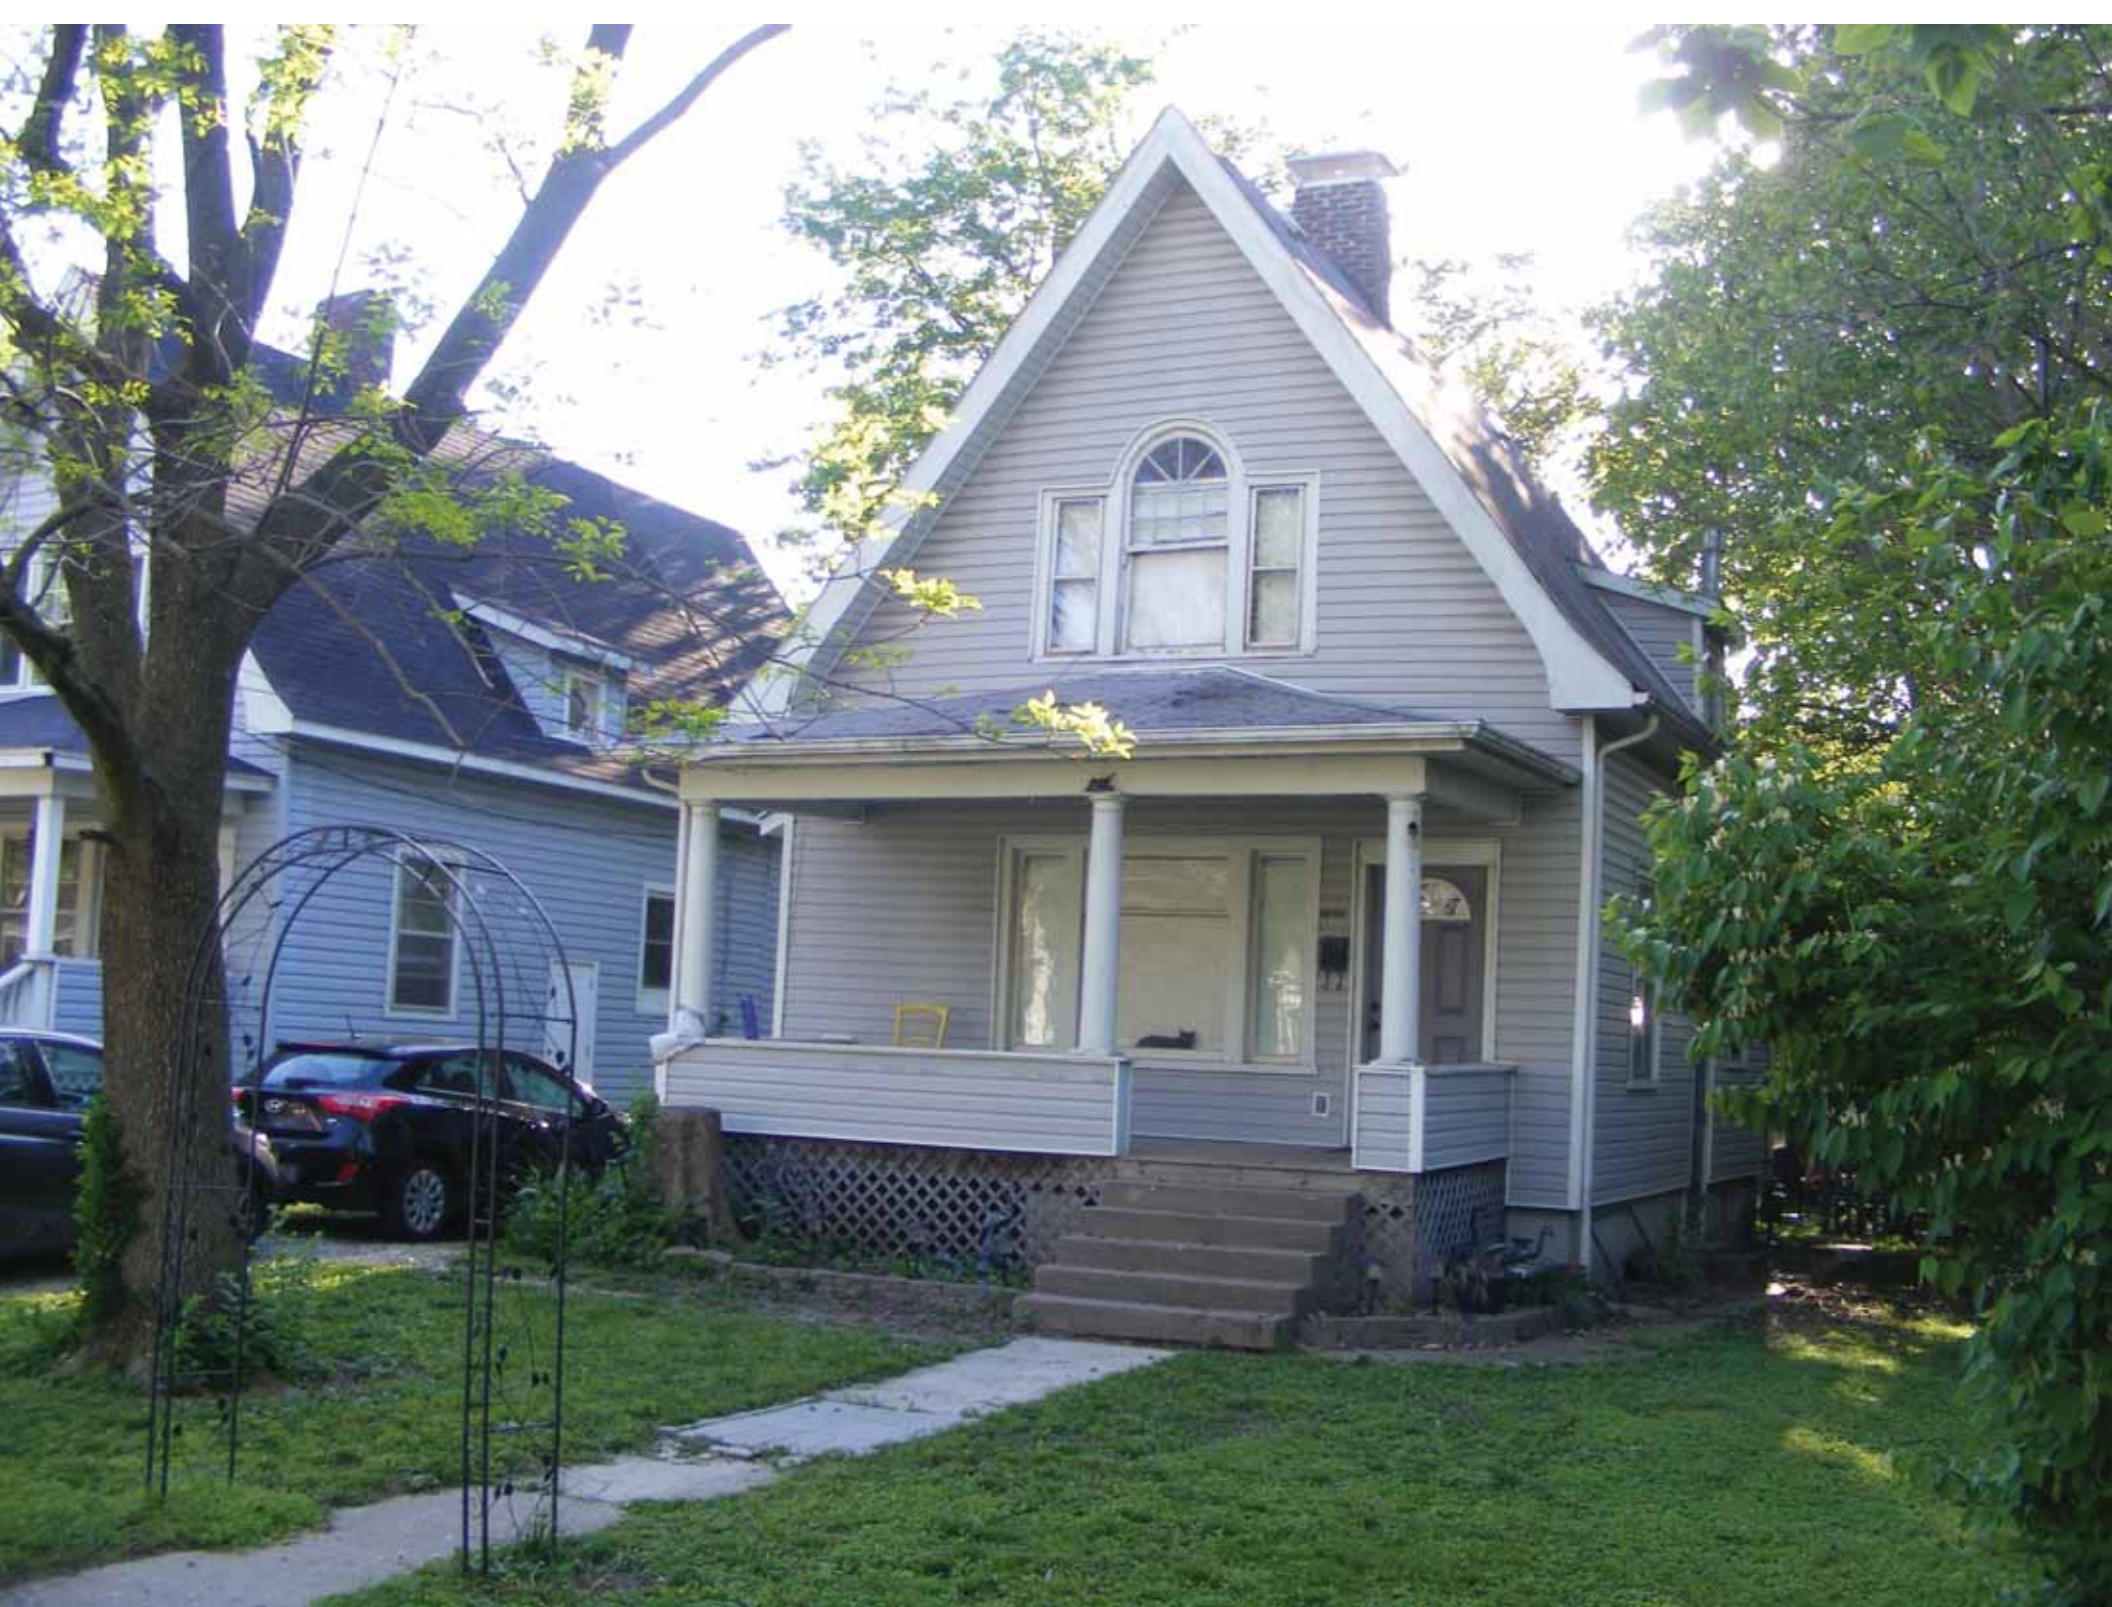
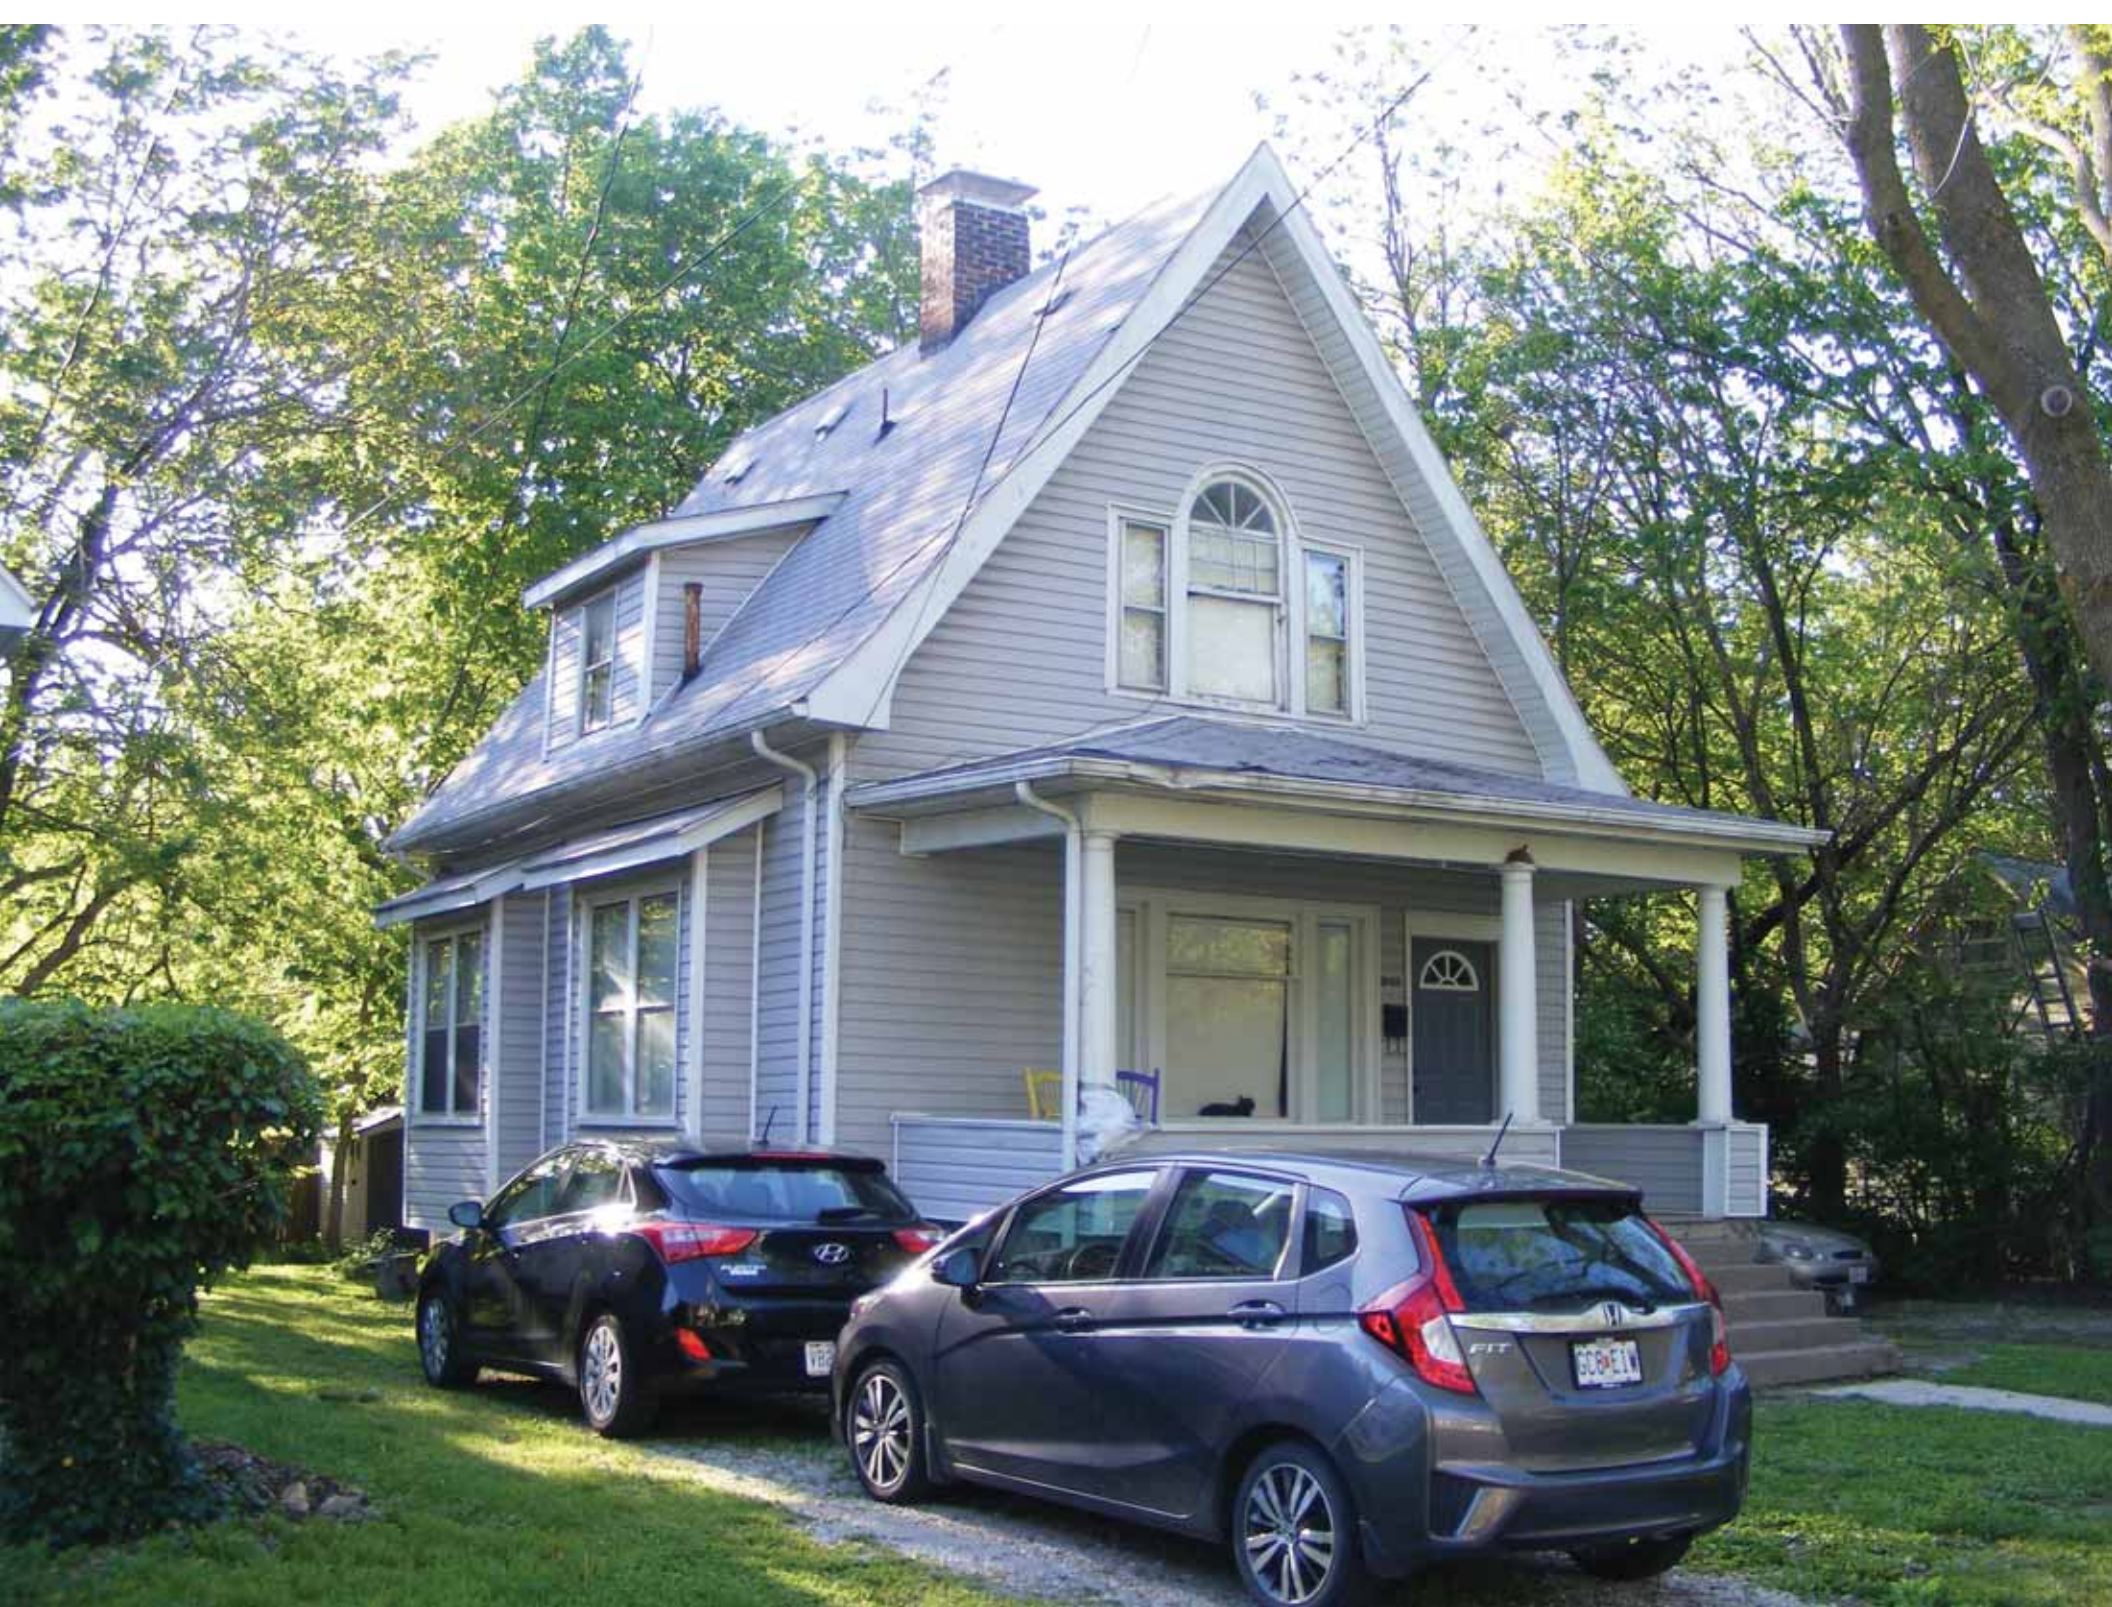
The property is a two-story dwelling with a steeply pitched front gable roof clad with asphalt shingles. The dwelling has exterior vinyl siding and a concrete foundation. The primary (east) elevation has a single-story hipped three-quarters width porch supported by original tapered Tuscan columns resting on a solid balustrade clad with vinyl siding. Concrete porch steps are off center on the north end. Within the porch bay is a single replacement door with an upper fanlight. The door is offset by a tripartite window. The bay has a central original wide two-light window flanked by slender fixed single-light replacement windows. Most windows are original, including the large Palladian style window above the porch. Fenestration bays are original. Shed dormers are situated on the roofline slopes of the north and south elevations. The dwelling appears identical in plan to the house at 1001 N. Eighth Street.

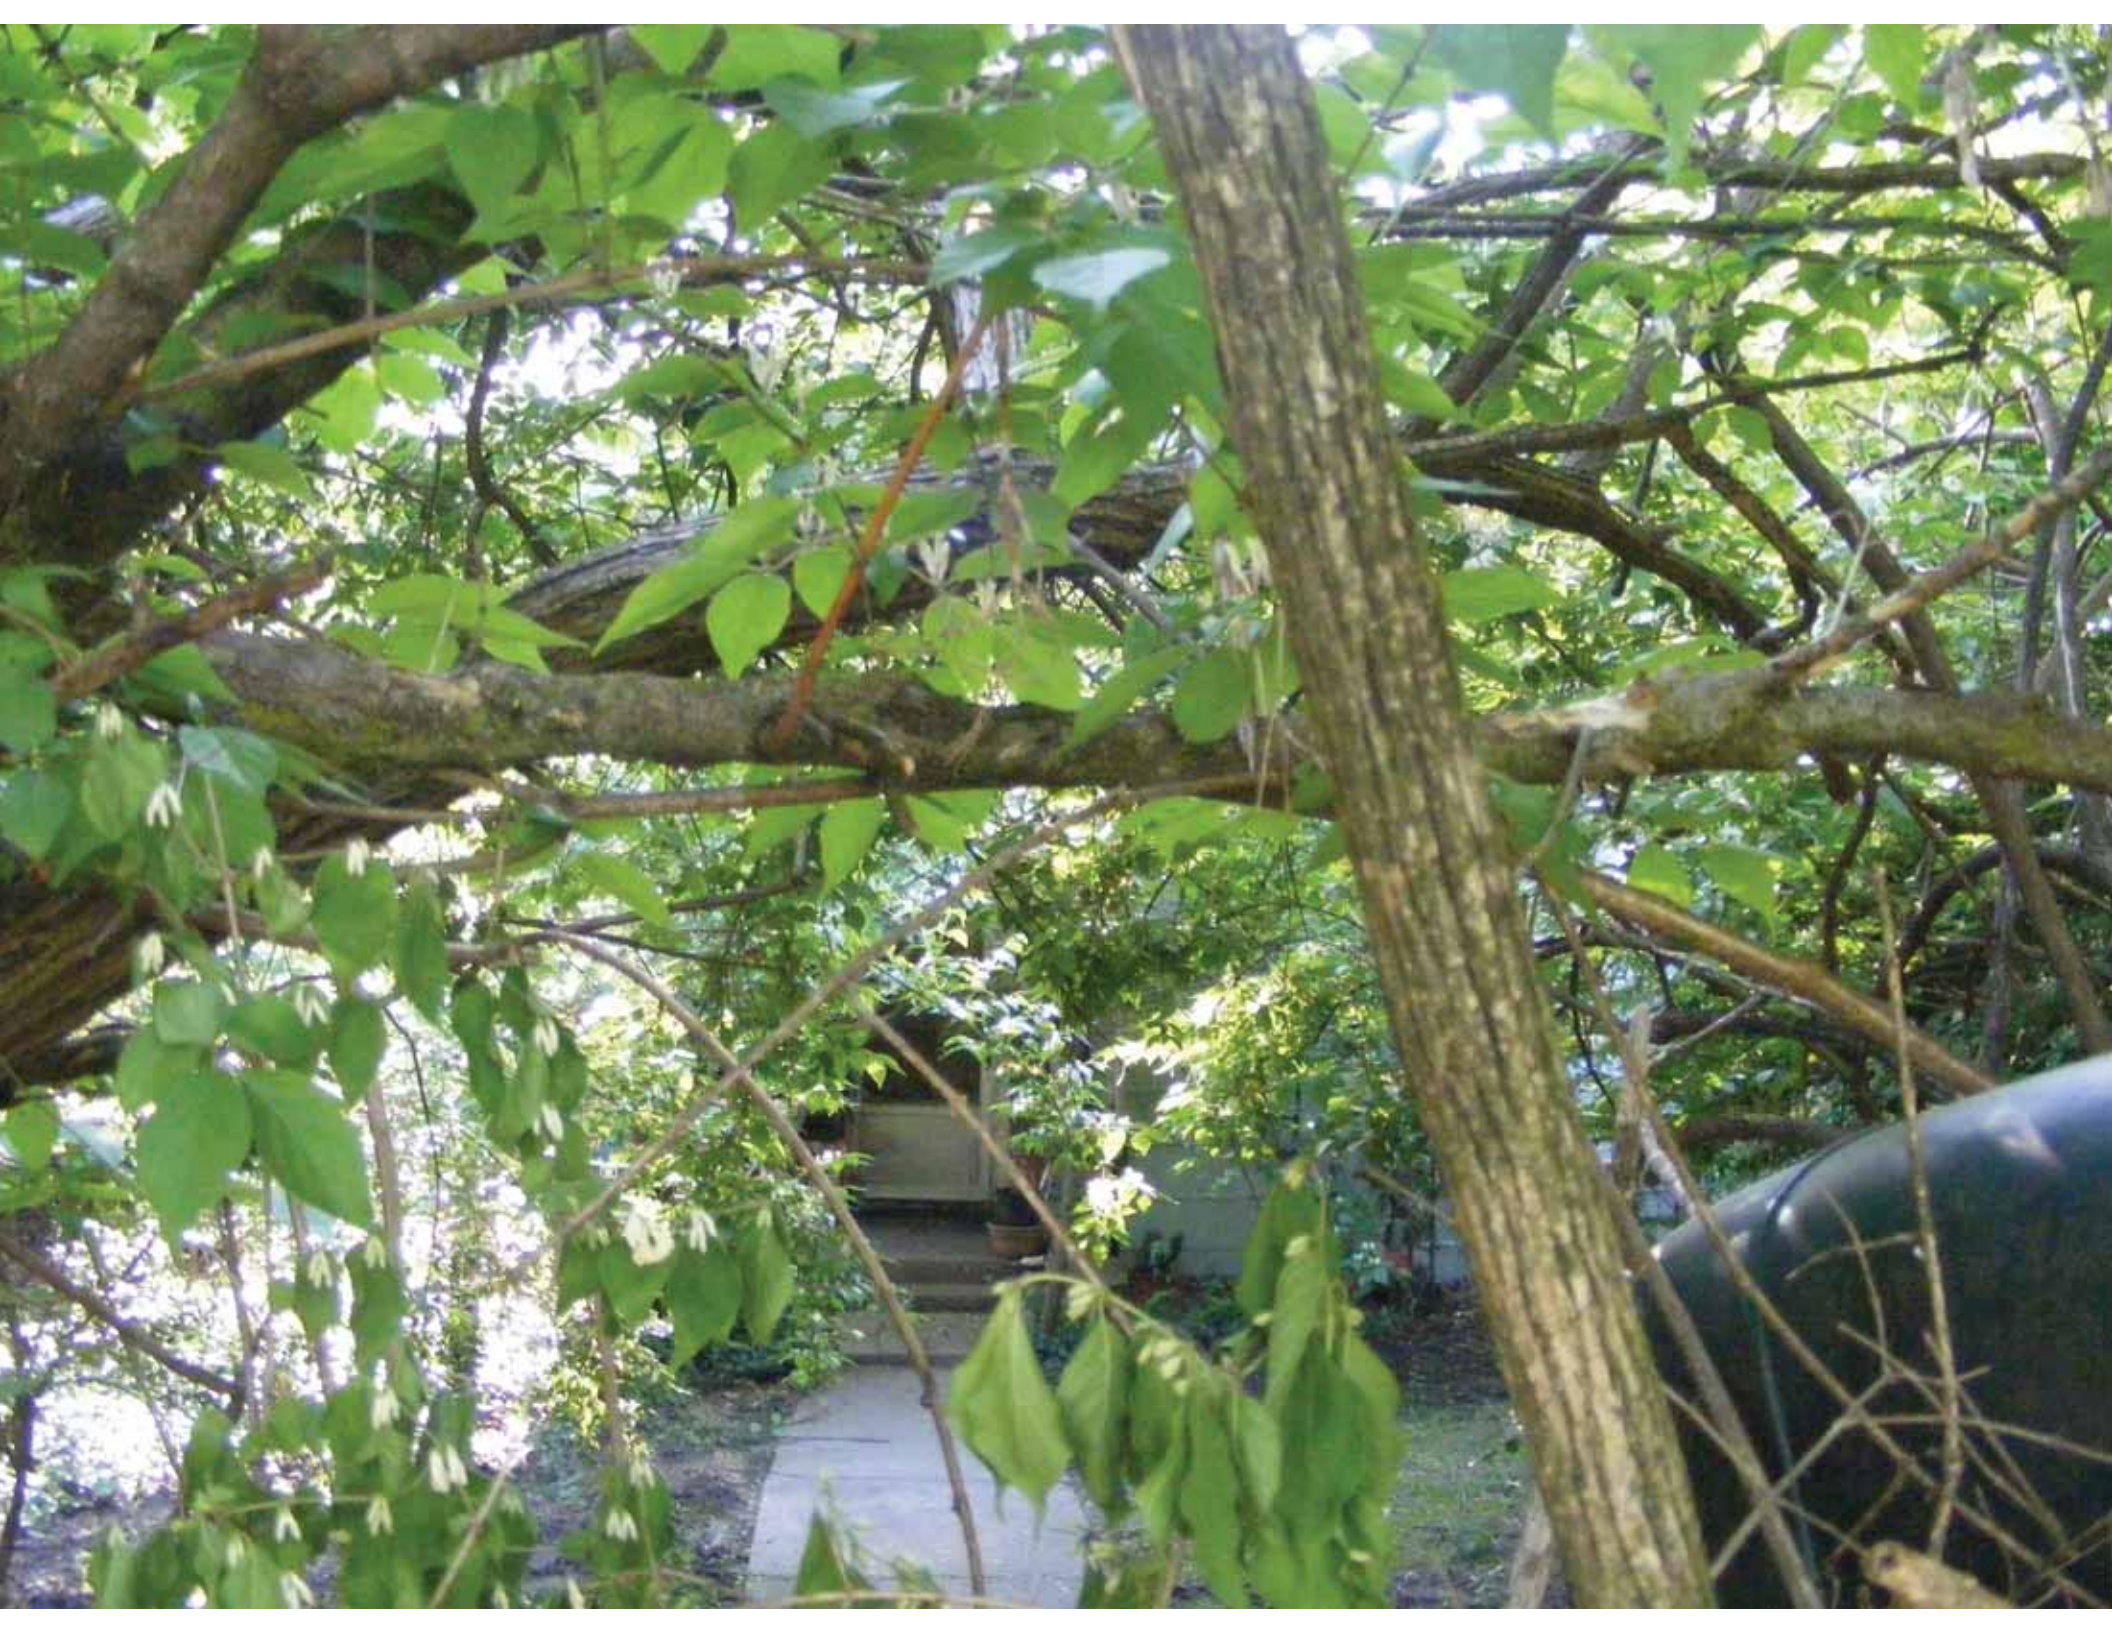
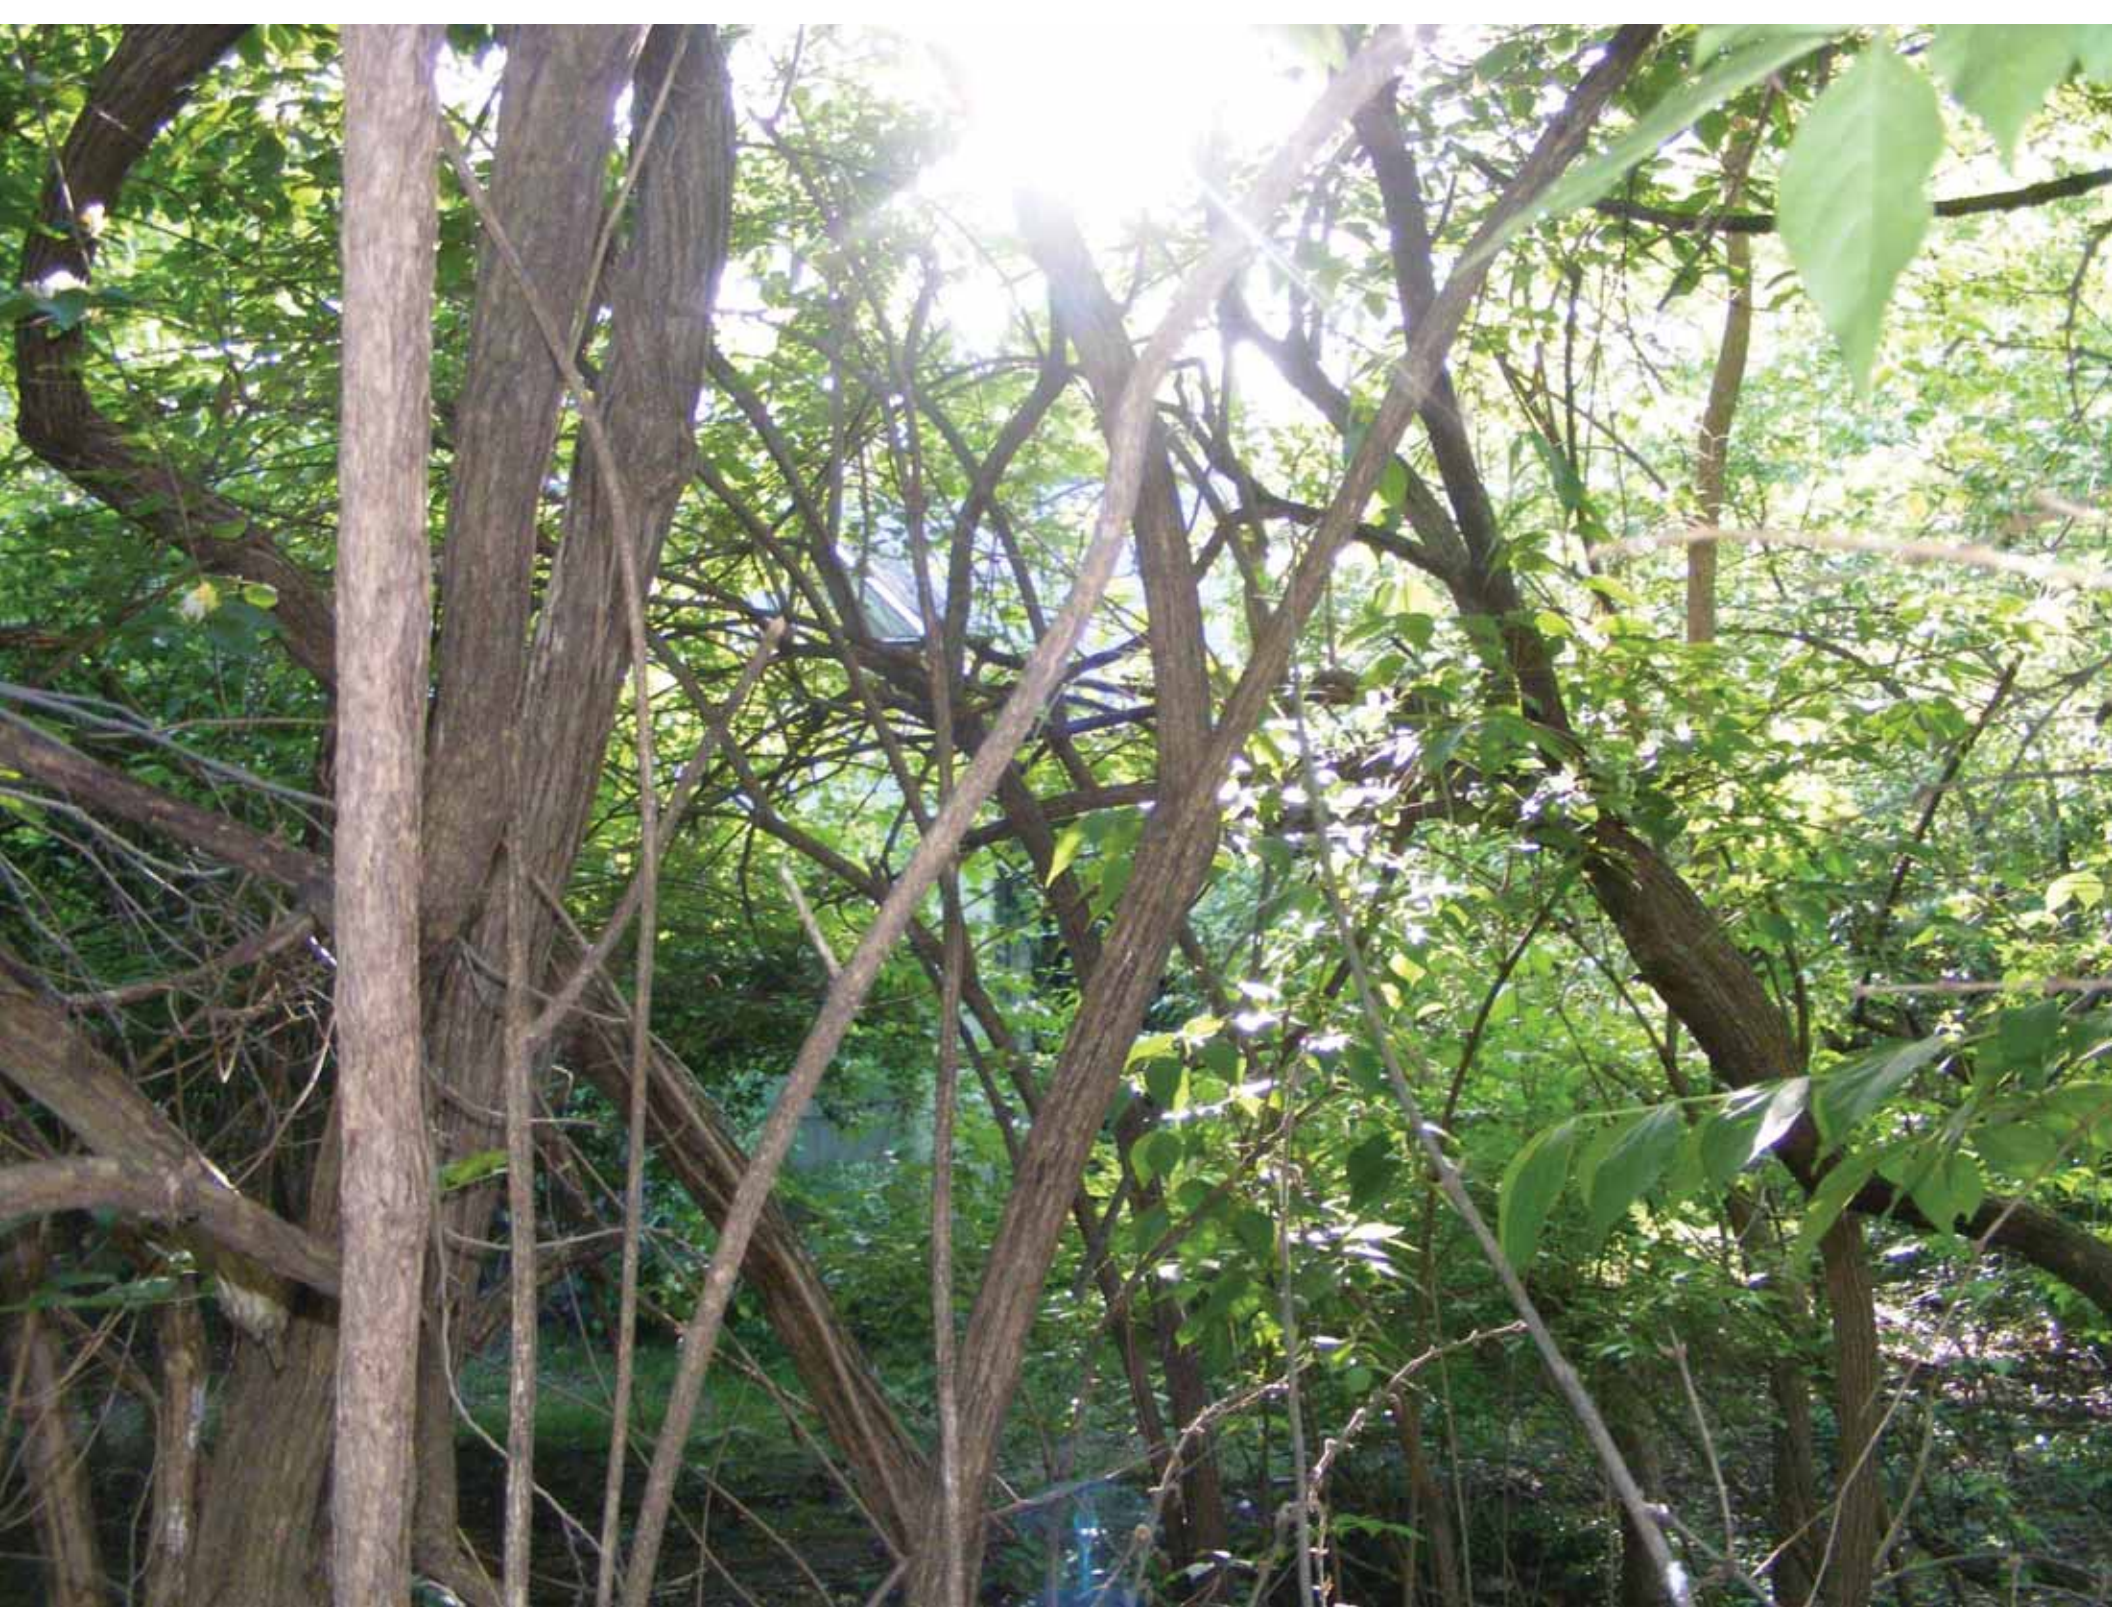
Information is limited due to the fact that the property is obscured by heavy foliage. The dwelling has an asphalt-shingled cross-gable plan roof, exterior asbestos shingle siding and what appear to be original one-over-one windows. The single-story hipped porch is half-width on the façade, extending from the south elevation of the projecting gabled wing. Windows are situated on the front facing gable wing (1) and offsetting the primary entry bay within the porch (1).
