MISSOURI DEPARTMENT OF NATURAL RESOURCES
STATE HISTORIC PRESERVATION OFFICE, P.O. Box 176, Jefferson City, MO 65102
ARCHITECTURAL/HISTORIC INVENTORY FORM

1. Survey No. BO-AS-011-0087		2. Survey name: North Central Columbia Survey Phase II	
3. County: Boone		4. Address (Street No.) 902	Street (name) N. Seventh Street
5. City: Columbia	Vicinity: <input type="checkbox"/>	6. Geographical Reference:	7. Township/Range/Section: T: R: S:
8. Historic name (if known):		9. Present/other name (if known):	
10. Ownership: <input checked="" type="checkbox"/> Private <input type="checkbox"/> Public		11a. Historic use (if known): Domestic/single dwelling	11b. Current use: Domestic/single dwelling

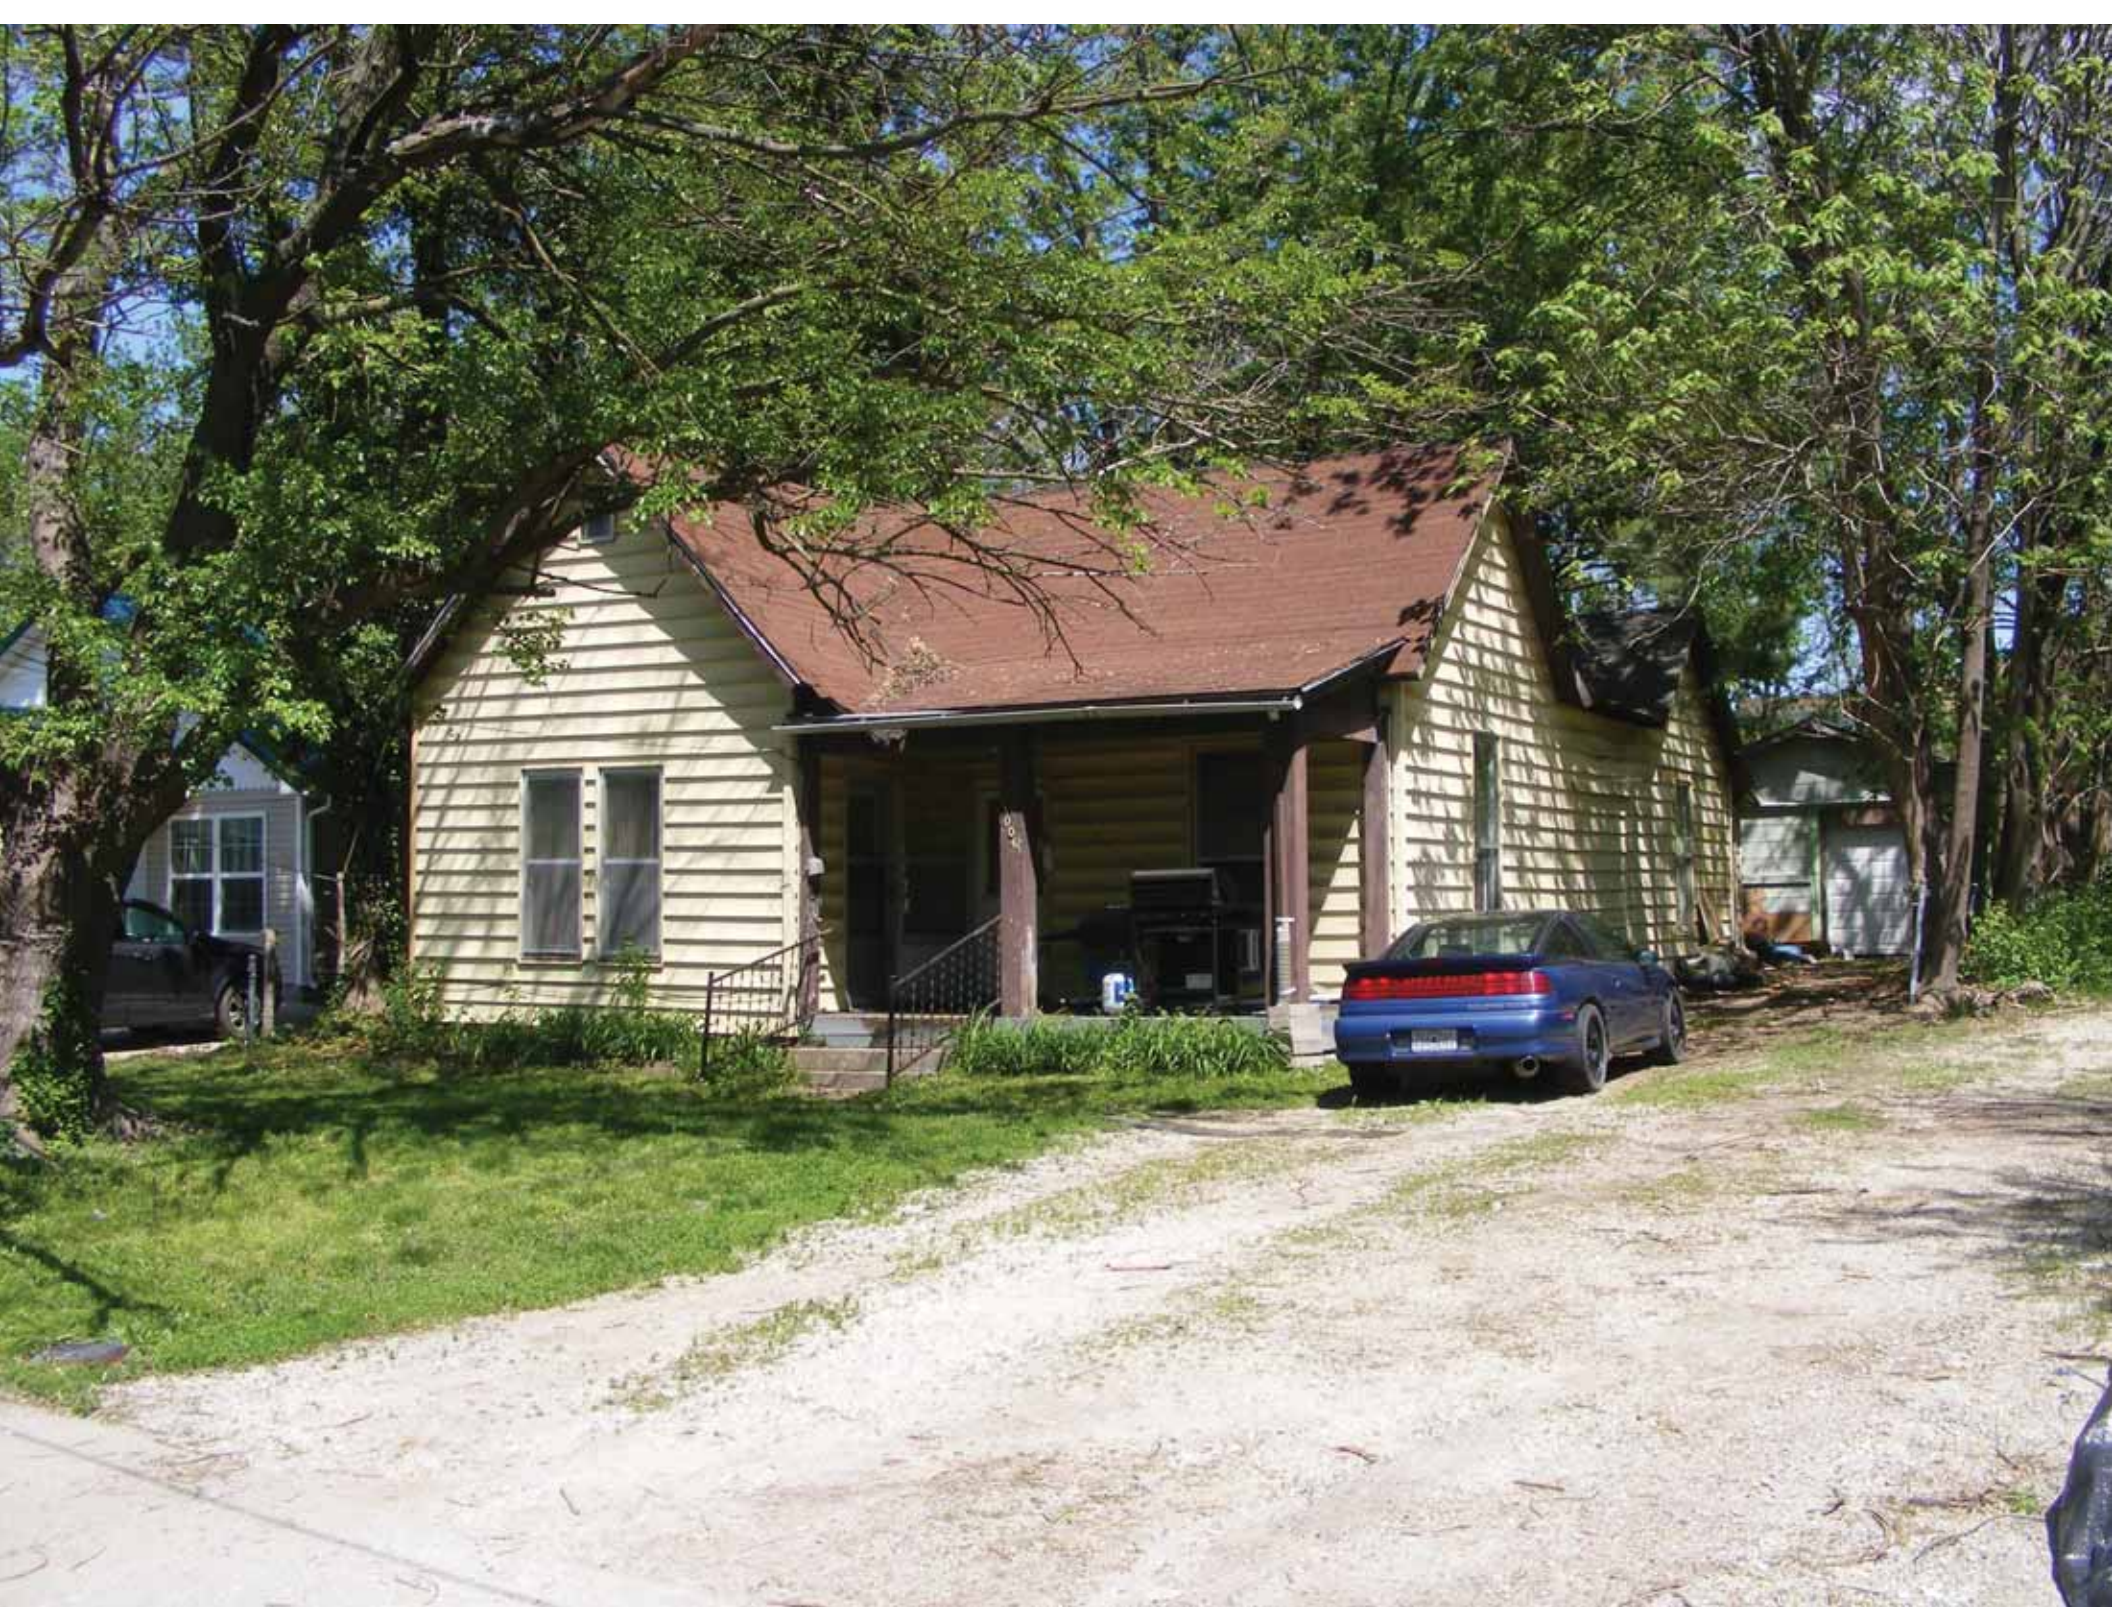
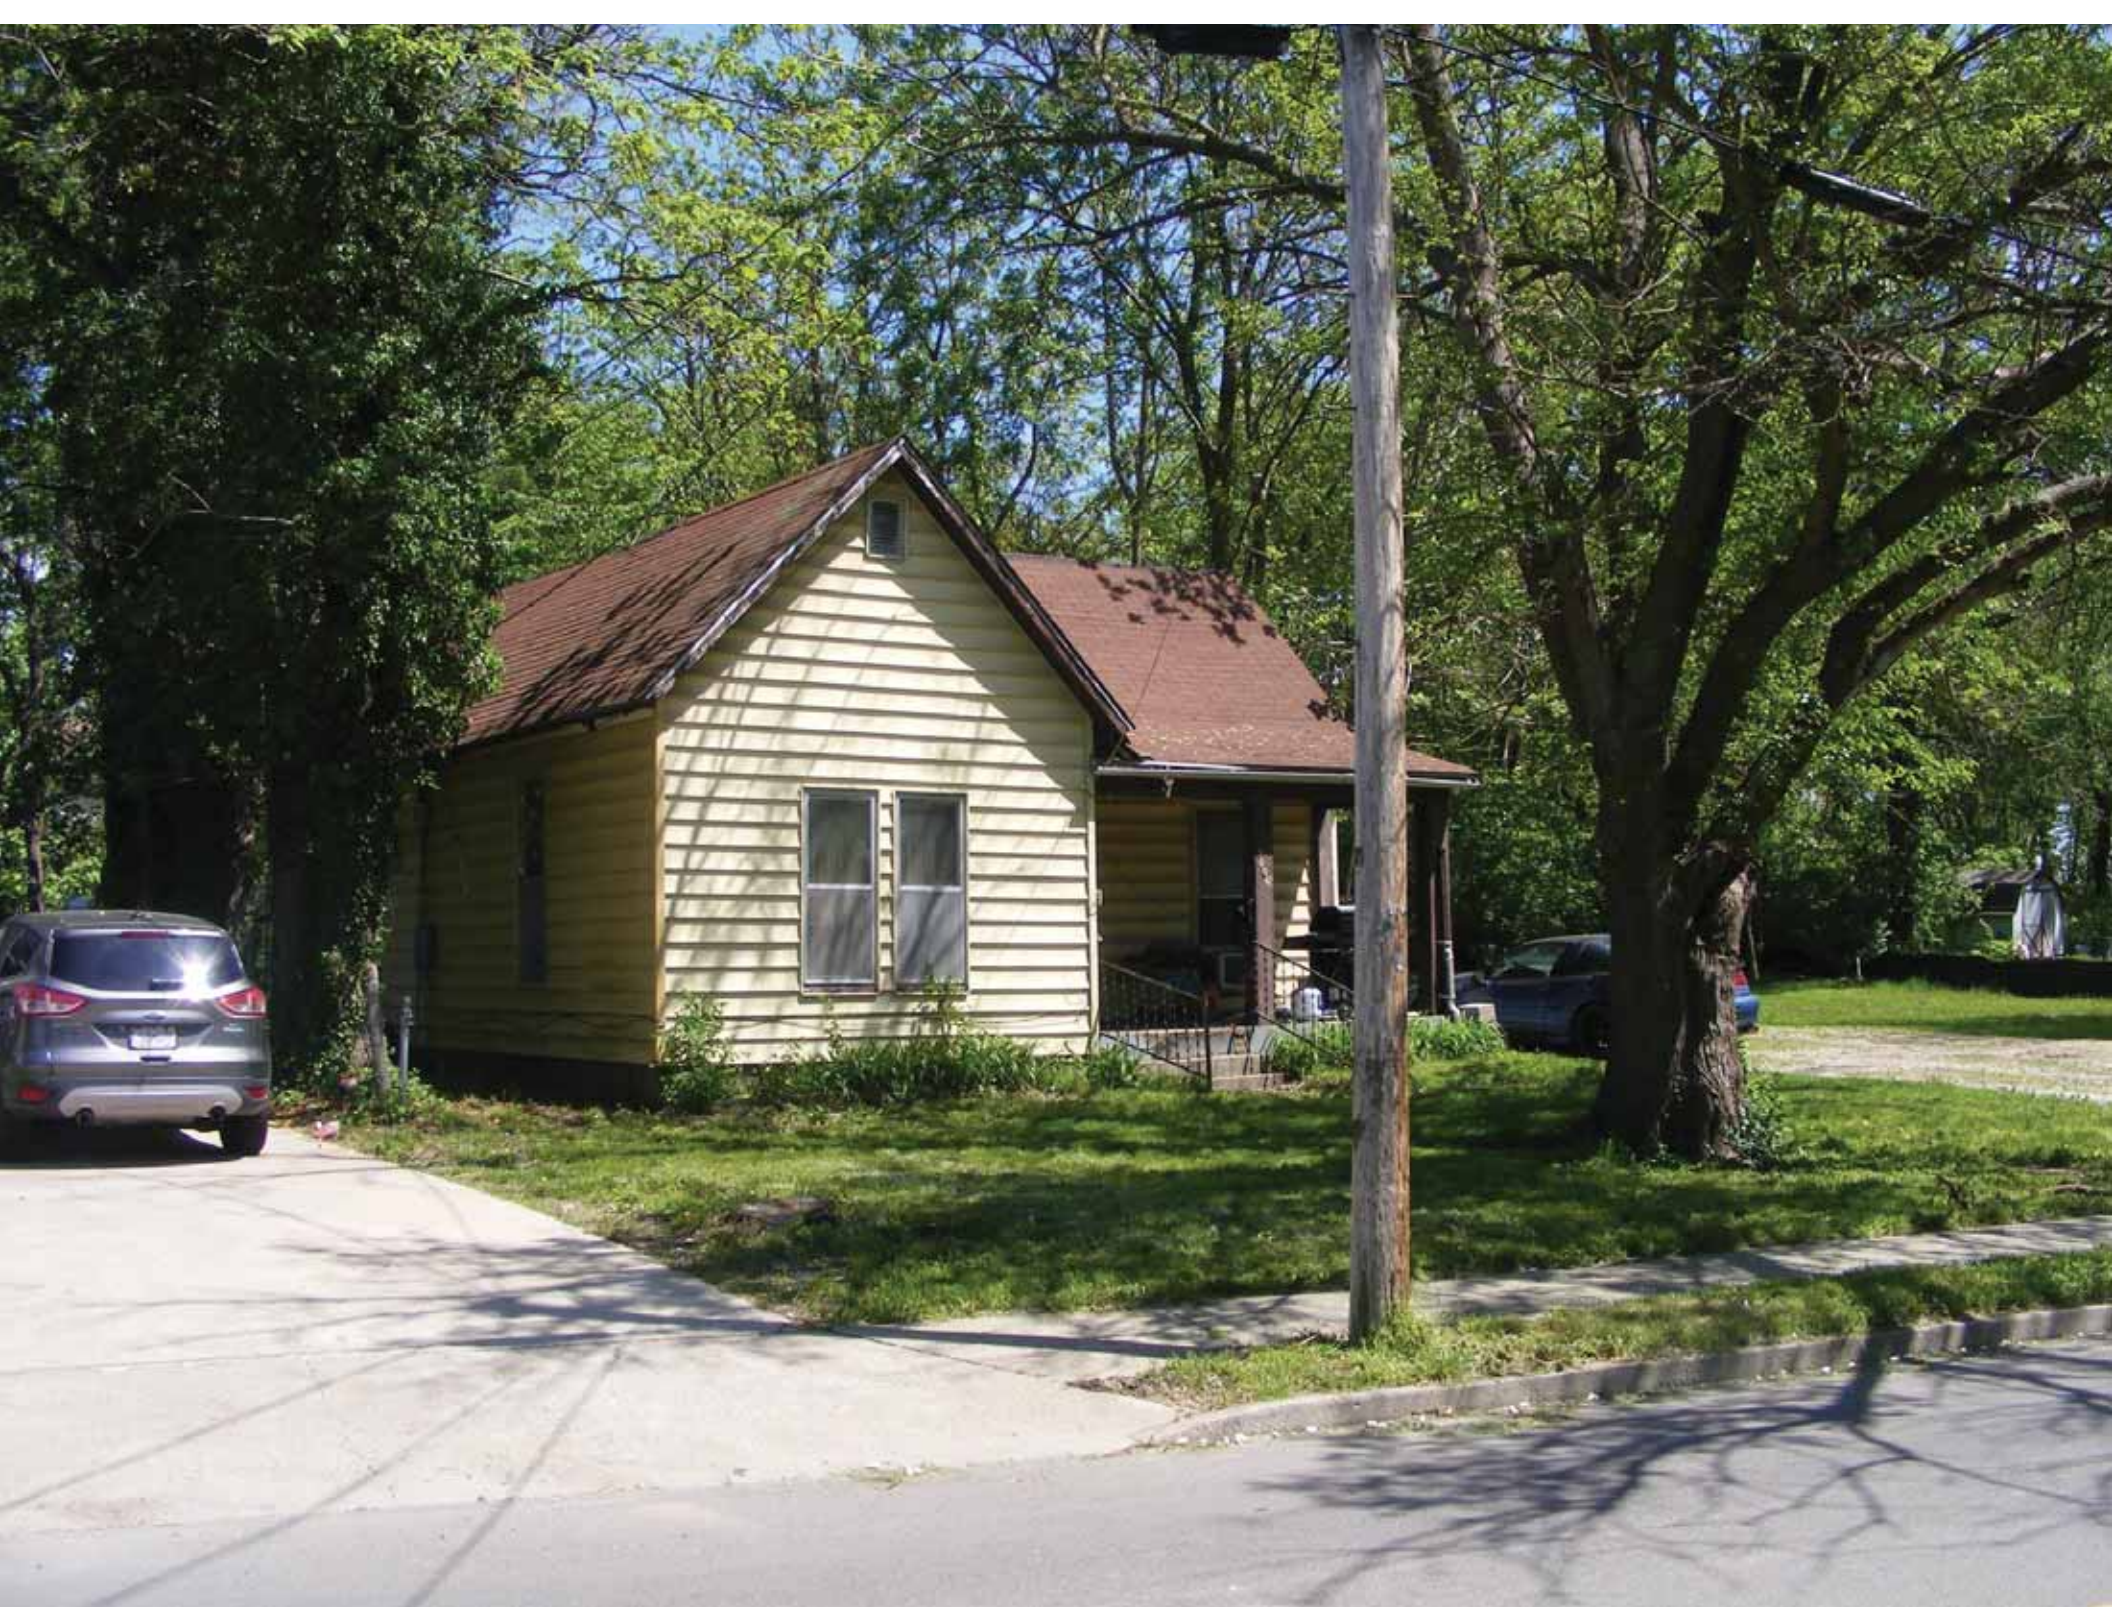
The single-story dwelling has an asphalt-shingled gable roof, exterior synthetic siding and a concrete foundation. The dwelling is composed of a front facing gable wing and two rear cross gable wings. The primary (west) elevation supports a half-width shed porch created by the cross-gabled plan. The porch is supported by square wood columns and has concrete steps with wrought iron handrails. Within the porch bay are two single doors – one facing south and one facing west. Windows are one-over-one on the façade. Some side elevation windows retain original two-light upper and/or lower sashes. One side elevation window (south) retains a nine-over-nine window that appears original.

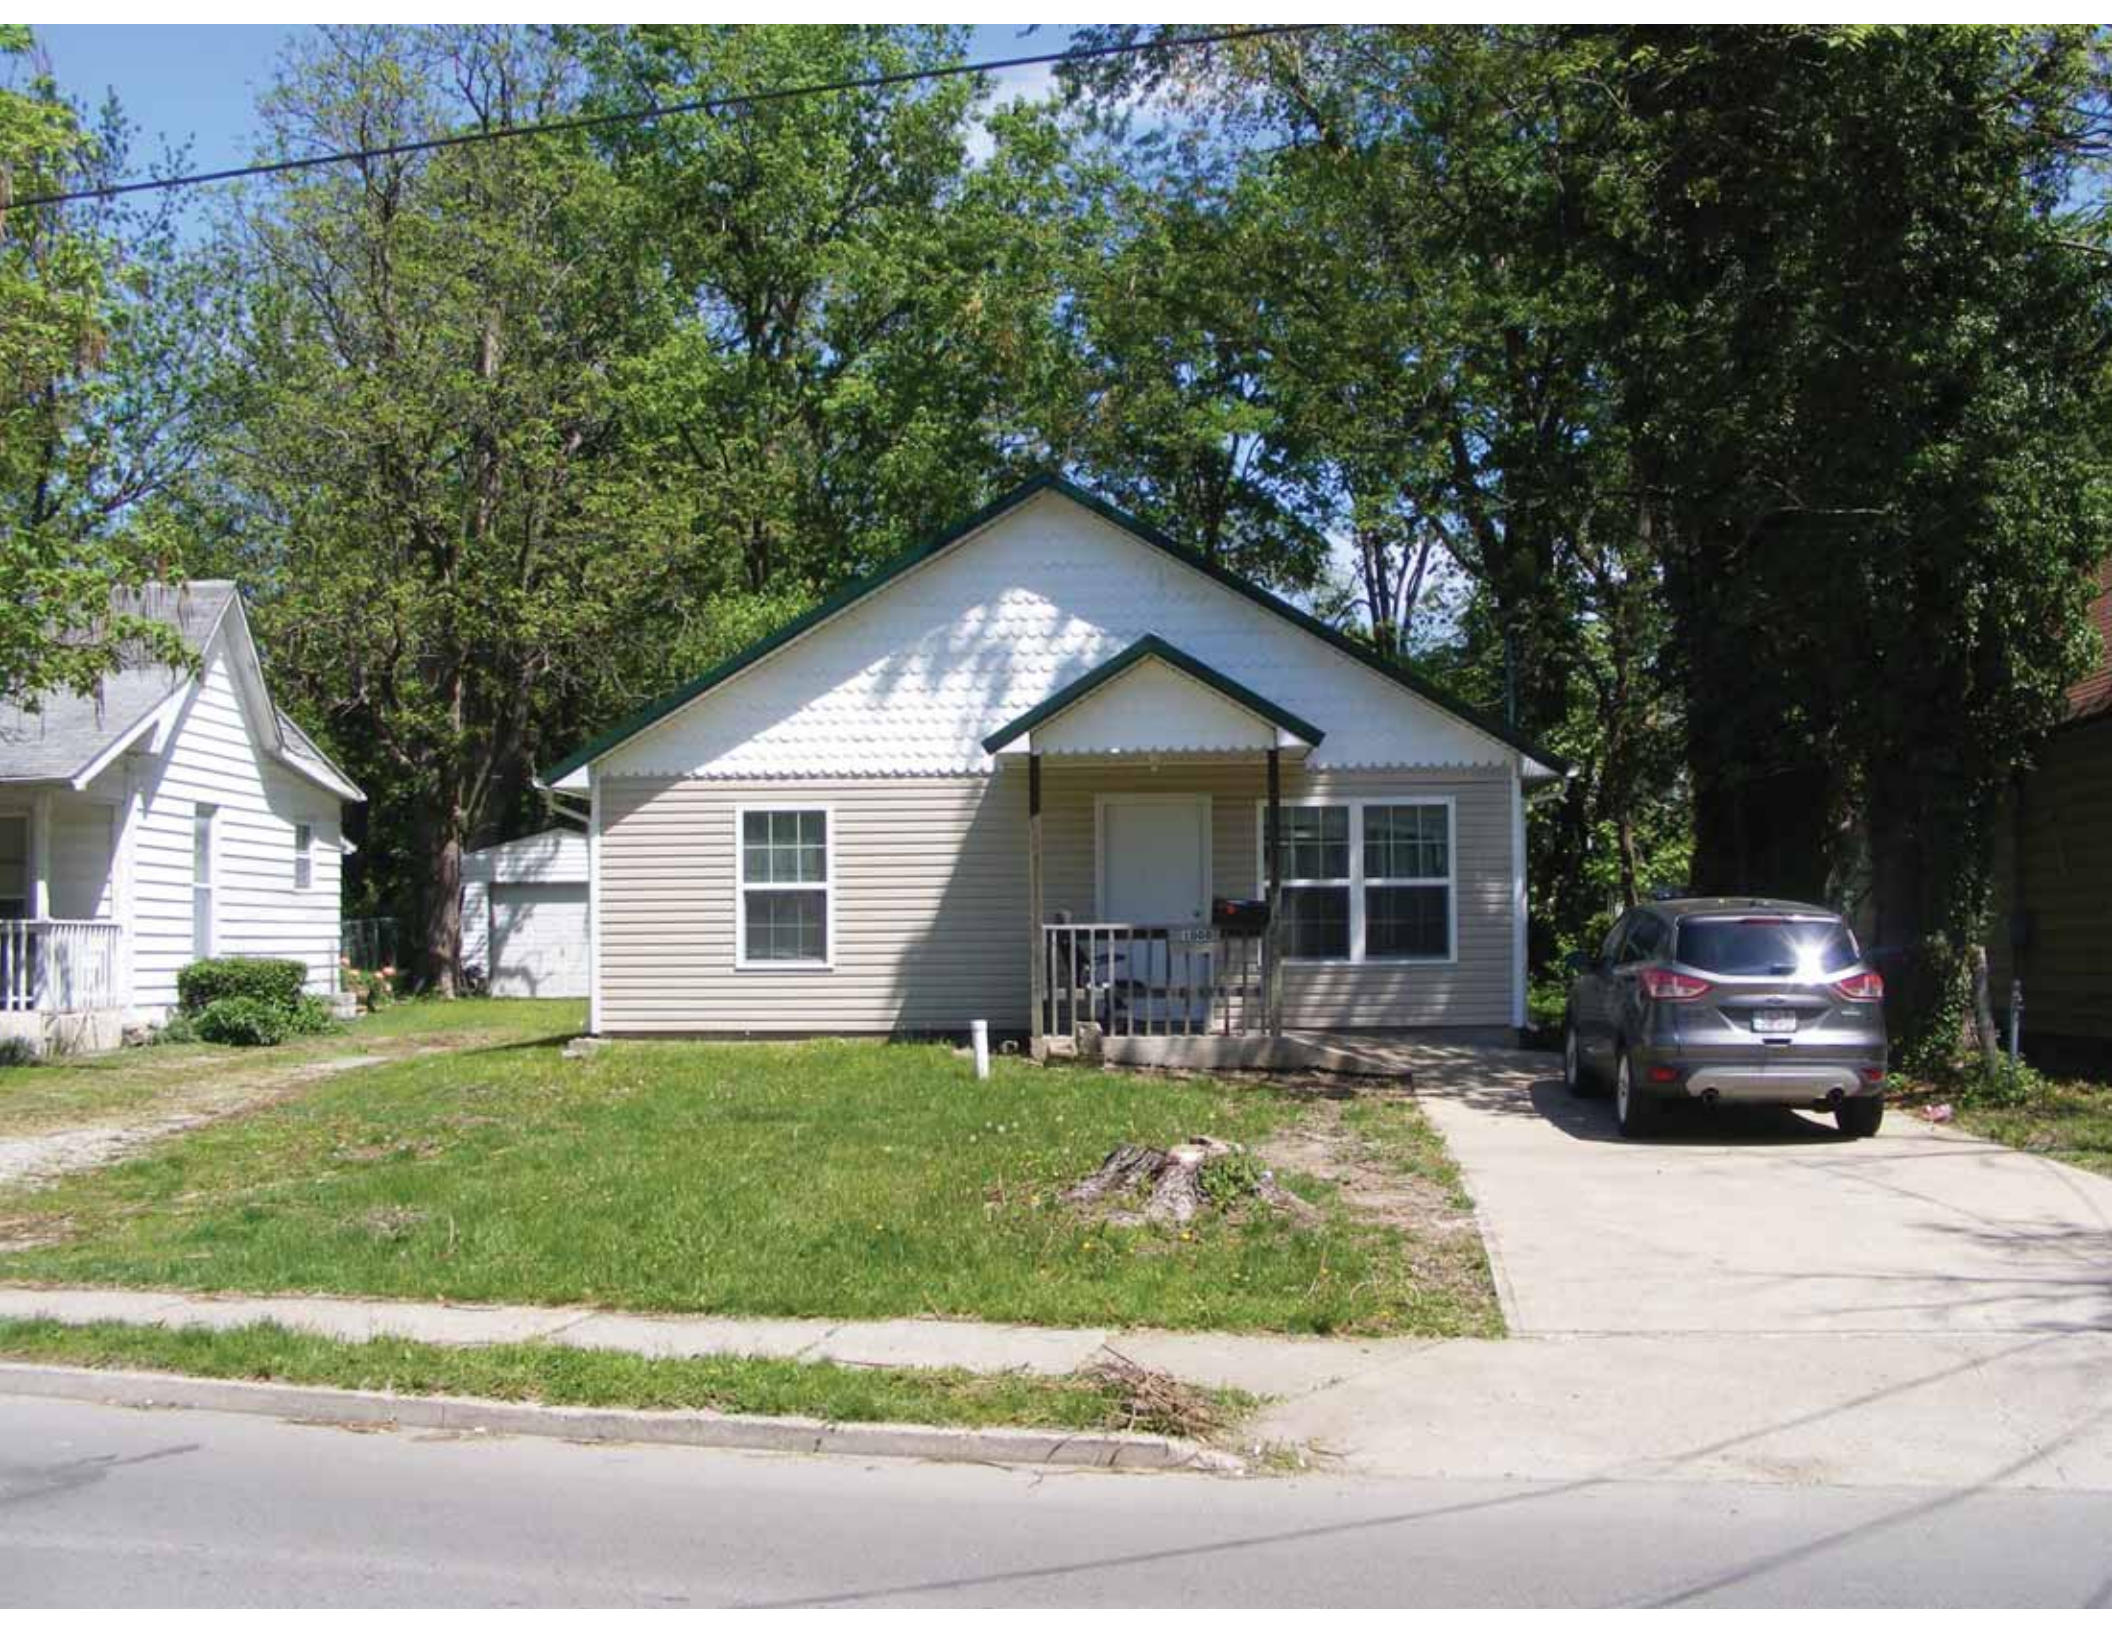
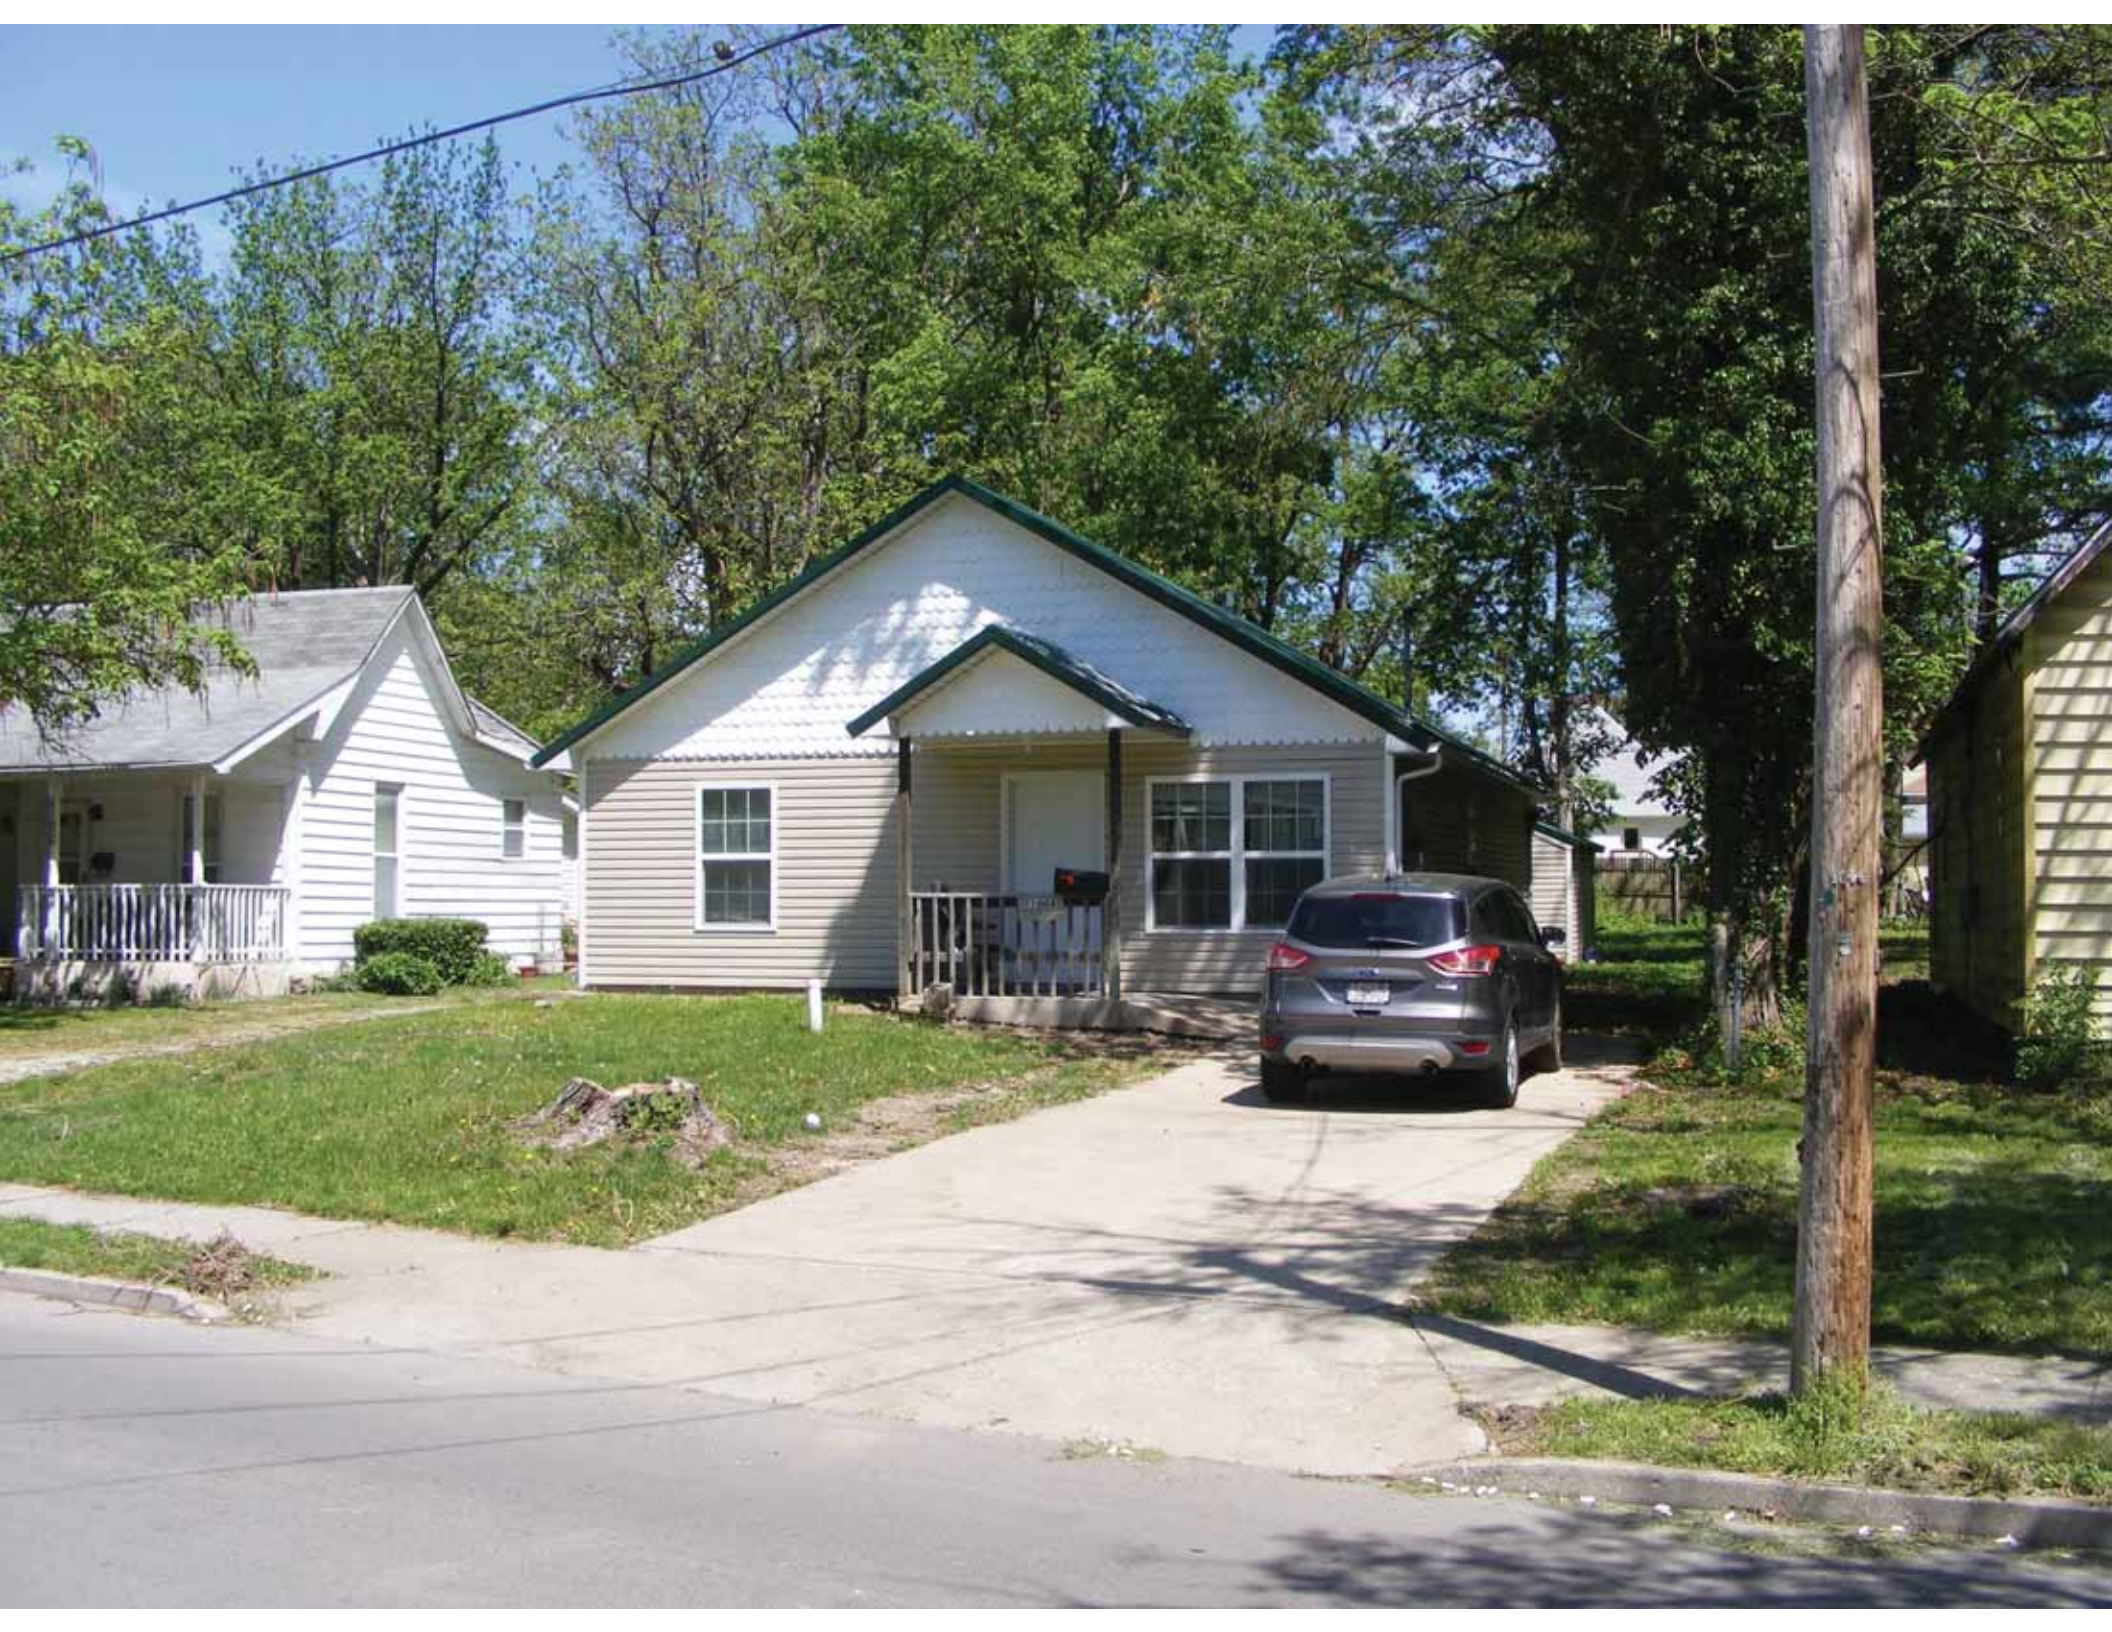
The dwelling is a gable-front plan with an asphalt-shingled roof, exterior vinyl siding and a concrete foundation. The front gable is filled with scalloped siding. This latter feature is also within the gable field of the portico, which is supported by slender wood columns. The portico is slightly off-center and has a frame balustrade. Within the bay of the small porch is a solid paneled door. Flanking the door are paired and single six-over-six windows.

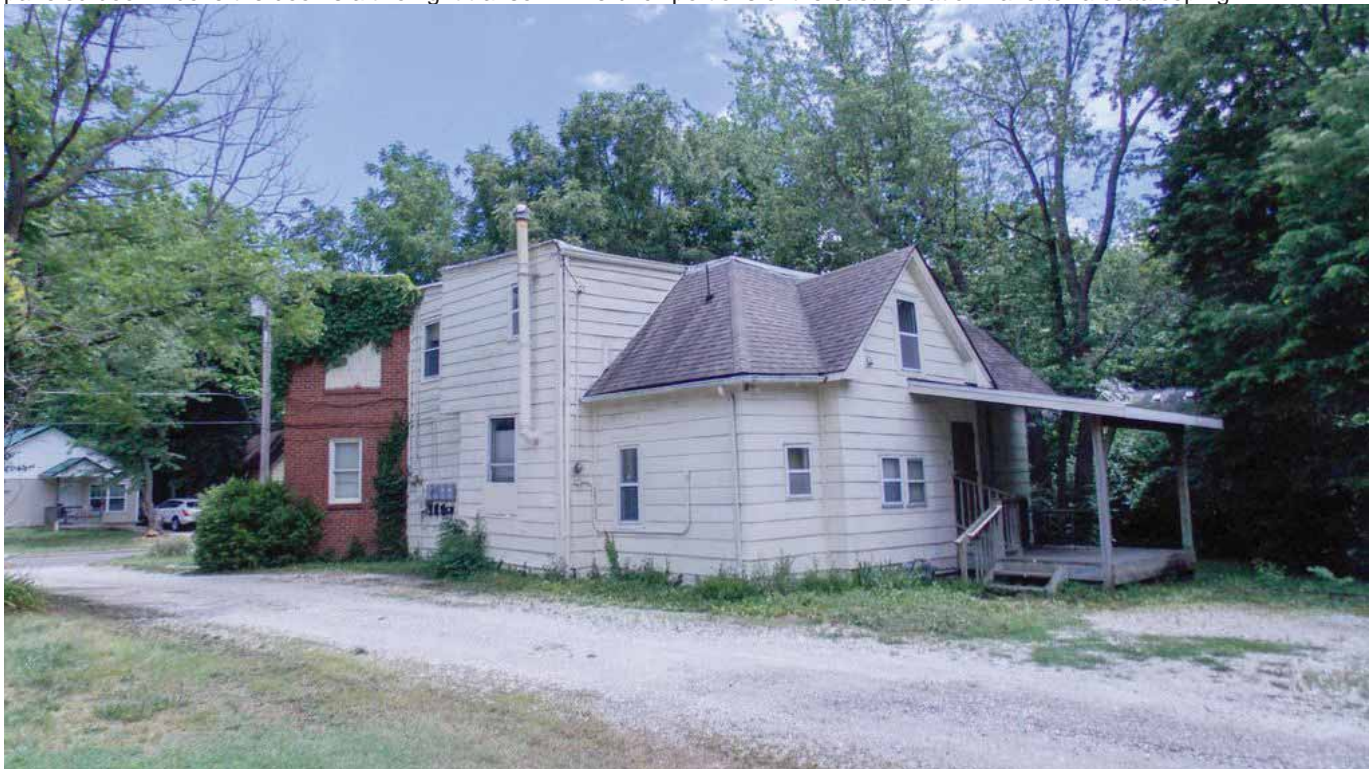
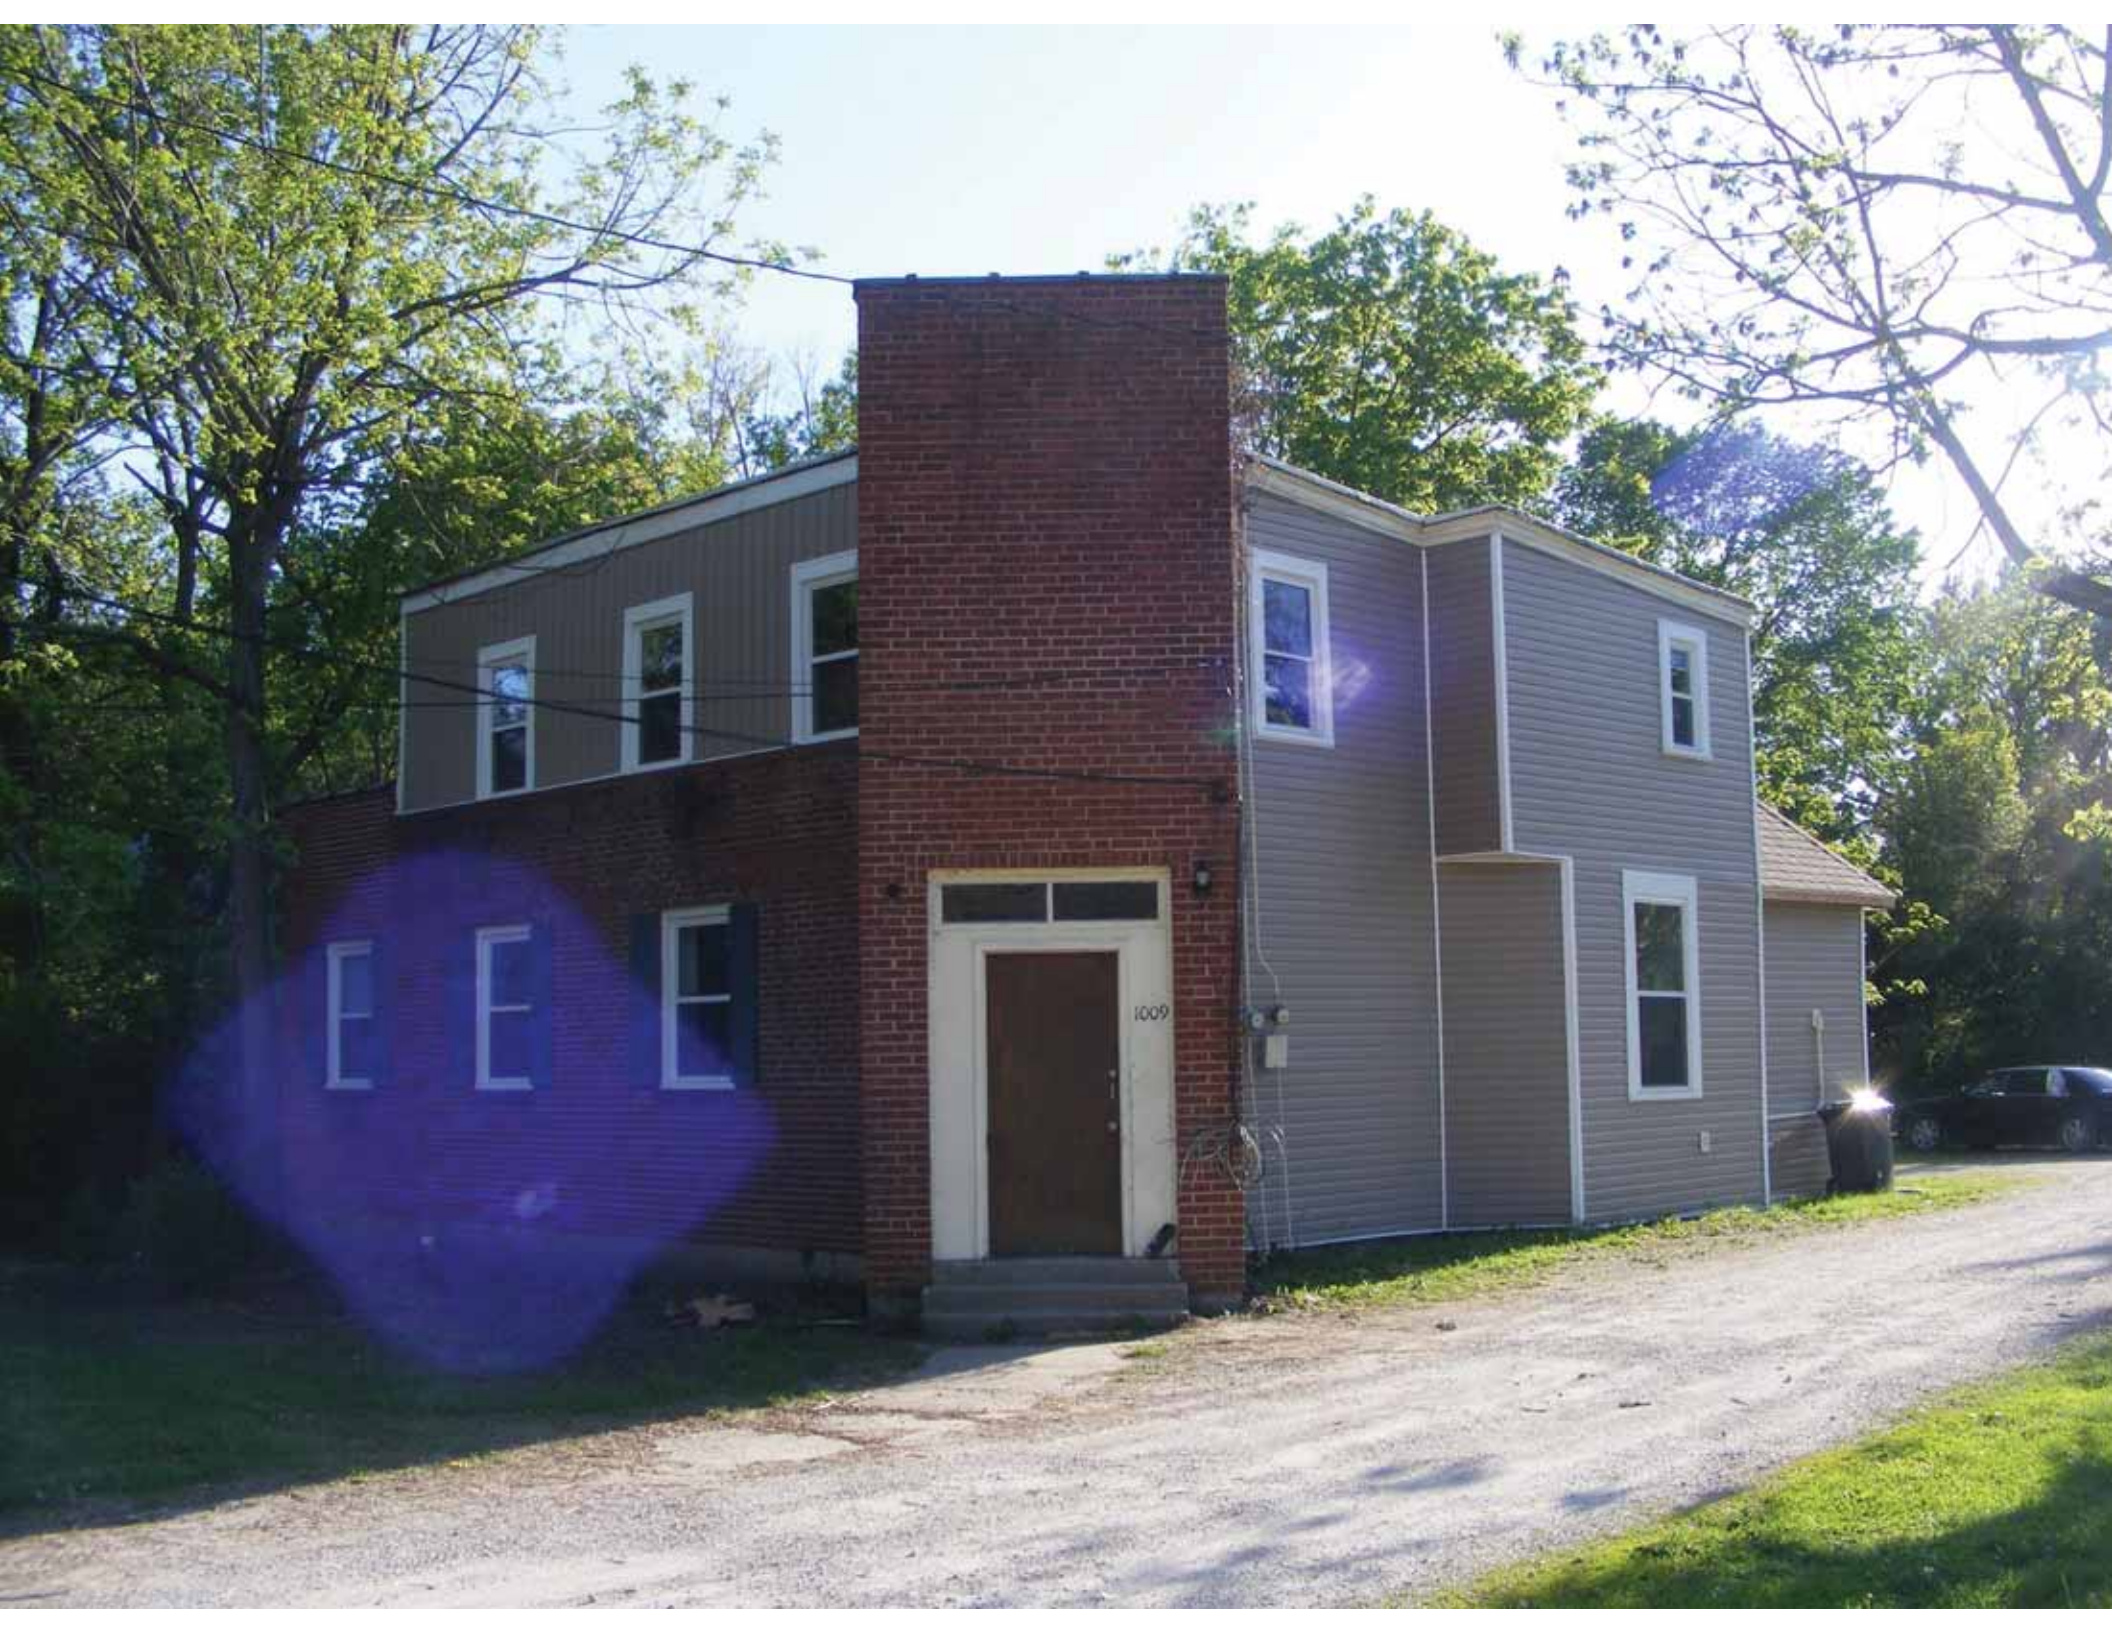
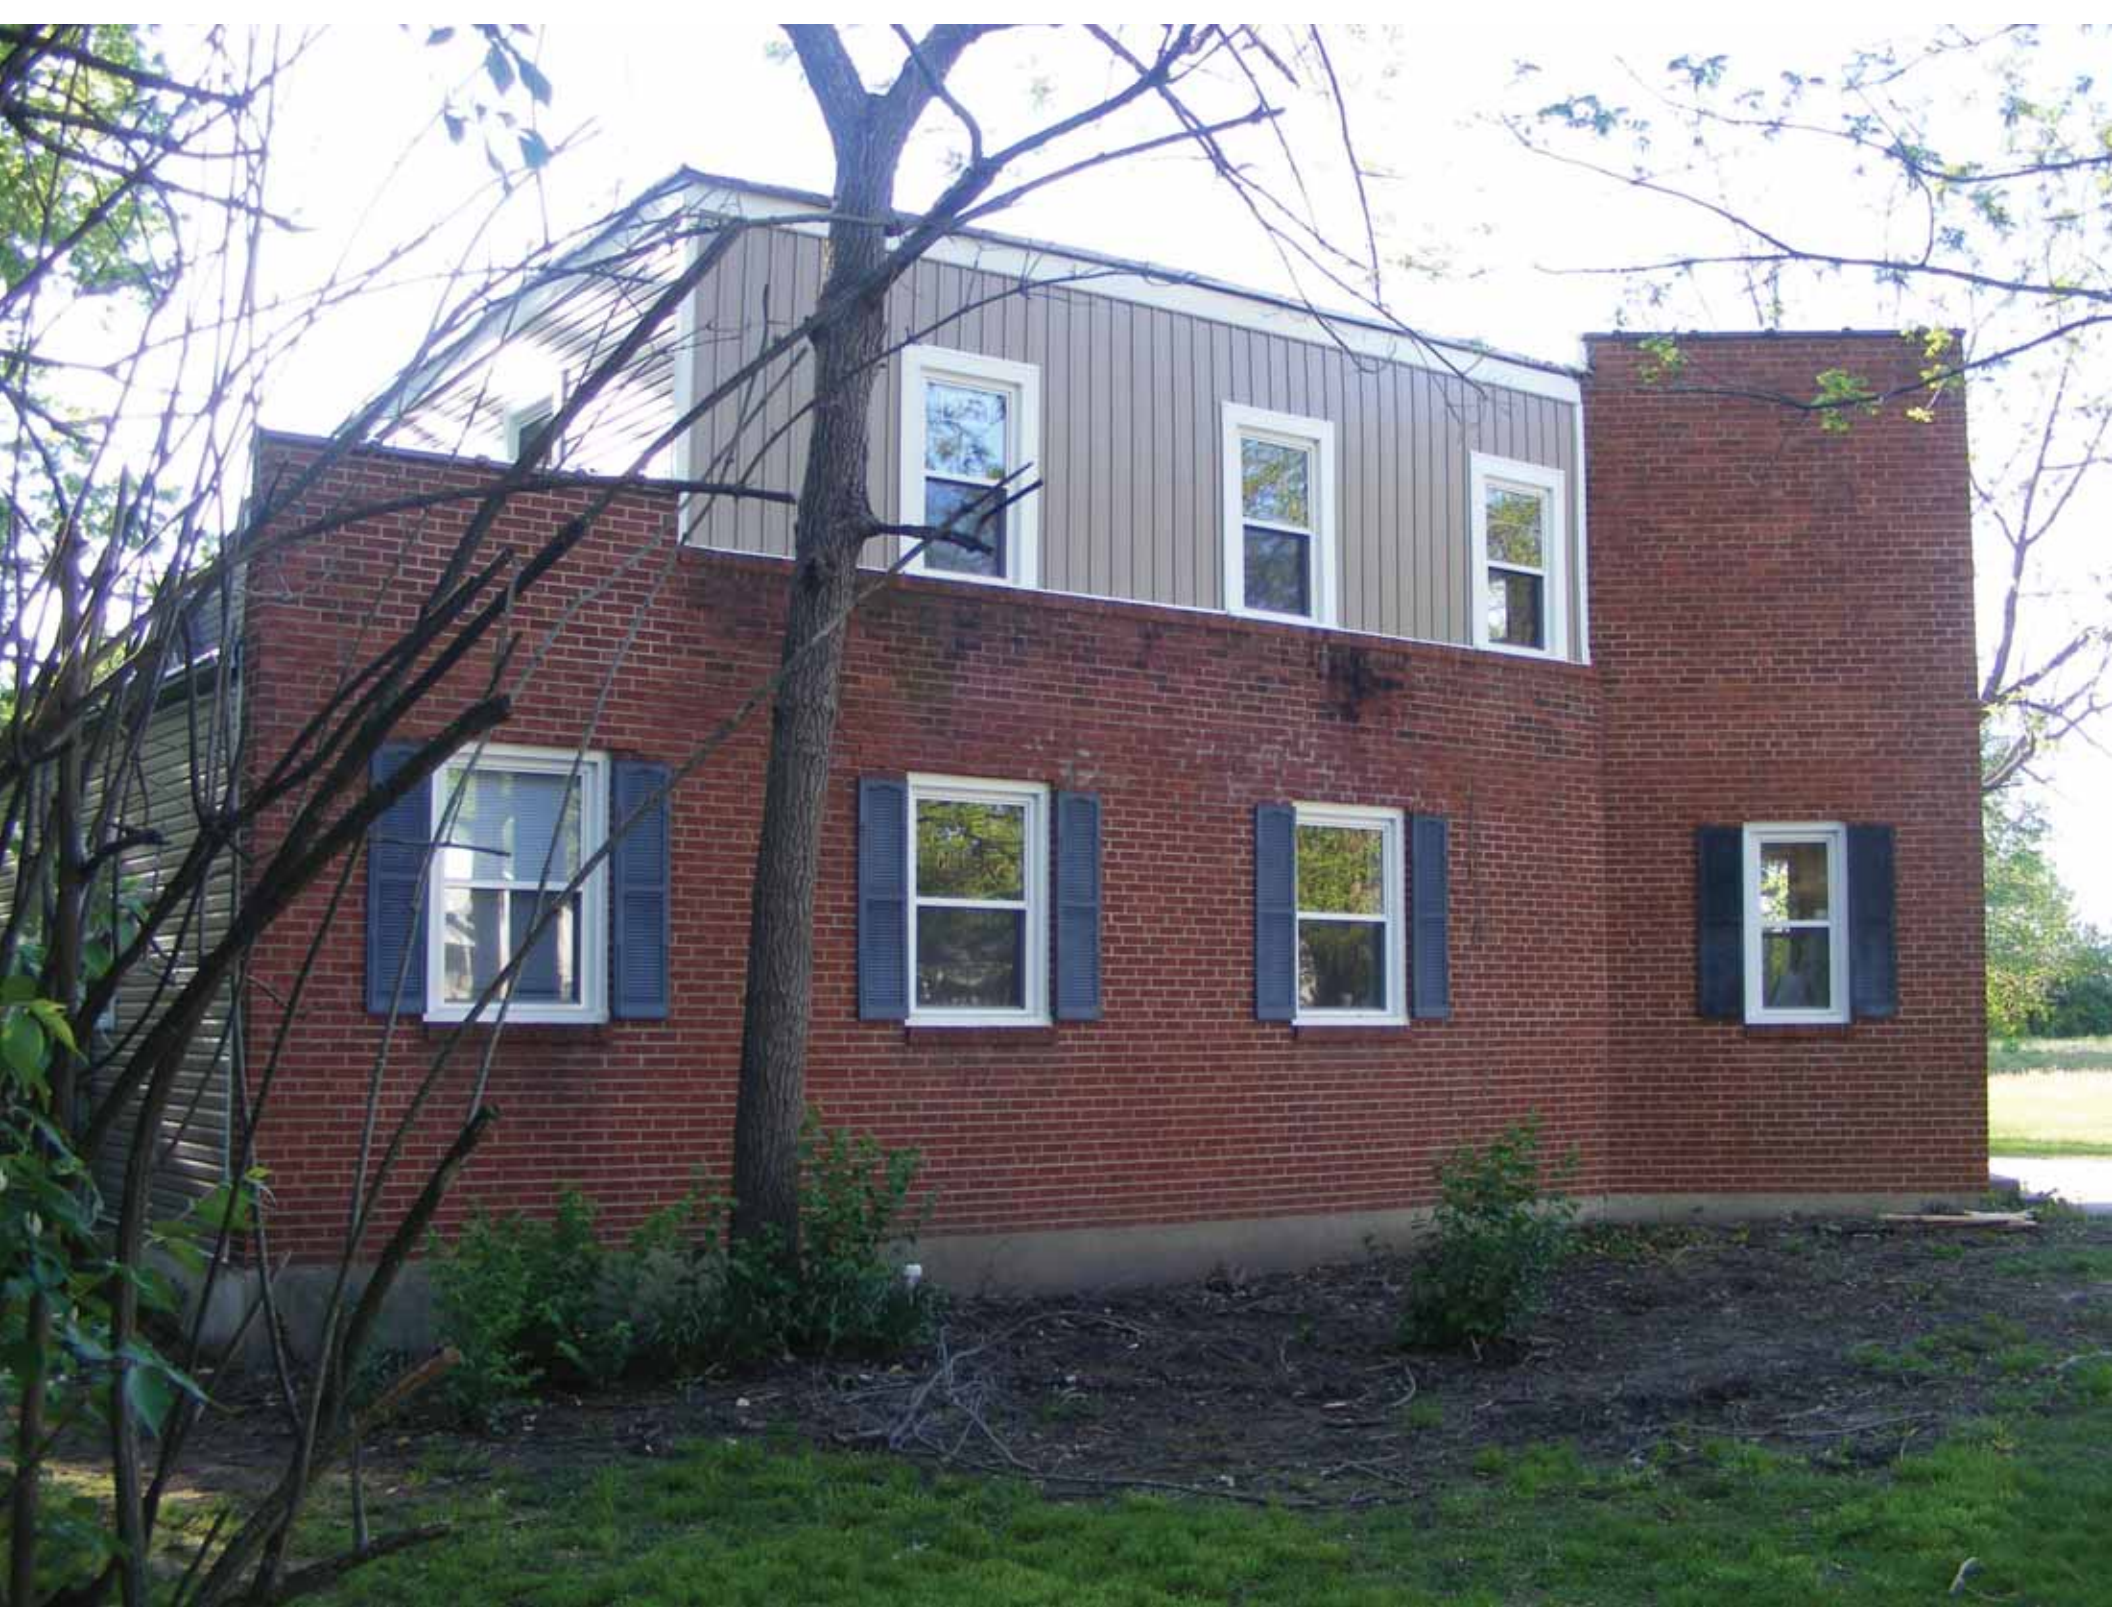
This multi-family building has been extensively altered since construction c. 1920. Sanborn maps show a single-family dwelling (1925, 1931, and 1948). The rear (west) end of the building (based on realtor's records) supports a wing that illustrates a single-family c. 1920 dwelling with a high hipped roof and rear shed porch (see image below). The bulk of the building is two stories in height with a flat roof. Most of the two-story elevations are clad with vinyl with exception of the façade, which has brick surrounding the corner entry (northeast bay) and first-story east elevation. Windows are replacement one-over-one. The entry bay is angled and holds a contemporary solid paneled door. Above the door is a two-light transom. The brick portions of the east elevation have terra cotta coping.
