MISSOURI DEPARTMENT OF NATURAL RESOURCES
STATE HISTORIC PRESERVATION OFFICE, P.O. Box 176, Jefferson City, MO 65102
ARCHITECTURAL/HISTORIC INVENTORY FORM

1. Survey No. BO-AS-011-0087		2. Survey name: North Central Columbia Survey Phase II	
3. County: Boone		4. Address (Street No.) 902	Street (name) N. Seventh Street
5. City: Columbia	Vicinity: <input type="checkbox"/>	6. Geographical Reference:	7. Township/Range/Section: T: R: S:
8. Historic name (if known):		9. Present/other name (if known):	
10. Ownership: <input checked="" type="checkbox"/> Private <input type="checkbox"/> Public		11a. Historic use (if known): Domestic/single dwelling	11b. Current use: Domestic/single dwelling

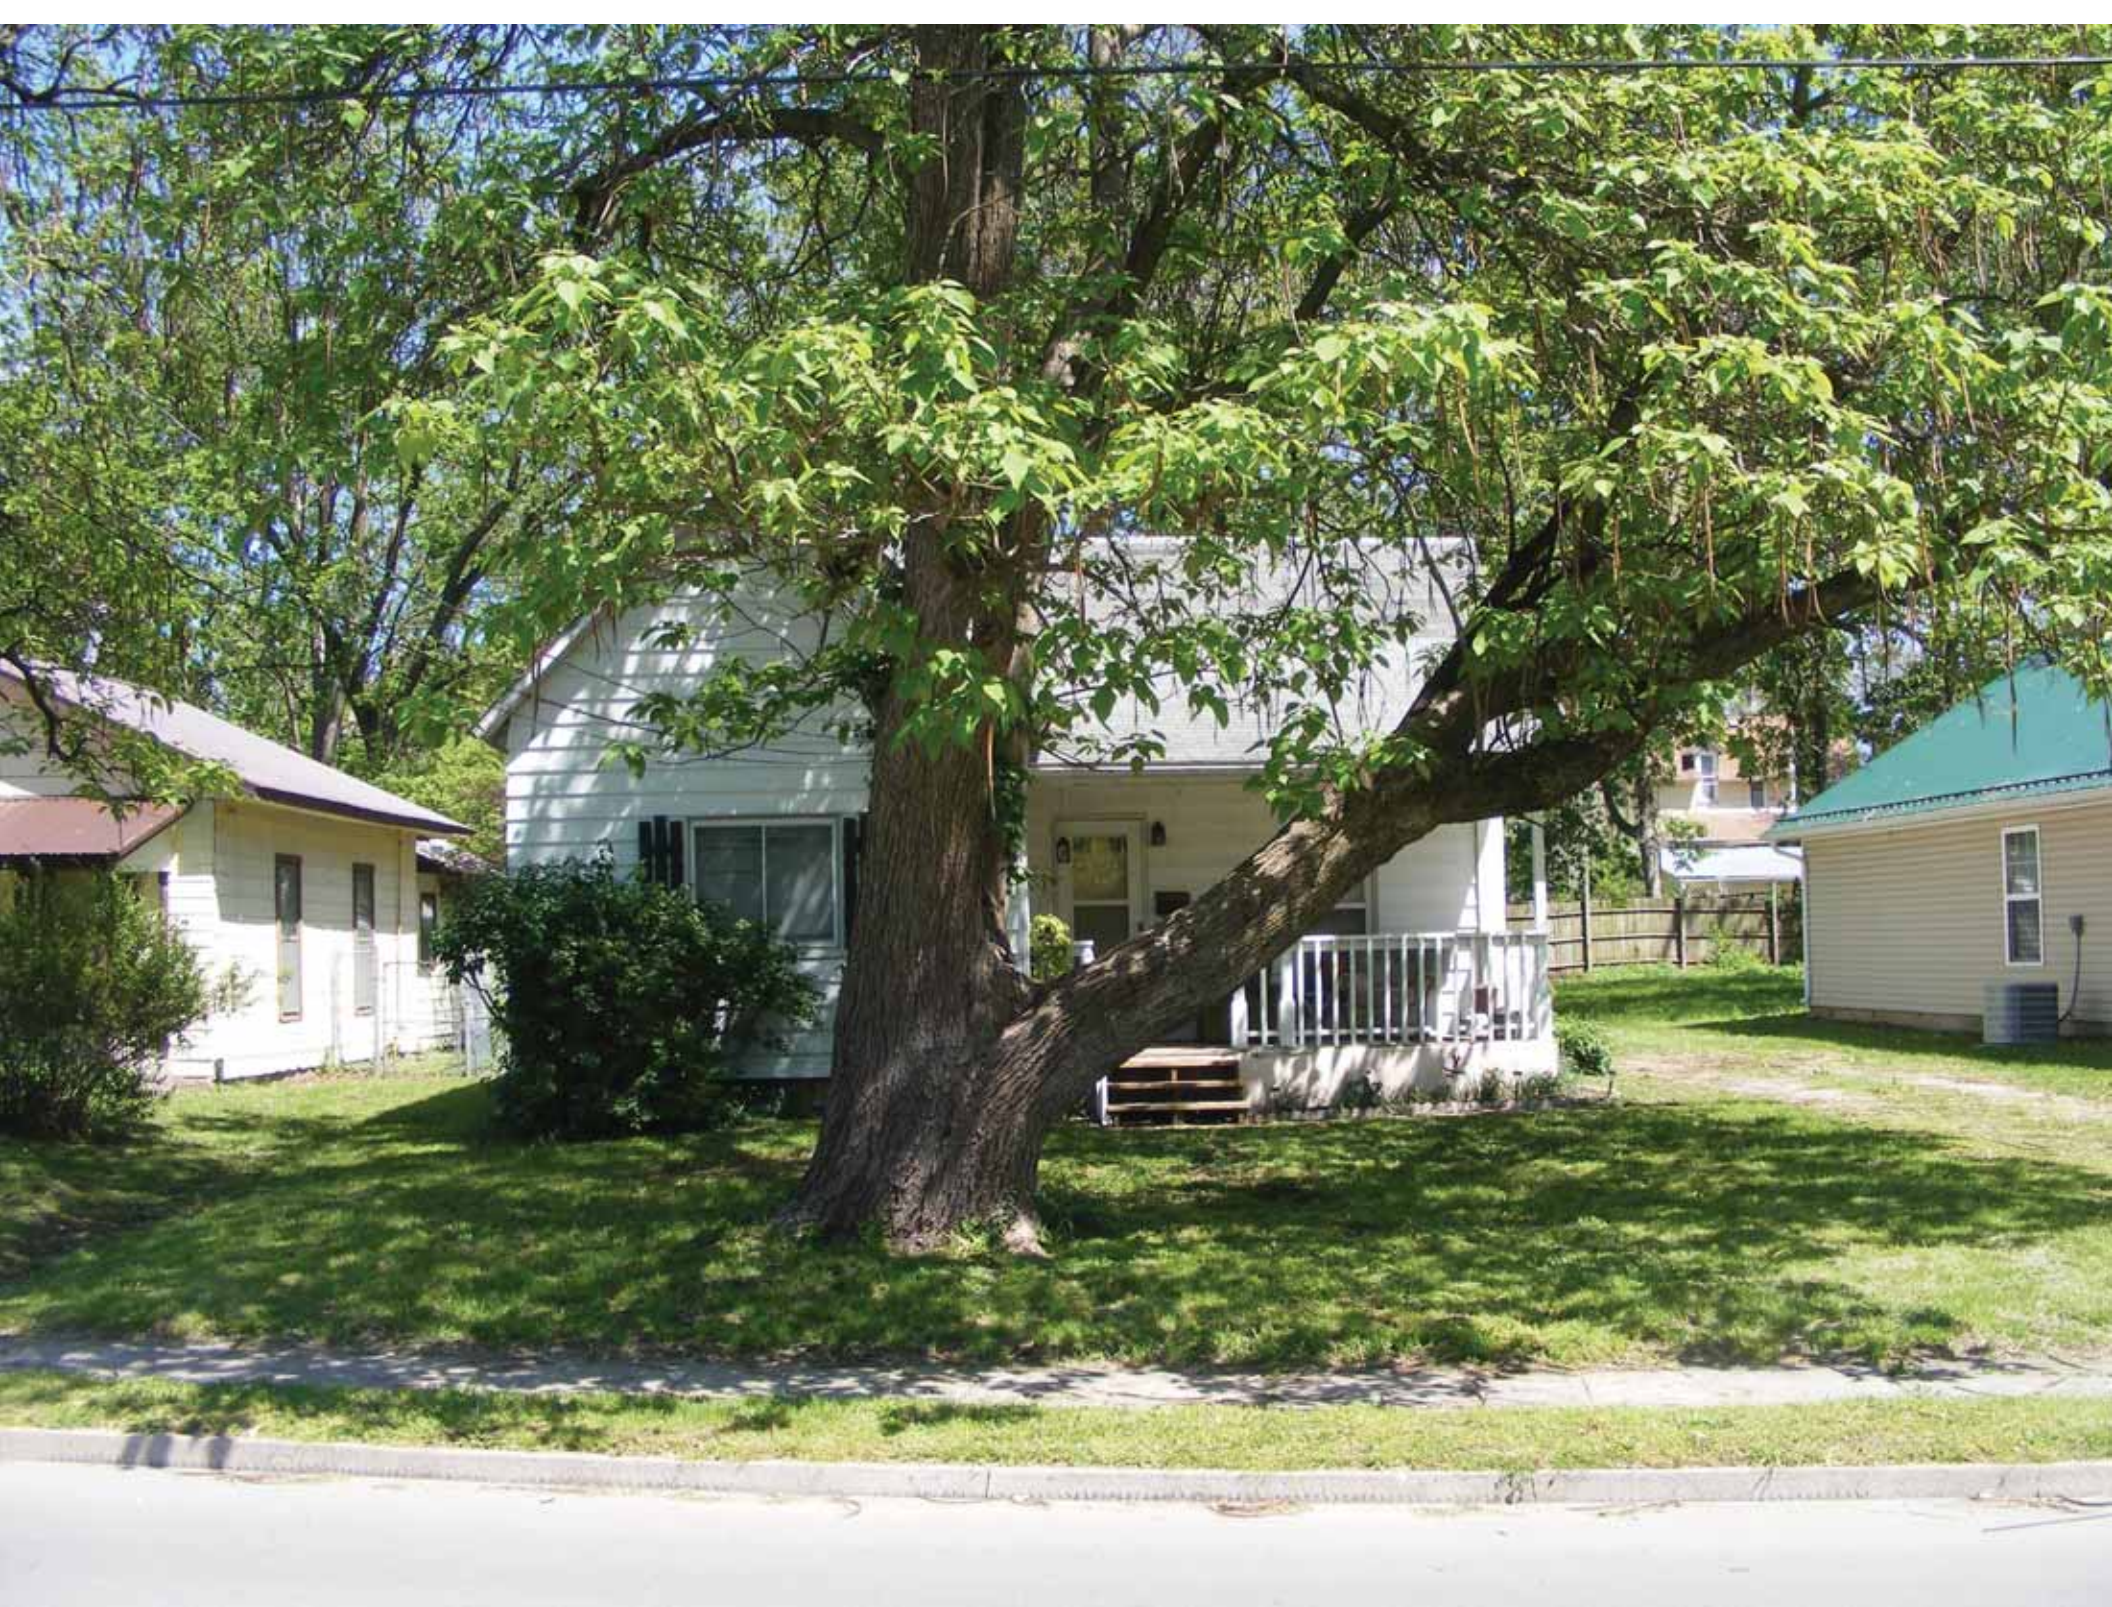
The single-story dwelling has an asphalt-shingled gable roof, exterior synthetic siding and a concrete foundation. The primary (west) elevation has a shed porch supported by chamfered columns. The porch is surrounded by a frame balustrade. Wood non-original steps lead to the porch from the yard. The front elevation (north of the porch) holds a replacement two-by-two sliding window with faux shutters. Remaining windows appear to be original one-over-one and are void of shutters. The primary entry is within the porch bay, filled with a paneled door with two upper lights. The door is offset by a one-over-one window.

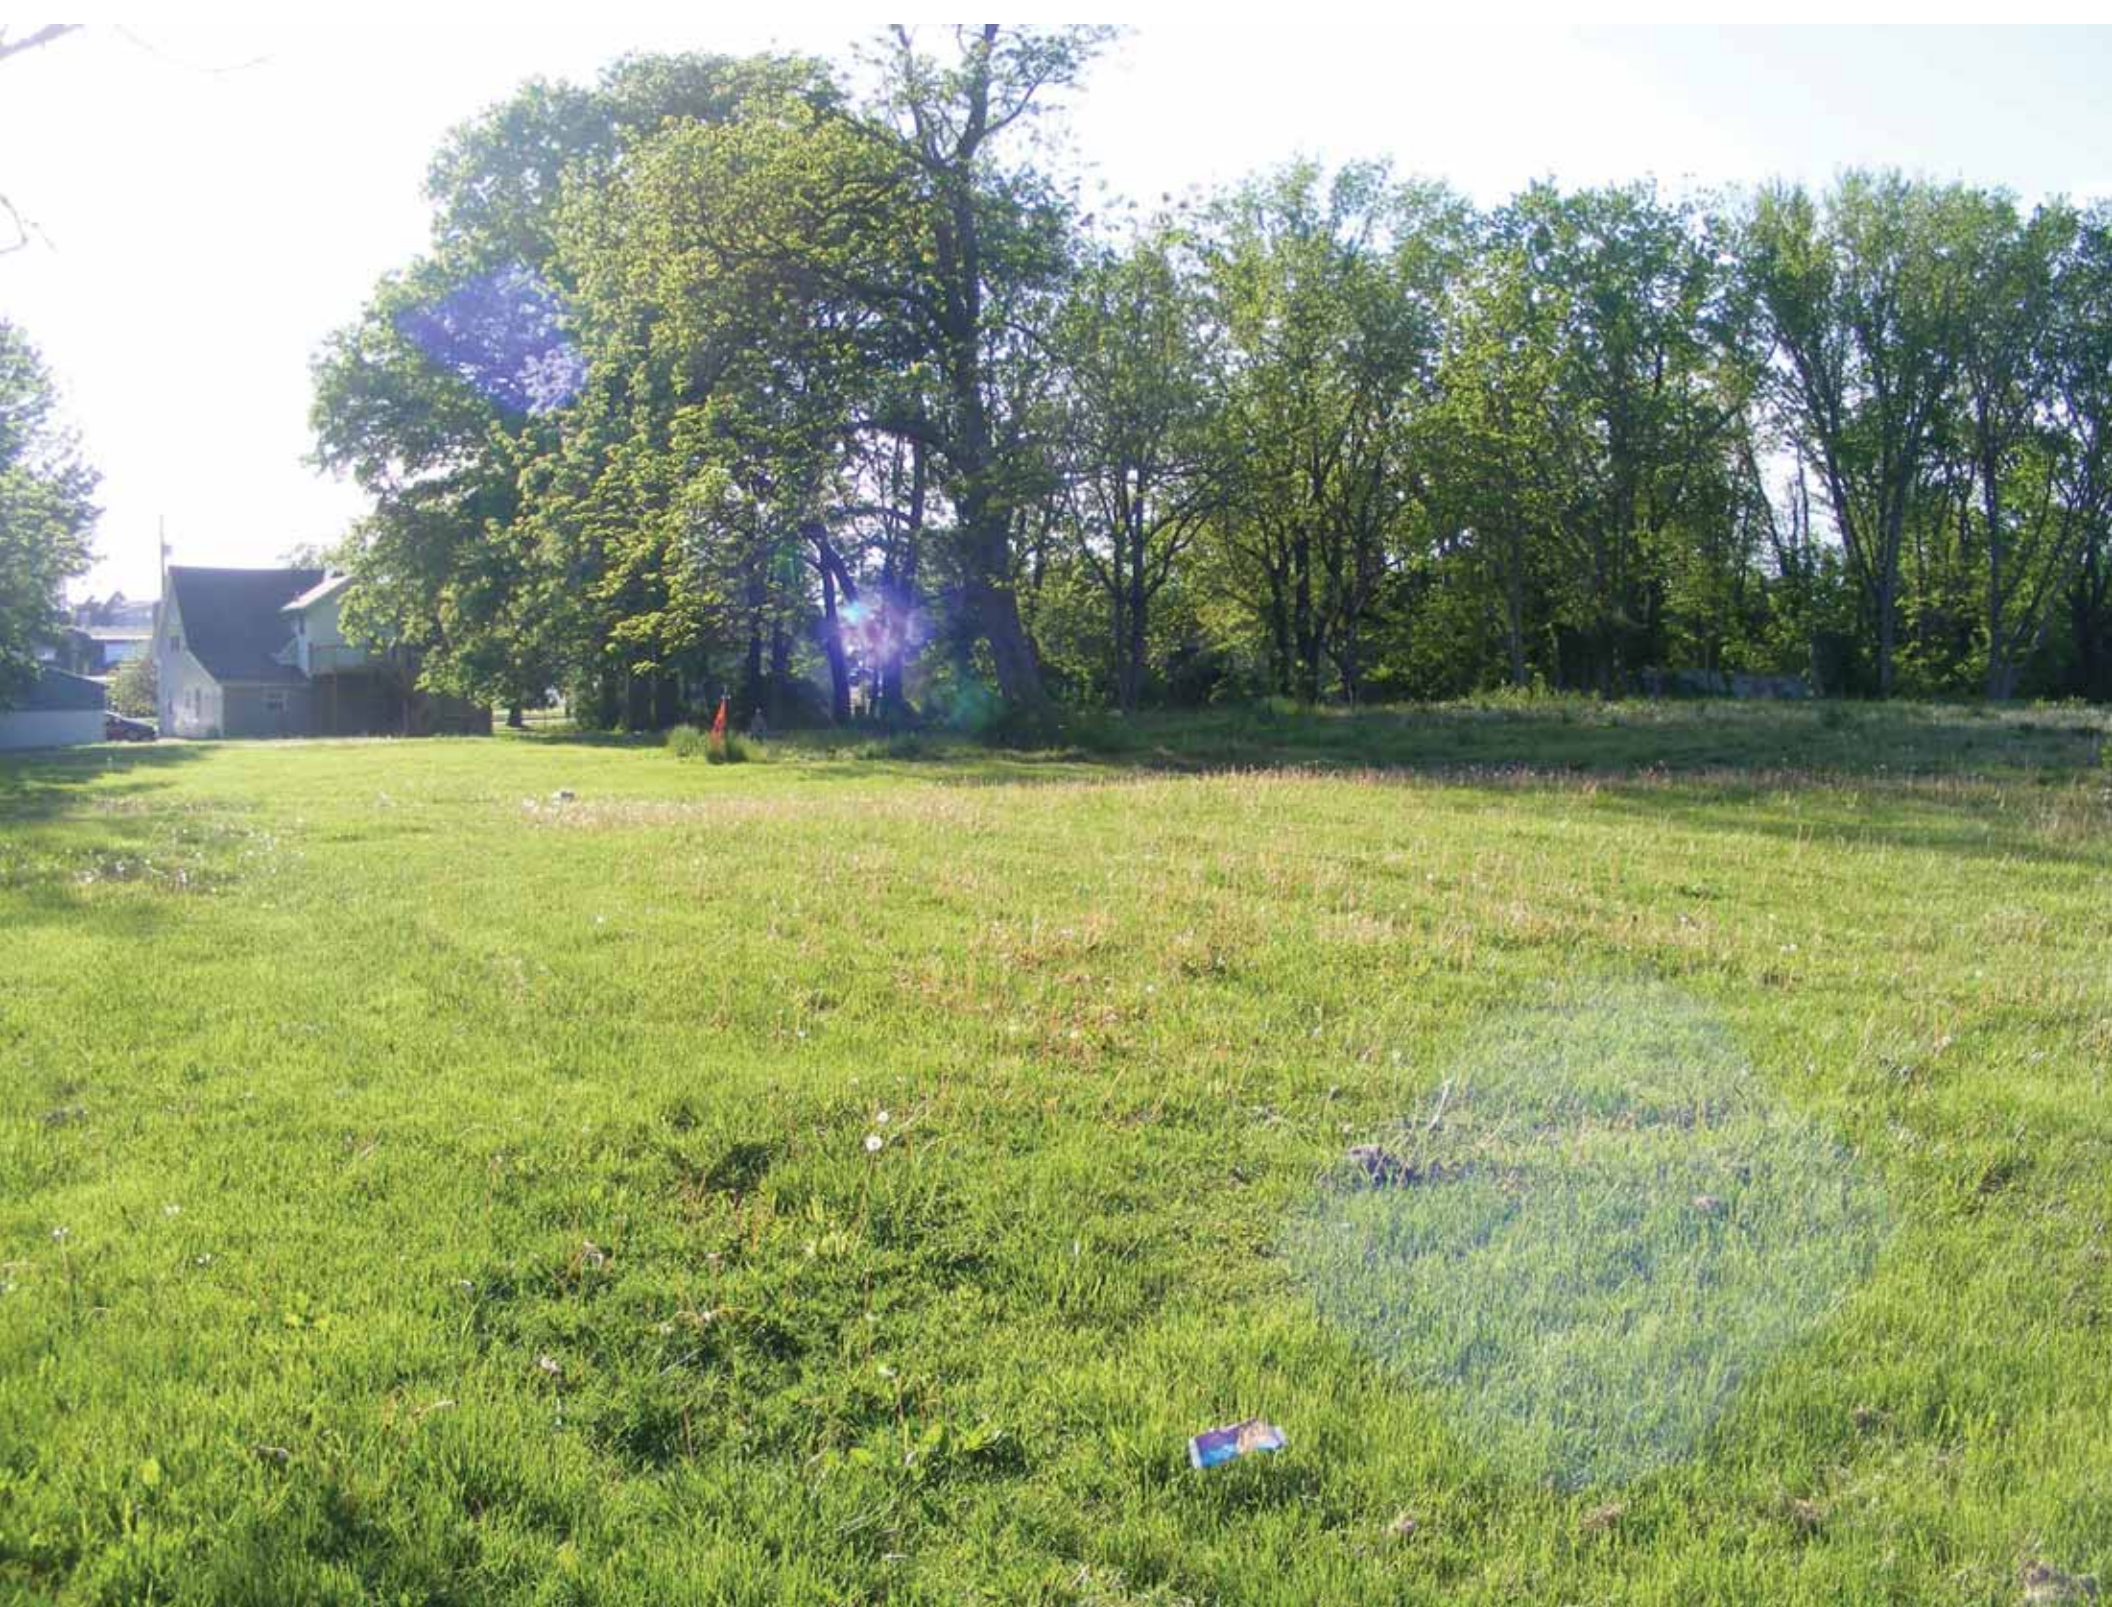
This 0.39-acre vacant lot held a single-family dwelling previously (per Sanborn Fire Insurance Maps, 1925 and 1948). The lot is as above, covered with grass and bounded by the public sidewalk at the east end of the lot. There are no buildings on the lot.

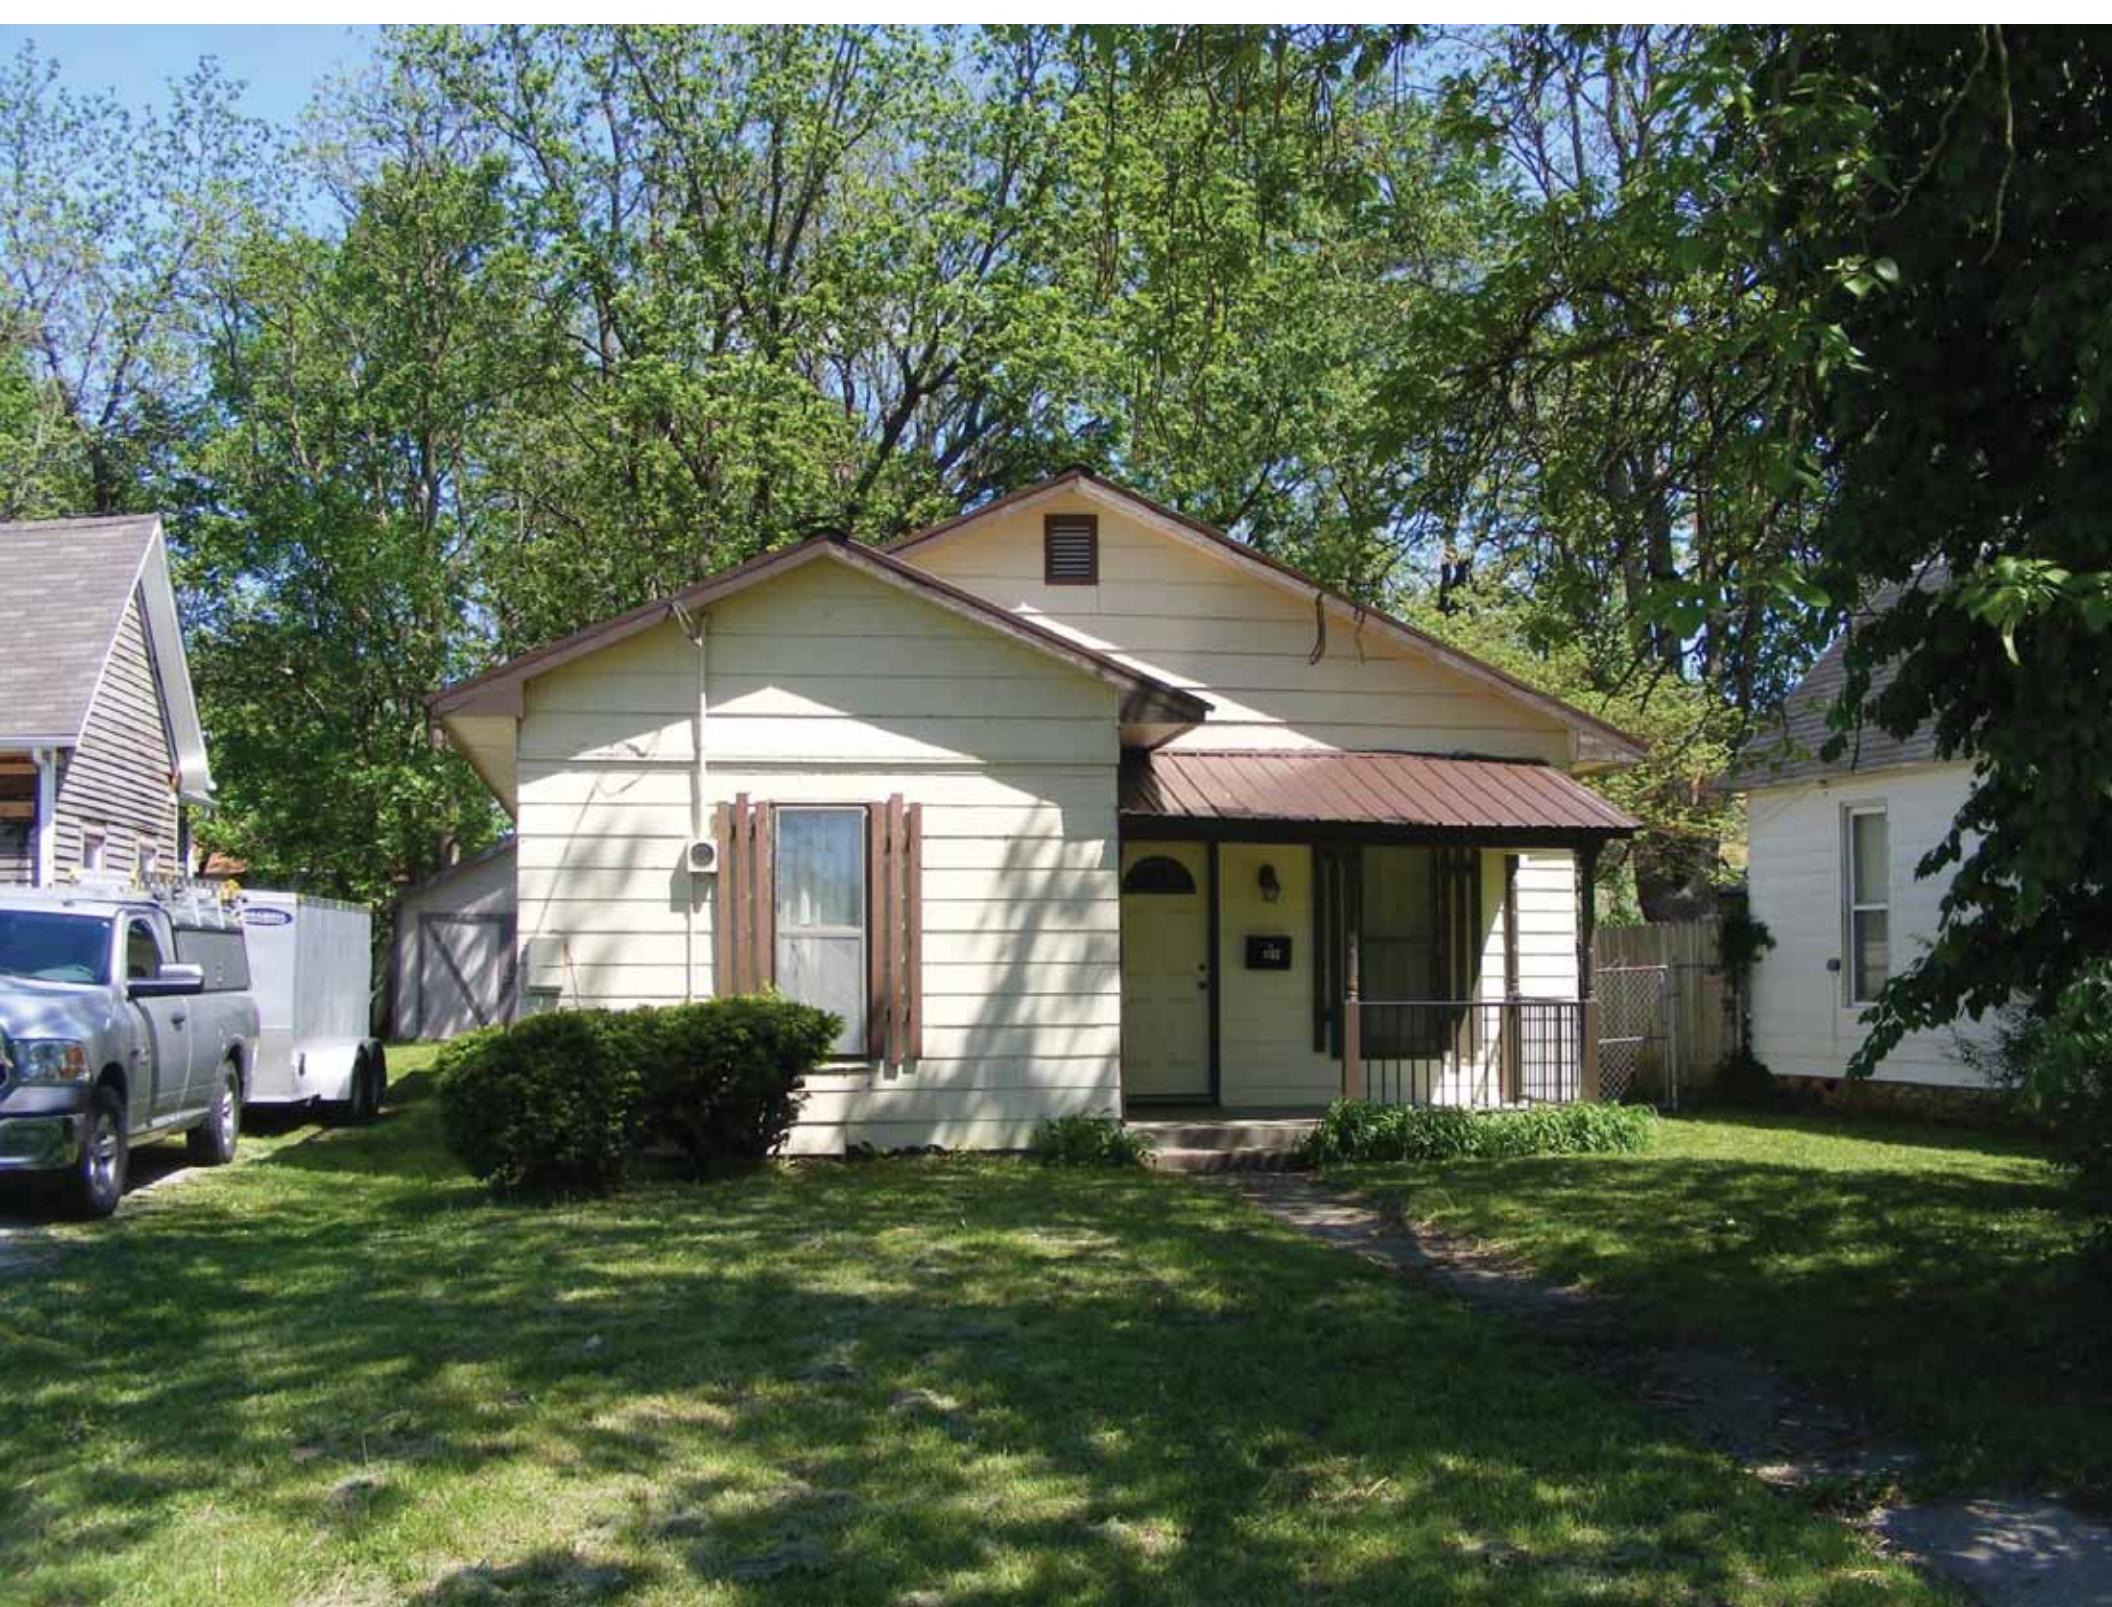
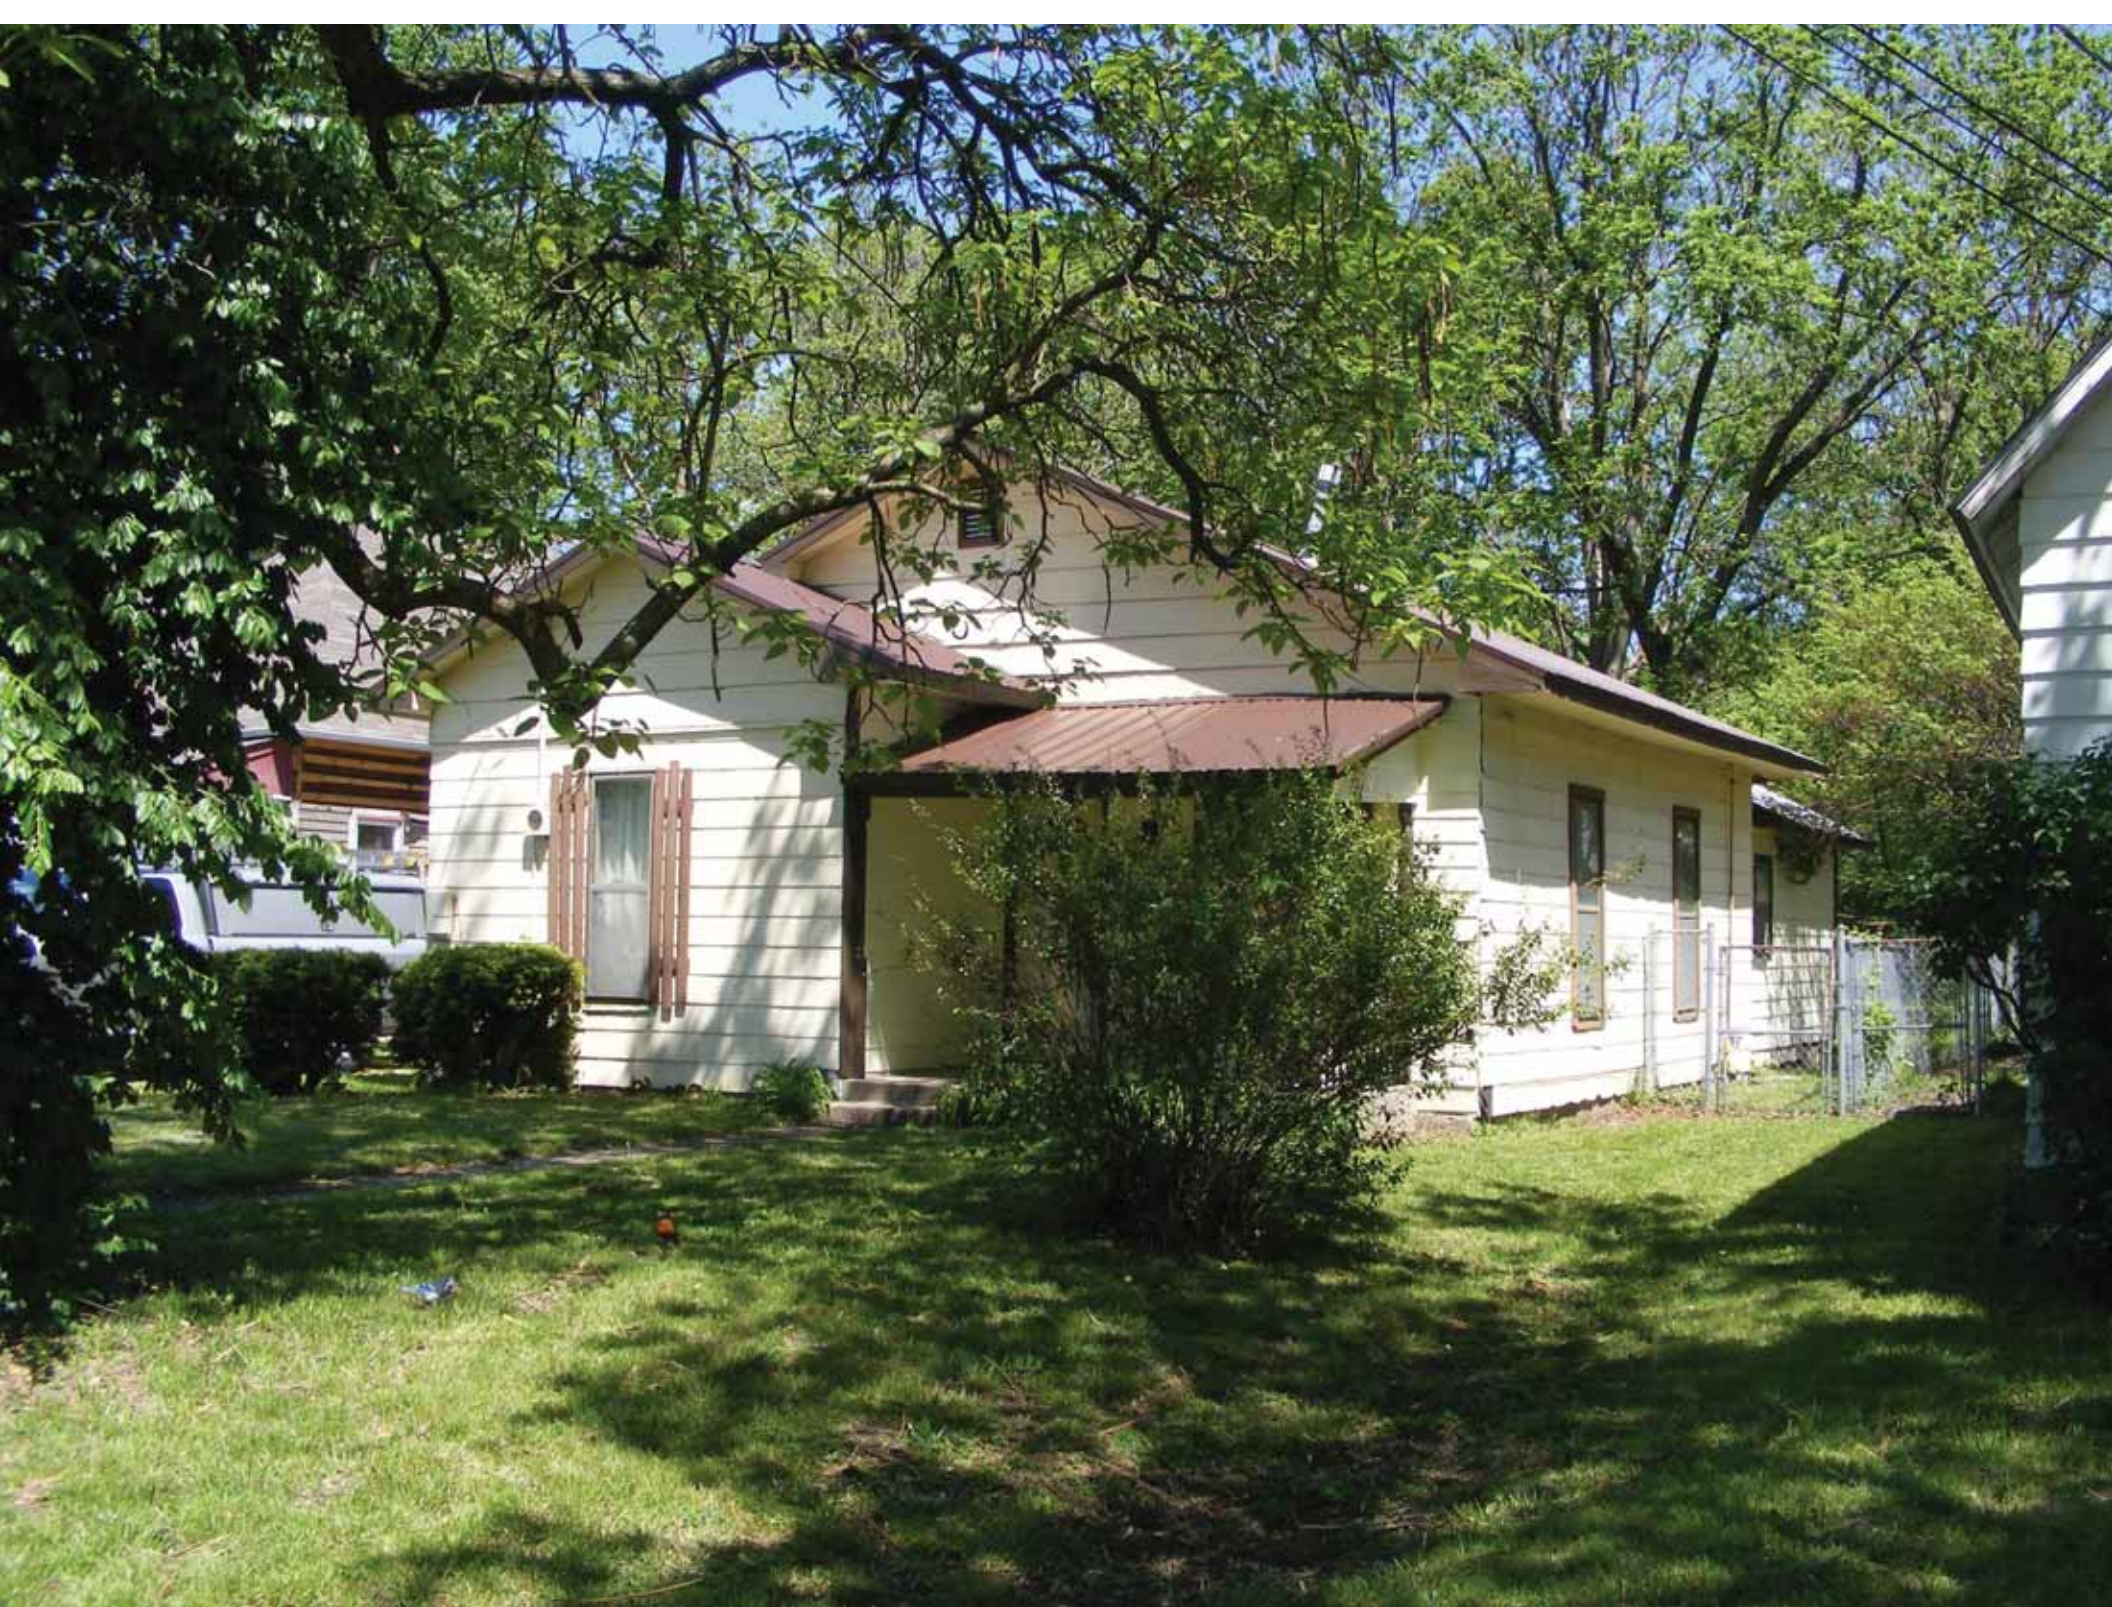
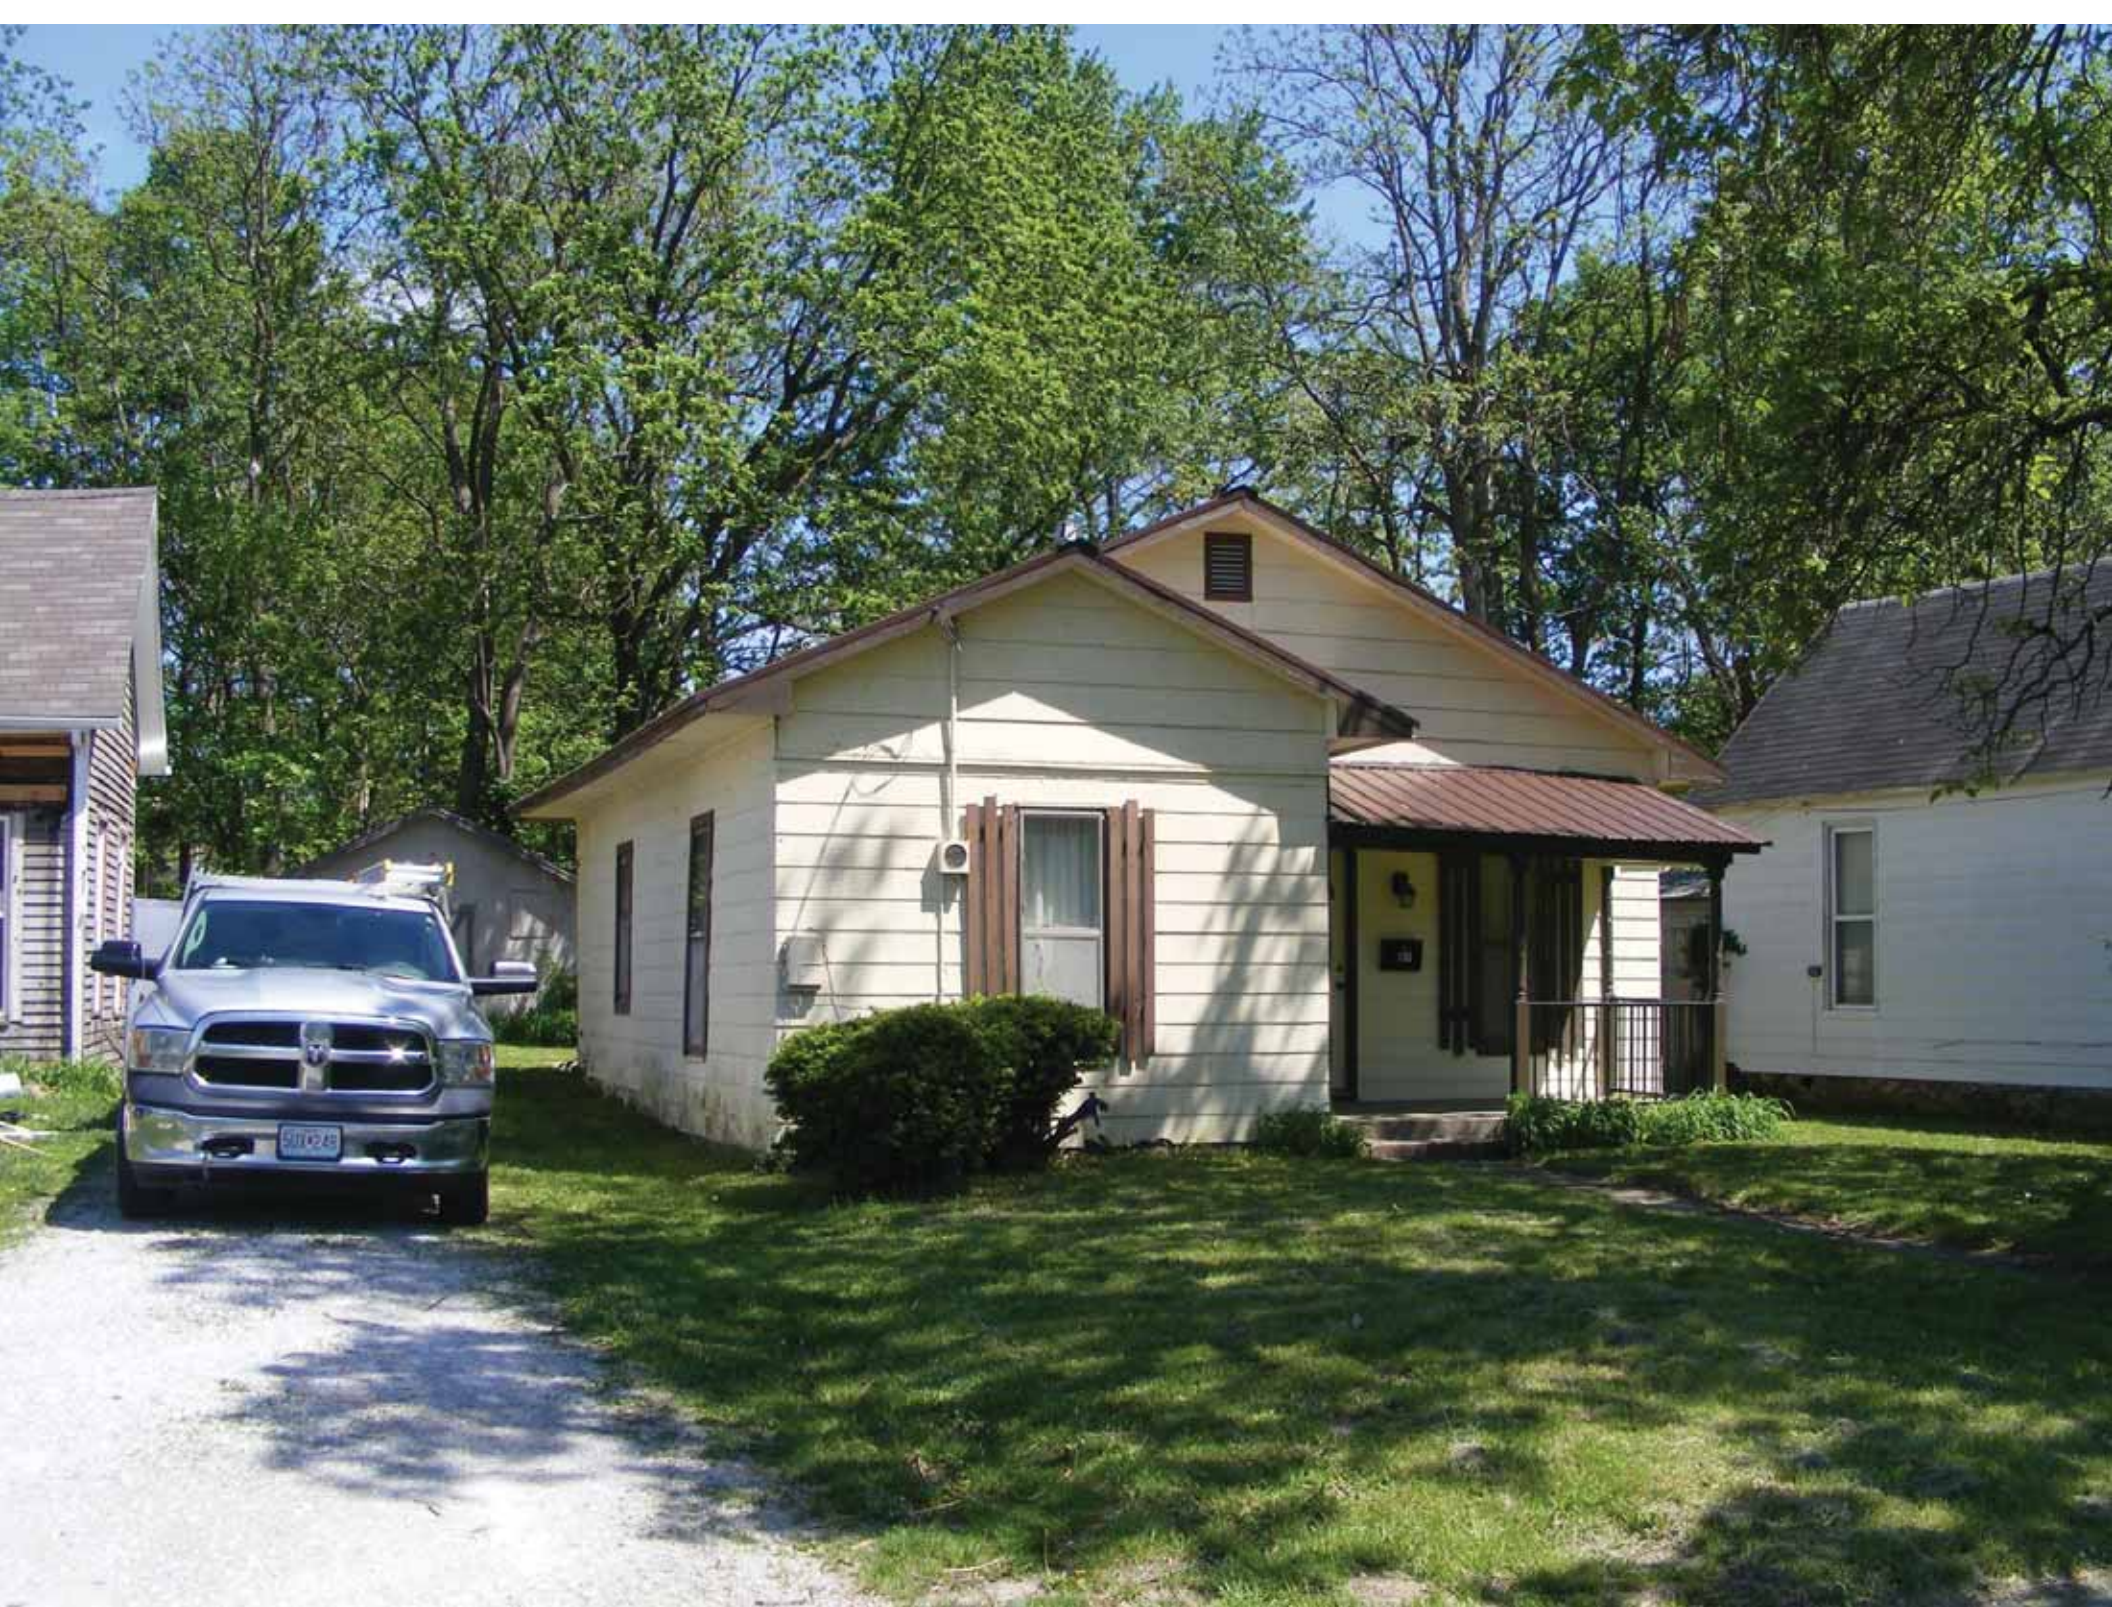
The gable-front plan dwelling has a metal clad roof, exterior replacement siding (which appears to be asbestos) and a concrete foundation. At the north end of the façade is a shorter gable-front wing that extends west, toward the street. The remaining façade supports a half-width porch. The porch has a shed seamed metal roof supported by spindled contemporary columns. The porch has a contemporary balustrade. Within the porch is a single entry bay filled with a c.2000 paneled door featuring an upper fan shaped window. The window on the façade that offsets the entrance – as well as the single window on the front projecting gabled wing – appears original, one-over-one design. Both windows have original faux shutters. The upper gable field of the taller gabled wing has a louvered vent. The rear elevation supports a small gabled wing.
