MISSOURI DEPARTMENT OF NATURAL RESOURCES
STATE HISTORIC PRESERVATION OFFICE, P.O. Box 176, Jefferson City, MO 65102
ARCHITECTURAL/HISTORIC INVENTORY FORM

1. Survey No. BO-AS-011-0087		2. Survey name: North Central Columbia Survey Phase II	
3. County: Boone		4. Address (Street No.) 902	Street (name) N. Seventh Street
5. City: Columbia	Vicinity: <input type="checkbox"/>	6. Geographical Reference:	7. Township/Range/Section: T: R: S:
8. Historic name (if known):		9. Present/other name (if known):	
10. Ownership: <input checked="" type="checkbox"/> Private <input type="checkbox"/> Public		11a. Historic use (if known): Domestic/single dwelling	11b. Current use: Domestic/single dwelling

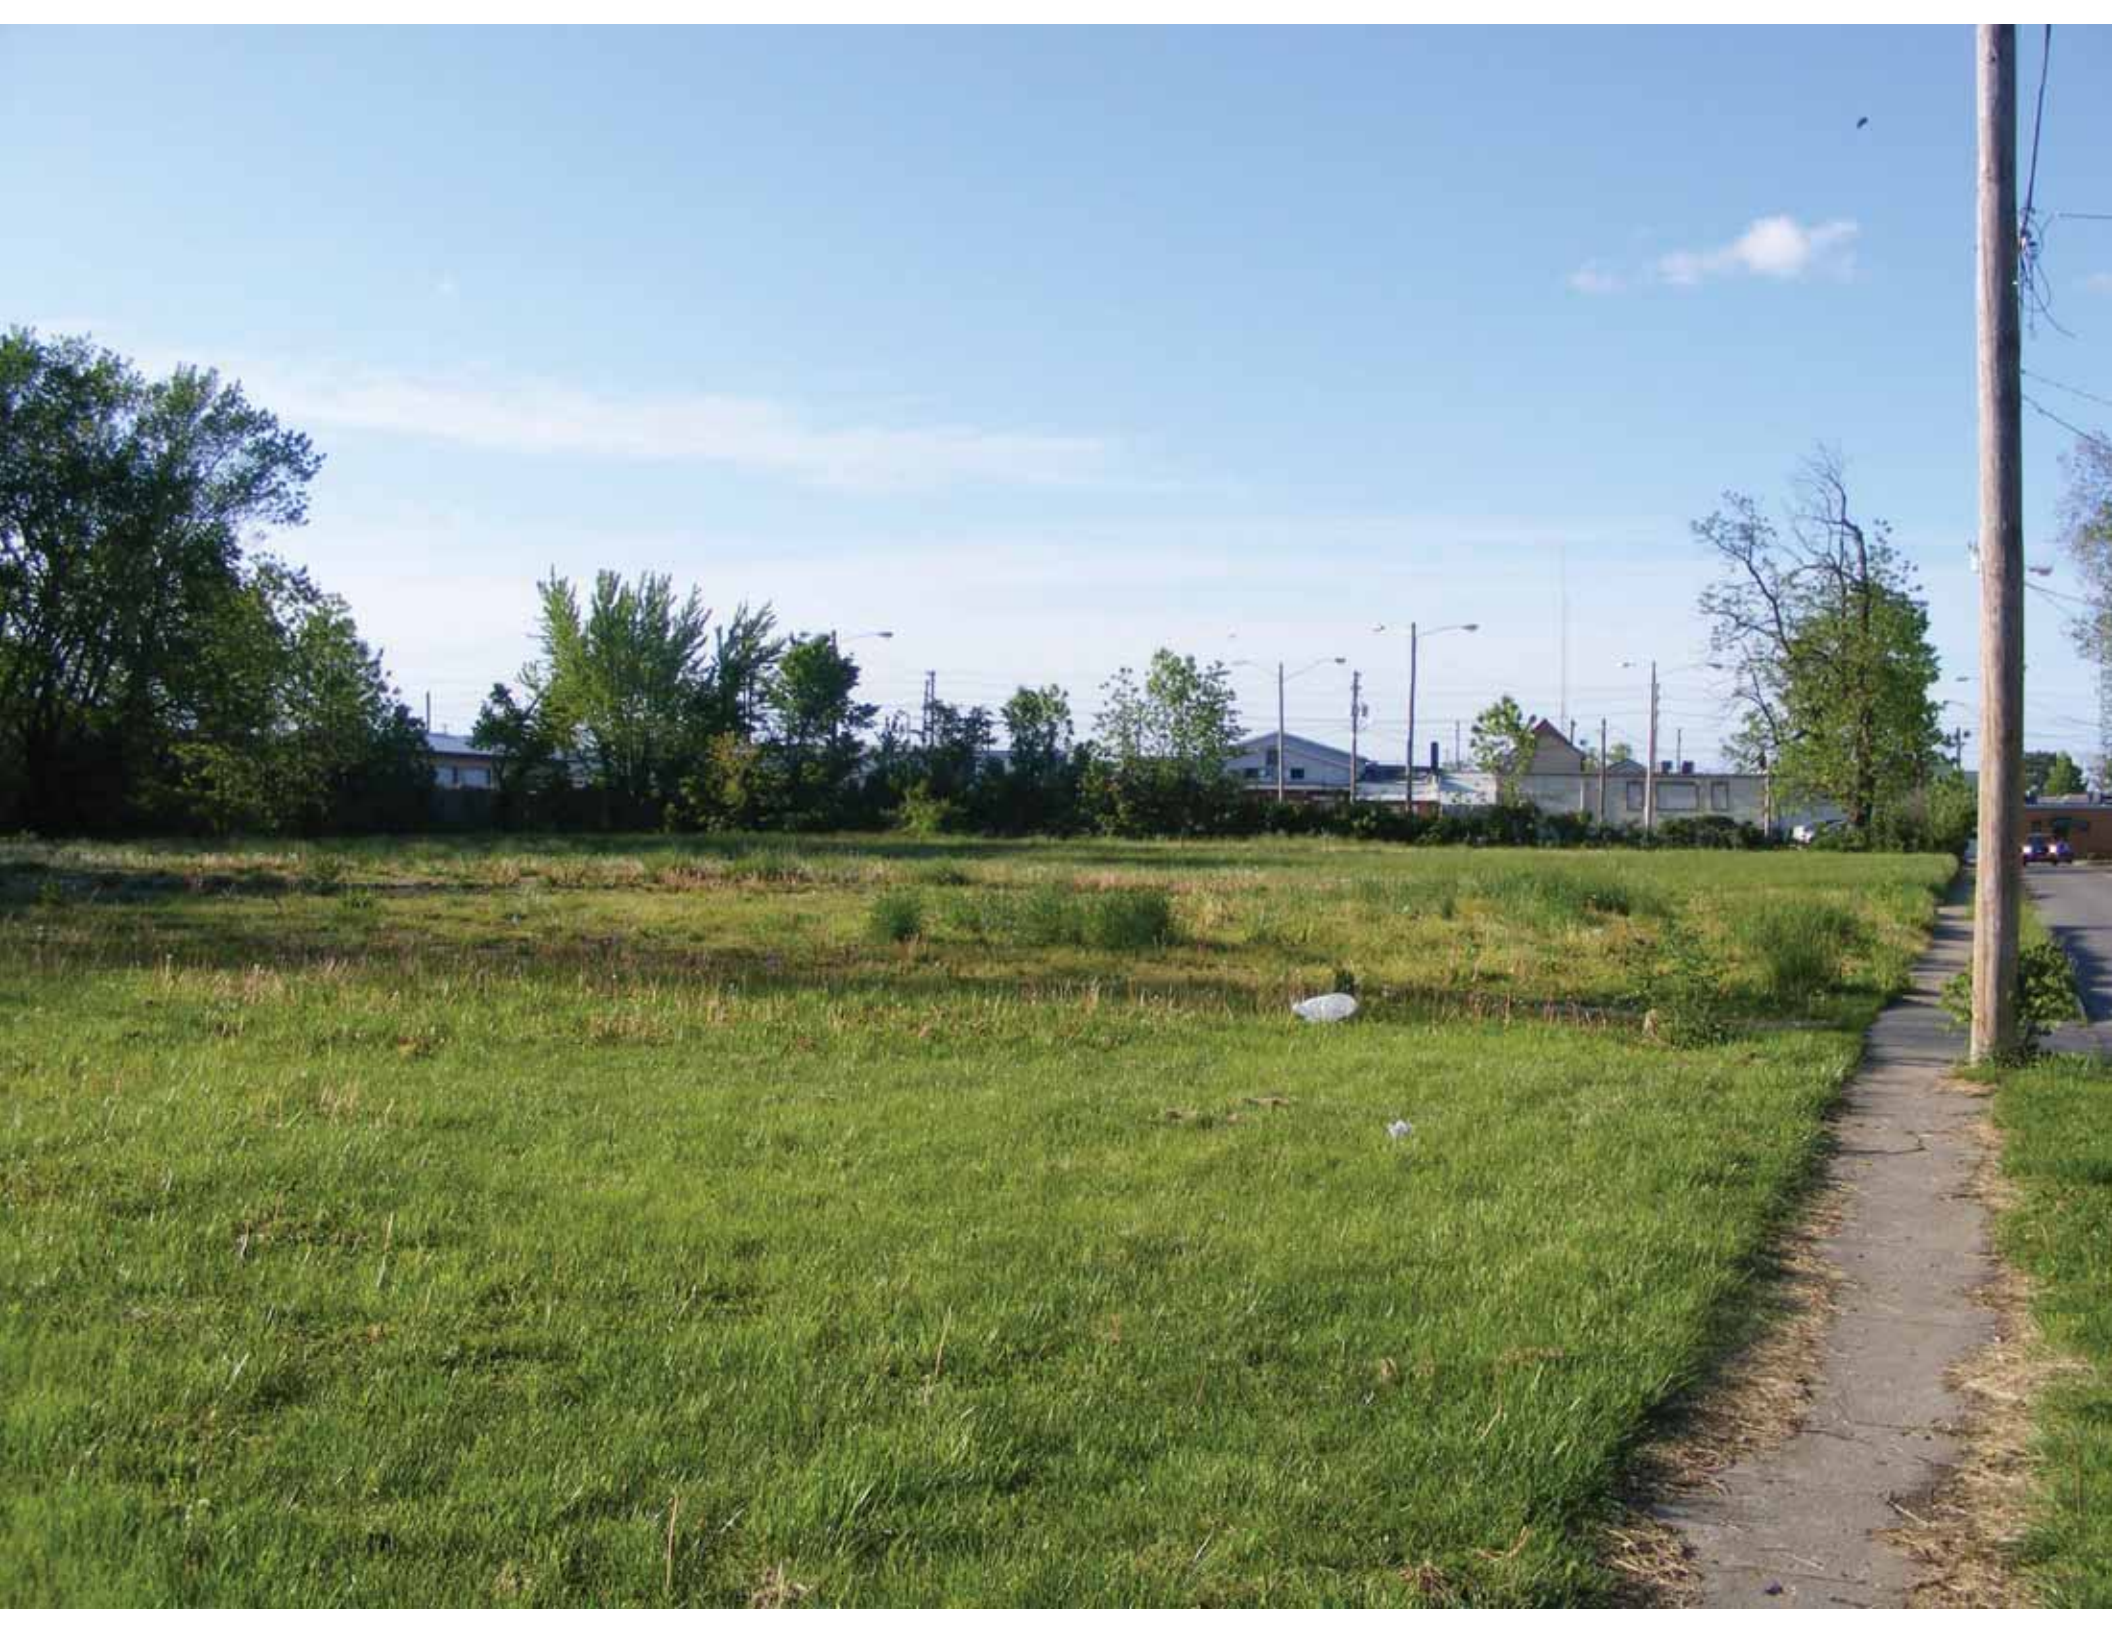
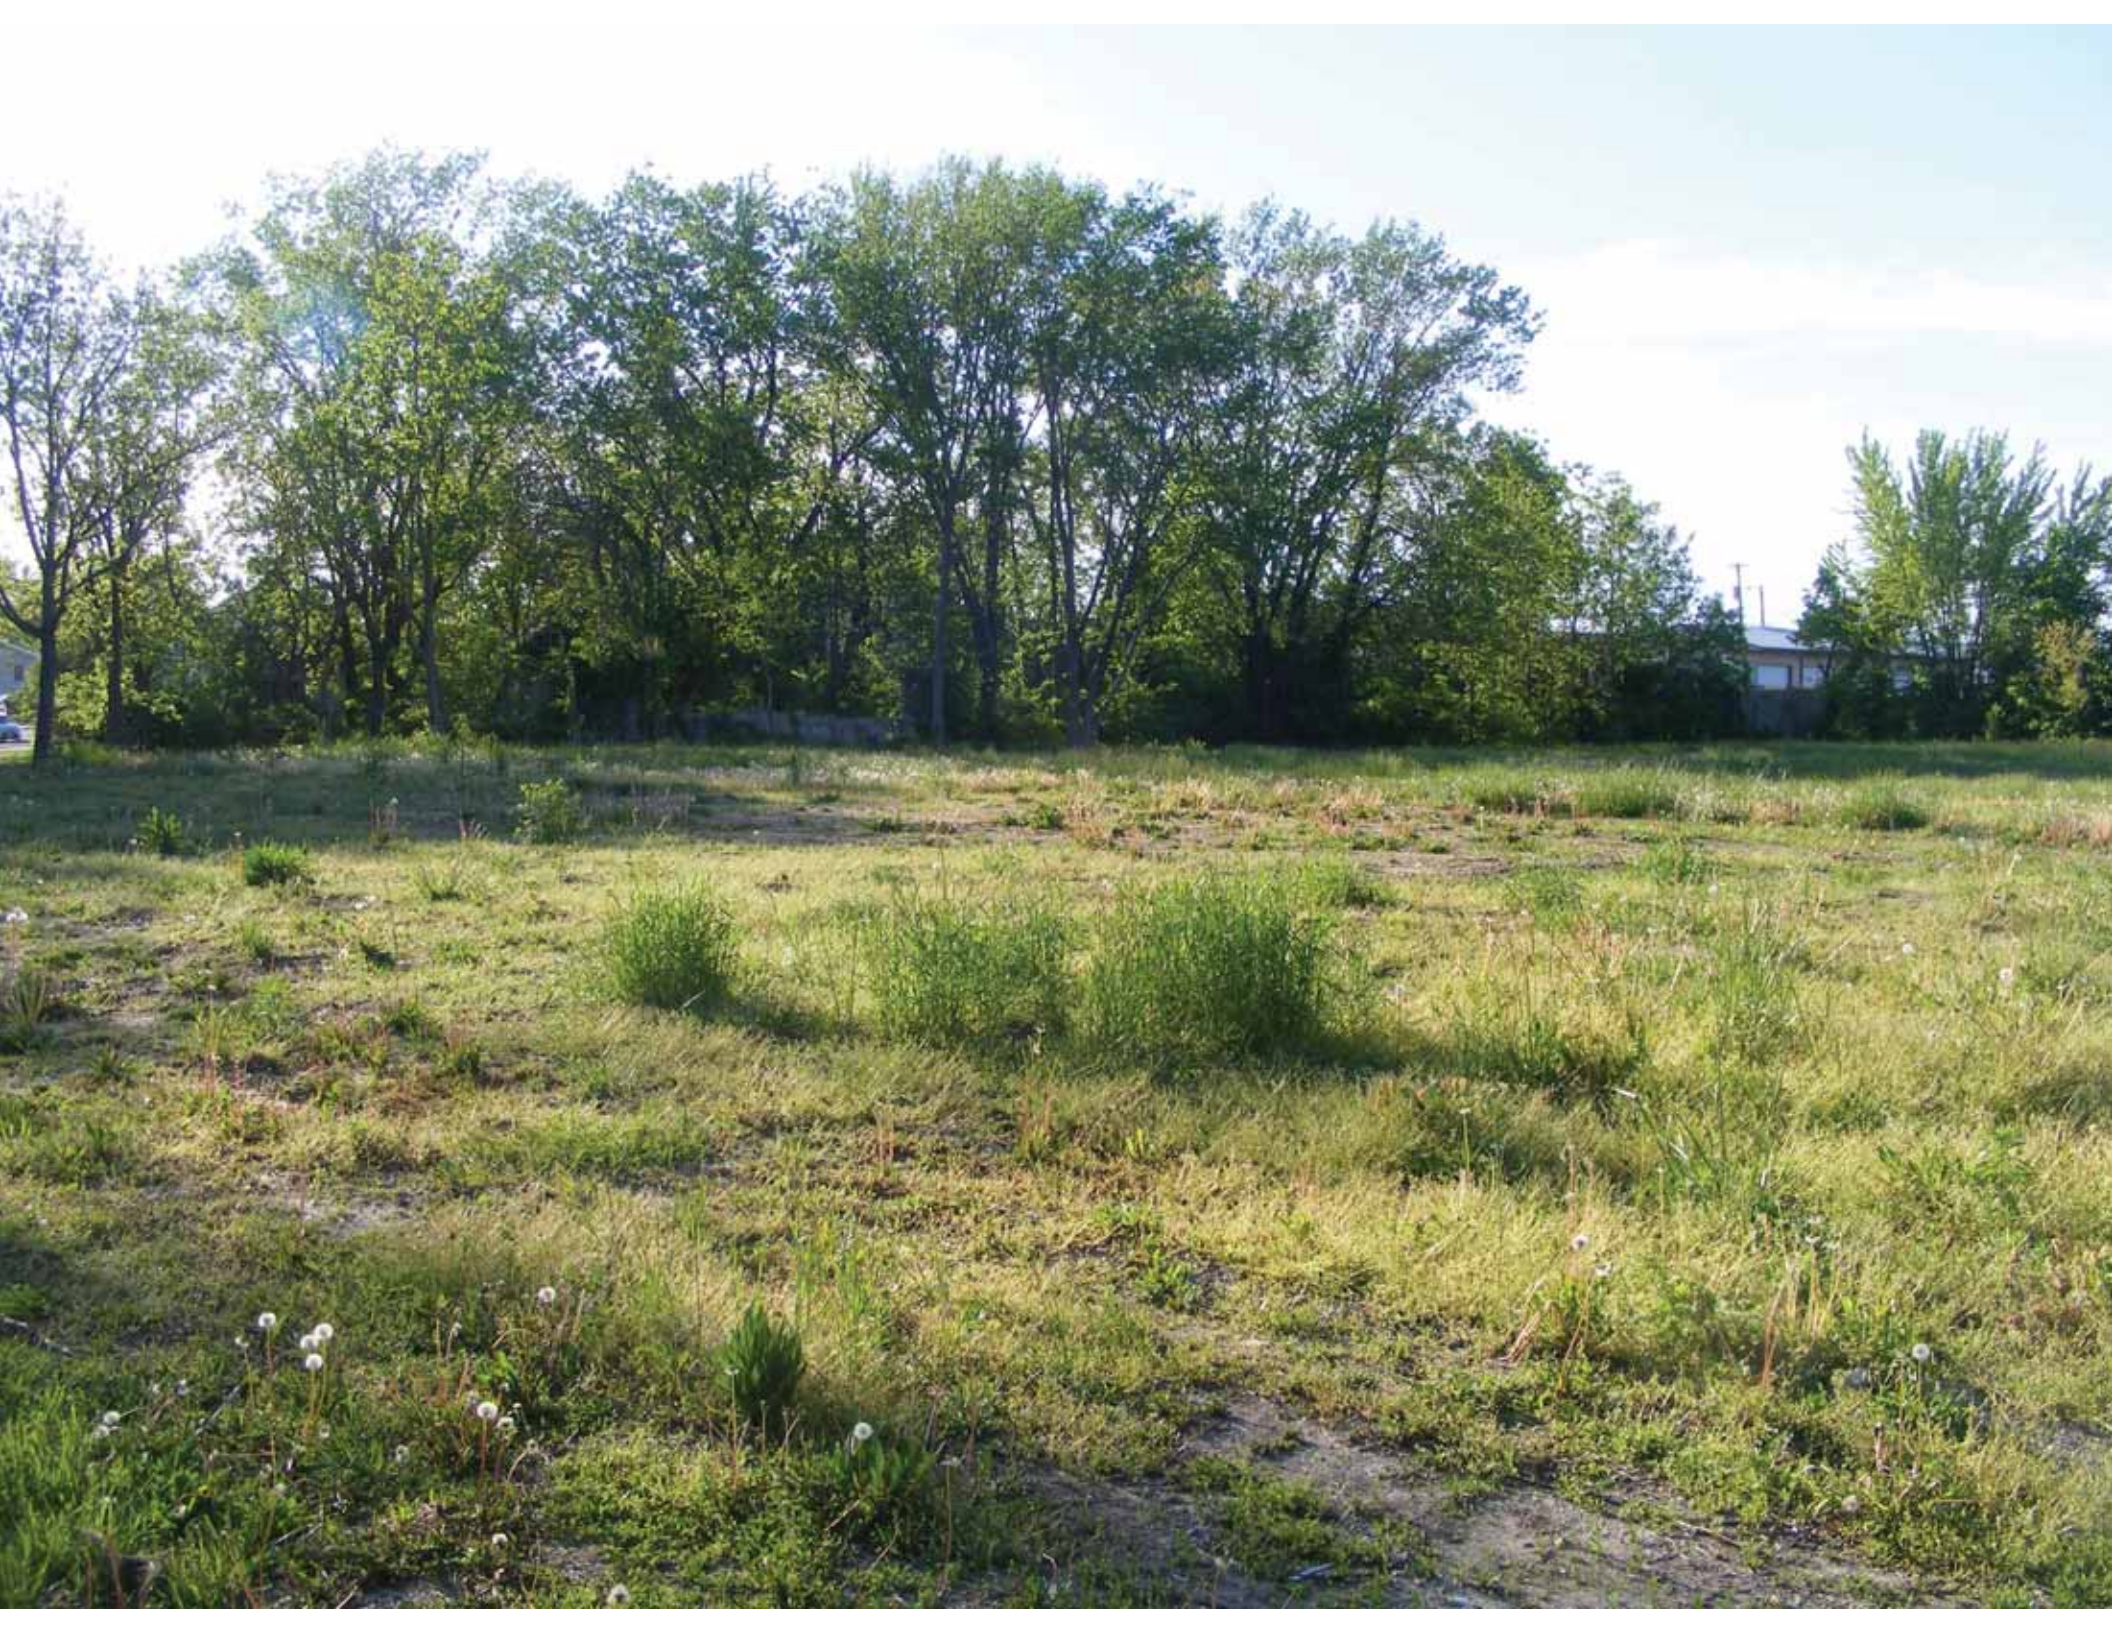
This 0.4-acre vacant lot held a single-family dwelling previously (per Sanborn Fire Insurance Maps, 1925 and 1948). The lot is as above, covered with grass and bounded by the public sidewalk at the east end of the lot. There are no buildings on the lot.

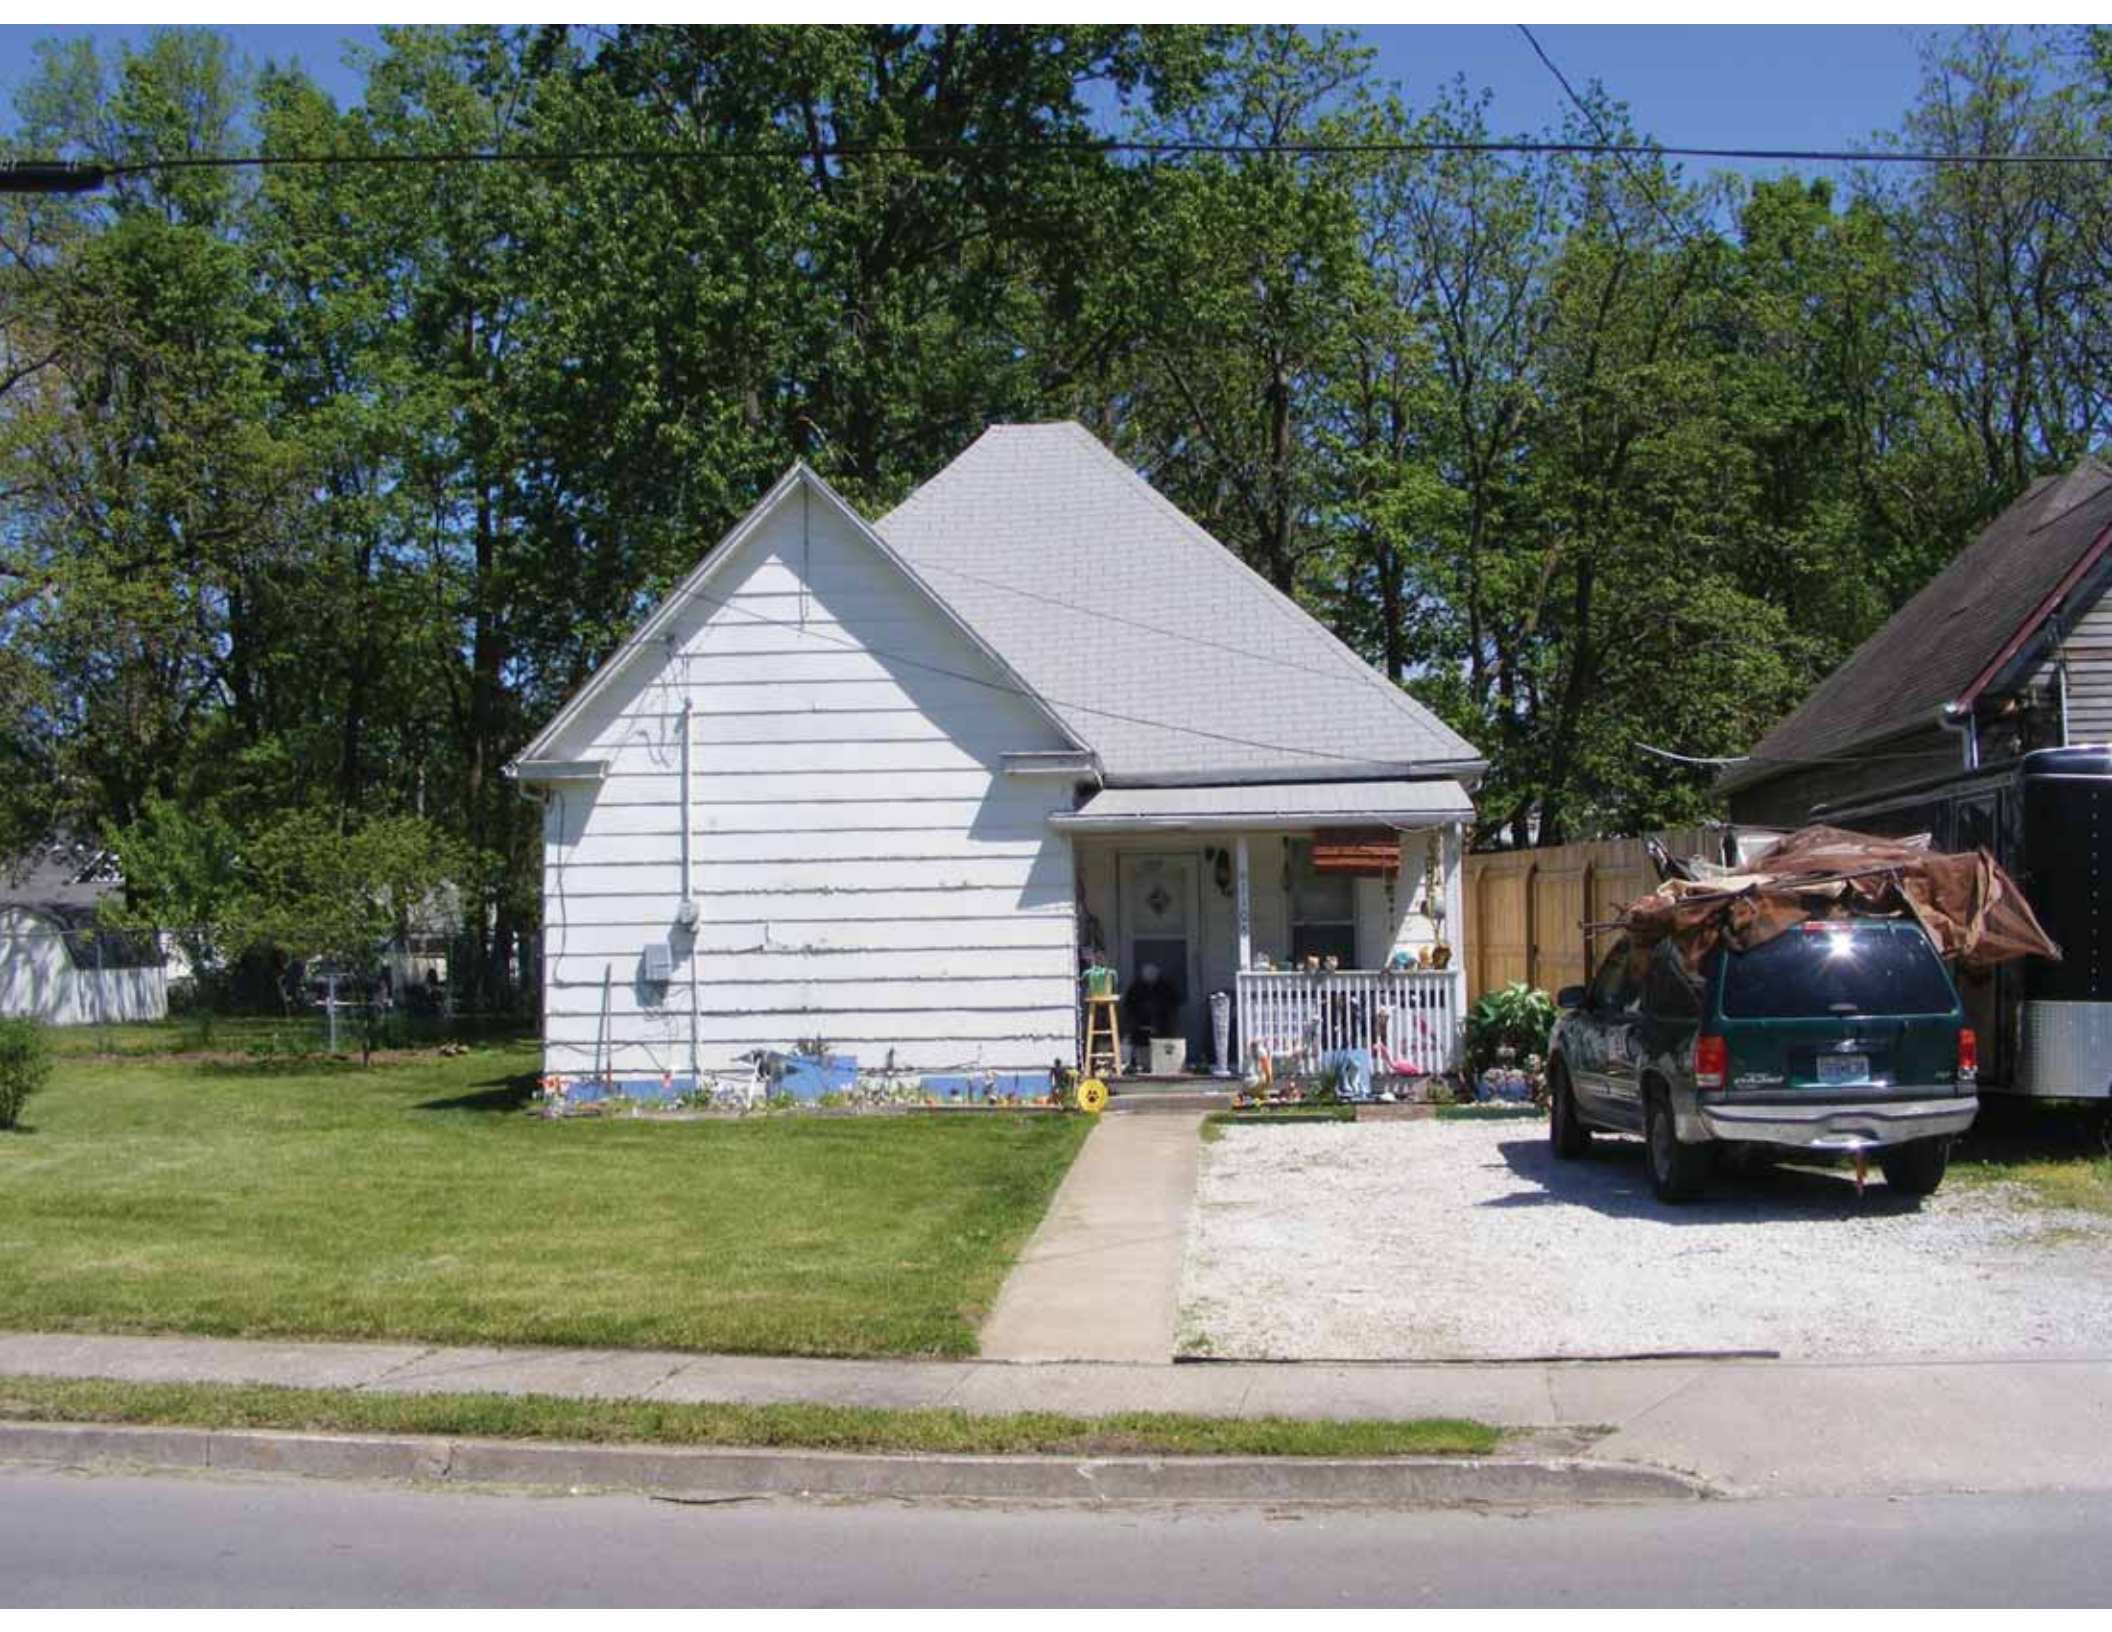
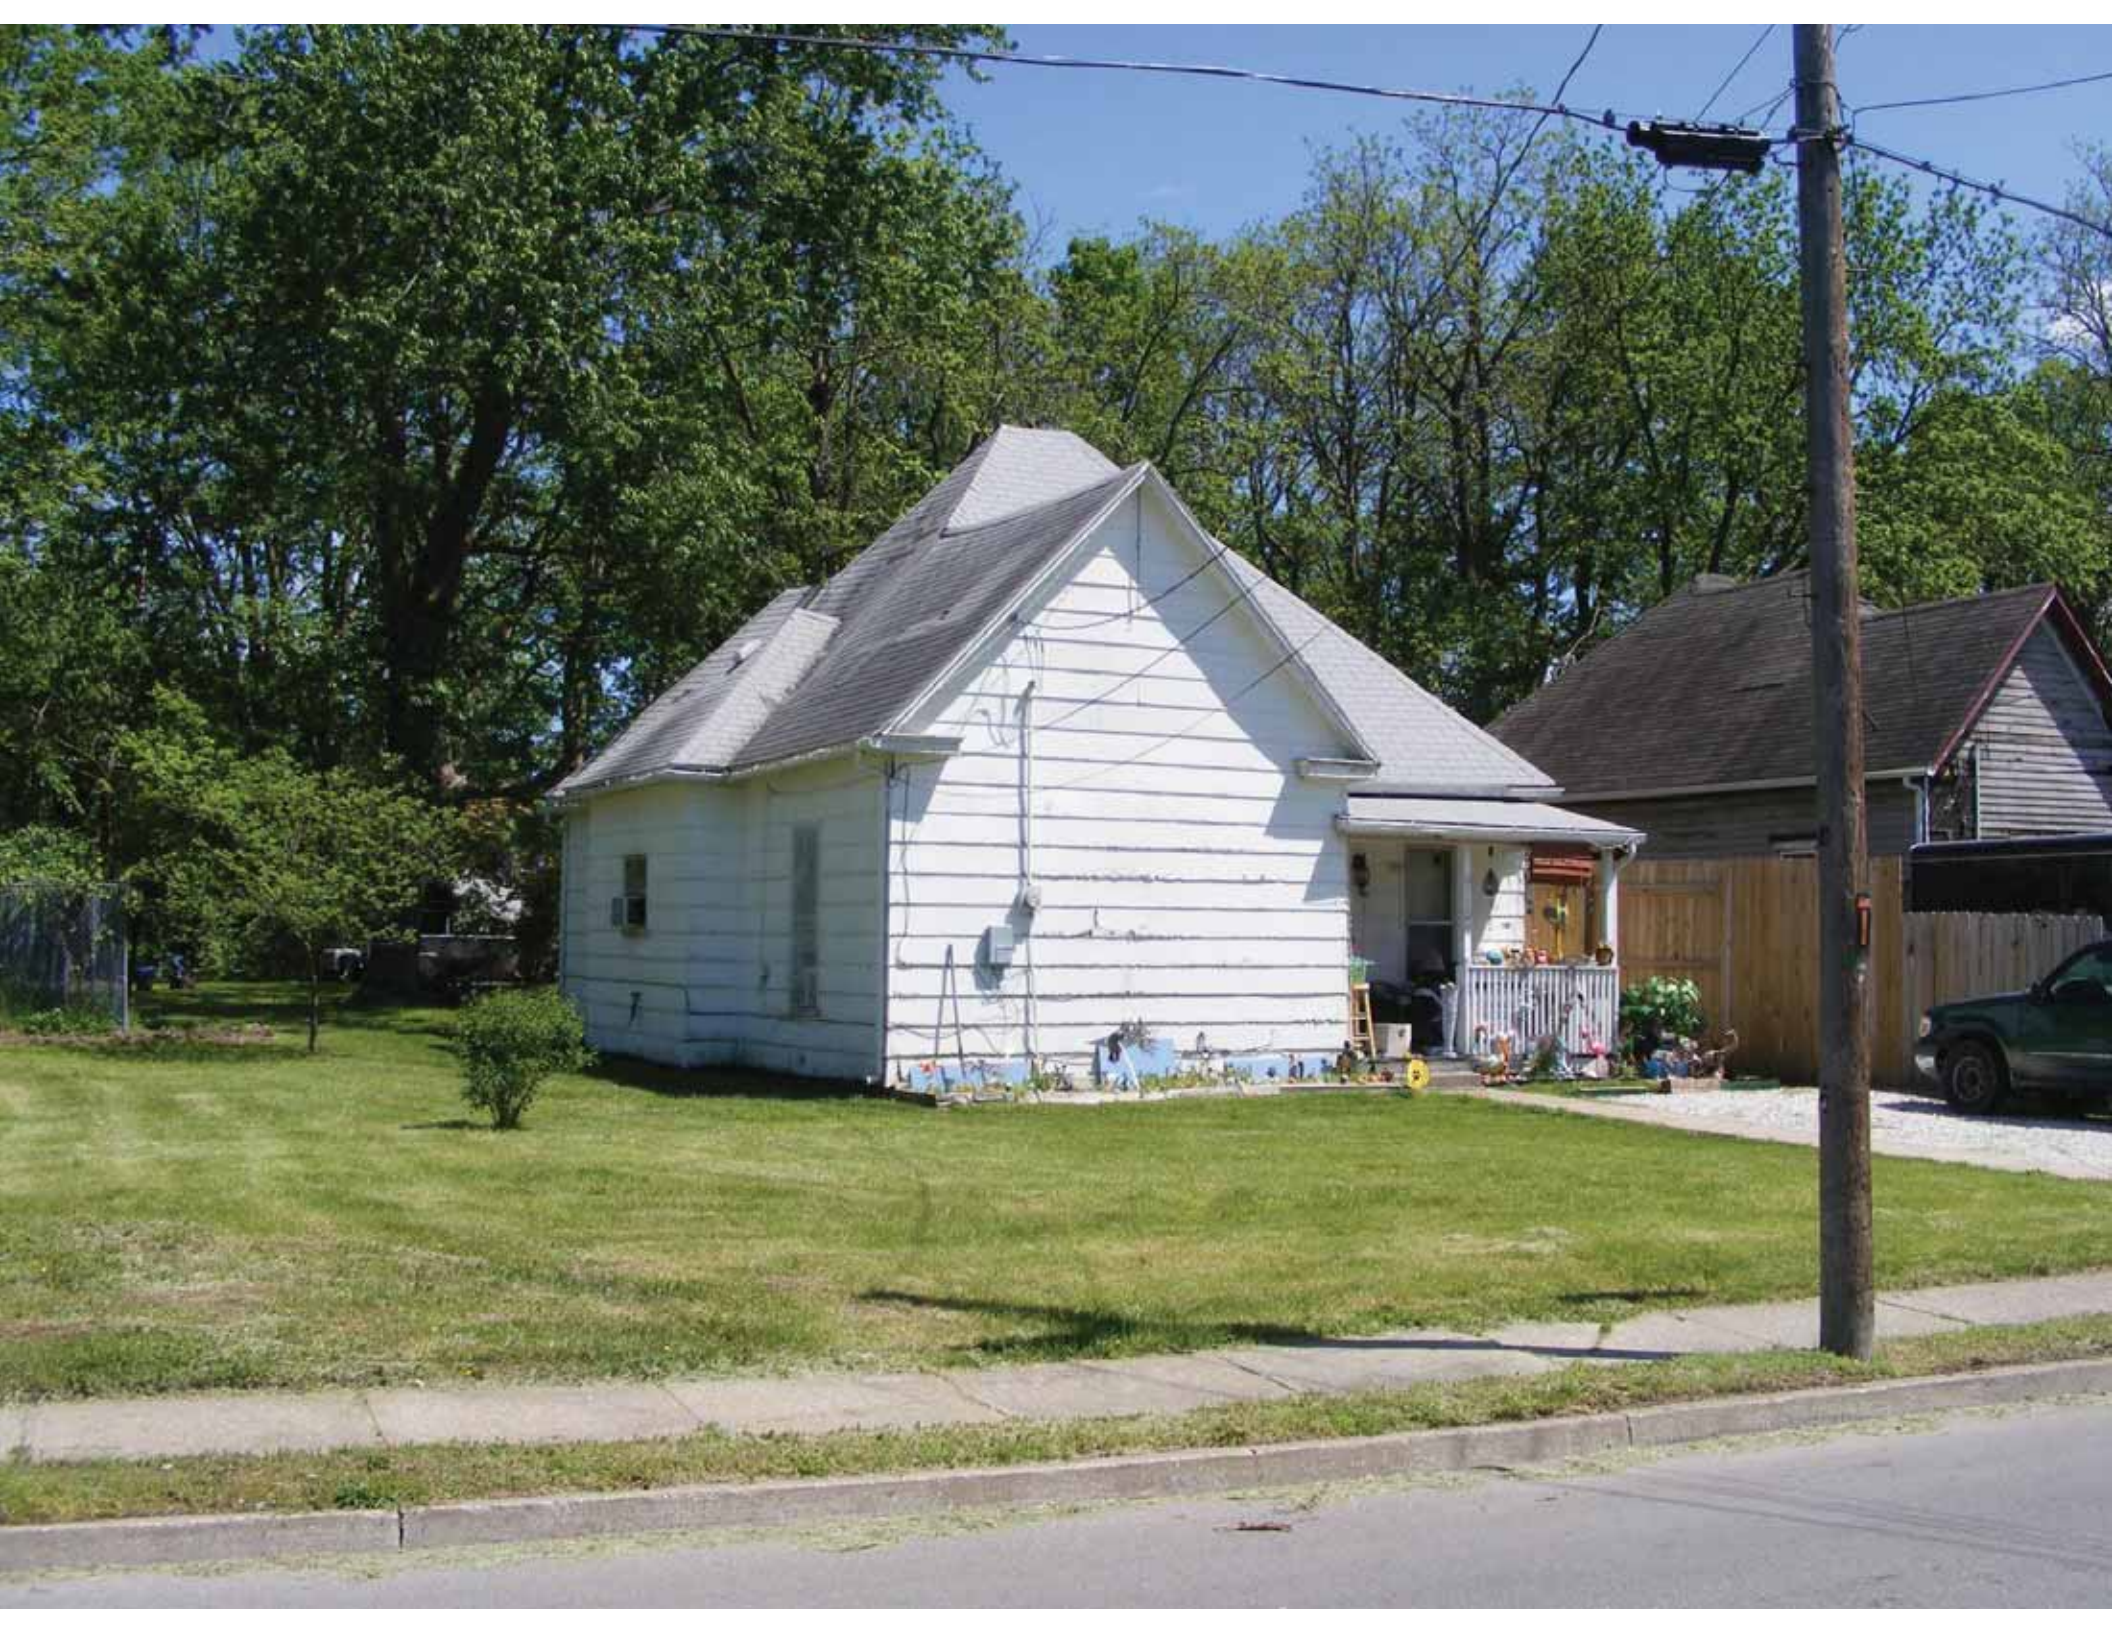
The dwelling has a high hipped roof and front facing gable wing. The roof is clad with asphalt shingles and the front gable has original returns. The dwelling's exterior is clad with asbestos siding and the foundation is concrete. On the façade (west elevation), the front gabled wing likely had an original window that has been covered by the non-historic siding. Offsetting the wing on the south is a half-width shed porch. The porch is supported by milled replacement columns and has a frame balustrade. The columns and balustrade appear to be recent additions (c. 2010). Within the porch bay are a single entry and single window. The entry bay holds a c. 1960 door with upper diamond shaped light. The window is one-over-one and appears original.

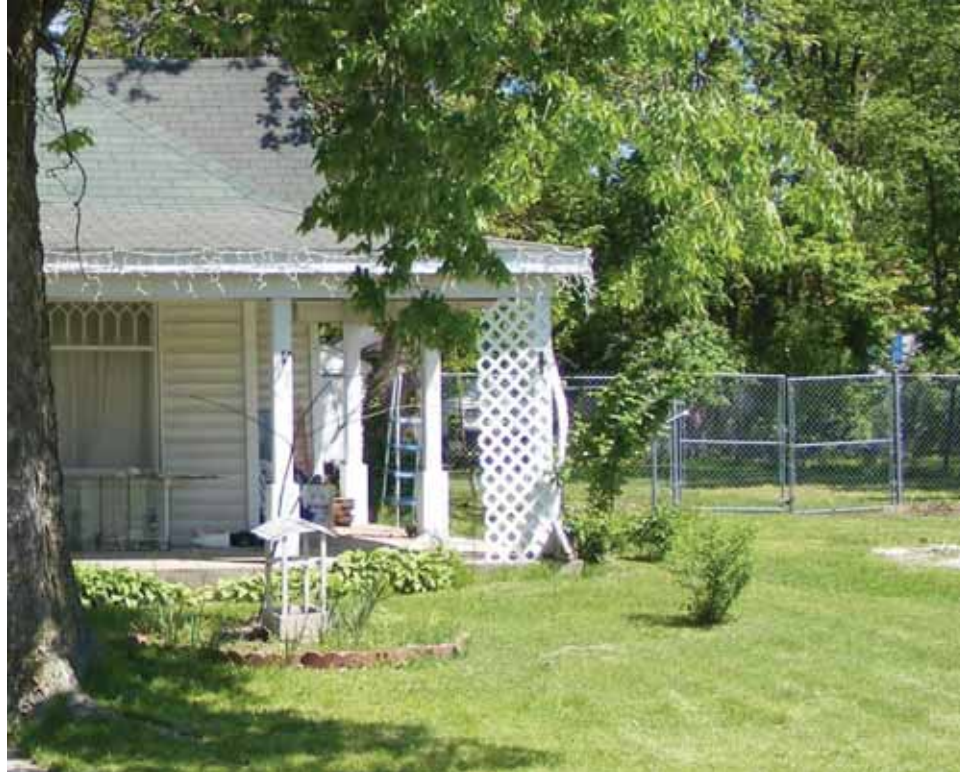
This 0.15-acre vacant lot held a single-family dwelling previously (per Sanborn Fire Insurance Maps, 1925 and 1948). The lot is as above, covered with grass and bounded by the public sidewalk at the west end of the parcel. There lot supports the outbuilding described above. A chain link fence surrounds the outbuilding, indicating its current association with the dwelling/parcel at 1110 N. Eighth Street.

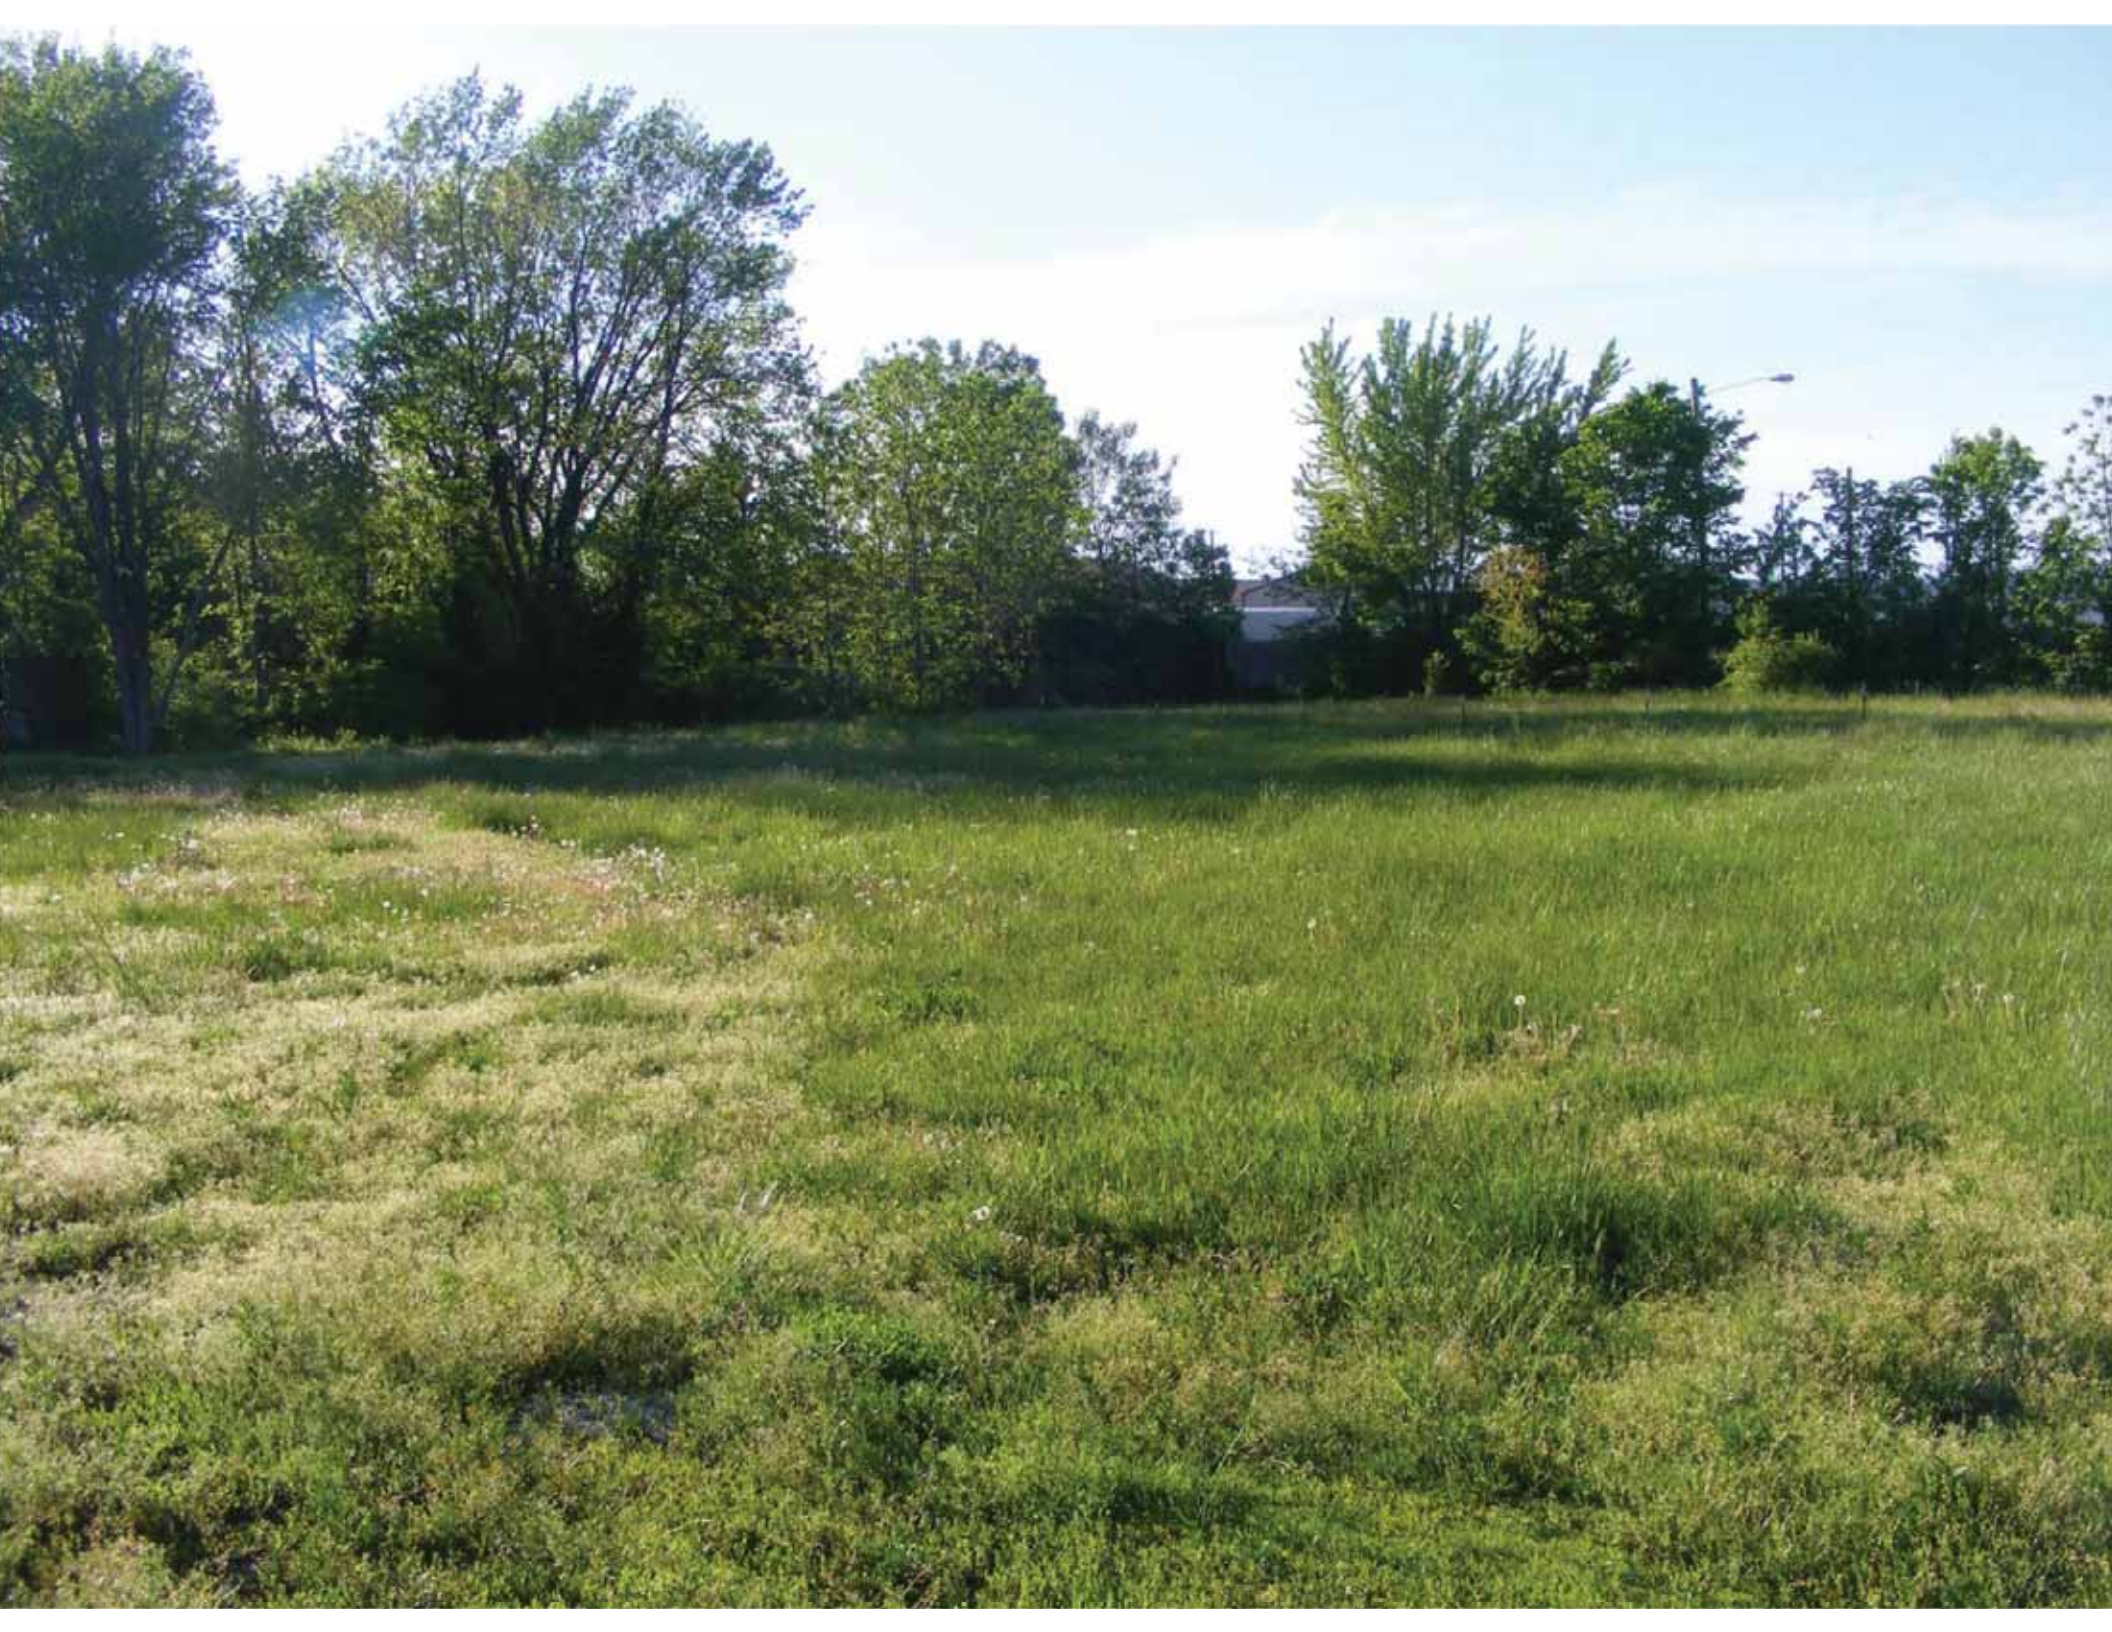
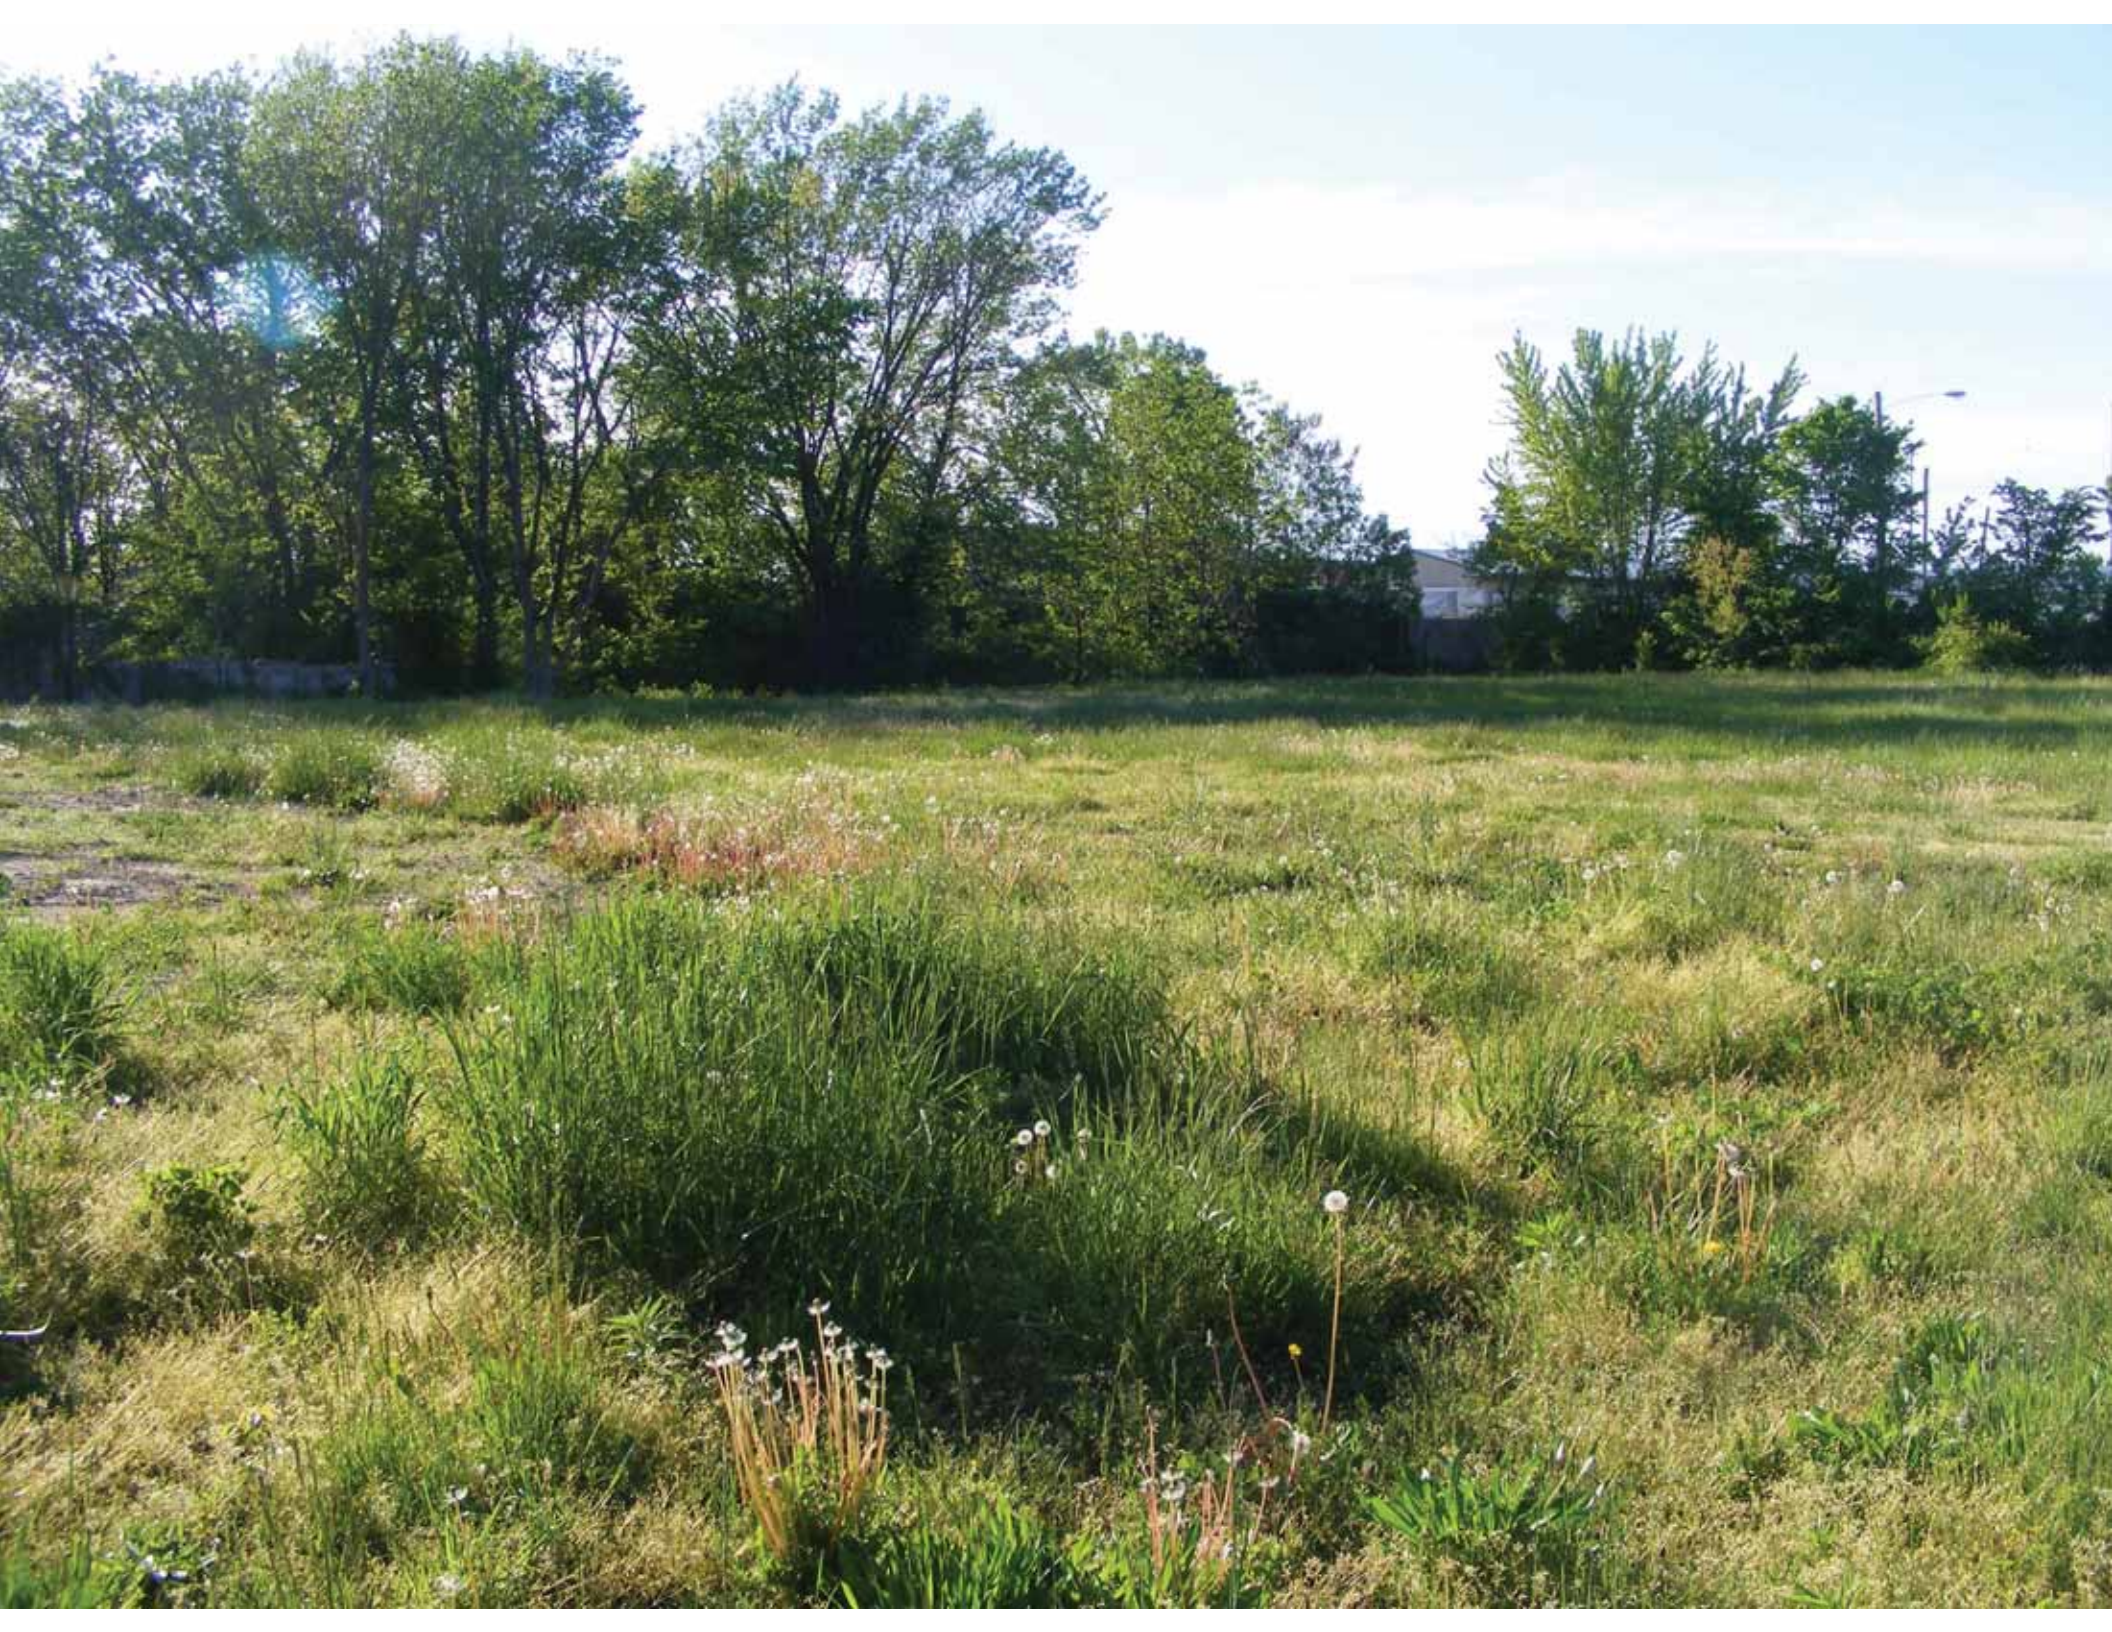
This 0.49-acre vacant lot held a single-family dwelling previously (per Sanborn Fire Insurance Maps, 1925 and 1948). The lot is as above, covered with grass and bounded by the public sidewalk at the east end of the lot. There are no buildings on the lot.
