MISSOURI DEPARTMENT OF NATURAL RESOURCES
STATE HISTORIC PRESERVATION OFFICE, P.O. Box 176, Jefferson City, MO 65102
ARCHITECTURAL/HISTORIC INVENTORY FORM

1. Survey No. BO-AS-011-0087		2. Survey name: North Central Columbia Survey Phase II	
3. County: Boone		4. Address (Street No.) 902	Street (name) N. Seventh Street
5. City: Columbia	Vicinity: <input type="checkbox"/>	6. Geographical Reference:	7. Township/Range/Section: T: R: S:
8. Historic name (if known):		9. Present/other name (if known):	
10. Ownership: <input checked="" type="checkbox"/> Private <input type="checkbox"/> Public		11a. Historic use (if known): Domestic/single dwelling	11b. Current use: Domestic/single dwelling

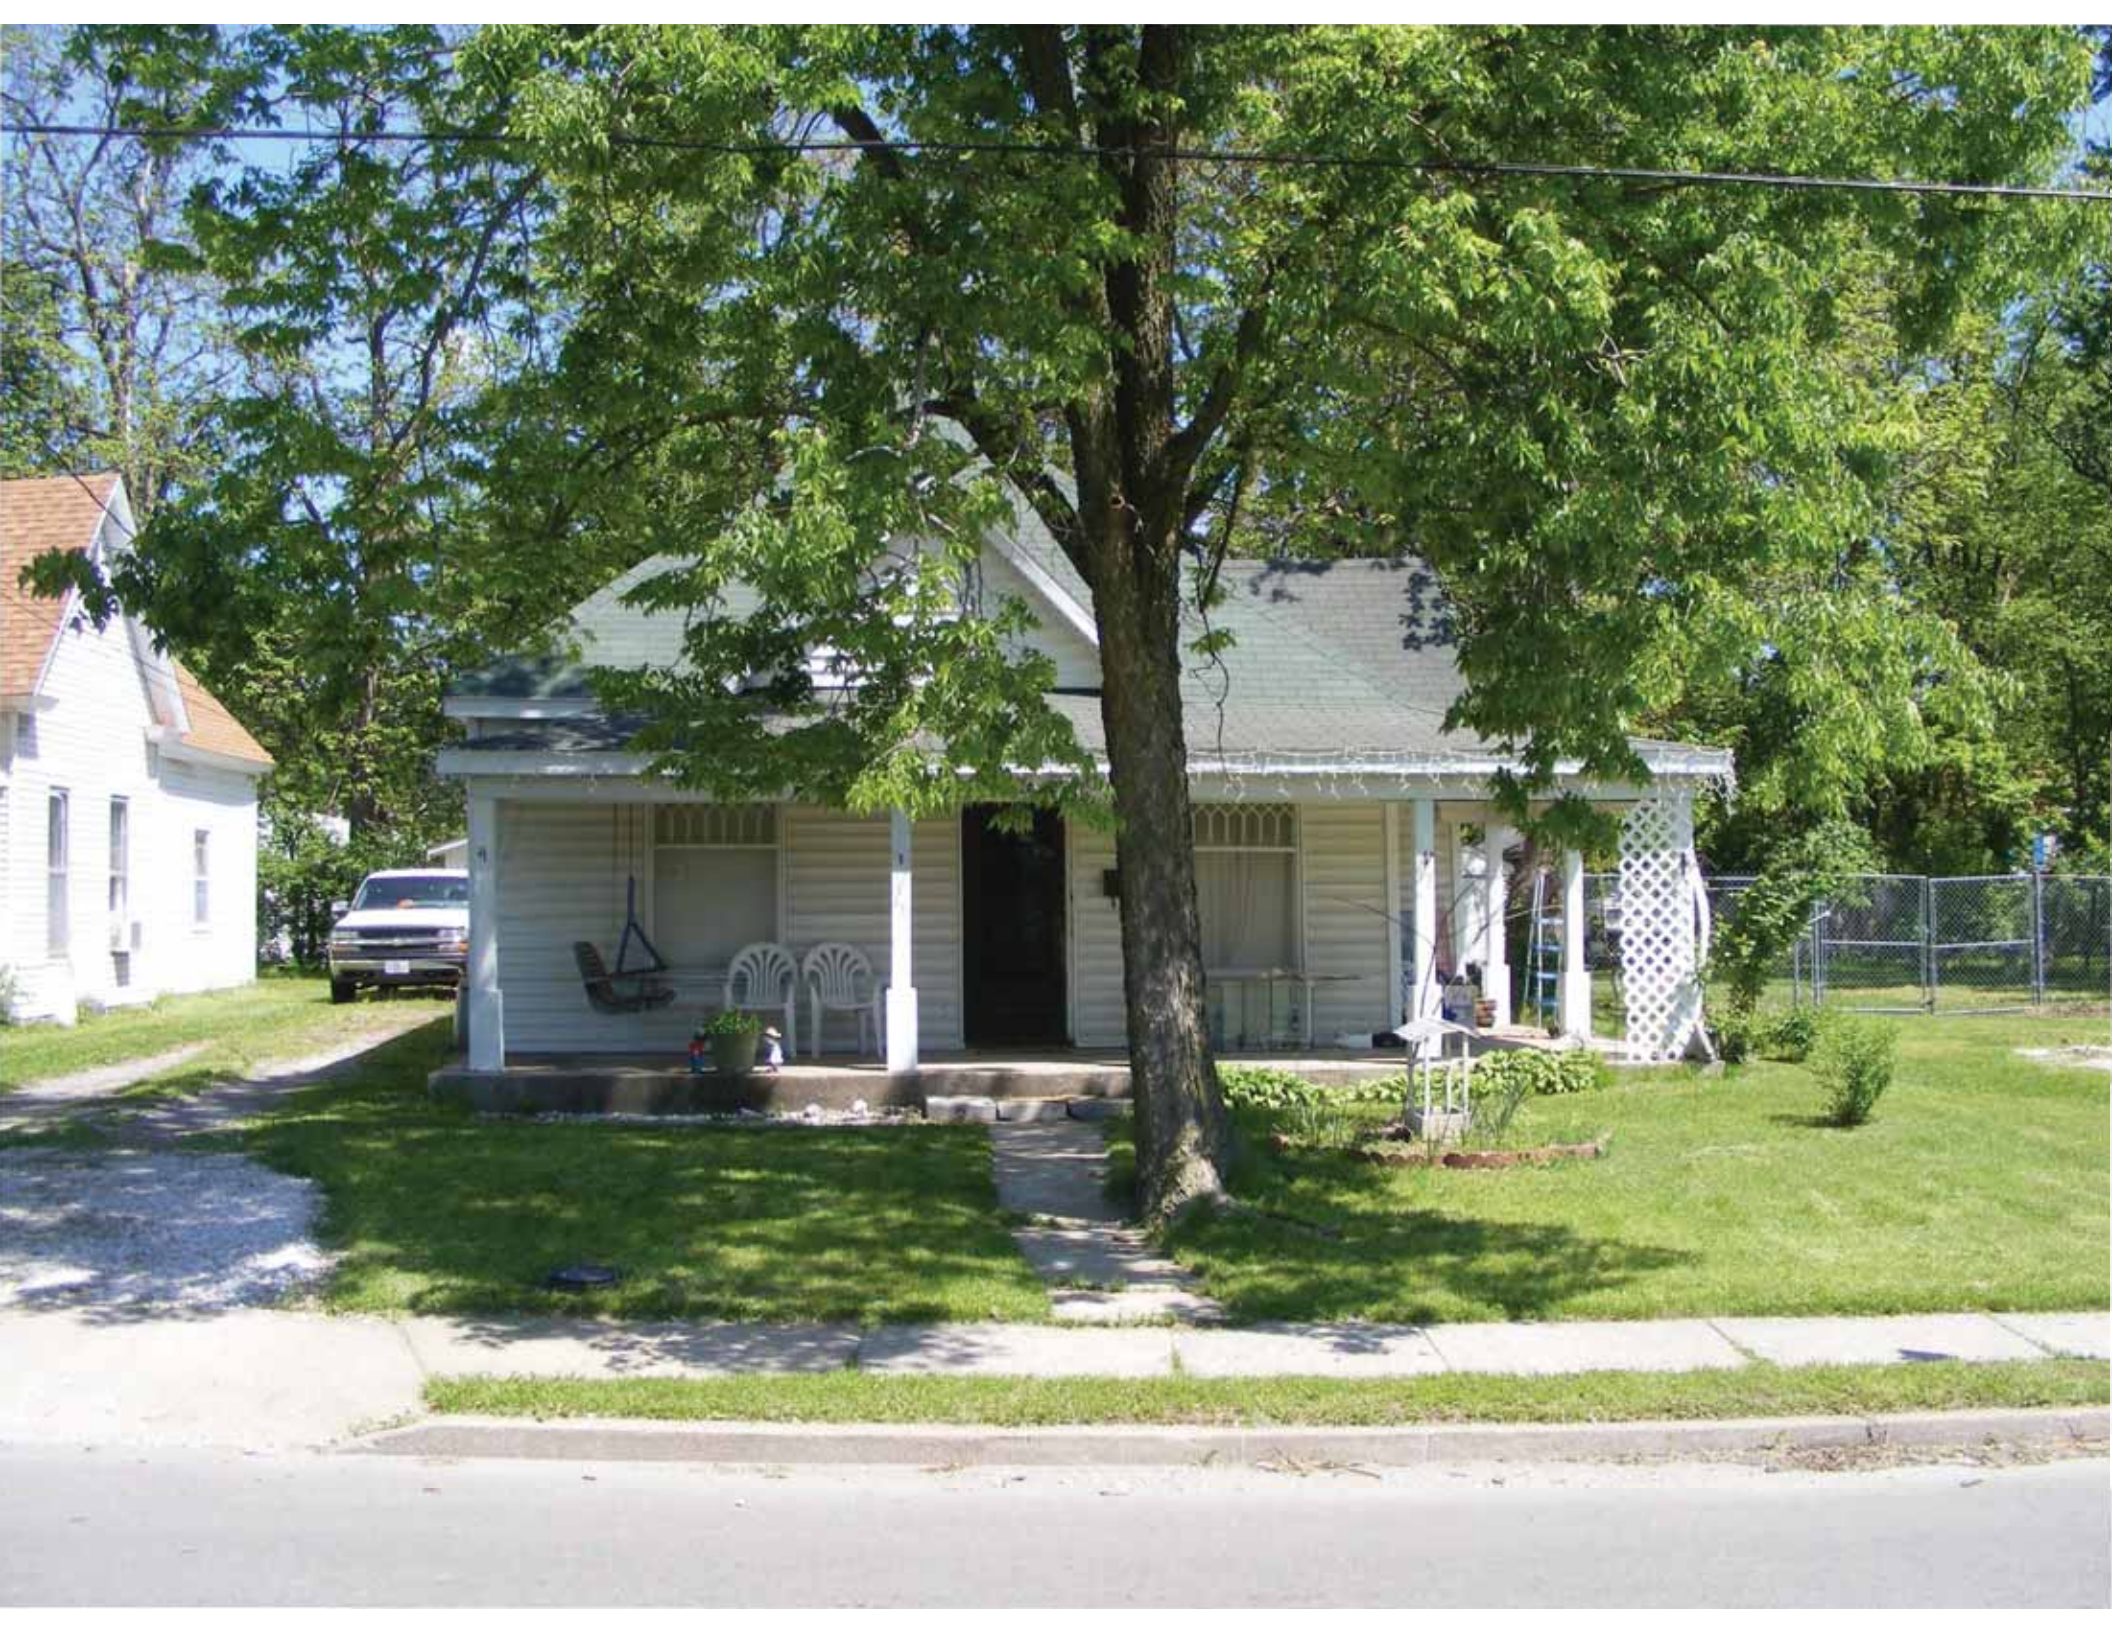
The dwelling is a single-story Folk Victorian style house with a steeply pitched asphalt clad hipped roof, cross gables on the primary (west) and south roofline, exterior synthetic siding and a concrete foundation. On the façade and south elevations, the dwelling supports a hipped wrap-around single-story porch. The porch is supported by wood columns resting on painted wood piers. Within the porch bay on the façade (west elevation) is a central entry. The door is obscured by a contemporary screen door. Flanking the entry are original windows. The windows have multi-light patterned upper sashes. Remaining windows are one-over-one. A rear shed wing, south elevation, holds a one-by-one sliding window. Lattice frames the southwest corner of the porch. There is no fenestration on the south wall facing the porch.

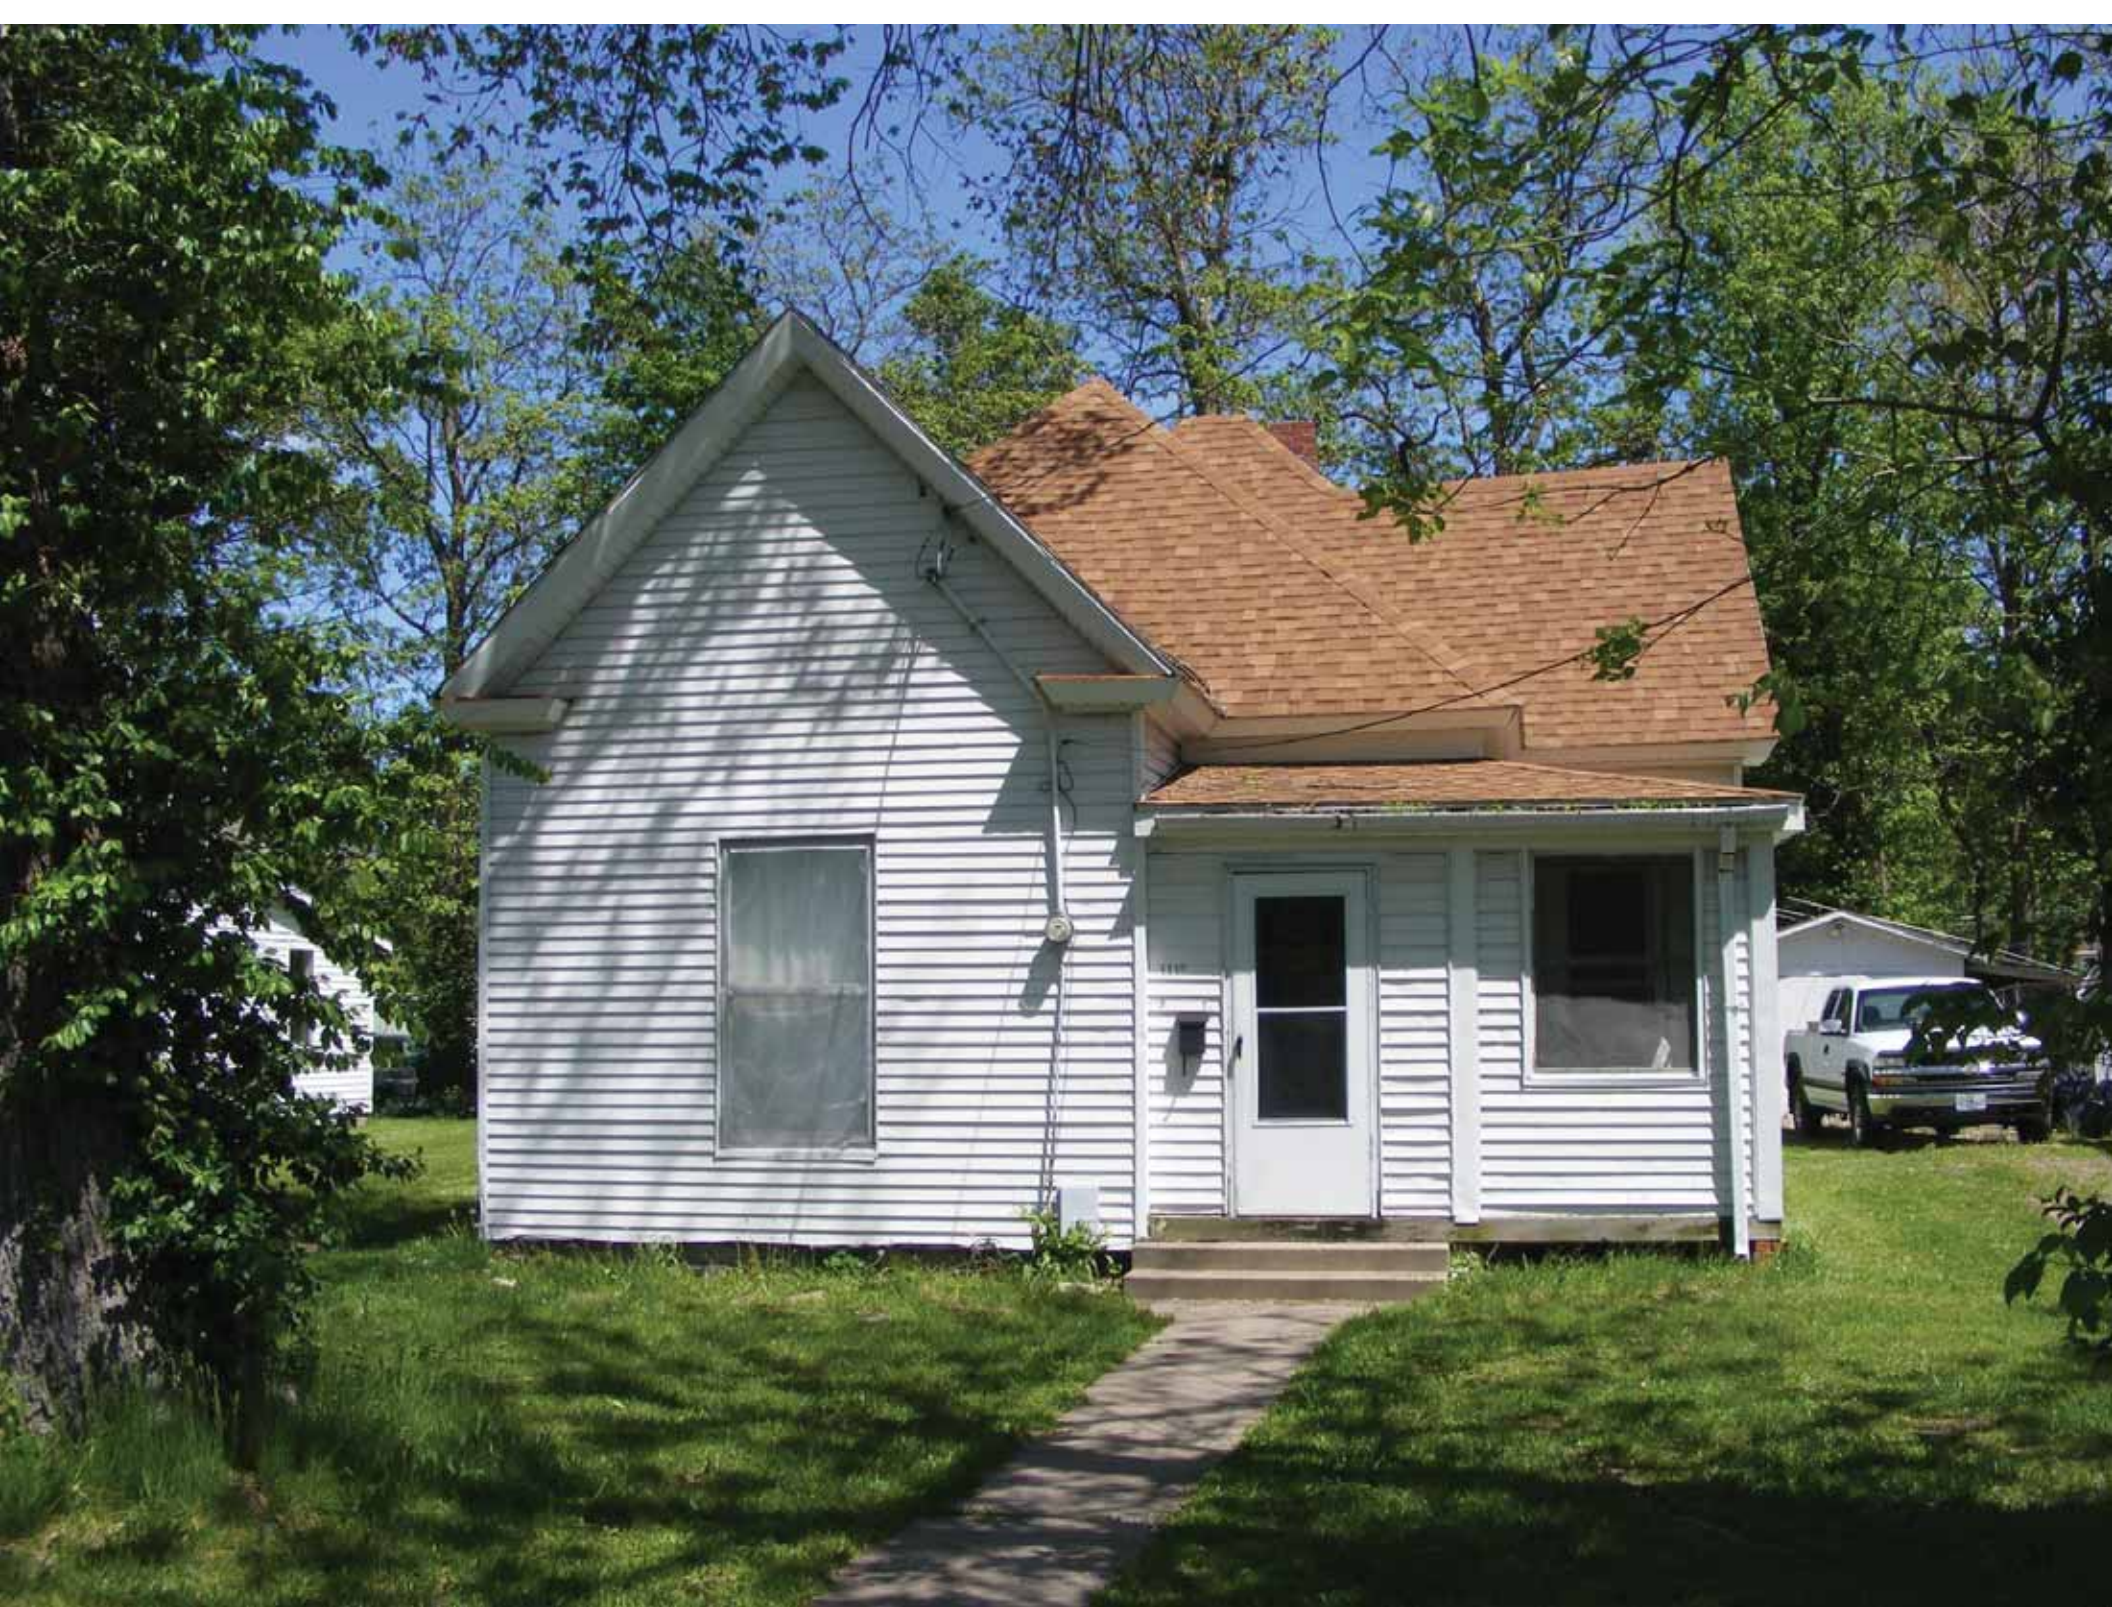
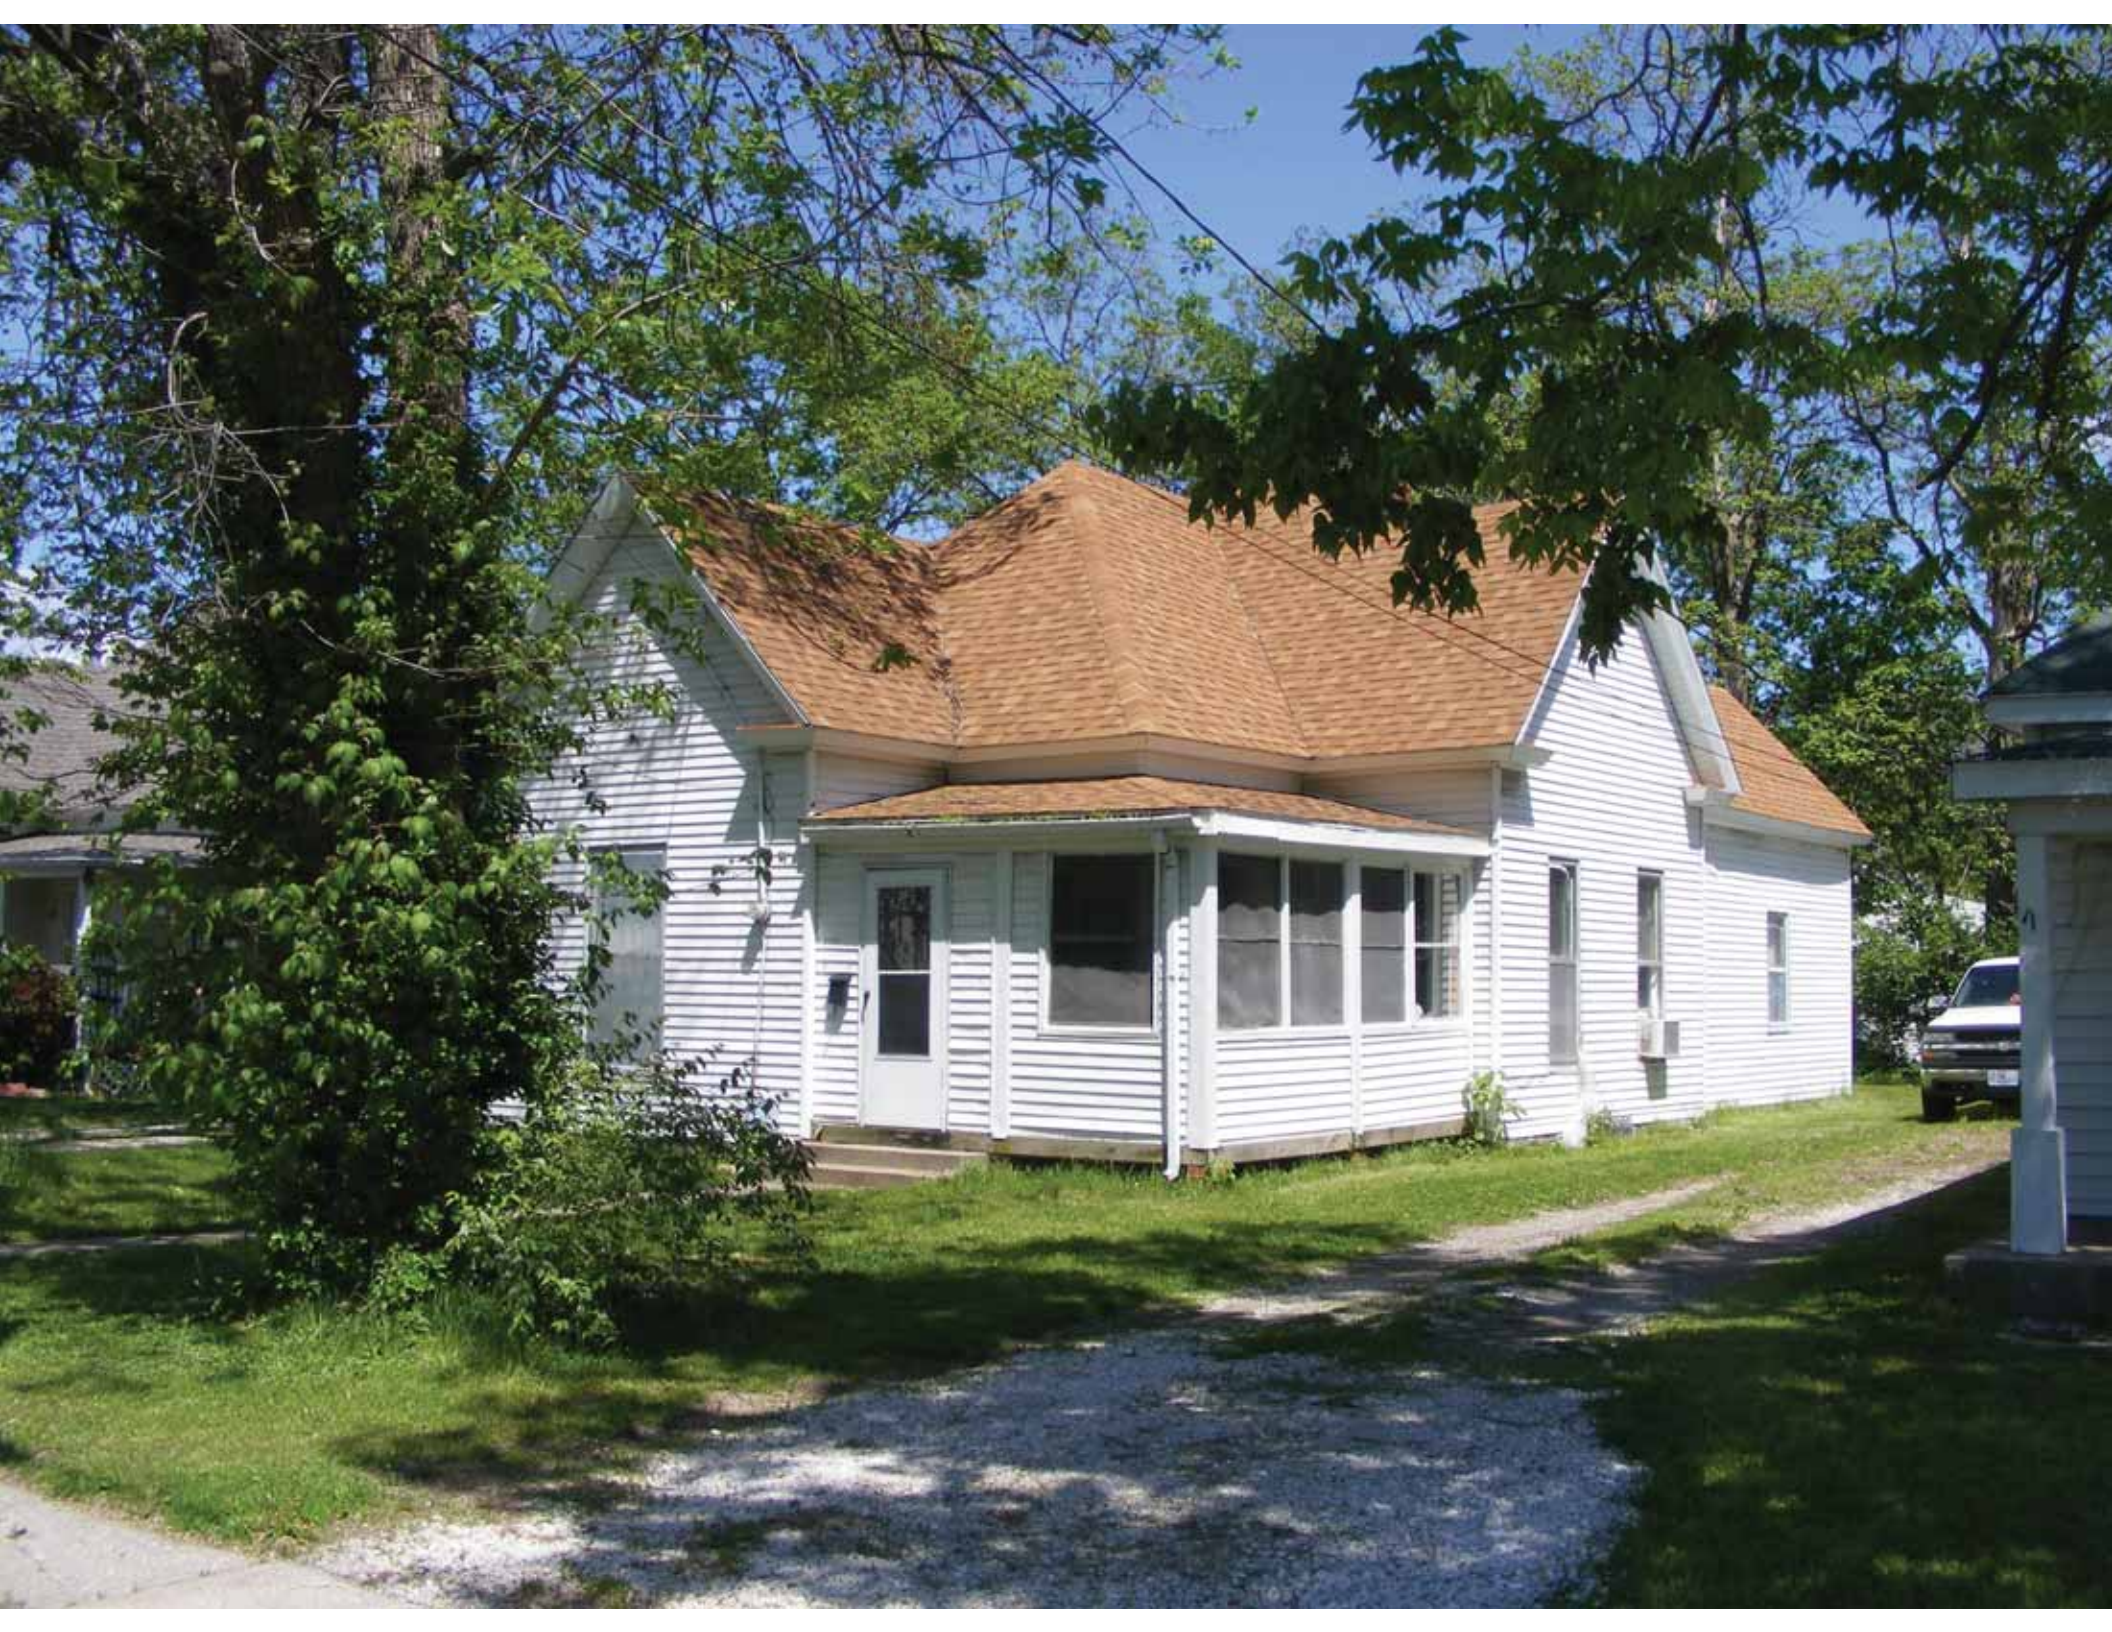
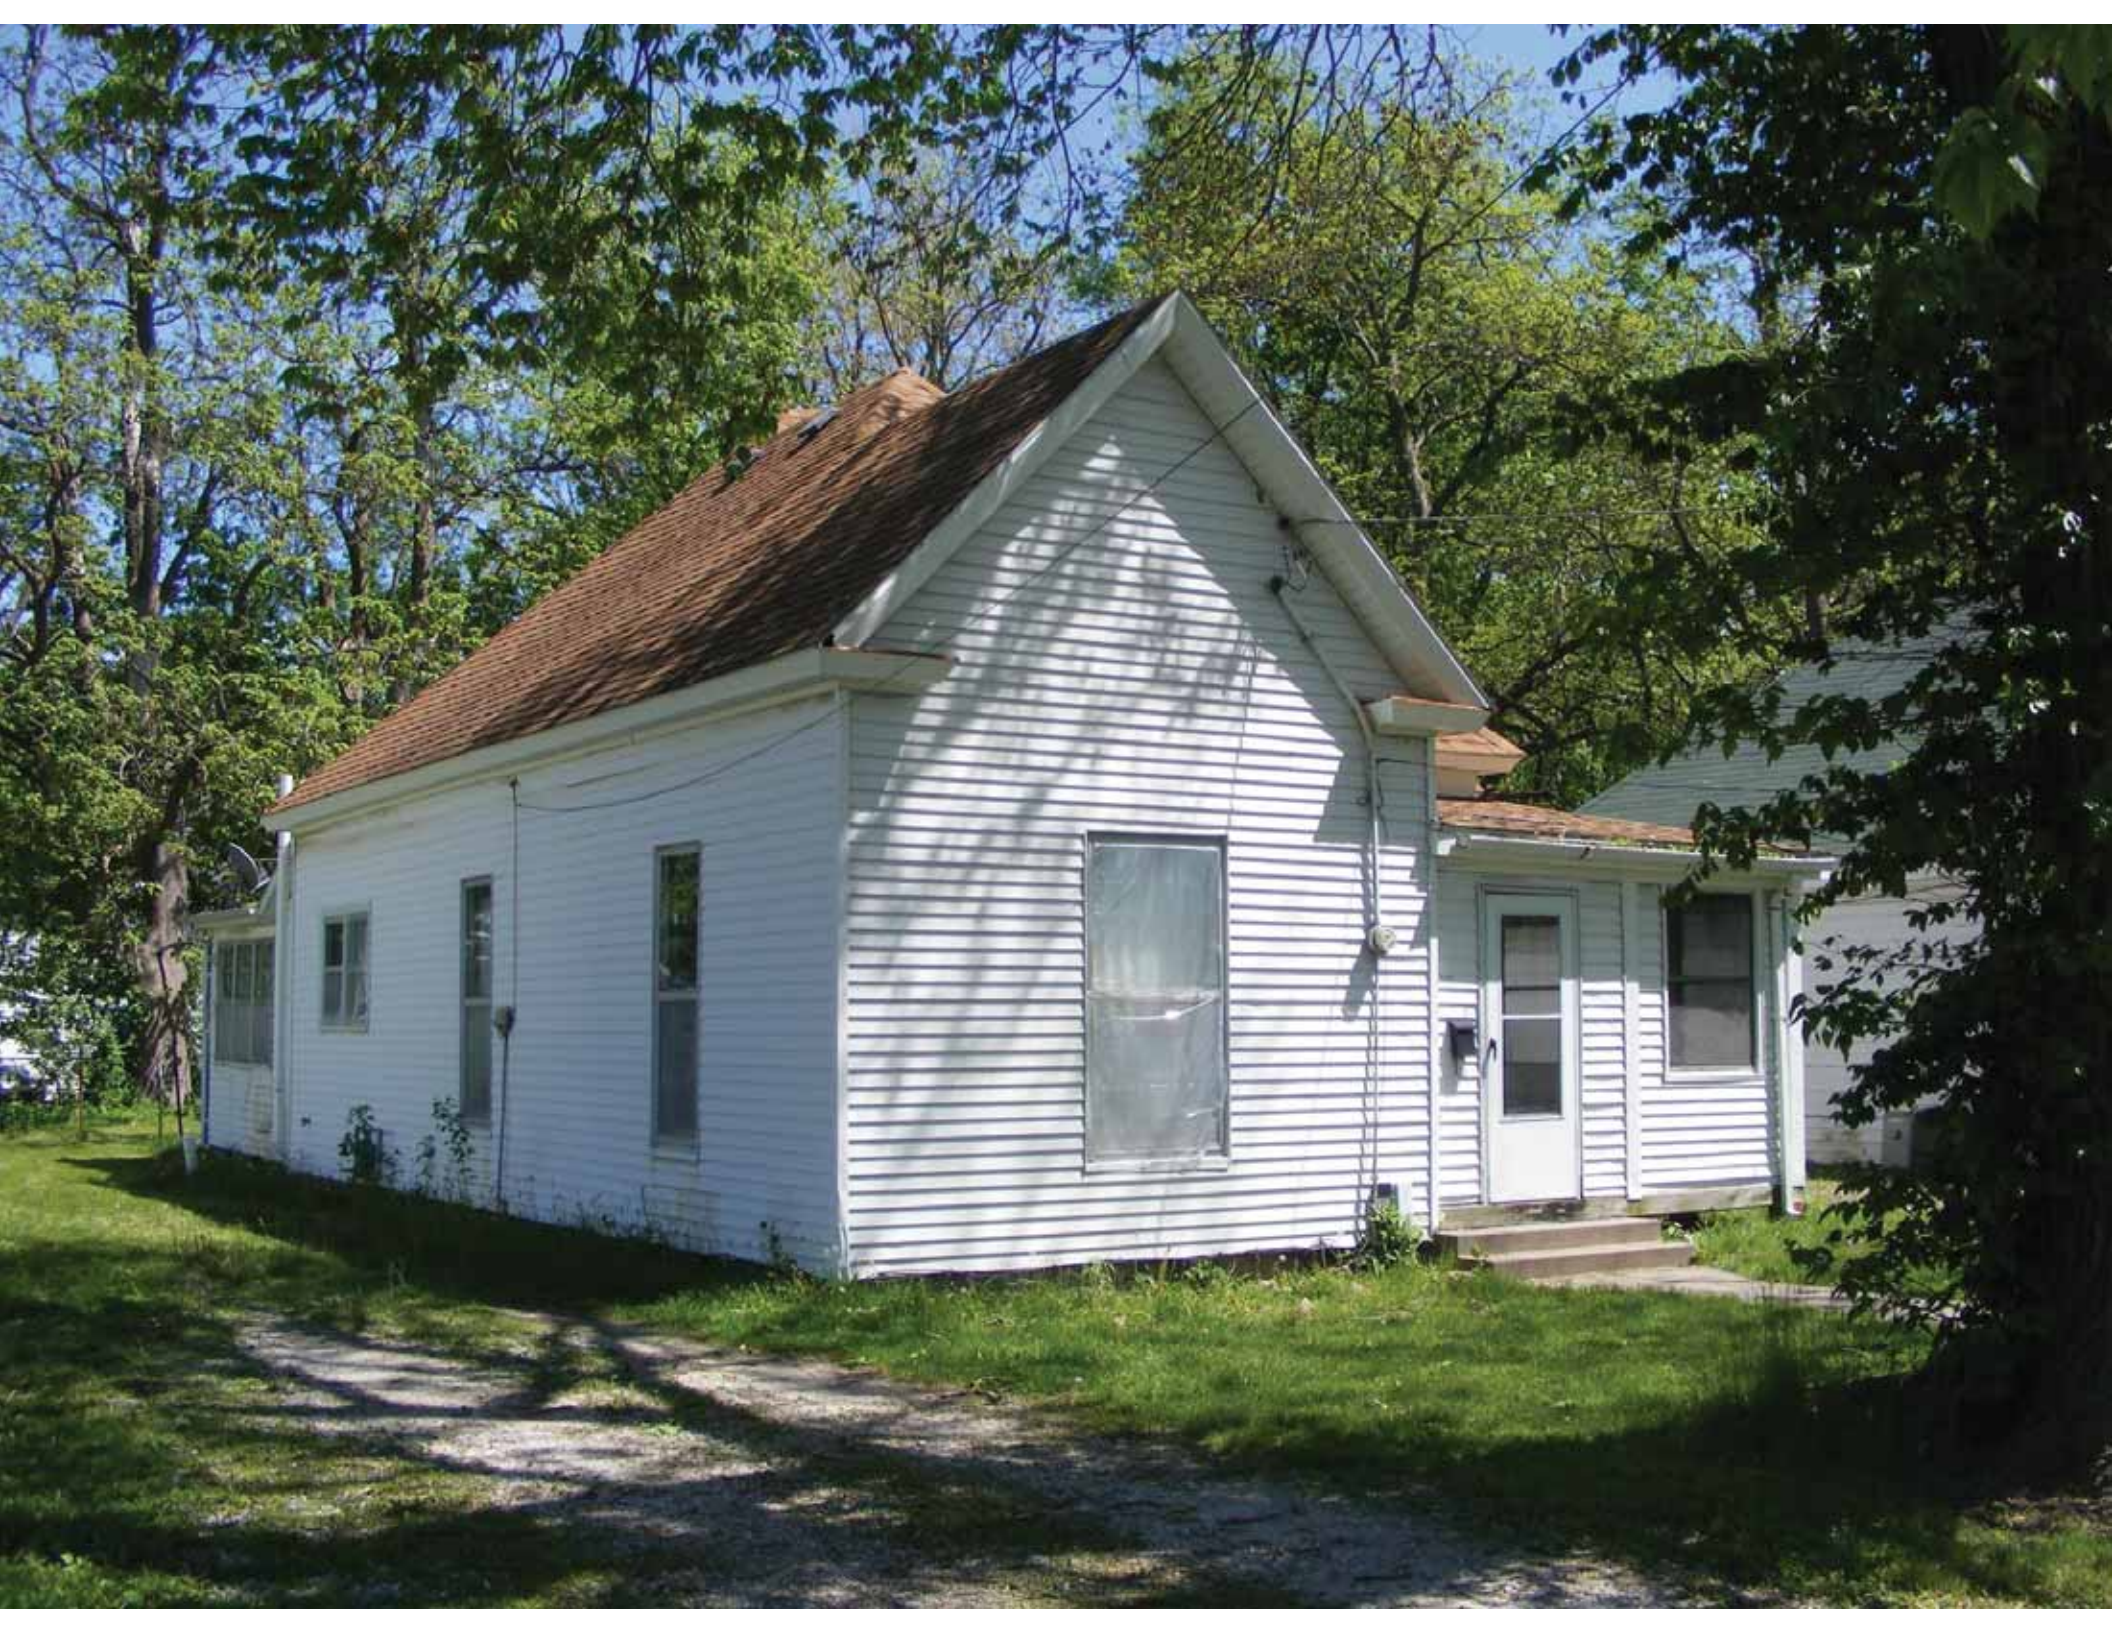
Similar in plan/design to 1104 and 1114 N. Eighth Street, this dwelling has a hipped and gabled roof illustrating its original Folk Victorian design. The dwelling's roof is clad with asphalt shingles and the exterior is clad with vinyl siding. The dwelling has a concrete foundation and enclosed façade porch. The façade features a front facing gabled wing on the north end. Below the gable returns, the elevation (west) holds a one-over-one window. A hipped porch offsetting the wing to the south has been enclosed. Square column supports are visible. A contemporary door is situated on the west elevation of the enclosed area, offset by a one-over-one window. As the porch wraps to the south side, the south elevation is likewise covered with vinyl siding and supports a band of four one-over-one windows. At the rear (east) elevation is a single-story shed wing, also clad with vinyl siding.
