MISSOURI DEPARTMENT OF NATURAL RESOURCES
STATE HISTORIC PRESERVATION OFFICE, P.O. Box 176, Jefferson City, MO 65102
ARCHITECTURAL/HISTORIC INVENTORY FORM

1. Survey No. BO-AS-011-0087		2. Survey name: North Central Columbia Survey Phase II	
3. County: Boone		4. Address (Street No.) 902	Street (name) N. Seventh Street
5. City: Columbia	Vicinity: <input type="checkbox"/>	6. Geographical Reference:	7. Township/Range/Section: T: R: S:
8. Historic name (if known):		9. Present/other name (if known):	
10. Ownership: <input checked="" type="checkbox"/> Private <input type="checkbox"/> Public		11a. Historic use (if known): Domestic/single dwelling	11b. Current use: Domestic/single dwelling

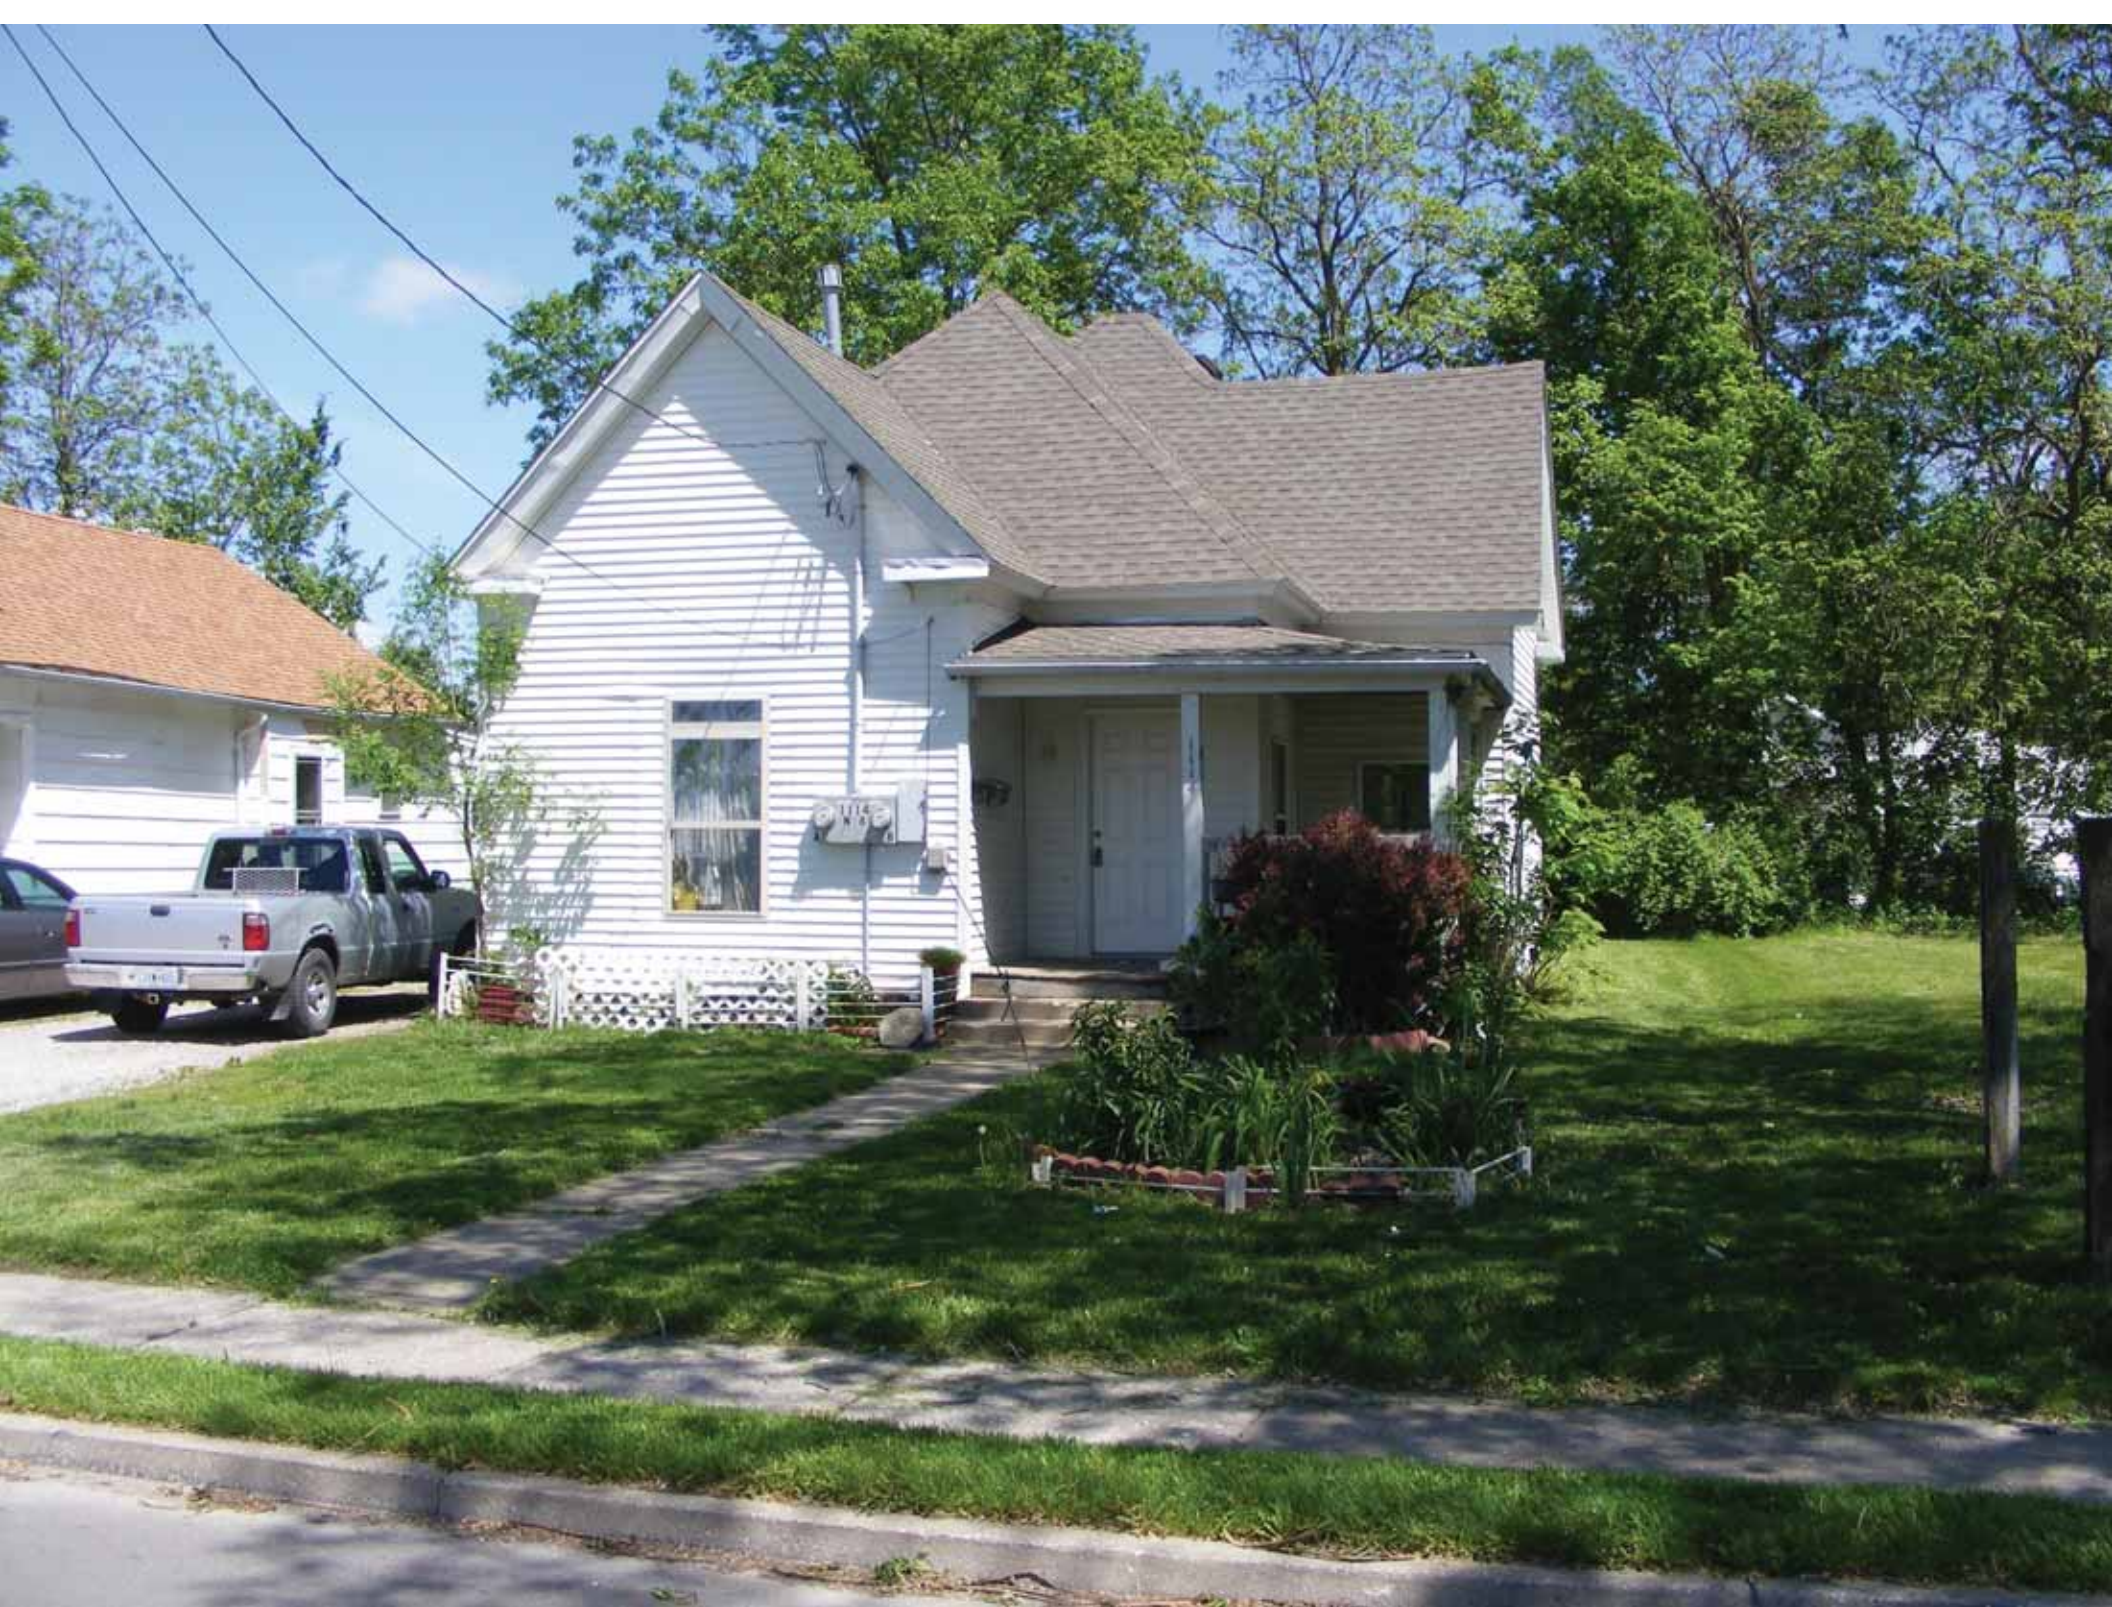
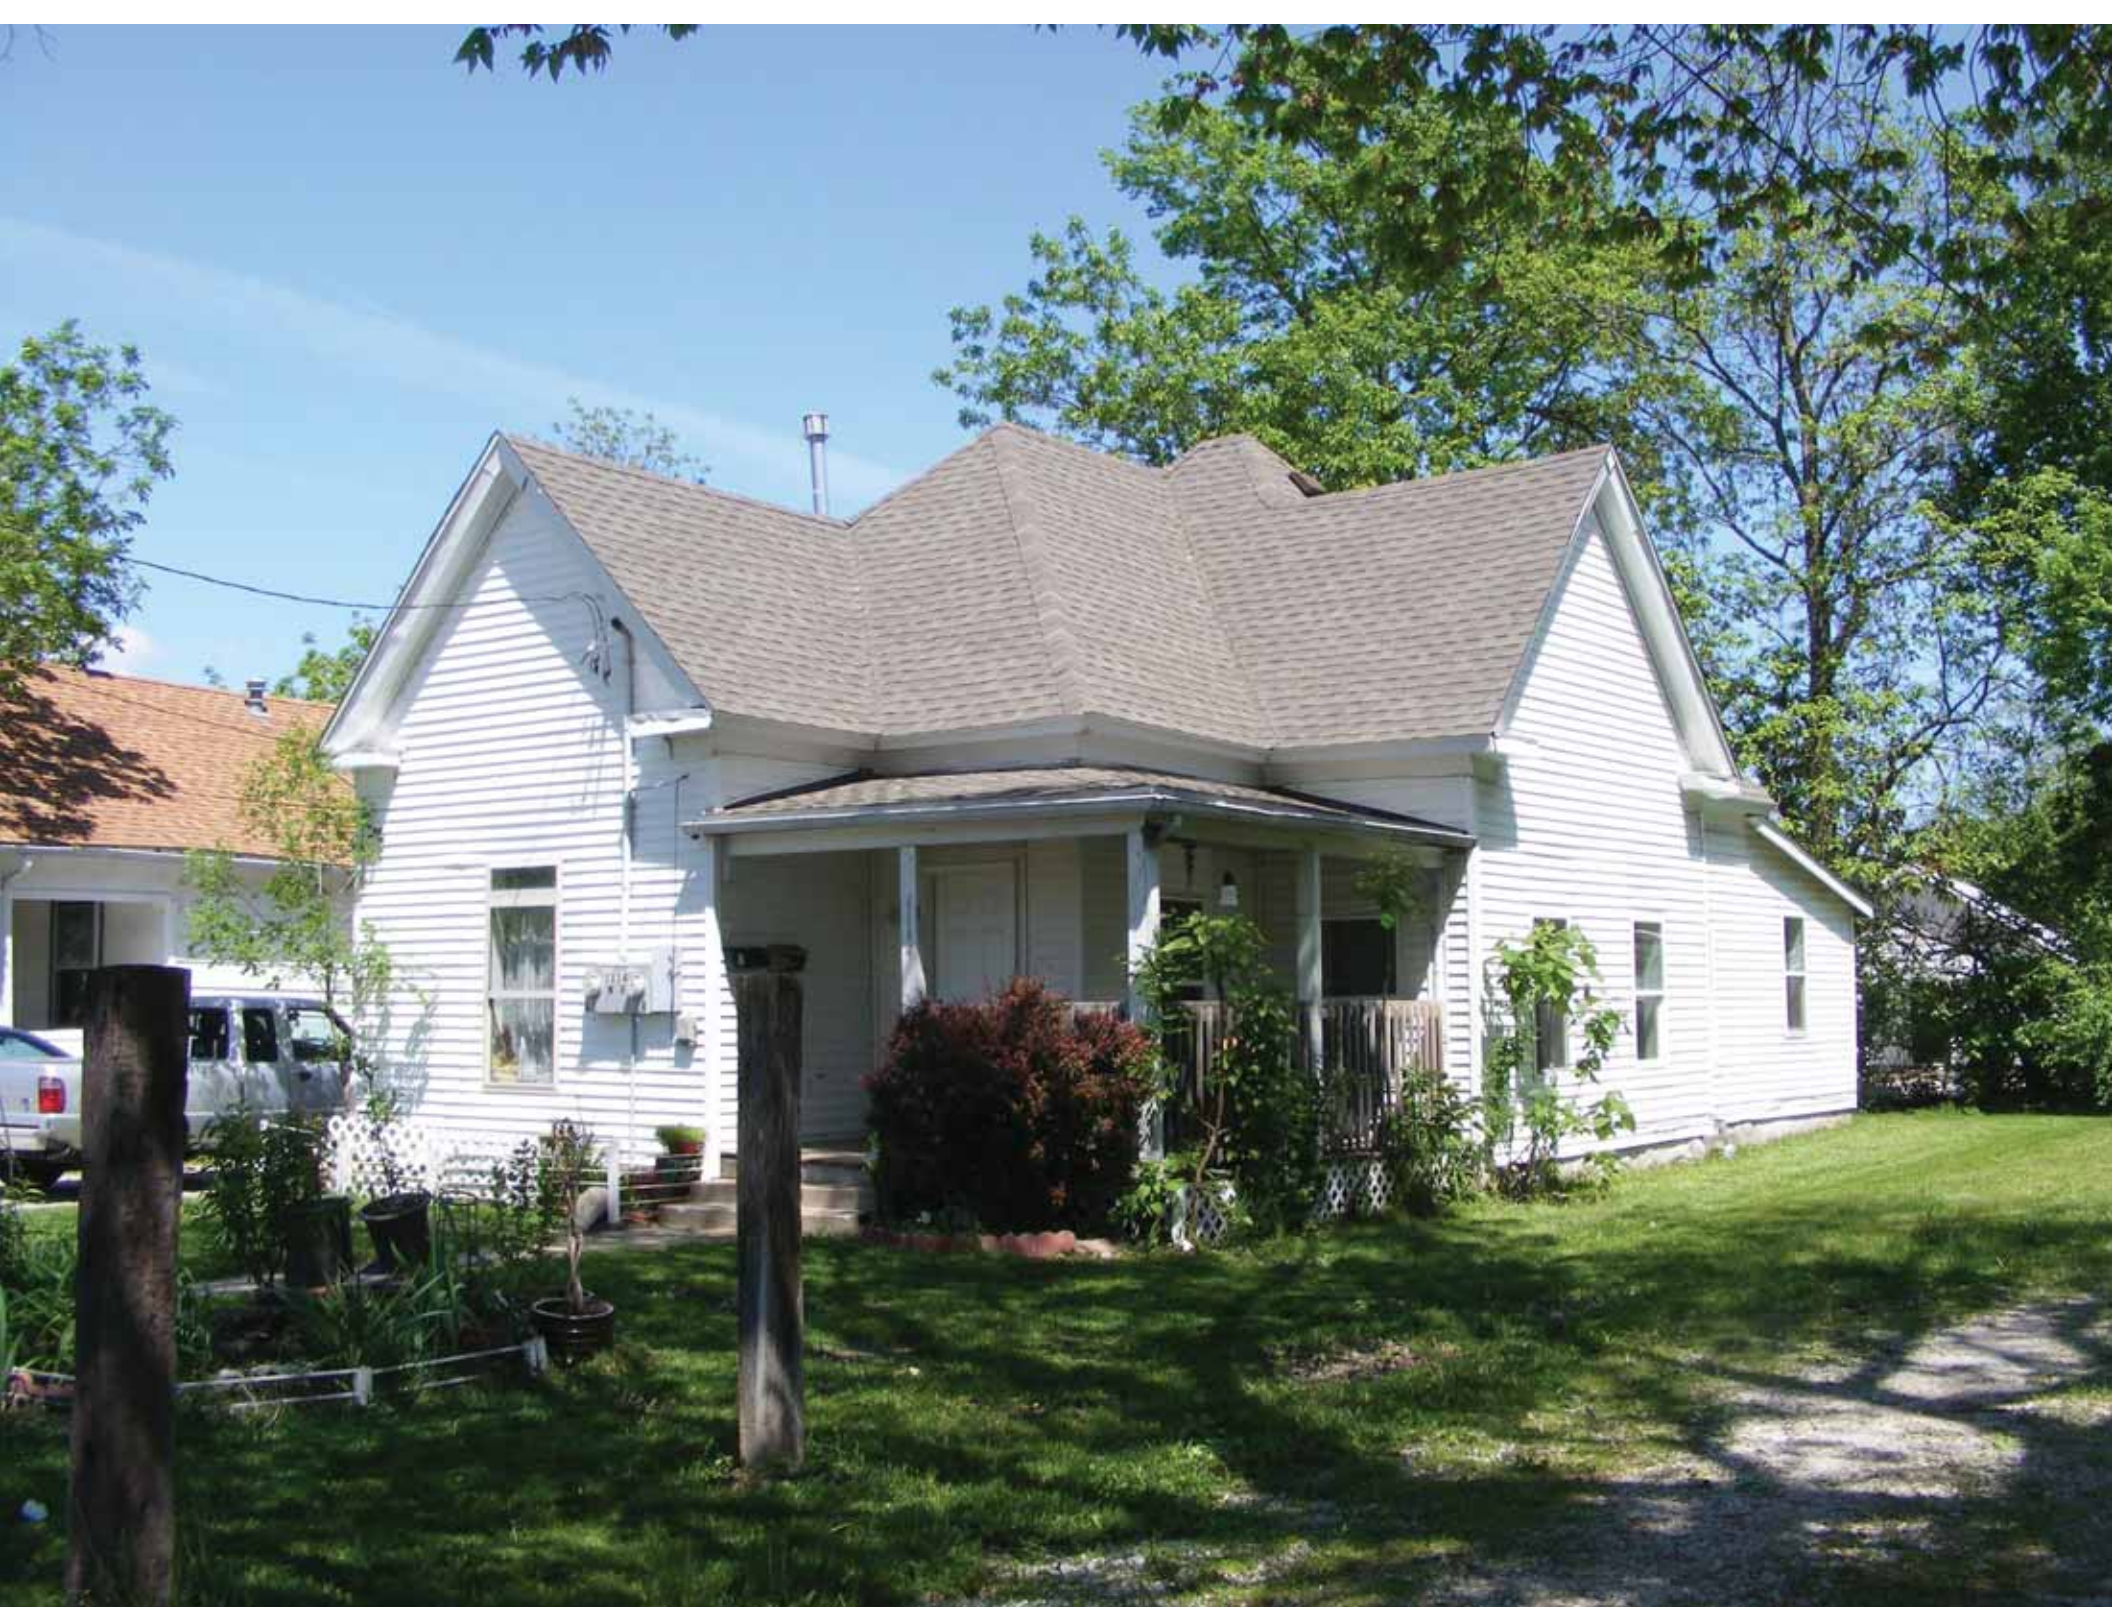
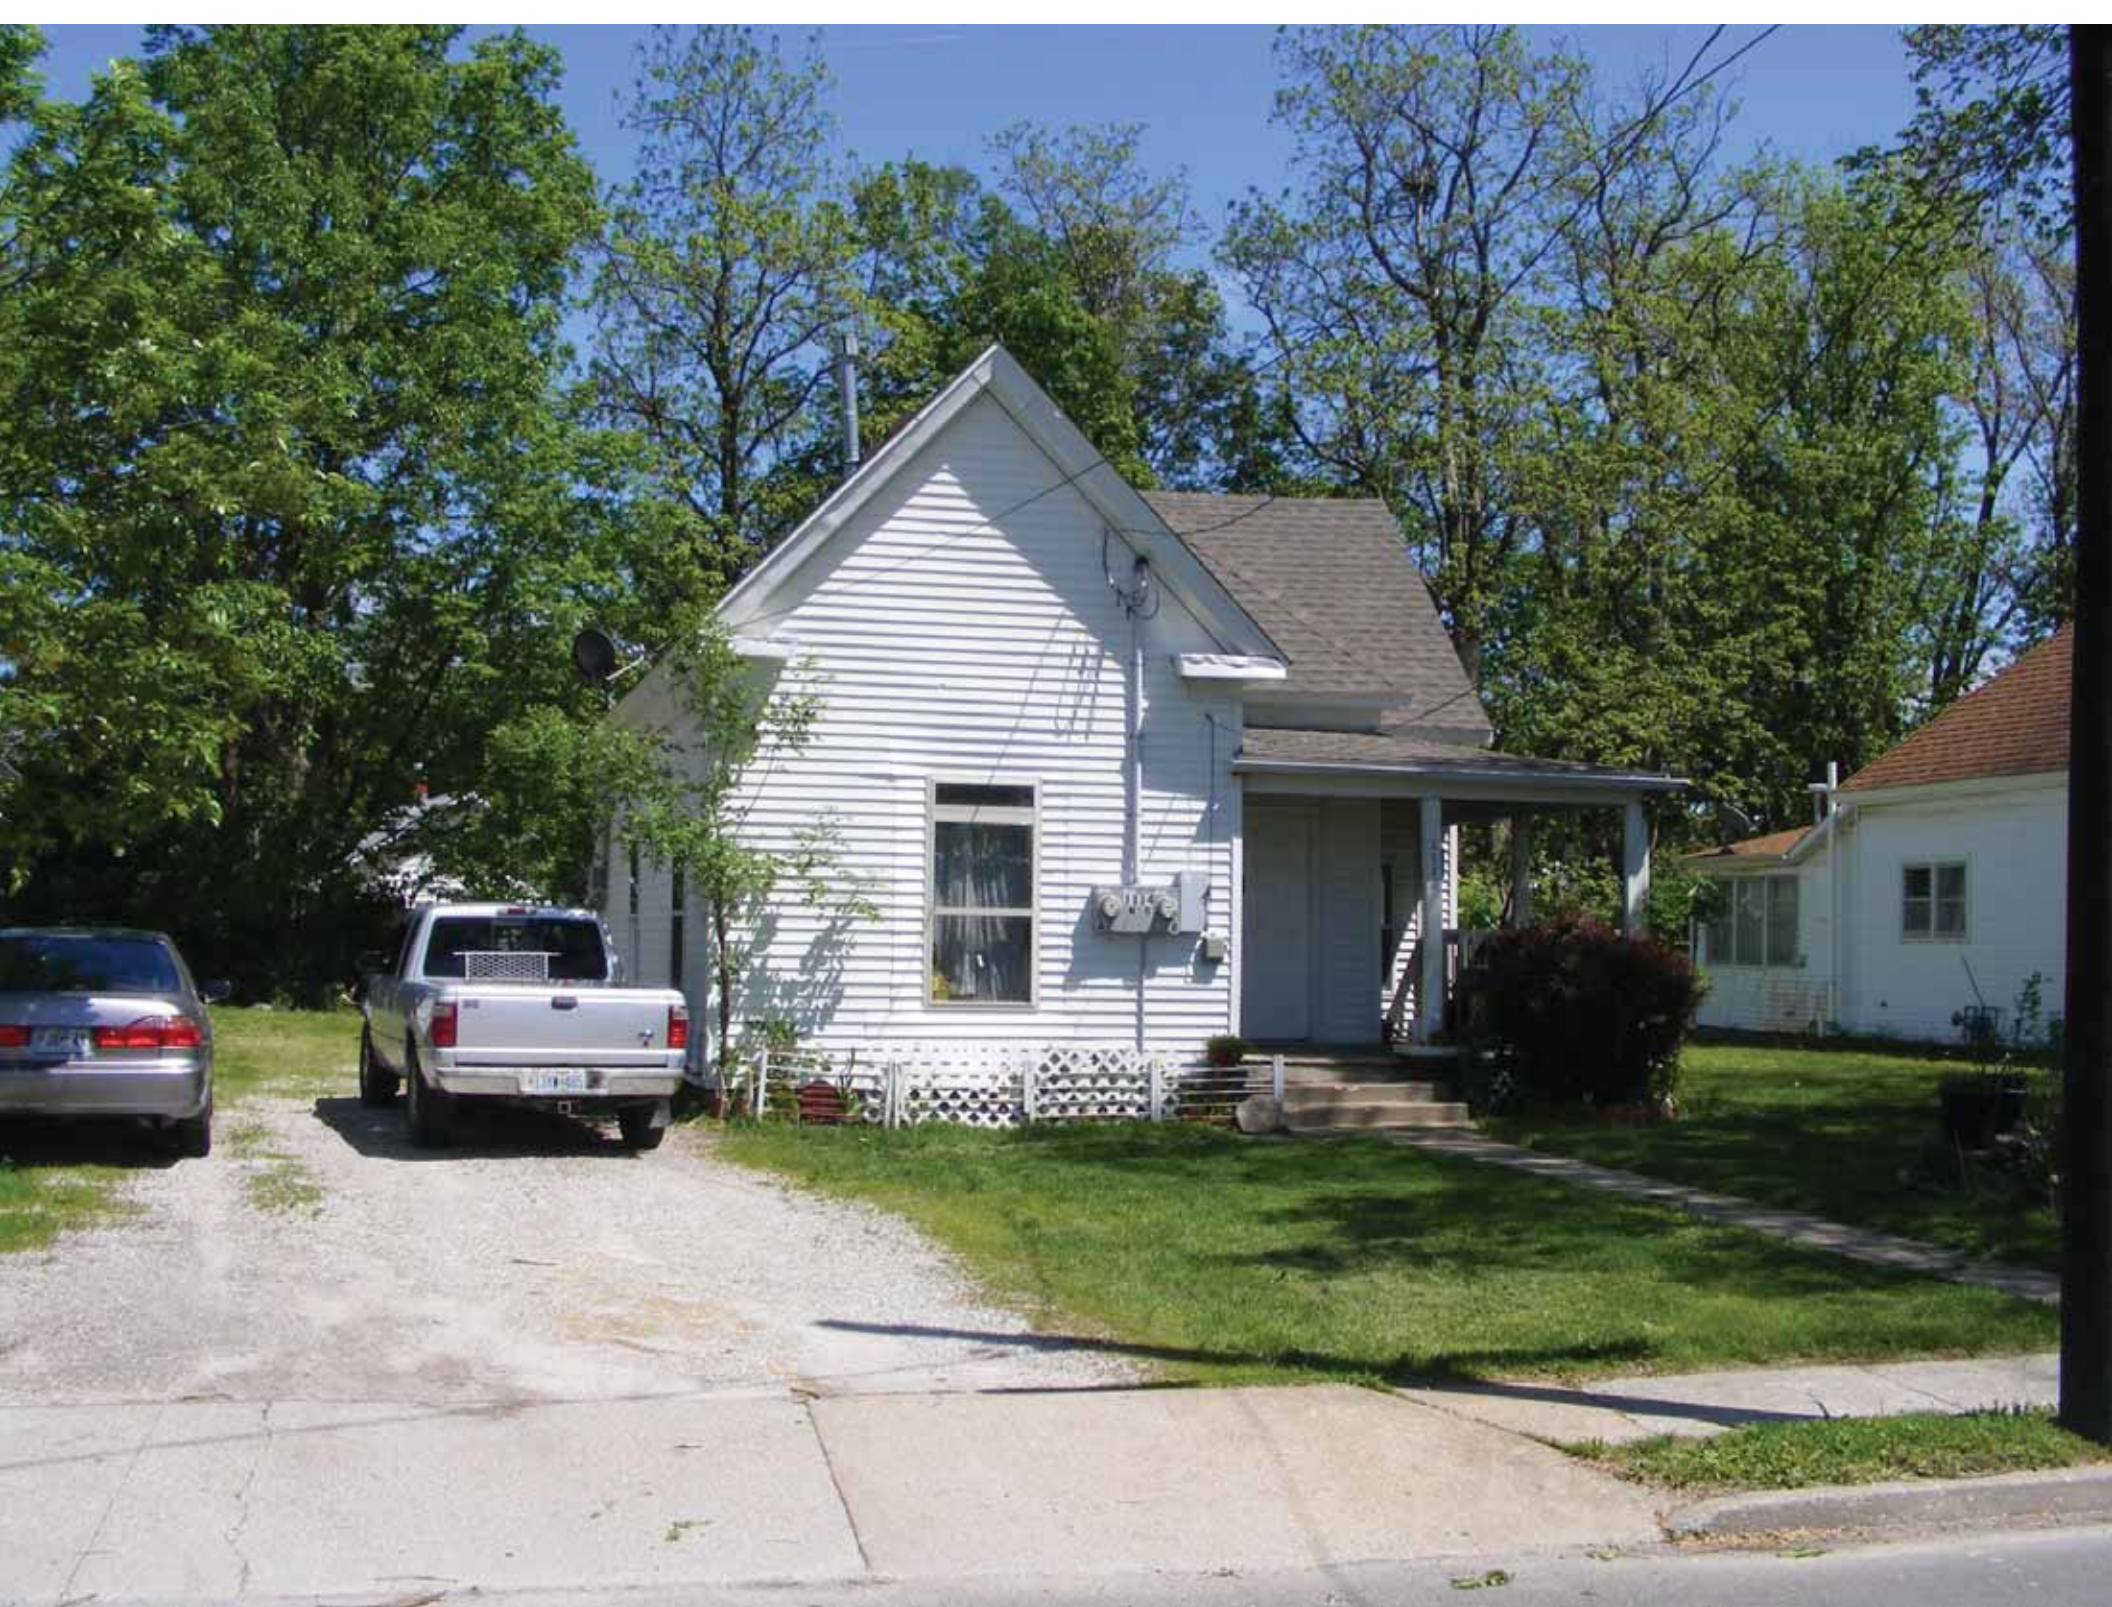
The dwelling is similar in plan to the houses at 1112 and 1104 N. Eighth Street. The dwelling has a hipped and gabled roof clad with asphalt shingles. Exterior walls are clad with vinyl and the gables retain original returns. The foundation is concrete. On the façade (west elevation), the front facing gabled elevation (north end) holds a replacement window of one-over-one design. The window has an upper fixed sash transom (replacement, c. 2015). Offsetting the projecting wing on the south is an original hipped porch supported by square wood columns. Within the porch bay is a replacement paneled door (c. 2015). The porch wall is angled with windows (one on each wall) facing south and west. All windows appear to be c. 2015 one-over-one replacement design. The dwelling has a rear single-story shed wing.

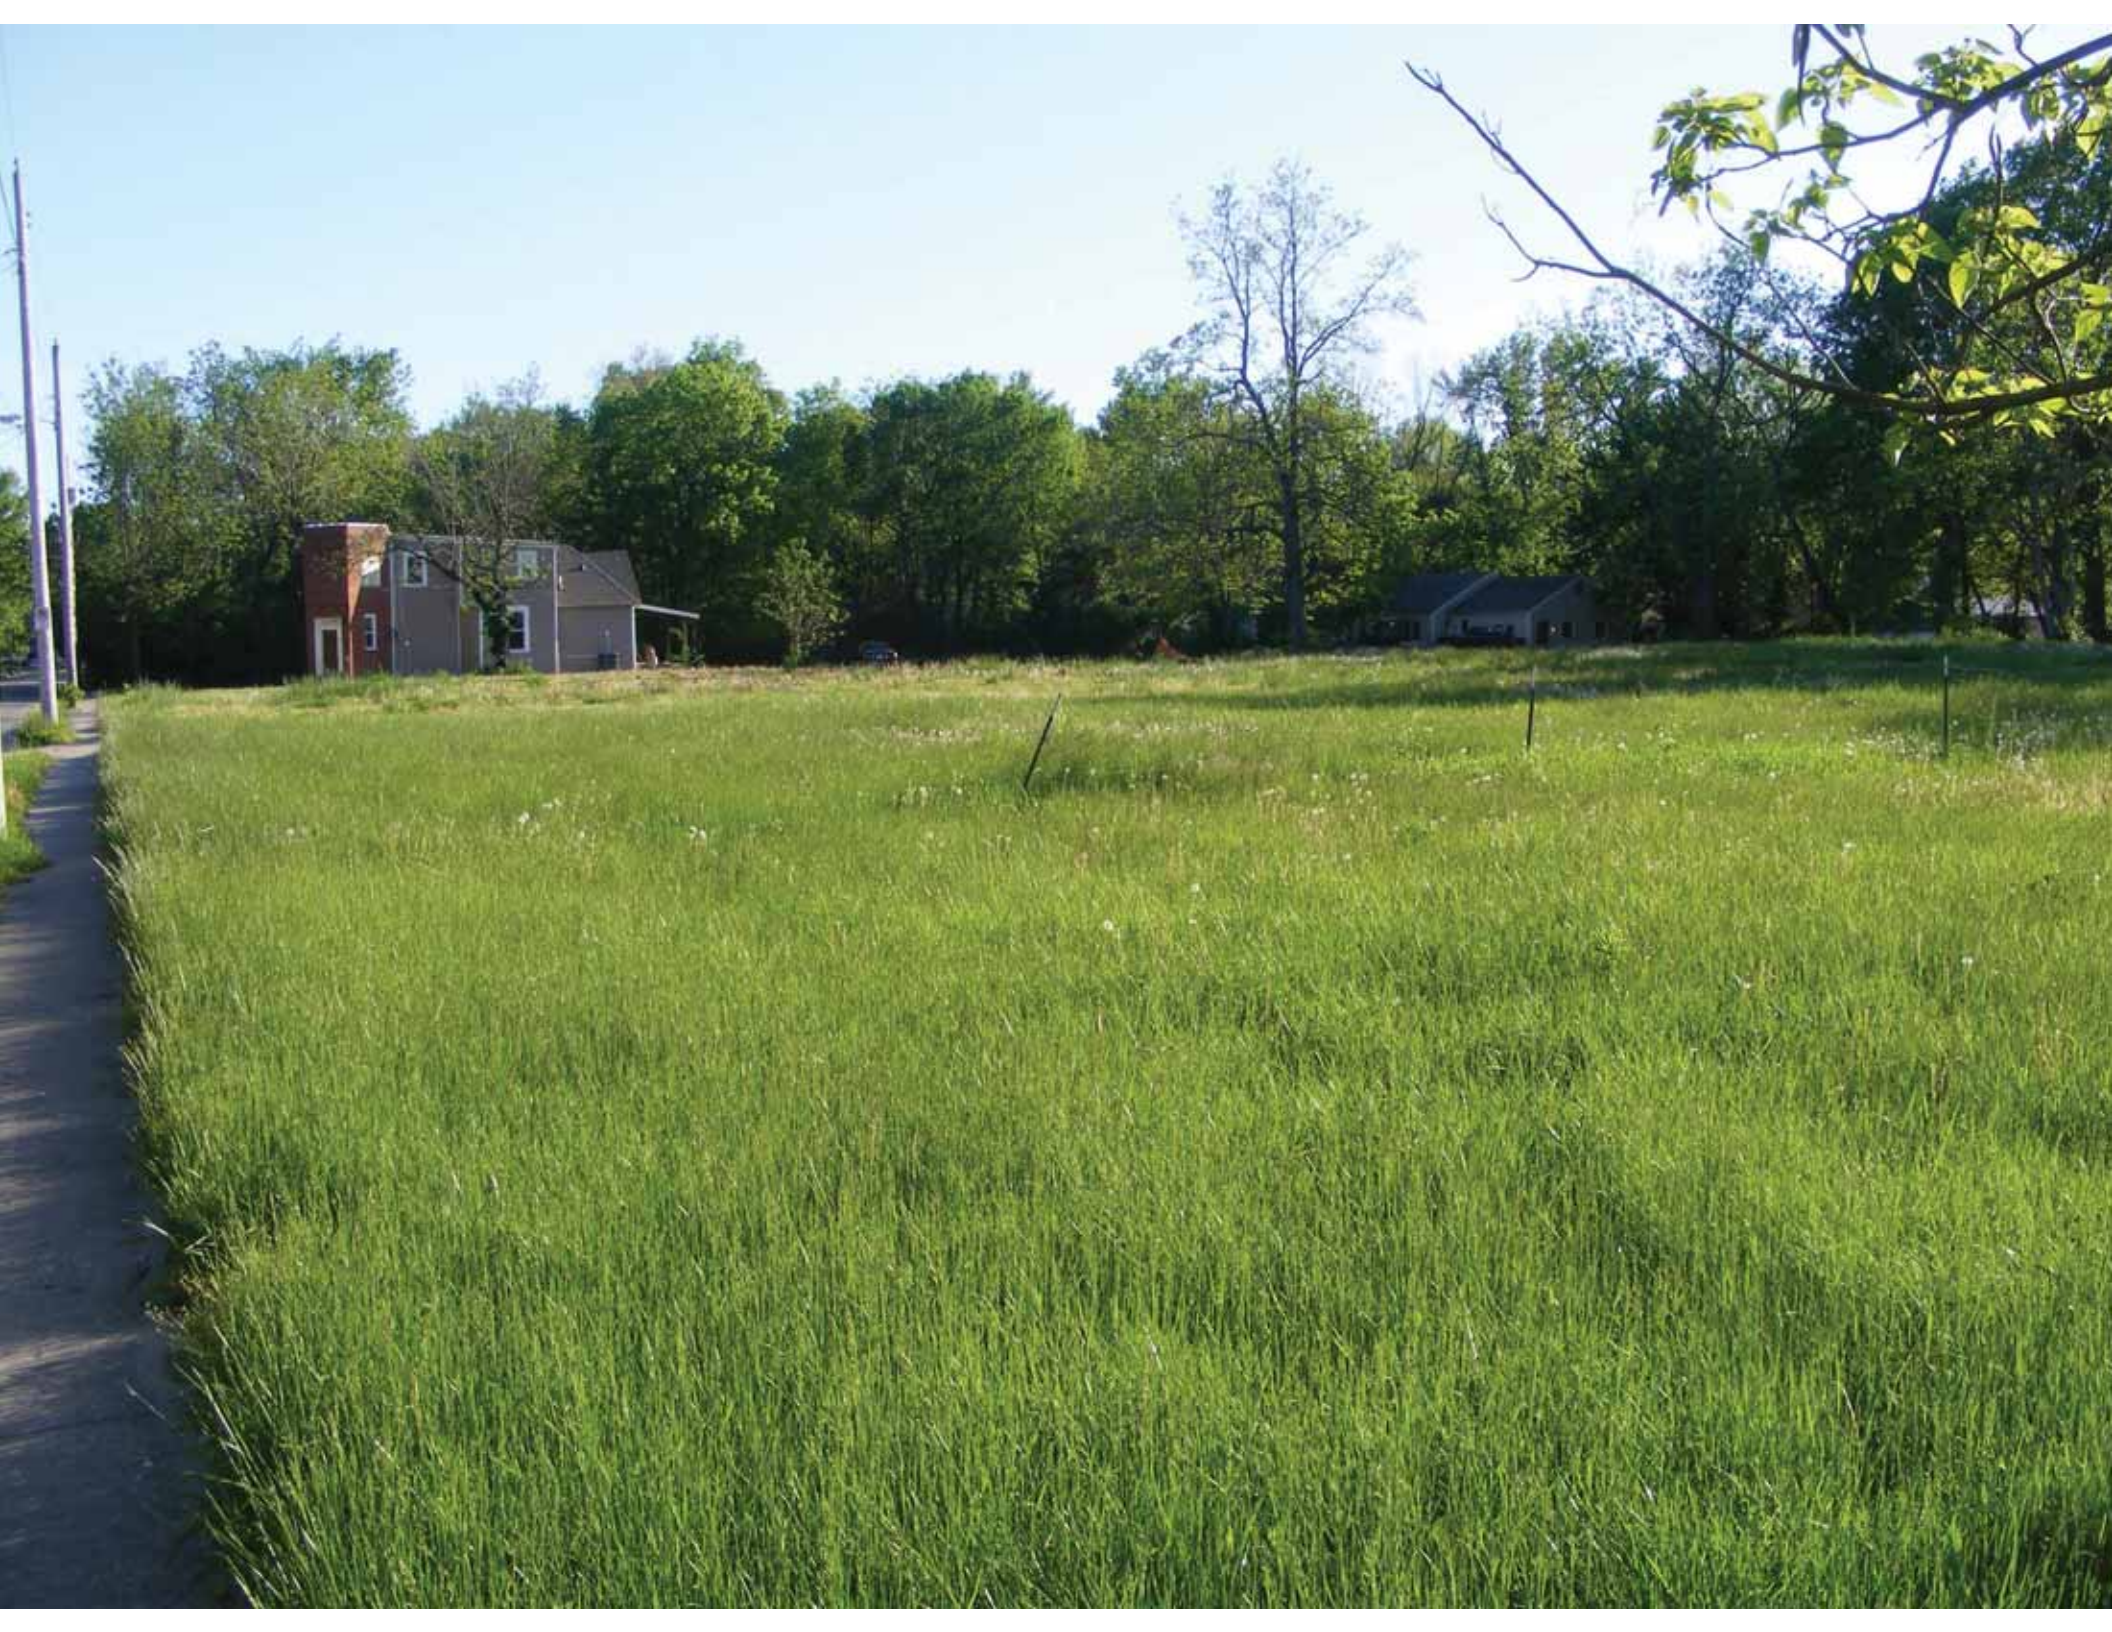
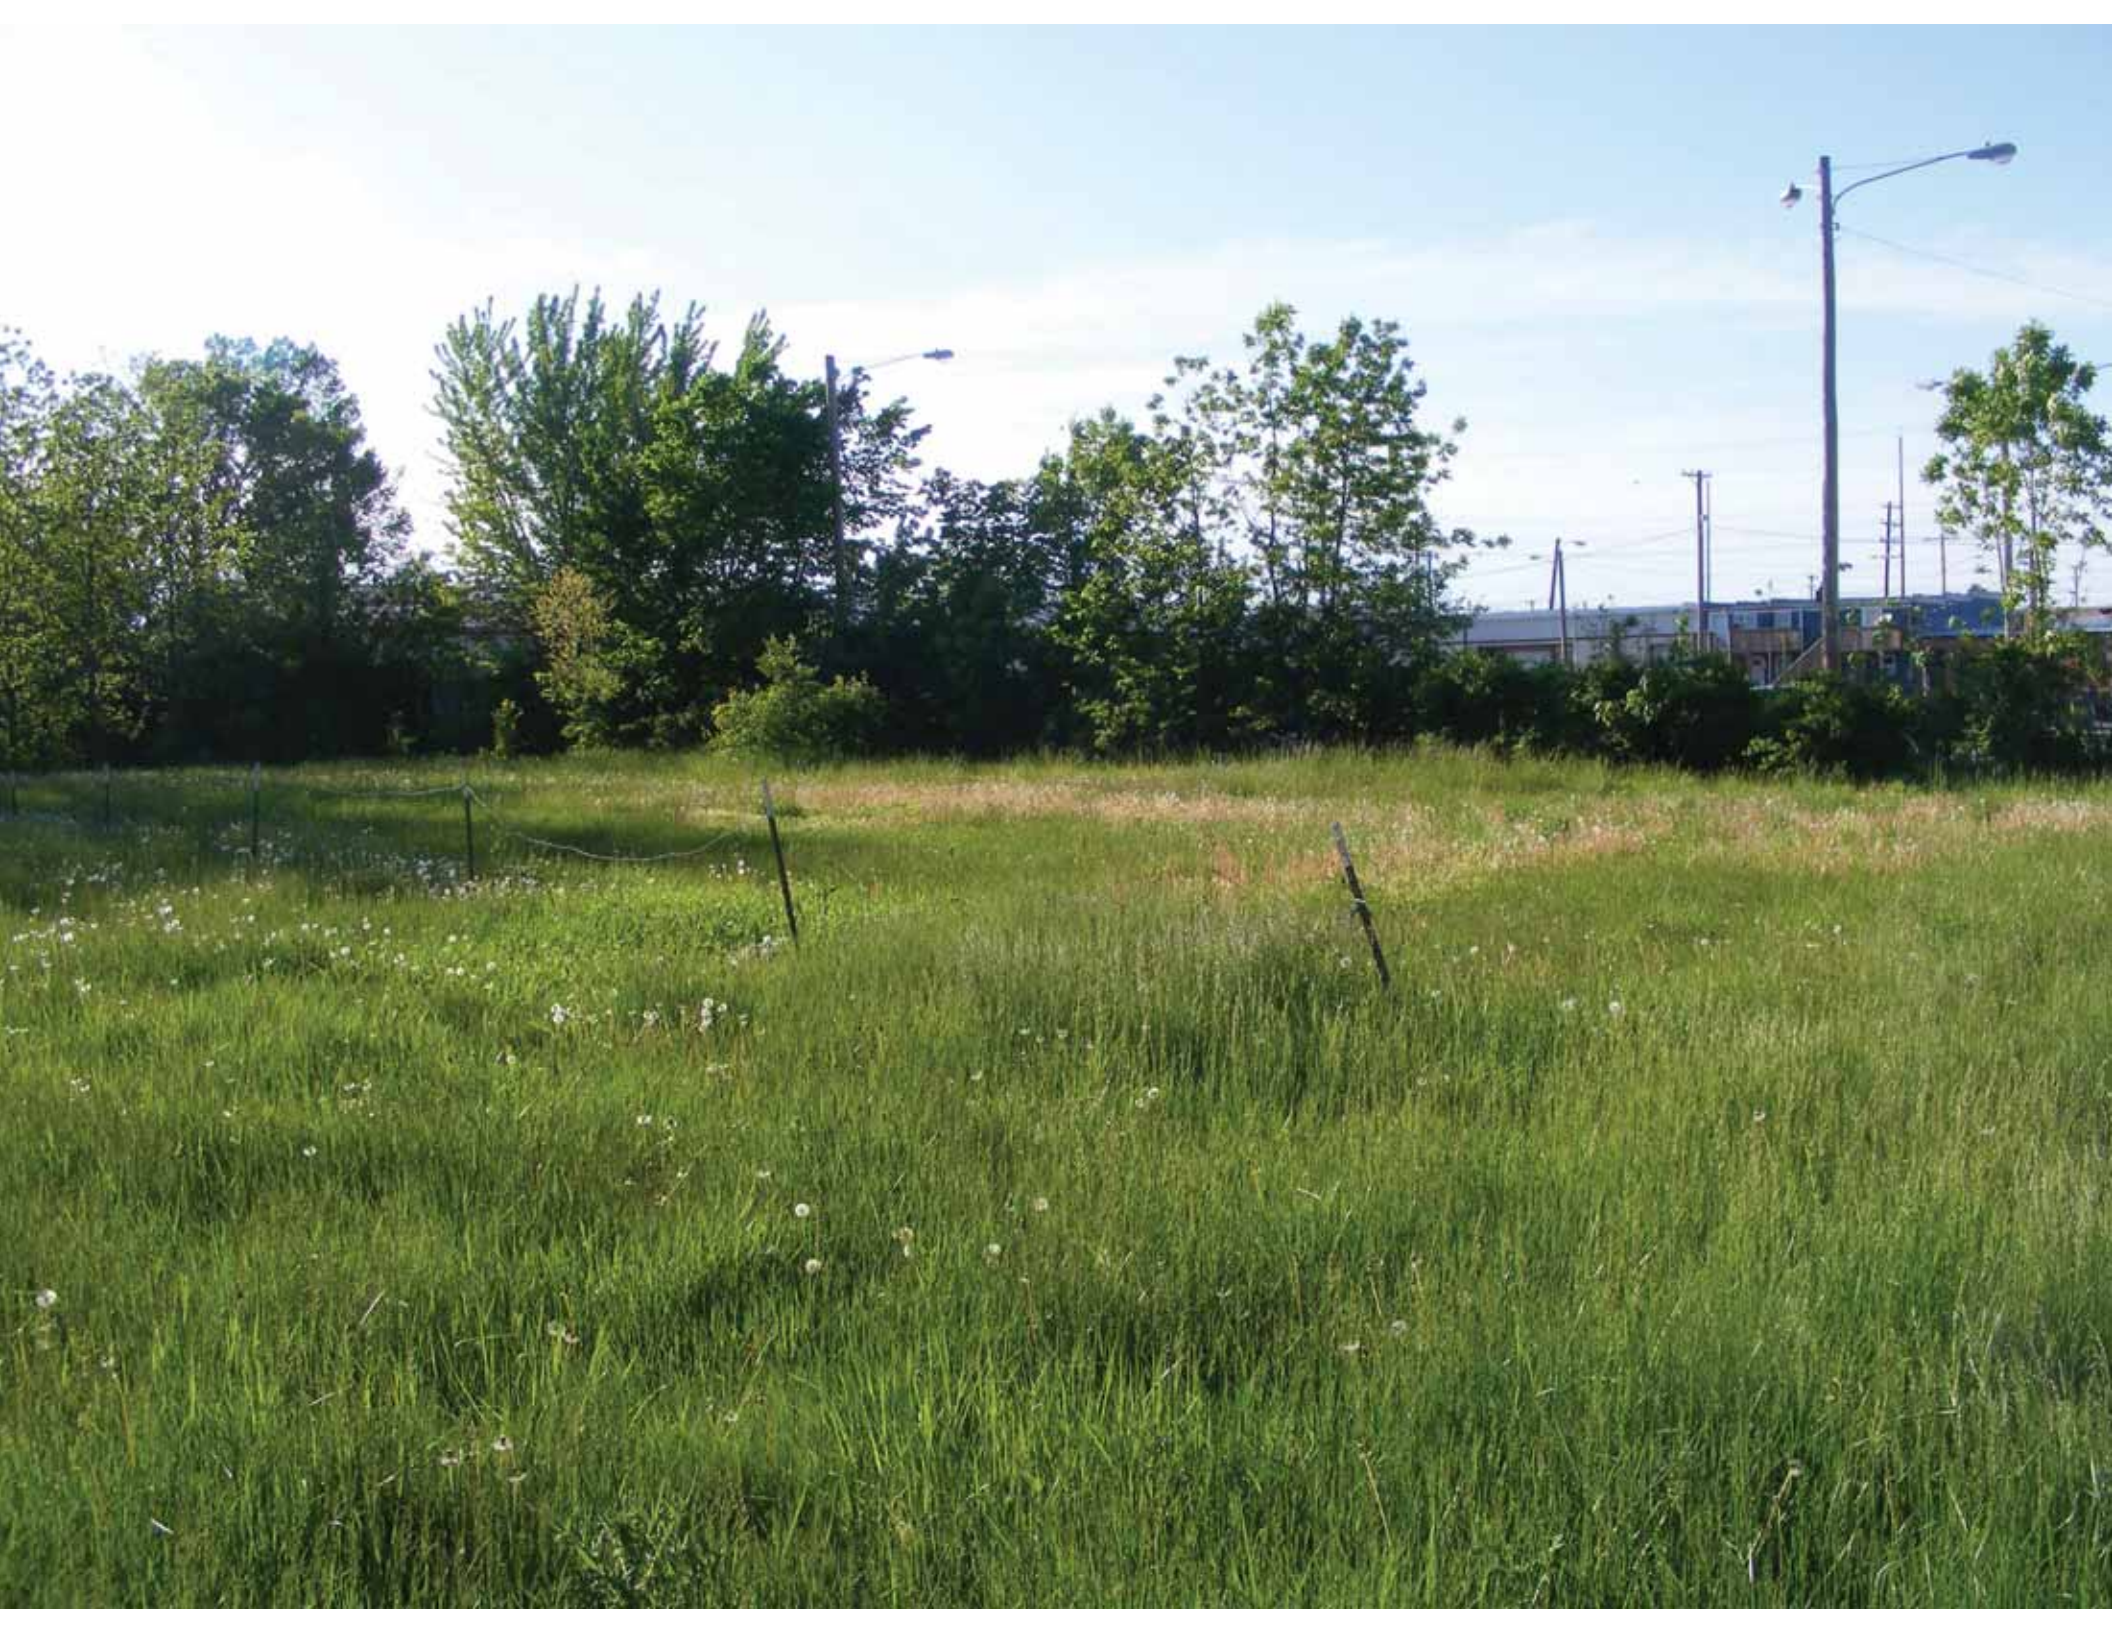
This 0.43-acre vacant lot held a single-family dwelling previously (per Sanborn Fire Insurance Maps, 1925 and 1948). The lot is as above, covered with grass and bounded by the public sidewalk at the east end of the lot. There are no buildings on the lot.
