MISSOURI DEPARTMENT OF NATURAL RESOURCES
STATE HISTORIC PRESERVATION OFFICE, P.O. Box 176, Jefferson City, MO 65102
ARCHITECTURAL/HISTORIC INVENTORY FORM

1. Survey No. BO-AS-011-0087		2. Survey name: North Central Columbia Survey Phase II	
3. County: Boone		4. Address (Street No.) 902	Street (name) N. Seventh Street
5. City: Columbia	Vicinity: <input type="checkbox"/>	6. Geographical Reference:	7. Township/Range/Section: T: R: S:
8. Historic name (if known):		9. Present/other name (if known):	
10. Ownership: <input checked="" type="checkbox"/> Private <input type="checkbox"/> Public		11a. Historic use (if known): Domestic/single dwelling	11b. Current use: Domestic/single dwelling

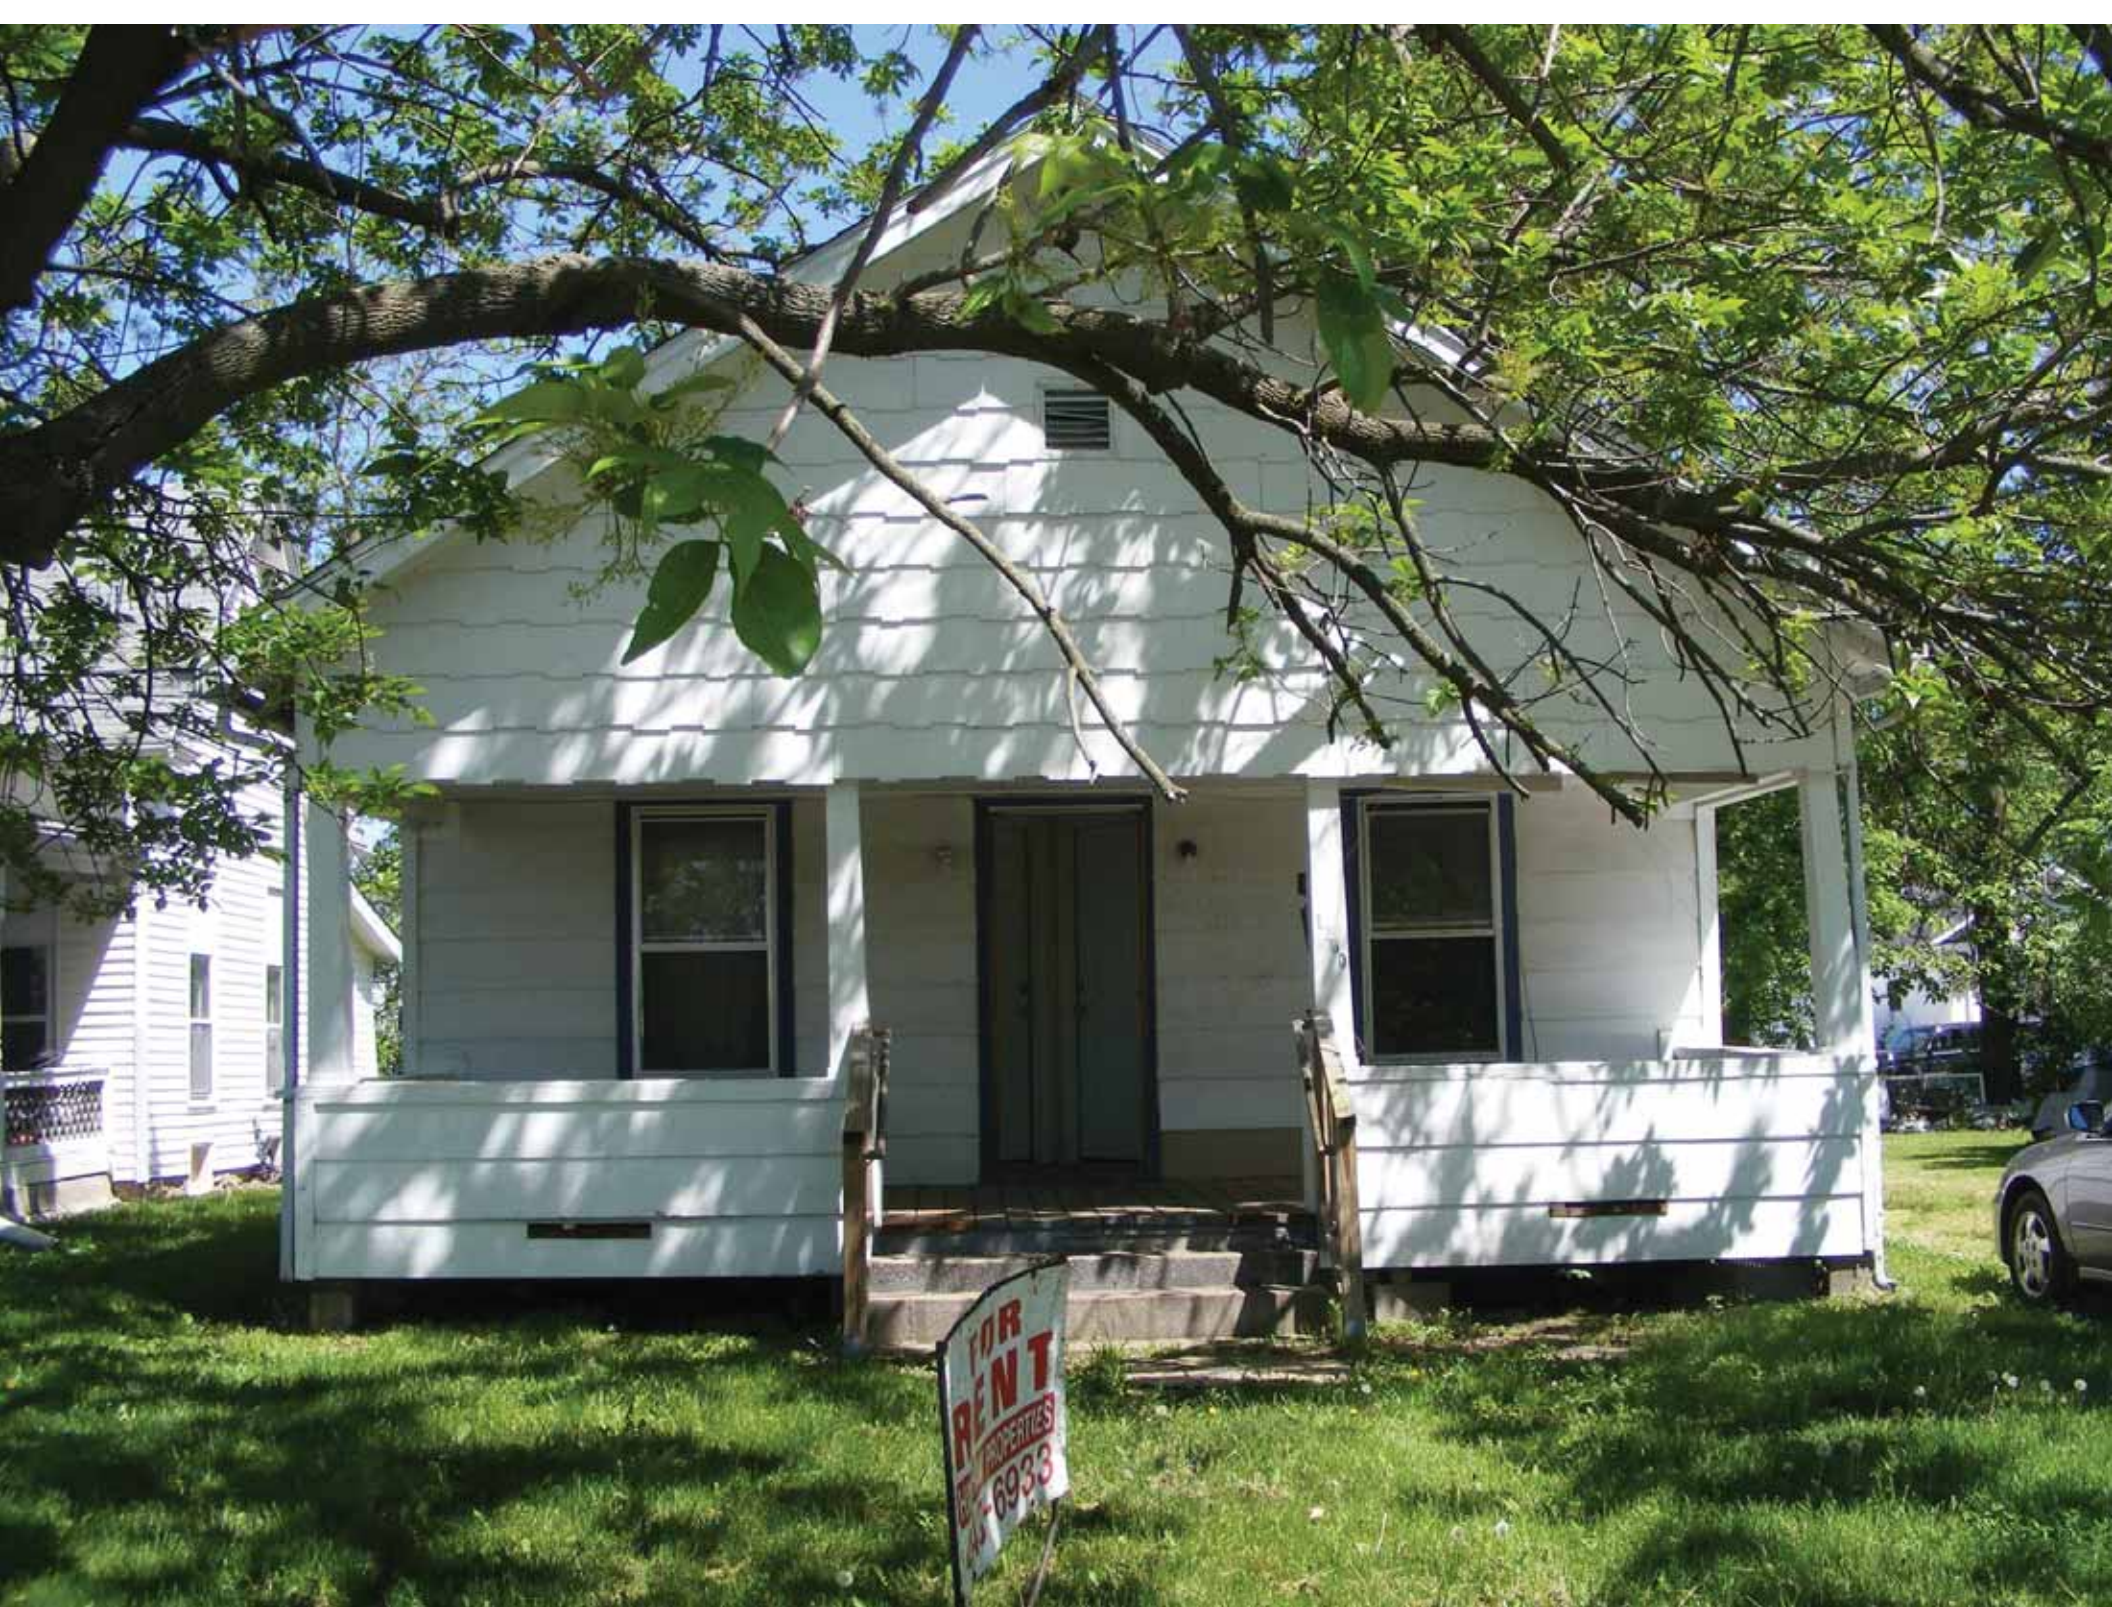
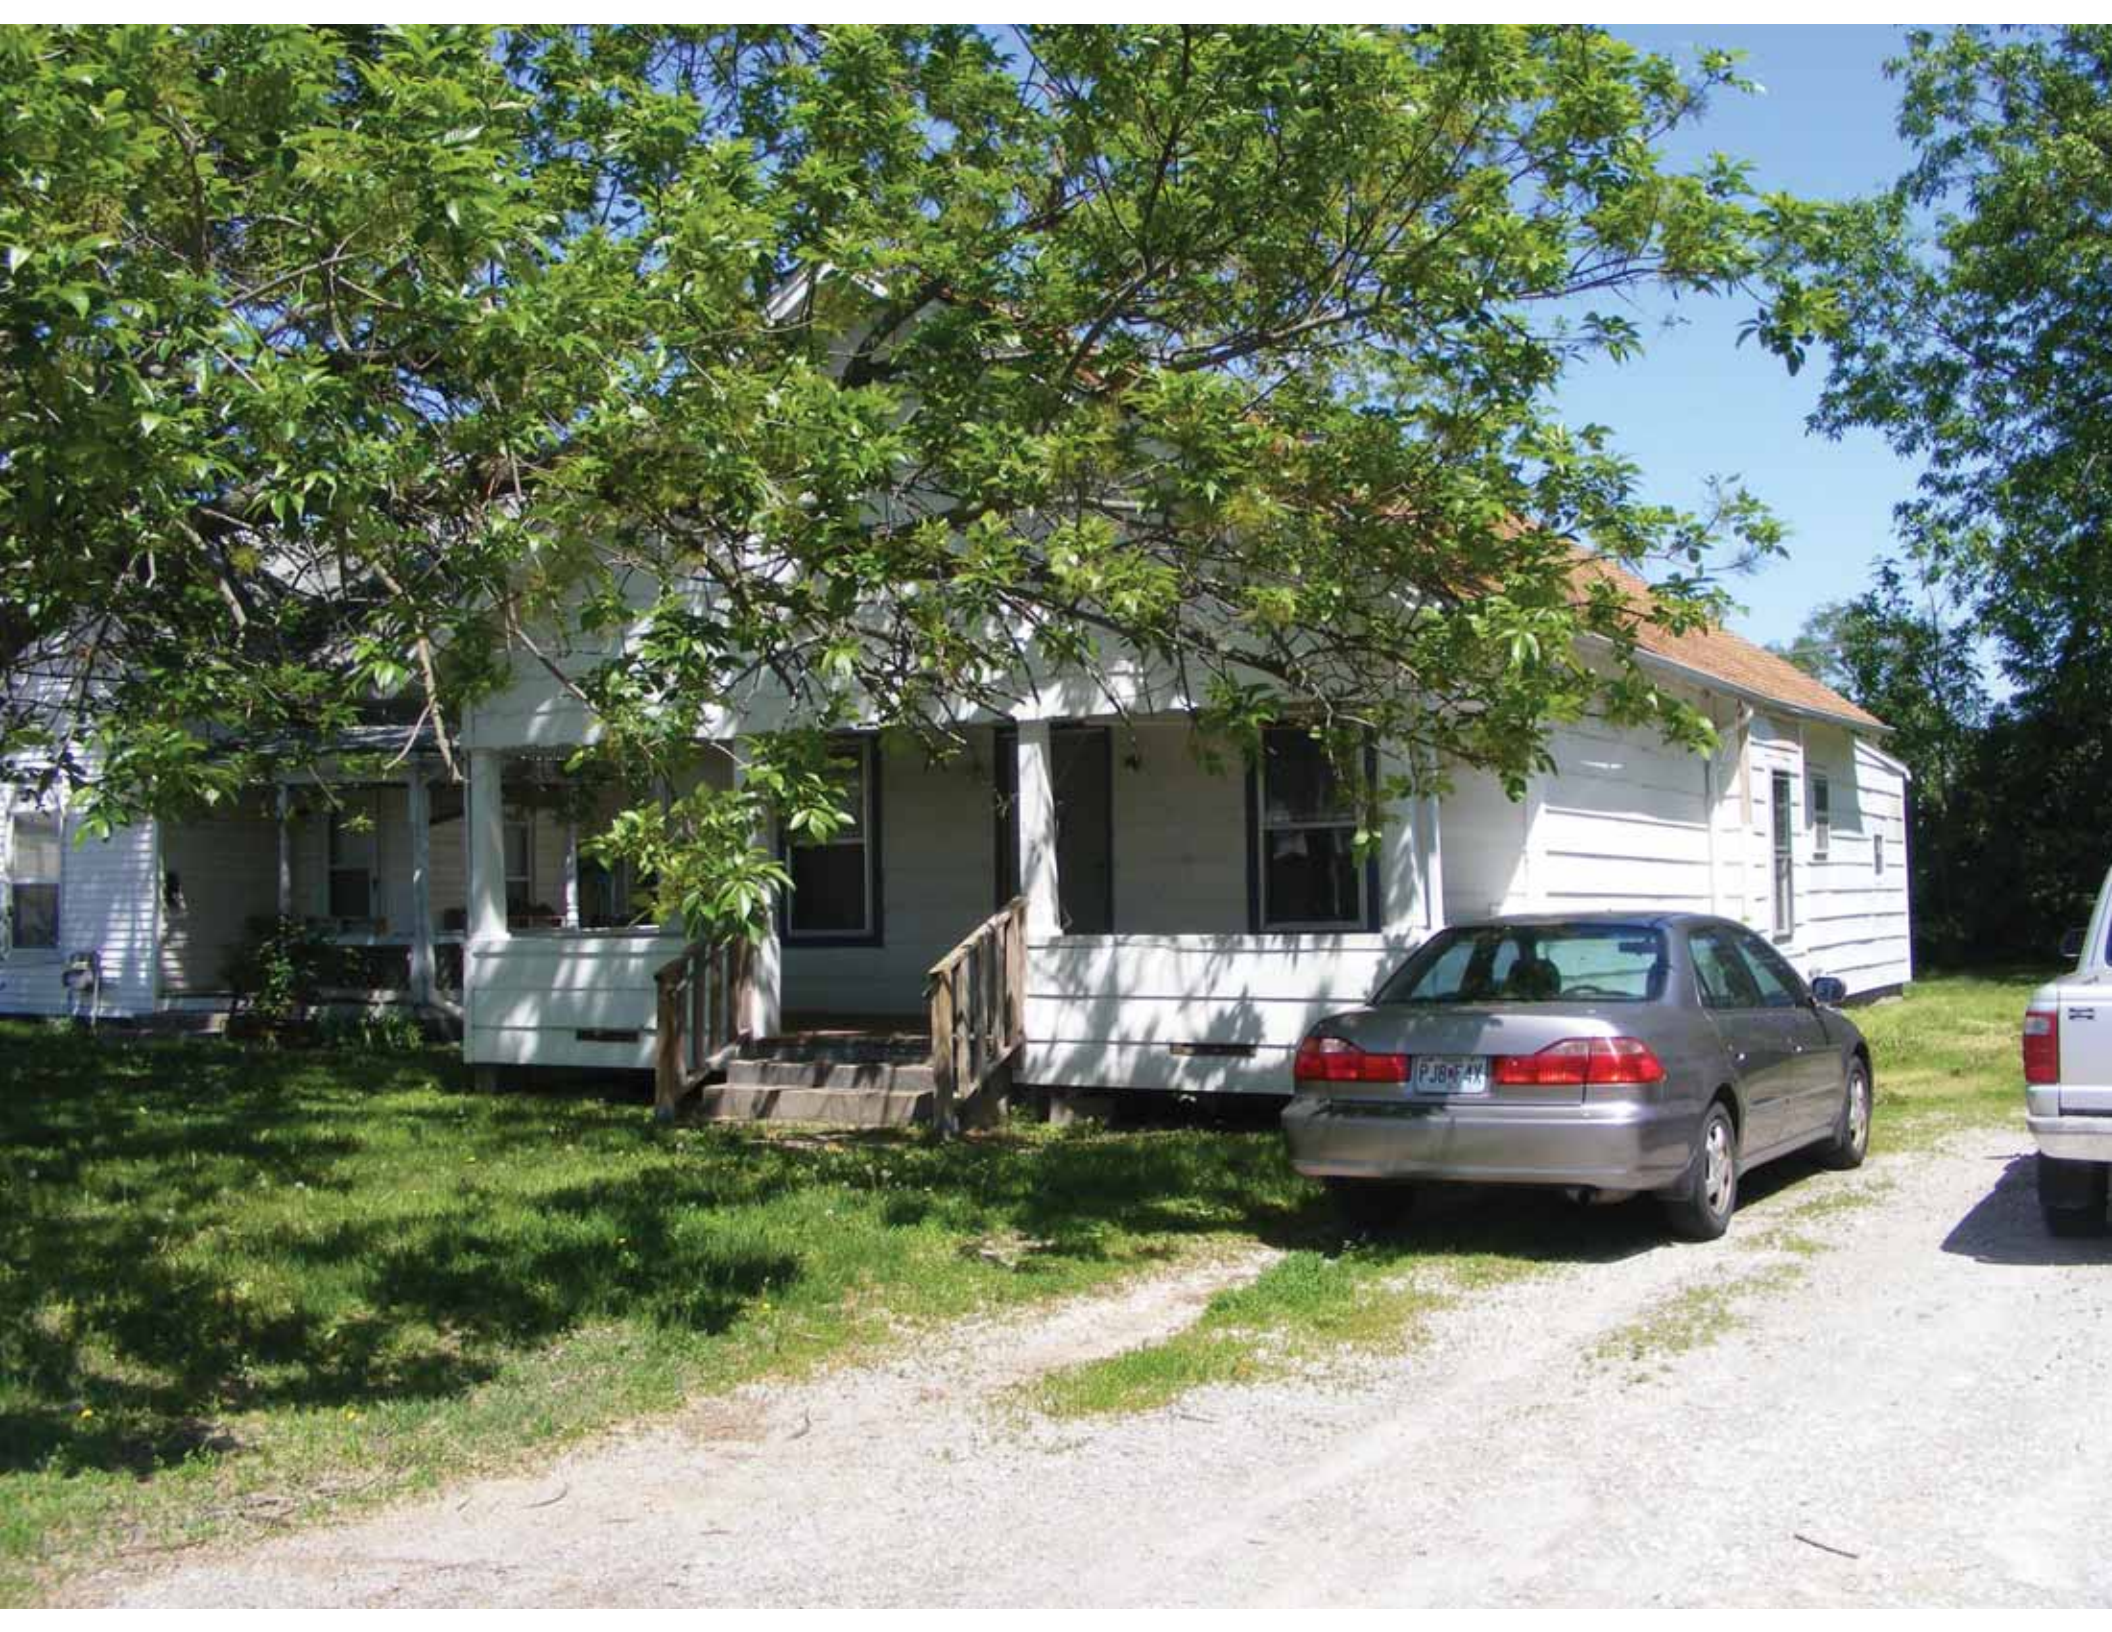
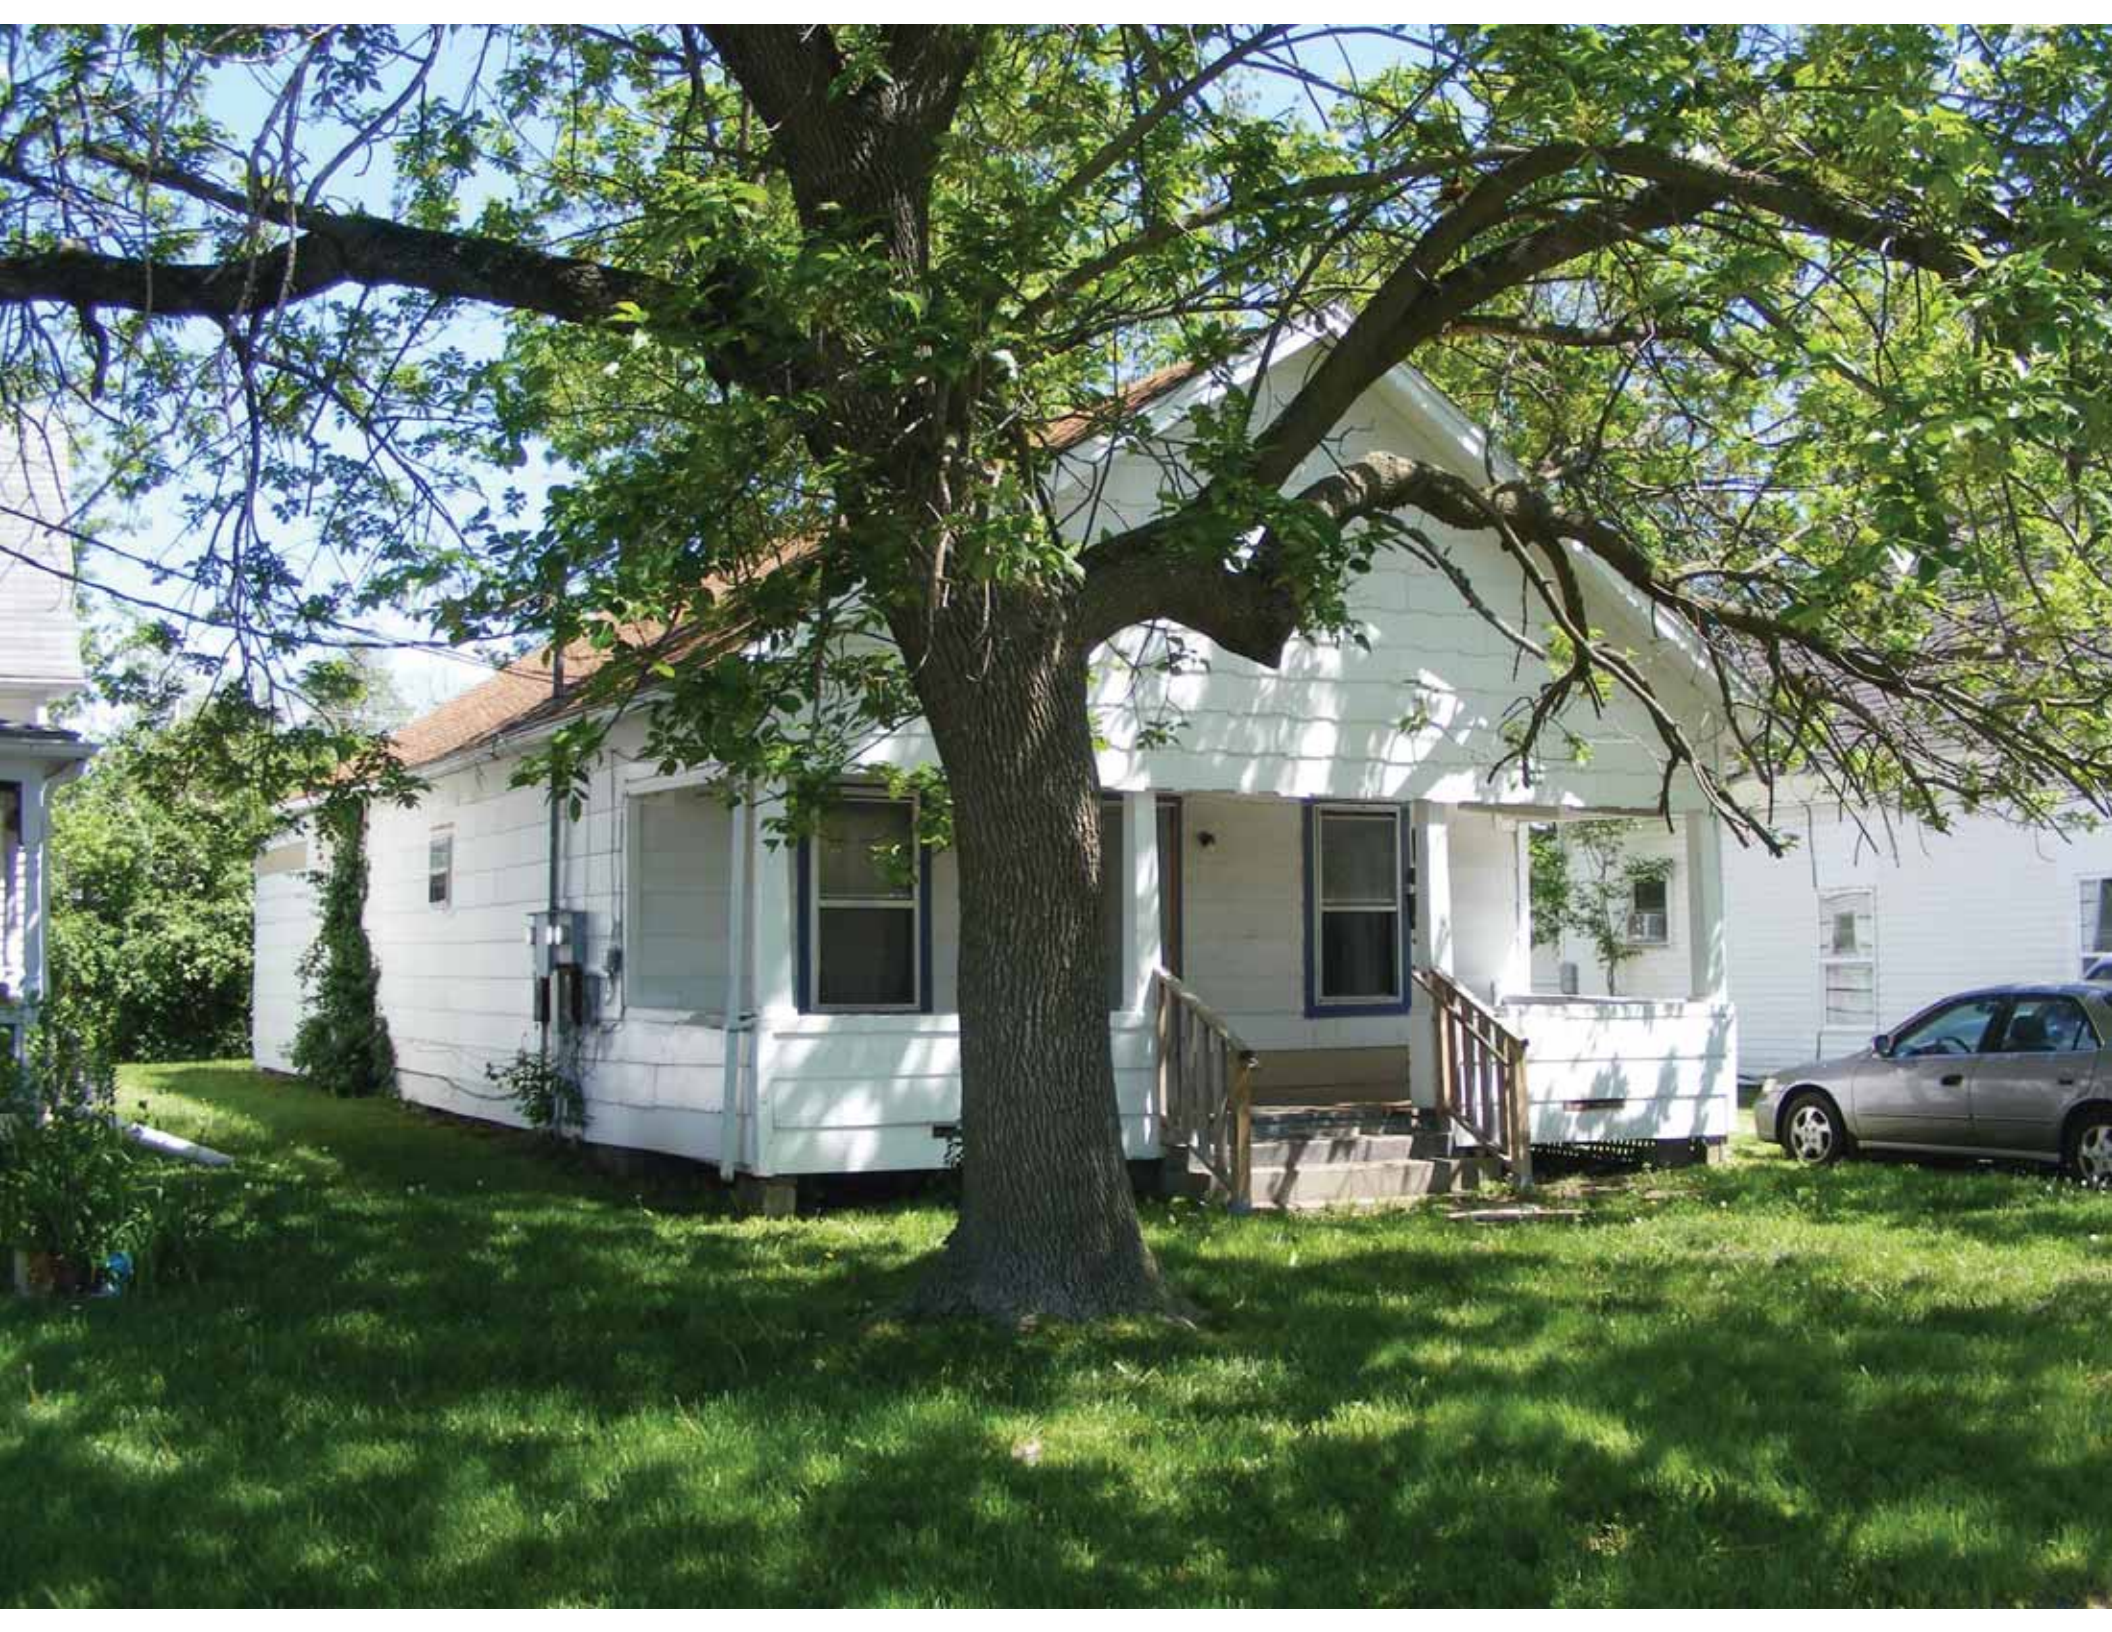
This gable-front plan dwelling has an asphalt-shingled roof and exterior pressed wood siding that appears to have been recently added (c. 2015). The front gable field has c. 2015 shaped wood shingles. The porch has an enclosed (with wide wood siding) balustrade and non-original wood handrails that flank concrete steps leading to the porch. The foundation is concrete – the central and rear portion of the foundation is poured concrete; the west end of the dwelling is supported by concrete block piers. The porch is supported by original tapered wood piers resting on the balustrade. Within the porch bay (façade) is a centered entry filled with a replacement c. 2015 paneled door. Flanking the door are individual one-over-one windows. The dwelling has a rear shed one-story wing.

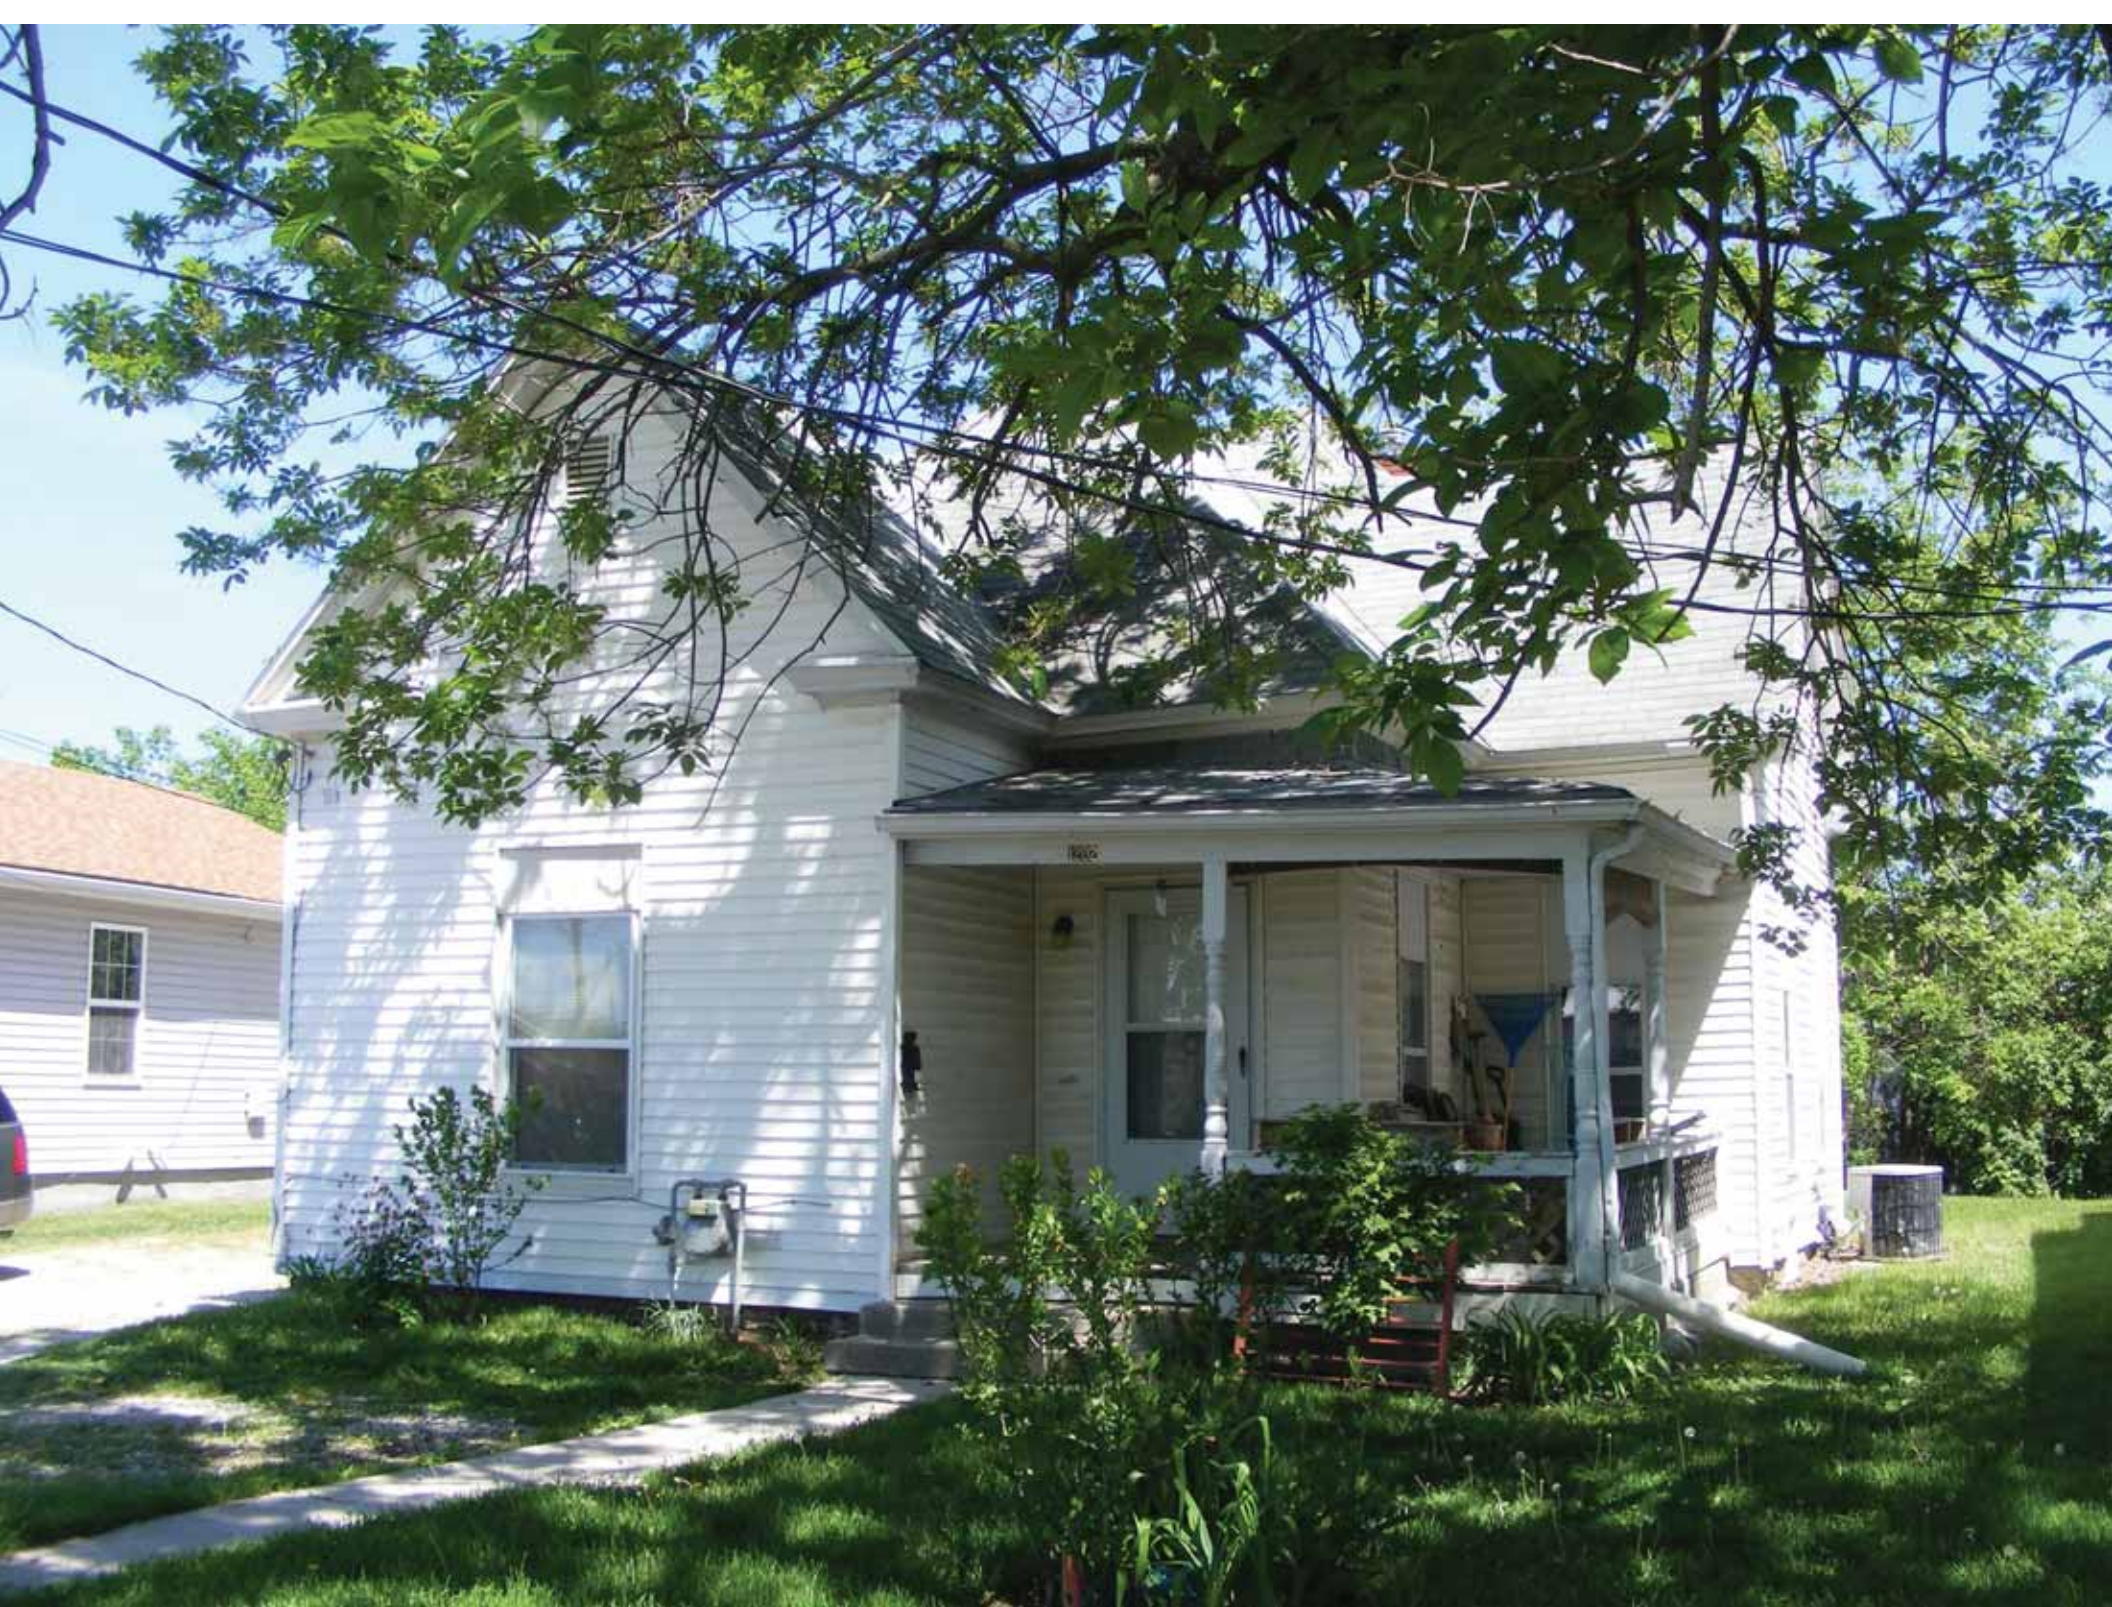
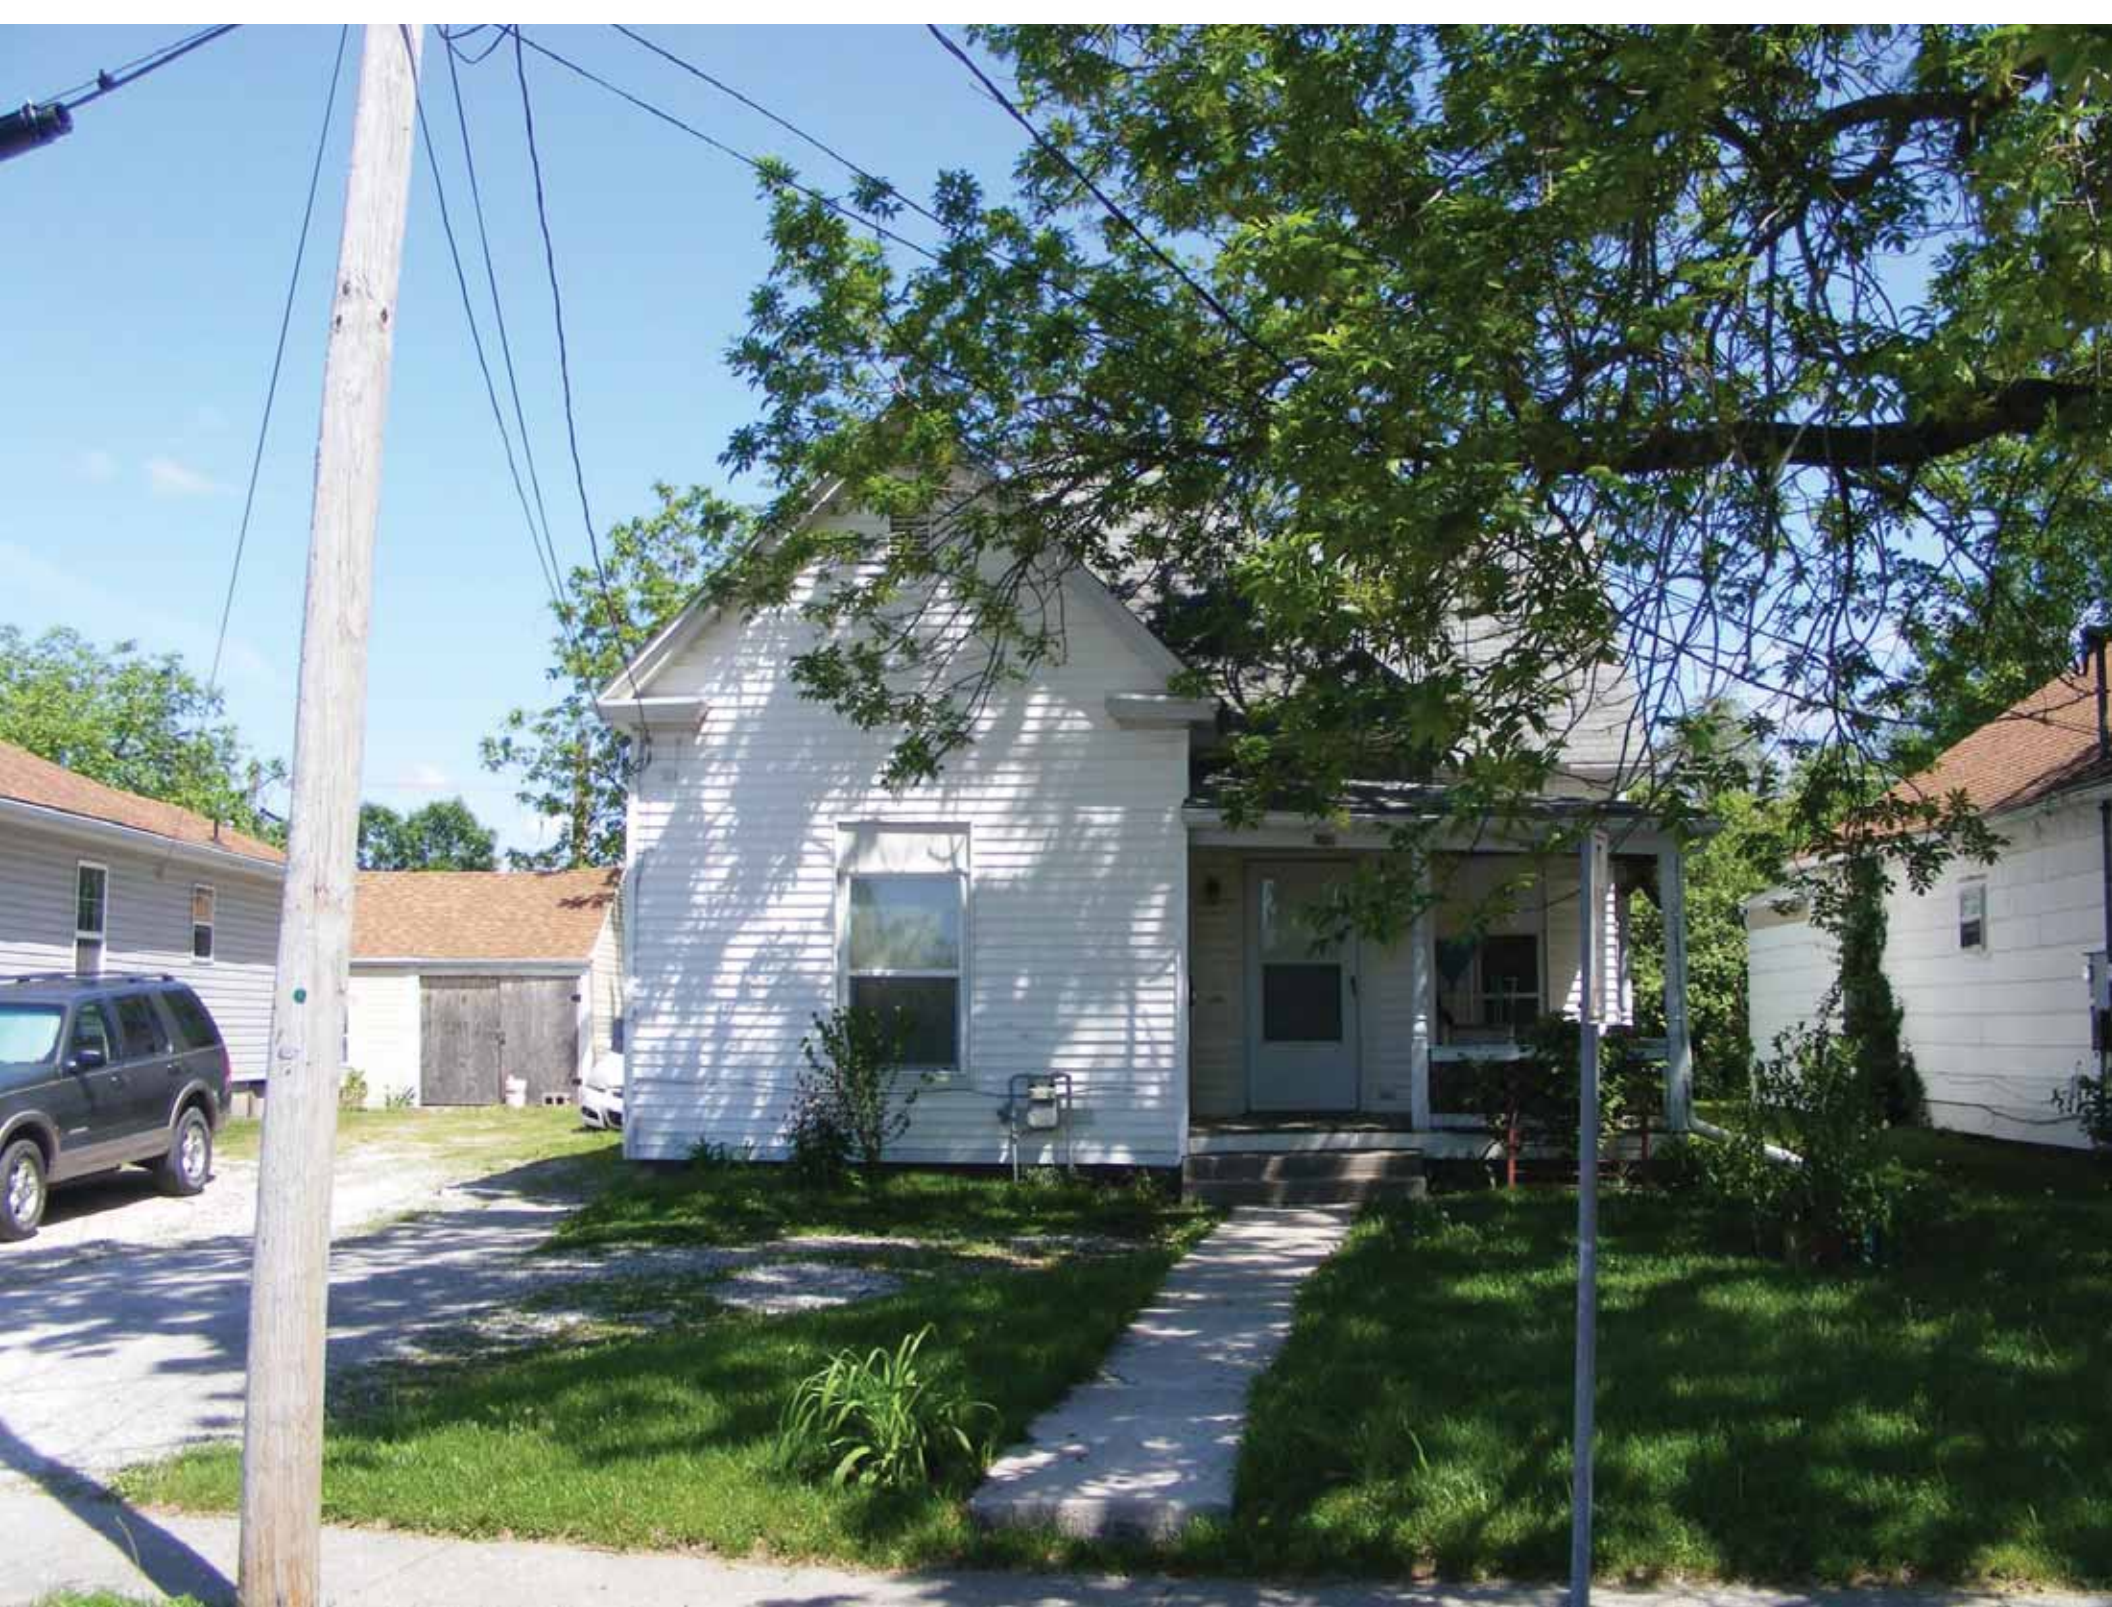
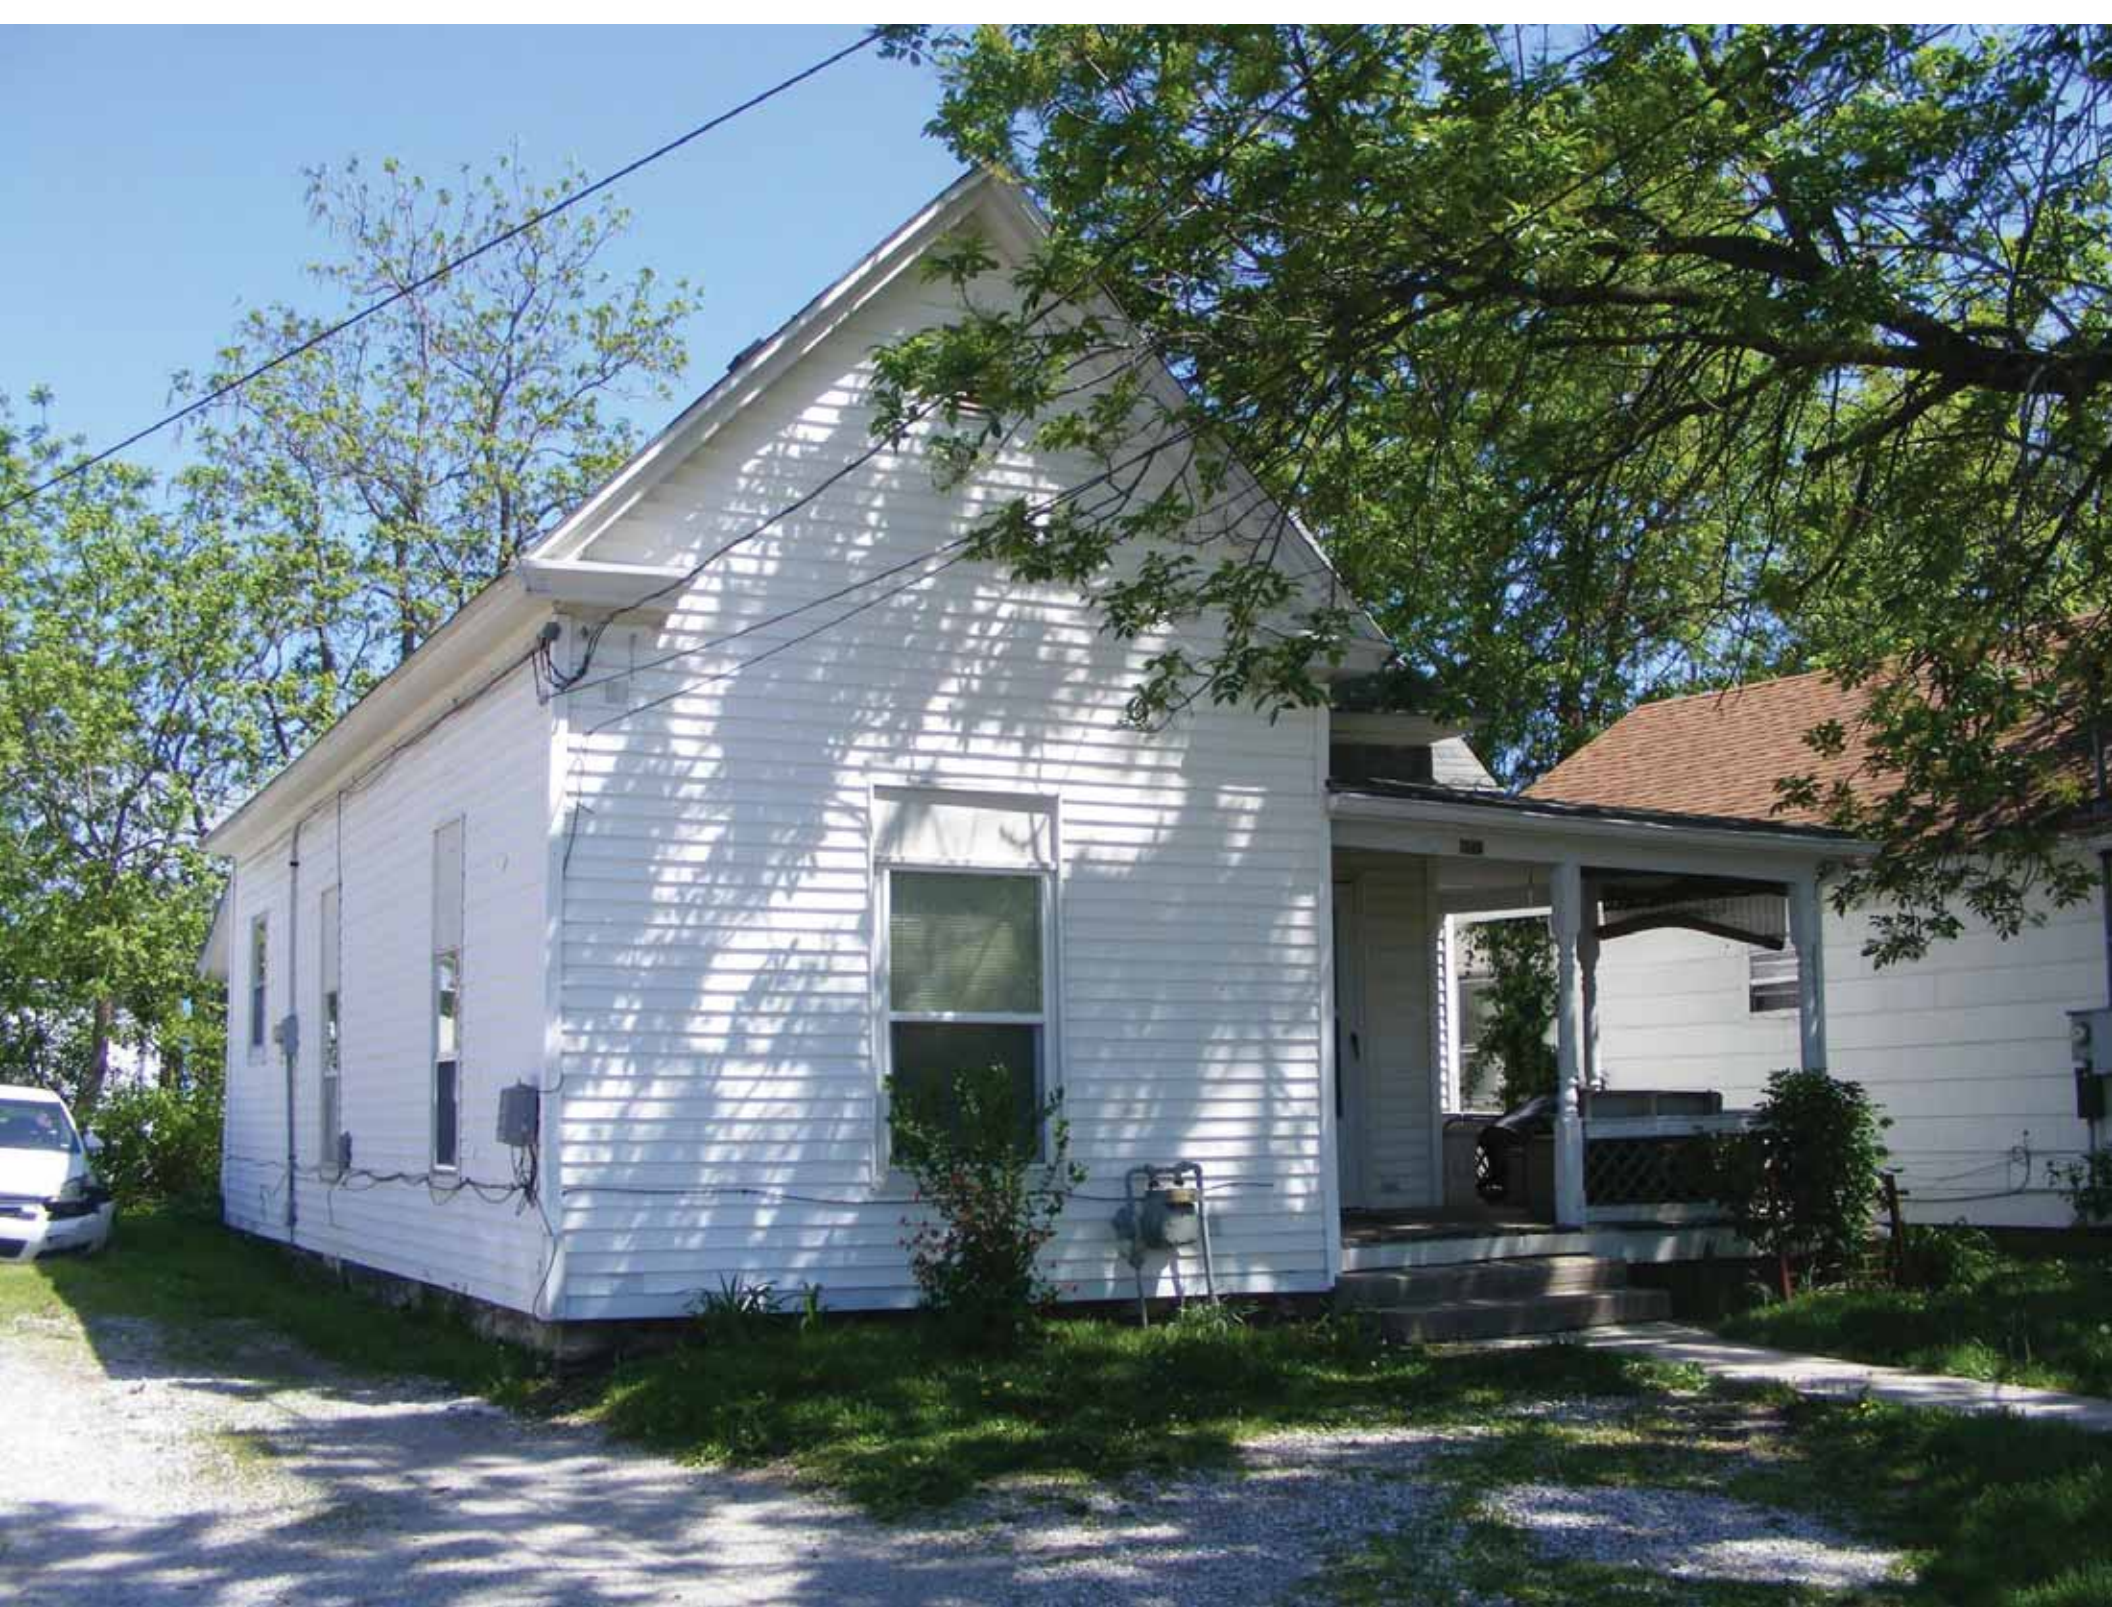
The dwelling has an asphalt-shingled gabled and hipped roof, exterior synthetic siding, gable returns and a concrete foundation. The dwelling is similar in plan to other dwellings on the block, including 1104, 1112, 1114 and 1202 N. Eighth Street. The primary elevation (west) features a north end gabled projecting wing offset by a half-width shed porch on the south. The gabled wing has a one-over-one window with enclosed upper transom. The gable field holds a louvered vent. The porch is supported by original milled columns. The balustrade is likewise original with lattice infill between the columns. The porch bay features individual doors on the primary and recessed west walls (the porch wall is angled south of the primary door). The primary entry bay holds a paneled door. The remaining entry bay accessible via the porch has an enclosed transom. A similar transom enclosure is noted on the porch's south wall, above a window. The dwelling has a rear shed single-story wing.
