MISSOURI DEPARTMENT OF NATURAL RESOURCES
STATE HISTORIC PRESERVATION OFFICE, P.O. Box 176, Jefferson City, MO 65102
ARCHITECTURAL/HISTORIC INVENTORY FORM

1. Survey No. BO-AS-011-0087		2. Survey name: North Central Columbia Survey Phase II	
3. County: Boone		4. Address (Street No.) 902	Street (name) N. Seventh Street
5. City: Columbia	Vicinity: <input type="checkbox"/>	6. Geographical Reference:	7. Township/Range/Section: T: R: S:
8. Historic name (if known):		9. Present/other name (if known):	
10. Ownership: <input checked="" type="checkbox"/> Private <input type="checkbox"/> Public		11a. Historic use (if known): Domestic/single dwelling	11b. Current use: Domestic/single dwelling

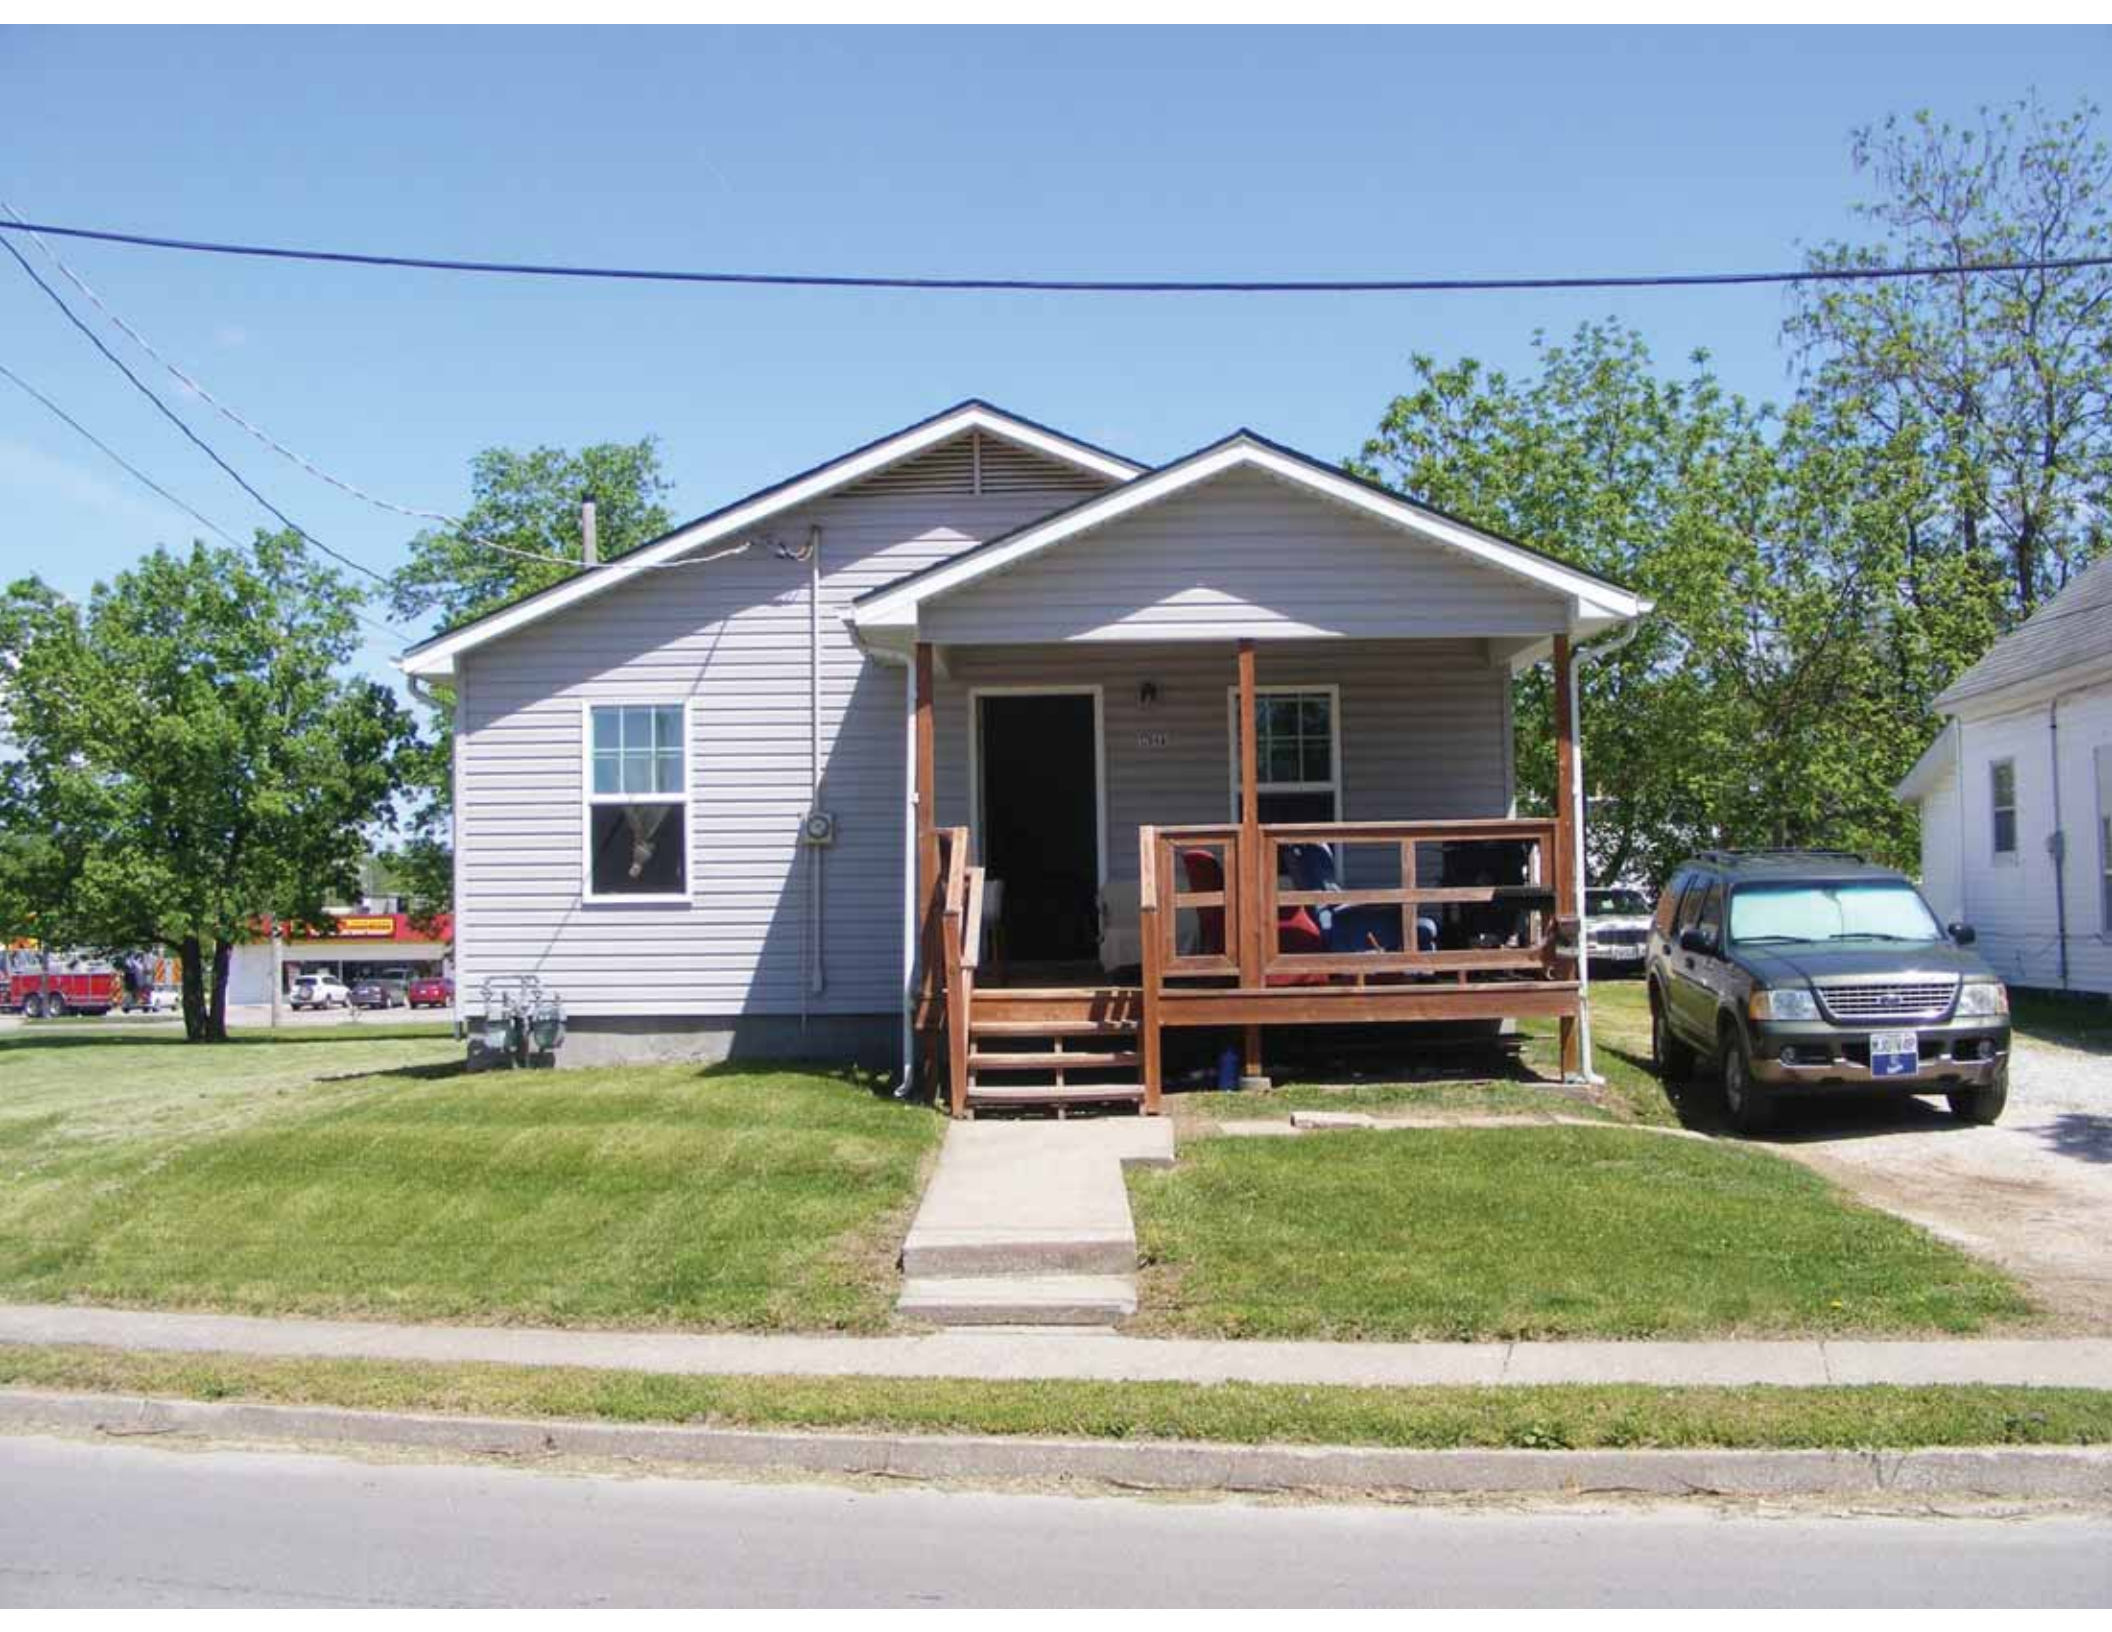
The dwelling has a gable-front plan asphalt-shingled roof, exterior synthetic siding and a concrete foundation. The primary (west) elevation has an off-center gabled porch supported by wood columns. A frame balustrade surrounds the porch. Within the porch bay, the entry is centered on the façade, flanked by six-over-six replacement windows. Remaining windows are of similar configuration. The upper gable field holds an original louvered vent.

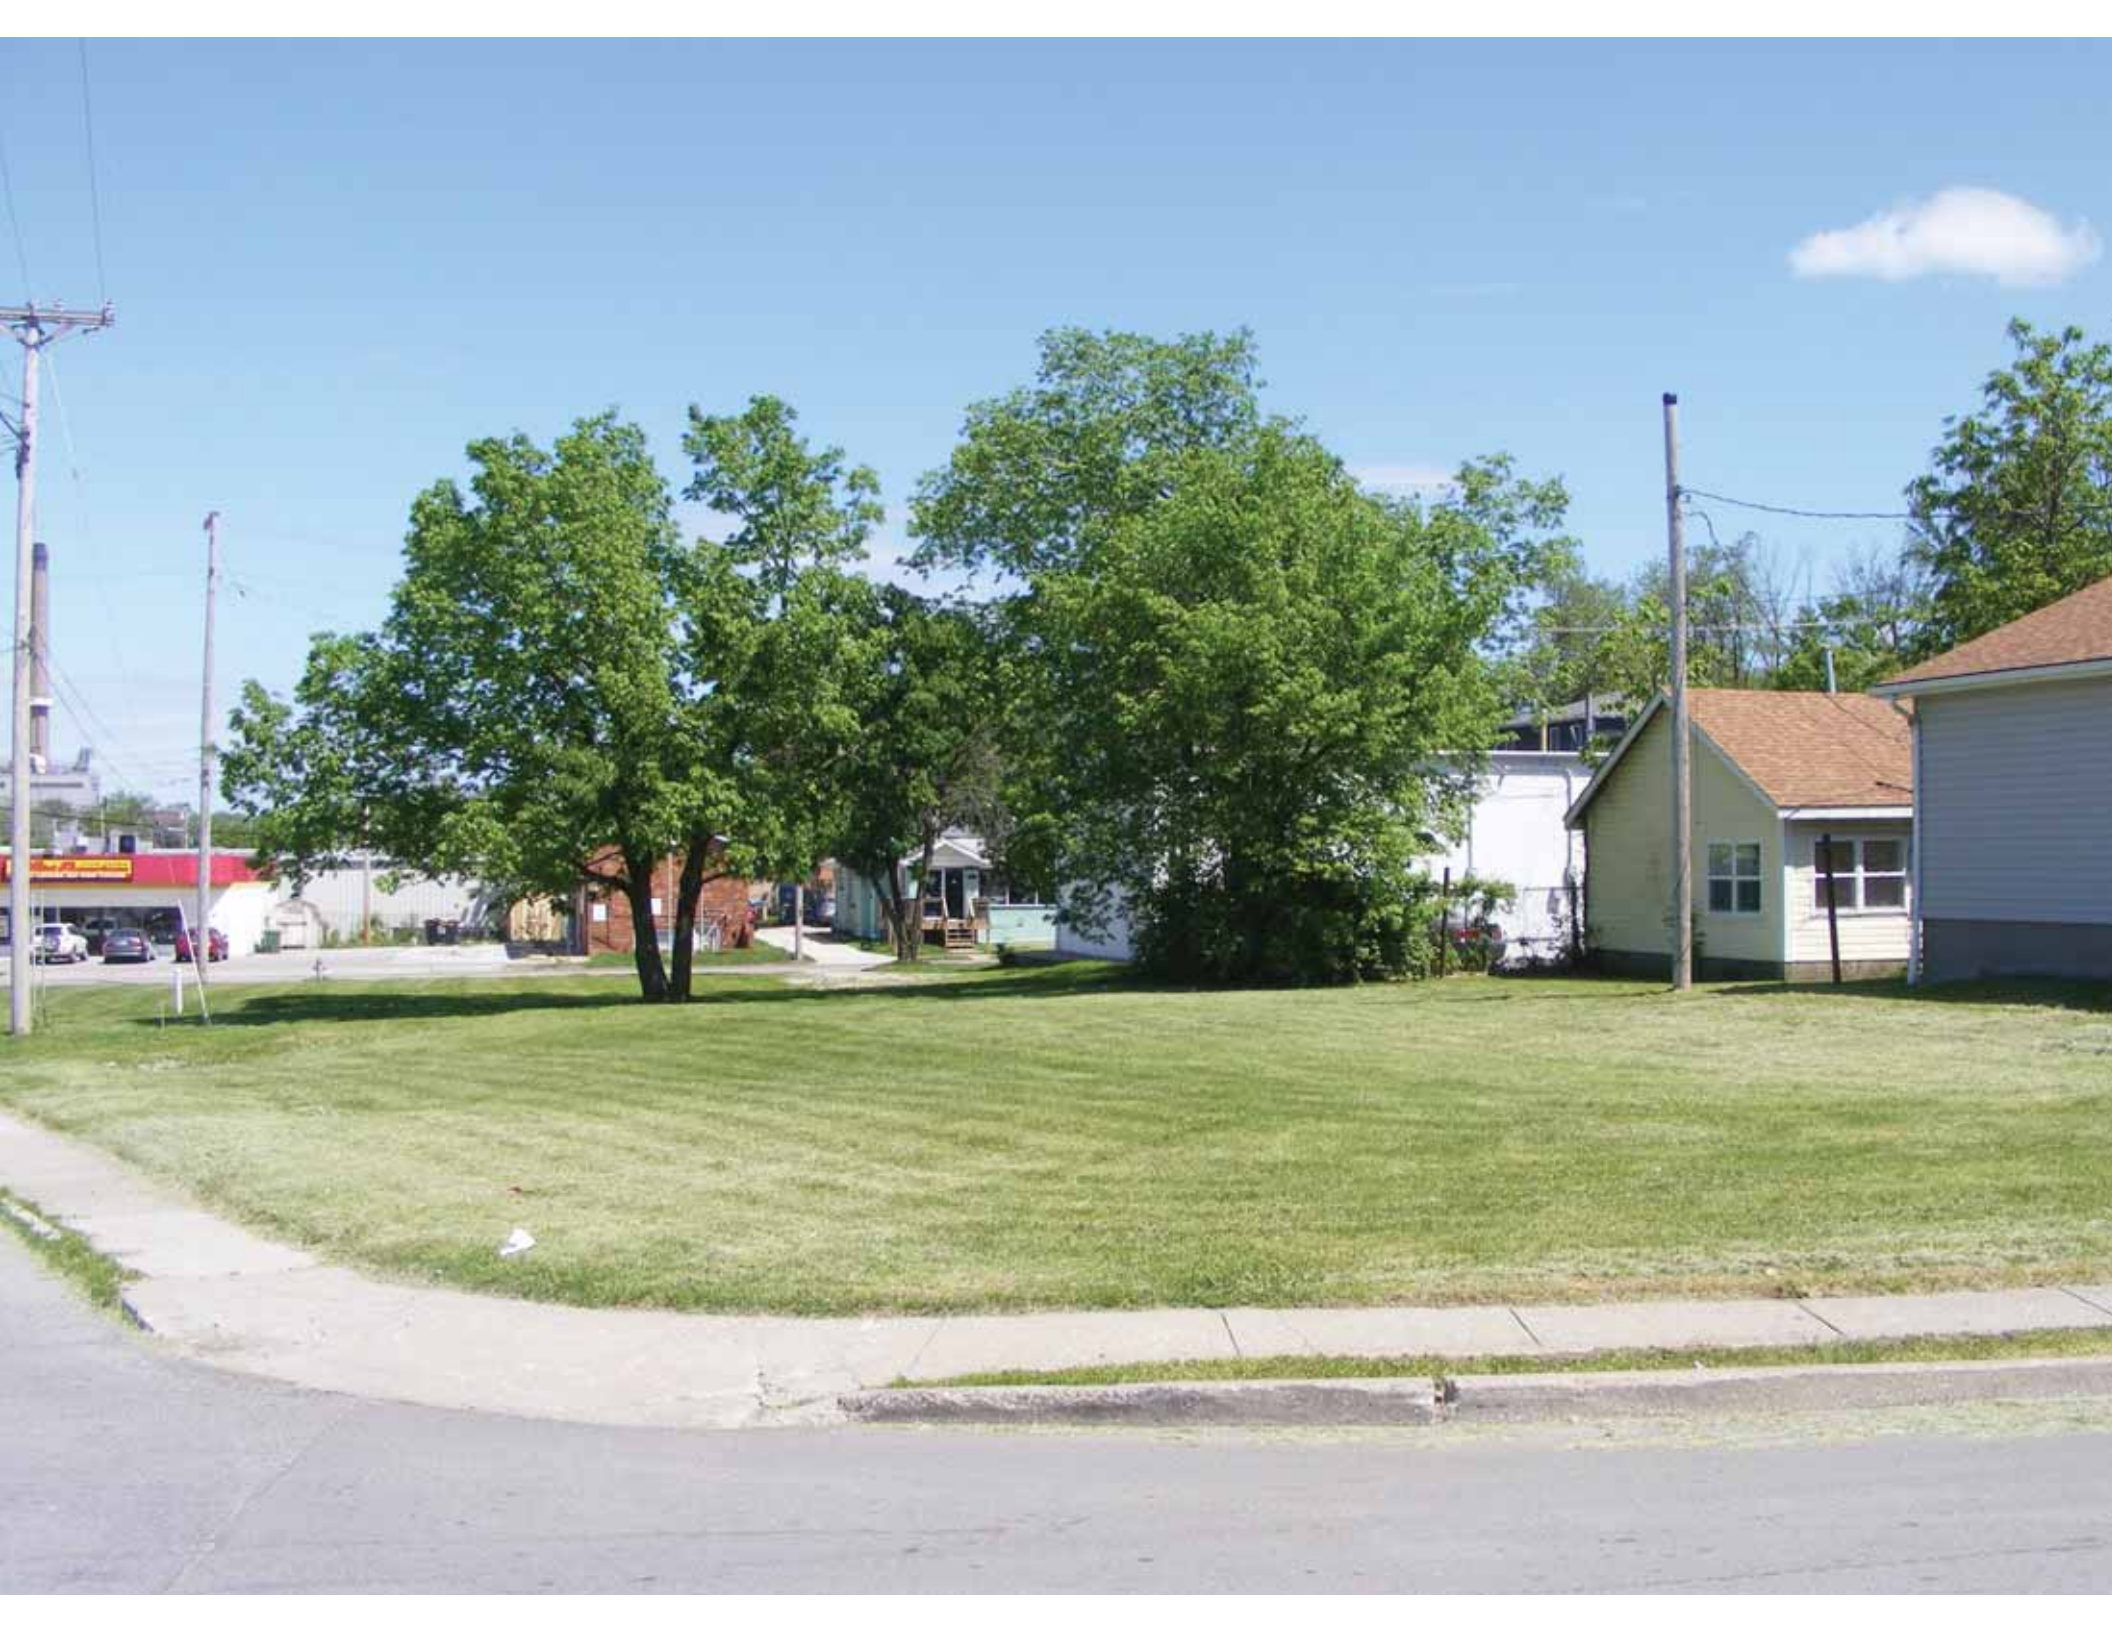
This 0.09-acre vacant lot held a single-family dwelling previously (per Sanborn Fire Insurance Maps, 1925 and 1948). The lot is as above, covered with grass and bounded by the public sidewalks at the north and west ends of the lot. There are no buildings on the lot.

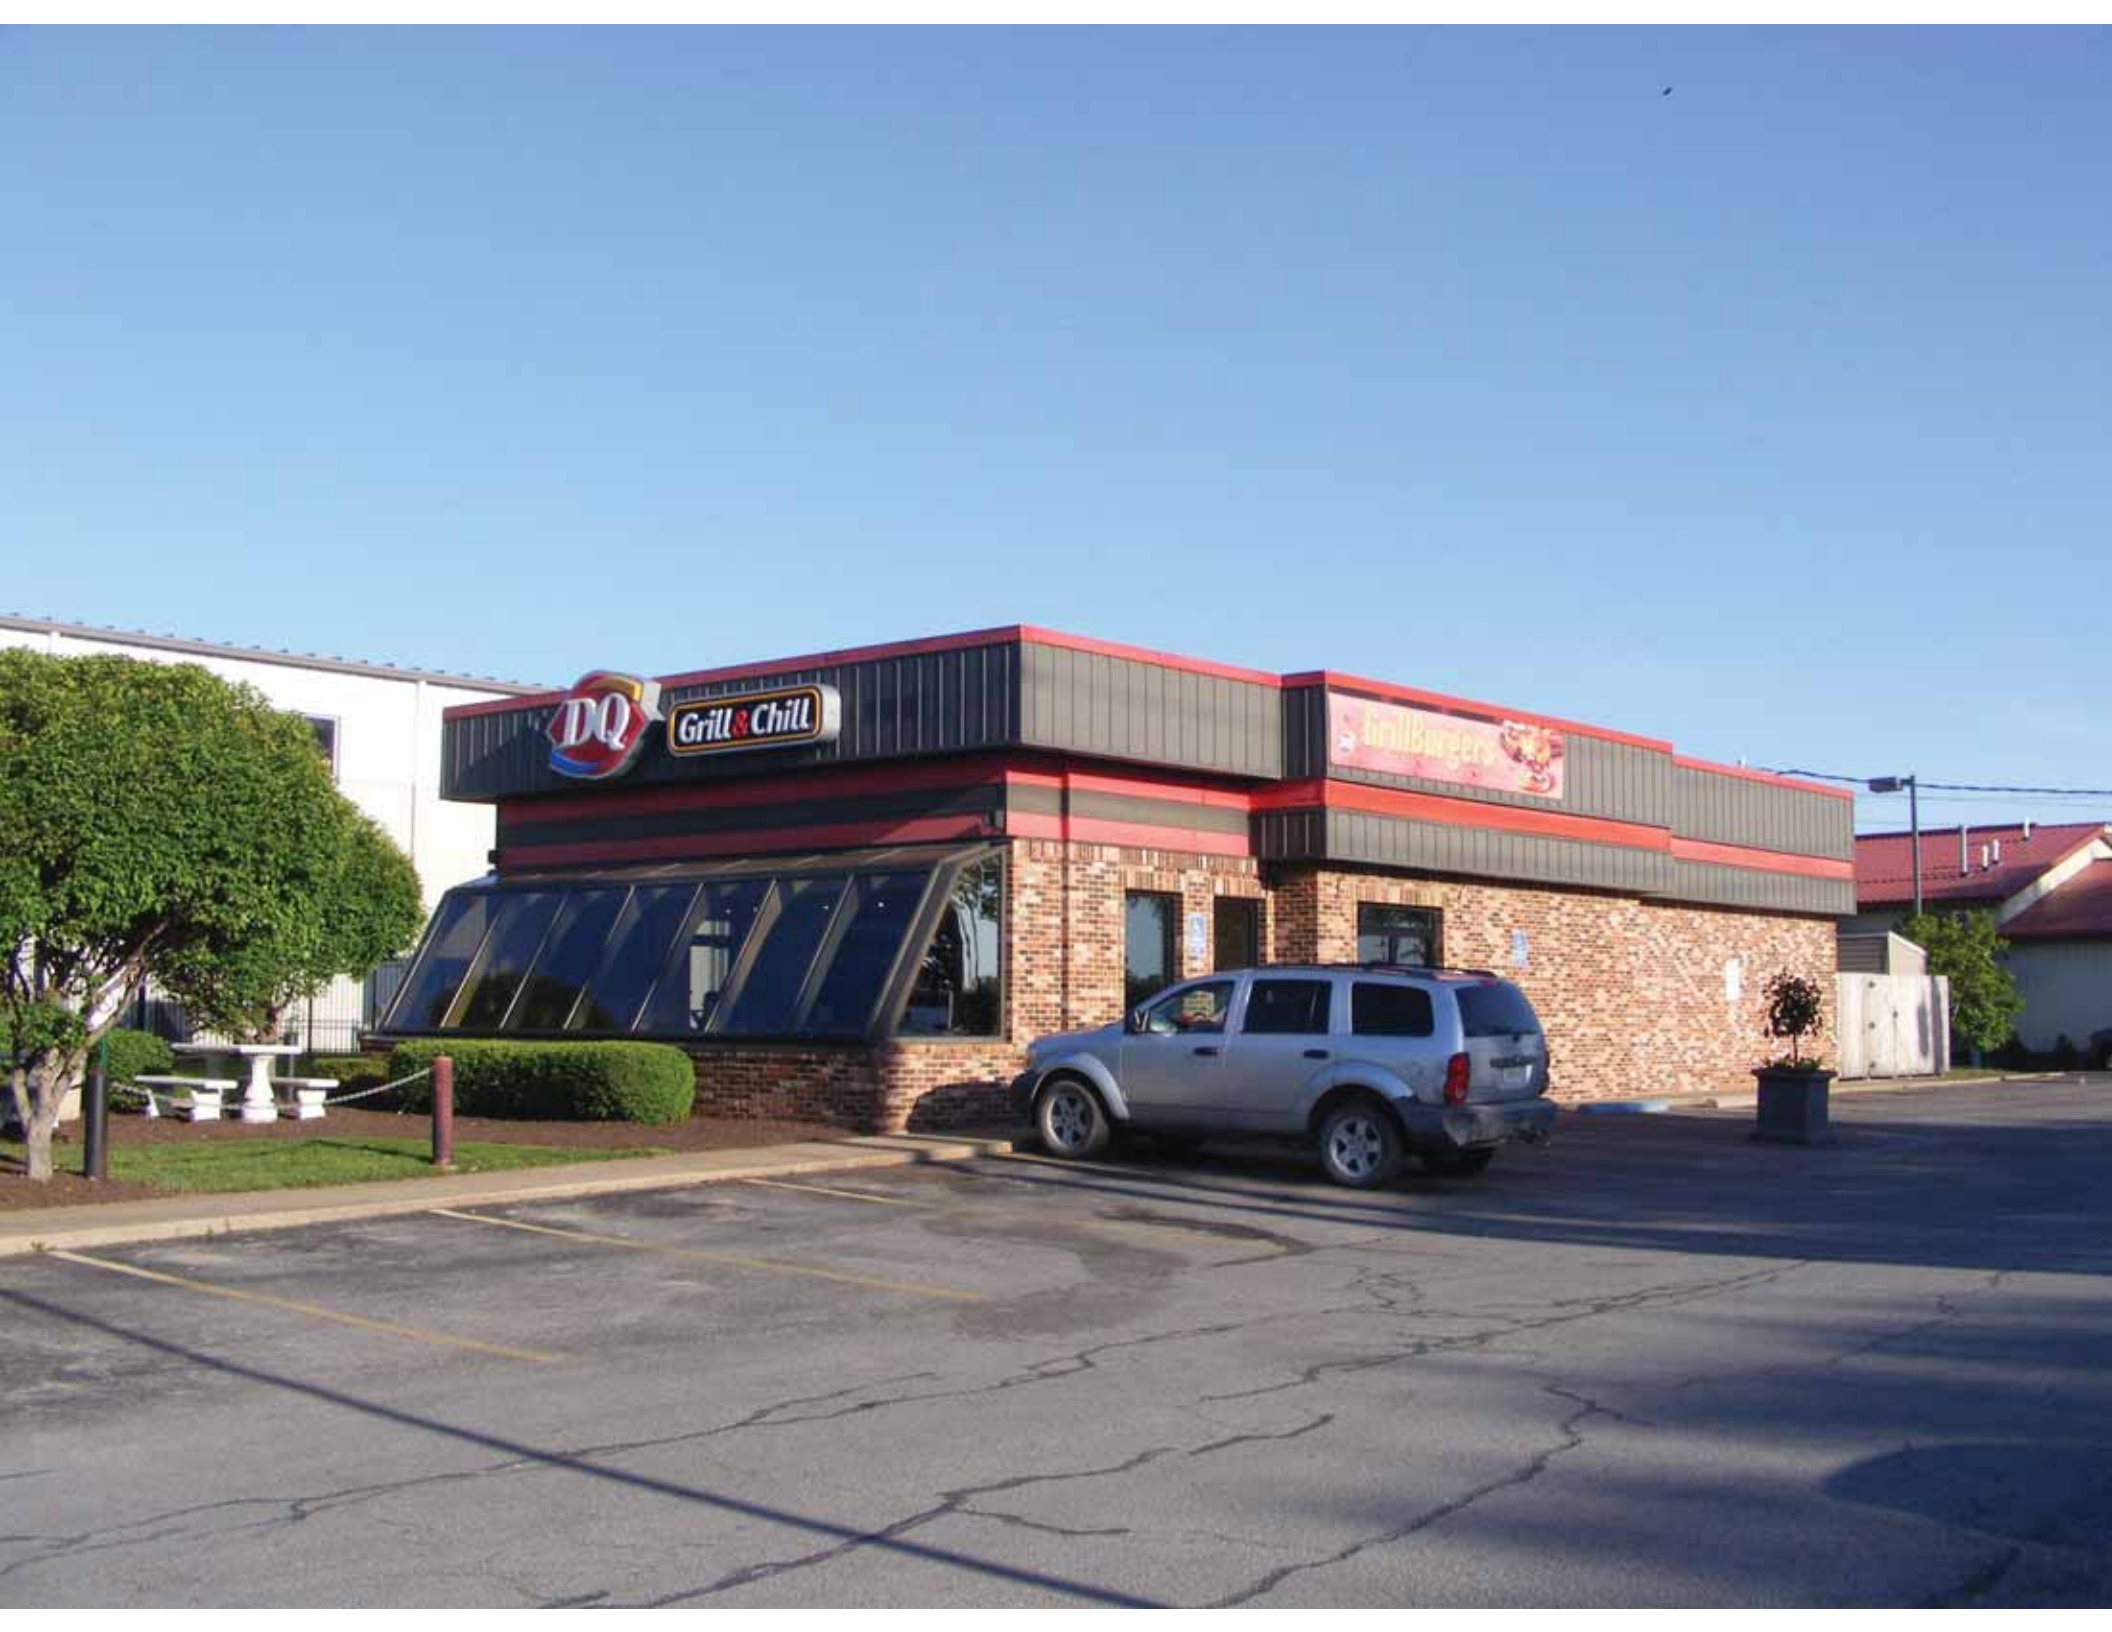
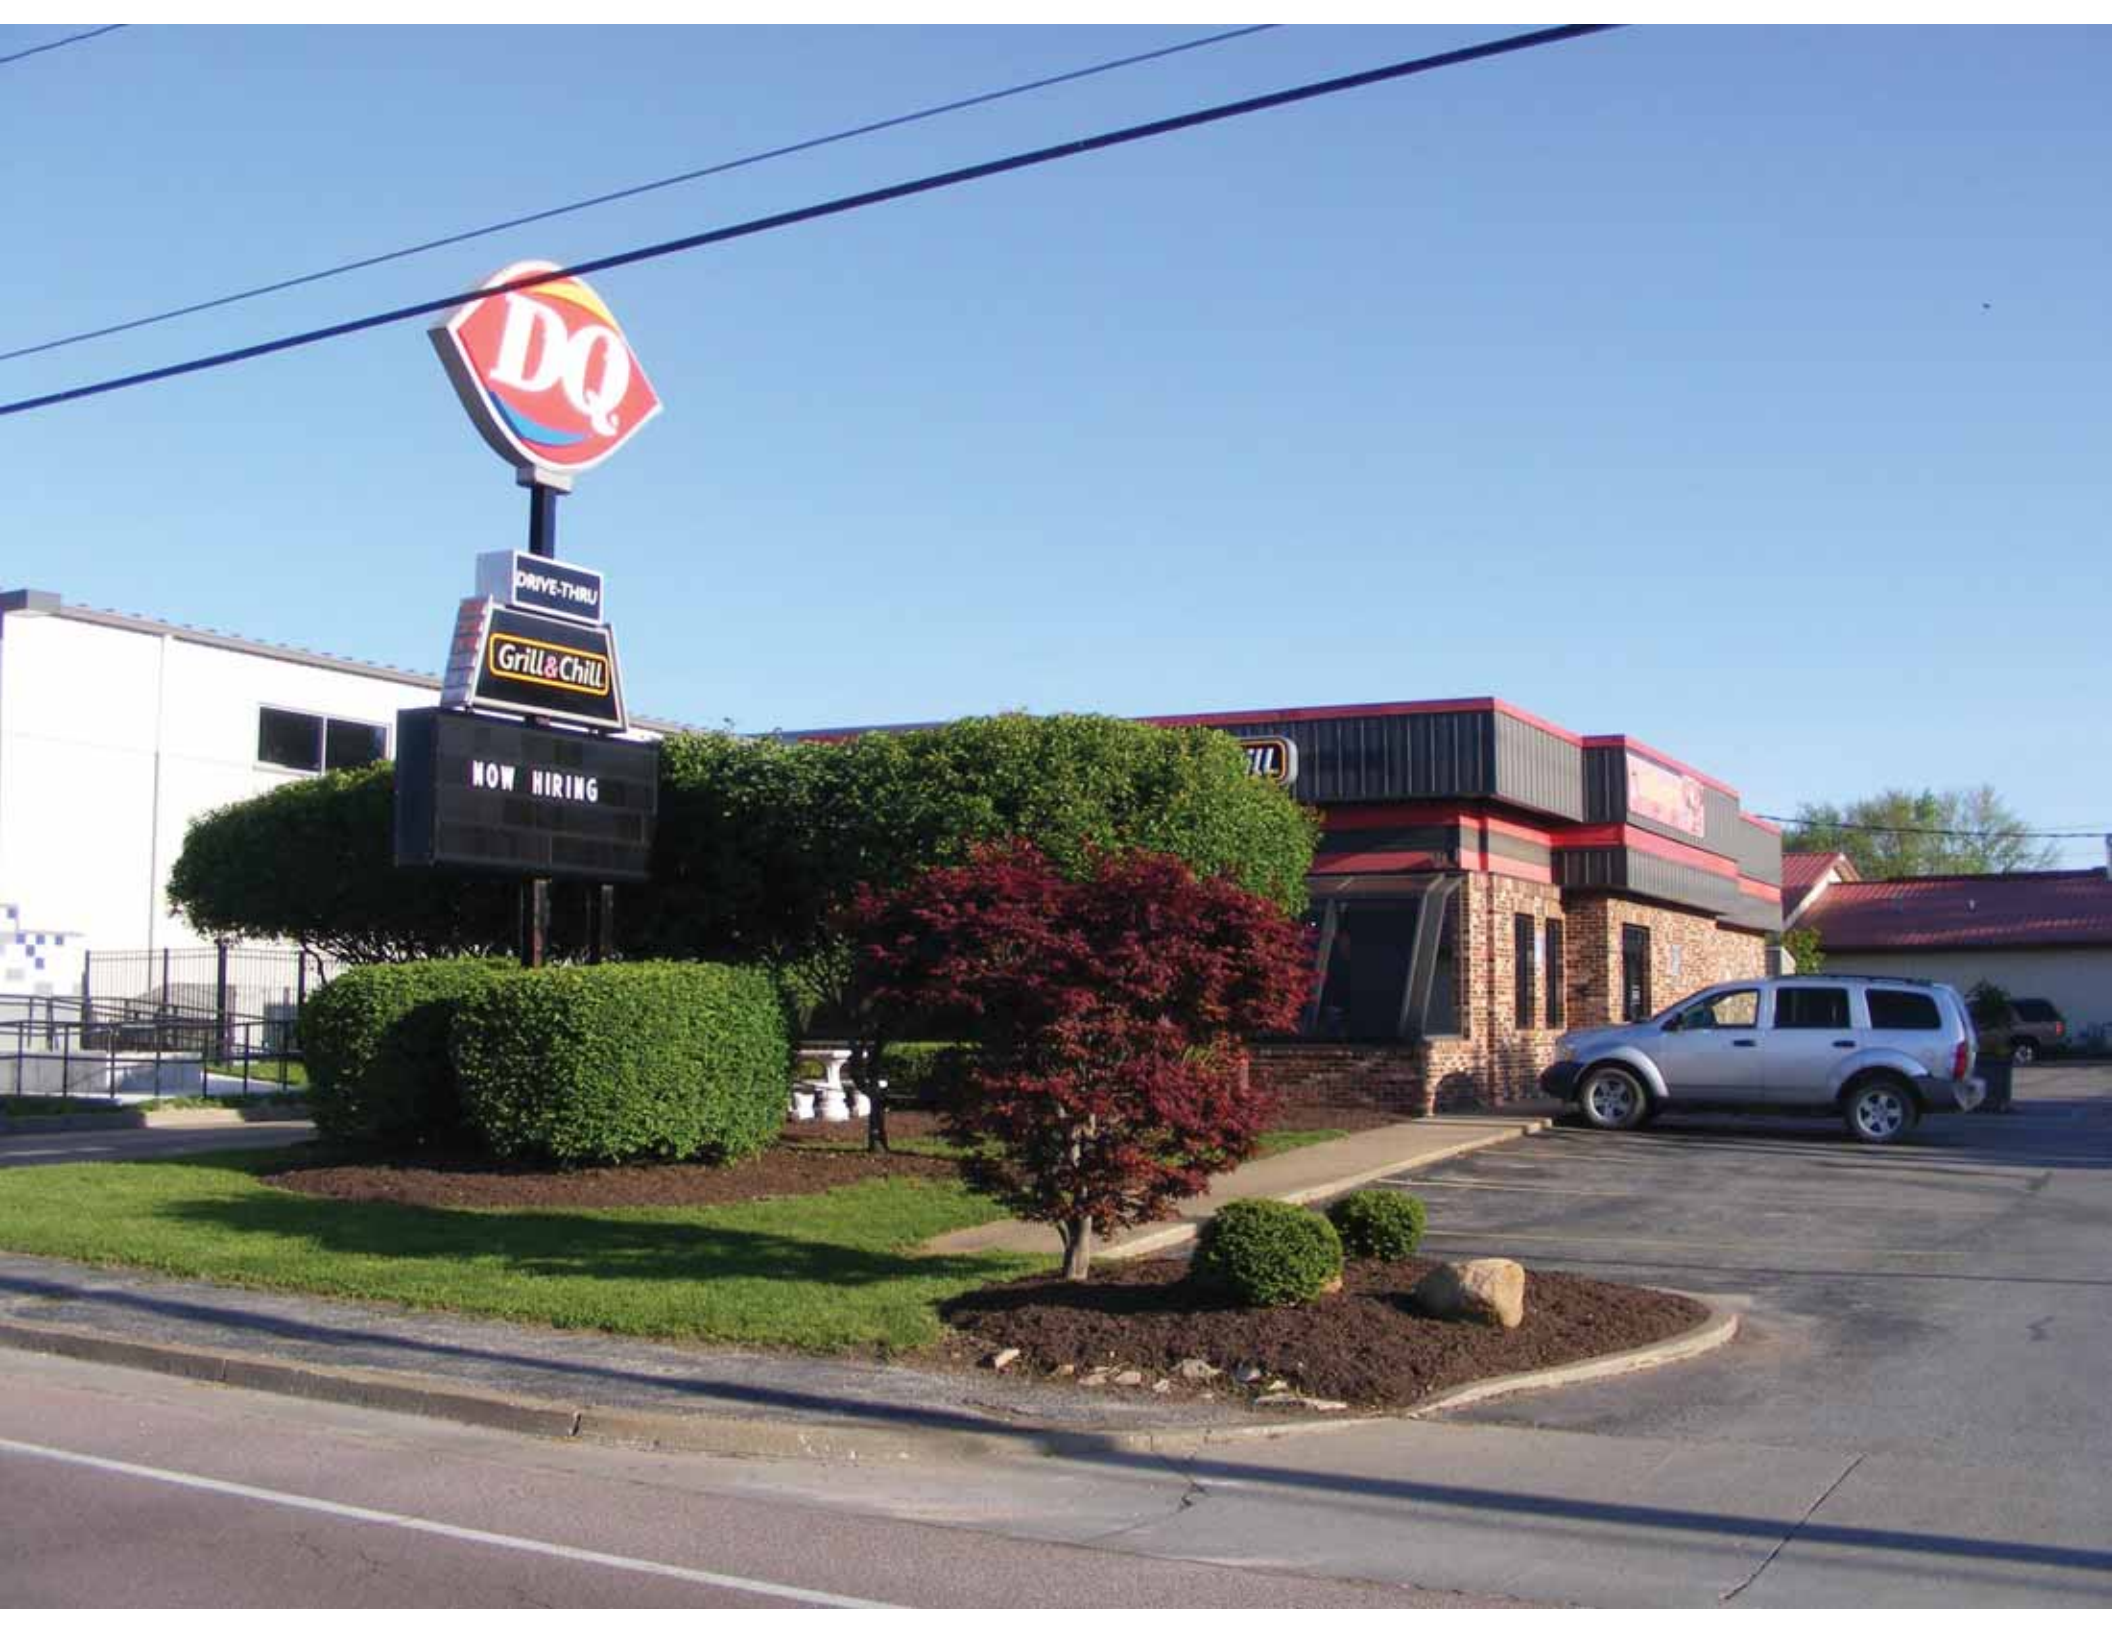
This single-story commercial building is a standard plan Dairy Queen with a built-up metal ridge roofline, exterior brick walls and a brick covered (likely concrete slab) foundation. The primary (north) elevation facing Business Loop 70 has a continuous garden-style angled window bay comprised of seven continuous fixed sash commercial lights. The primary entry is situated on the west elevation (near the façade), filled with a paired single-light metal framed commercial doors. This portion of the elevation projects slightly. The recessed area (north end, west elevation) holds two fixed single-sash commercial windows. The remaining west elevation has no additional fenestration. The rear (south) elevation has a solid pedestrian door and is partially obscured by a frame privacy fence. The east elevation has a drive-through portico with a flat roof and square brick columns. The building's east wall supports a drive-through style sliding window. The north end of the east elevation holds a single-light commercial style door offset by a single-sash commercial window.
