MISSOURI DEPARTMENT OF NATURAL RESOURCES
STATE HISTORIC PRESERVATION OFFICE, P.O. Box 176, Jefferson City, MO 65102
ARCHITECTURAL/HISTORIC INVENTORY FORM

1. Survey No. BO-AS-011-0087		2. Survey name: North Central Columbia Survey Phase II	
3. County: Boone		4. Address (Street No.) 902	Street (name) N. Seventh Street
5. City: Columbia	Vicinity: <input type="checkbox"/>	6. Geographical Reference:	7. Township/Range/Section: T: R: S:
8. Historic name (if known):		9. Present/other name (if known):	
10. Ownership: <input checked="" type="checkbox"/> Private <input type="checkbox"/> Public		11a. Historic use (if known): Domestic/single dwelling	11b. Current use: Domestic/single dwelling

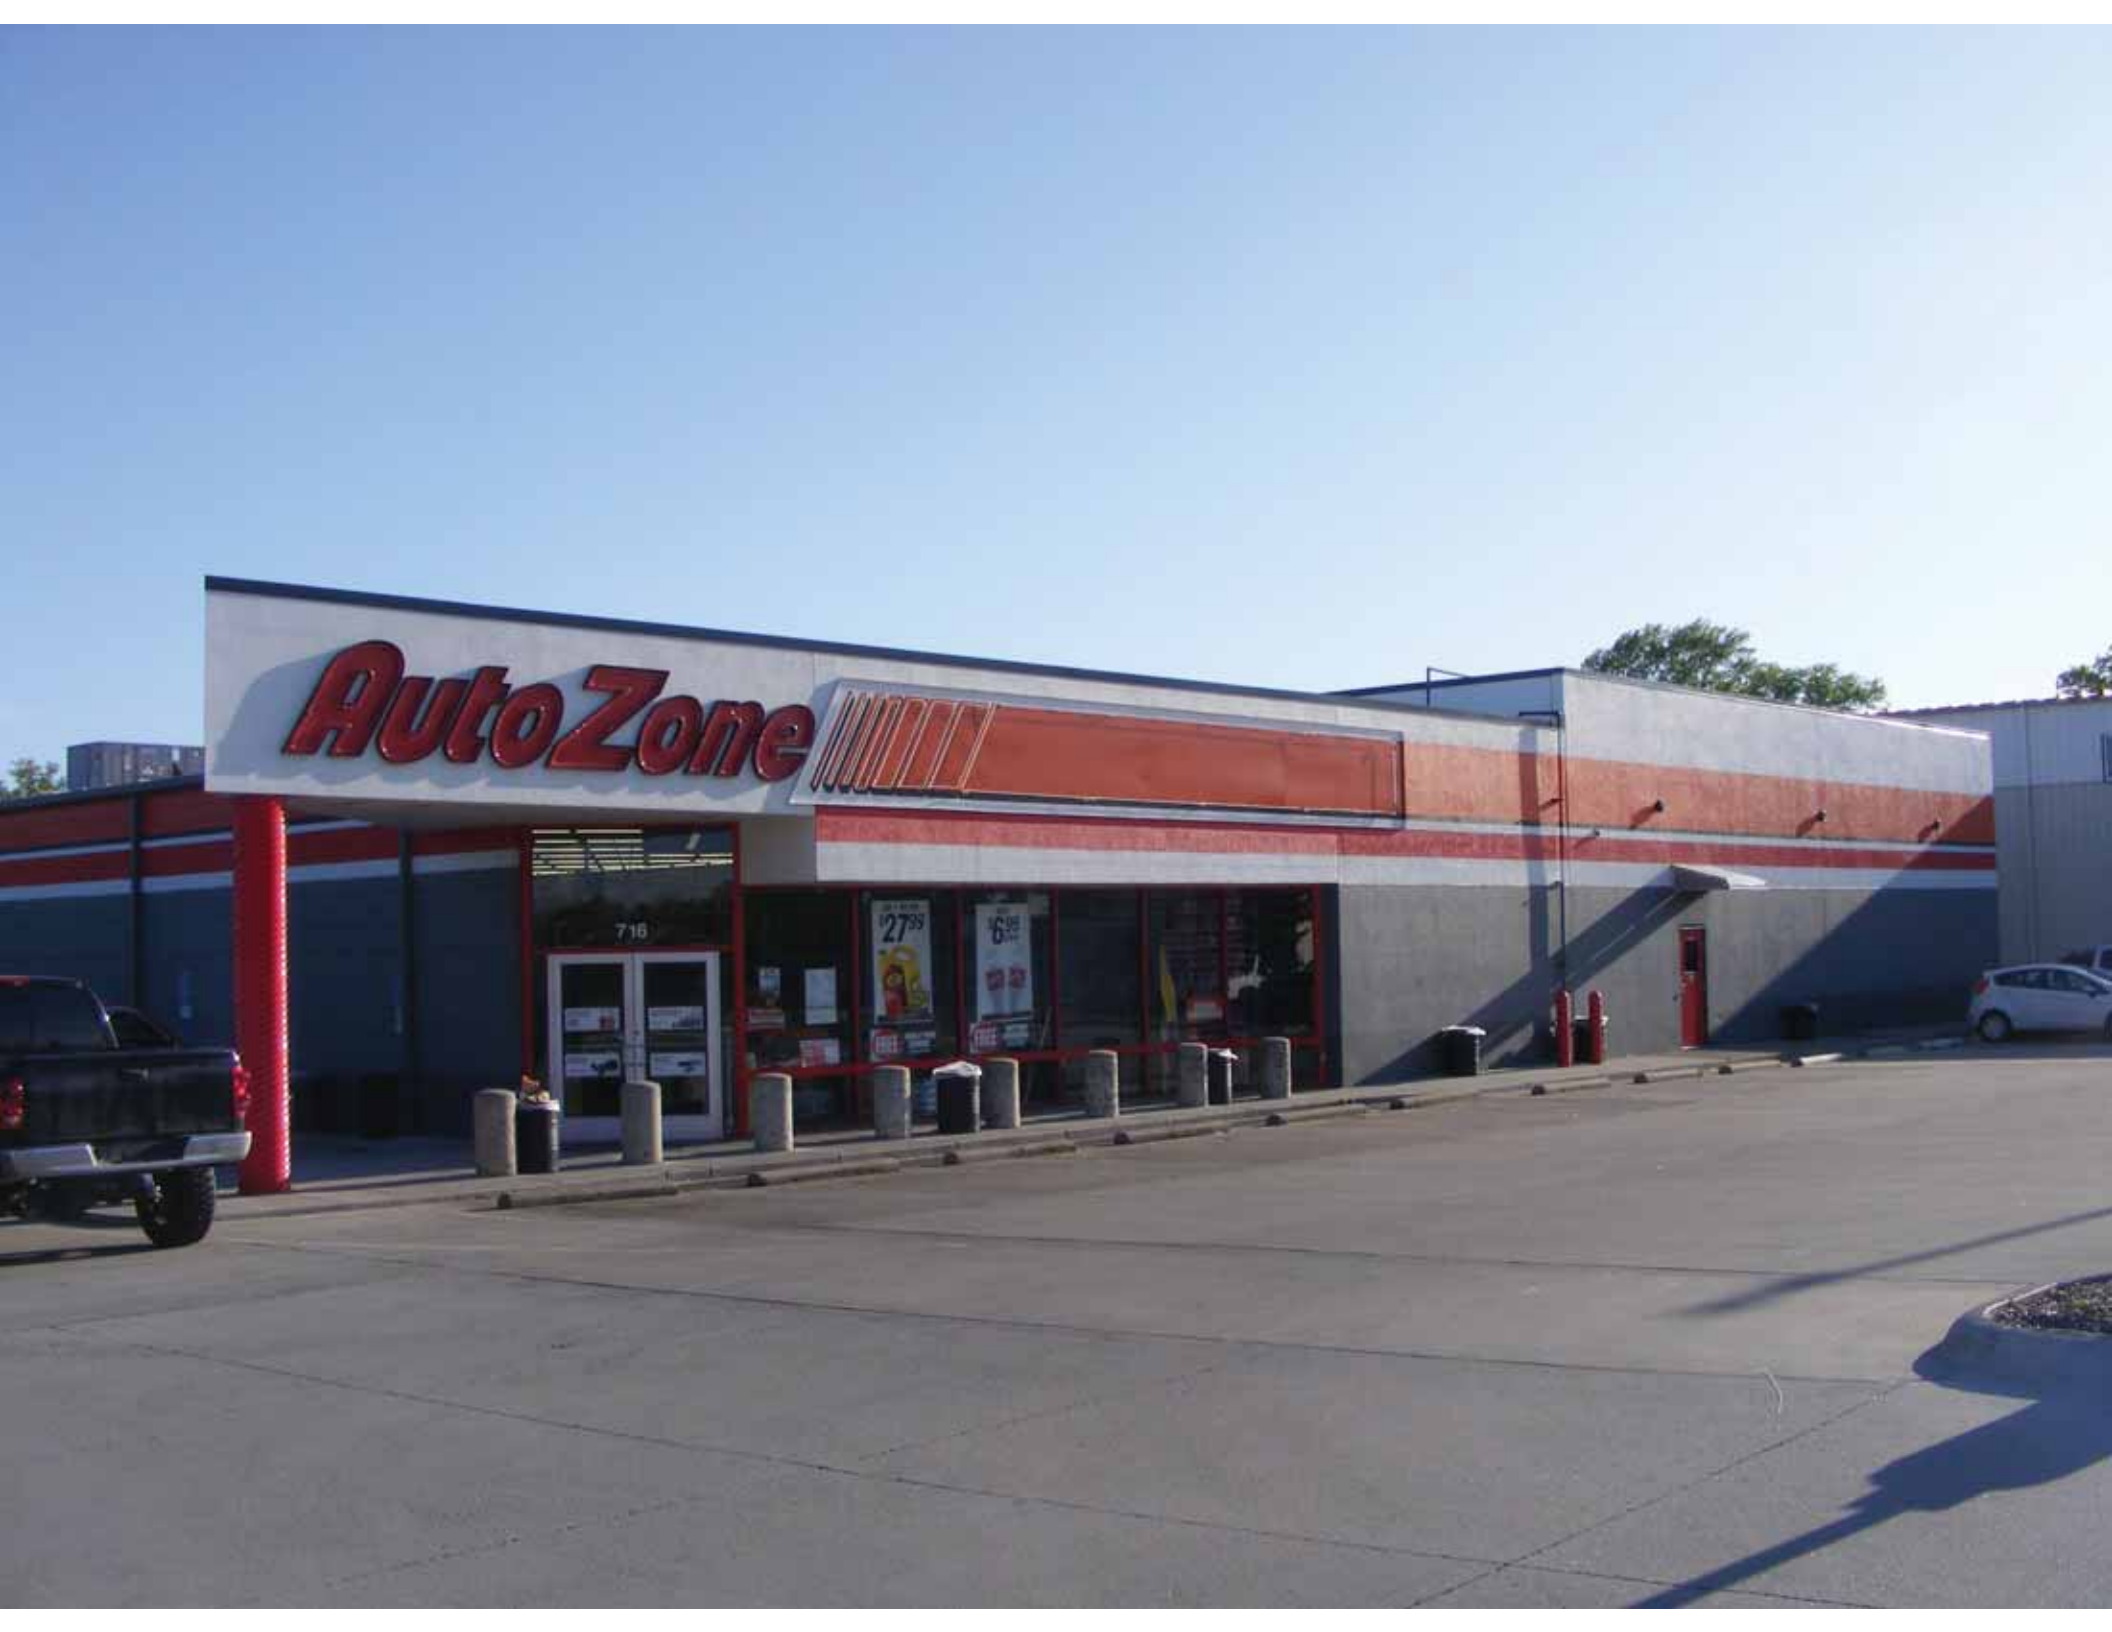
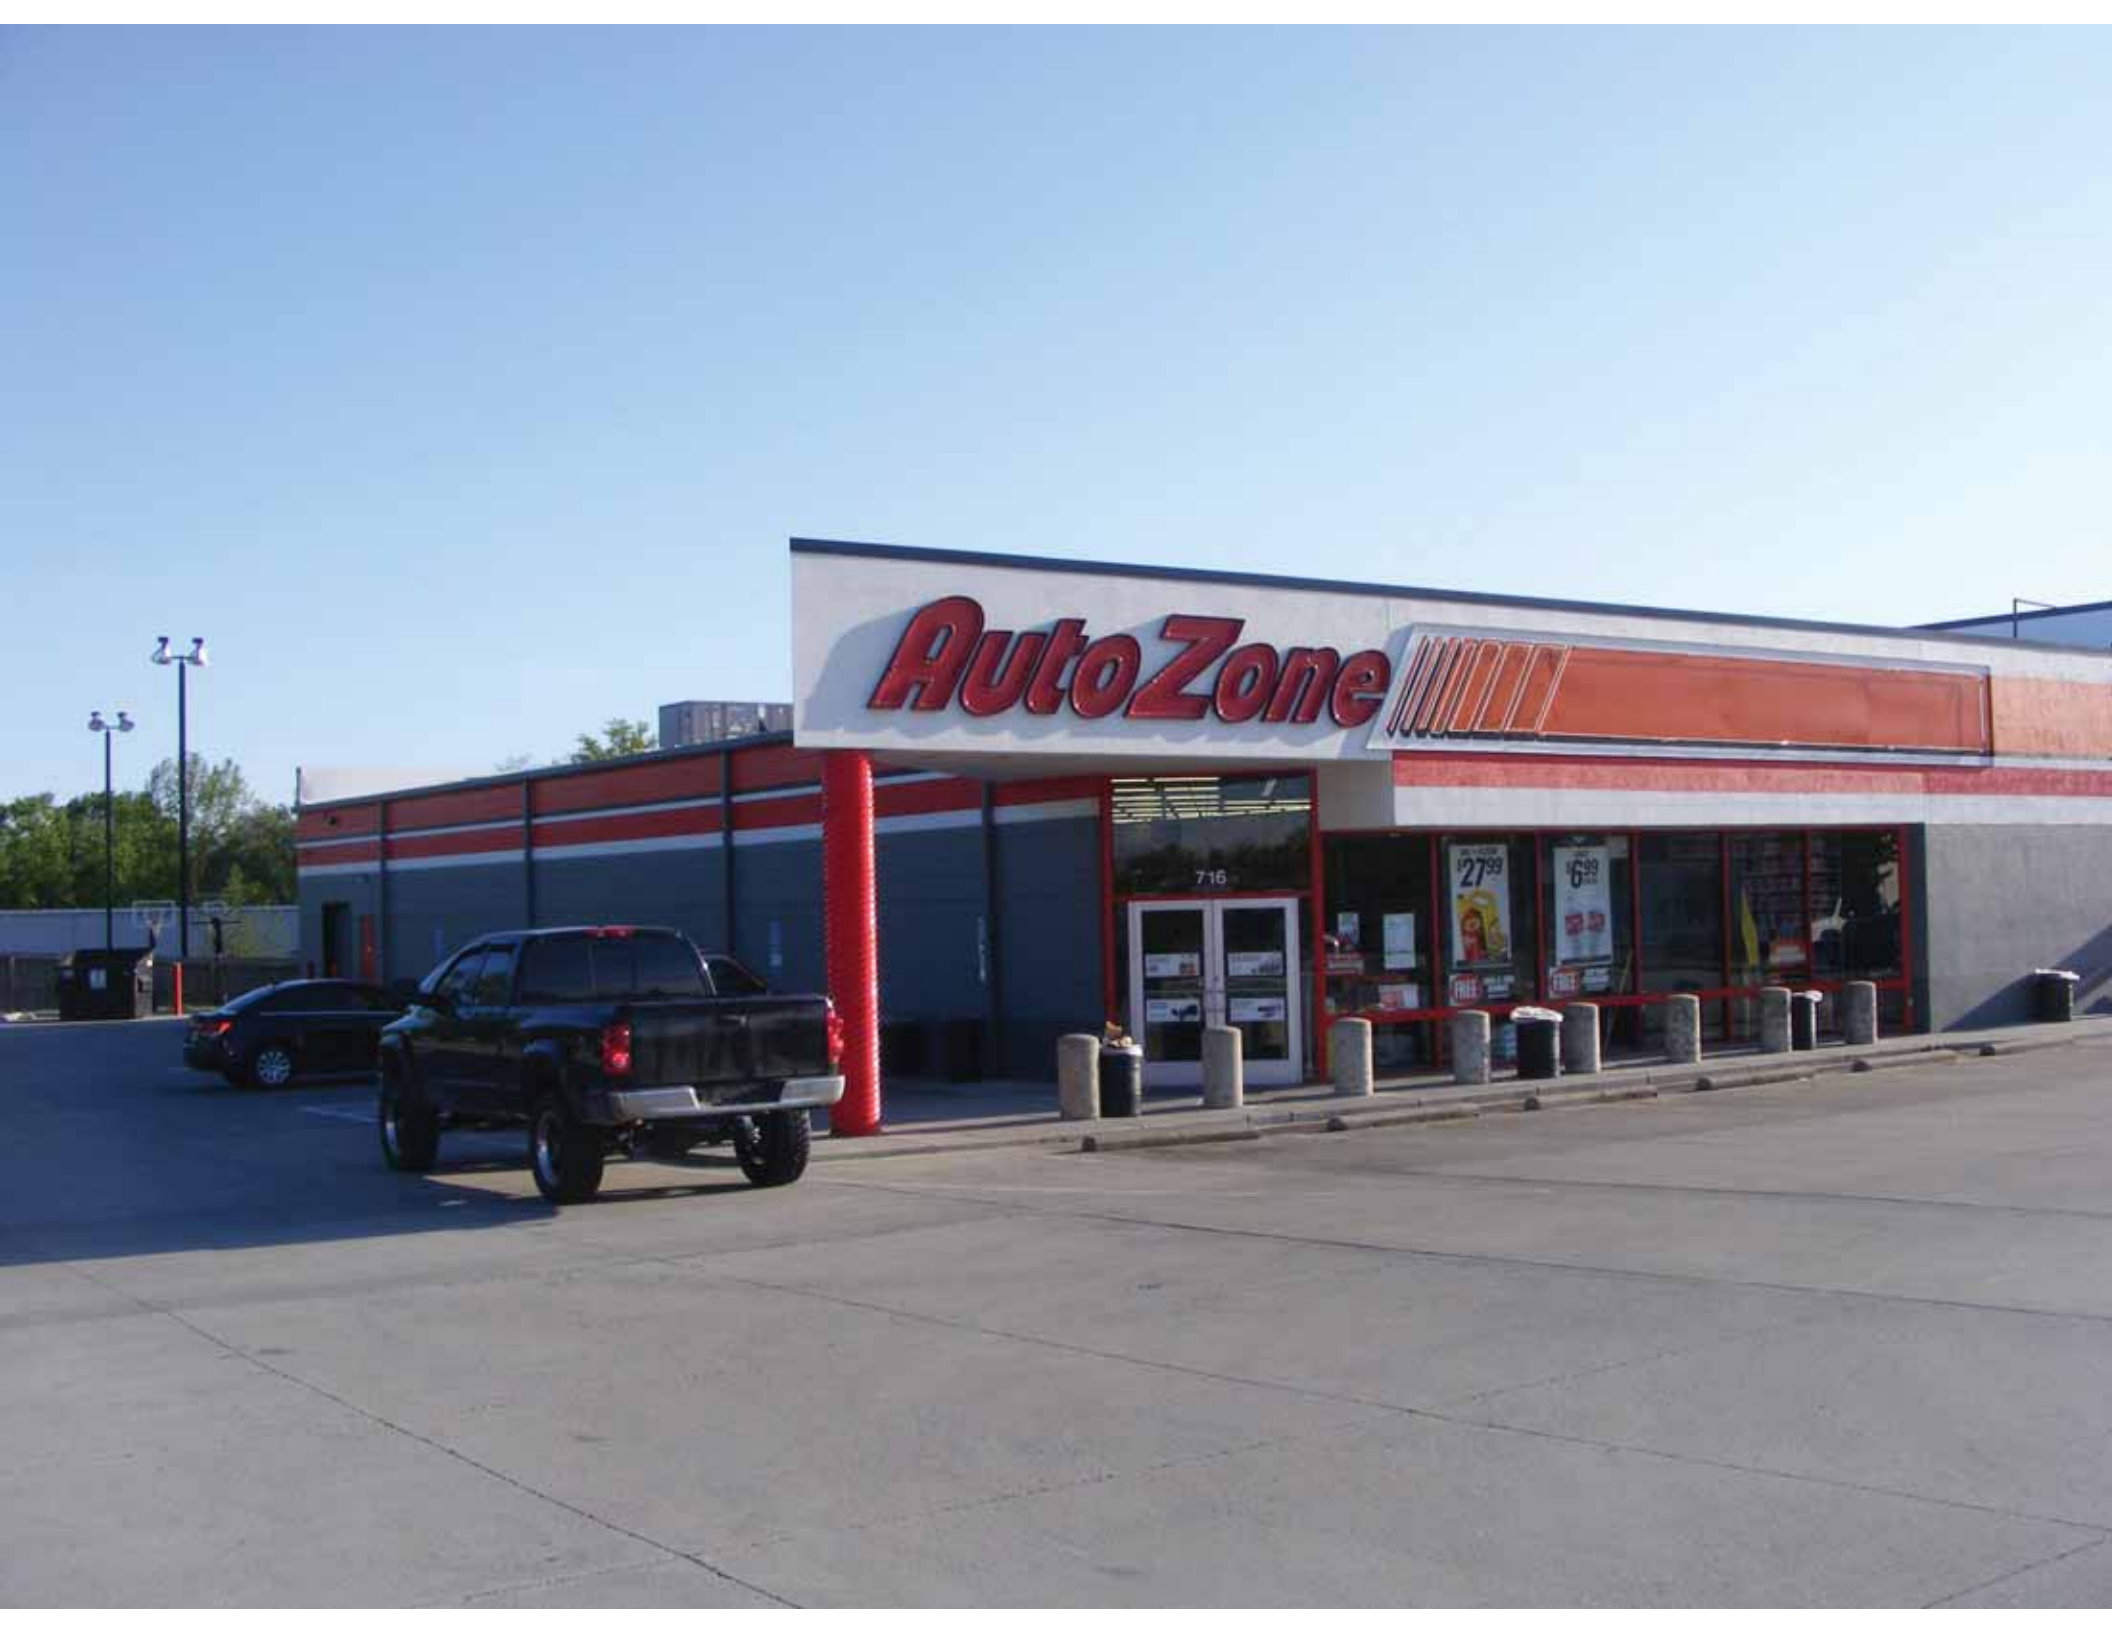
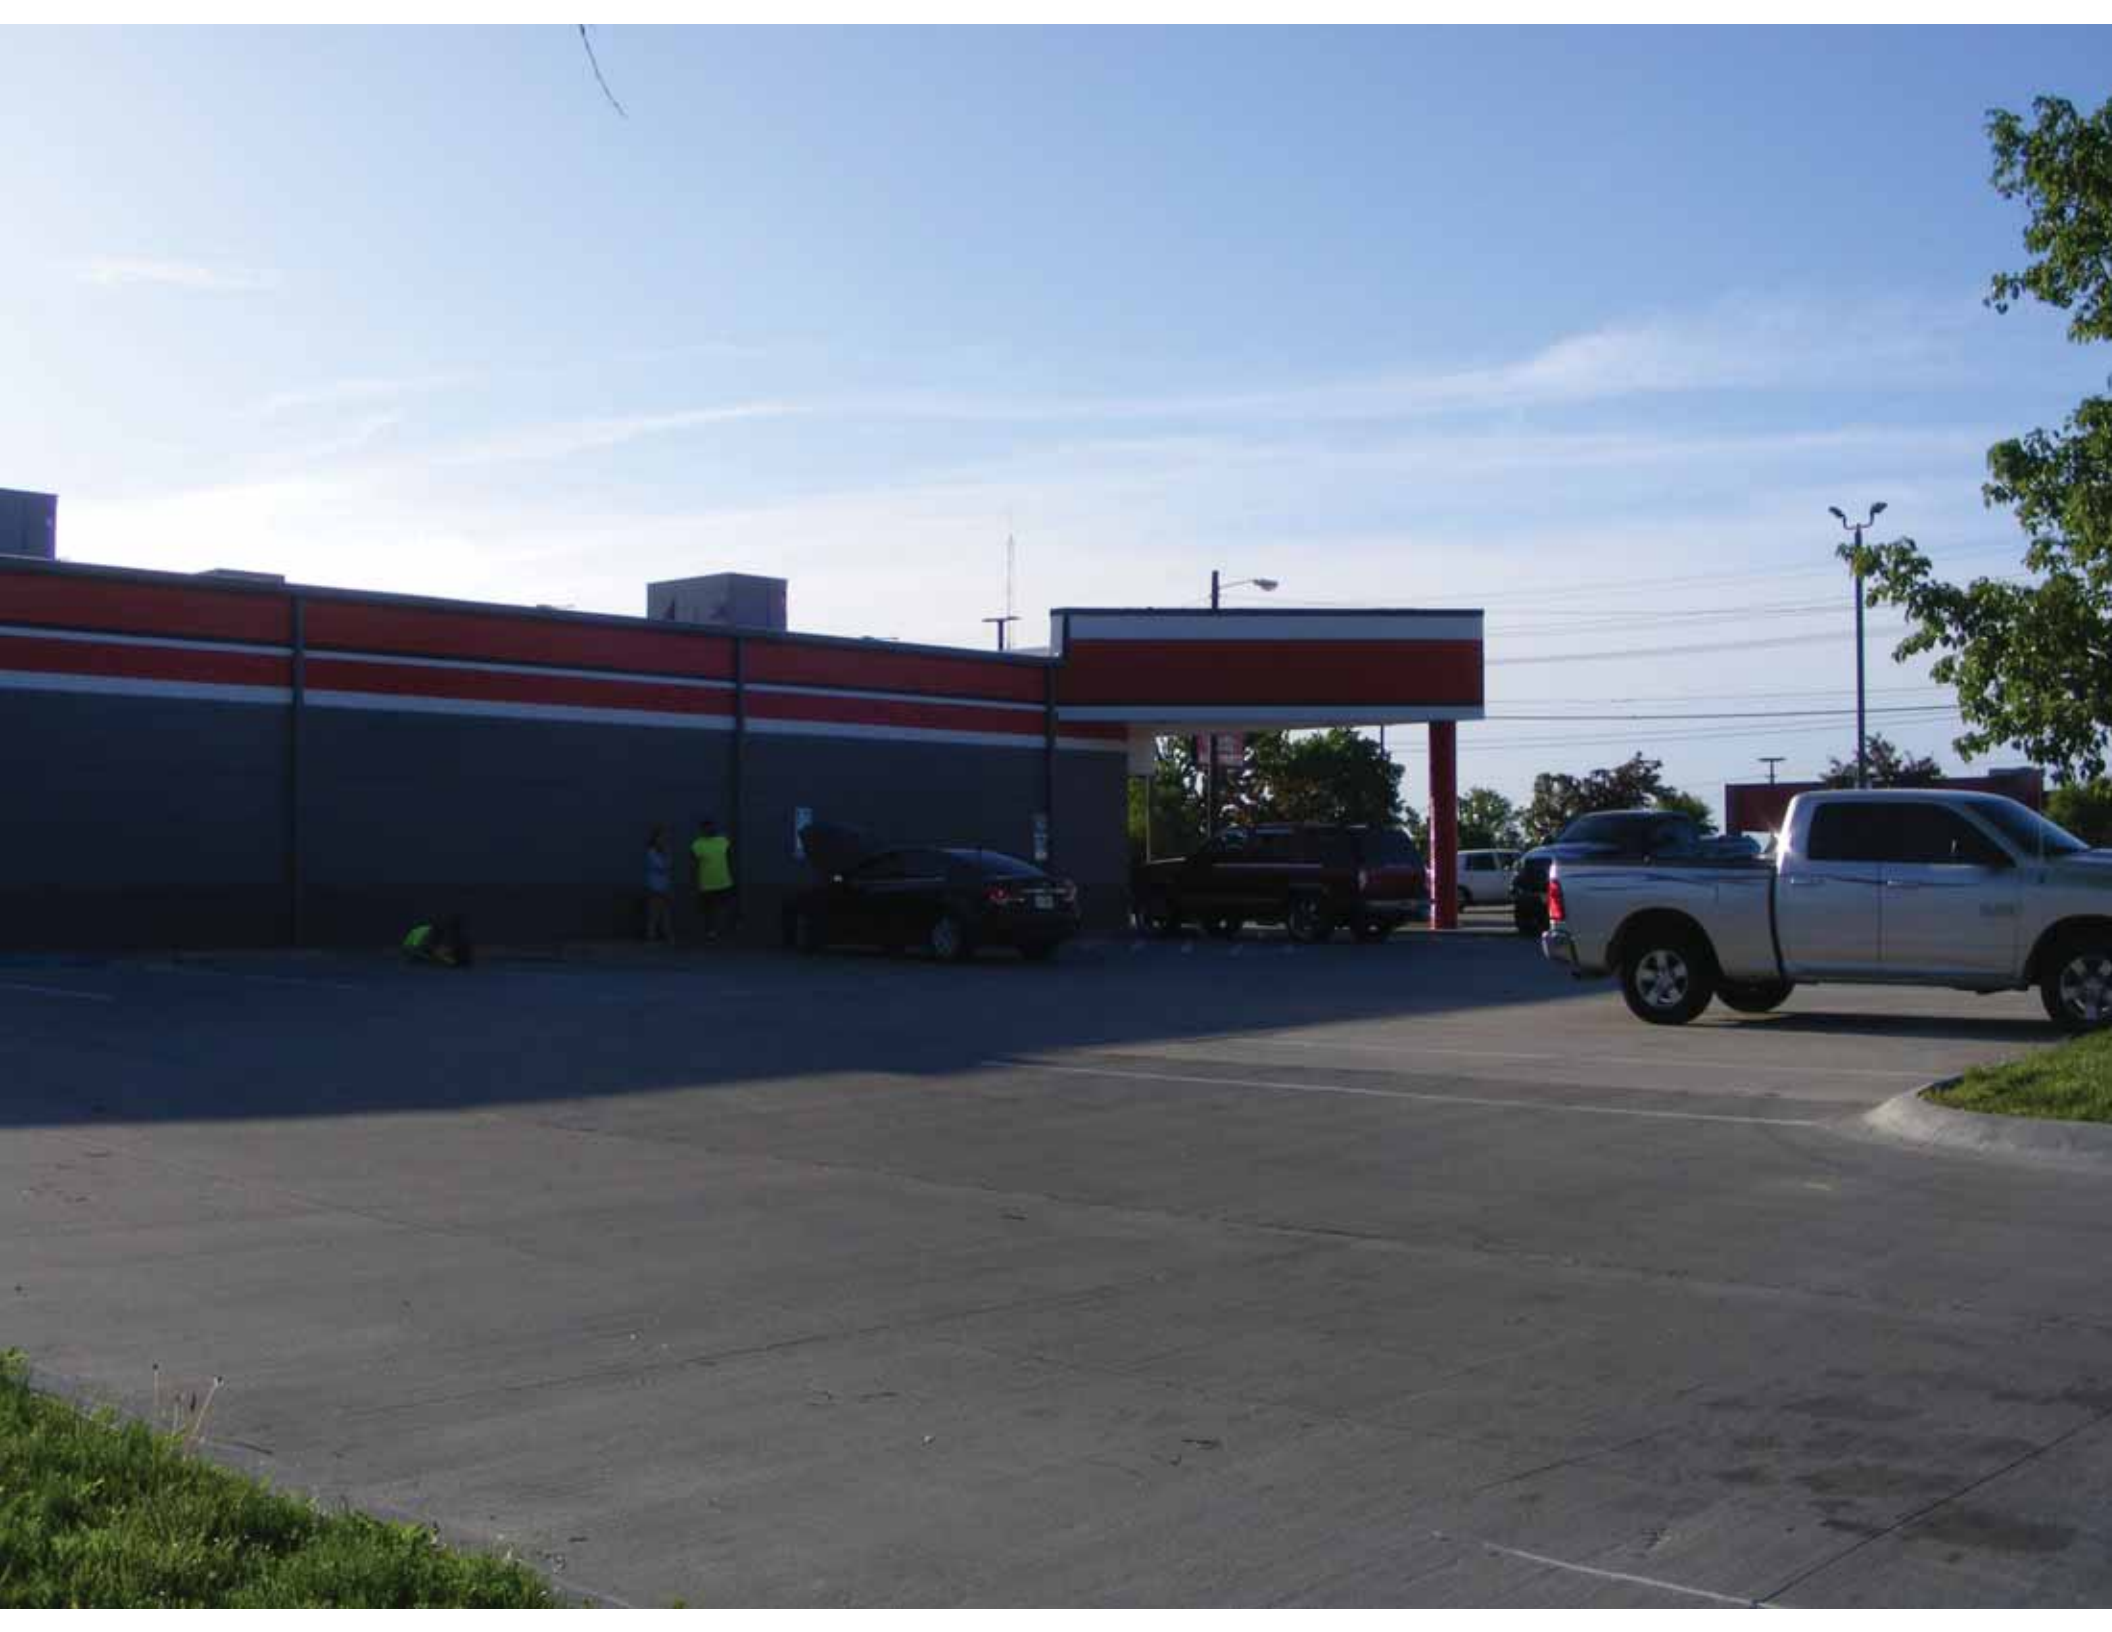
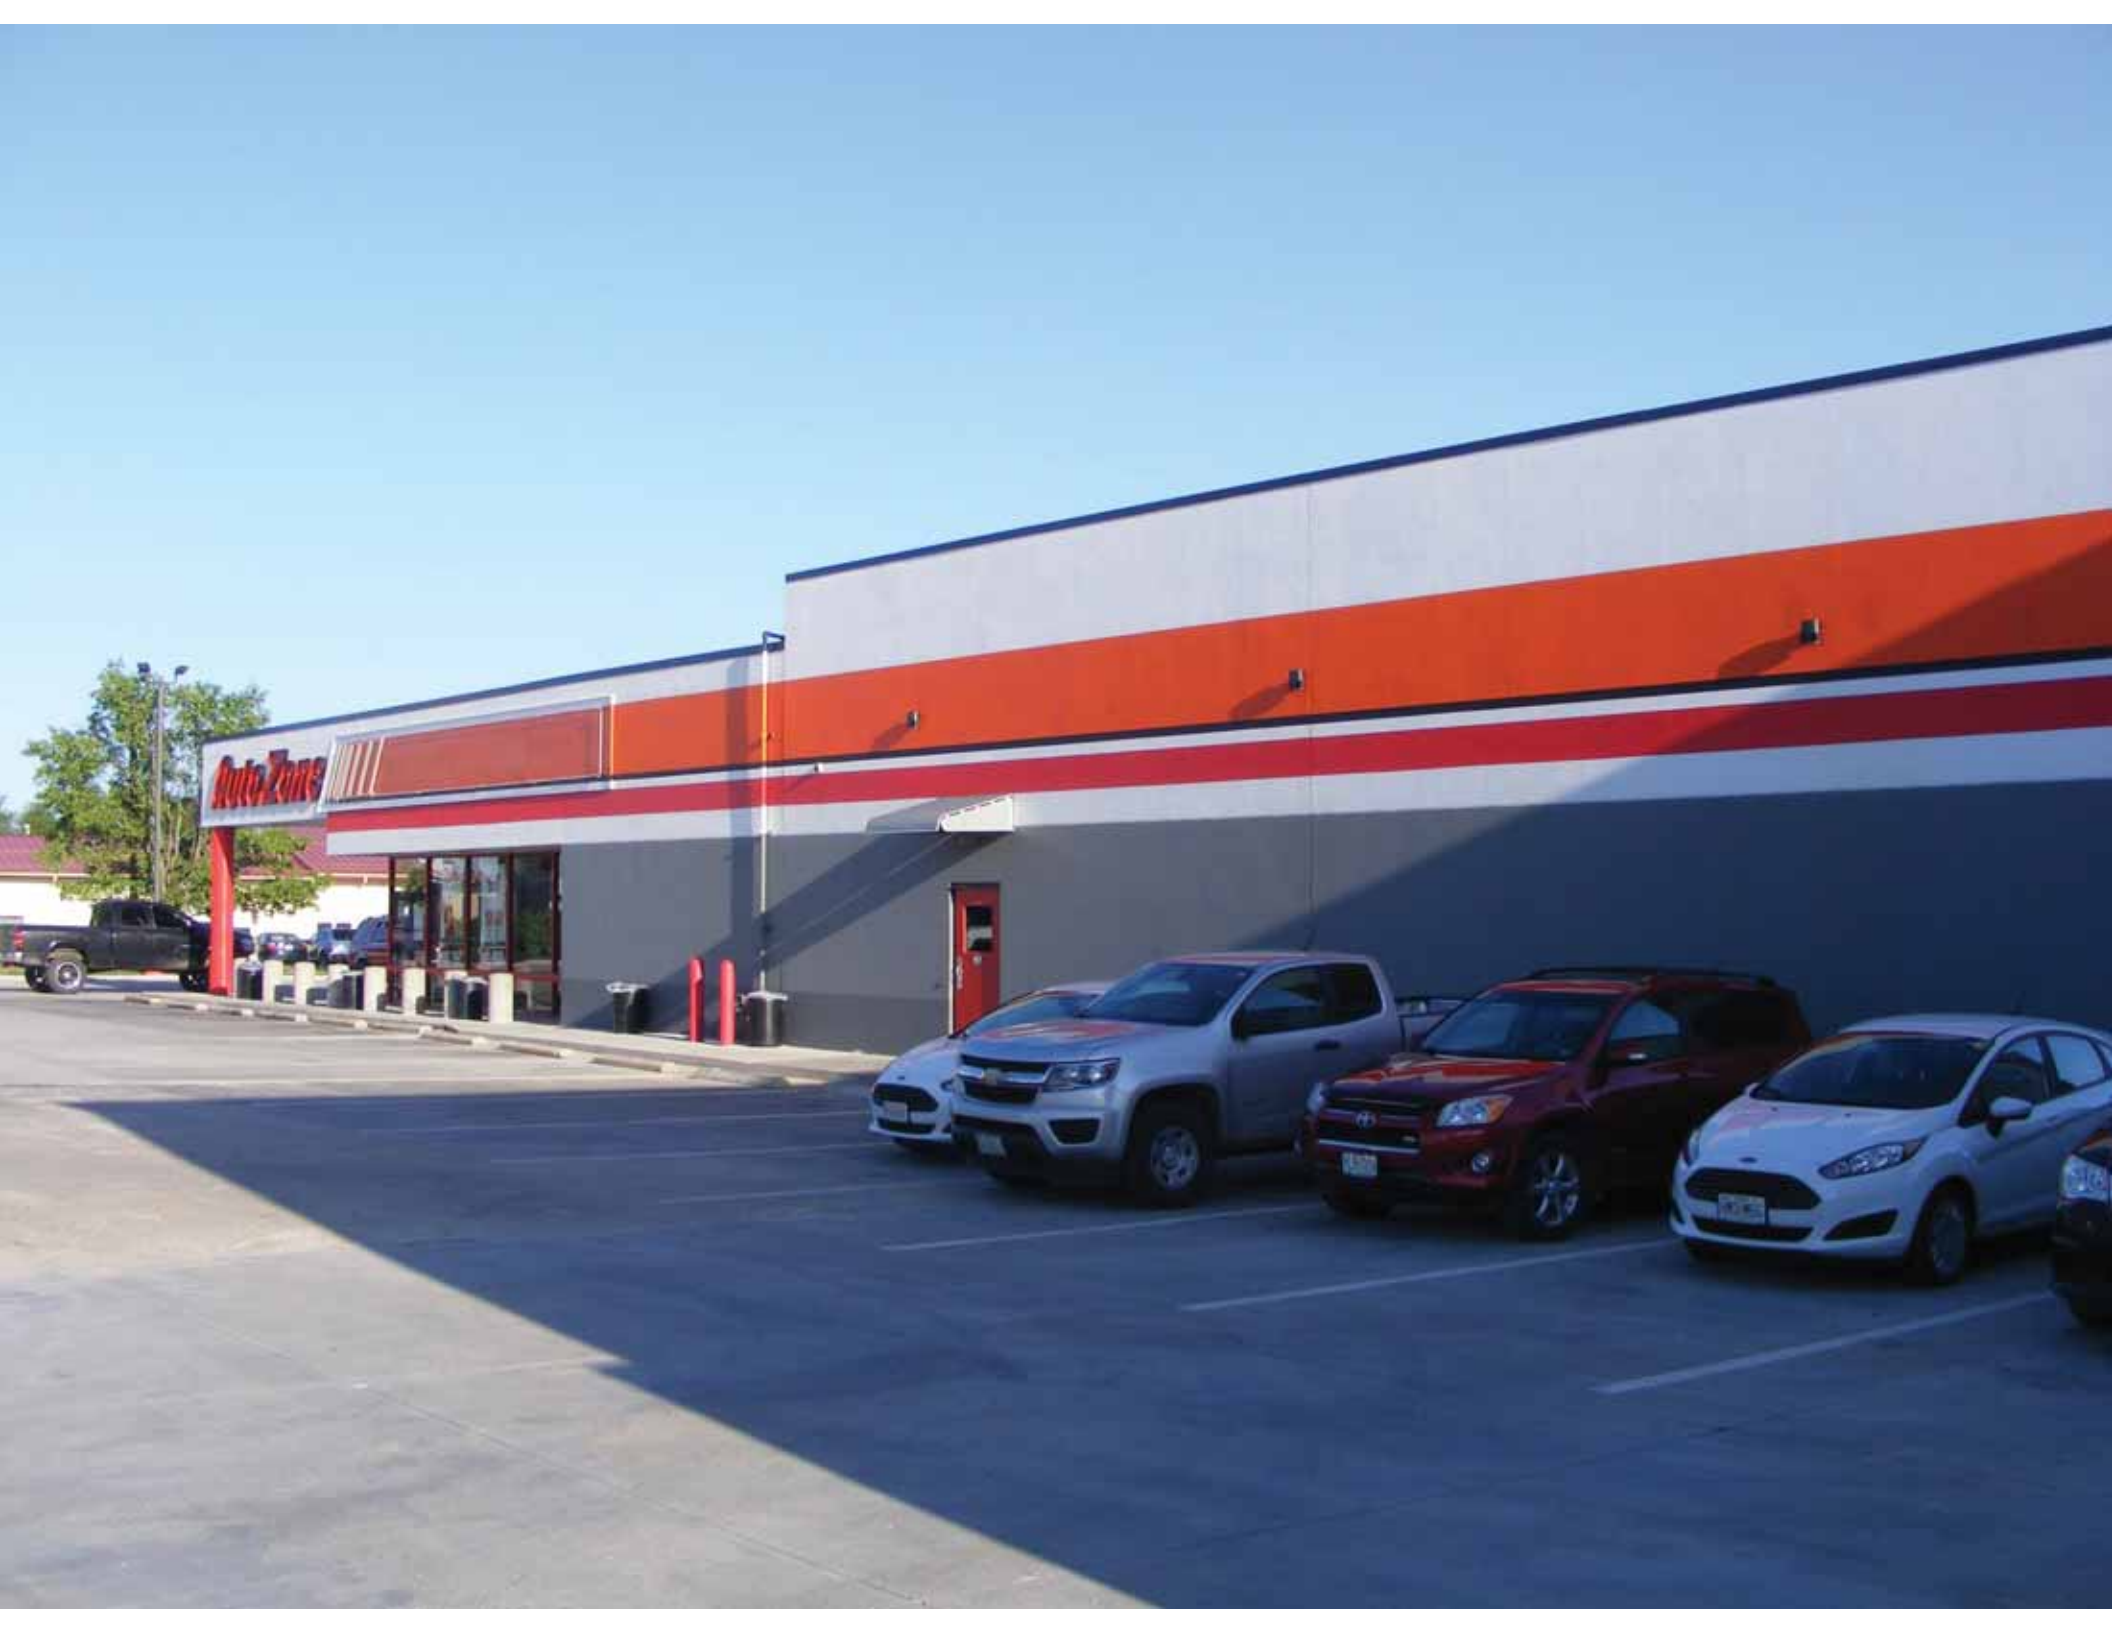
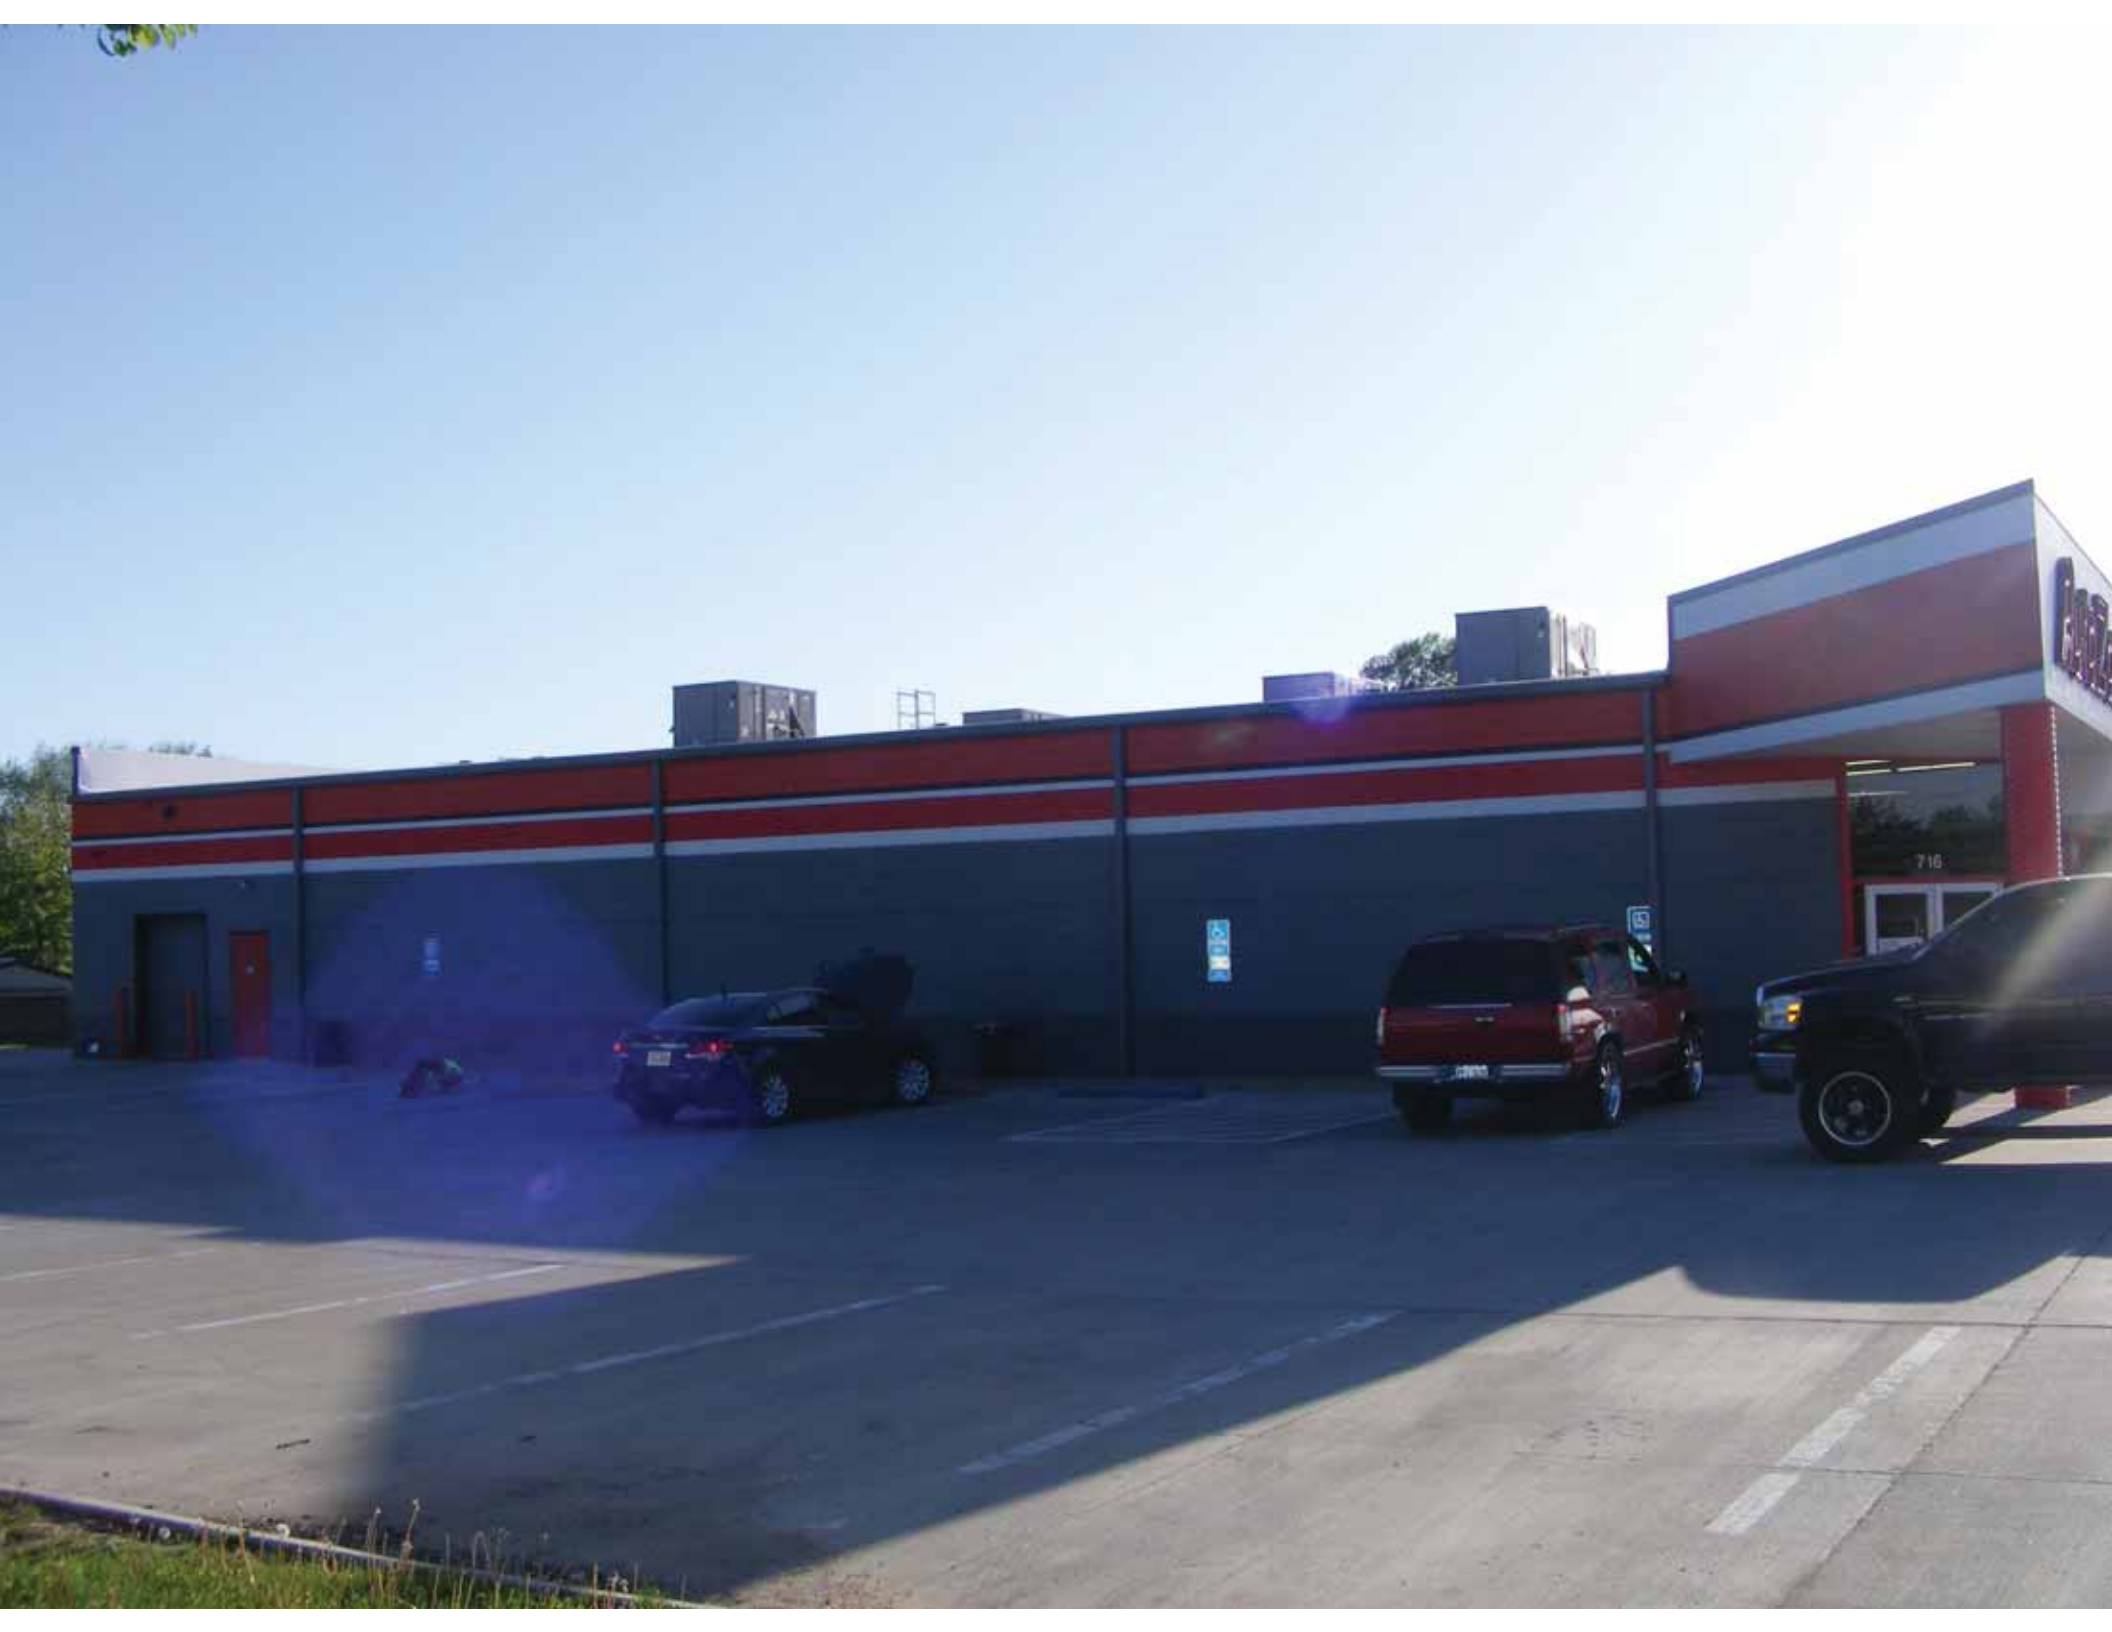
The commercial building has a flat roof with metal roofline coping. Walls are smooth concrete on the east, north and west elevations. The rear (south) elevation is concrete block. An oversized triangular portico bearing the business name extends toward the parking area on the building's northeast corner. The sign is supported by a large metal pole and shelters paired glass and metal commercial doors at the northeast corner. The doors have a large single-light transom and are offset on the west by a band of six fixed sash two-light commercial windows. The elevation also features a pedestrian door with upper single light west of the commercial entry. This door is set below a fixed awning. The east elevation has a pedestrian solid door and loading bay near the south end of the elevation. The east elevation is partially obscured but appears to have no fenestration.

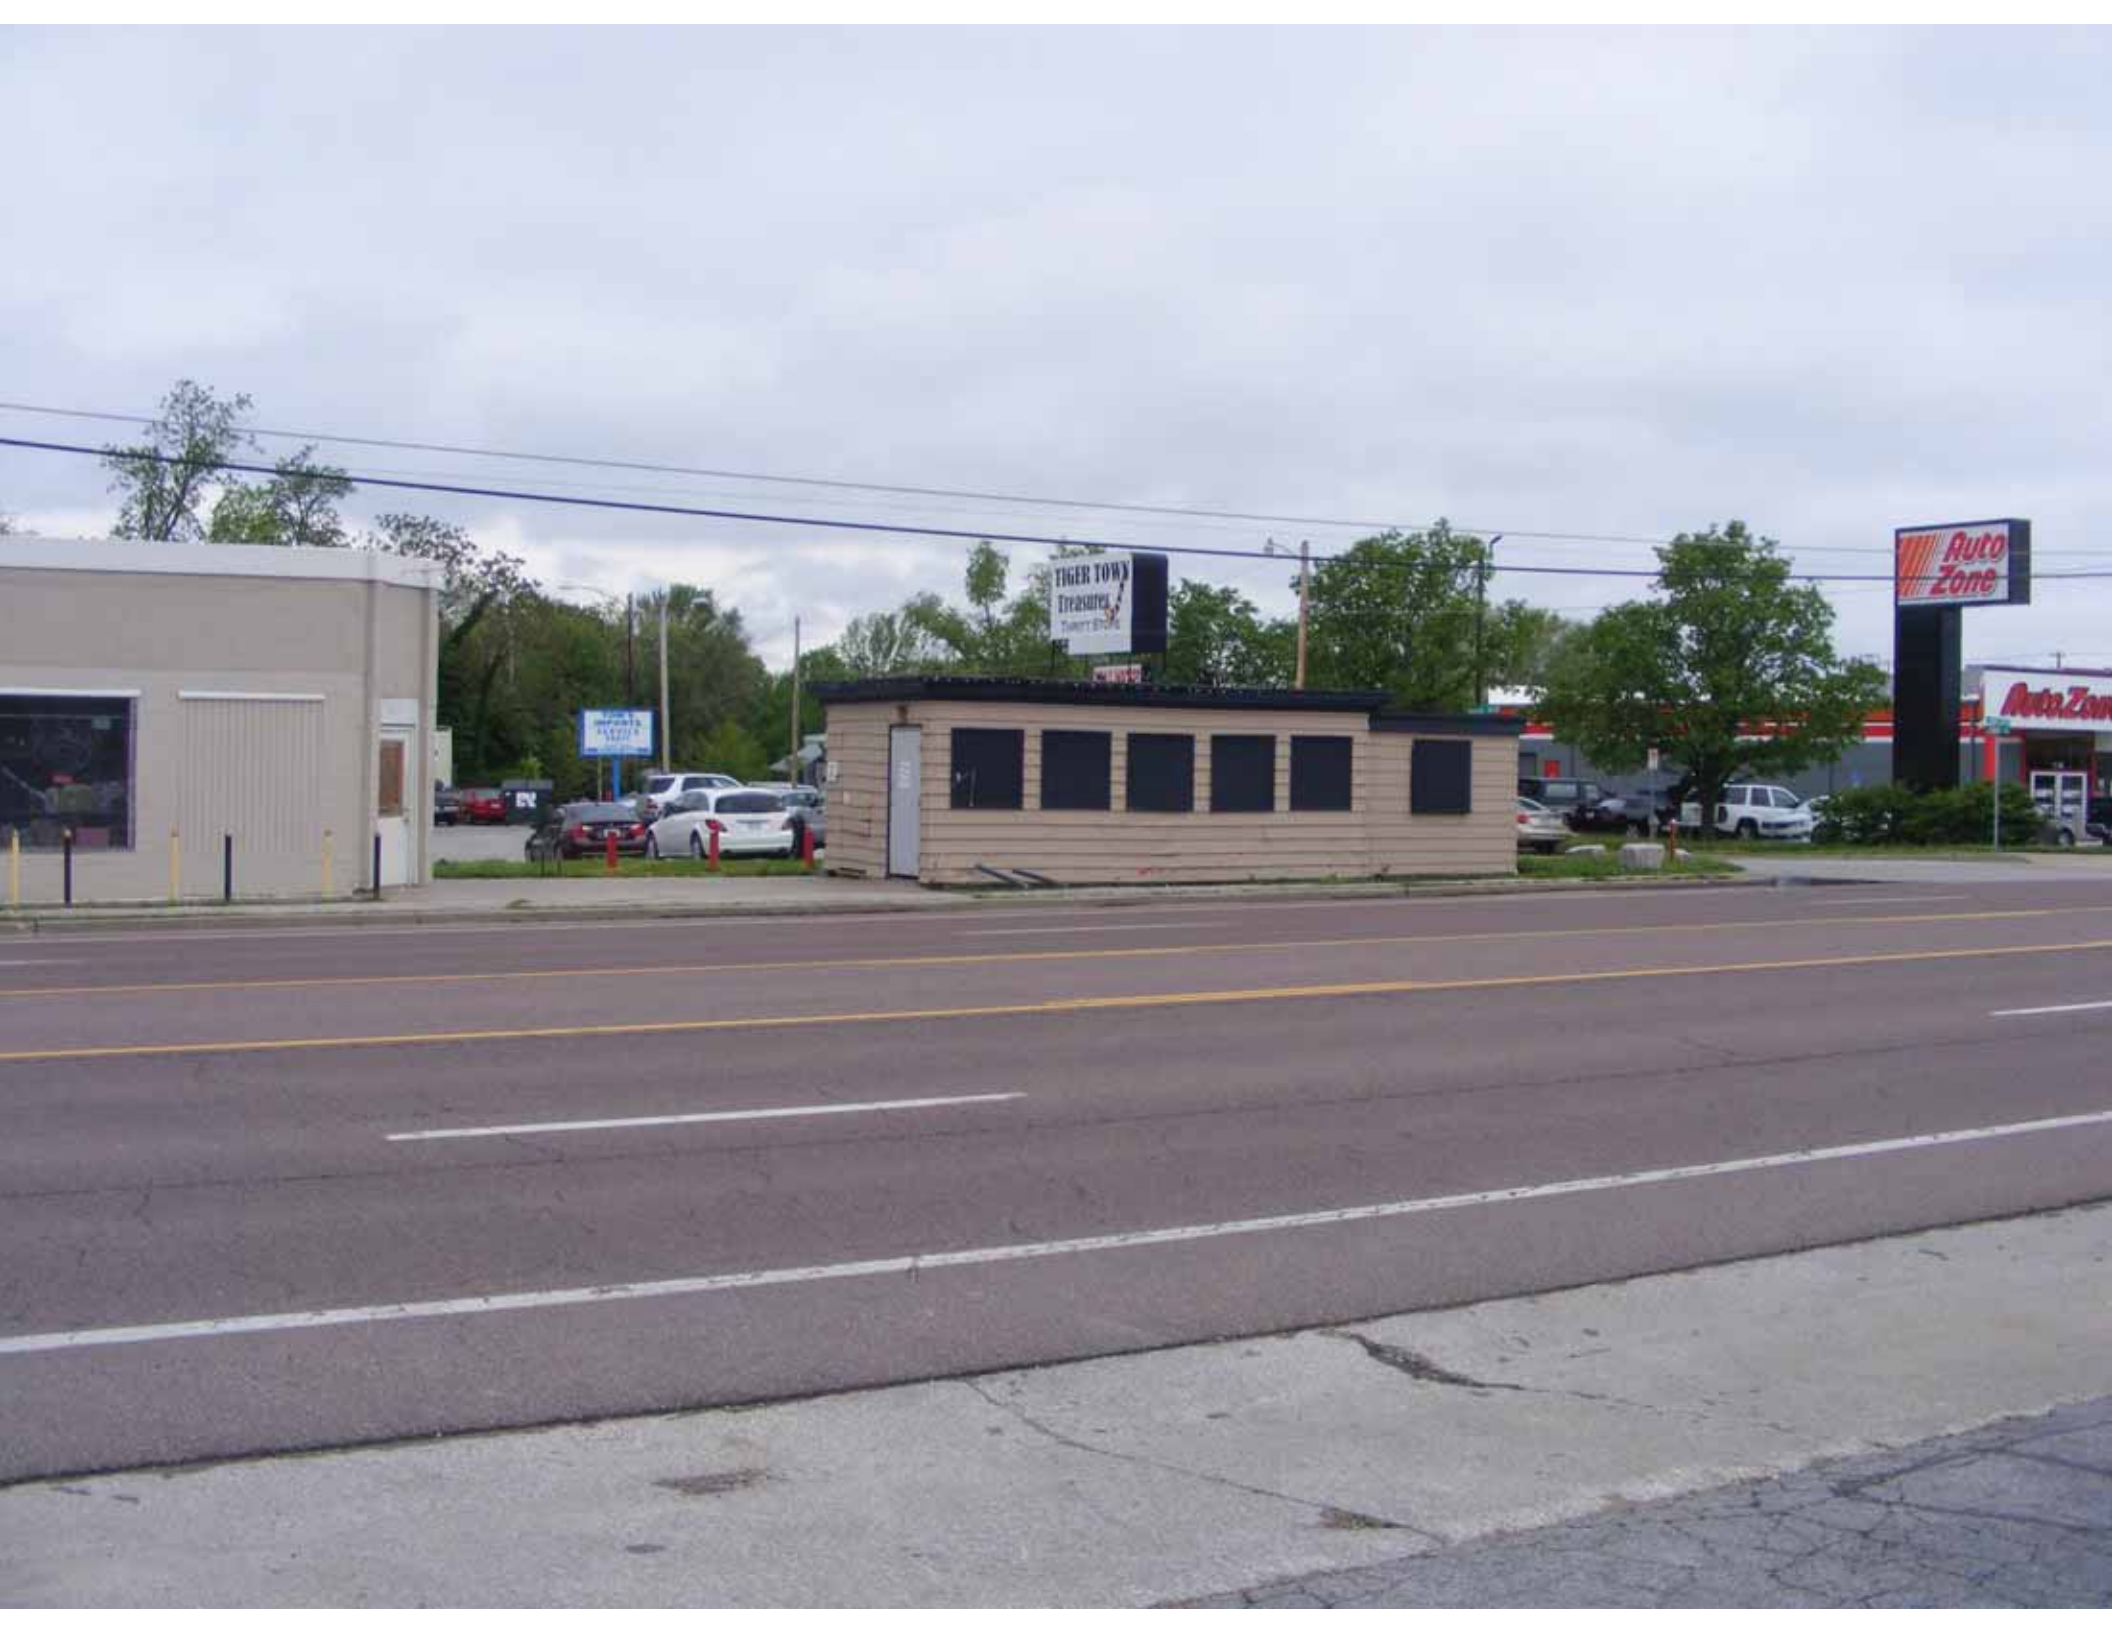
The small building, currently in use as a thrift store, has single solid doors on the east and rear (south) elevations. The north elevation (facing E. Business Loop 70) six window bays, all of which are covered with wood. A single window on the west elevation is also covered with wood. The building has a flat roof supporting a sign that bears the name of the business. The exterior is clad with aluminum siding.
