MISSOURI DEPARTMENT OF NATURAL RESOURCES
STATE HISTORIC PRESERVATION OFFICE, P.O. Box 176, Jefferson City, MO 65102
ARCHITECTURAL/HISTORIC INVENTORY FORM

1. Survey No. BO-AS-011-0087		2. Survey name: North Central Columbia Survey Phase II	
3. County: Boone		4. Address (Street No.) 902	Street (name) N. Seventh Street
5. City: Columbia	Vicinity: <input type="checkbox"/>	6. Geographical Reference:	7. Township/Range/Section: T: R: S:
8. Historic name (if known):		9. Present/other name (if known):	
10. Ownership: <input checked="" type="checkbox"/> Private <input type="checkbox"/> Public		11a. Historic use (if known): Domestic/single dwelling	11b. Current use: Domestic/single dwelling

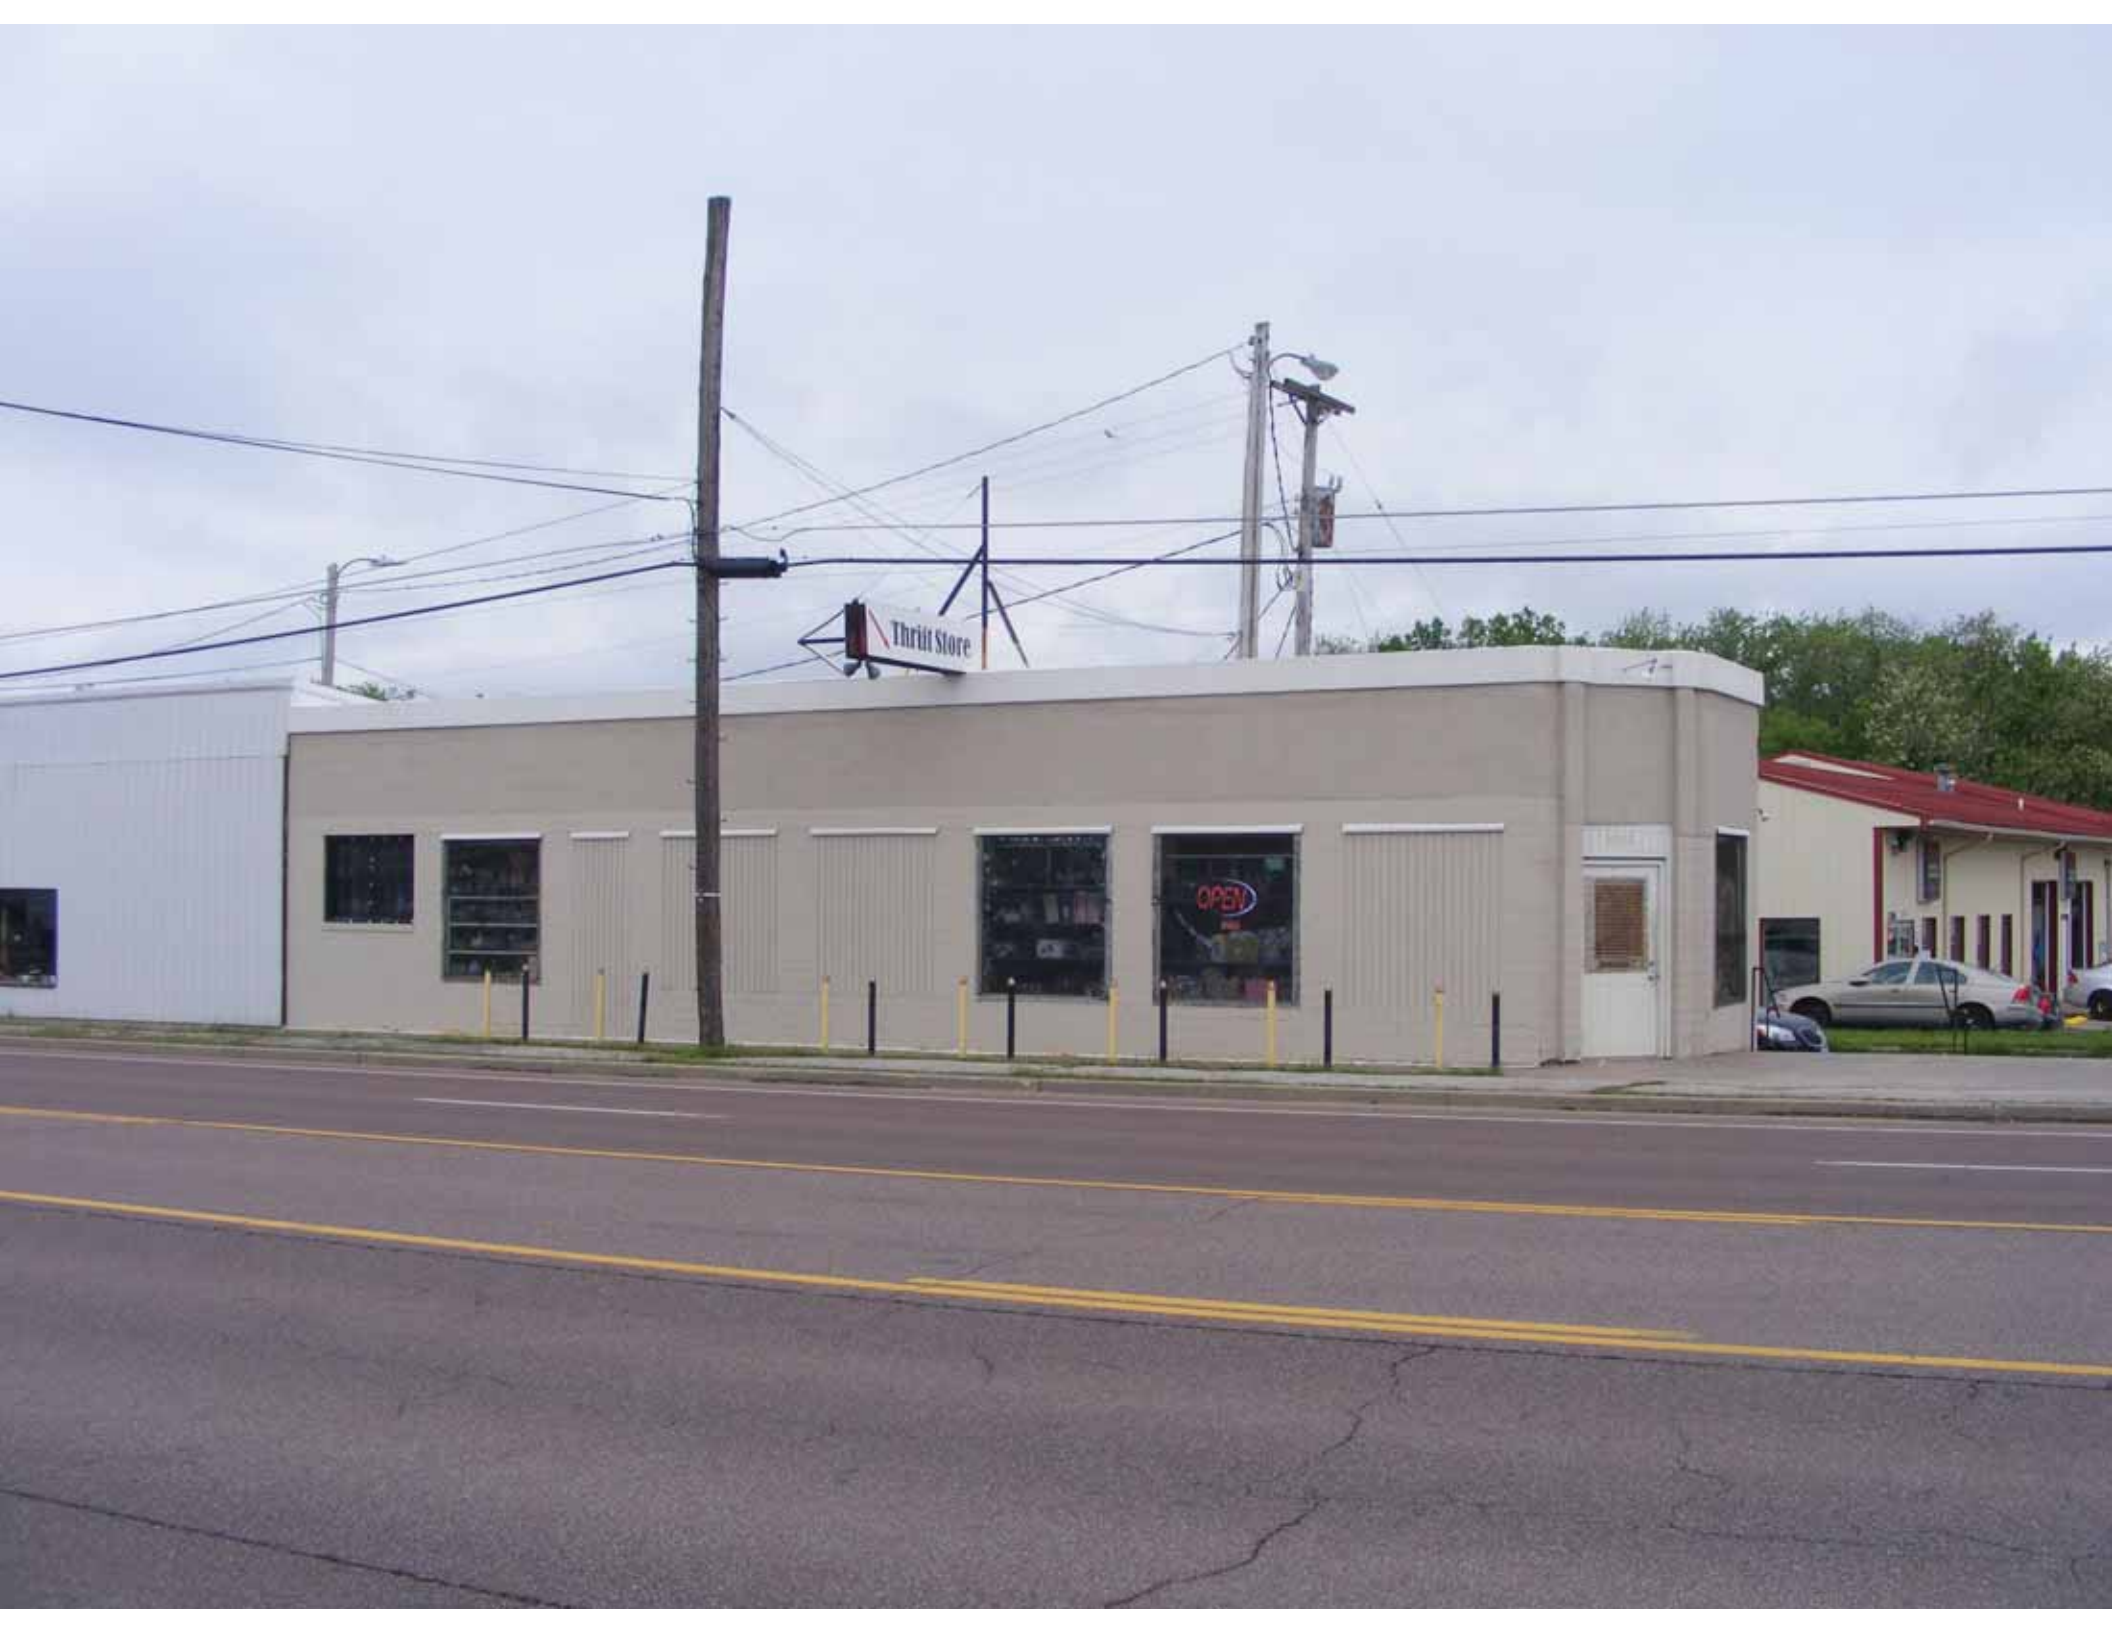
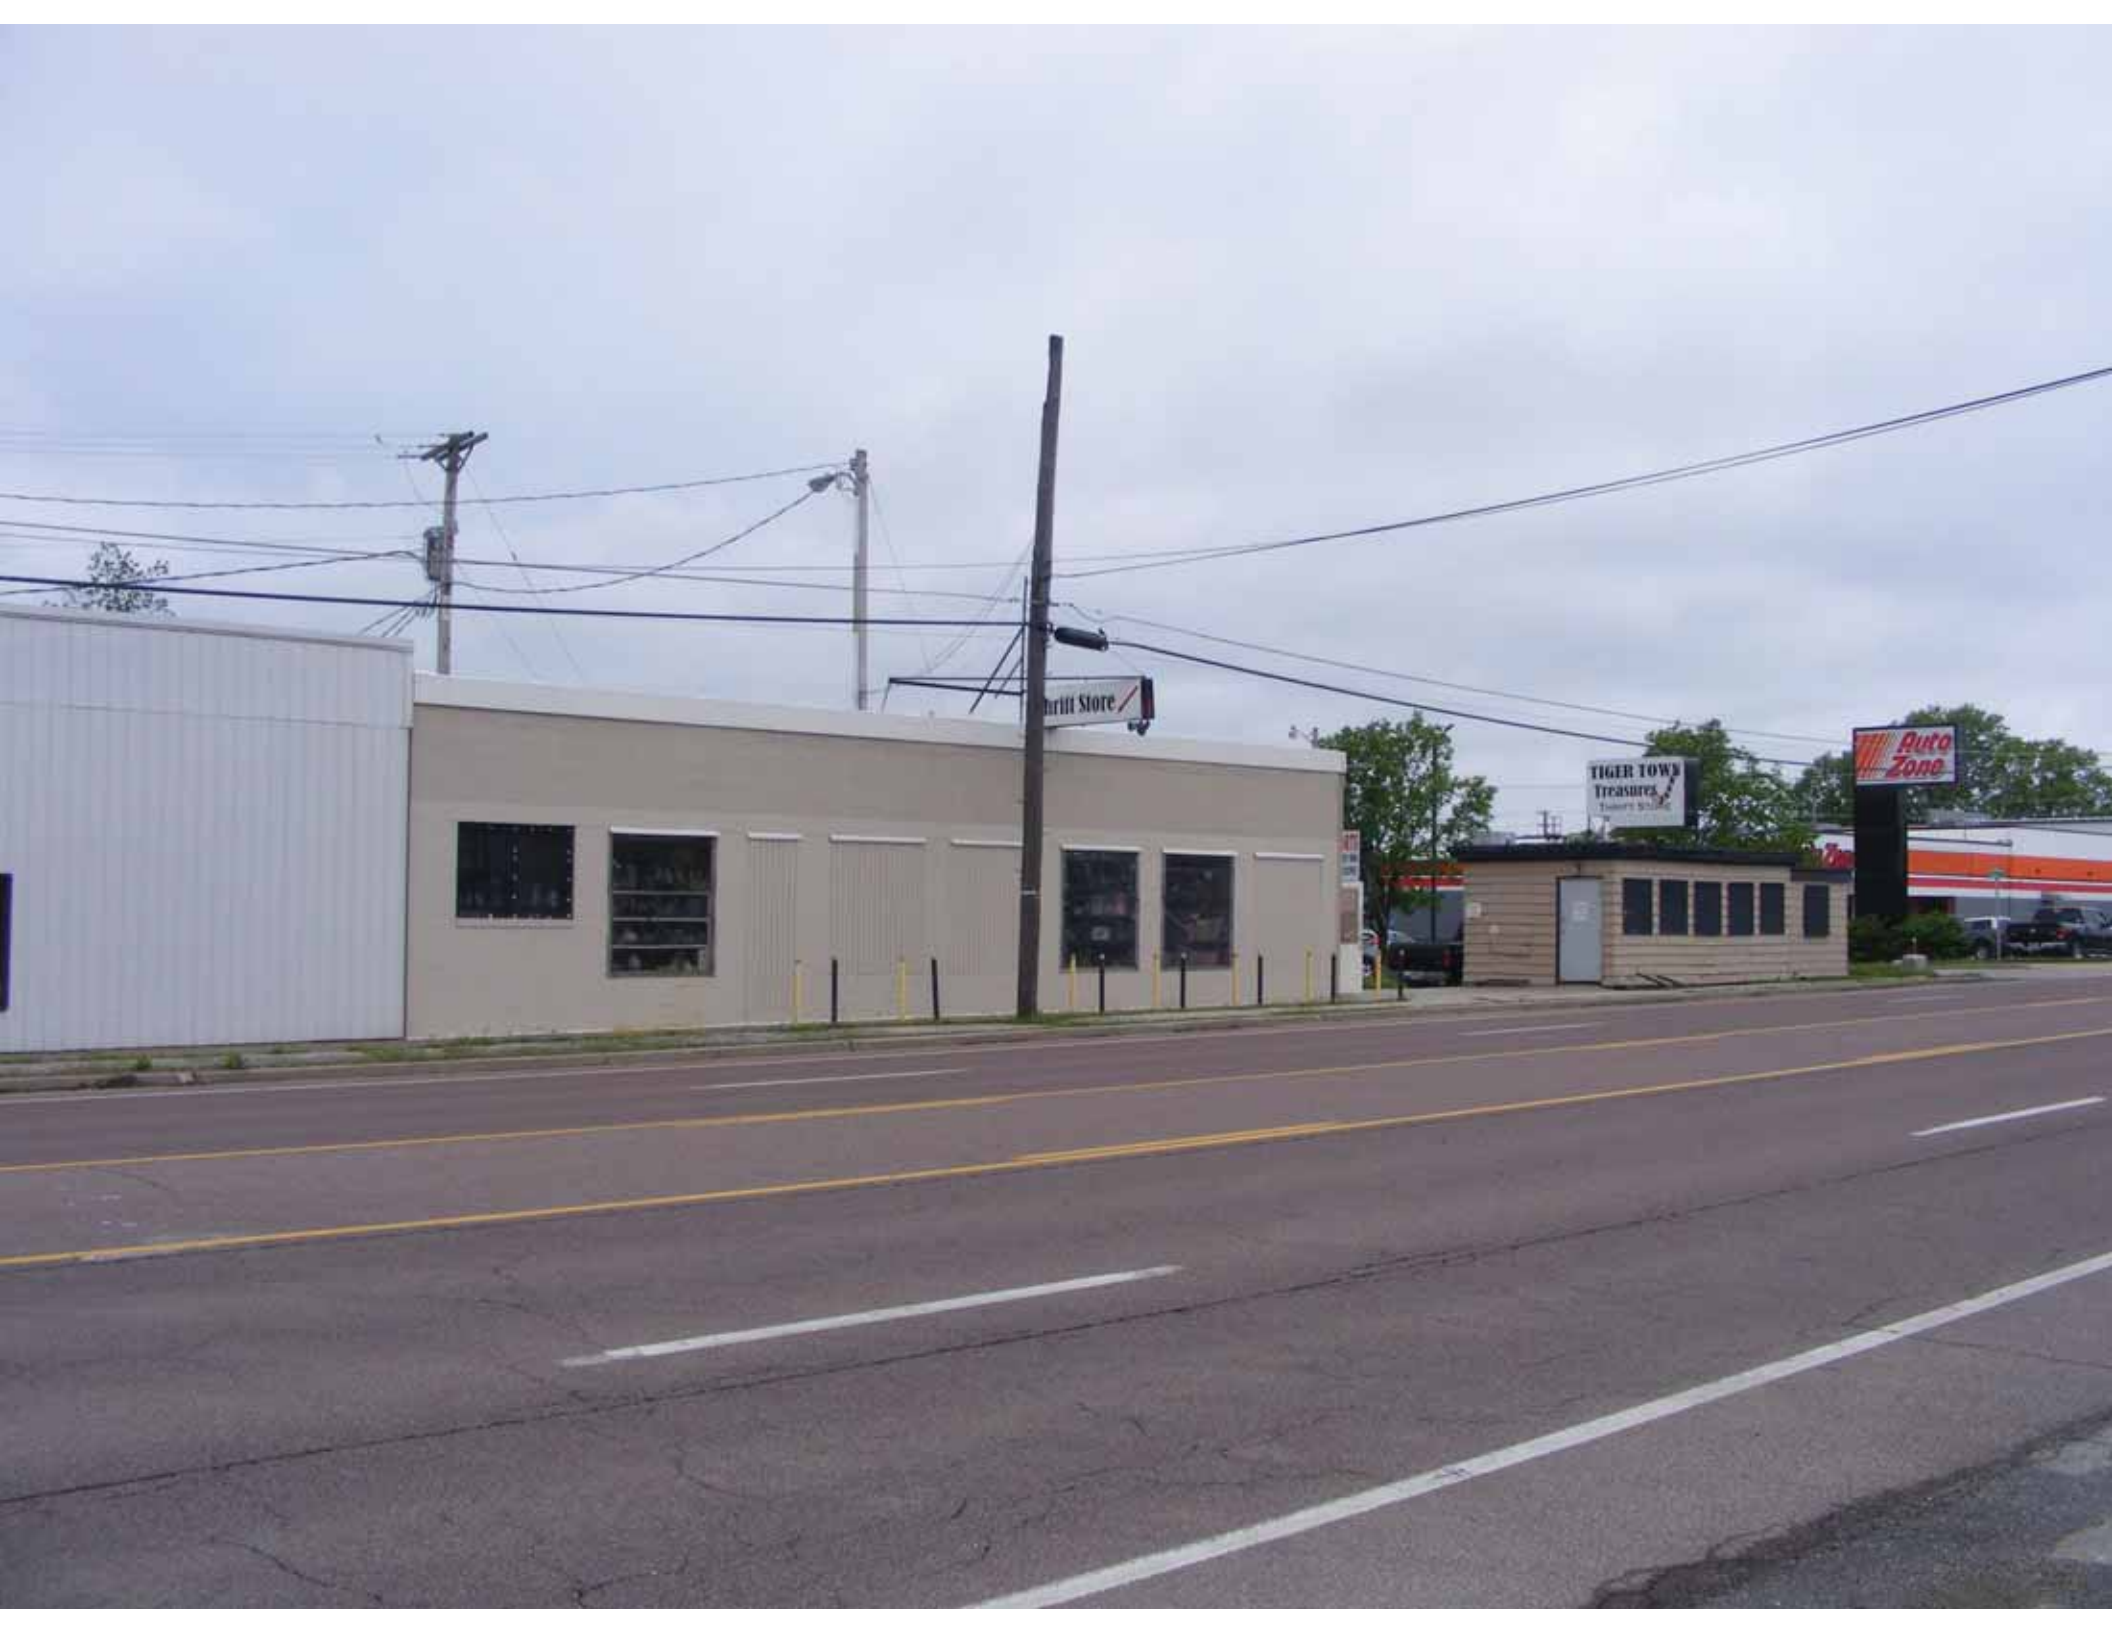
The single-story brick warehouse has a flat built-up roof, exterior Dryvit on the west, north and east elevations and a rear brick (south) wall. The north elevation holds eight window bays. Four of the windows are filled with single-sash commercial style windows. The remaining windows are covered with vertical siding. An angled primary entry bay is situated at the west end of the elevation, filled with a single-light commercial door. The west elevation holds a single-sash commercial window. The south elevation has a solid pedestrian door with a replacement paneled door and a filled window bay. The east elevation is attached to 806 E. Business Loop, another commercial building.

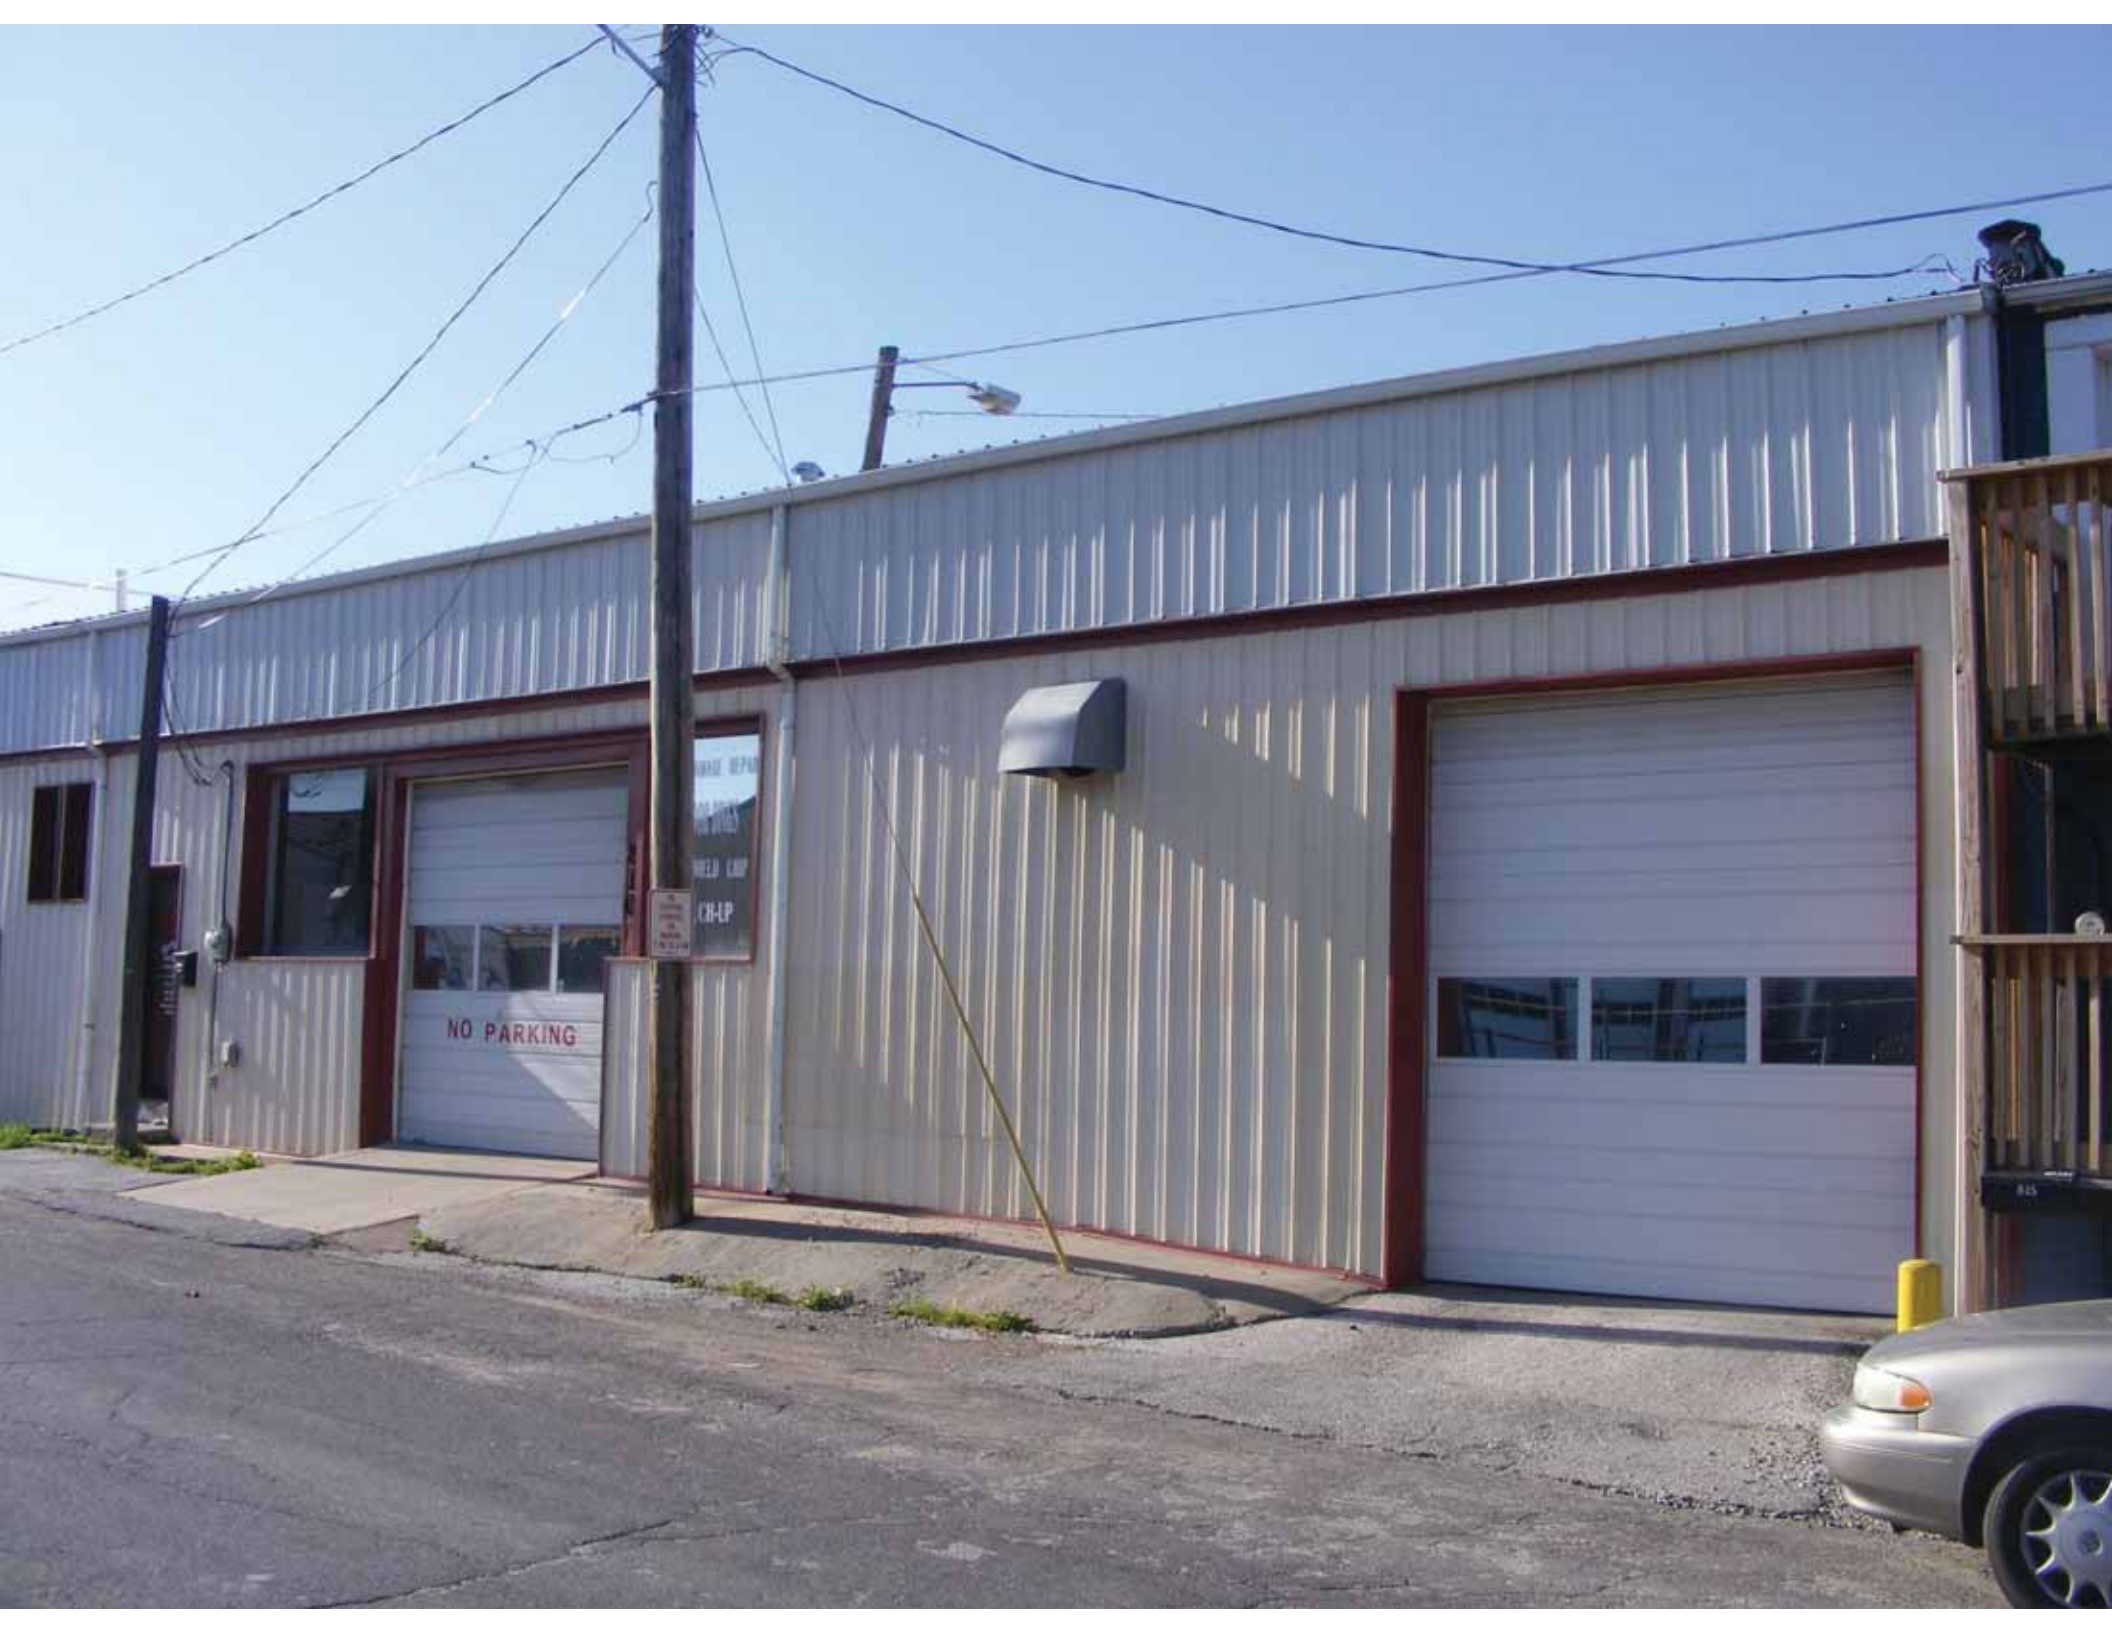
This large warehouse has a flat built-up roof, exterior metal siding and a concrete foundation covered by the siding. The south elevation siding is ribbed (c. 1980) and features a ribbed projection rising above the roofline that is capped by metal coping. The north elevation has more contemporary siding (c. 1990) that is similar (but not identical) in appearance. The north elevation holds (from east to west) an overhead track door with upper windows, a central solid pedestrian door and at the east end of the elevation, a two-by-two fixed sash window, fixed four-light window and single-light commercial window. The rear (south) elevation supports (from east to west) an overhead track three-light door, single-light commercial window, solid metal pedestrian door, two-by-two window, solid metal pedestrian door, fixed-light commercial window, solid door with upper fanlight (with concrete steps and a metal handrail) and three windows of single-sash design. Separating two of the west end single-sash windows is a small one-over-one window.

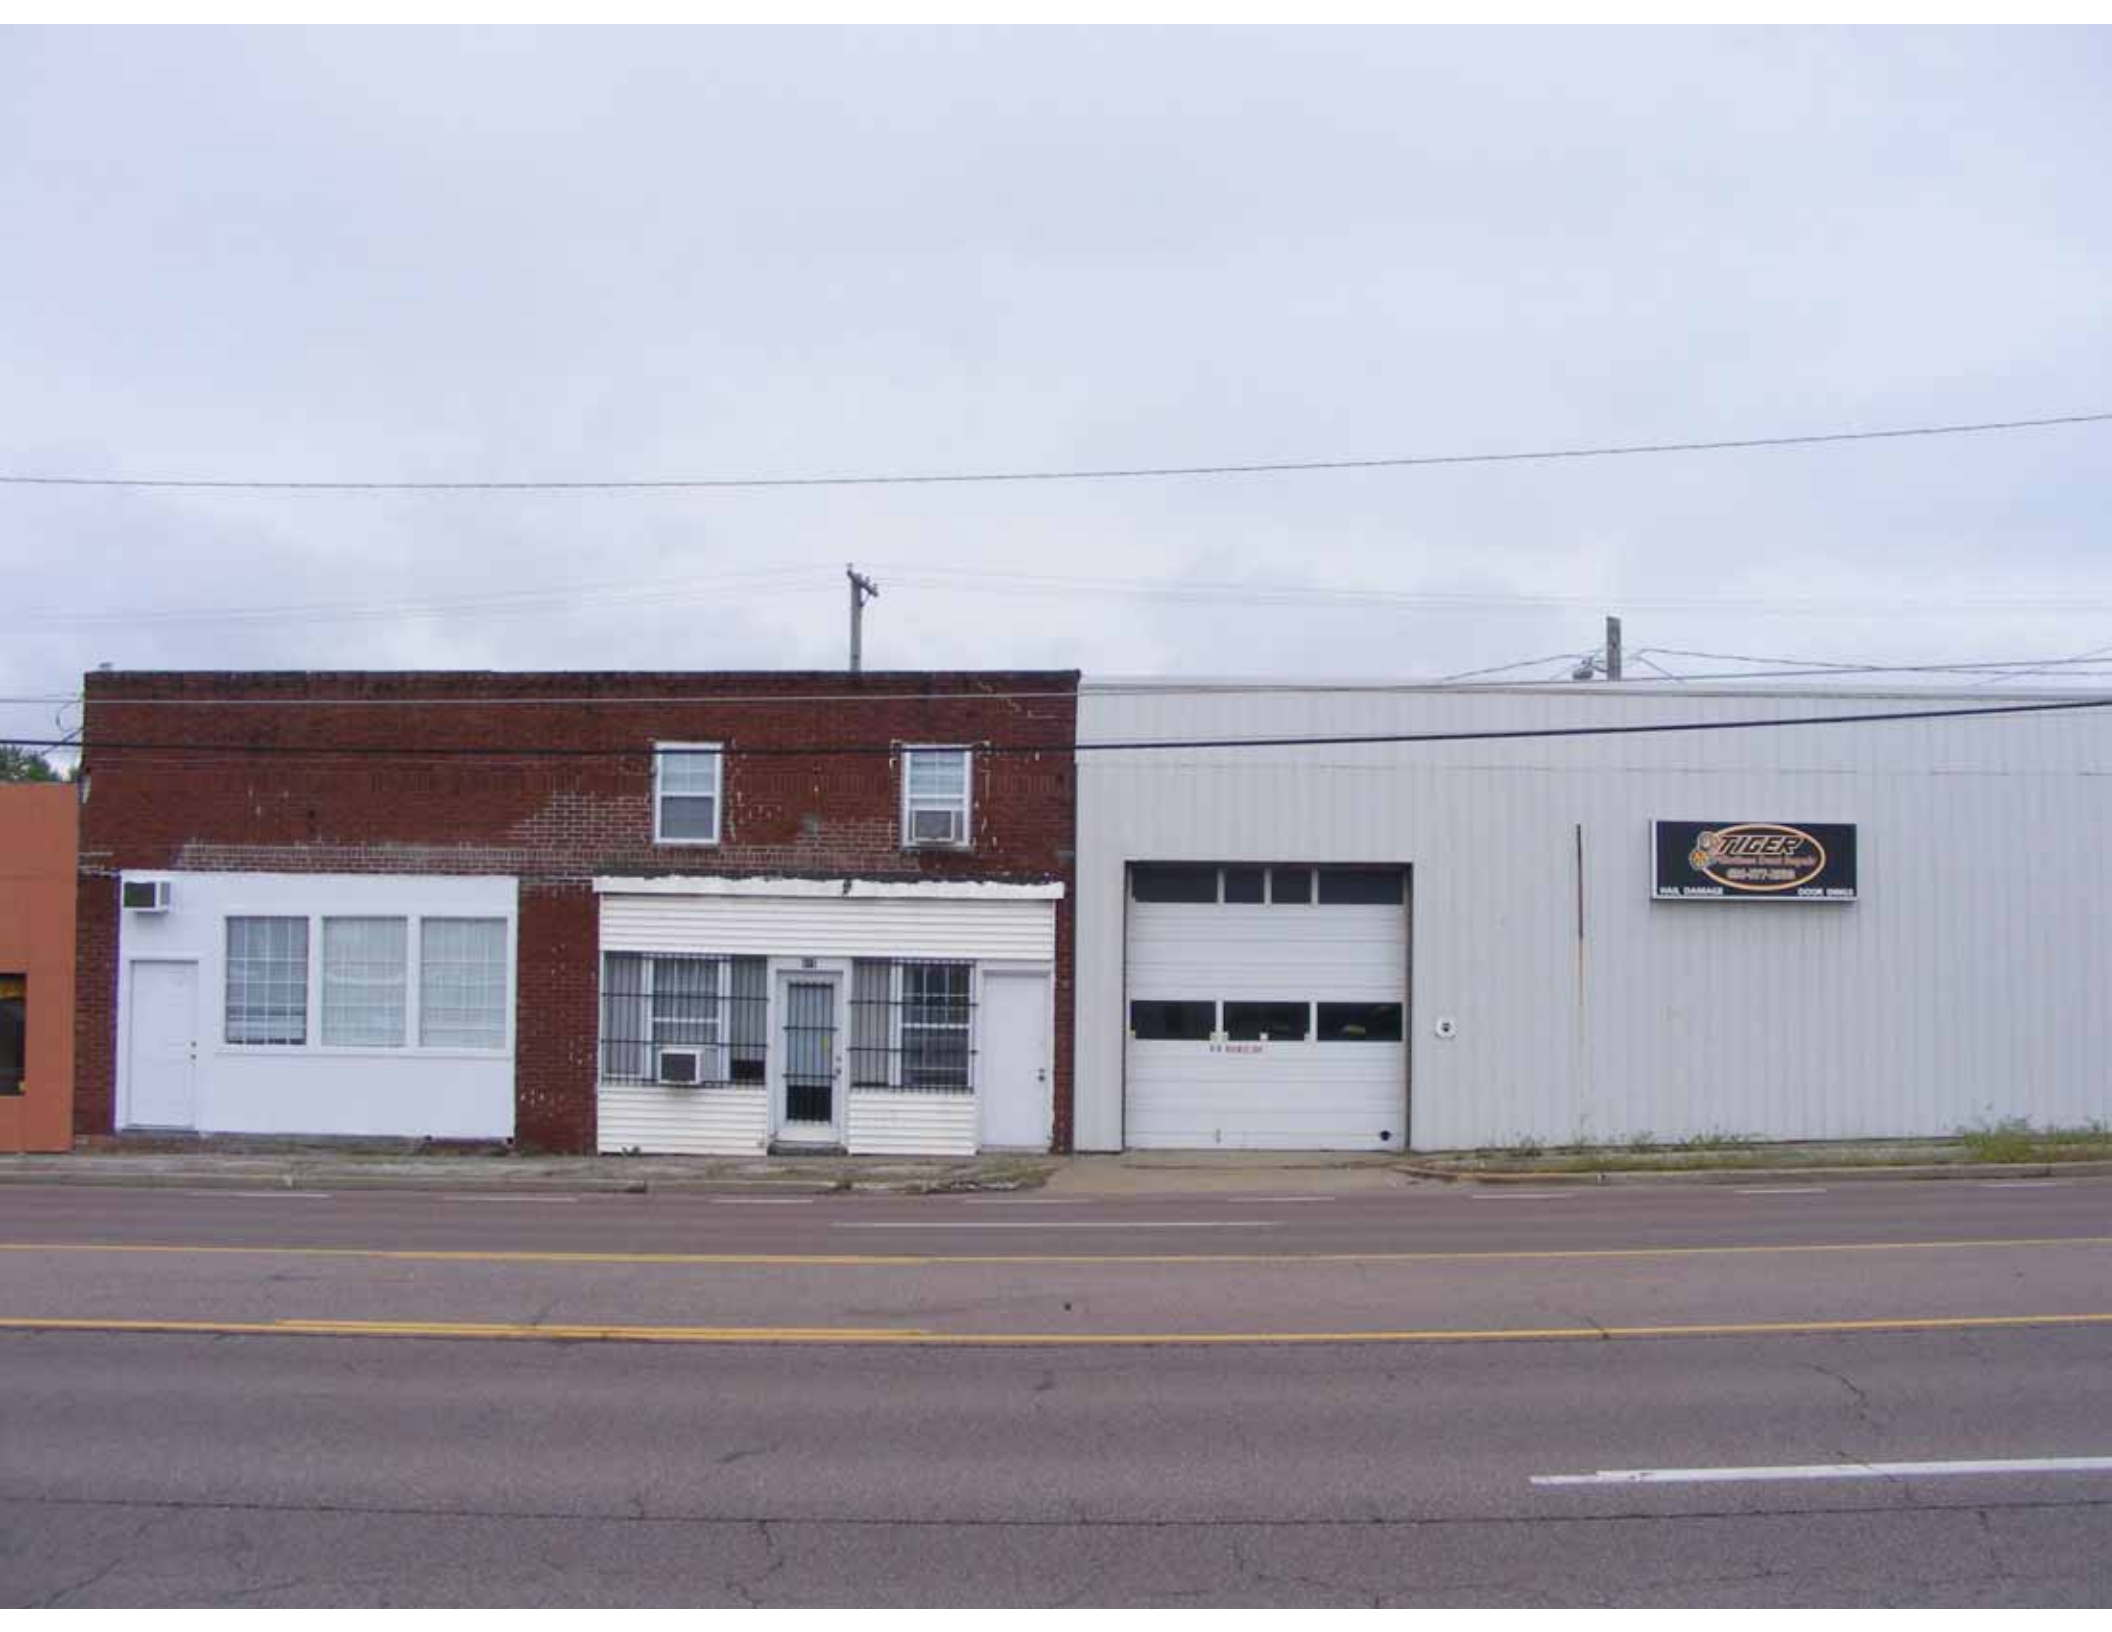
This two-story building has a flat roof, exterior brick walls and a concrete/brick foundation. On the primary (north) elevation are two first-floor commercial bays. The east commercial bay has a solid pedestrian door offset by three multi-sash windows. The west commercial bay has a central single-light original commercial door flanked by tripartite windows, each consisting of a six-over-six replacement window flanked by single-sash sidelights. The west window bay has only one sidelight (east); the west sidelight has been eliminated due to the addition of a contemporary solid door. Synthetic siding surrounds the commercial bay. Above the west commercial bay are two six-over-six replacement windows. The rear (south) elevation has two doors on the first floor – each is a c. 2015 paneled door with an upper fanlight. The doors are offset by one-over-one windows. The upper story has single doors offset by windows, leading to a frame balcony (c. 2015). The balconies join in the center and provide frame steps leading to the first-floor level. The rear (south) entries are addressed as 815 (west) and 817 (east) E. Business Loop 70.
