MISSOURI DEPARTMENT OF NATURAL RESOURCES
STATE HISTORIC PRESERVATION OFFICE, P.O. Box 176, Jefferson City, MO 65102
ARCHITECTURAL/HISTORIC INVENTORY FORM

1. Survey No. BO-AS-011-0087		2. Survey name: North Central Columbia Survey Phase II	
3. County: Boone		4. Address (Street No.) 902	Street (name) N. Seventh Street
5. City: Columbia	Vicinity: <input type="checkbox"/>	6. Geographical Reference:	7. Township/Range/Section: T: R: S:
8. Historic name (if known):		9. Present/other name (if known):	
10. Ownership: <input checked="" type="checkbox"/> Private <input type="checkbox"/> Public		11a. Historic use (if known): Domestic/single dwelling	11b. Current use: Domestic/single dwelling

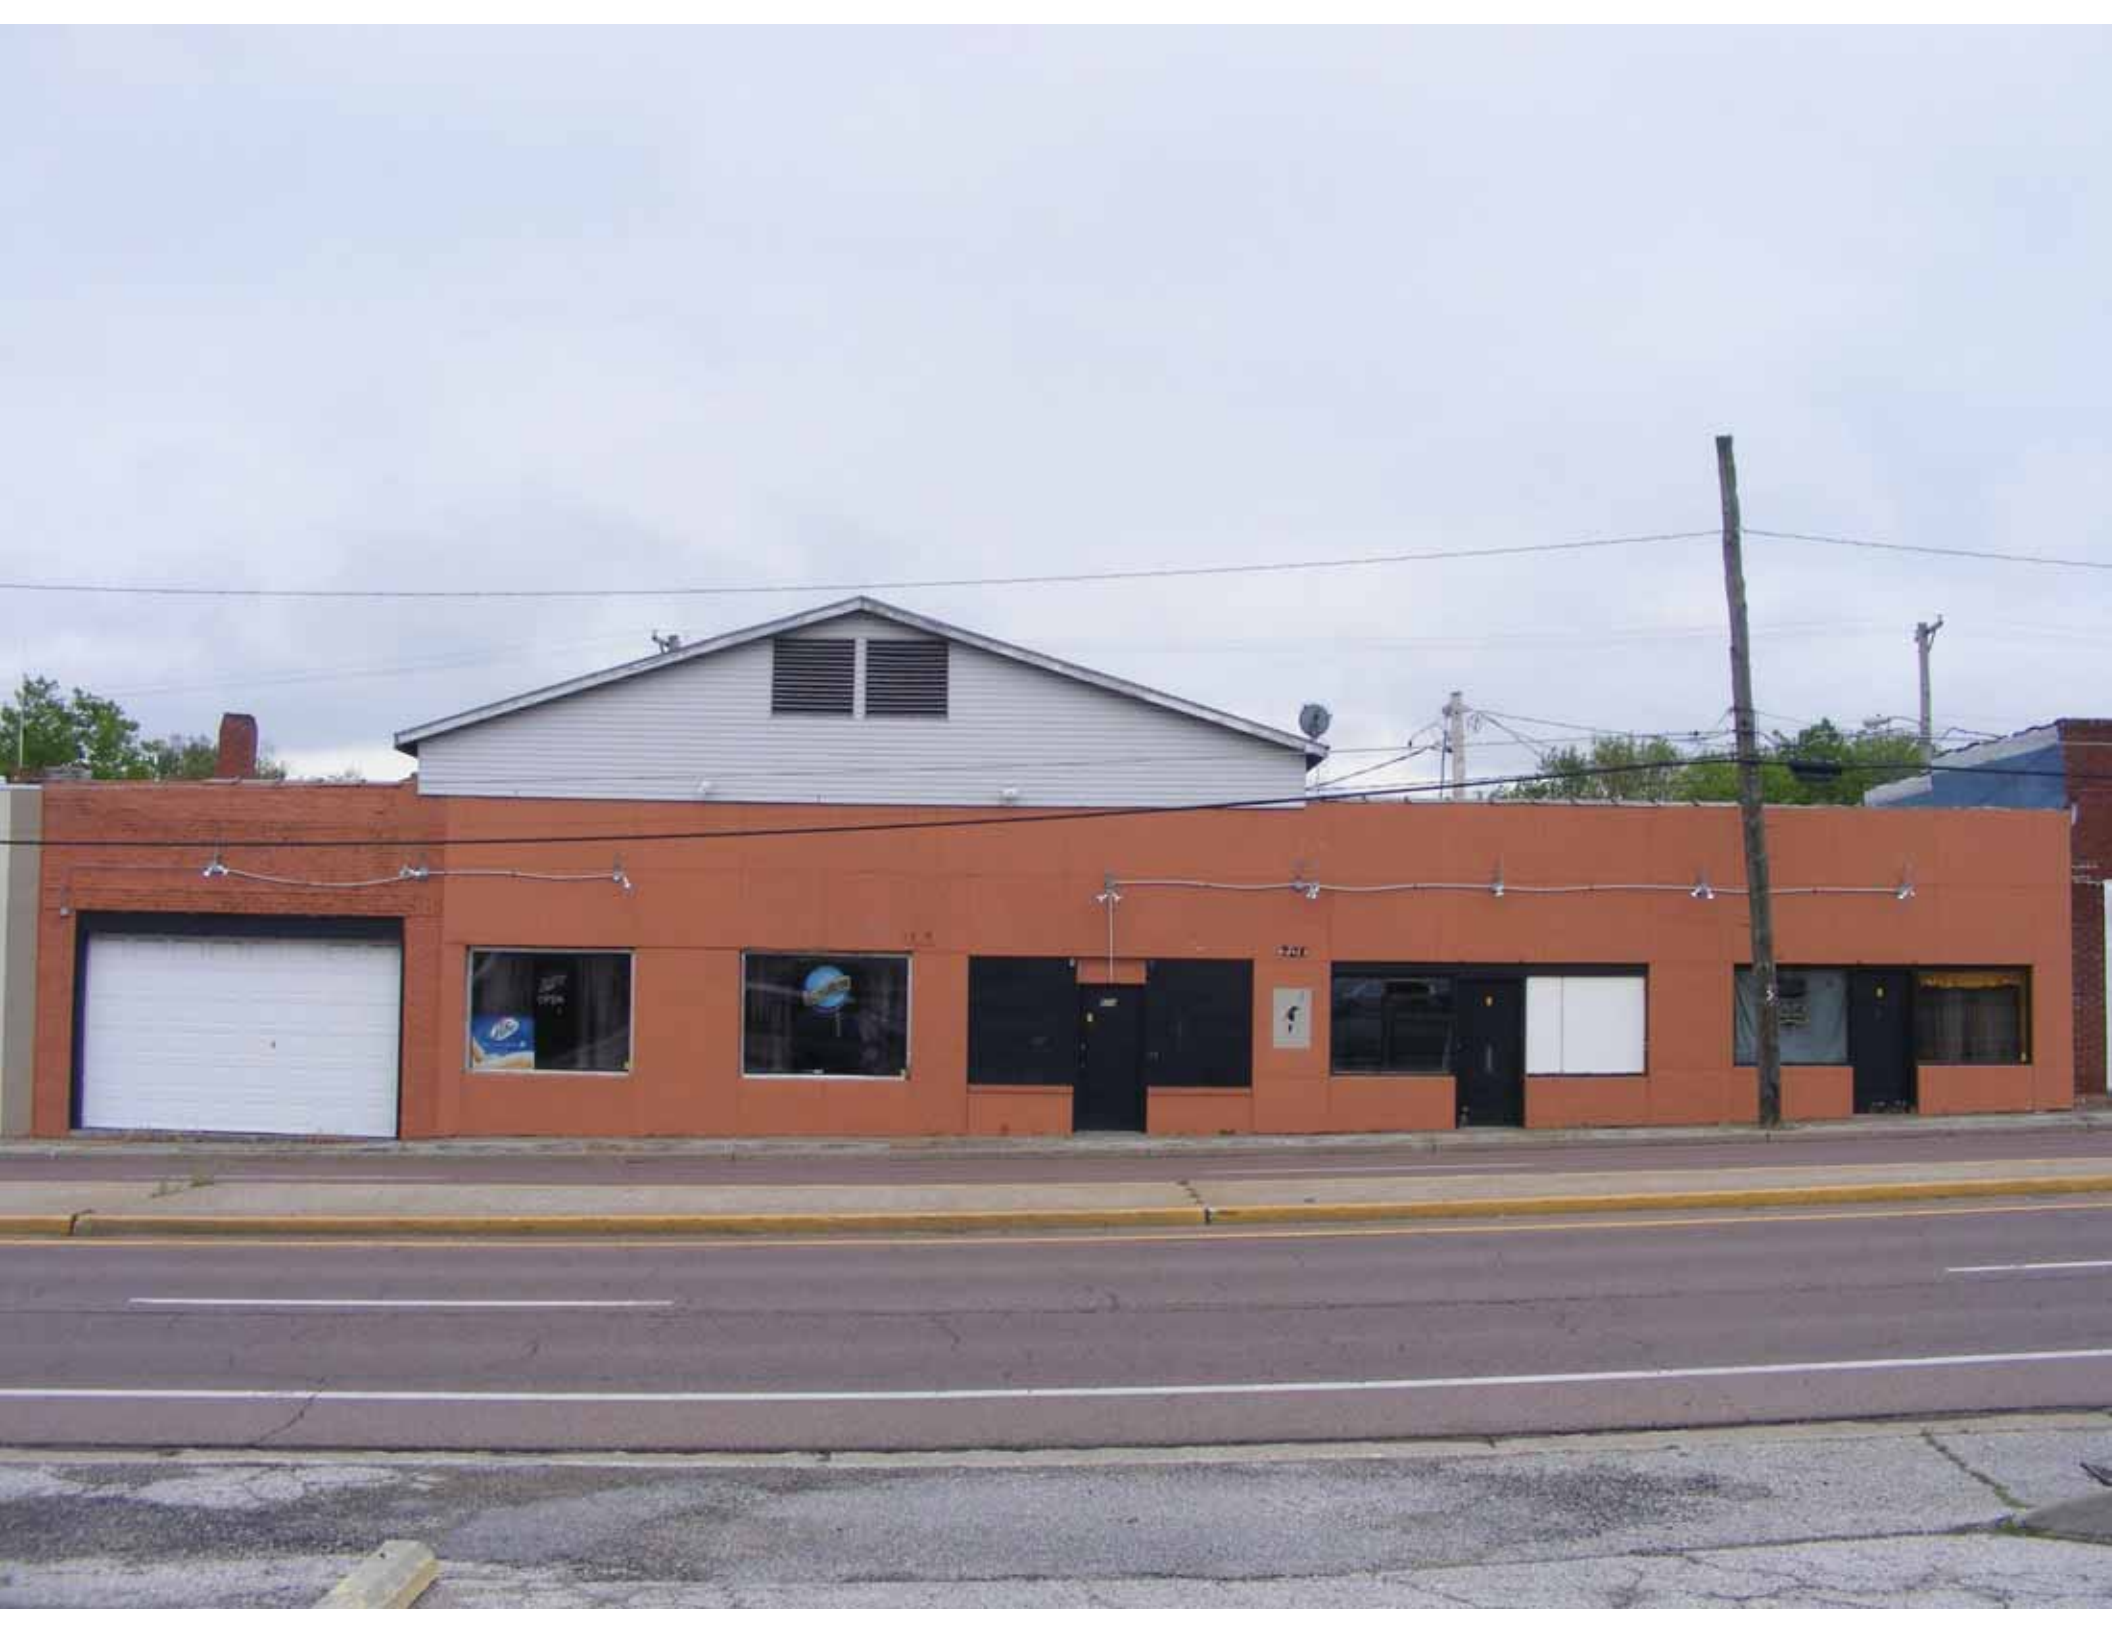
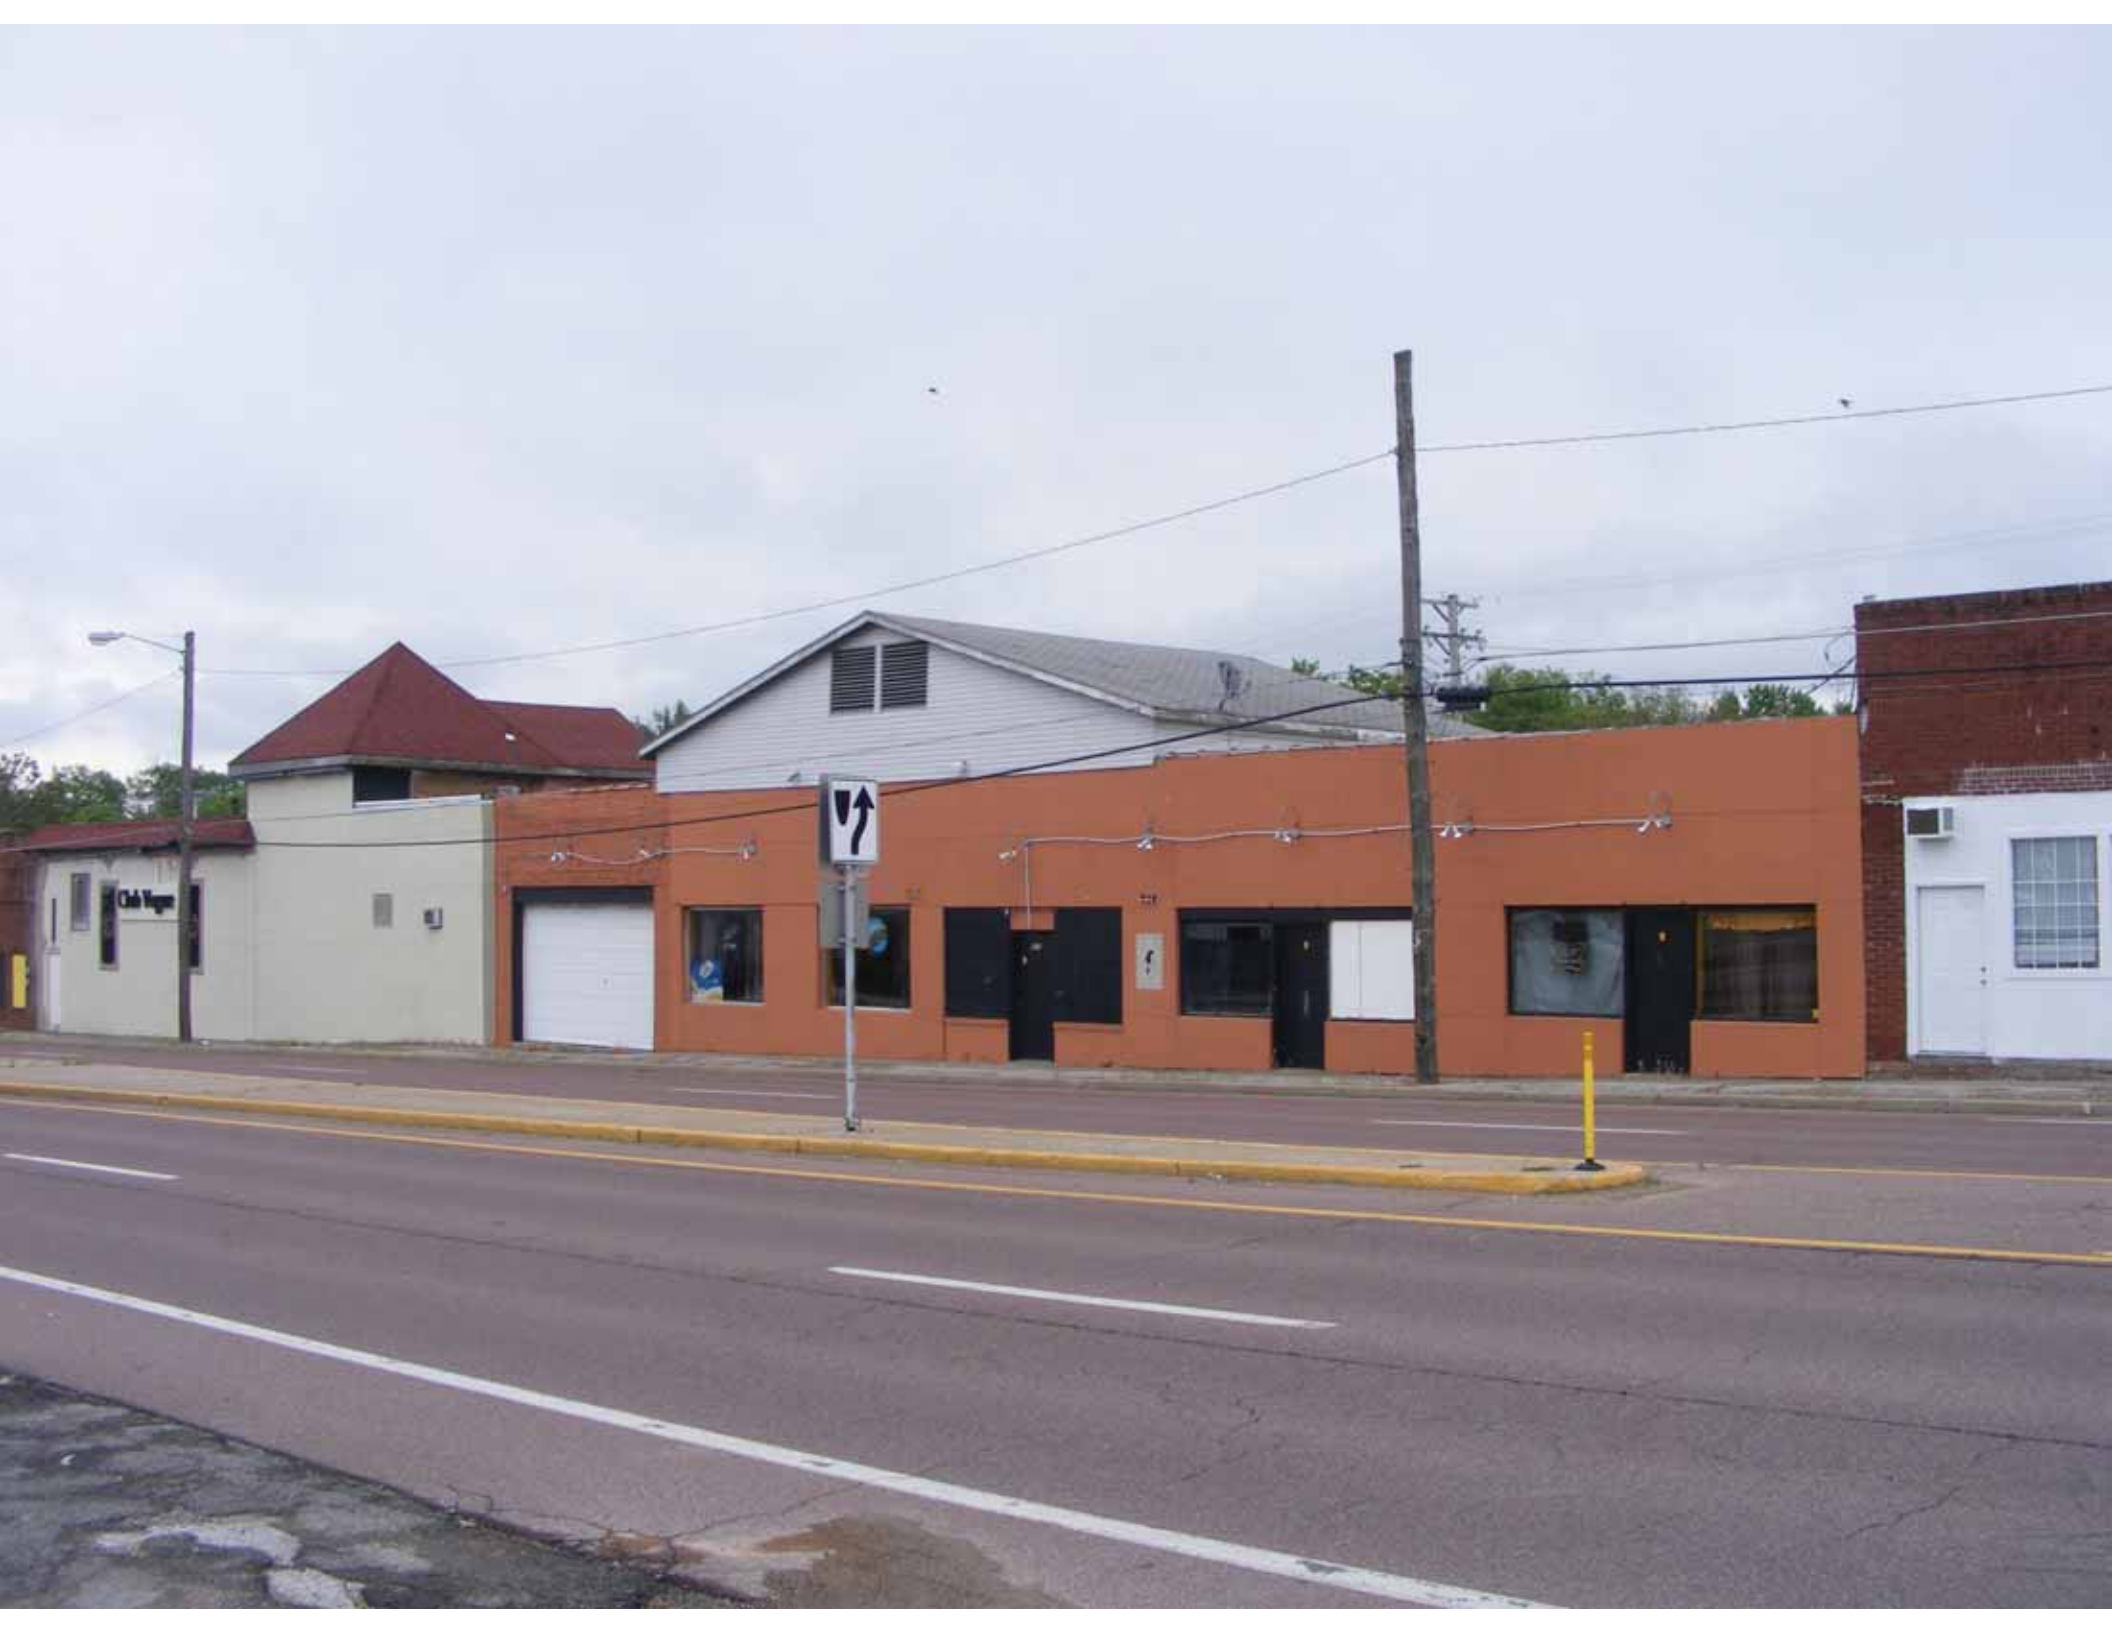
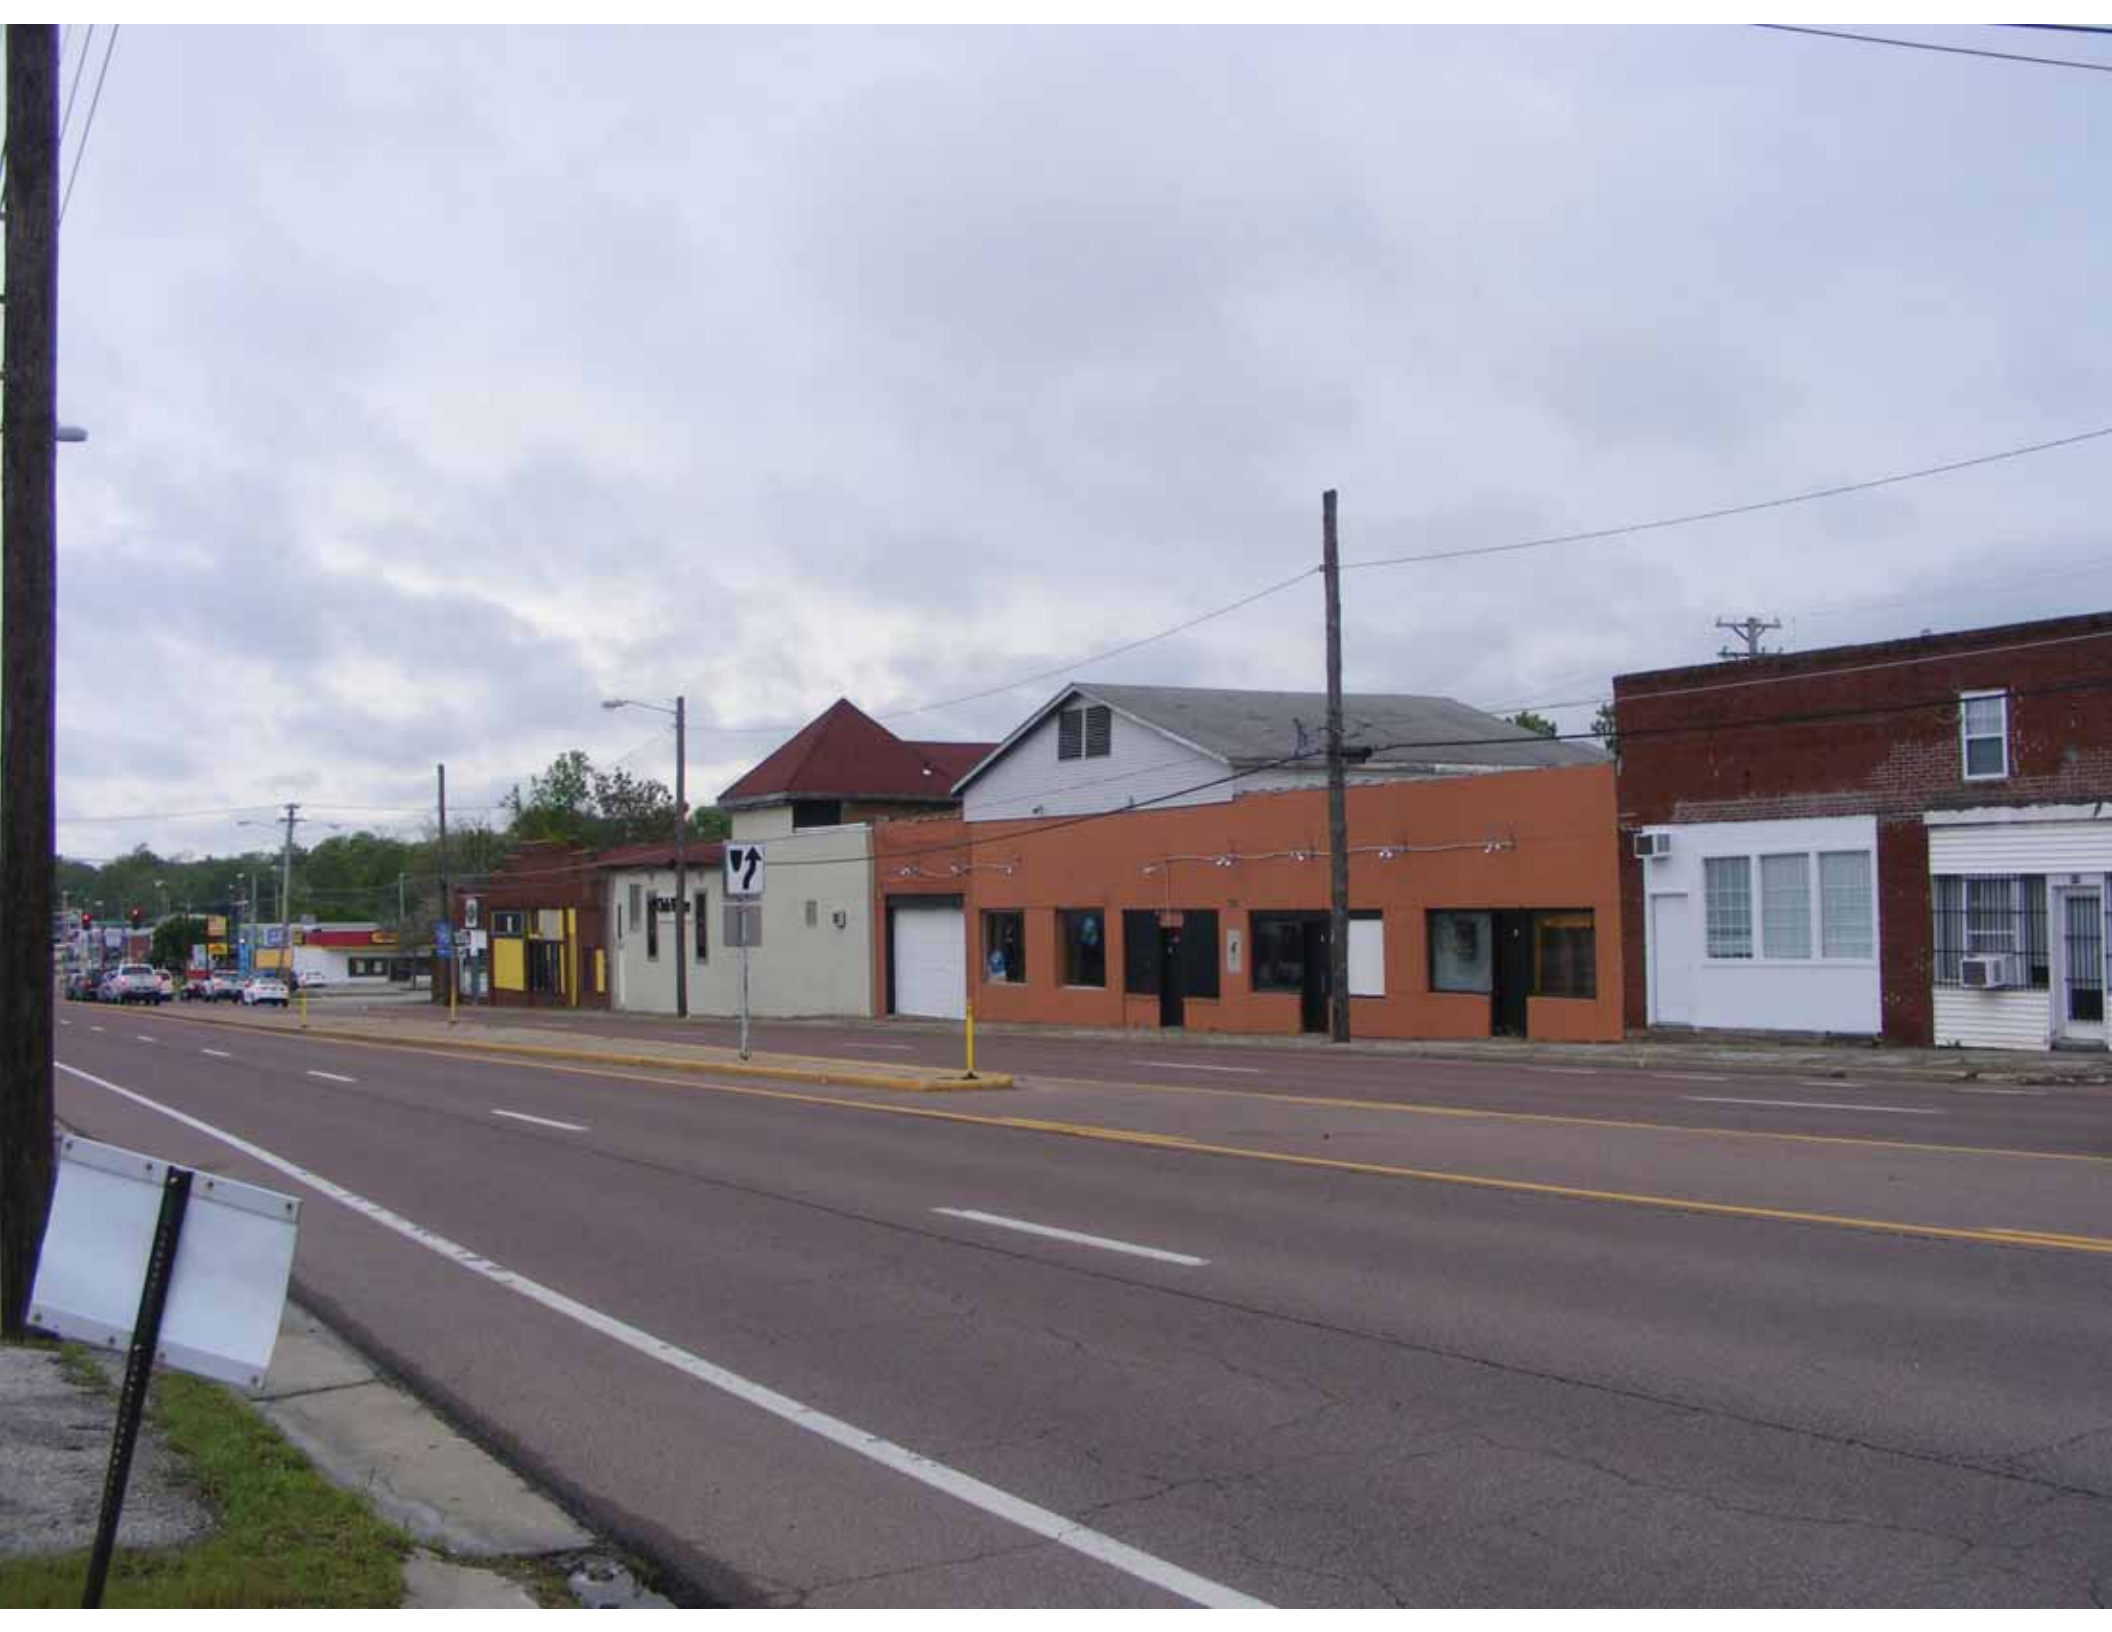
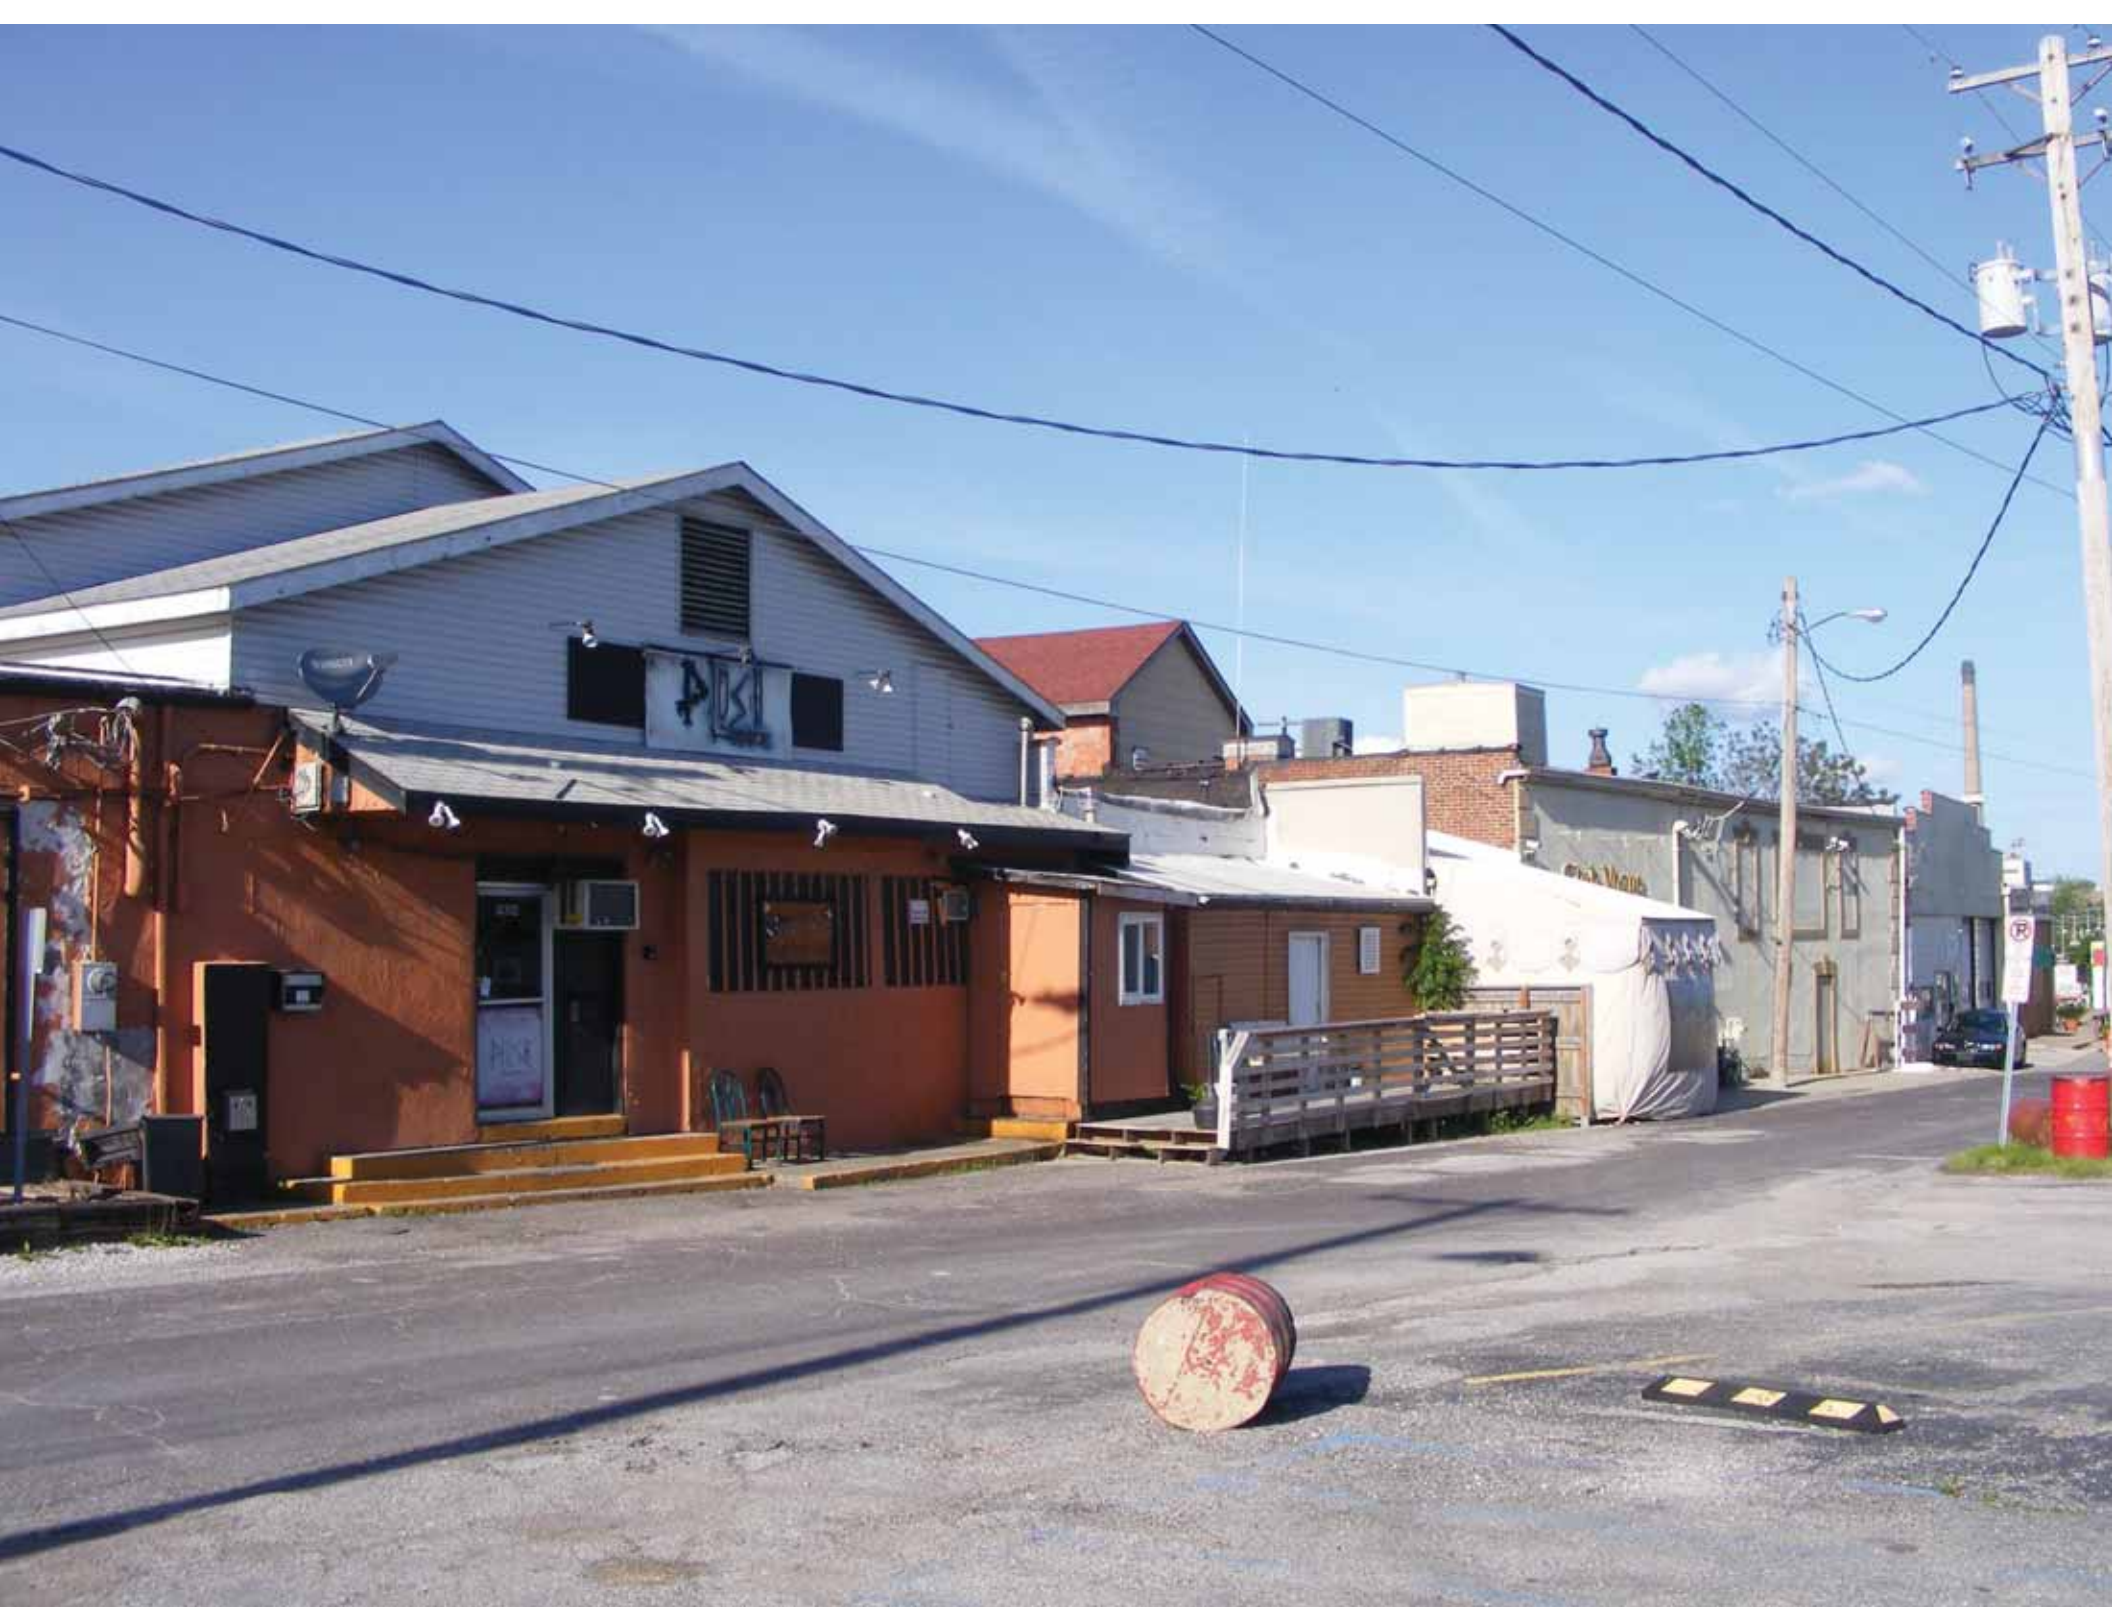
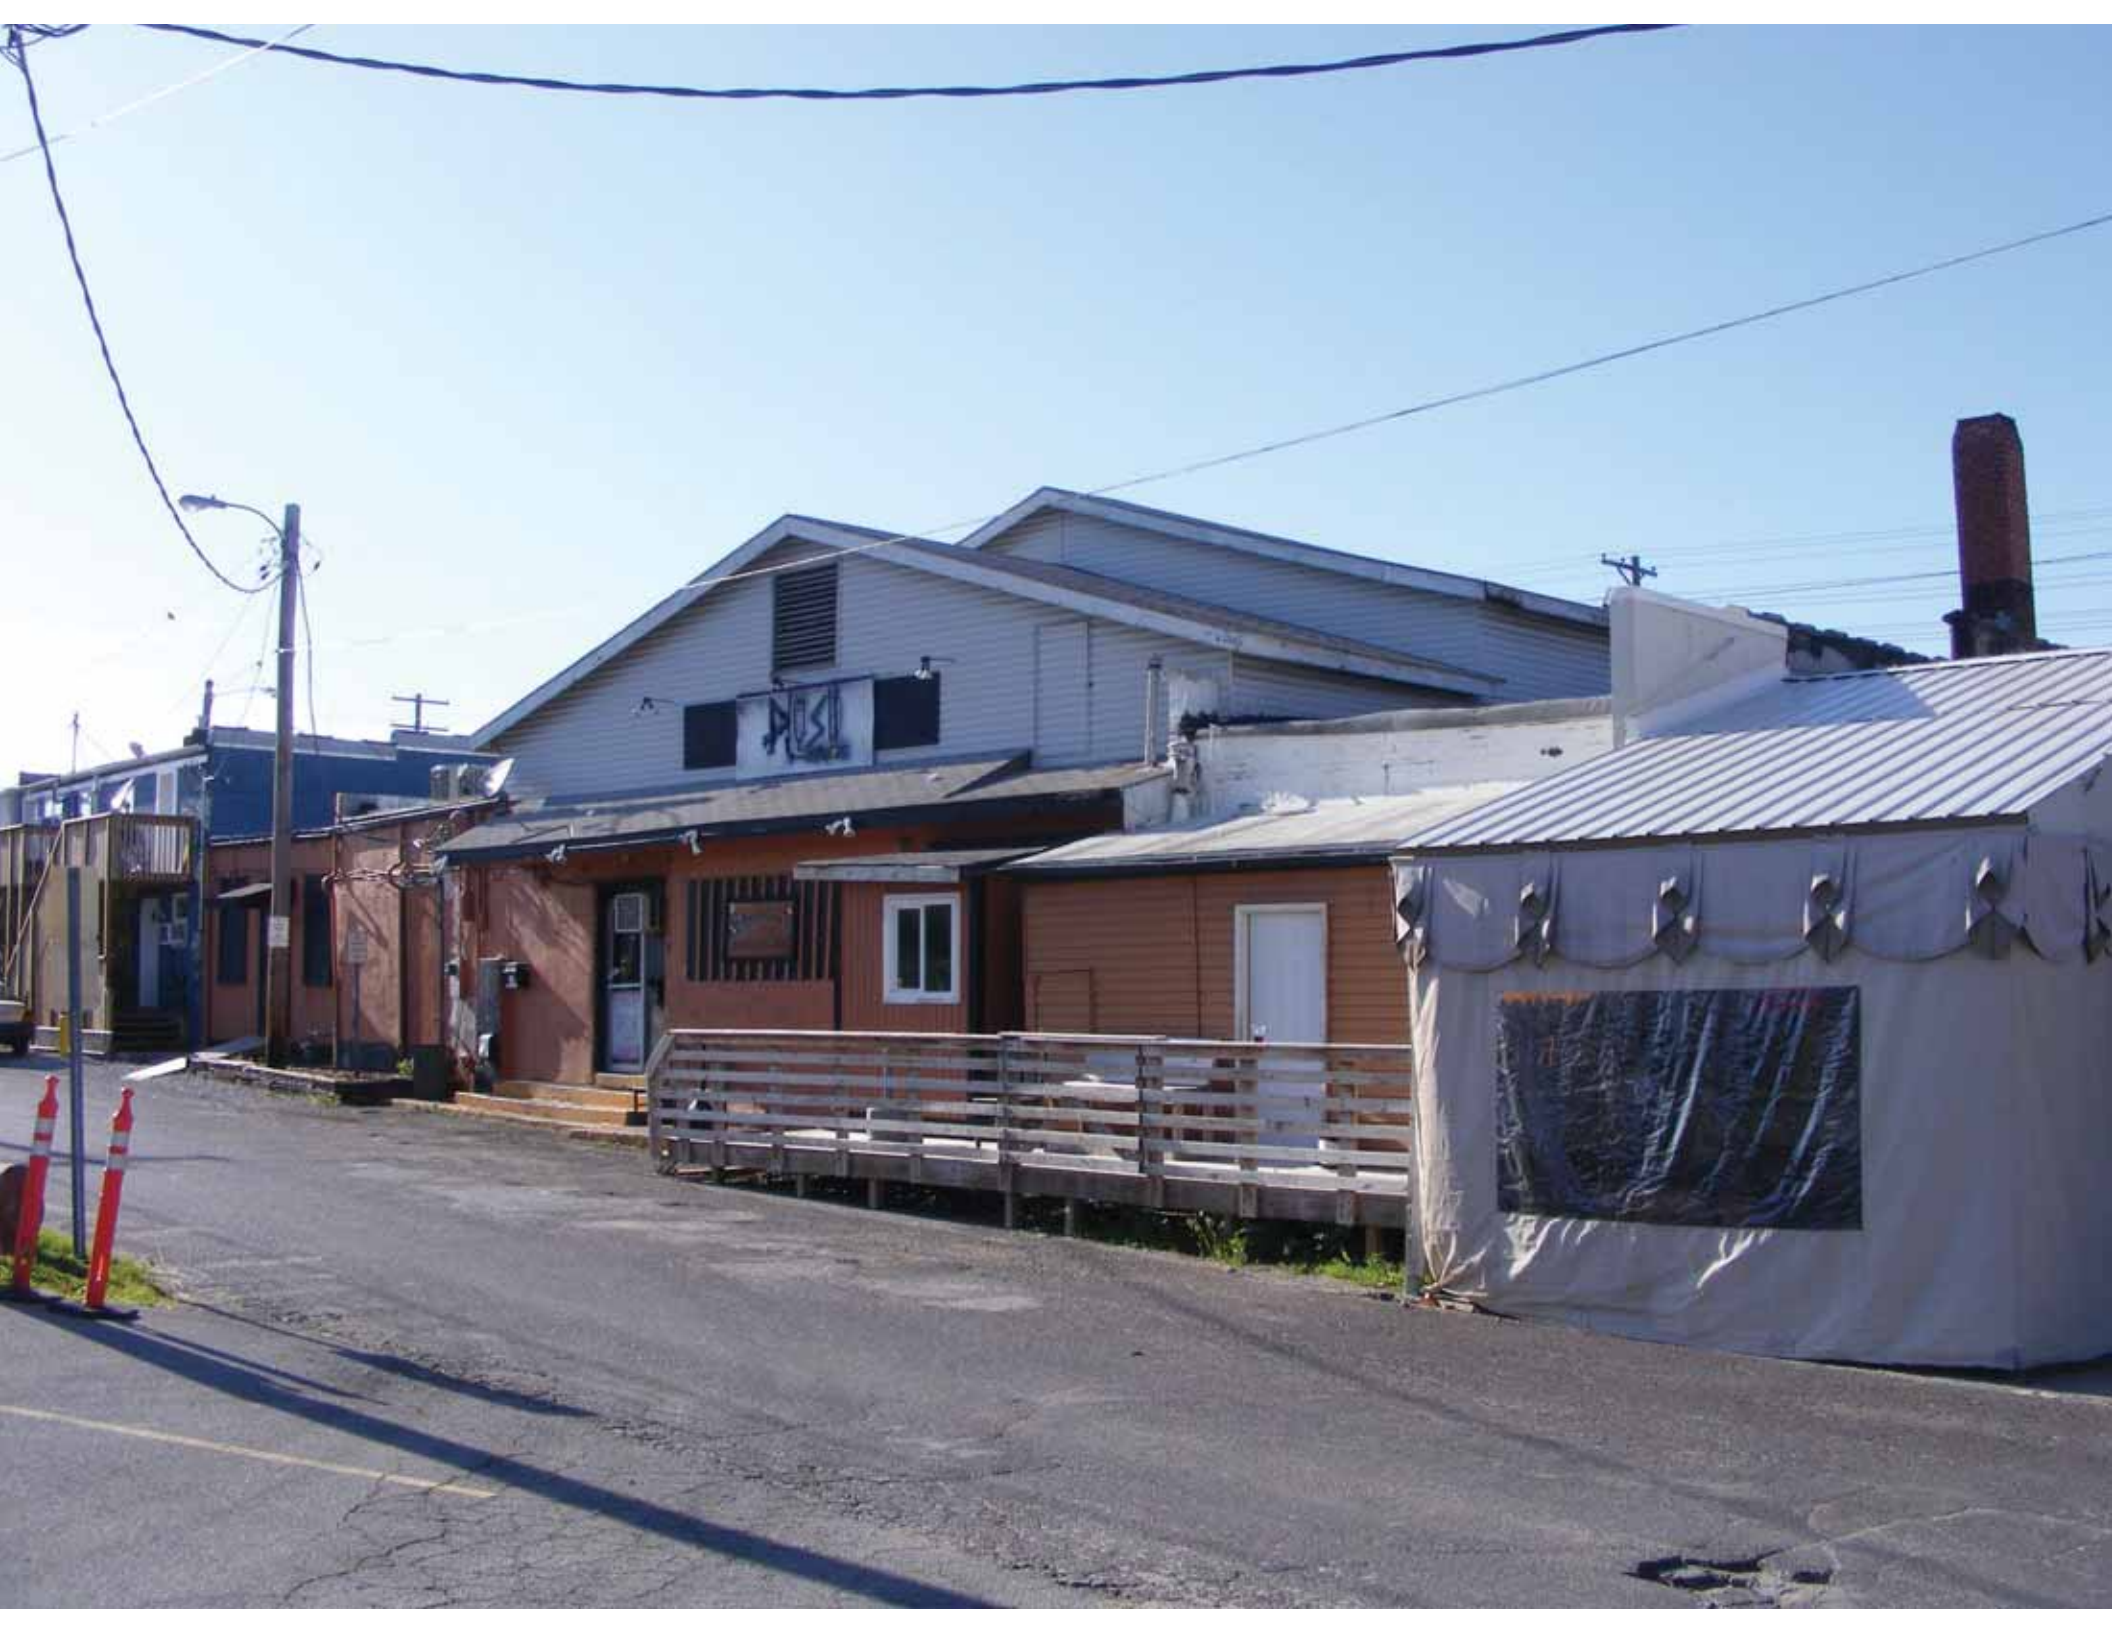
This commercial property is composed of two construction phases. The center of the building, which is the earliest section and likely the former residence, has a gable-front roof that rises above the business façade (north elevation) facing the business loop. The gabled portion of the building is clad with vinyl siding and features paired louvered vents on the façade; a single louvered vent on the rear (south elevation). Fronting the property on the business loop is a wide single-story one-part commercial building (c. 1950). The front wall rising above the wing's flat roof is capped with terra cotta coping. The east end retains an original brick wall. This area holds an overhead track door that is not original. The remaining north elevation is clad with Dryvit panels. The storefront consists of three commercial style doors flanked by fixed commercial windows (remodeled c. 2015). Two fixed commercial style windows (c. 2015) separate these entries from the garage bay on the east end. The rear (south) elevation has three shed wings. Two of the wings support rear pedestrian doors. The central (smallest of the three) supports a two-by-two sliding window. A frame ramp with a balustrade flanks the smallest wing and shed wing on the east end.
