MISSOURI DEPARTMENT OF NATURAL RESOURCES
STATE HISTORIC PRESERVATION OFFICE, P.O. Box 176, Jefferson City, MO 65102
ARCHITECTURAL/HISTORIC INVENTORY FORM

1. Survey No. BO-AS-011-0087		2. Survey name: North Central Columbia Survey Phase II	
3. County: Boone		4. Address (Street No.) 902	Street (name) N. Seventh Street
5. City: Columbia	Vicinity: <input type="checkbox"/>	6. Geographical Reference:	7. Township/Range/Section: T: R: S:
8. Historic name (if known):		9. Present/other name (if known):	
10. Ownership: <input checked="" type="checkbox"/> Private <input type="checkbox"/> Public		11a. Historic use (if known): Domestic/single dwelling	11b. Current use: Domestic/single dwelling

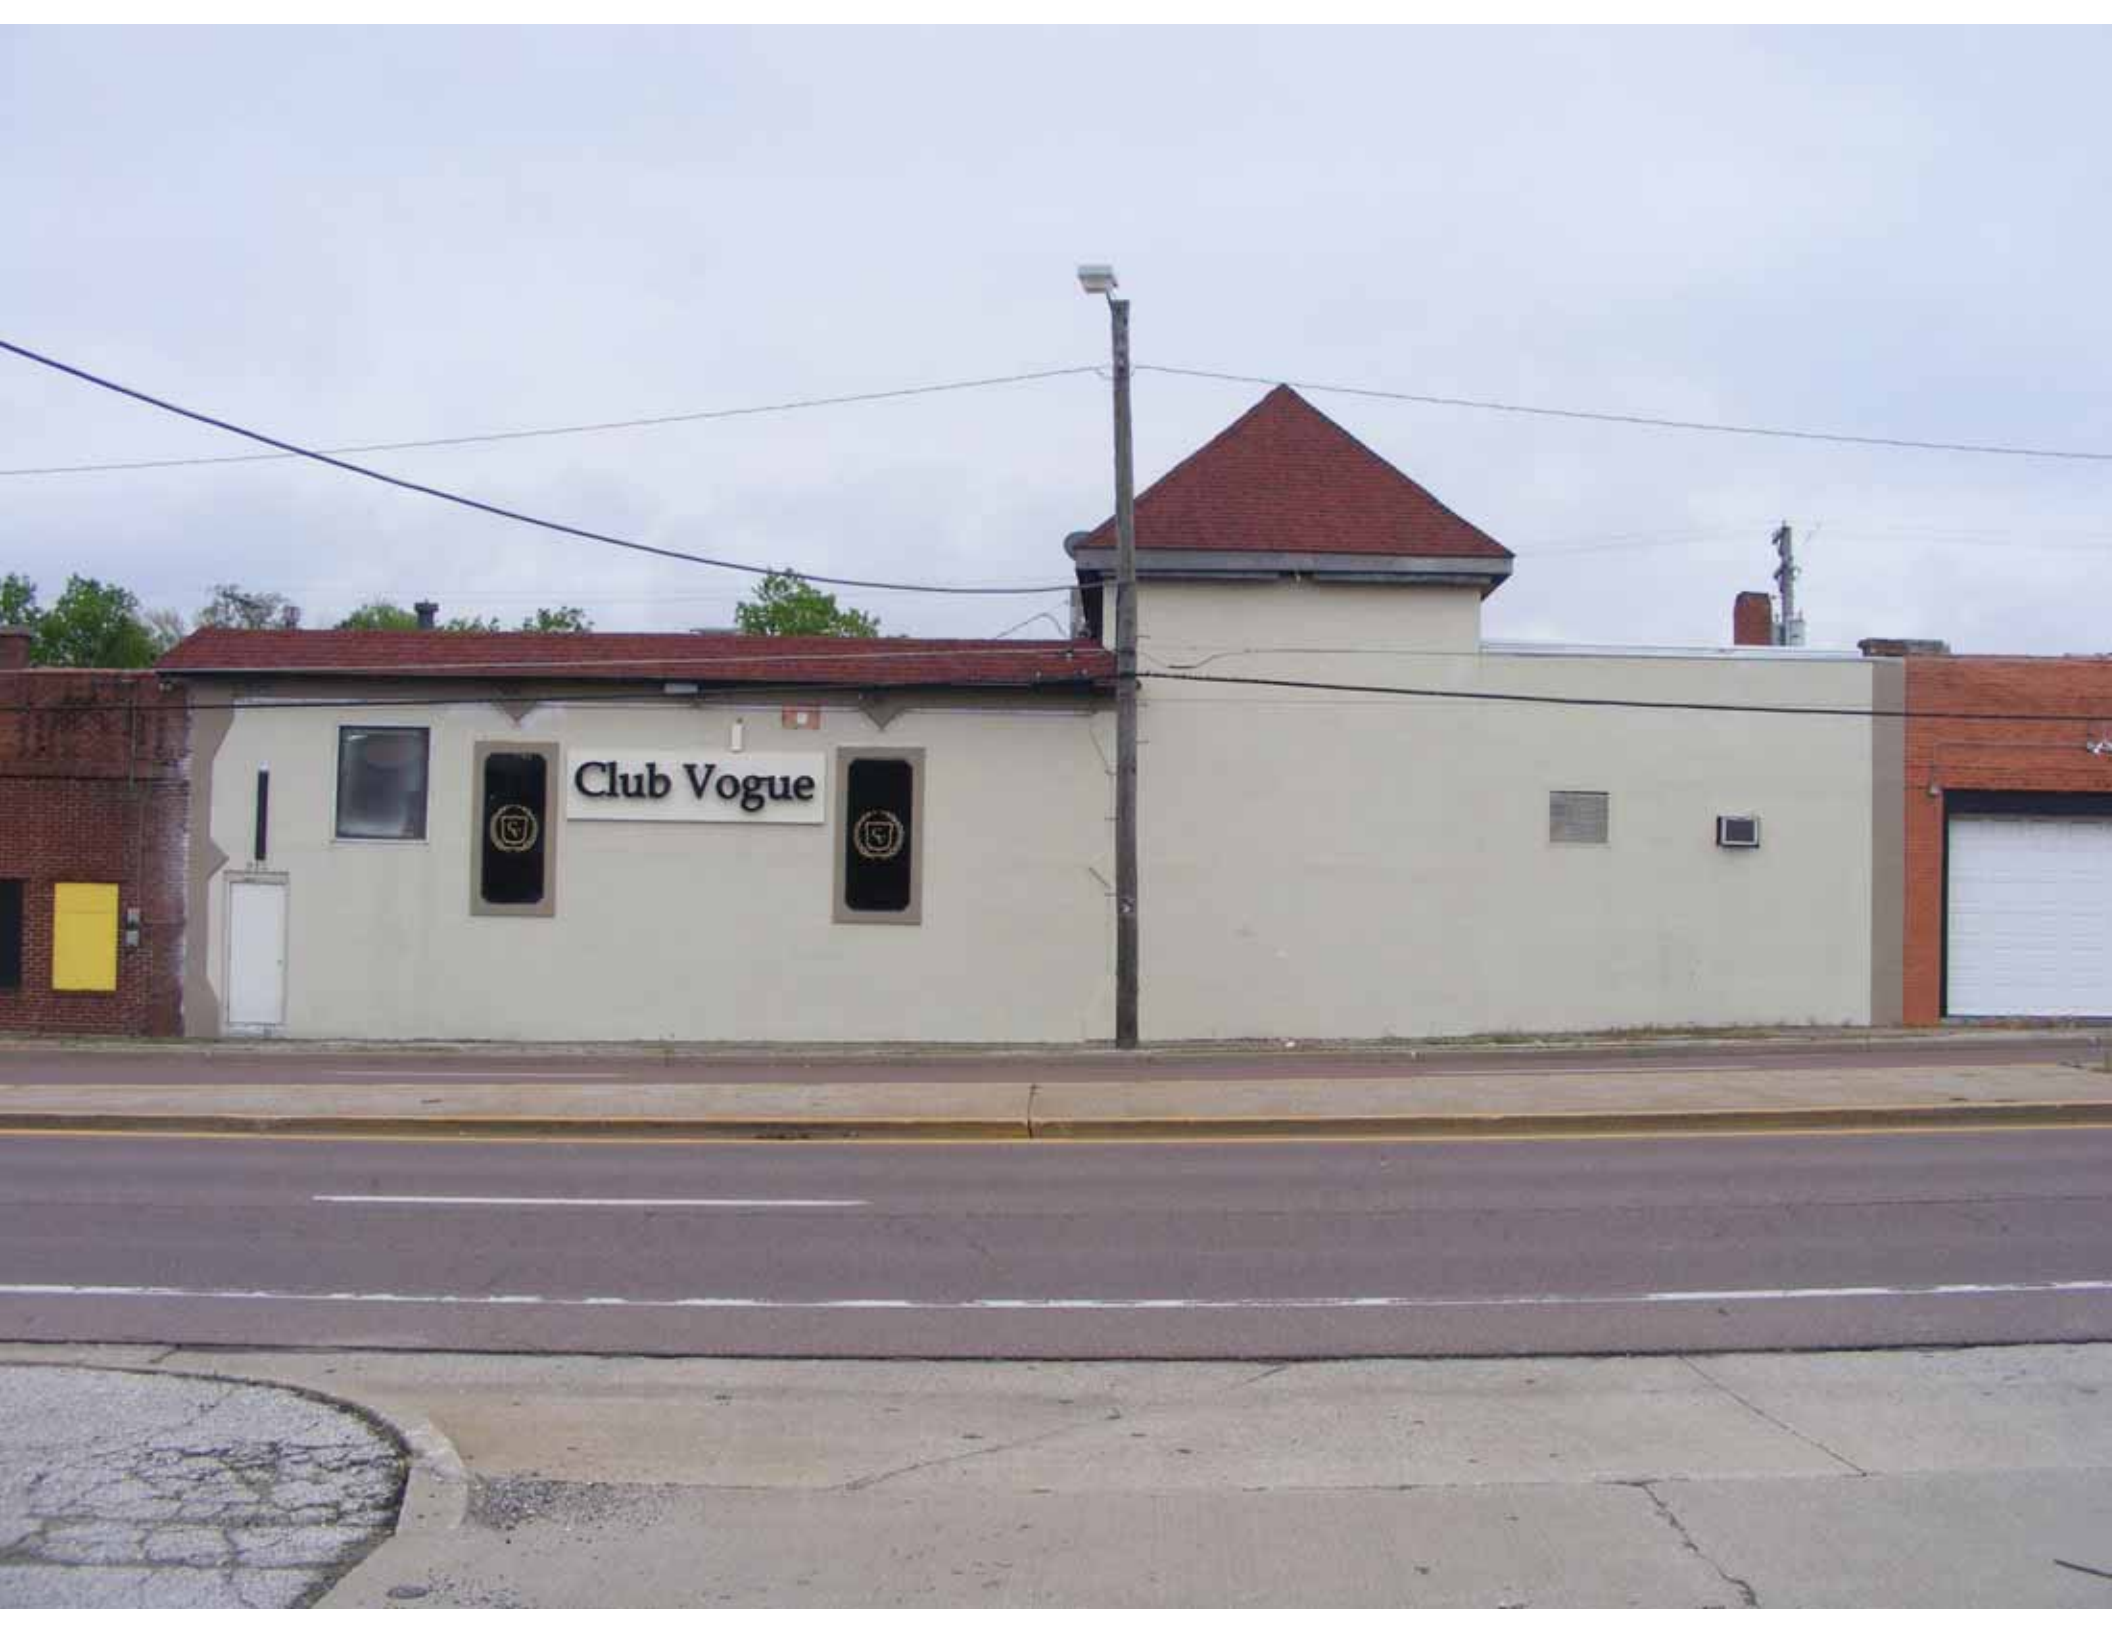
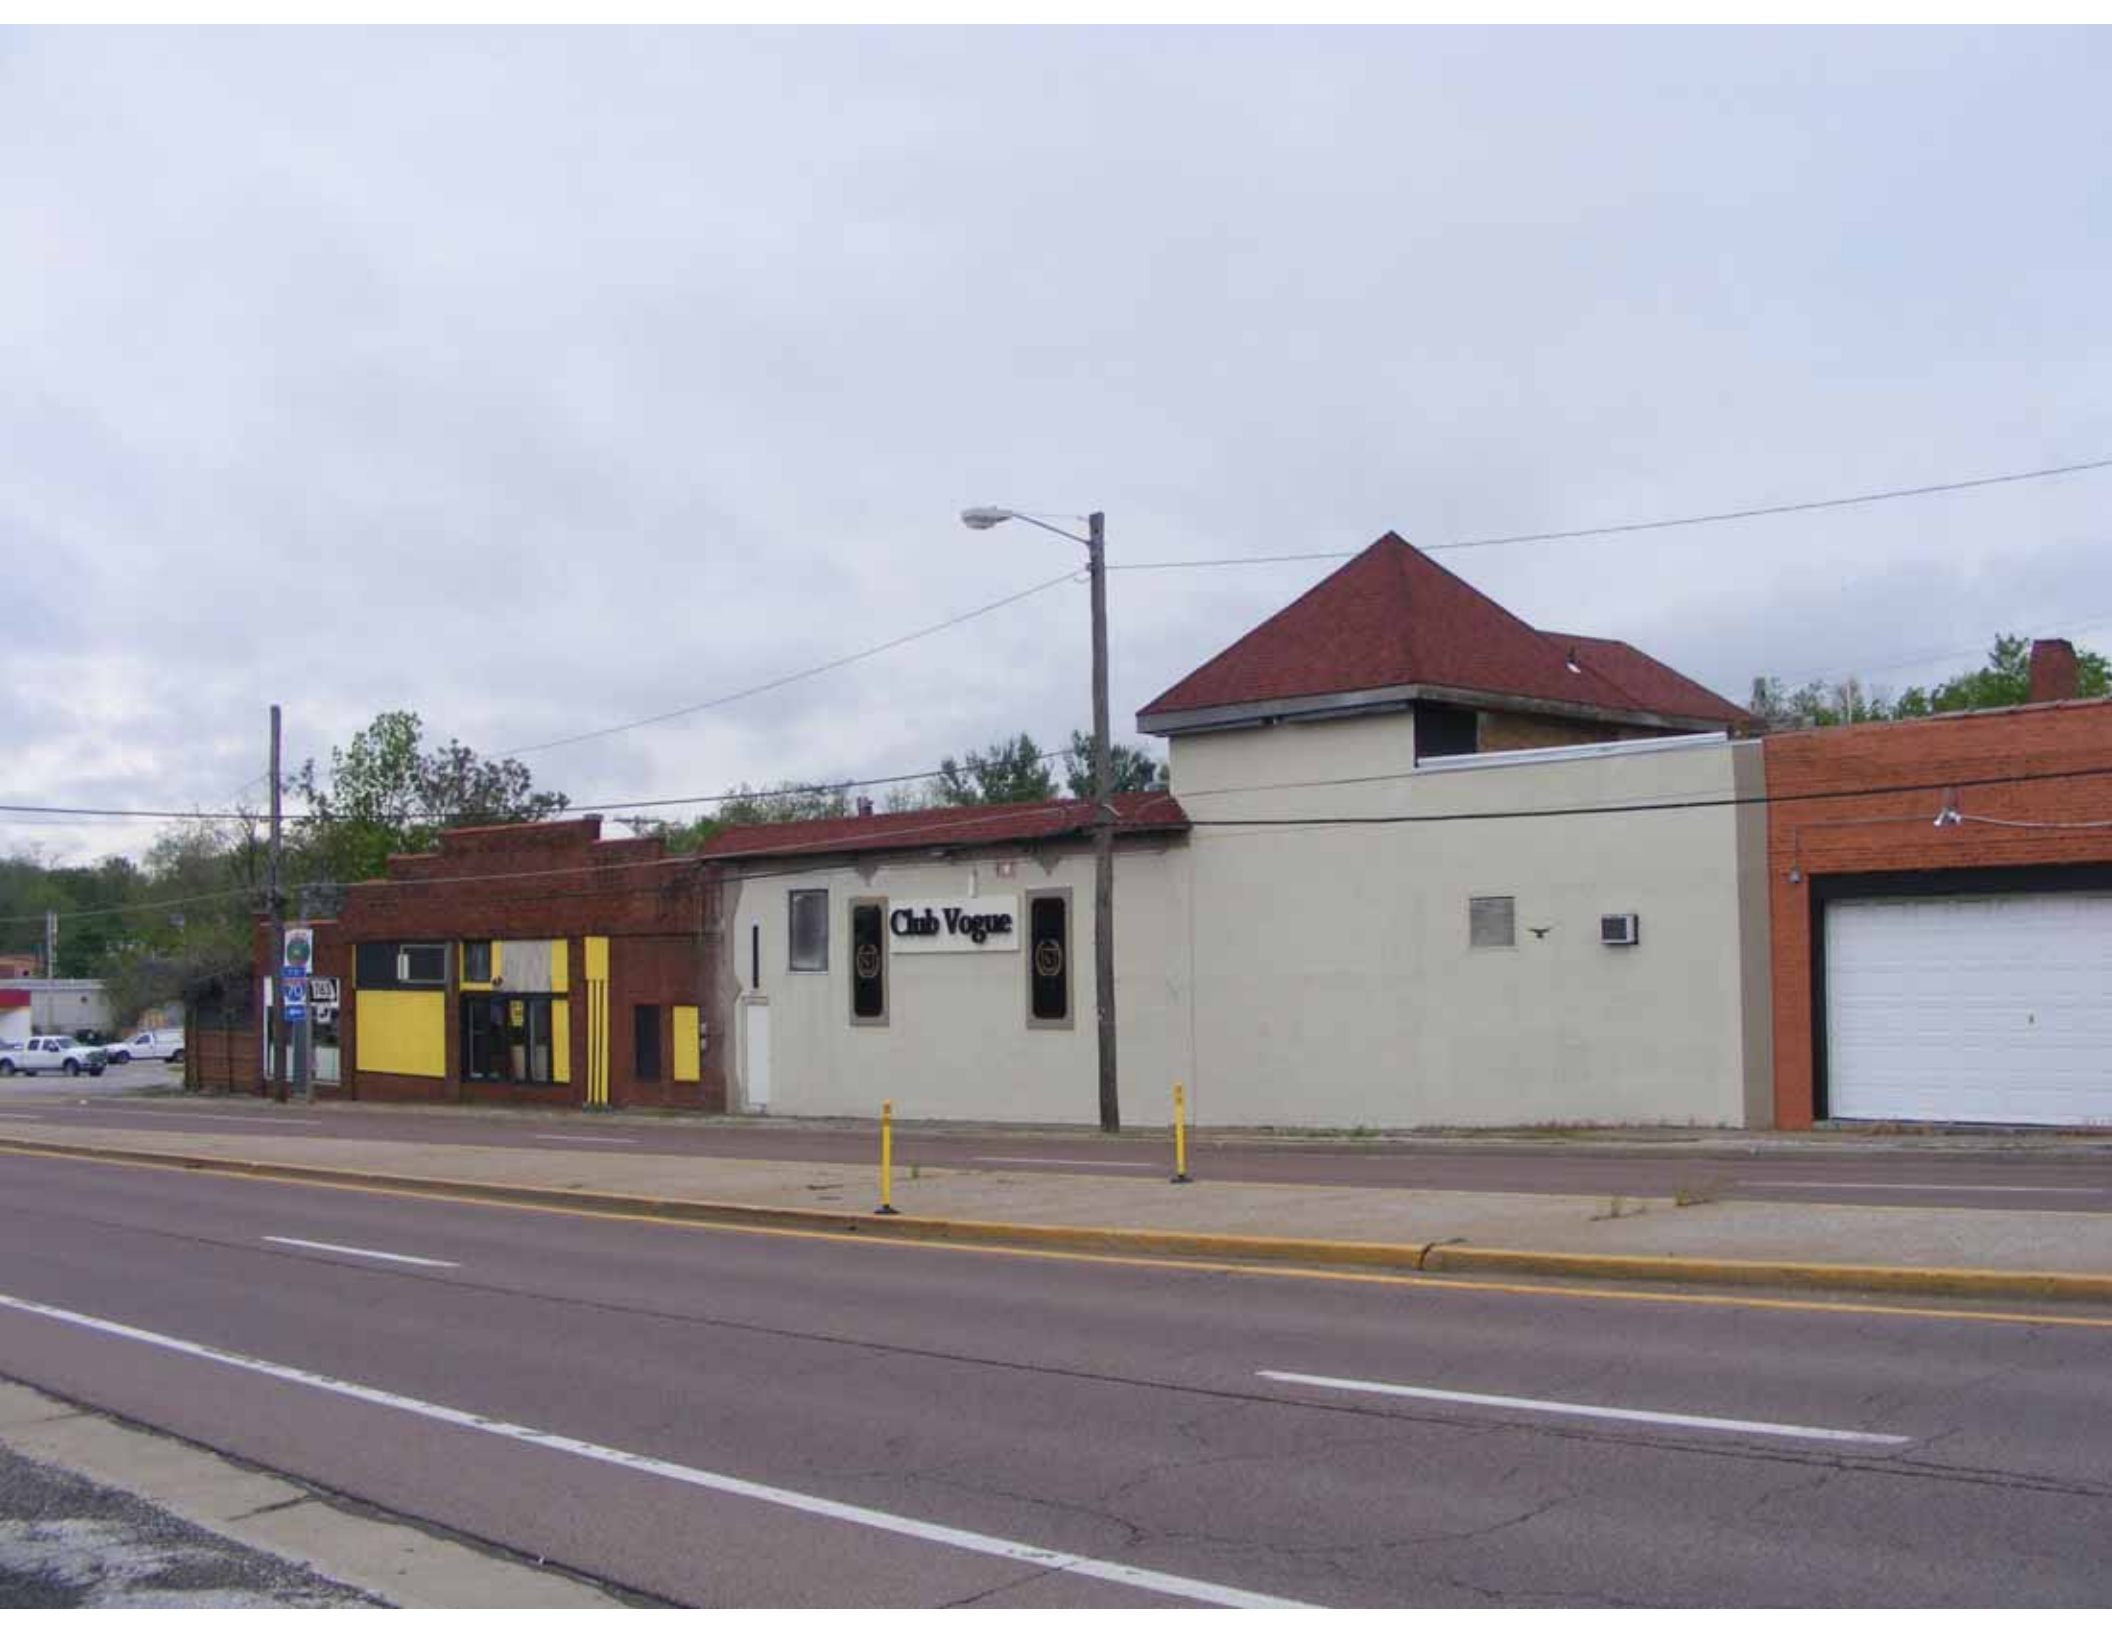
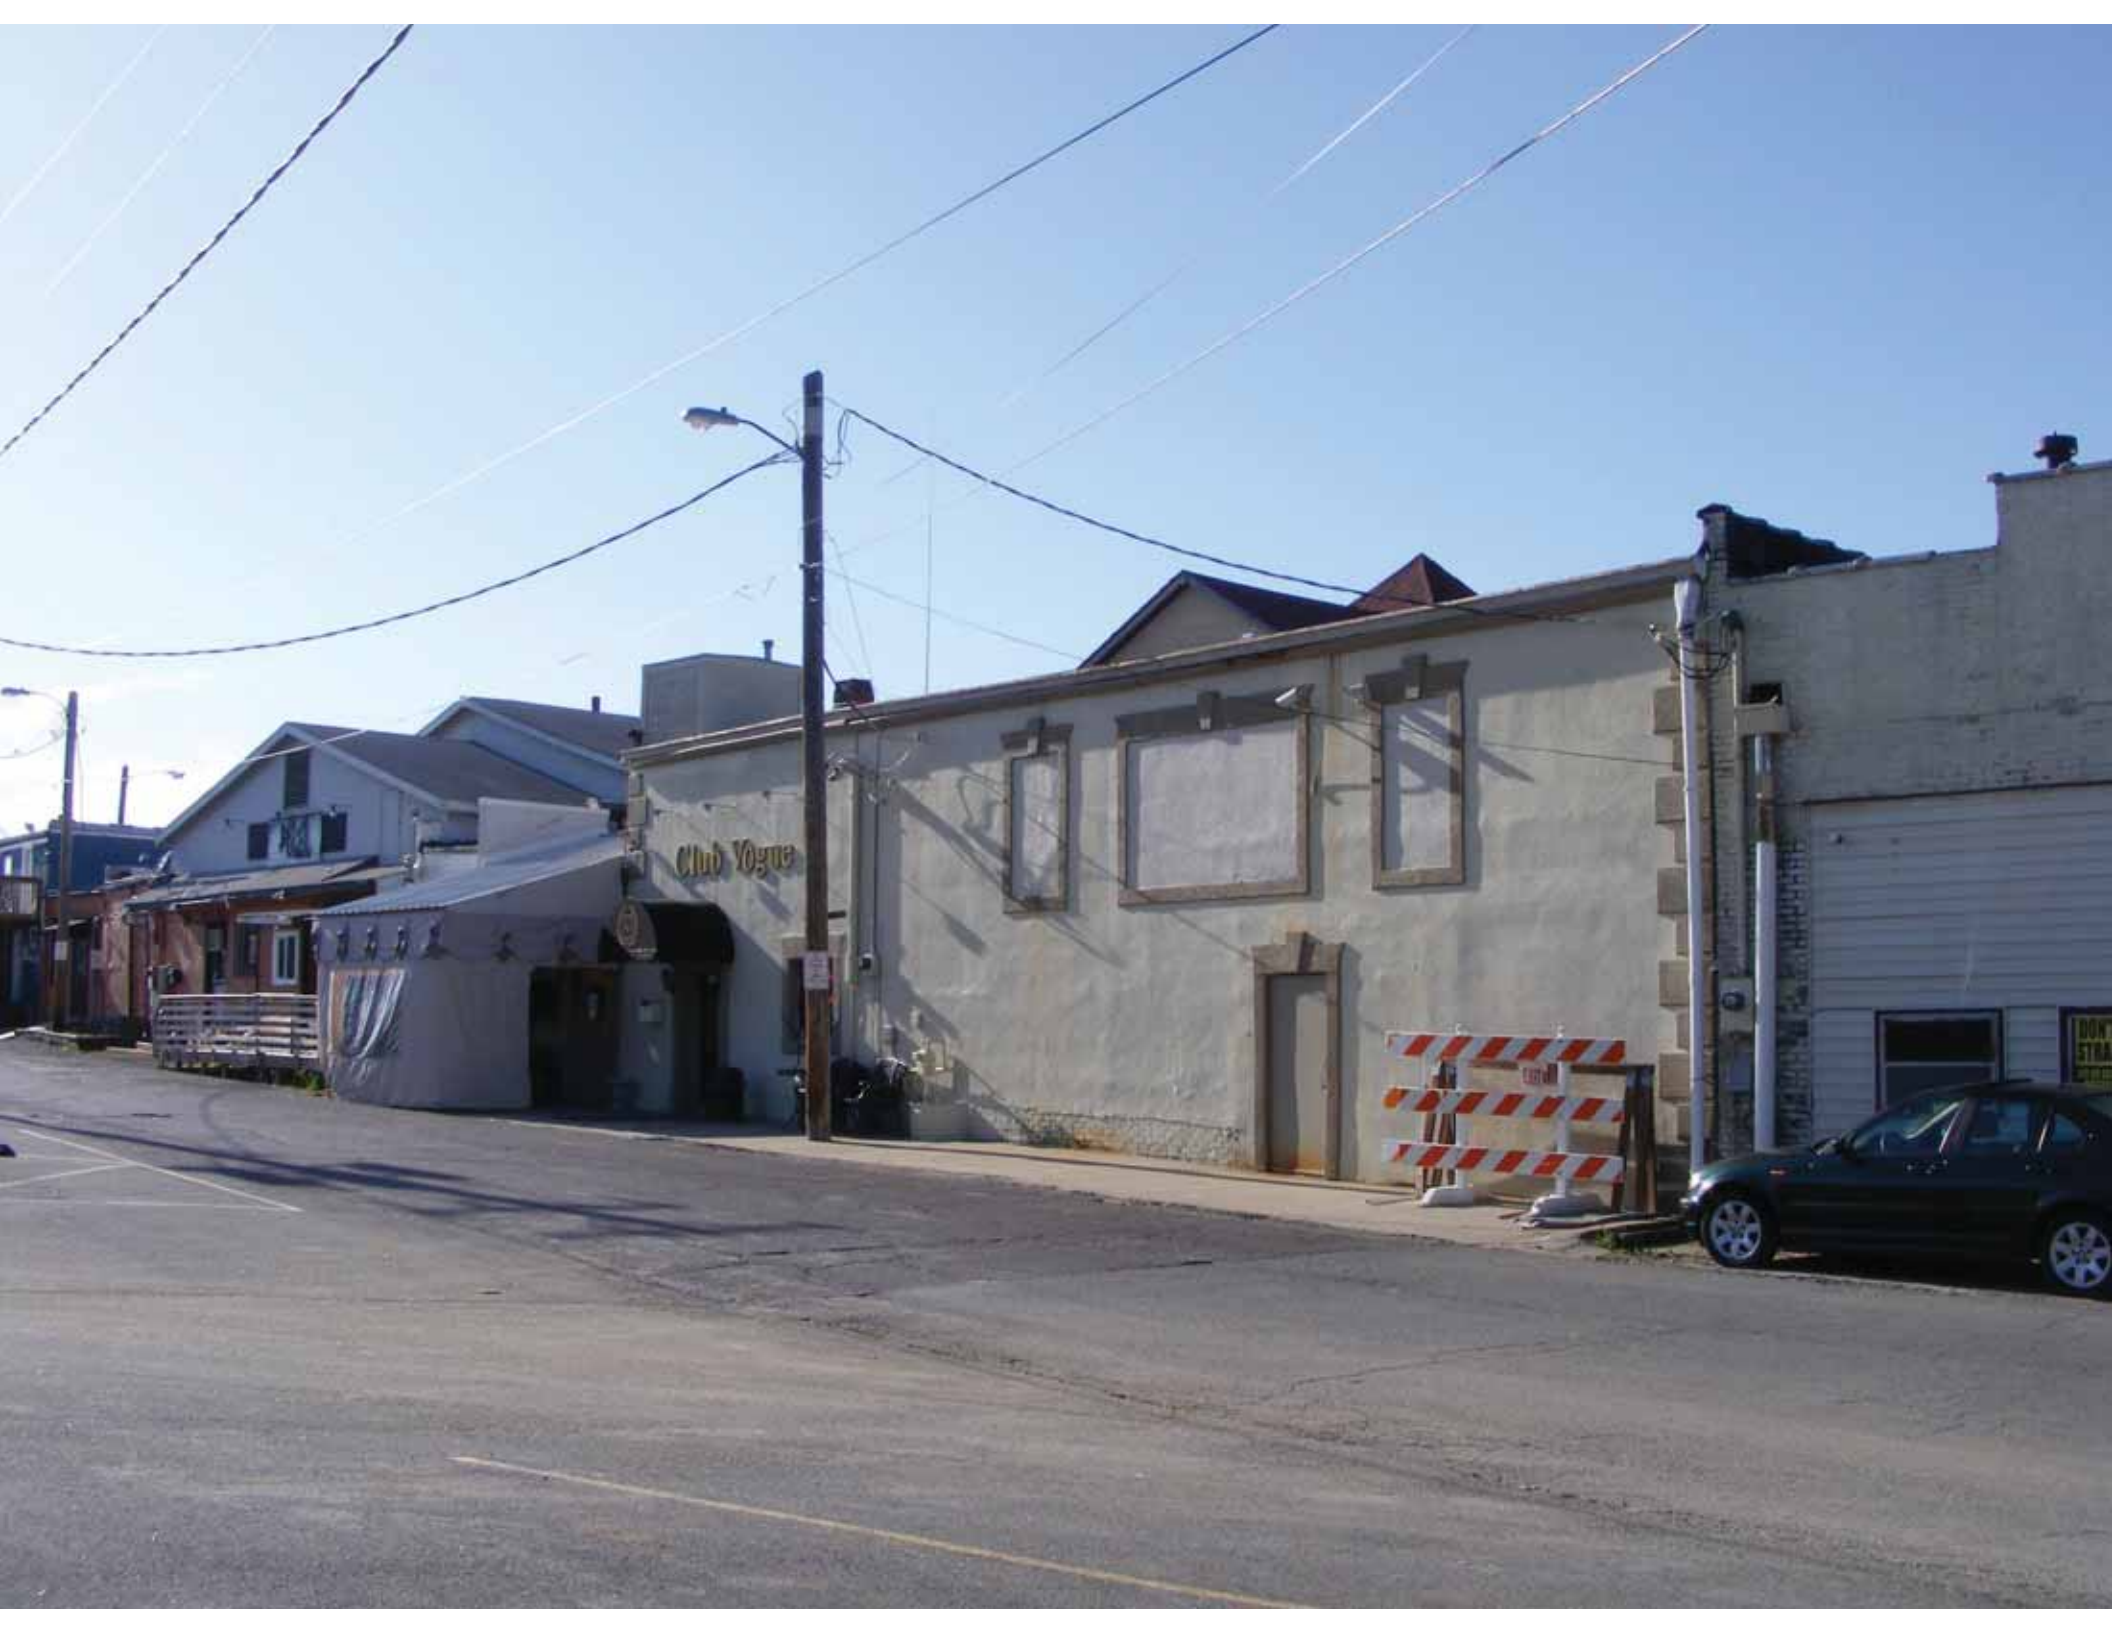
This extensively altered building appears to have been designed as a Spanish Revival commercial property. The roofline supports a central towered bay with a pyramidal roof and shed awning on the east end that were likely clad with clay tile originally. The remaining façade bears no evidence of the original design, covered with Dryvit. On the façade are a solid pedestrian door (east end) and three fixed windows obscured by dark/patterned glass. Two vents are situated near the west end of the elevation. The rear (south) elevation retains some original details such as corner quoins and original bay hoods (with a central keystone), sills and framing. All window bays are filled with Dryvit. The pedestrian entries (two) hold solid replacement doors. A tent wing is attached at the west end of the rear elevation near the club's primary entry. Above the primary door is a rounded canvas awning. The name of the business is attached to the rear wall above the awning.

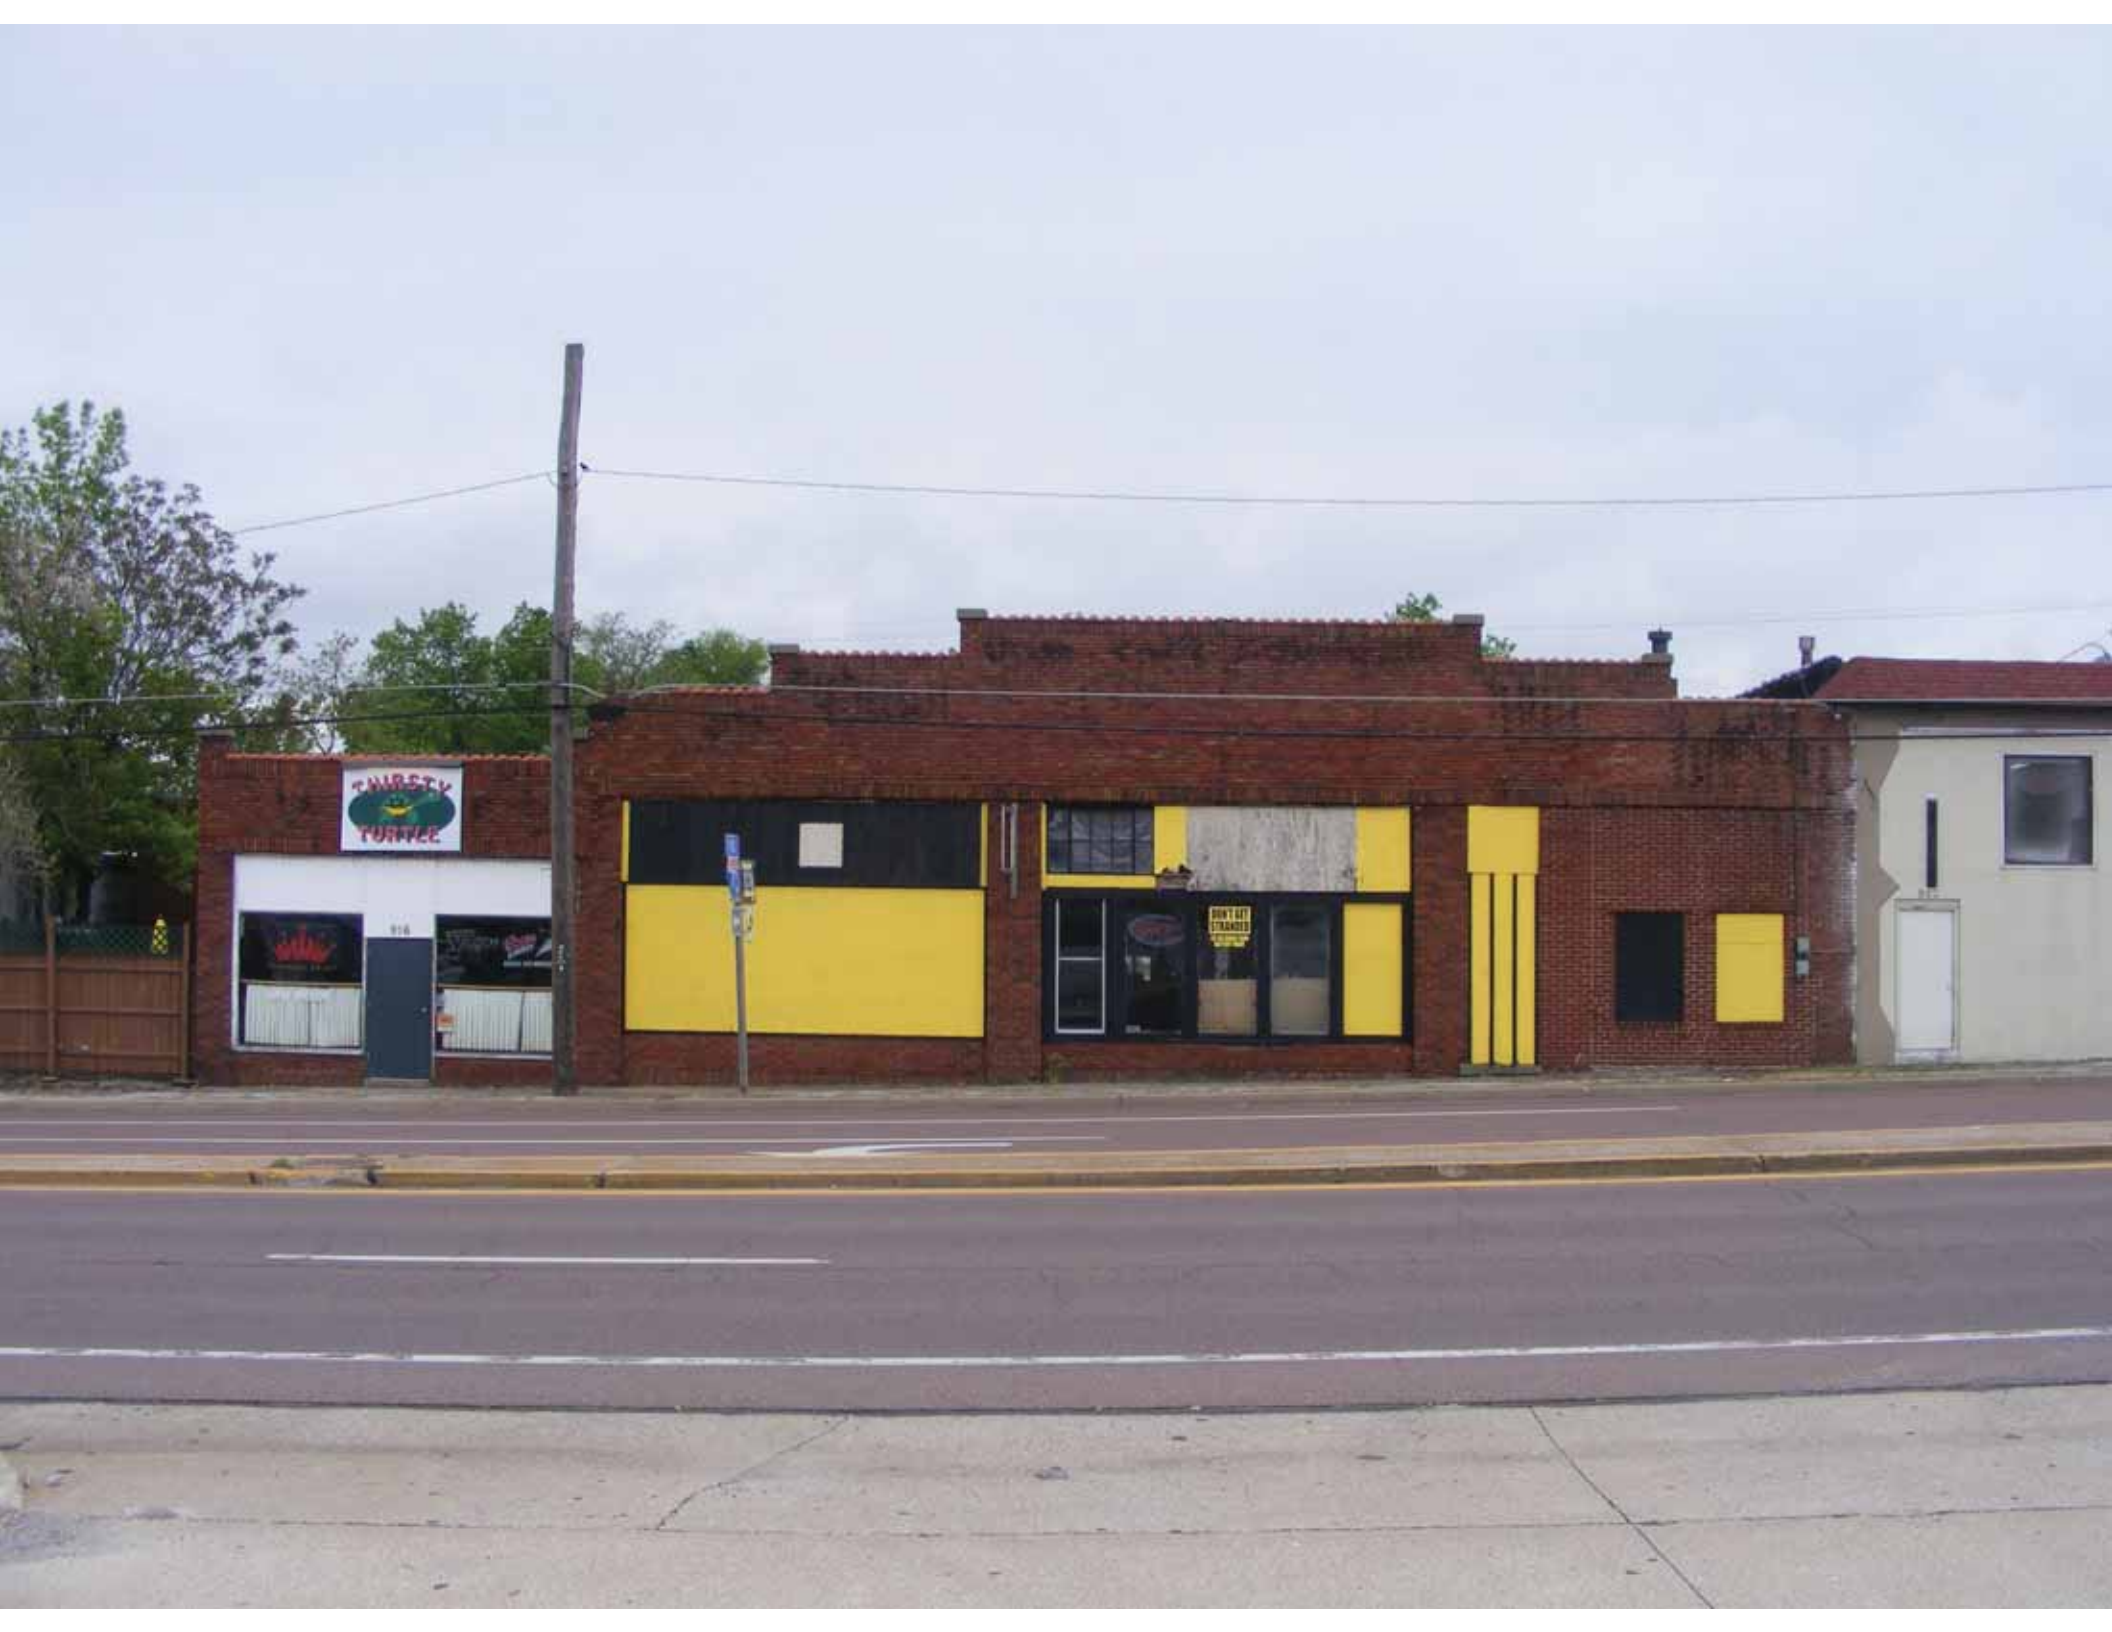
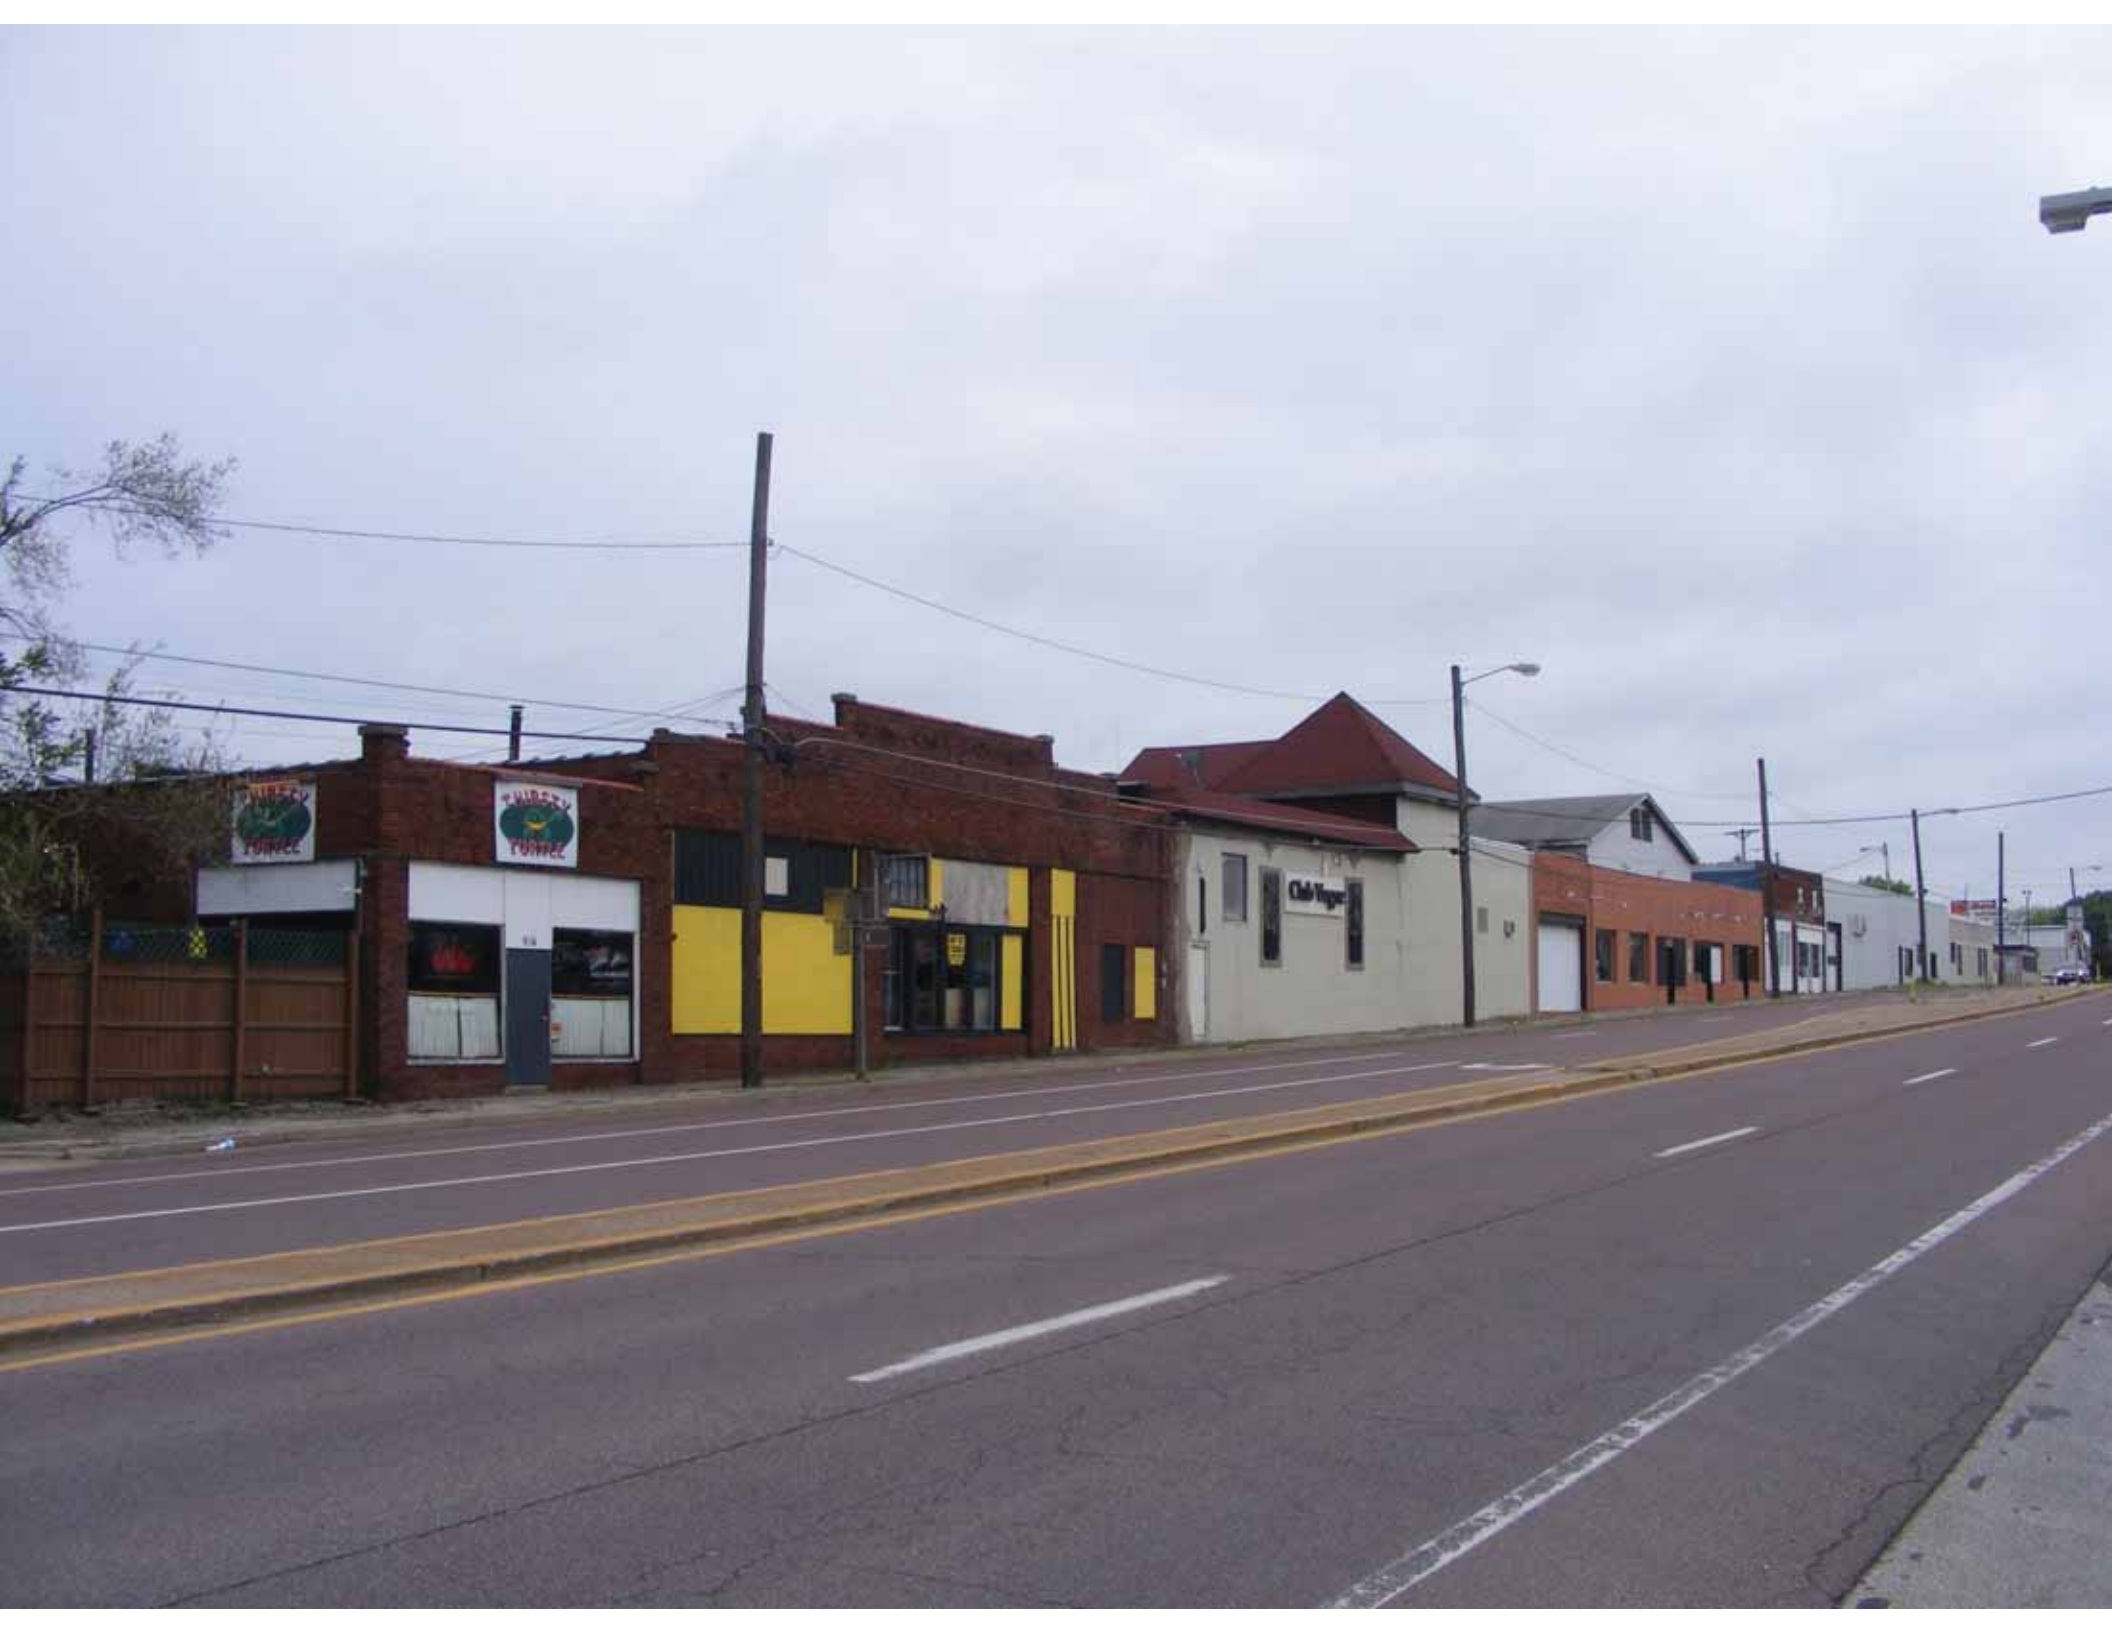
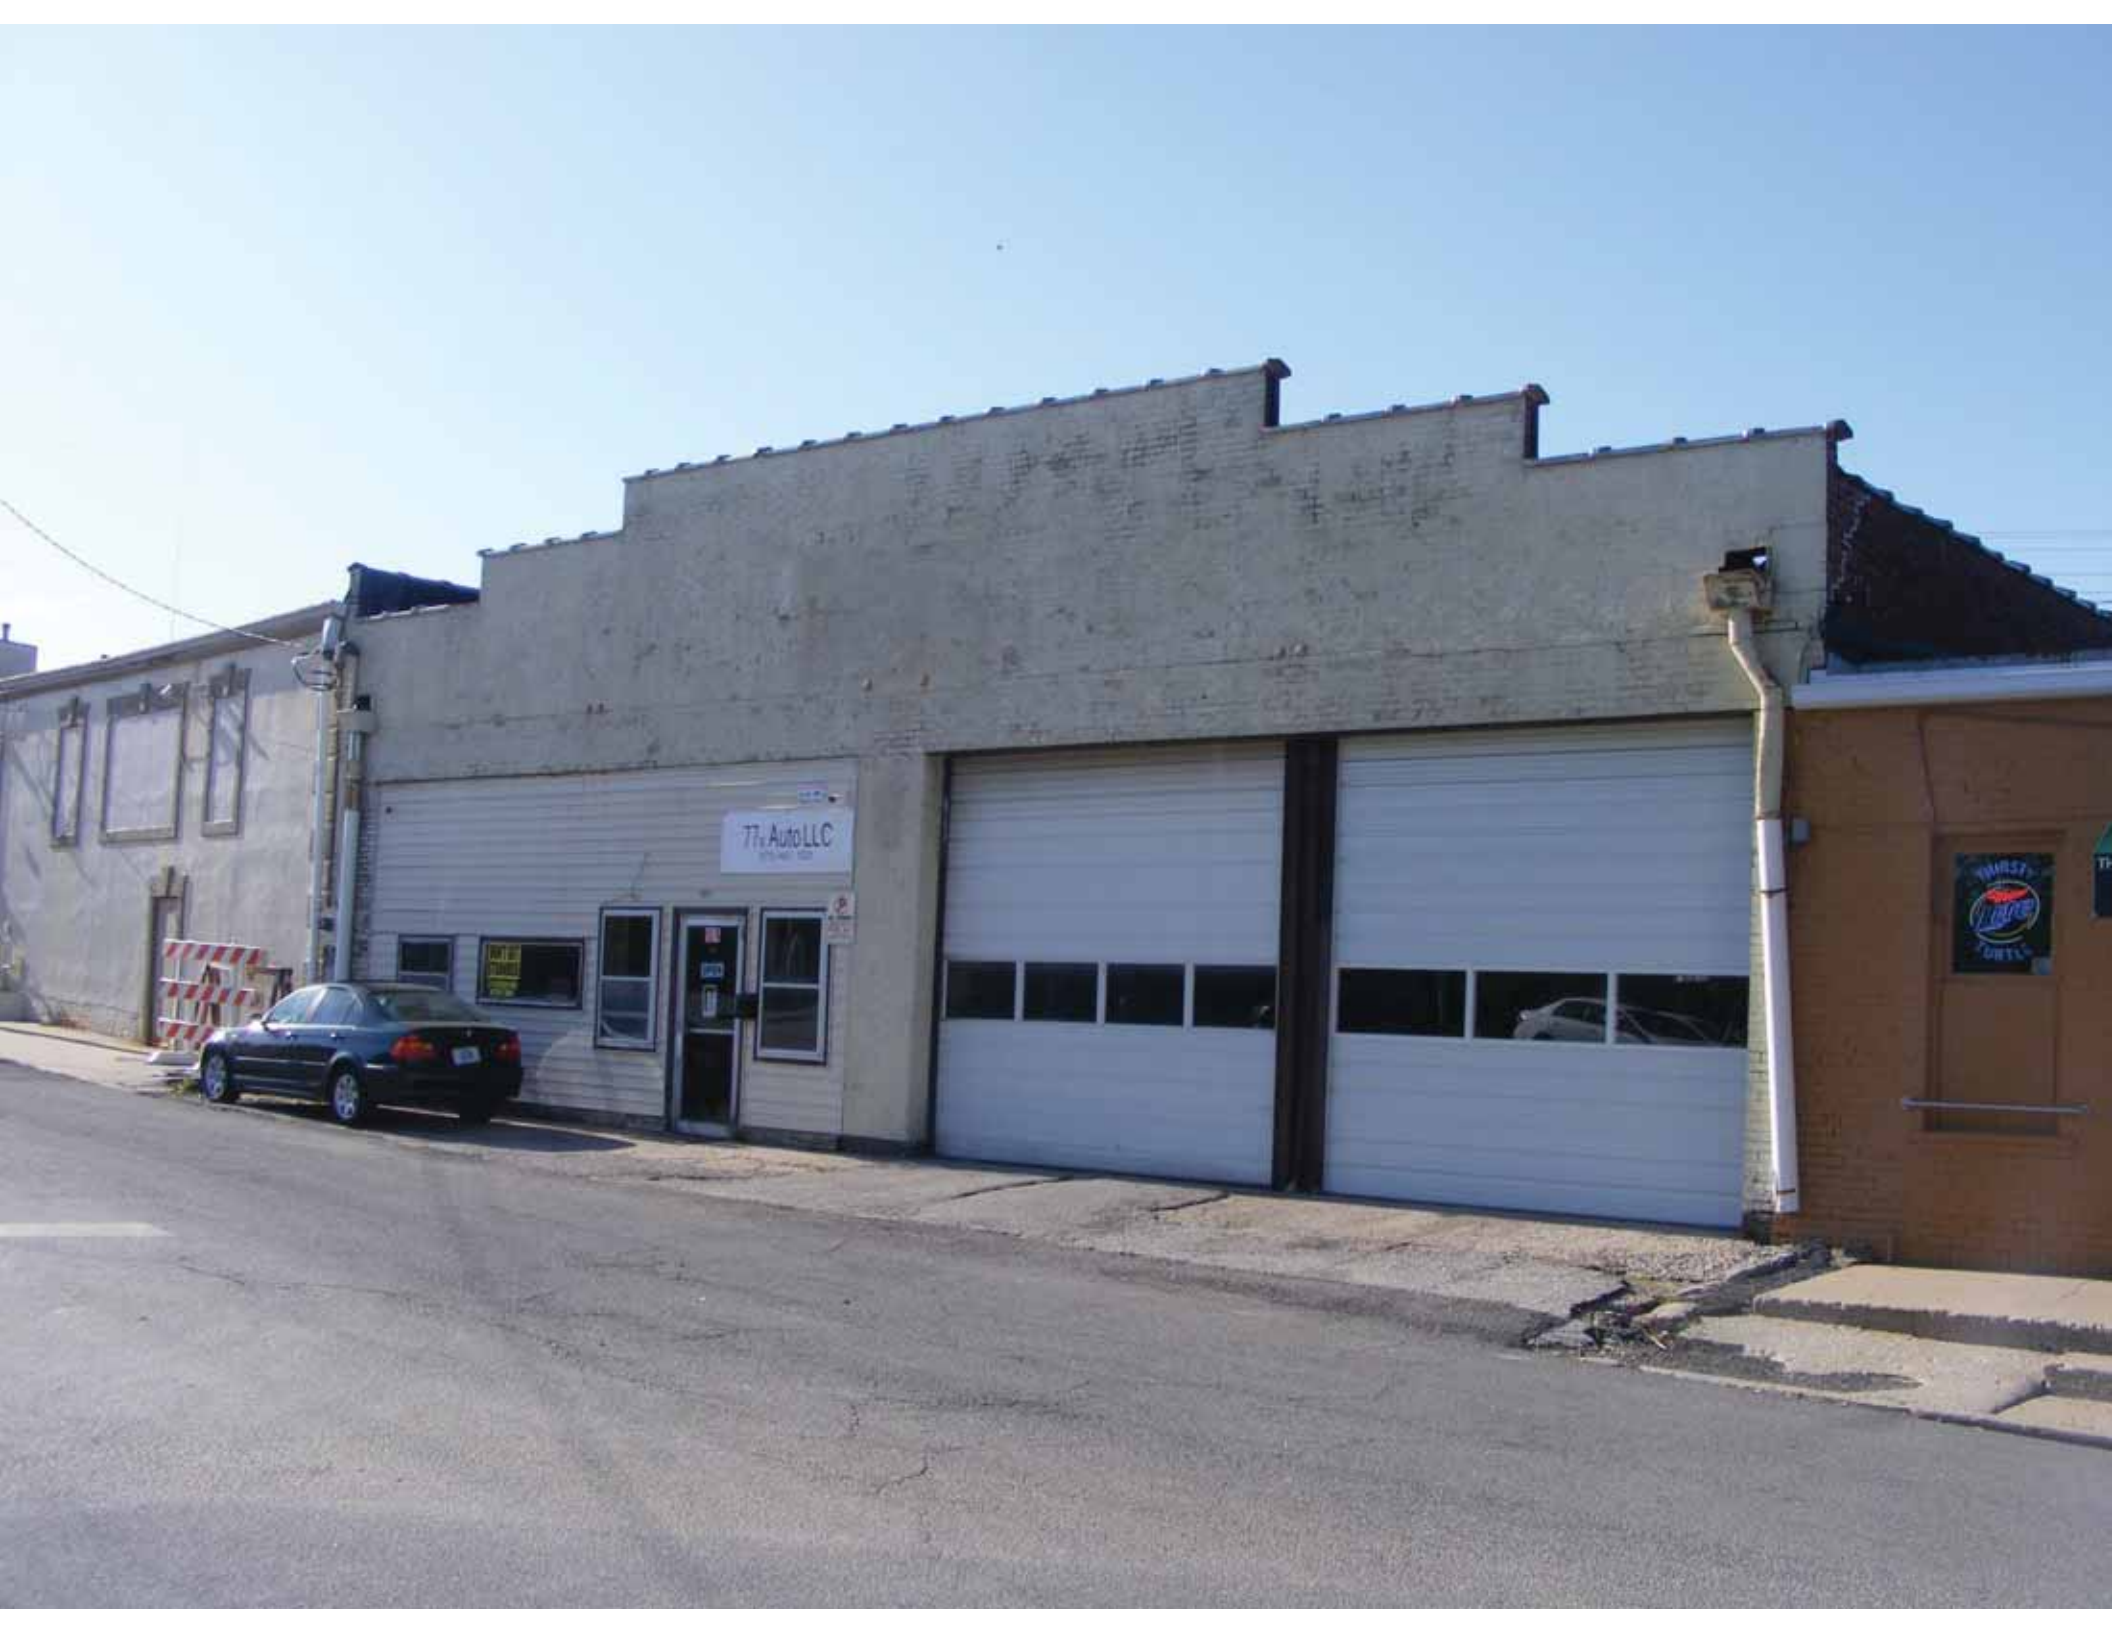
The building's primary (north) elevation has a stepped parapet capped with terra cotta coping. At each end of the stepped areas are decorative brick posts capped with concrete. The storefront on the façade consists of (east to west), a large commercial window that has been enclosed, a central entry/commercial bay filled with a single-light glass and aluminum door offset by four fixed light c. 2015 windows. Above the entry/windows is a transom largely infilled. The east end of the transom is open and supports ten original steel sash lights. East of this area the elevation holds a filled entry bay and transom. The east end of the elevation holds two filled window bays. The brick surrounding the two east windows appears as though this end of the façade originally supported an automobile garage bay. The rear (south) elevation has a built-up stepped parapet capped with terra cotta coping. On the west end, the bay is filled with horizontal siding that surrounds an off-center glass and aluminum commercial door flanked by one-over-one windows. Offsetting the door and windows on the west are two fixed horizontal sash windows. The east end of the elevation holds two overhead track c. 2000 doors with centered lights.
