MISSOURI DEPARTMENT OF NATURAL RESOURCES
STATE HISTORIC PRESERVATION OFFICE, P.O. Box 176, Jefferson City, MO 65102
ARCHITECTURAL/HISTORIC INVENTORY FORM

1. Survey No. BO-AS-011-0087		2. Survey name: North Central Columbia Survey Phase II	
3. County: Boone		4. Address (Street No.) 902	Street (name) N. Seventh Street
5. City: Columbia	Vicinity: <input type="checkbox"/>	6. Geographical Reference:	7. Township/Range/Section: T: R: S:
8. Historic name (if known):		9. Present/other name (if known):	
10. Ownership: <input checked="" type="checkbox"/> Private <input type="checkbox"/> Public		11a. Historic use (if known): Domestic/single dwelling	11b. Current use: Domestic/single dwelling

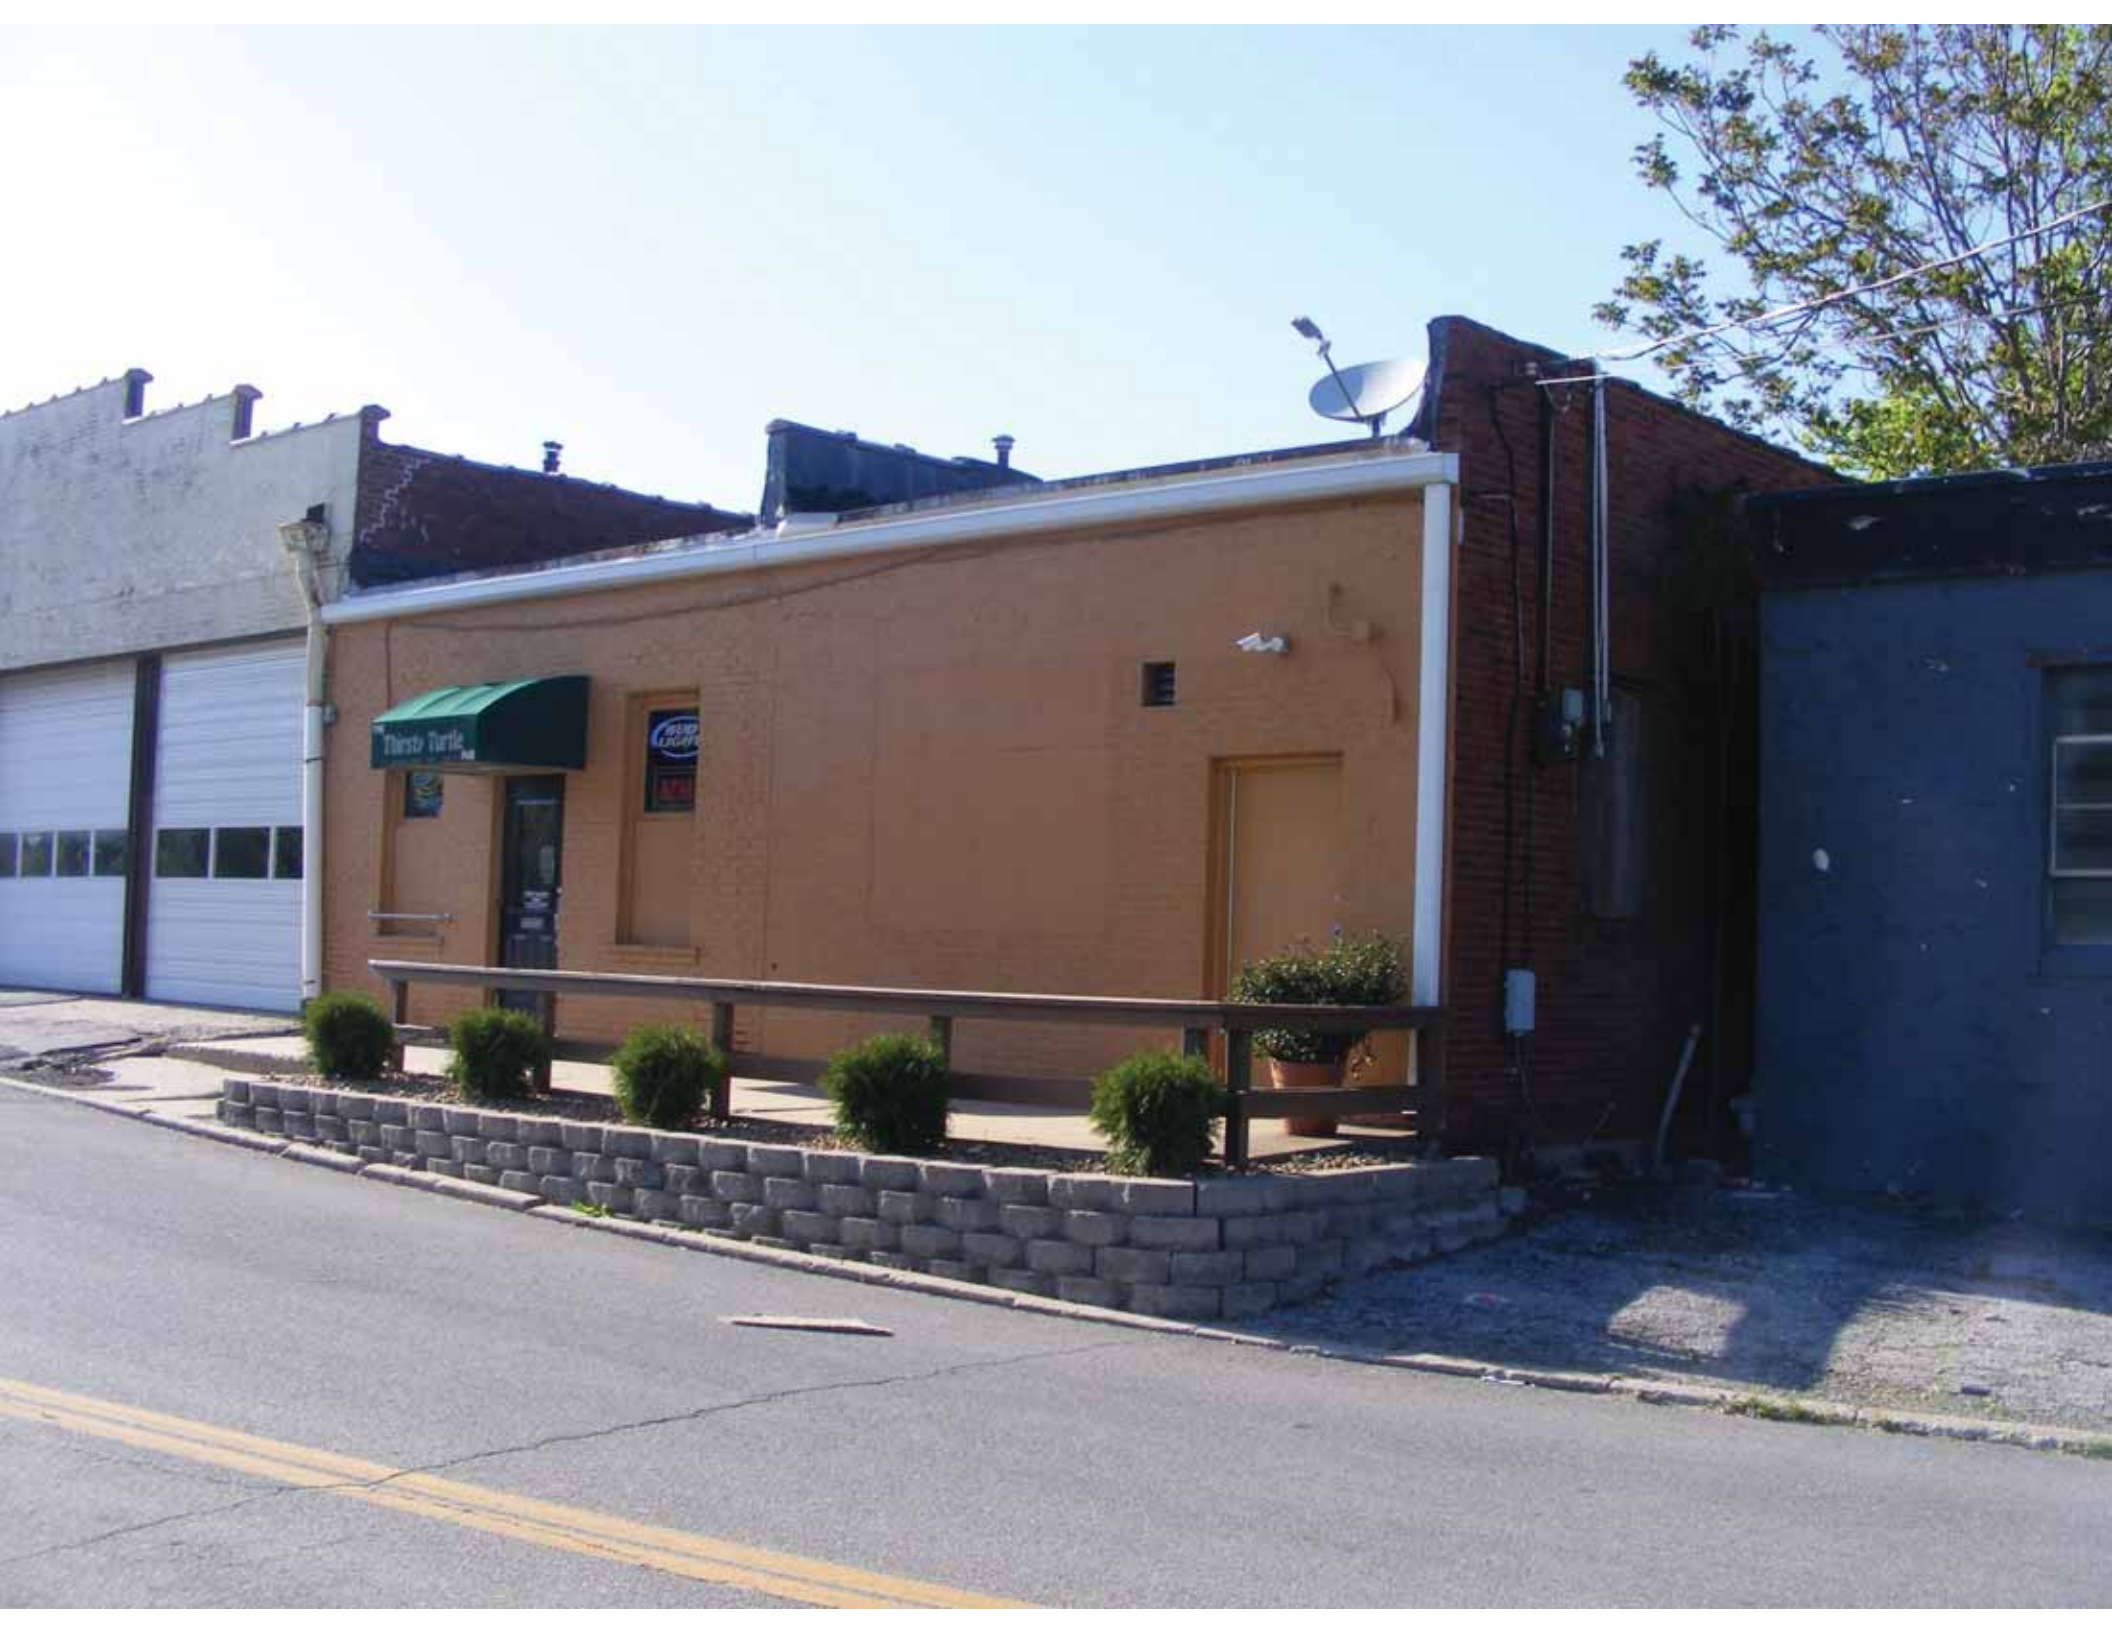
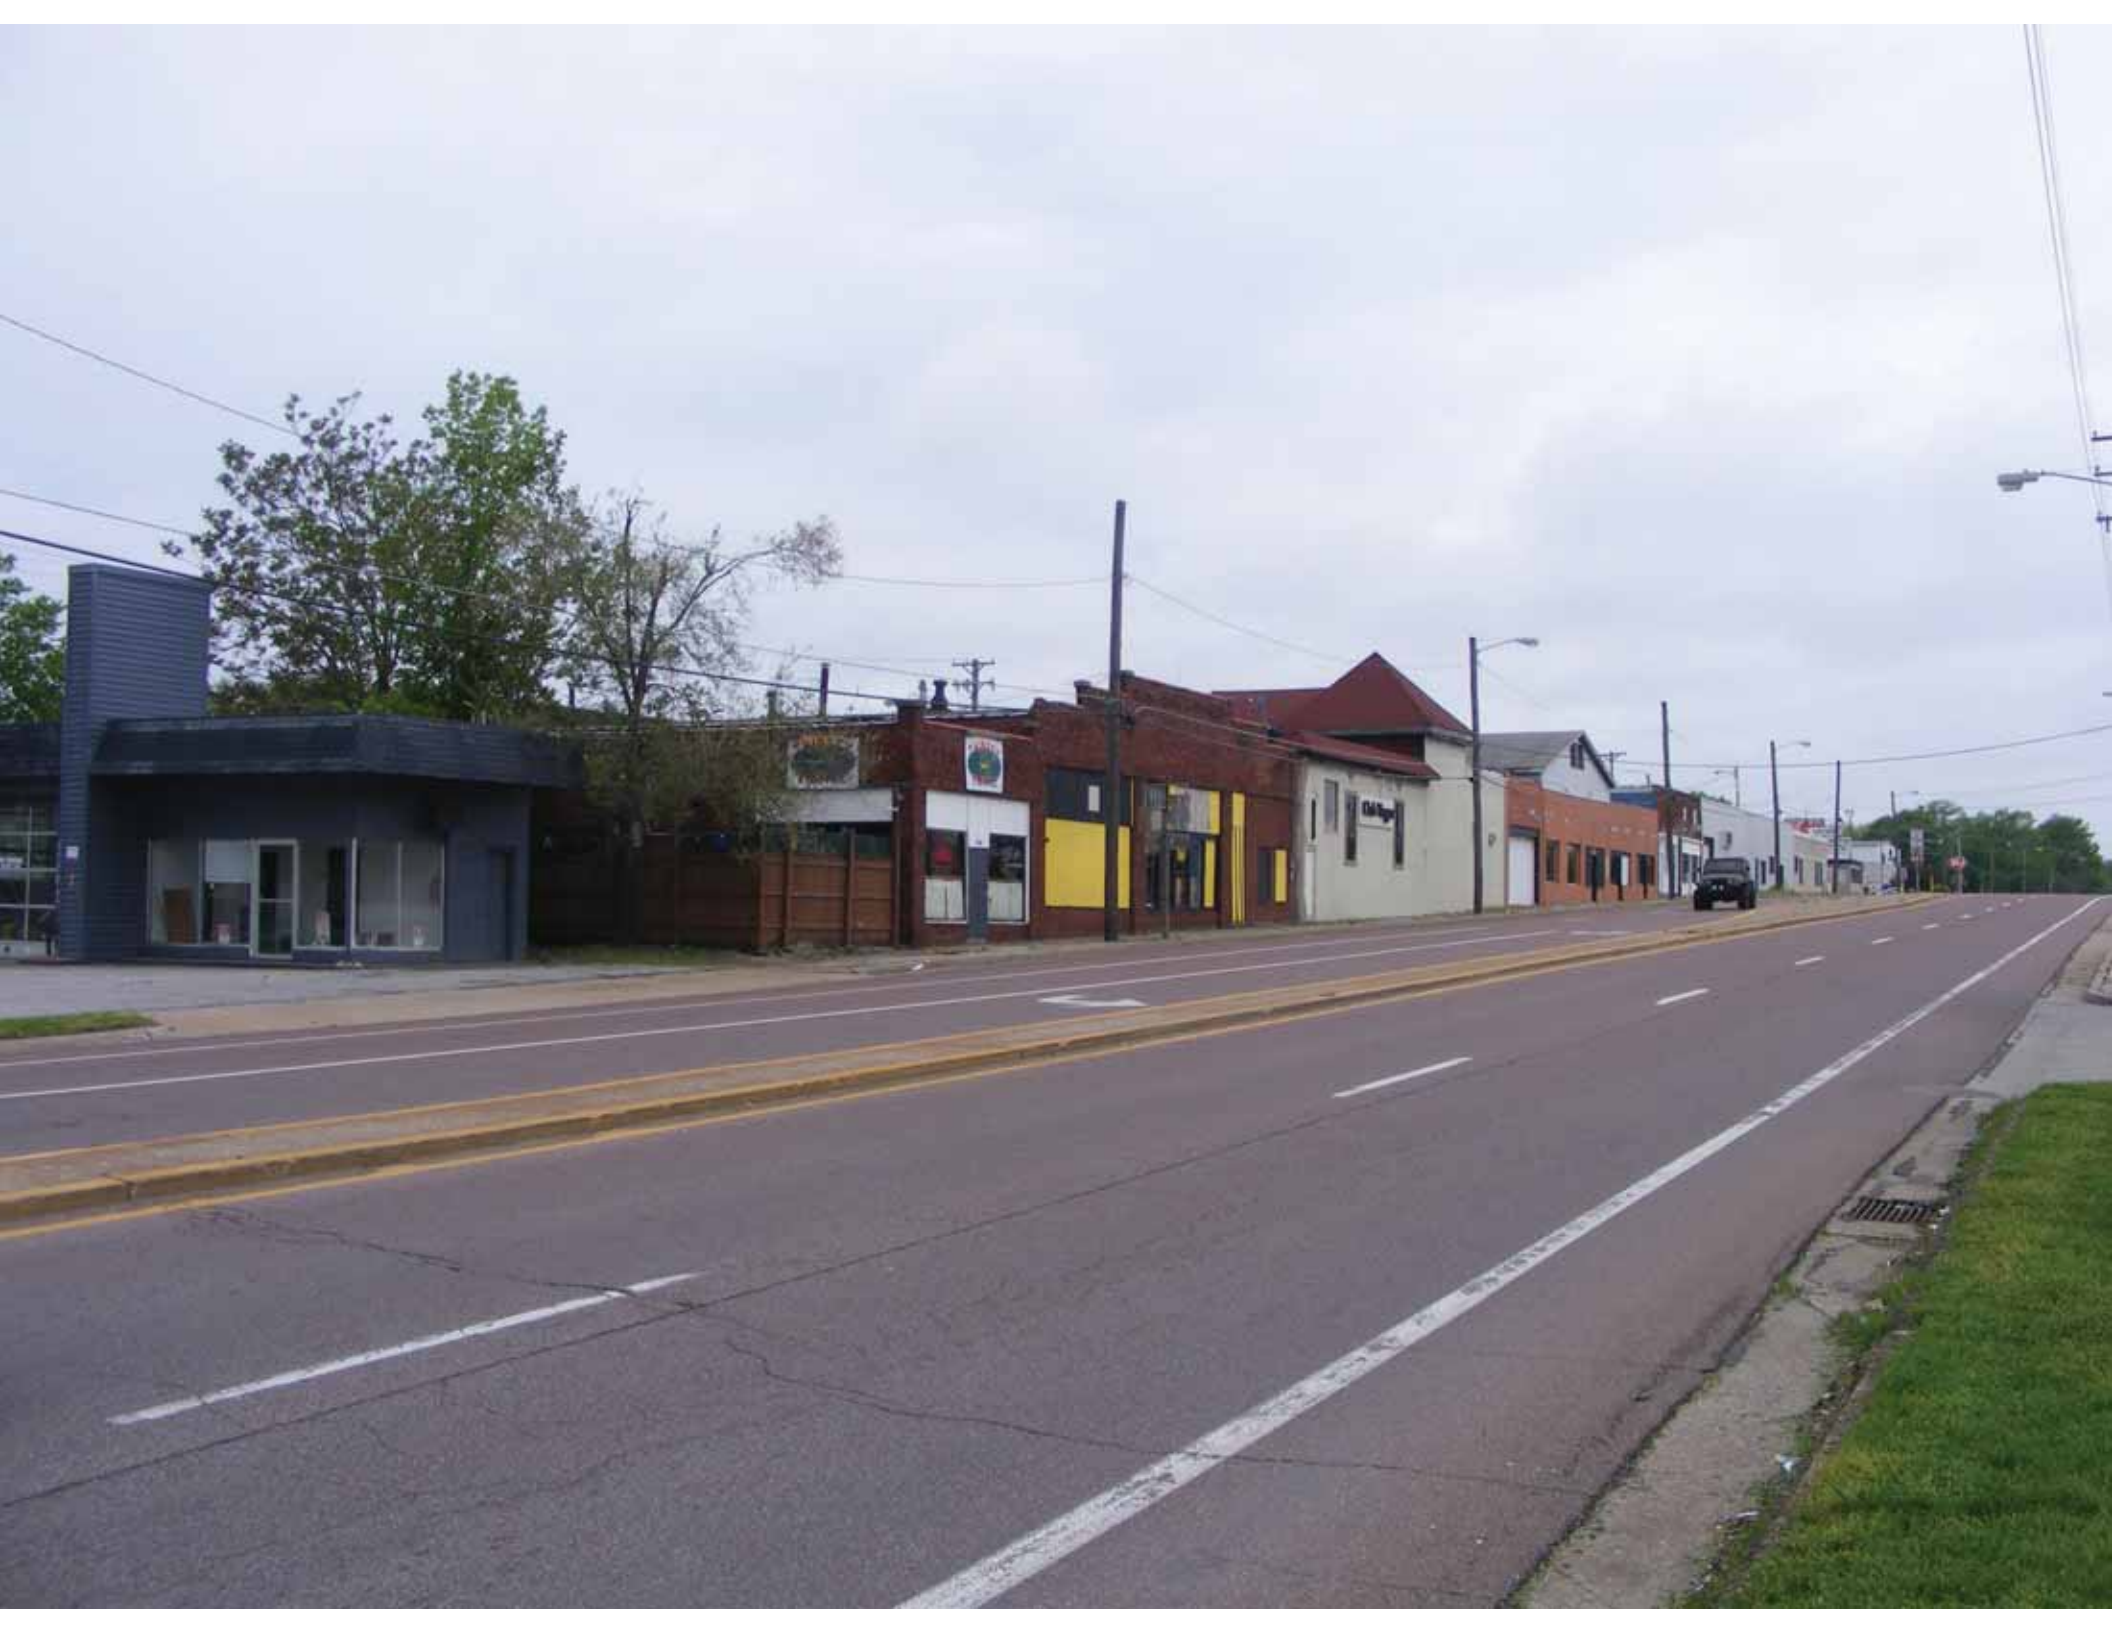
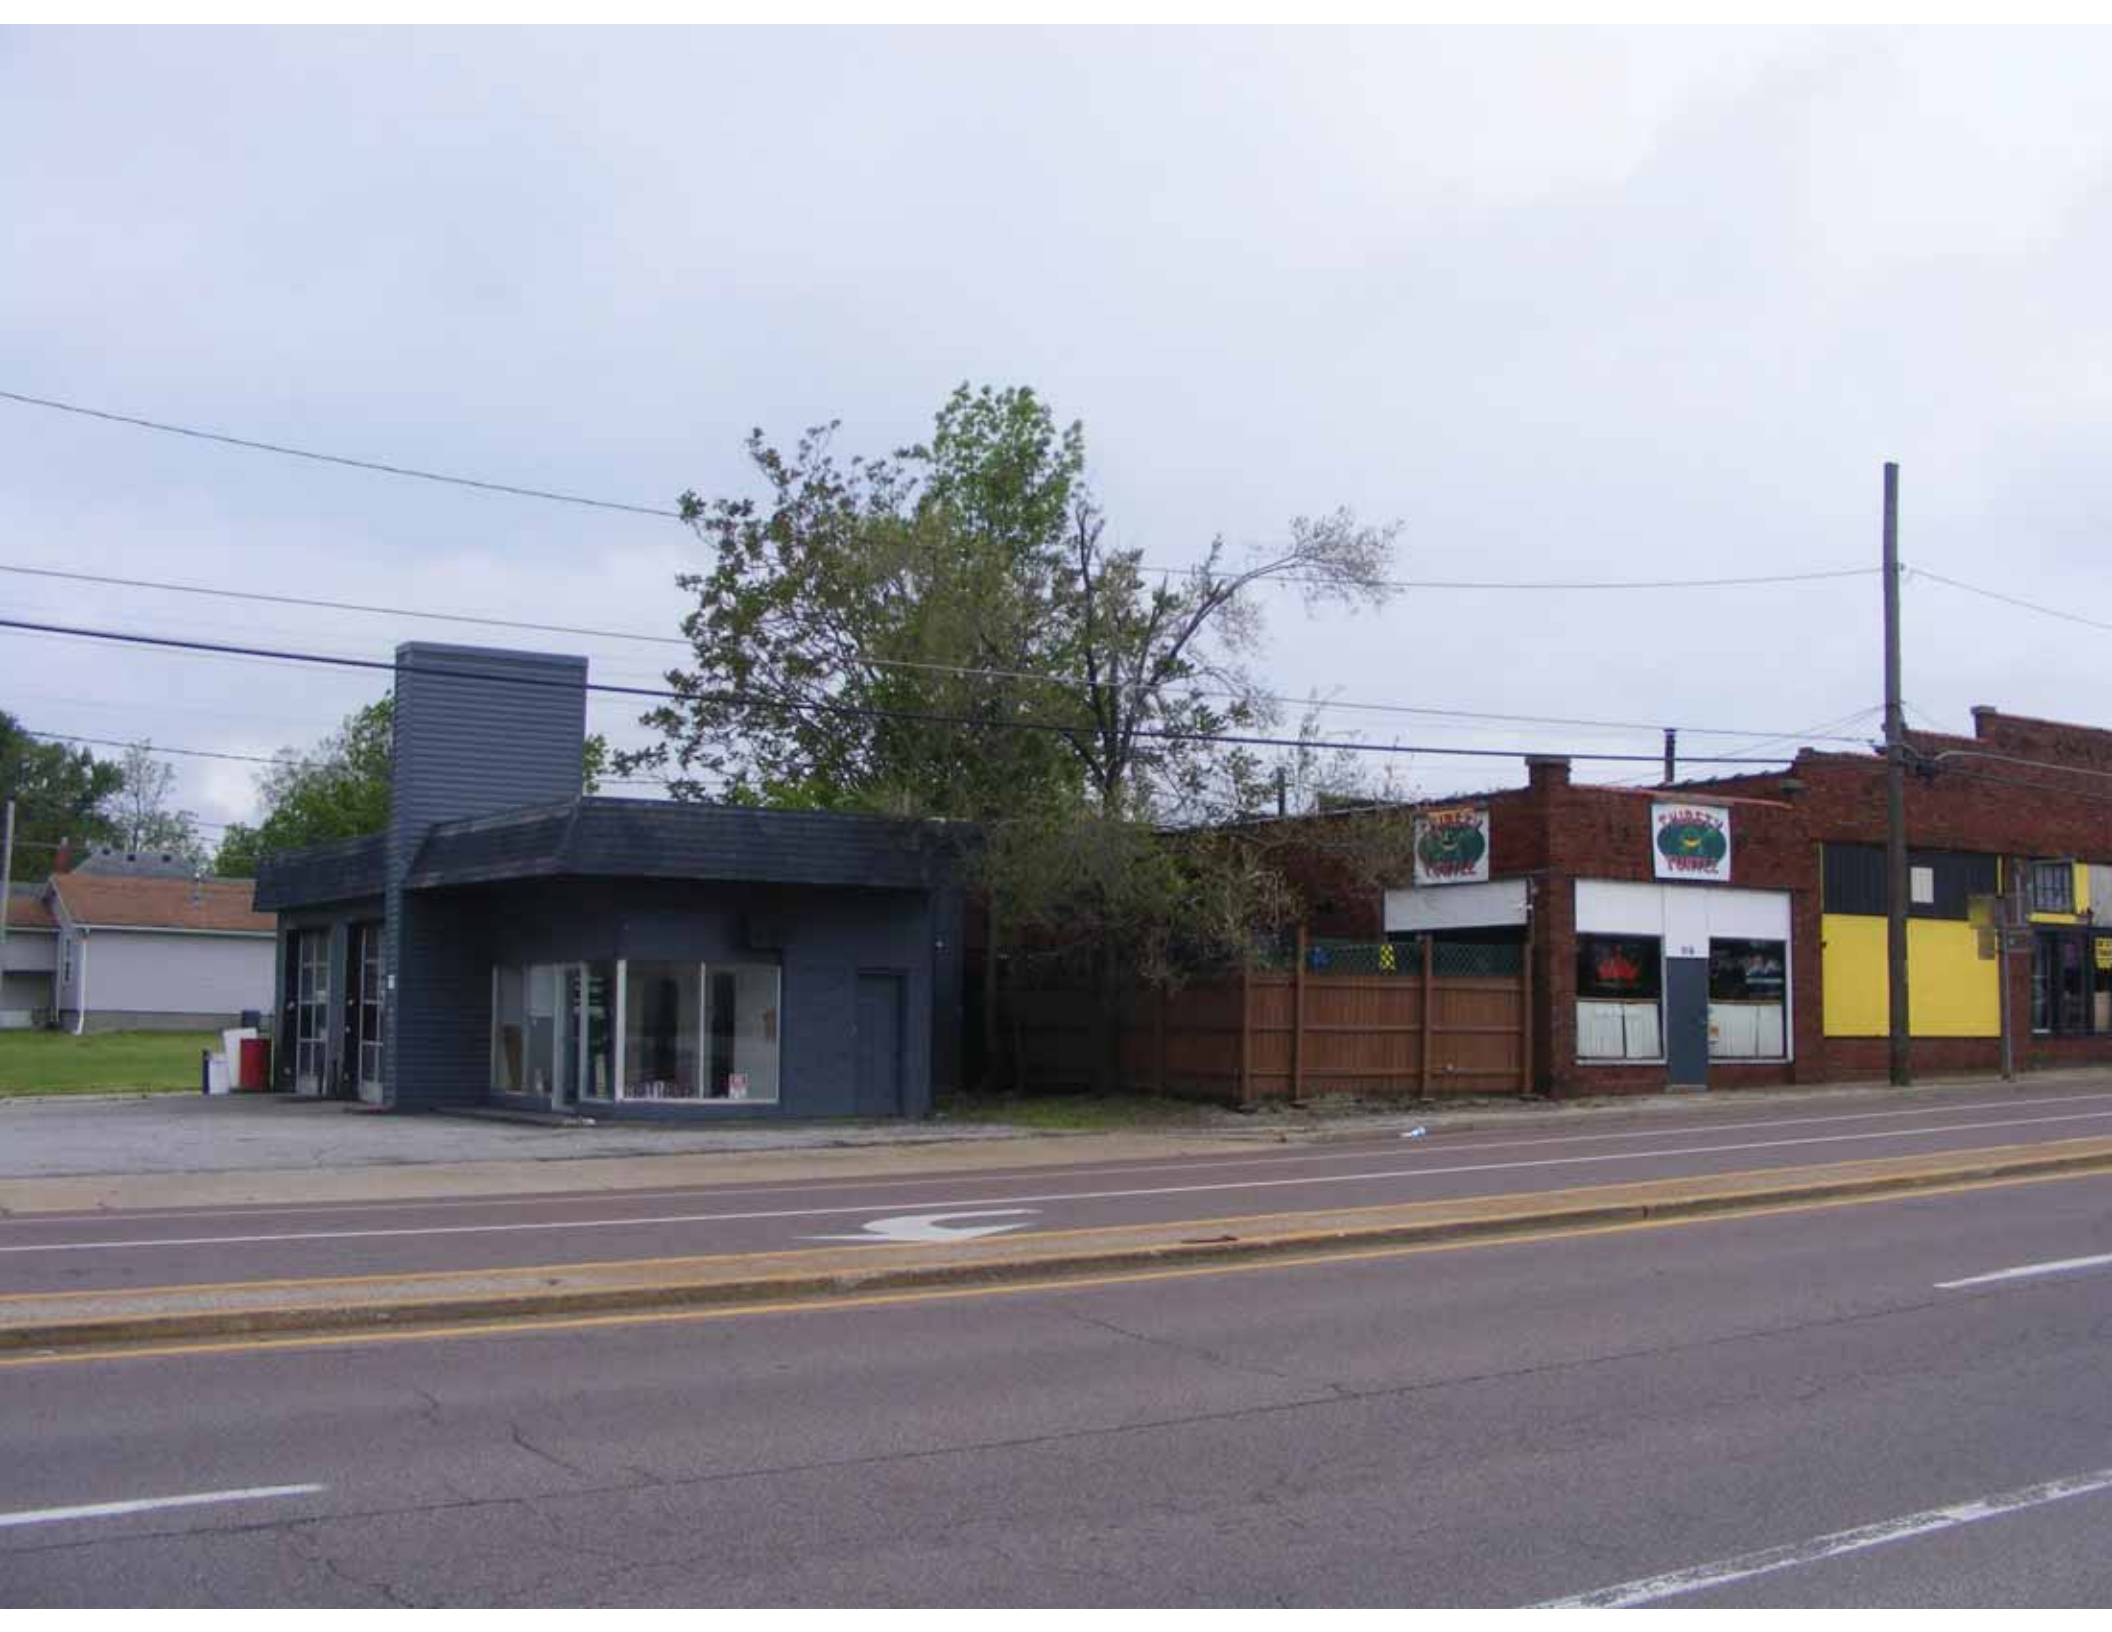
The one-story building has a built-up façade wall capped with terra cotta coping. Ends of the coping support original brick piers with concrete caps. The façade is filled by a commercial bay consisting of a central solid door flanked by fixed commercial style windows (c. 2000). Above the door and windows is vertical synthetic siding. The business sign is centered above the sided portion of the façade. A frame privacy fence extends east, attached to the east exterior wall. The fence obscures an outdoor dining area. The rear (south) elevation has a solid door on the east end and a single-light commercial door flanked by infilled windows on the west end. A canvas awning bearing the business name extends above the glass door.

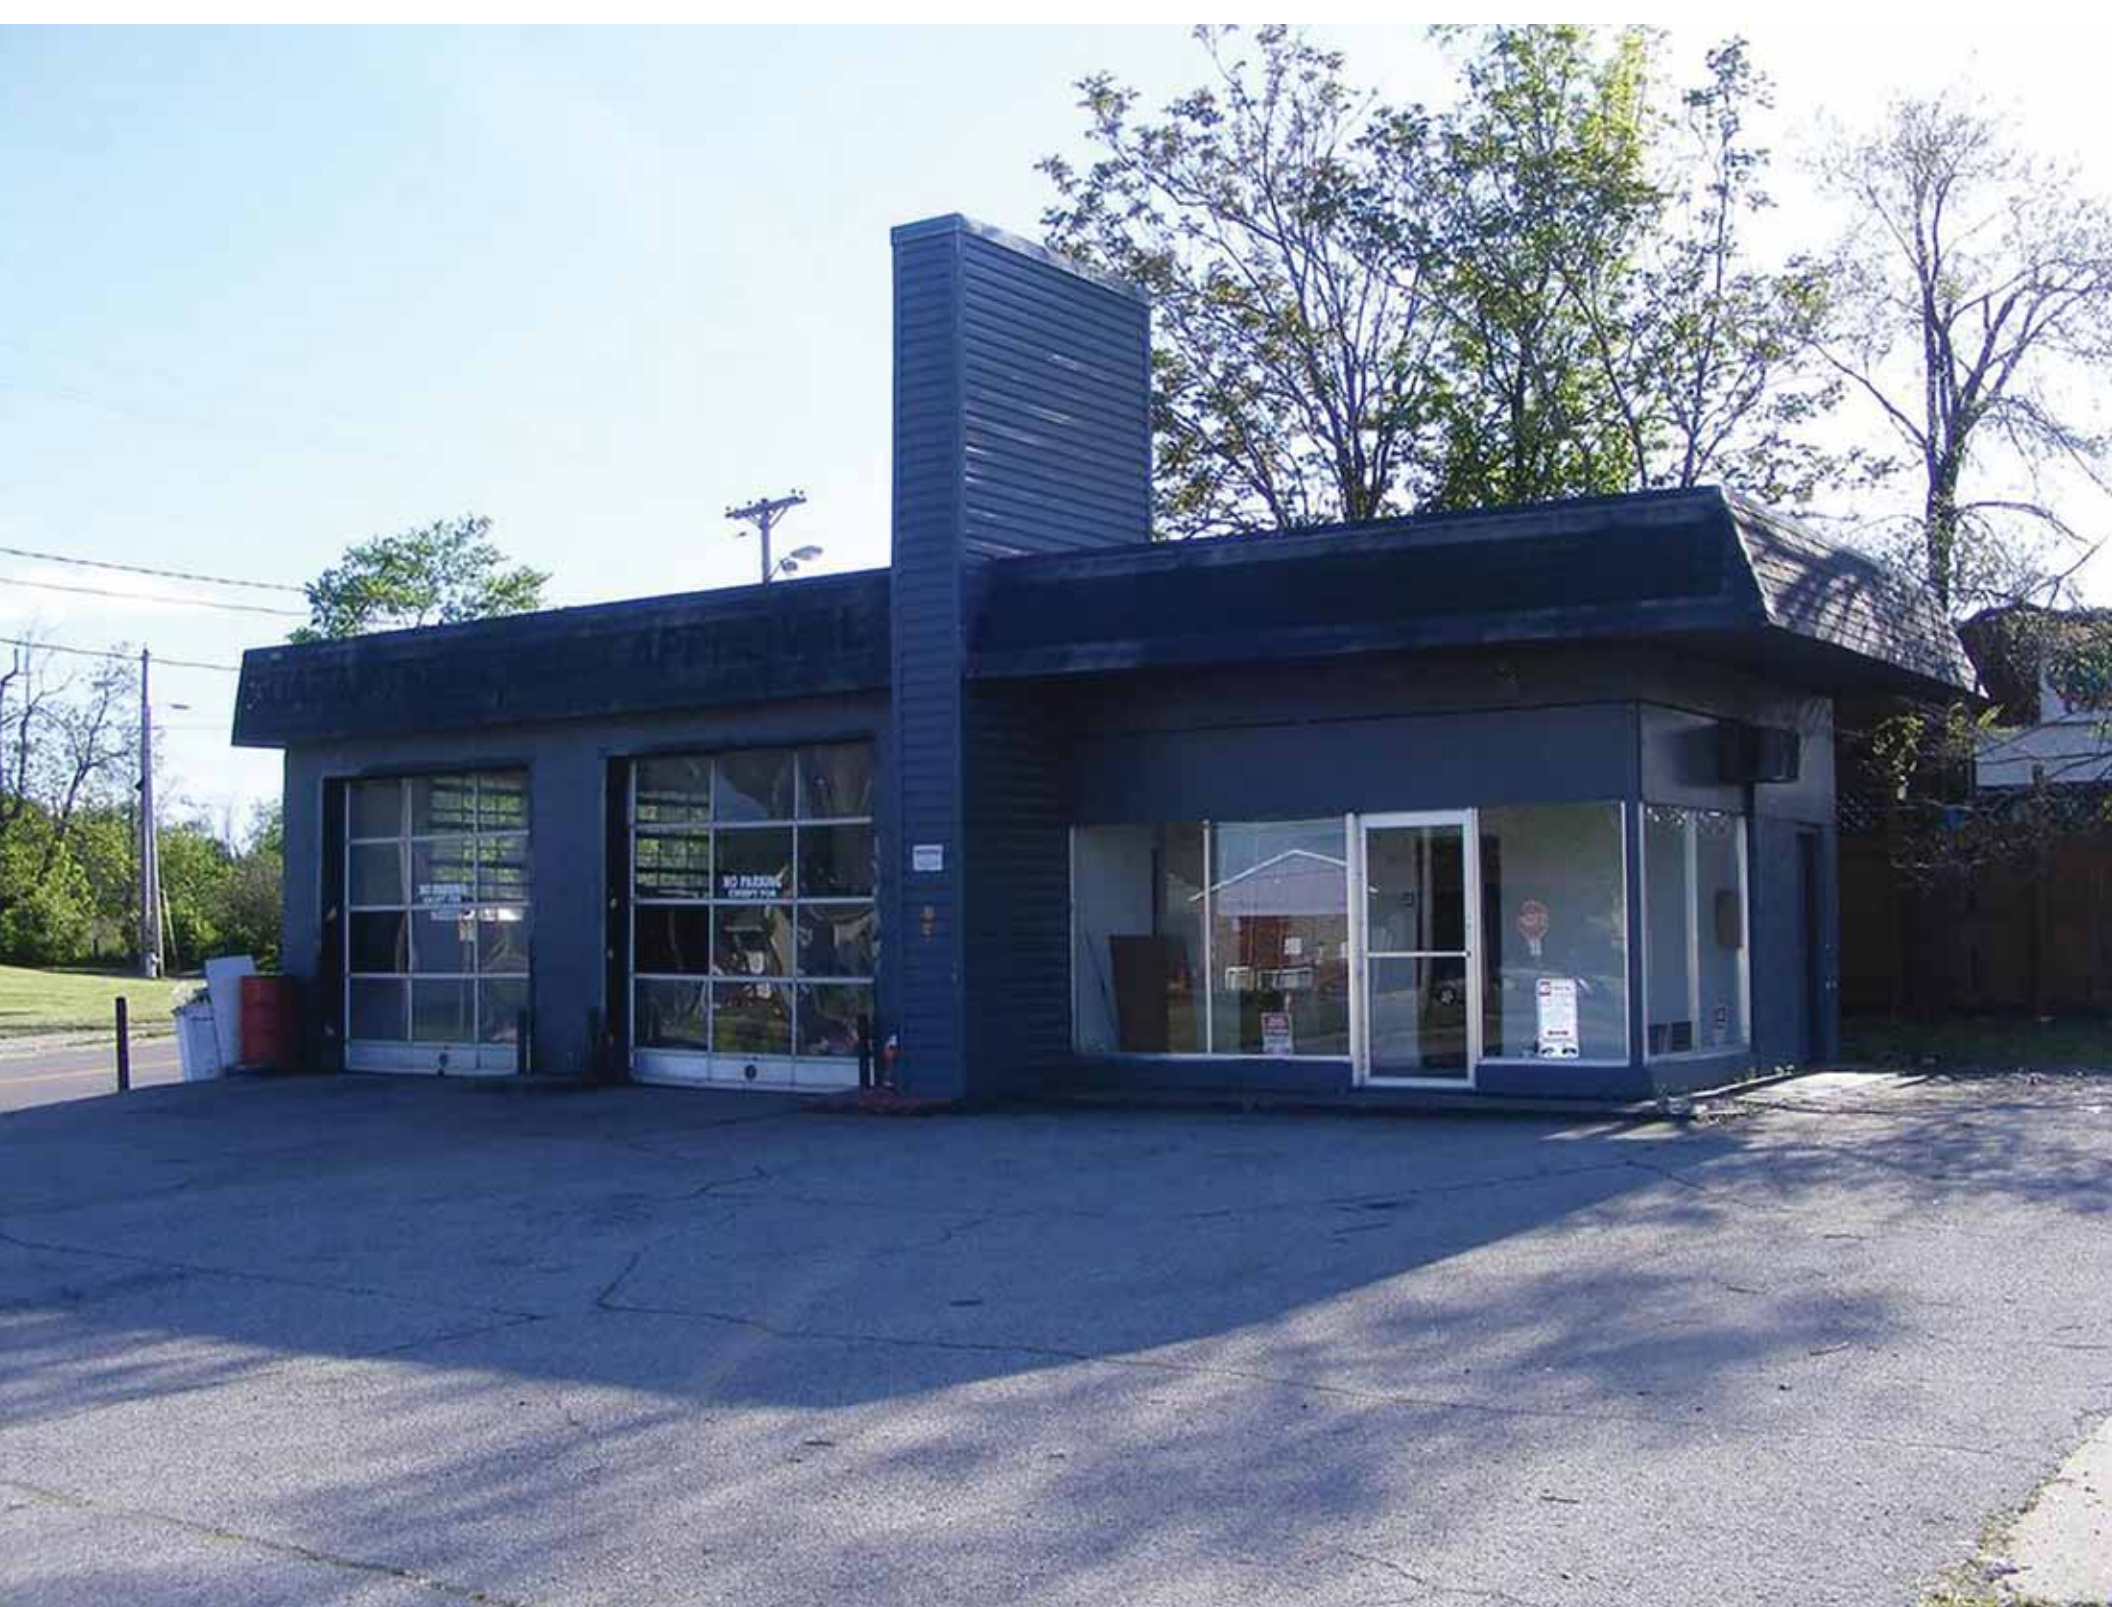
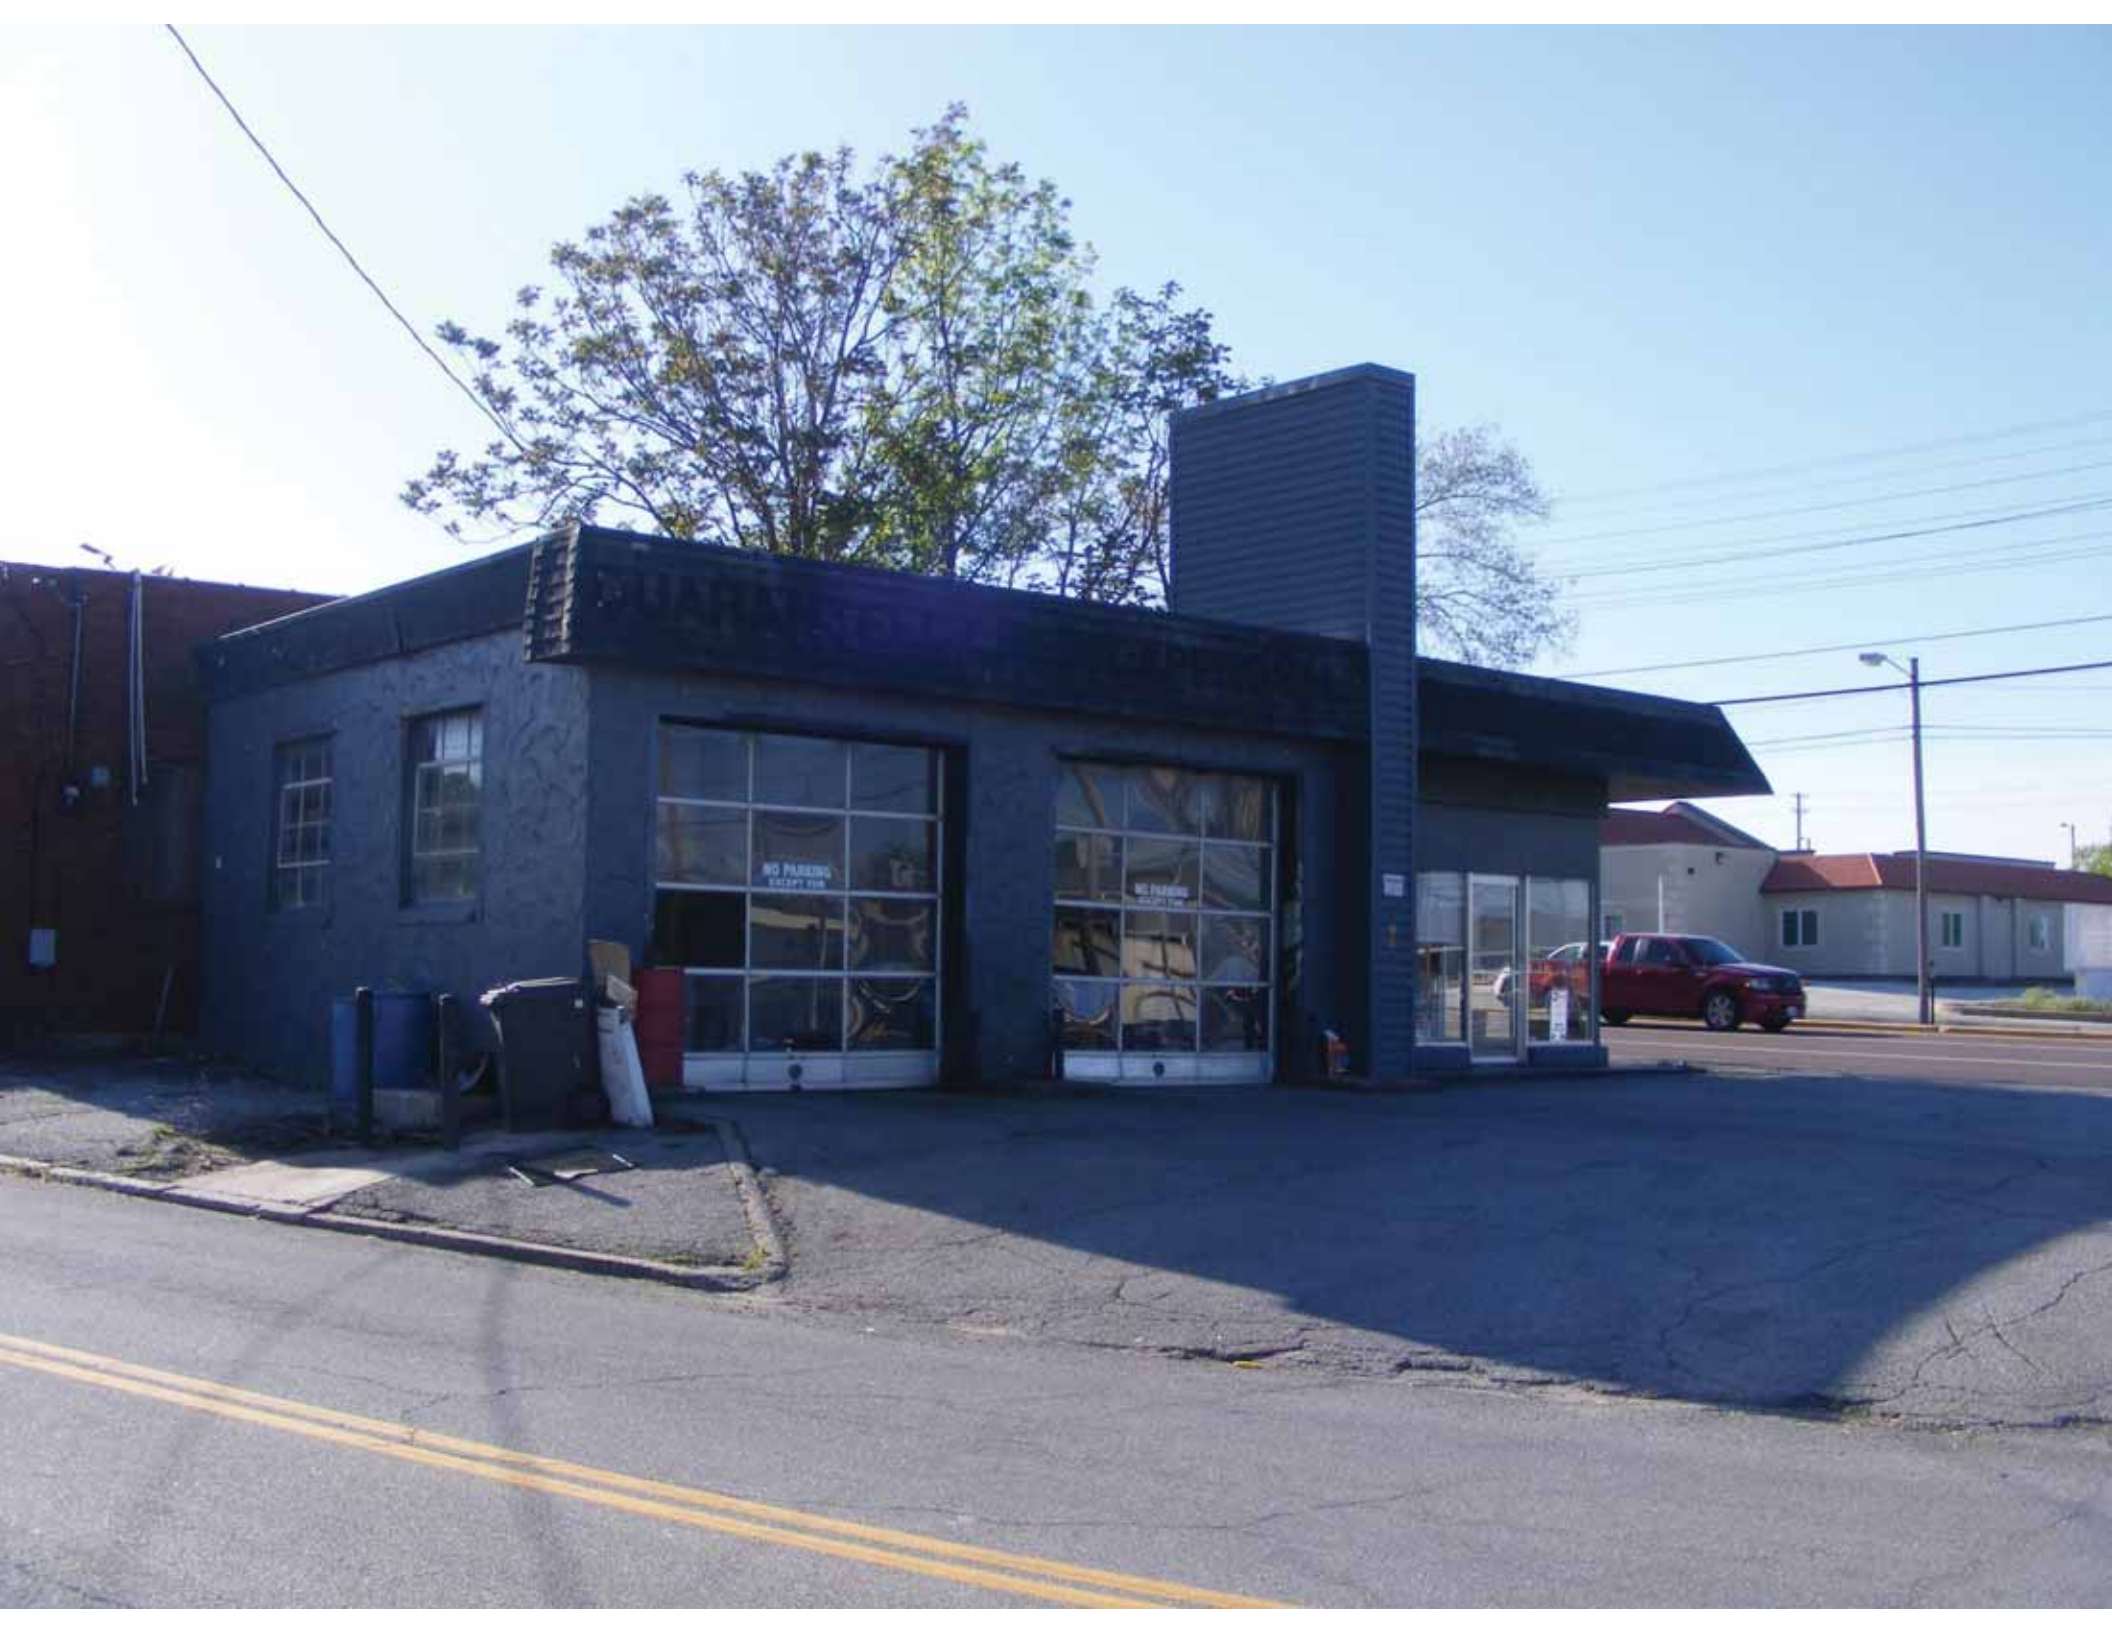
The former gas station, currently used as a used auto sales lot, has a flat roof with an asphalt shingled canopy. Exterior walls are clad with stucco and the foundation is a concrete slab. At the roofline is a central projecting wall that divides the customer/service areas of the building. This projection rises well above the roofline and may have originally illustrated the business name. The projection is clad with c. 2000 dropped synthetic siding and capped with metal. The façade (east elevation) has two original overhead track multi-light doors (south) and an original office area with a glass and aluminum commercial door flanked by a band of aluminum sash commercial windows that wrap to the side (north) elevation. West of the north elevation windows is a solid door (likely providing access to the restroom). The south elevation has two multi-light original steel sash hopper windows.

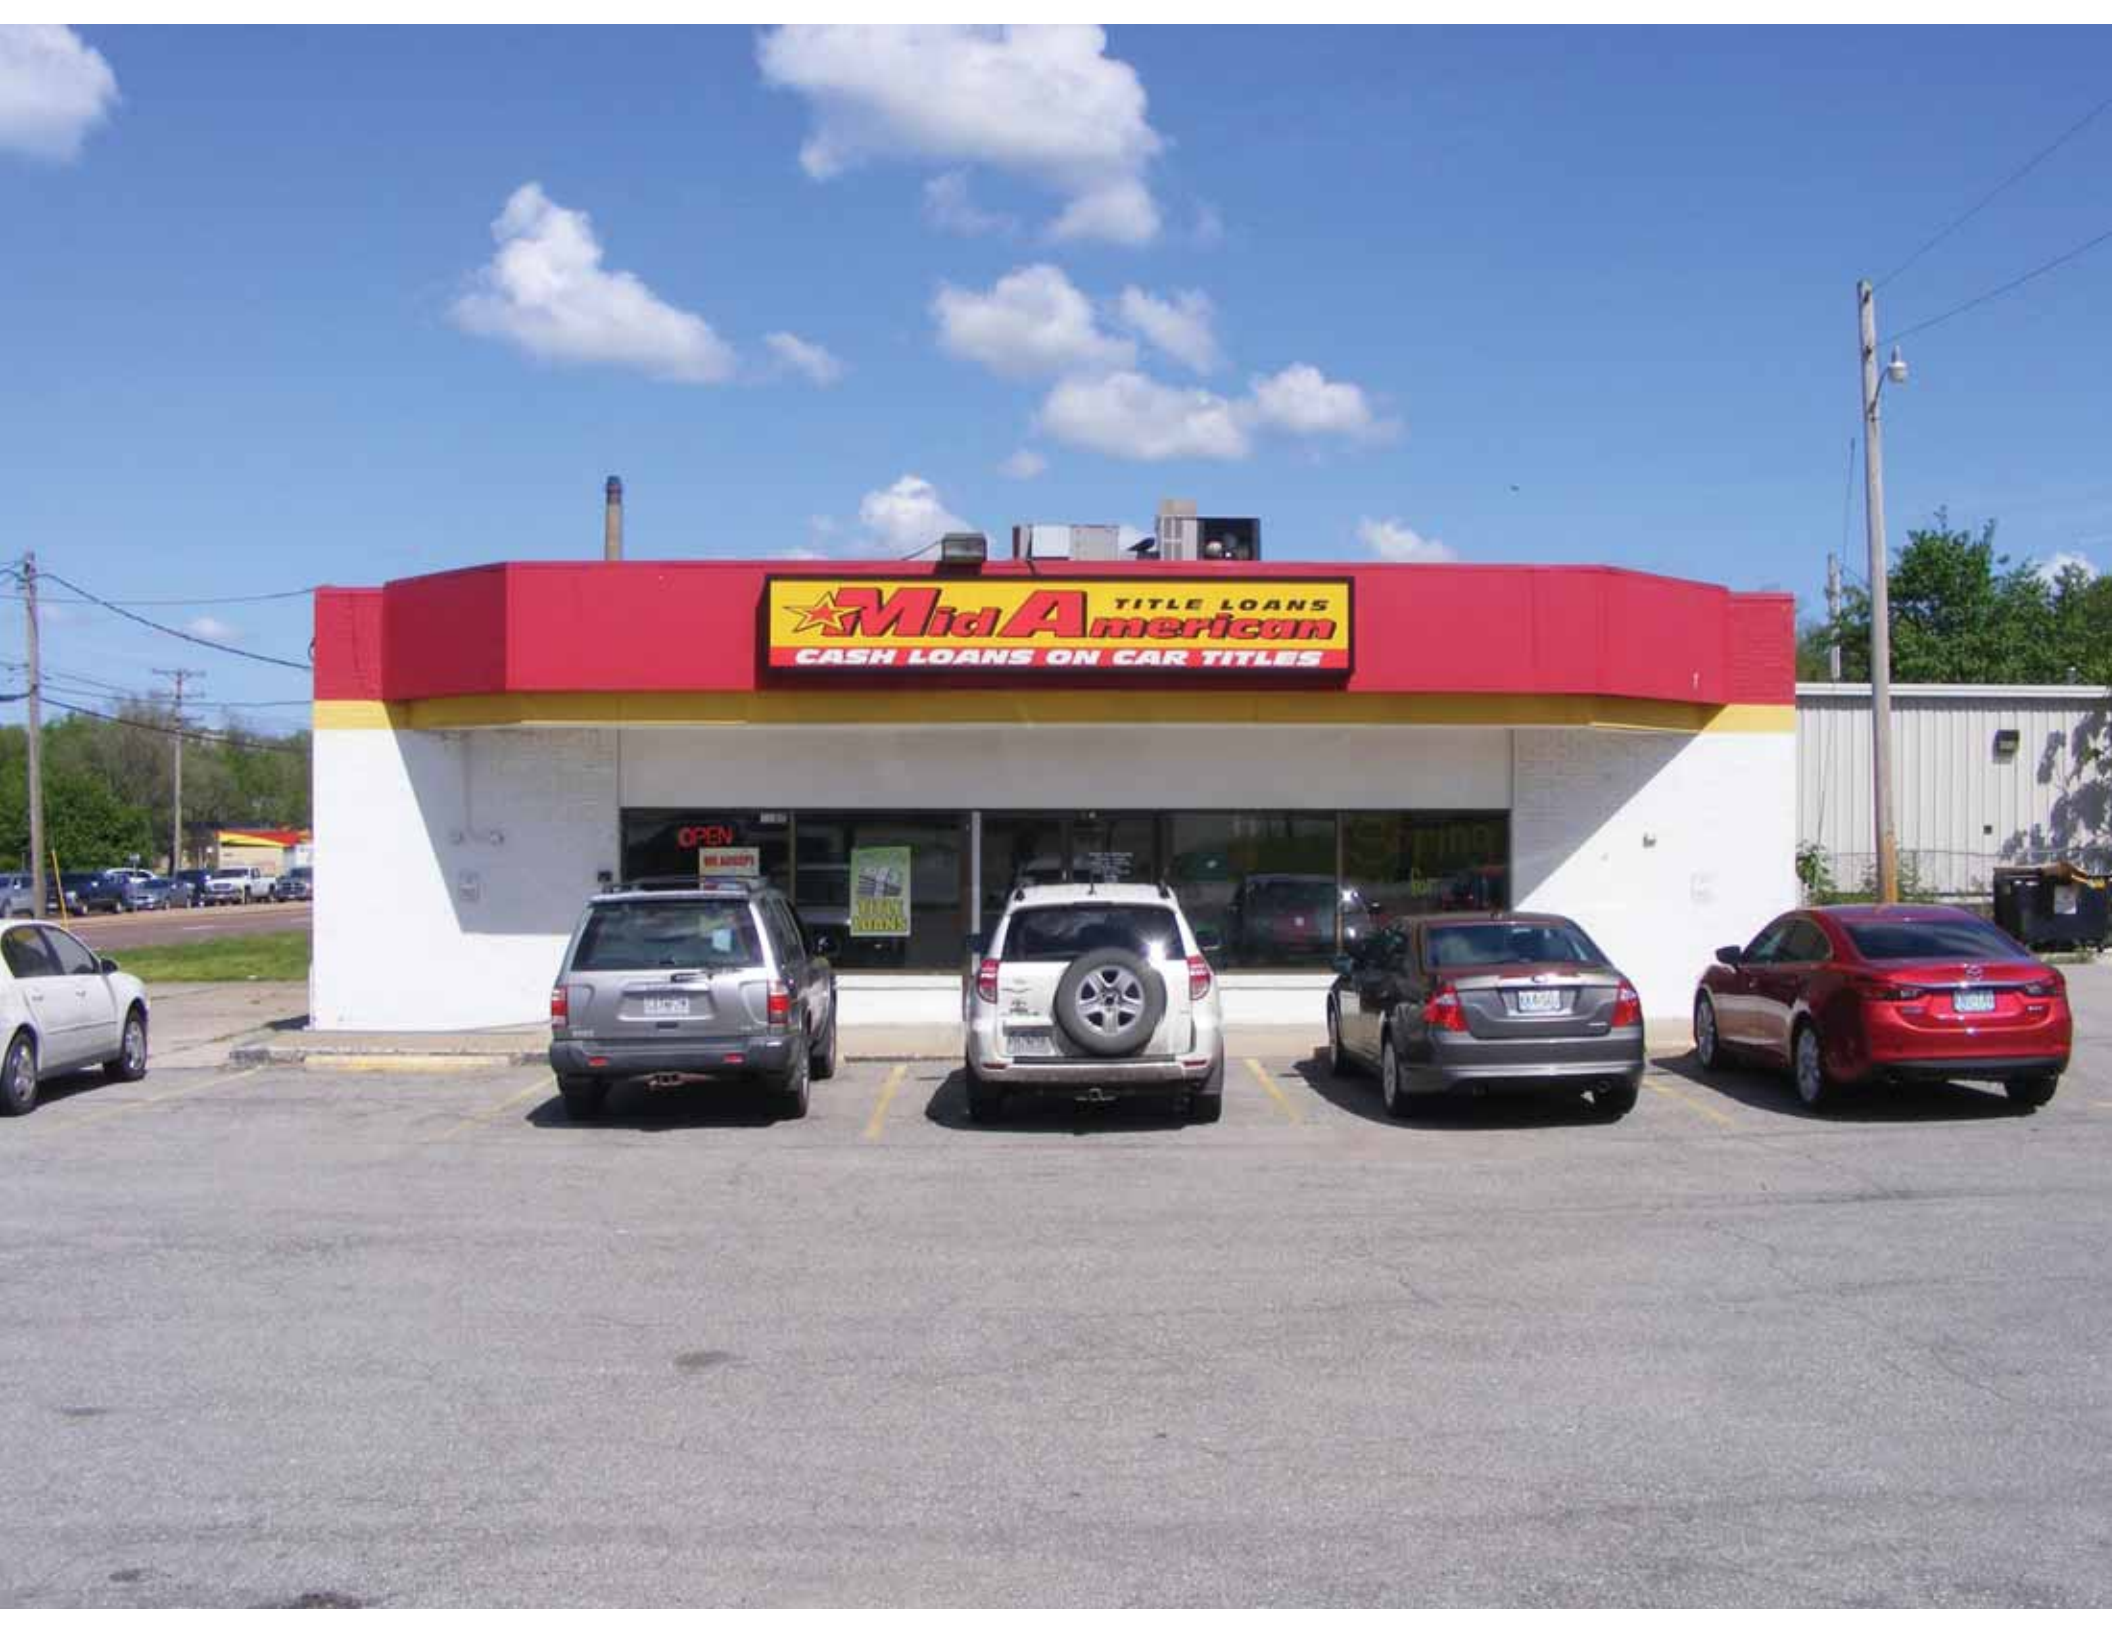
A one story brick commercial building with a flat roof on a concrete slab foundation. The façade (west) features a centered entrance (glass/metal) flanked by paired display windows; windows and entrance are tinted. A projecting shed awning shelters the storefront. The building is painted white with a yellow and red horizontal stripe at the top section. The north elevation features an entrance at the back corner.
