MISSOURI DEPARTMENT OF NATURAL RESOURCES
STATE HISTORIC PRESERVATION OFFICE, P.O. Box 176, Jefferson City, MO 65102
ARCHITECTURAL/HISTORIC INVENTORY FORM

1. Survey No. BO-AS-011-0087		2. Survey name: North Central Columbia Survey Phase II	
3. County: Boone		4. Address (Street No.) 902	Street (name) N. Seventh Street
5. City: Columbia	Vicinity: <input type="checkbox"/>	6. Geographical Reference:	7. Township/Range/Section: T: R: S:
8. Historic name (if known):		9. Present/other name (if known):	
10. Ownership: <input checked="" type="checkbox"/> Private <input type="checkbox"/> Public		11a. Historic use (if known): Domestic/single dwelling	11b. Current use: Domestic/single dwelling

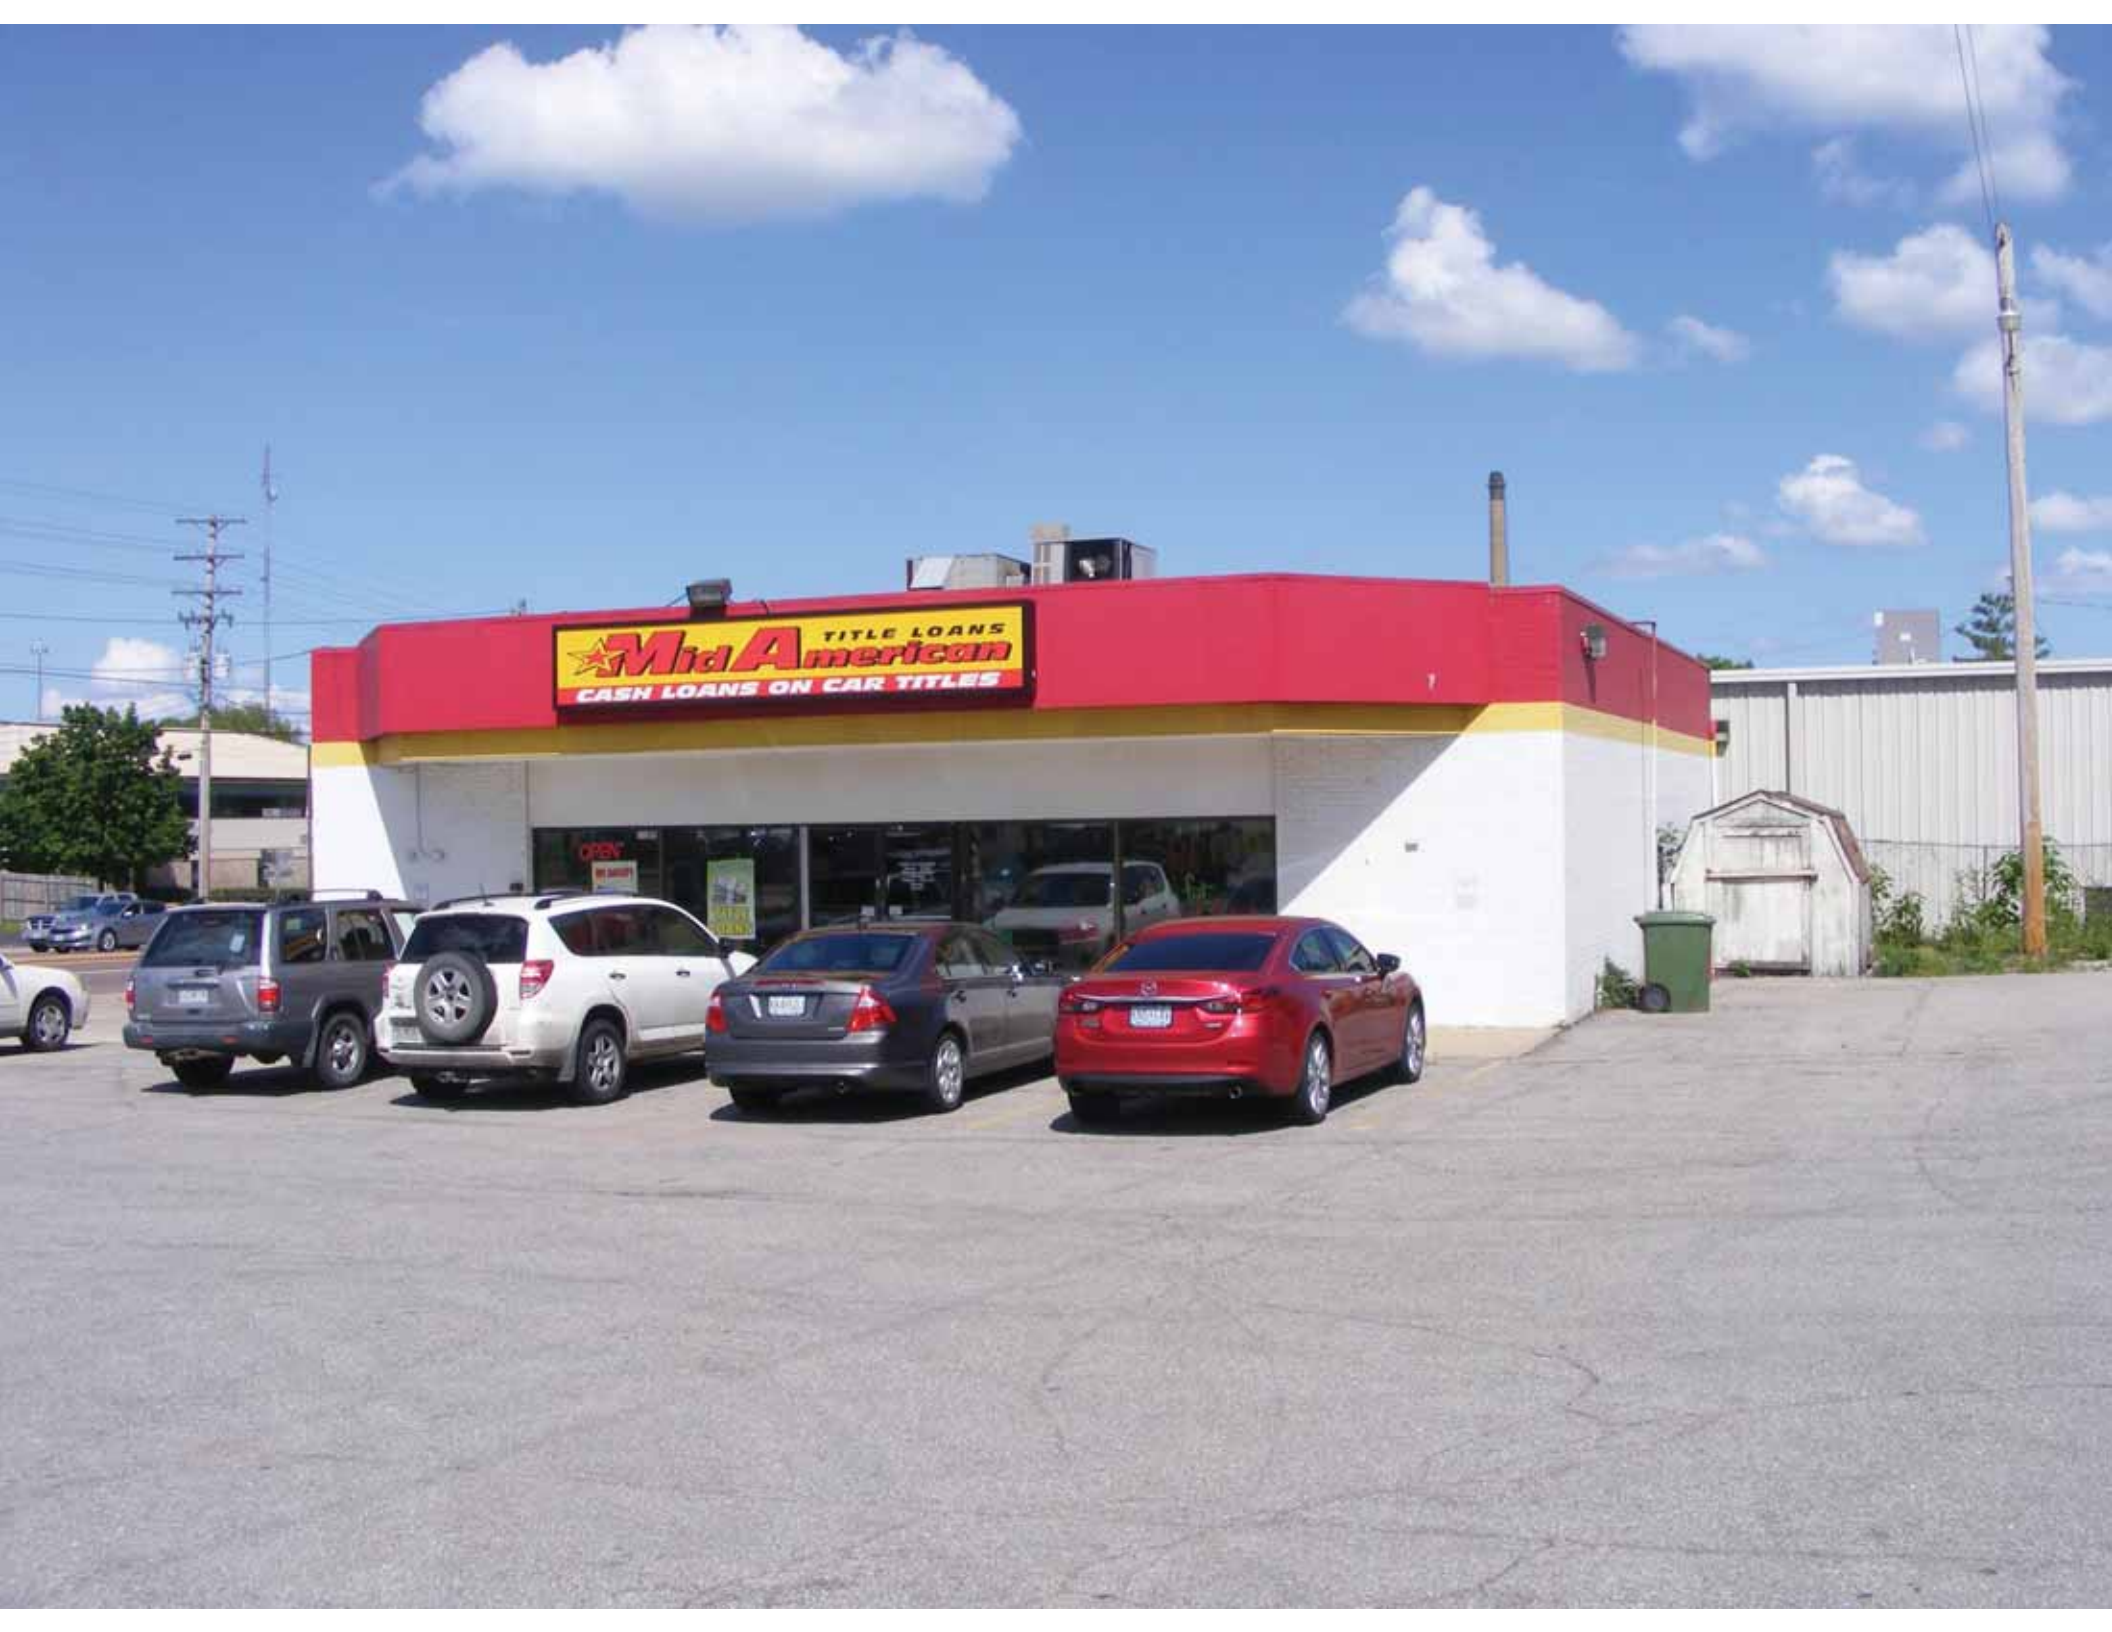
A one story brick commercial building with a flat roof on a concrete slab foundation. The façade (west) features a centered entrance (glass/metal) flanked by paired display windows; windows and entrance are tinted. A projecting shed awning shelters the storefront. The building is painted white with a yellow and red horizontal stripe at the top section. The north elevation features an entrance at the back corner.

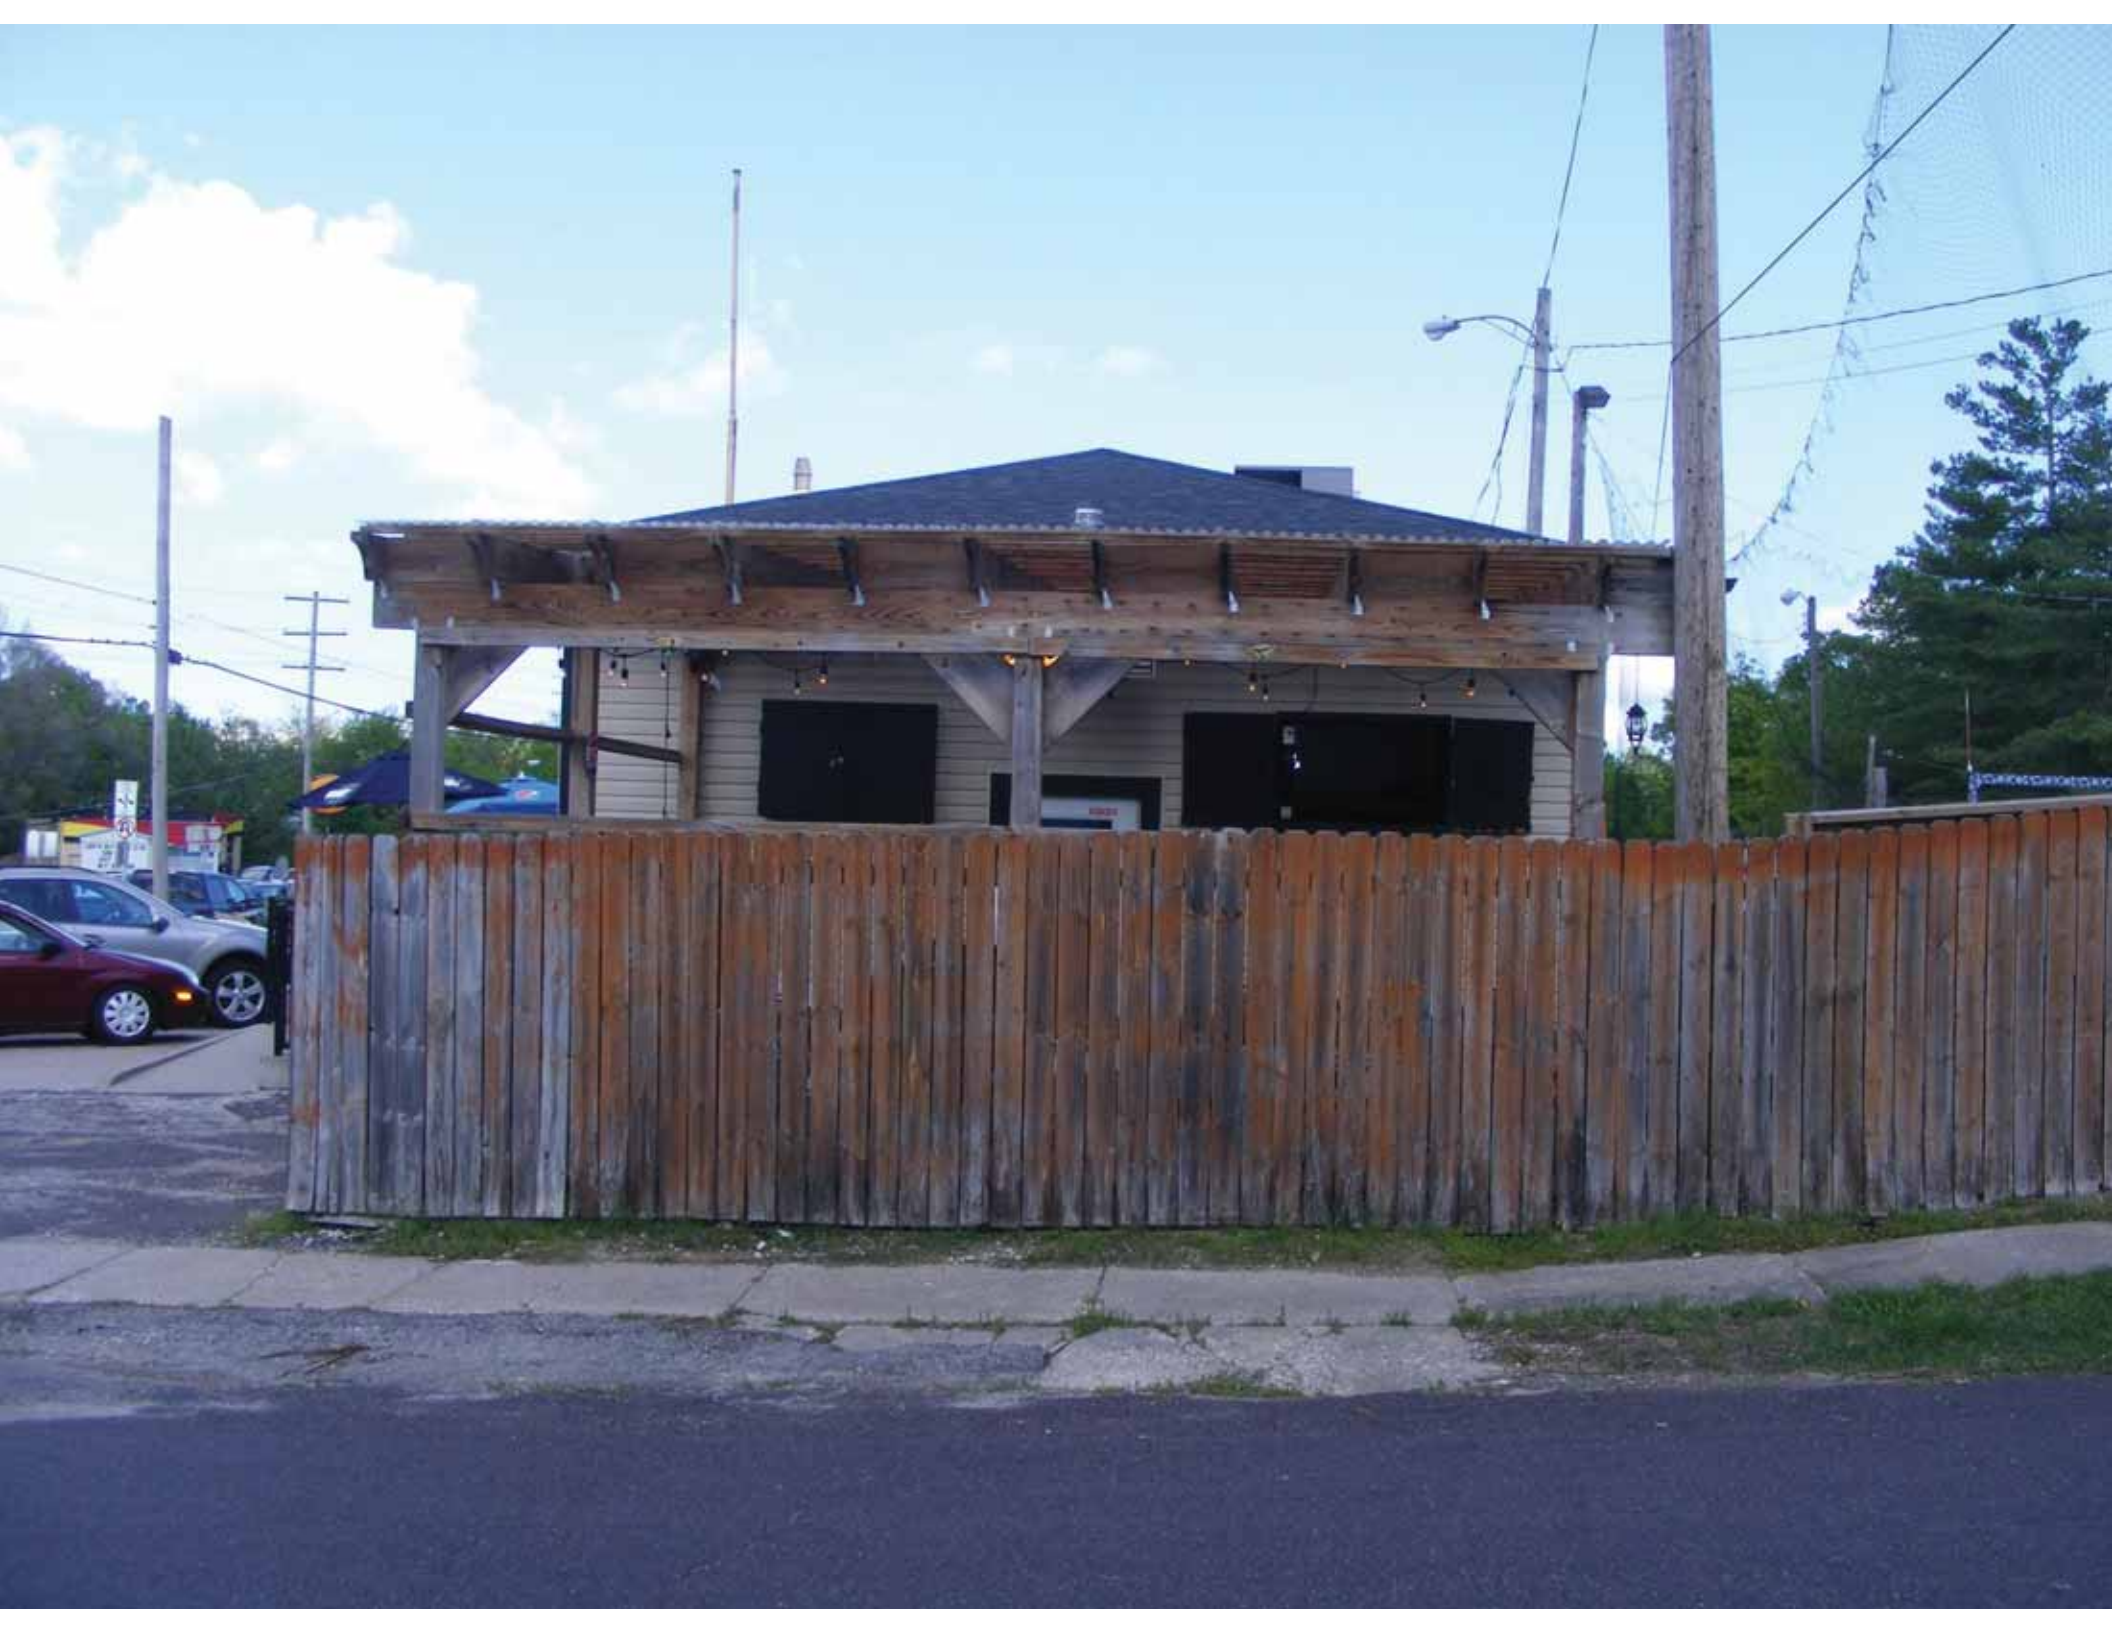
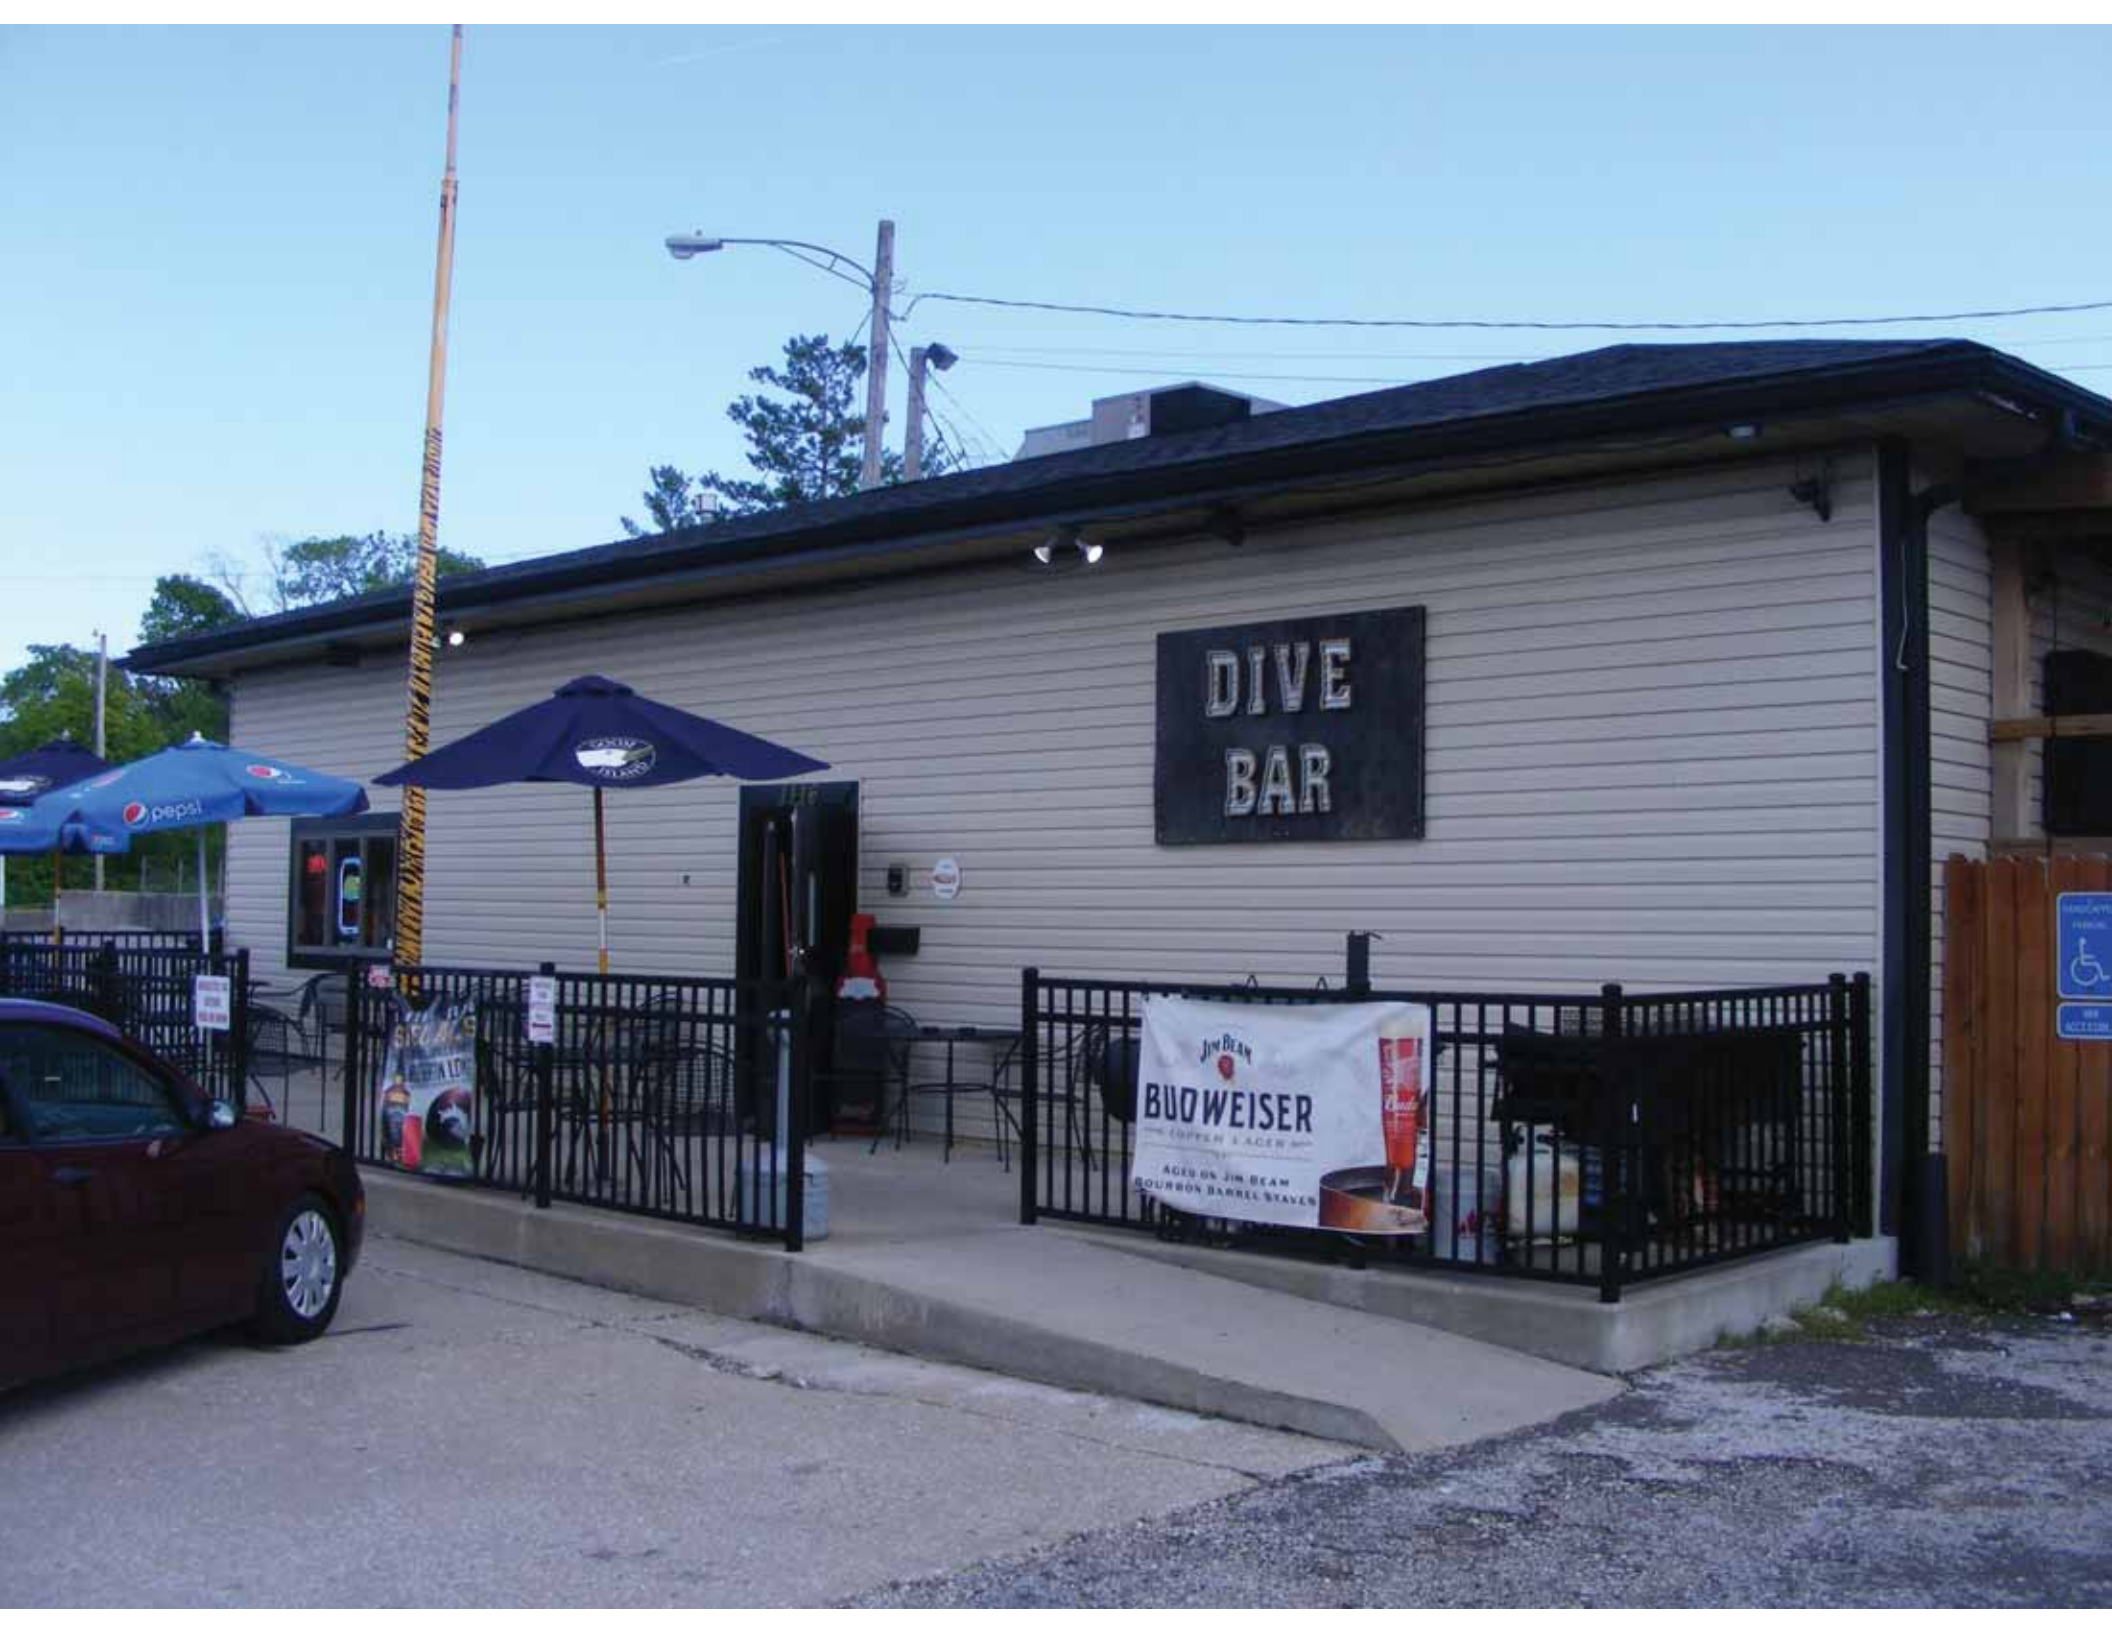
41. (cont.) Description of primary resource. Expand box as necessary, or add continuation pages.
A one story asphalt-shingled hip roof commercial building clad in vinyl siding with a concrete foundation. The façade (north) features a raised full-width concrete patio surrounded by an iron fence type railing. The entrance is centered with a metal and narrow rectangular light door offset to the left by a fixed three light window. The rear (south) obscured by a privacy fence. The west elevation holds an entrance and two windows; a wooden pergola shelters the outside area; west elevation partially obscured by a privacy fence. The east elevation is void of openings.
