MISSOURI DEPARTMENT OF NATURAL RESOURCES
STATE HISTORIC PRESERVATION OFFICE, P.O. Box 176, Jefferson City, MO 65102
ARCHITECTURAL/HISTORIC INVENTORY FORM

1. Survey No. BO-AS-011-0087		2. Survey name: North Central Columbia Survey Phase II	
3. County: Boone		4. Address (Street No.) 902	Street (name) N. Seventh Street
5. City: Columbia	Vicinity: <input type="checkbox"/>	6. Geographical Reference:	7. Township/Range/Section: T: R: S:
8. Historic name (if known):		9. Present/other name (if known):	
10. Ownership: <input checked="" type="checkbox"/> Private <input type="checkbox"/> Public		11a. Historic use (if known): Domestic/single dwelling	11b. Current use: Domestic/single dwelling

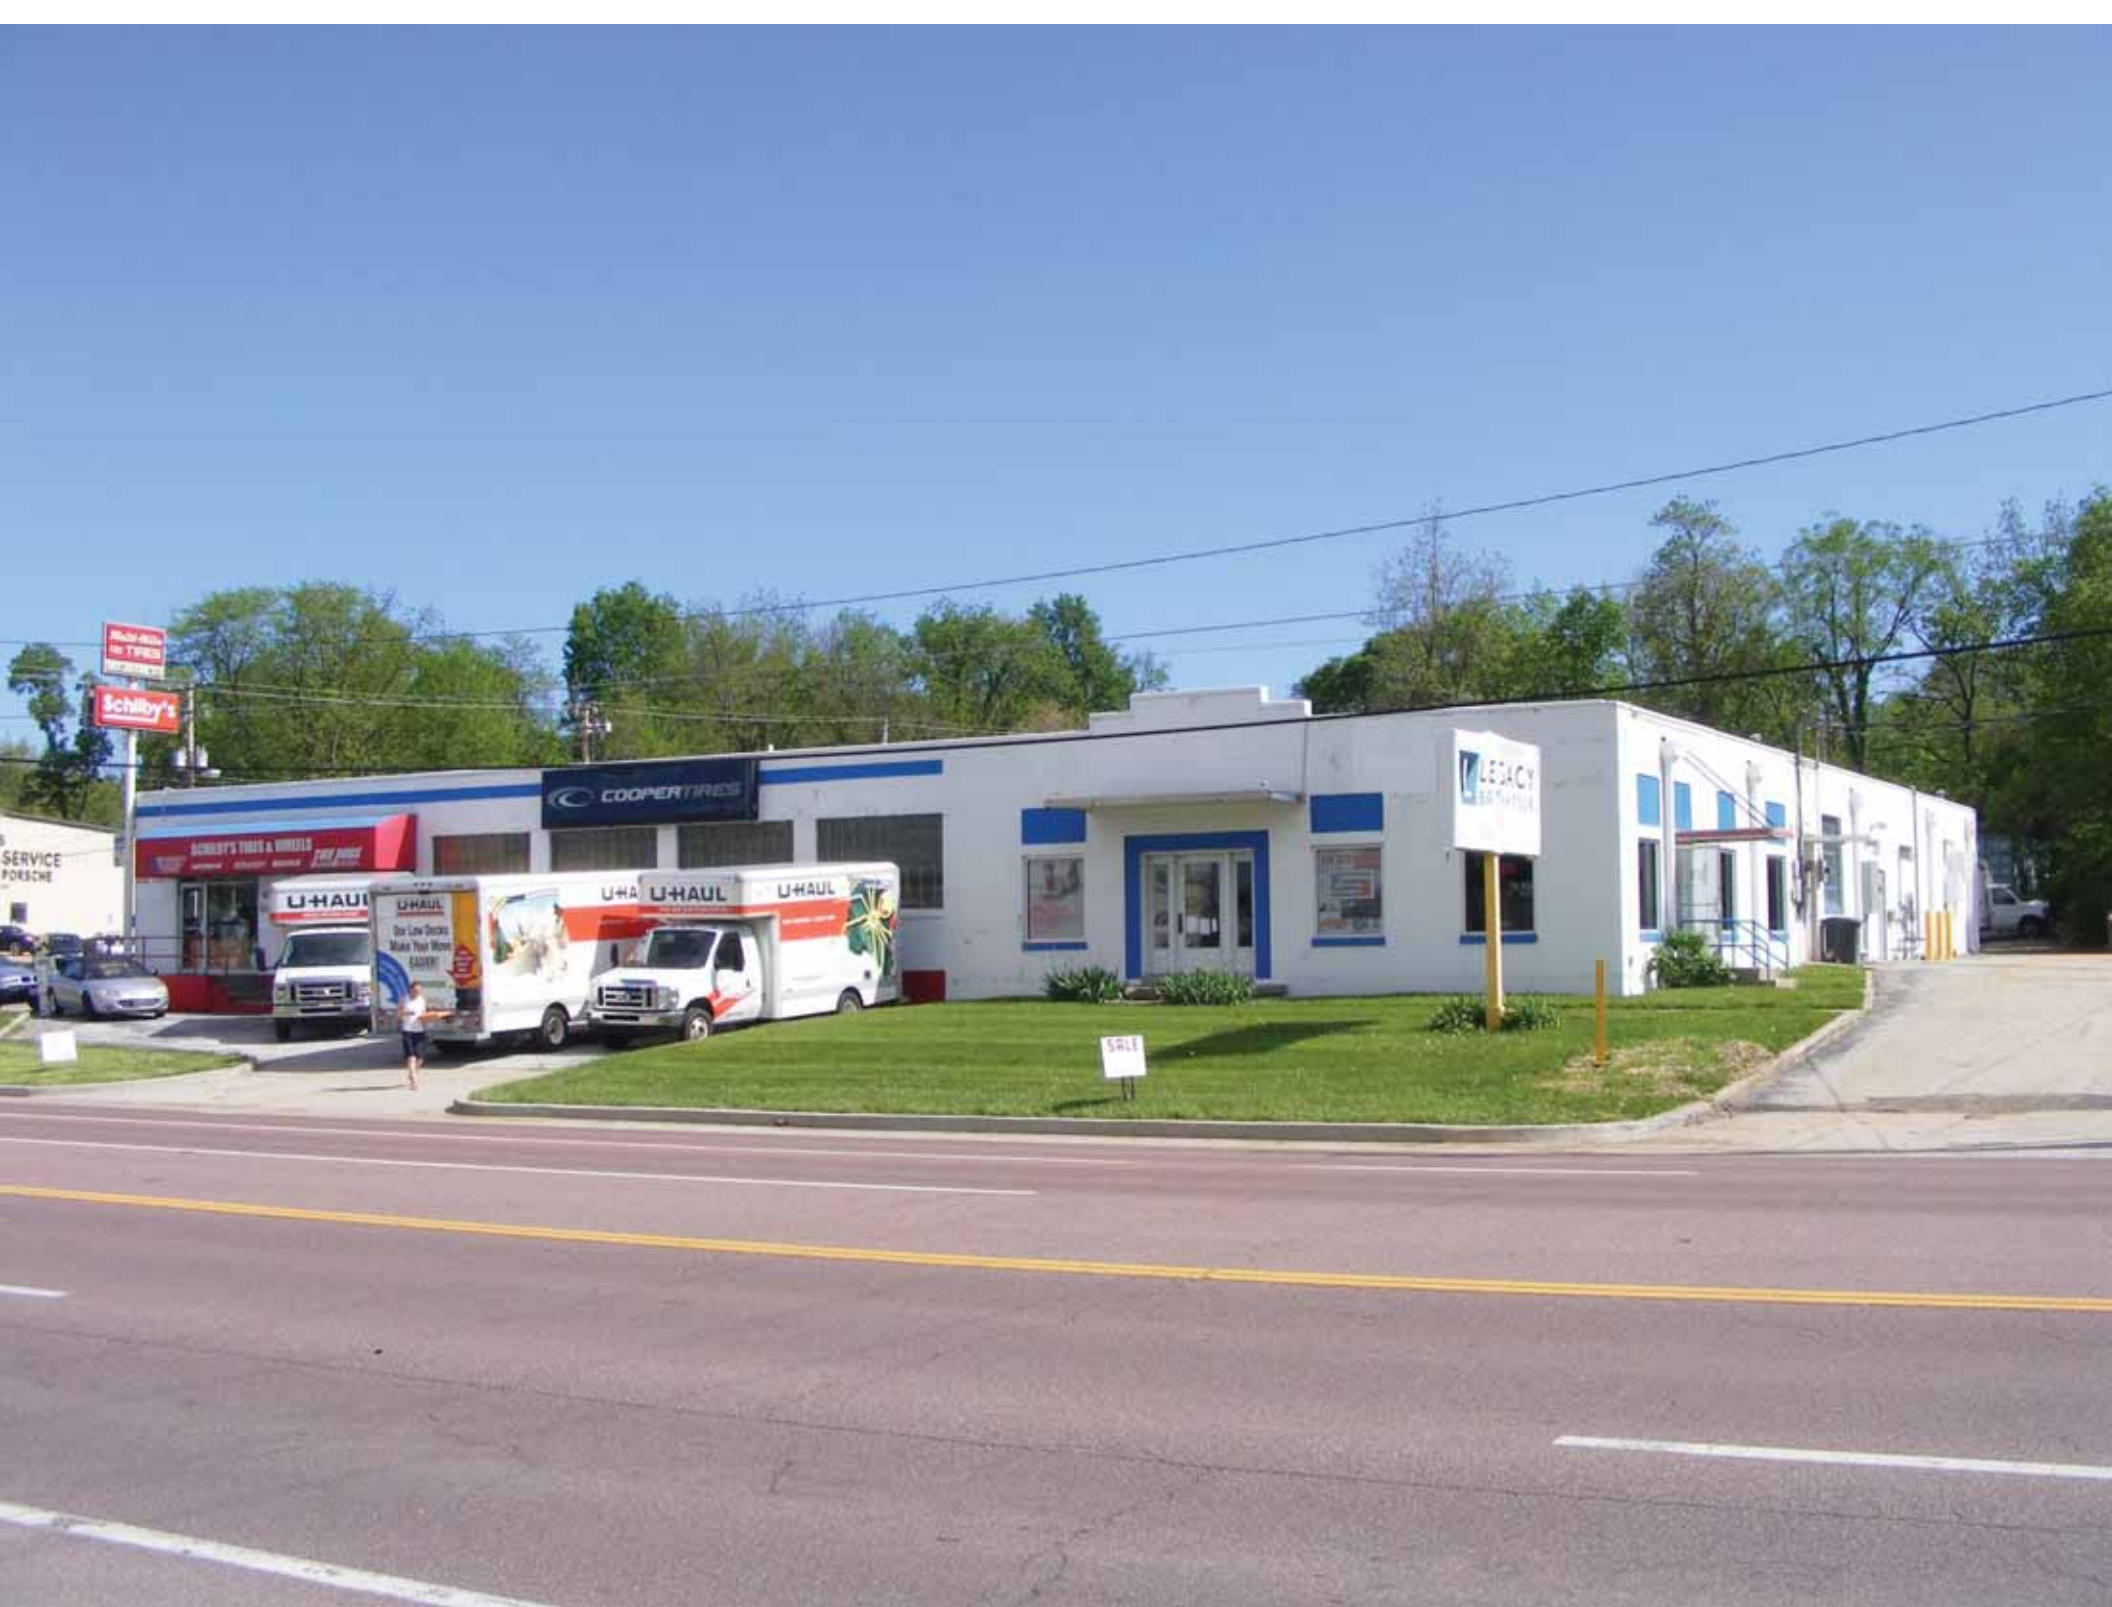
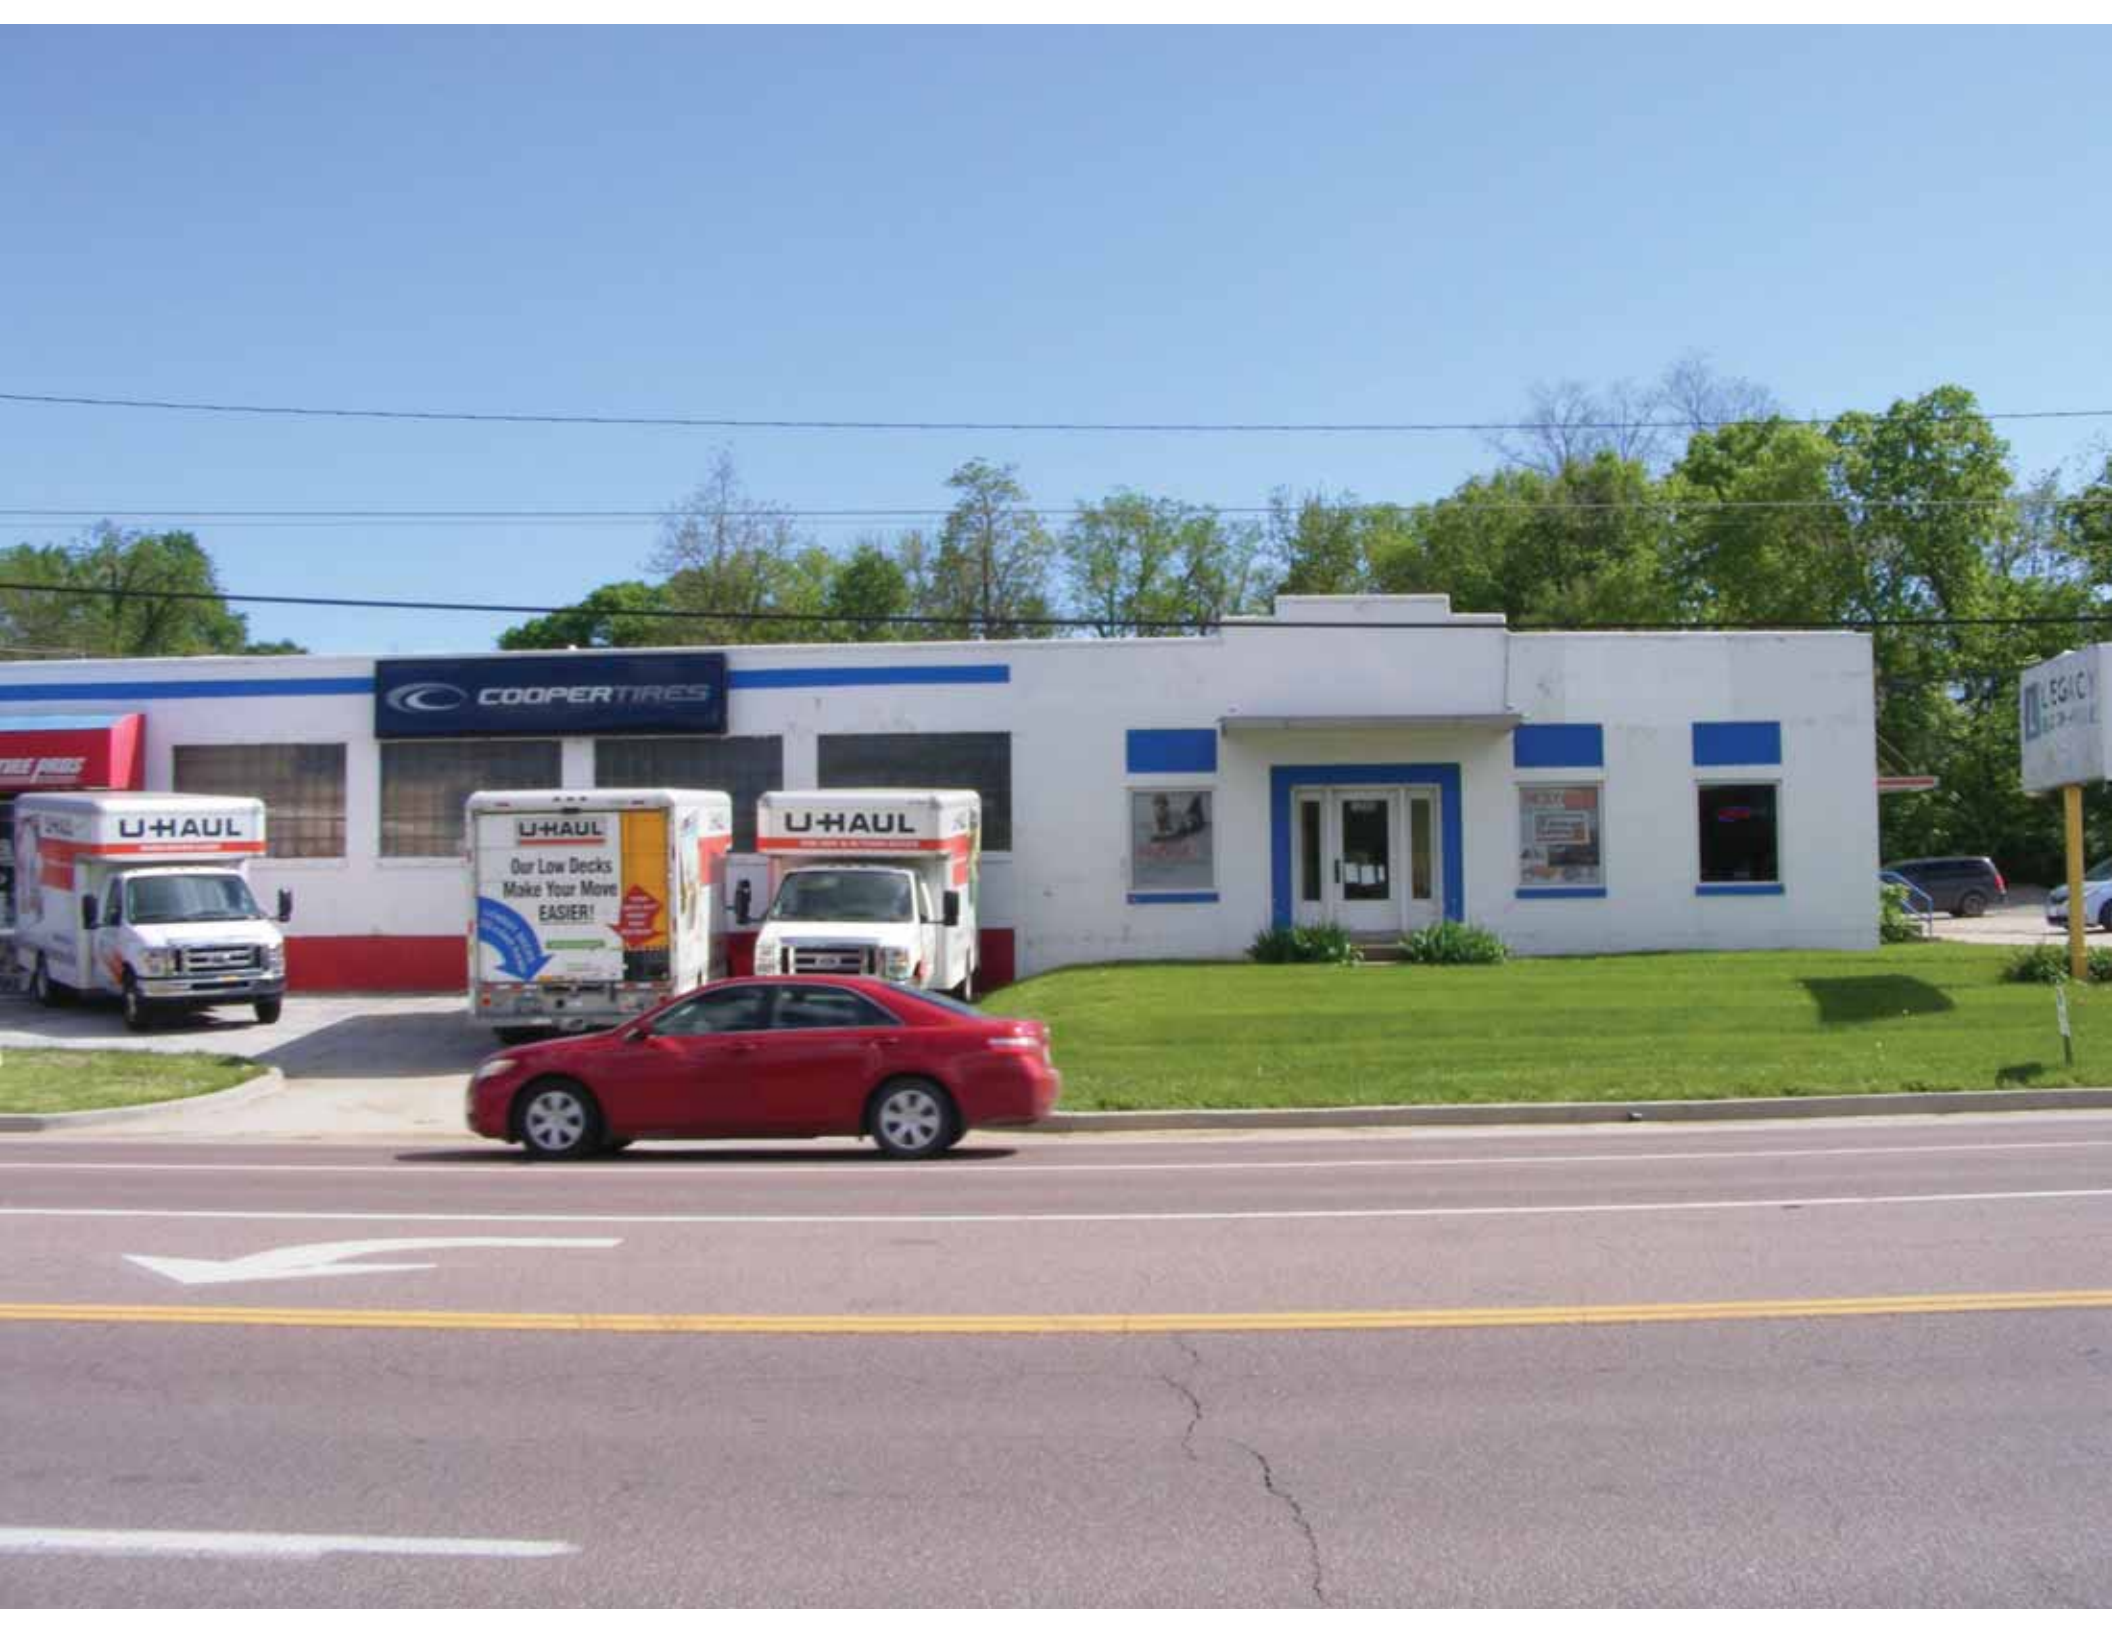
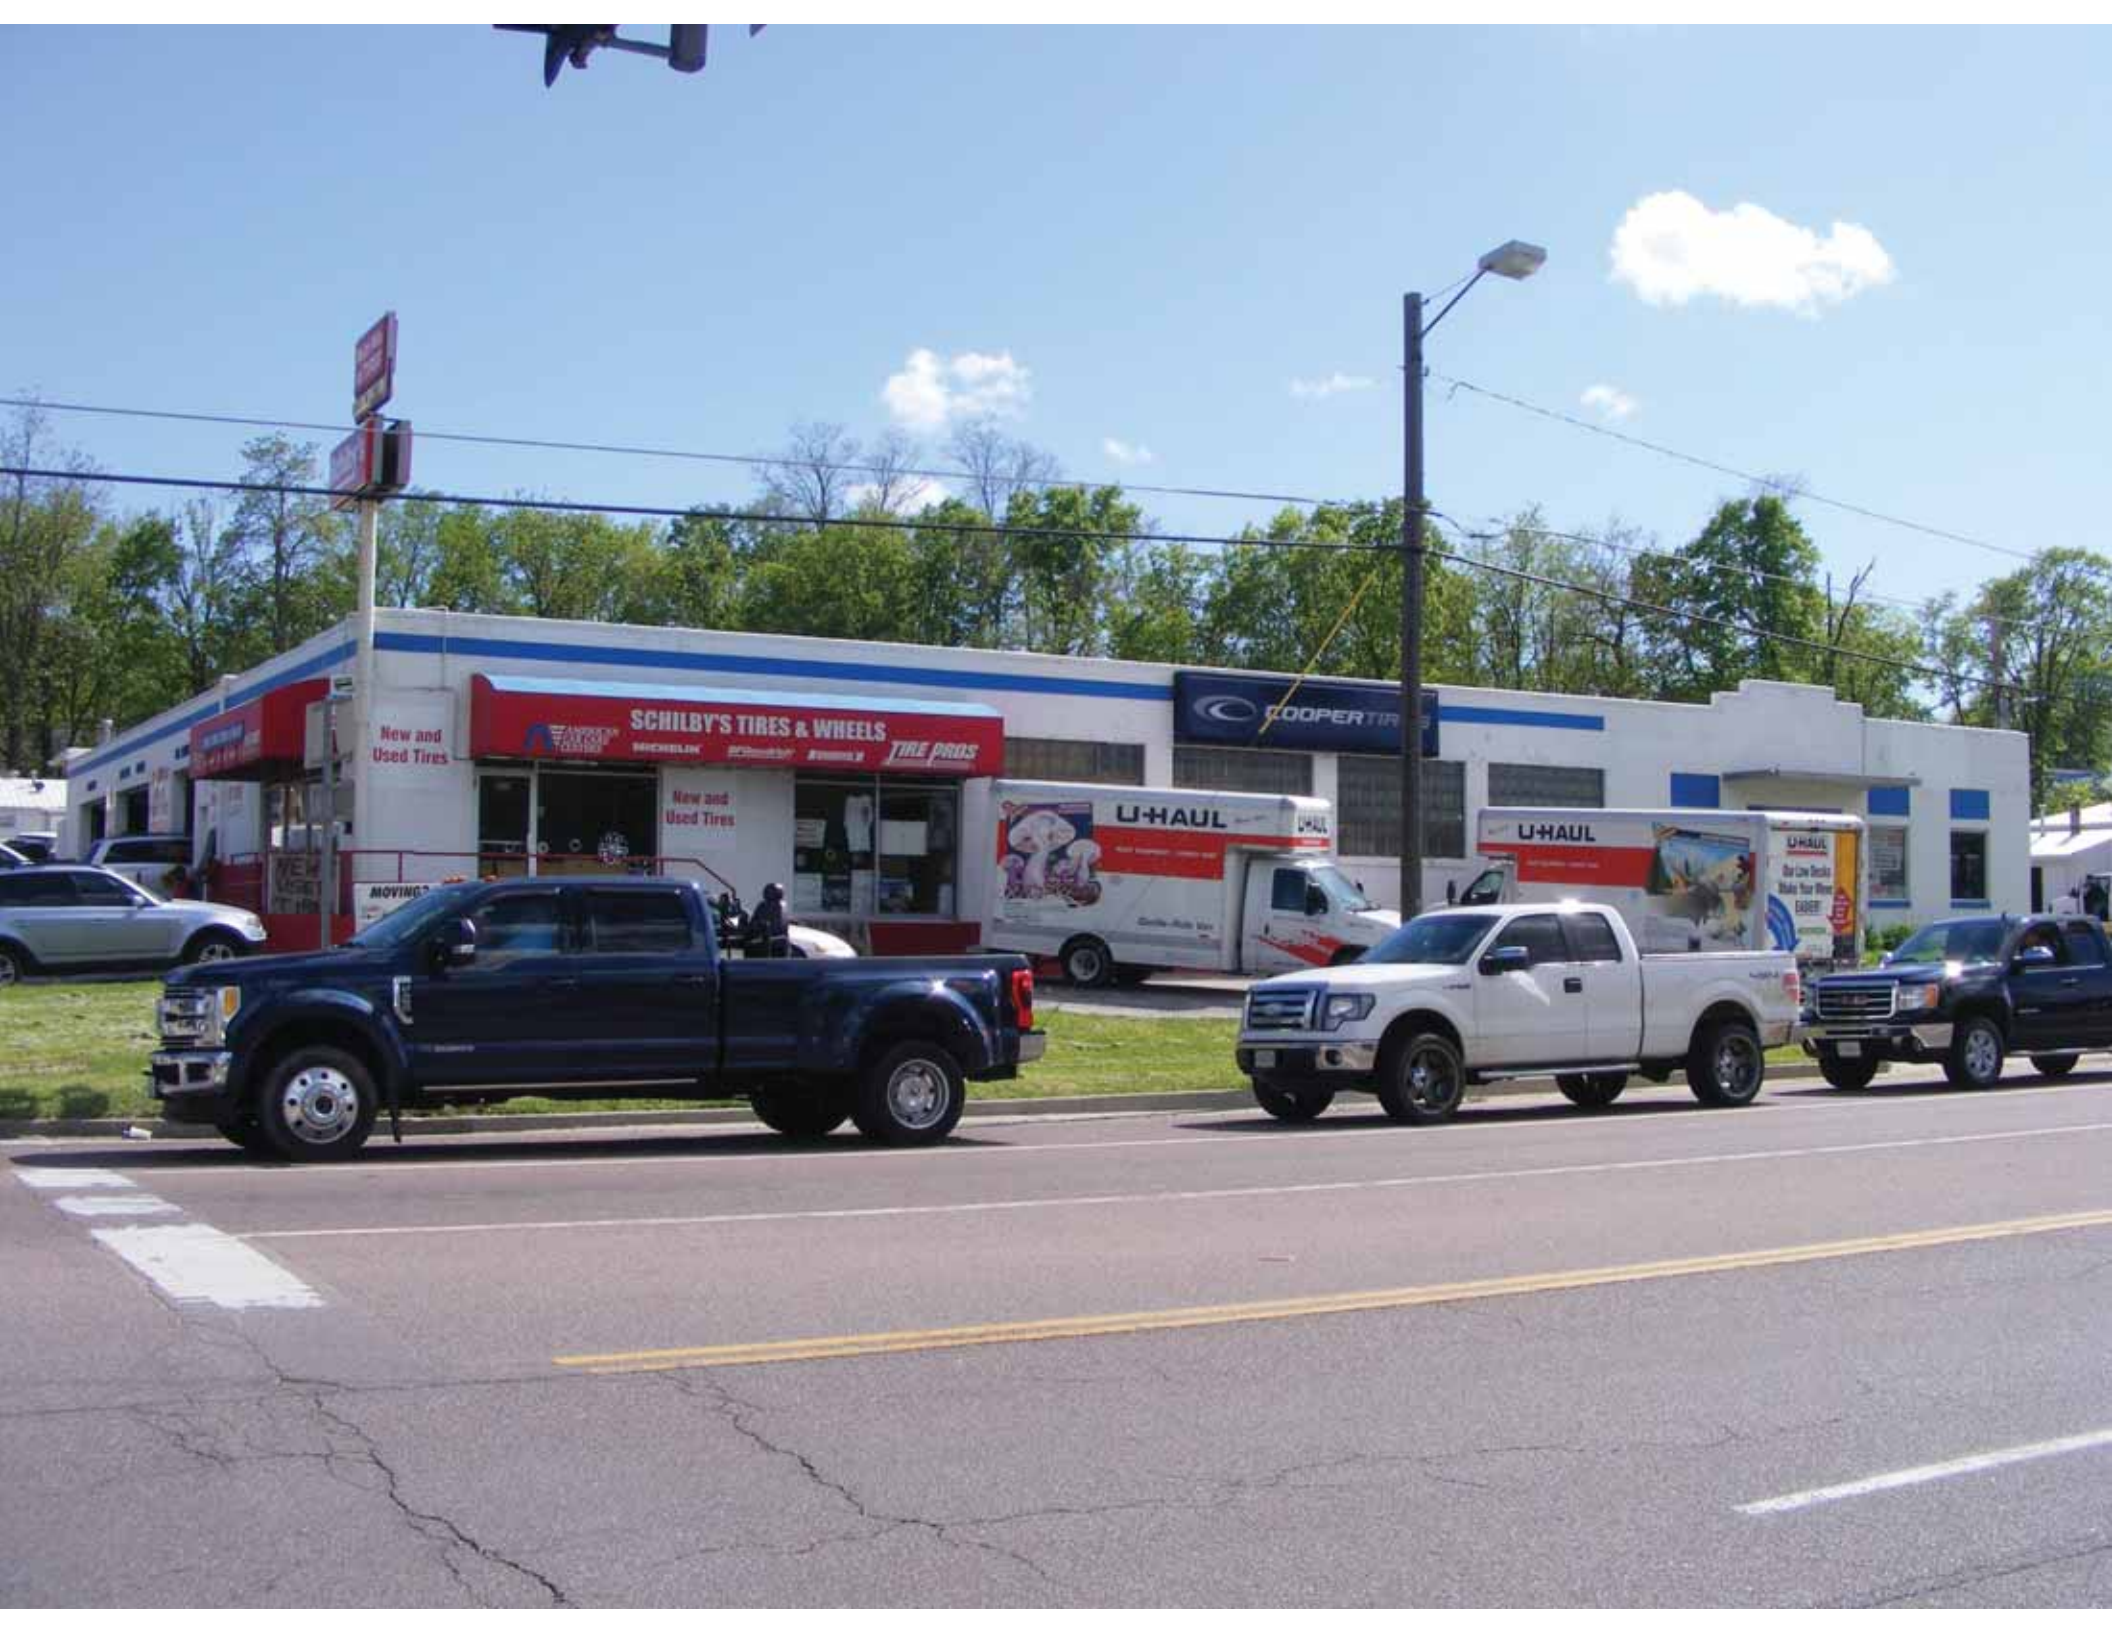
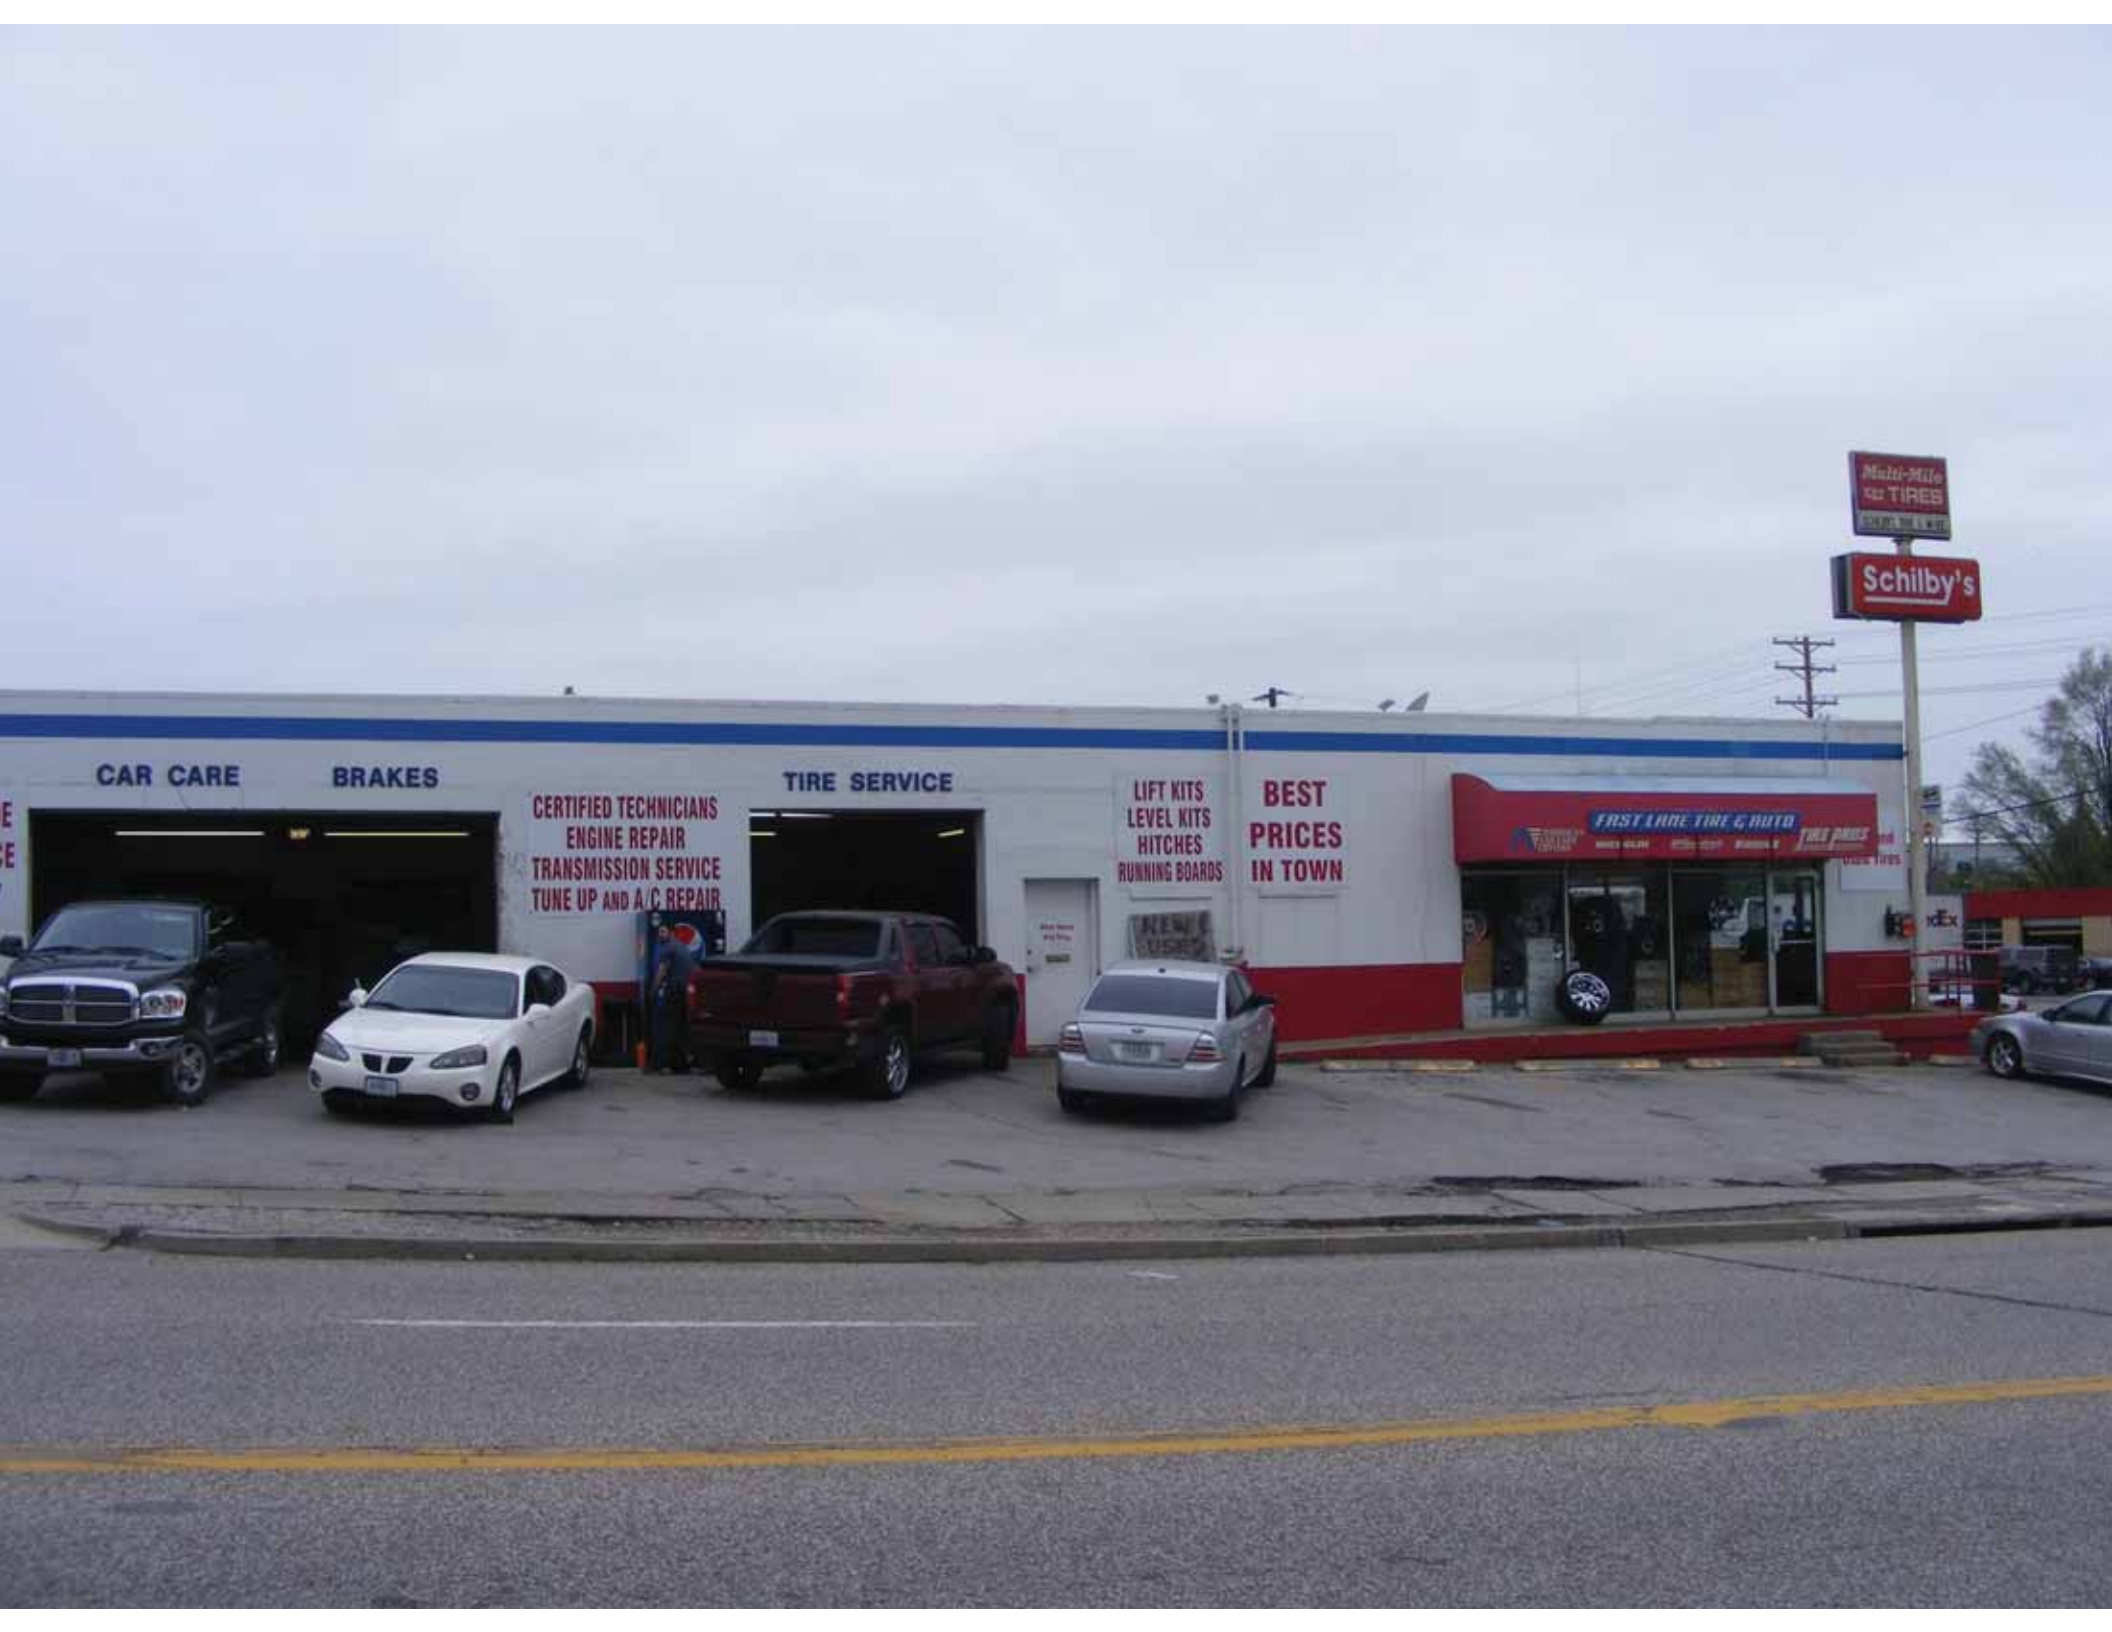
This is a one story commercial building of painted concrete block, flat roof with a concrete slab foundation. The façade holds 10 bays. The right end of the façade has a projecting stepped parapet centered over the stoop entrance that holds a glass/wood door with sidelights offset to the right by two display windows and to the left by one display window. The left section of the façade holds a raised concrete stoop entrance with iron railings with a glass/metal door and transom and glass/metal display window with transom; flanked to left by paired metal /glass display with transoms. A cloth dome awning shelters the two bays. To the right of these two bays are four multiple light industrial type windows. The N. College Ave. elevation holds a glass/metal storefront at the façade corner; entrance offset to left by tripled paired display windows – door and display windows feature transoms. A matching awning to the façade is over the storefront. A concrete decking sloped from right to left with steps provide access to the side storefront. Three garage bays with metal and multiple light doors and a solid metal single entrance door complete the side elevation. The rear elevation holds a setback area sheltered by a shed roof and holds garage bays.
